SUBJECT: Unannounced Inspection of KCBX Terminals Company  
Chicago, Illinois

Facility: KCBX Materials Terminal

Inspection Date: May 10, 2012

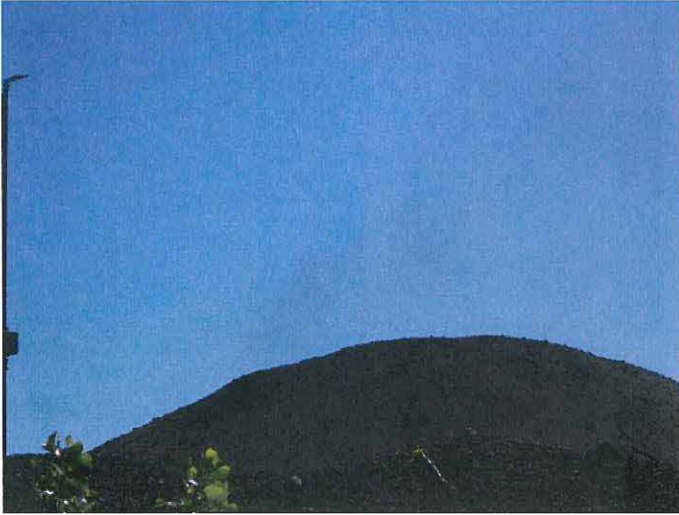
On May 10, 2012, Roshni Brahmabhatt, Ray Cullen, Danny Marcus, and I drove around the plant site and stopped in various locations to see if coal dust was crossing the property line. While driving around, I saw coal dust coming off a coal pile on the western side of the property. I estimated the maximum opacity to be 15%. Figure 4 shows a picture of this pile. This picture does not coincide with the point in time of maximum instantaneous opacity. After driving around the property, we met Joe Kotas, an inspector for the Illinois Environmental Protection Agency (IEPA), outside the facility and then drove up to the gate, showed our credentials, and parked the car in the parking lot.

**Figure 1:** Coal pile with particulate emissions that was read at 15% opacity (but the picture does not correlate with that moment in time)

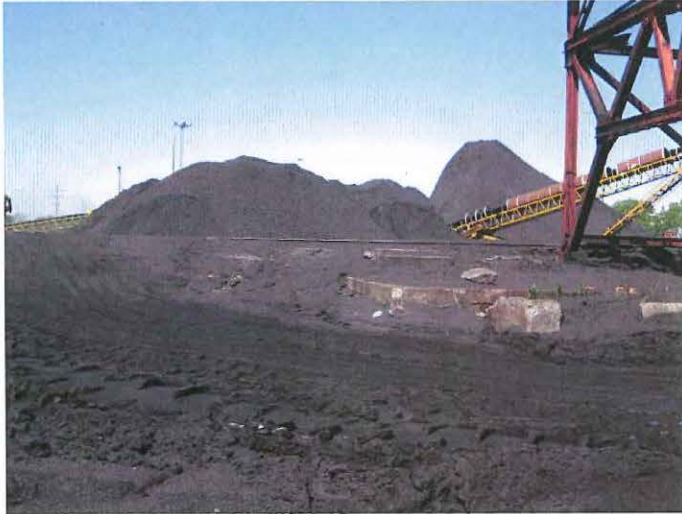
The Facility uses various pieces of equipment to facilitate the movement of the materials around the property. There are many conveyors and seven of the conveyors by the coal piles are moveable. Some moveable conveyors are shown in Figures 2 and 3. There is a main conveyor system that is not moveable called the collector belt. The rubber belt starts in the railcar unloading area: a metal house where the materials fall out of the bottom of the railcars through hoppers onto the collector belt. Materials are sprayed with water as they fall onto the belt. This area is shown in Figures 5,6, and 7. After this the belt carries the coal to a pad or a vessel. There are two major transfer points on the main conveyor system. The first one is called Transfer Tower 1 which is where material transfers from the collector belt to the incline belt. The incline belt takes the material to Transfer Tower 2 where the material is sent to the pad (storage area) or to a vessel or barge. There are five end loaders that move material.

Figure 2: A conveyor going into a coal pile

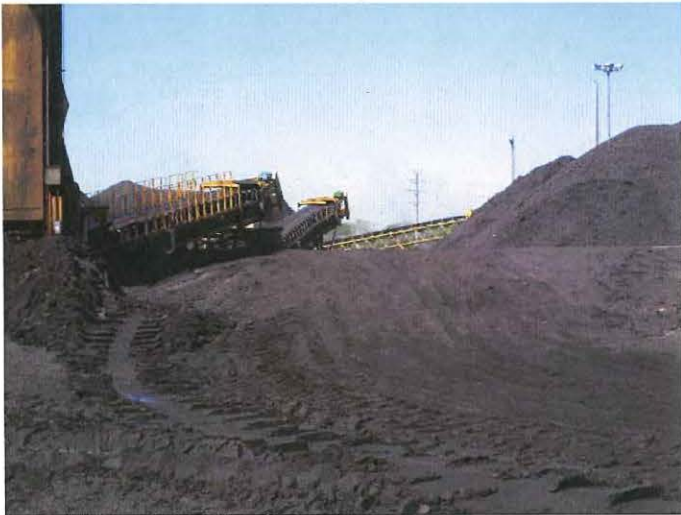
Figure 3: Picture of a moveable conveyor

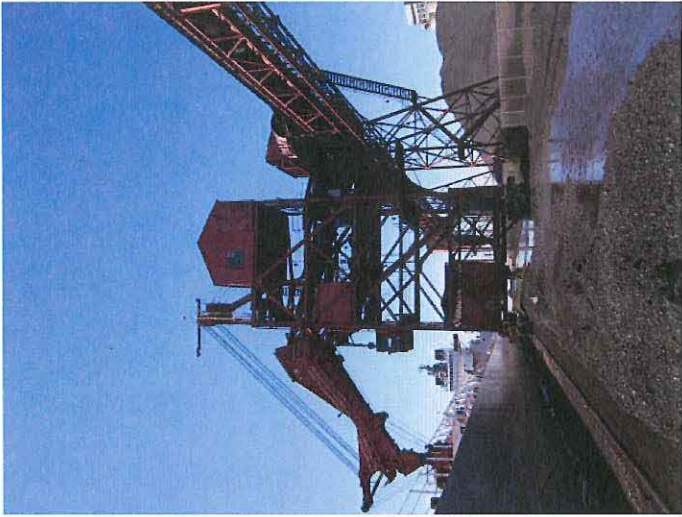
- The coal piles were fairly wet and it looked as if the water cannons had just been used. There were standing puddles in many places as shown in the pictures at the end of the report.
- Mr. Cullen used the range finder and determined that one of the piles was 54 feet high.
- There was an odor by the screening area.

Figure 4: Conveyor to vessel with a large puddle, suggesting the Facility may have been overwatered

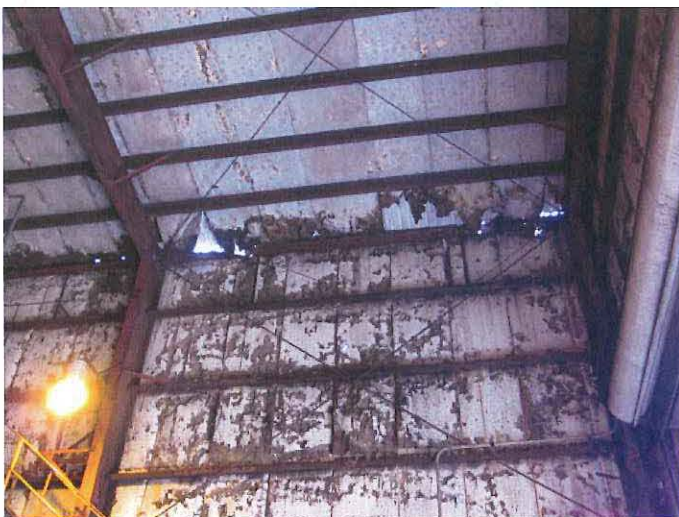
- There were holes in the roof of the building over the railcar unloading area. A picture of this is at the end of the report.
- The railcar loading and unloading area was covered in black particulate matter that covered my hand when I touched the railing by the stairs.

Figure 6: Holes in the top of the building over the railcar unloading

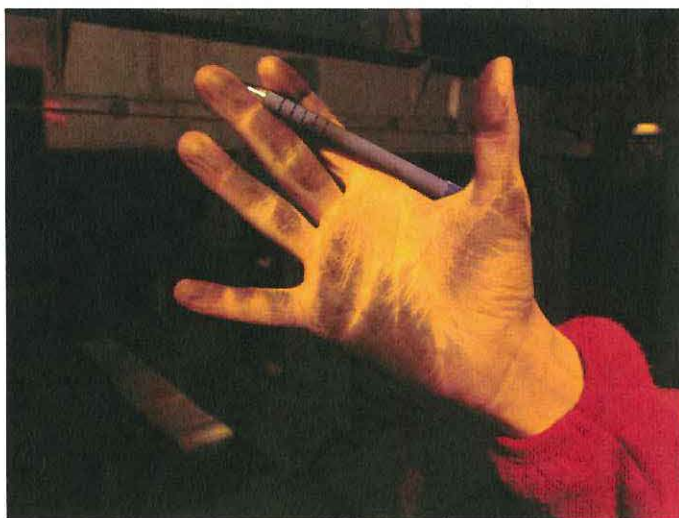
Figure 7: Coal particles on my hand after using the railing by the railcar unloading area

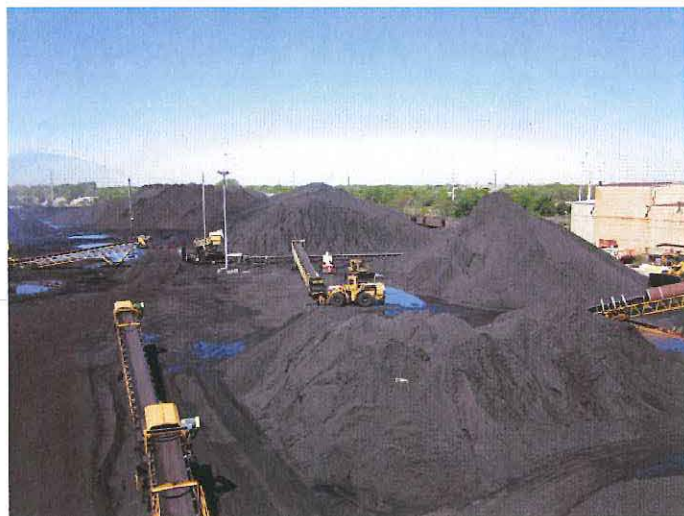
Figure 9: View from a catwalk of the property with many large puddles

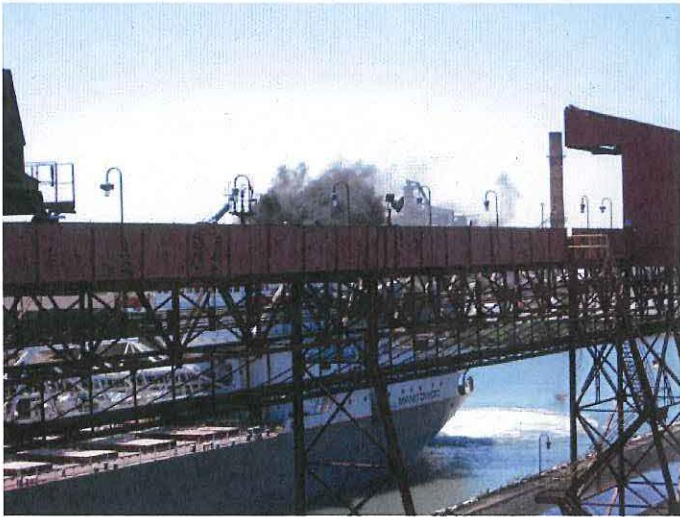
- I observed a large ship that was being loaded with coal to have an instantaneous opacity of 100% at its stack.
- Mr. Kotas said, based on the activities he had seen at the Facility before, it did not look like the Facility was operating.

Figure 10: Smoke with 100% opacity coming off the Manitowoc (vessel being loaded with bulk materials)

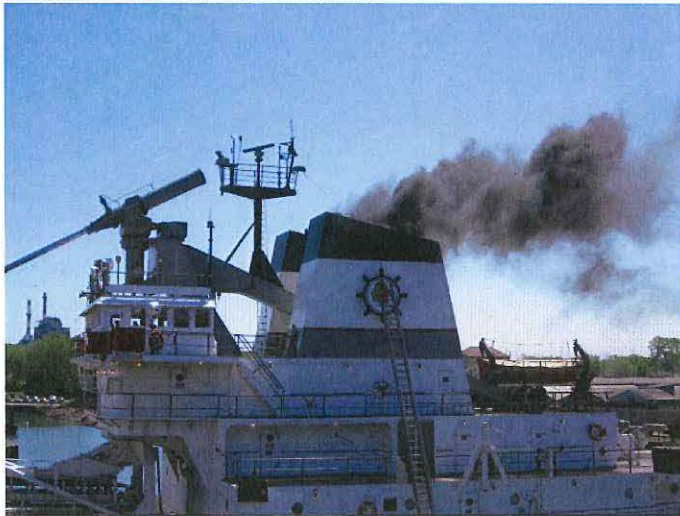
Figure 11: Another view of the vessel being loaded with 100% opacity smoke
