**EPA Evaluation of Subsurface Engineered  
Barriers at Waste Sites**

**Volume II  
Appendix B**

**Appendix B**

**Site Summaries**

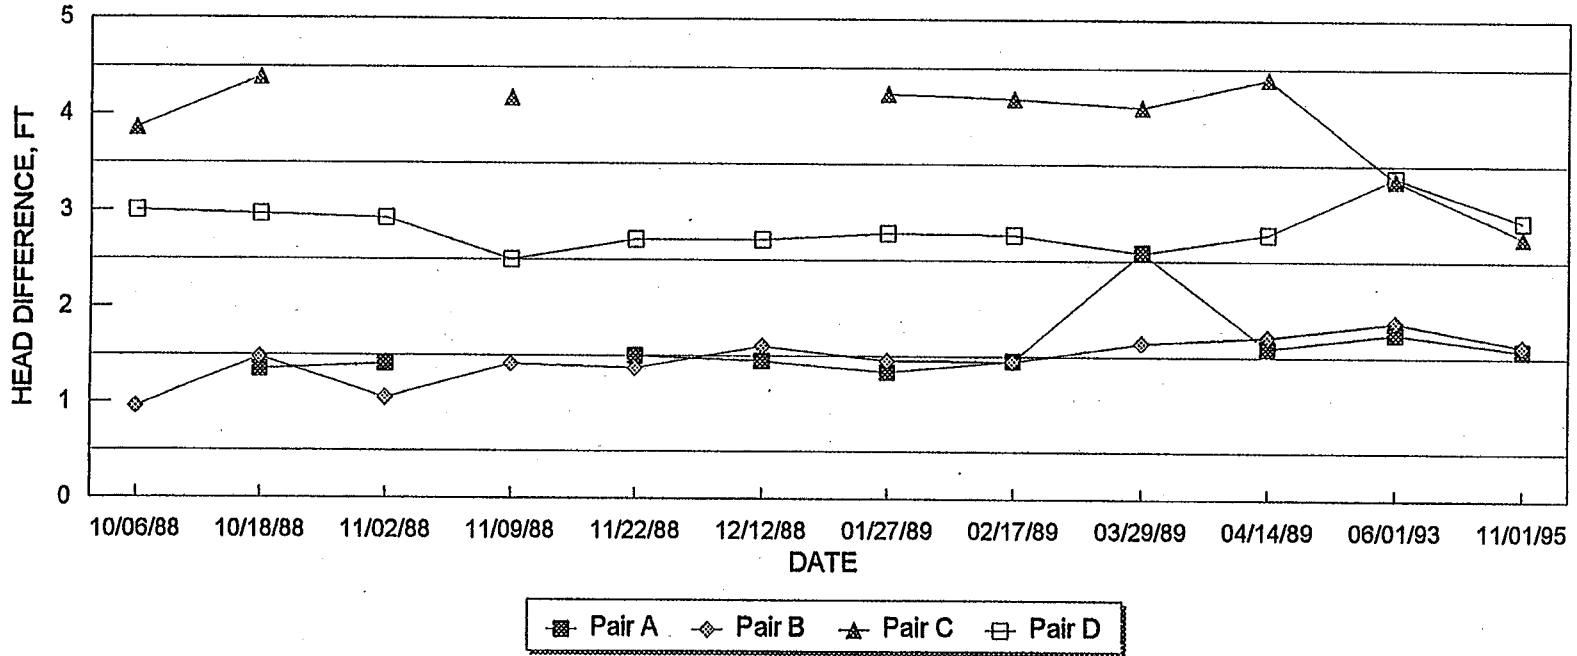
Site 16  
FIGURE 2  
HEAD DIFFERENCE vs TIME  
Tetra Tech EM Inc.

An attempt was made to measure physical integrity of the wall using self-potential geophysical methods. The streaming self-potential method was used. This method measures changes in electrical potential as a result of ions in solution passing through a porous medium. The survey was performed on 25-foot centers along the cutoff wall and was intended to measure leakage. Background noise and poor response resulted in inconclusive data. In areas believed to have some possible leakage based on geophysical findings, hydraulic head measurements revealed no unusual head loss, and presumably no leakage.

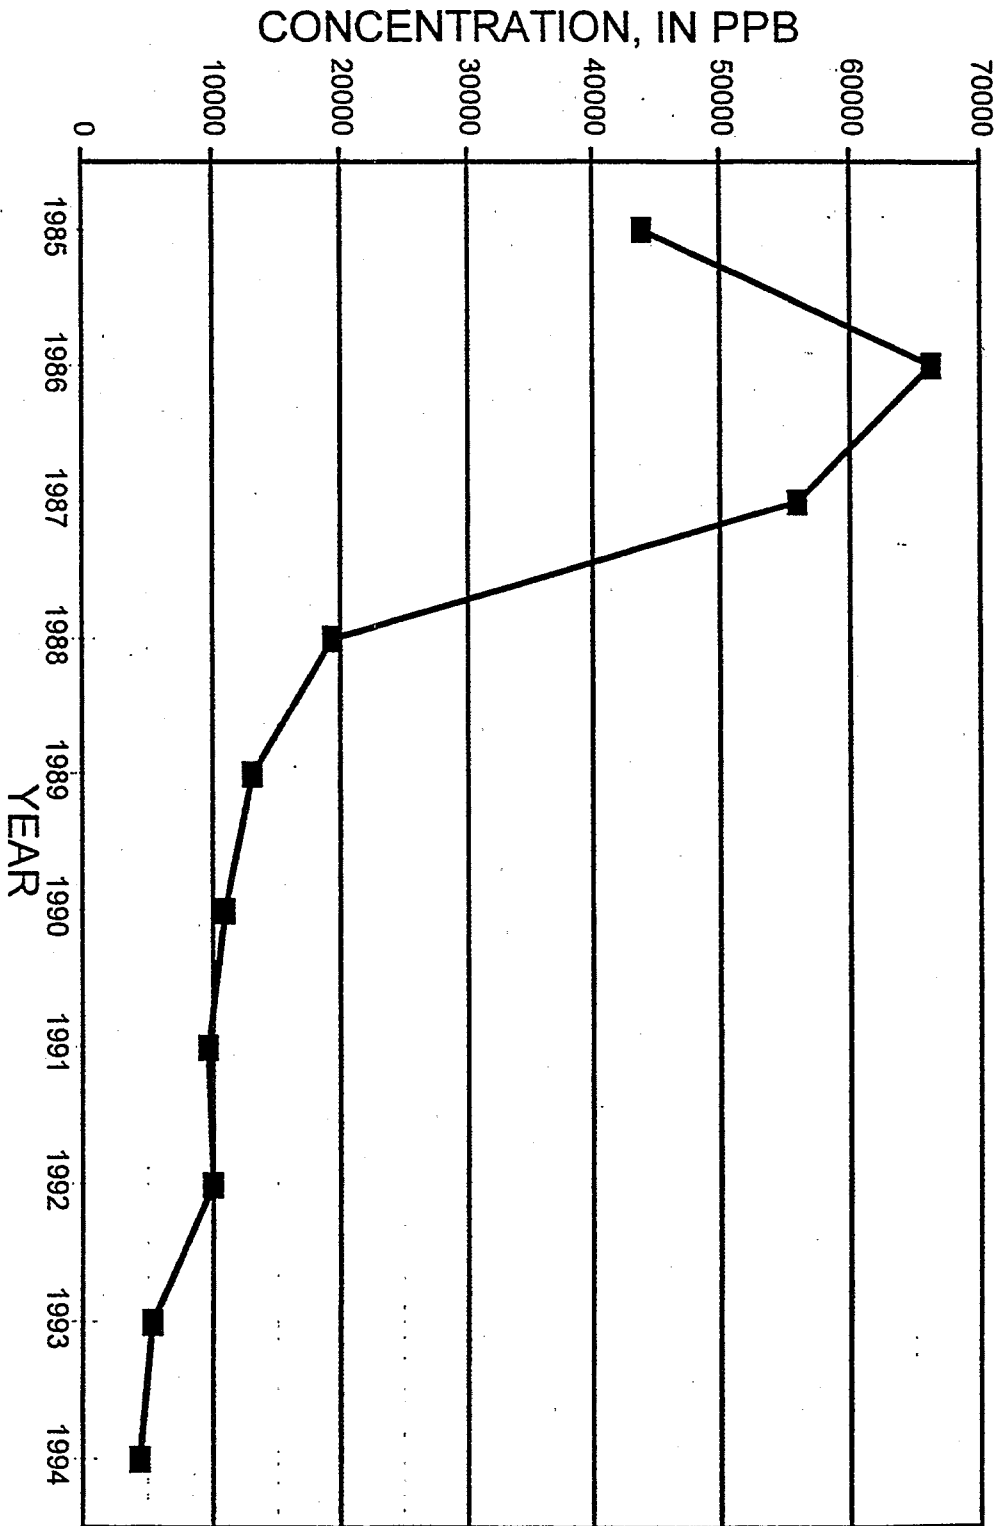
FIGURE 2  
AVG. CONCENTRATION - TOTAL VOCs  
INSIDE BARRIER WALL

The monitoring program for Site 19 involved a better than acceptable effort. Groundwater and surface water quality was measured periodically to assess plume migration and the effectiveness of the pumping and recirculation system. Hydraulic head was also measured at nested piezometers inside and outside the barrier to evaluate the pumping system's effectiveness in maintaining a zero gradient condition, not only for lateral flow but also for vertical flow and barrier underflow.

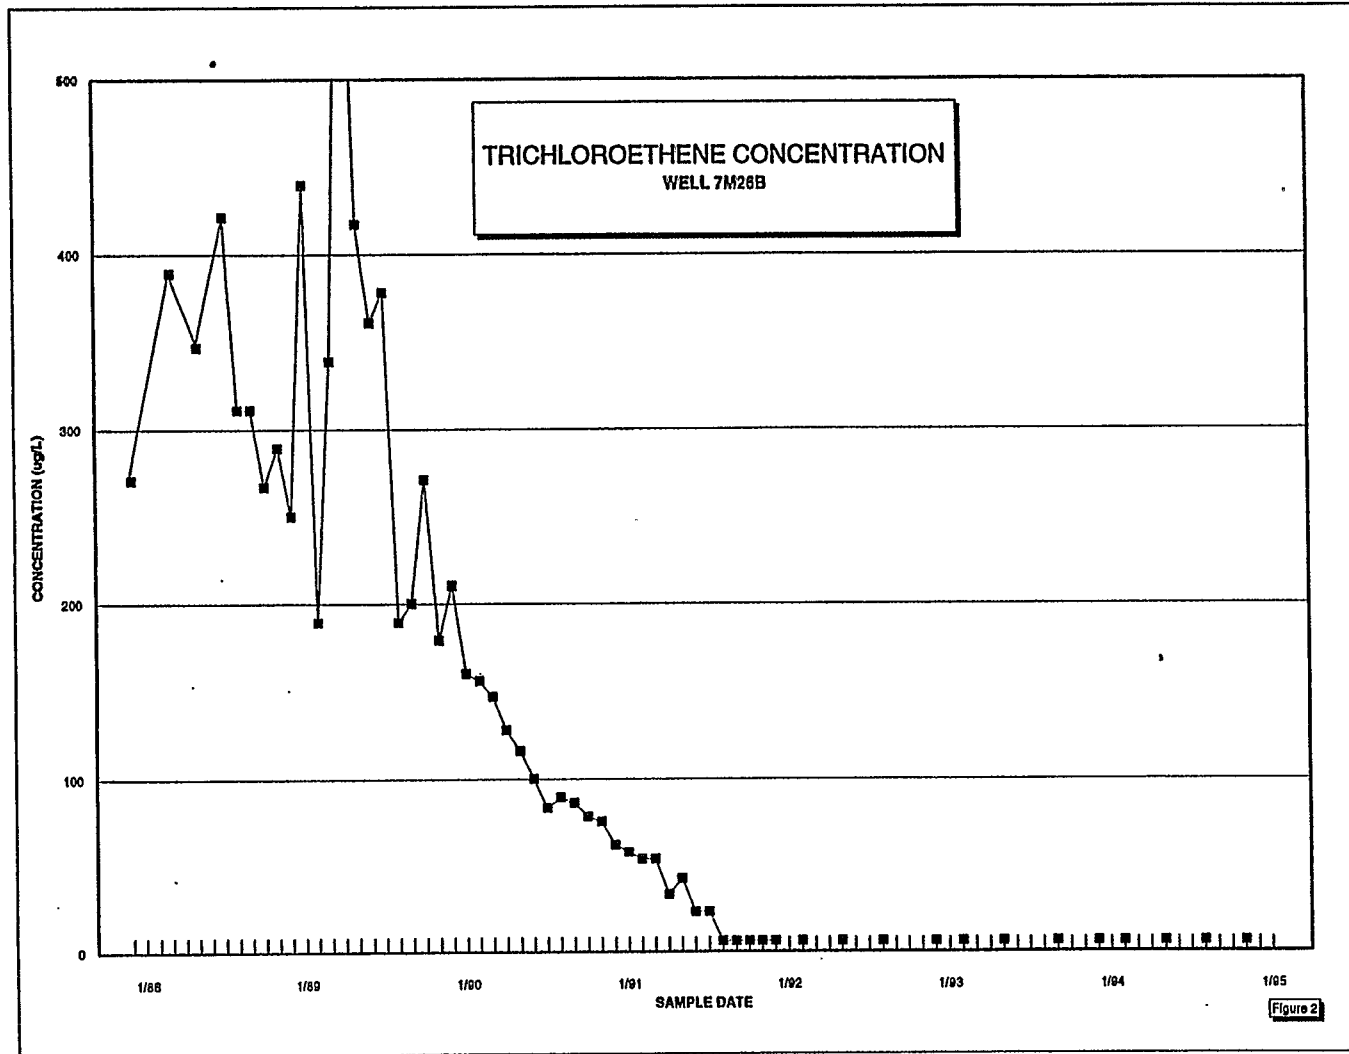
Site 25  
FIGURE 2  
TRICHLOROETHENE CONCENTRATION  
Tetra Tech EM Inc.

Based on the established inward gradient and groundwater quality data, the containment system has been successful in containing and reducing the contamination in on-site shallow groundwater. Figure 2 displays TCE concentrations in groundwater from an off-site monitoring well; the location of this well is
