**SUBJECT:** Transmittal of Final Report - High Lead at Three Residences in Flint, Michigan

## High Lead Levels in Flint, Michigan

The purpose of this report is to present the findings of activities conducted in response to high lead levels in drinking water reported to the United States Environmental Protection Agency Region 5 Office (EPA) by a resident in the City of Flint, Michigan.

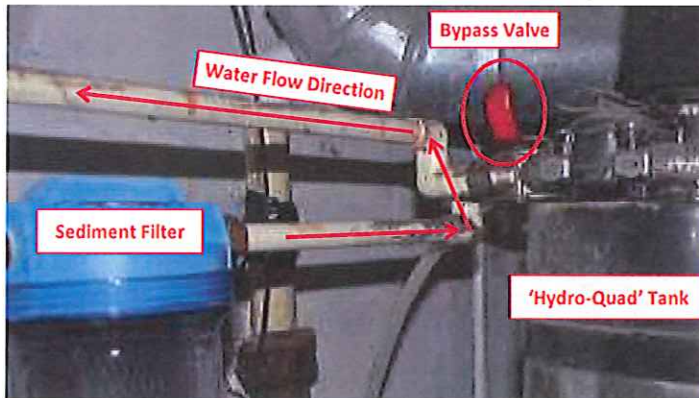
Treatment Units – [REDACTED]

The [REDACTED] home has a whole-home sediment filter, as well a non-functioning 'Hydro-Quad Commercial Water Processor' which is bypassed. There was no iron filter in the home as had been previously reported.

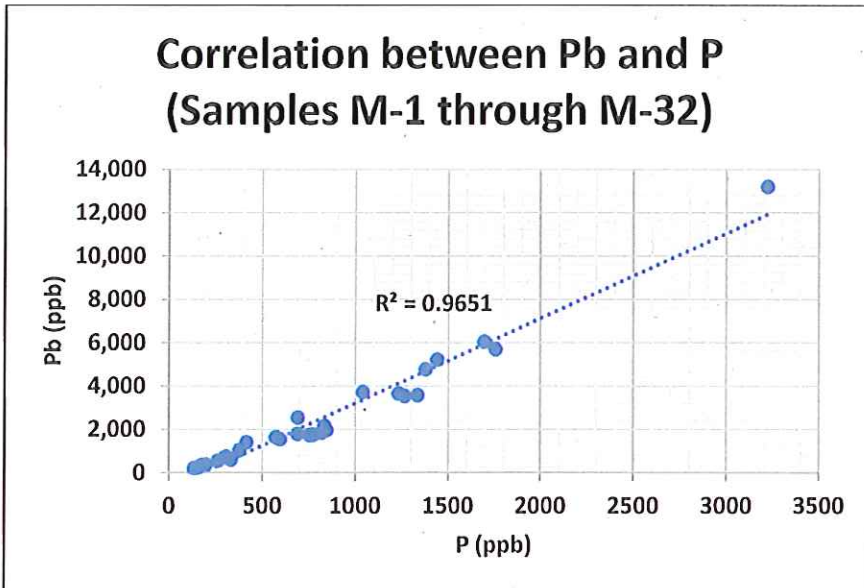
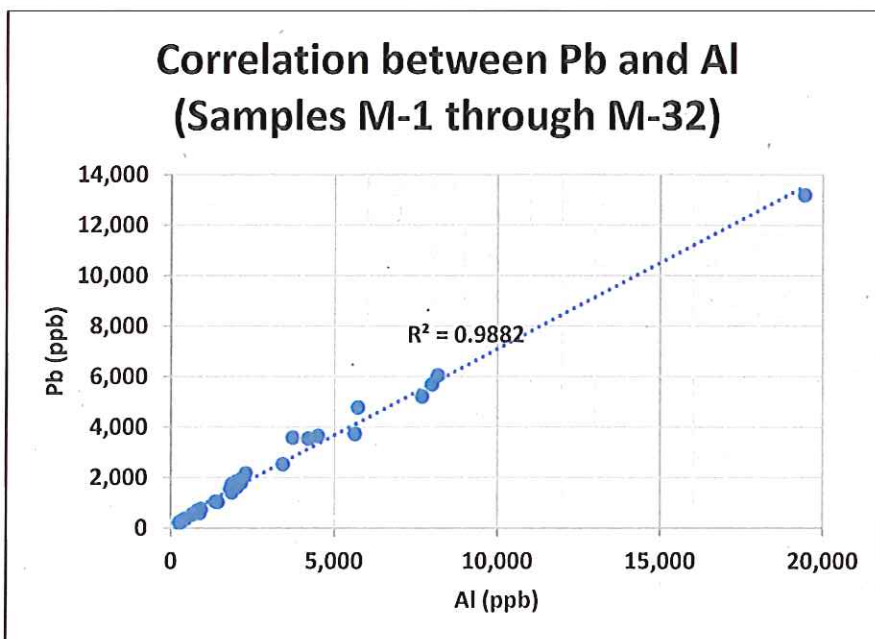
**Correlation between lead, phosphorus and aluminum**

The correlation of lead and phosphate, as well as lead and aluminum, indicate that the samples were captured scale and sediment that had formed inside the pipes while the City of Flint was purchasing water from Detroit. The absence of these chemicals in the current treatment provided by Flint indicate that these elements were not in the water passing through the pipes, but came from the scales inside the service line which had disintegrated into the water or were dislodged into the water.

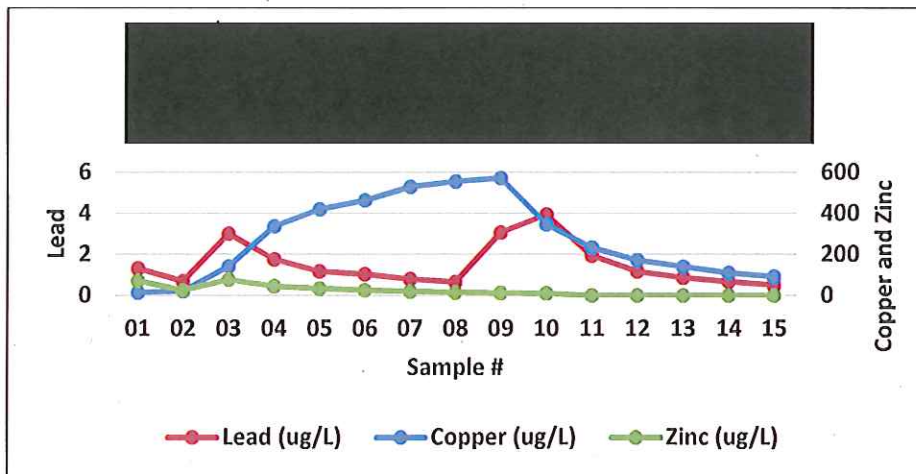
Following the replacement of the █ original service line, a series of 15 sequential samples were collected from the kitchen tap to measure the lead levels and other parameters to ensure that the high lead from the original service line had not contaminated the interior plumbing at the █ home. With the exception of two areas, lead levels were low throughout the █ plumbing following the service line replacement. The two sources of lead that were still detected in the plumbing are likely the water meter (Sample 3) and the new external service shut-off valve (Samples 9-11). Although new brass plumbing components must be lead-free, there can still be some lead that is released from these components.

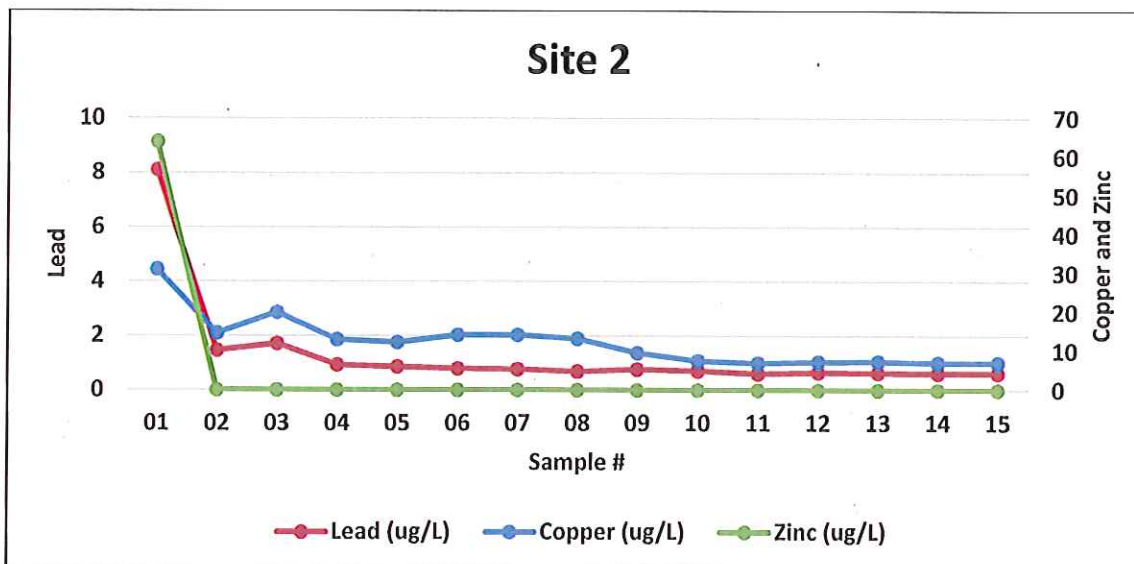
Site #2 (Bryant Street)

Based on the results found at this home, it does not appear that any portion of the service line is made of lead, and as a result, the lead levels are low in most samples. The exception is in Sample 1 which reflects water within approximately 15 feet of the kitchen tap and is likely due to brass components in the faucet, underlying valves and fixtures.

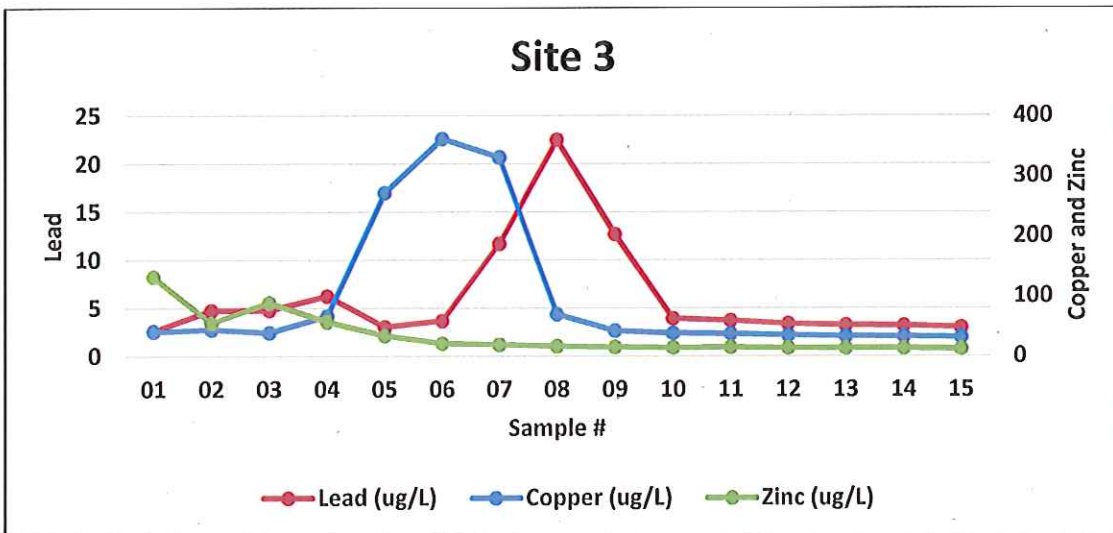
Site #3 (Bryant Street)

Based on the results found at this home, it appears that the portion of the service line from the external service shut-off valve to the water main is made of lead as indicated by the increase in lead levels in samples 7 through 9.

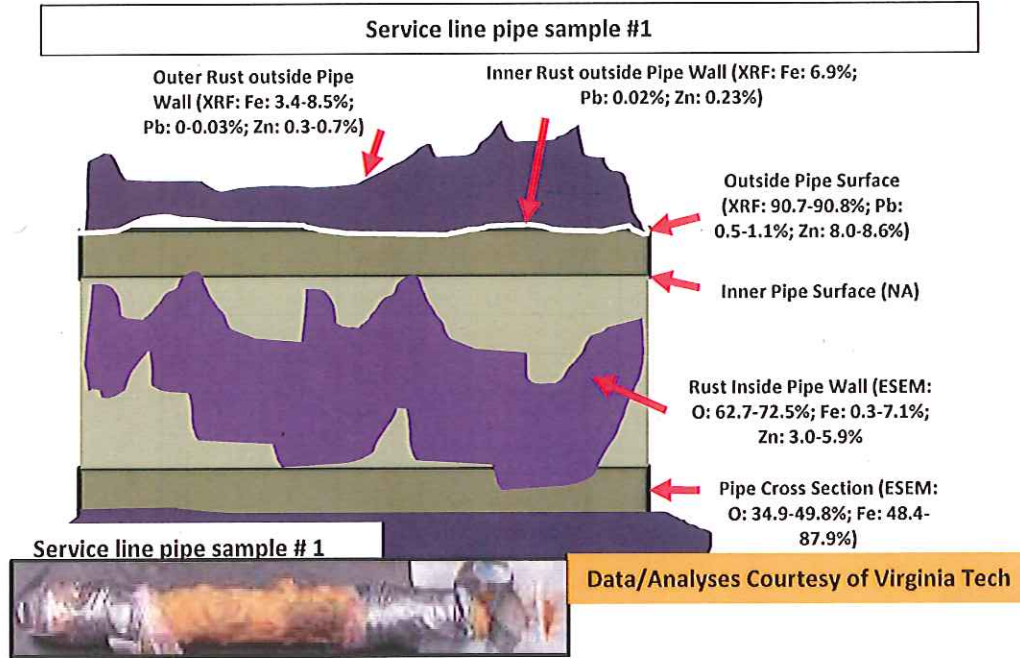
Below are the results of the galvanized pipe analyses conducted by Virginia Tech on the two sections of galvanized iron pipe from the [redacted] original service line. The analyses indicate that the [redacted] original service line was a typical galvanized iron pipe.
