**Operating Experience
Overview and
SF₆ Emission
Reduction Efforts at
Seabrook Station**

Seabrook Station

345-kV Distribution System

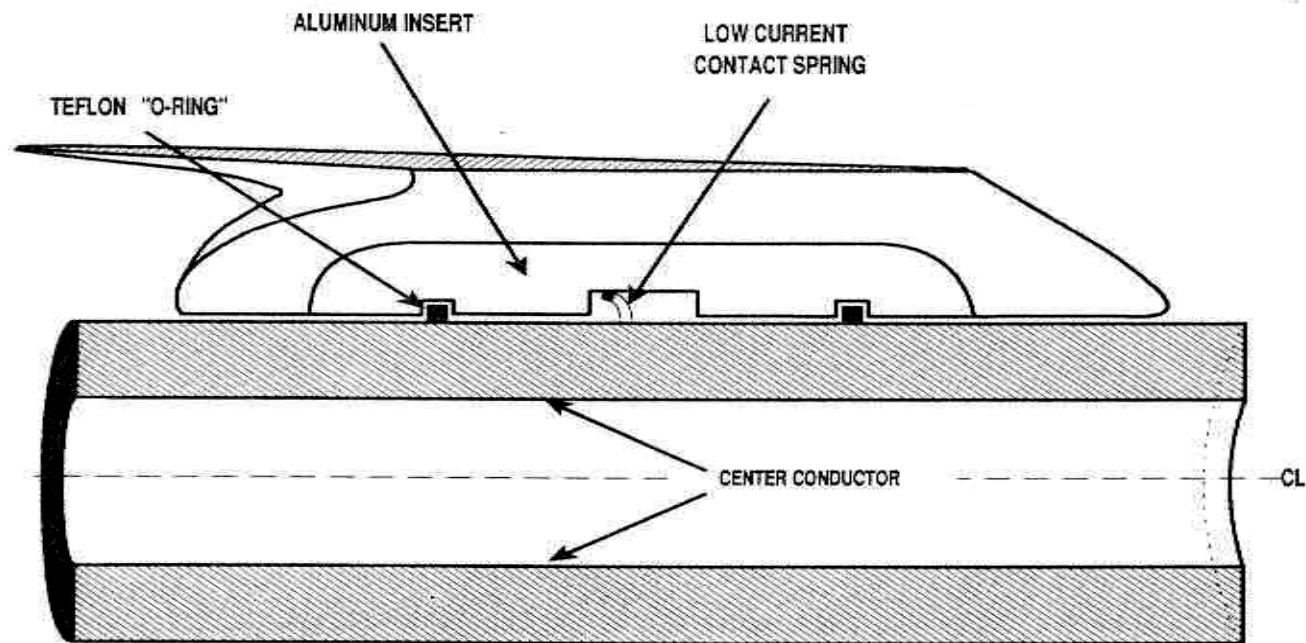
SF6 INSULATOR
WITH CENTER CONDUCTOR

- **Insulator failures (8 total) attributed to:**
 - **Aluminum particle contamination, resulting in partial discharges and SF₆ breakdown (1 failure).**
 - **Loss of spring contact at the conductor surface resulting in a floating component (4 failures).**
 - **Voids between epoxy coating and the aluminum insert (2 failures).**
 - **Indeterminate (1 failure).**
- **Air bushing failures (2 total) attributed to:**
 - **Excessive mechanical loading from cable contraction during cold conditions.**
 - **Excessive mechanical loading from cable sway during wind conditions.**

- **Bus duct modifications, Zones 2 and 4 – replace with new Westinghouse/ABB design.**
 - Implemented in 1992 for Zone 2.
 - Implemented in 1997 for Zone 4.
 - Cost: \$1.9 million.
- **Porcelain air bushing replacement with epoxy composite bushings.**
 - Replacement implemented in 1993, but not before two additional failures occurred in 1991 and 1992.
 - Cost: \$900,000 for 9 composite bushings.
- **Establish an on-site facility for repair of SF₆ bus duct sections and power circuit breakers.**
 - Implemented in 1992.
 - Cost: \$430,000.

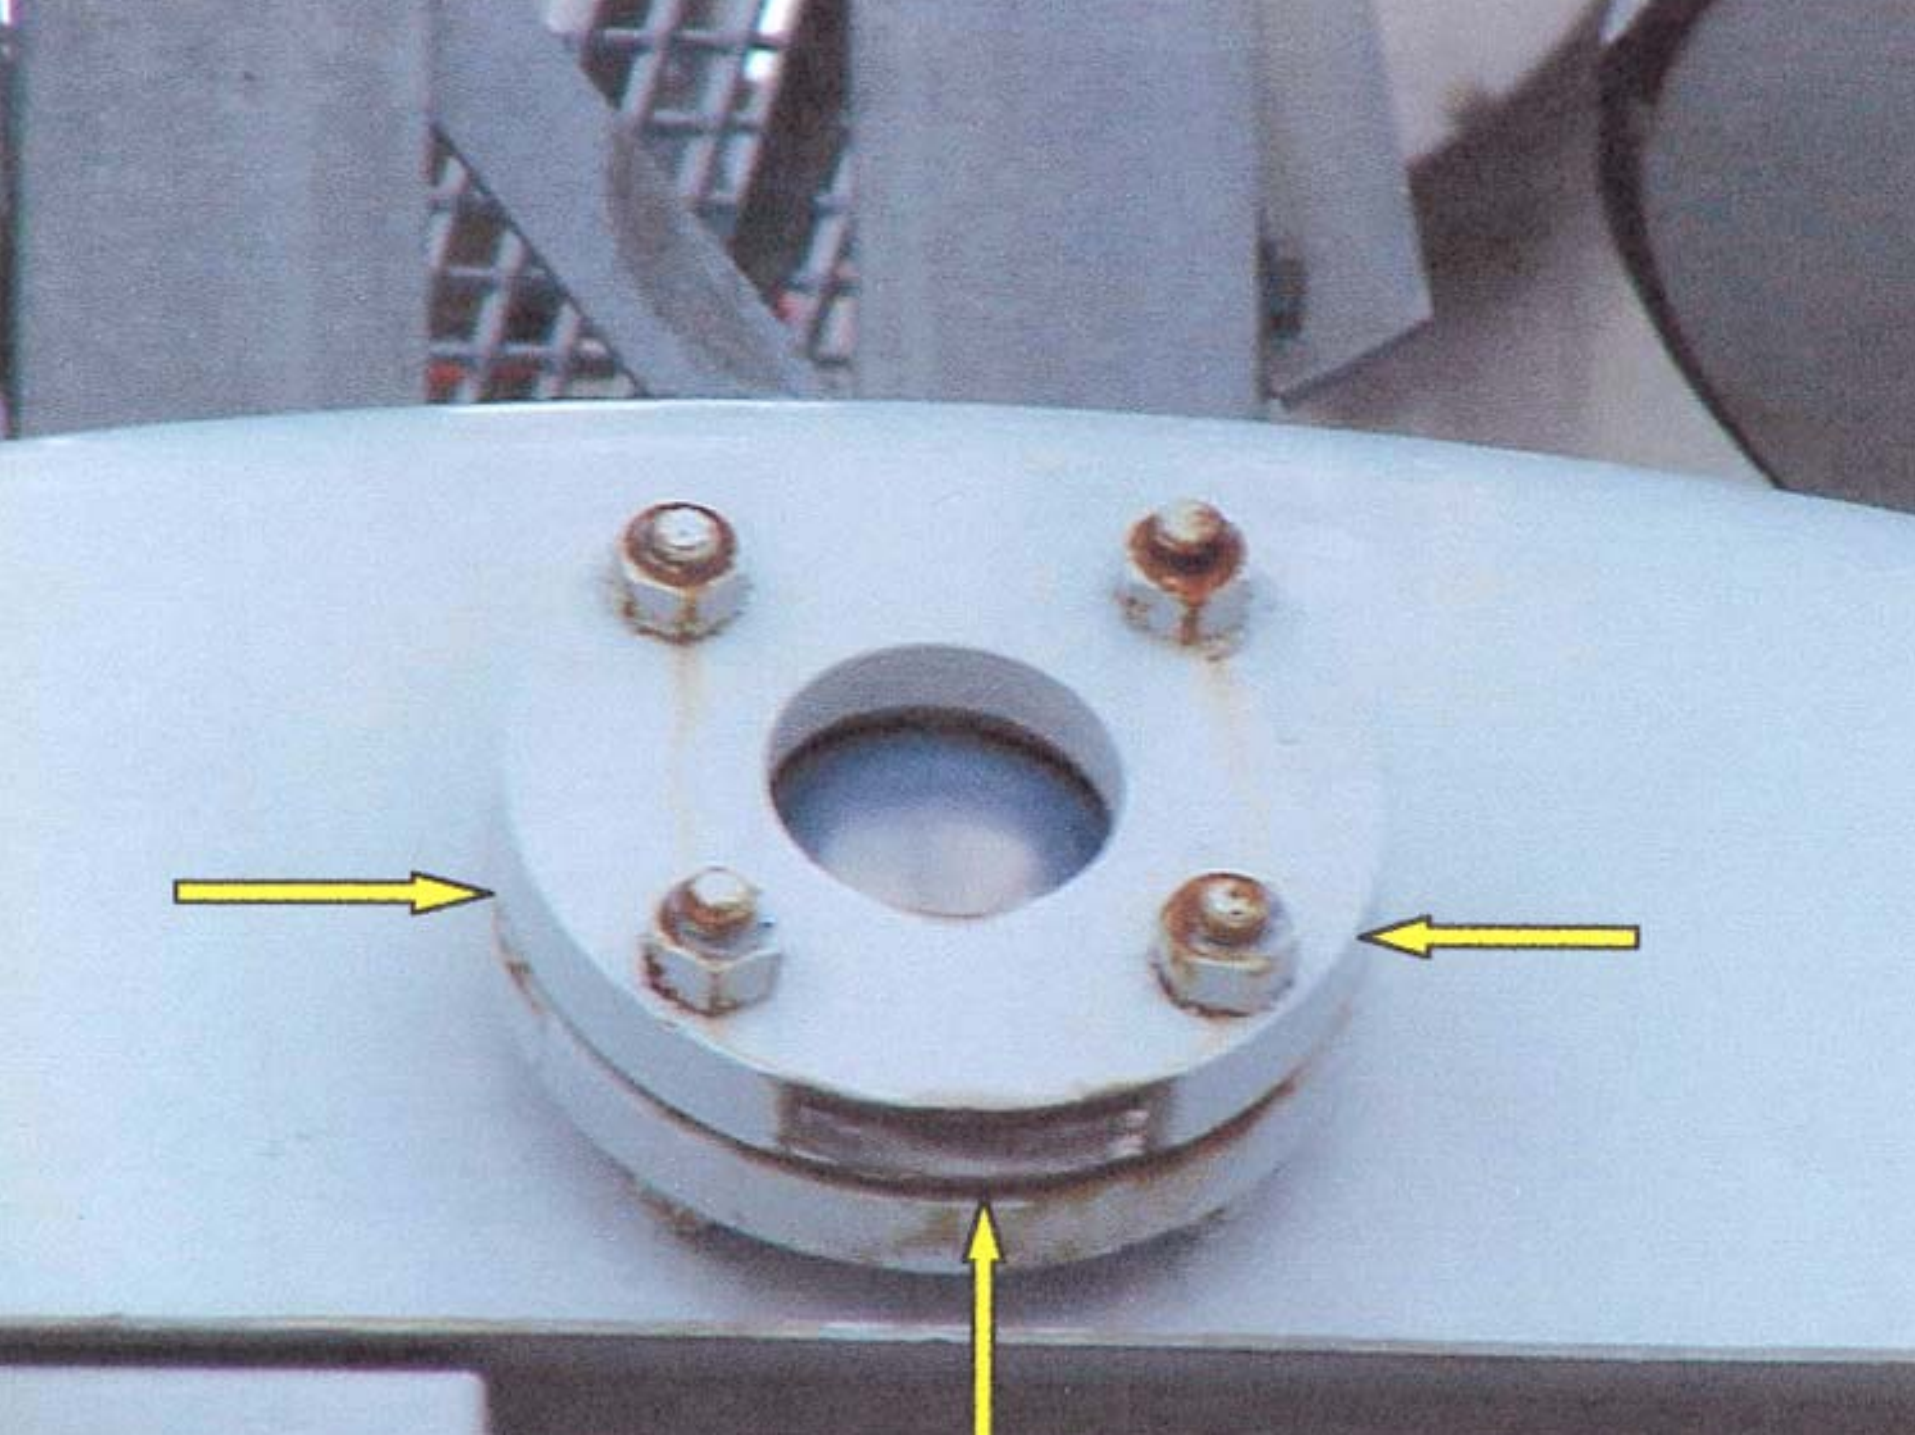
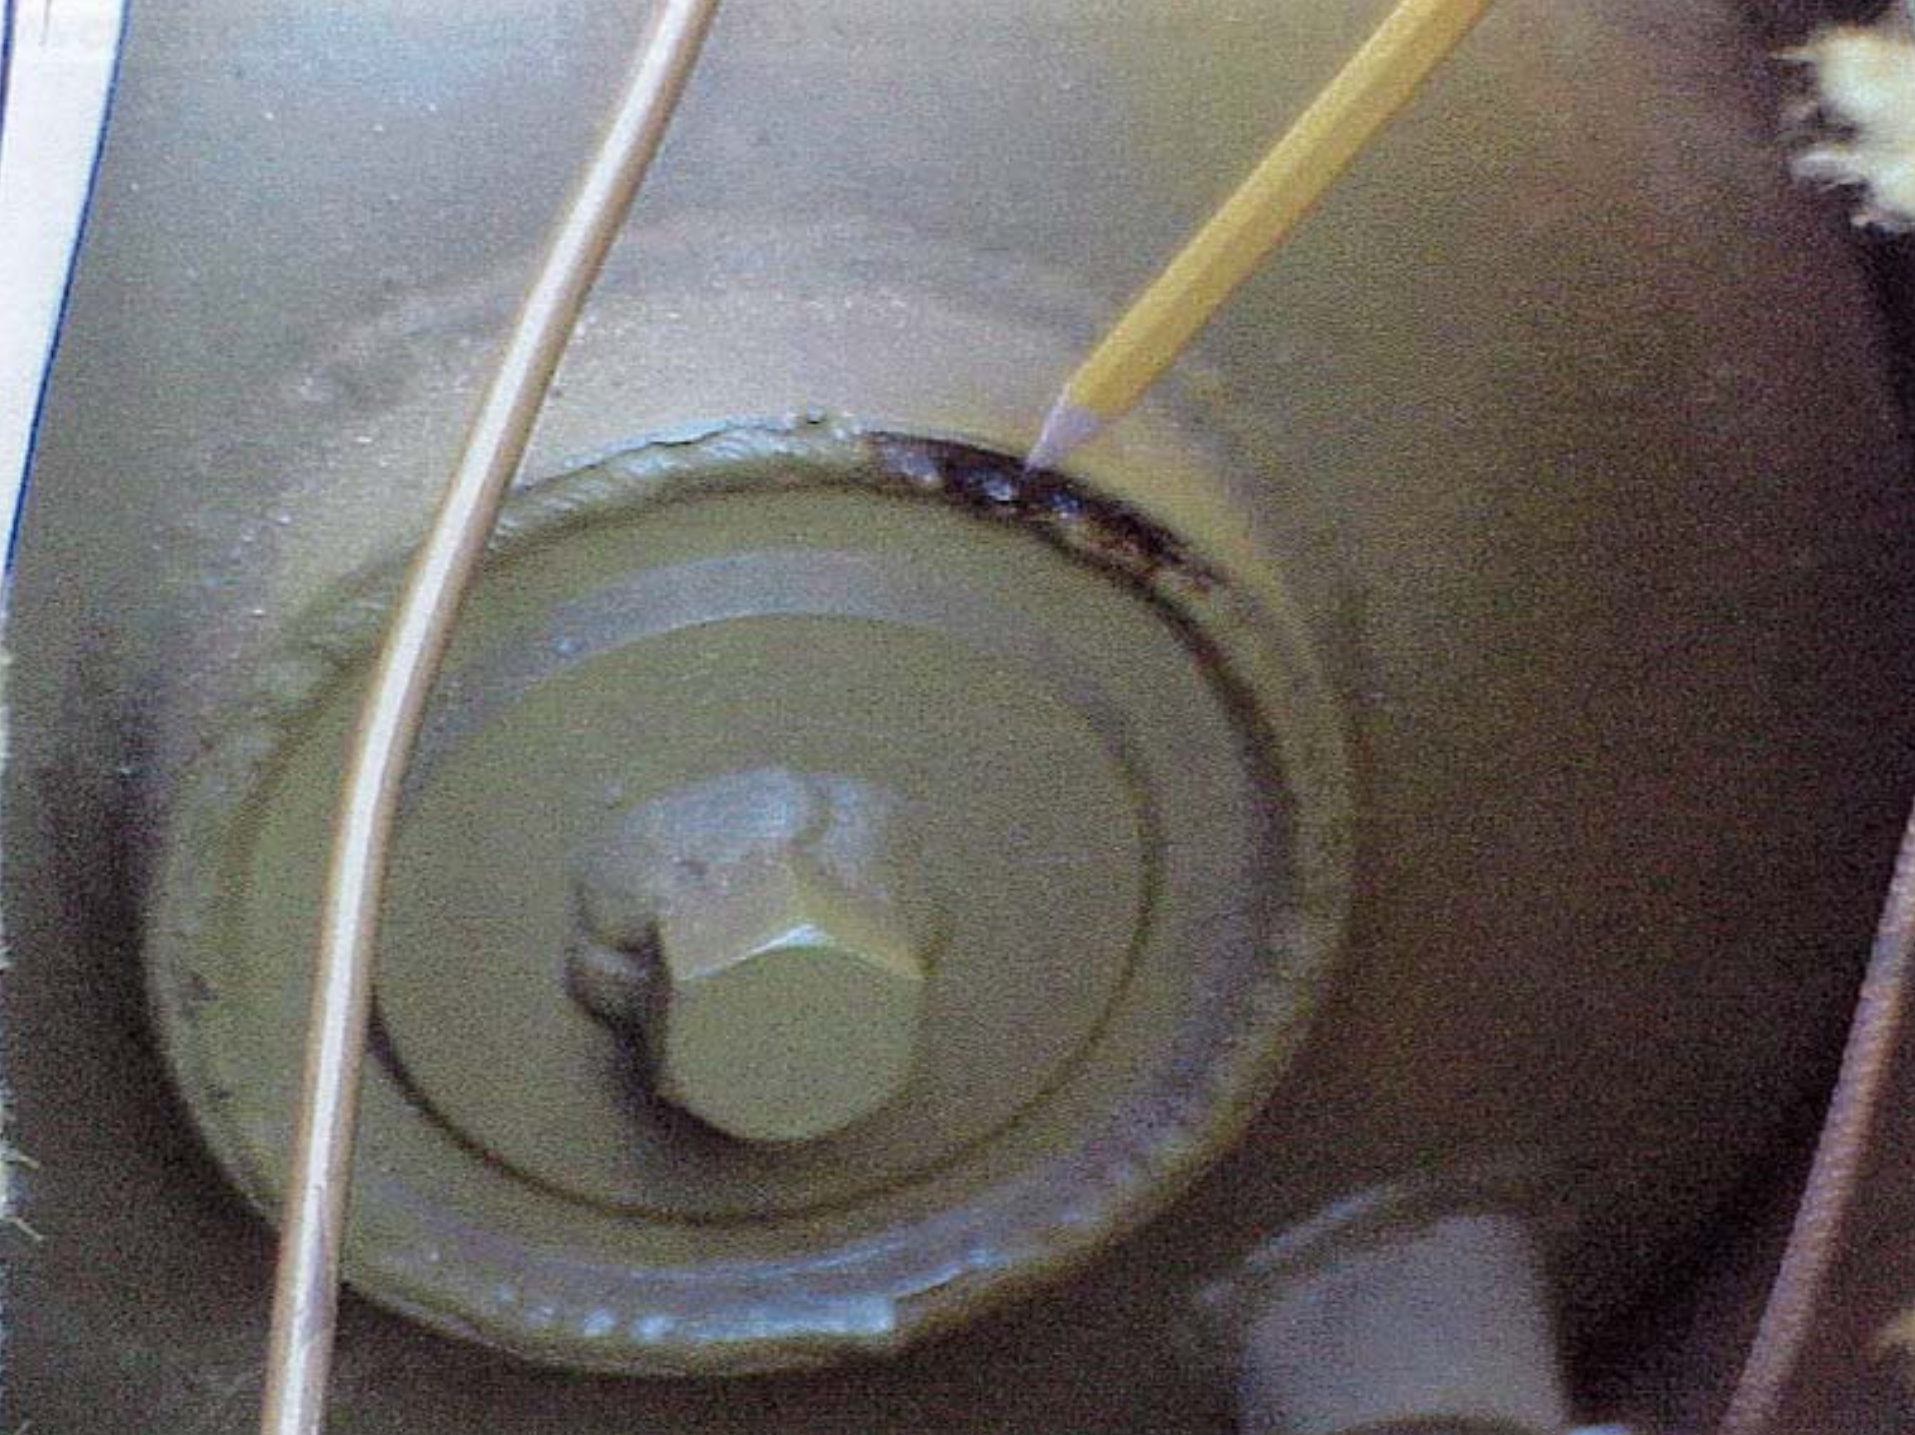
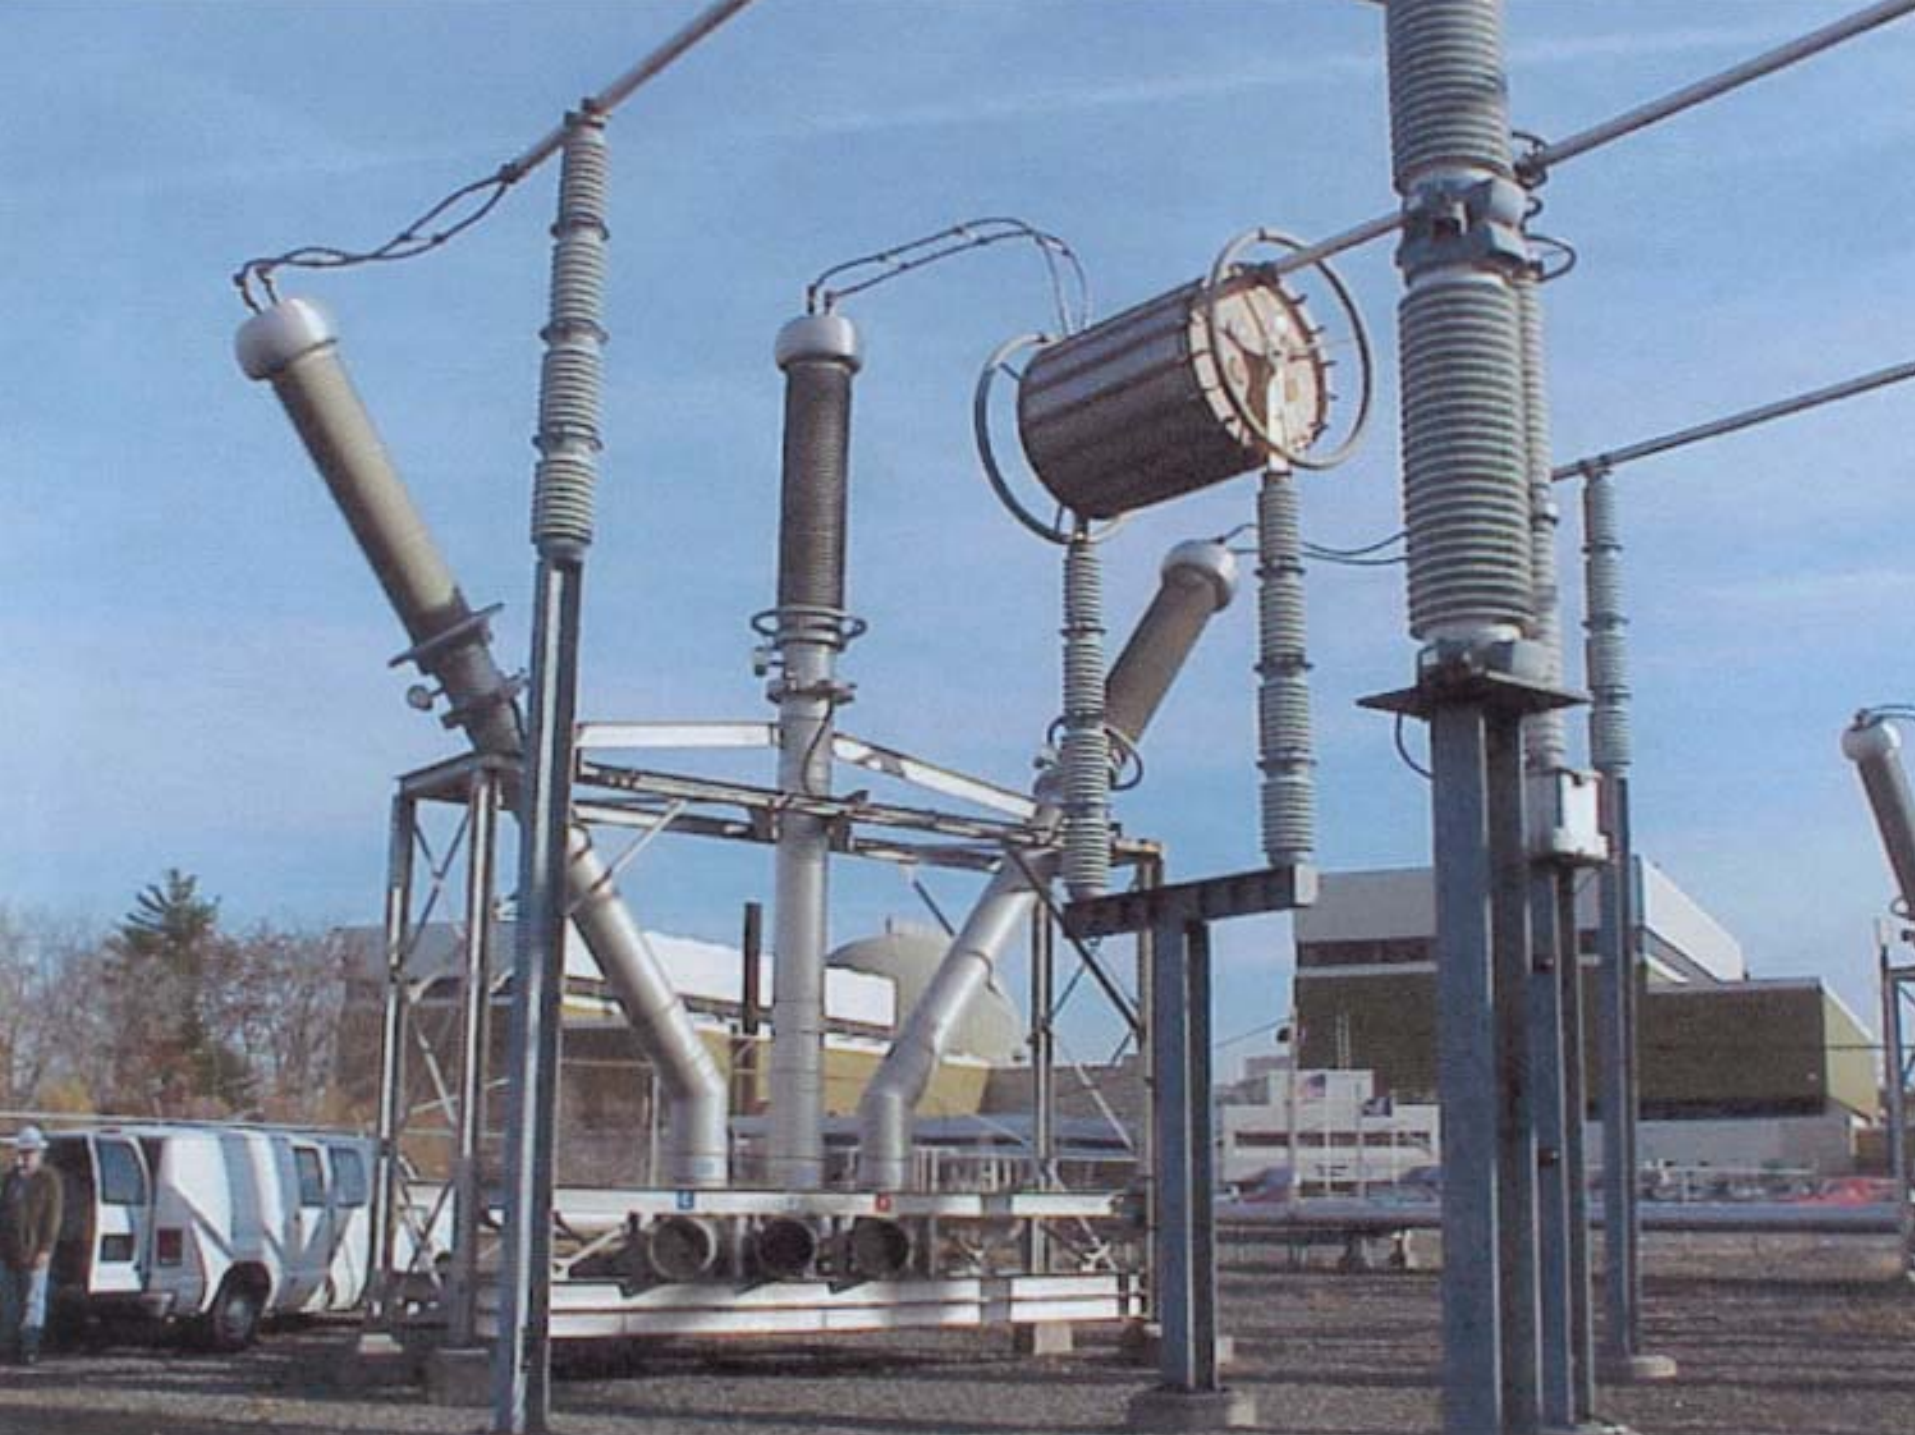
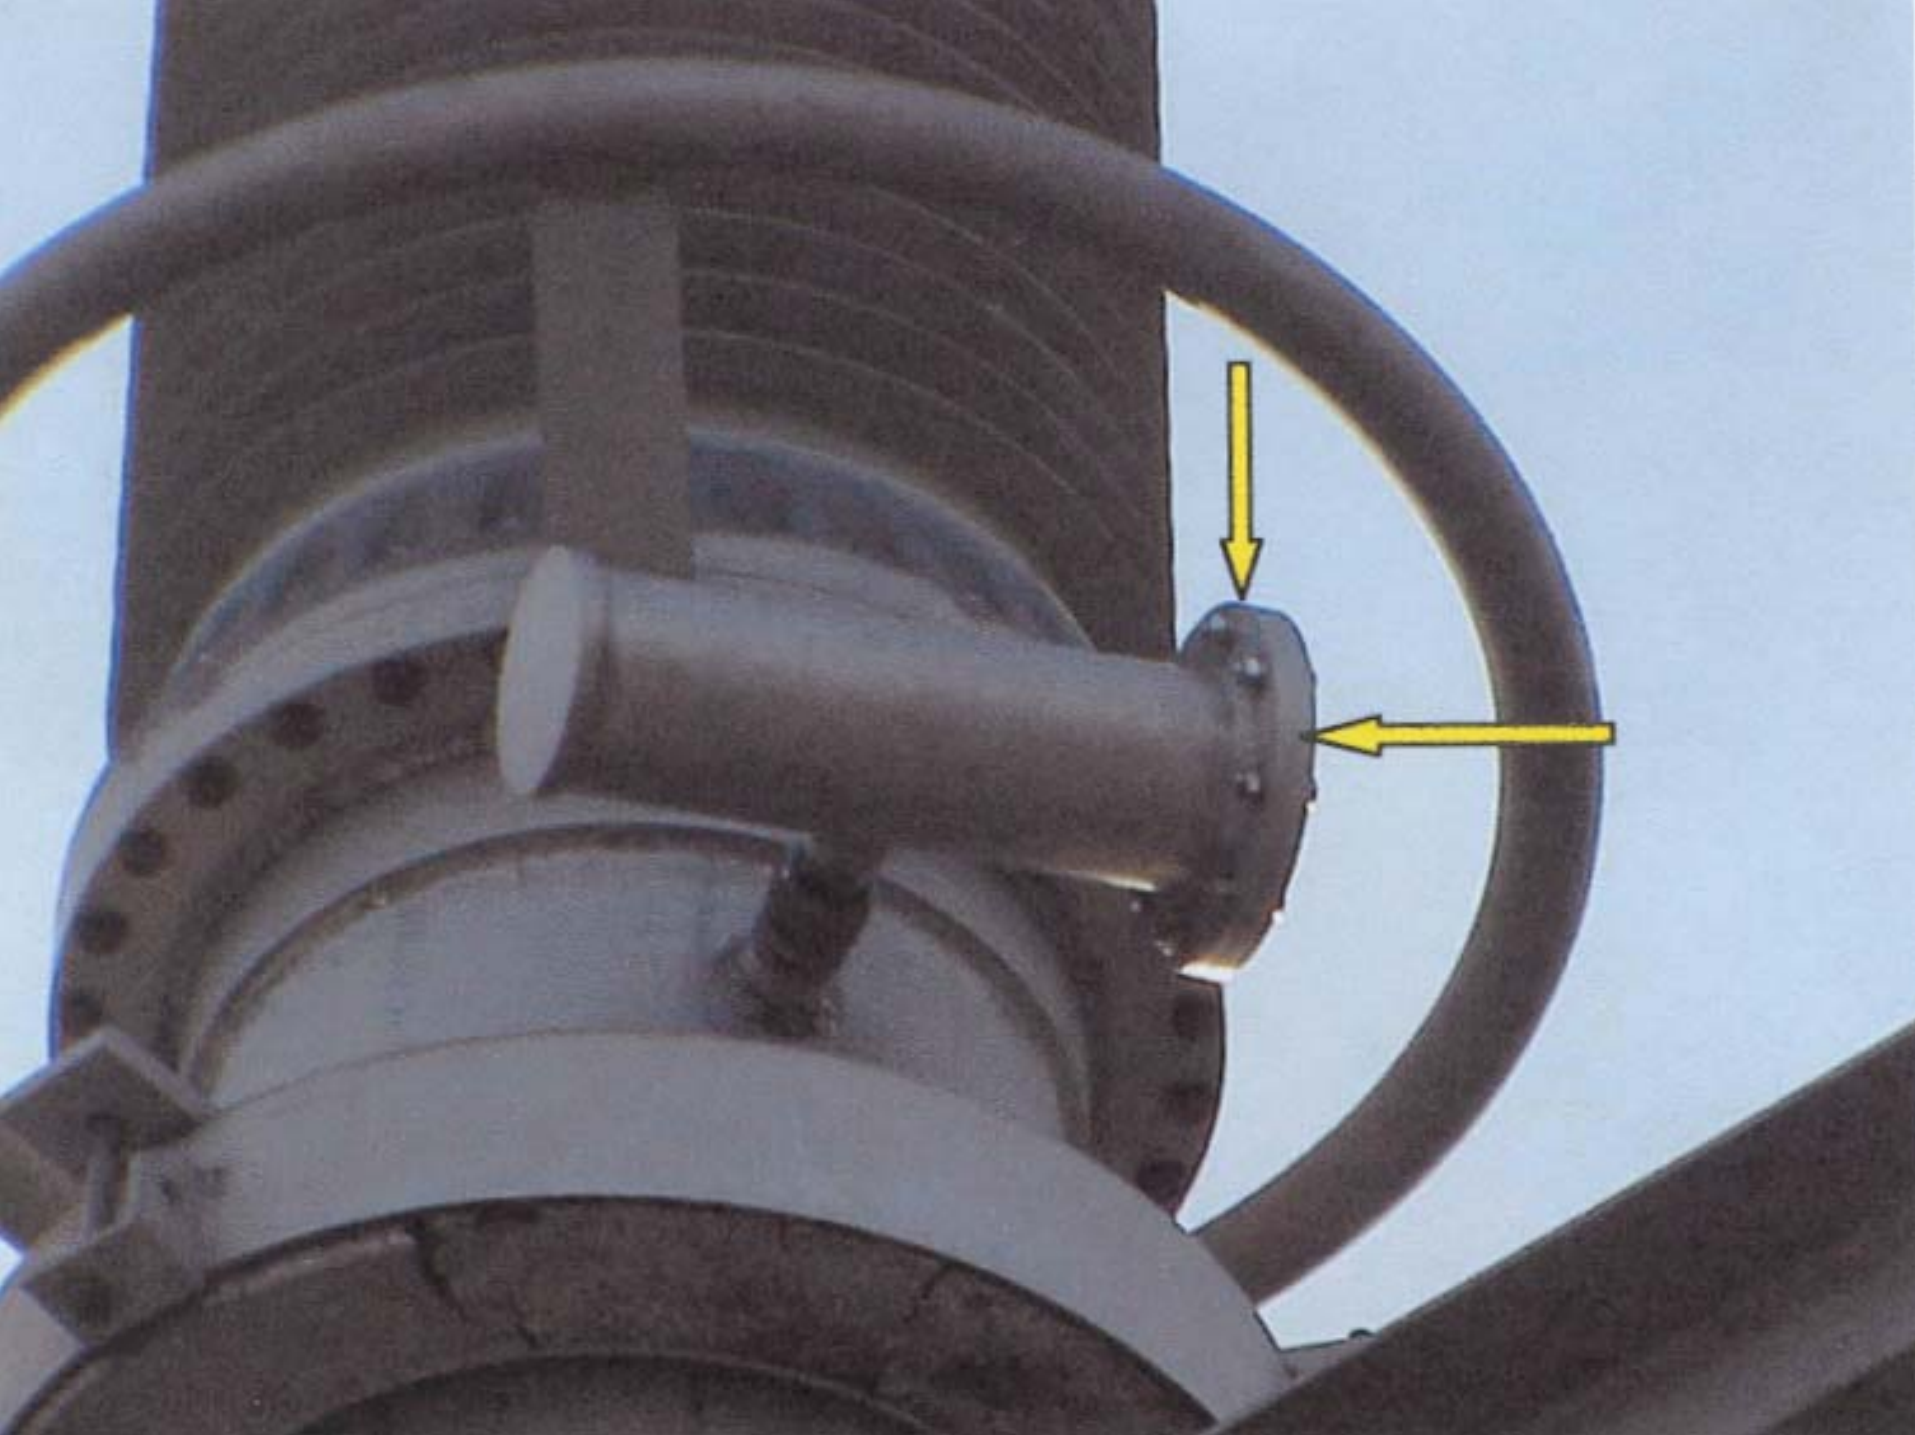
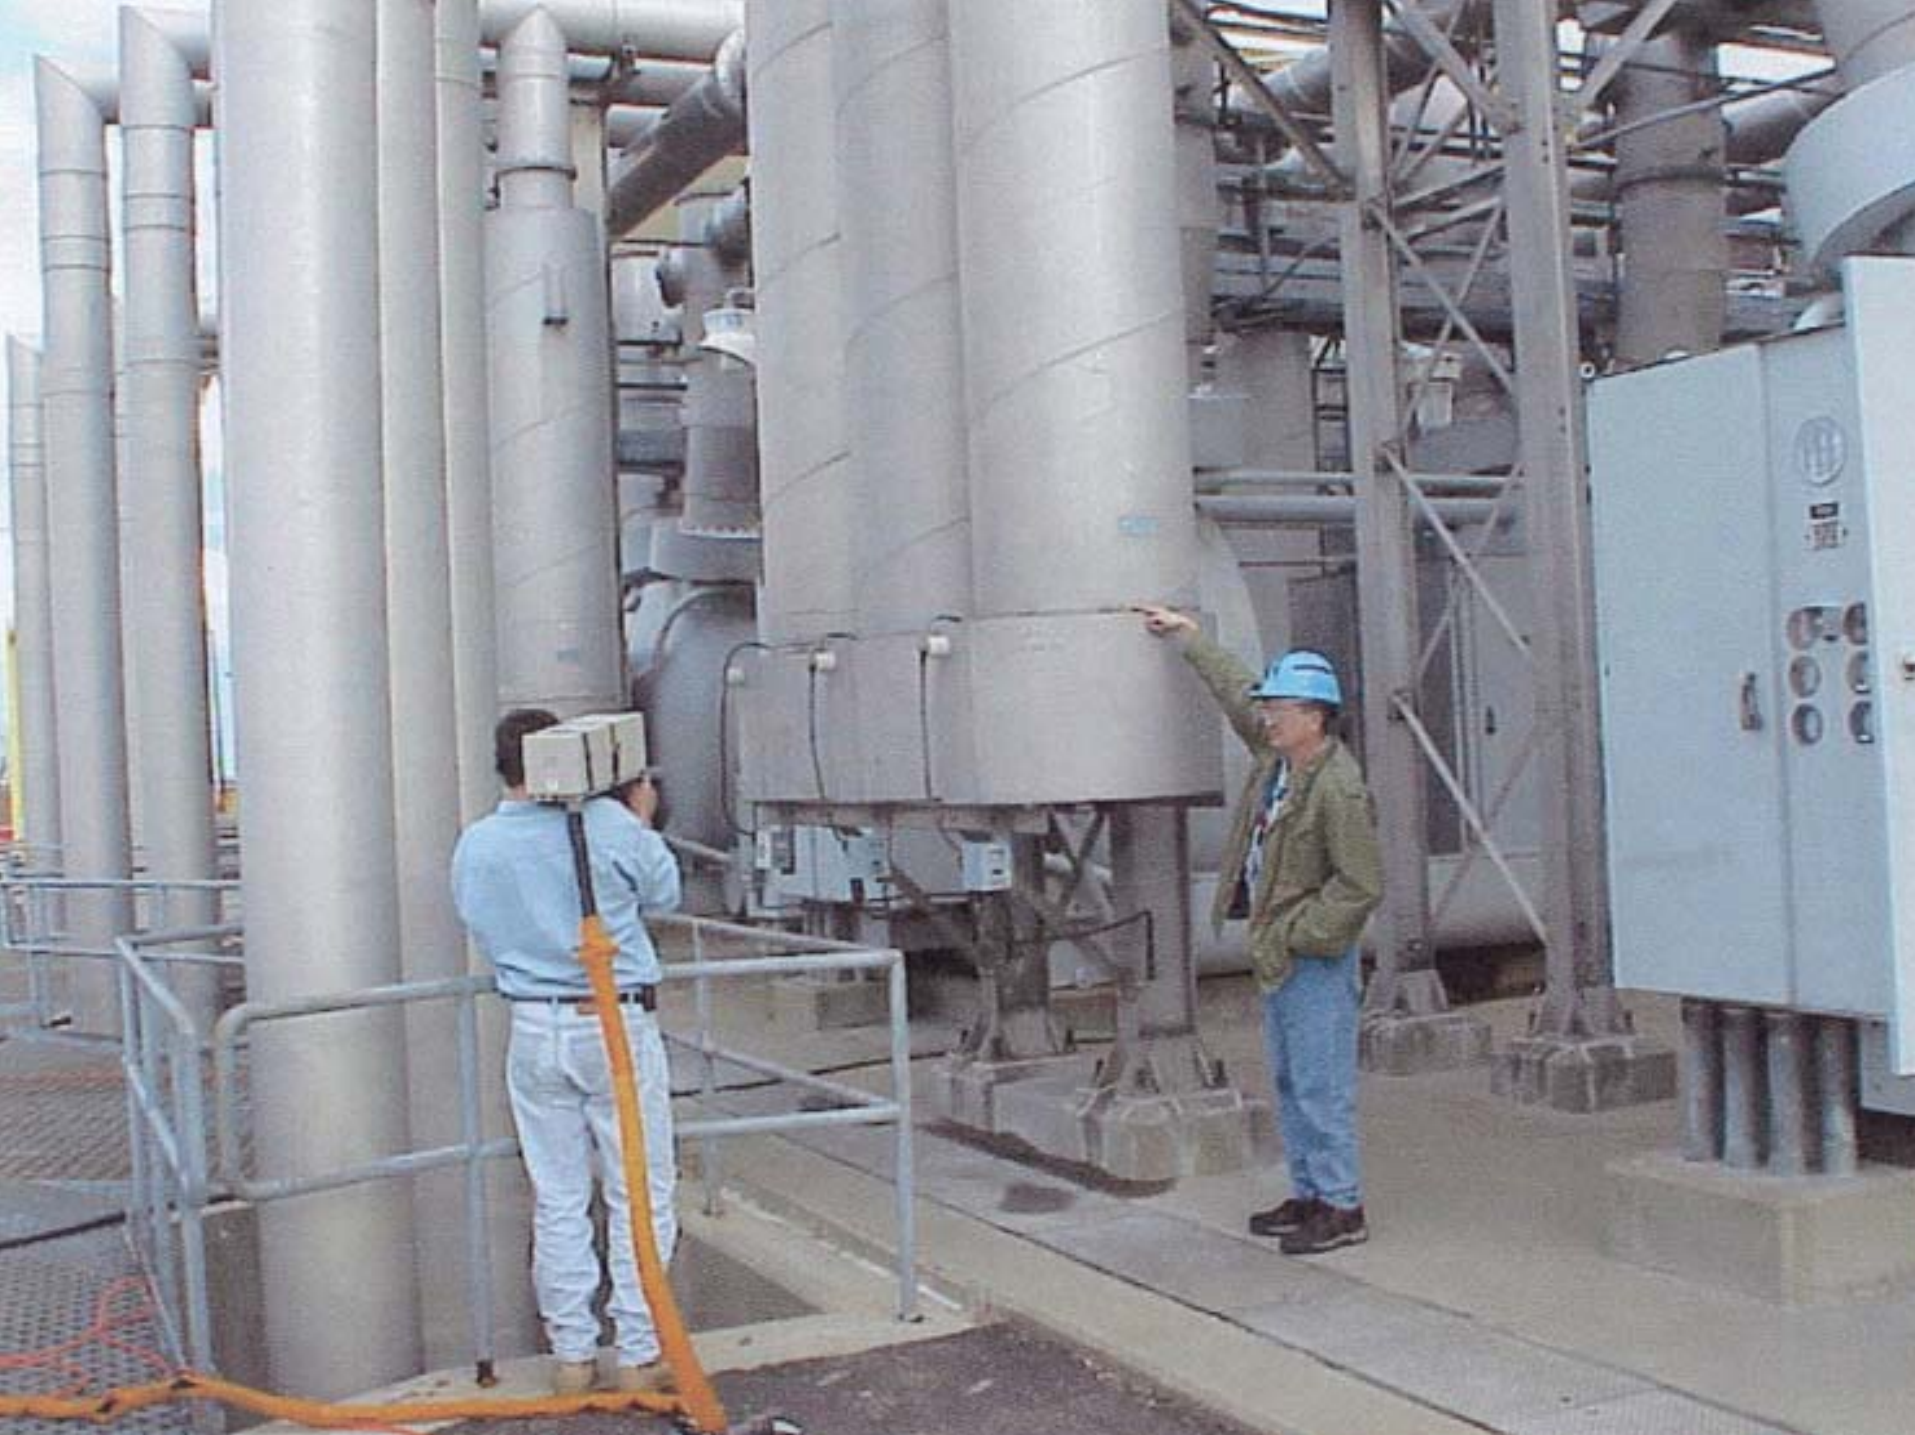
- **October 1999 EPRI Gas-Vue Leak Detection System survey of SF₆ bus ducts and power circuit breakers.**
- **Identified leakage areas have been reviewed and repair activities have been incorporated into the station maintenance schedule for 2000-2002.**
- **Follow-up survey planned following completion of repair activities.**
