# Laser Imaging SF<sub>6</sub> Inspection for Chicago White Metal Casting, Inc.

#### SF<sub>6</sub> System Specifications

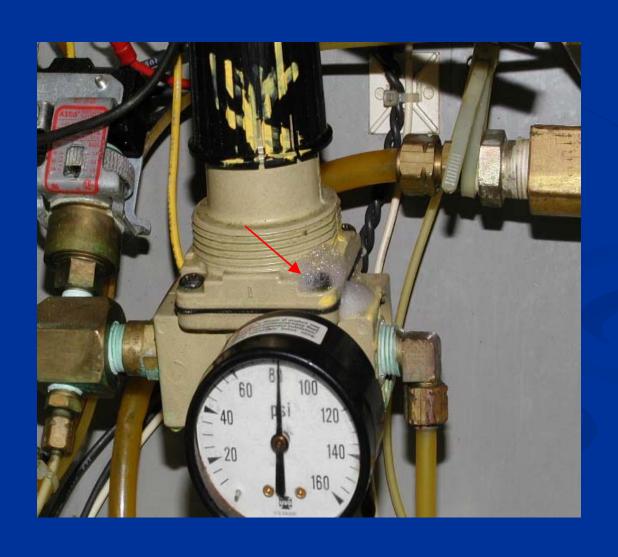
# Confirmed regulator leak using soap test

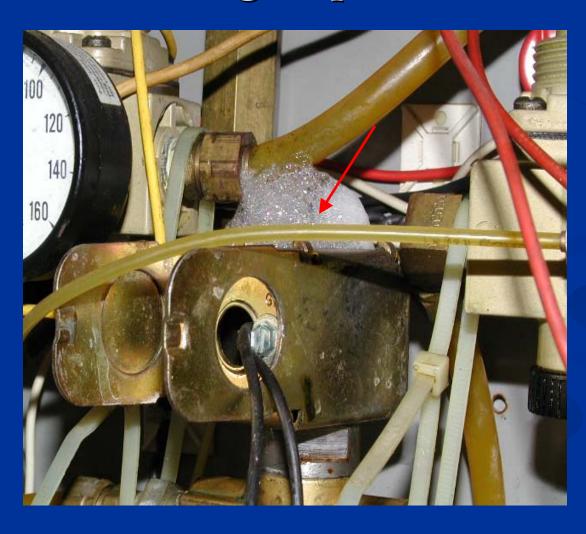
# Confirmed solenoid valve leak using soap test

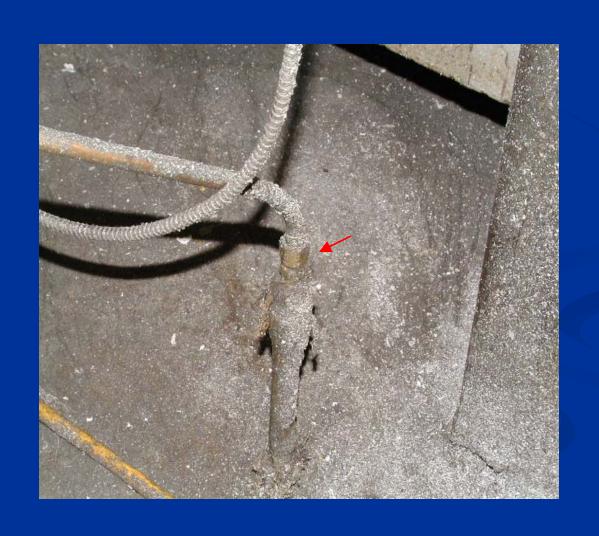
#### #29 Machine – copper fitting leak

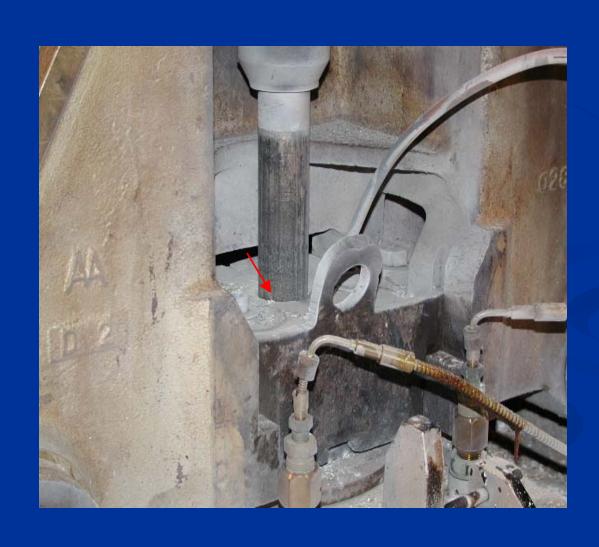
#### Shaft seal leaking on all machines

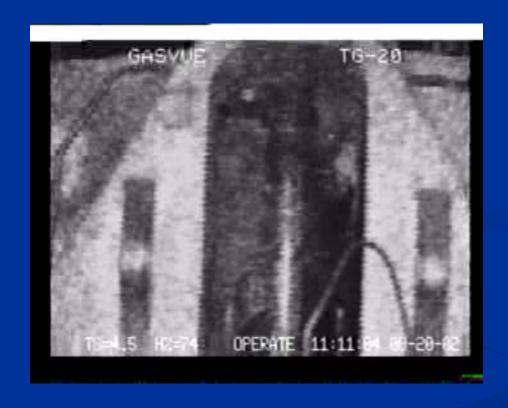
### Shaft seal leaking
