City of Colorado Springs Phase I MS4 Inspection Report
Colorado Discharge Permit System, Permit # COS000004

Inspection Dates: August 18, 2015–August 19, 2015

Prepared by
PG Environmental, LLC

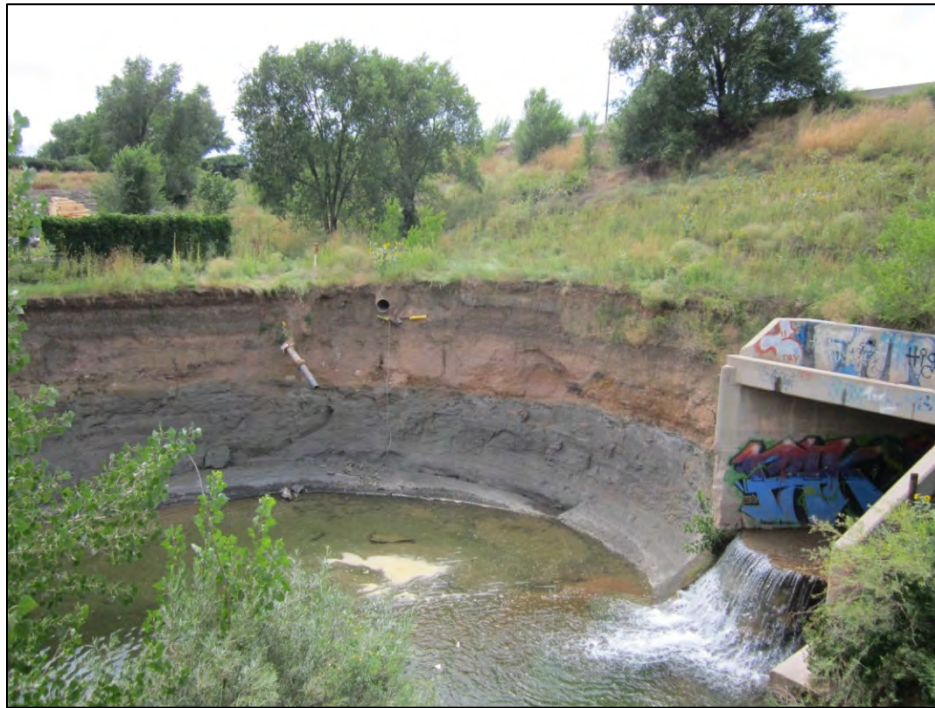
View of significant erosion and scouring of N. Douglas Creek downstream of I-25 box culvert outlet. The vertical dirt embankment was estimated to be approximately a 40 feet high. Portions of the concrete box culvert were present in N. Douglas Creek below the area of this photograph. Also, note that the Creek bed would have been approximately even with the base of the culvert at the time the culvert was constructed and at the time of the 2015 Inspection it appears to be almost 6 feet lower. In addition there is significant undercutting beneath the base of the culvert.

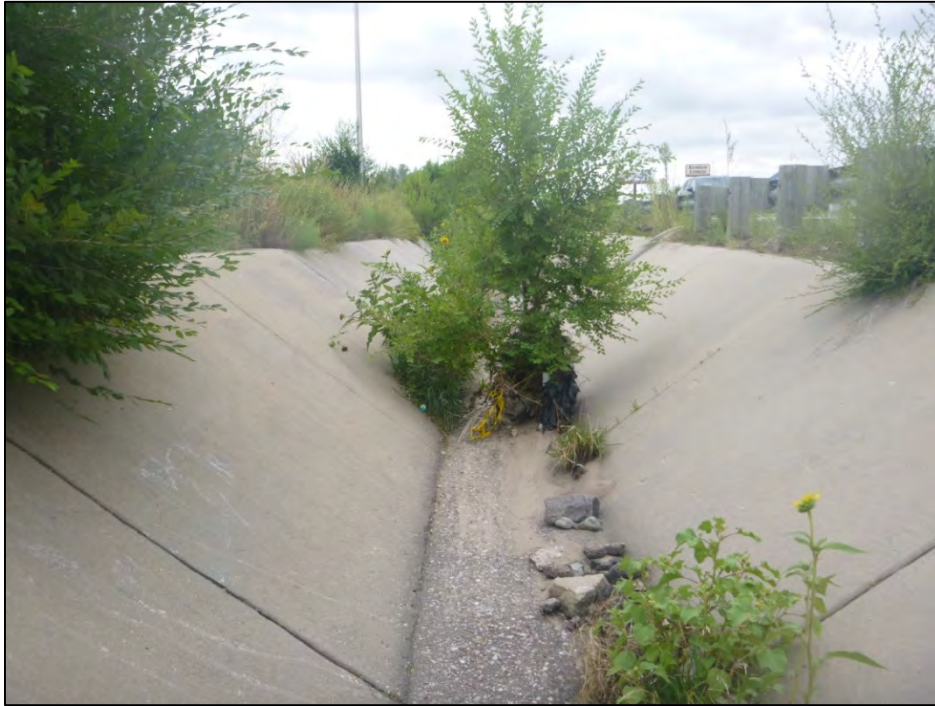
View of CS – 130 concrete lined MS4 conveyance channel. Close-up view of vegetative growth (e.g., shrubs) and accumulated debris in the channel.

- The source document for CS – 130 is the SWENT database and the Project Description documented the undermining and unmaintained concrete channel MS4 infrastructure. It should be noted that this issue was identified prior to the SWENT which was disbanded in 2009 (and still has not been addressed).
- The summary of the problem for CS – 137 states that nearby “[r]esidents (1998) complain that rear of complex smells very badly in the drainage ditch” indicating that the ditch may not have been installed to a grade that allowed proper drainage and decomposing organic matter caused a foul odor in the area.
- The source document for CS – 362 is a Spring Creek Drainage Basin study from 1993 indicating that the concrete channel sizing and at least some of the presently existing erosion problems were identified at least 20 years ago.

- An unmaintained/deteriorated (e.g., undercut) concrete lined MS4 conveyance channel with accumulated sediment and dense vegetative growth was observed at CS – 130 location, which subsequently drains to Sand Creek.

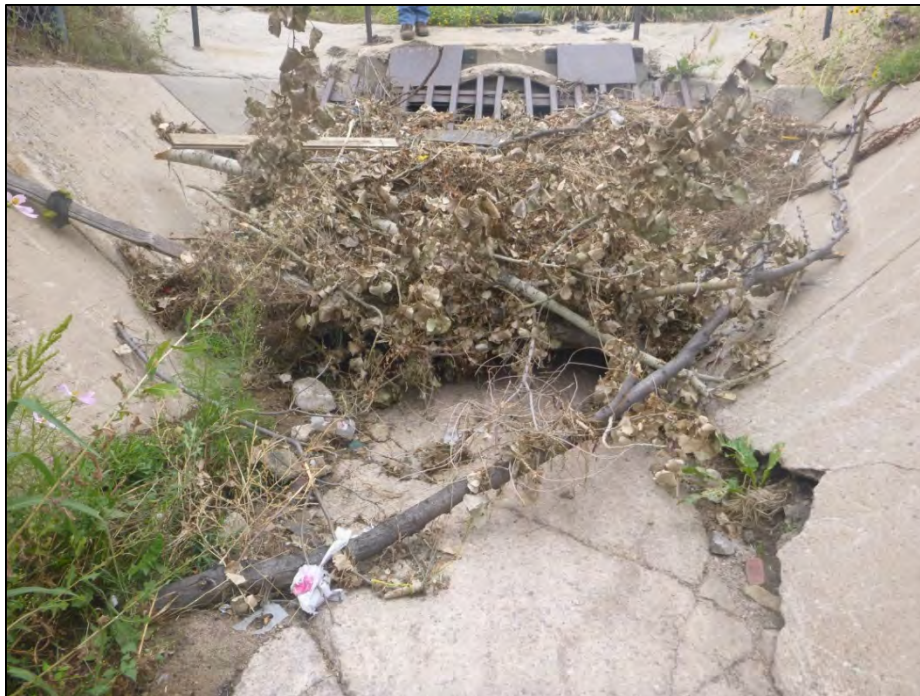
View of CS – 060 Hancock Expressway Drainage channel. View in channel of trash, debris, accumulated sediment, vegetative growth, and deteriorated concrete channel lining at the culvert pipe inlet trash rack and within the concrete lined channel itself.

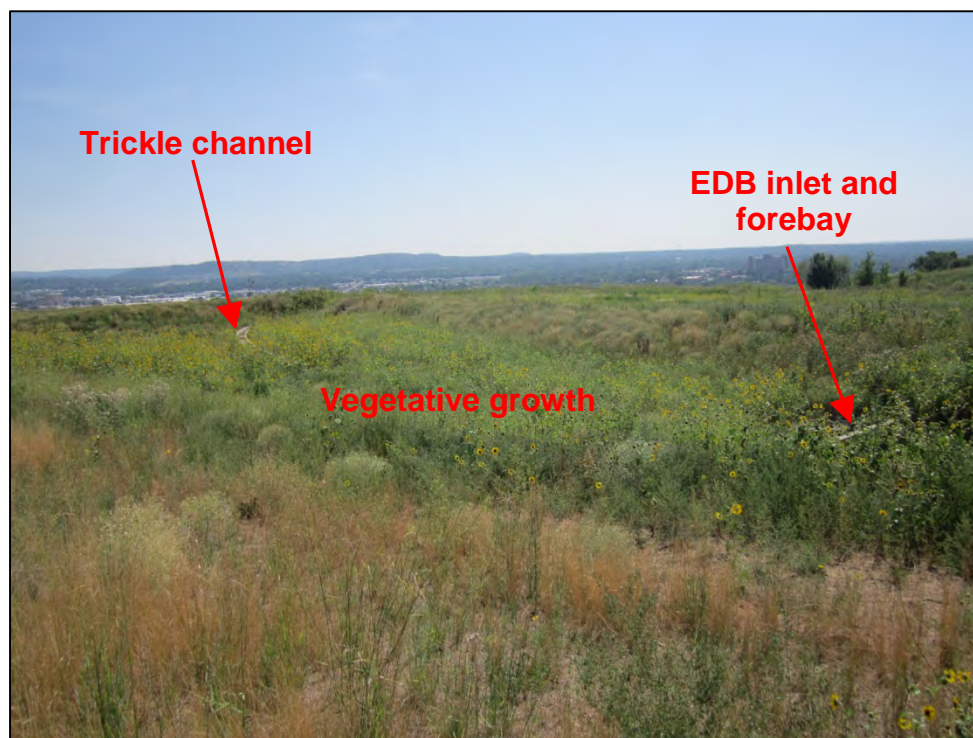
View of ID-57 VA Hospital Extended Detention Basin. Note the extensive dense vegetative growth throughout the basin.

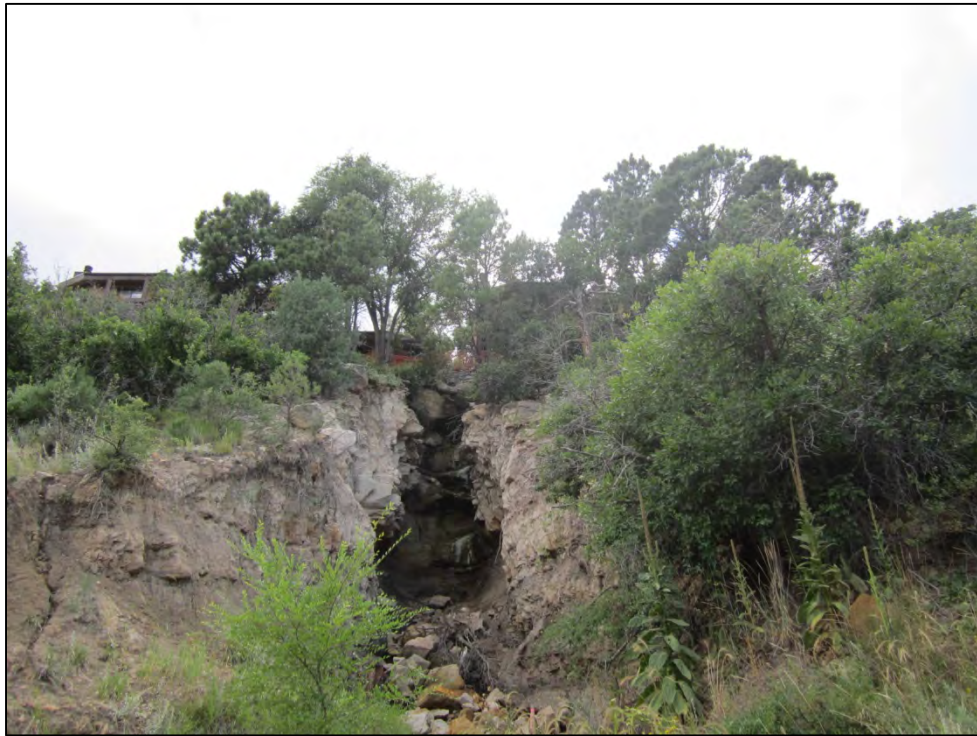
- Significant erosion and scouring and the formation of a large ravine adjacent to and downgradient of the City’s MS4 outfall for CS – 022.
- The photos CH2MHill included in their 2013 report for location CS – 060 showed accumulated trash and debris on the culvert pipe inlet trash rack. Additional accumulated sediment, trash, debris and vegetative growth was observed by the EPA Inspection Team at this location during the inspection. The Streets Department staff stated that they did not have any records of maintenance at this location; therefore, it appeared that the additional accumulated sediment, trash, debris, and vegetative growth observed at this location at the time of the inspection was due to a lack of maintenance at this site.

View of CS – 022 significant erosion and scouring downgradient of the City’s MS4 outfall from the Pebblewood at Pinecliff subdivision, including the formation of a large ravine and numerous erosion gullies.

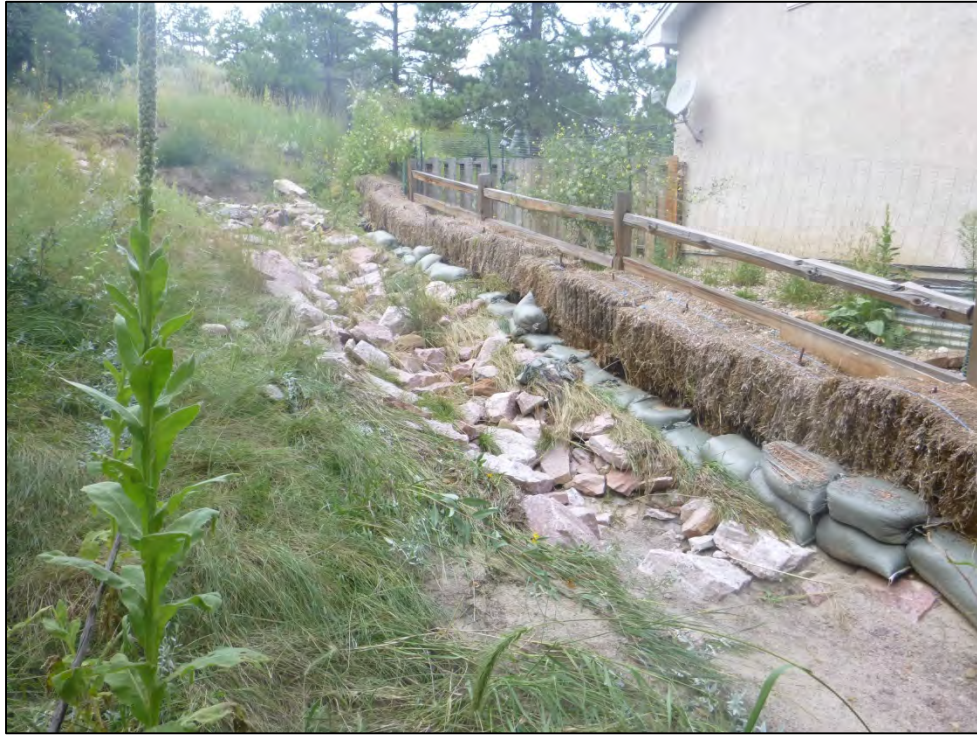
View of evidence of previous stormwater runoff and erosion adjacent to the Chiramonte private property. The City had installed straw bales and sandbag BMPs along the property boundary.

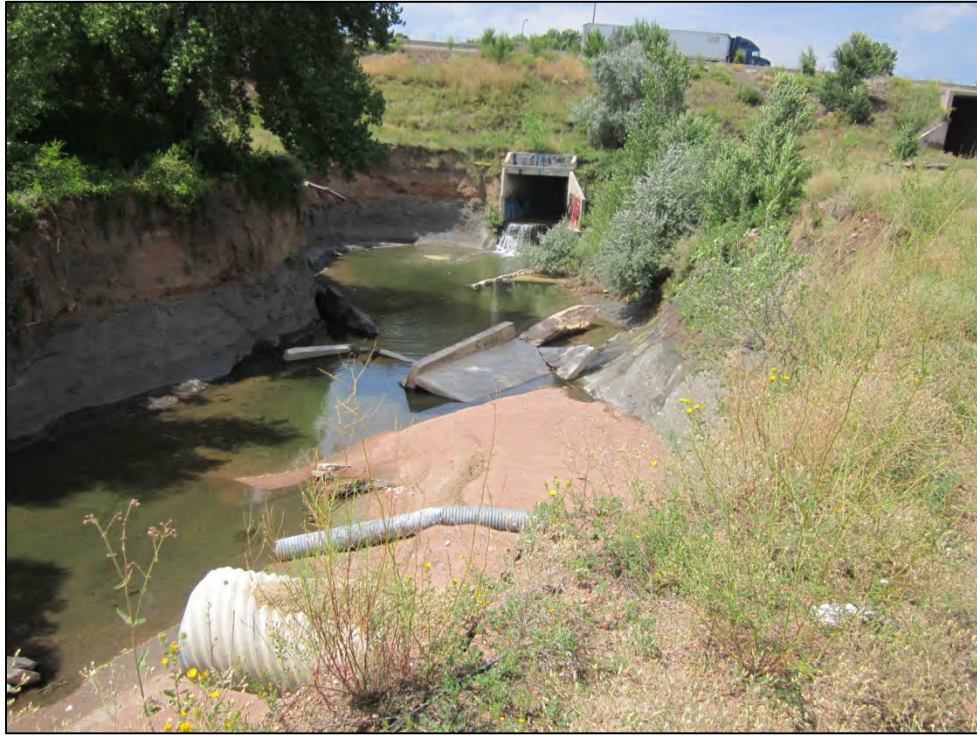
View, facing upstream and toward I-25, of erosion and scouring, concrete debris, old CMP culvert pipe, and sediment deposition in North Douglas Creek.

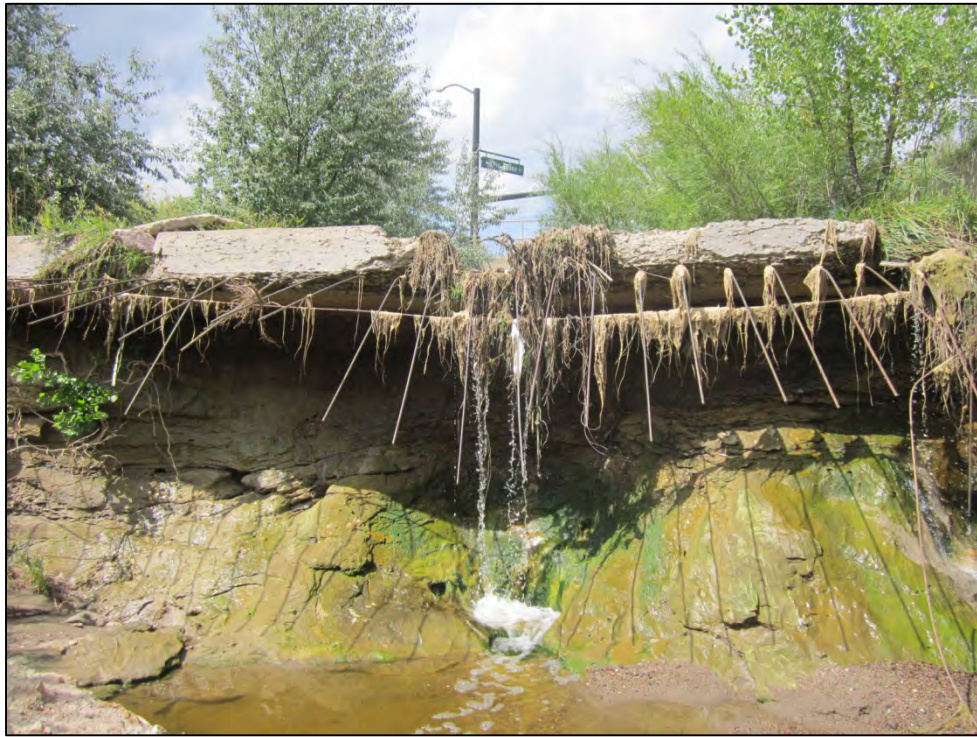
View, facing upstream, of unmaintained and deteriorated concrete drop structure in Rockrimmon Channel. Note the significant deterioration and undercutting of the concrete drop structure.

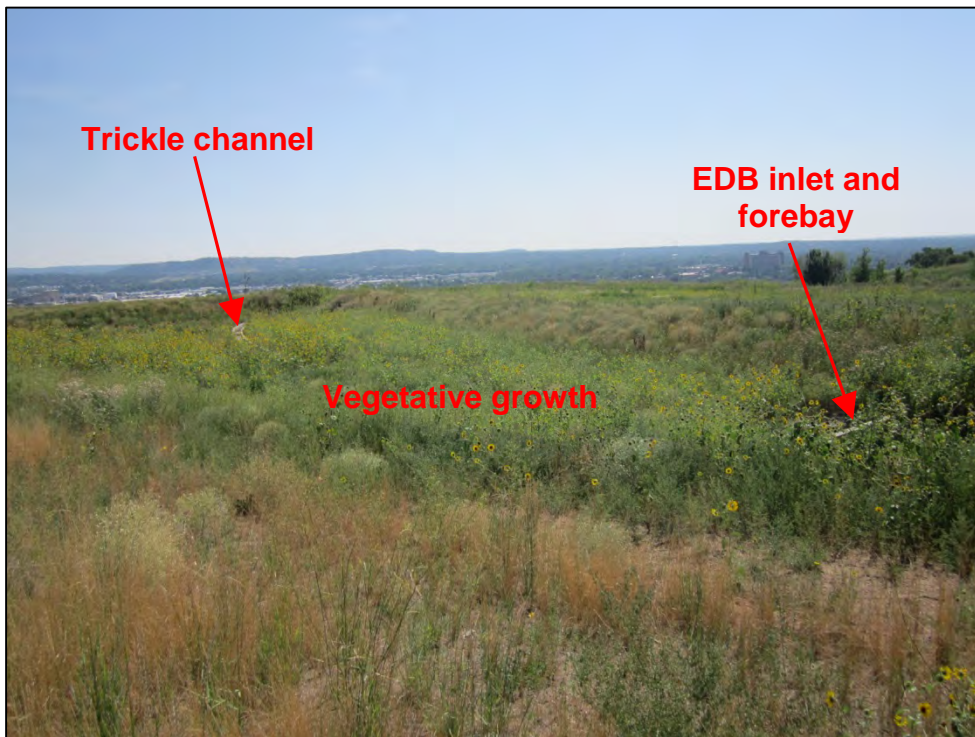
Photograph 10. View of ID-57 VA Hospital EDB. Note the extensive dense vegetative growth throughout the basin.

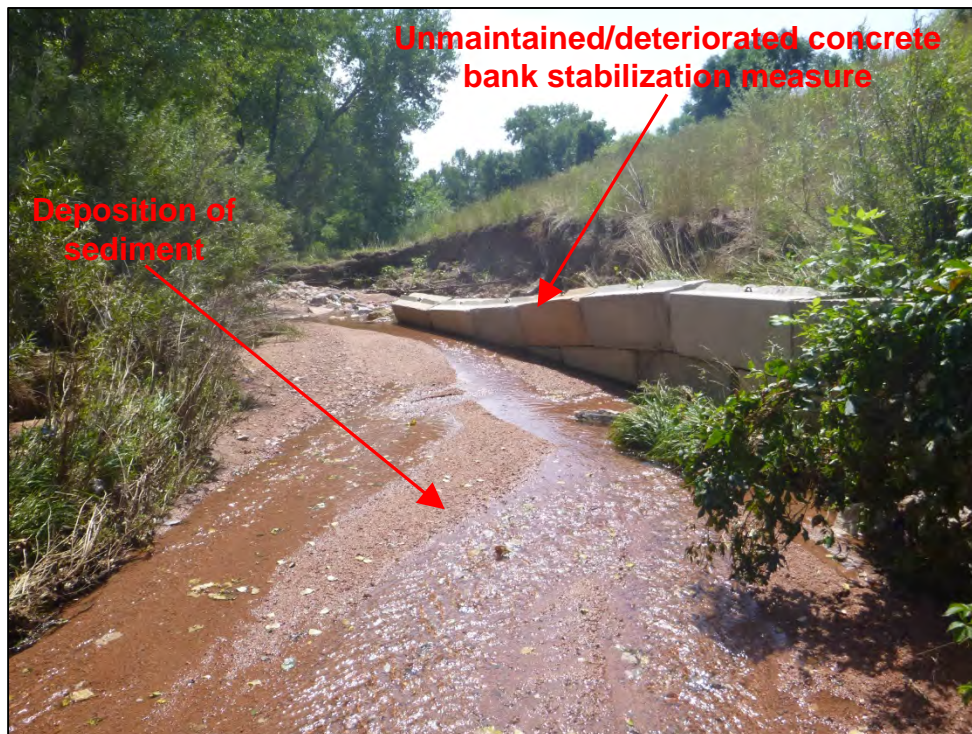
Photograph 22. View of an unmaintained and deteriorated concrete bank stabilization measure. Also note the deposition of sediment within Douglas Creek.

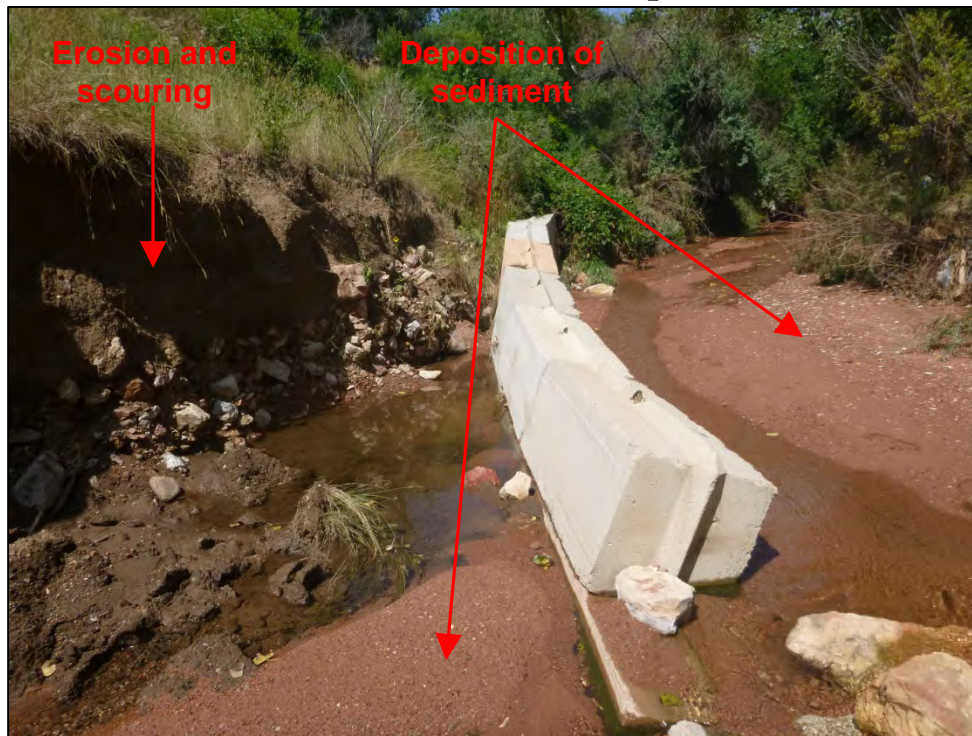
Photograph 23. View, facing upstream, of an unmaintained and deteriorated in-stream concrete bank stabilization measure. Note the deposition of sediment and erosion and scouring of the Douglas Creek channel.

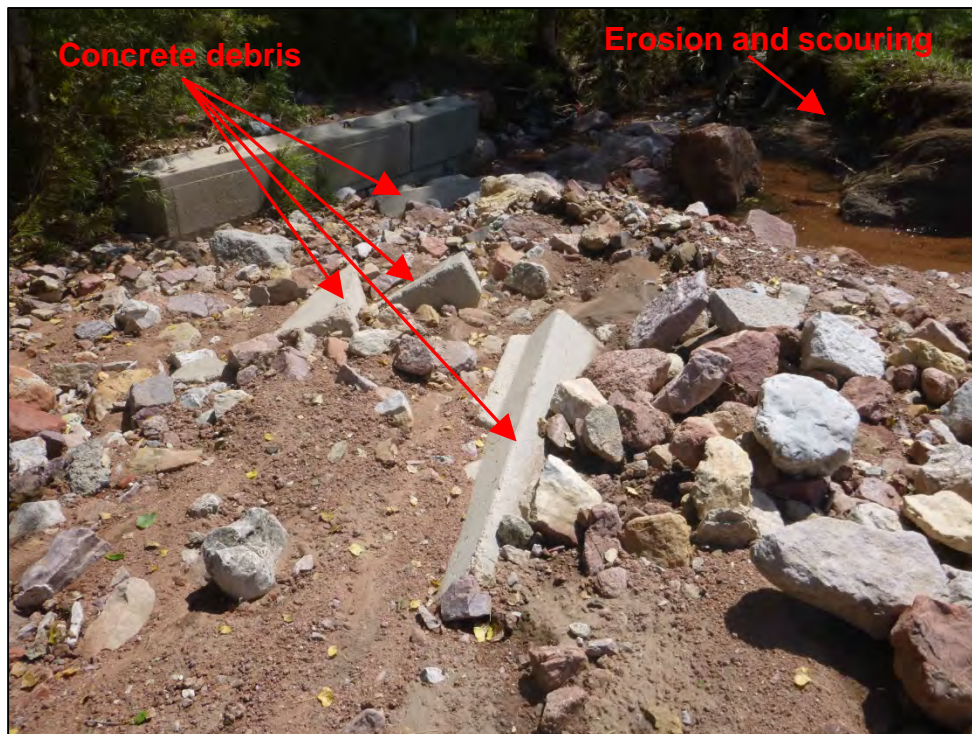
Photograph 24. View, facing downstream, of concrete debris scattered about Douglas Creek, located downgradient of the unmaintained and deteriorated concrete bank stabilization measure shown in Photographs 22 and 23.

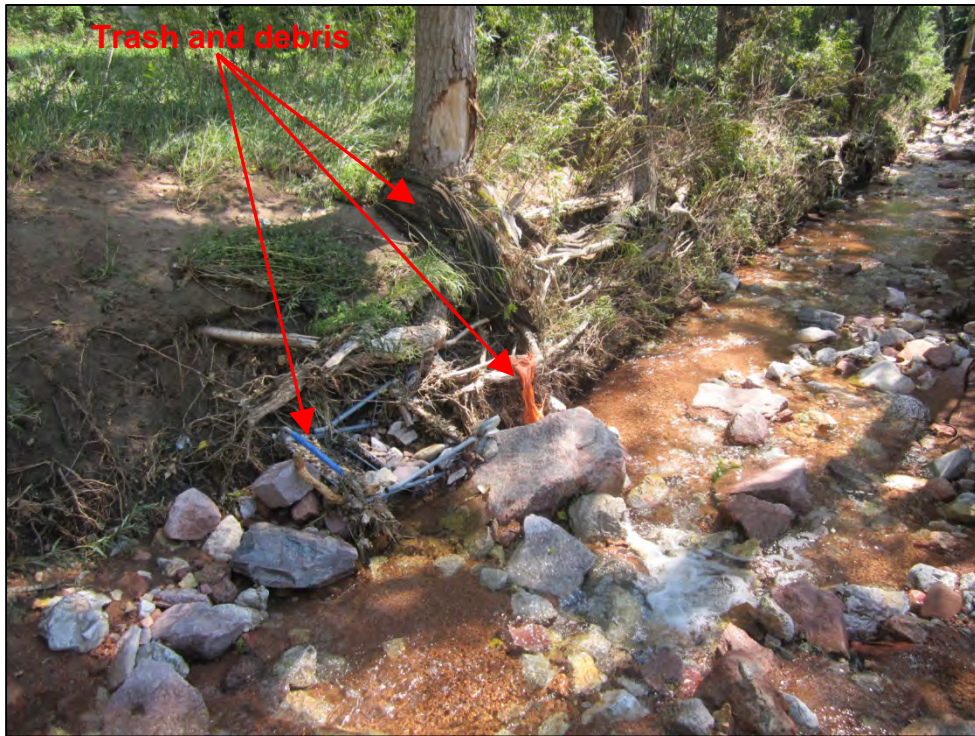
Photograph 25. View of trash and debris in Douglas Creek.

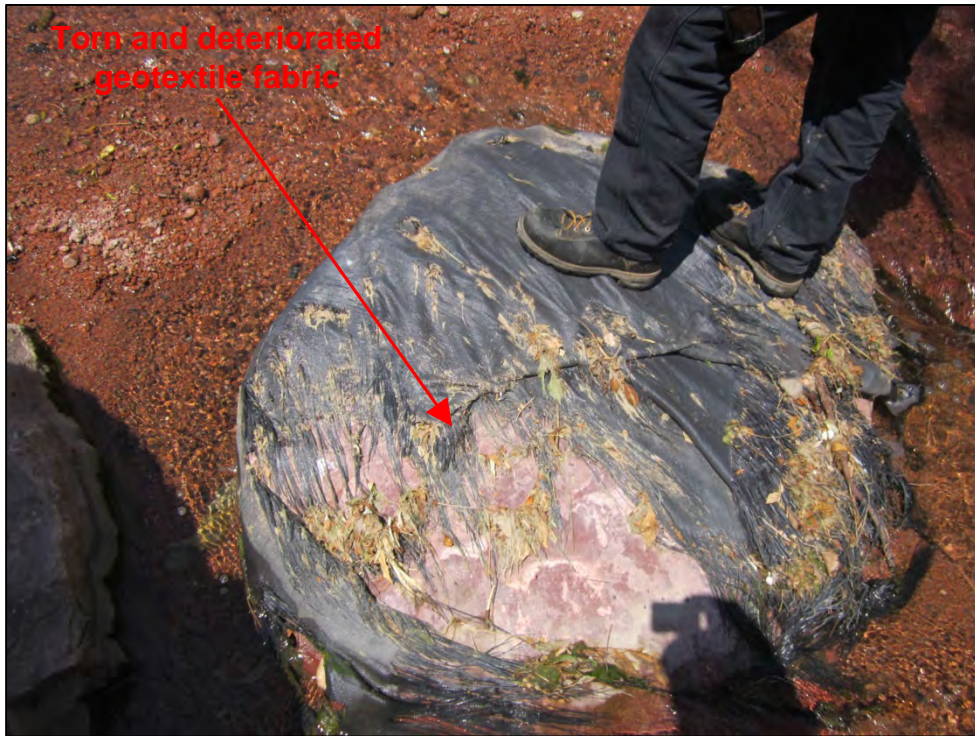
Photograph 27. Close-up view of torn and deteriorated geotextile fabric on in-stream rip-rap. Note that the geotextile appeared to be placed in Douglas Creek along with the rip-rap as part of the recent channel/grade control project.

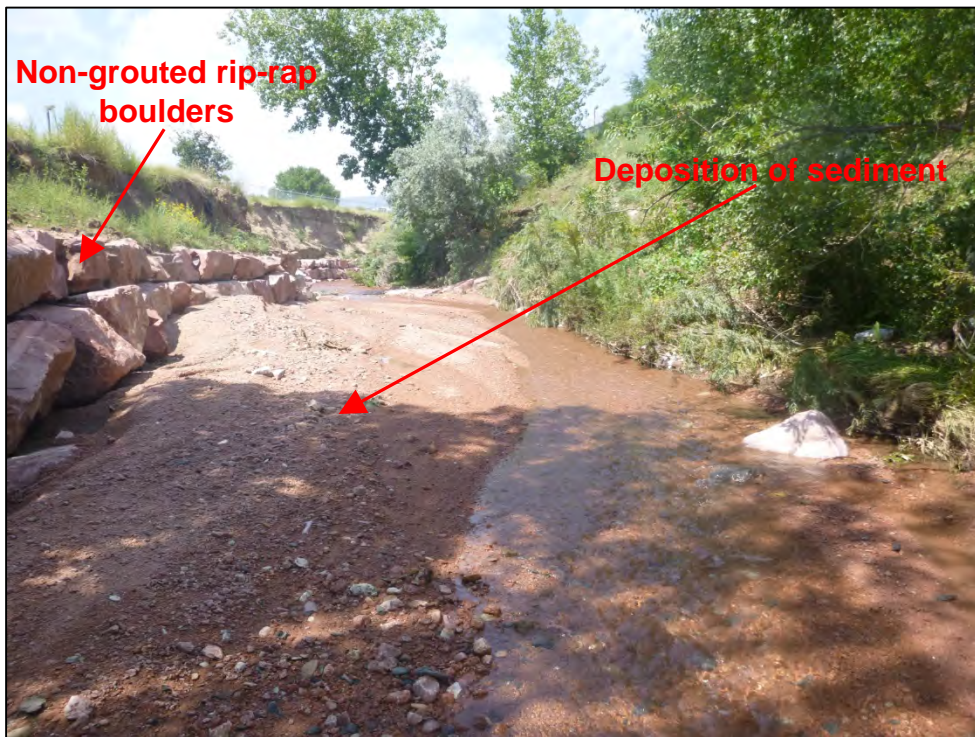
Photograph 28. View, facing upstream, of significant deposition of sediment within Douglas Creek adjacent to the stream bank stabilization project.

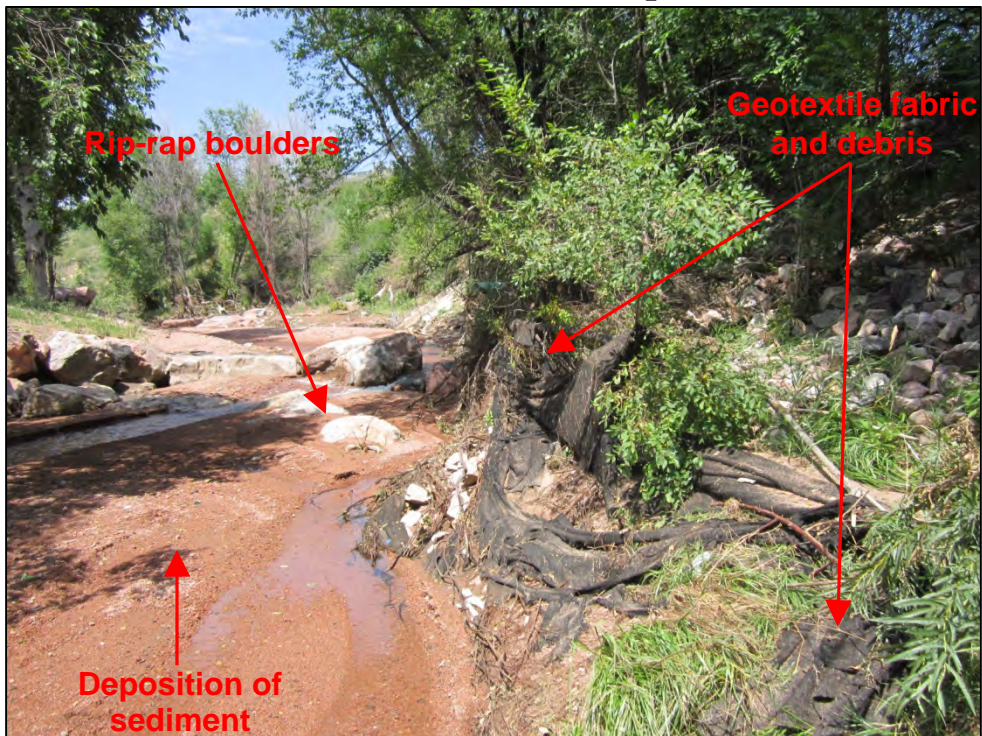
Photograph 29. View, facing upstream, of Douglas Creek. Note the geotextile fabric, debris, and rip-rap boulders scattered about the channel. Also note the deposition of sediment in the channel.

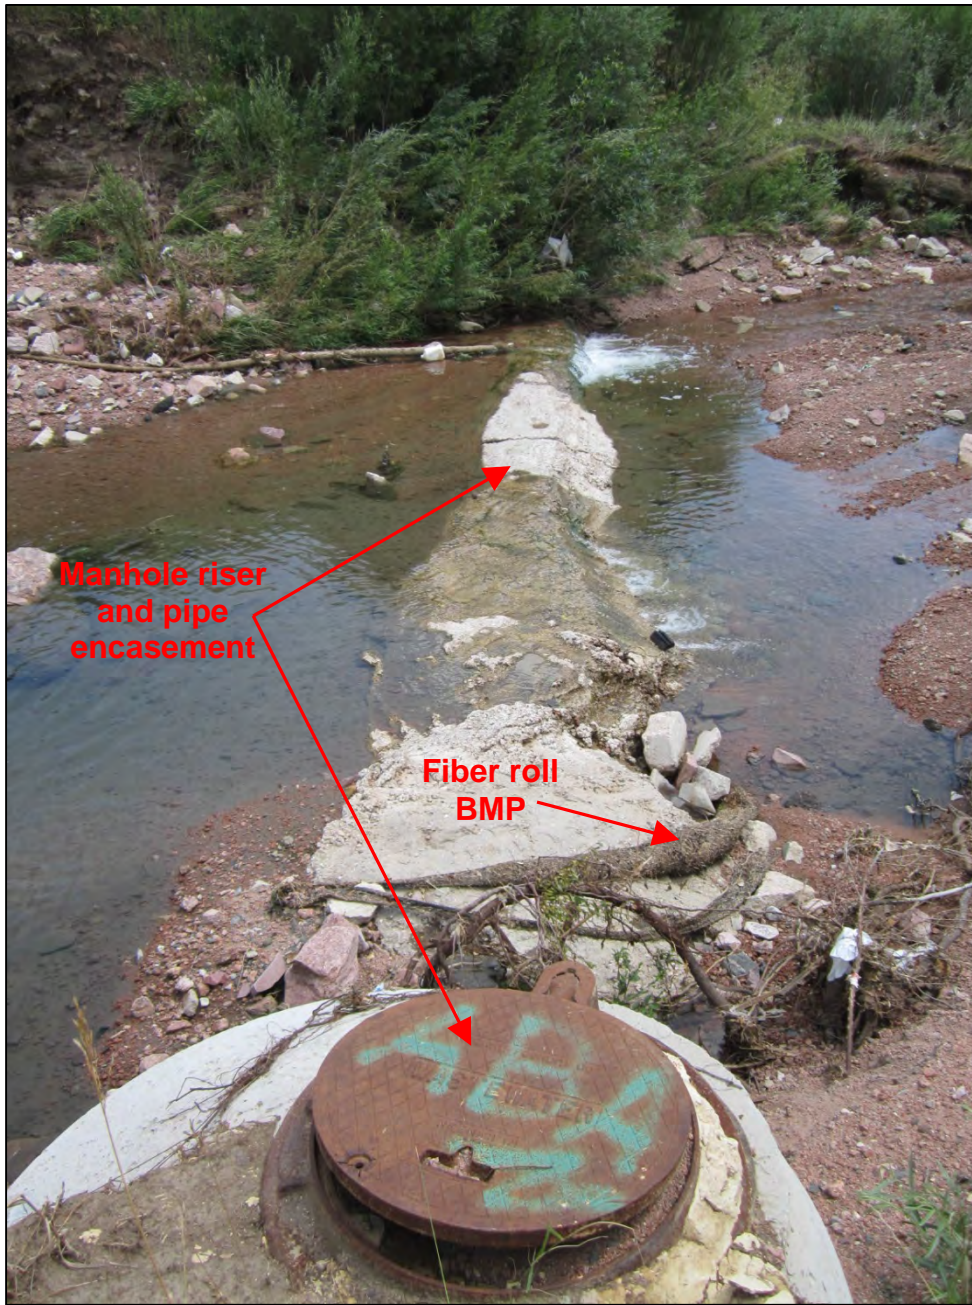
Photograph 34. Additional view of abandoned wastewater manhole riser and pipe encasement crossing N. Douglas Creek, shown in Photograph 33. Note what appears to be a fiber roll BMP in the foreground.

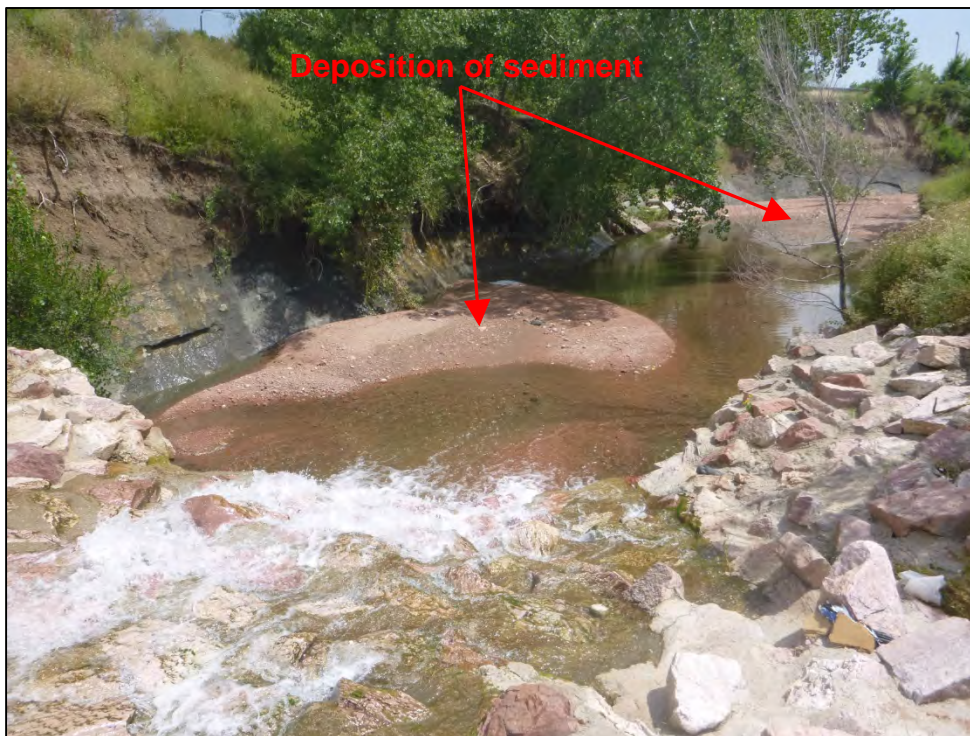
Photograph 42. View of deposition of sediment in N. Douglas Creek located just below the Norfolk Southern railroad bridge. It should be noted that it appeared the railroad may have completed the grouted rip-rap boulder channel stabilization measures in the vicinity of the railroad bridge.

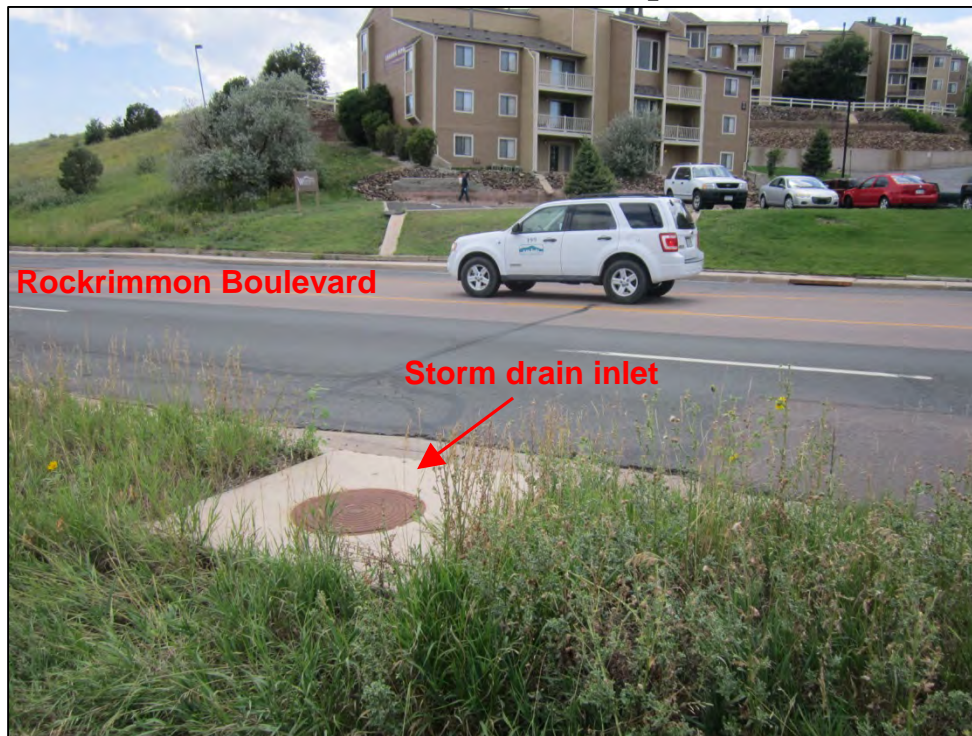
Photograph 43. View of CS – 015 storm drain inlet on Rockrimmon Boulevard. Note that the upgradient drainage areas from private residential development areas and City streets appeared to lack source control BMPs for flow attenuation.

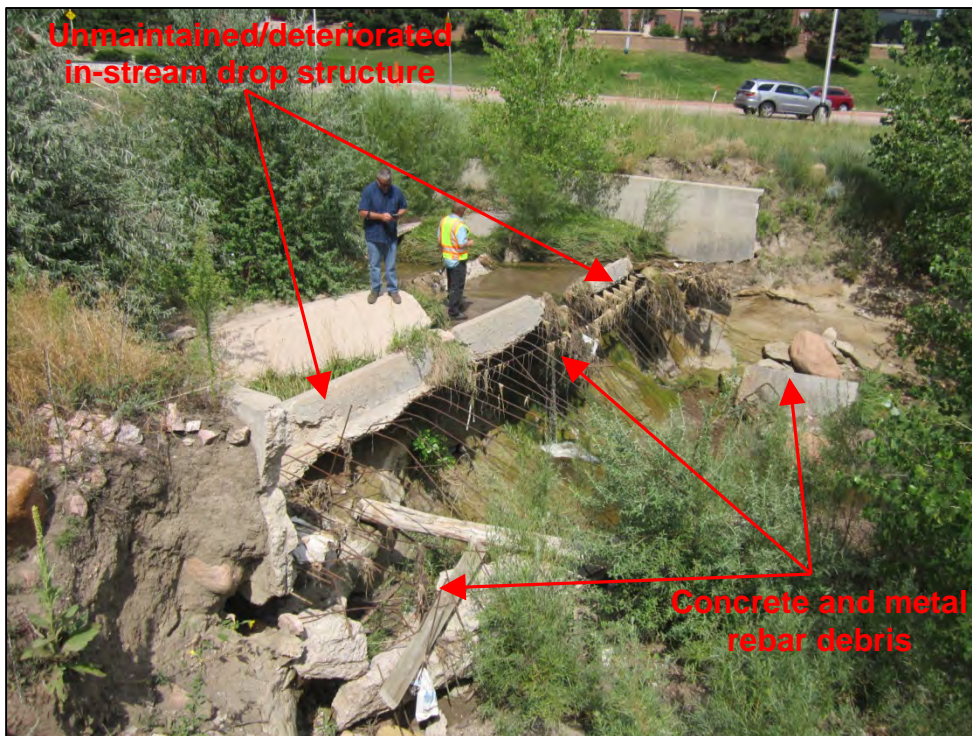
- The summary of the problem and source document for CS – 222 states “Repair outfall...” and the source was a PPRTA – Stantec Field Assessment (2010 – 2012); indicating the City assessed the need for improvements at least 3 years ago. As further described in Appendix C – MS4 Inspection Exhibit Log, Exhibits 9 through 13, a drainage report from the 1970s annotated the expected high run-off velocities from the Pebblewood subdivision.
- The source document for CS – 060 includes the City’s 2006 – 2010 Capital Improvements Program and Needs Assessment; which indicates that the improper grading of the culvert pipe underneath Hancock Expressway was identified at least 9 years ago (and still has not been repaired).

- An unmaintained and deteriorated concrete wing wall below the MS4 outfall, and erosion and scouring of the channel bank in the vicinity of the in-stream structure and outfall for CS – 222.

Photograph 46. View of CS – 222 Rockrimmon Channel unmaintained and deteriorated concrete drop structure. Note the significant long-term deterioration including concrete debris and metal rebar scattered about the channel.

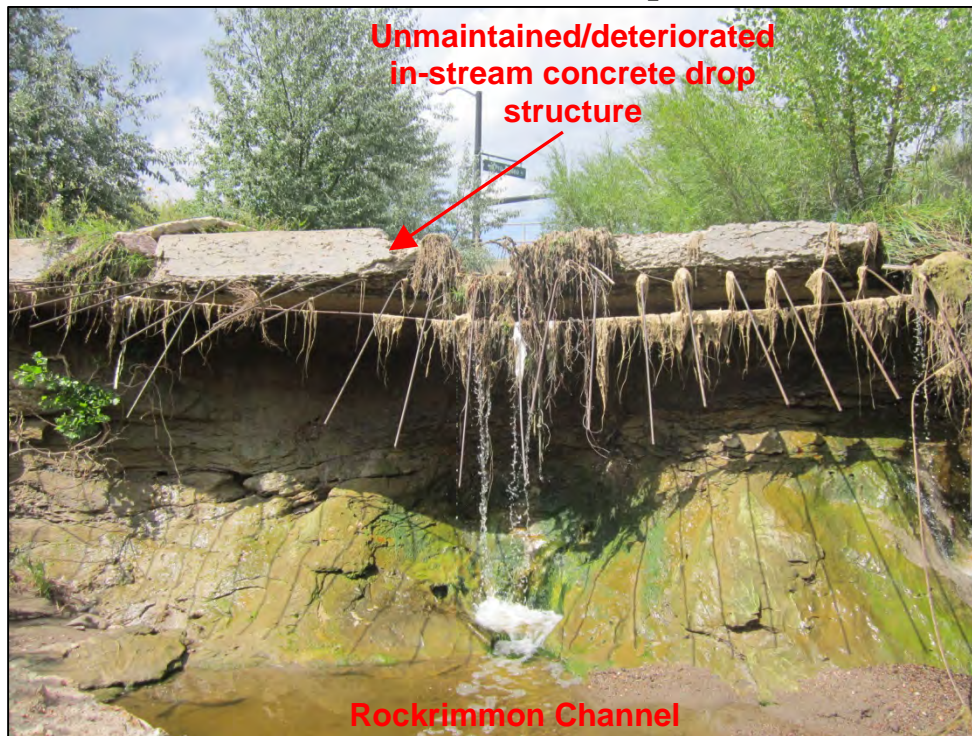
Photograph 47. View, facing upstream, of unmaintained and deteriorated concrete drop structure, shown in Photograph 46. Note the significant deterioration and undercutting of the concrete drop structure.

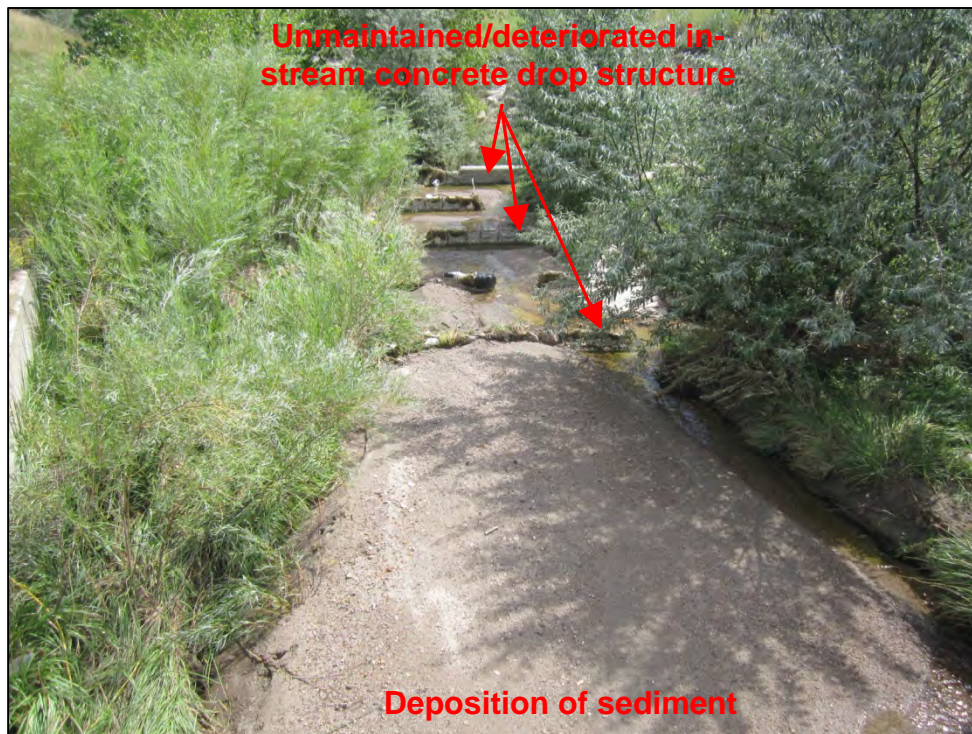
Photograph 48. View of deposition of sediment above the deteriorated in-stream drop structure shown in Photograph 47, above.

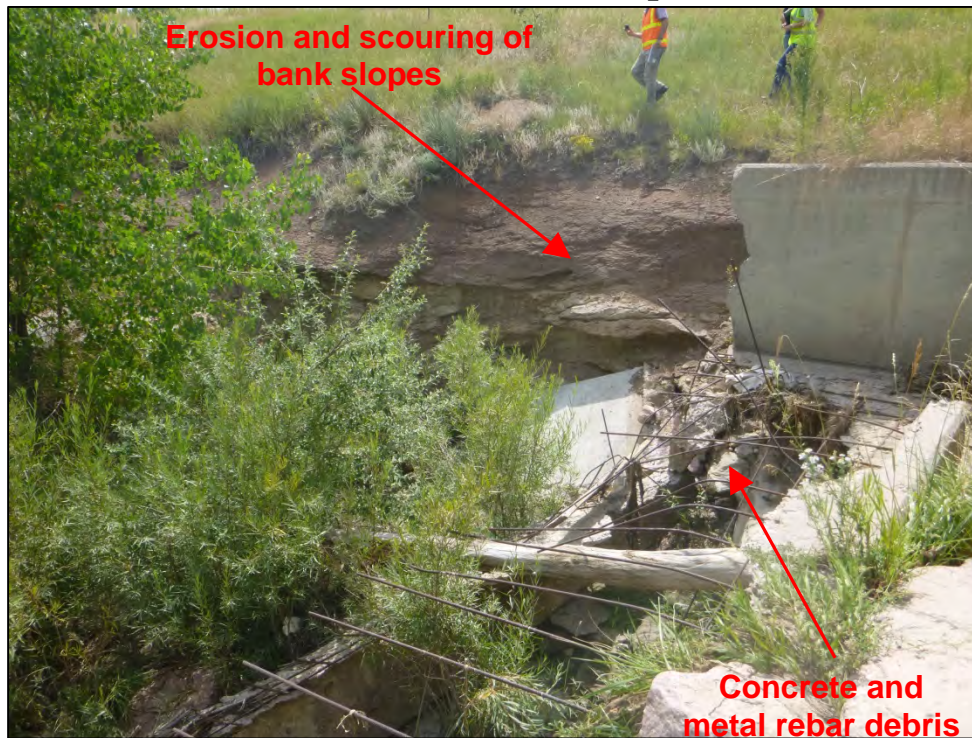
Photograph 49. View of unmaintained and deteriorated in-stream concrete drop structure. Note the concrete and metal rebar debris and erosion and scouring of the Rockrimmon Channel bank slopes.

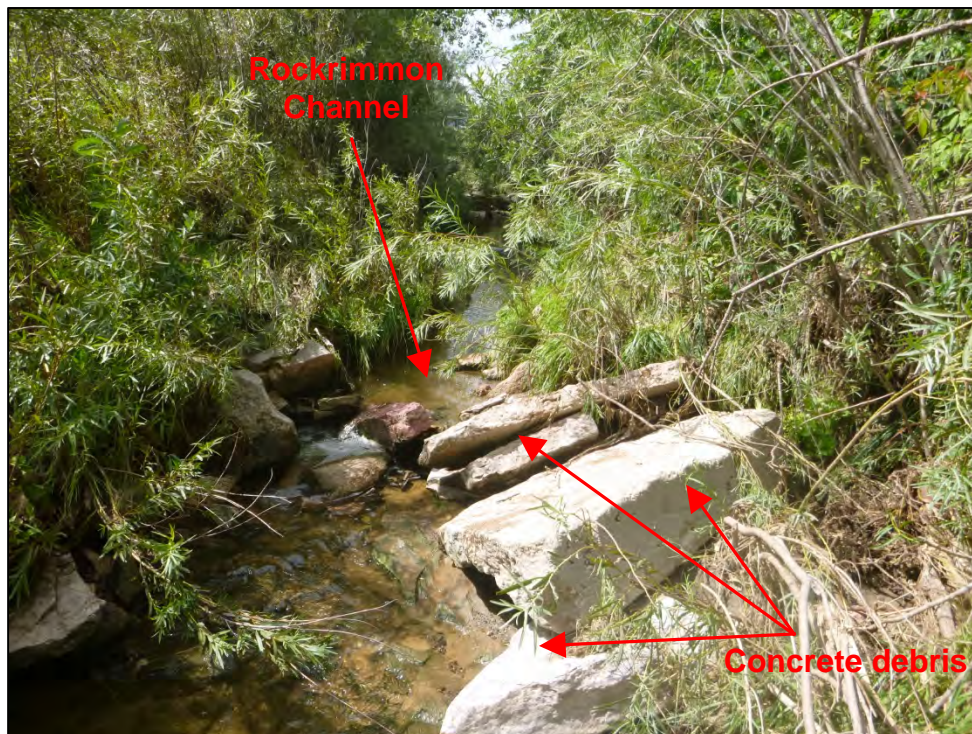
Photograph 50. View of concrete debris scattered about Rockrimmon Channel downstream of the deteriorated concrete drop structure.

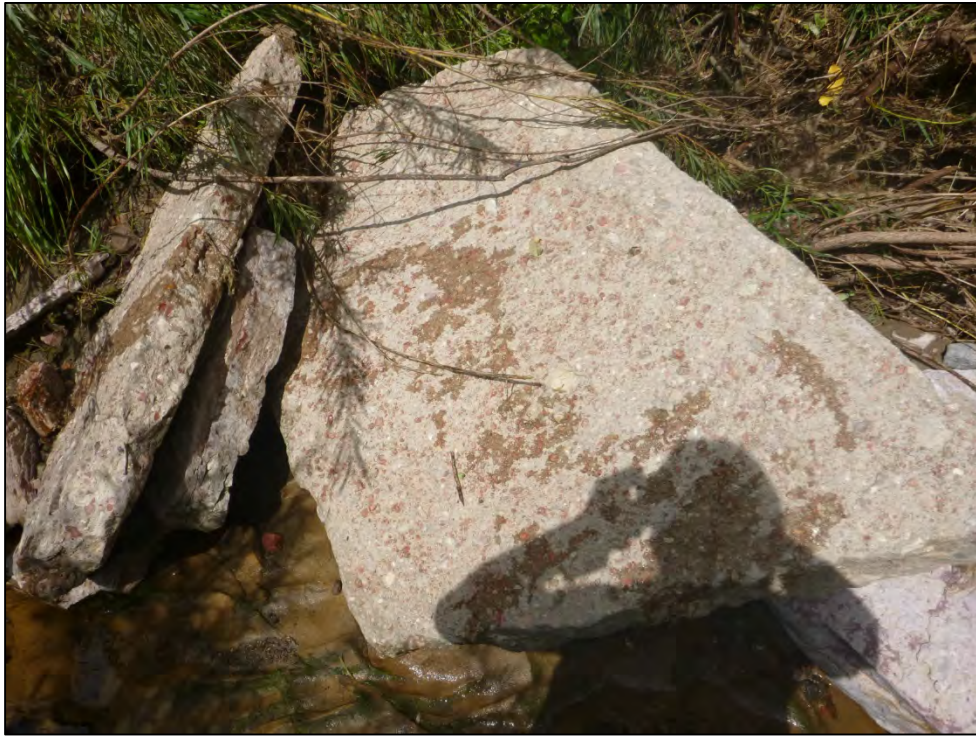
Photograph 51. Close-up view of the concrete debris within the Rockrimmon Channel, shown in Photograph 50.

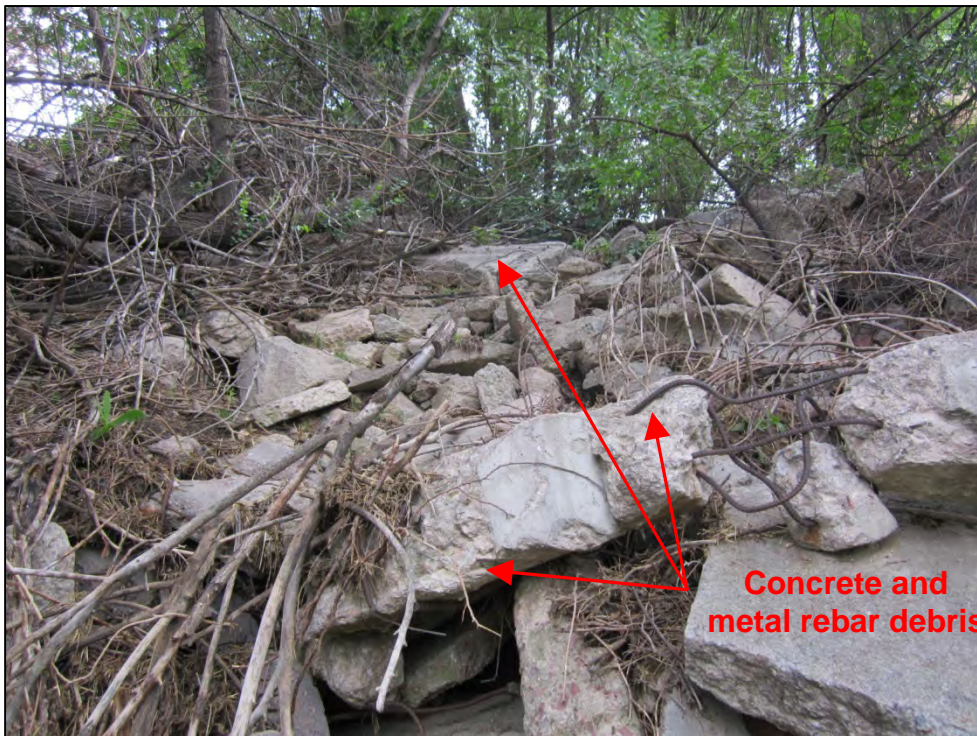
Photograph 52. Additional view of concrete and metal rebar debris in the Rockrimmon Channel located downstream of the unmaintained drop structure.

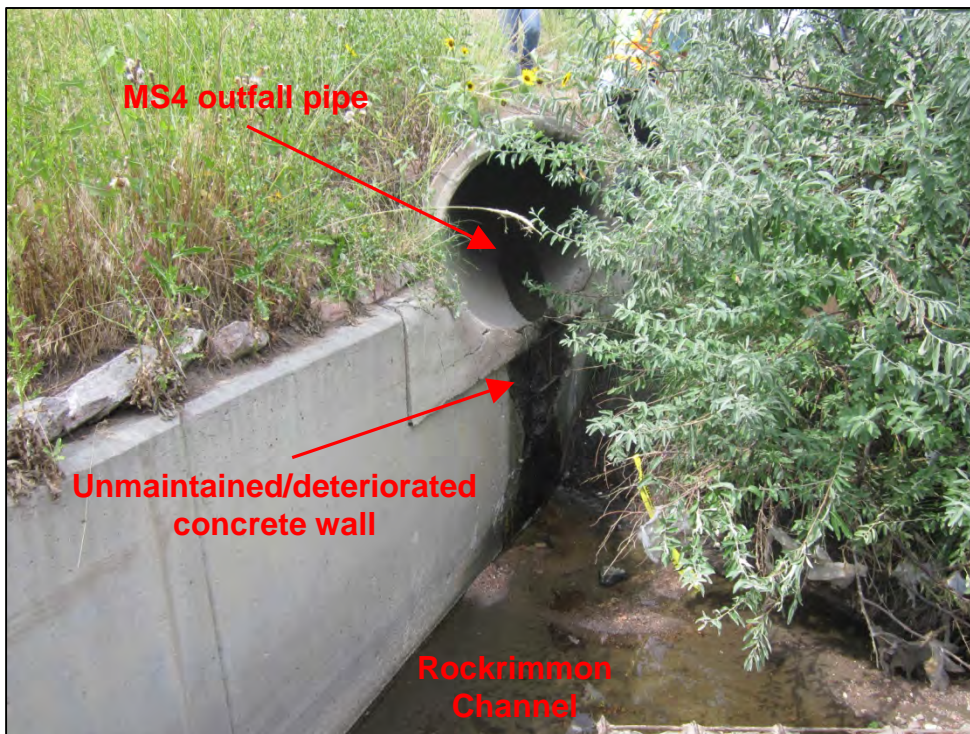
Photograph 54. Additional view of the MS4 outfall pipe, shown in Photograph 53. Note the unmaintained and deteriorated concrete wall below the MS4 outfall pipe and lack of flow dissipation device downgradient of the outfall in Rockrimmon Channel.

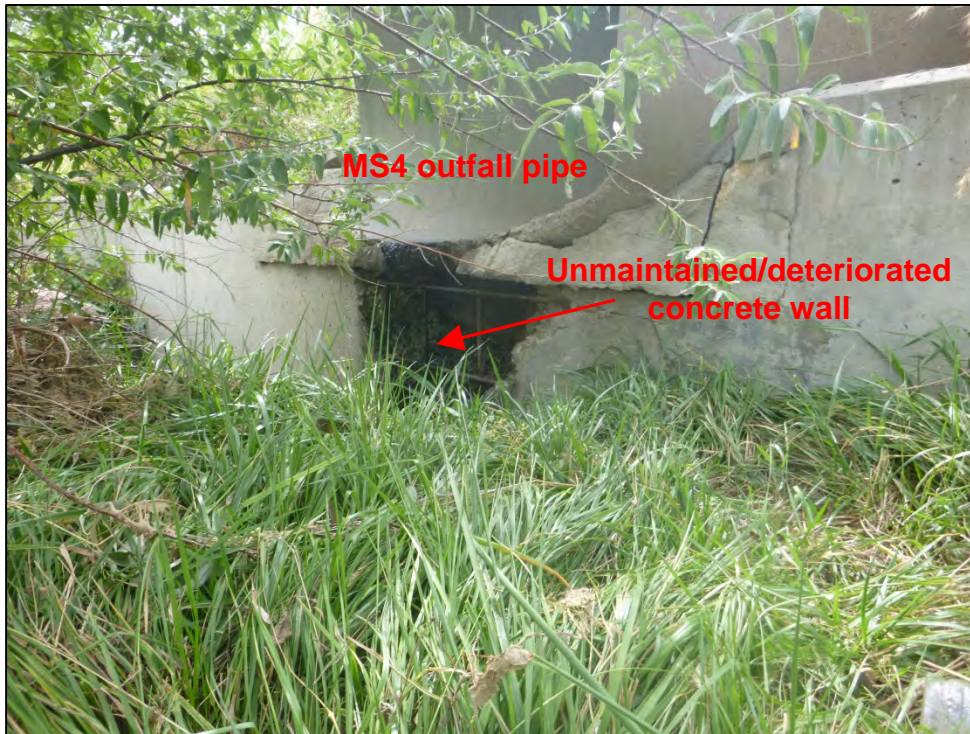
Photograph 55. Close-up view of the unmaintained and deteriorated concrete wall below the MS4 outfall pipe, shown in Photograph 54.
