City of Colorado Springs Phase I MS4 Inspection Report
Colorado Discharge Permit System, Permit # COS000004

Inspection Dates: August 18, 2015–August 19, 2015

Prepared by
PG Environmental, LLC

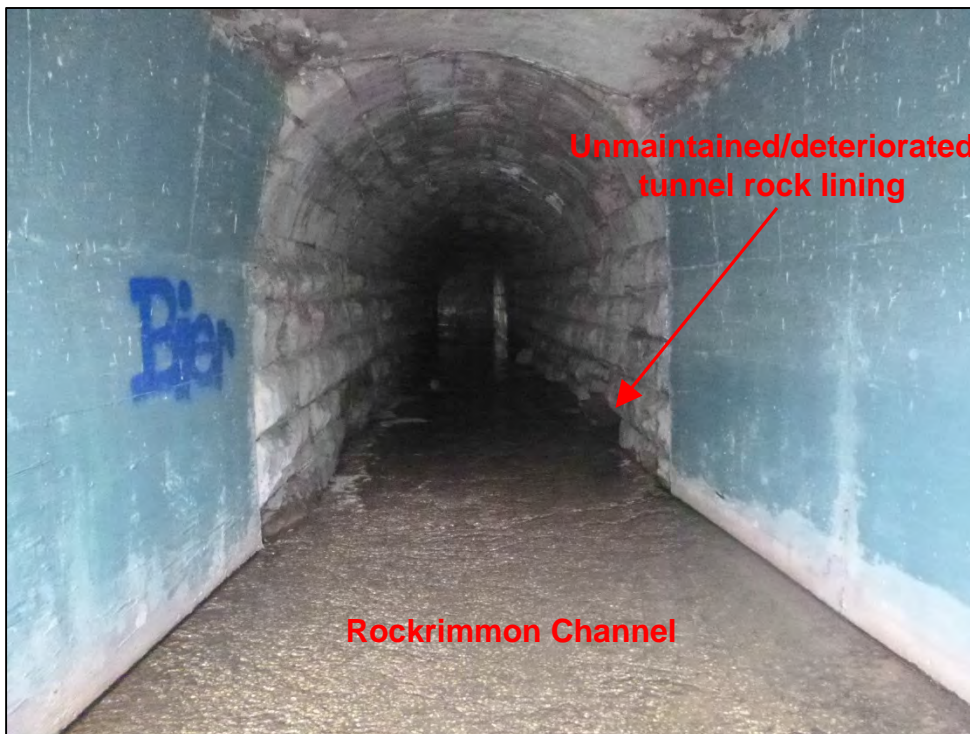
Photograph 56. View of Rockrimmon Channel conveyance tunnel under Norfolk Southern railroad bridge and Mark Dabbling Boulevard. Note the unmaintained and deteriorated tunnel rock lining.

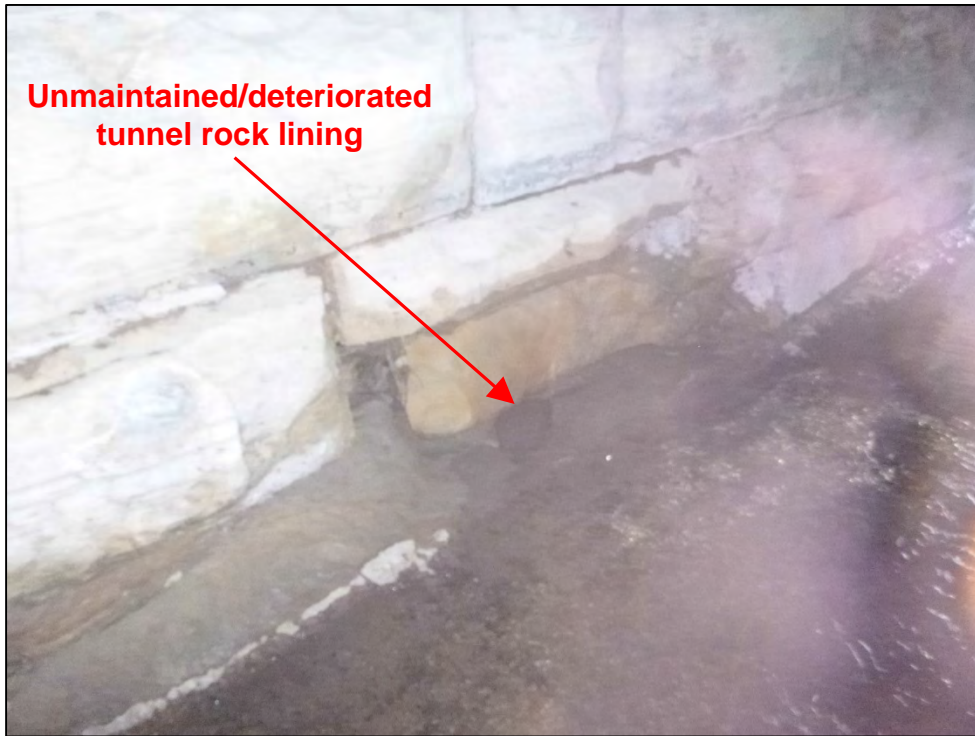
Photograph 57. Close-up view of the unmaintained and deteriorated tunnel rock lining.

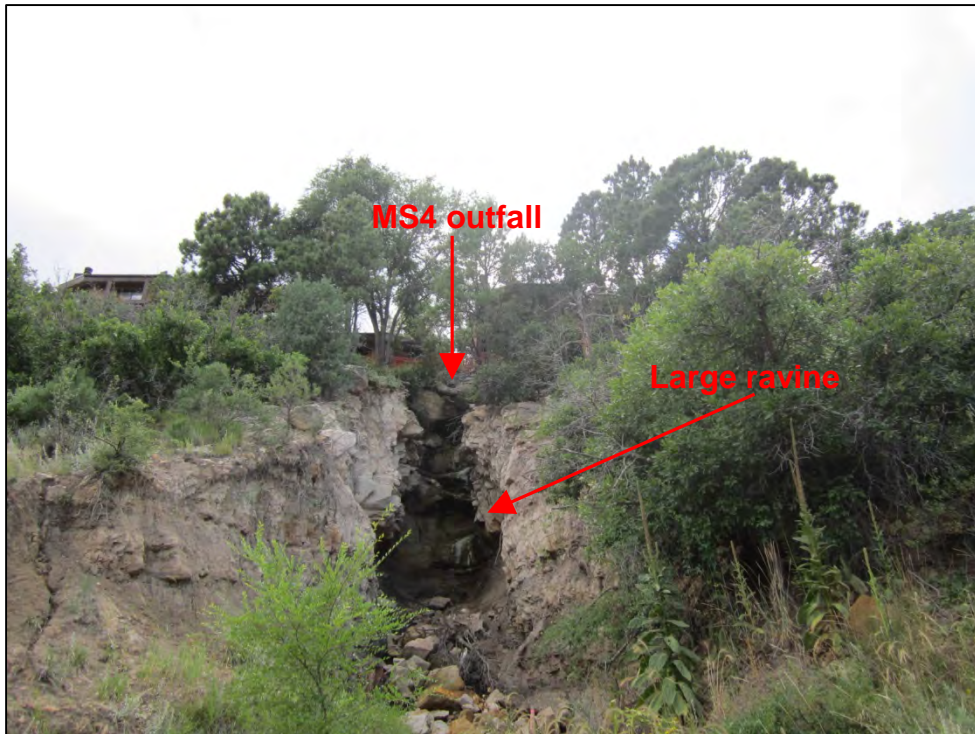
Photograph 58. View of CS – 022 significant erosion and scouring downgradient of the City's MS4 outfall from the Pebblewood at Pinecliff subdivision, including the formation of a large ravine and numerous erosion gullies.

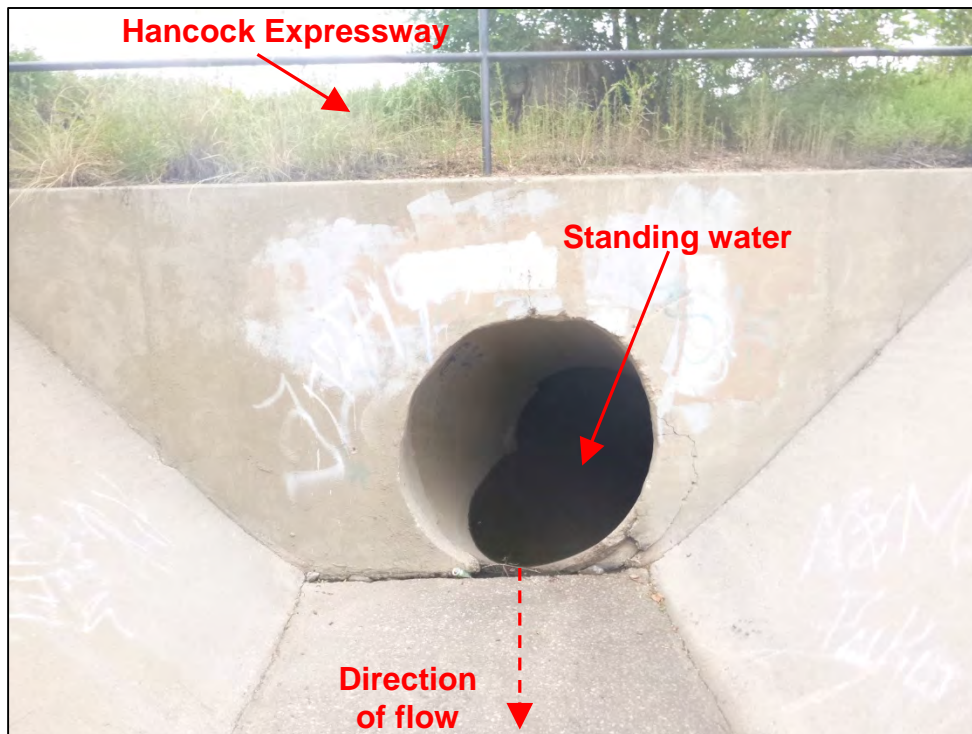
Photograph 64. View of CS – 060 Hancock Expressway Drainage culvert pipe outlet to concrete lined channel. Note the culvert pipe did not appear to be installed at the proper grade to convey flow as standing water was observed within the pipe.

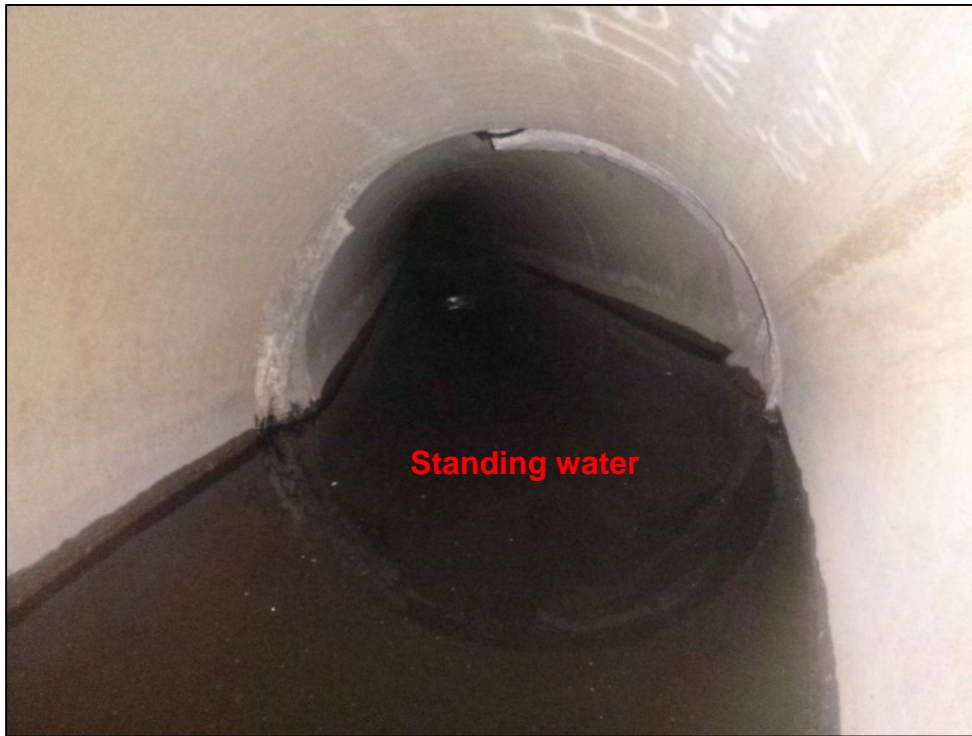
Photograph 65. Close-up view of standing water within the culvert pipe, shown in Photograph 64. Note that this culvert pipe did not appear to have been properly constructed to convey stormwater flow downgradient.

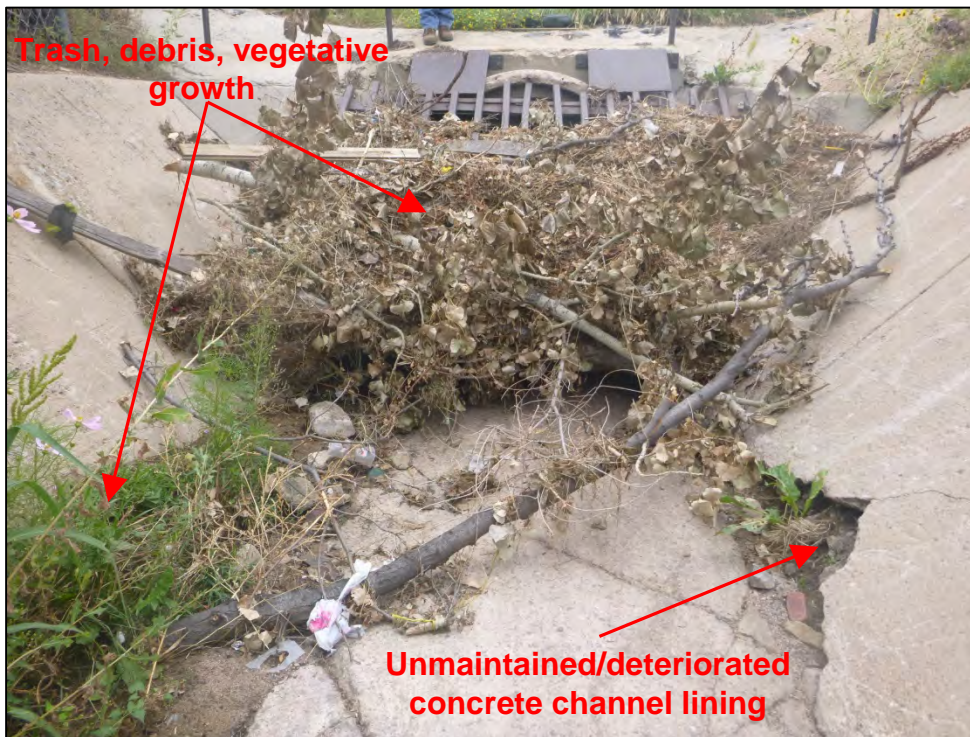
Photograph 68. Close-up view of trash, debris, vegetative growth, and unmaintained/deteriorated concrete channel lining at the culvert pipe inlet trash rack.

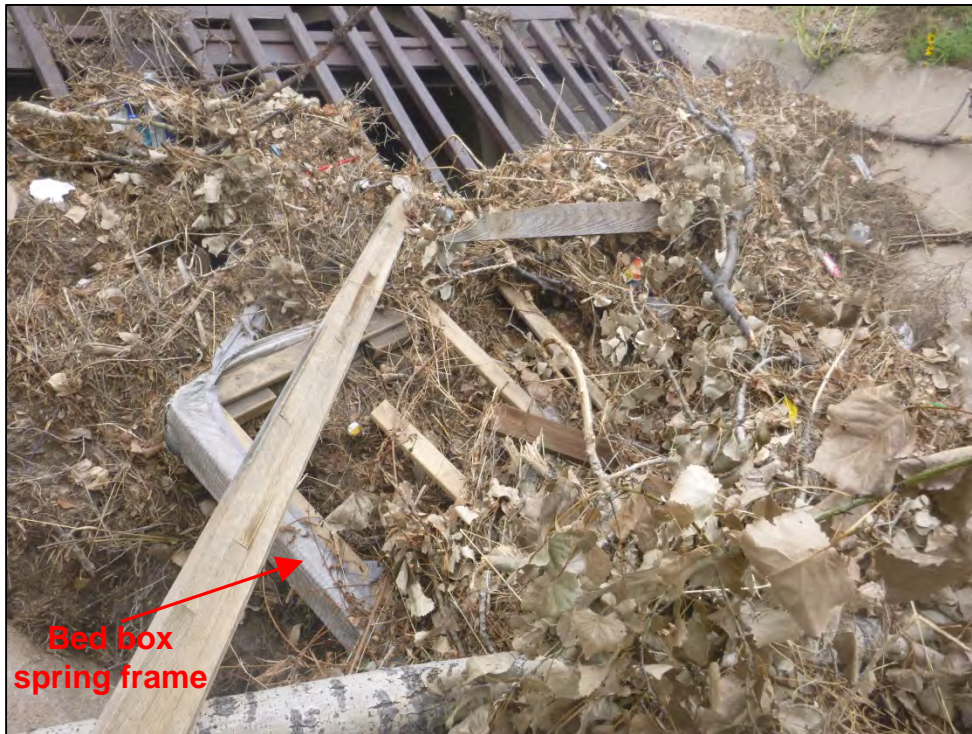
Photograph 69. Additional close-up view of trash and debris at the culvert pipe inlet trash rack. Note the bed box spring frame and other debris accumulation.

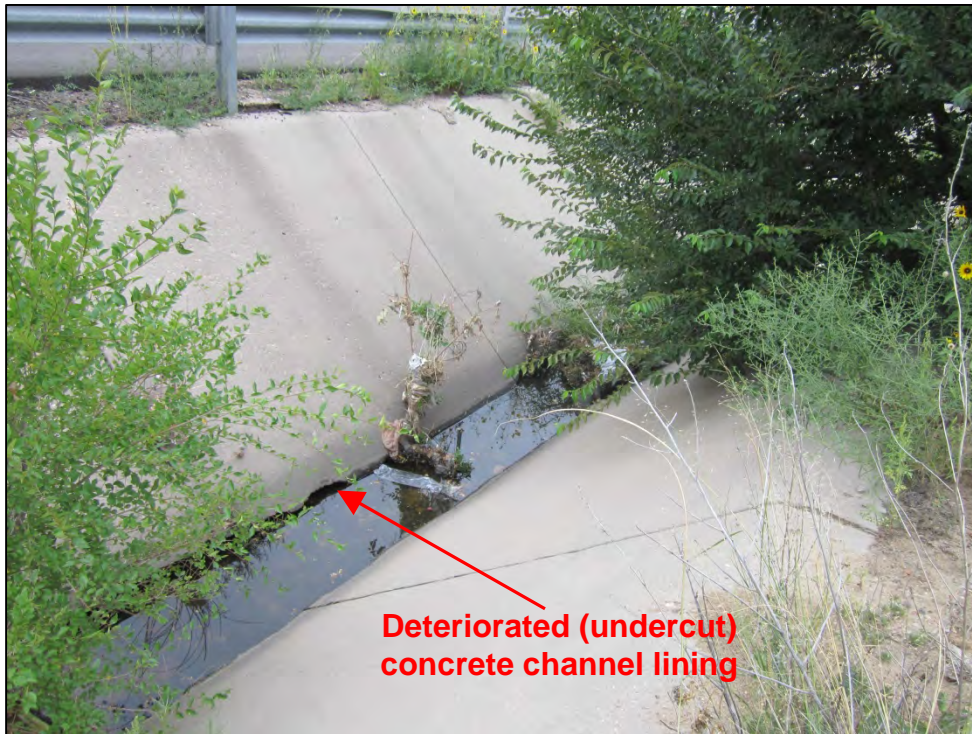
Photograph 73. View of unmaintained/deteriorated (undercut) concrete channel lining.

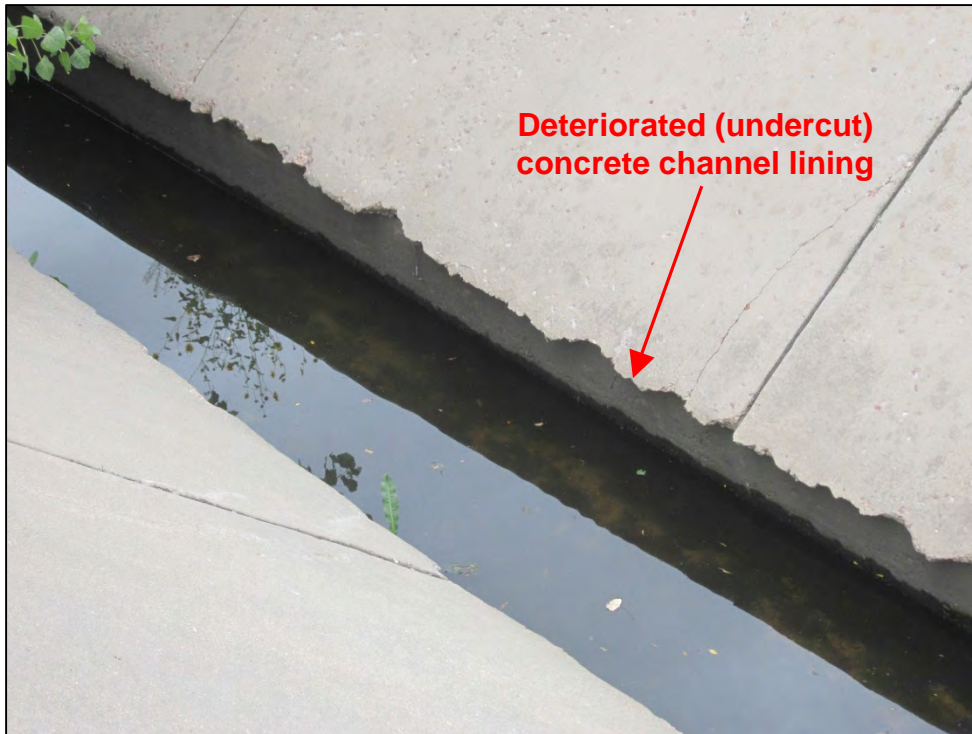
Photograph 74. Close-up view of deteriorated (undercut) concrete channel lining, shown in Photograph 73.

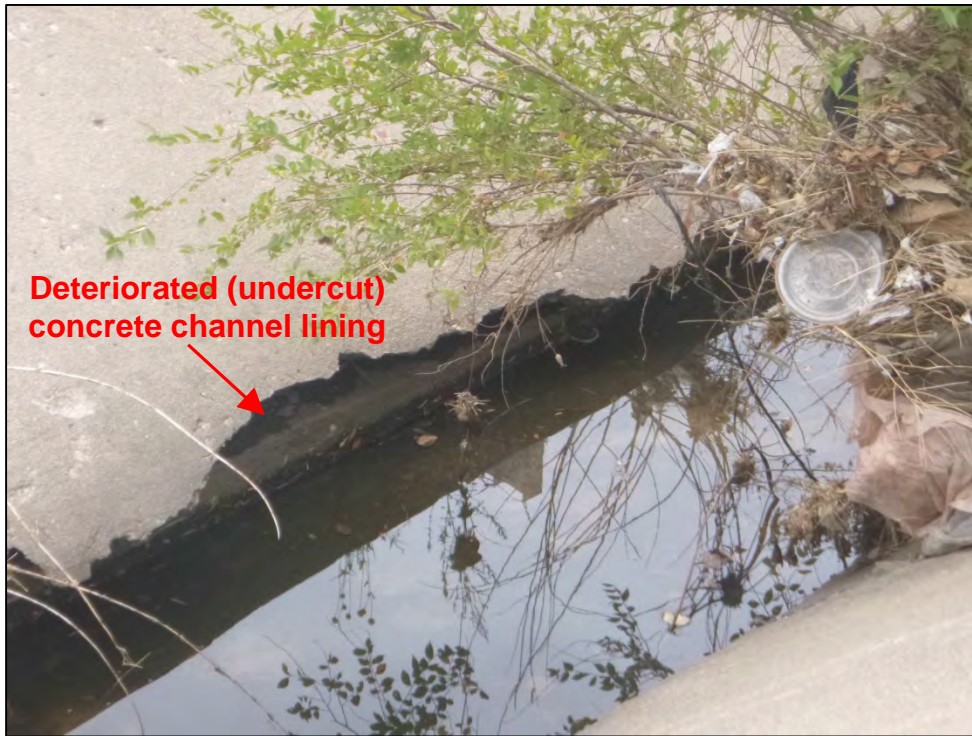
Photograph 75. Additional close-up view of deteriorated (undercut) concrete channel lining.

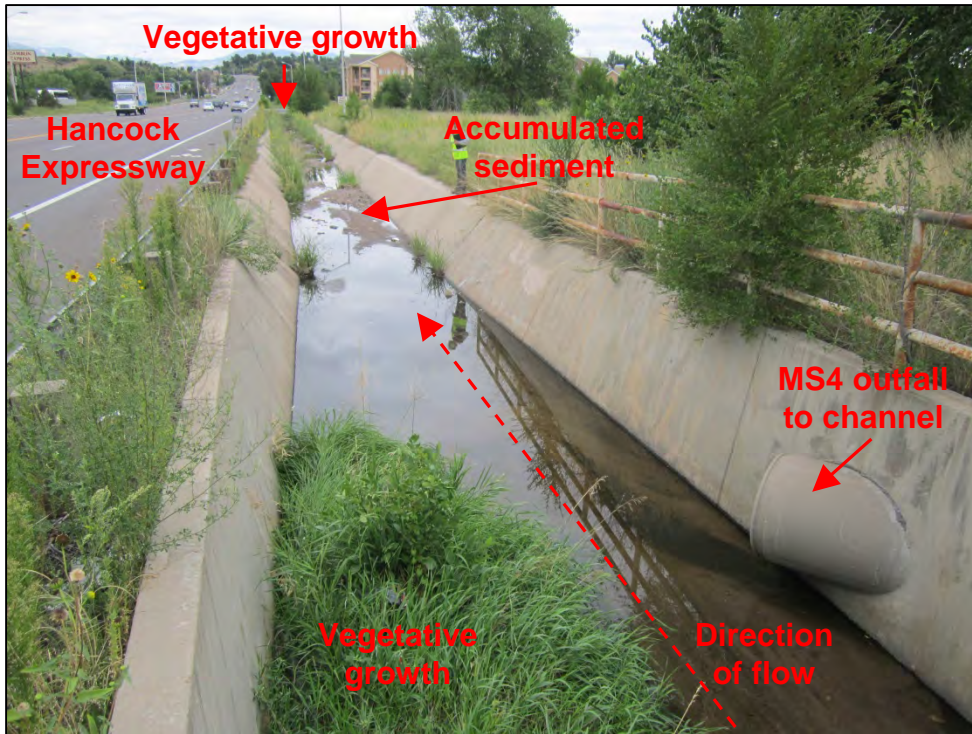
Photograph 76. View, facing downstream, of concrete lined MS4 conveyance channel located along Hancock Expressway near Astrozon Boulevard. Note the vegetative growth and accumulated sediment in the channel.

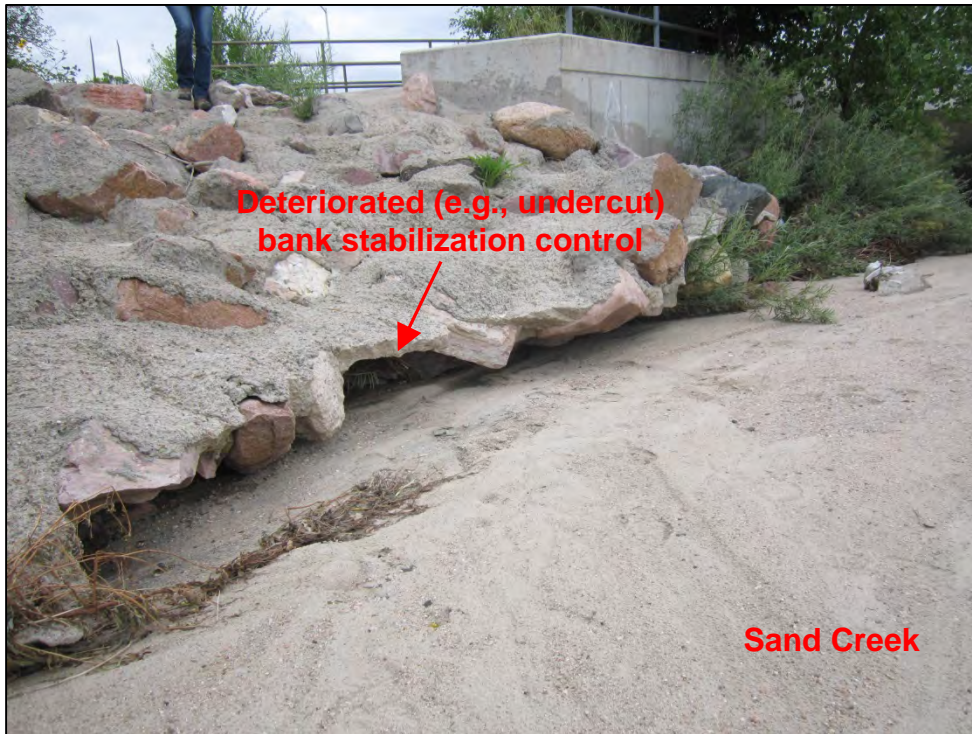
Photograph 81. Close-up view of a deteriorated (e.g., undercut) Sand Creek bank stabilization control. Also note the deposition of sediment in Sand Creek.

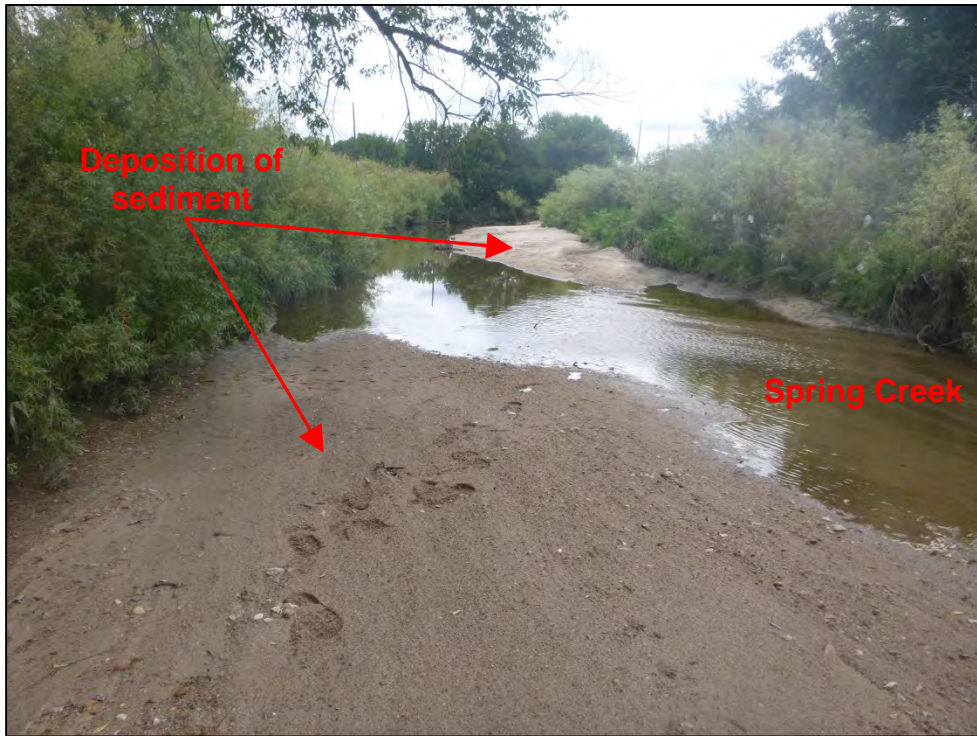
Photograph 87. View of significant deposition of sediment in Spring Creek located behind the private property residences on Teal Court.

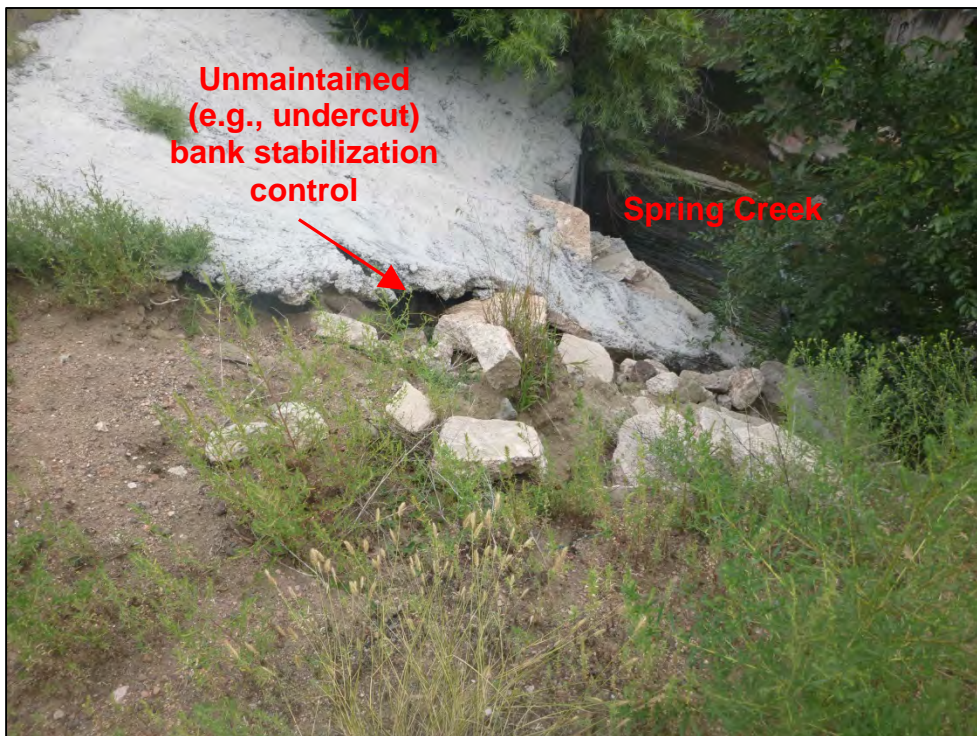
- The EPA Inspection Team observed accumulated sediment and debris and the need for street cleaning activities at the CS – 362 location on Bijou Street. It did not appear that the City had performed any street cleaning activities recently at this location.

Photograph 88. View of CS – 362 Spring Creek near 3667 E. Bijou Street. Note the unmaintained (e.g., undercut) Spring Creek box culvert bank stabilization control.

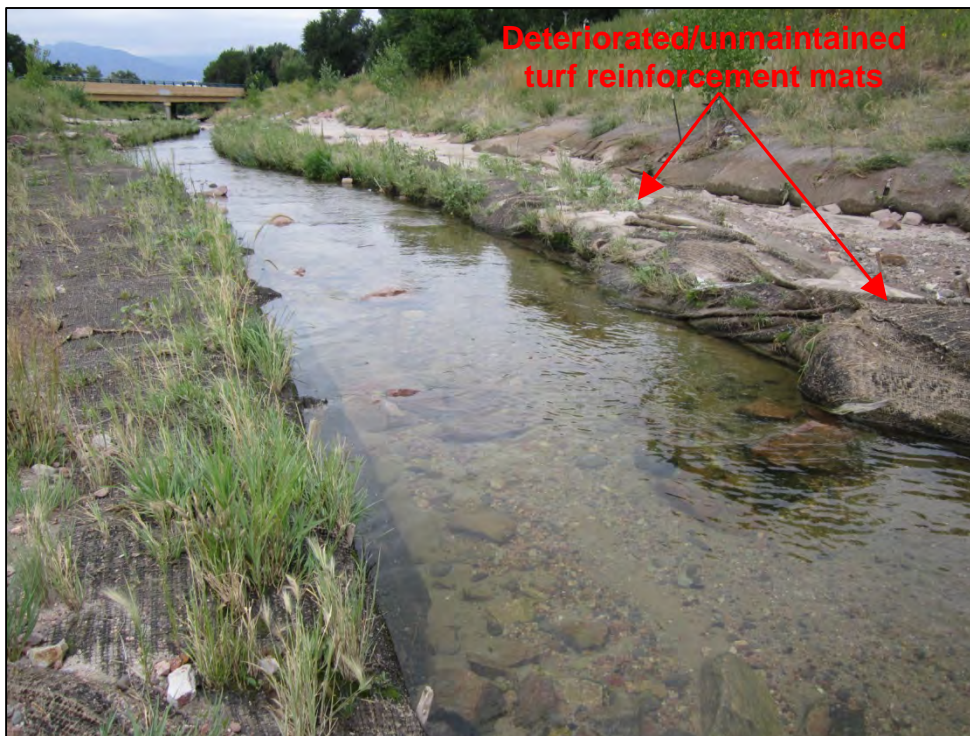
Photograph 104. View of BMPs (turf reinforcement mats) implemented in Sand Creek. Note the turf reinforcement mats were observed deteriorated and unmaintained.

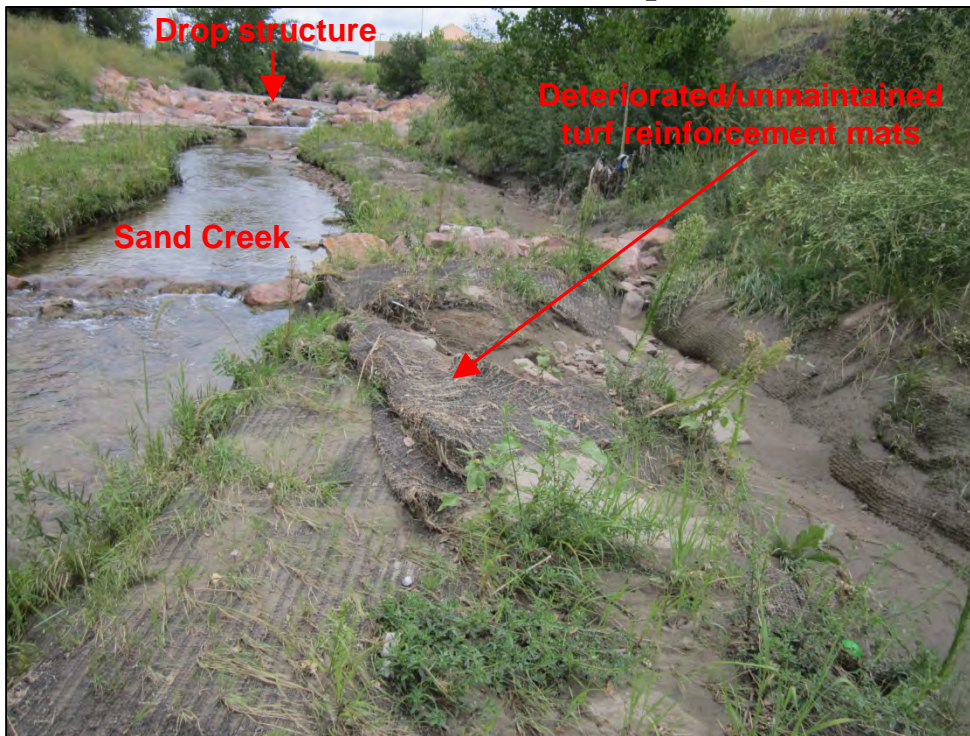
Photograph 105. Additional view of deteriorated and unmaintained turf reinforcement mat BMPs implemented in Sand Creek downstream of an engineered in-stream drop structure, shown in Photograph 103.

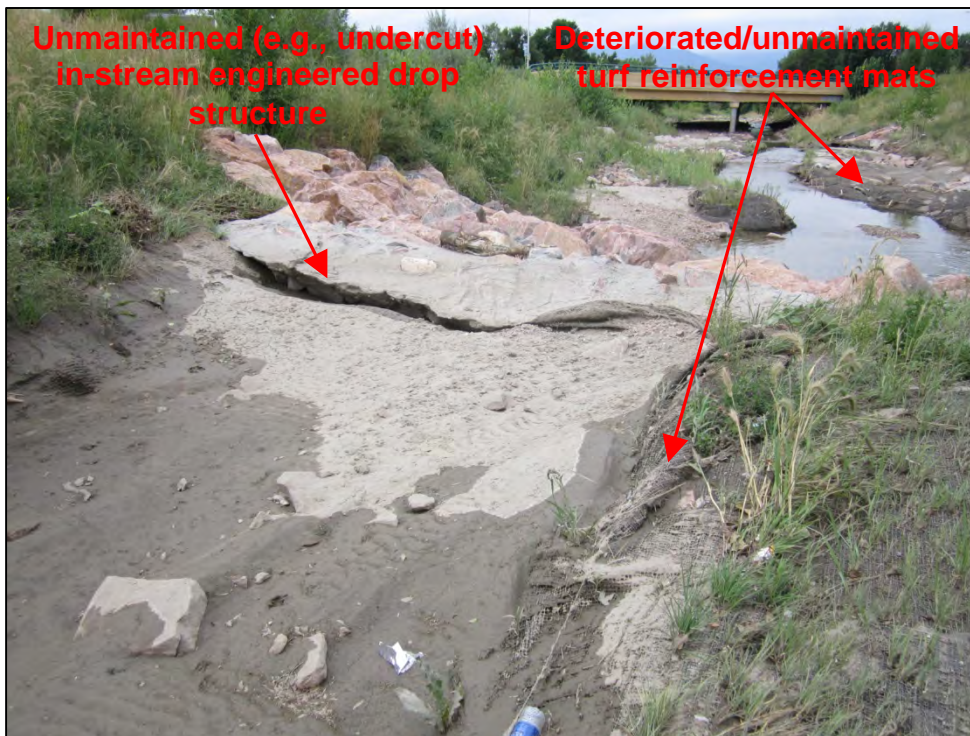
Photograph 106. View of deteriorated and unmaintained turf reinforcement mat BMPs implemented in Sand Creek. Also note the unmaintained (e.g., undercut) grouted rip-rap boulder in-stream engineered drop structure.

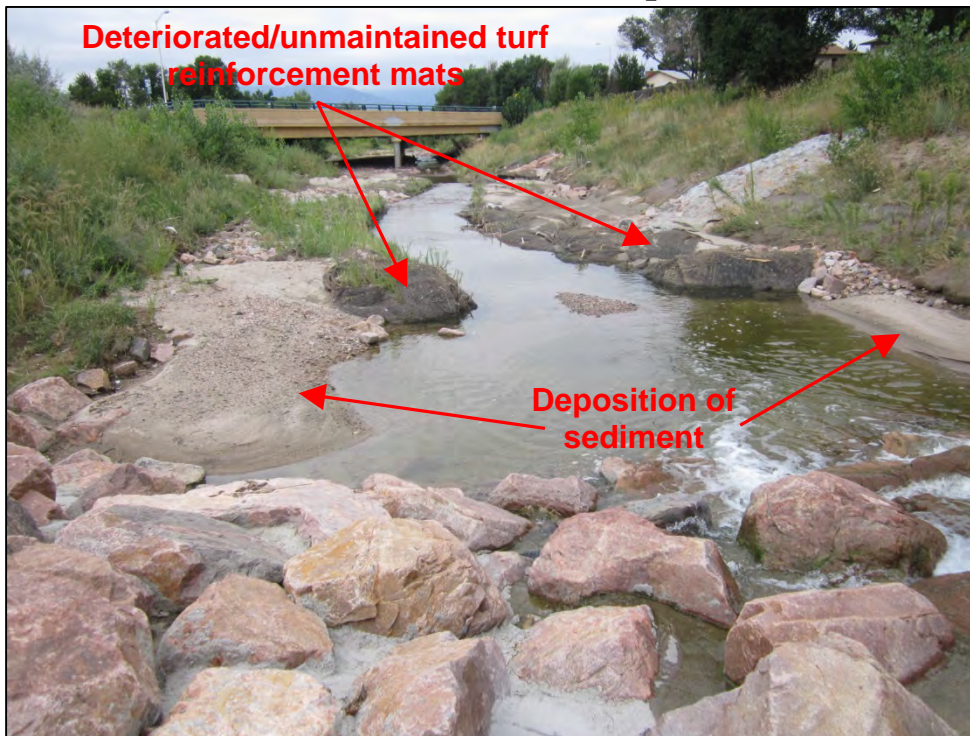
Photograph 107. Additional view of deteriorated and unmaintained turf reinforcement mat BMPs in Sand Creek downstream of drop structure shown in Photograph 106. Also note the deposition of sediment.

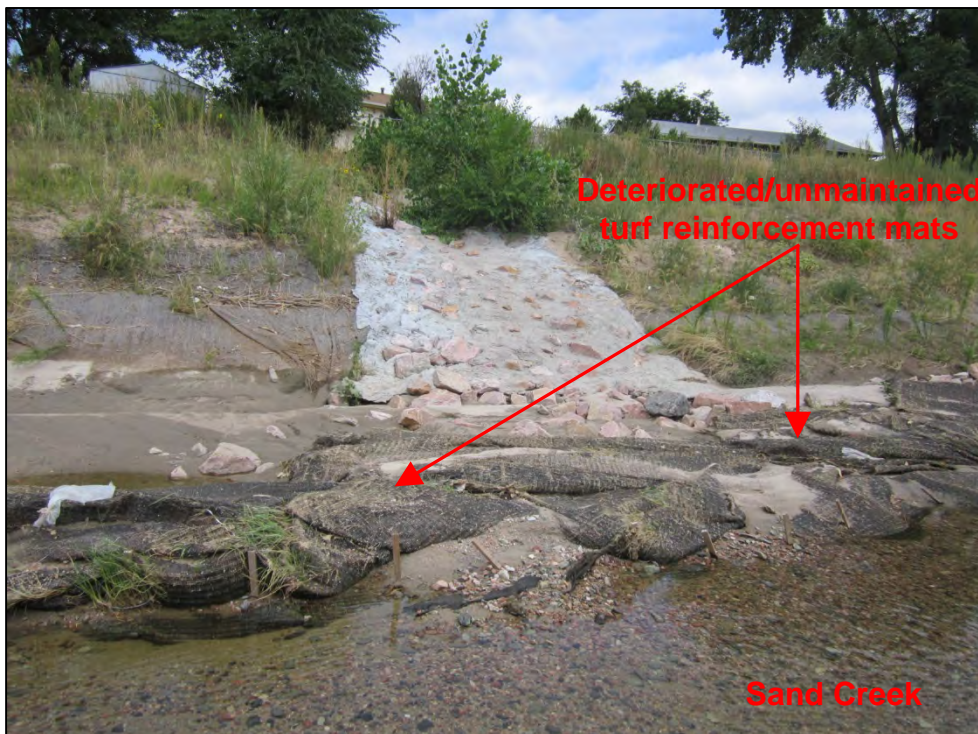
Photograph 108. View of deteriorated and unmaintained turf reinforcement mat BMPs implemented in Sand Creek. Note the in-stream BMPs had been implemented below a grouted rip-rap stormwater conveyance channel (i.e., potential area of concentrated flow) outfall.

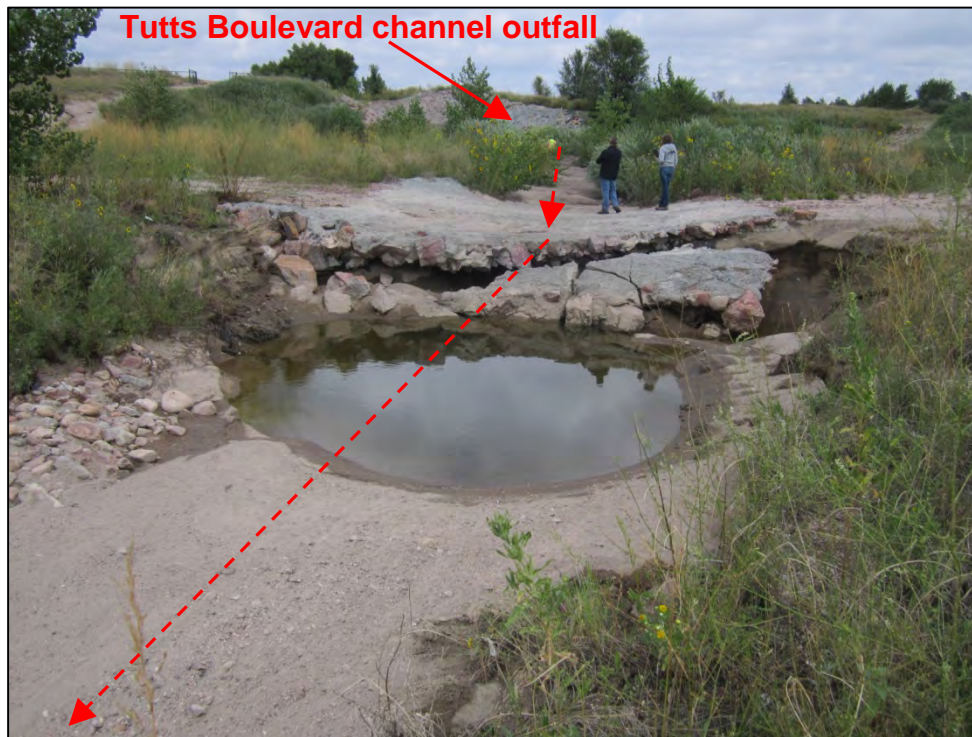
Photograph 122. View, facing upstream, of a deteriorated and unmaintained concrete channel crossing downgradient of the Tutts Boulevard channel outfall which drains to Sand Creek Detention Basin No. 1.

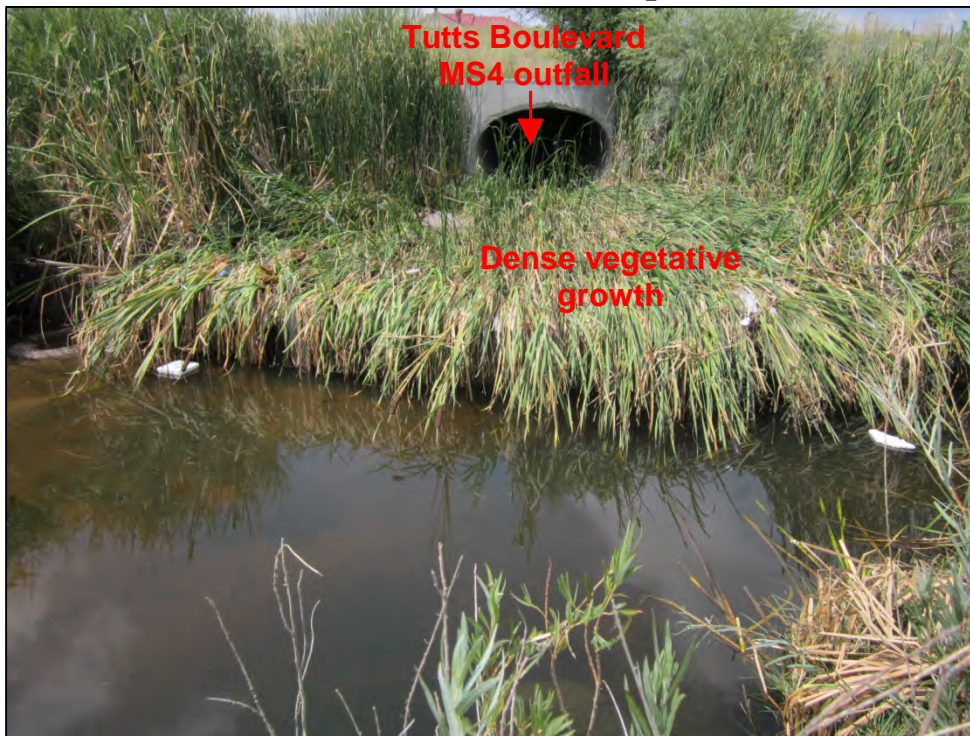
Photograph 123. View of unmaintained (e.g., dense vegetative growth) Tutts Boulevard MS4 outfall rip-rap flow dissipation device, which subsequently drains to Sand Creek Detention Basin No. 1.

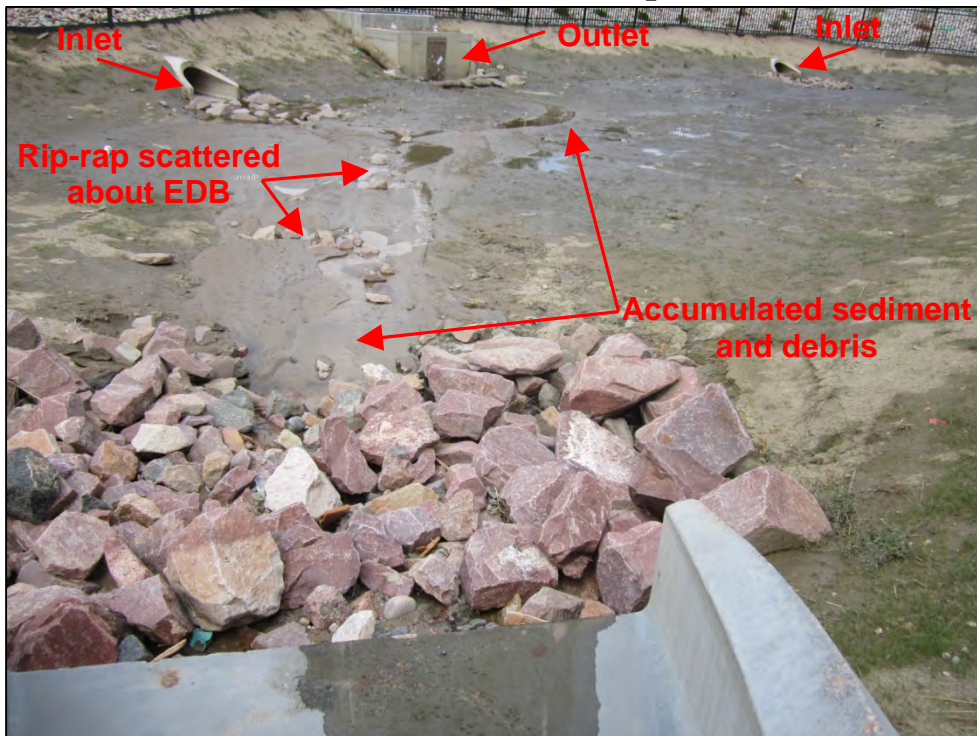
Photograph 129. View of accumulated sediment and debris at additional inlet and forebay. Also note the rip-rap scattered about the EDB.

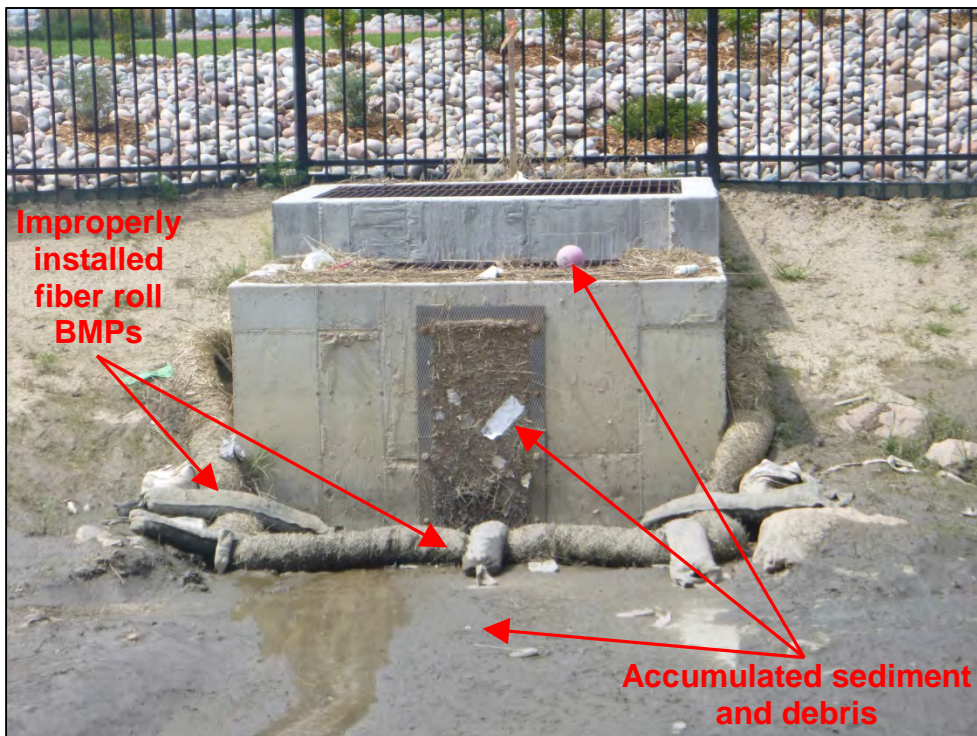
Photograph 130. View of accumulated sediment and debris at outlet structure and on orifice plate. Also note the improperly installed (e.g., not entrenched or staked) fiber roll BMPs at the outlet structure.

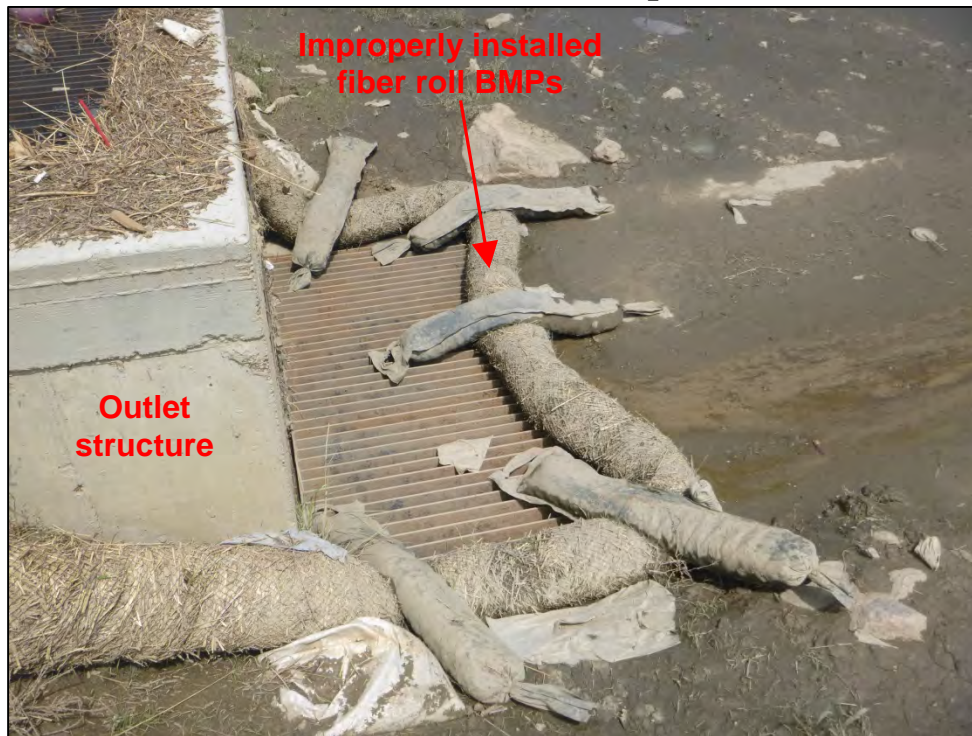
Photograph 131. Close-up view of the improperly installed (e.g., not entrenched or staked) fiber roll BMPs at EDB outlet structure. Also note the gravel bags placed on the fiber roll BMP subsequently reducing the effective height of the BMP.

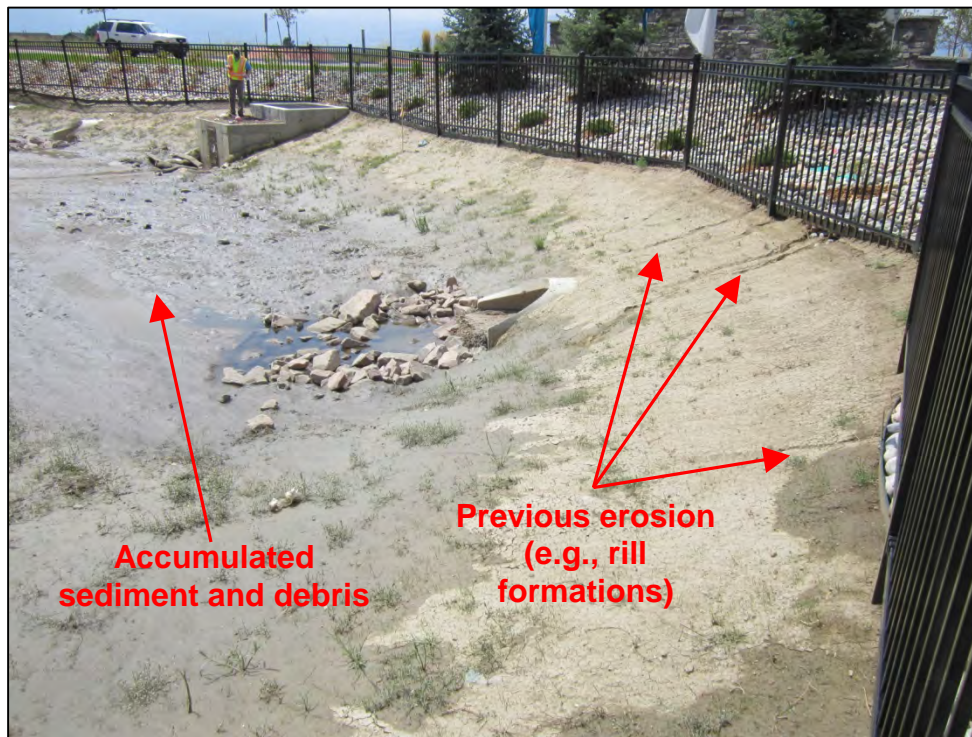
Photograph 132. View of evidence of previous erosion (e.g., rill formations) on the EDB side slopes and accumulated sediment and debris in the basin itself.

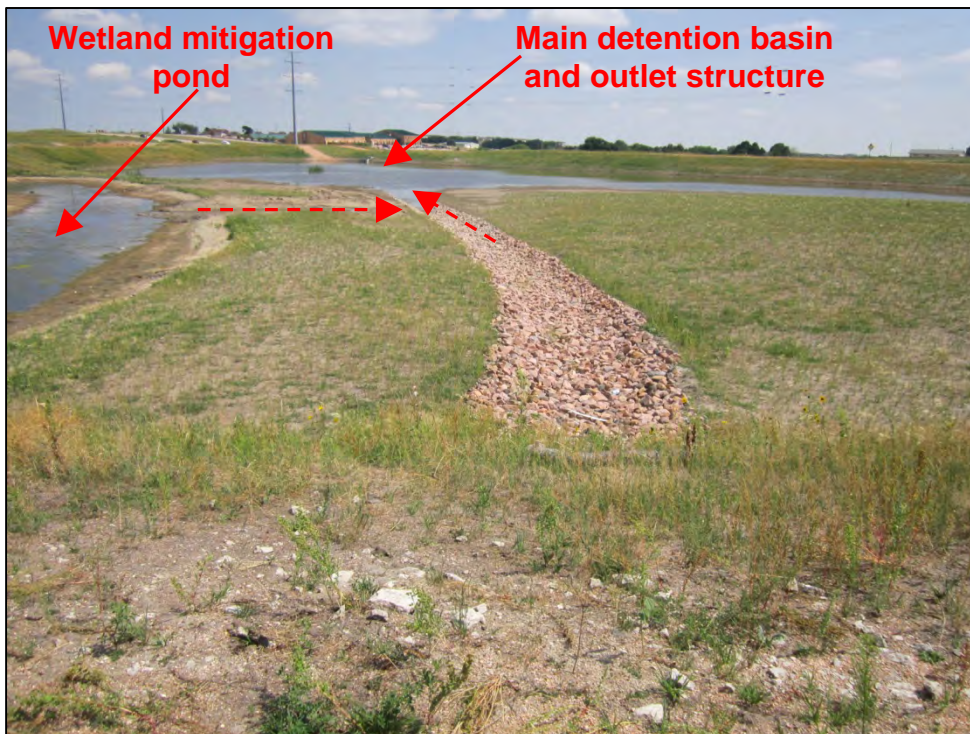
Photograph 138. View of wetland mitigation pond and connection to main detention basin. Note that the area between the wetland mitigation pond and main detention basin was observed unstabilized at the time of the inspection.

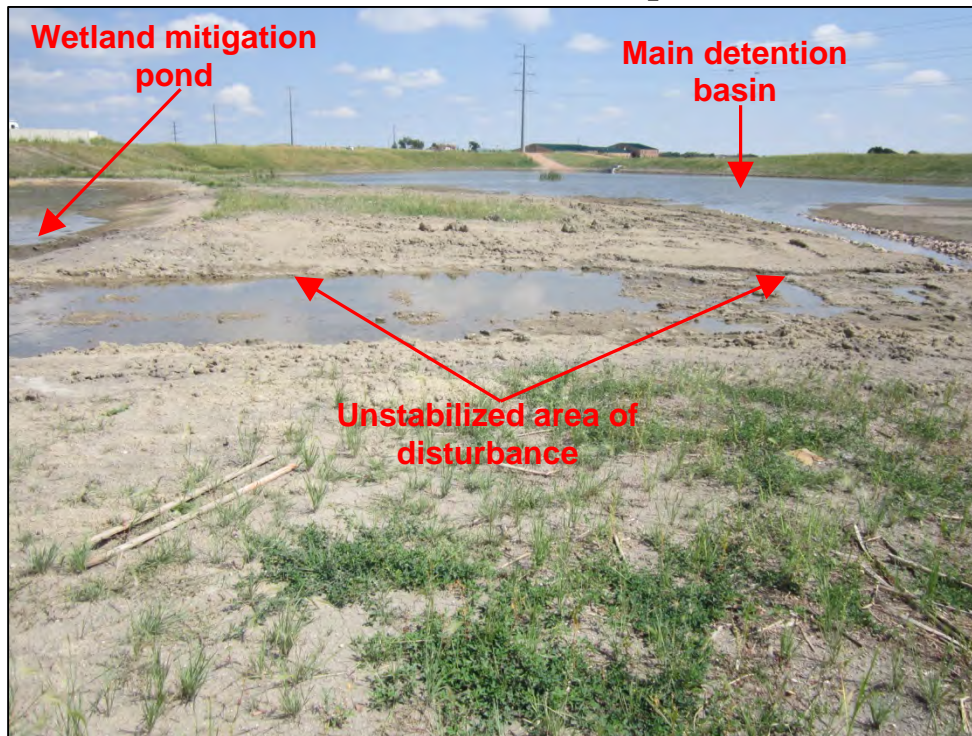
Photograph 139. View of unstabilized area of disturbance between the wetland mitigation pond and main detention basin.

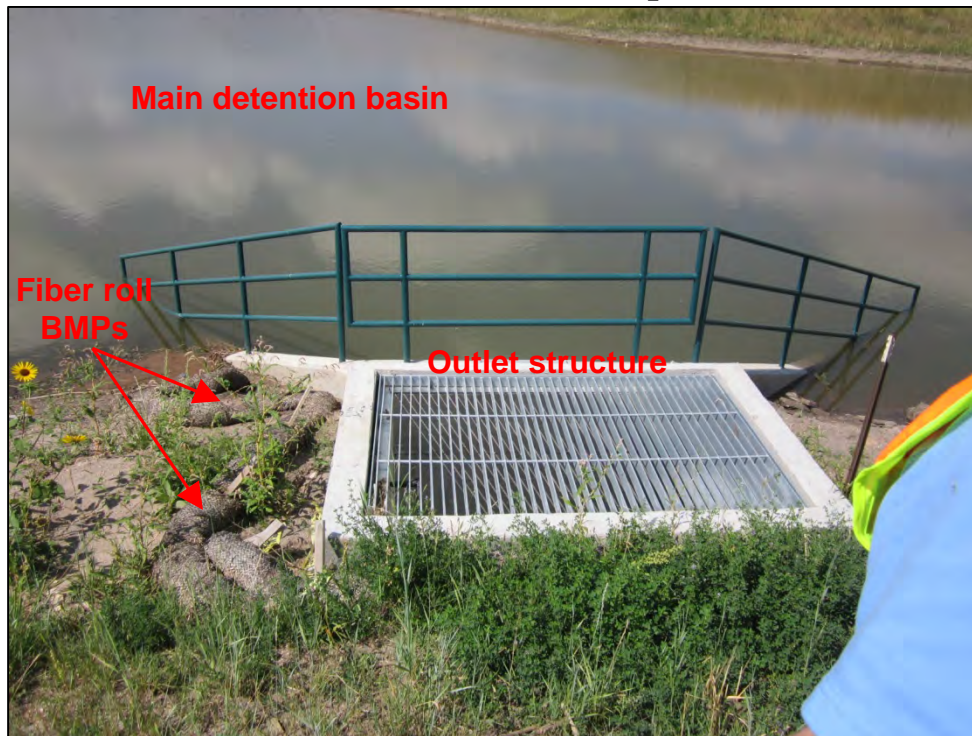
Photograph 141. View of main detention basin outlet structure. Note the improperly installed and maintained fiber roll BMPs located adjacent to the outlet.

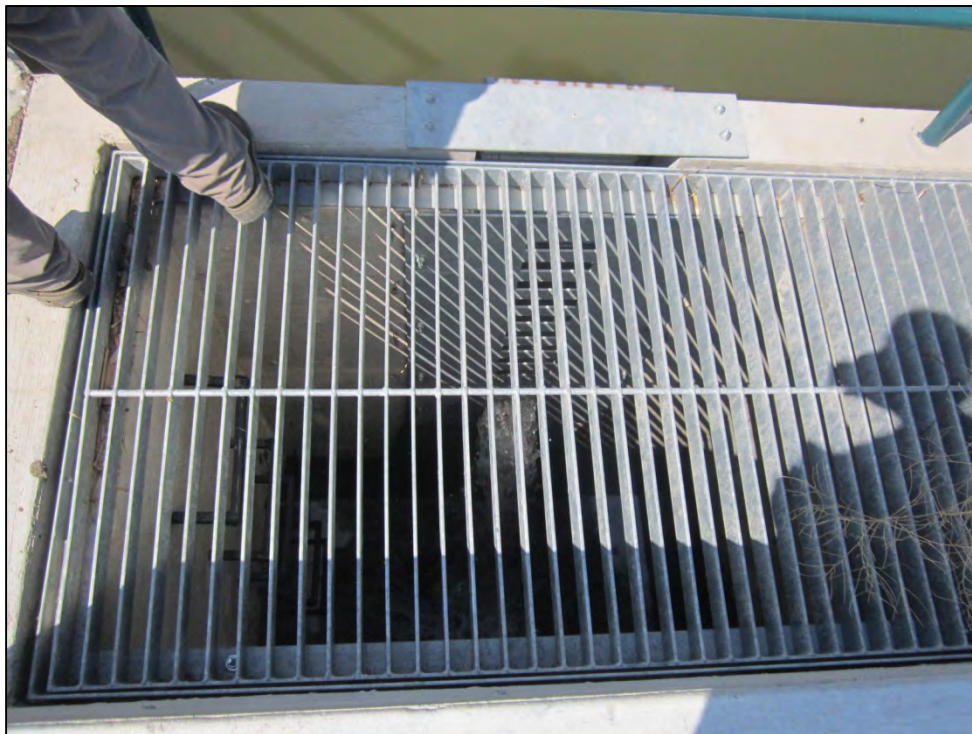
Photograph 142. Close-up view in main detention basin outlet structure. Note that flow was observed flowing through the structure at the time of the inspection.

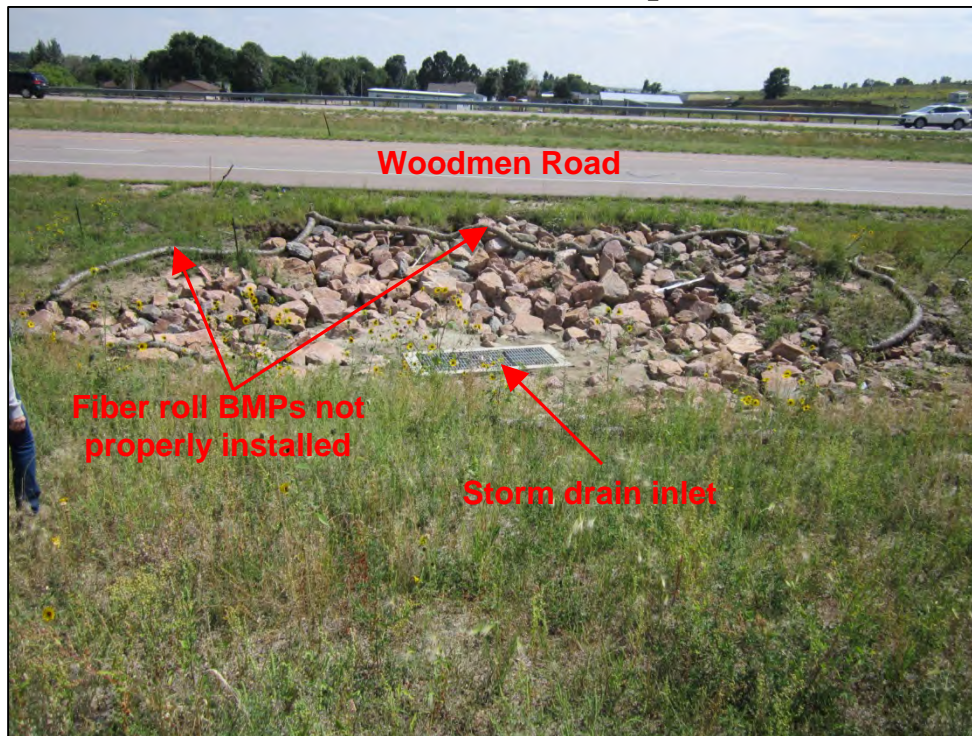
Photograph 143. View of storm drain inlet with fiber roll BMPs not properly installed (e.g., not staked or entrenched, placed on rip-rap) located adjacent to Woodmen Road. It should be noted that this storm drain inlet is inline with the main detention basin outlet structure conveyance pipe.
