City of Colorado Springs Phase I MS4 Inspection Report
Colorado Discharge Permit System, Permit # COS000004

Inspection Dates: August 18, 2015–August 19, 2015

Prepared by
PG Environmental, LLC

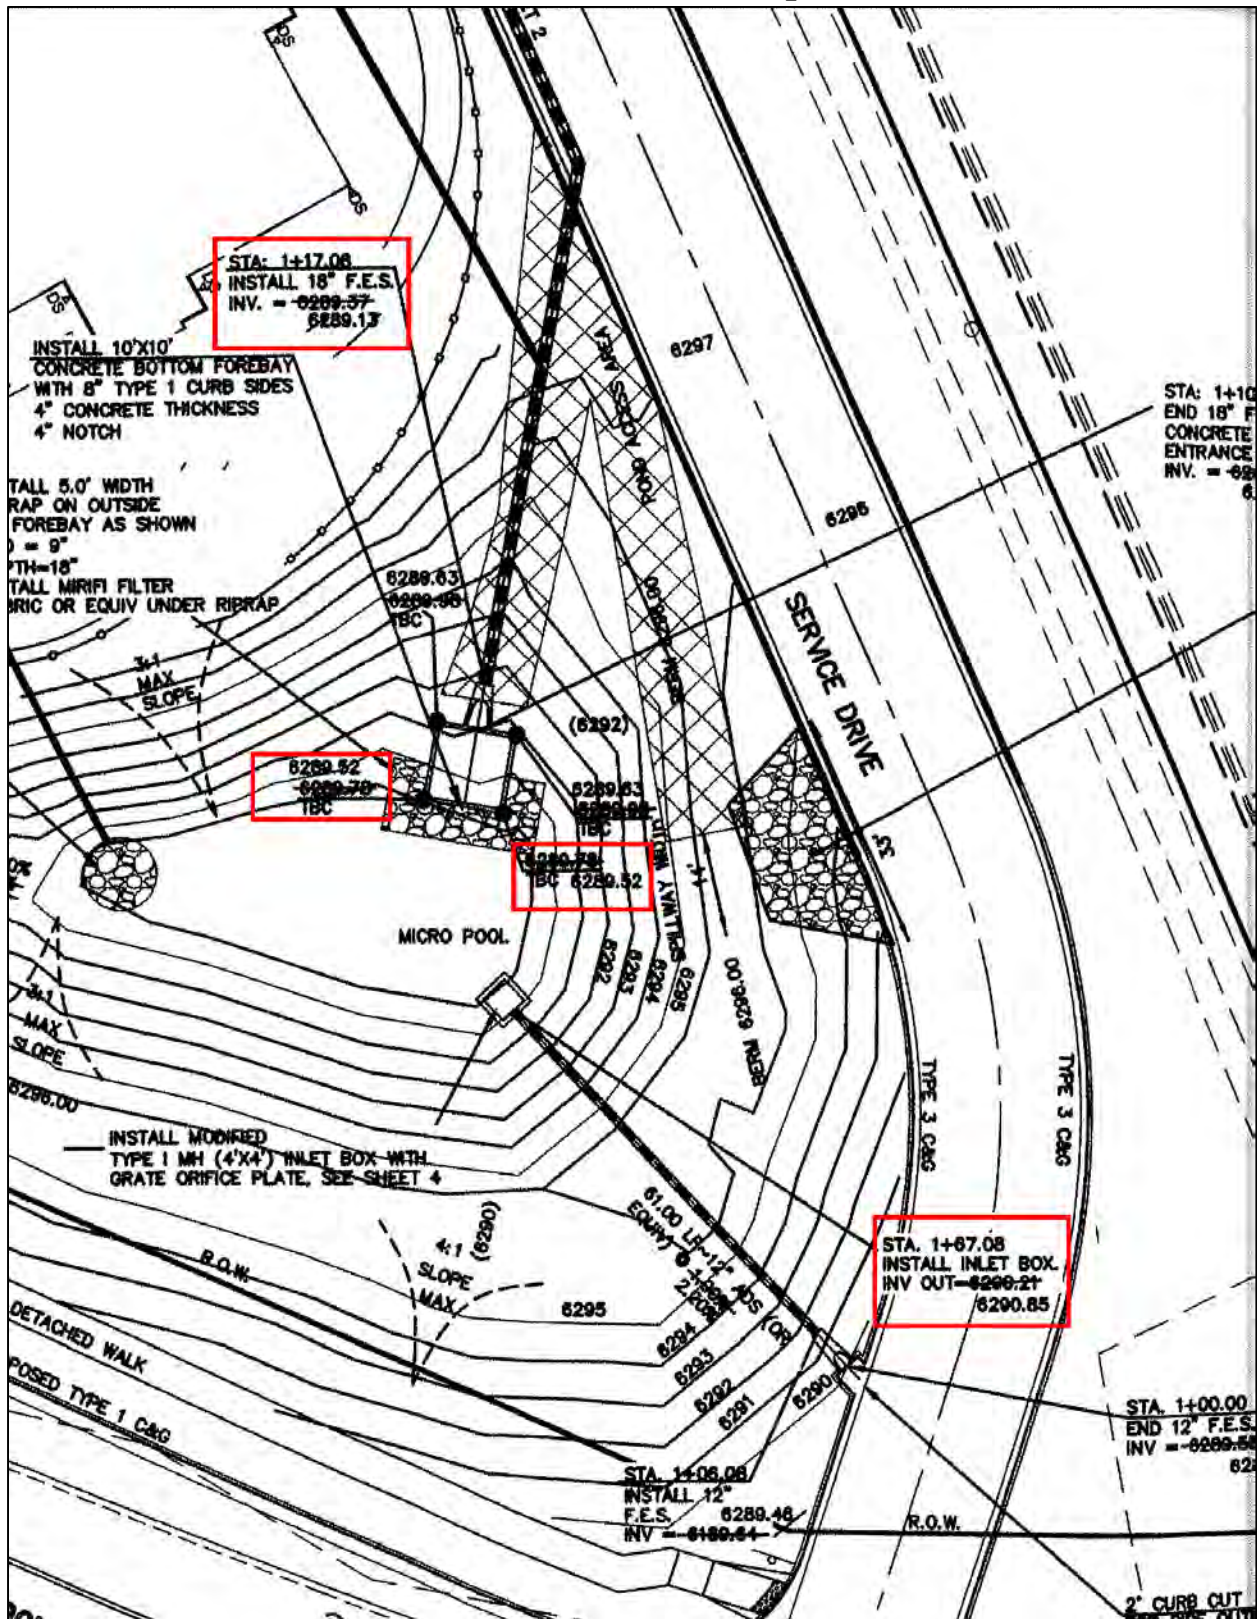
Exhibit 1. Scan of ID-158 Morning Star at Bear Creek EDB as-built plans (dated October 3, 2014; Sheet 1 of 2) provided by Joel Mackey (City Engineering Inspector). Note that the approved design and as-built elevations of the inlet pipe and forebay were approximately one foot lower than the outlet pipe invert resulting in an impaired forebay and drain time for WQCV.
