UNITED STATES ENVIRONMENTAL PROTECTION AGENCY  
REGION 8

Re: Municipal Storm Water Inspection Report,  
NPDES Permit Number – COS000004

Enclosed is a copy of the inspection report for the Environmental Protection Agency's (EPA's) inspection of the City of Colorado Springs Municipal Separate Storm Sewer System on February 4-7, 2013. Findings were noted during the inspection and are summarized in the enclosed report.

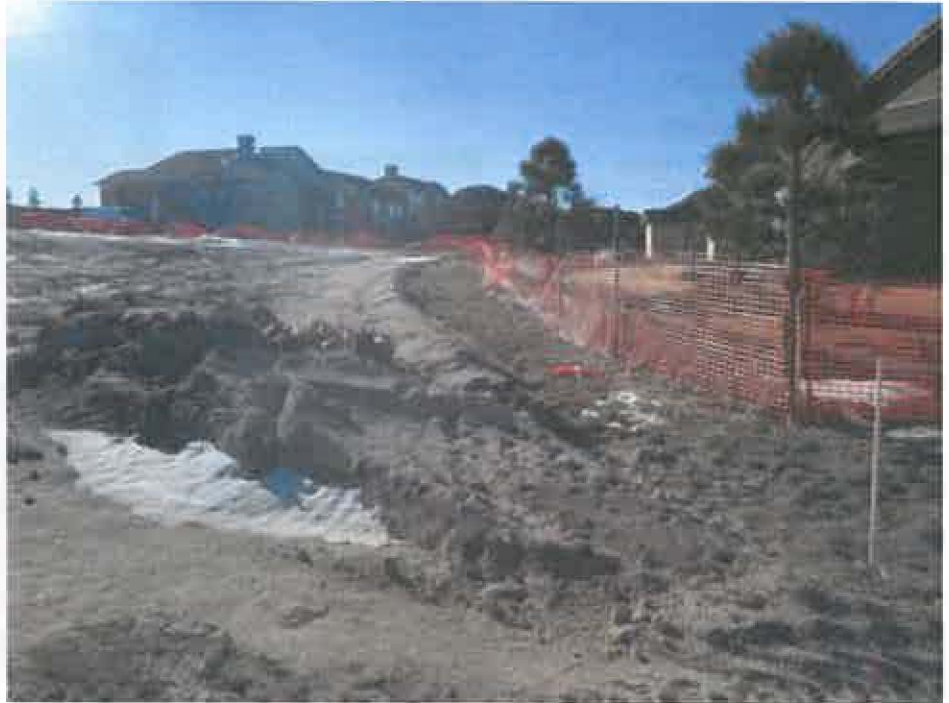
**Photo Number** 3  
**Inspection Date** 2/6/2013  
**Photographer** K. Sable  
**Description** Flying Horse Construction Inspection - Earthen berm that needed to be turned around the corner (front right) and rip rap removed.

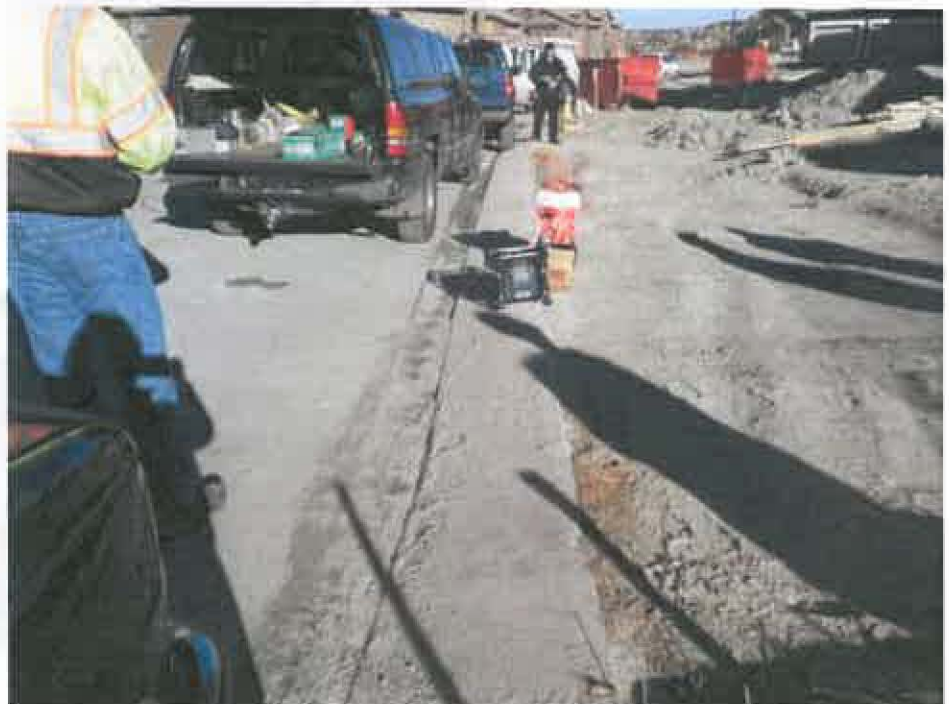
**Photo Number** 4  
**Inspection Date** 2/6/2013  
**Photographer** K. Sable  
**Description** Flying Horse Construction Inspection - Sediment discharge in street down slope from disturbed area.

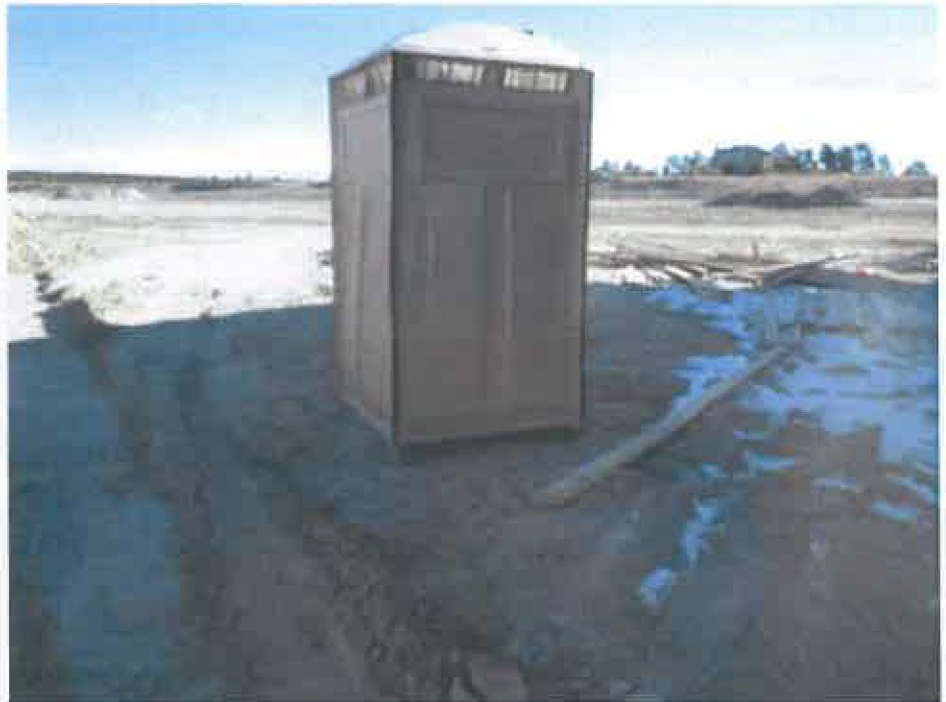
**Photo Number** 5  
**Inspection Date** 2/6/2013  
**Photographer** K. Sable  
**Description** Flying Horse Construction Inspection - Portable toilet that was not staked.

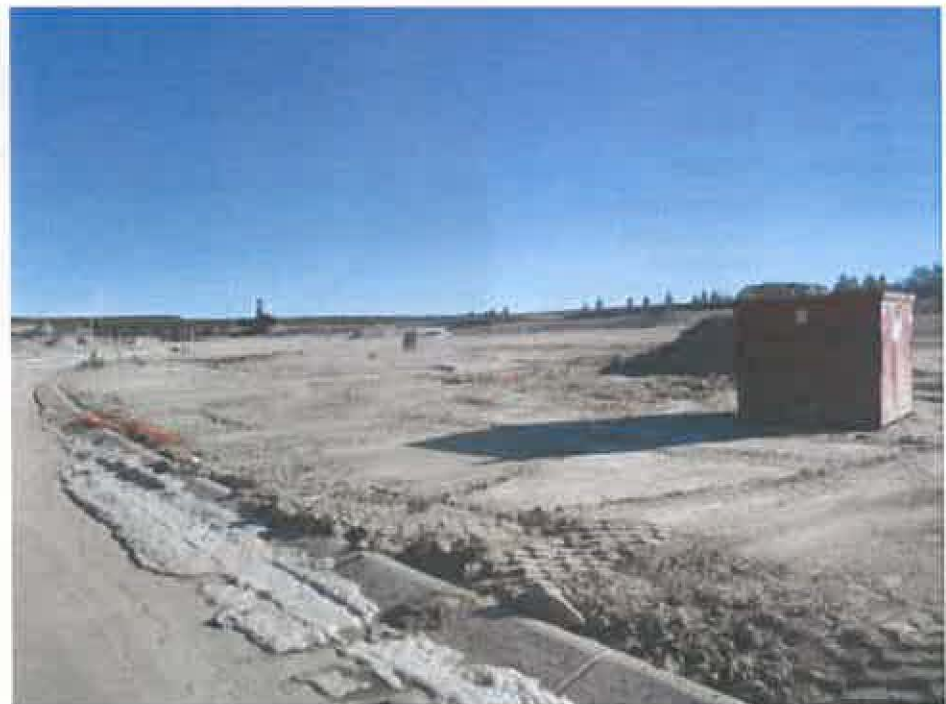
**Photo Number** 6  
**Inspection Date** 2/6/2013  
**Photographer** K. Sable  
**Description** Flying Horse Construction Inspection - Undisturbed areas with no perimeter controls.

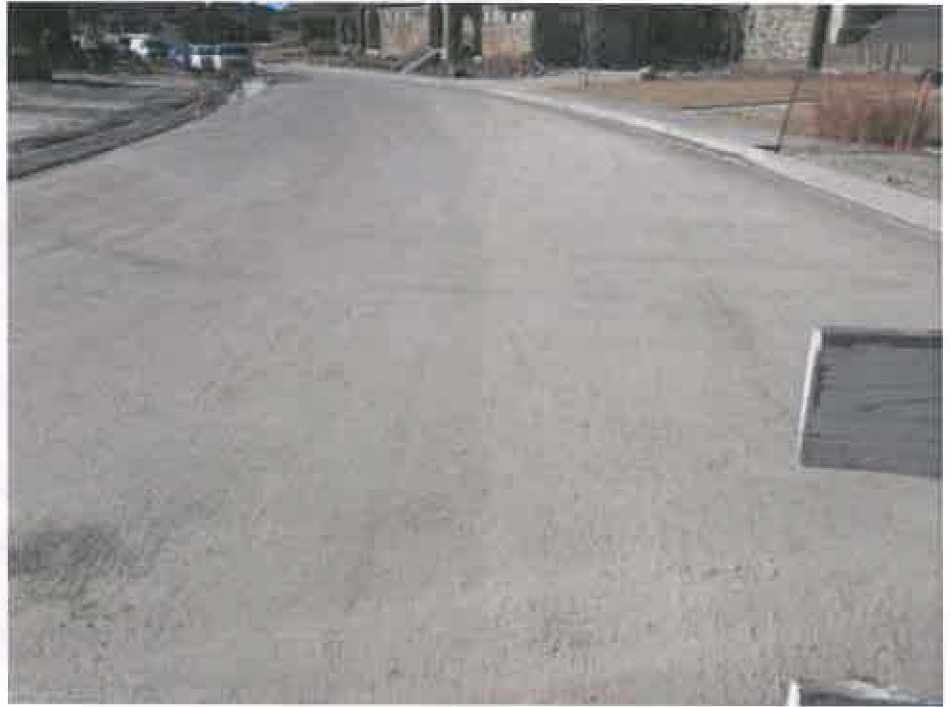
**Photo Number** 7  
**Inspection Date** 2/6/2013  
**Photographer** K. Sable  
**Description** Flying Horse Construction Inspection - Track out onto subdivision road from disturbed area.

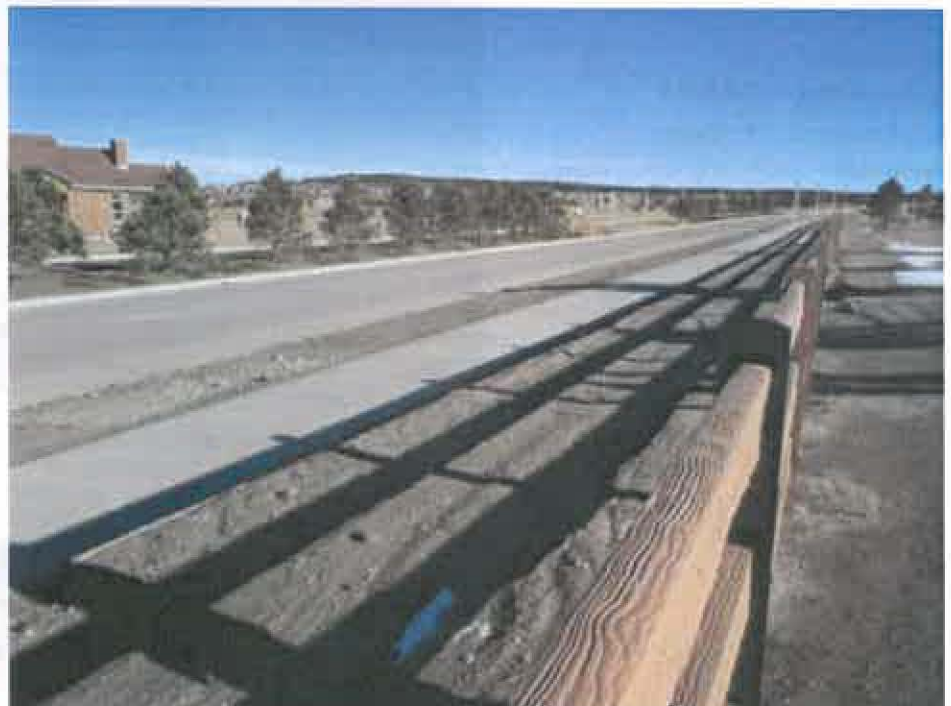
**Photo Number** 8  
**Inspection Date** 2/6/2013  
**Photographer** K. Sable  
**Description** Flying Horse Construction Inspection - Disturbed areas by new sidewalk with no perimeter controls.

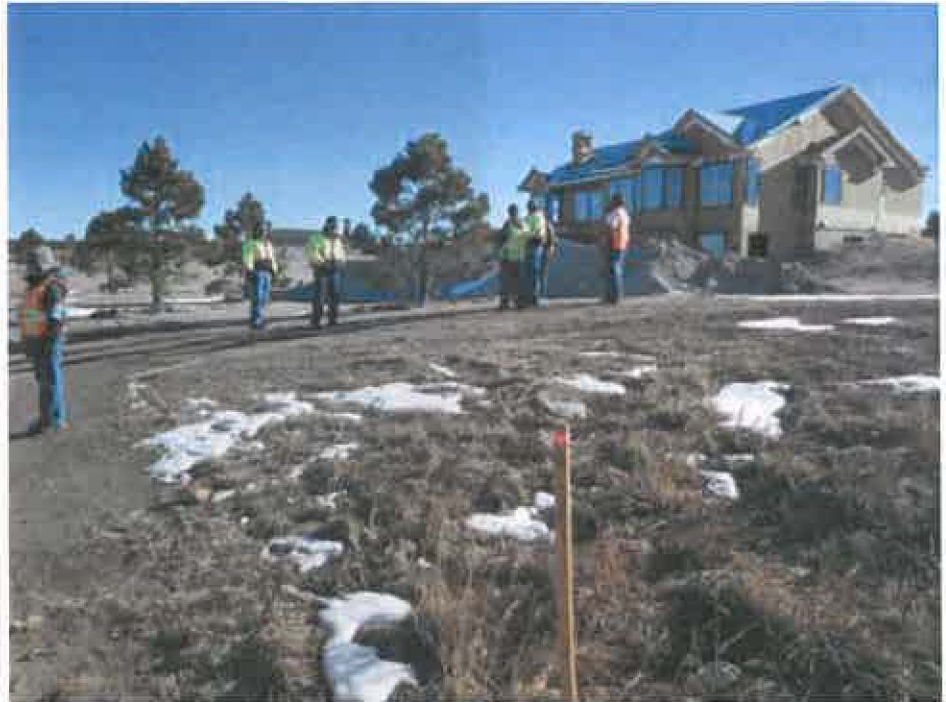
**Photo Number** 9  
**Inspection Date** 2/6/2013  
**Photographer** K. Sable  
**Description** Flying Horse Construction  
Inspection - Upslope view of disturbed area which drains towards the street and sidewalk (pic 8).

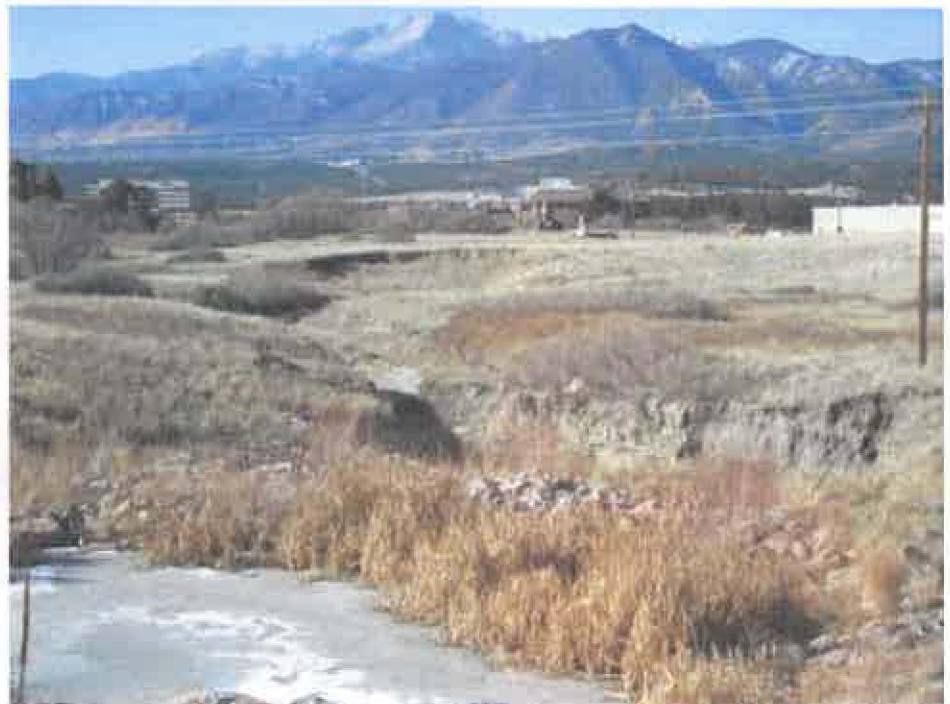
**Photo Number** 12  
**Inspection Date** 2/6/2013  
**Photographer** K. Sable  
**Description** Flying Horse Pond - Photographer facing downstream from pond where storm flow was discharged. Note: channel erosion.

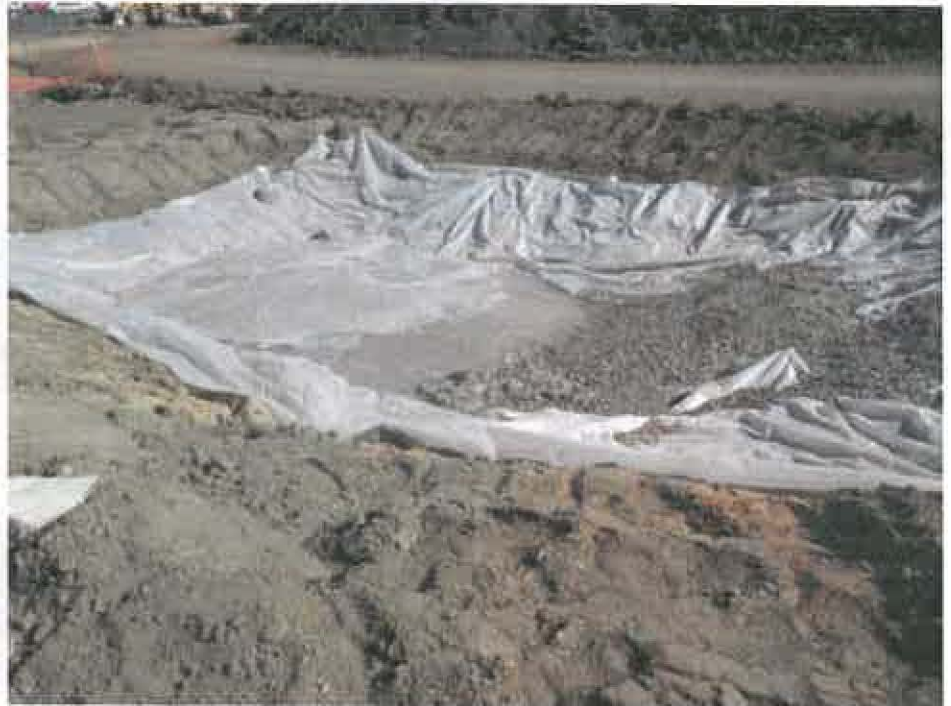
**Photo Number** 15  
**Inspection Date** 2/6/2013  
**Photographer** K. Sable  
**Description** Walmart  
Construction  
Inspection -  
Concrete wash out  
with no perimeter  
berm or liner  
stabilization.

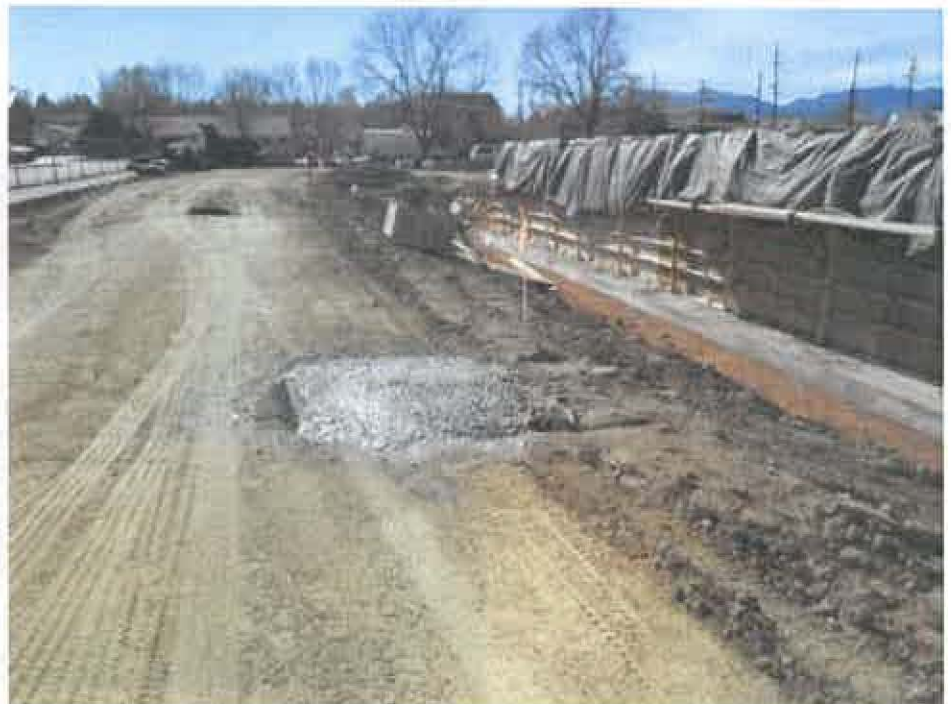
**Photo Number** 16  
**Inspection Date** 2/6/2013  
**Photographer** K. Sable  
**Description** Walmart  
Construction  
Inspection -  
Concrete spill on  
ground.

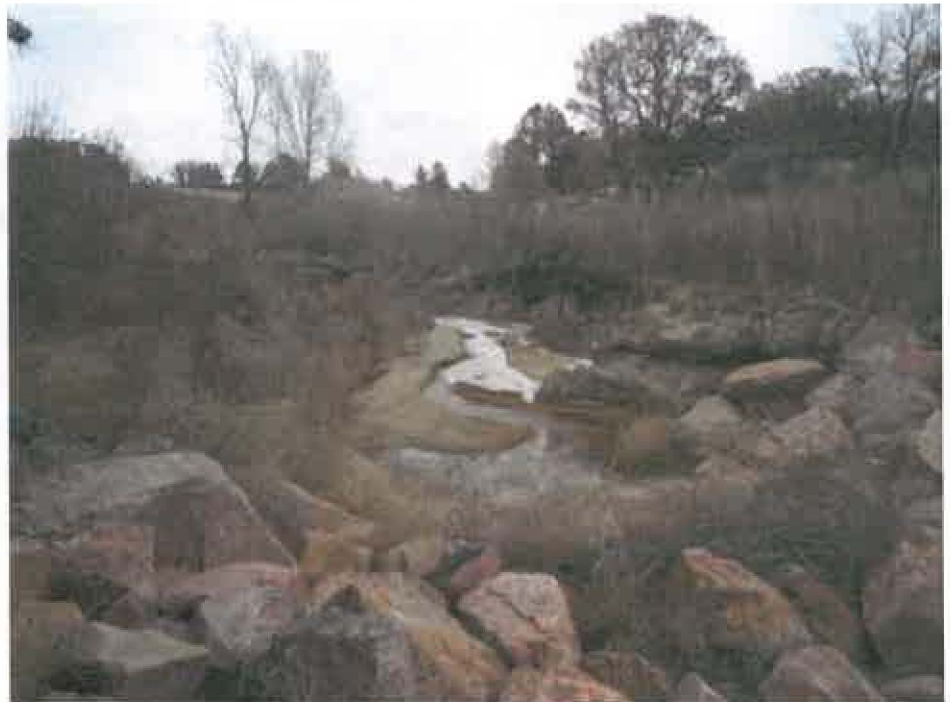
**Photo Number** 18  
**Inspection Date** 2/6/2013  
**Photographer** K. Sable  
**Description** Monument Branch-  
behind TCA school -  
Photo taken facing  
upstream of rip rap  
apron showing  
channel erosion.

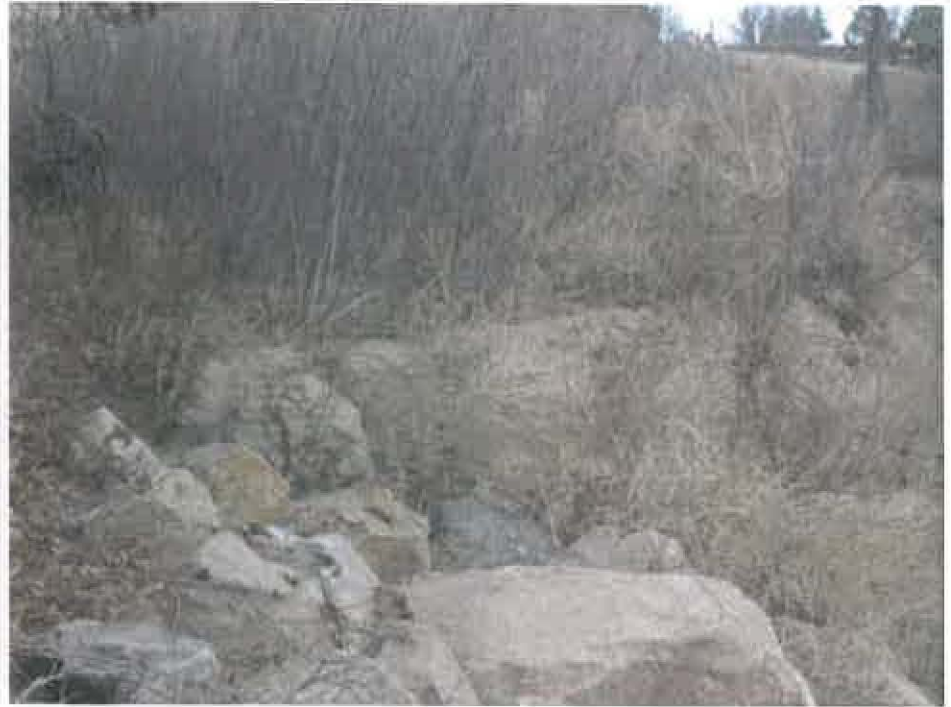
**Photo Number** 19  
**Inspection Date** 2/6/2013  
**Photographer** K. Sable  
**Description** Monument Branch, behind TCA school - Close-up of bank erosion upstream of rip rap apron.

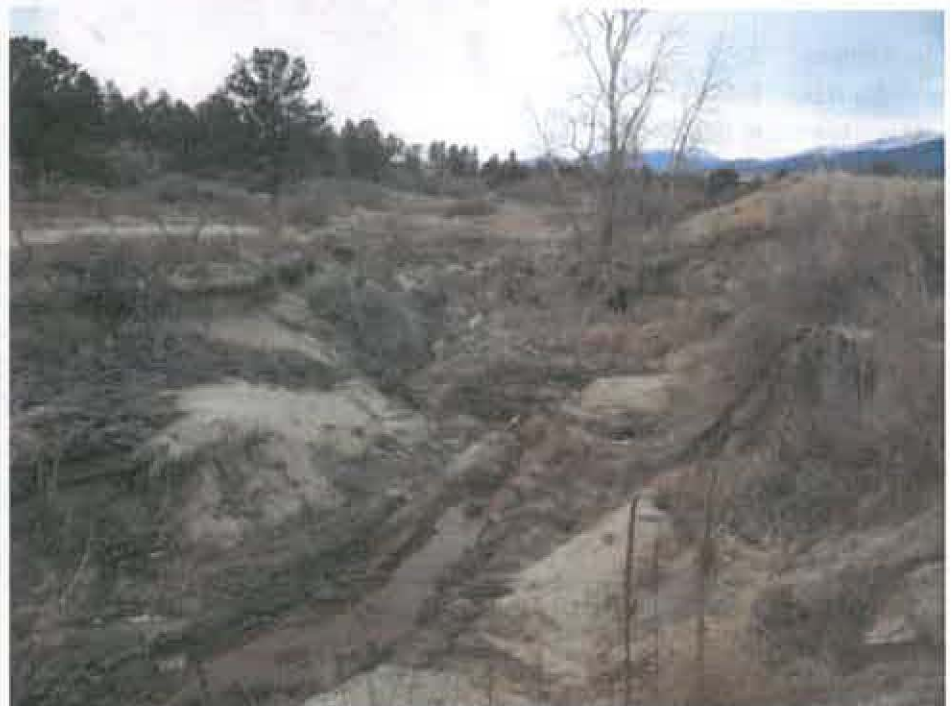
**Photo Number** 20  
**Inspection Date** 2/6/2013  
**Photographer** K. Sable  
**Description** Monument Branch, behind TCA school - Active bank erosion down stream from rip rap apron.

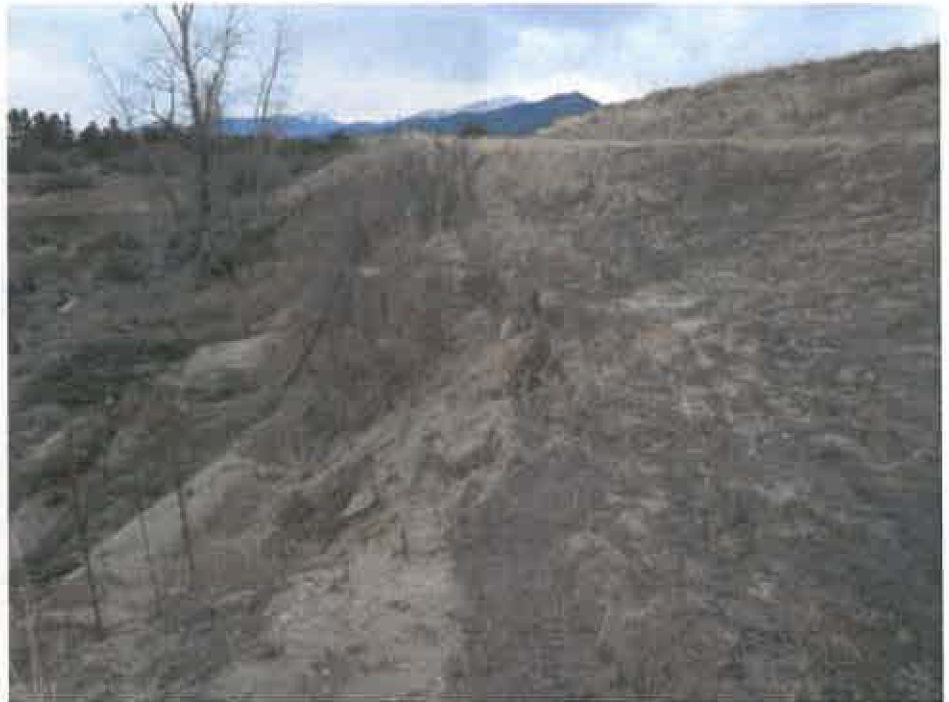
**Photo Number** 21  
**Inspection Date** 2/6/2013  
**Photographer** K. Sable  
**Description** Monument Branch, behind TCA school - Close-up of active erosion and location of sediment blanked carved by flow.

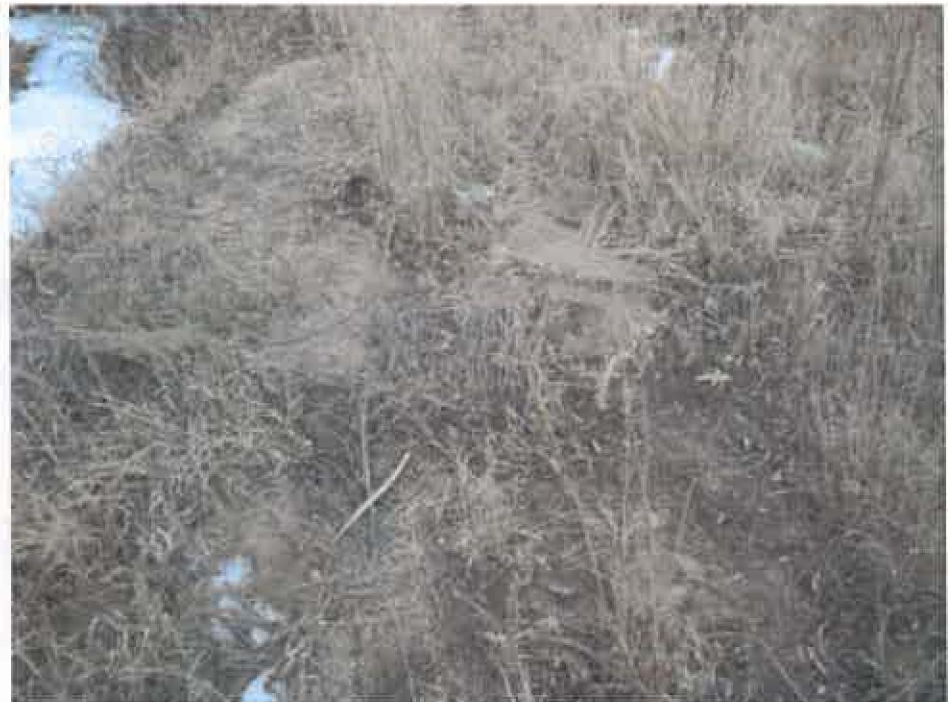
**Photo Number** 22  
**Inspection Date** 2/6/2013  
**Photographer** K. Sable  
**Description** Monument Branch, southwest of pond and north of TCA school - Close-up of sediment point bar on channel bed.

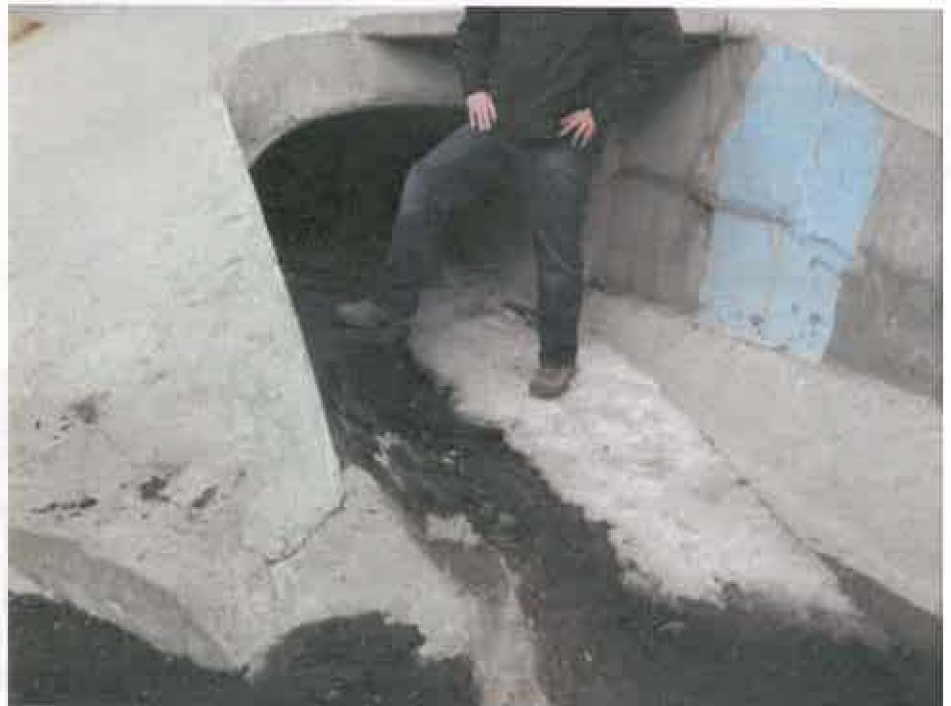
**Photo Number** 28  
**Inspection Date** 2/6/2013  
**Photographer** K. Sable  
**Description** Neighborhood downstream of Cathedral Ridge - Close-up of discharge location of storm flow conveyed via pipe. Note ash deposition.

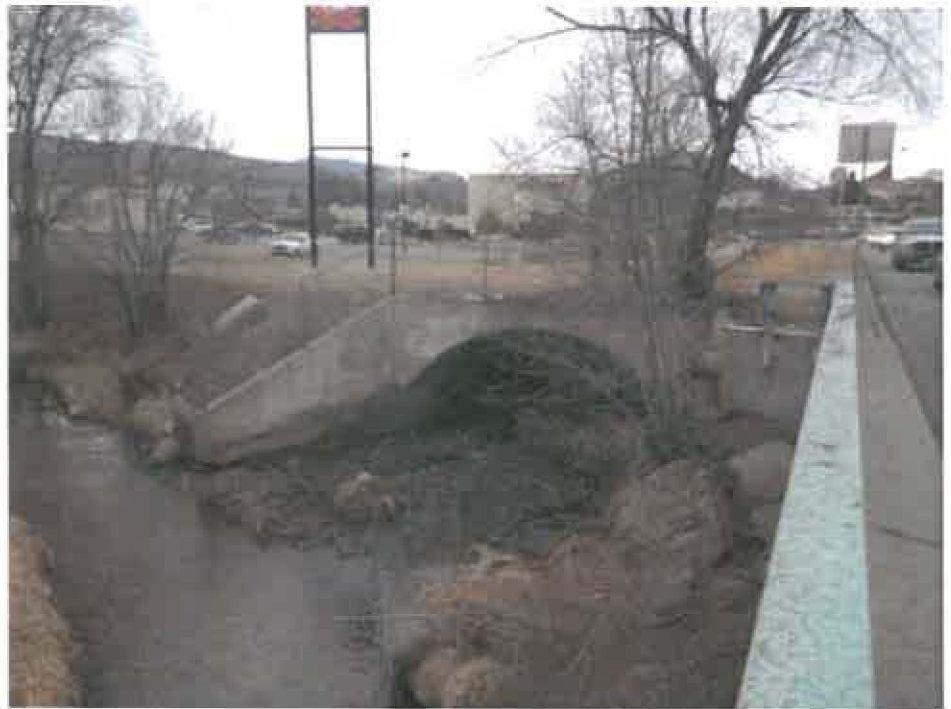
**Photo Number** 31  
**Inspection Date** 2/6/2013  
**Photographer** K. Sable  
**Description** Fountain Creek at Kentucky Fried Chicken - Discharge location of storm flow conveyed from open channel to Fountain creek (ash visible).

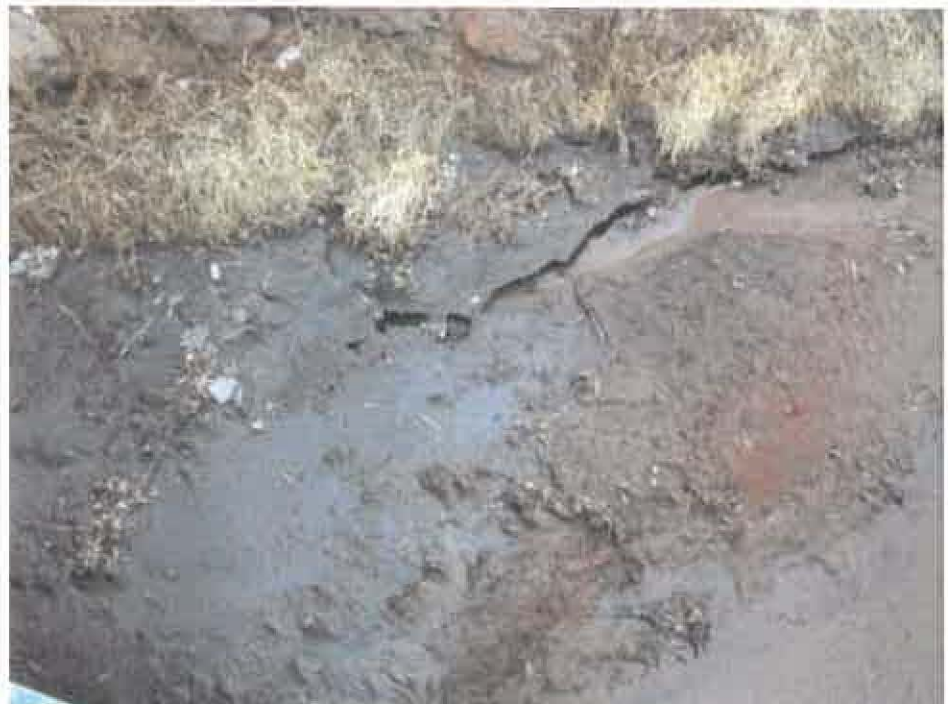
**Photo Number** 32  
**Inspection Date** 2/6/2013  
**Photographer** K. Sable  
**Description** Fountain Creek at Kentucky Fried Chicken - Ash across Fountain Creek across from discharge location.

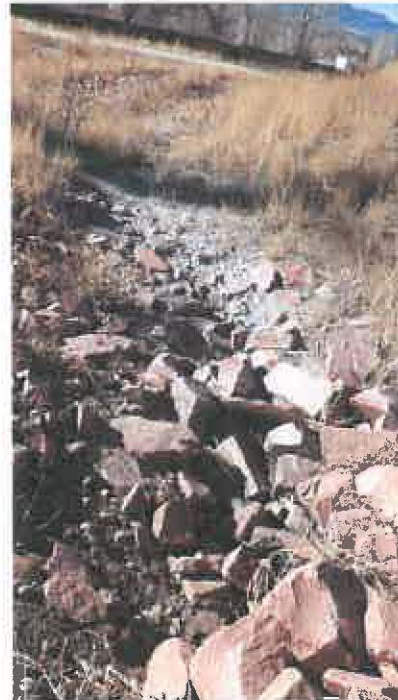
**Photo Number** 666  
**Inspection Date** 2/5/2013  
**Photographer** D. Gwisdalla  
**Description** Briargate Service Center: Outfall rock protection from the storm drain inlet shown in photo 665 on the southwest side of the property taken looking to the northwest. Note the white stain which is believed to be salt deposits discharged from the facility.

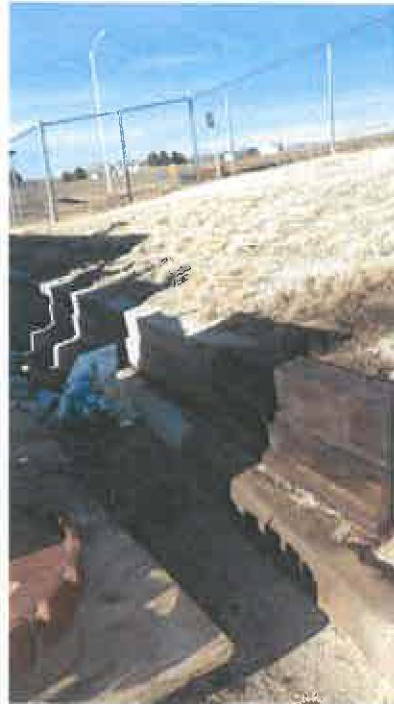
**Photo Number** 667  
**Inspection Date** 2/5/2013  
**Photographer** D. Gwisdalla  
**Description** CSU, Pinkerton Service Center:  
Taken on the eastern portion of the site looking east. Hydraulic oil stored here with significant staining. It was located at this site and recently moved (as observed by the container mark on the grassy area, photo 668).

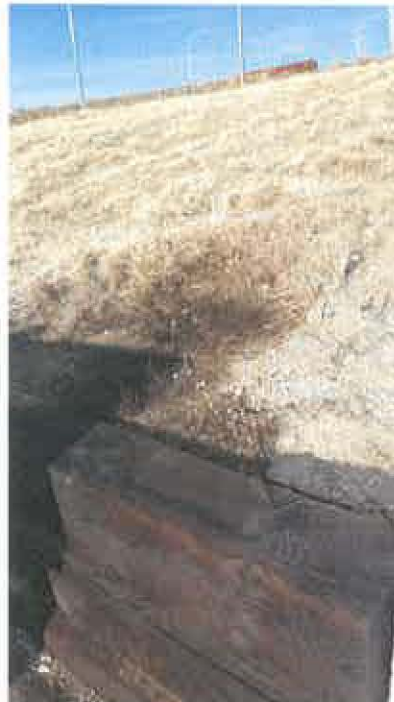
**Photo Number** 668  
**Inspection Date** 2/5/2013  
**Photographer** D. Gwisdalla  
**Description** CSU, Pinkerton Service Center:  
Close-up of the staining at this location.

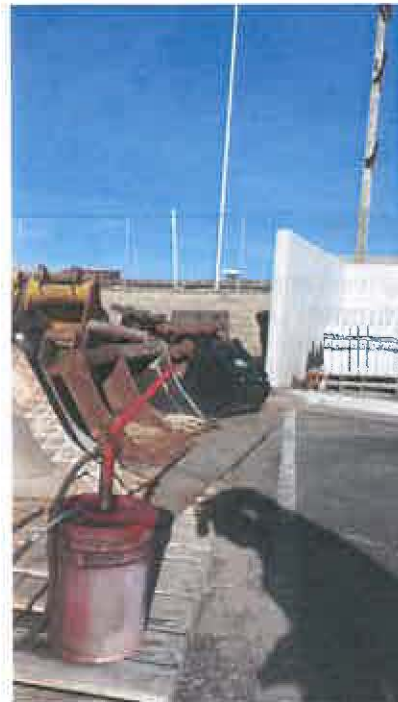
**Photo Number** 669  
**Inspection Date** 2/5/2013  
**Photographer** D. Gwisdalla  
**Description** Hydraulic material shown believed to cause staining in the previous photos (667 and 668) is shown in the photo's center. The container appeared to have been moved to this location from a location adjacent to the white wall in the rear of the photo.

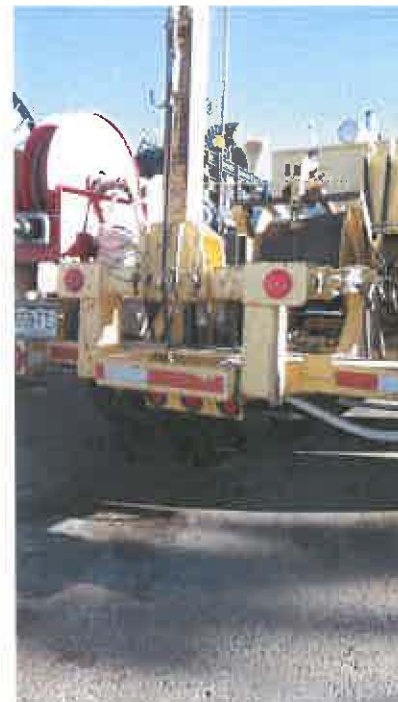
**Photo Number** 670  
**Inspection Date** 2/5/2013  
**Photographer** D. Gwisdalla  
**Description** CSU, Pinkerton Service Center: Taken in the central vehicle/equipment storage area. This equipment was observed as leaking onto the ground. Photo taken looking to the south.

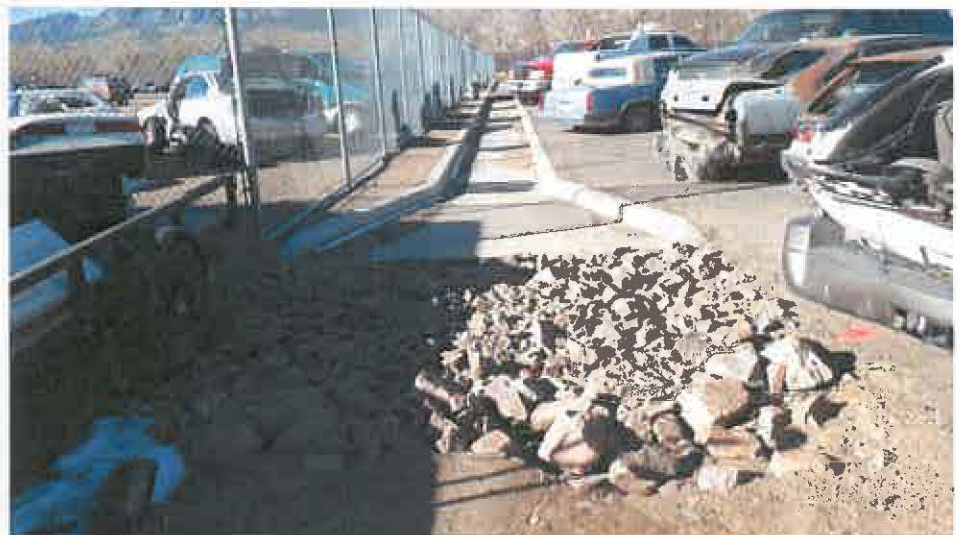
**Photo Number** 676  
**Inspection Date** 2/6/2013  
**Photographer** D. Gwisdalla  
**Description** Police Impound Facility: Stormwater drainage structure. Note the condition of rock protection.

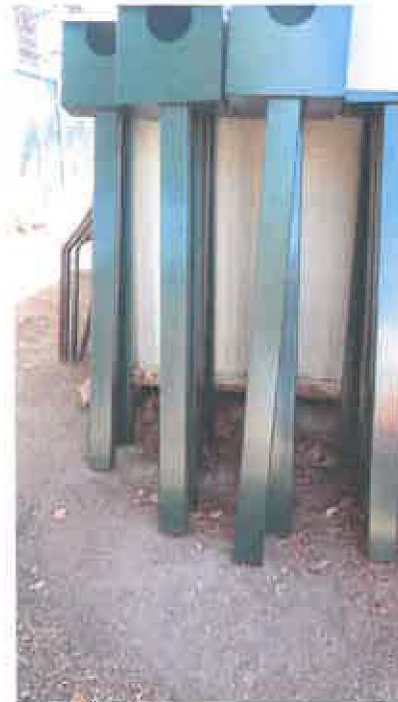
**Photo Number** 686  
**Inspection Date** 2/6/2013  
**Photographer** D. Gwisdalla  
**Description** The bird houses noted in photo 685 leaning against the Conex box. The cement staining shown flowing towards and underneath the Conex box.

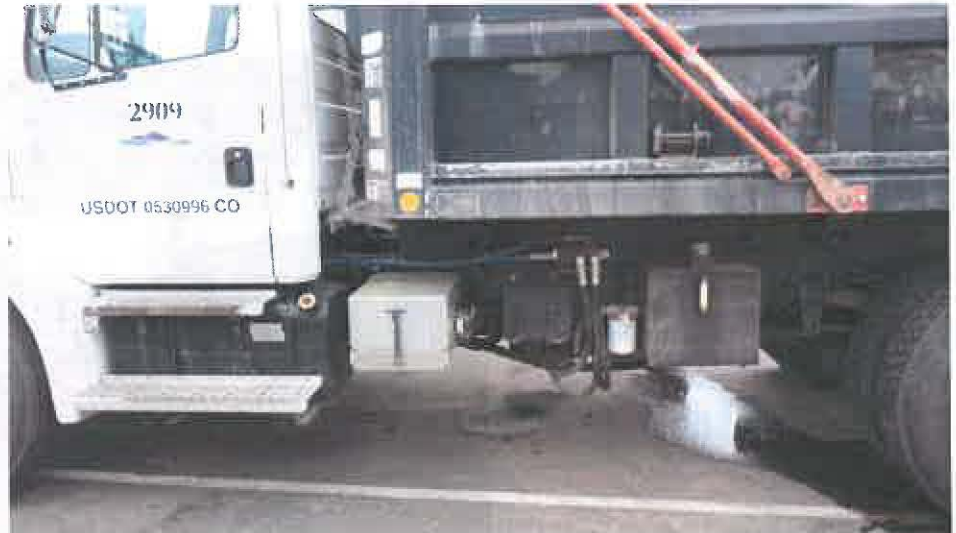
**Photo Number** 694  
**Inspection Date** 2/6/2013  
**Photographer** D. Gwisdalla  
**Description** Fontanero Service Center, Fleet Maintenance. Leaking equipment. Note the liquid staining underneath the dump truck. The vehicle was dripping a fluid (possibly fuel) onto the ground. The vehicle was moved immediately to the leaking vehicle storage area.

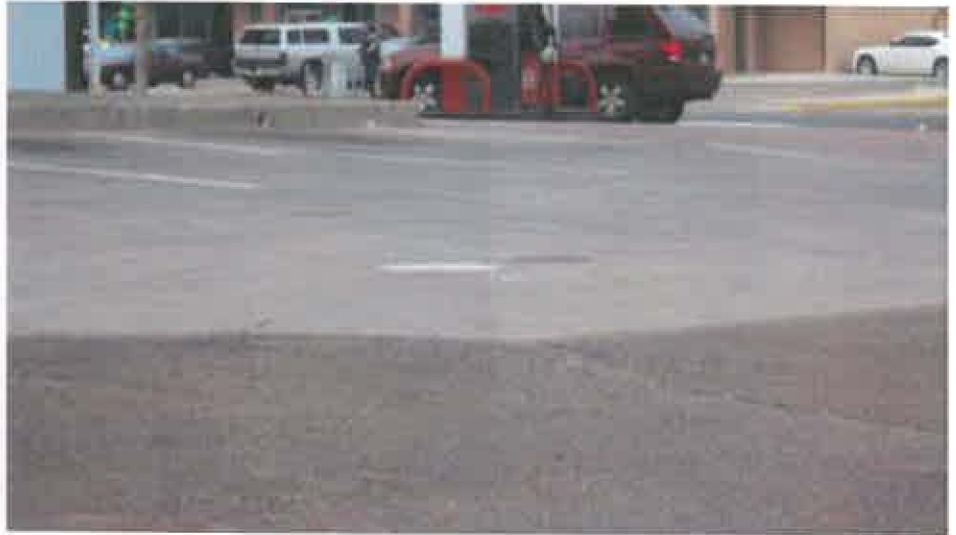
**Photo Number** 258

At the time of the follow-up inspection, it appeared that all clean-up activities had concluded. The EPA inspectors observed traces of the dry absorption chemical cleaning product on the pavement at the spill location (see photos 258-260 of IDDE Oversight photo log). There was also a sheen observed in a nearby storm sewer drain that had received the discharge (see photos 261 and 262 of IDDE Oversight photo log). Mr. Bouton indicated that he would follow-up with the responsible party to request additional clean-up of the site upon returning to the City office. It was brought to Mr. Bouton's attention that the weather conditions were overcast and snow was forecasted that afternoon. The EPA inspectors and Mr. Bouton left the site at 2:08 p.m. Snow began to fall in the area around 3:00 p.m., at which time Mr. Bouton had yet to contact the responsible party to instruct them to clean-up the residual materials observed at the site.

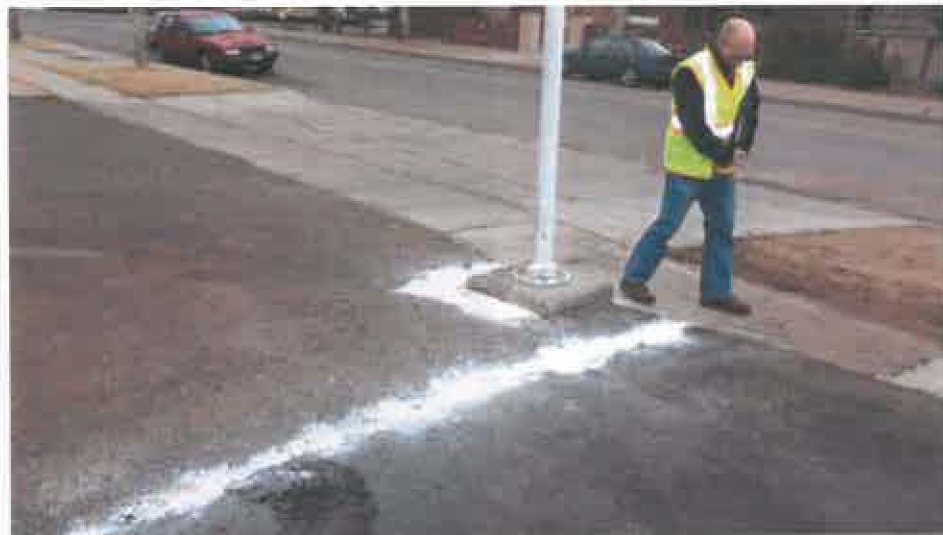
**Photo Number** 260  
**Inspection Date** 2/6/2013  
**Photographer** A. Tien  
**Description** Conoco Site Visit-  
Photo of gasoline  
spill area. Note  
staining on  
pavement and  
residual white dry  
clean-up chemicals  
remaining on site.

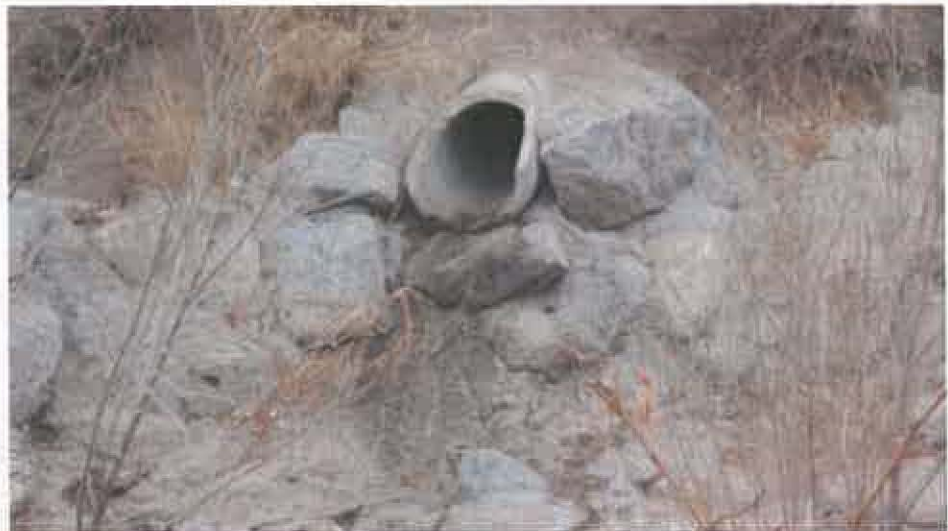
**Photo Number** 264  
**Inspection Date** 2/6/2013  
**Photographer** A. Tien  
**Description** Sunrise Kennels and  
Dog Training Center  
Site Visit - Close- up  
of pipe (center of  
photo) with evidence  
of discharge along  
the hillside behind  
the facility.
