Leak Detection & Repair

COMMONWEALTH UTILITIES CORPORATION WATER DIVISION

Leak Detection and Repair Phase II

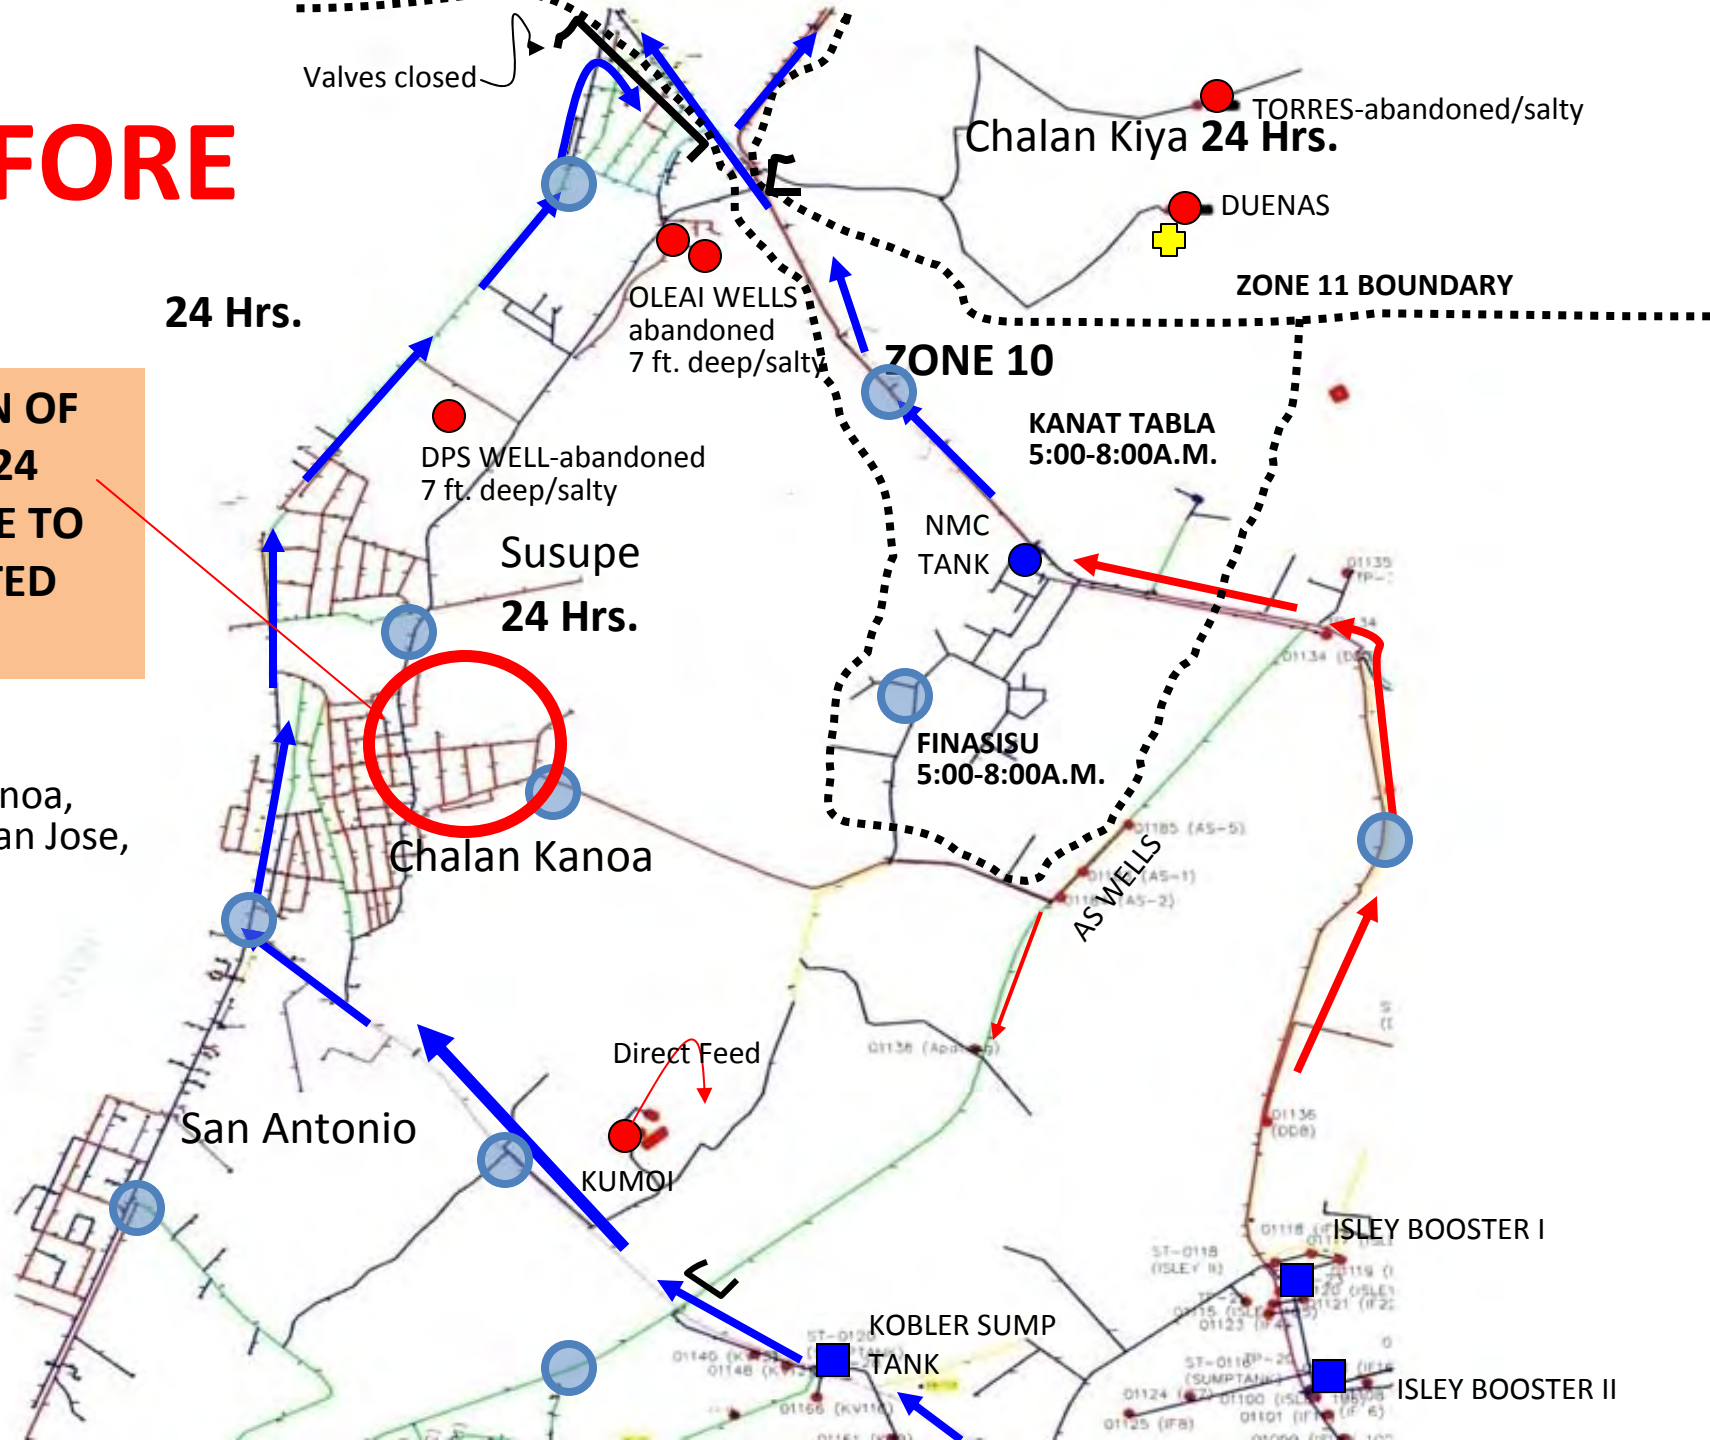
PORCION OF CK NOT 24 HRS. DUE TO SUSPECTED LEAKS

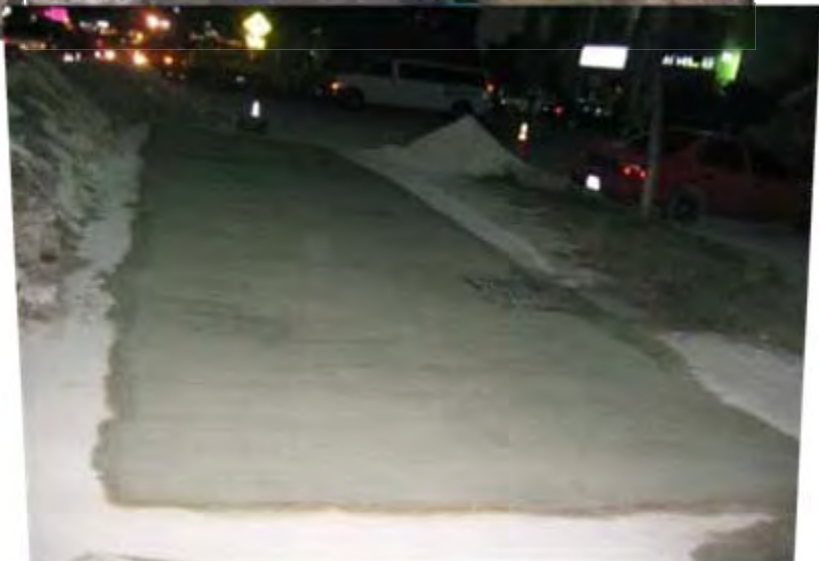
Leak Repair – 12" Ø PVC

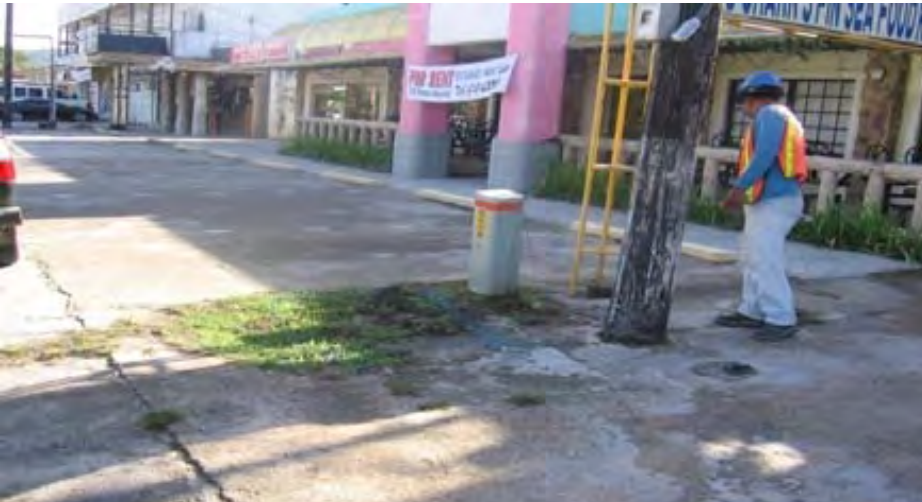
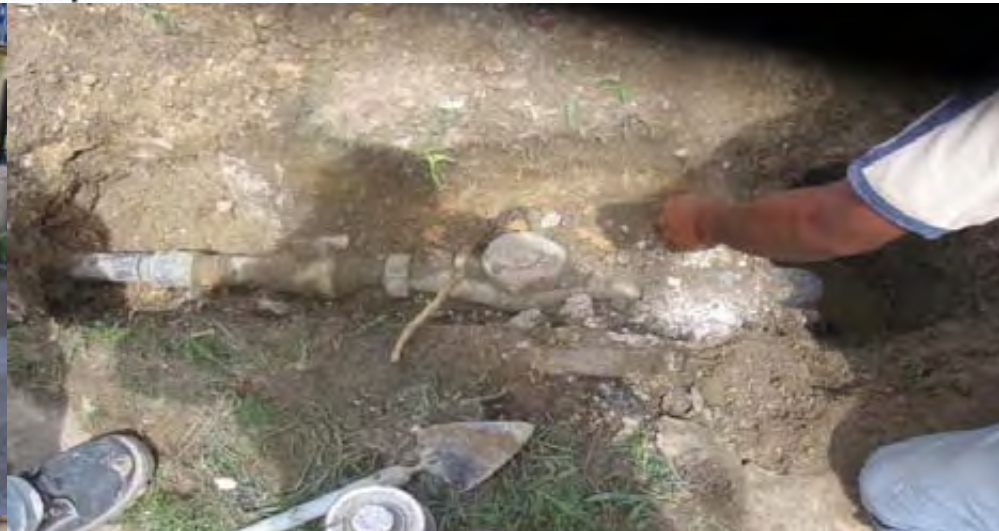
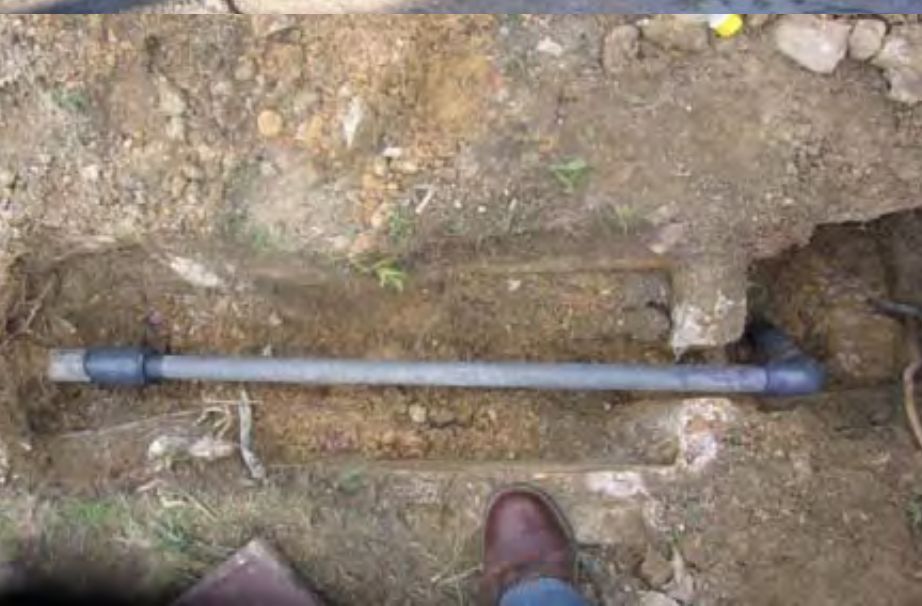
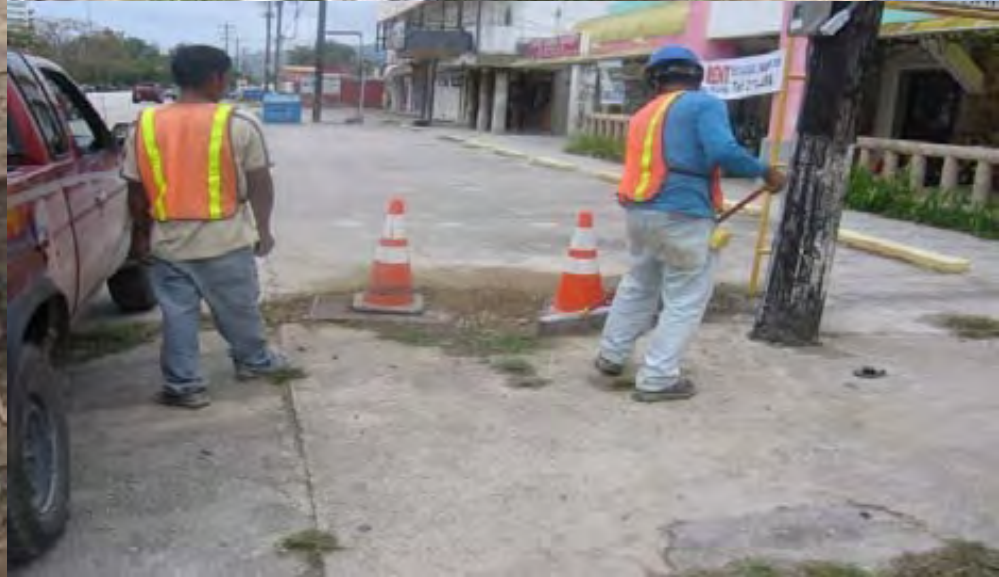
Leak Repair –2" x 1-1/4" dia PVC

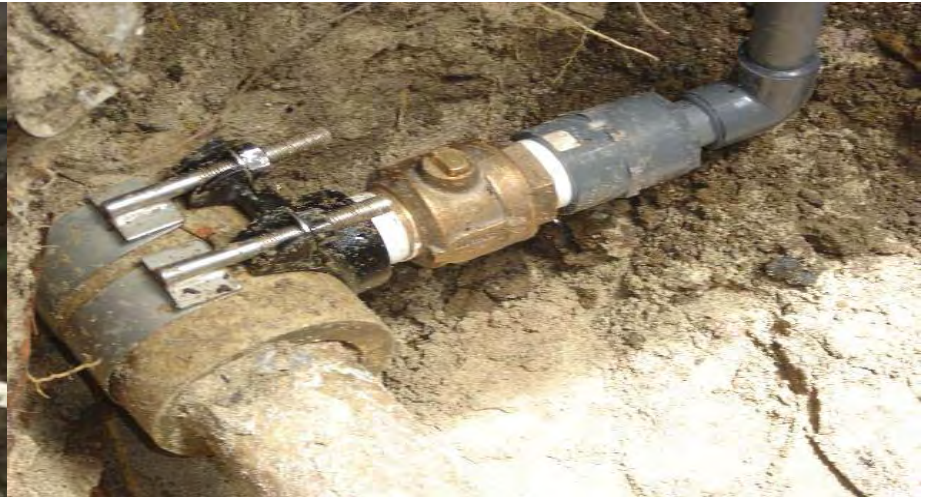
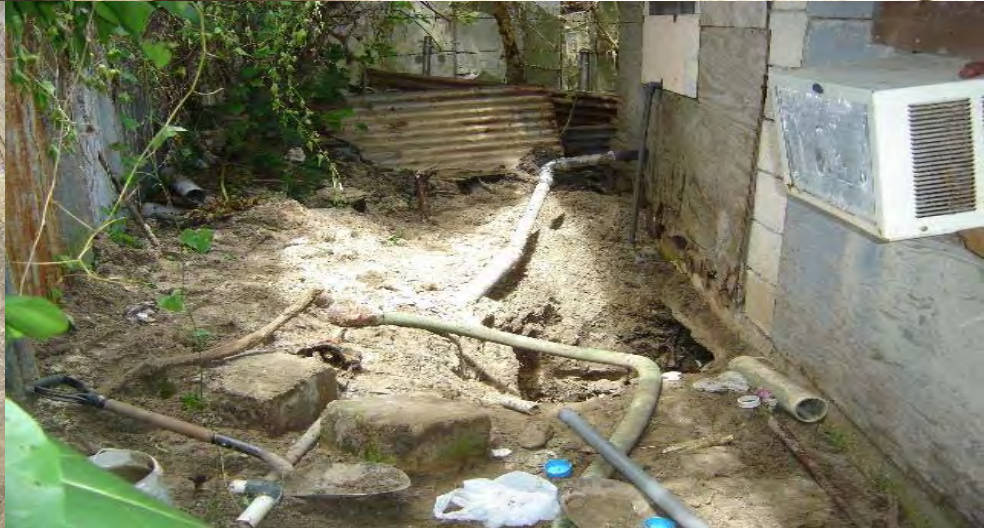
Leak Repair –6" x 2" Service Saddle and 2" Corporation Stop
San Antonio

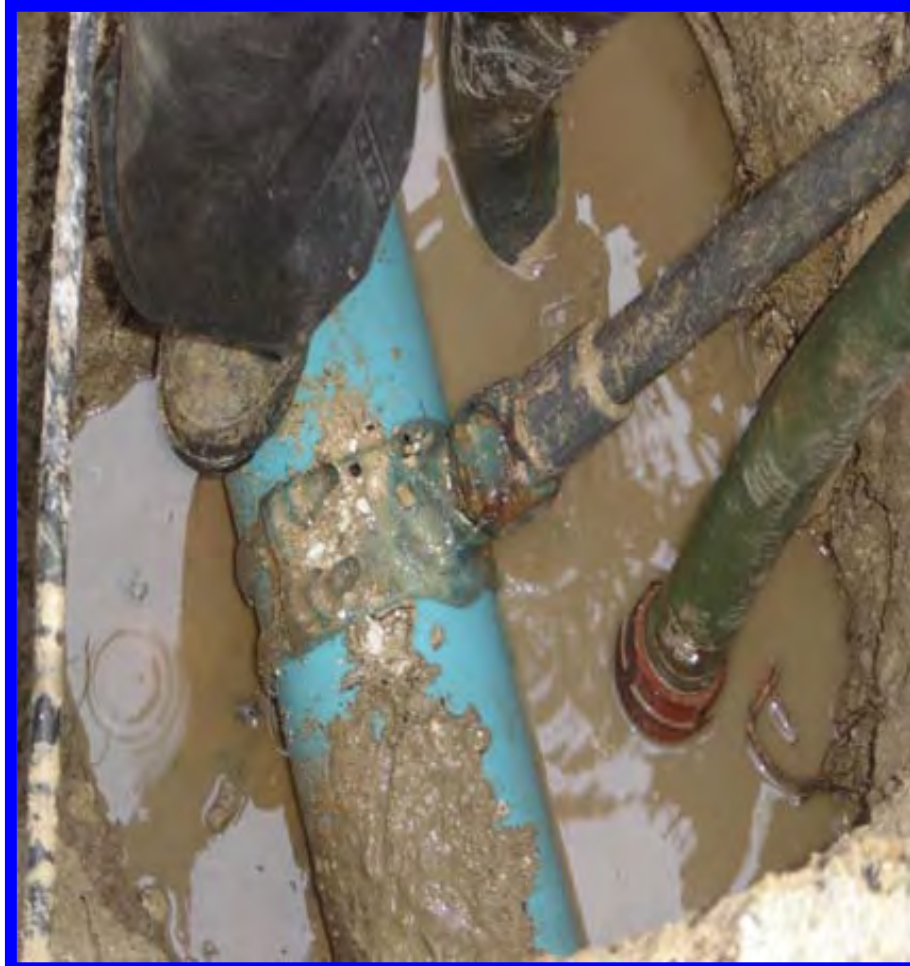
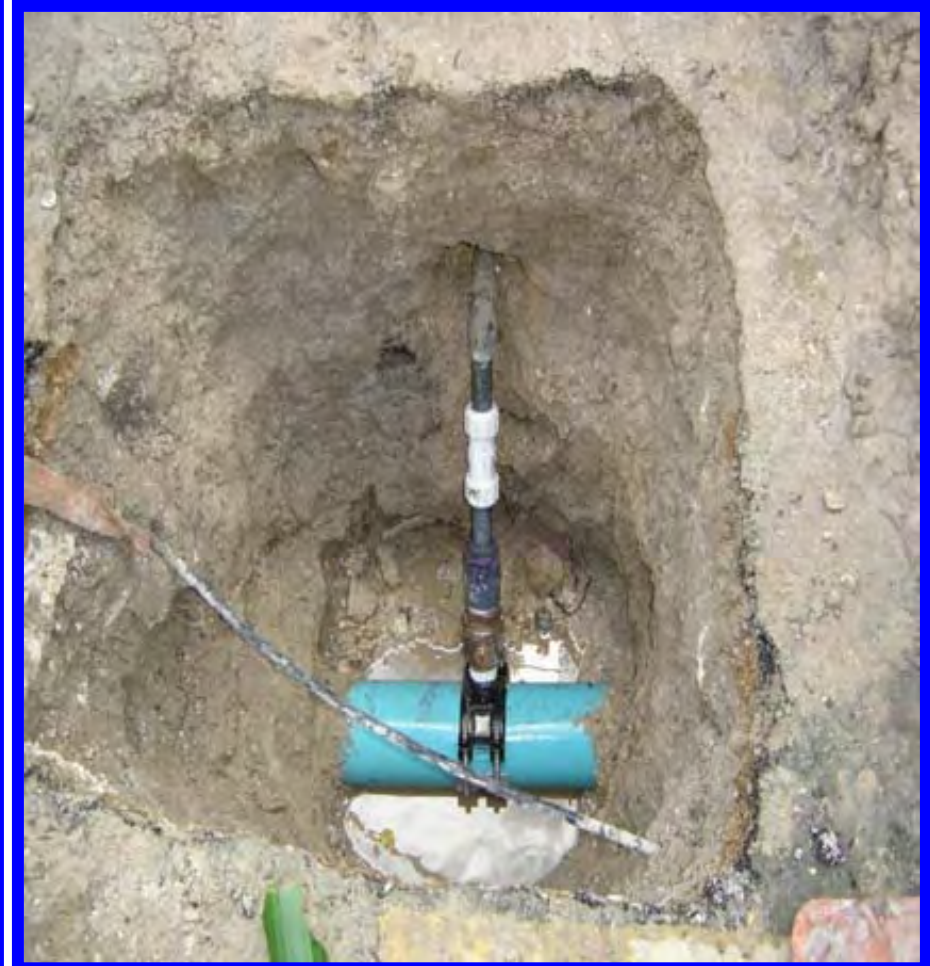
Leak Repair –6" x 2" Service Saddle and 2" Corporation Stop
Chalan Kanoa

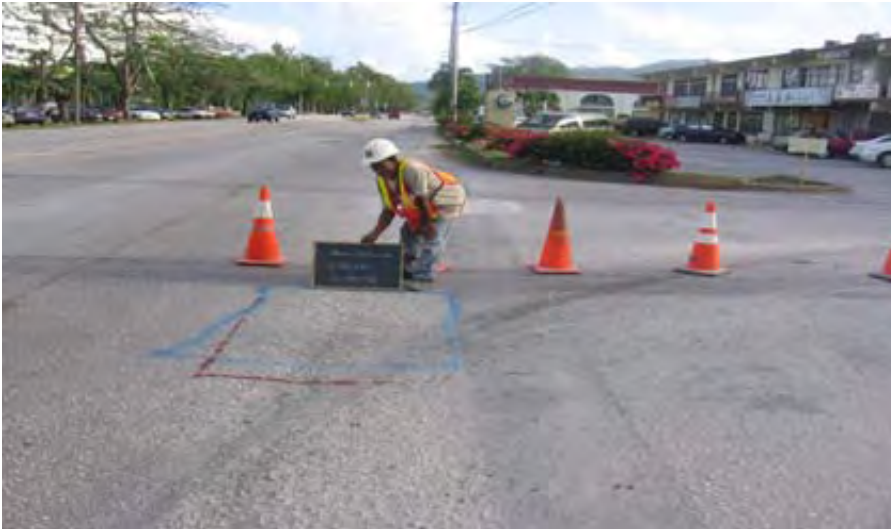
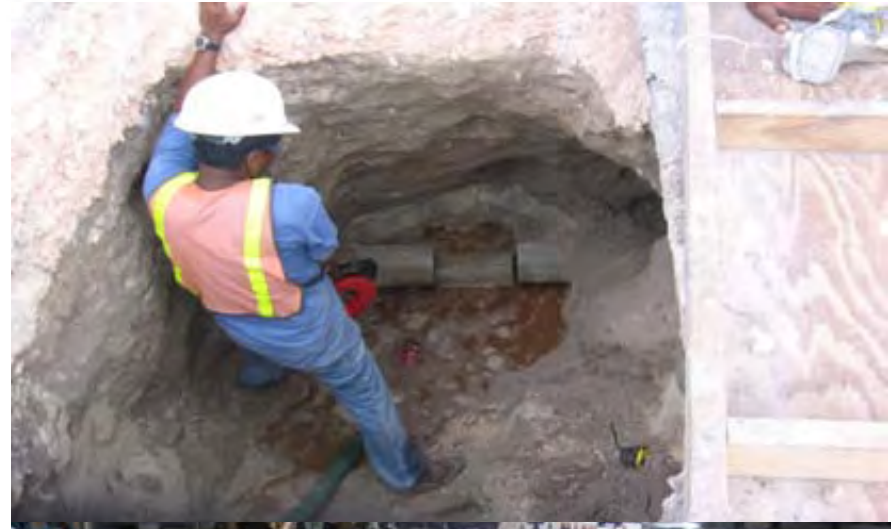
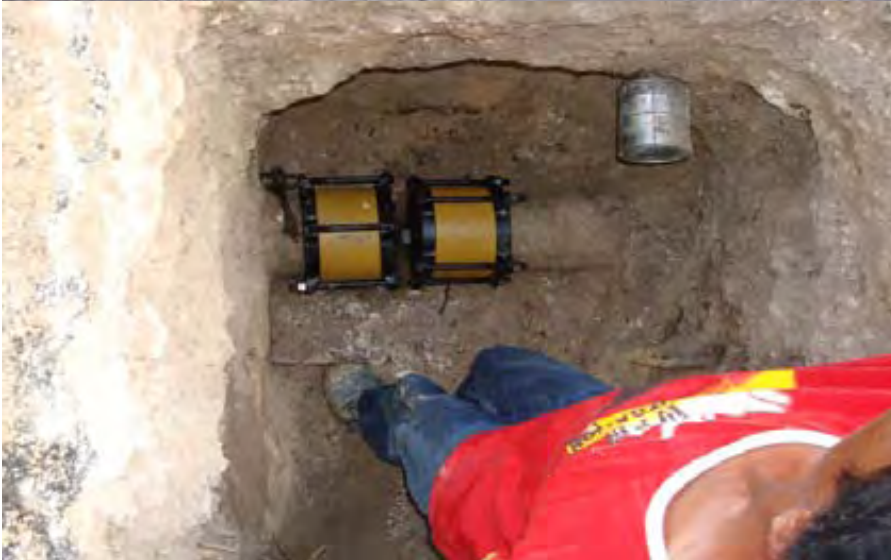
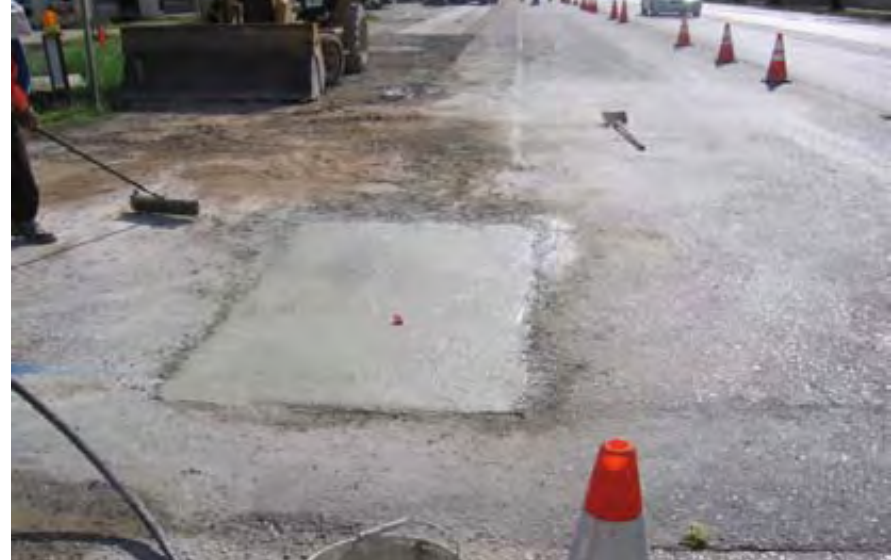
Cut & Cap –6" ACP
Susupe

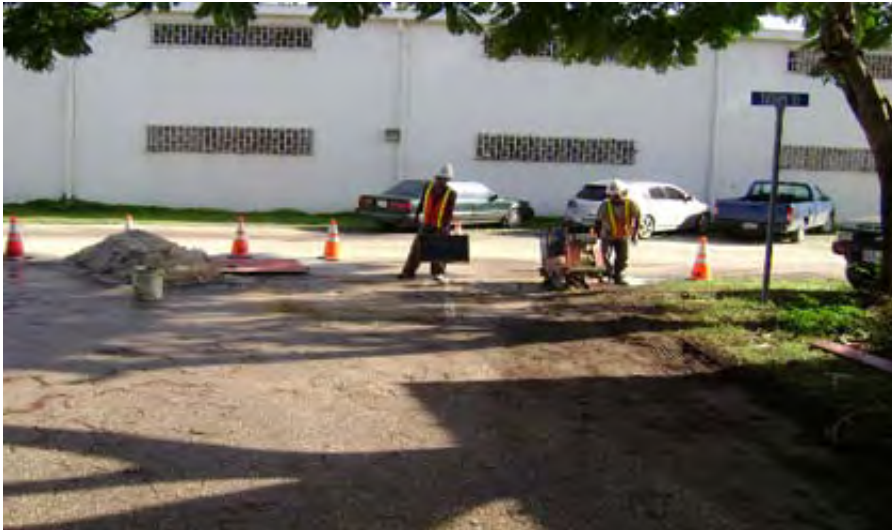
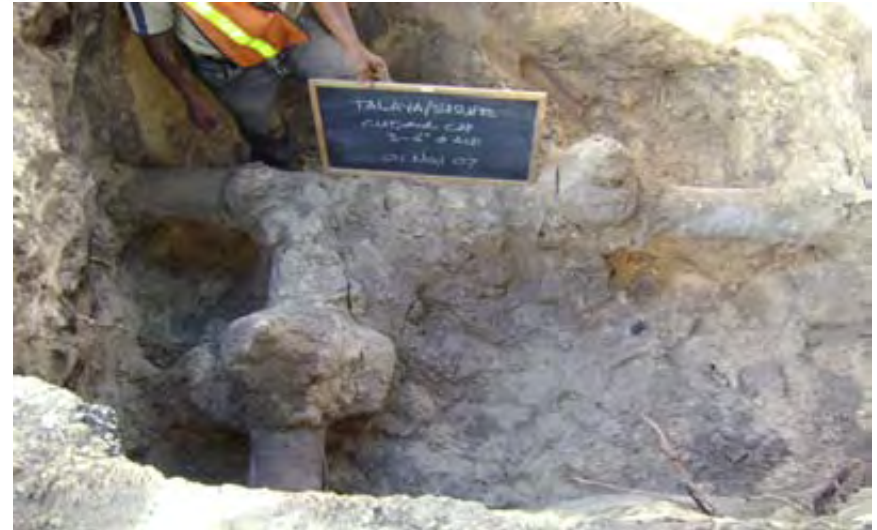
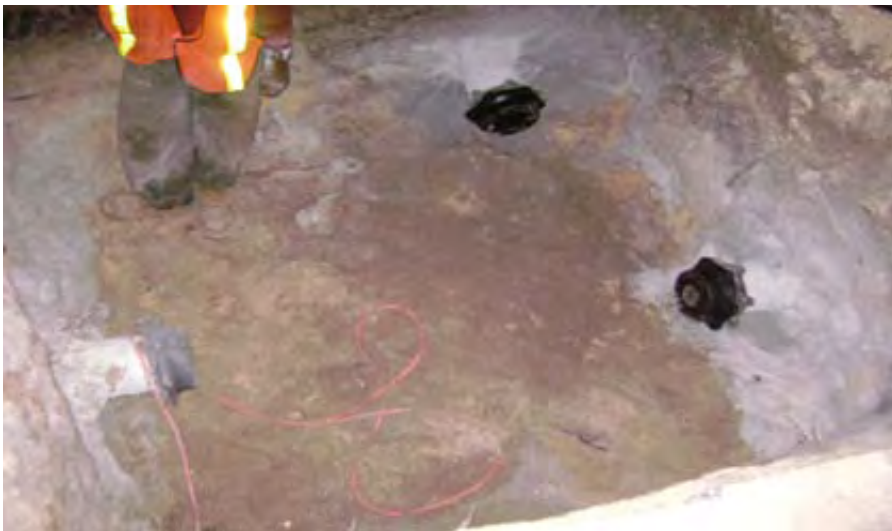
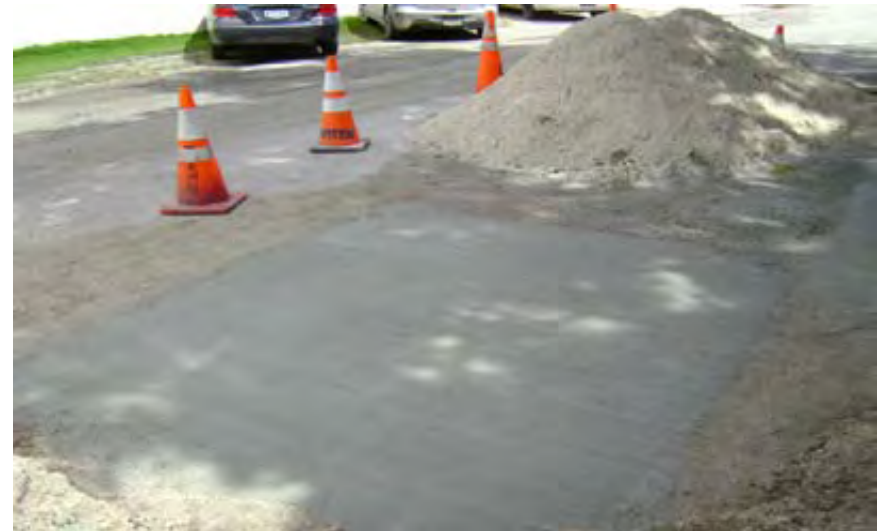
Cut & Cap 6" ACP

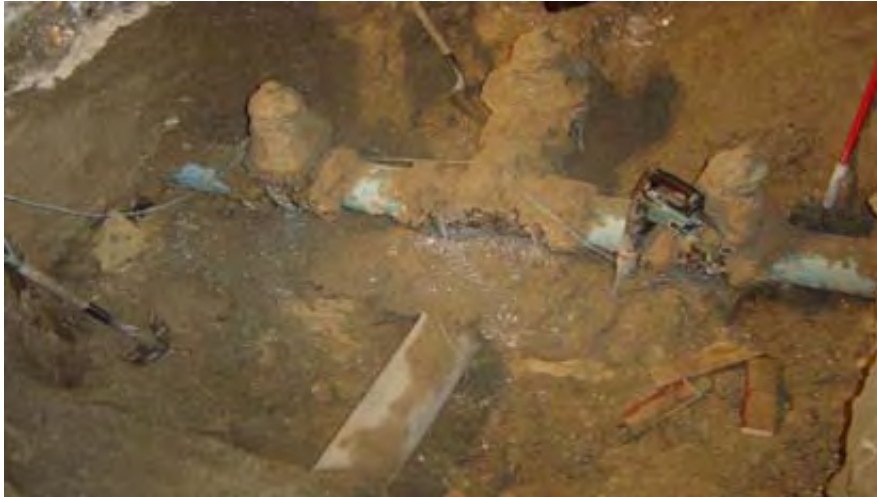
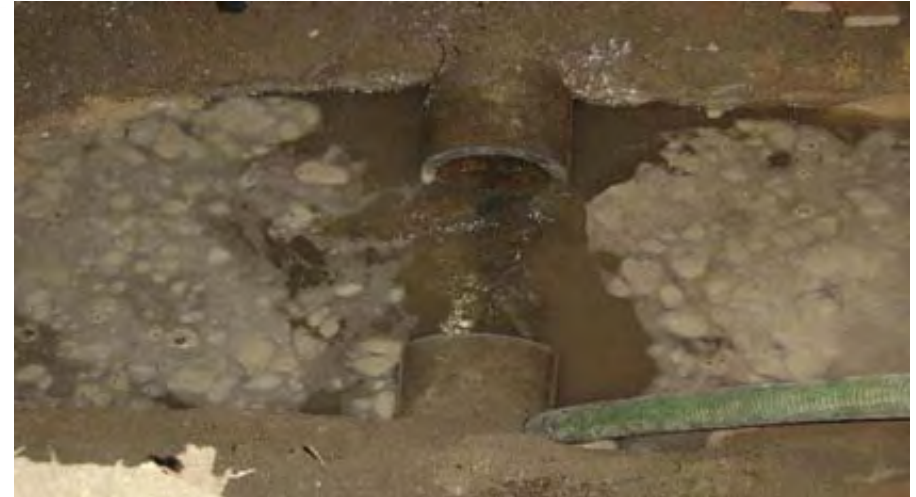
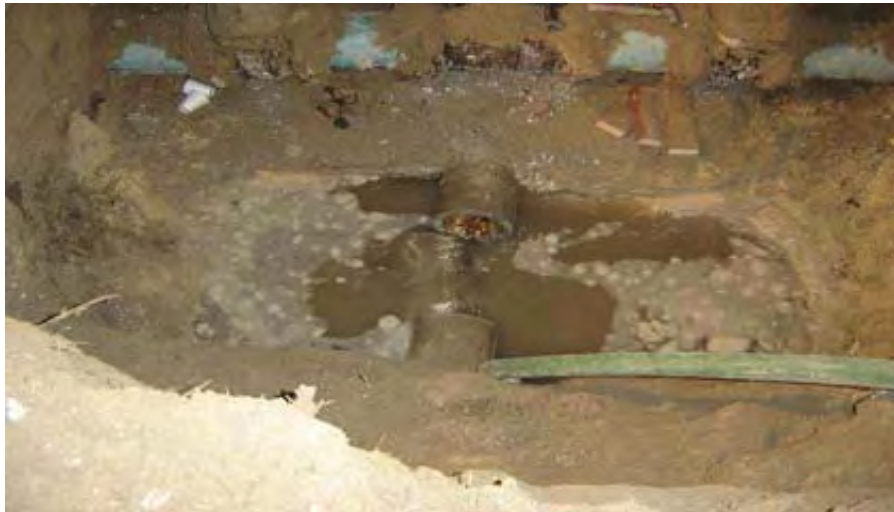
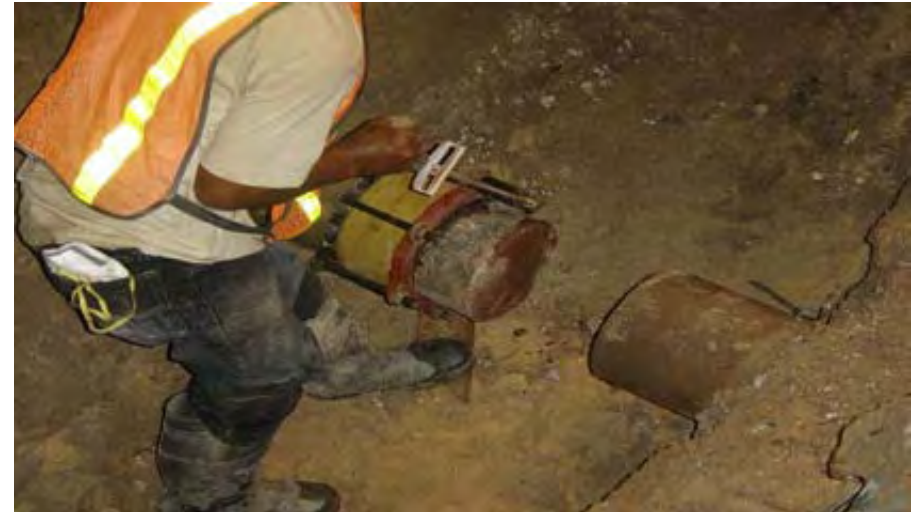
Cut & Cap – Undocumented Lines

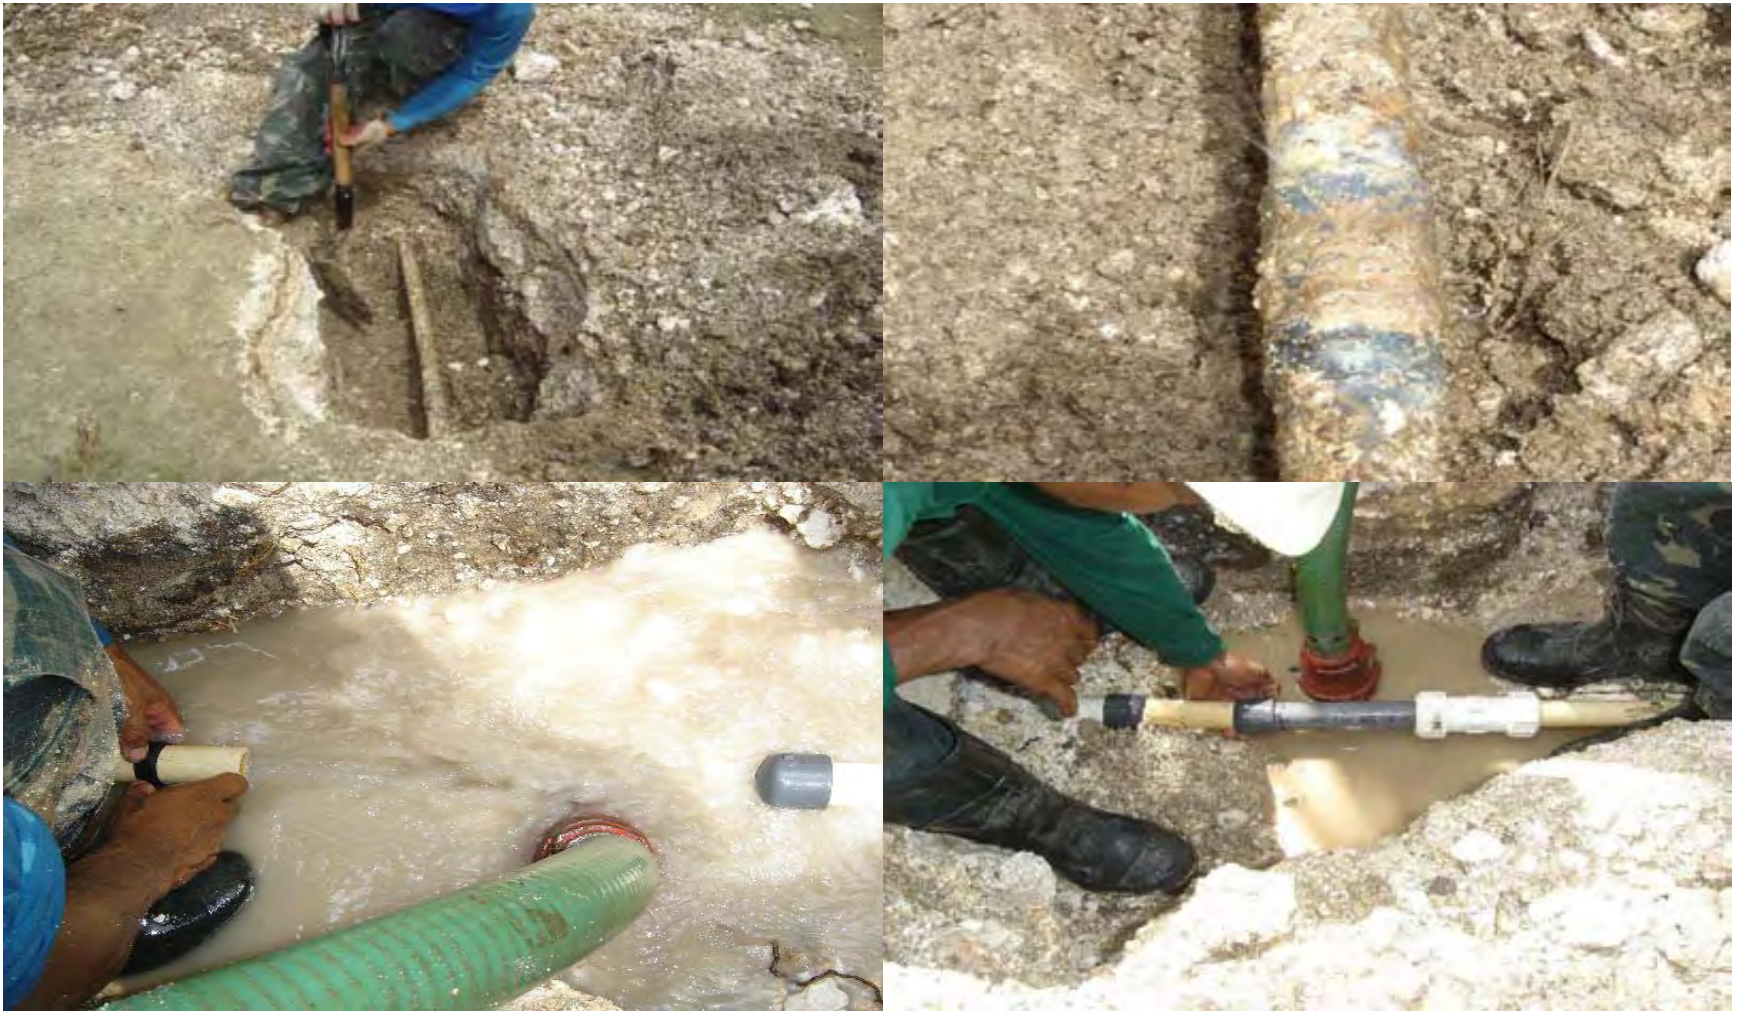
Cut & Cap – Undocumented Lines
San Antonio, Across from PIC

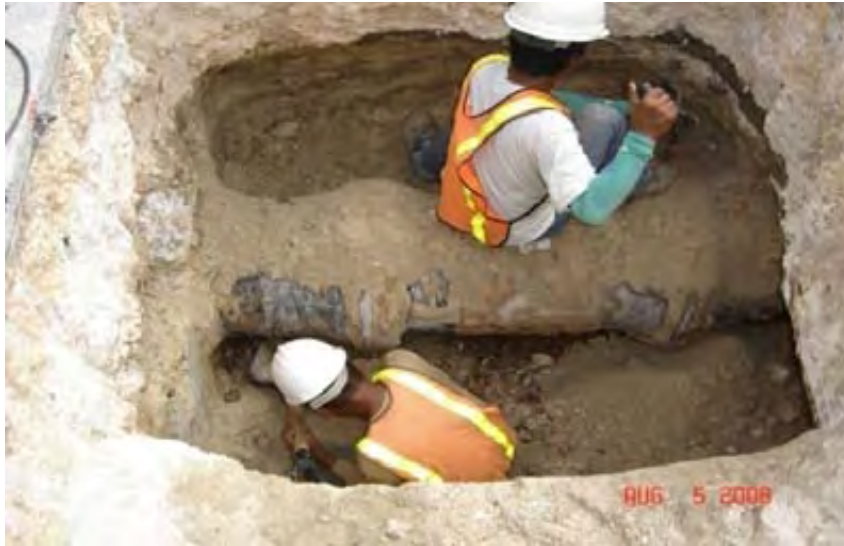
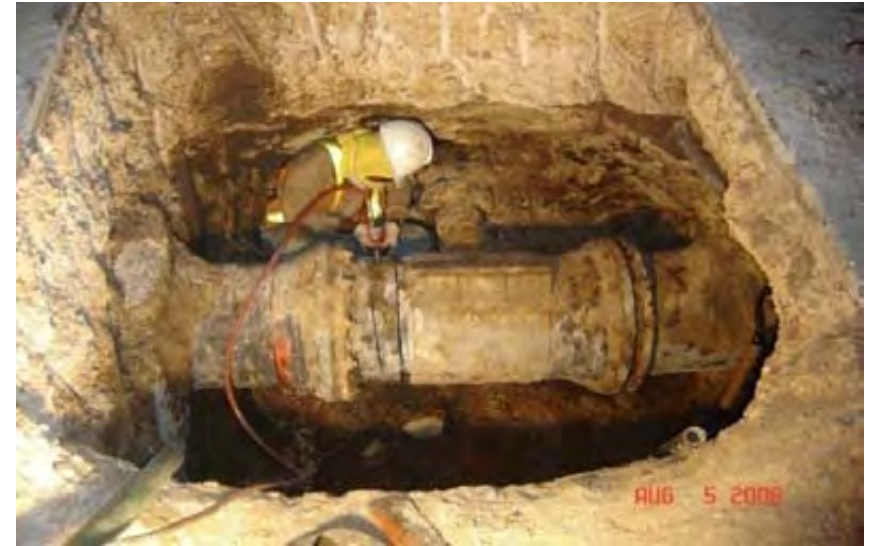
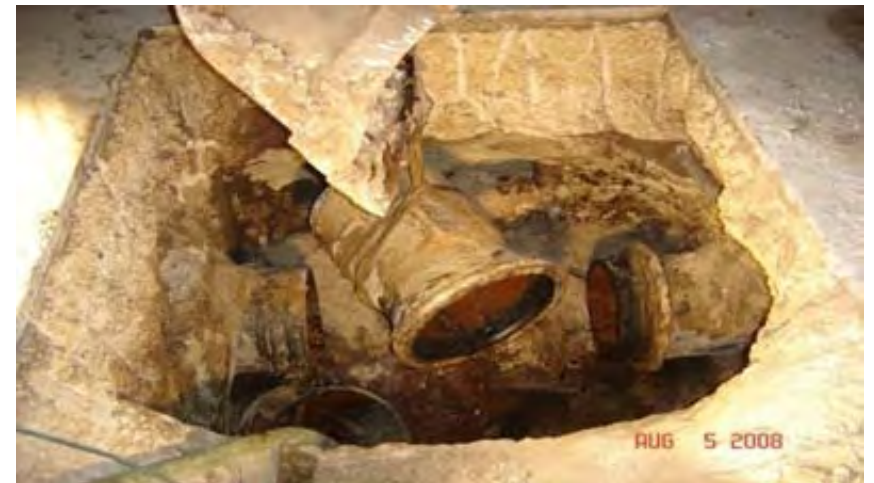
Butterfly Valve Installation – 18" Ø Butterfly Valve

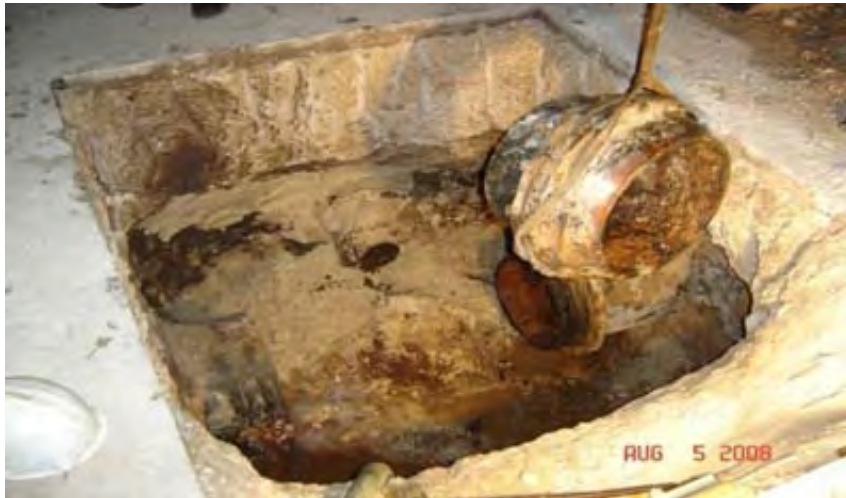
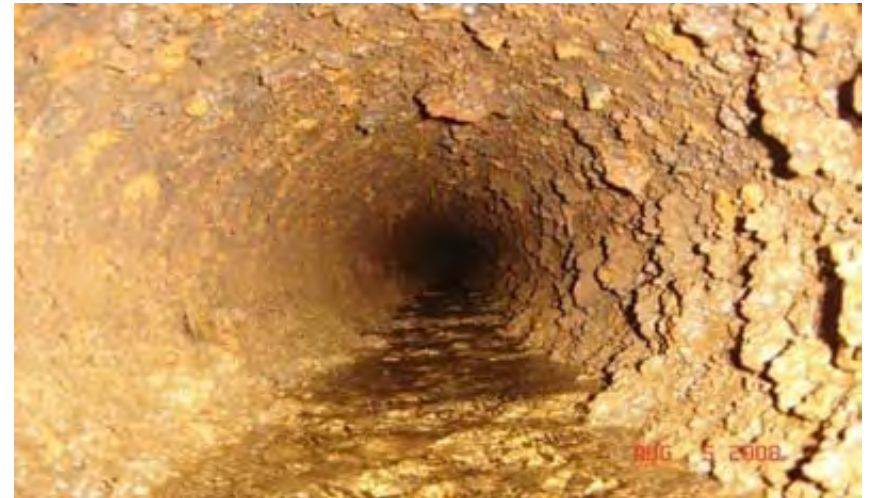
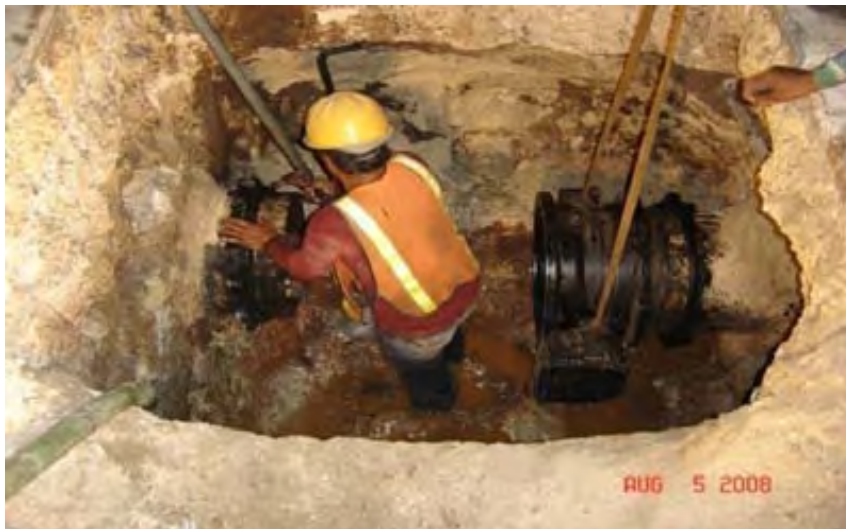
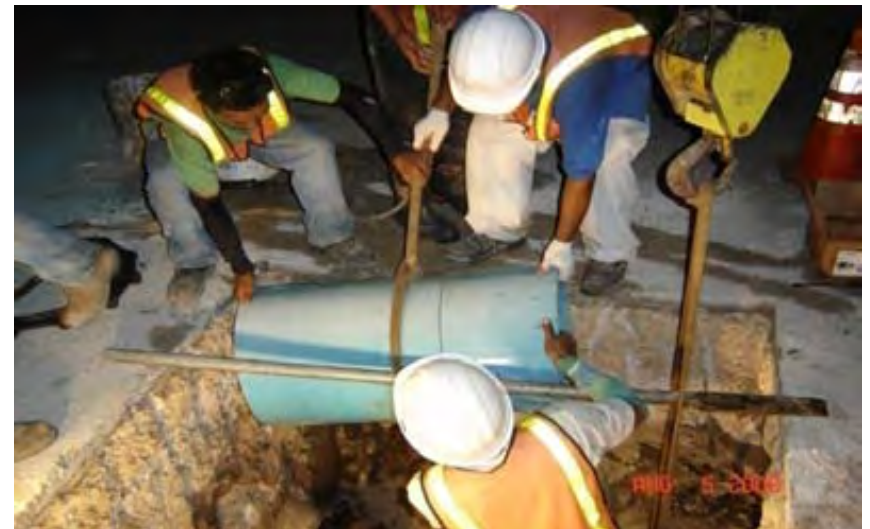
Butterfly Valve Installation – 18" Ø Butterfly Valve
As Perdido

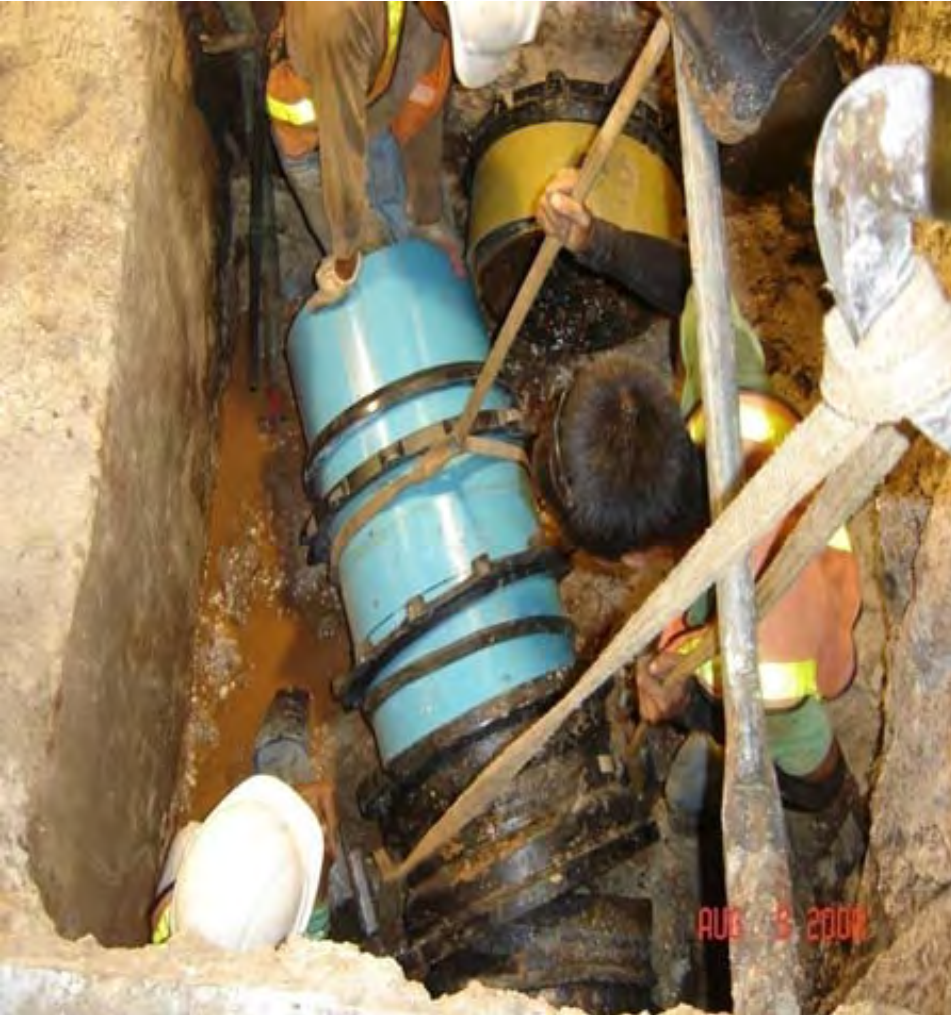
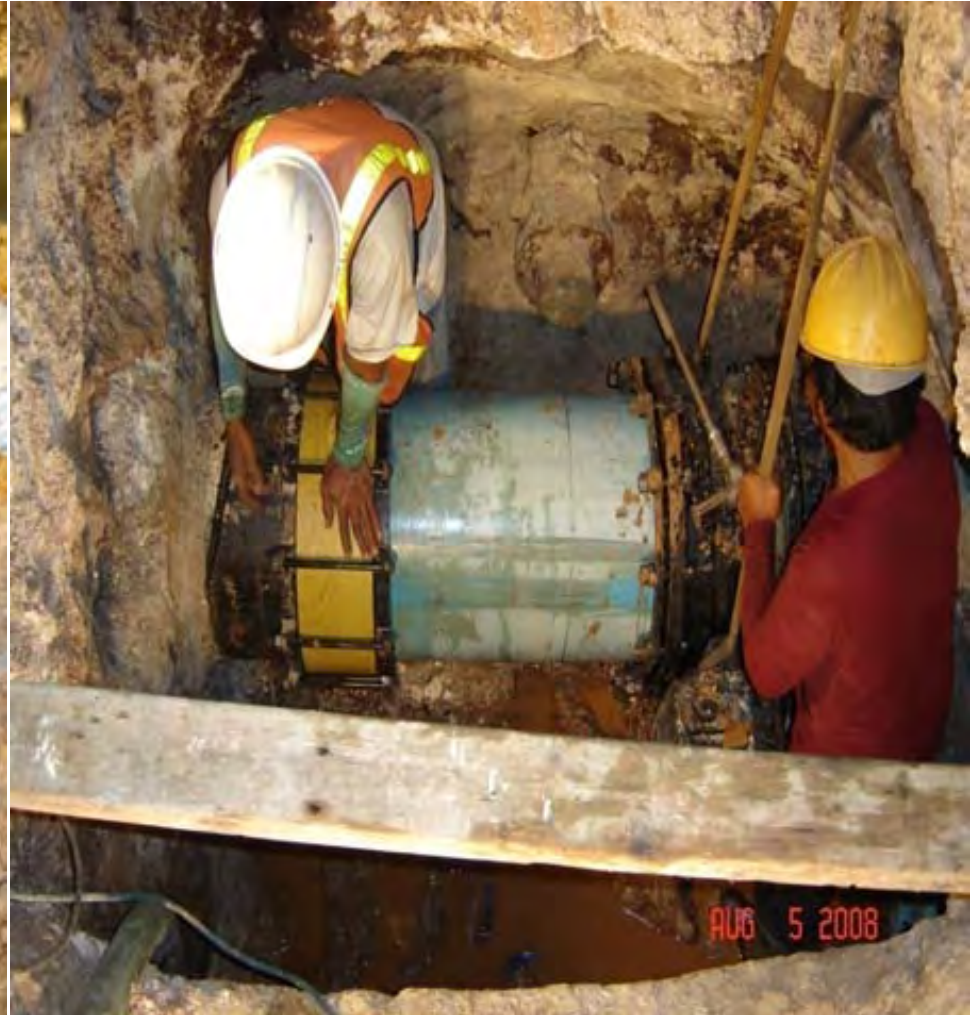
Butterfly Valve Installation – 18" \varnothing Butterfly Valve
As Perdido

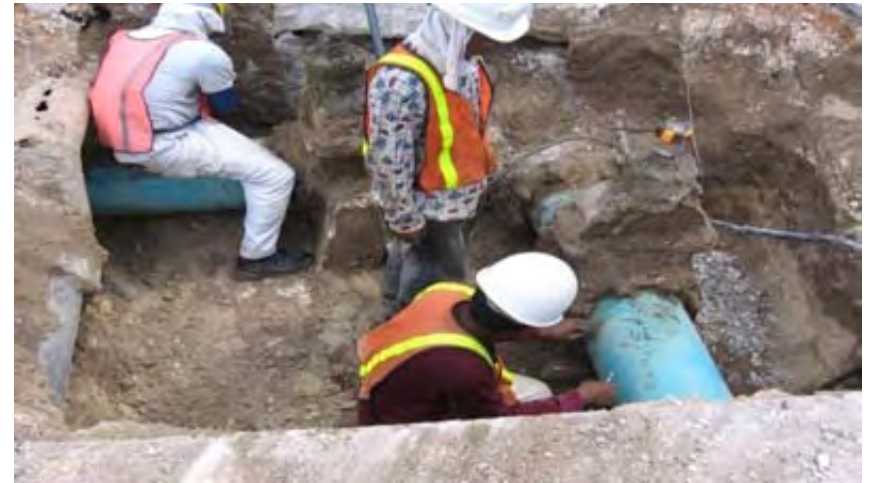
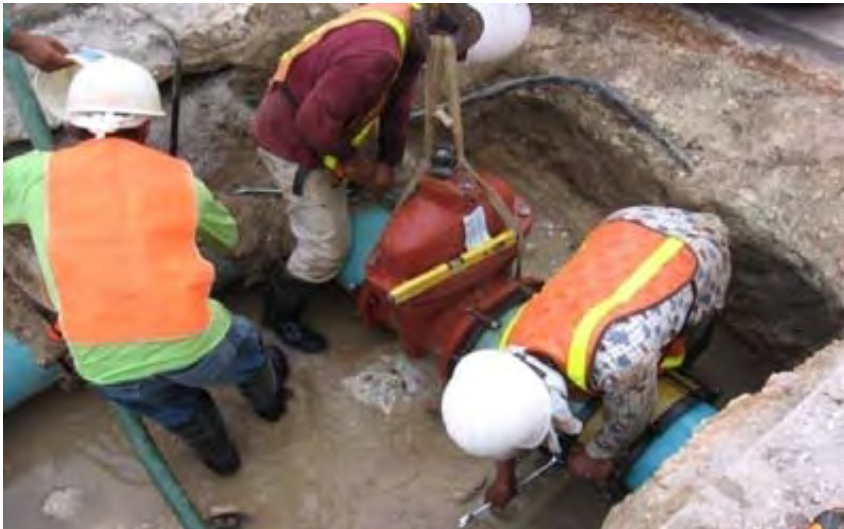
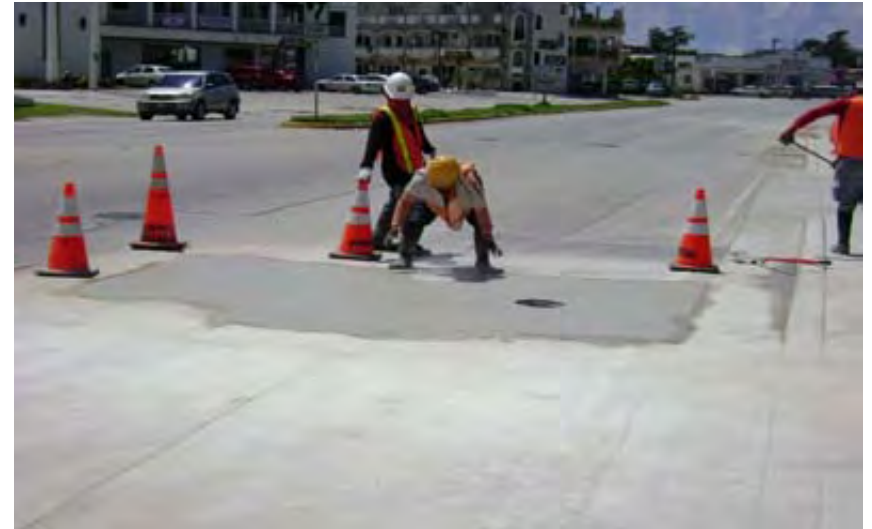
Gate Valve Replacement – 12" Ø Gate Valve
As Perdido

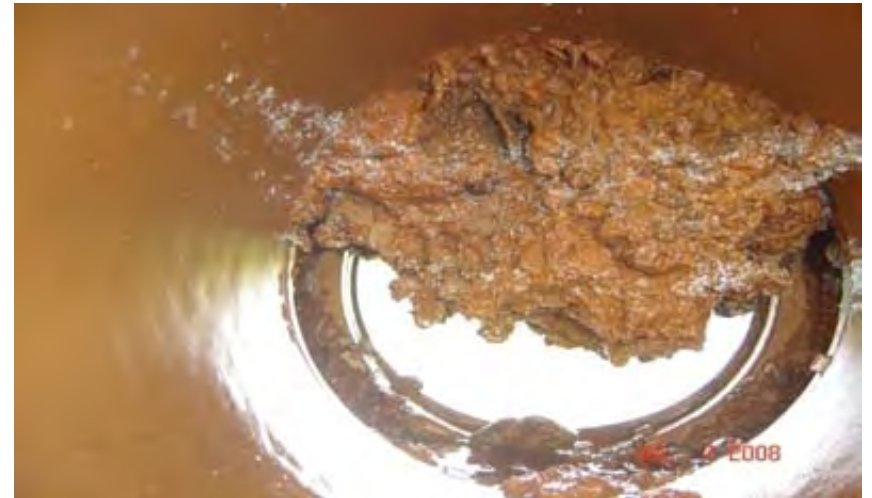
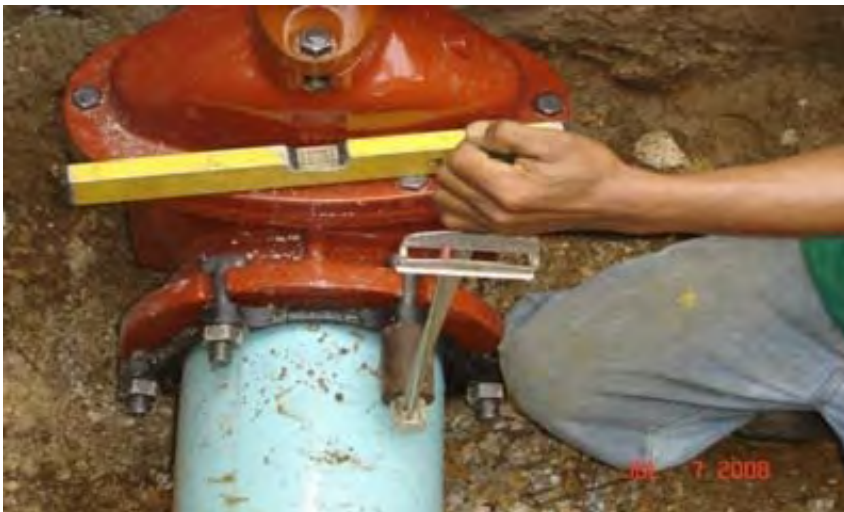
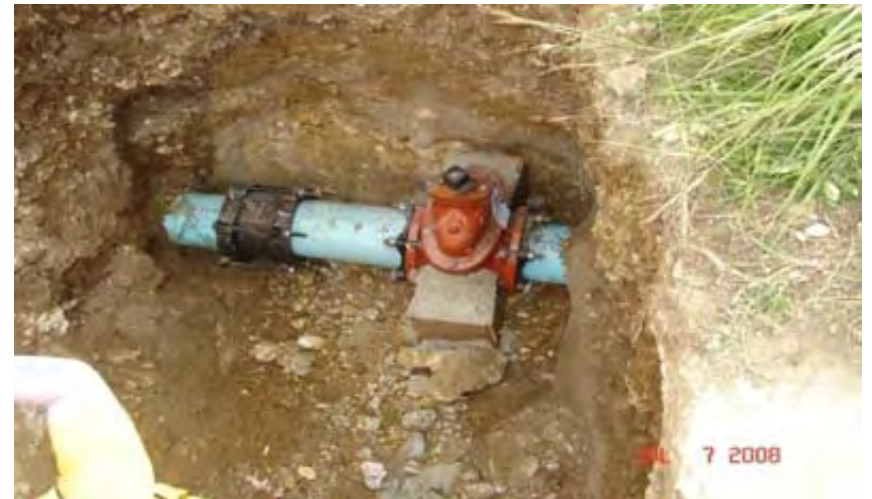
Gate Valve Replacement – 8" Ø Gate Valve
Koblerville
