Leak Detection & Repair

COMMONWEALTH UTILITIES CORPORATION WATER DIVISION

Leak Detection and Repair Phase II

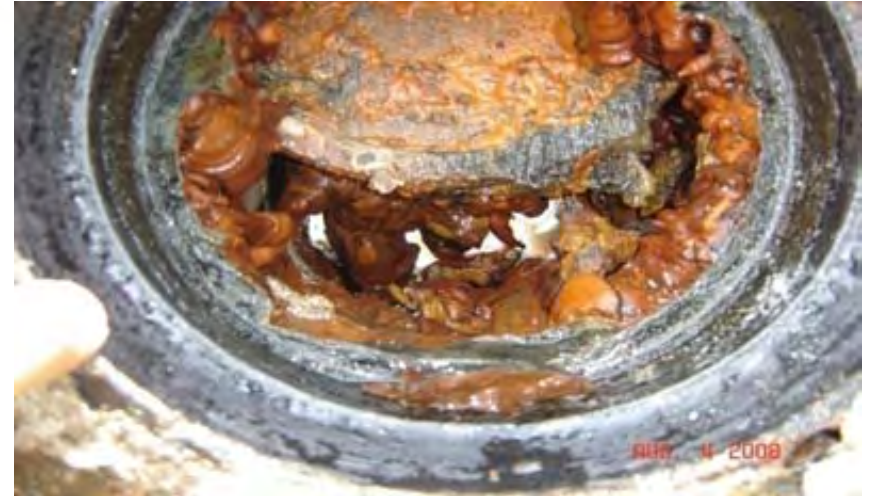
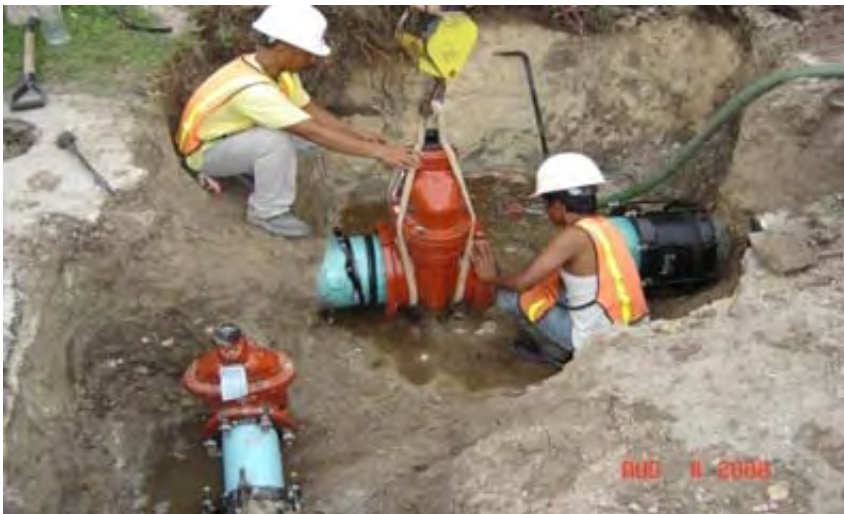
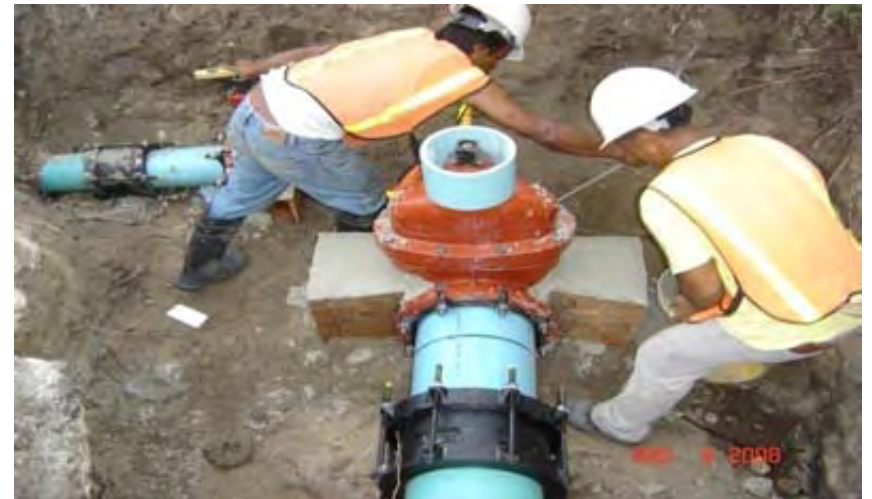
Gate Valve Replacement –6" and 12" Ø Gate Valve

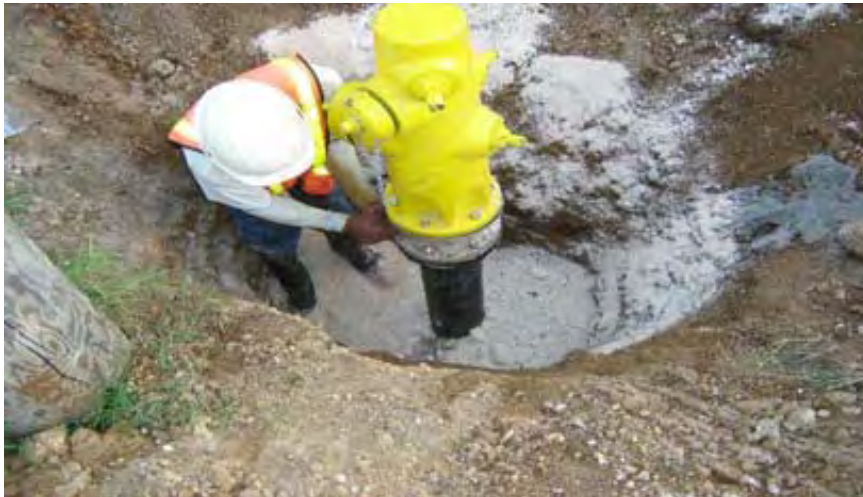
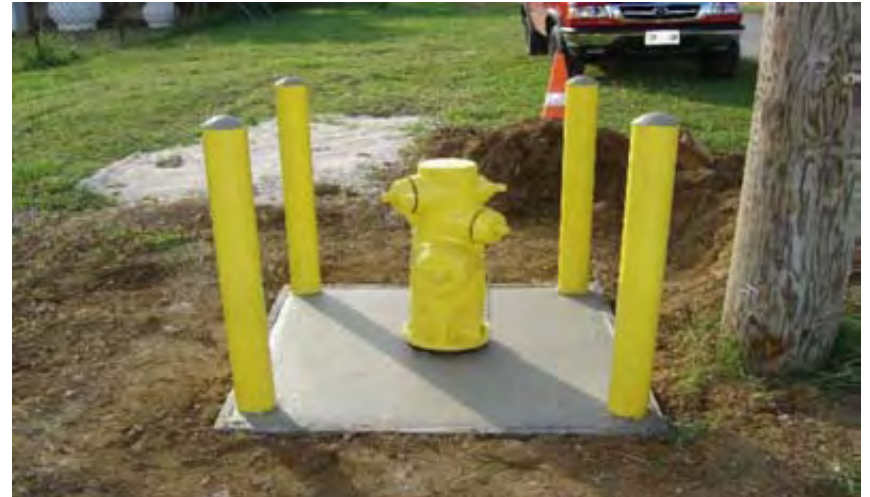
Replacement of Fire Hydrant & Assemblies
Koblerville

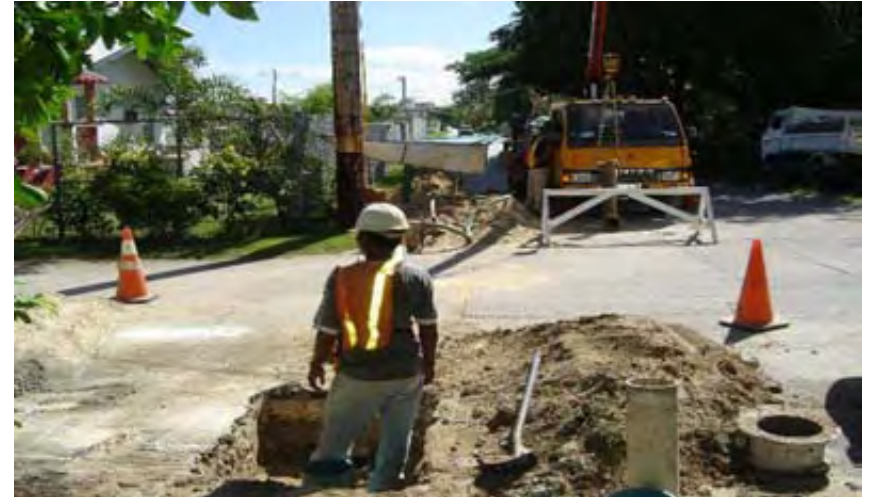
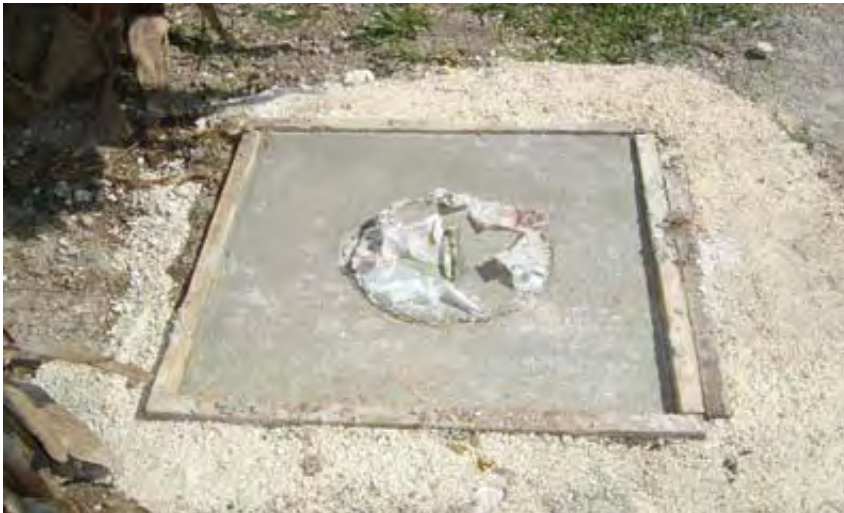
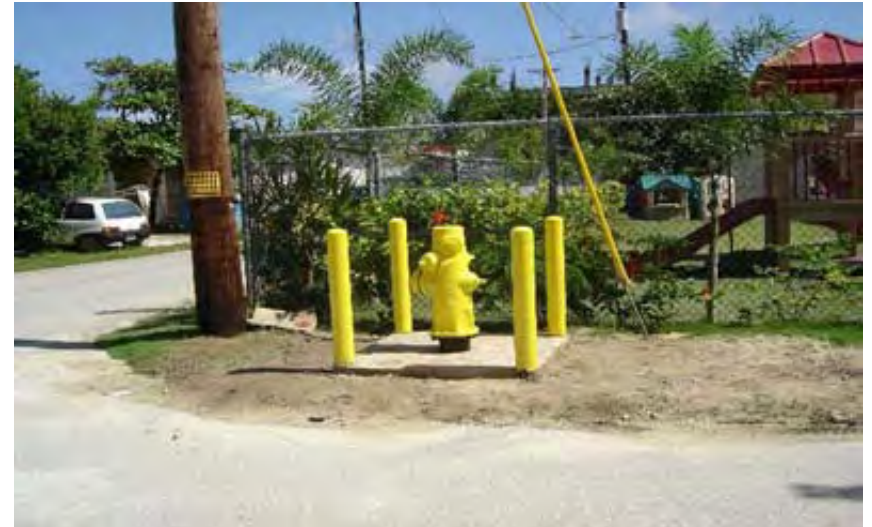
Replacement of Fire Hydrant & Assemblies

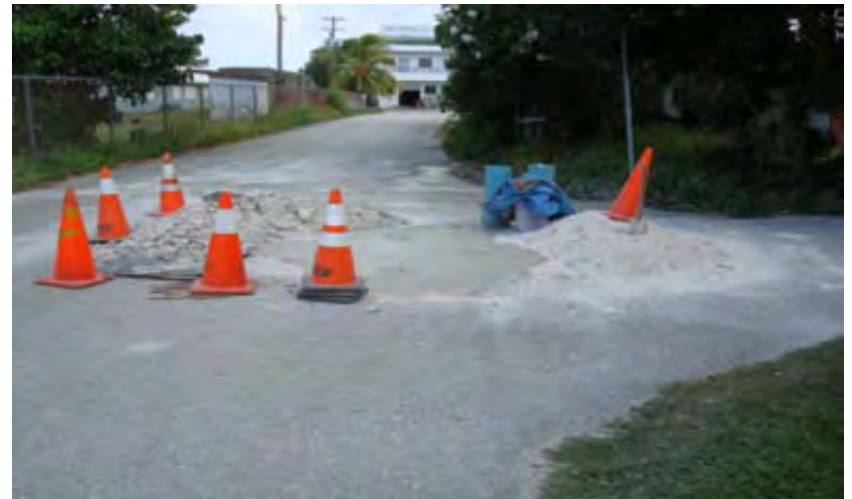
Valve Box Raising
Chalan Kanoa
