UNITED STATES ENVIRONMENTAL PROTECTION AGENCY
REGION IX
75 Hawthorne Street
San Francisco, CA 94105

WASTE MANAGEMENT DIVISION
RCRA ENFORCEMENT OFFICE

Purpose: RCRA Investigation

Facility: Chemical Waste Management, Inc.

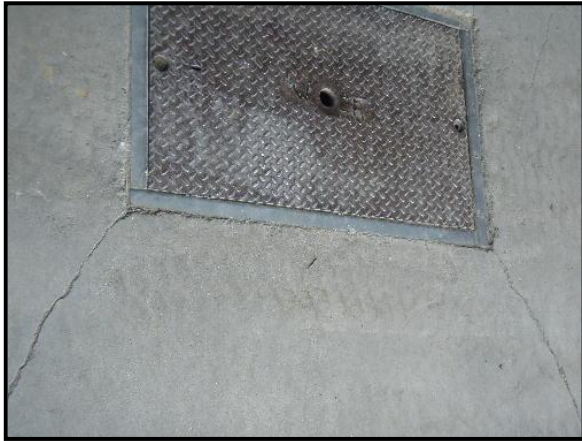
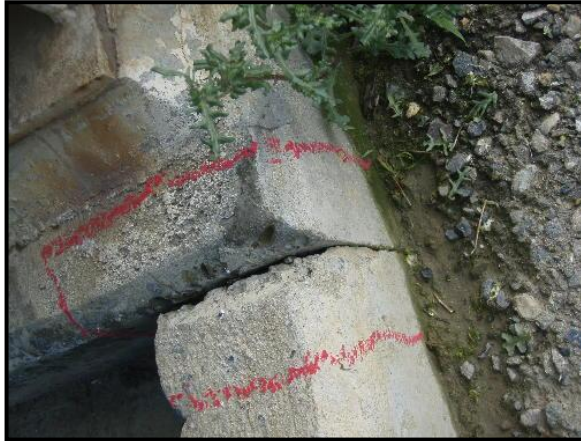
The base of the unit consists of a concrete pad underlain by a high density polyethylene (HDPE) liner. The pad is equipped with an HDPE-lined sump. The inspectors noted some cracks in the concrete flooring and in the berm which runs along the perimeter of the DSU (see photographs below).

EPA's review of the DSU's as-built diagram verified that the secondary containment capacity calculations were based on the footprint of each cell and not the perimeter of the DSU where the cracks in the above photographs were observed.

EPA observed that cracks located within the secondary containment area were repaired.

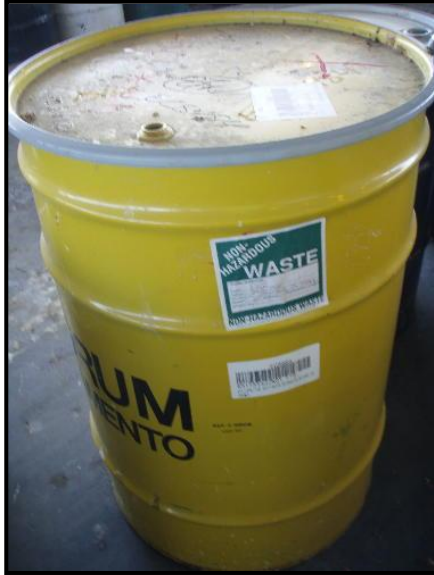
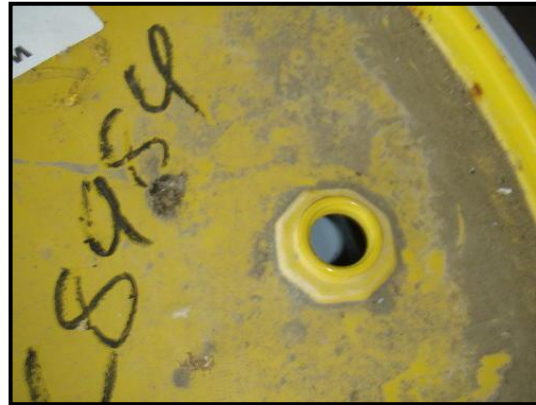
In B-Cell the inspectors noted one 55-gallon container filled with non-RCRA oily water that had an open bung (see photographs below). The facility representatives replaced the missing bung while the inspectors were there.

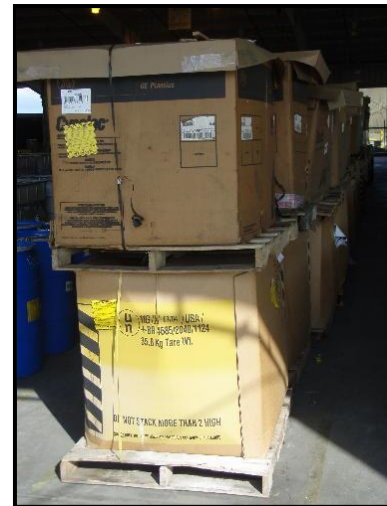
In C-Cell the inspectors noted that cardboard one-cubic card boxes were being stacked two high with a pallet underneath and between the boxes (see photograph to the right). CWM's Hazardous Waste Facility Permit allows for containers to be stacked to 72 inches in total container height, not including any pallet between the stacked containers. It appeared that the containers were right at the height limit so the inspectors cautioned CWM to ensure that none of their containers were stacked too high.

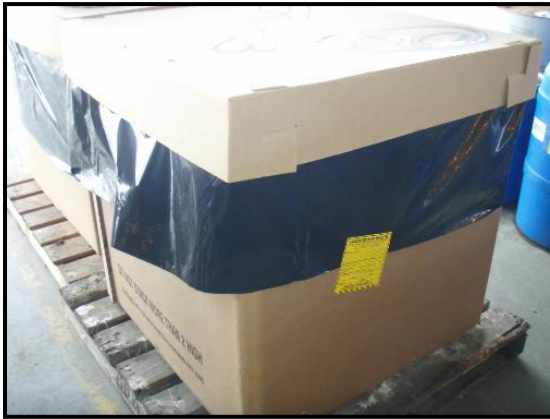
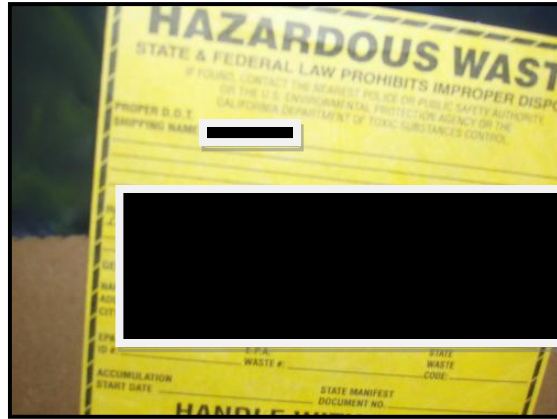
The inspectors noted a couple of dented containers in the F-Cell area although neither appeared to be leaking. The inspectors also found two cardboard cubic yard boxes filled with used aerosol cans (see photographs below). The generator's hazardous waste labels described the contents as "flammable aerosol cans-spent (Universal Waste)". It was unclear to the inspectors whether the aerosol cans were to be shipped off as hazardous waste or universal waste. According to facility representatives, CWM accepts universal waste, repackages it (if appropriate), and then sends it off to Veolia Environmental Services for recycling. When the inspectors returned to the DSU the following day they noted that the hazardous waste label had been removed and a new label affixed that described the contents as universal waste flammable aerosol cans.

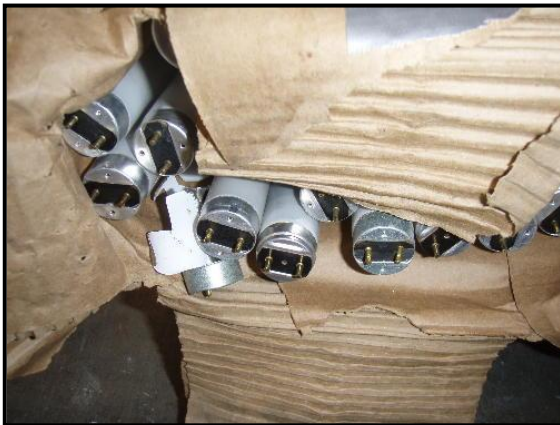
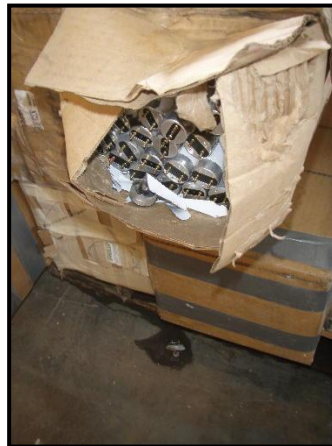
G-Cell

The inspectors found two containers of universal waste lamps that were left open (see photographs below). A lamp in one of the containers was broken and a small amount of liquid (rainwater which collected on the container from the recent rain) and glass were observed on the floor underneath the container (see photograph below on the right). The containers also were not marked with the words "universal waste – lamps" as required.

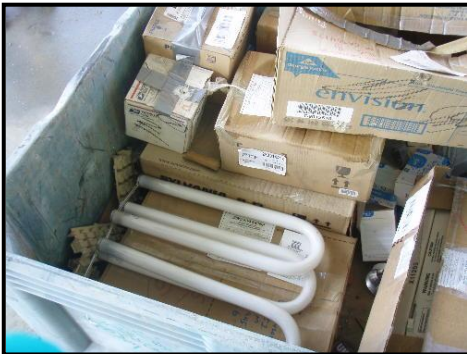
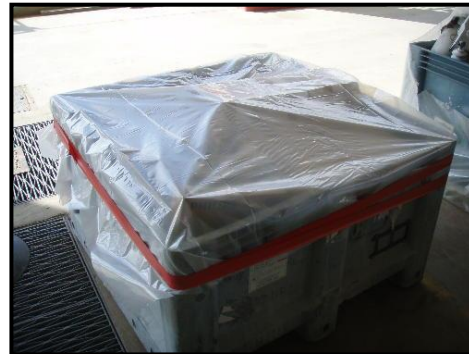
The inspectors also noted an open tote container filled with miscellaneous universal waste lamps in this area. Several of the lamps were not in an enclosed container as required (see photograph below on the left). When the inspectors returned to the DSU on the third day of the investigation they noted that facility representatives had corrected the potential violation and that all lamps were fully enclosed in cardboard boxes and that the tote container had been covered with plastic (see photograph below on the right).

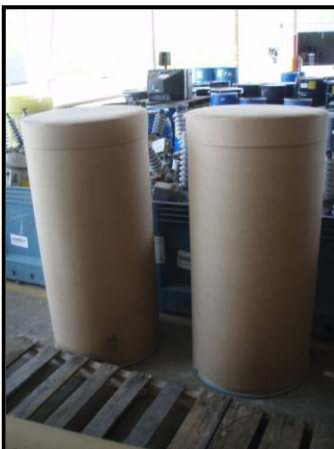
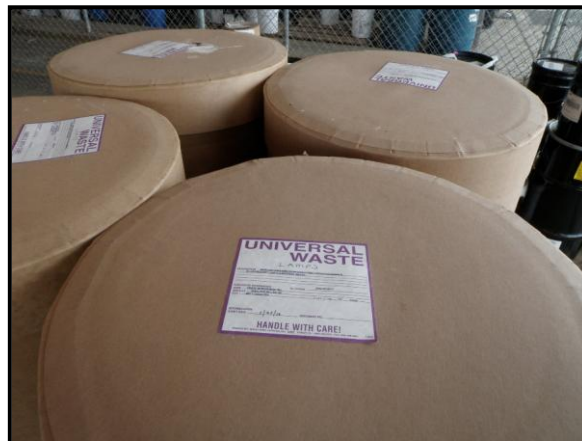
On the third day of the investigation, the inspectors observed two containers of universal waste lamps which were being filled, but were not labeled as required (see photograph below on the left). When the inspectors returned to the DSU the following day this issue had been resolved (see photograph below on the right).

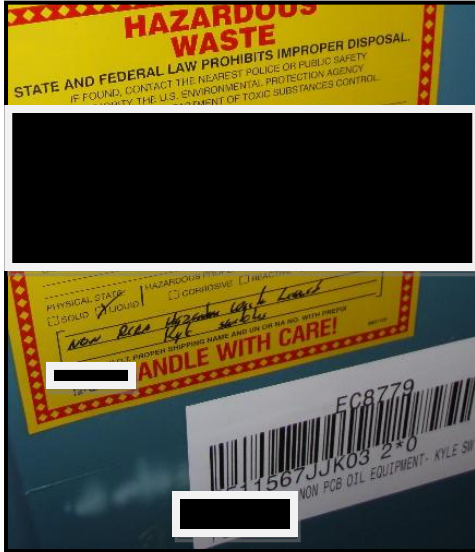
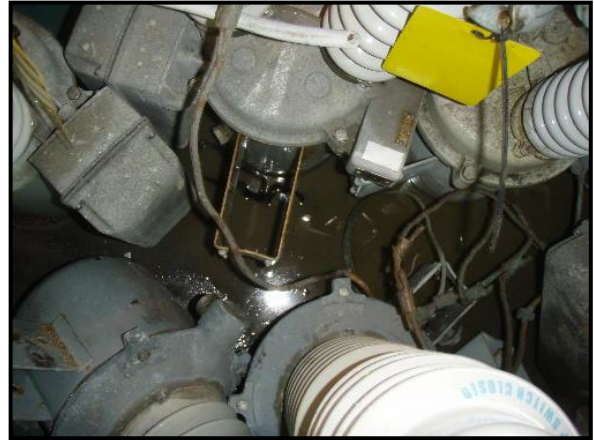
In another row in the G-Cell area, the inspectors observed several open bulk containers of electrical equipment which were filled with non-RCRA hazardous waste oil (see photographs below). Several of the containers had liquid in the bottom and oily sheens on the equipment indicating possible equipment leaks (see photograph below on the right).

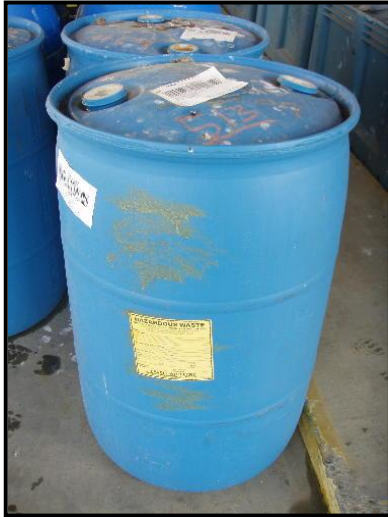
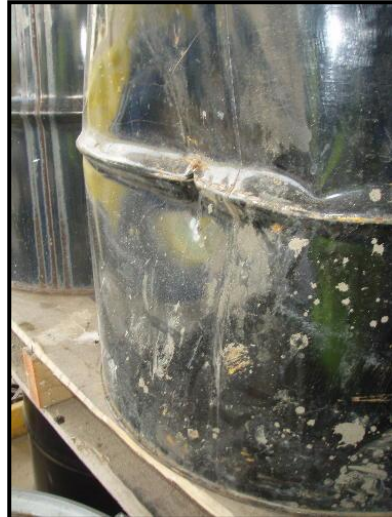
The inspectors observed a slightly bulging 55-gallon container of acid lab waste (see photograph below on the left) as well as a couple dented drums (see photograph below on the right) in the H-Cell area. No leaks were detected.

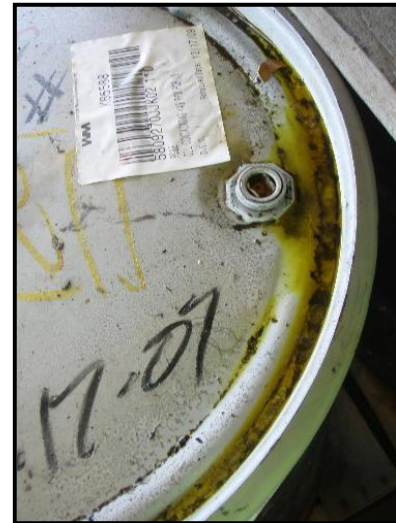
The inspectors also observed a 55-gallon drum of non-RCRA hazardous waste (used oil) which had a small amount of yellowish liquid on the top of the drum cover (see photograph to the right). When the inspectors returned to the DSU on the third day of the investigation the facility representatives pointed out that they had cleaned up and properly disposed of the small amount of used oil liquid which had accumulated on top of the drum.

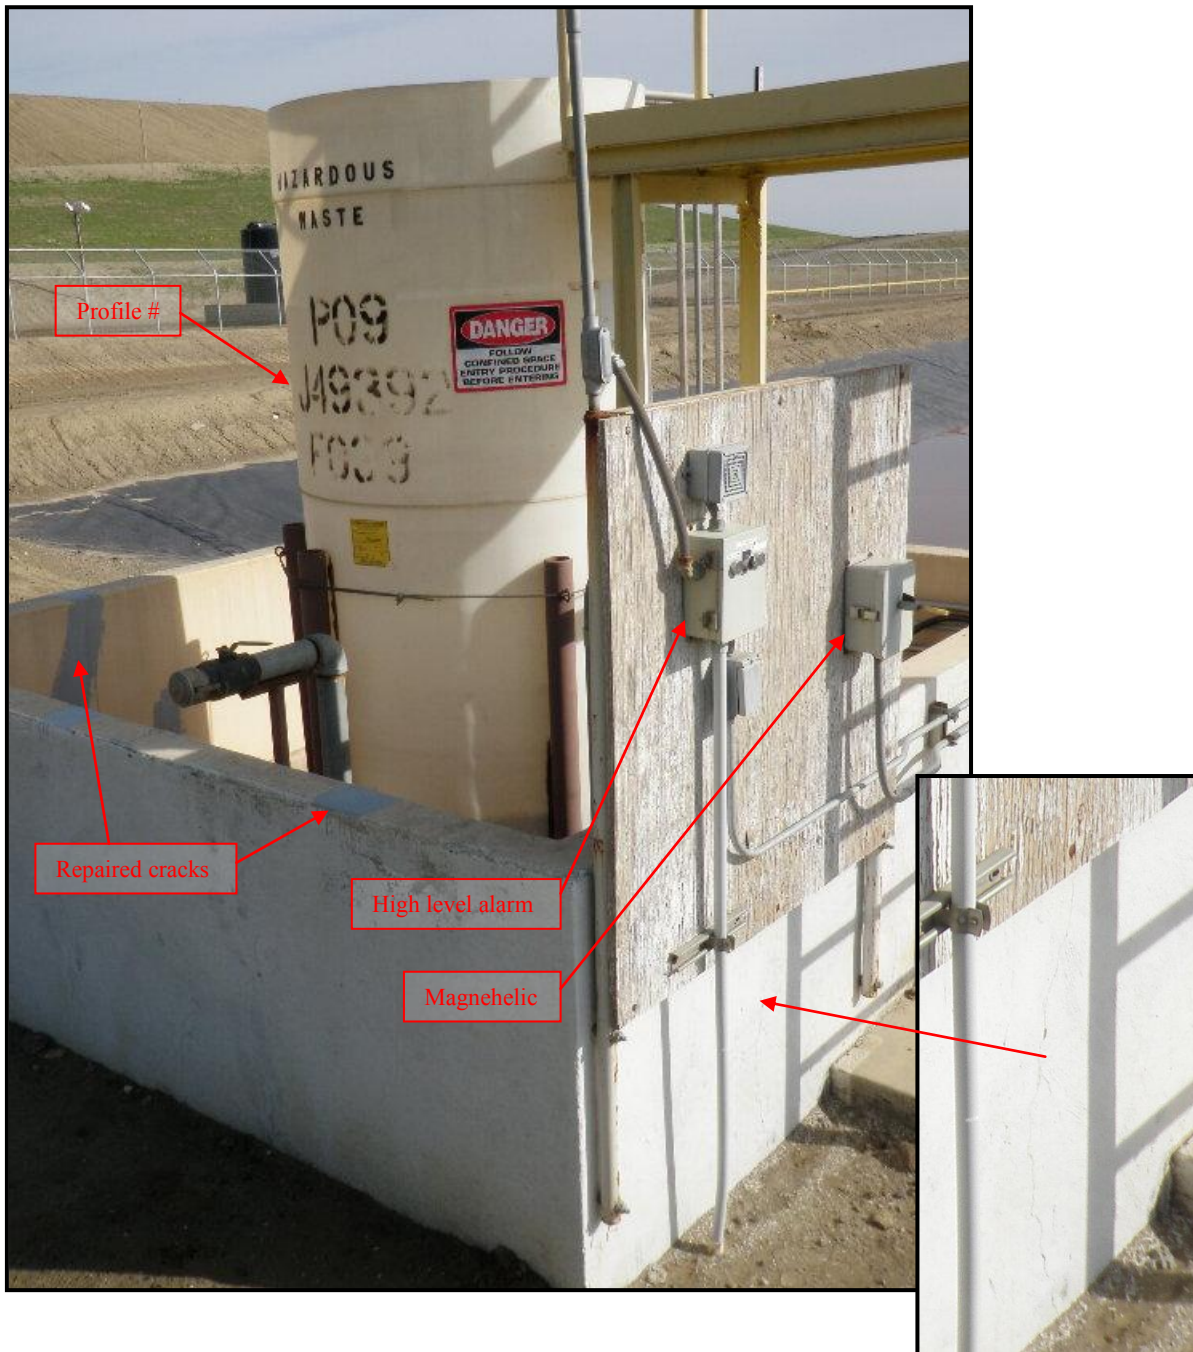
The inspectors noted cracks on the outside wall of the secondary containment system (see cropped and enlarged inset). The inspectors also noted that the cracks on the inside walls and floor of the secondary containment system were repaired.

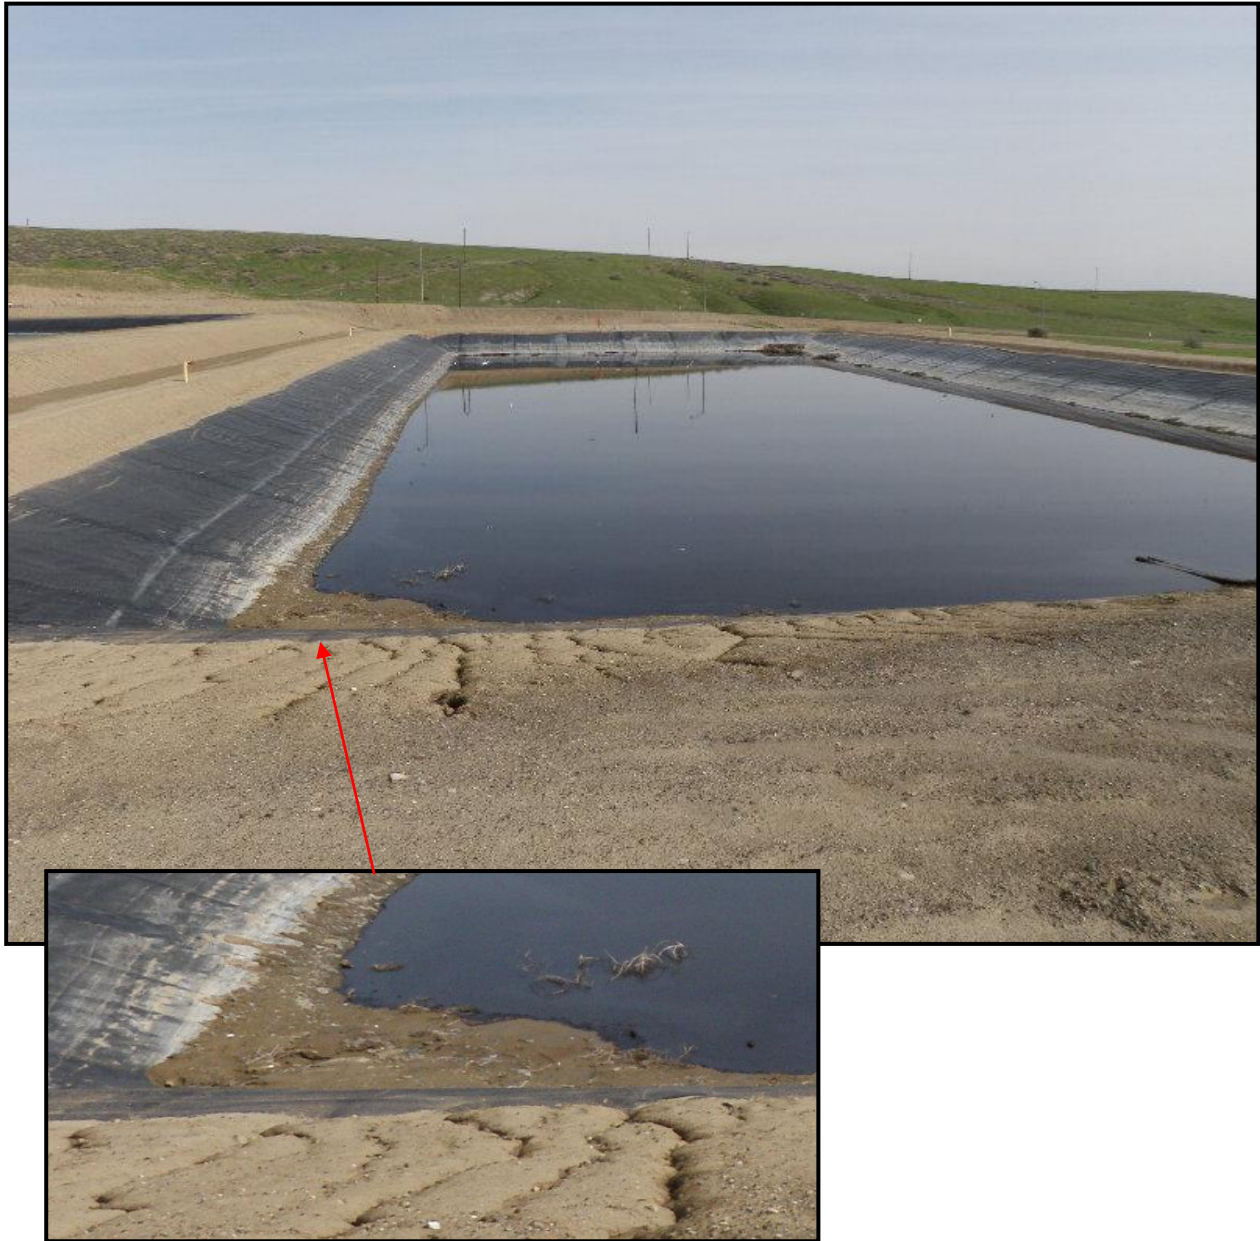
The inspectors observed an accumulation of unknown material along the waterline of P-14 (see photograph above - facing east). The cropped and enlarged inset photograph shows a close-up of some of the unknown material. Note: The P-14 leachate collection tank is located off-camera to the right.

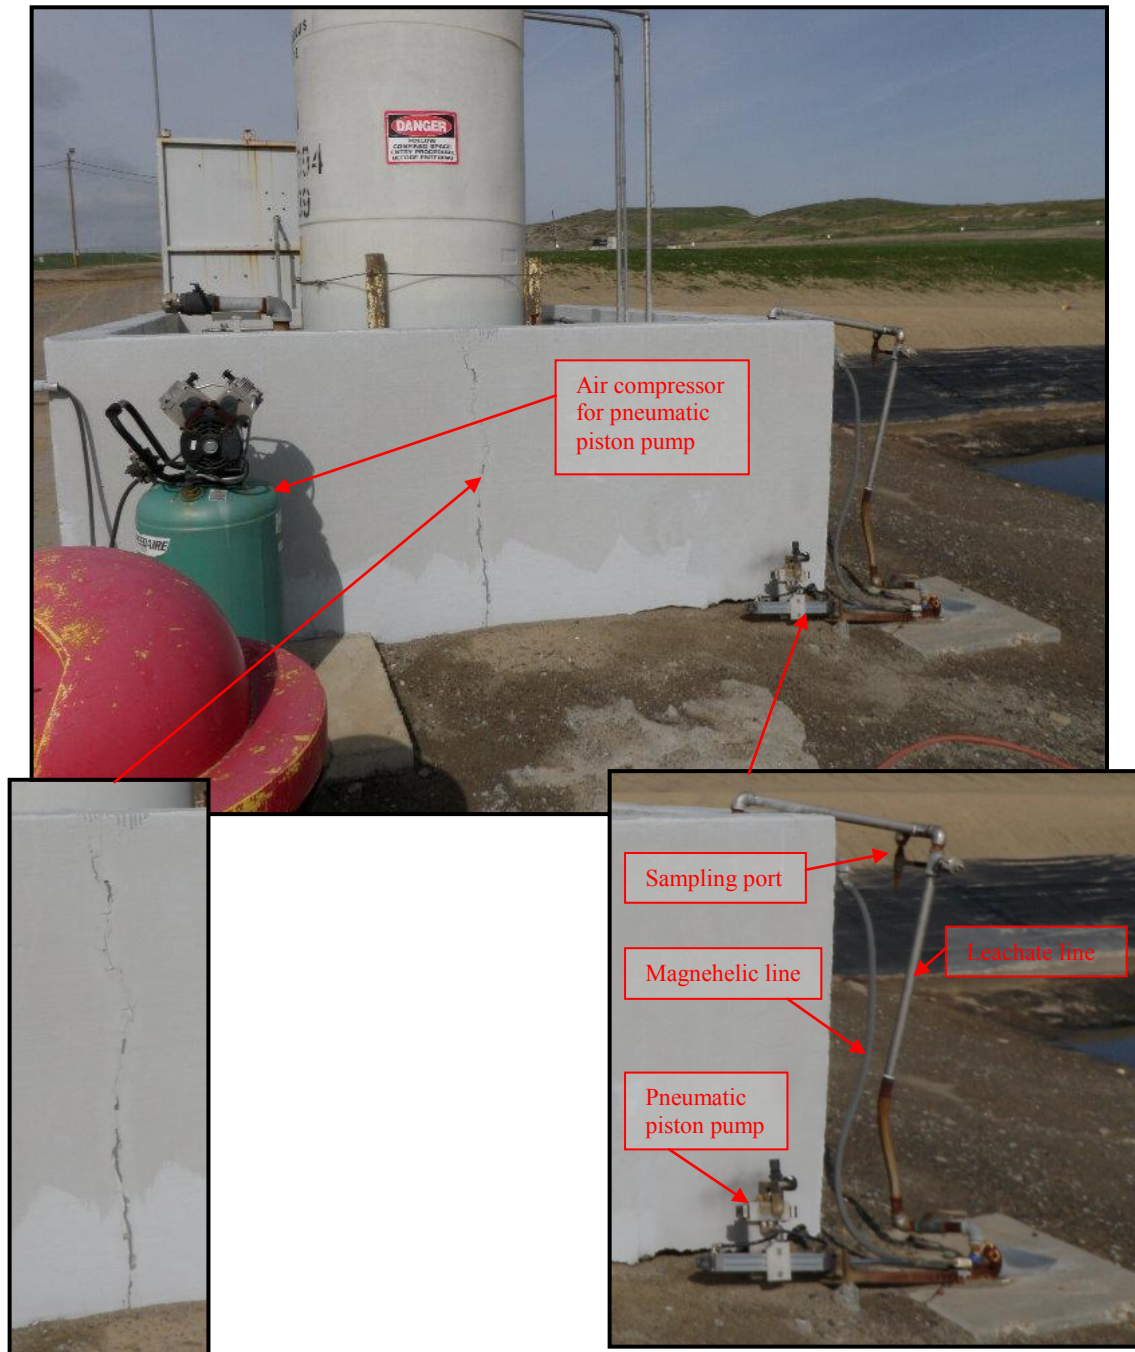
The inspectors noted cracks along the outside portion of the secondary containment system for the P-14 leachate collection tank (facing north; see cropped and enlarged inset on the left). As noted on the previous page, the cracks inside the secondary containment system were repaired.

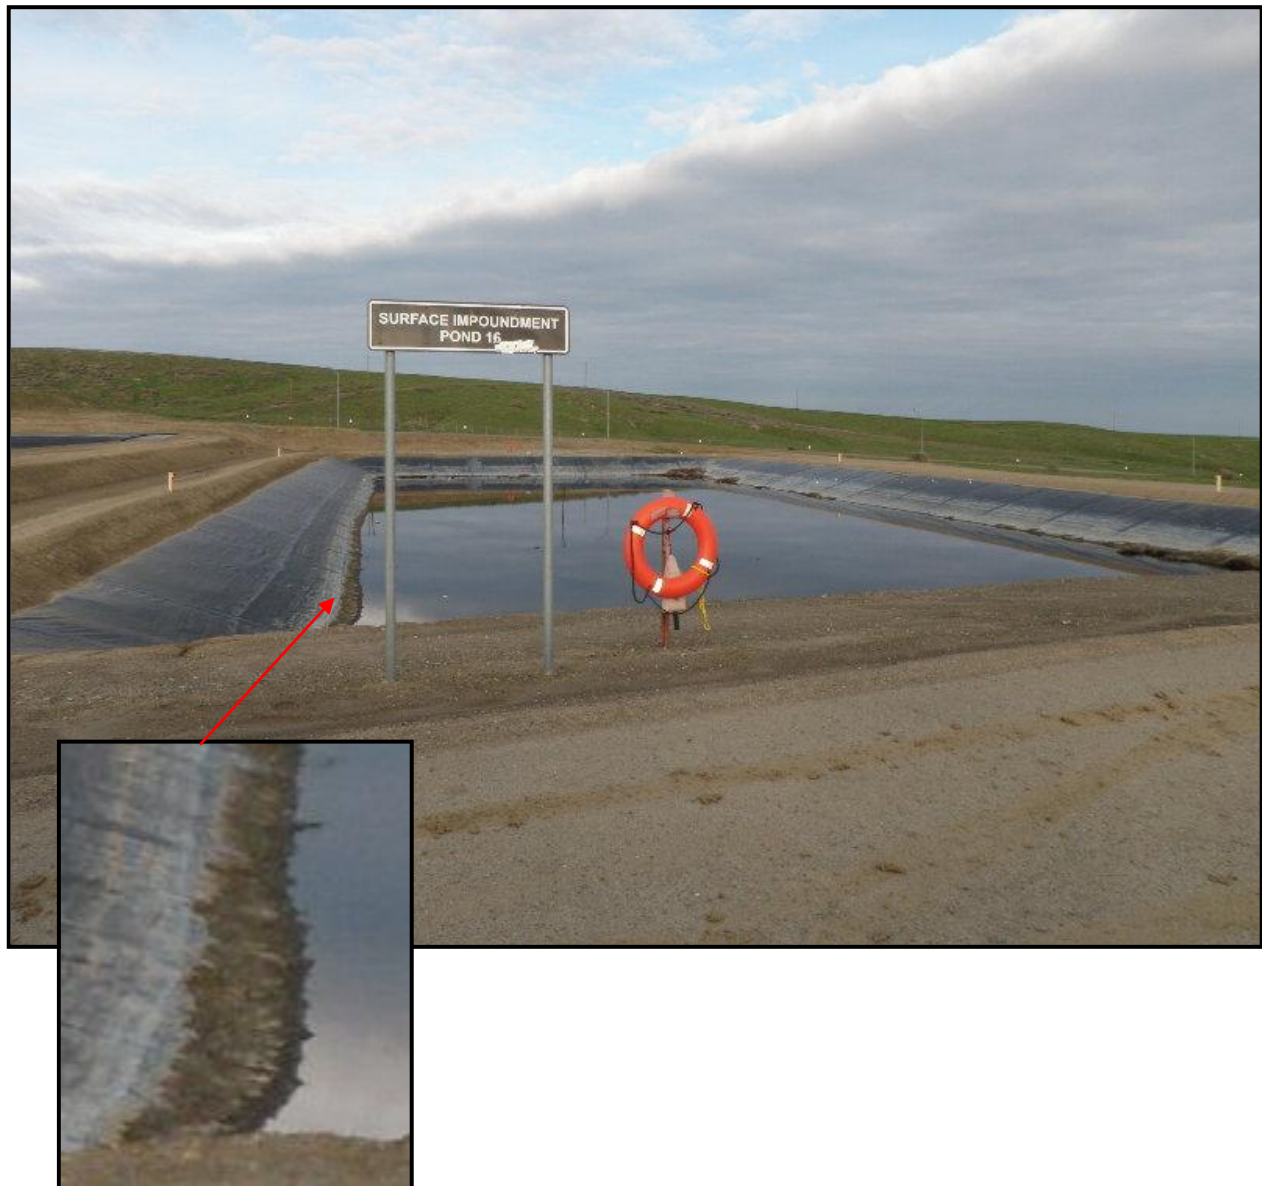
The inspectors observed an accumulation of unknown material along the waterline of P-16 (see photograph above - facing east). The cropped and enlarged inset photograph shows a close-up of some of the unknown material. Note: The P-16 leachate collection tank is located off-camera to the right.

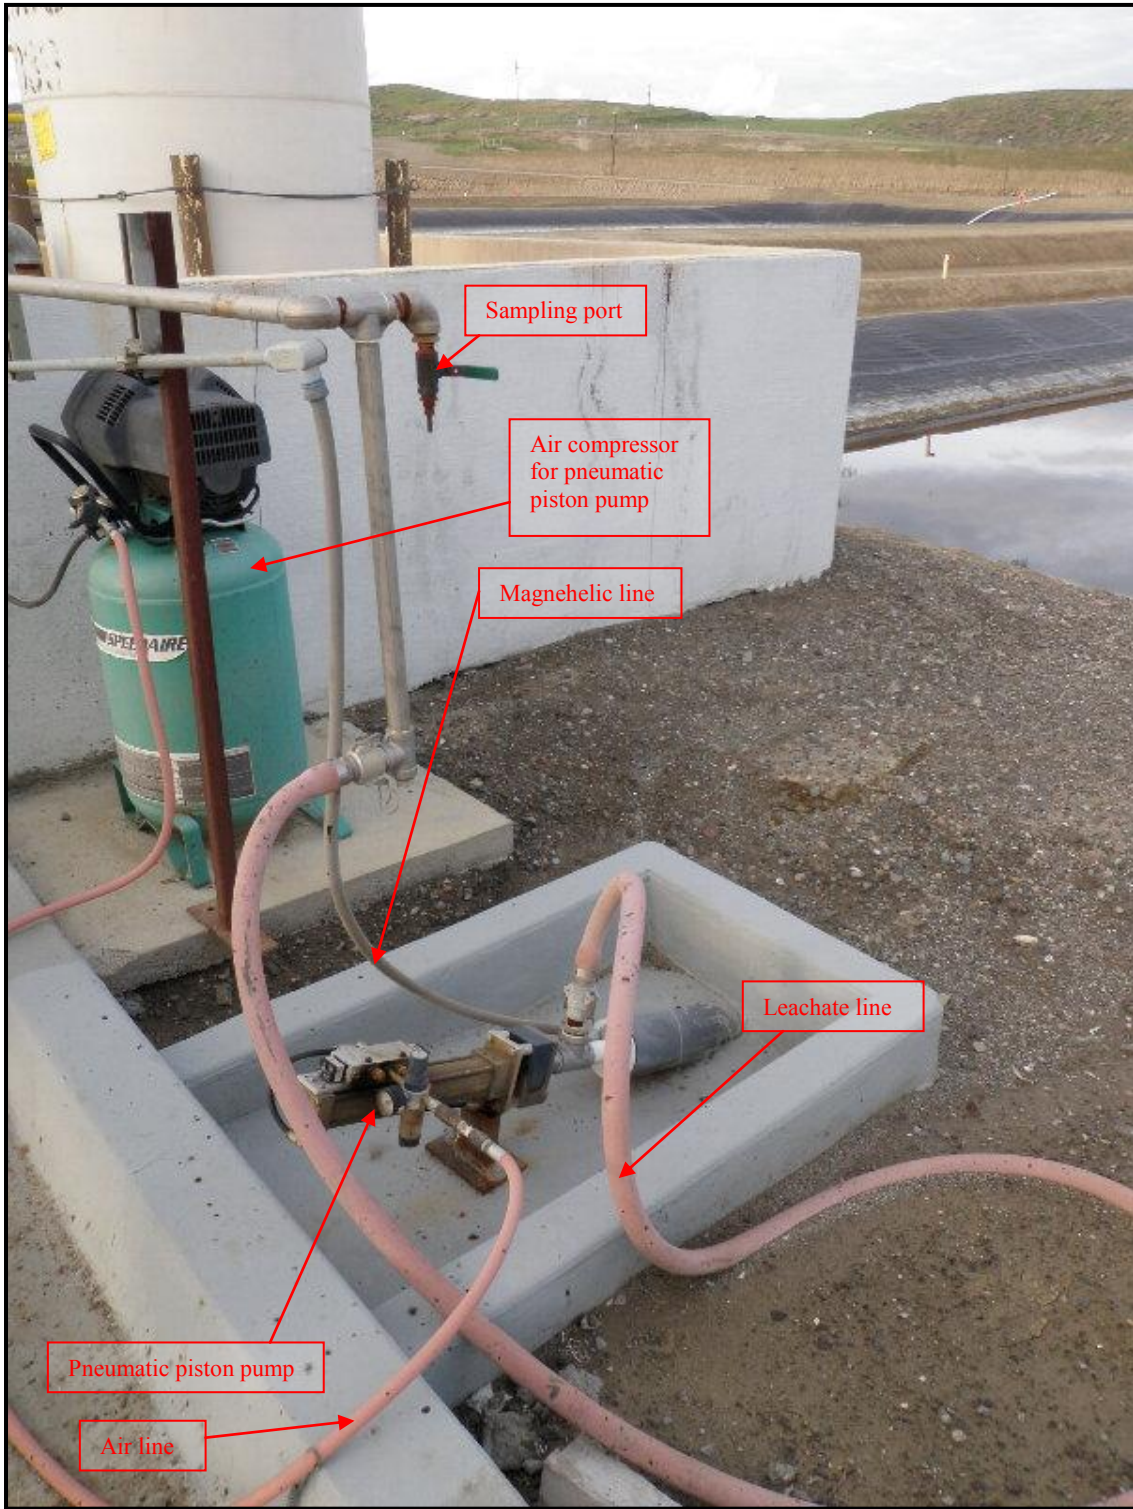
The inspectors noted cracks along the outside portion of the secondary containment system for the P-16 leachate collection tank (facing east; cropped and enlarged).
