# Observation Report

PROJECT NO. 385687.F1.01

(1) DAY: Tuesday DATE: 6/25/13 WORK PERIOD: 7:45 AM a.m. TO 11:20 PM a.m. REPORT NO. \_\_\_\_\_  
p.m.

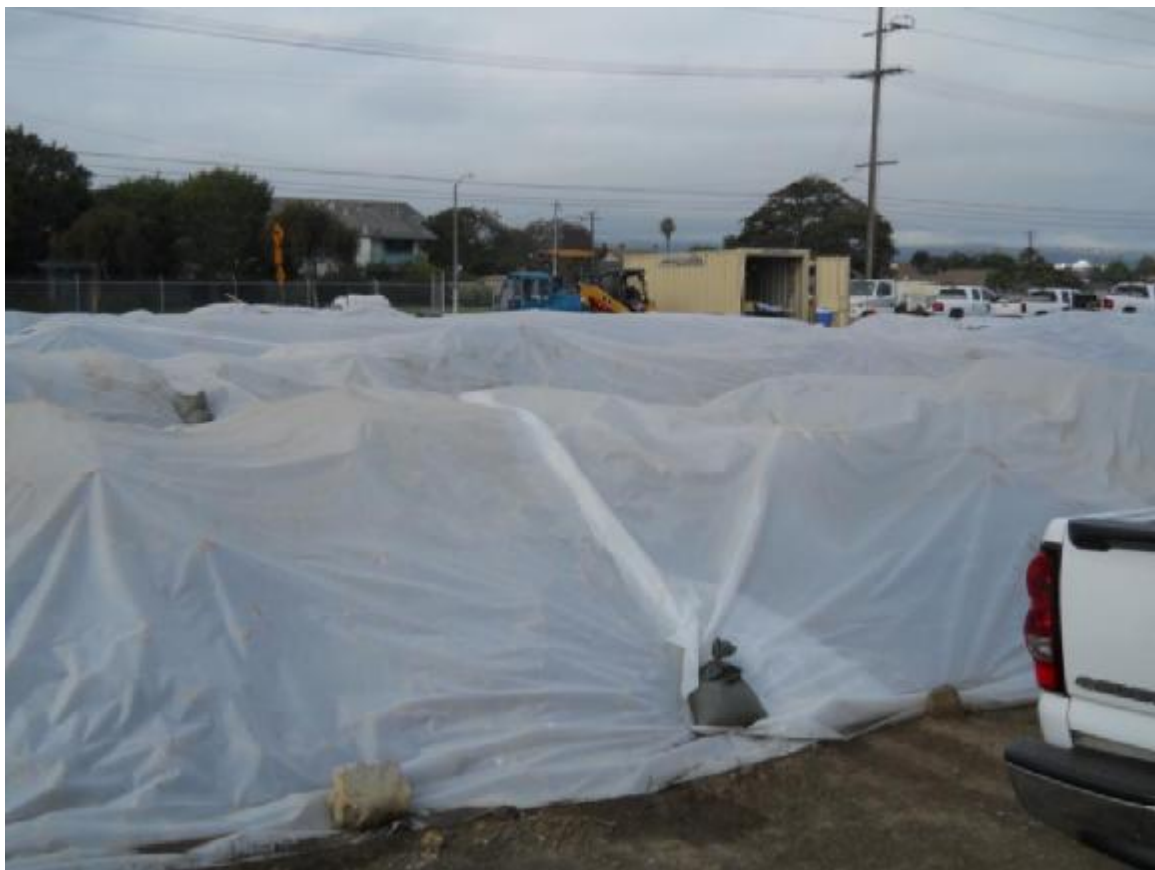
**Figure 1: Covered stock piles at Waste Management site.**

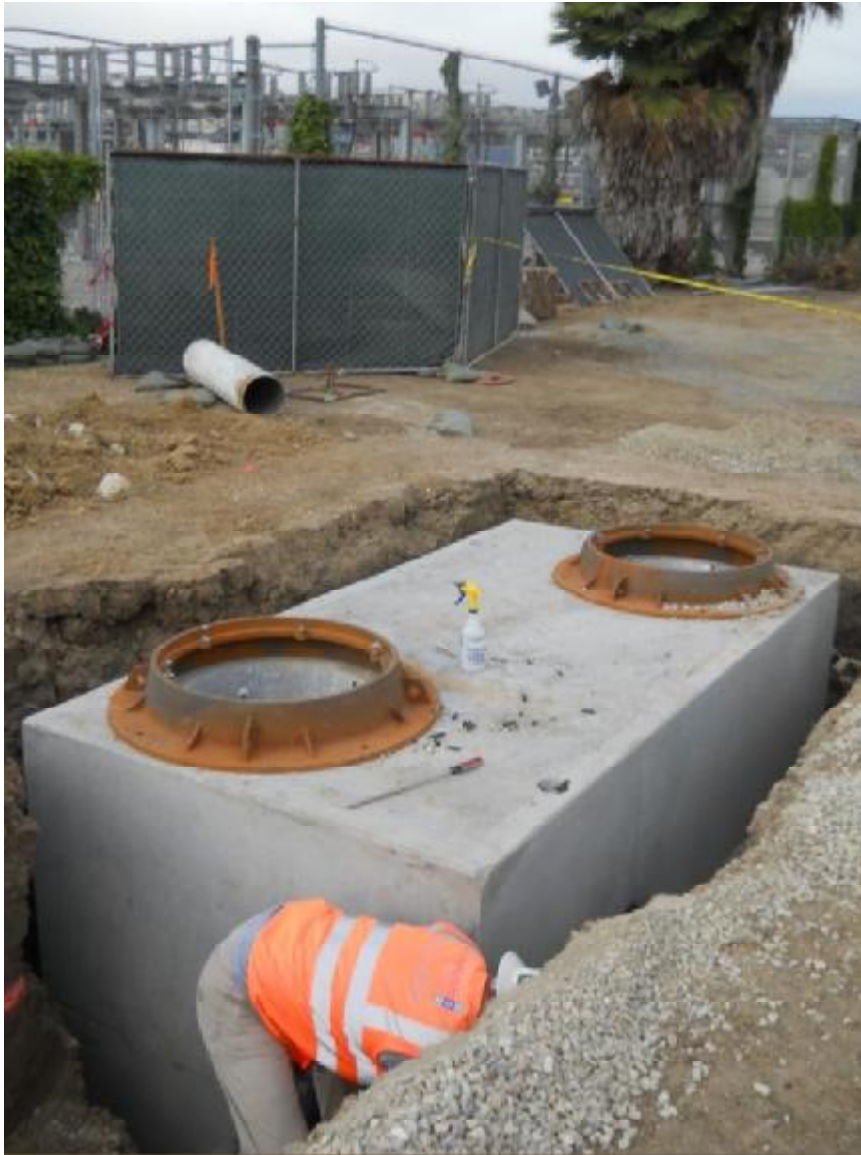
**Figure 2: Injection Well 2 (IW2)**

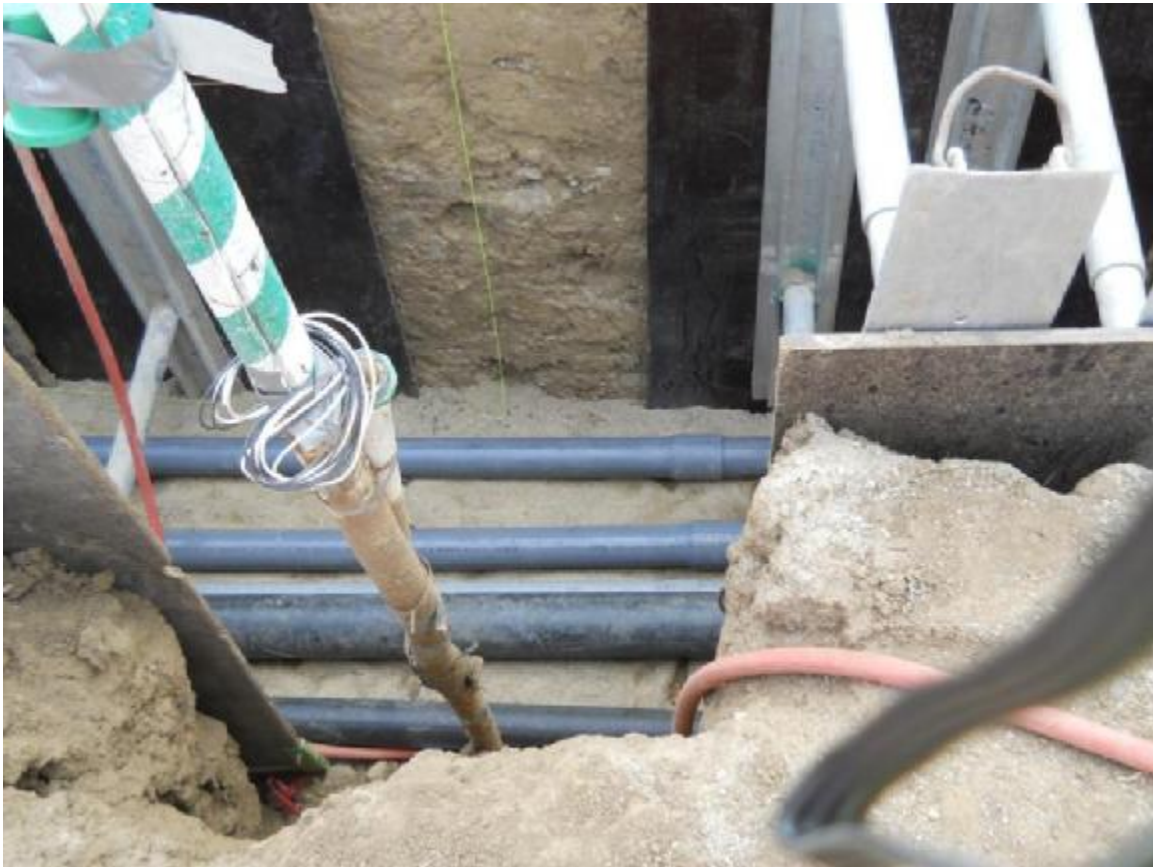
**Figure 3: Close-up view of pipes in trench with shoring**

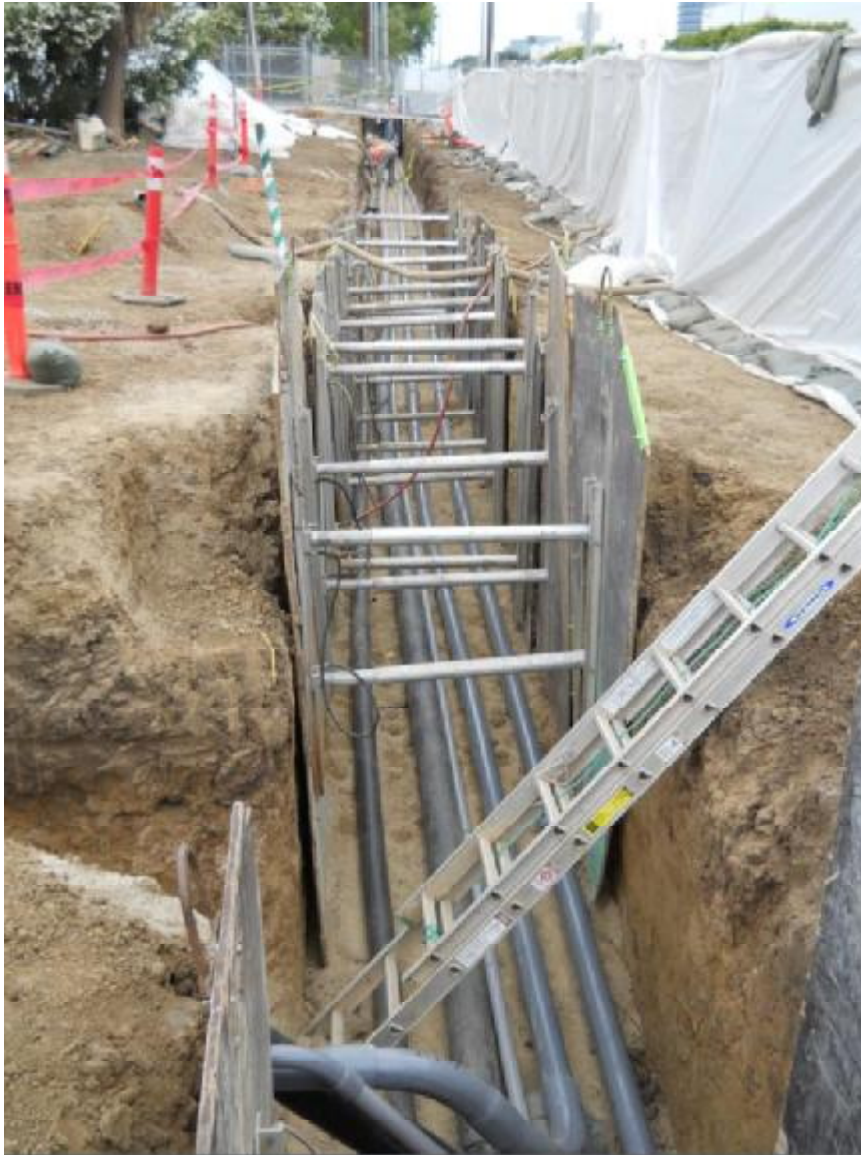
**Figure 4: Pipes in trench with shoring**

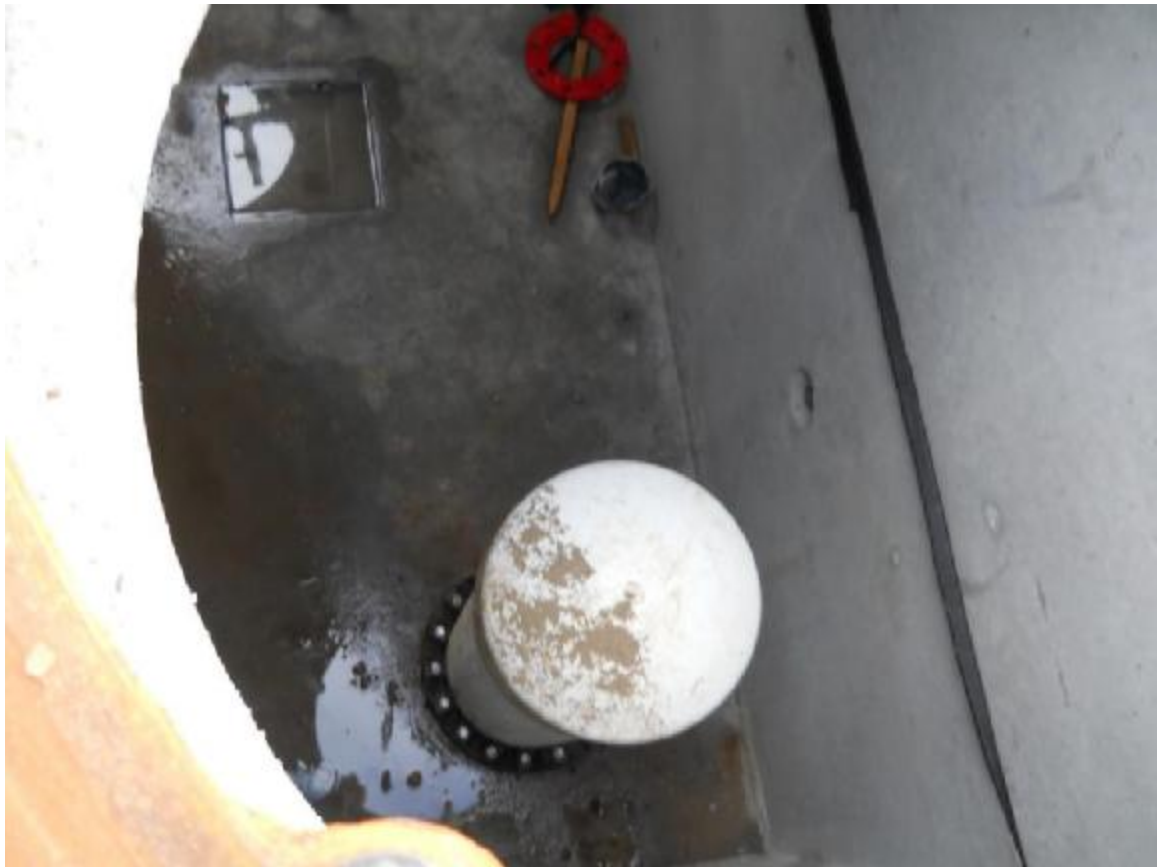
Lines were pressurized at 5:50 AM on the day of the test. Pressure gauges were inside a precast vault designated Injection Well 5 (IW5). Pressure readings were made by Sal Vitoria (ICS). Kevin Thomas filled out a pressure test form that was signed by Sal Vitoria, Steve Nyman, and Trai Chatman.

Figure 5: Inside IW5 with pressure gauges

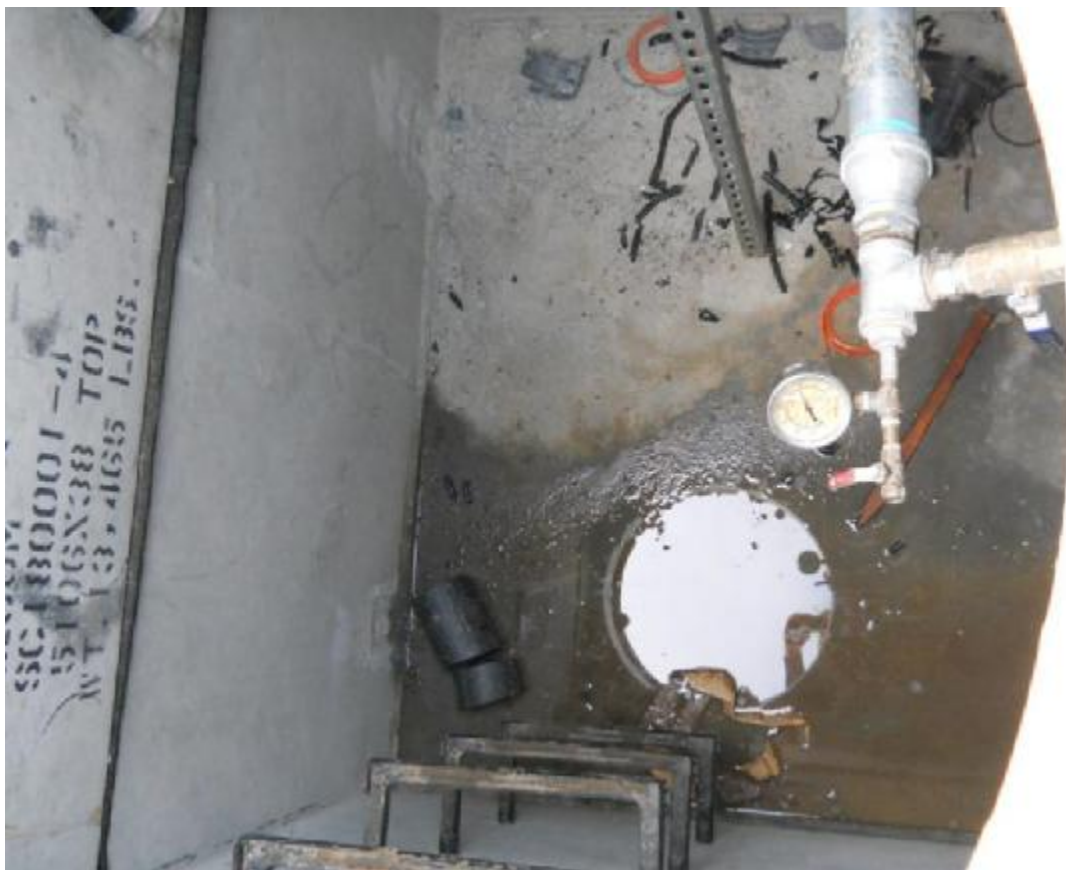
| Time | 4-inch HDPE Redevelopment Line | 4-inch HDPE Injection Line (6-inch Header) | Notes |
|---|---|--|---|
| 9:35 | 111 PSI | 112 PSI | 6-inch Line appeared to be settling more tested again for another hour to verify integrity. |
| 10:37 | - | 111 PSI | Retest complete, no significant drop in pressure. |

Figures 6: Pressure gauge for 4-inch Injection line with 6-inch header

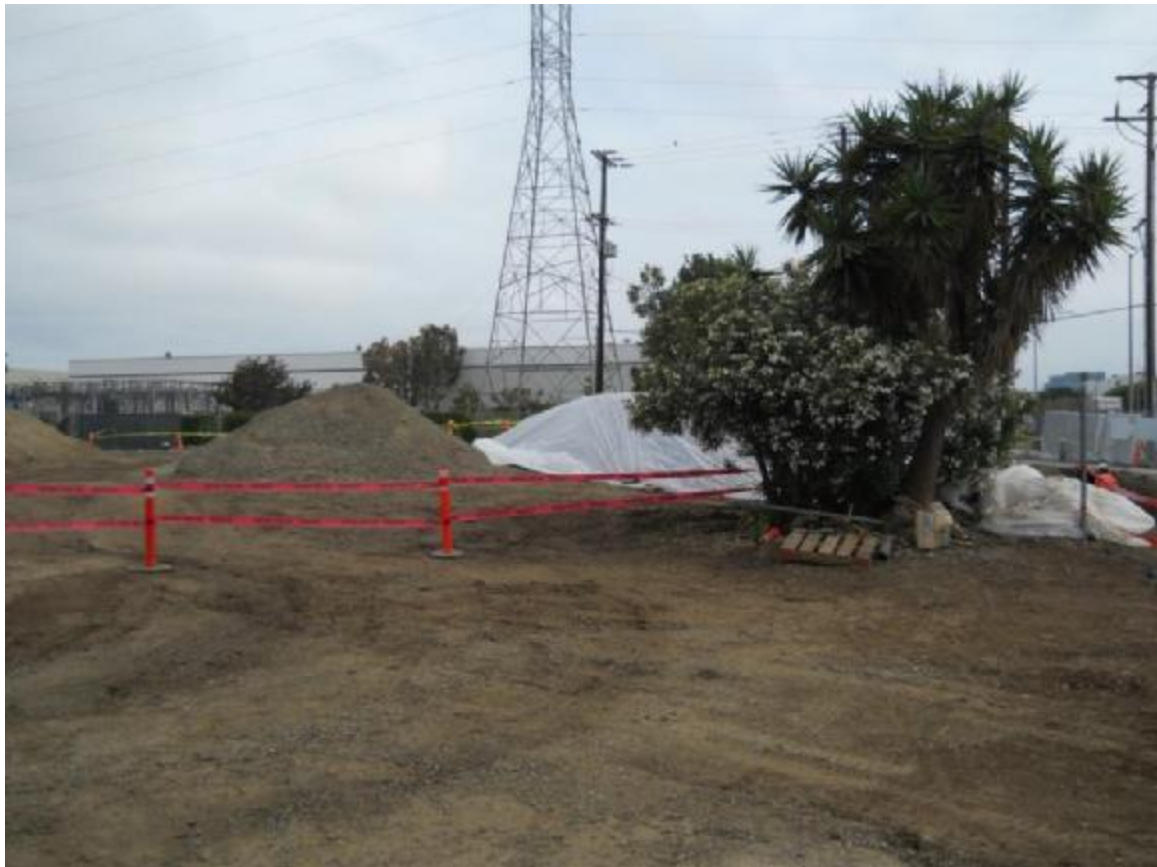
**Figure 7: Gravel stockpile and covered soil stockpile**

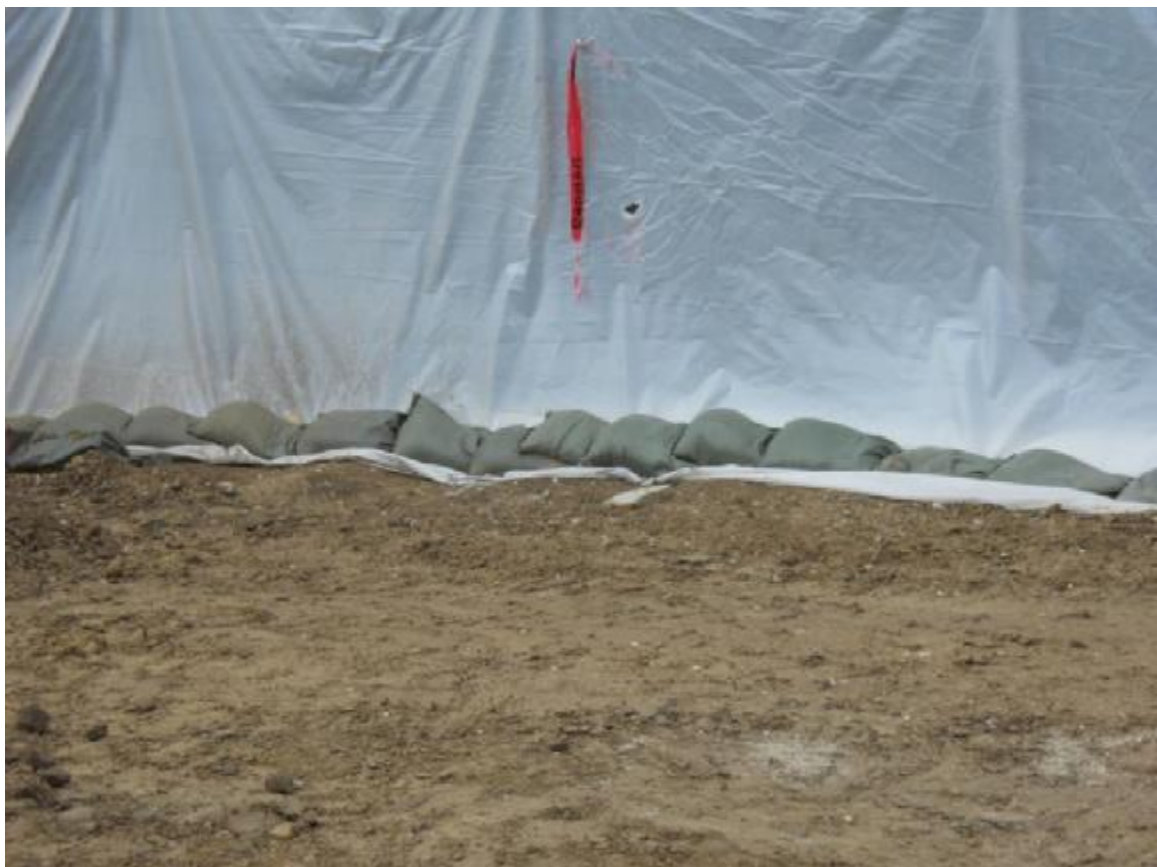
**Figure 8: Property line fence with plastic to prevent dust migration**

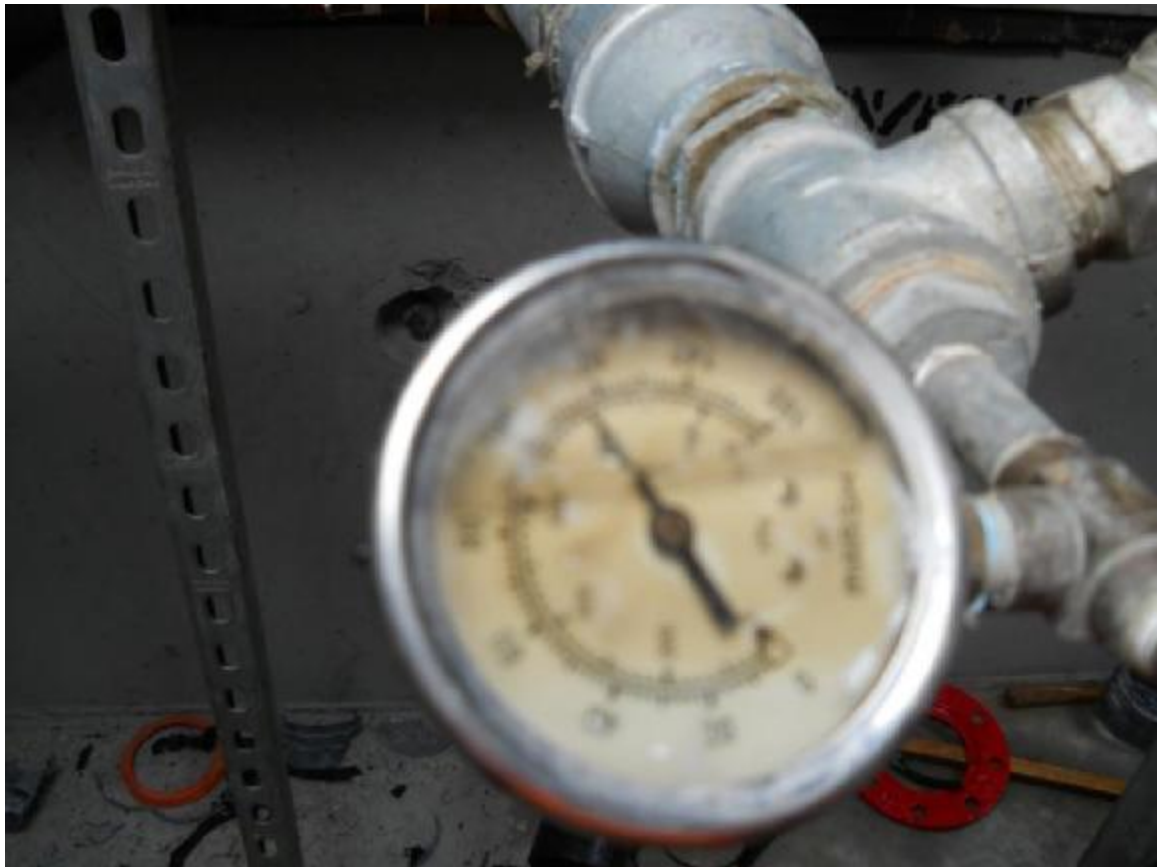
Figure 9: Close-up view of pressure gauge for 4" injection line with 6" header

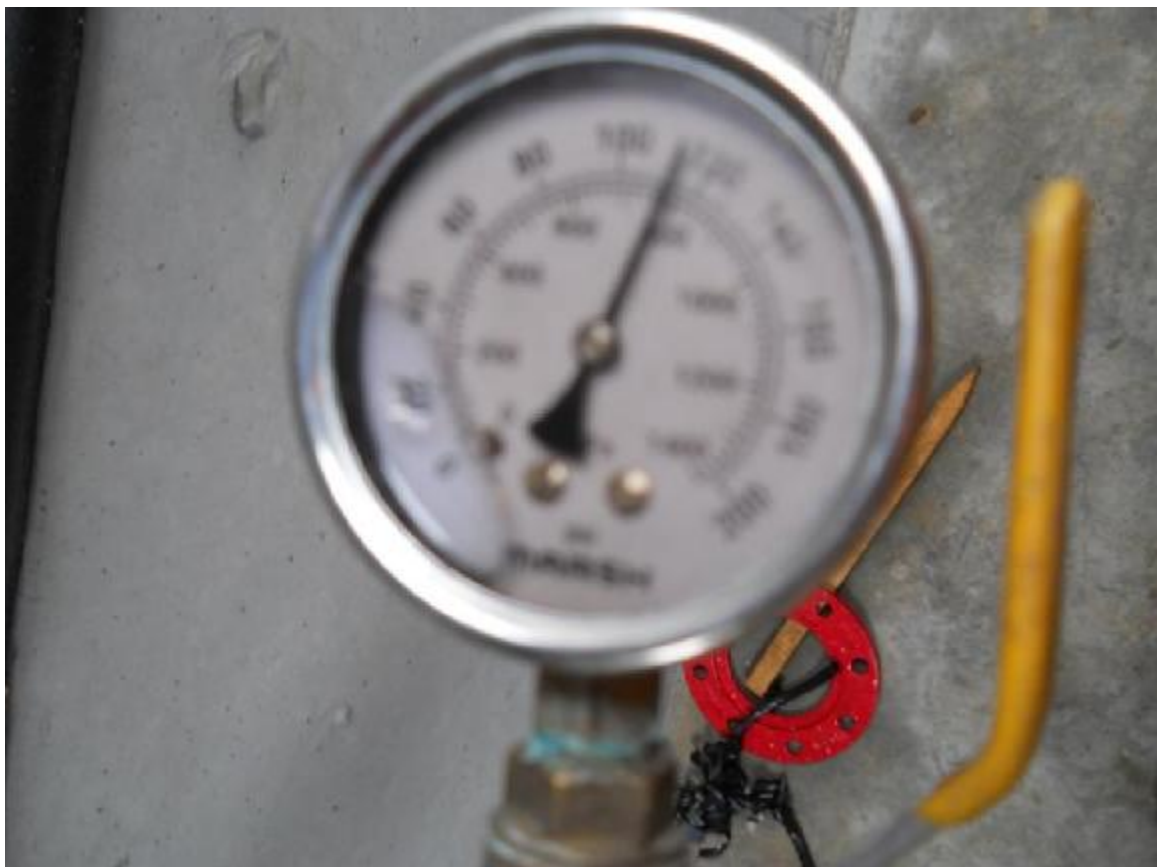
Figure 10: Close-up view of pressure gauge on 4-inch redevelopment return line

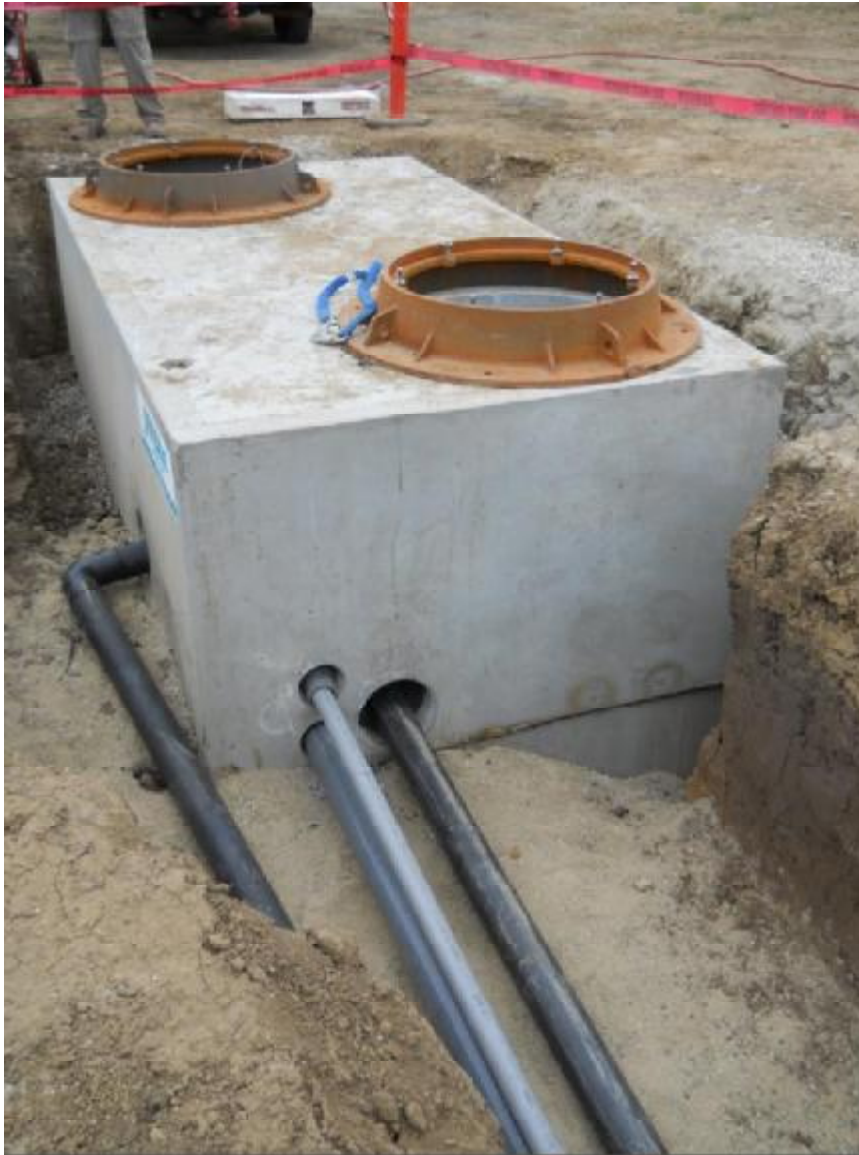
**Figure 11: Precast vault that contained the pressure gauges**

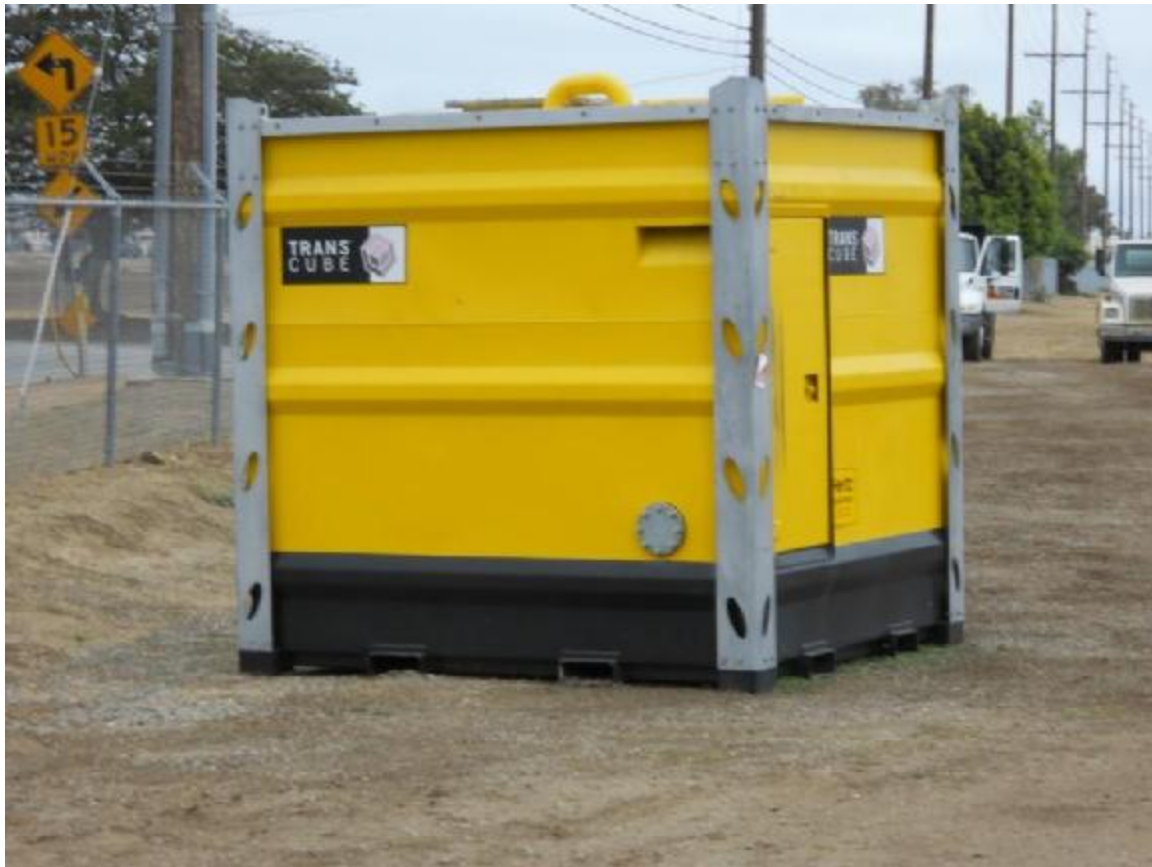
Figure 12: Portable storage container used to store fuel for diesel powered pumps during injection testing

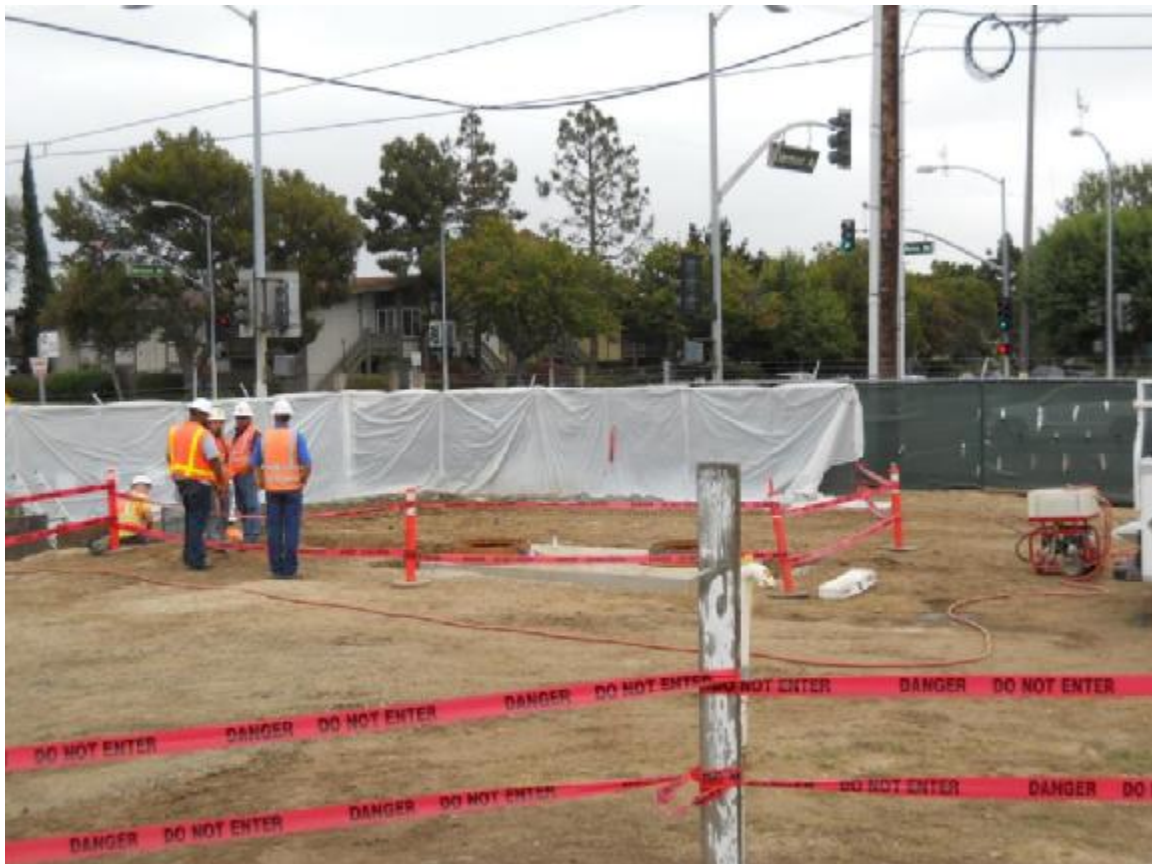
Figure 13: General site view of Injection Well 5

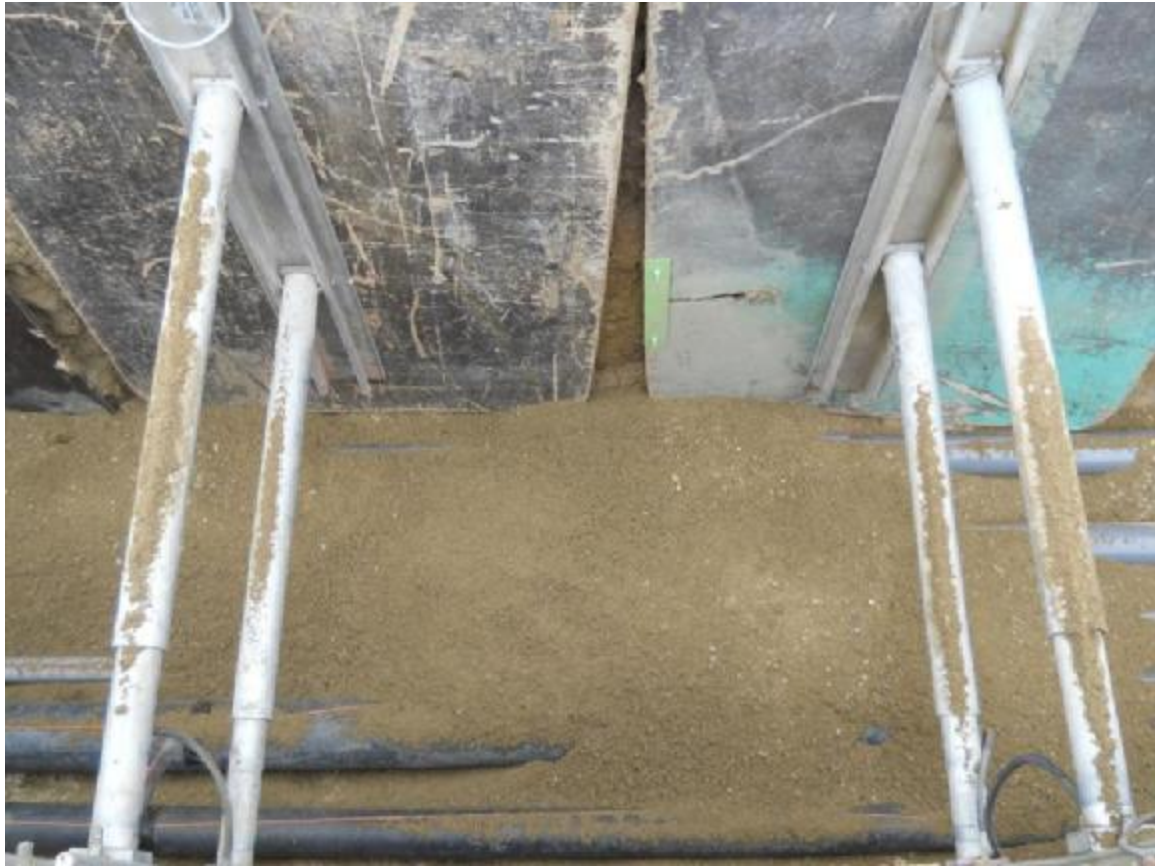
**Figure 14: Trench with some sand backfill**

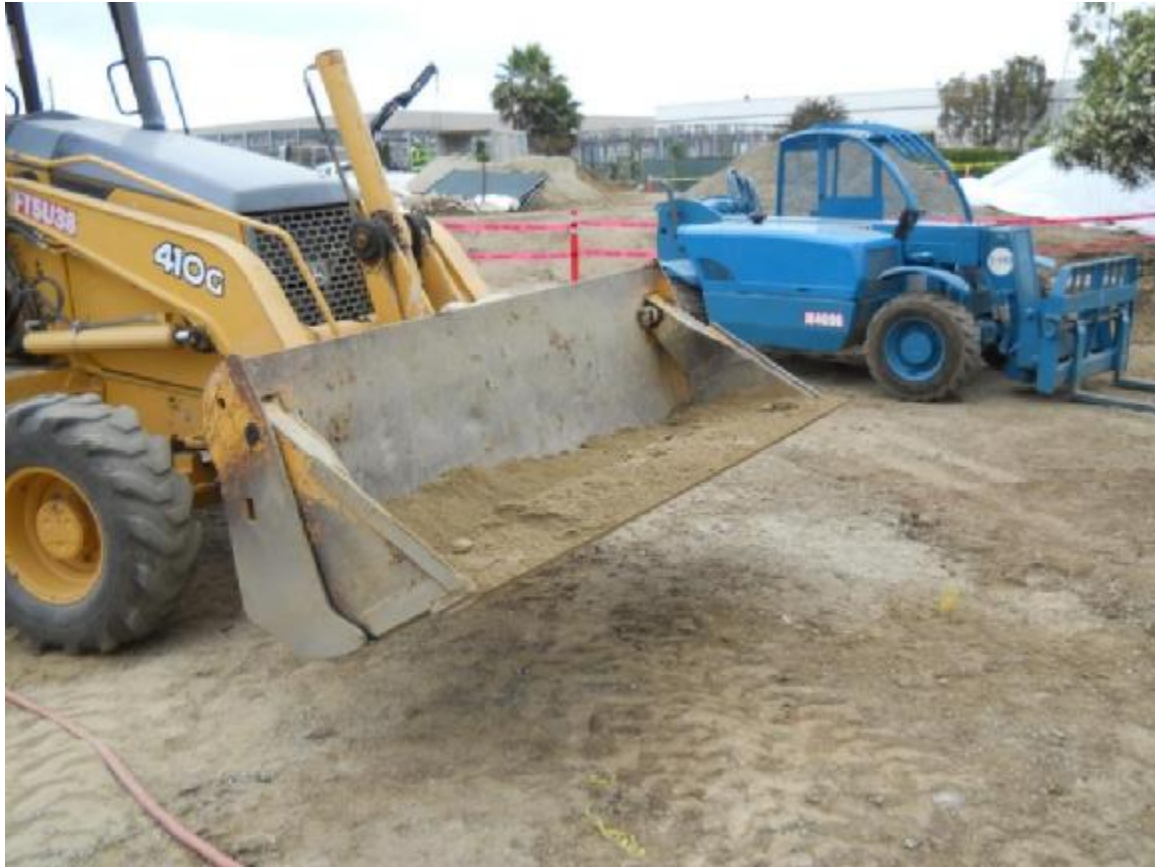
**Figure 15: Loader with bucket of sand to begin backfill**

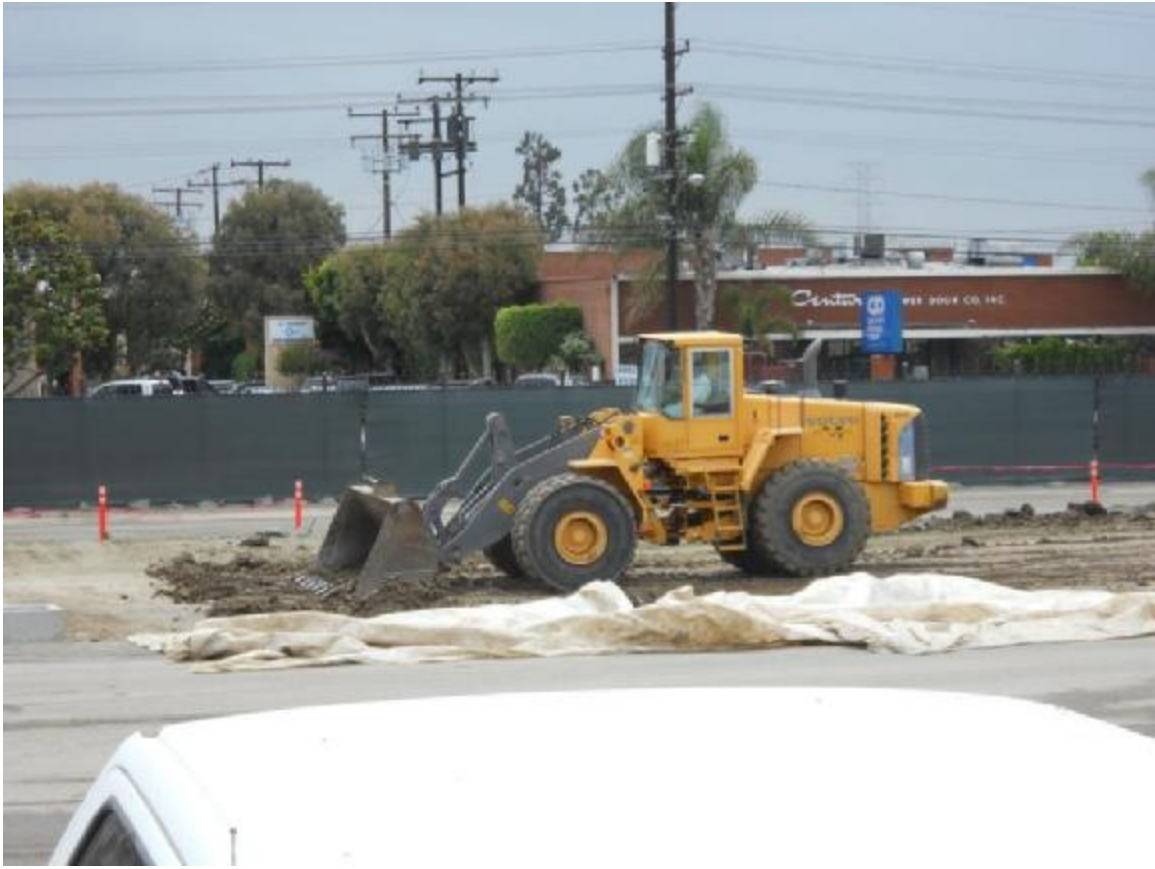
Figure 16: Montrose site grading in progress

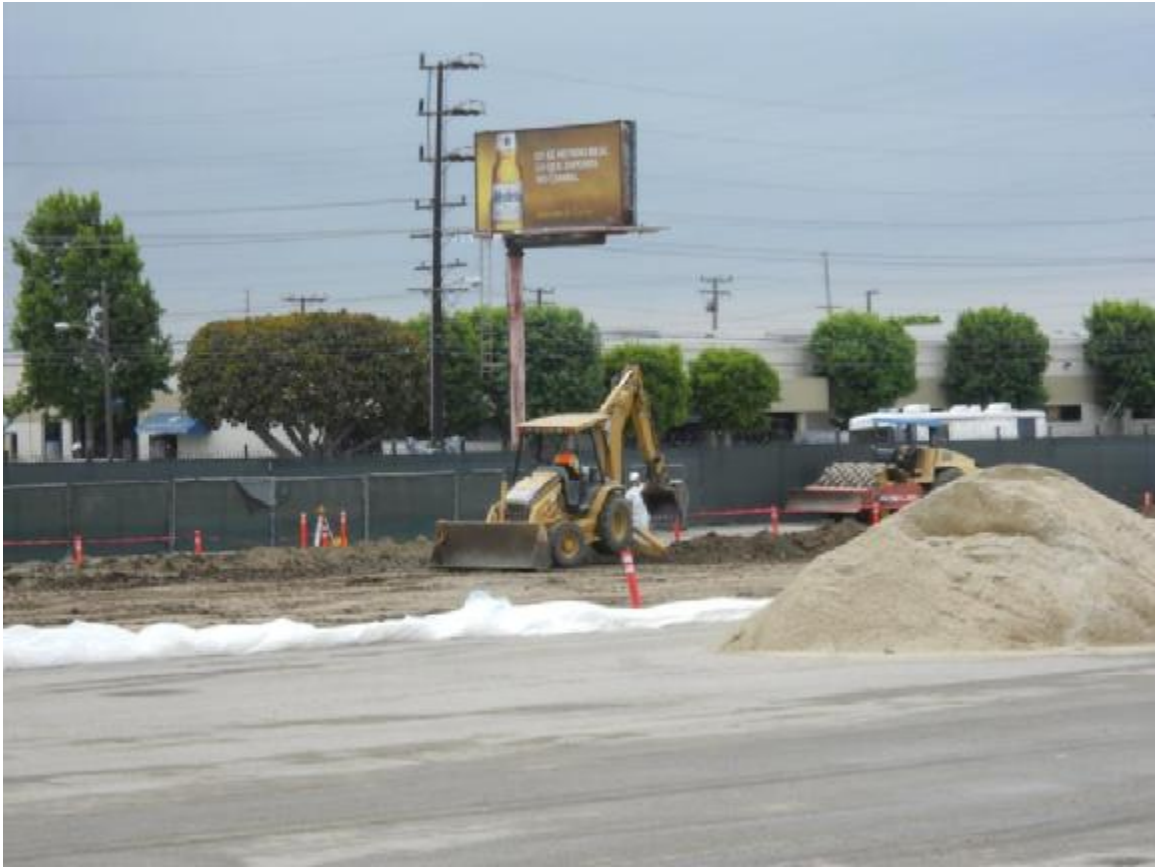
Figure 17: Montrose site trenching in progress

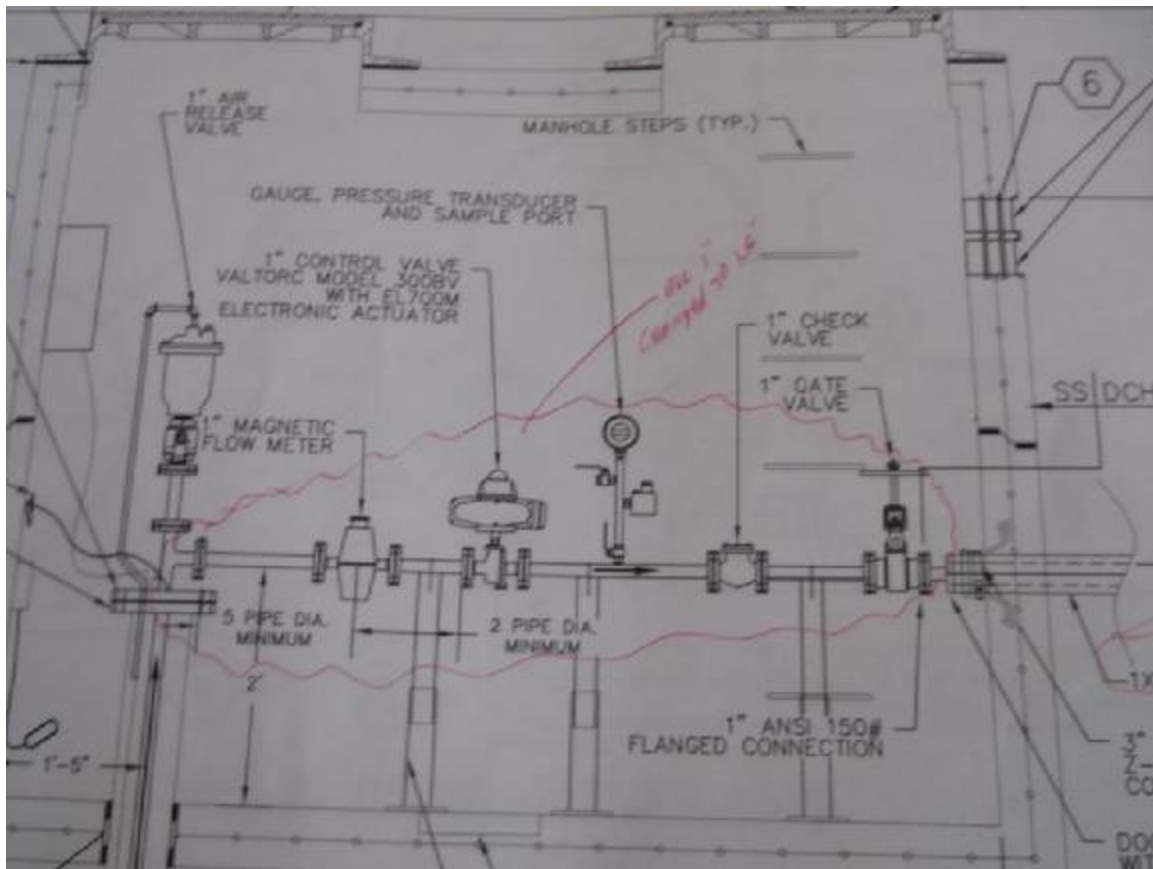
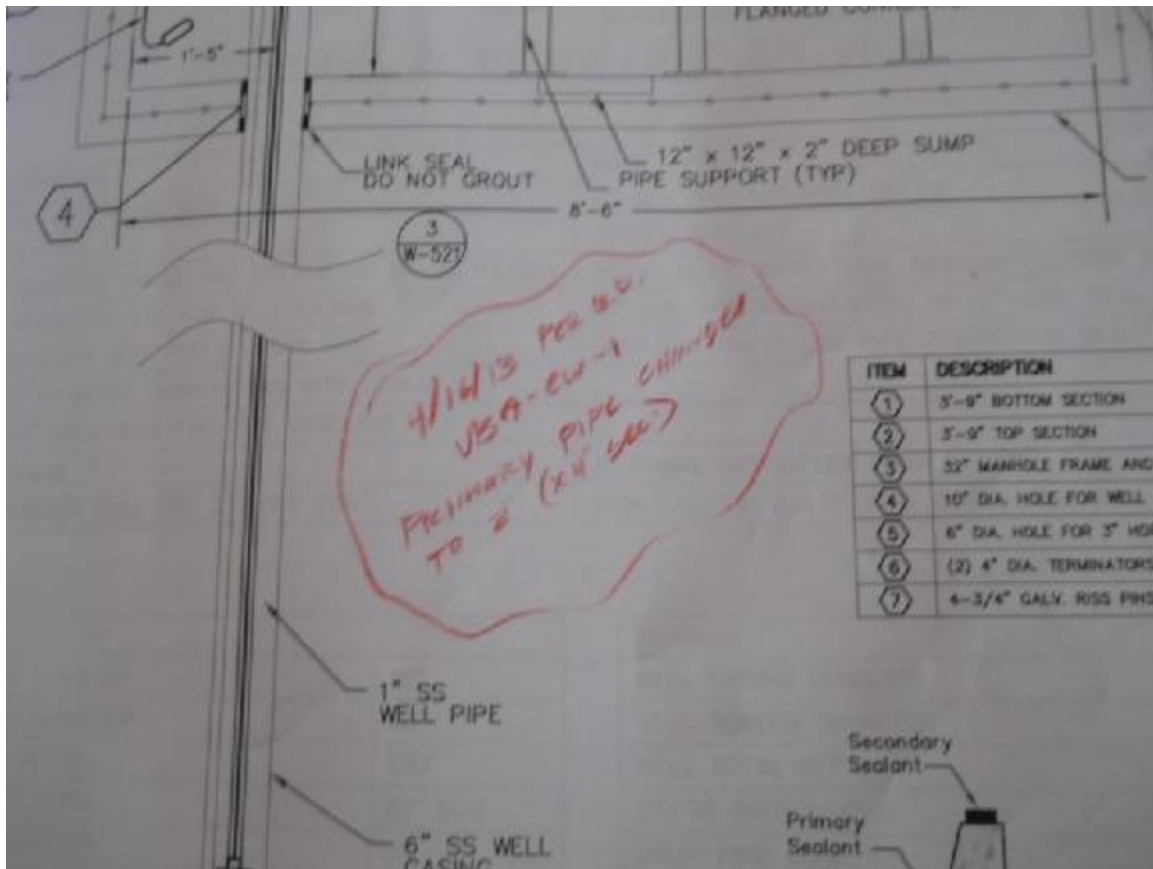
B) Issues concerning conformance to specifications and/or design:  
 The three (3) well heads and trenches that were installed were different than originally designed but in accordance with a redesign in RFI 008, which were triggered by changes in the injection well positions.

Figure 18: Diameter change on well head due to higher than expected well production

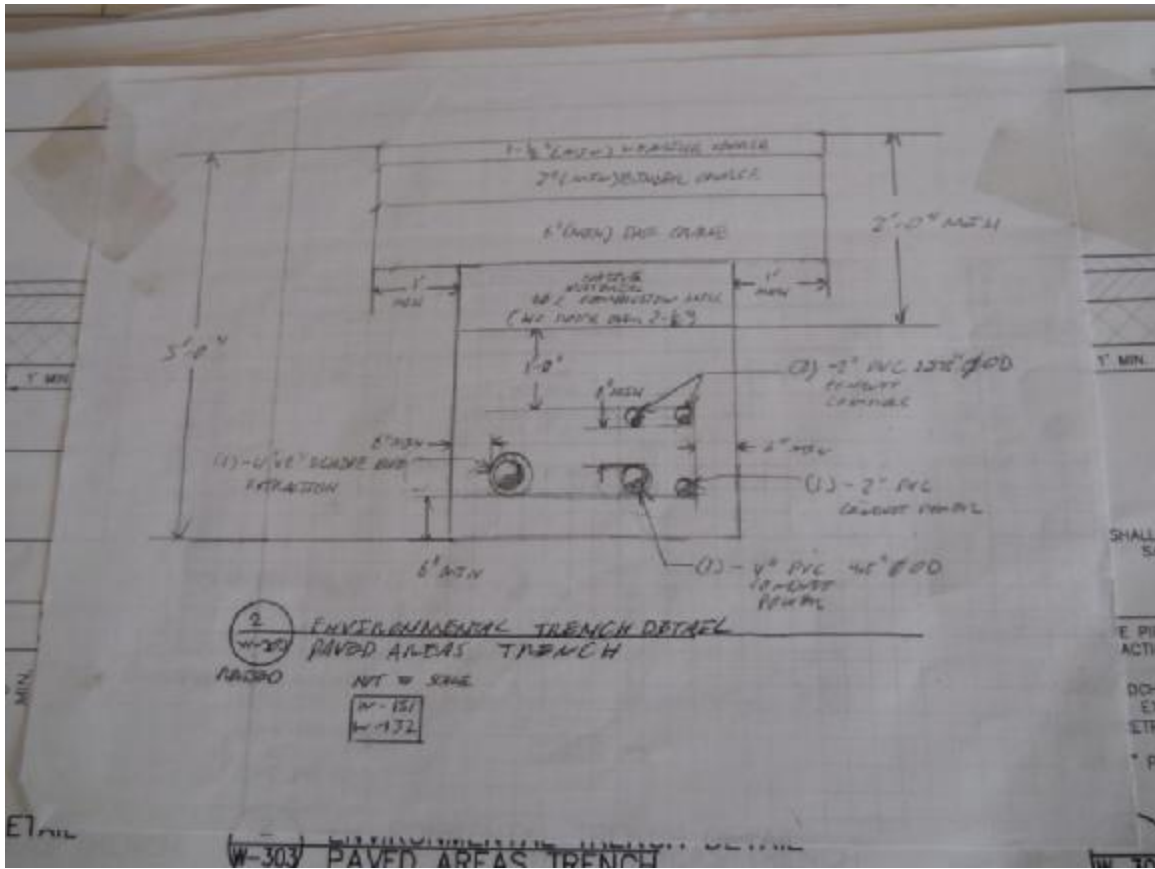
Figure 19: Modified Trench Layout

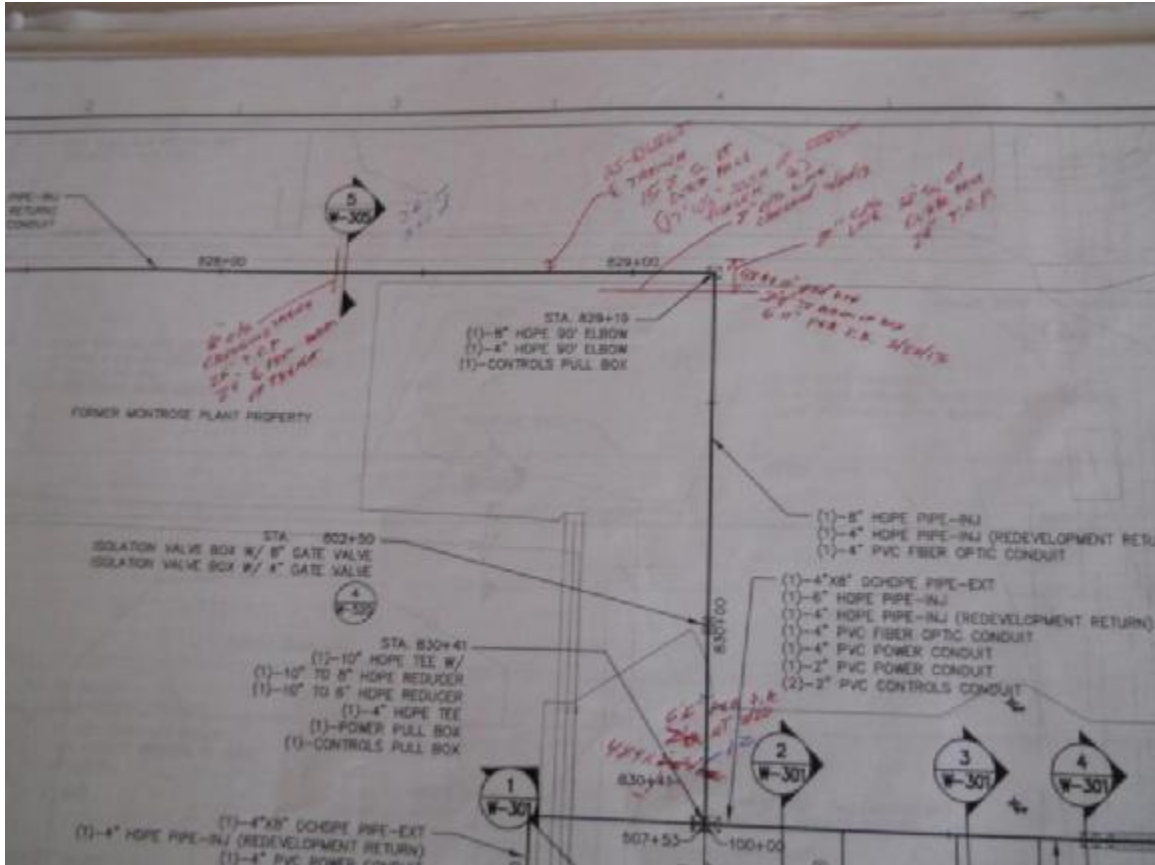
Figure 20: Realigned trench at north edge of Montrose site

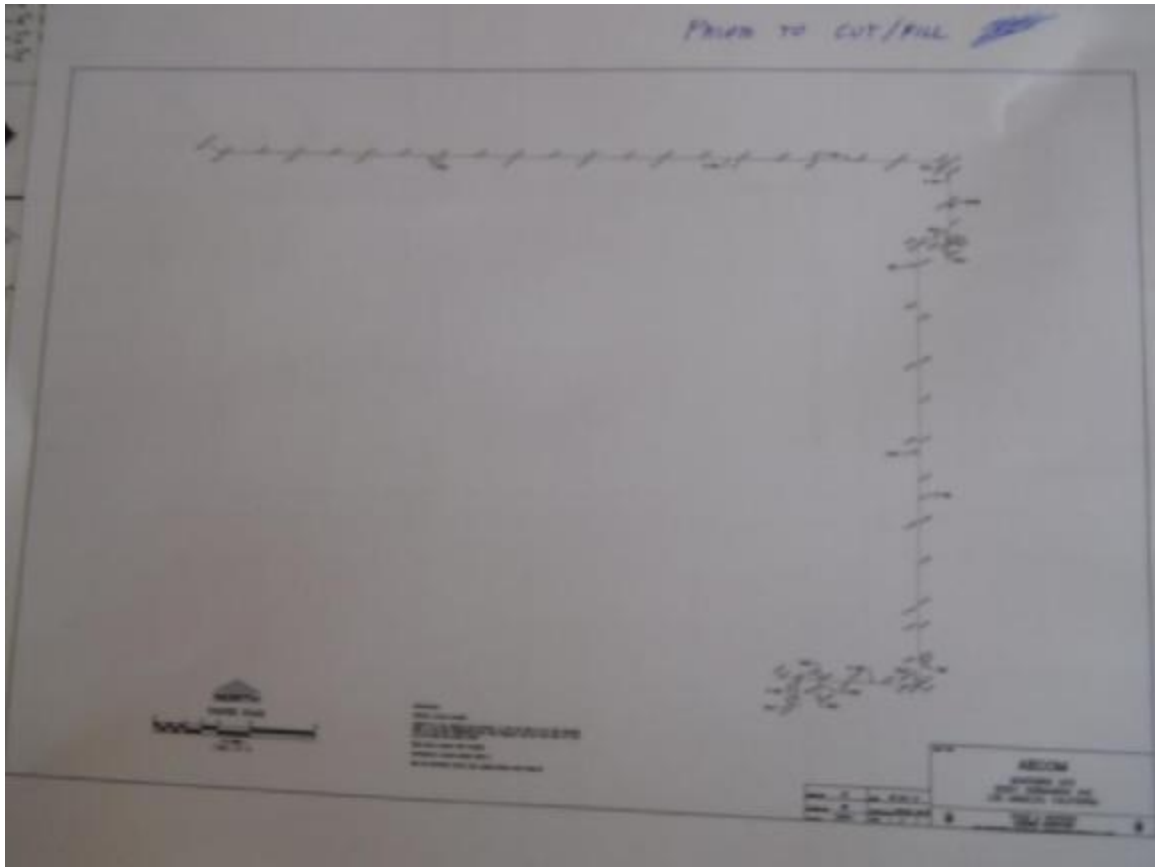
Figure 21: Record survey of realigned trench
