# Observation Report

PROJECT NO. 385687.F1.01

(1) DAY: Tuesday DATE: 6/25/13 WORK PERIOD: 7:45 AM a.m. TO 11:20 PM a.m. REPORT NO. \_\_\_\_\_  
p.m.

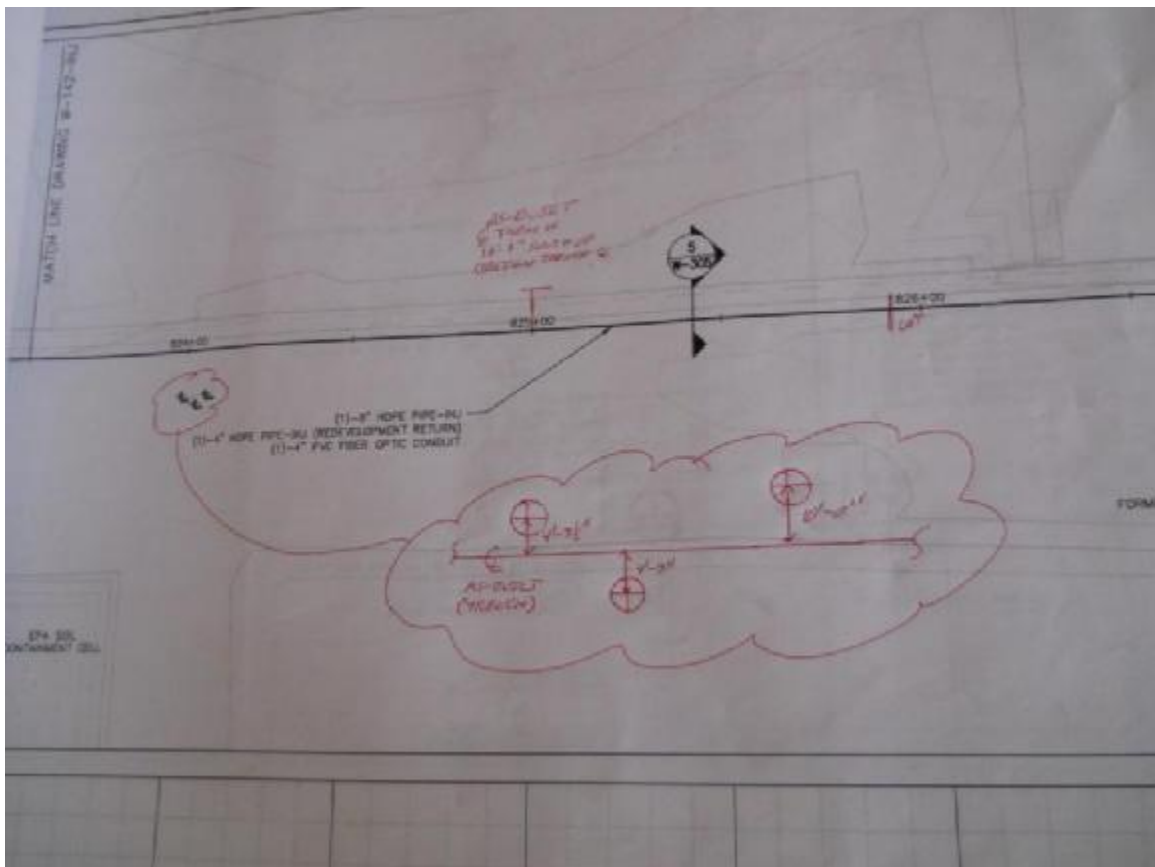
Figure 22: Realigned trench referenced to design trench

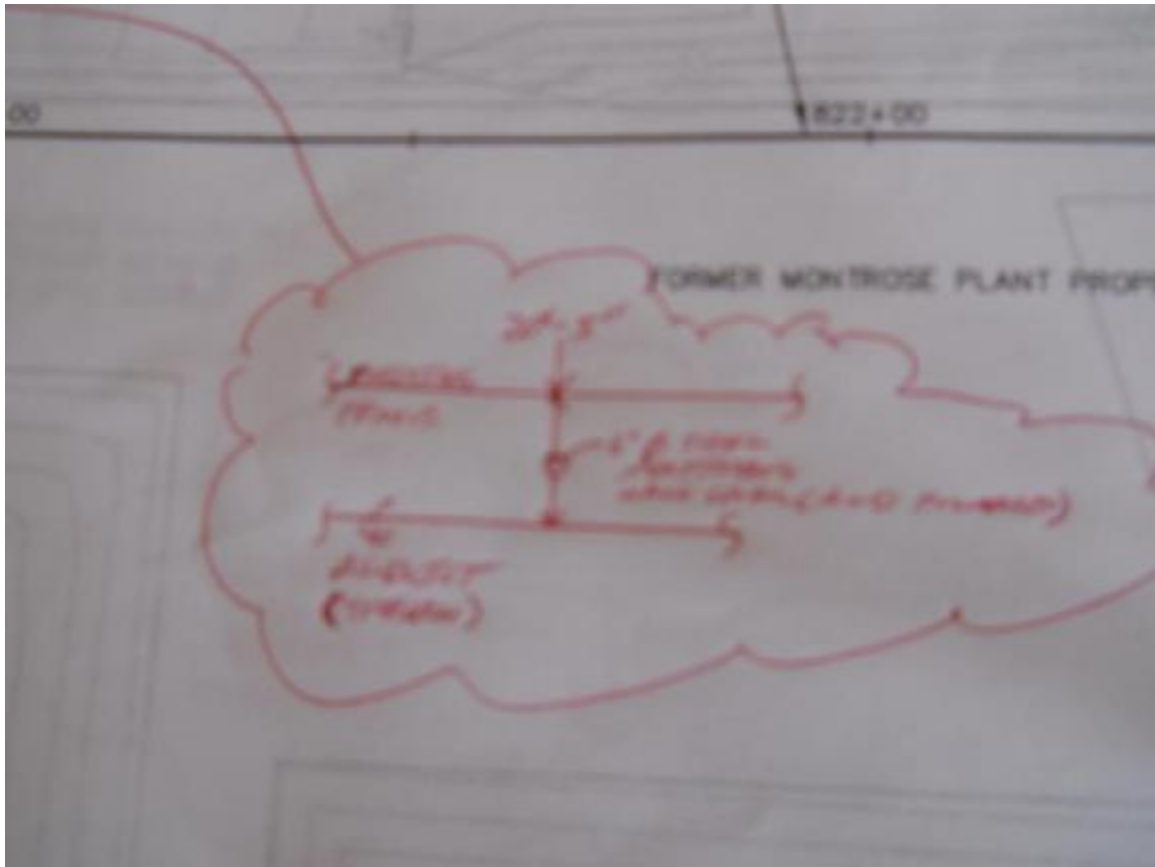
Figure 23: Realigned trench referenced to fence line

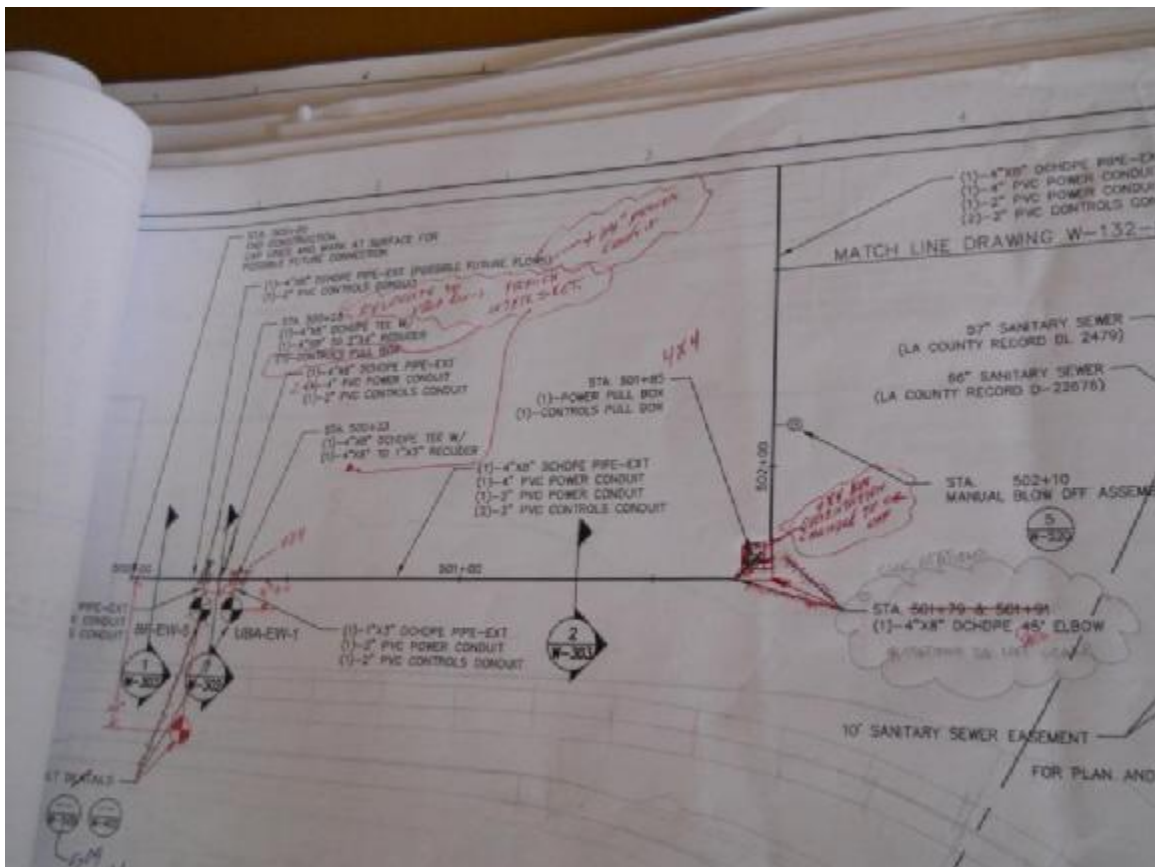
Figure 24: Rotated pull box

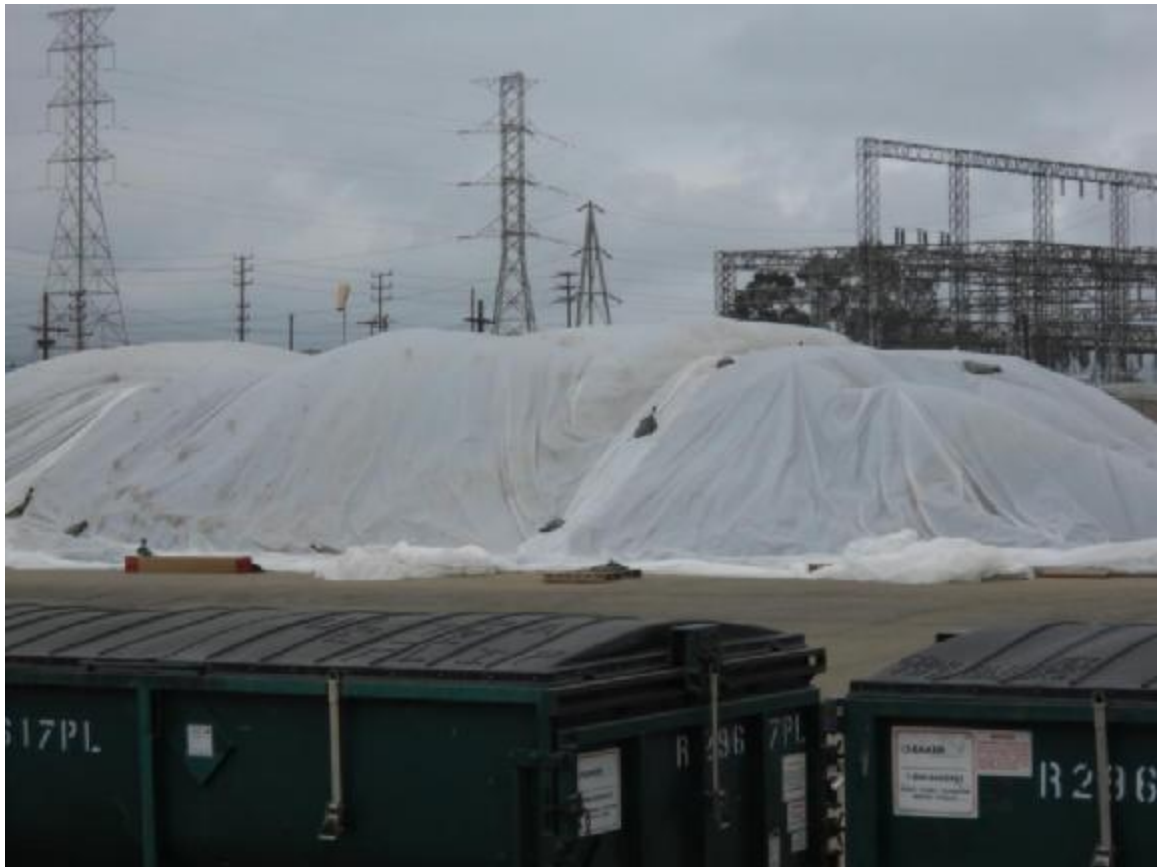
**Figure 25: Covered stockpile at center of Montrose site**

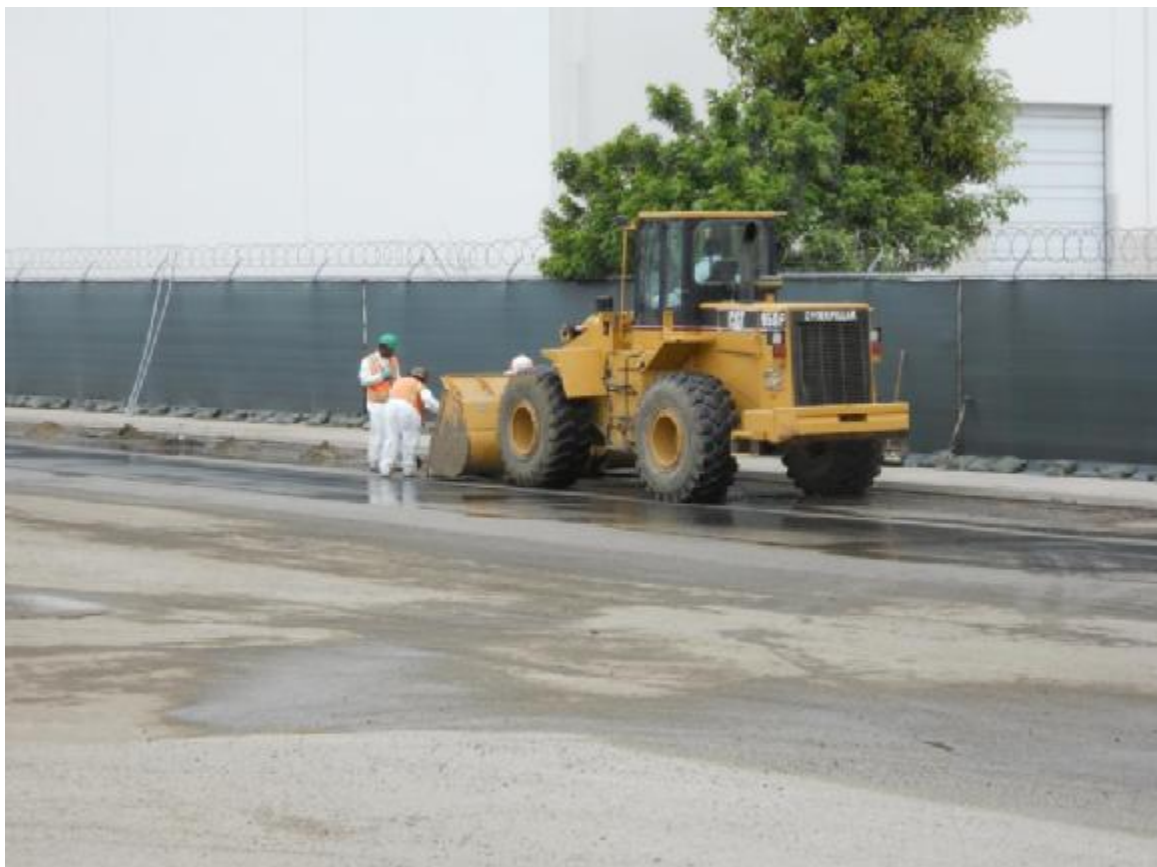
**Figure 26: Workers cleaning up along newly installed realigned trench**
