U.S. Environmental Protection Agency Region 9 Oil Program

SPCC PHOTOGRAPHIC LOG

ALLENCO ENERGY LOS ANGELES CA

11/6/2013

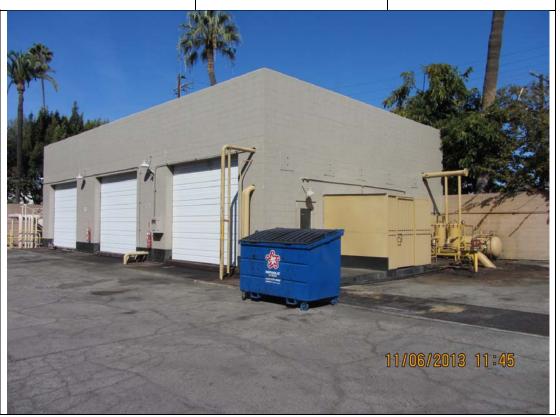
Photo No. Time: 1 045*

EXTERIOR OF WATER INJECTION PUMP HOUSE. TRENCH SUMP UNDER GRATING.

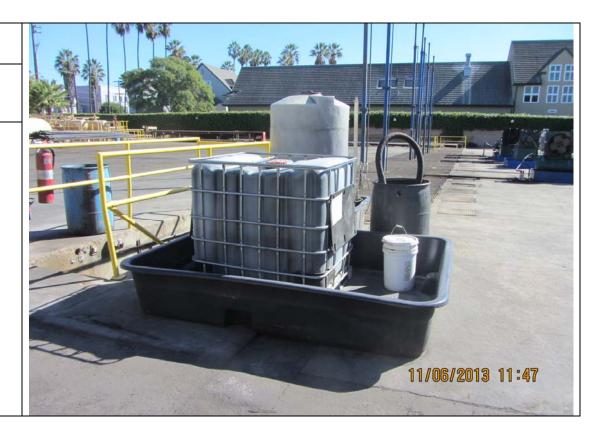
Photo No.

PORTABLE CONTAINERS OF INHIBITORS (e.g. CORROSION) IN SECONDARY CONTAINMENT

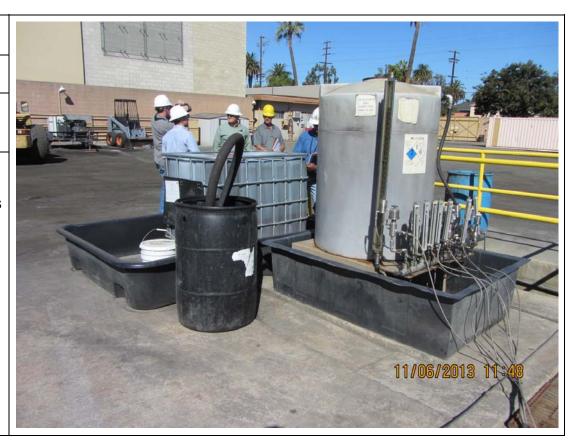
Photo No. Time: 1048

ADDITIONAL VIEW OF INHIBITOR CONTAINERS IN SECONDARY CONTAINMENT

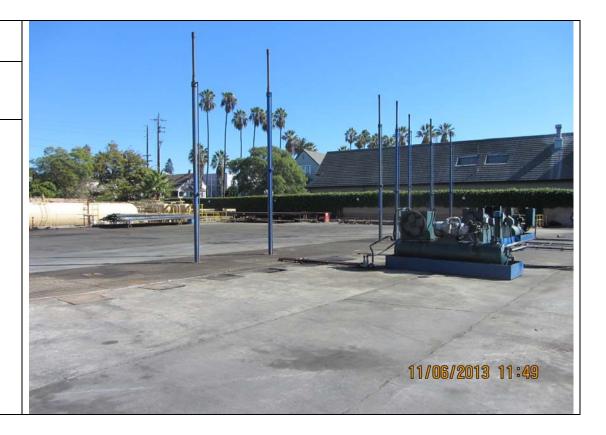
Photo No.

VIEW ABOVE WELL GALLERY

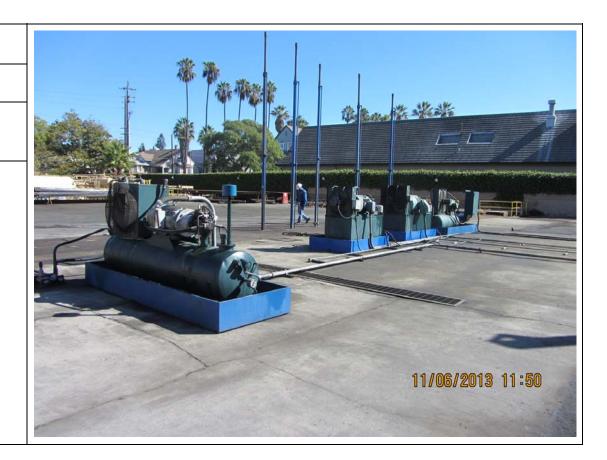
Photo No. 5 Time: 1050

AREA ABOVE WELL GALLERY

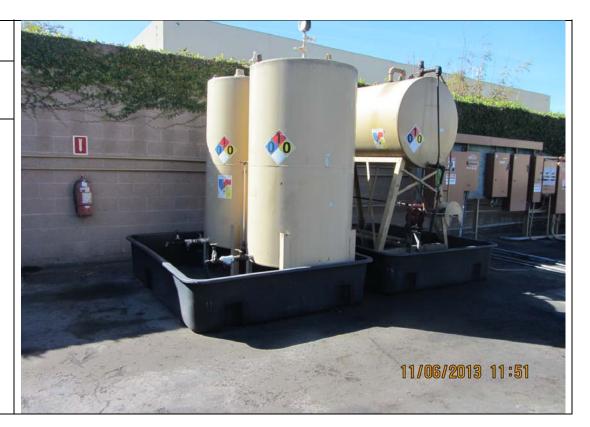
Photo No. 6 Time: 1051

HYDRAULIC OIL TANKS IN SECONDRY CONTAINMENT – TANK AT RIGHT IN USE

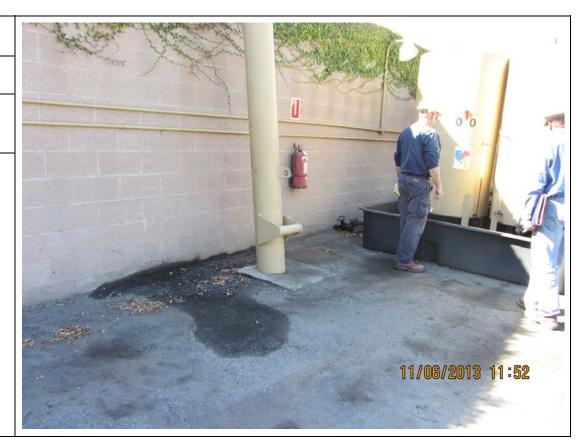
Photo No. Time: 7 1052

AREAS OF DISCOLORATION, POSSIBLY WEEPING FROM HISTORICAL EVENT, OR SEEPAGE FROM BEYOND WALL. HYDRAULIC OIL TANKS AT RIGHT OF IMAGE.

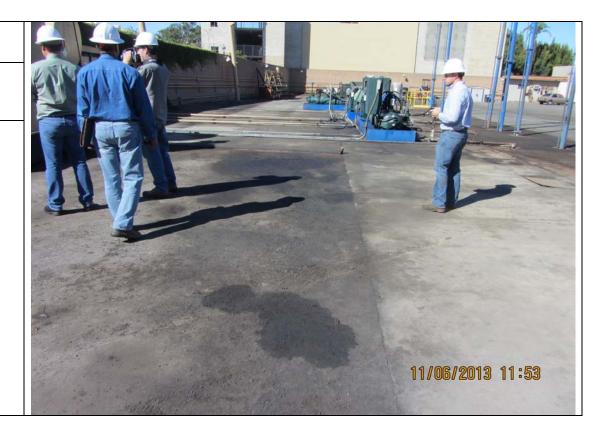
Photo No.

SOME AREAS OF DISCOLORATION ON PAVED AREA.

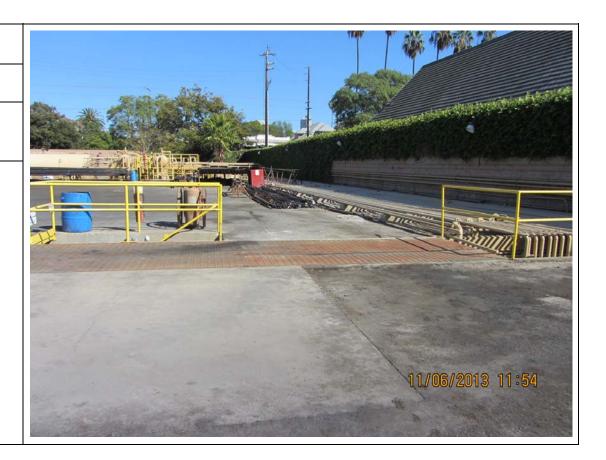
Photo No. Time: 9 1054

WELL GALLERY EAST ENTRANCE AND TRANSFER PIPES AT RIGHT.

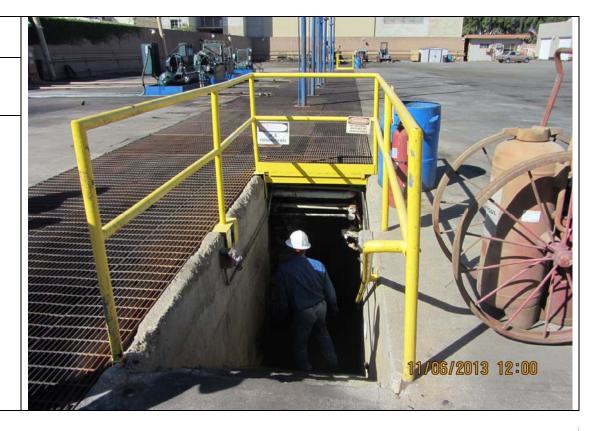
Photo No. 10 Time: 1100

WELL GALLERY EAST ENTRANCE WITH H2S WARNING SIGN IN PLACE ON RAIL.

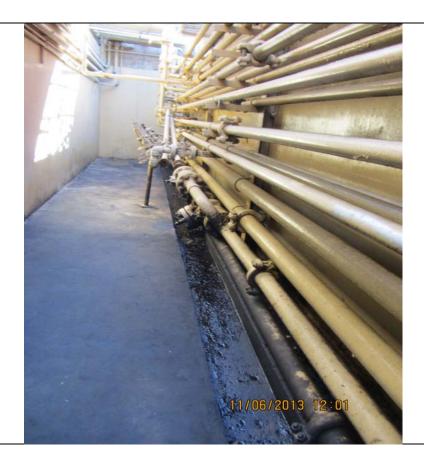
Photo No. 11 1101

WELL PIPING AND TRENCH IN GALLERY

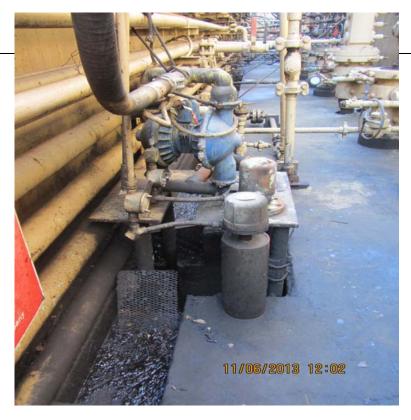
Photo No. 12 Time: 1102

TRENCH PUMP IN WELL GALLERY TRENCH

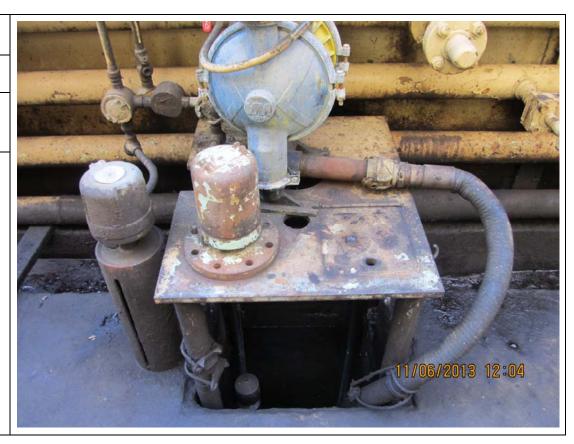
Photo No. 13 Time: 1104

TRENCH PUMP IN WELL GALLERY TRENCH

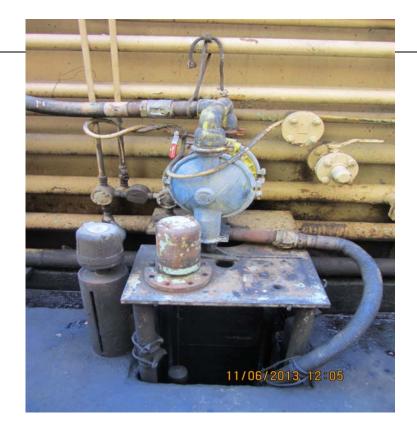
Photo No. 14 Time: 1105

TRENCH PUMP IN WELL GALLERY TRENCH

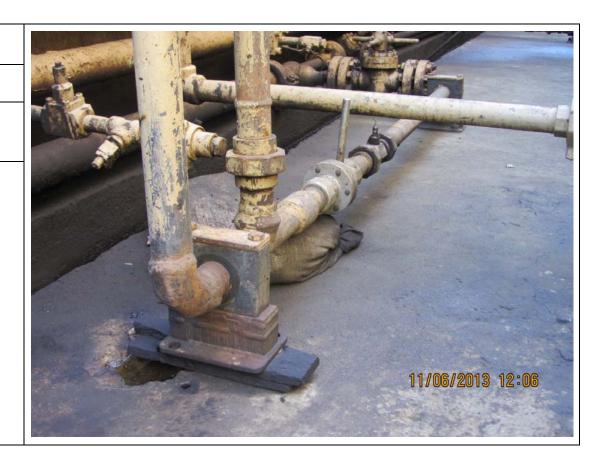
Photo No. 15 Time: 1106

PIPING SUPPORTS IN WELL GALLERY

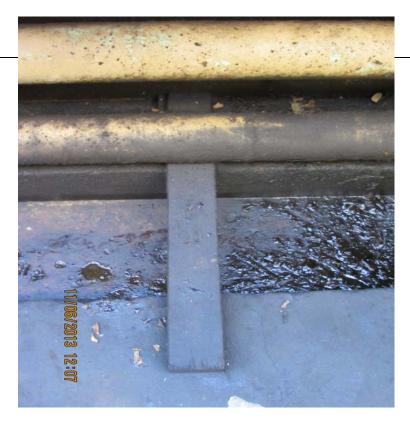
Photo No. 16 Time: 1107

LUMBER USED AS PIPING SUPPORT IN WELL GALLERY

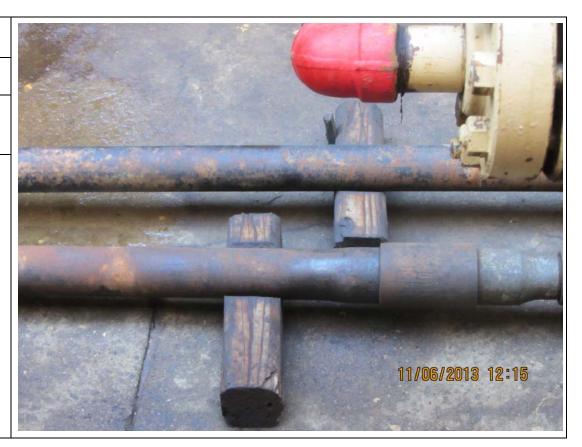
Photo No. 17 1115

LUMBER USED AS PIPING SUPPORTS FOR WELL #19 TEST LINES (CURRENTLY IDLE)

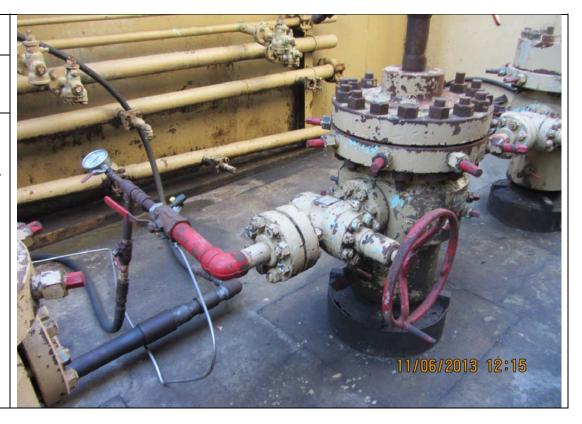
18
 1115

TEST LINES (AT LEFT) TO WELL #19 (IDLE) AND #19 WELL HEAD AT RIGHT

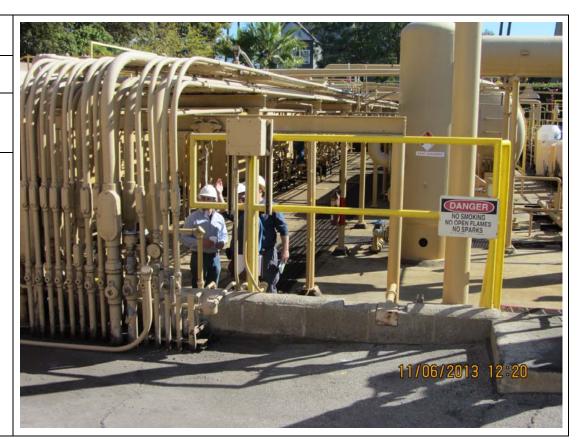
Photo No. 19 1120

PHOTO OF TANK FARM CONTAINMENT AREA; VIEW INCLUDES LOCATION WHERE H2S DANGER SIGN HAD PREVIOUSLY BEEN ON RAILING

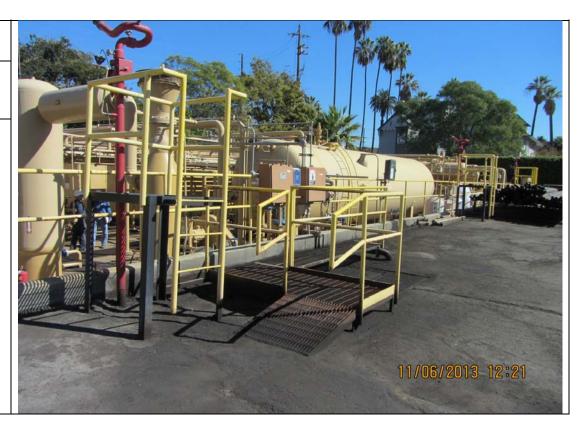
Photo No. 20 Time: 1121

TANK FARM CONTAINMENT AREA, SCRUBBER AT LEFT (IN PIT).

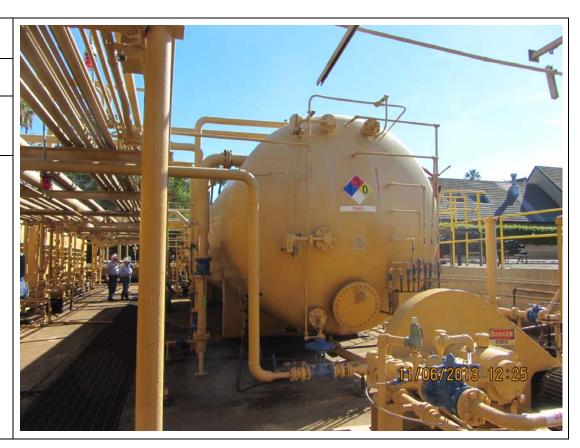
Photo No. Time: 1125

FREE WATER KNOCK OUT TANK – CAPACITY 500 BBLS (21,000 GAL) PER SPCC PLAN.

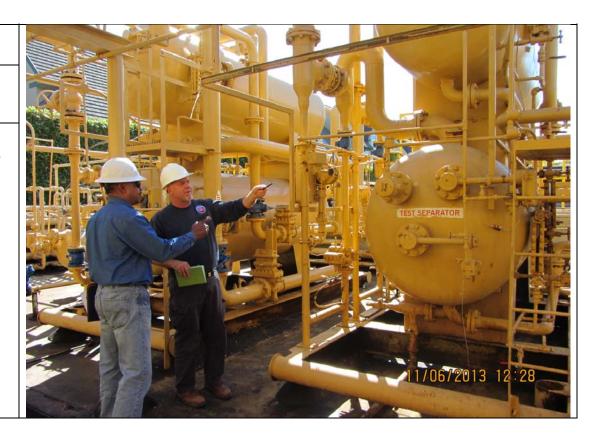
Photo No. 22 1128

TRAVIS CAIN, JEREMY JOHNSTONE AND SEPARATOR TANKS

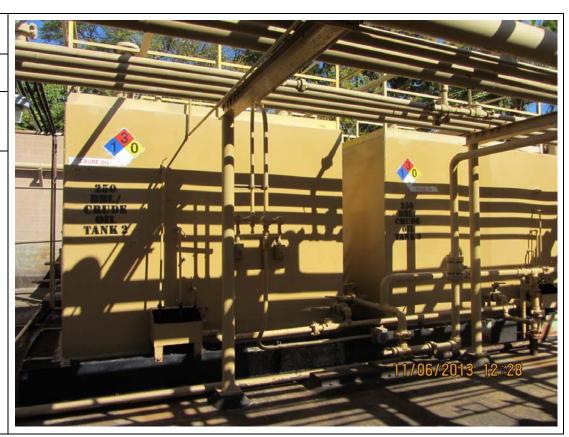
Photo No. Time: 1128

CRUDE OIL TANK 2 AND TANK 3, MARKED 250 BBLS EACH (10,500 GAL)

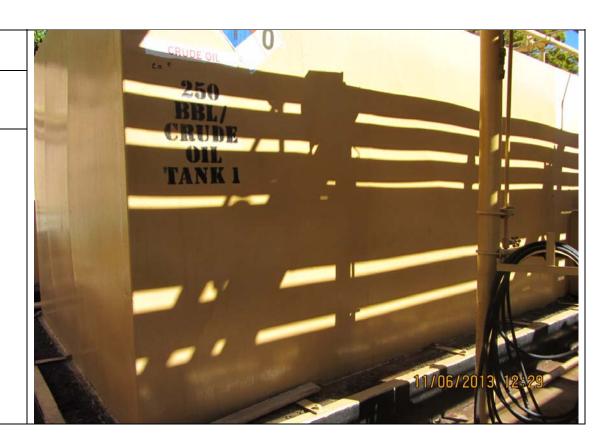
Photo No. 24 1129

CRUDE OIL TANK 1, MARKED 250 BBLS (10,500 GAL)

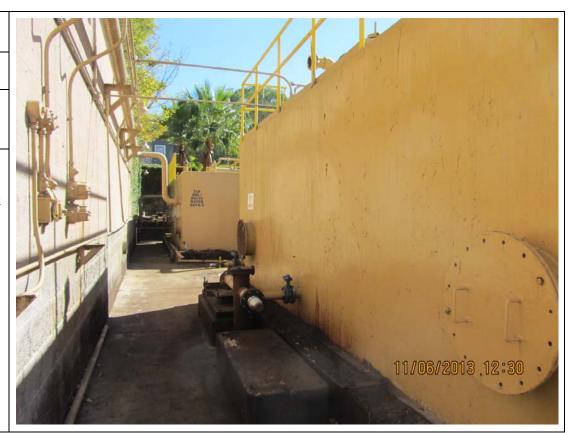
Photo No. 25 Time: 1130

BRINE WATER TANK #3 AT REAR, BRINE WATER TANK #2 AT RIGHT, EACH MARKED 250 BBLS

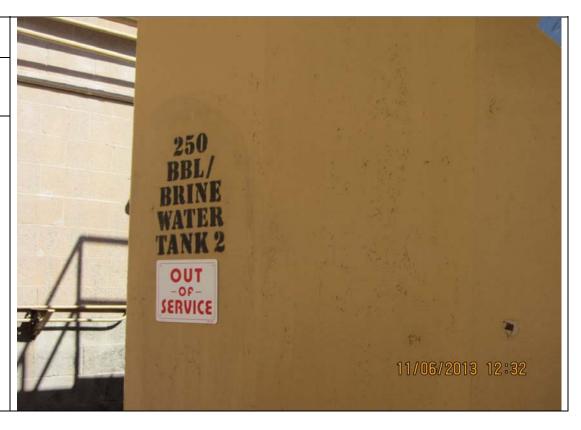
Photo No. 26 Time: 1132

BRINE WATER TANK #2, MARKED OUT OF SERVICE (NO OOS DATE FOUND ON TANK)

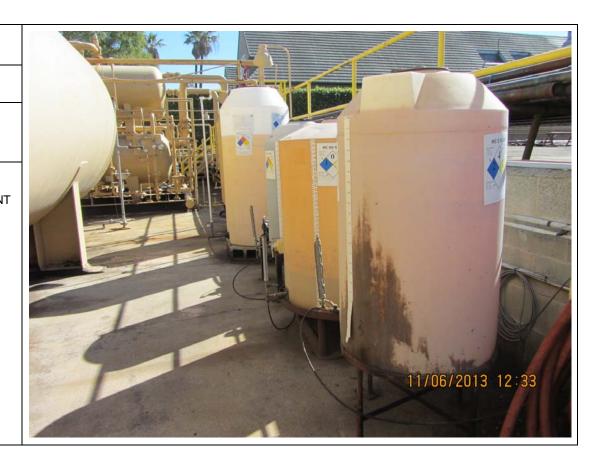
Photo No. 27 1133

CHEMICAL TREATMENT AREA, INSIDE TANK FARM CONTAINMENT AREA. STANDS/SUPPORTS FOR TANKS NOT ALL PROPERLY ENGINEERED.

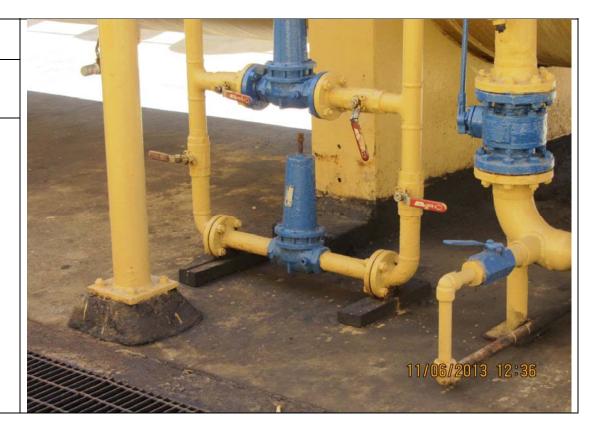
Photo No. 28 Time: 1136

LUMBER USED FOR PIPING SUPPORTS AT FWKO TANK

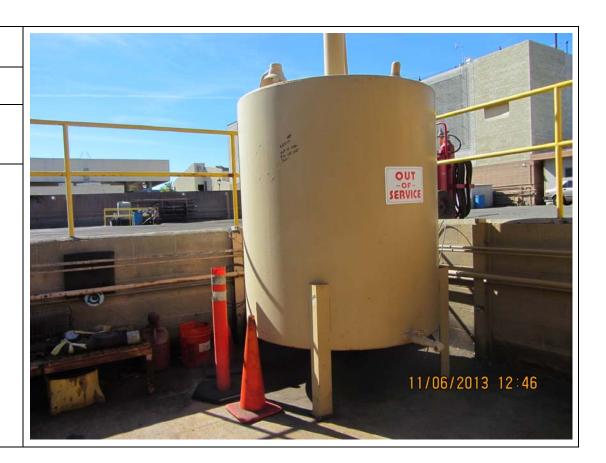
Photo No. 29 1146

#10 OLD VENT TANK LABELED OUT OF SERVICE, MARKED WITH OOS DATE OF 4/25/13

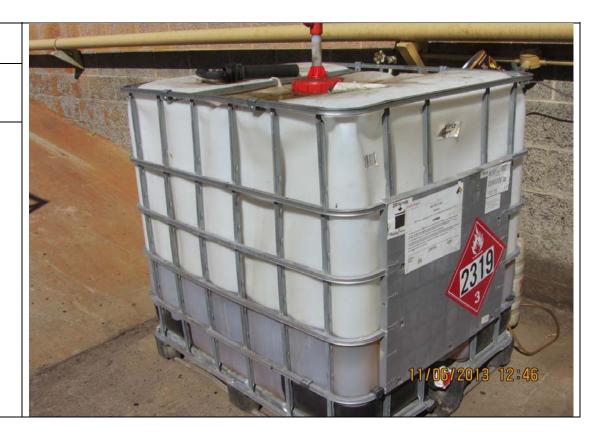
Photo No. 30 Time: 1146

ORANGE-SCENTED SOLVENT TOTE IN TANK FARM CONTAINMENT AREA

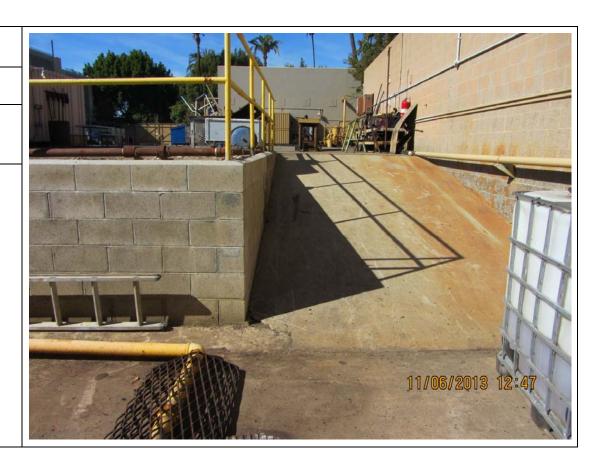
Photo No. 31 Time: 1147

RAMP AT TANK FARM CONTAINMENT AREA; PIPING PROTECTED FROM VEHICLES BY METAL GUARDS

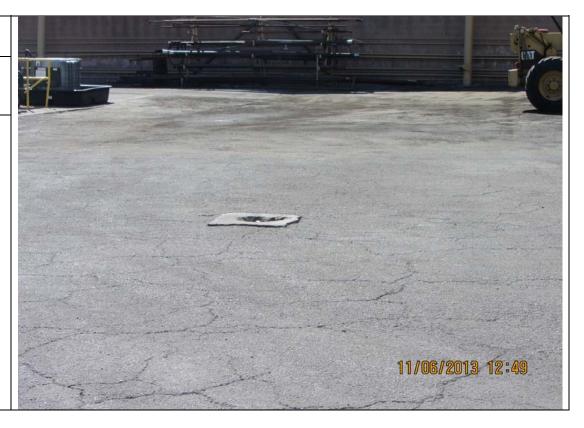
Photo No. 32 Time: 1149

VIEW OF PAVEMENT IN AREA SHOWING EXCESSIVELY DARK IN GOOGLE MAP IMAGE – SEE END OF PHOTOLOG

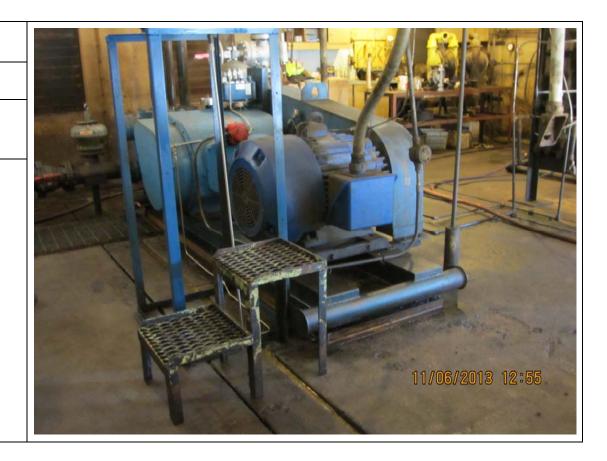
Photo No. 33 Time: 1155

PUMP IN WATER INJECTION PUMP HOUSE.

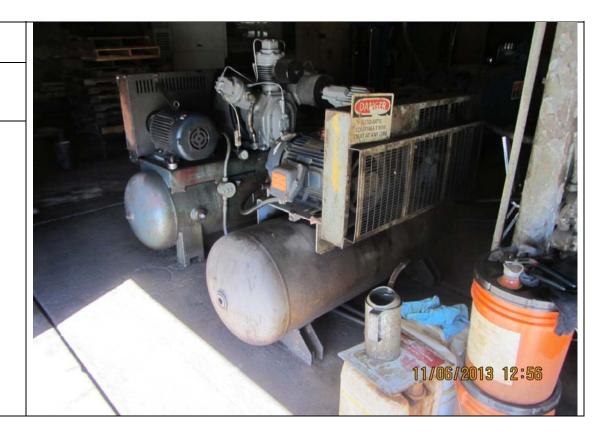
Photo No. 34 Time: 1156

COMPRESSOR VESSELS IN WATER INJECTION PUMP HOUSE.

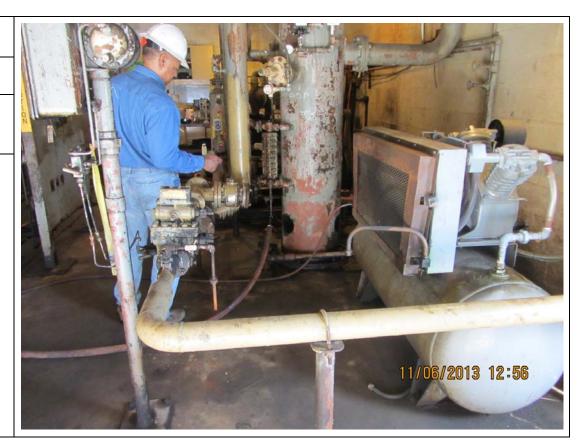
Photo No. Time: 1156

VAPOR RECOVERY UNIT AT REAR, COMPRESSOR AT RIGHT, AND PIPING - IN WATER INJECTION PUMP HOUSE.

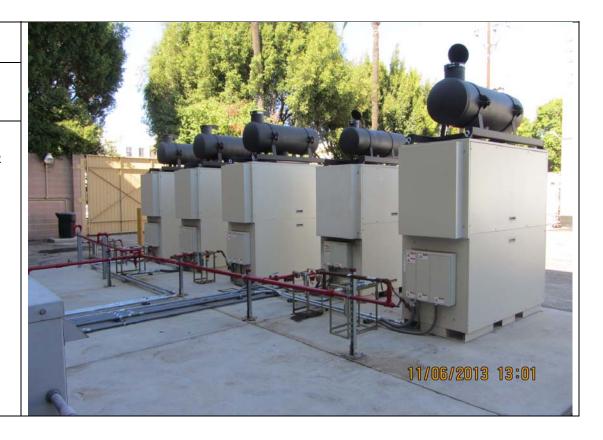
Photo No. 36 Time: 1201

MICROTURBINES FOR GAS EXTRACTED AT FACILITY.

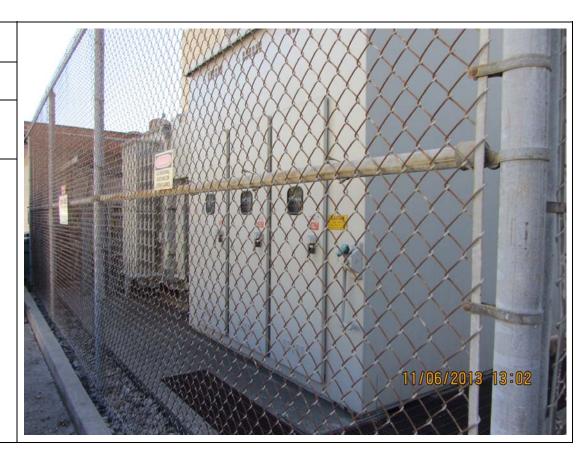
Photo No. 37 1202

UTILITY OWNED/OPERATED EQUIPMENT – INDUSTRIAL STATION IS-1332

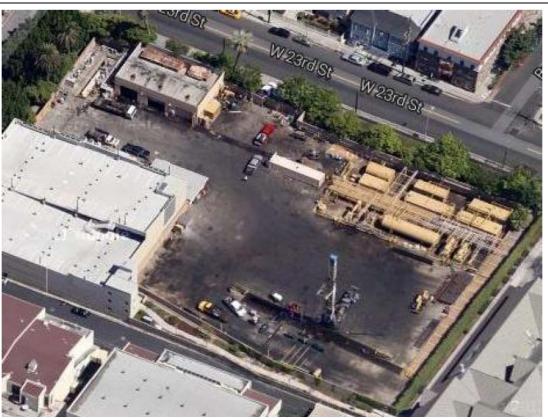
Photo No. Time: N/A UNKWN

GOOGLE MAP IMAGE OF FACILITY (AND PARKING STRUCTURE AT LEFT) FROM UNKNOWN YEAR
