**UNITED STATES ENVIRONMENTAL PROTECTION AGENCY
REGION IX
75 Hawthorne Street
San Francisco, CA 94105**

Purpose: RCRA Compliance Evaluation Inspection

Facility: **Consolidated Tire Recyclers, Inc.**

Date of Investigation: August 17, 2011

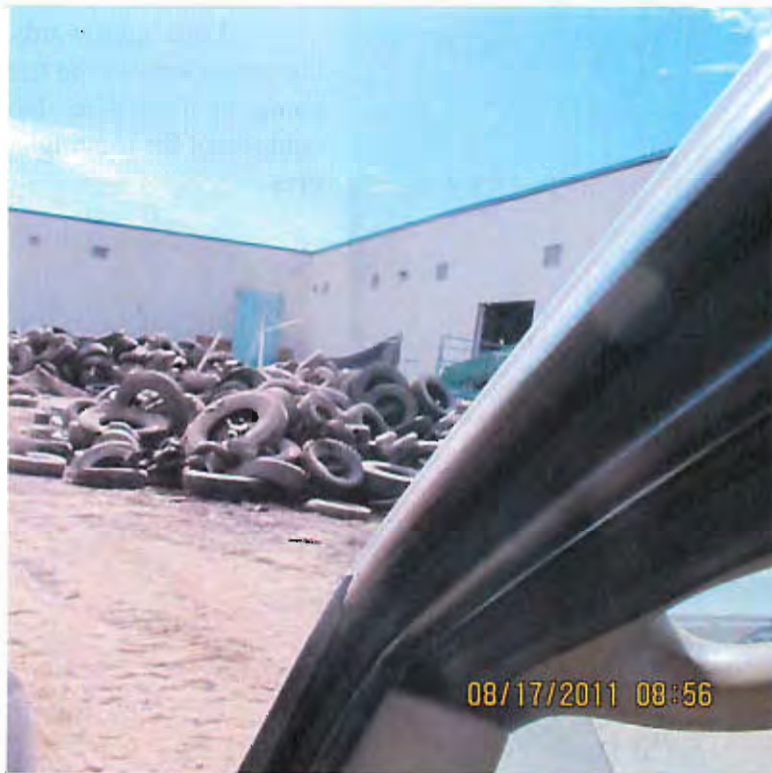
A significant number of tires remained in the loading area, leaning on and adjacent to the processing building. The current survey shows many tires remain in the same location.

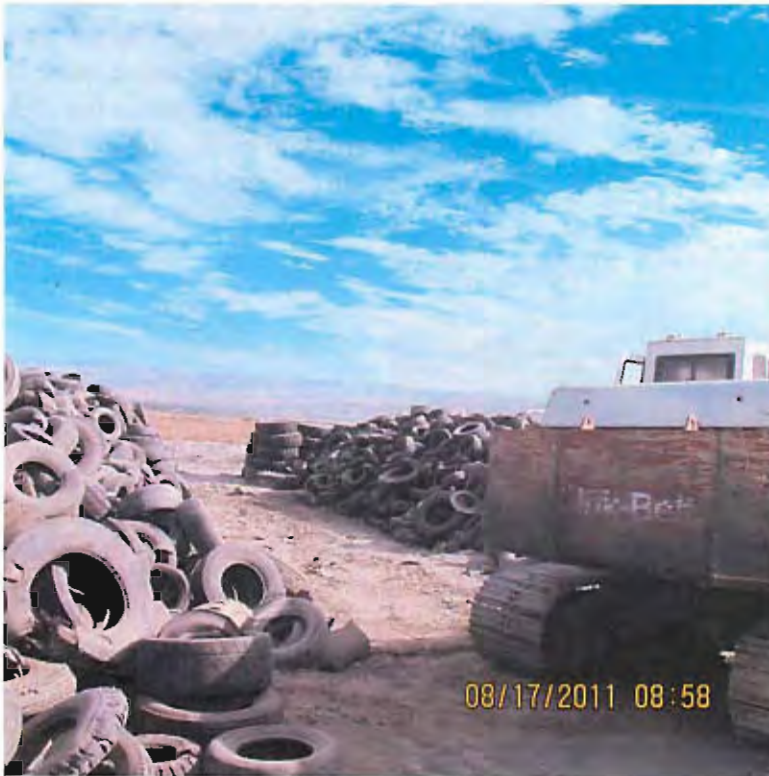
Aisle space between the rows is adequate for the tire equipment, but too narrow for fire trucks. The current survey shows a wider but still narrow lane.

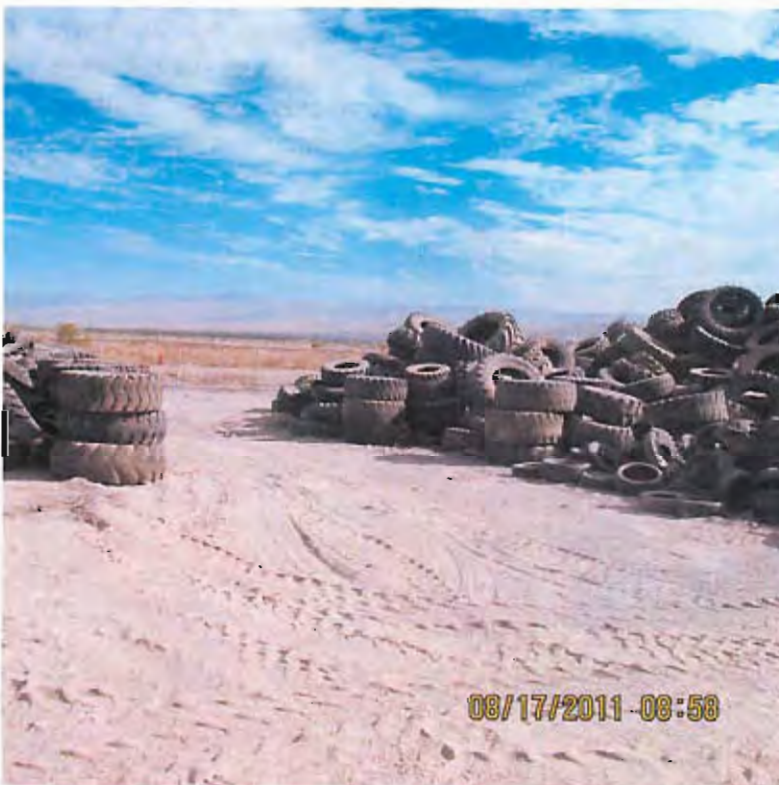
A second lane in the north tire pile area.

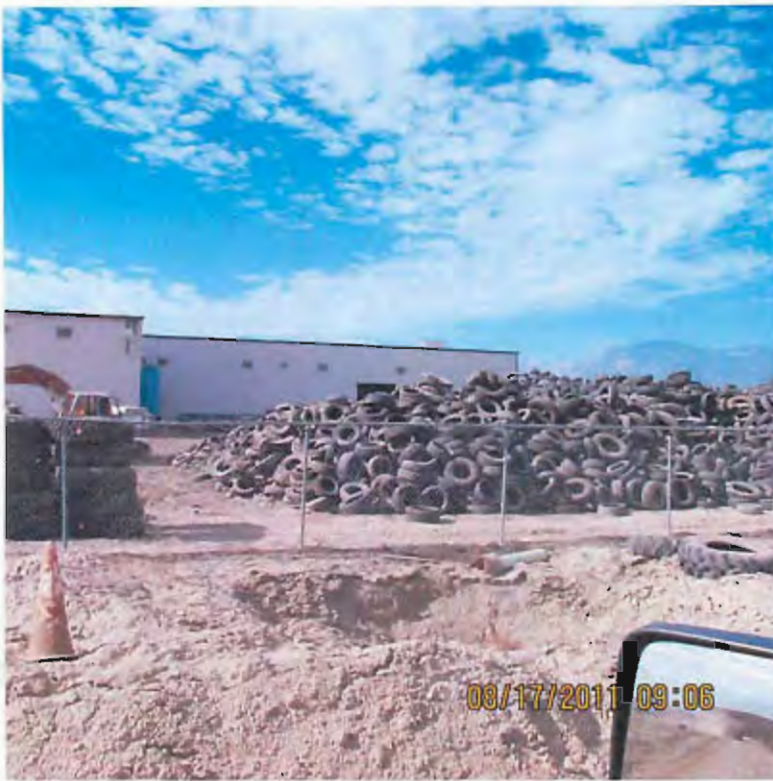
A view of the aisle with the tire handling equipment from outside the facility. The current survey photo is very similar. The tires outside of the fence, visible on the right, were placed to form a barrier for a hole that was excavated to repair piping.

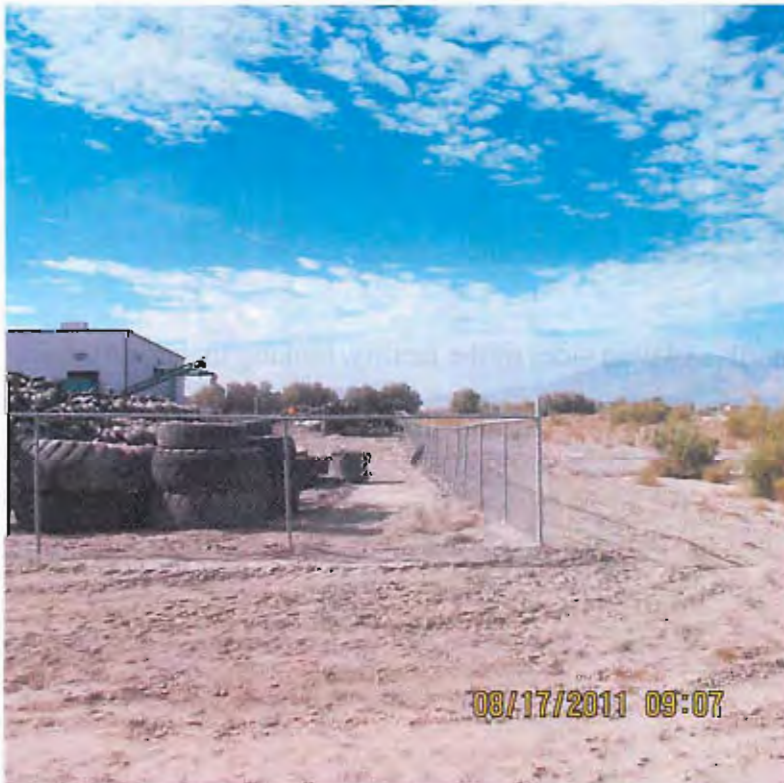
North-west corner of the facility, showing the western fence line. The current survey shows improvement along the west fence line.

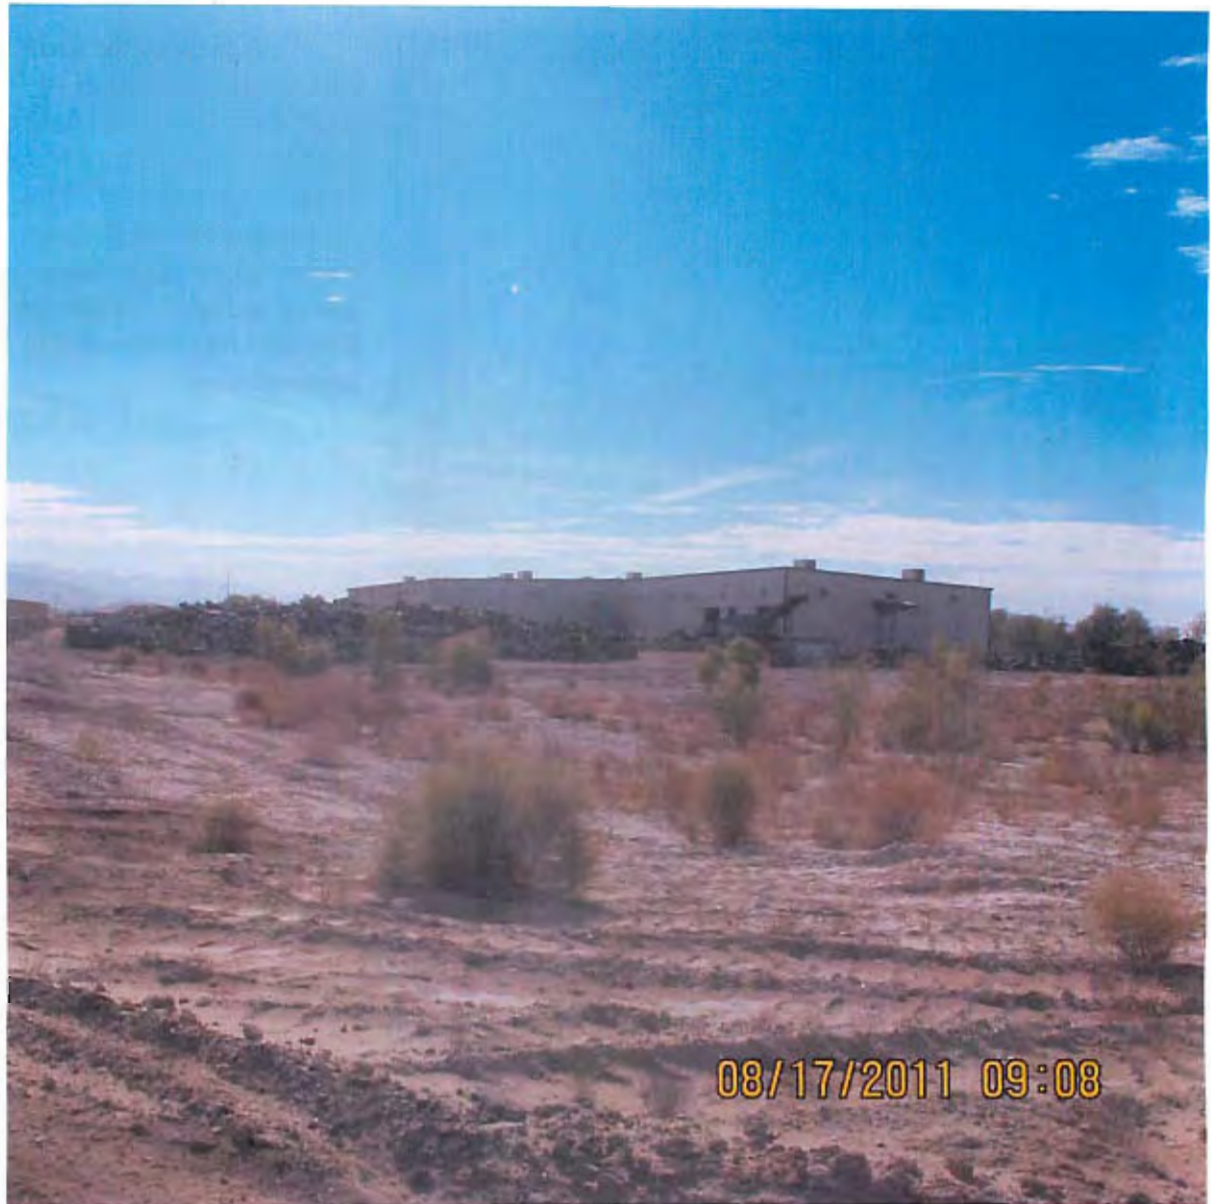
Overall view of the north and west sides of the facility, looking towards the east.

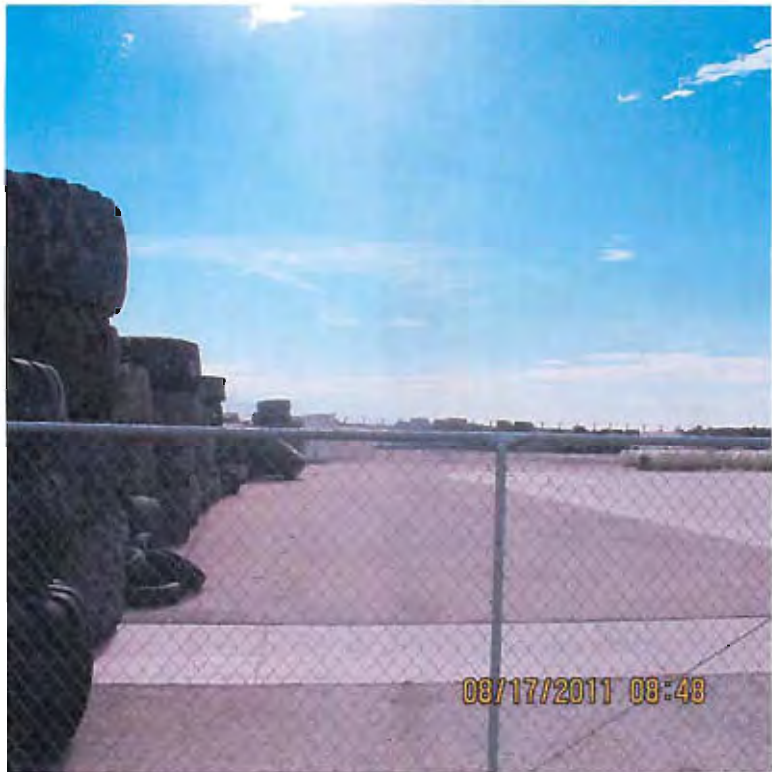
View from a gate on the west side of the former Specialty Alloys site, looking to the east.

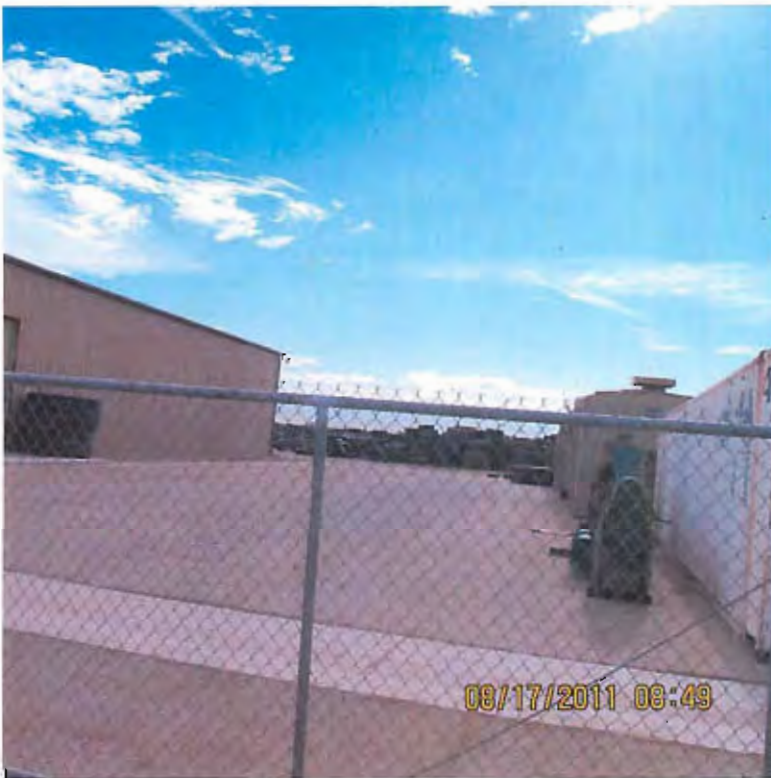
View from the southwest corner of the former Specialty Alloys site. Note the large tires adjacent to the building. All the photos in the current survey of the former Specialty Alloys site are very similar to these. The two large tires have not been moved.
