**U.S. Environmental Protection Agency, Region IX  
CWA Compliance Office  
Report of Clean Water Act Inspection**

***Site Location:*** State Route 179 Improvement Project  
Between Mile Posts 310.5 and 313.8  
Oak Creek/Sedona, AZ

***Date and Time of Visit:*** February 5, 2010, 8:30 a.m. – 1:30 p.m.

### **Photograph Log for EPA's 02/05/10 Site Visit to AZ DOT SR 179 Improvement Project – Oak Creek Bridge to Chapel Road, Yavapai and Coconino Counties, Arizona**

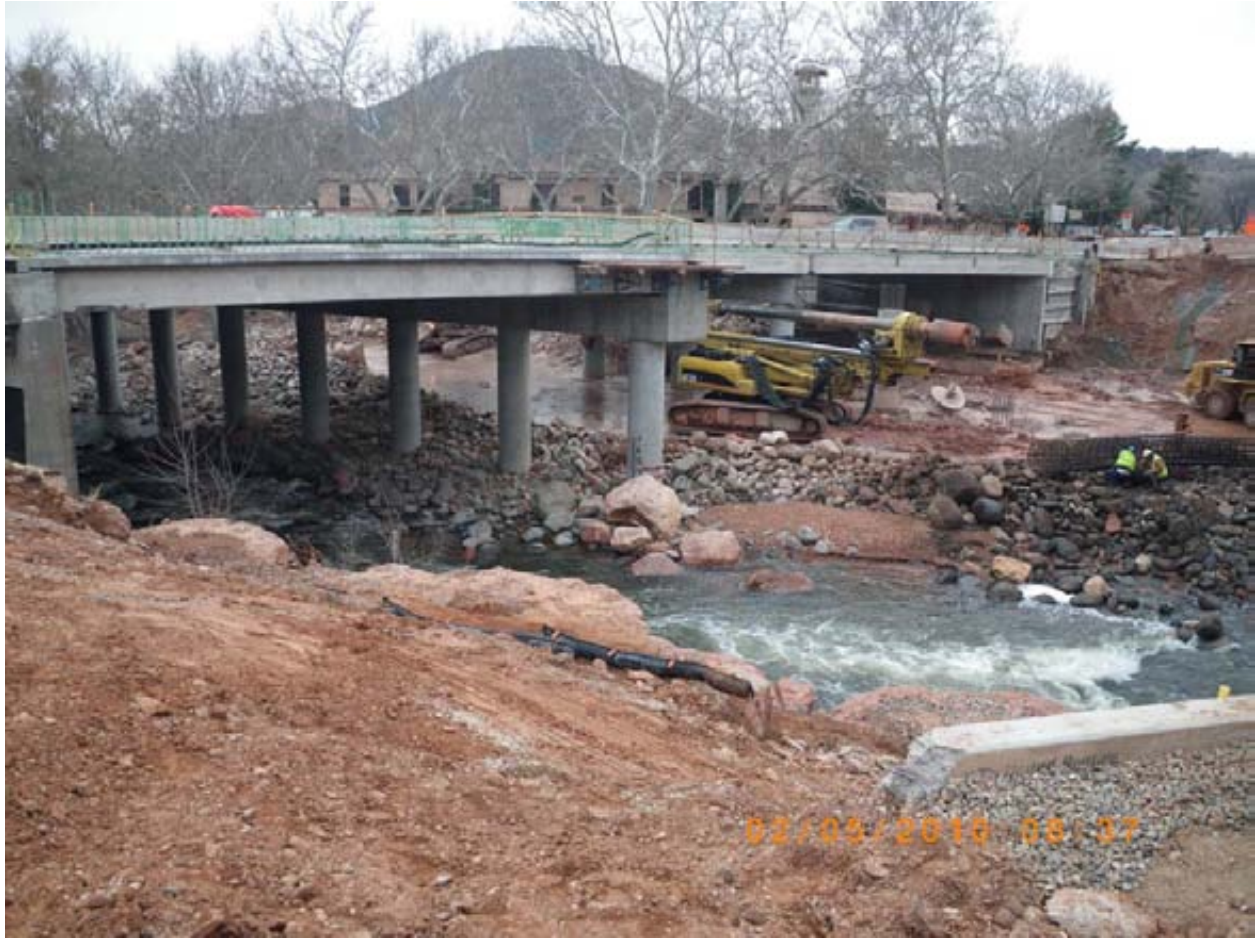
IMGP0003

Observations: The inspection began at the eastern end of the pedestrian bridge, above the Garland slope. This slope is directly above the active channel (see Photos 0003, 0044). The slope was disturbed without adequate best management practices (BMPs) installed. At the foot of the slope were three 'gator-eels' (heavy logs to slow the flow of water). At the top of the slope, a small basin was installed to slow the flow of water (see Photo 0045). This basin was undersized, given the amount of run-on entering the site at this location. This slope has been unprotected since January 9, 2010, when ADOT/Fisher removed the last bridge abutment. Prior to the January 19-22 storm event, ADOT/Fisher installed three steel I-beams across the slope in an attempt to stabilize the slope. Because the I-beams served as dams rather than filters, they were inadequate and the slope eroded underneath and around the beams, discharging sediment to Oak Creek.

IMG0003 – Taken from top of Garland (east) slope of Oak Creek, looking west toward Tlaquepaque (west) slope, Oak Creek's confined channel, and vehicular bridge. Note that steel girders have been removed from Garland slope after they were compromised during Jan 15-20<sup>th</sup>, 2010 storm. Gator eels installed at toe of slope.

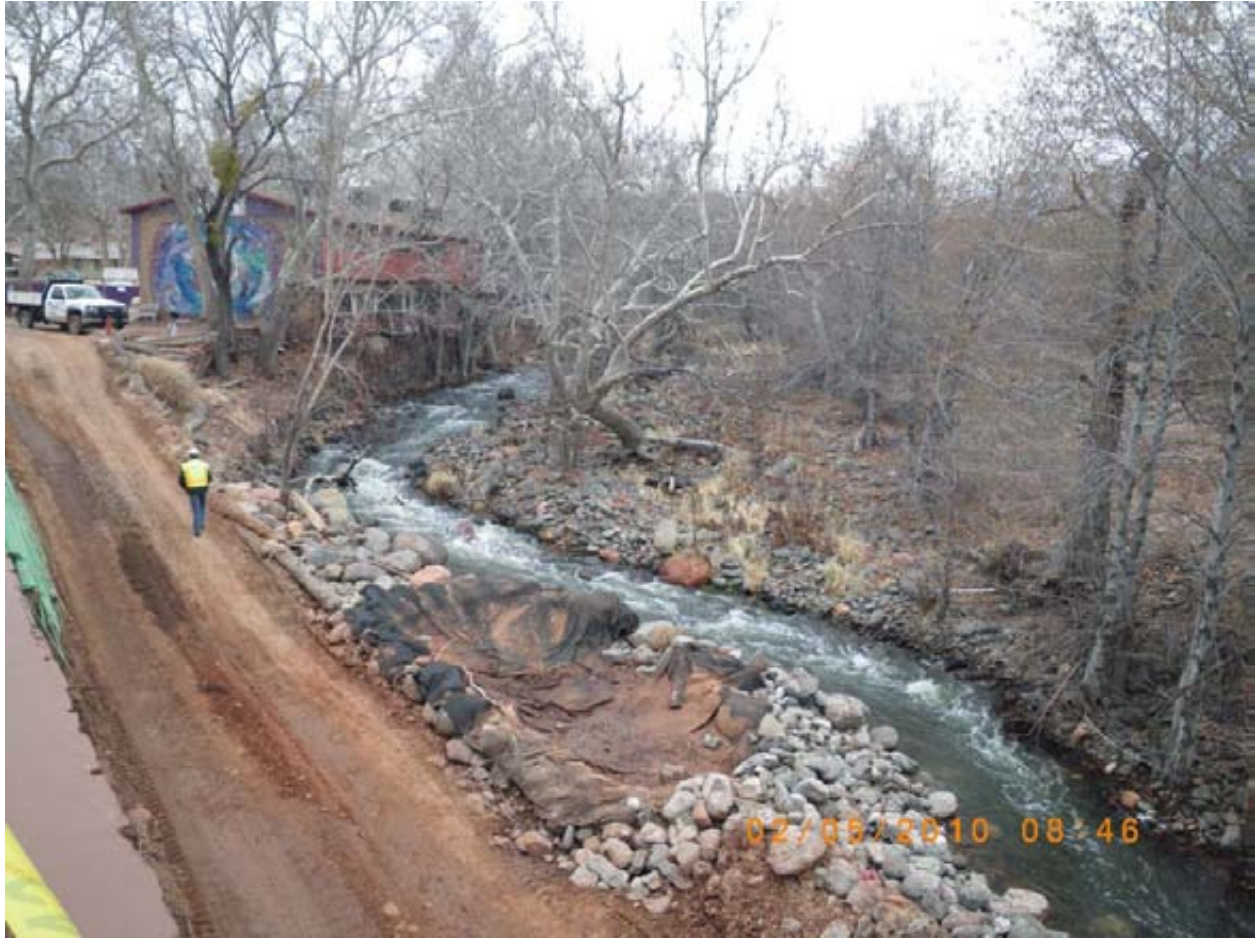
IMGP0006

IMG0006 – From north side of pedestrian bridge, looking north toward west braid of Oak Creek, upstream of bridges. Note sediment basin between creek and access road used for occasional filtering of sediment-laden water collected in coffer dam. Filter fabric is sagging from north side of basin, creating escape route for fine sediment. On-site contractors noted that this sediment basin has never over-topped.

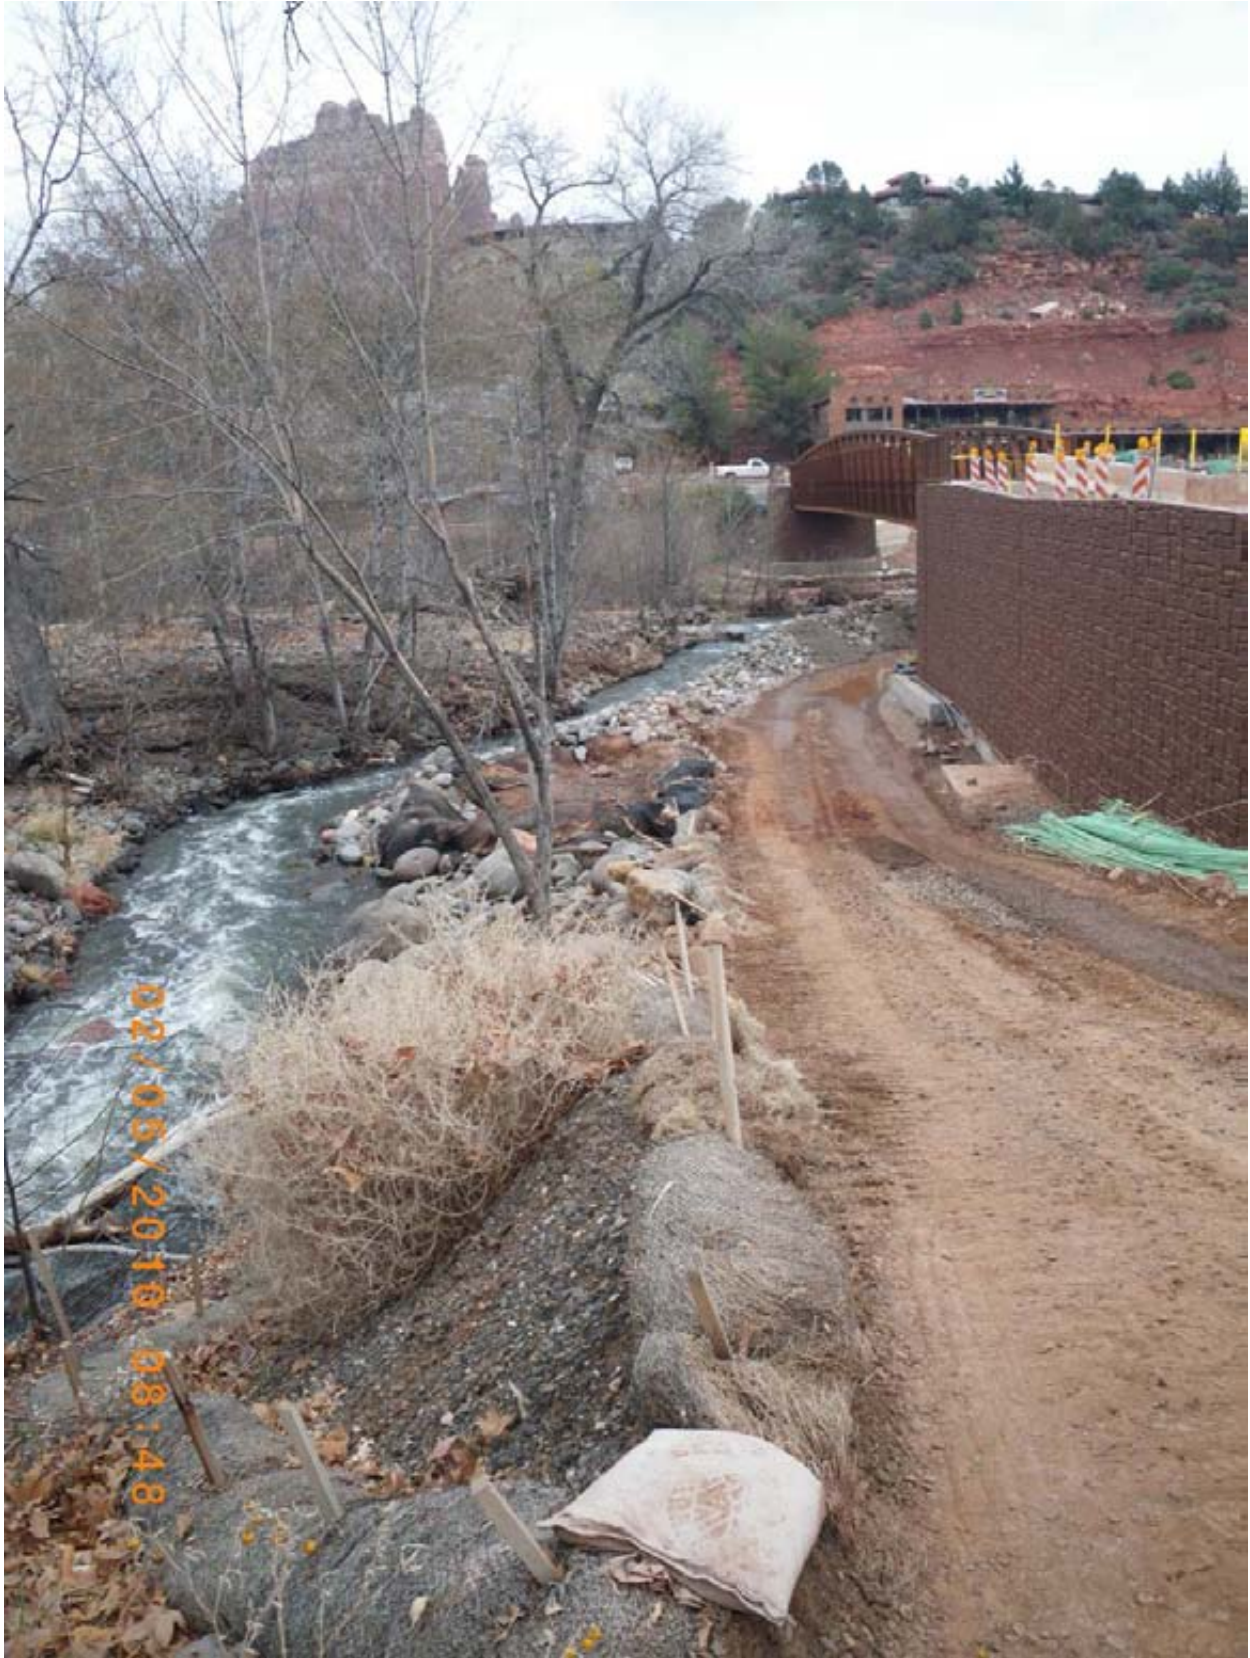
IMGP0007  
6 of 86

IMG0007 – From northwest corner of project site at top of access road, looking east toward Garland slope and pedestrian bridge. Note sediment from access road deposited on rock bank adjacent to creek.

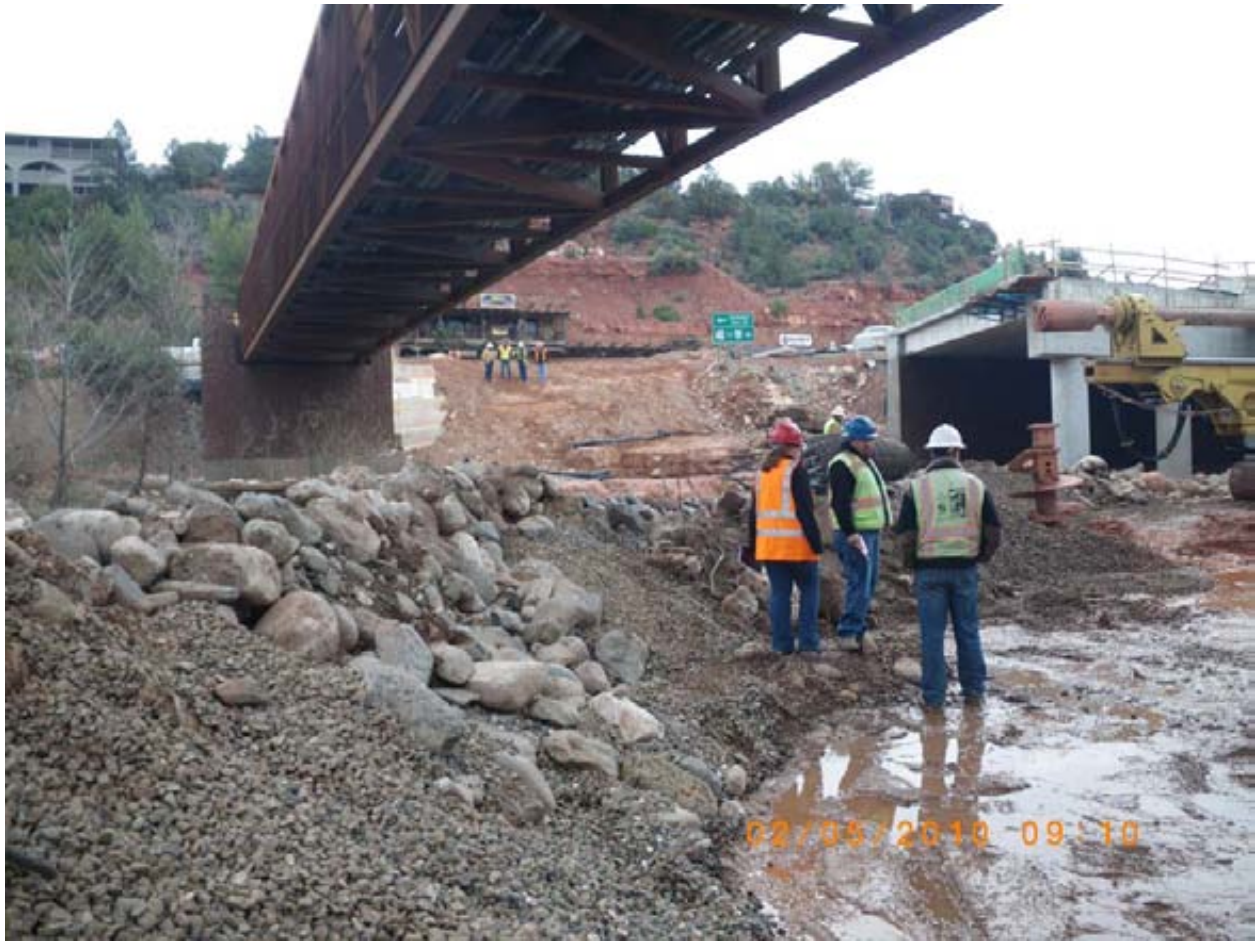
IMGP0008

IMG0008 – From under pedestrian bridge, west side of creek bed, facing Garland slope. Note imported boulders and gravel in creek bed work area.

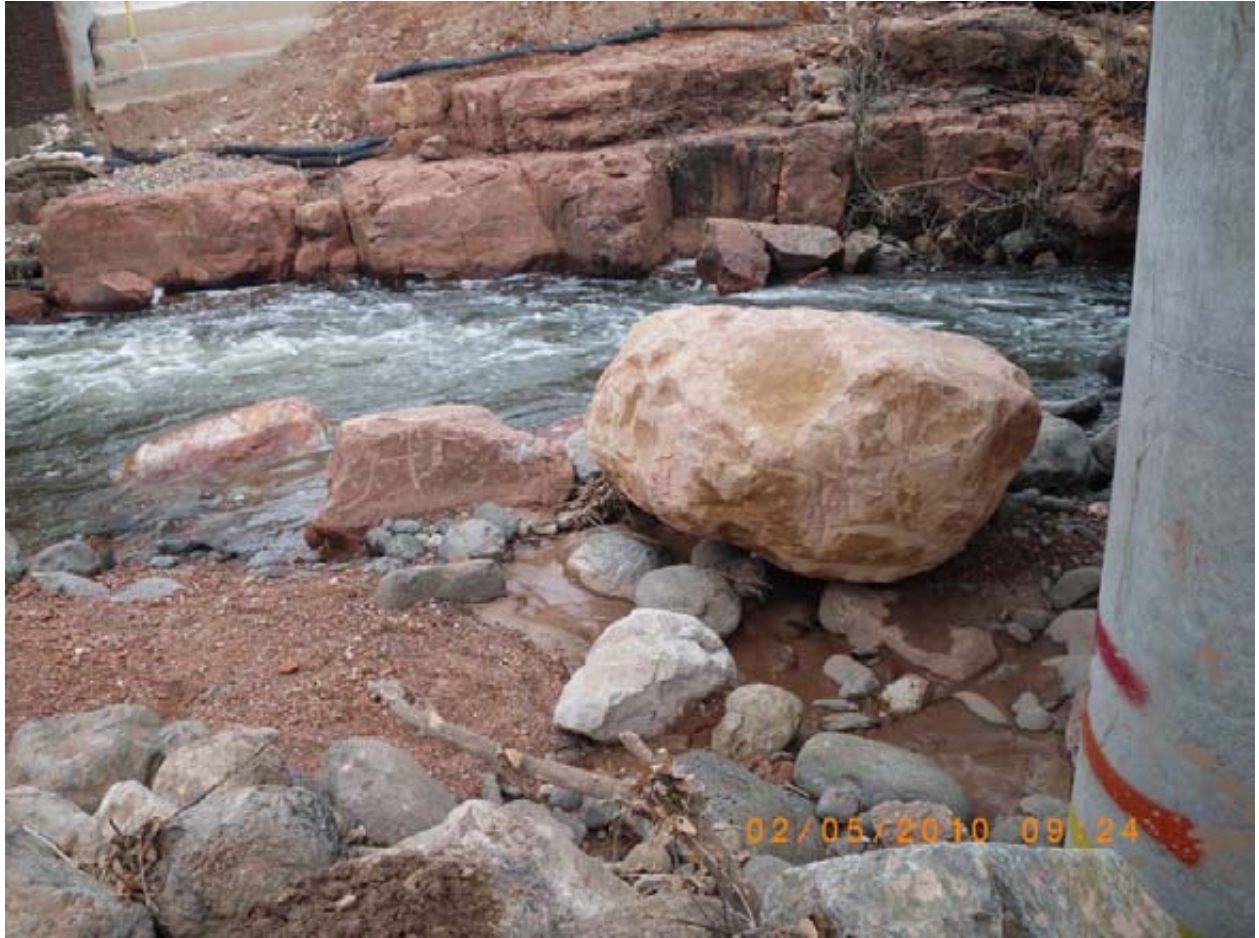
IMGP0020 – From west side of creek, northernmost pier of vehicular bridge, facing east. Creek flows from left to right of picture frame. Sediment is probably from upstream sources.

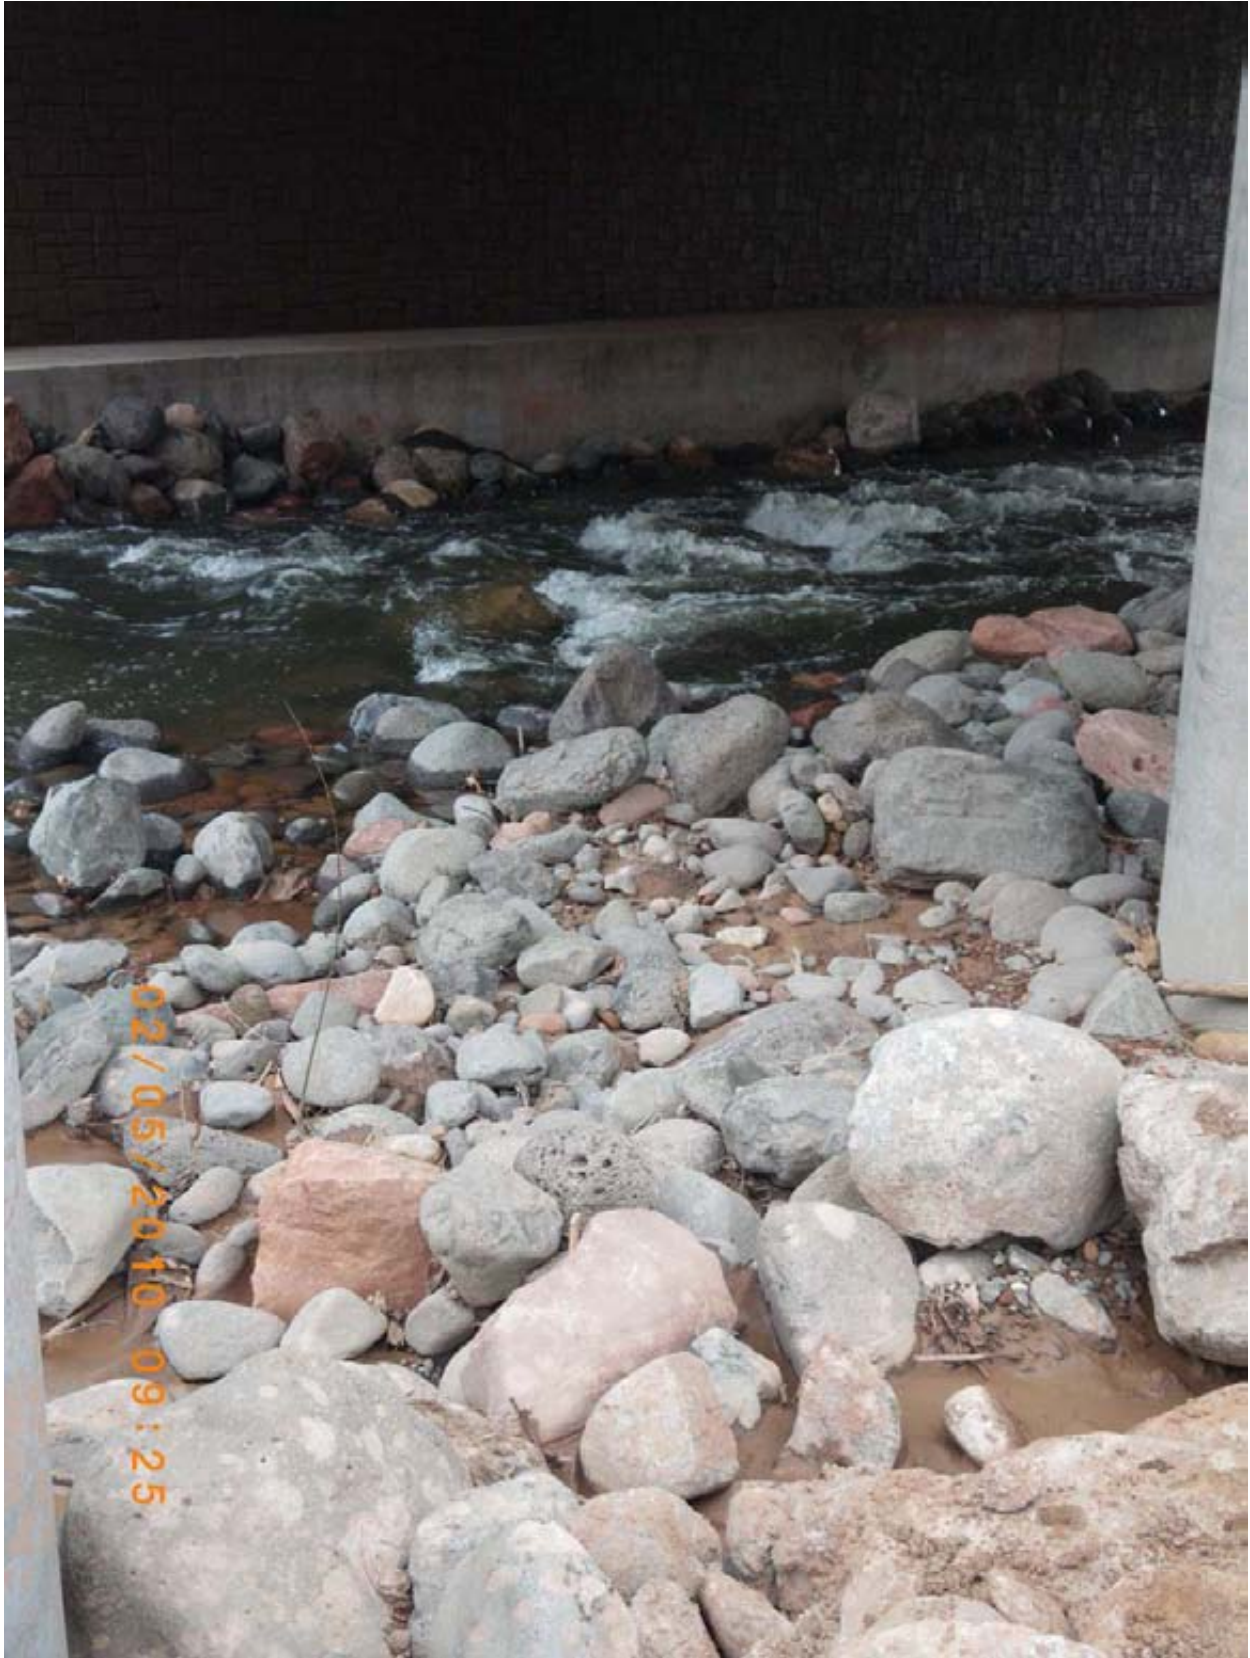
IMGP0022  
21 of 86

IMGP0022 – Close-up of fine sediments from IMGP0021.

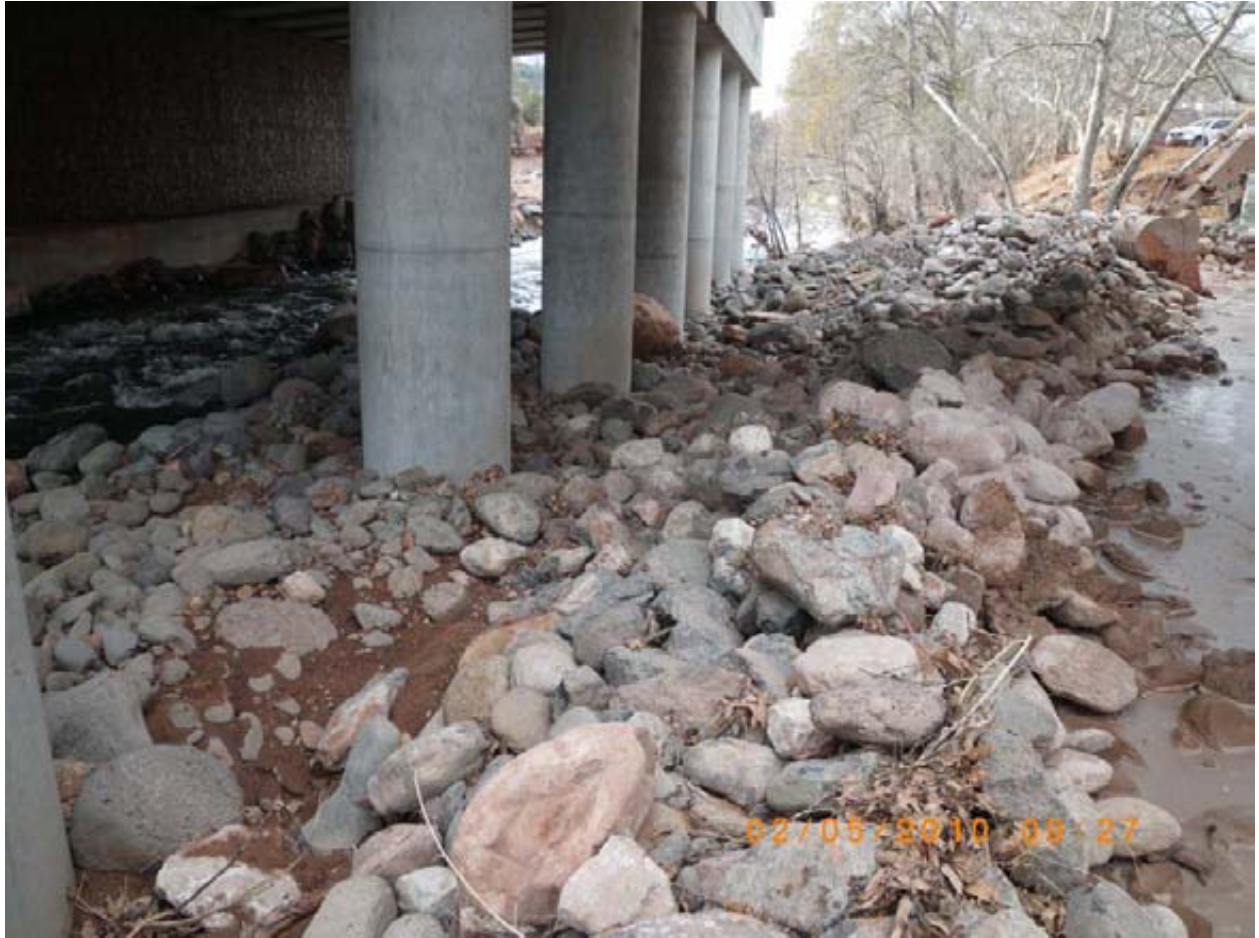
IMGP0023 – From top of coffer dam, facing south/downstream direction of Oak Creek (shown on left side of picture frame). Note fine sediments on creek side of coffer dam.

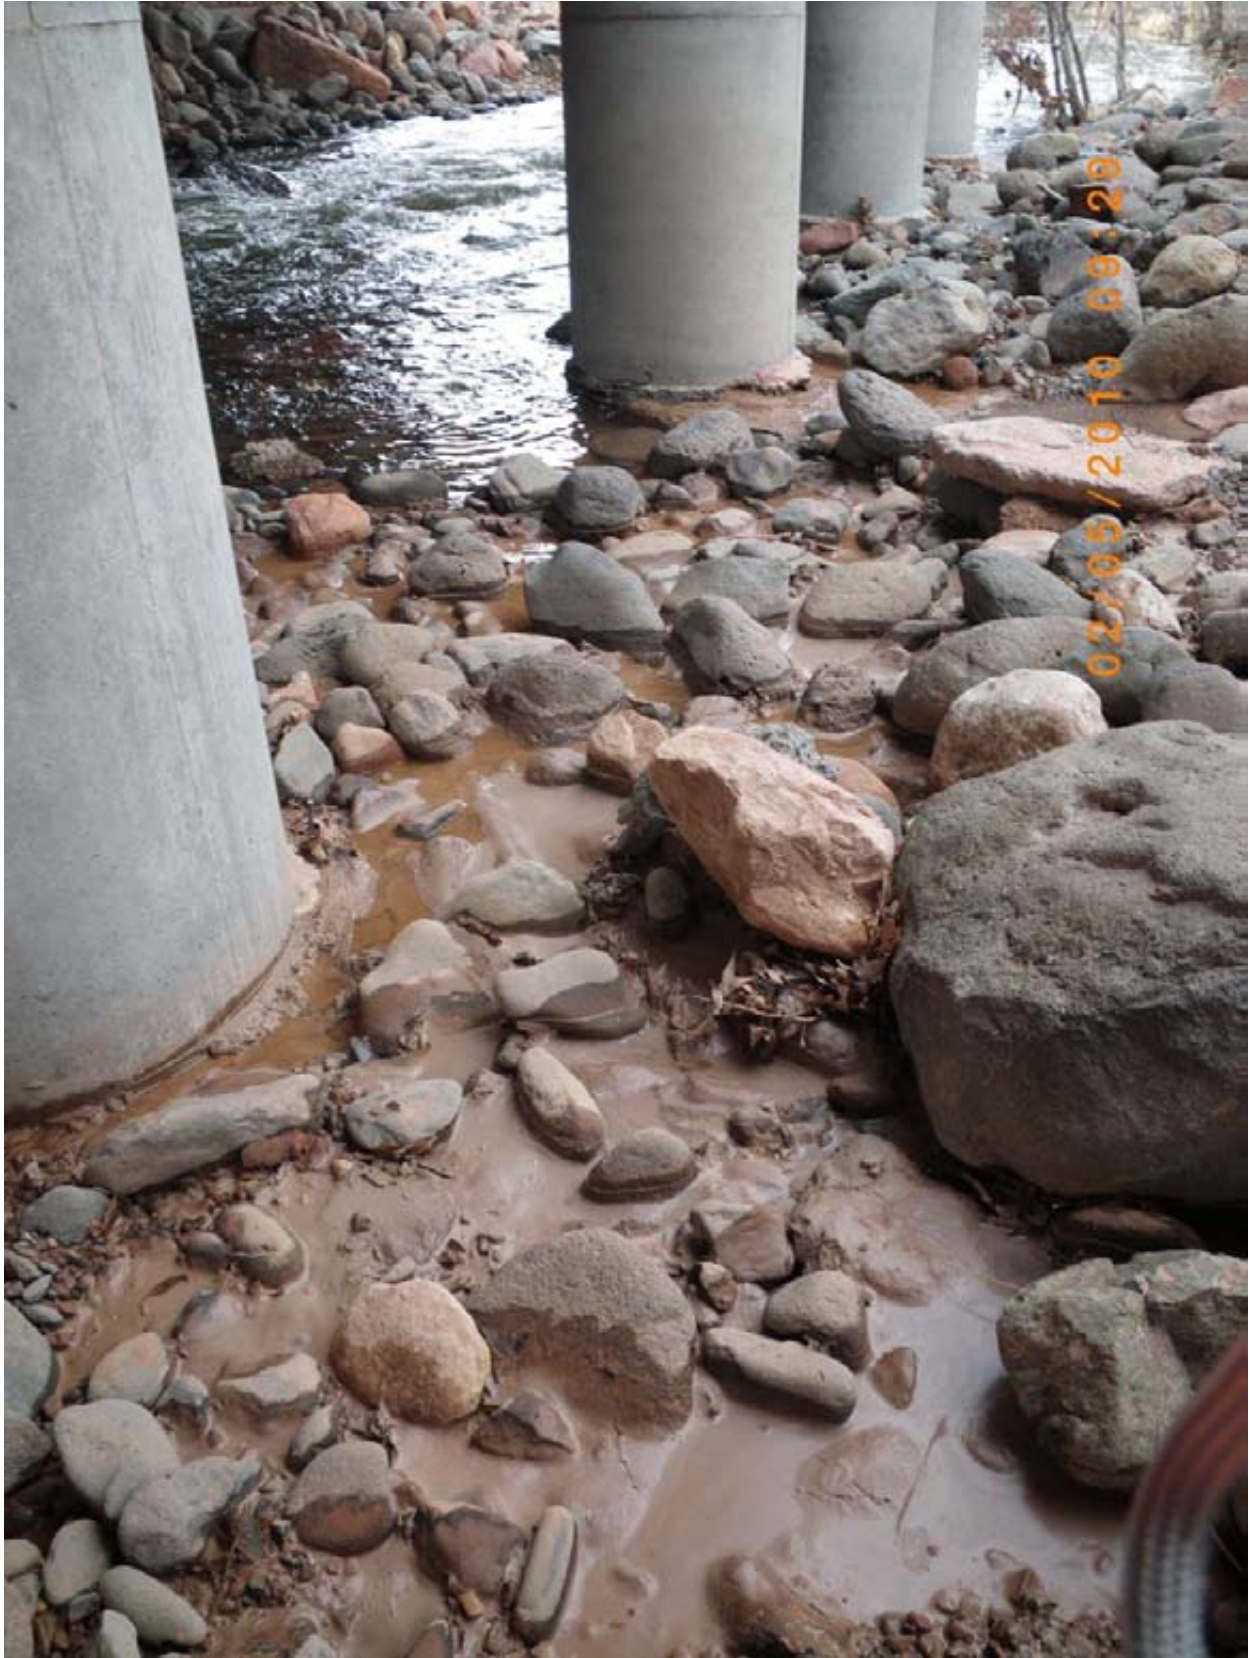
IMGP0024  
23 of 86

IMGP0024 – Close-up of fine sediments from IMGP0023.

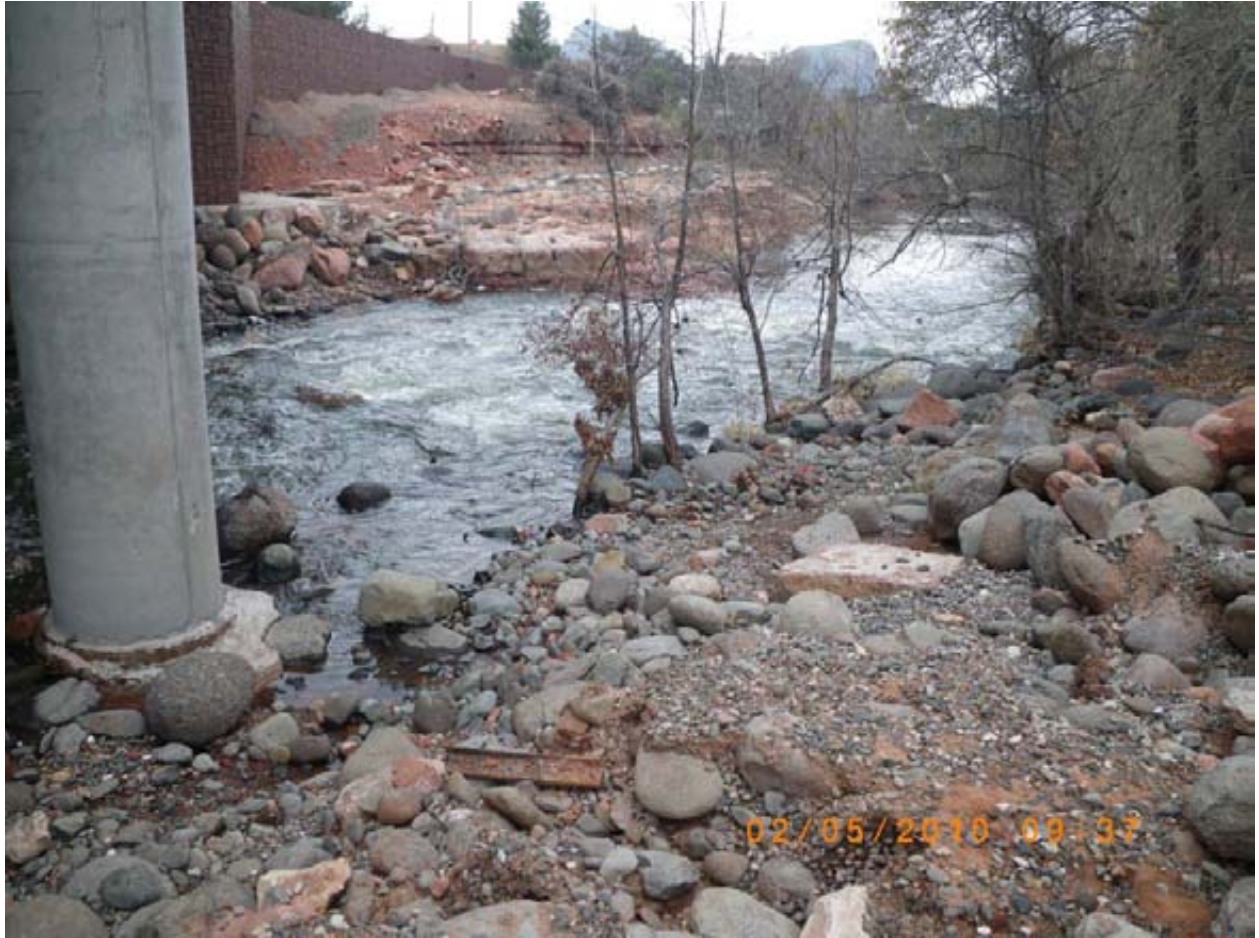
IMG0026

IMGP0026 – From west side of creek (southeast edge of coffer dam), facing southeast/downstream direction of Oak Creek. Note fine sediments in foreground.

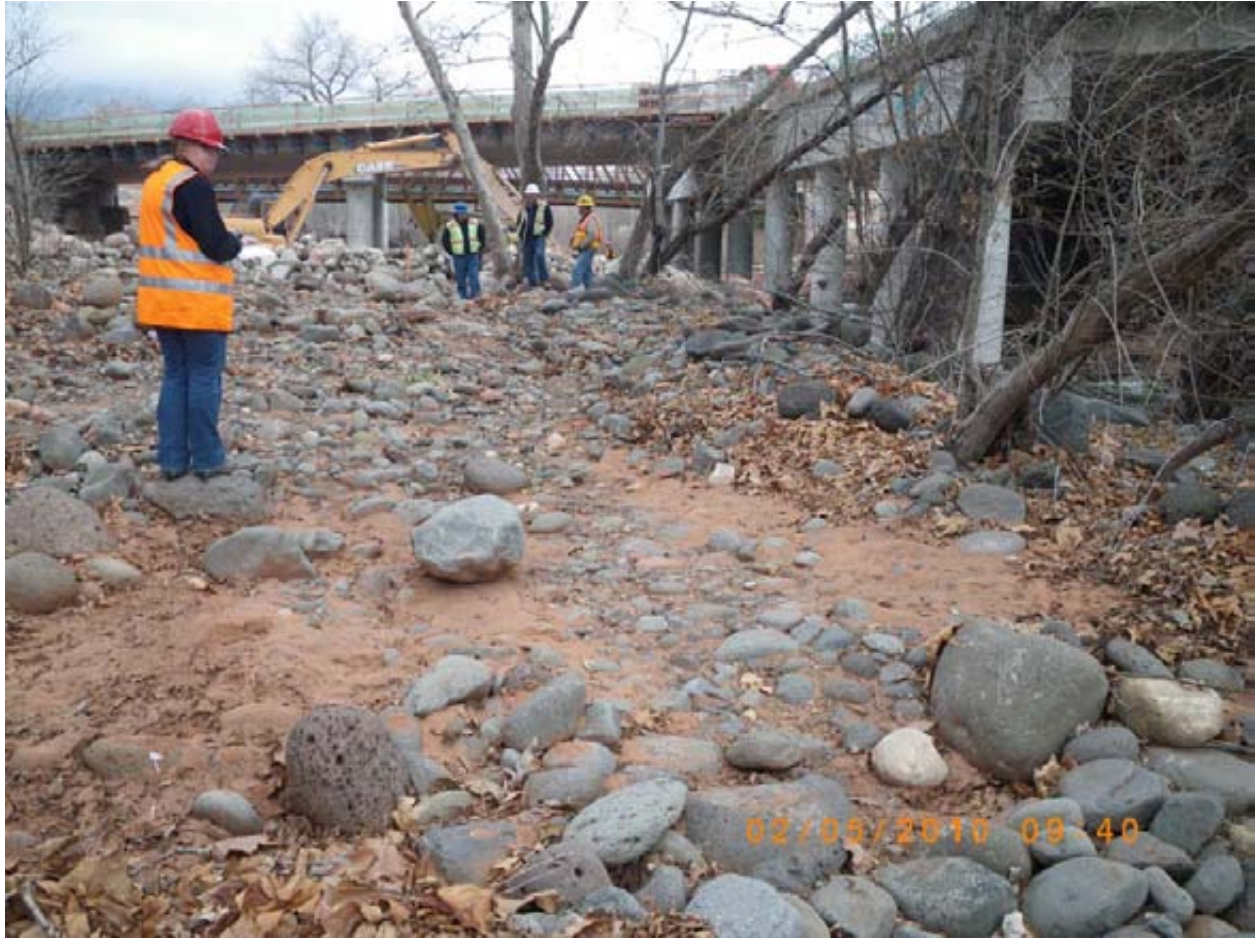
IMG0027

IMGP0027 – From west side of creek (southeast edge of coffer dam), facing north toward bridges. Note fine sediment.

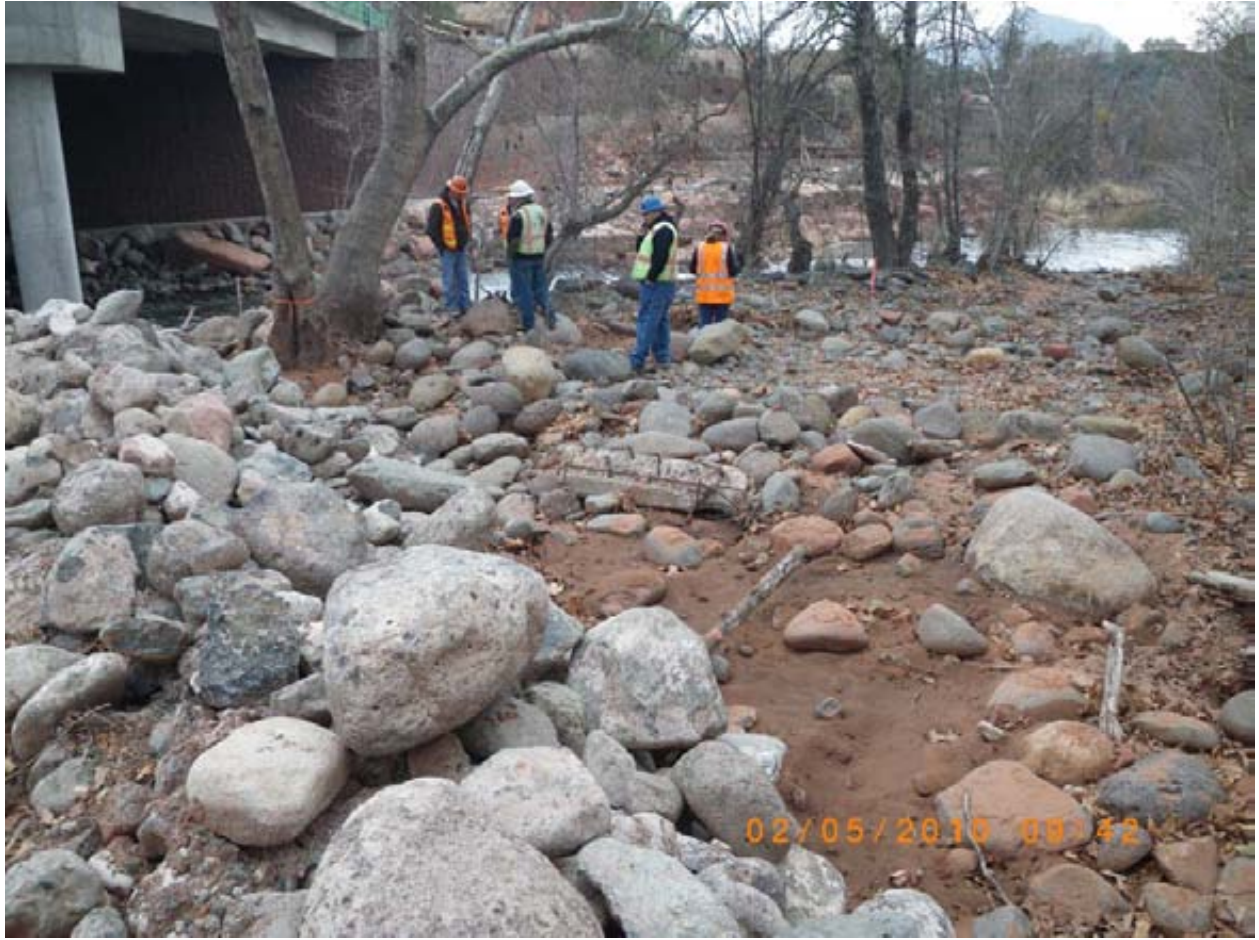
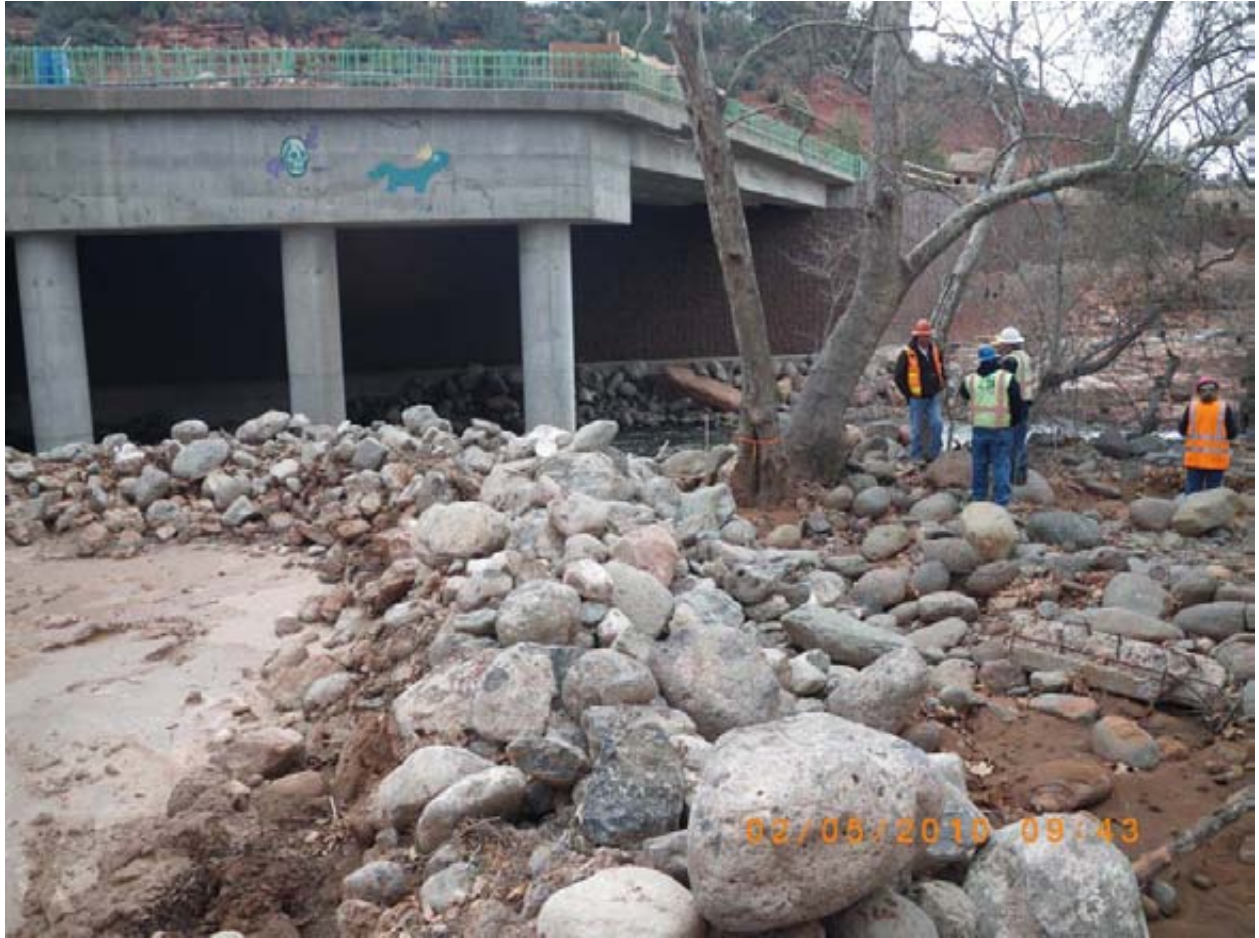
IMGP0028, 29 – From west side of creek (southwest edge of coffer dam) at end of grading work, facing southeast toward creek. Note fine sediments in foreground. Creek flows from left to right side of picture frame.

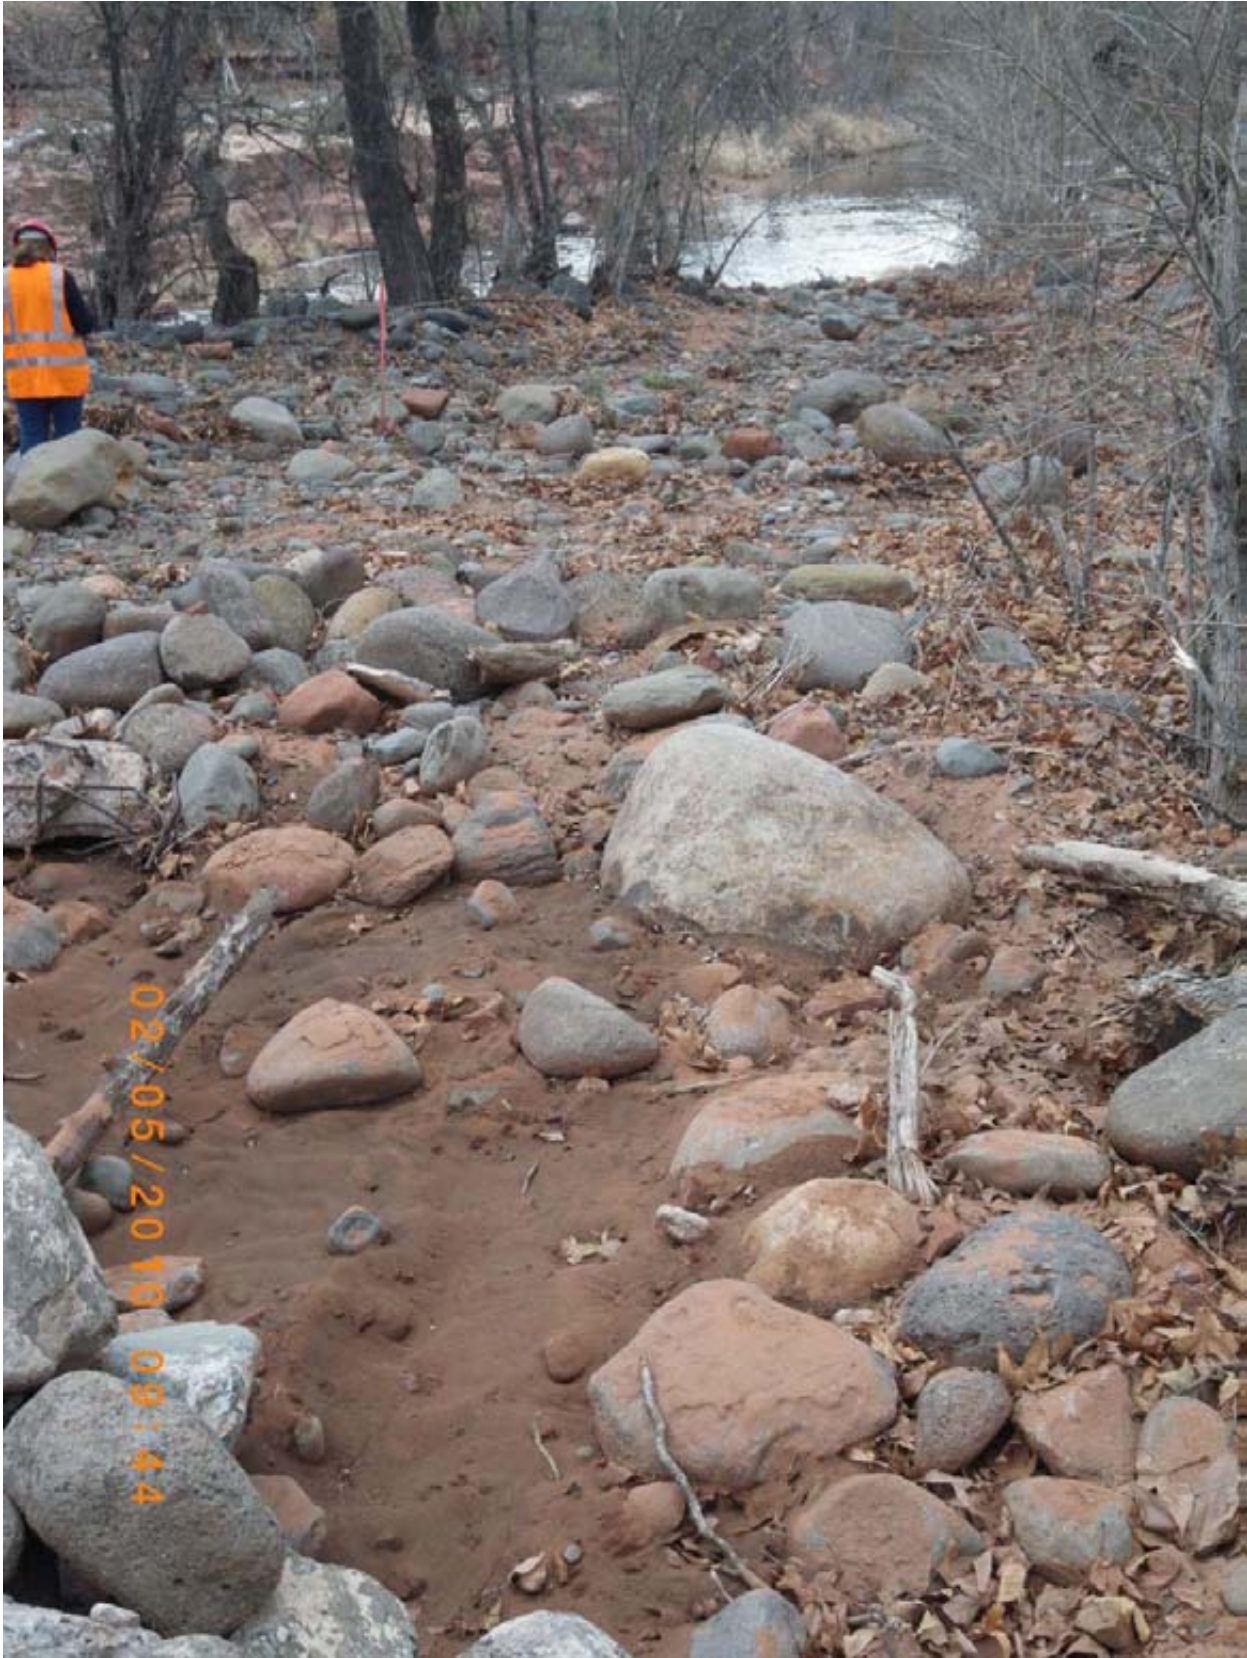
IMGP0030  
29 of 86

IMGP0030 – From west side of creek at southern edge of coffer dam, facing southeast. Note fine sediment deposit in foreground.

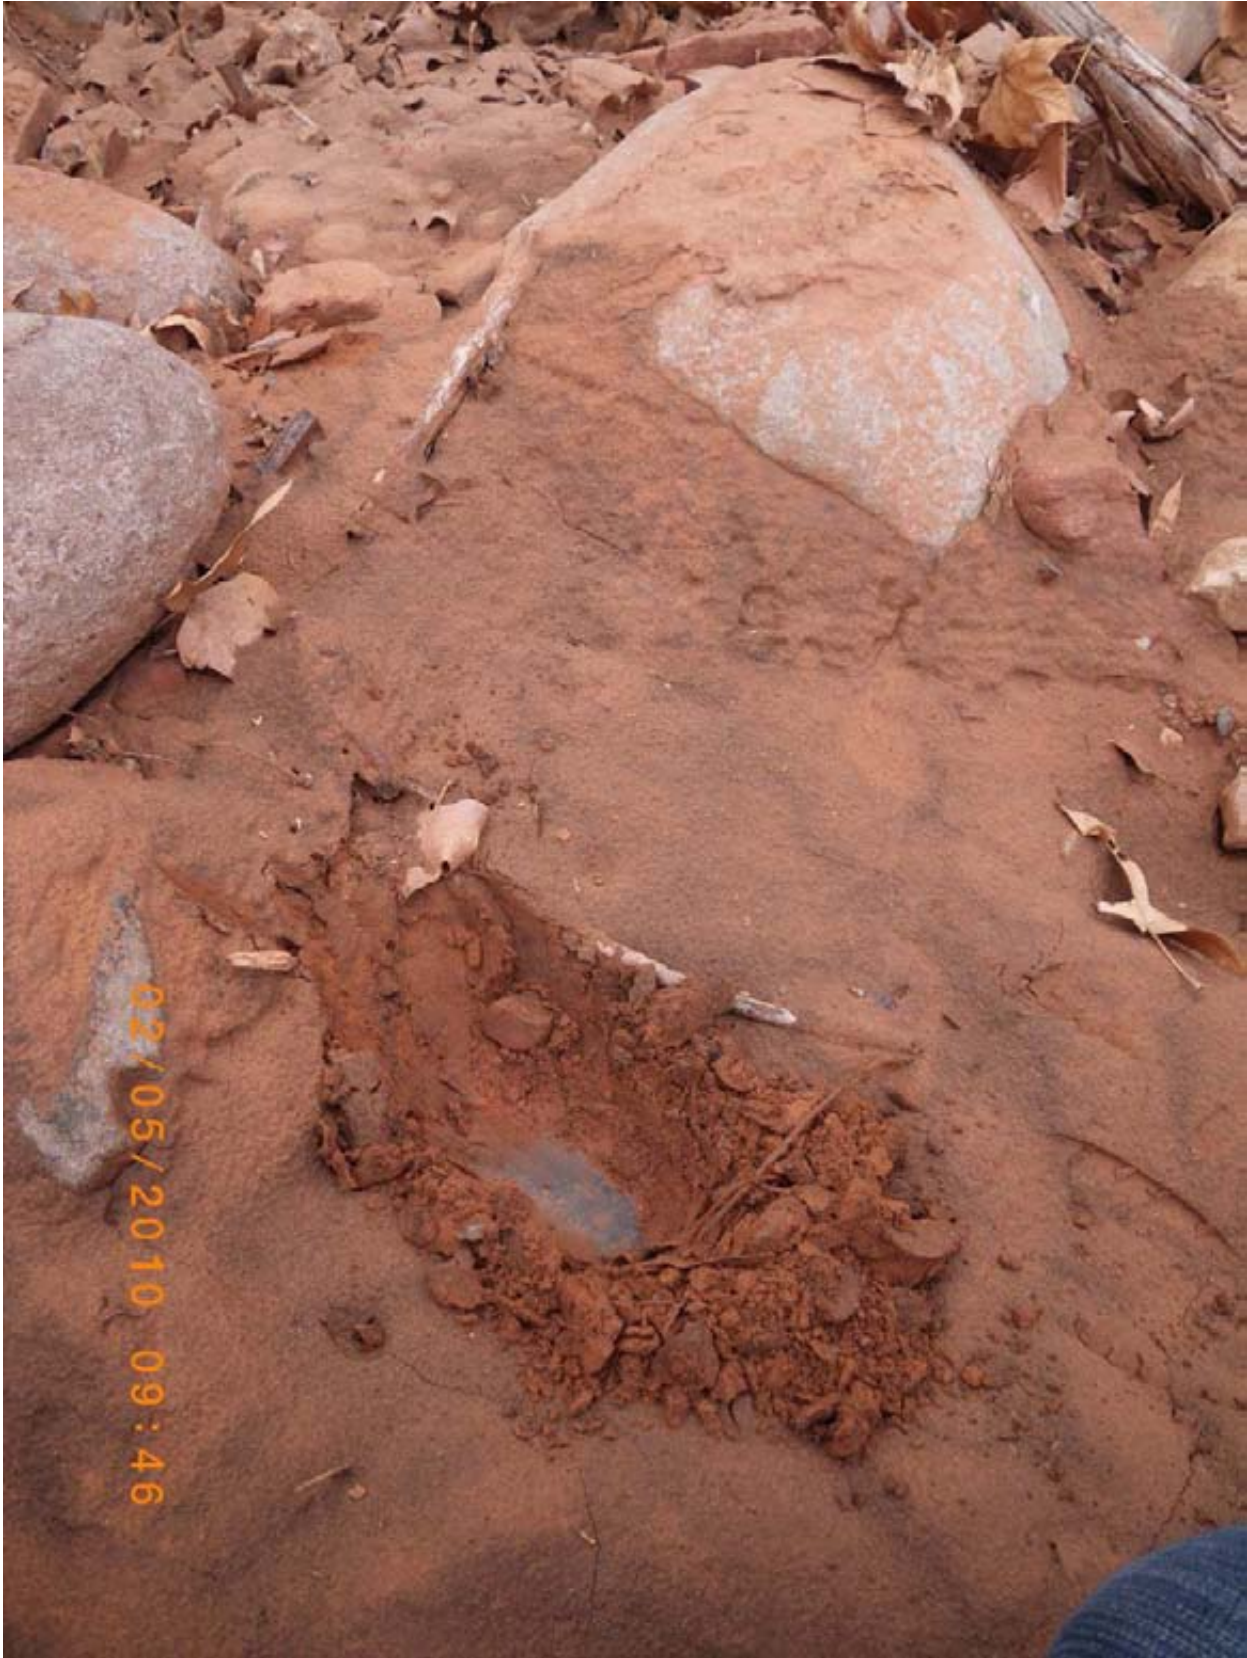
IMGP0031  
30 of 86

IMGP0031 – Same as IMGP0030, showing depth of fine sediment deposit.

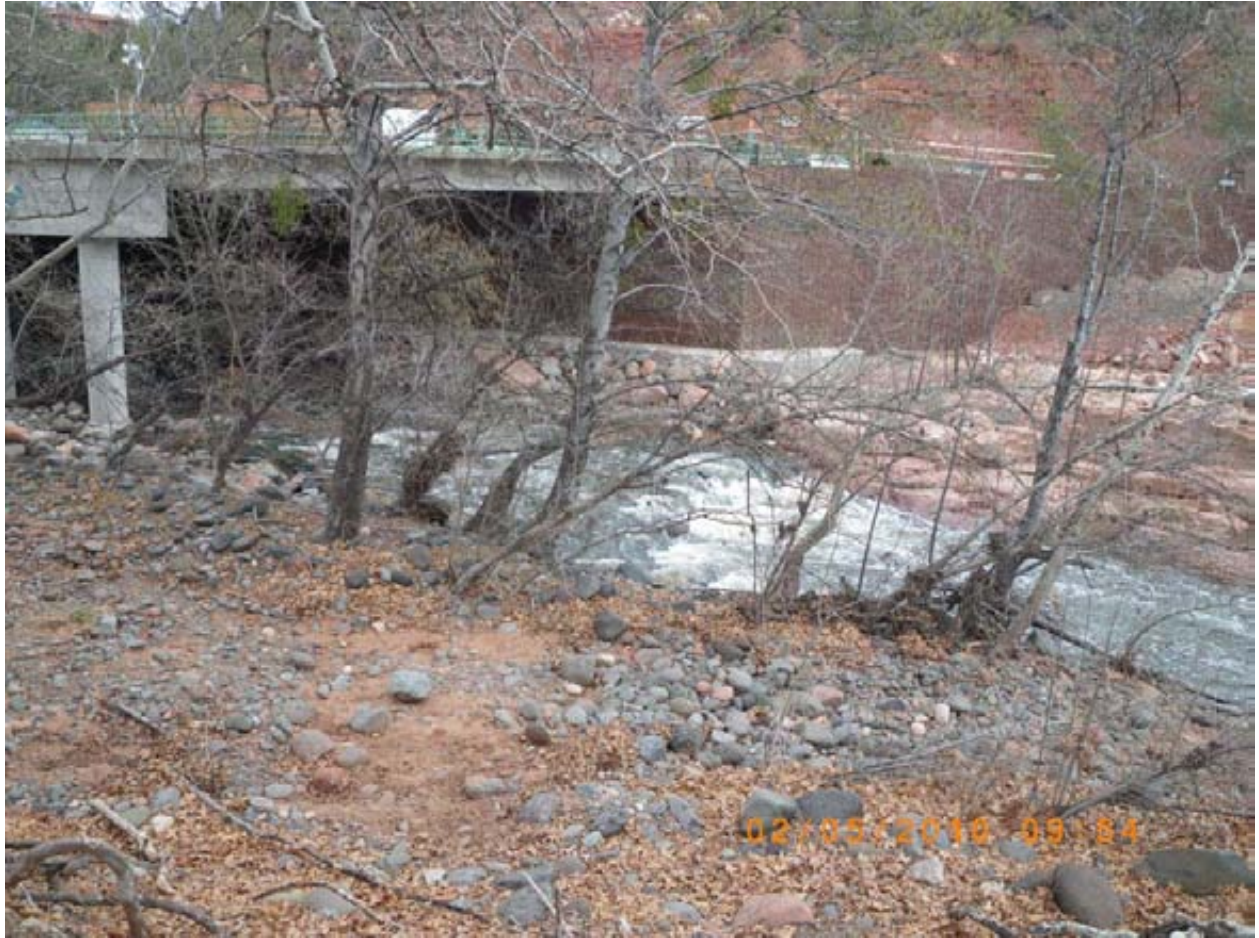
IMG0035

IMGP0035 – From west side of creek, facing northeast toward vehicular bridge. Note fine sediment deposit in foreground.
