**U.S. Environmental Protection Agency, Region IX  
CWA Compliance Office  
Report of Clean Water Act Inspection**

***Site Location:*** State Route 179 Improvement Project  
Between Mile Posts 310.5 and 313.8  
Oak Creek/Sedona, AZ

***Date and Time of Visit:*** February 5, 2010, 8:30 a.m. – 1:30 p.m.

### **Photograph Log for EPA's 02/05/10 Site Visit to AZ DOT SR 179 Improvement Project – Oak Creek Bridge to Chapel Road, Yavapai and Coconino Counties, Arizona**

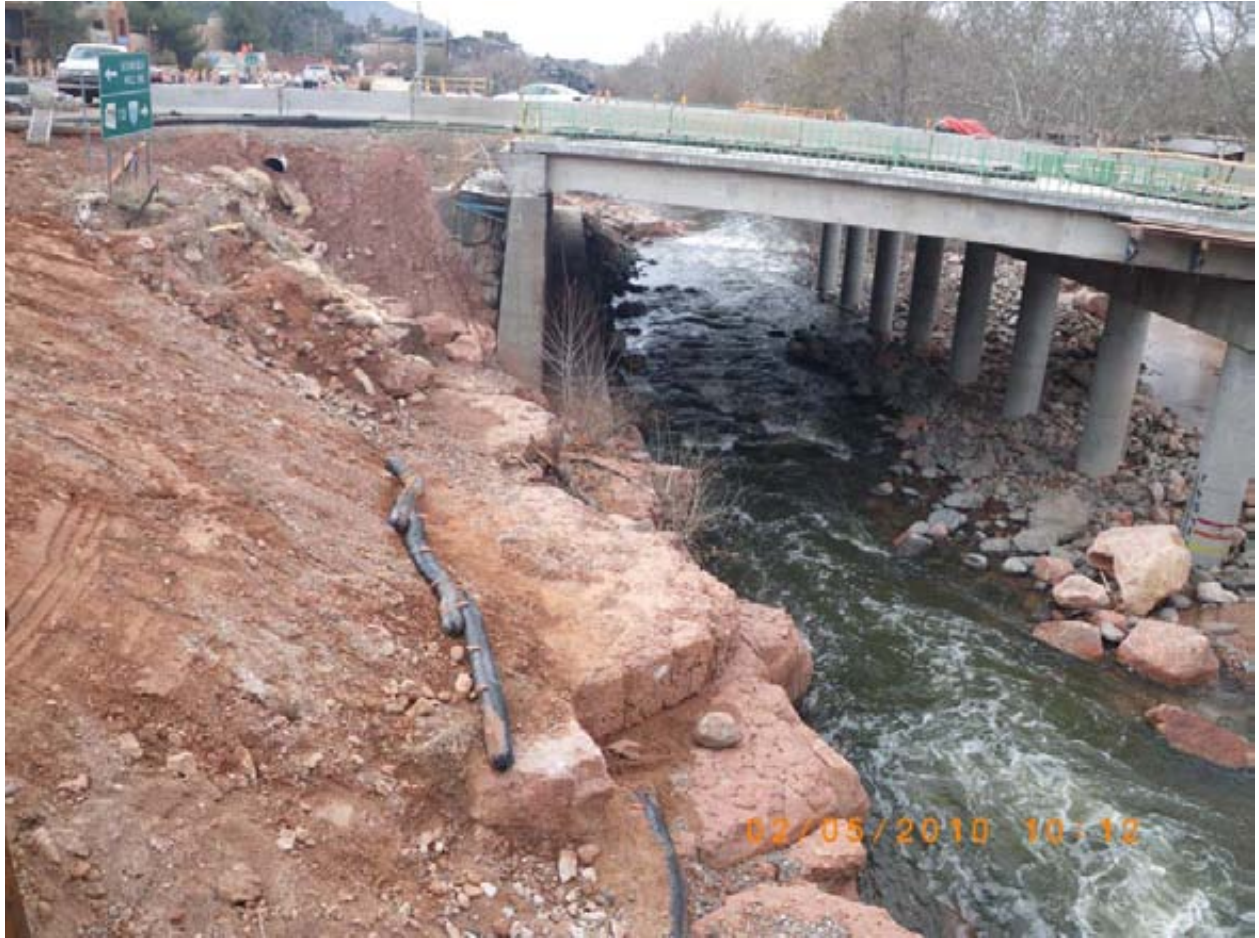
Observations: The inspection began at the eastern end of the pedestrian bridge, above the Garland slope. This slope is directly above the active channel (see Photos 0003, 0044). The slope was disturbed without adequate best management practices (BMPs) installed. At the foot of the slope were three 'gator-eels' (heavy logs to slow the flow of water). At the top of the slope, a small basin was installed to slow the flow of water (see Photo 0045). This basin was undersized, given the amount of run-on entering the site at this location. This slope has been unprotected since January 9, 2010, when ADOT/Fisher removed the last bridge abutment. Prior to the January 19-22 storm event, ADOT/Fisher installed three steel I-beams across the slope in an attempt to stabilize the slope. Because the I-beams served as dams rather than filters, they were inadequate and the slope eroded underneath and around the beams, discharging sediment to Oak Creek.

IMG0044 – From east end of pedestrian bridge on Garland slope, facing south toward downstream direction of creek. Note ineffectiveness of gator eel BMPs to capture sediment on slope.

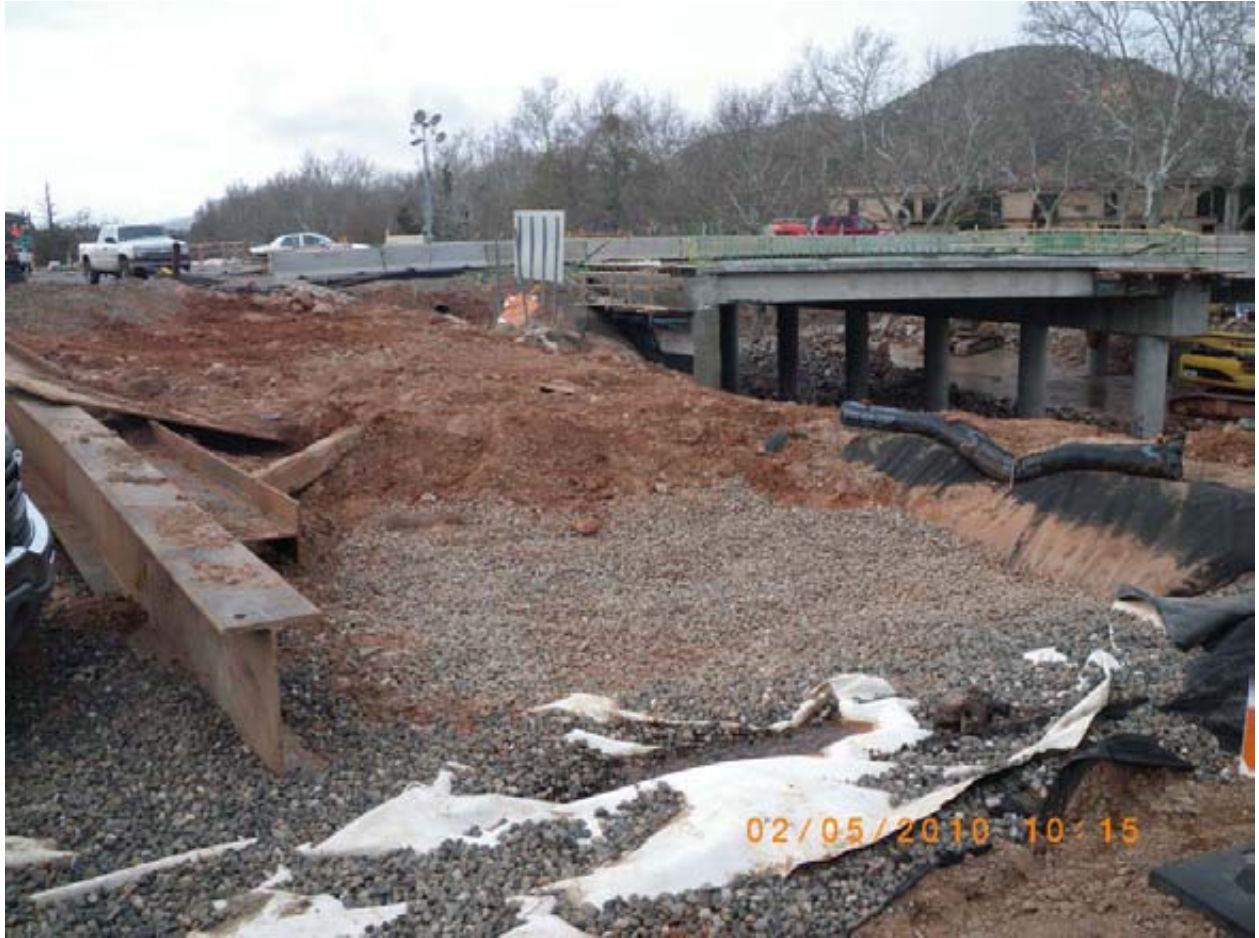
IMG0045 – From east Garland slope, at end of pedestrian bridge, facing southwest toward vehicular bridge. Note undersized sediment basin in foreground and stacked I-beams, which were previously embedded in Garland slope, but failed as stabilization measure.

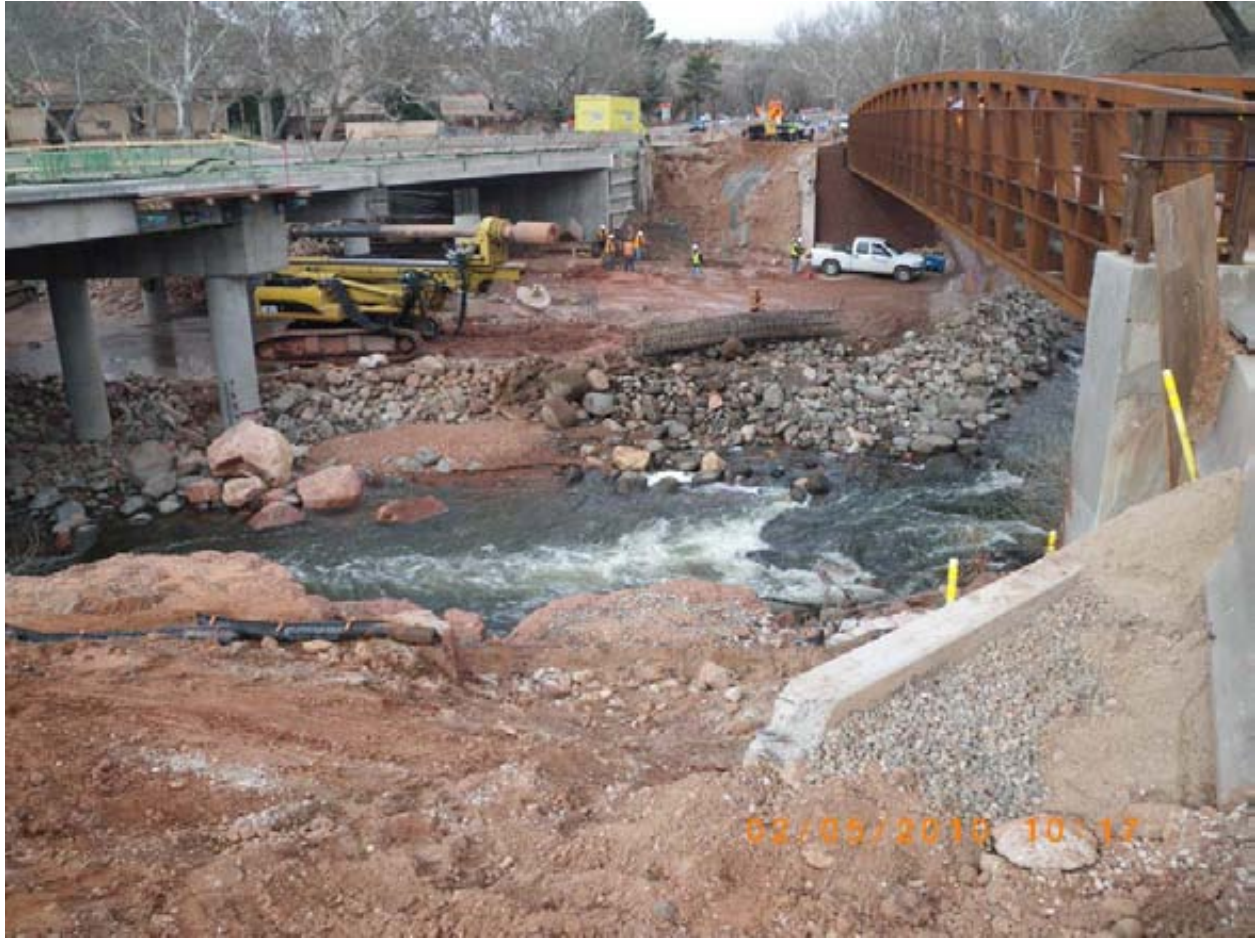
IMGP0046

is currently designed to function as a sediment basin (see Photo 0046). Prior to the January 19-22 storm event, ADOT/Fisher used small check dams in this area to filter the runoff before it entered Oak Creek. However, before the January storm event, large rocks (9-24") were brought into the site to serve as a coffer dam. These rocks will later be used in gabion baskets to be placed elsewhere on site. According to Harris, the emergency spillway on the coffer dam functioned as designed during the January storm event. However, the void spaces between the large cobbles and boulders are too large to serve as an effective filter. We observed large amounts of fines deposited on the downstream side of the coffer dam (see Photos 0024, 0027-32). Additionally, ¾" gravel was placed in the work area to provide a more stable work surface. According to Harris, after the last pylon is set, the channel will be dug out and this material will be removed as much as possible; however it is being pressed very deeply into the creek bed and will likely be very difficult to remove.

IMG0046 – From east Garland slope, between pedestrian and vehicular bridge abutments, facing west toward Tlaquepaque slope.

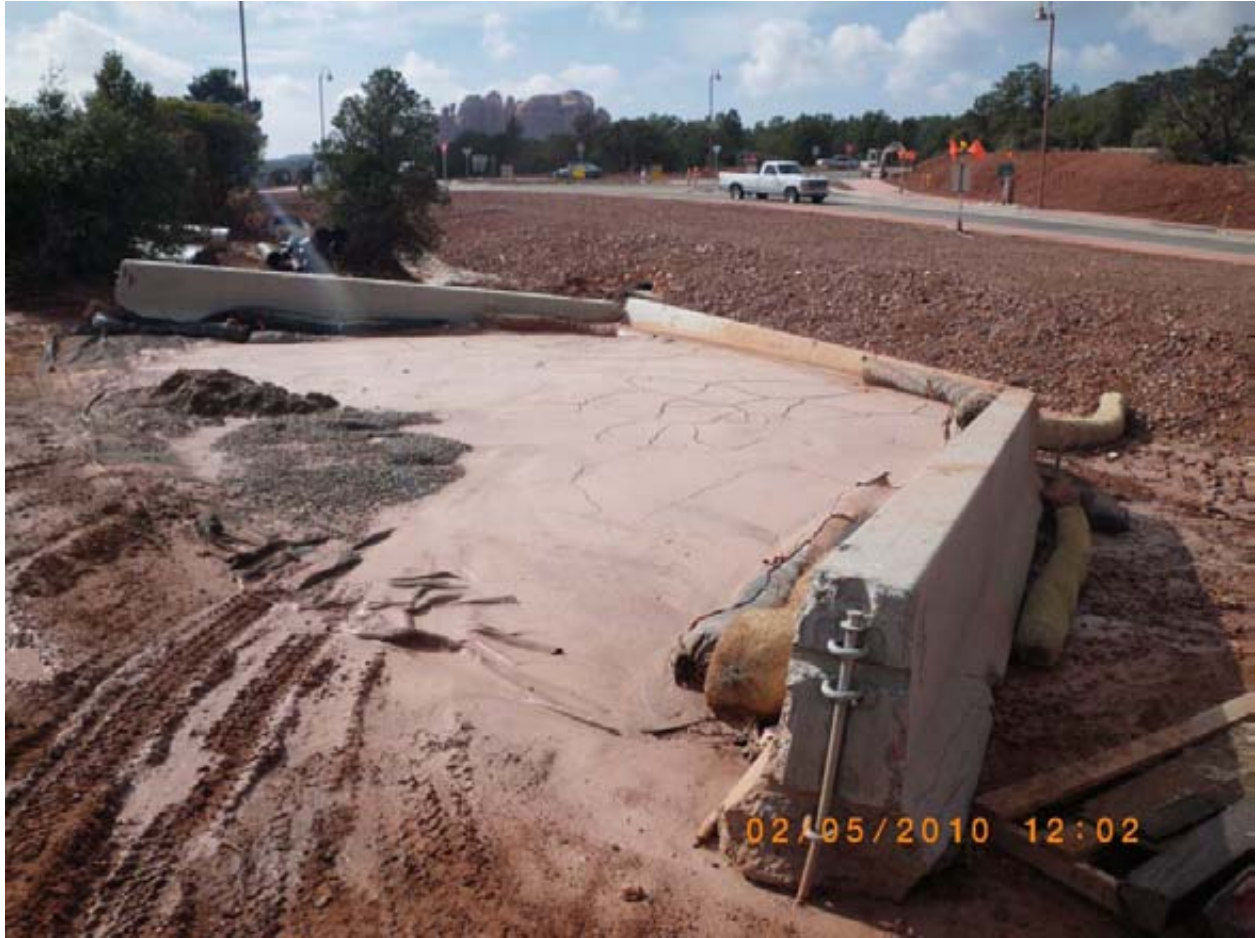
IMGP0047

The BMP in use during the inspection for this pump water discharge at the Chapel staging yard was a poorly designed settling basin (see Photos 0047, 0053, 0055, 0062, and 0064) that discharged to the sediment-laden drainage ditch described above. The basin was made of three K-rails and lined with filter-fabric wrapped sediment logs. However, the basin was over 90% full and sediment covered the sediment logs (see Photo 0055). According to Fisher, another pump delivery was scheduled for that afternoon, before the basin could be cleaned out and repaired. On February 5, 2010 (the day of the inspection) a BMP update sheet was placed in the SWPPP, describing this BMP. This could indicate that the SWPPP was not being updated in a timely fashion. As described above, this BMP is undersized and inadequate. I instructed ADOT/Fisher representatives

IMG0047 – Facing southwest. Water pumped from Oak Creek Bridge coffer dam area is transported here, filtered through makeshift check dam, and discharged into drainage ditch that flows north and east to unnamed tributary of Oak Creek. Check dam is constructed of three K-rails lined with filter fabric. The filter fabric is slumping, resulting in sediment discharge into drainage ditch.

on site to clean it out and suggested a range of options to repair the BMP before using it again. We also discussed moving this BMP to an upland area above the drainage ditch.

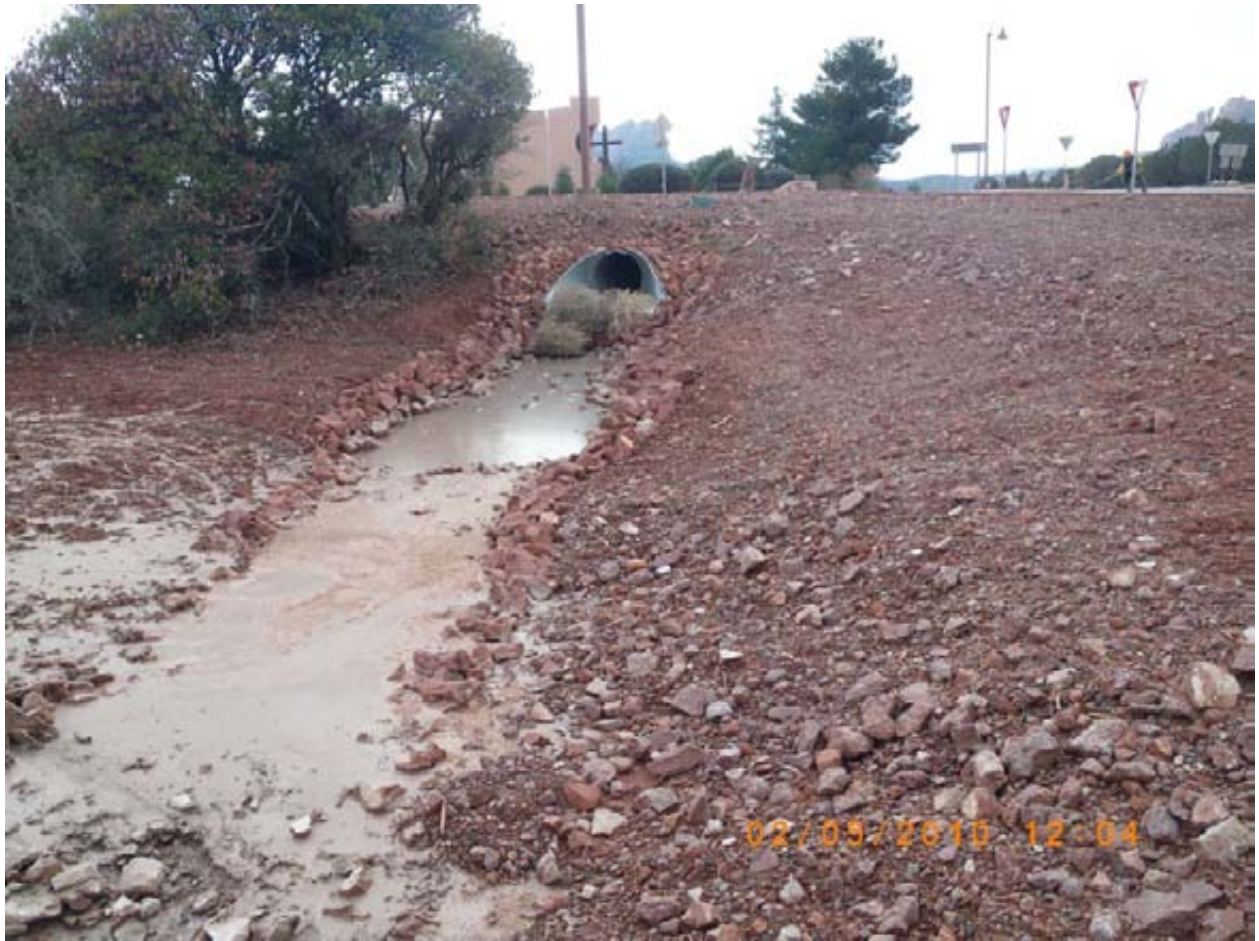
IMGP0048

IMG0048 – Facing south within drainage ditch toward culvert outlet. Note relatively clean water coming from Chapel Road culvert mixes with discolored water in foreground, where bridge crew previously discharged water pumped from coffer dam.

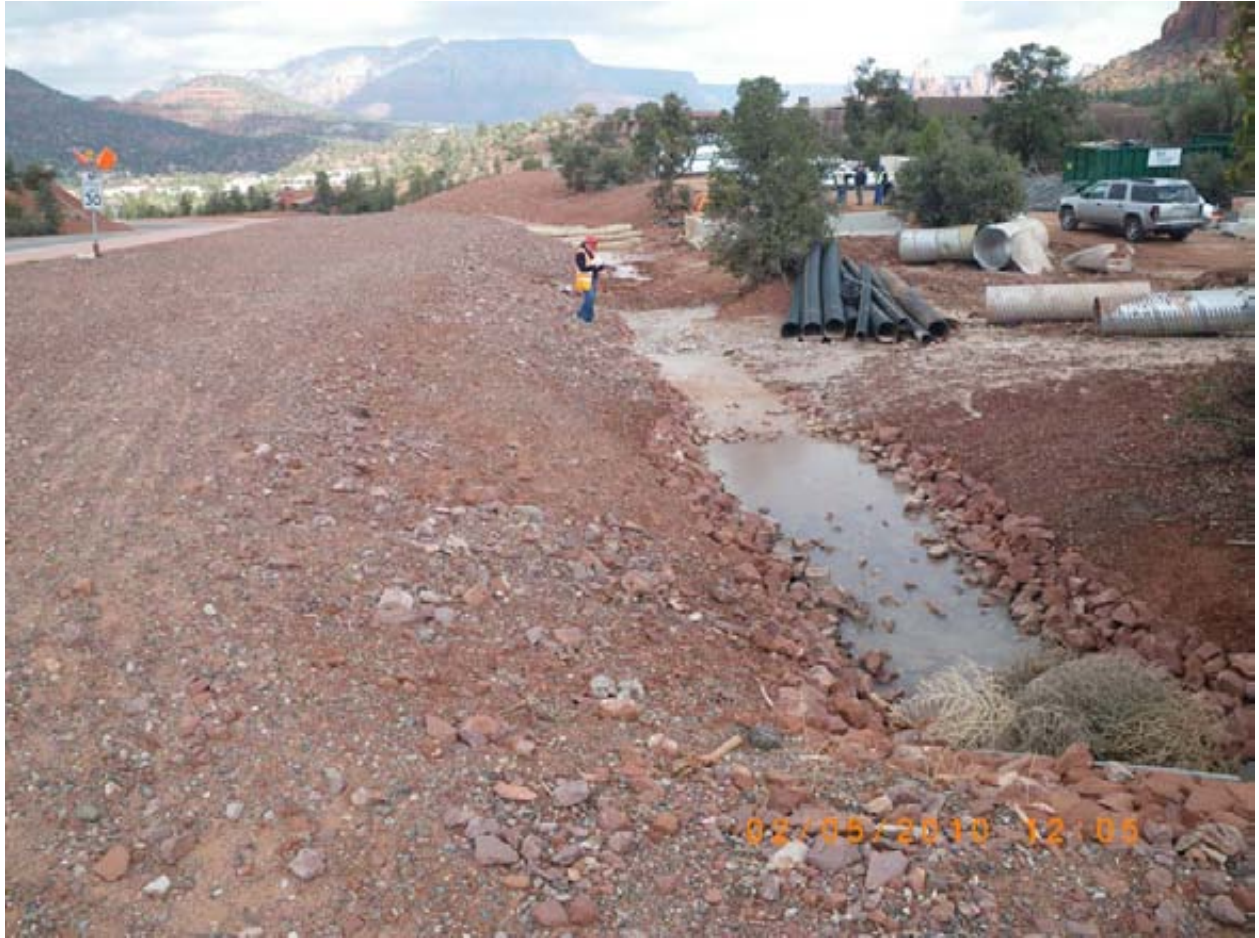
IMGP0049

IMG0049 – From top of culvert facing north. Note disarray of construction materials where pumped water was discharged through downstream straw wattles (recently replaced). K-rail check dam is located in background behind trees. Drainage ditch water flows north, from bottom to top of picture frame.

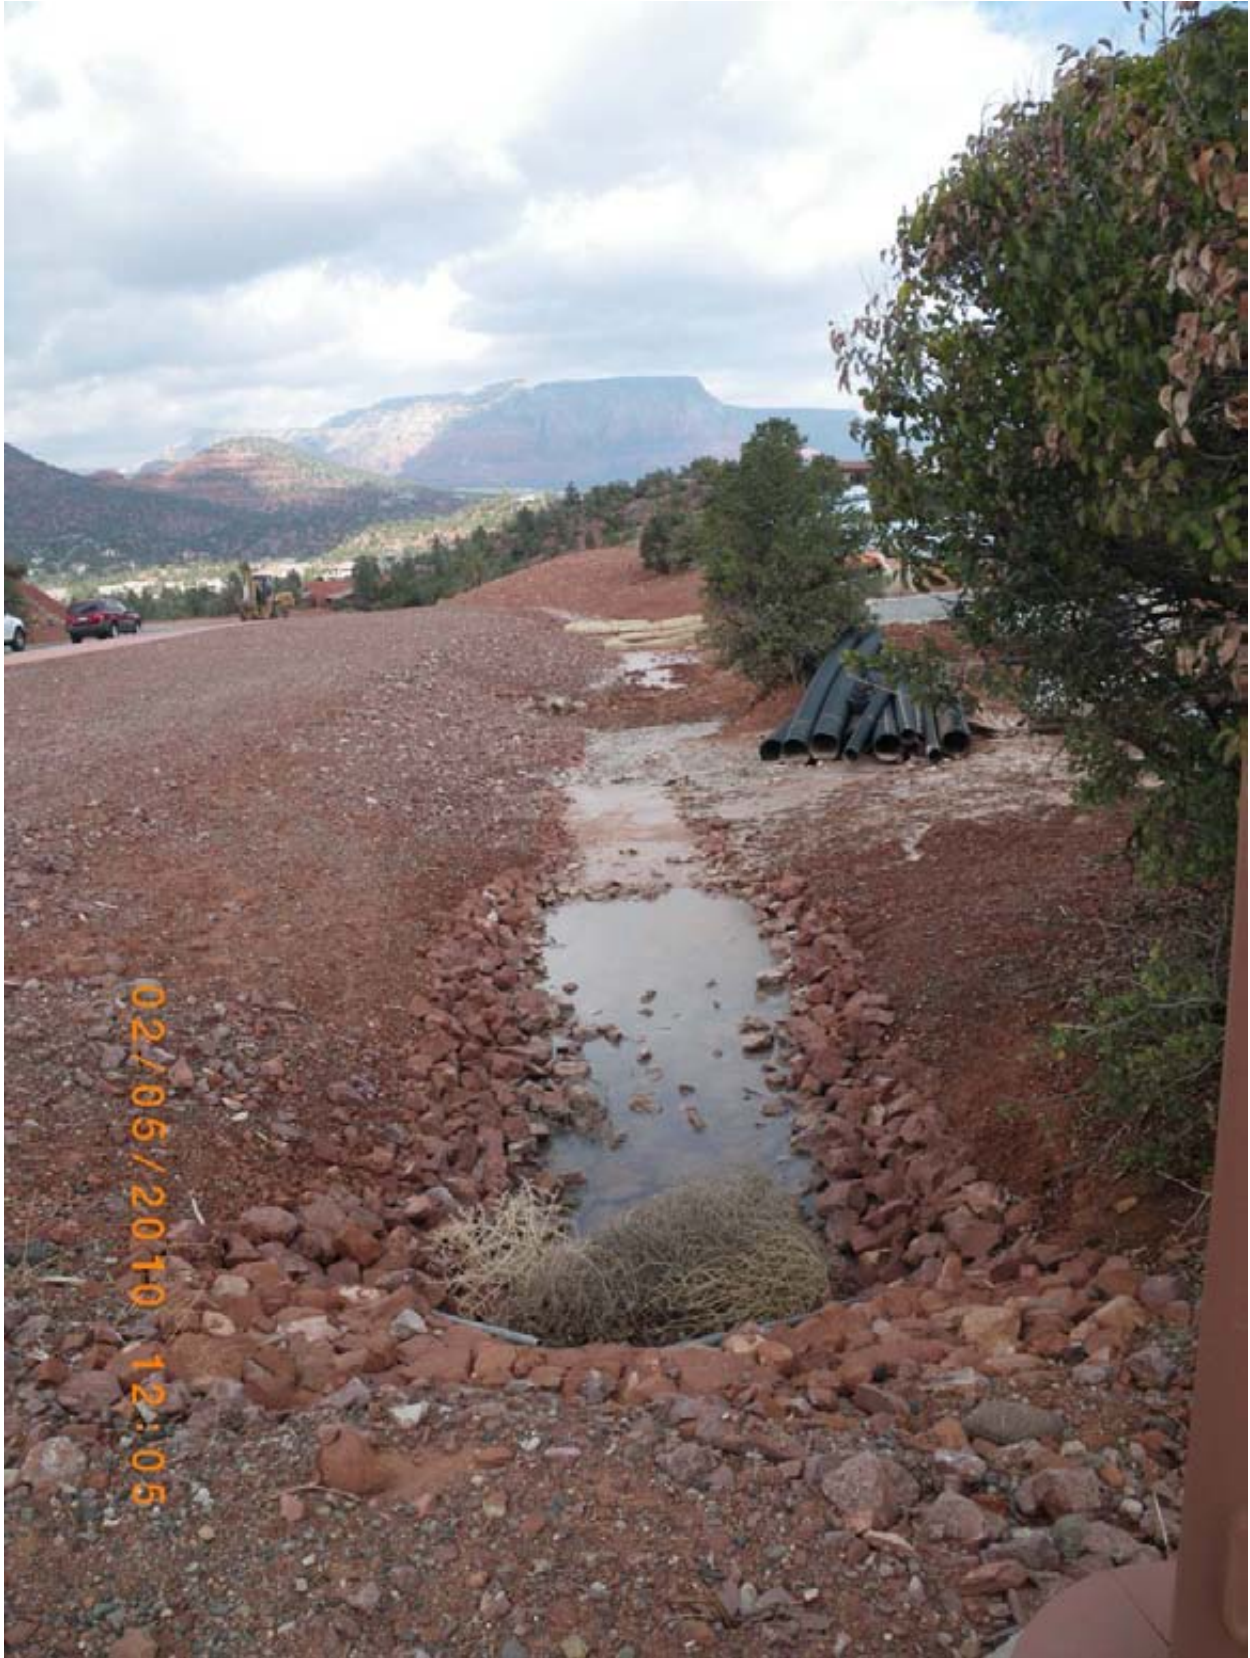
IMGP0050  
49 of 86

IMG0050 – From top of Chapel Road culvert facing north. Note coir logs further down drainage ditch, installed since last rain event. Discharge of pump water blew out previous straw wattles in drainage ditch.

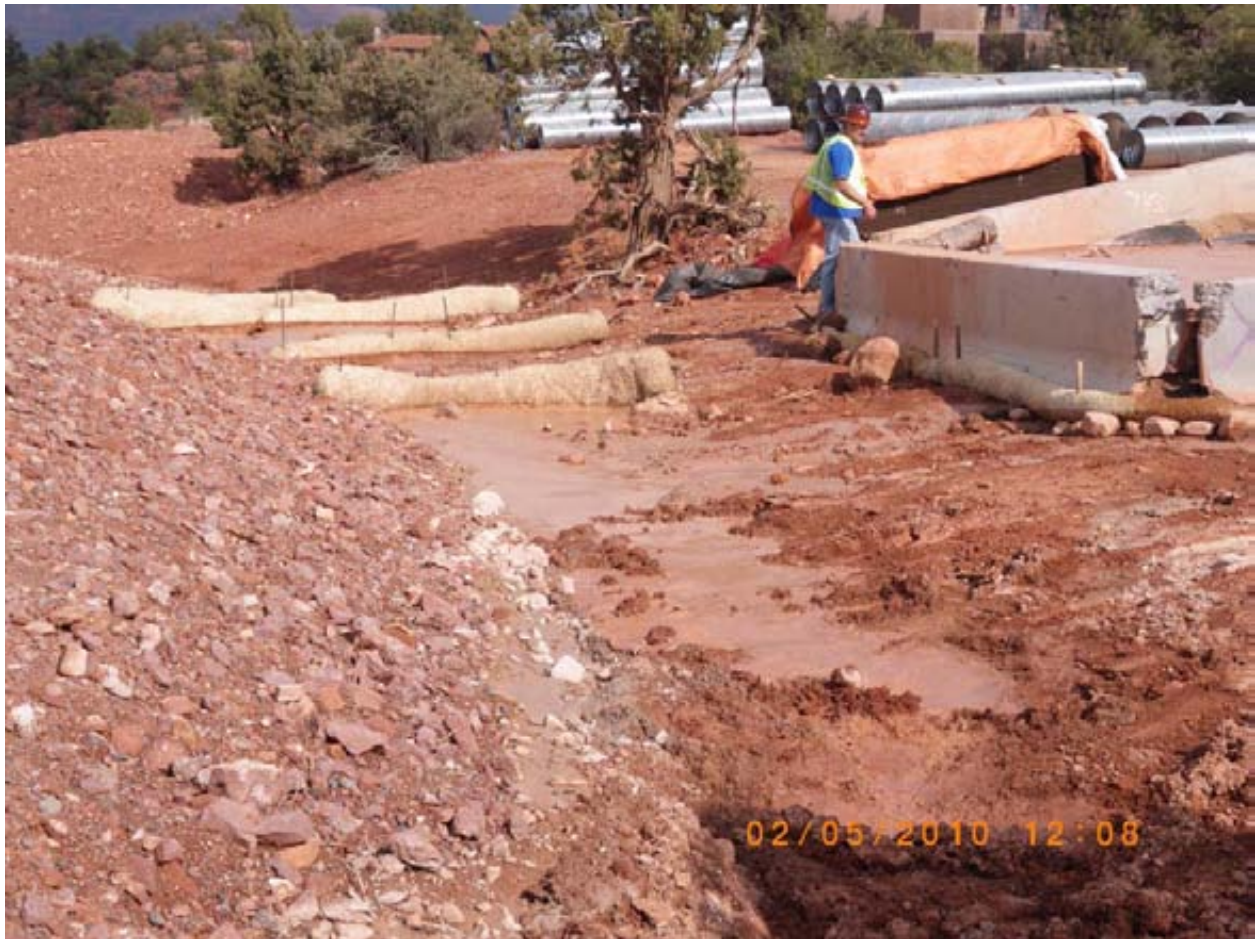
IMGP0053 – From west side of drainage ditch, facing northeast. Note discharges from check dam and fine sediments deposited in drainage ditch.

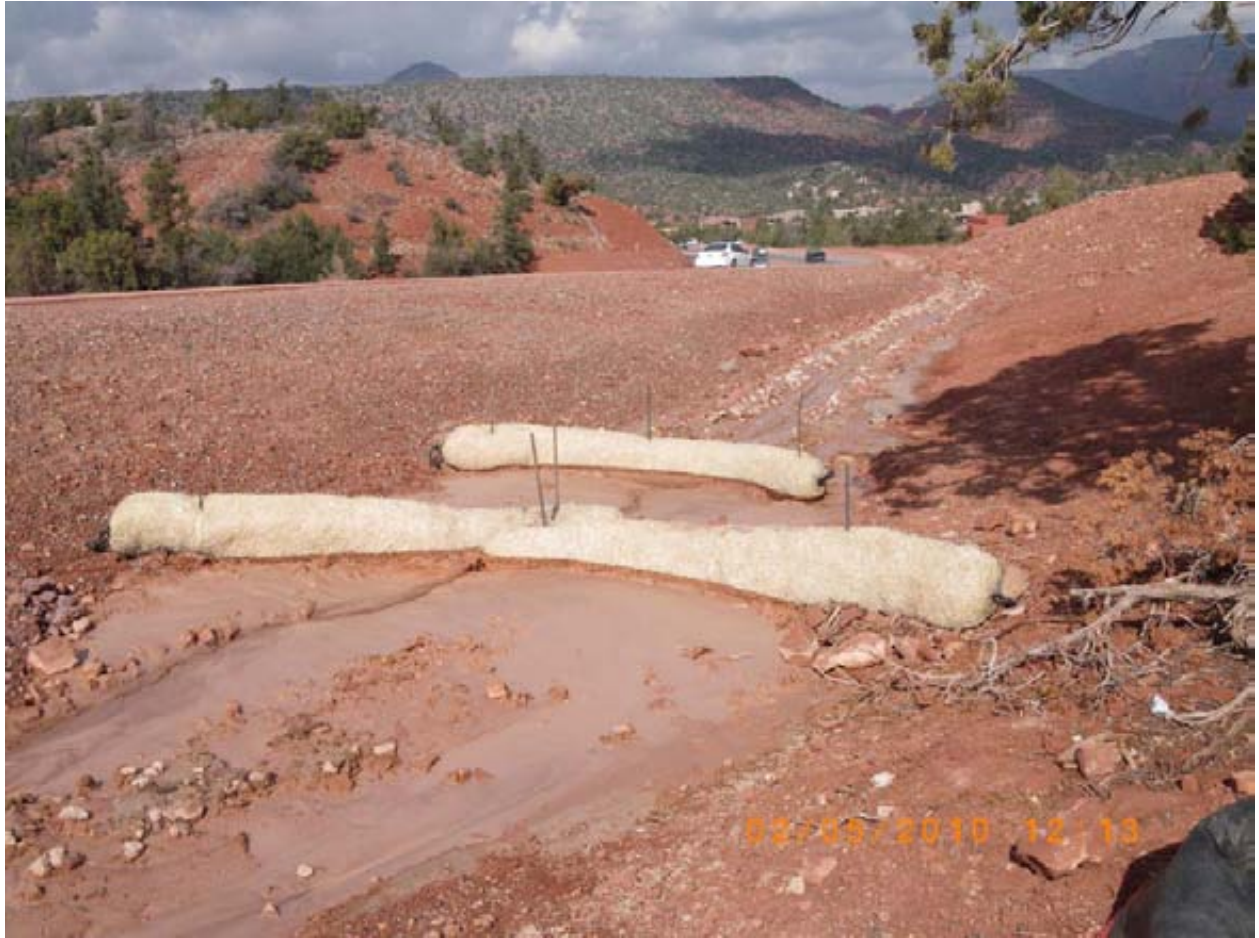
IMG0056

IMGP0056 – From east side of drainage ditch, facing northwest. Coir logs in drainage ditch are ineffective at filtering the volume of pumped water.

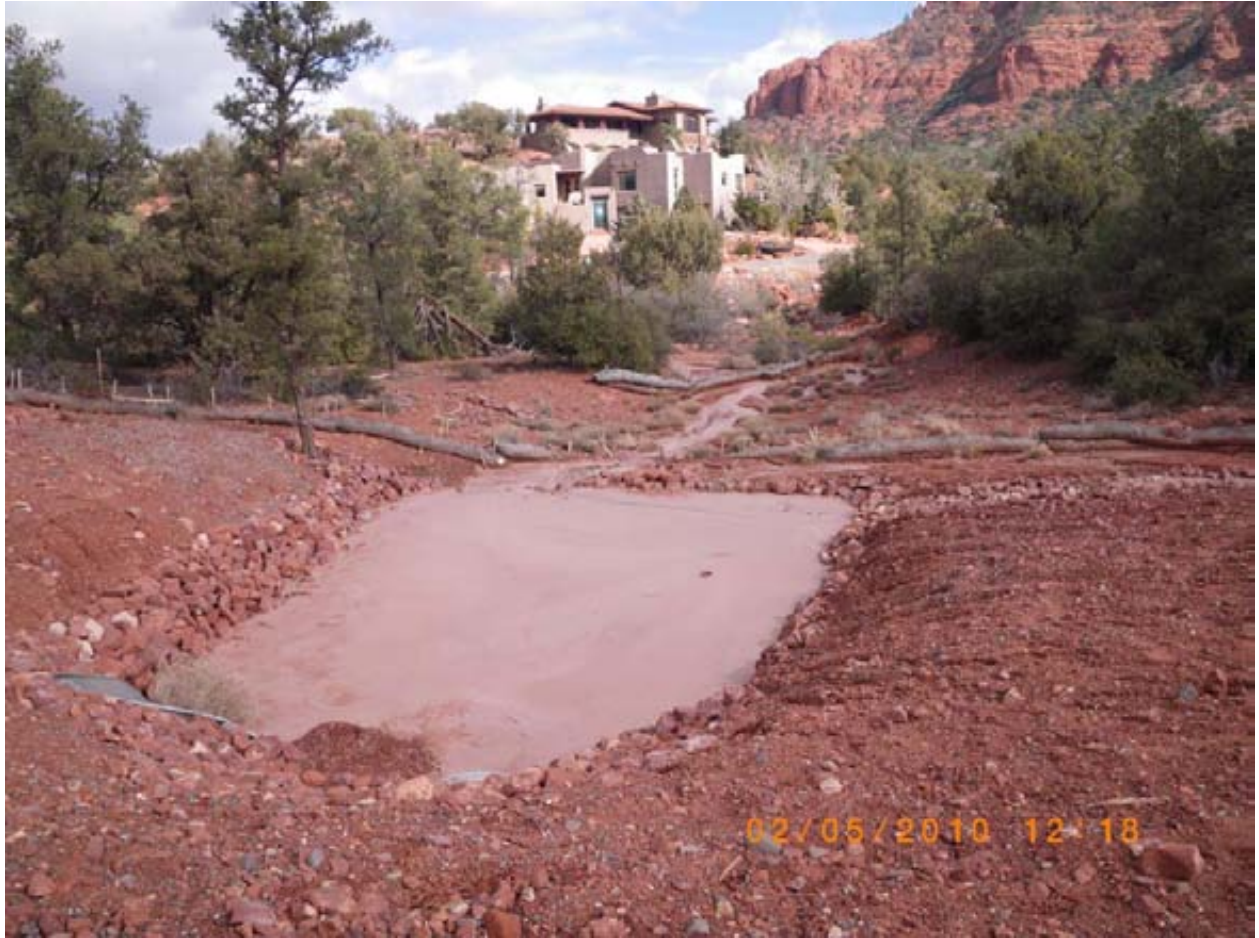
IMGP0059 – From top of SR 179 culverts in IMGP0058, facing east toward housing development/offsite runoff of fine sediments.

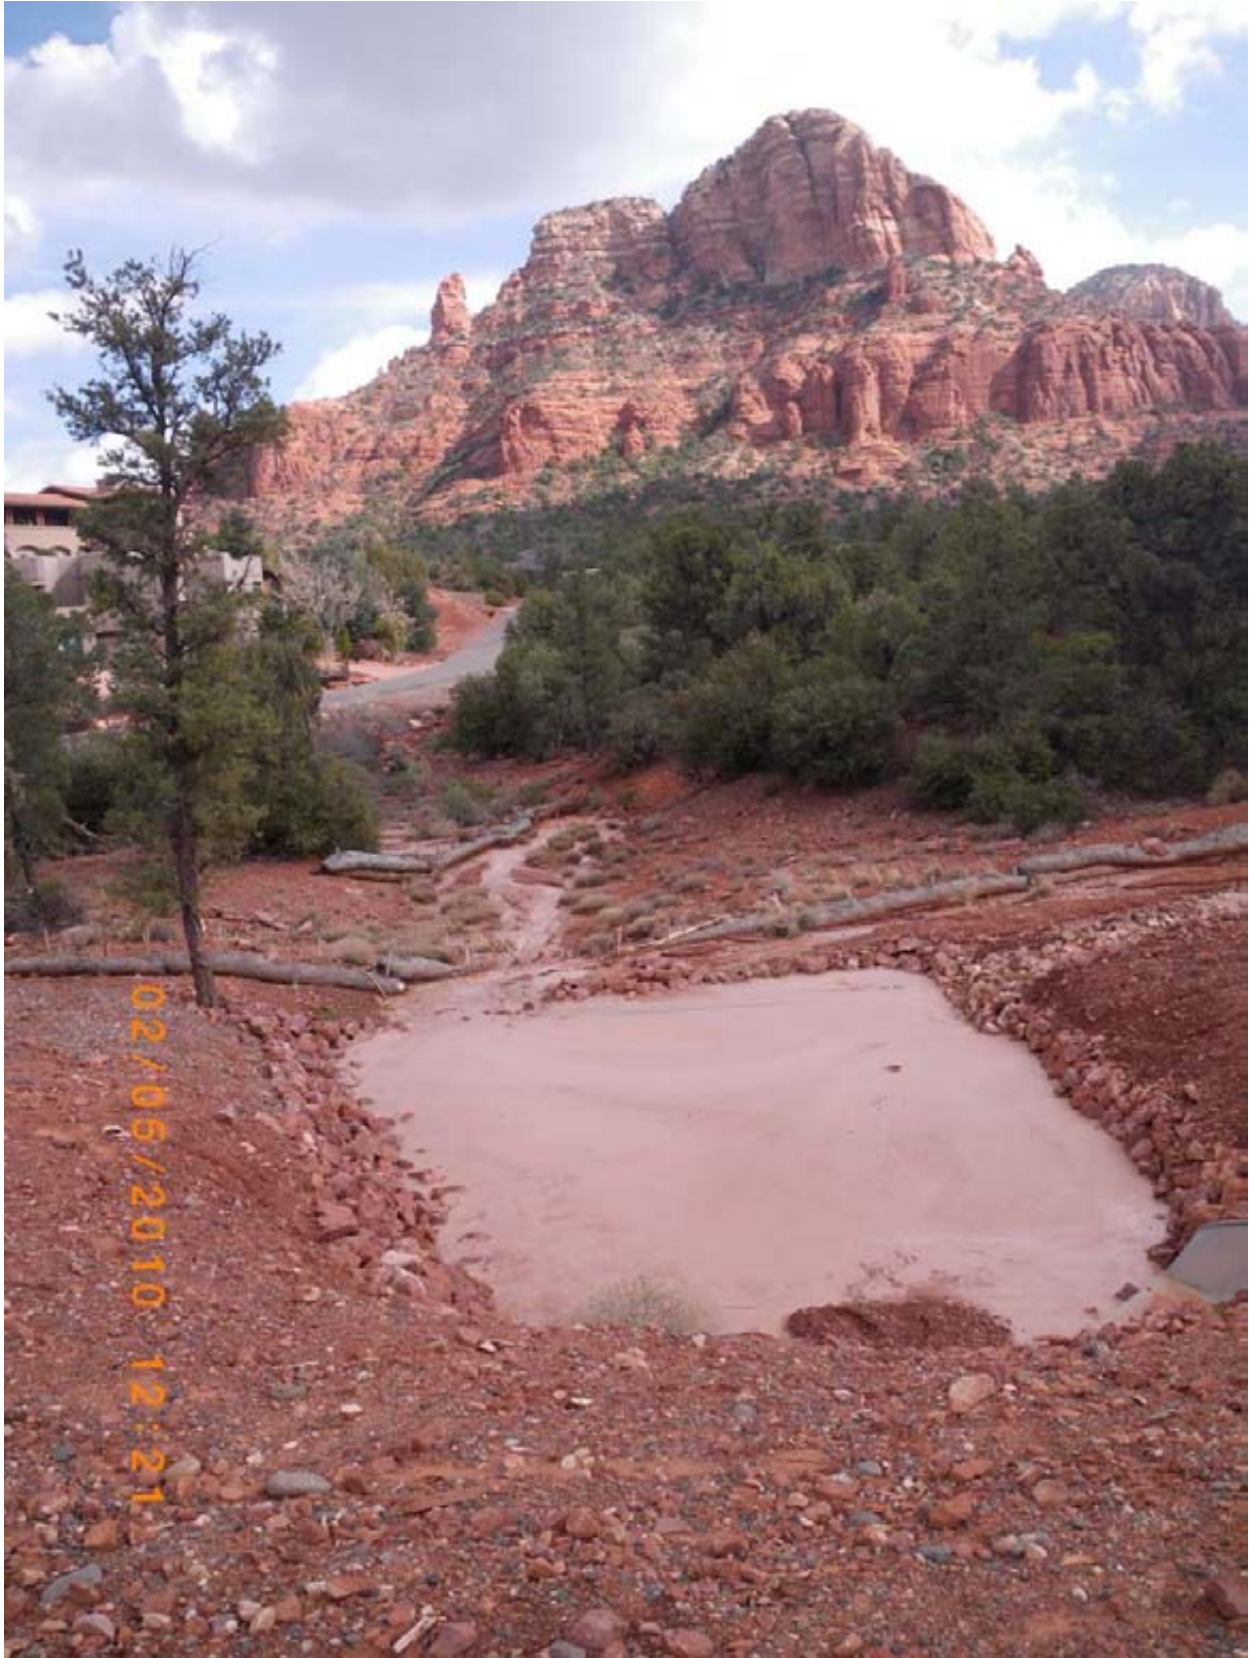
IMGP0061  
60 of 86

IMGP0061 – Same as IMGP0059, facing east. Closer view of culvert spillway discharging offsite.

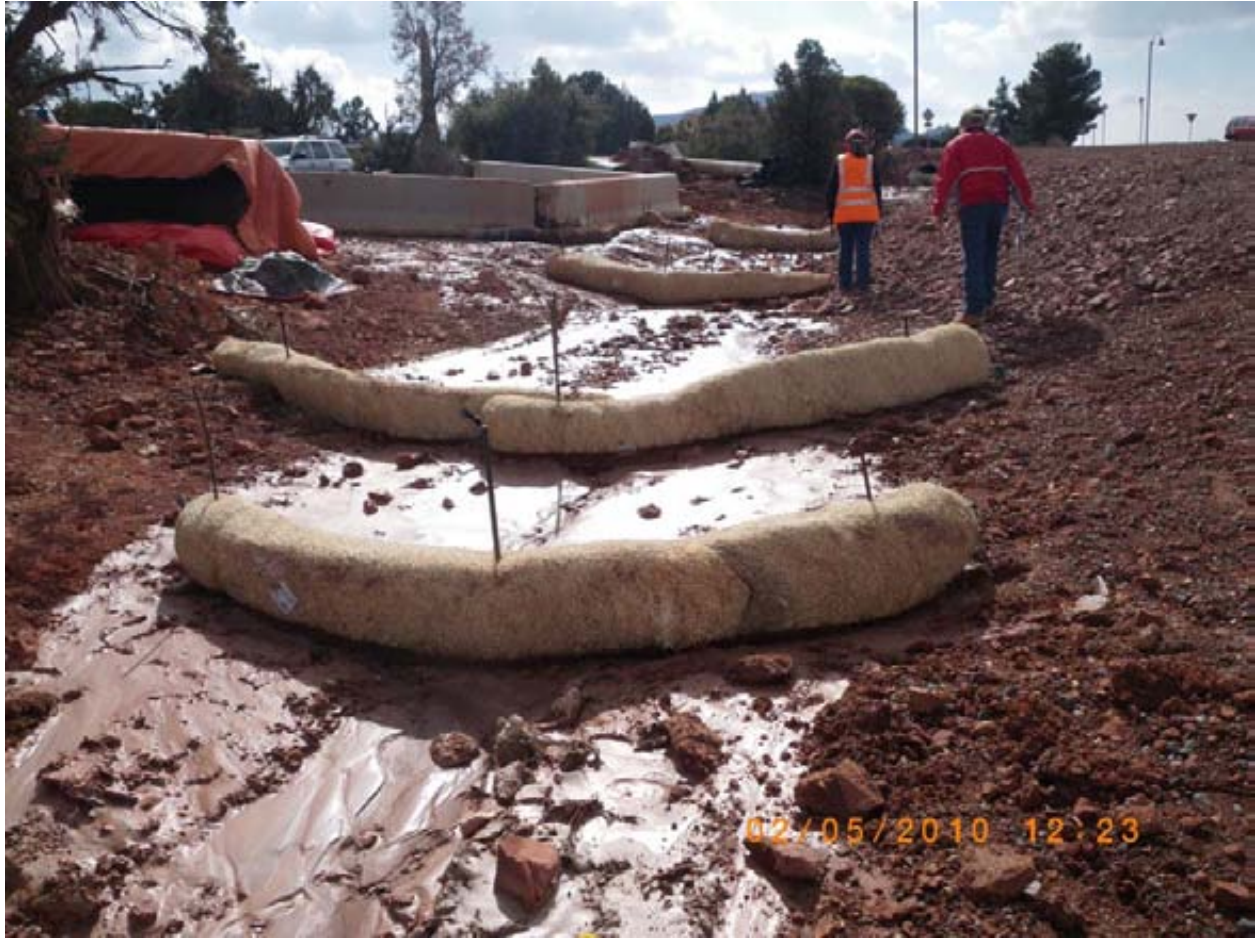
IMGP0062 – From drainage ditch, north of check dam and Chapel Road culvert, facing north. Coir logs placed on top of previous sediment discharge.

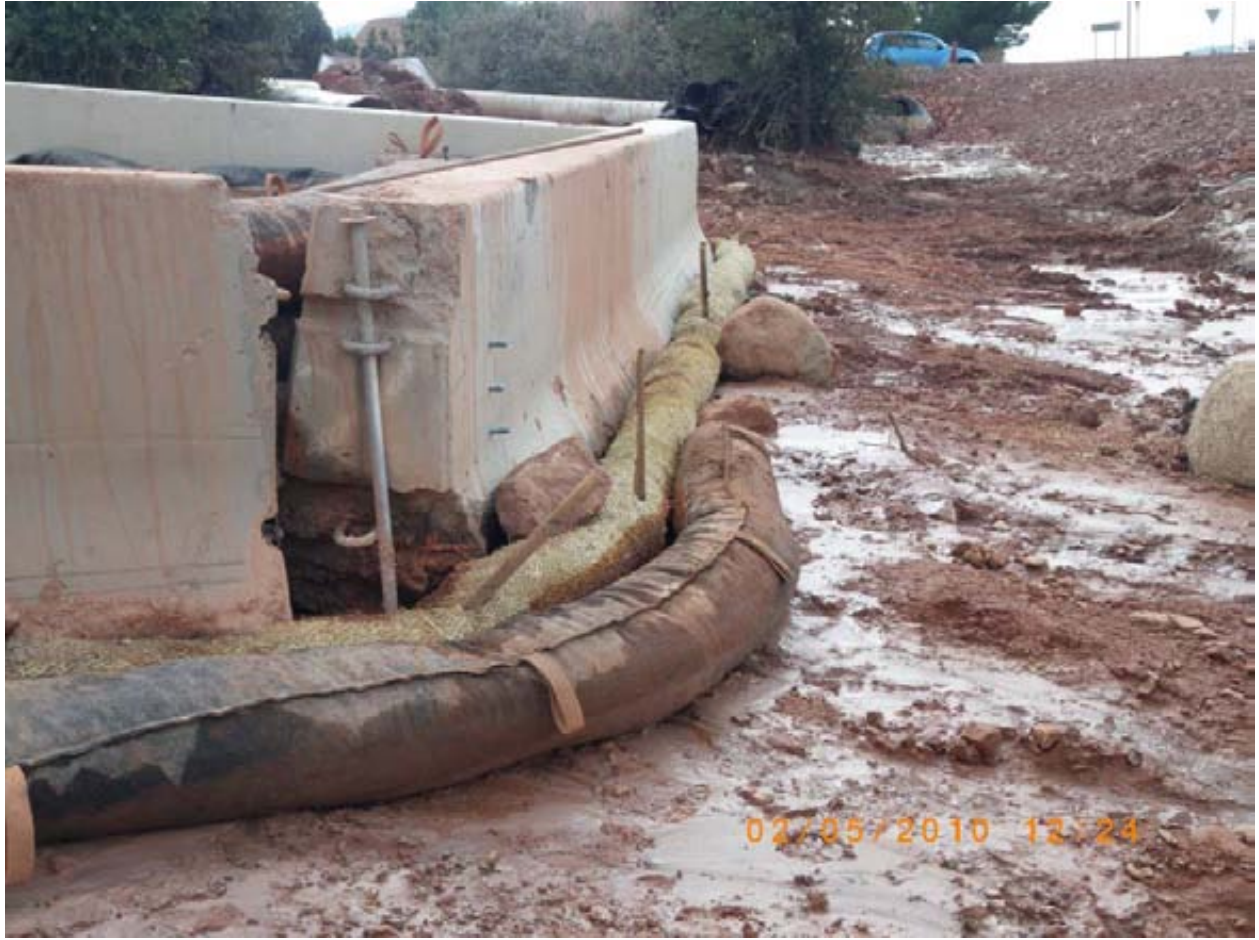
IMG0064

IMGP0064 – From northwest edge of check dam, within drainage ditch, facing north toward Chapel Road culvert. Note gap in K-rails and ineffectiveness of BMPs to filter fine sediments from check dam. Fine sediments are possibly overtopping check dam, evidenced by spill marks on K-rails.

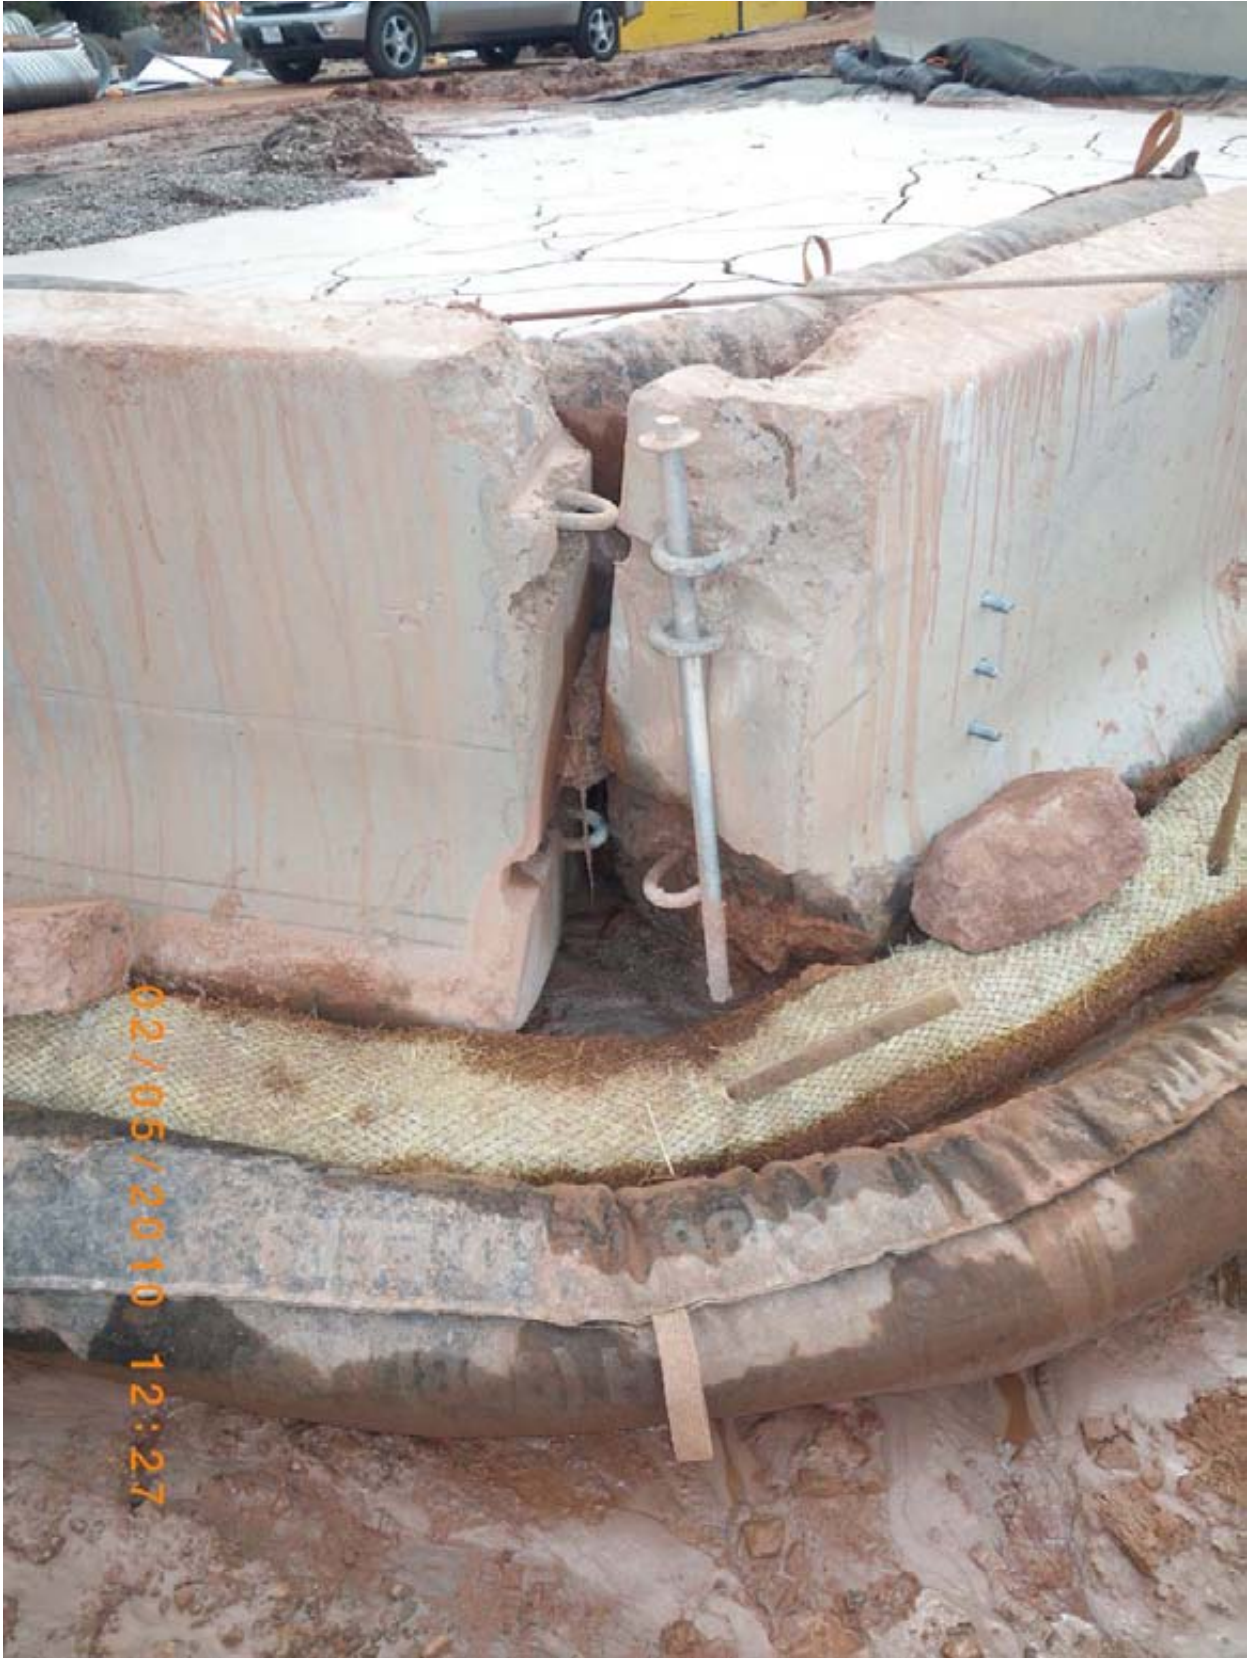
IMGP0065  
64 of 86

IMGP0065 – Close-up of northwest edge of check dam, where filter fabric is slumping.

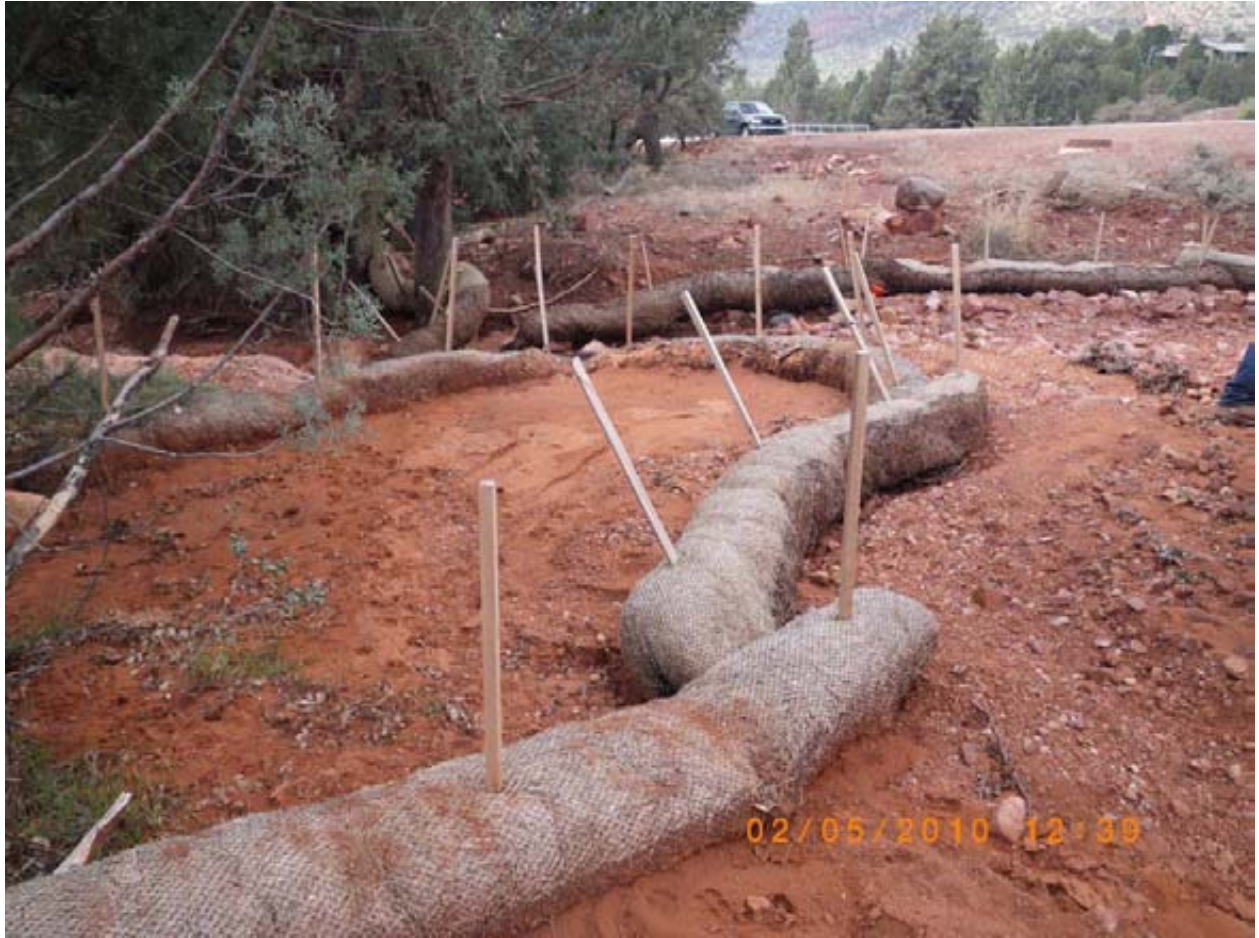
IMGP0066 – Facing south toward coir log check dam installed by ADOT out of the ROW. City of Sedona should maintain, evaluate for enforcement against private landowner.
