**U.S. Environmental Protection Agency, Region IX  
CWA Compliance Office  
Report of Clean Water Act Inspection**

***Site Location:*** State Route 179 Improvement Project  
Between Mile Posts 310.5 and 313.8  
Oak Creek/Sedona, AZ

***Date and Time of Visit:*** February 5, 2010, 8:30 a.m. – 1:30 p.m.

### **Photograph Log for EPA's 02/05/10 Site Visit to AZ DOT SR 179 Improvement Project – Oak Creek Bridge to Chapel Road, Yavapai and Coconino Counties, Arizona**

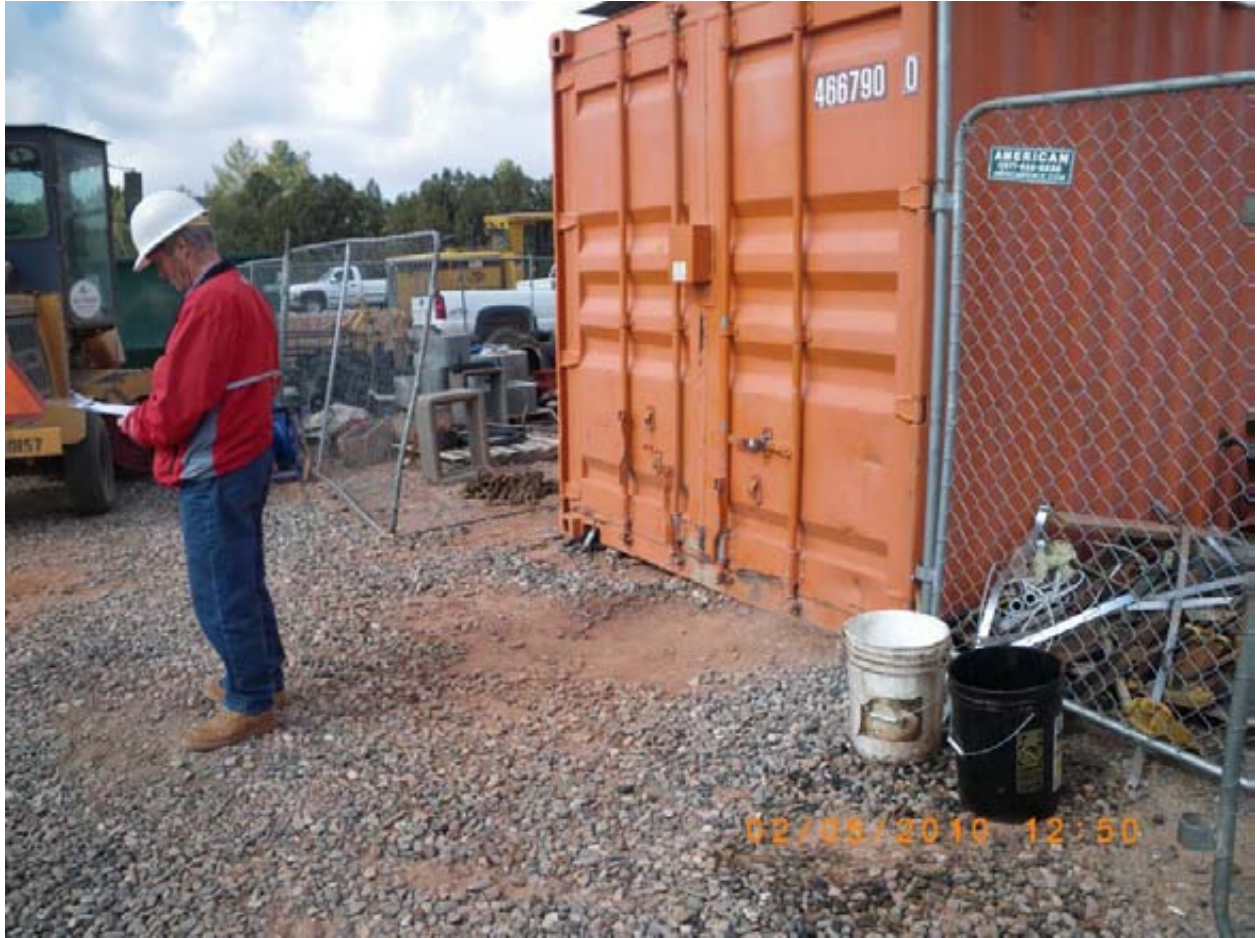
IMG0070

IMGP0070 – Facing west toward 179. Buckets in foreground contain an unknown oily waste.

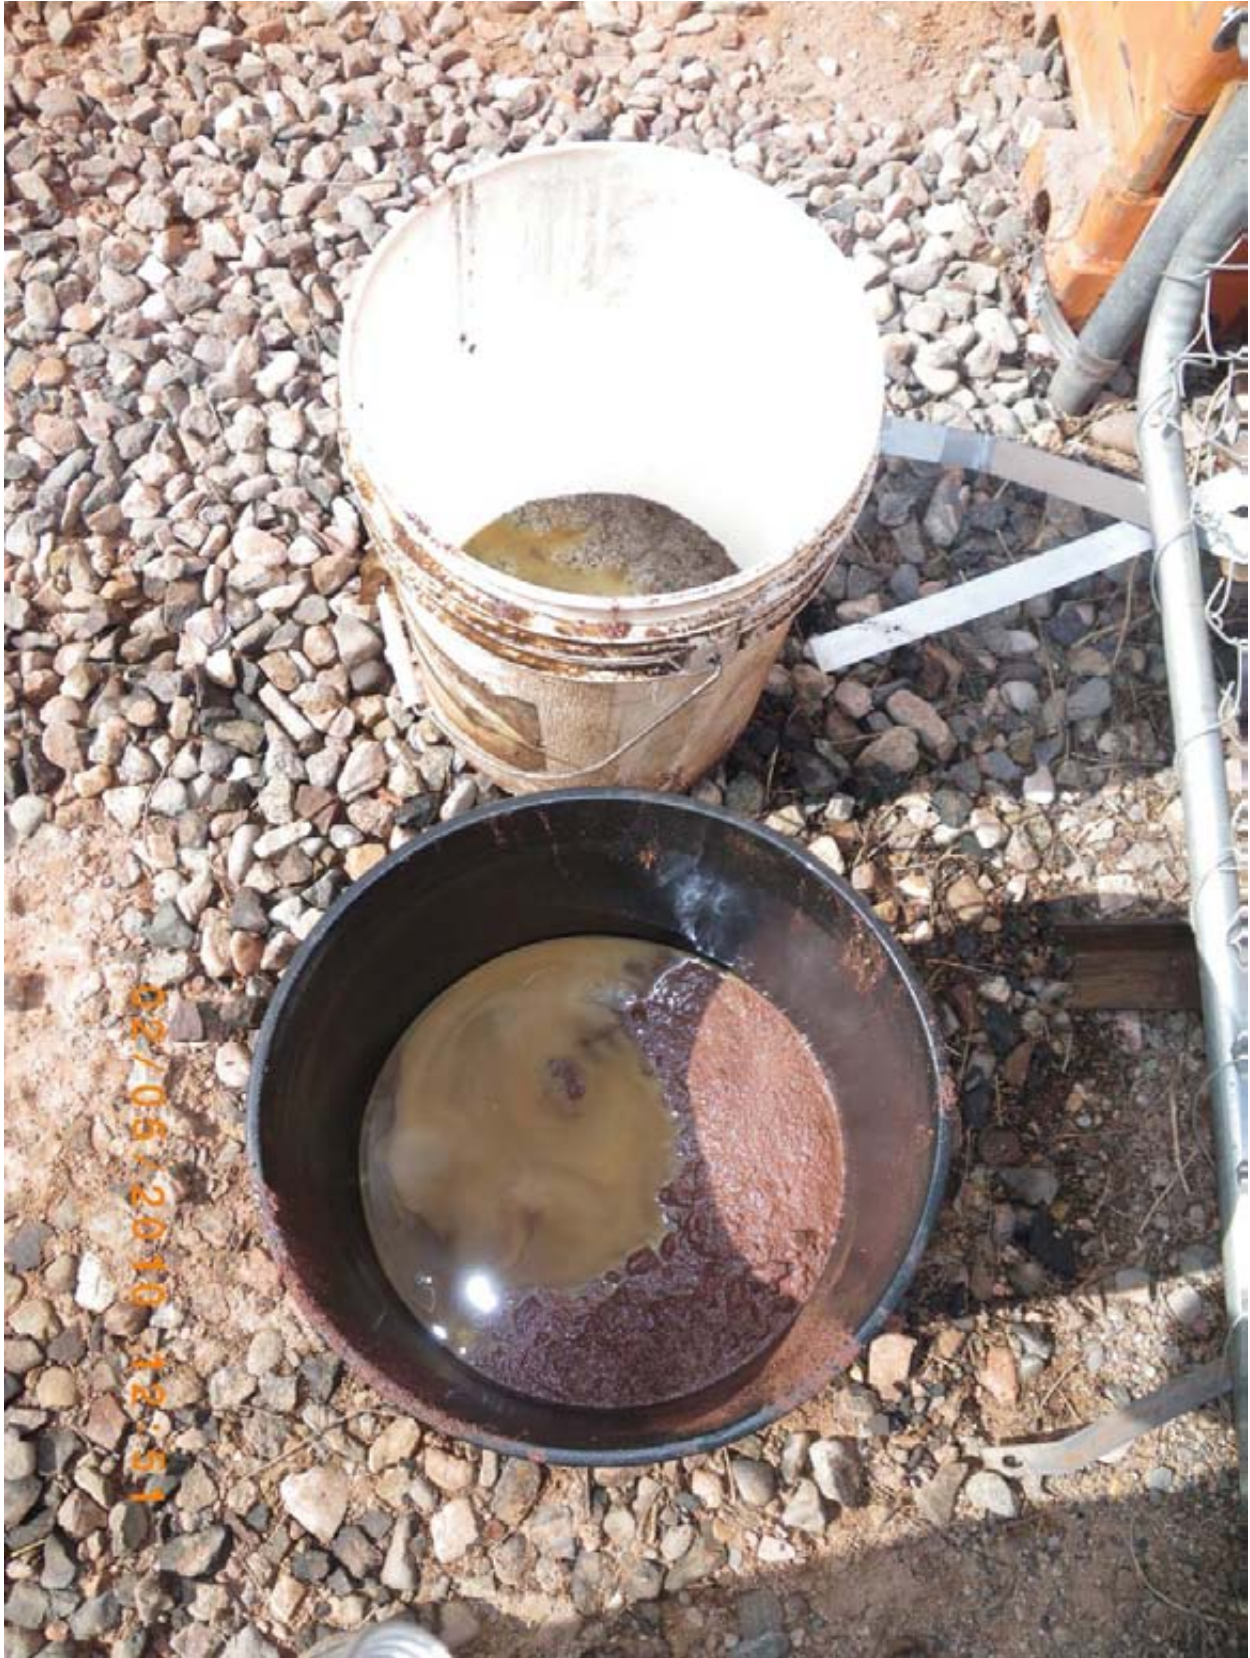
IMGP0071  
70 of 86

IMGP0071 – Close-up view of contents in buckets from IMGP0070.

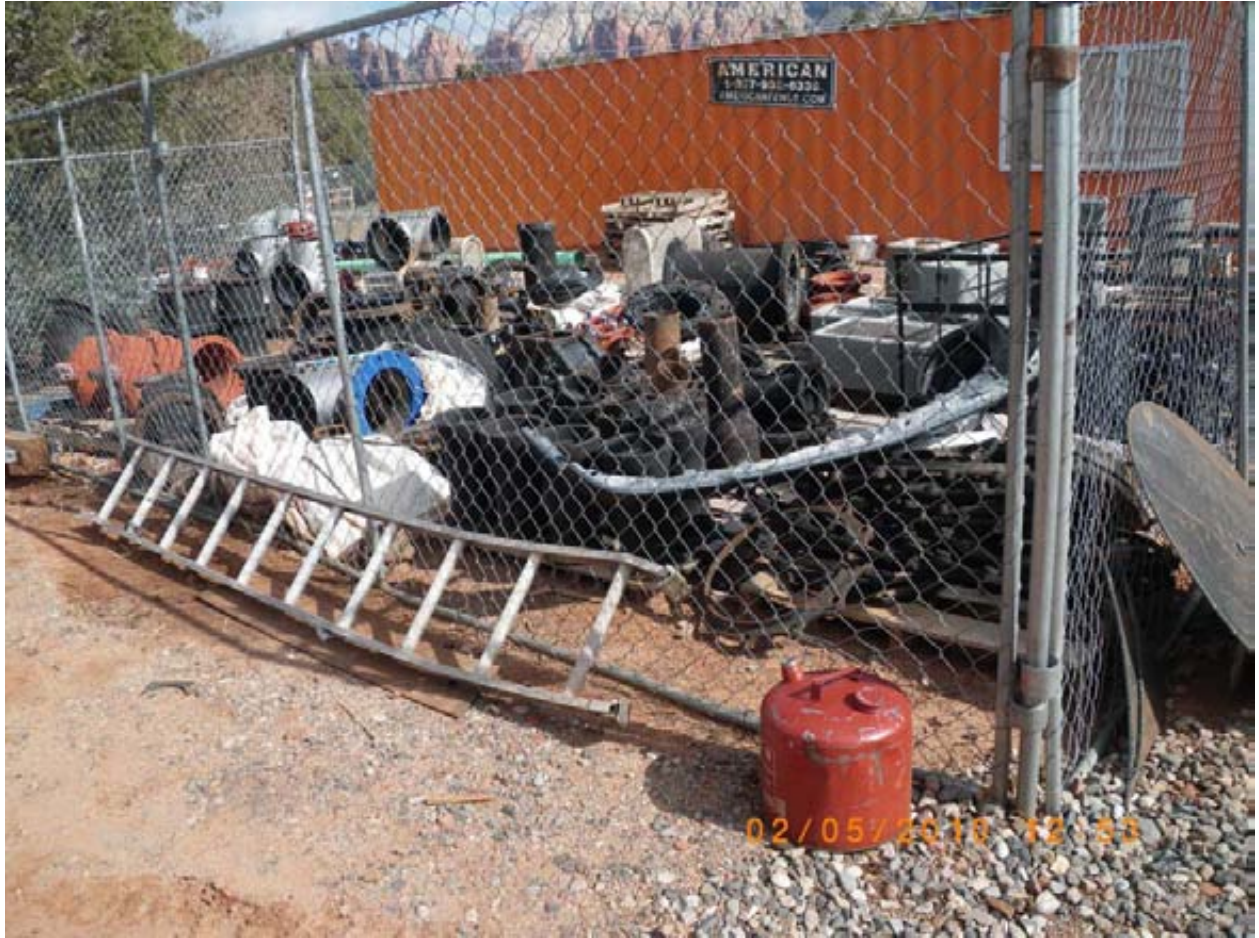
IMGP0072 – Facing northwest toward fenced material storage area. Note lack of secondary containment and labeling.

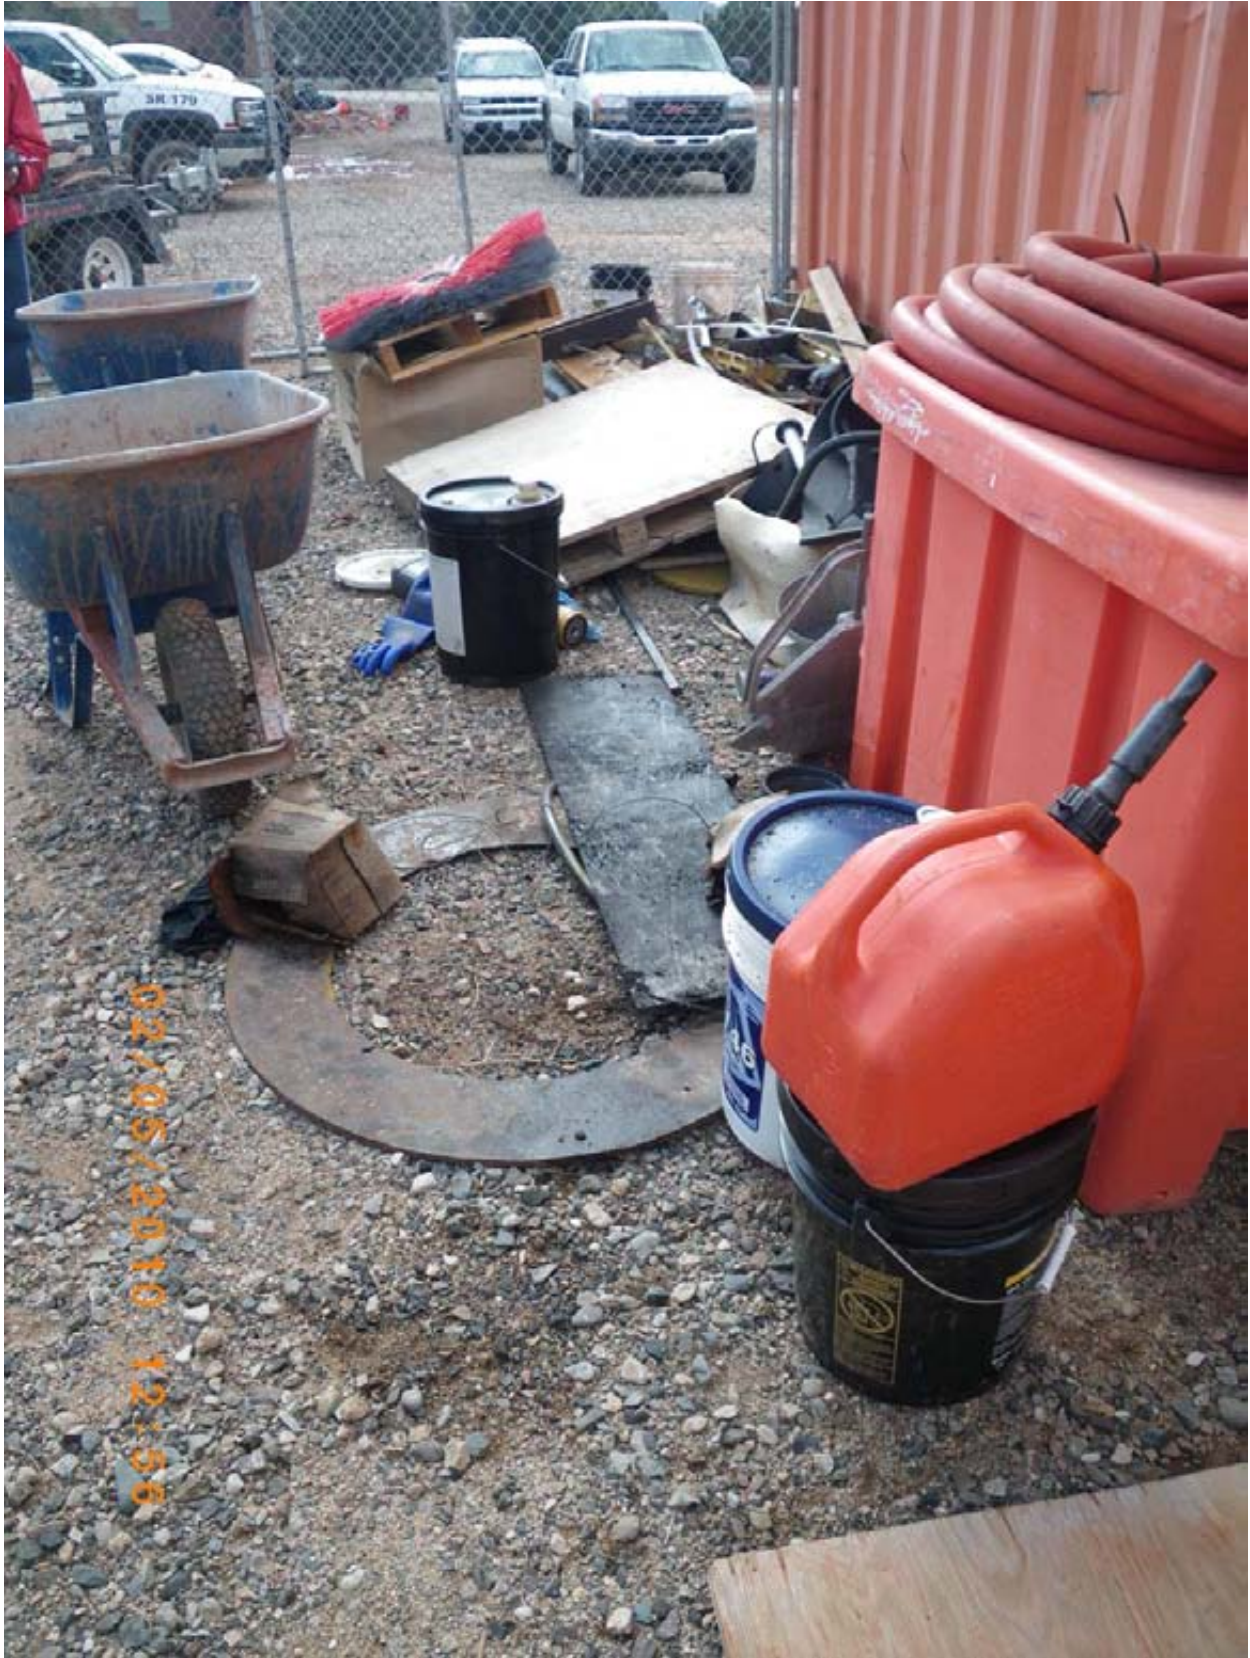
IMGP0075  
74 of 86

IMGP0075 – Close-up of materials in fenced storage area. Note lack of secondary containment for potentially toxic substances in buckets.

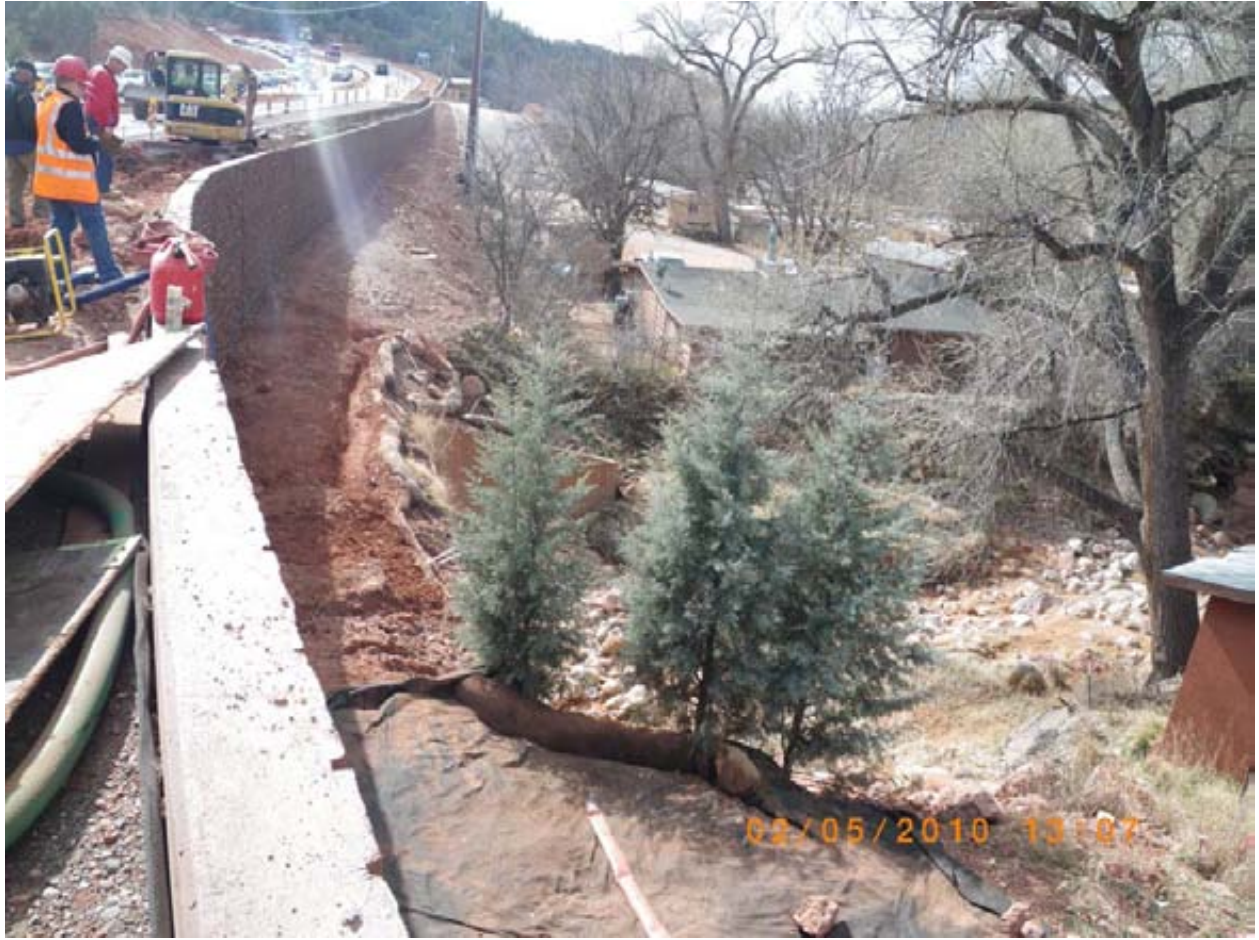
IMGP0078 – From west side of 179, facing south toward Morgan Wash. Note filter fabric in foreground to address concerns of sediment deposit in Morgan Wash.

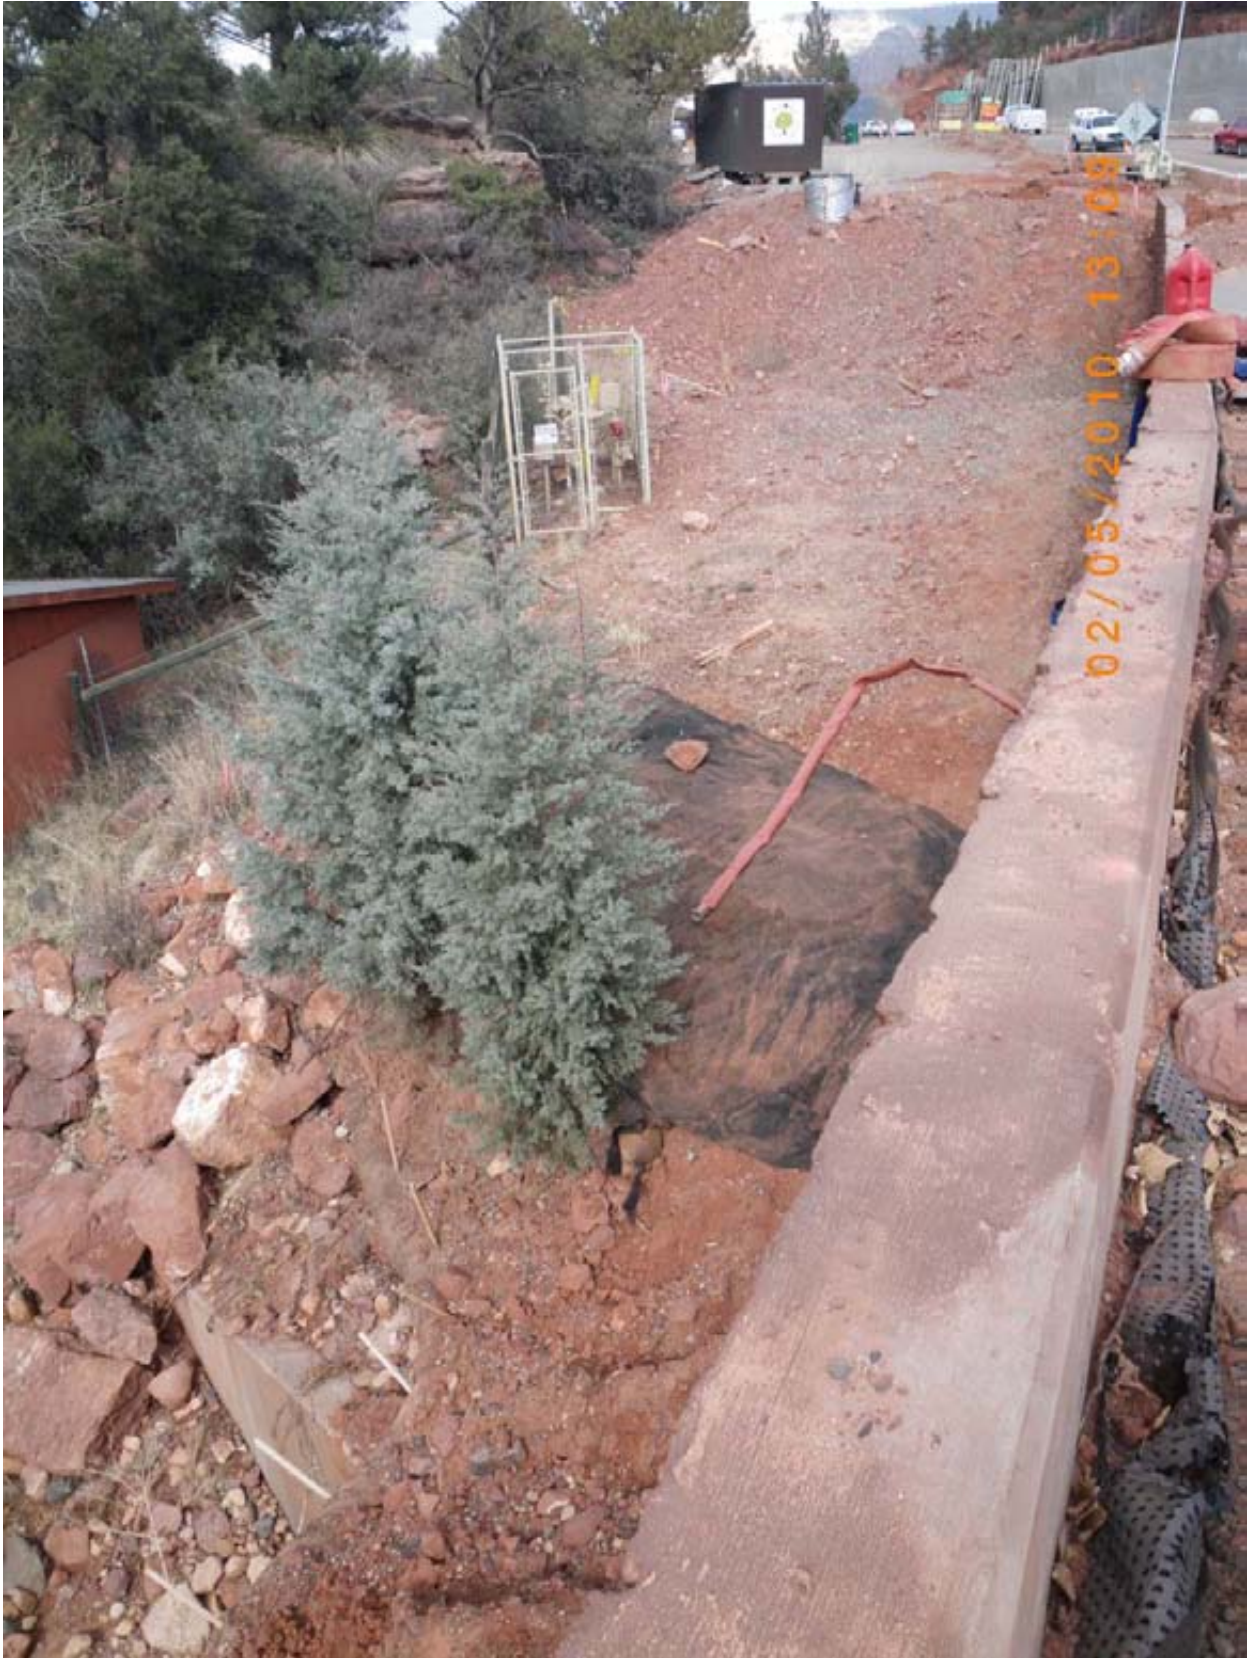
IMGP0079  
78 of 86

ADOT/Fisher is also working on SR 179 above Morgan Wash, which flows less than ¼ mile to Oak Creek. We observed evidence of storm water pooling across the highway at this location. According to ADOT/Fisher, this storm water is pumped and discharged into a small filtering basin built into the slope above Morgan Wash (see Photos 0078-79). We did not observe any pumping or discharging during the inspection, but the filtering area appeared to be undersized. Additionally, water discharged from this area and the small filtering basin will cross disturbed soil before entering Morgan Wash (see Photo 0079).
