## **Appendix D**

# **Construction Program Site Visit Reports**

**Site Visit No. 1**

**Thomes Creek Bridge Project**  
**Site Visit Date: 10/13/2009**

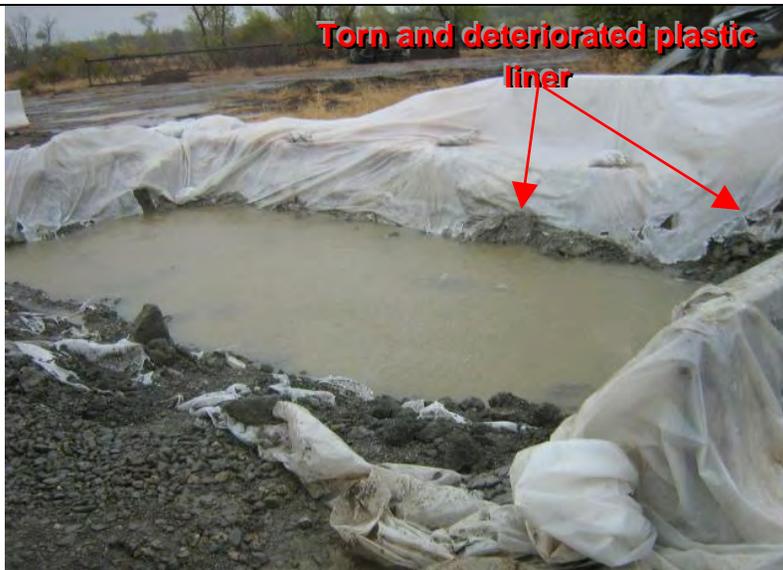
Photograph 1 – Concrete washout unmaintained (e.g., torn and deteriorated plastic liner)

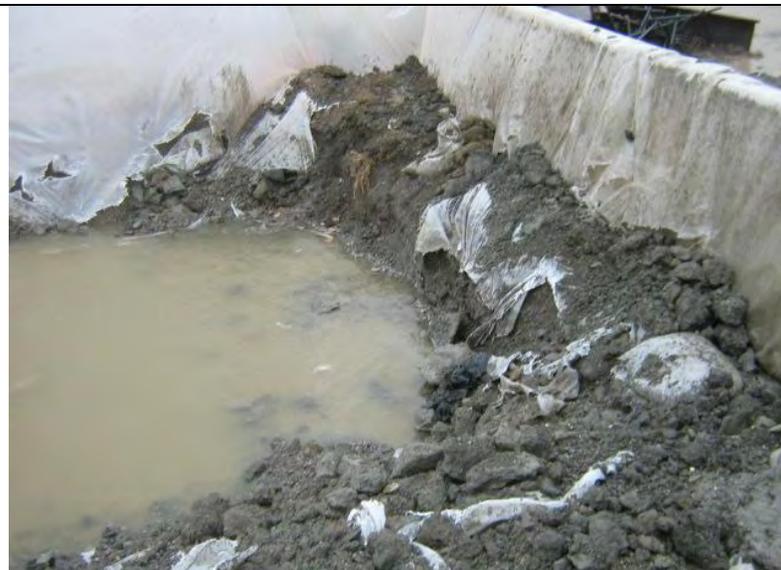
Photograph 2 – Close-up view of unmaintained (e.g., torn and deteriorated) concrete washout plastic liner

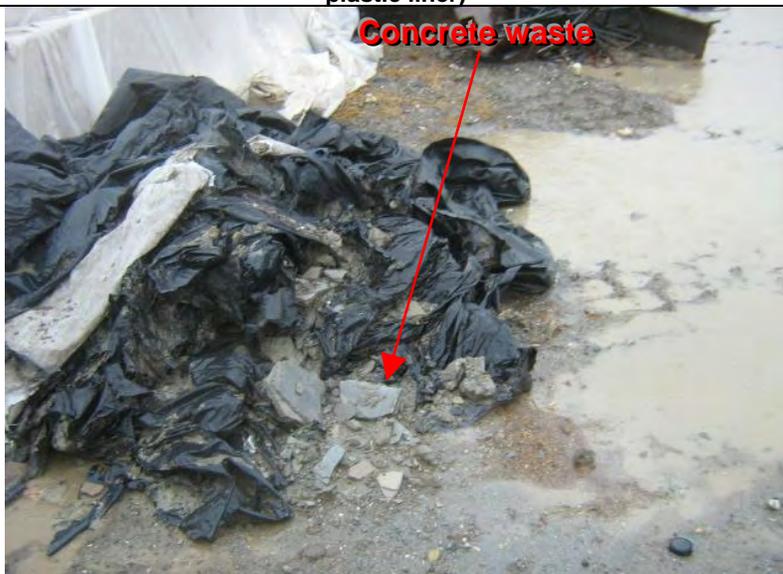
Photograph 3 – Concrete waste on the ground surface directly adjacent to the concrete washout

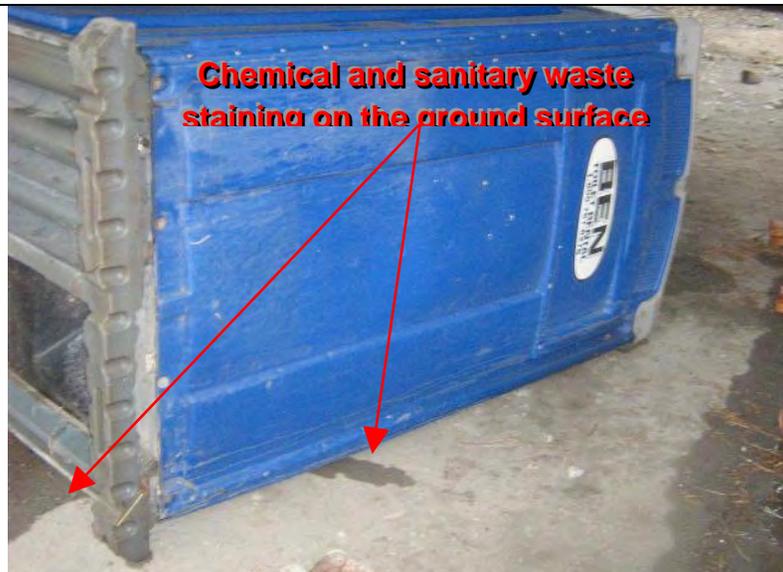
Photograph 14 – Visible chemical and sanitary waste staining on the ground surface

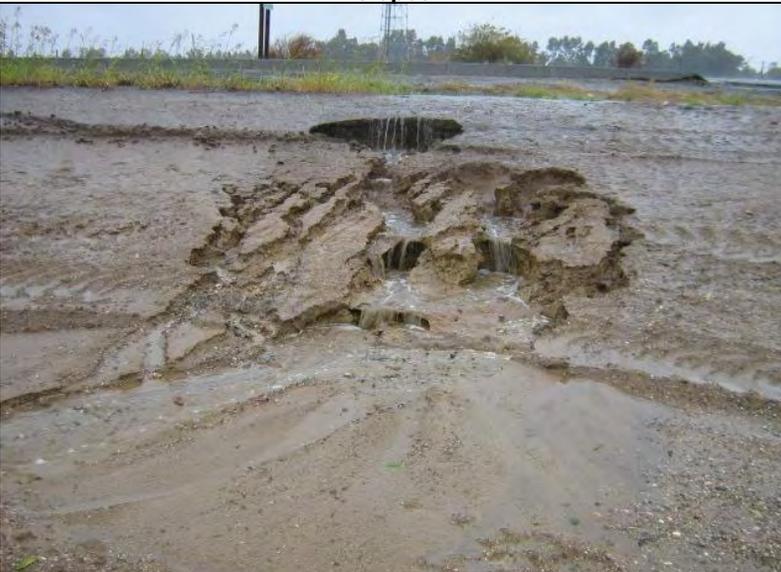
Photograph 3 – Sediment basin embankment slope erosion (e.g., gully formation) and failure

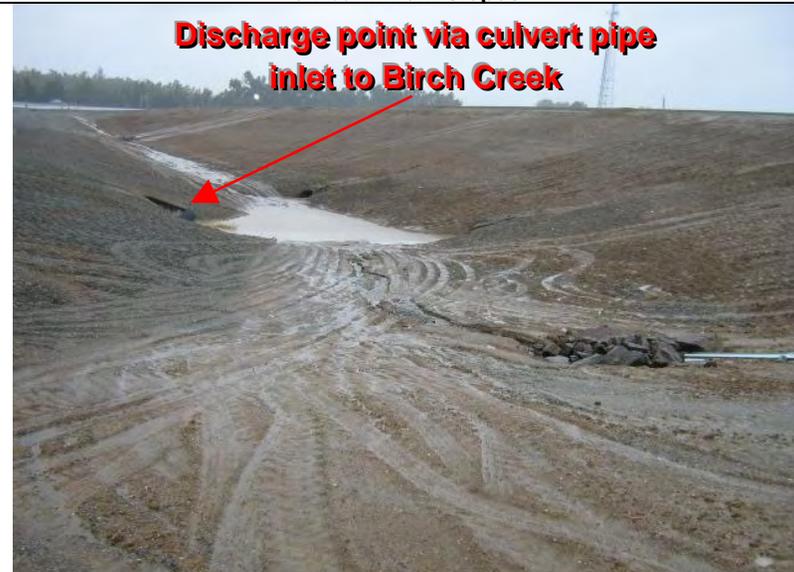
Photograph 4 – Adequate BMPs had not been implemented to prevent the discharge of sediment to the culvert inlet/drainage pipe leading to Birch Cr.

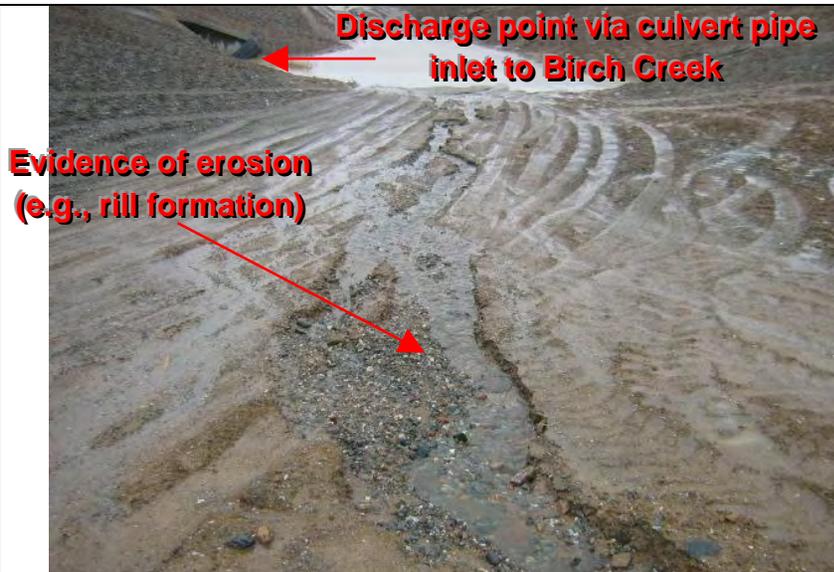
Photograph 5— Close-up of area in Photograph 4 depicting erosion (e.g., rill formation) and inadequate BMPs located adjacent to discharge point

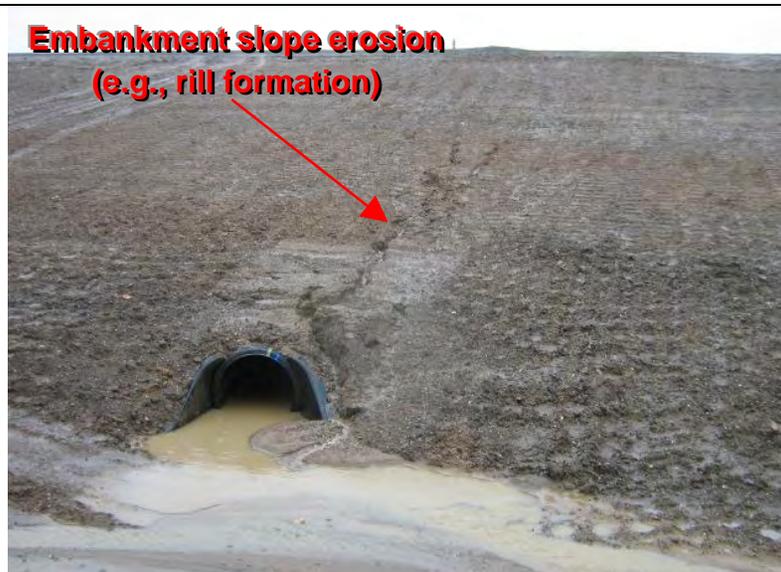
Photograph 6 – Embankment slope erosion (e.g., rill formation)

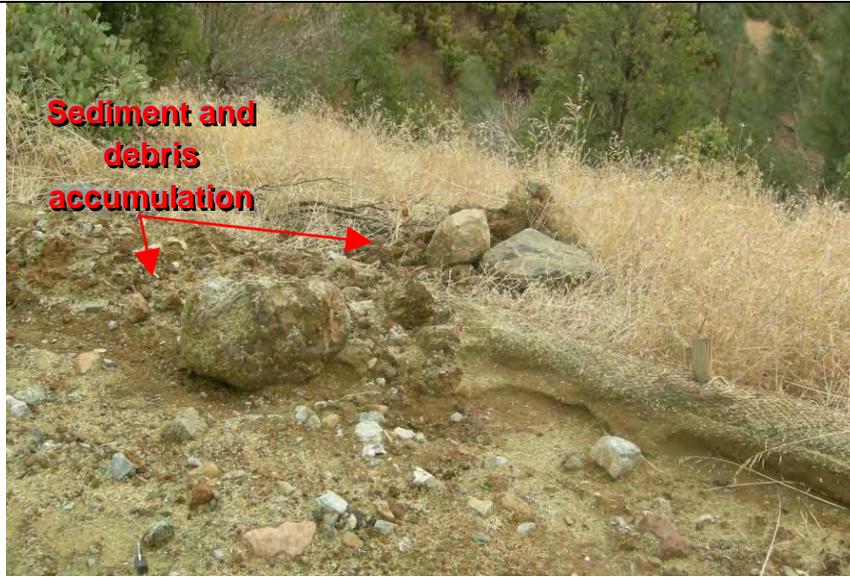
Specifically, BMPs were not adequately implemented and maintained along the perimeter of the disturbed area associated with the former construction site staging area. The Audit Team observed a visible flow path and erosion causing sediment and debris accumulation to surpass the straw wattles utilized along the southern perimeter of the former staging area (see Photograph 1). Erosion had caused the discharge of sediment and debris from several portions of the roadway drainage area adjacent to the sound wall into a storm drain inlet located along the west side of the highway shoulder (see Photographs 2, 3, and 4).

Photograph 1 – Perimeter control failure at the former staging area

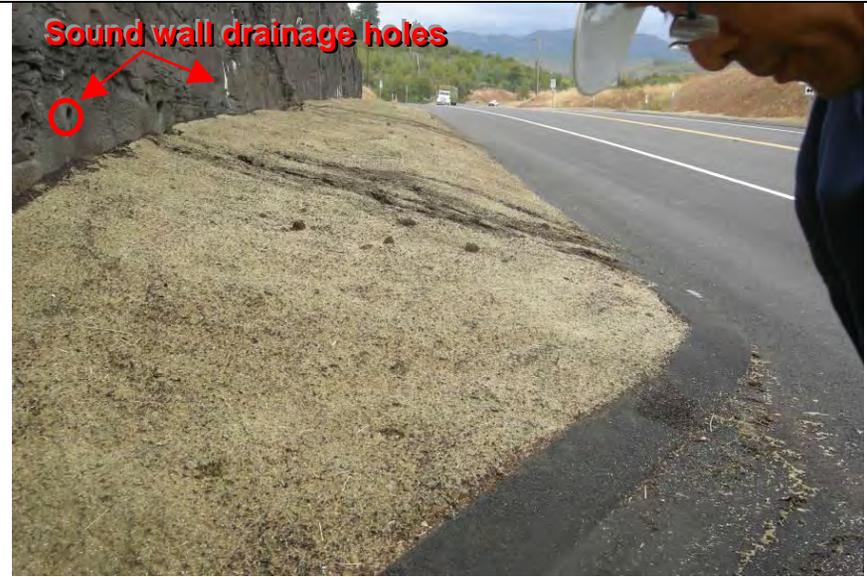
Photograph 2 – Run-off causing erosion along the highway shoulder

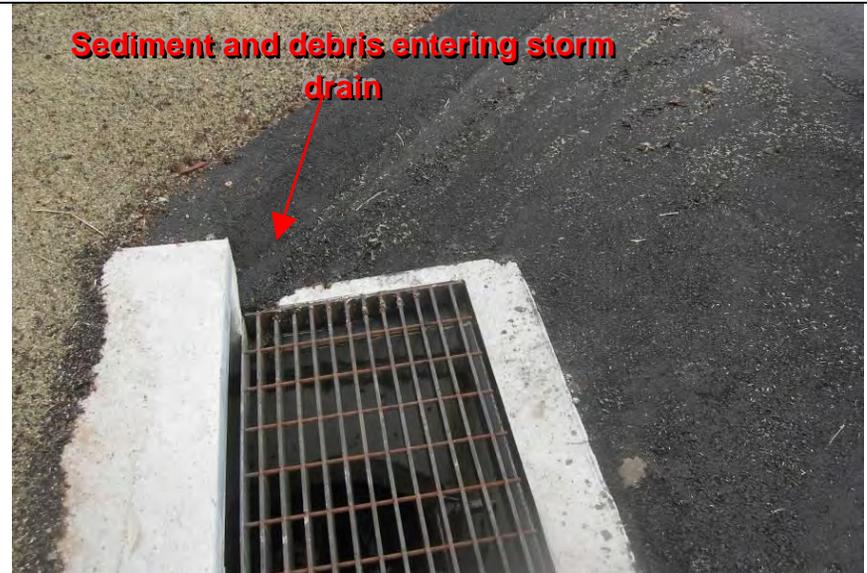
Photograph 4 – Storm drain located on the west side of Highway 299

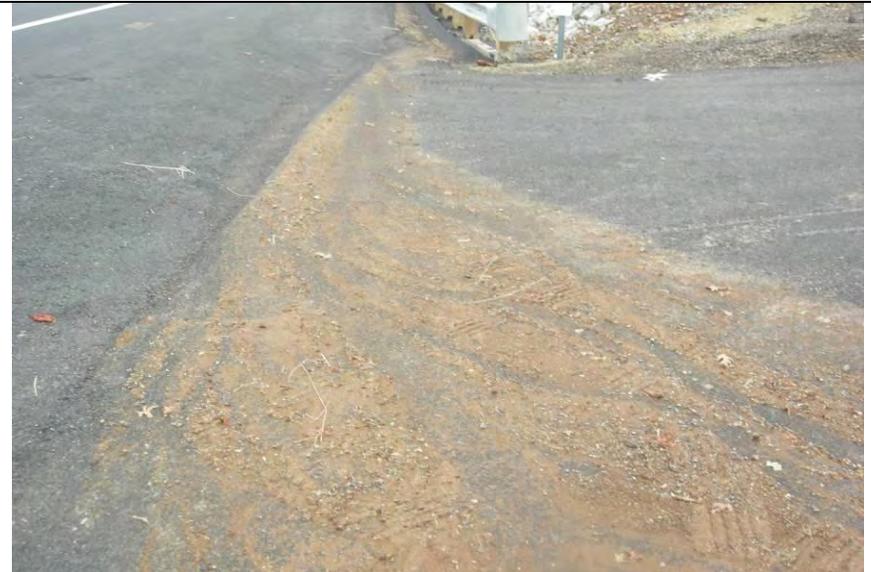
In addition, BMPs were not adequately implemented on the disturbed slope along the south side of the sound wall to prevent sediment discharge (see Photographs 5 and 6). Furthermore, sediment accumulation was observed along the flow path of a rock lined drainage swale leading to a down-gradient drainage pipe (see Photographs 7 and 8). The straw wattles utilized at the down-gradient drainage pipe inlet were not adequately maintained.

Photograph 5 – Lack of adequate BMPs to prevent discharge of sediment to the roadway

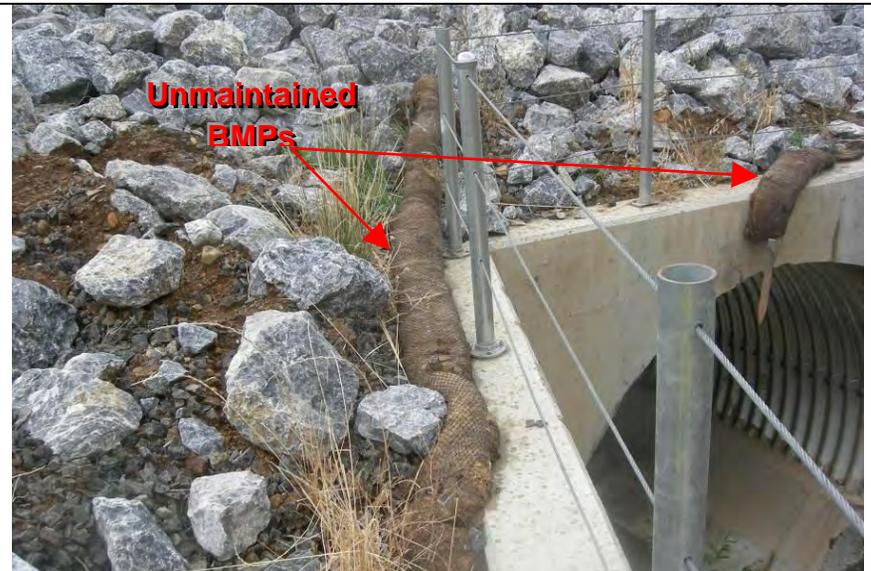
Photograph 8 – Inadequate straw wattle BMP maintenance at drainage pipe inlet

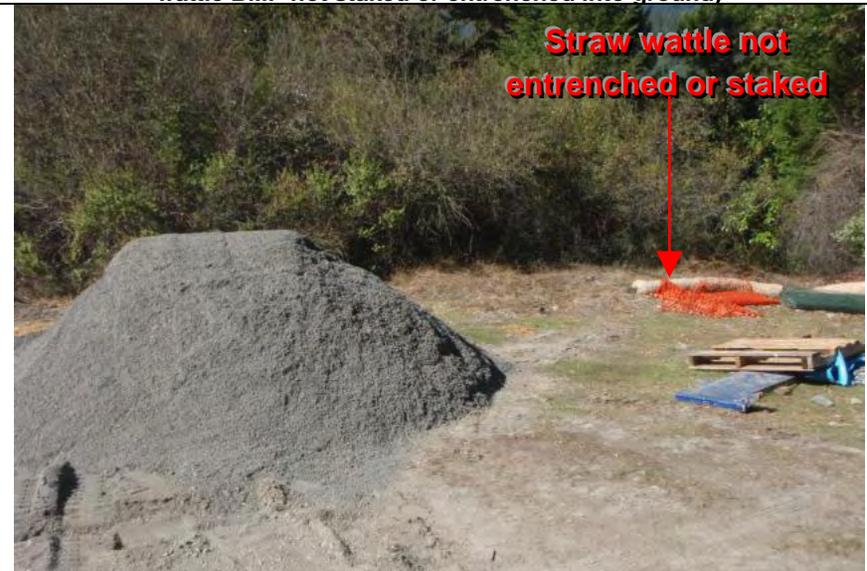
Photograph 12— Stockpile in staging area without BMPs for containment or coverage

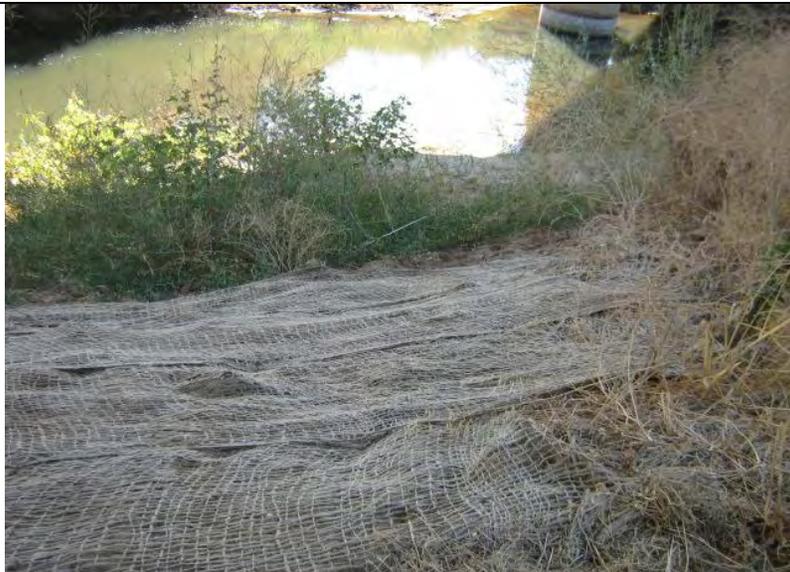
**Photograph 1 – Erosion control blanket not properly installed (e.g., improper overlap – not shingled downgradient) adj. to Bear River at top.**

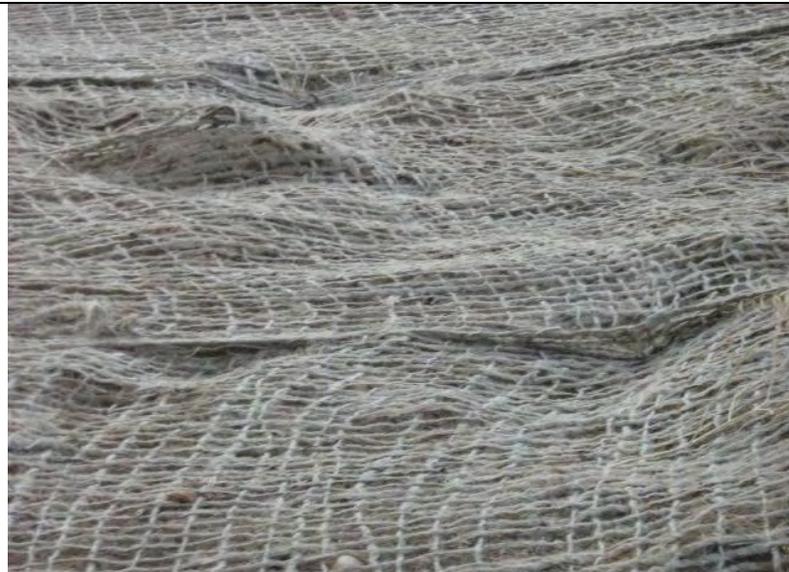
**Photograph 2 – Close-up of Photograph 1 looking down-gradient.**

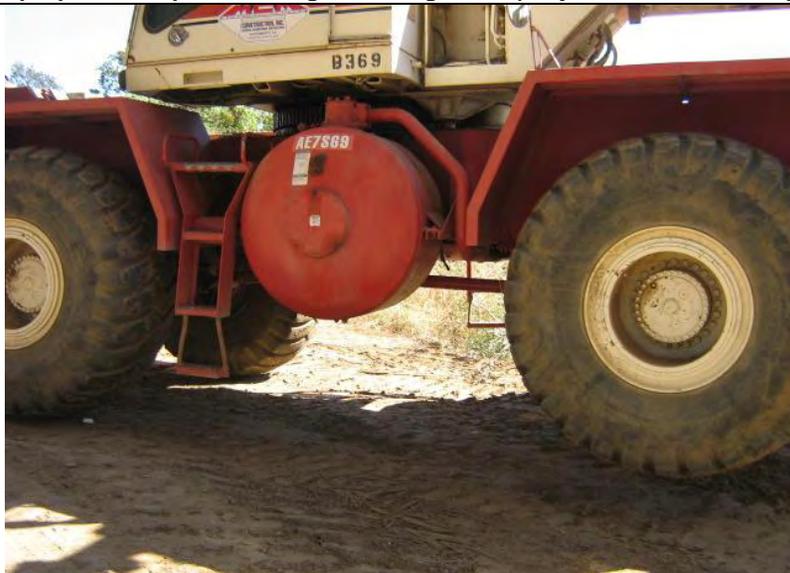
**Photograph 3 – Equipment with petroleum product leaking onto ground surface (see Photograph 4 for close-up view).**

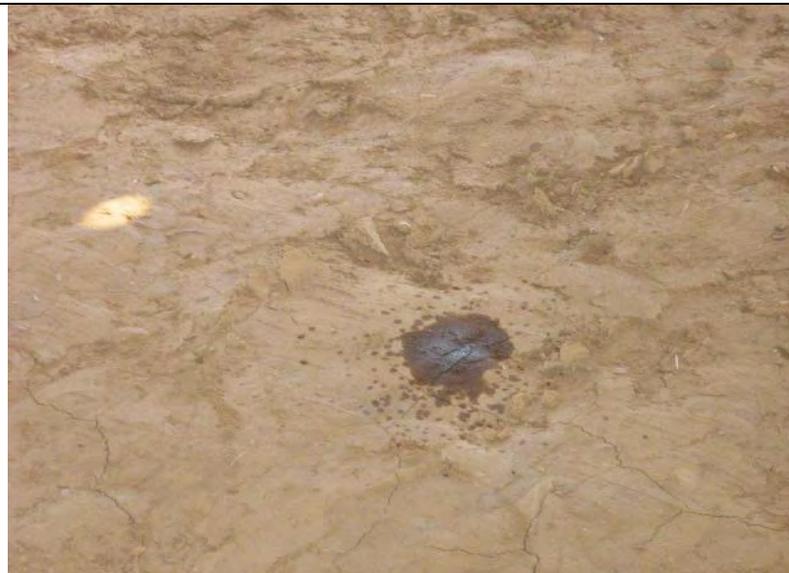
**Photograph 4 – Close-up view of petroleum product on ground surface**

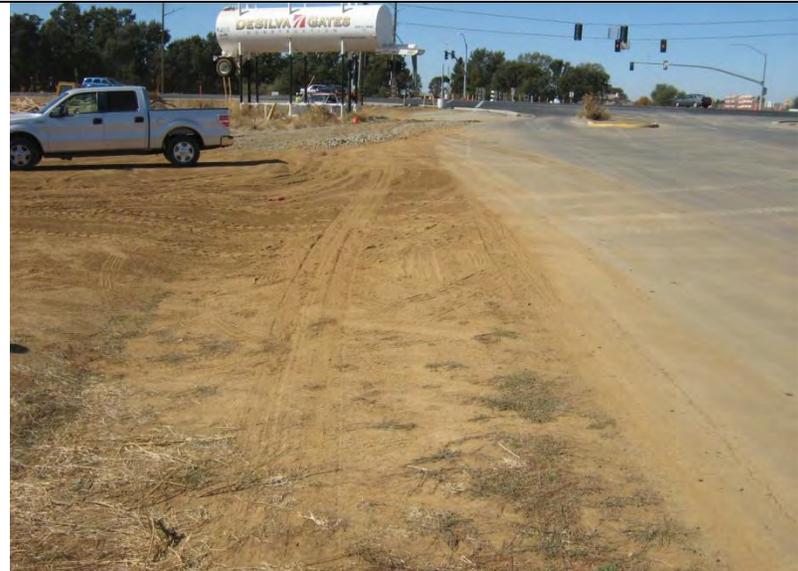
**Photograph 12 – Tracking control BMPs not implemented for disturbed area of contractor parking. Observed sediment transport to roadway**

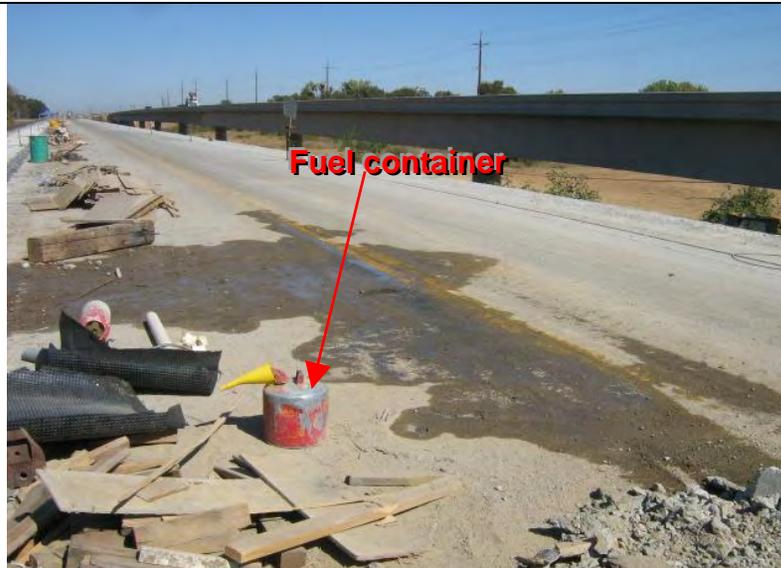
Photograph 18 – Inadequate materials handling and storage

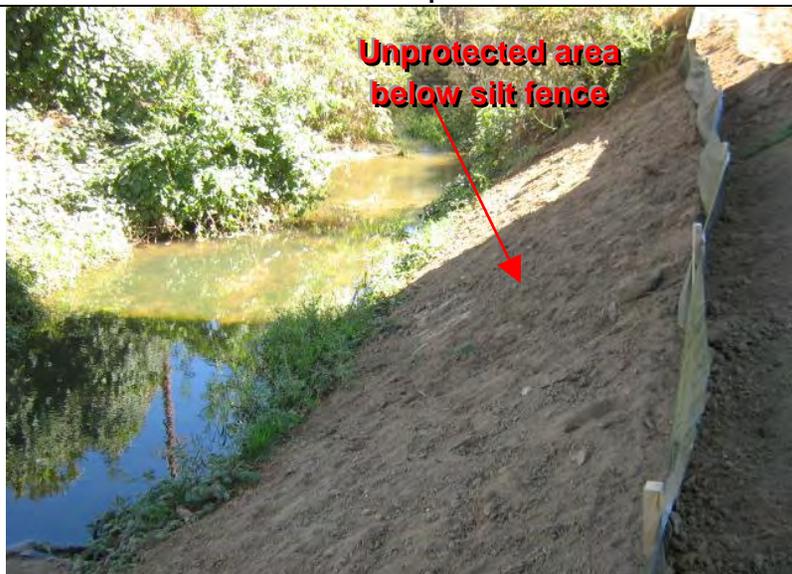
Photograph 19 – Unstabilized slope area adjacent to Yankee Slough

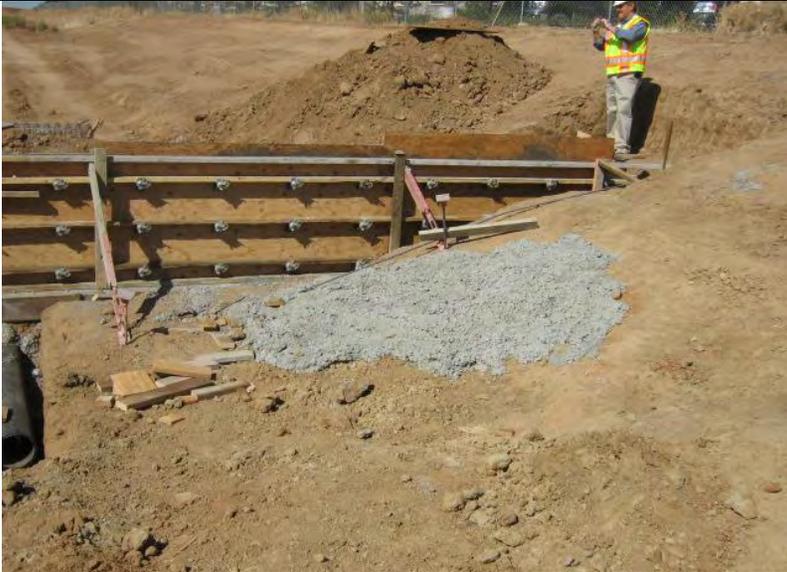
Photograph 1 – Improper concrete waste disposal practices

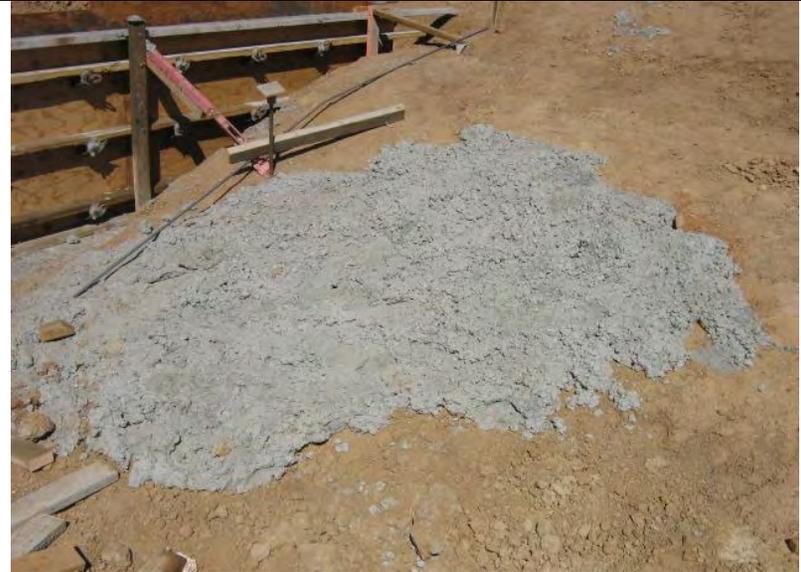
Photograph 2 – Close-up of Photograph 1

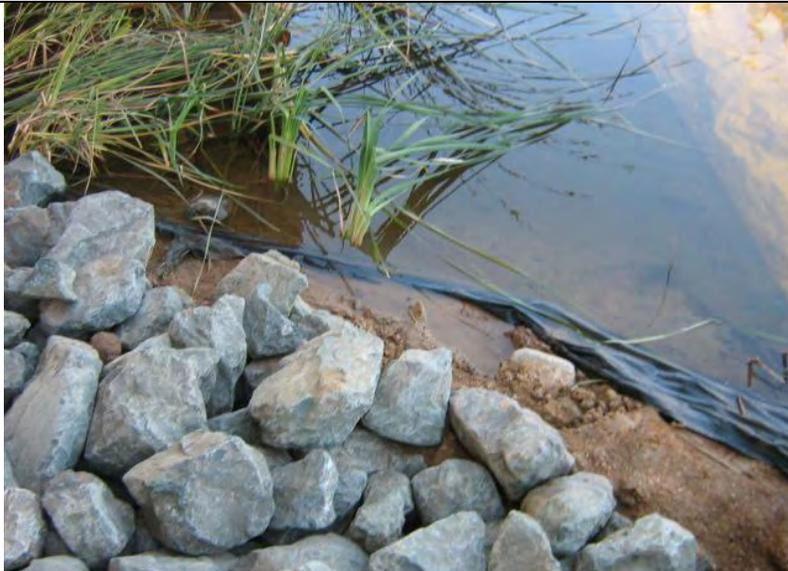
**Photograph 7 – Badly deteriorated silt fence BMP located in/adjacent to North Ingram Slough**

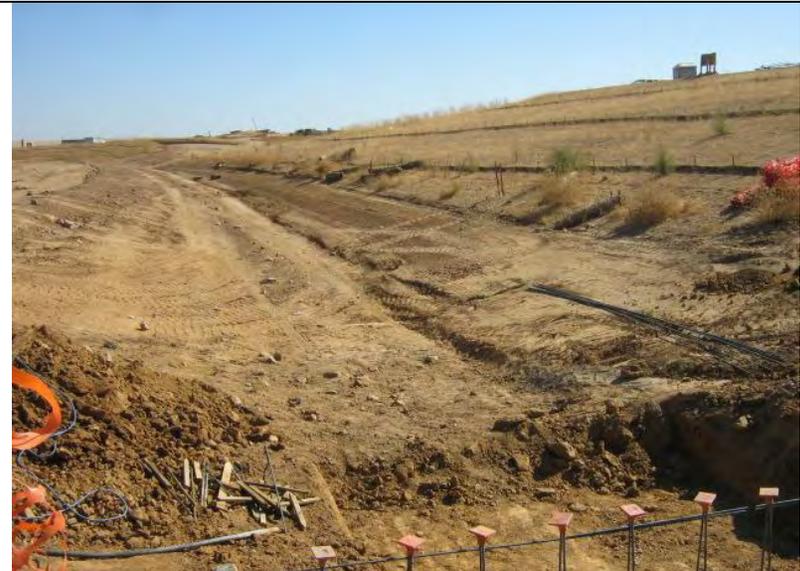
**Photograph 8 – Disturbed conveyance channel with no slope run-on BMPs or erosion and sediment control BMPs near the S. Ingram Slough.**

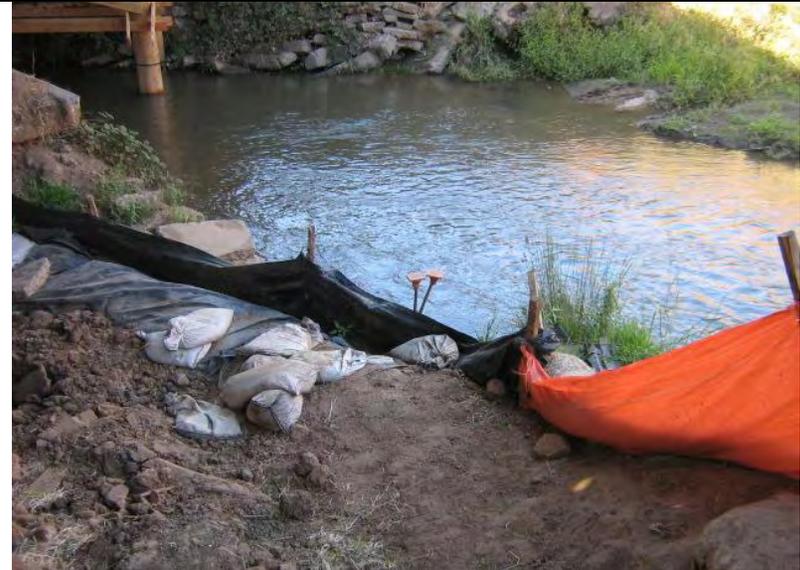
**Photograph 12 – Silt Fence BMP not adequately maintained (e.g., down in areas; deteriorated) adjacent to Auburn Ravine**

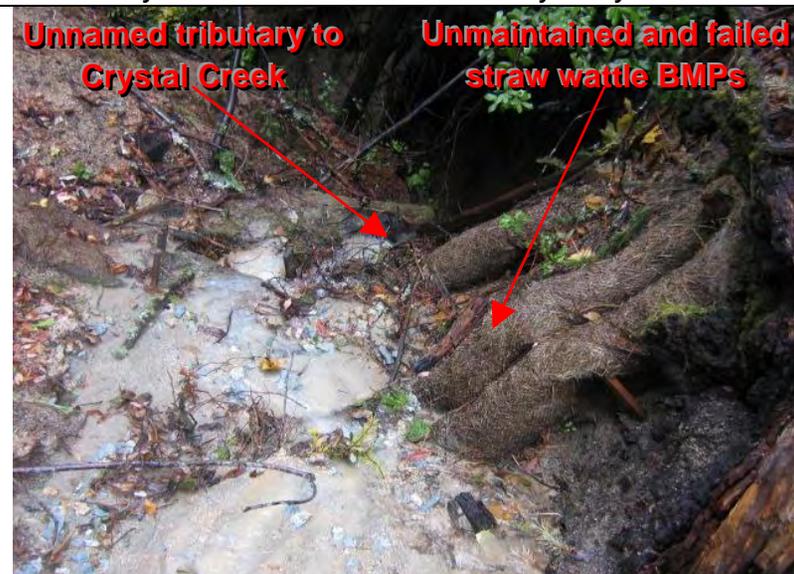
Photograph 8 – Visible evidence of the discharge of sediment to the unnamed tributary to Crystal Creek, and failed straw wattle BMPs observed

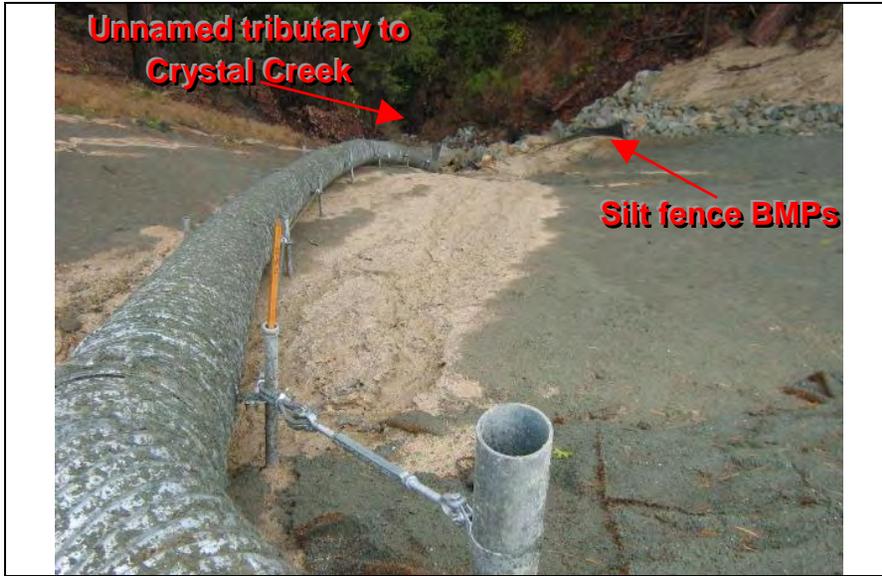
Photograph 13—Adequate BMPs were not implemented to prevent the discharge of sediment from upgradient disturbed slope areas

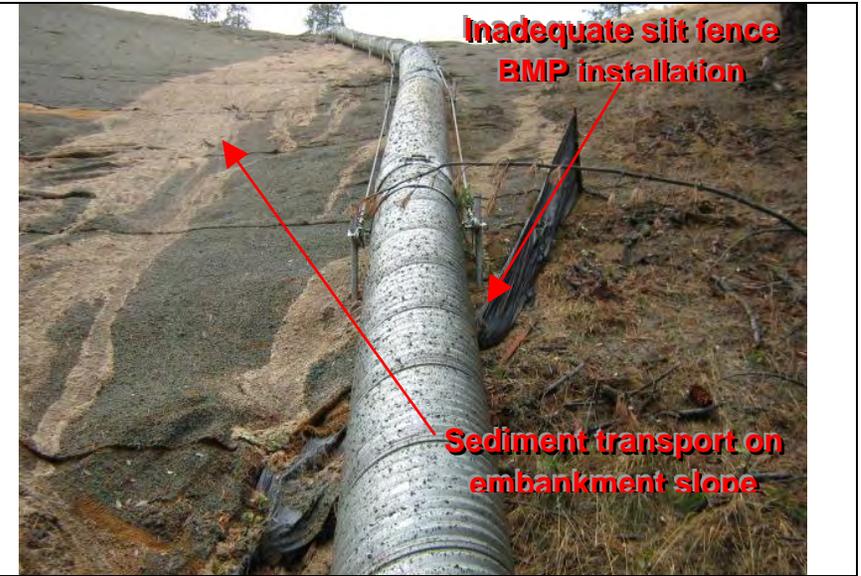
Photograph 14 – Evidence of sediment transport on the embankment slope of the field constructed sediment basin No. 2. Inadequate silt fence BMP installation under culvert pipe

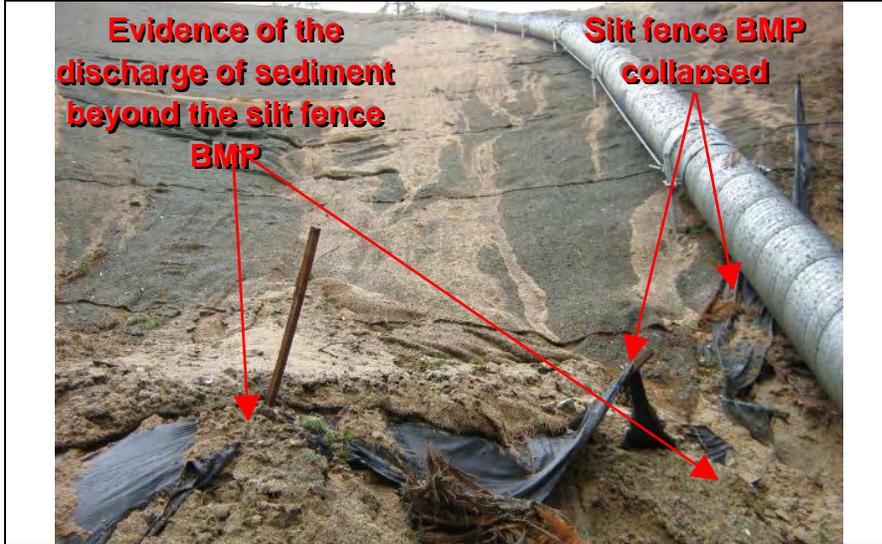
Photograph 15—SF BMPs were not adequately maintained (e.g., collapsed in areas) to prevent the discharge of sediment to the unnamed tributary.

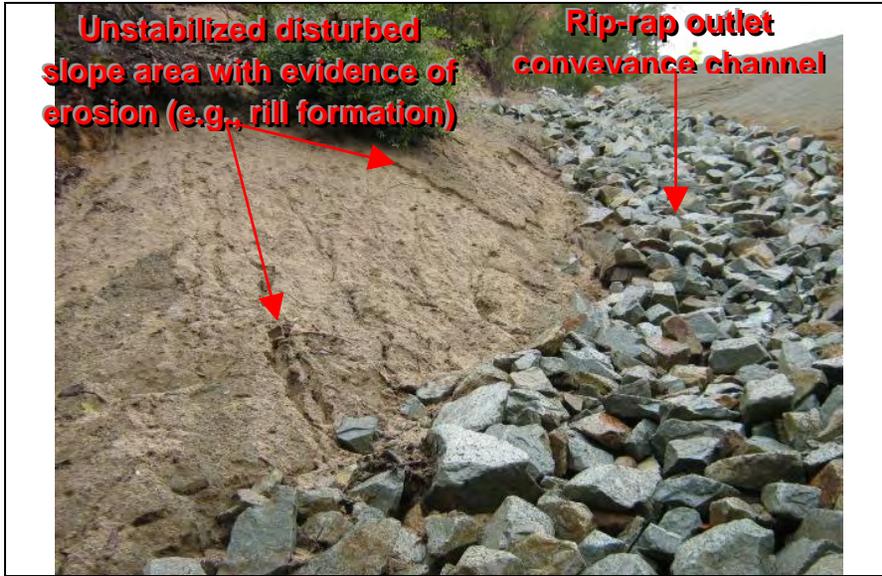
Photograph 17—Adequate BMPs were not implemented to prevent the discharge of sediment from disturbed slope area adjacent to the rip-rap conveyance channel which drains to the unnamed tributary.

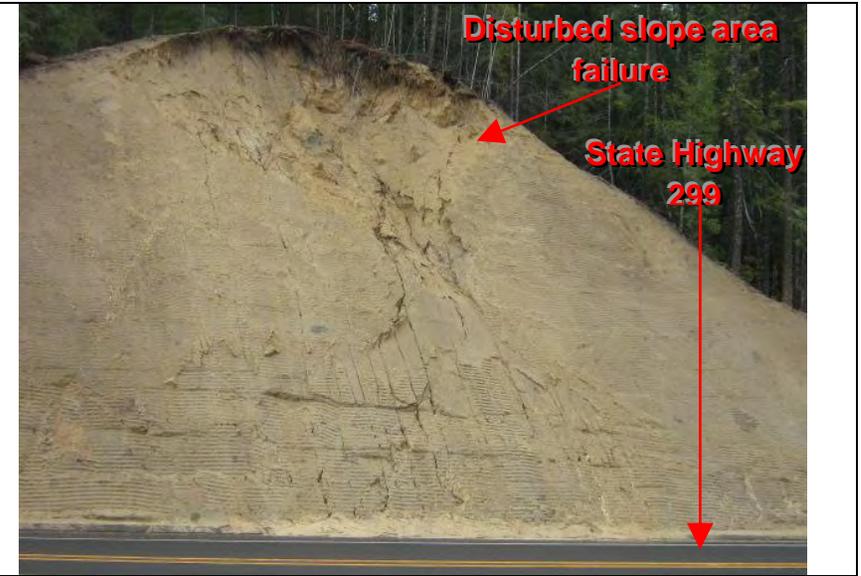
Photographs 18 – Adequate BMPs were not implemented to prevent the discharge of sediment from a disturbed cut slope area adjacent to State Highway 299.

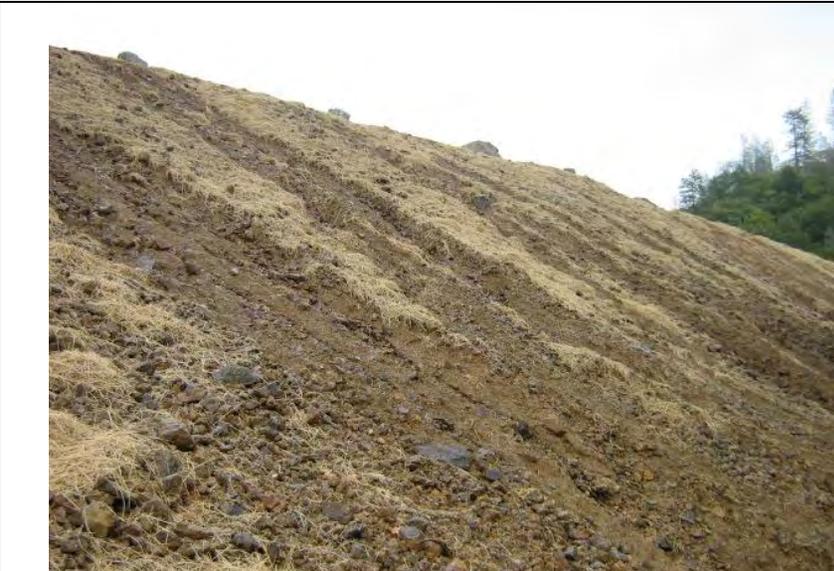
Photograph 1 – Evidence of erosion and slope failure on disturbed slope areas draining to Crystal Creek on the south side of State Highway 299

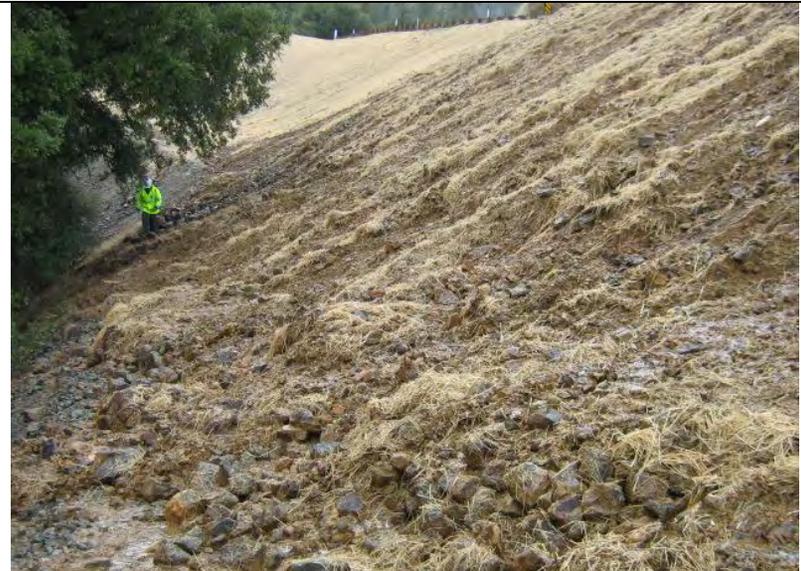
Photograph 2 – Evidence of erosion and slope failure on disturbed slope areas draining to Crystal Creek on the south side of State Highway 299

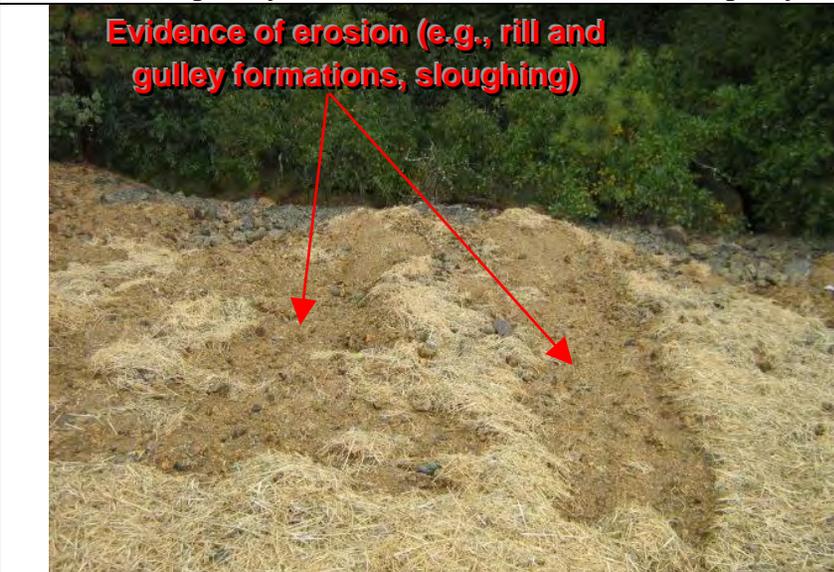
Photograph 3 – Evidence of erosion (e.g., rill and gully formation) and sediment transport from the disturbed slope failure

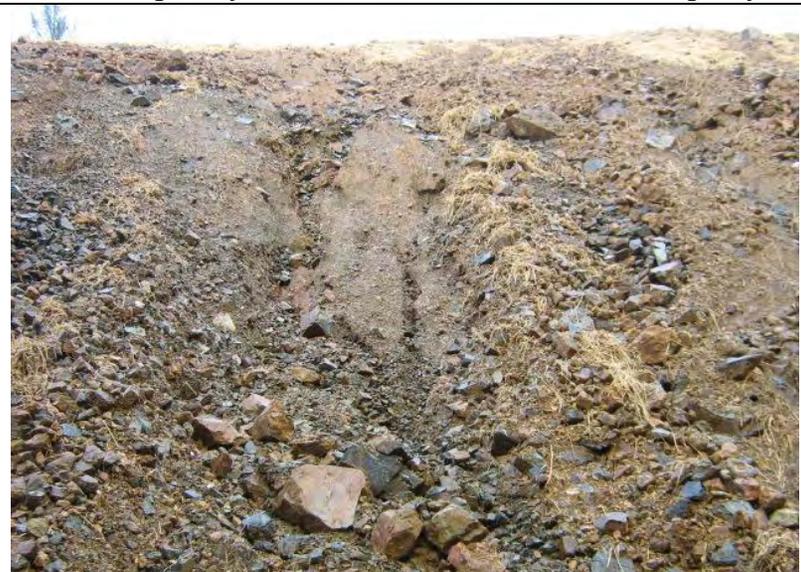
Photograph 4 – Visible evidence of erosion (e.g., rill and gully formation) on the disturbed slope area draining to Crystal Creek

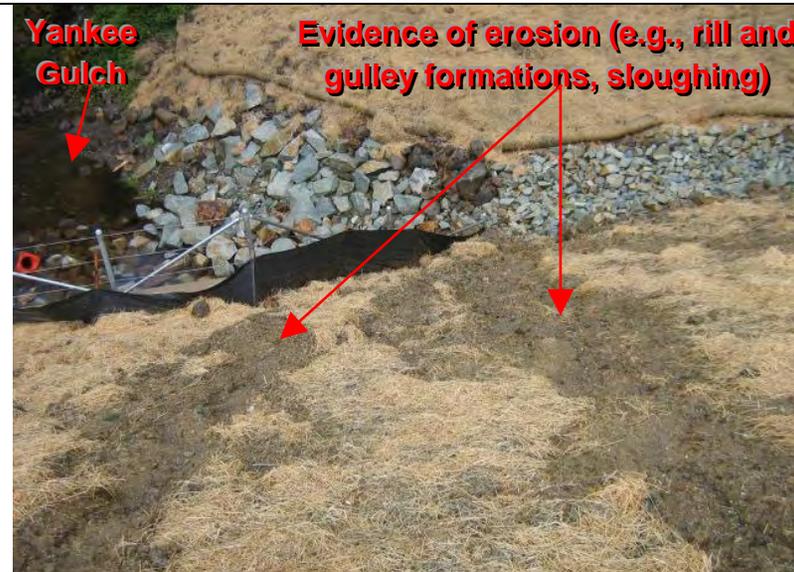
Photograph 8 – Evidence of erosion (e.g., rill and gully formation) and sediment transport from the disturbed slope failure

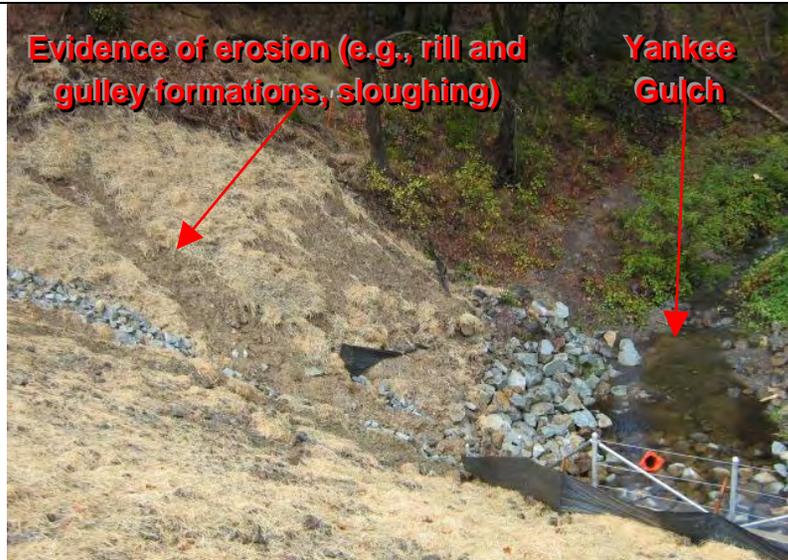
Photograph 9— Evidence of erosion (e.g., rill and gully formation) and sediment transport from the disturbed slope failure

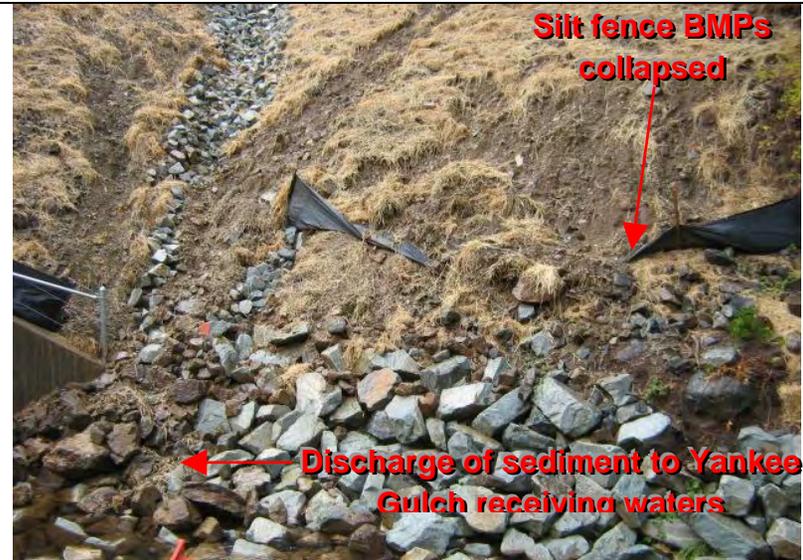
Photograph 10 – Silt fence BMPs collapsed in areas and evidence of the discharge of sediment to Yankee Gulch receiving waters

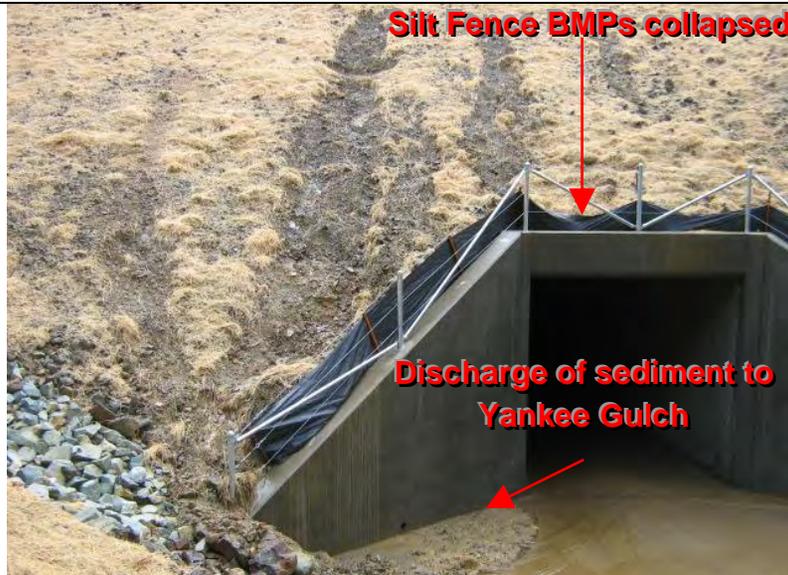
Photograph 11—Visible evidence of slope failure and the discharge of sediment to Yankee Gulch receiving water

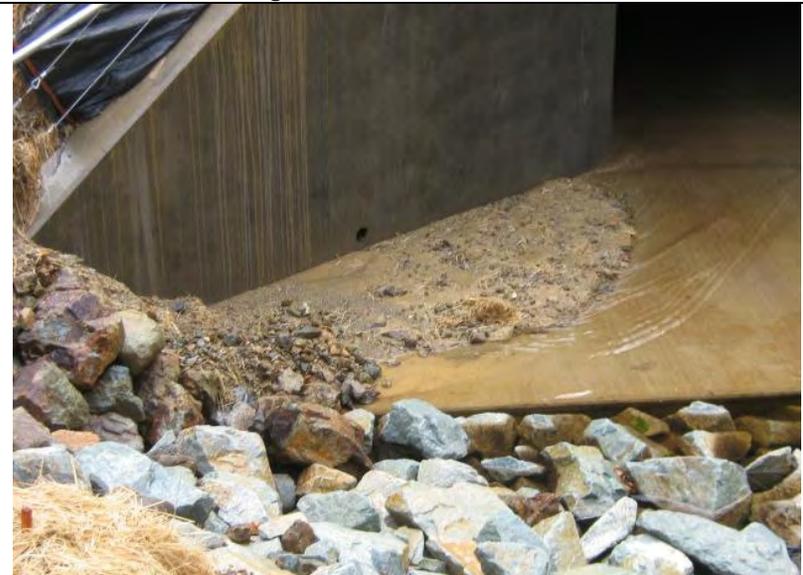
Photograph 12 – Close-up view of Photograph 11 depicting the discharge of sediment and sediment accumulation in Yankee Gulch

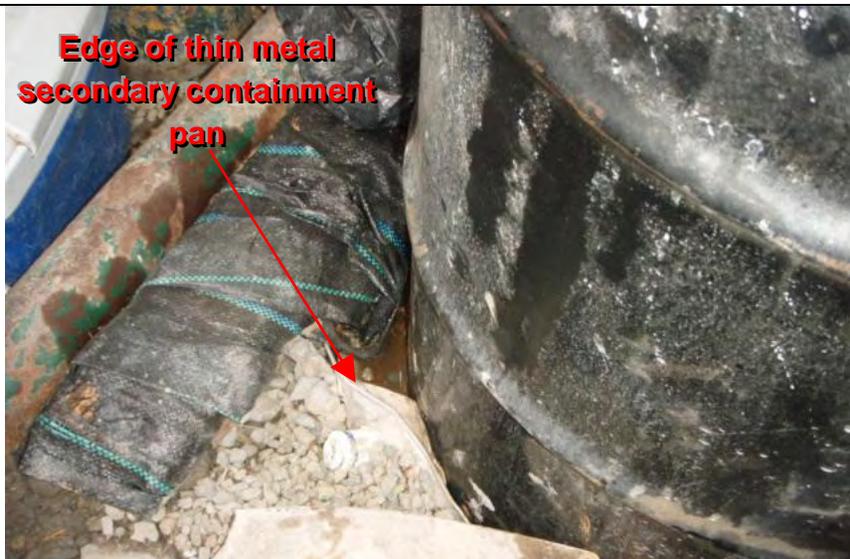
Photograph 9— Close-up view of damaged secondary containment pan underneath 55-gallon drum

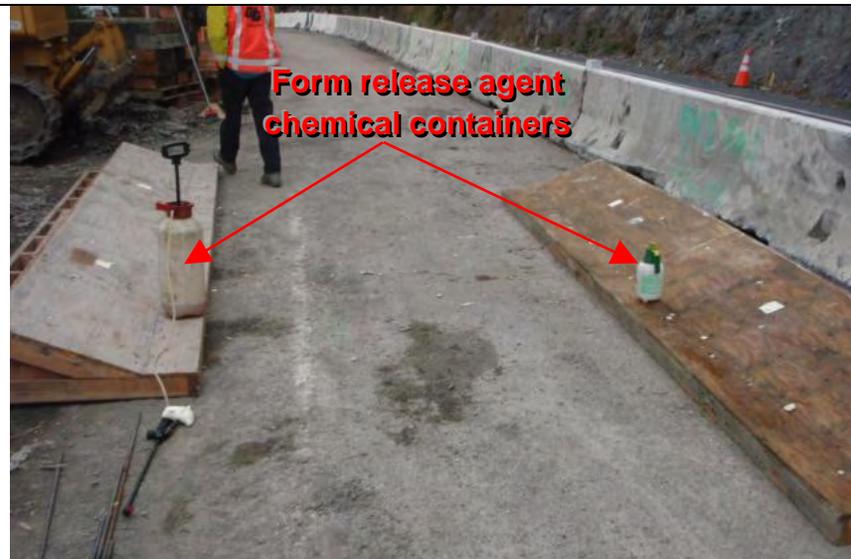
Photograph 10— Chemical sprayers not within secondary containment

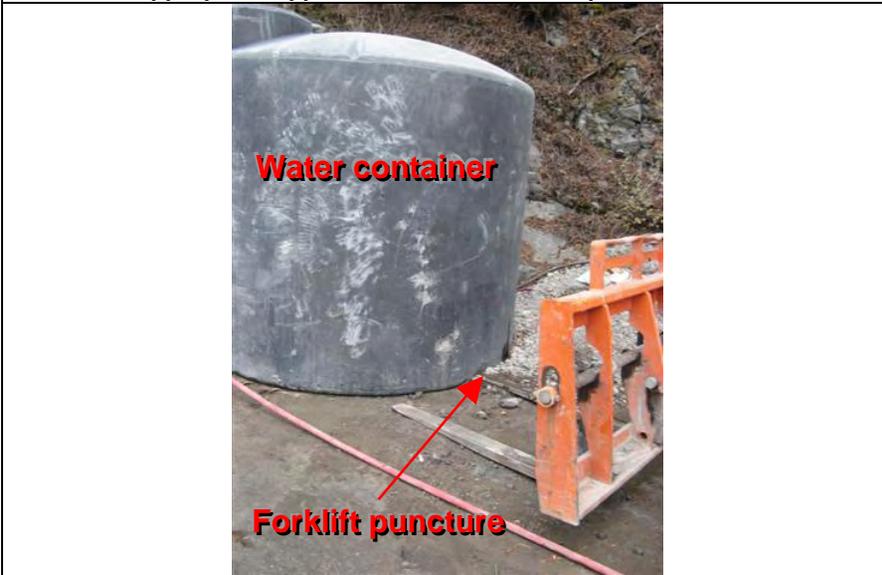
The EPA Audit Team observed that a water storage tank (approximately 1,000-gallon capacity) located up-gradient had been punctured by a forklift and was leaking (see Photographs 15 and 16). Water was observed slowly flowing underneath the straw wattle BMPs that been placed on the impervious roadway surface adjacent to K-rail barriers near the southern end of the construction project (see Photograph 17). The straw wattle BMPs had been installed prior to the puncture incident. Water had flowed underneath the straw wattles and jersey barriers and was observed on the adjacent roadway (see Photograph 18).

Photograph 15— View of forklift that had punctured the water container

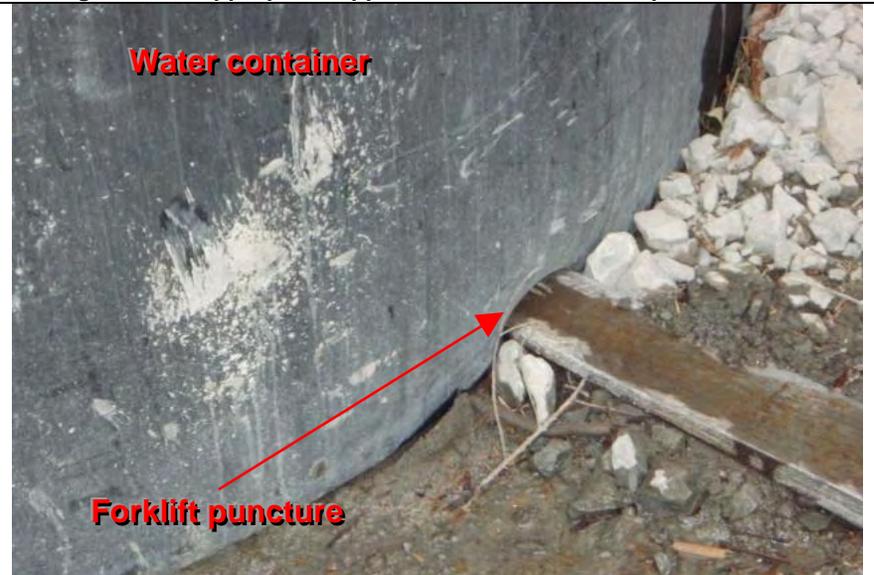
Photograph 16— Close-up view of puncture in water container
