## **Appendix D**

# **Construction Program Site Visit Reports**

**Site Visit No. 1**

**Thomes Creek Bridge Project**  
**Site Visit Date: 10/13/2009**

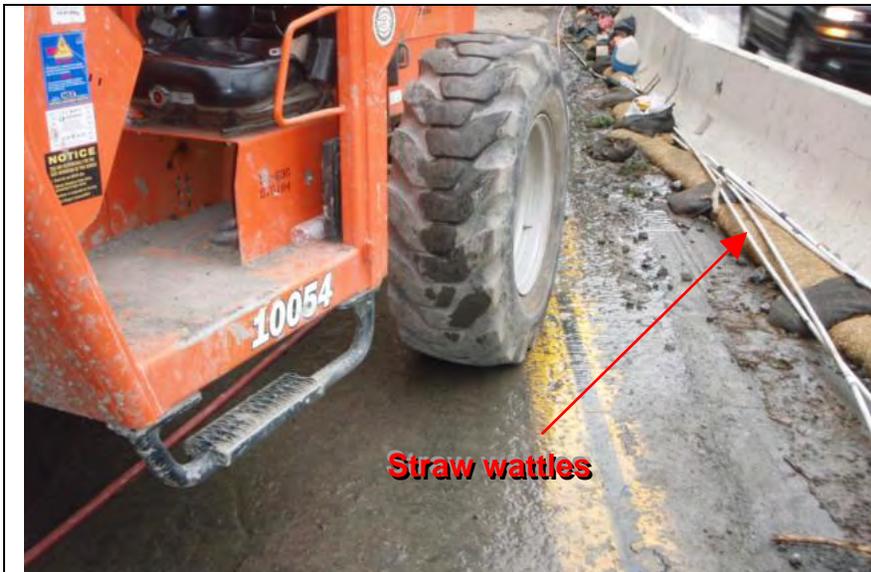
Photograph 17— View down-gradient from water container (Note: Wetness on impervious surface and placement of straw wattles)

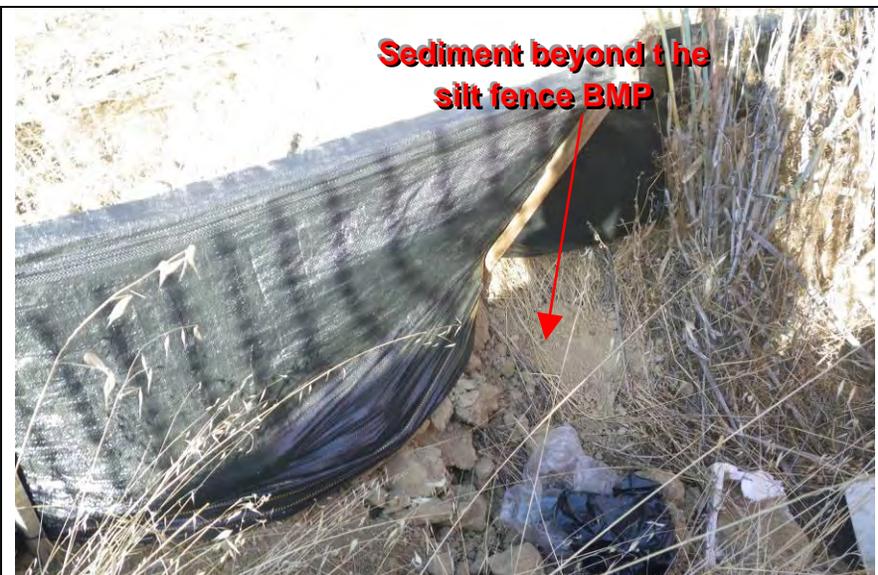
Photograph 5— Failure of first tier of silt fence shown in Photograph 4

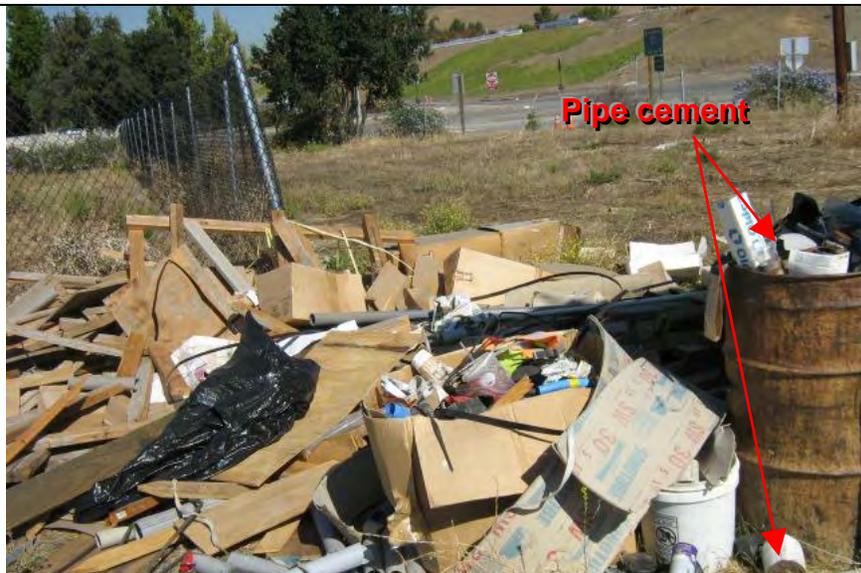
Photograph 1 – Construction wastes and chemicals improperly disposed

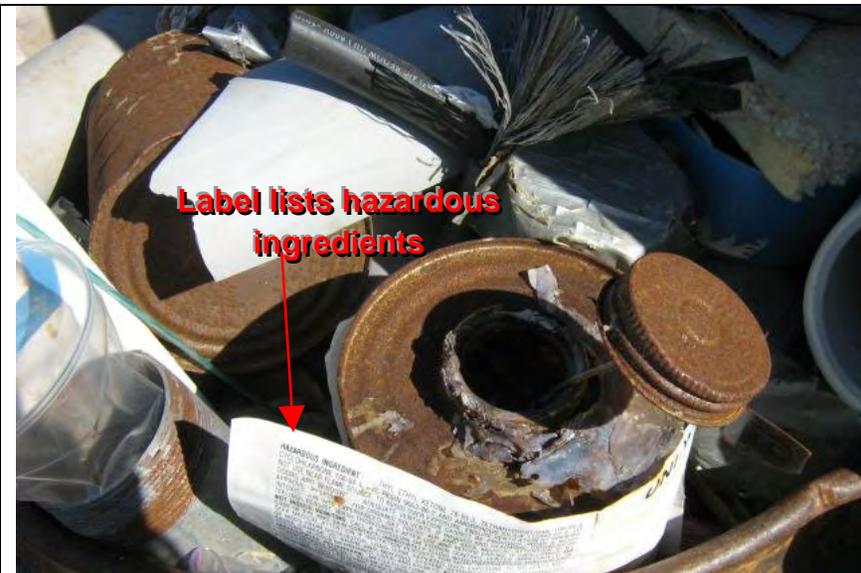
Photograph 2 – Close-up view showing open containers of pipe cement

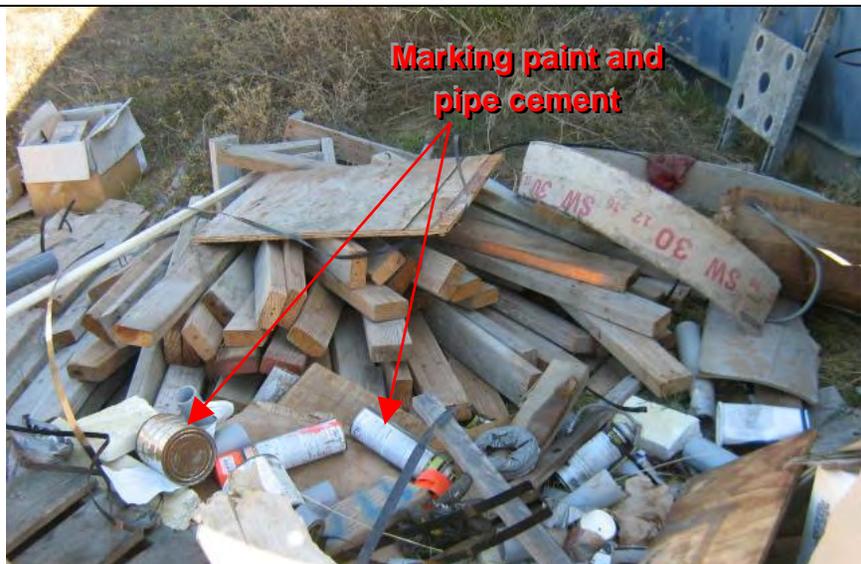
Photograph 3 – Construction wastes and chemicals improperly disposed

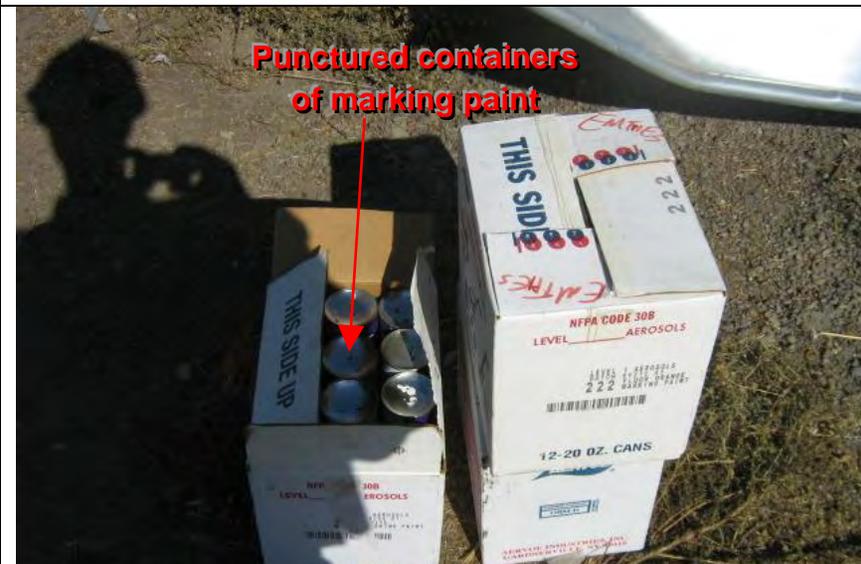
Photograph 4 – Construction wastes and chemicals improperly disposed

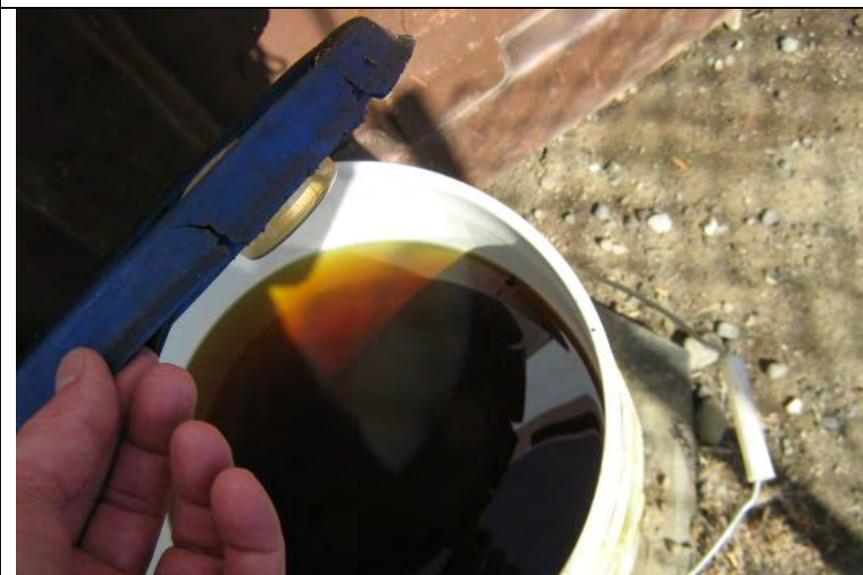
Photograph 8 – Petroleum product without secondary containment

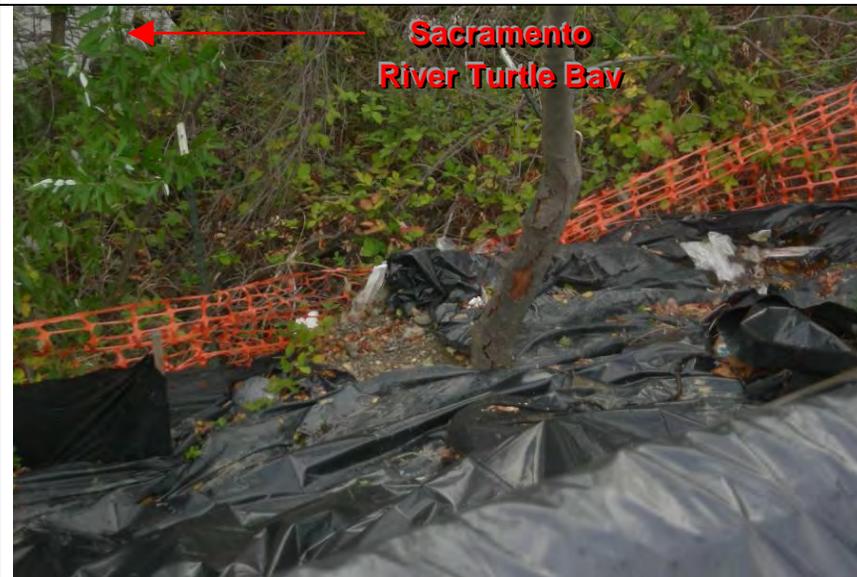
In an area along the northern portion of Interstate 5 and east of the Auditorium Drive Bridge, a perimeter control silt fence located at the toe of the slope had failed (see Photographs 2 and 3). As a result, there was potential for the discharge of sediment offsite into the Sacramento River Turtle Bay Park (see Photograph 3).

Photograph 3 – View of deteriorated slope stabilization BMP and collapsed silt fence in Photograph 2

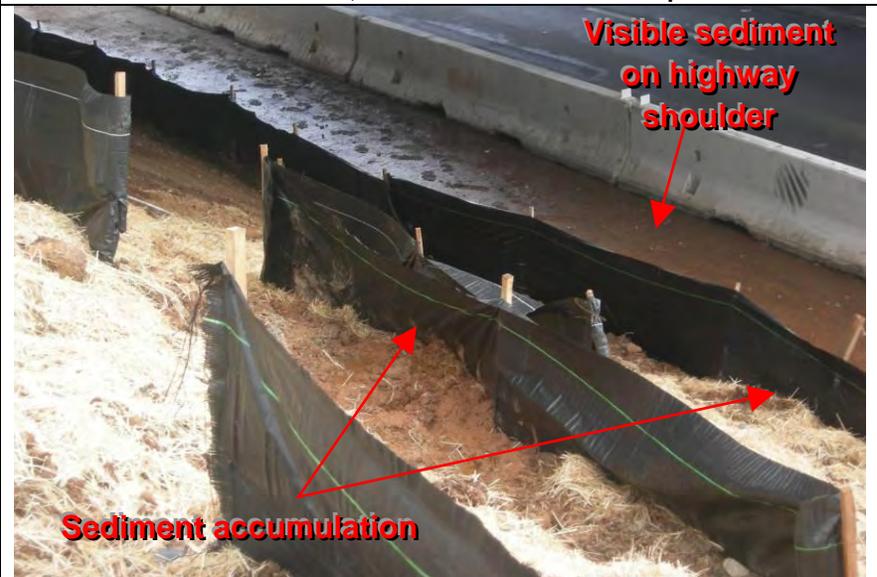
Adequate BMPs were not implemented for disturbed areas associated with the disturbed slope area under the Auditorium Drive Bridge overpass replacement and construction. Specifically, silt fence BMPs had accumulated sediment to approximately half the exposed silt fence height in several areas (see Photograph 4). Although three tiers of silt fence had been installed for BMP redundancy, the tiers were in need of maintenance (see Photograph 4), and sediment was visible beyond the BMPs on the highway shoulder.

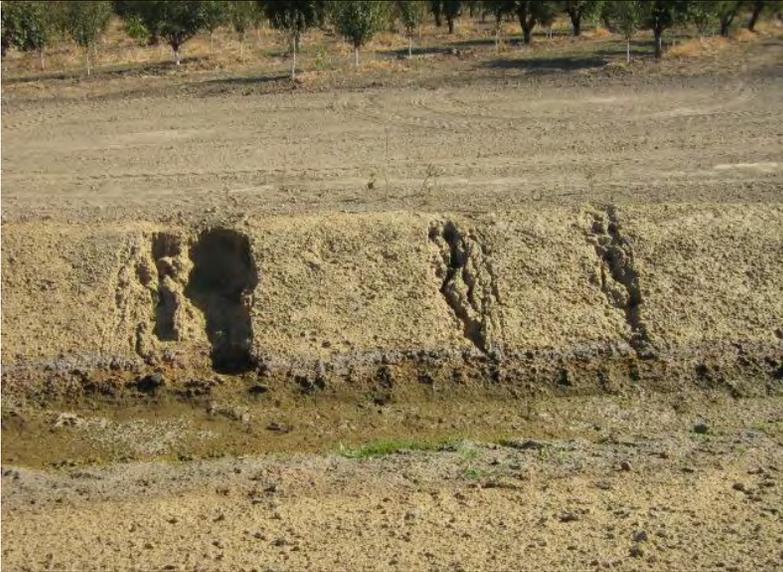
In addition, BMPs were not adequately maintained for the adjacent roadway drainage swale located at approximately Station 300 + 00 on the west side of the roadway. Evidence of erosion (e.g., rill and gully formations) was observed on the drainage swale embankment slopes (see Photographs 17 and 18). As a result, there was a potential for the discharge of sediment to the drainage swale which subsequently drains to the irrigation channel and levees at Sutter Bypass, and ultimately to the Sacramento River.

**Photograph 17 – Evidence of previous erosion (e.g., rill/gulley formation) was observed on the adjacent roadway drainage swale slopes (West side).**

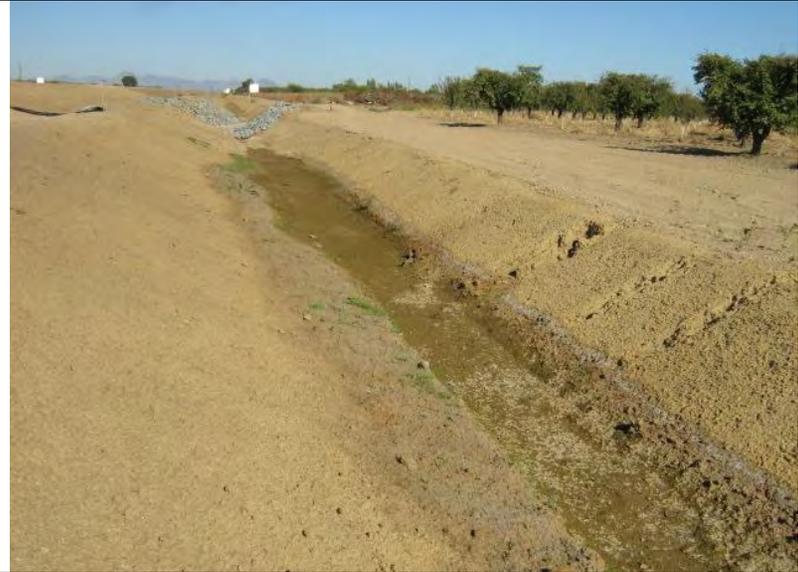
**Photograph 18 – Vantage point view of Photograph 17. Adjacent roadway swale drains to irrigation channel near top of Photograph.**

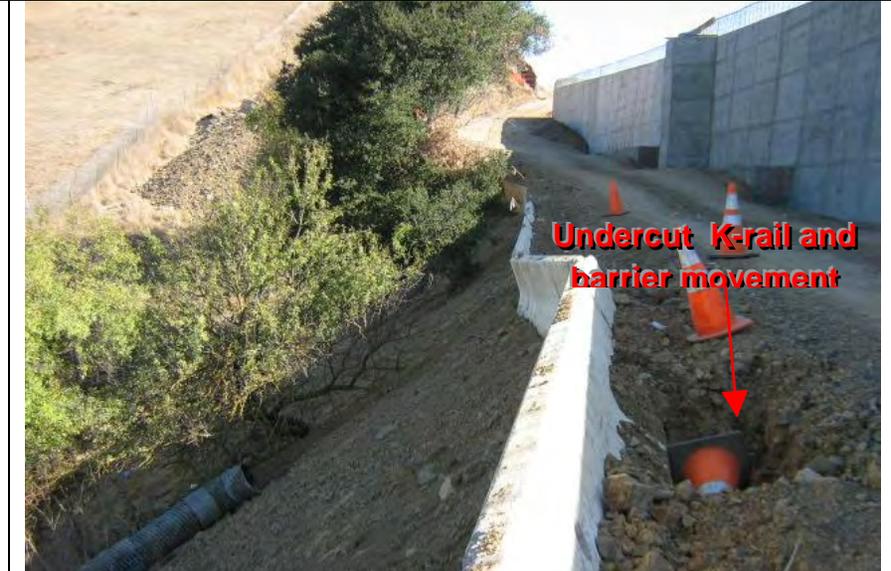
Photograph 2 – Failed fill slope along access road

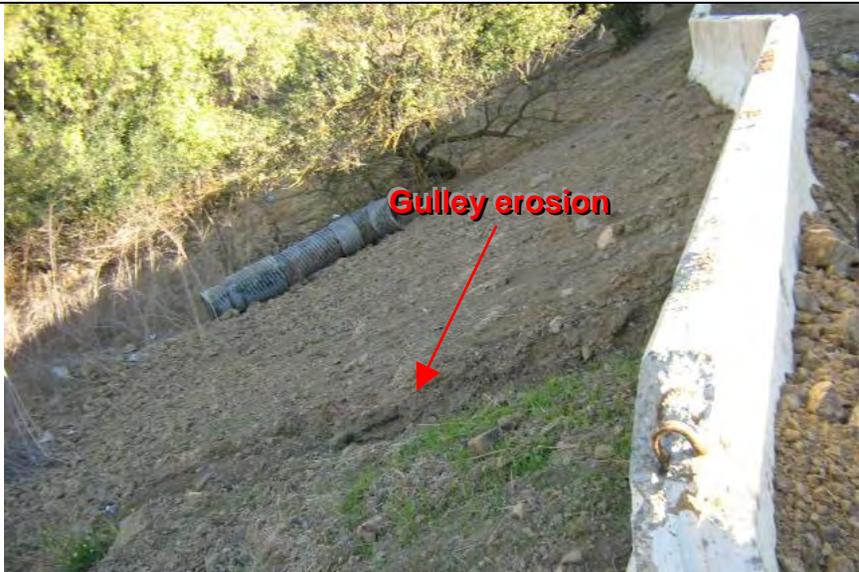
Photograph 3 – Slope erosion below undercut K-rail shown in Photograph 2

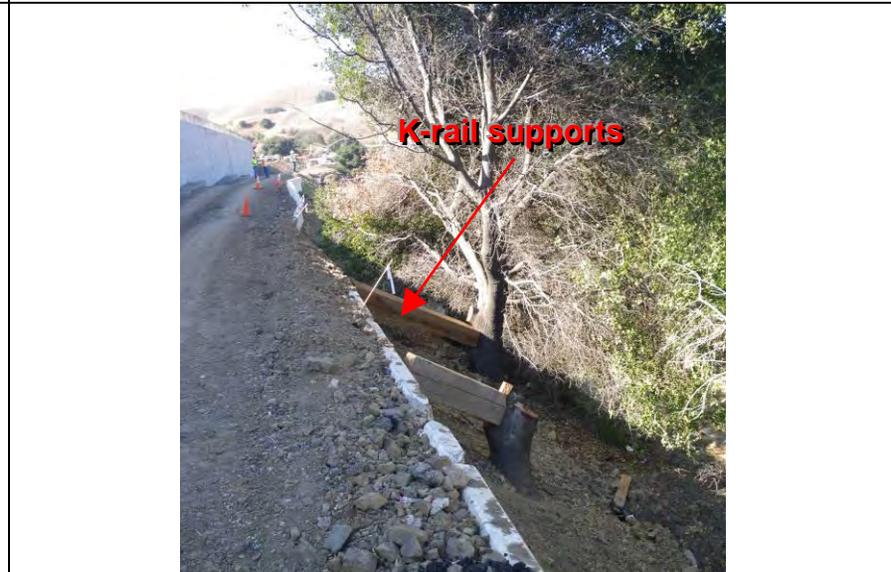
Photograph 4 – Failed area along access road

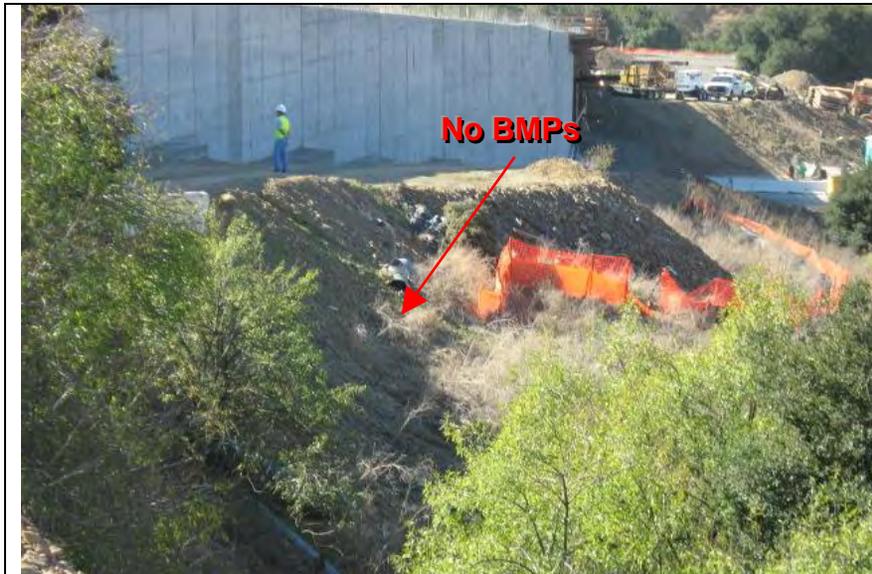
Photograph 5— Fill slope along access road without BMPs

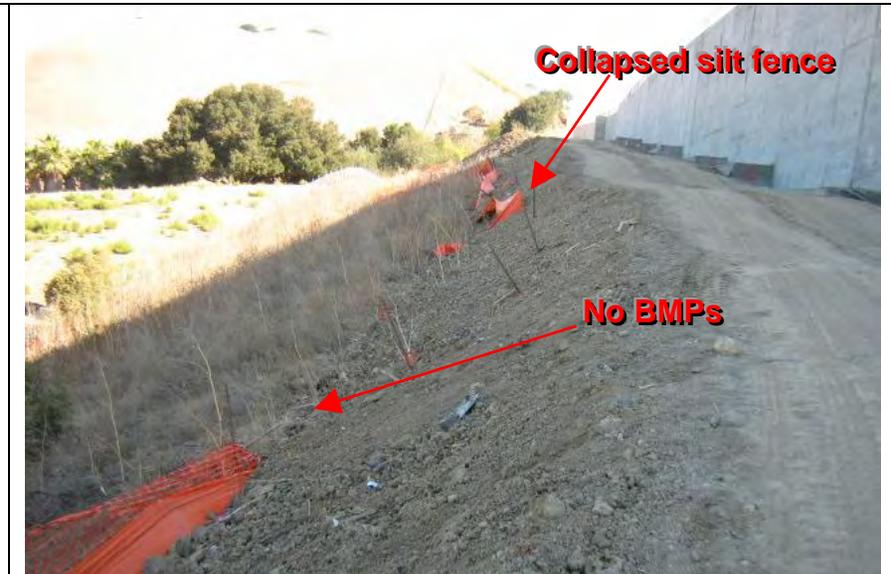
Appendix D of the Caltrans SWMP, Section 4.5.1, Temporary Sediment Control, states “repair undercut silt fences...repair or replace split, torn, slumping or weathered fabric.” The EPA Audit Team observed areas along the access road fill slope where the silt fence BMP had not been adequately inspected and maintained and several lengths of silt fence had collapsed (see Photographs 6 and 7).

Photograph 6 – Fill slope along access road without BMPs

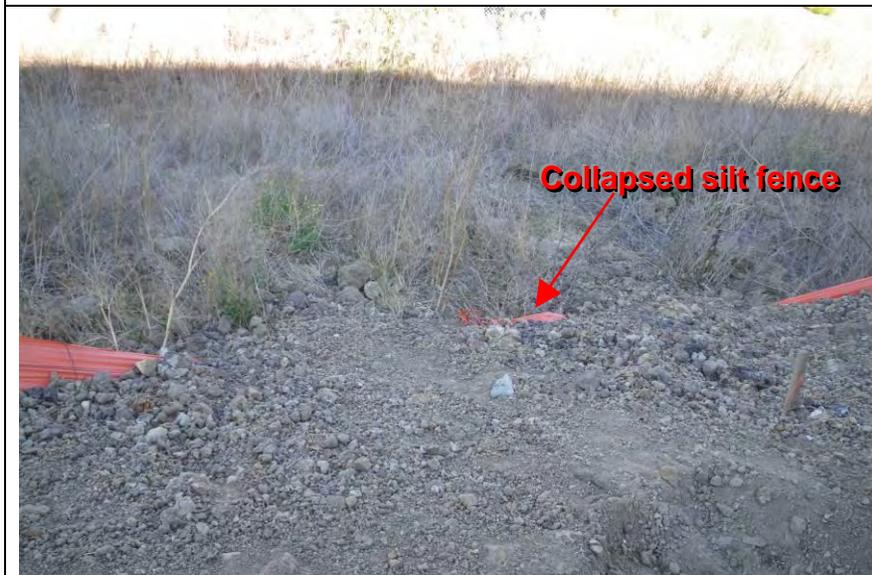
Photograph 7— Collapsed silt fence due to slide

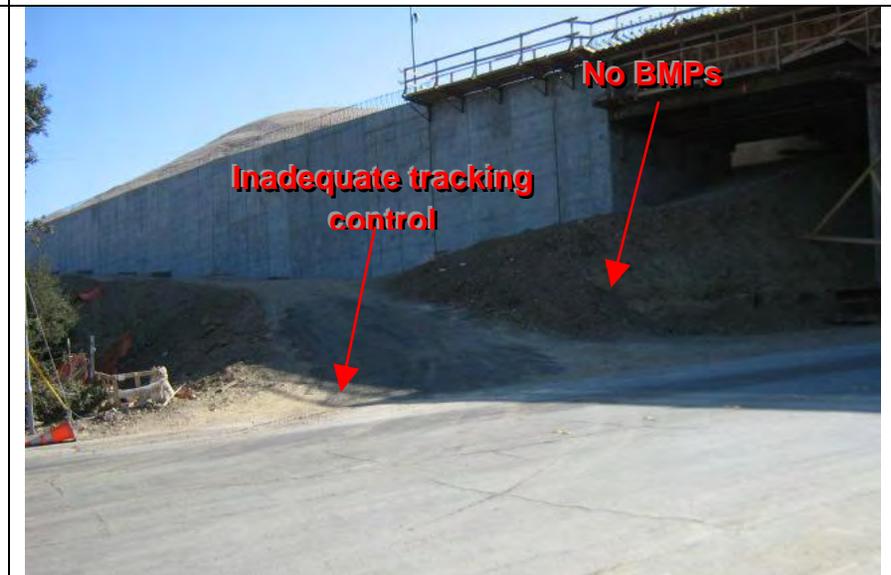
Photograph 8 – View of fill slope along access road without BMPs and vehicle tracking control pad

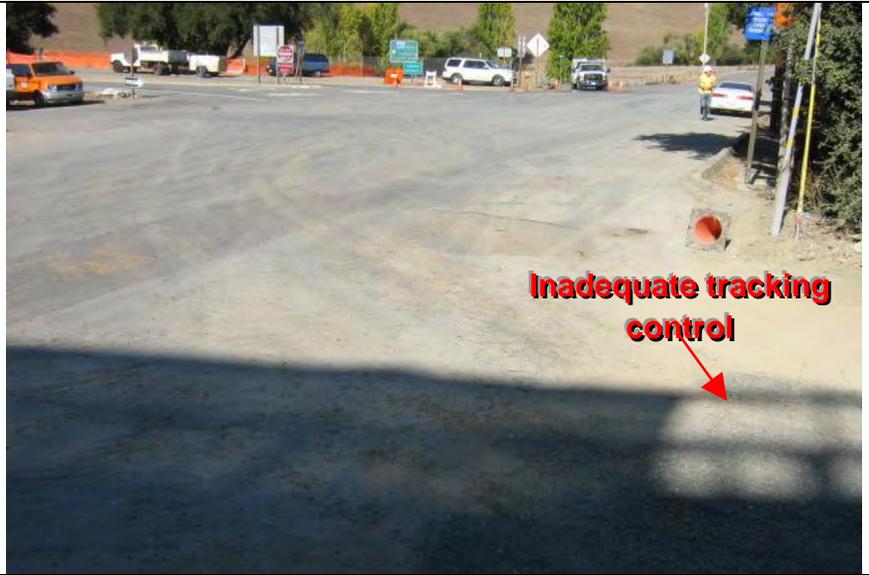
Photograph 9— Sediment conveyed onto roadway
