Appendix E

Maintenance Program Site Visit Reports

Site Visit No. 16

**Willow Creek Highway Maintenance Facility
Site Visit Date: 10/22/2009**

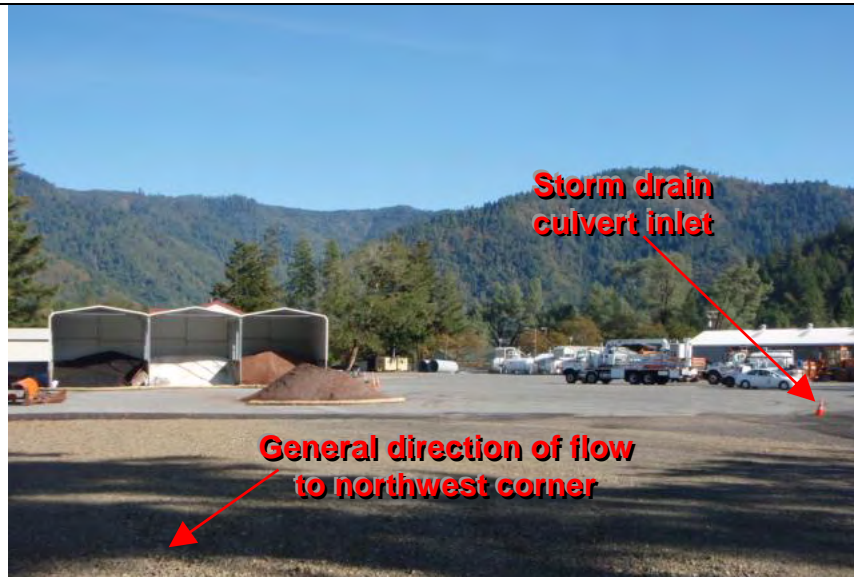
Photograph 1 – View from northwest corner of the facility

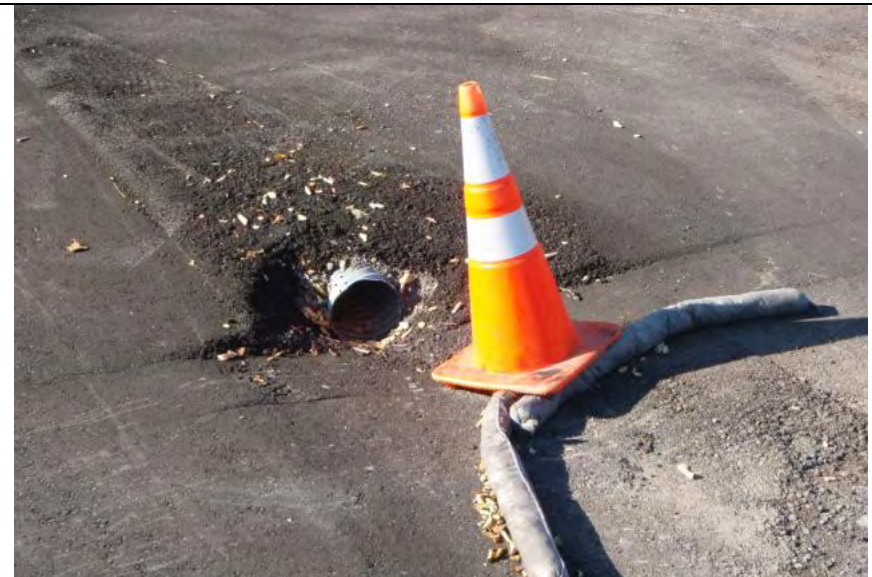
Photograph 2 – Culvert inlet that flows to northwest corner of facility

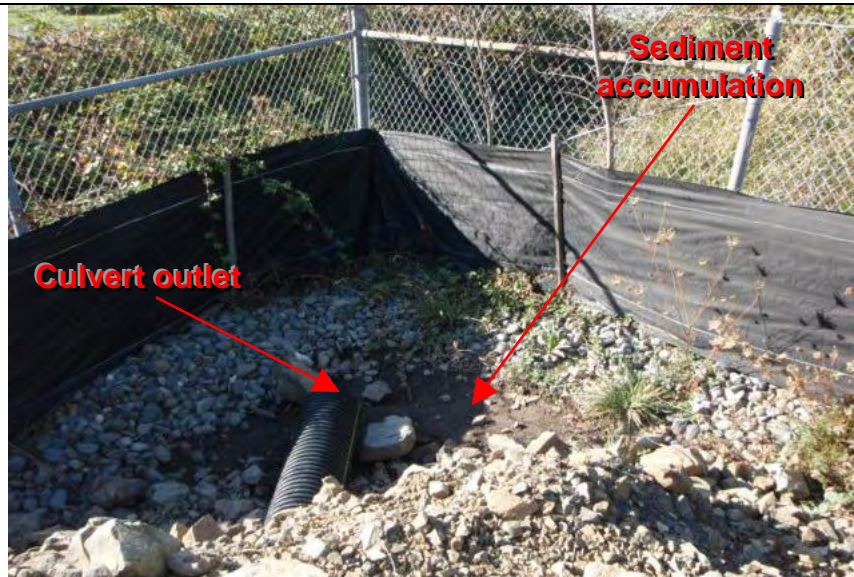
Provision I.3.b of the Permit requires Caltrans to provide appropriate site-specific BMPs for all maintenance facilities. As explained by the Highway Maintenance Supervisor, most of the storm water runoff at the facility flows to the northwest corner of the facility either by overland flow or through a culvert inlet and pipe (see [Photographs 1, 2 and 3](#)). He added that storm water runoff does not generally discharge off-site from this location to the adjacent PG&E facility but rather ponds and remains as standing water until it infiltrates into the ground or evaporates. Nonetheless, evidence of sediment discharged to the northwest corner of the facility was observed (see [Photograph 3](#)). Furthermore, a silt fence BMP had been installed in the concentrated flow pathway of the culvert outlet, was not entrenched into the ground, and had been installed backwards (see [Photographs 3 and 4](#)).

Photograph 3 – Culvert outlet to northwest corner of facility (Note: Silt fence BMP installed backwards)

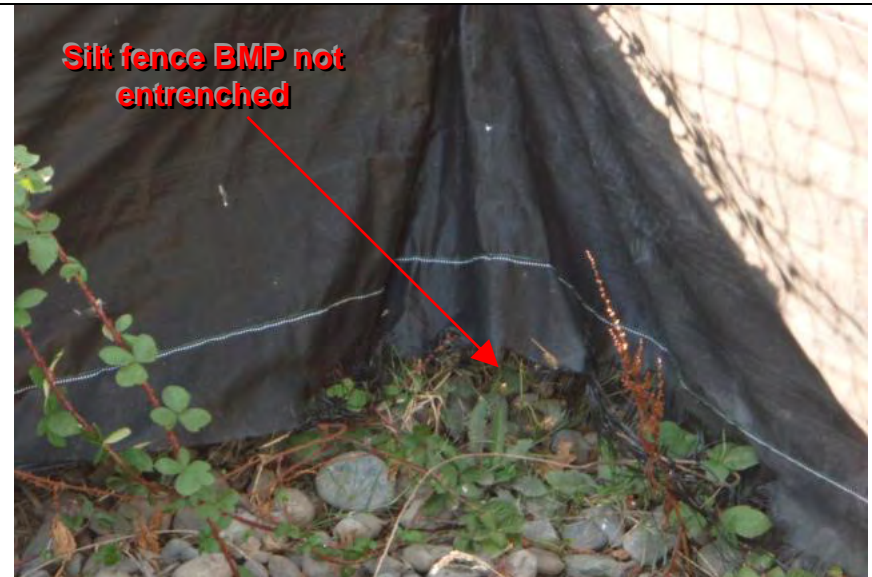
Photograph 4 – Closer view of silt fence BMP shown in Photograph 3

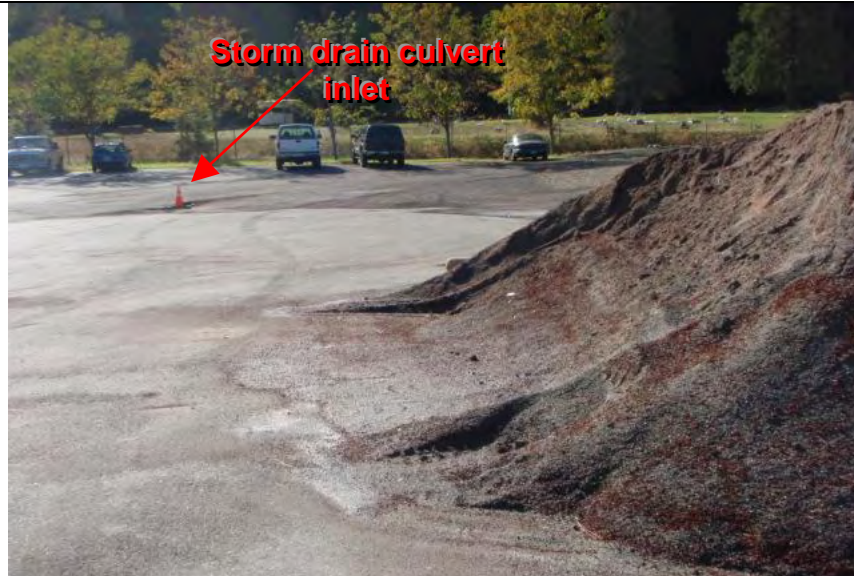
In addition, a stockpile of roadway abrasives was stored up-gradient of the storm drain culvert inlet in an uncovered area, and on the impervious ground surface (see [Photograph 5](#)). Straw wattle BMPs had been placed around the stockpile on the downslope side; however, the straw wattles were improperly installed on the impervious surface of the facility, and therefore were not properly entrenched in the ground to retain the stockpiled materials (see [Photograph 6](#)). Furthermore, what appeared to be a salt residue was observed around the stockpile which indicated that the stockpile itself contained salt, or the straw wattles had previously been used for the containment of a salt-bearing product (see [Photograph 7](#)). As a result, there was a potential for the discharge of stockpiled materials to the storm drain culvert inlet and subsequently off-site. Although placed under cover, a second stockpile containing salt also had a straw wattle BMP improperly installed on the impervious ground surface (see [Photographs 8 and 9](#)). Straw wattle BMPs are not intended to control salt products or other pollutants that will dissolve upon contact with water. As a result, adequate BMPs were not implemented for stockpile management.

Photograph 5— Stockpile of sand and ash mixture up-gradient of inlet

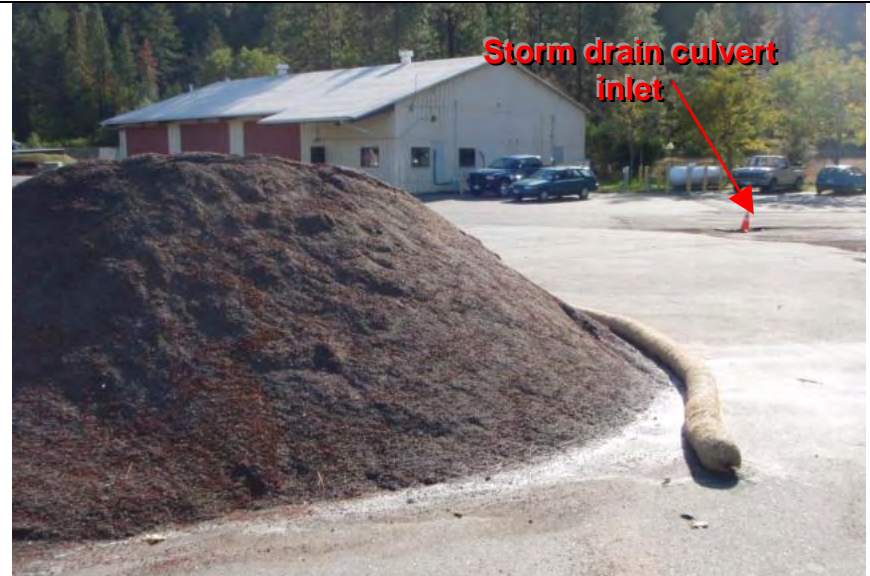
Photograph 6 – Inappropriate application of straw wattle BMP

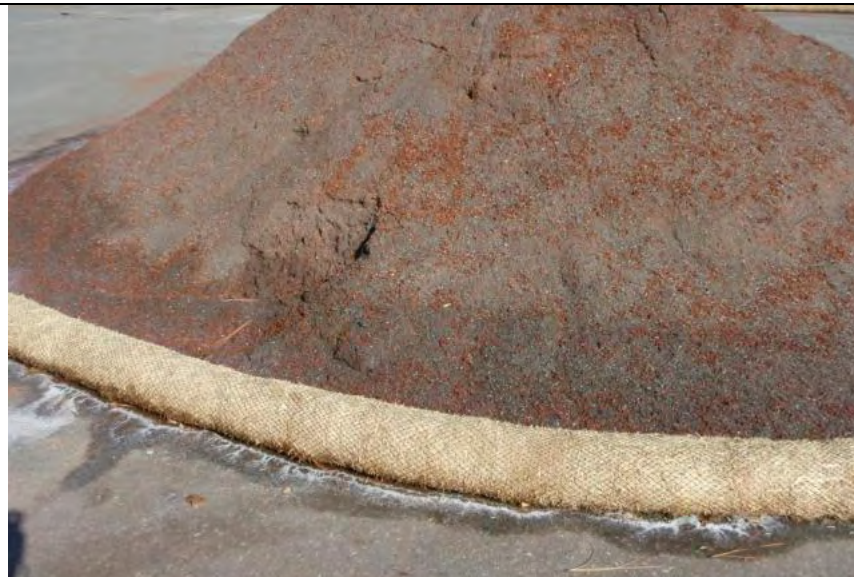
Photograph 7— Closer view of straw wattle BMP around stockpile
(Note: Apparent salt residue)

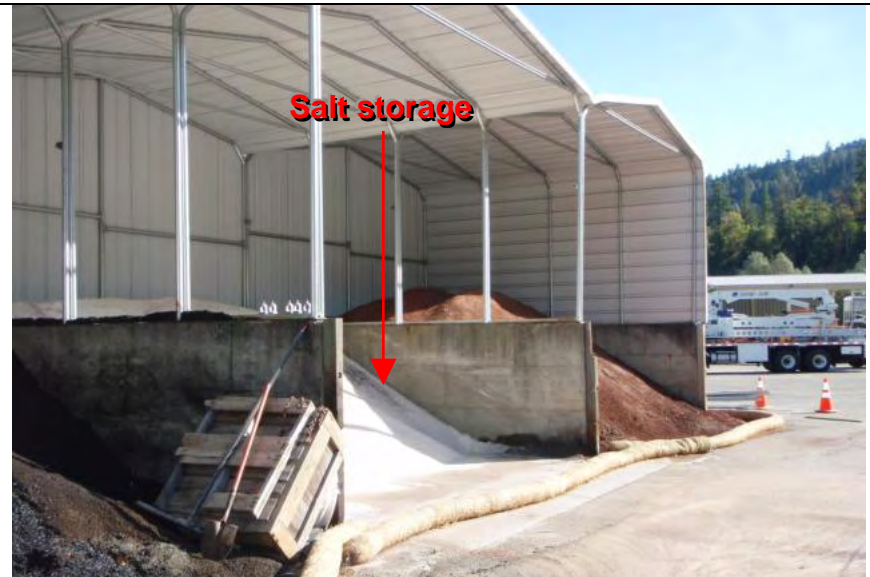
Photograph 8 – Inappropriate application of straw wattle BMP

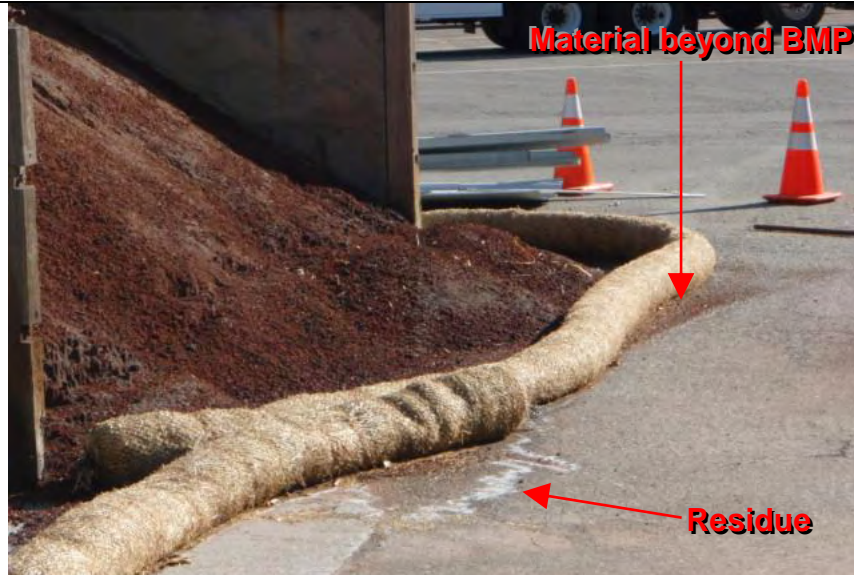
Photograph 9— Closer view of straw wattles implemented at edge of covered storage area

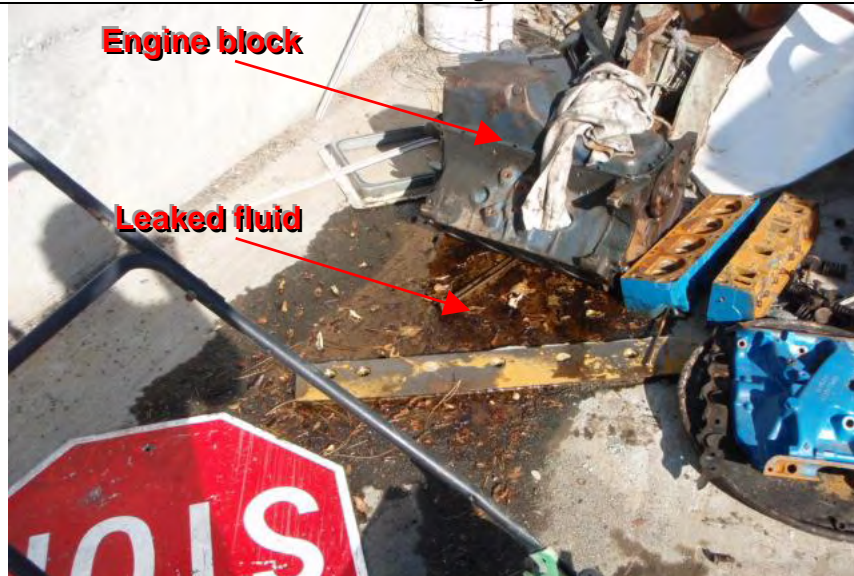
Photograph 11— Engine block stored in metal material storage area
(Note: Fluid on impervious ground surface)

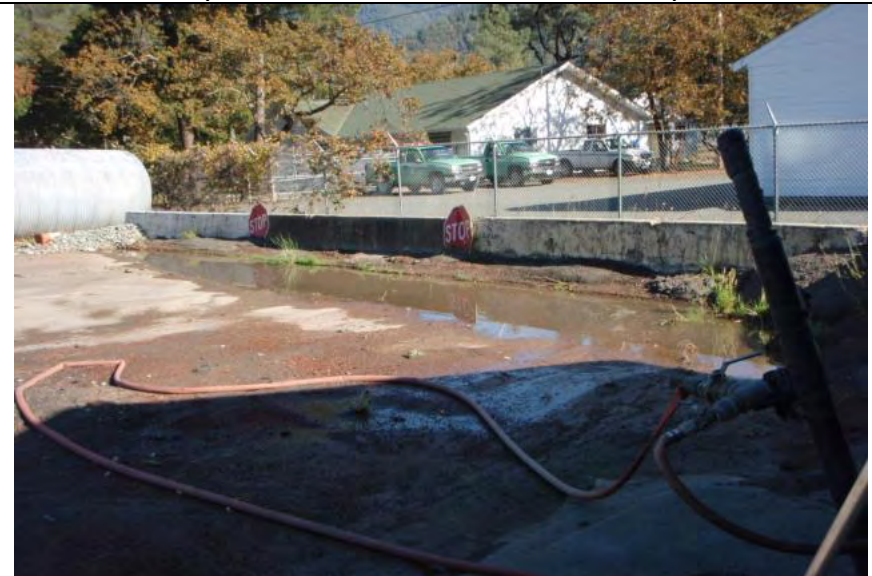
Although the facility is equipped with a designated and covered vehicle and equipment wash rack, a bermed area toward the southern end of the facility is used for truck bed washing (see [Photograph 12](#)). An area of wet soil was observed on the backside of the bermed area adjacent to a drainage ditch that flows off-site to the south (see [Photographs 13 and 14](#)). As a result, there was a potential for the discharge of pollutants to the drainage ditch, a component of the Caltrans MS4, and subsequently off-site. Appendix D of the Caltrans SWMP, Section 2.15.1, Vehicle and Equipment Cleaning, states “when possible, truck beds should be cleaned using dry cleanup technique (sweep up or shovel out).”

Photograph 12 – Bermed area used for truck bed washing

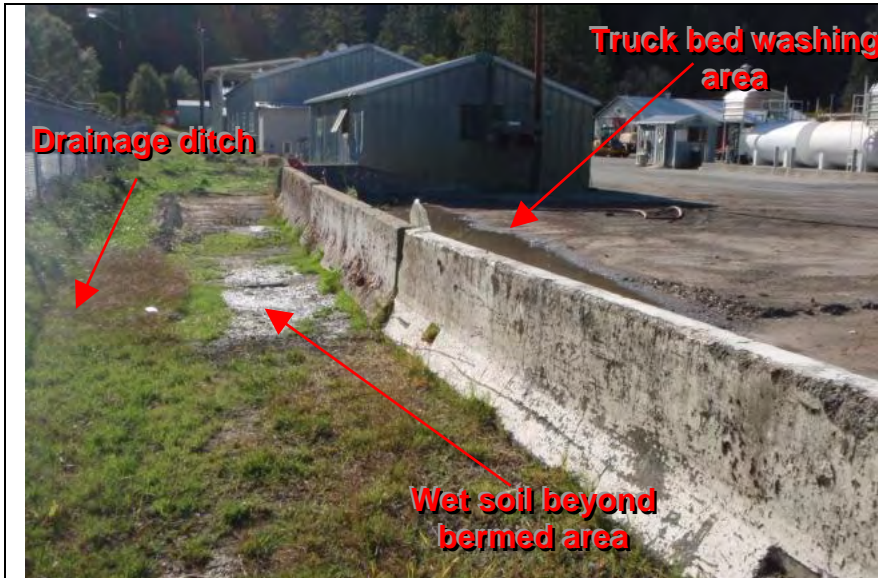
Photograph 13 – Another view of area used for truck bed washing

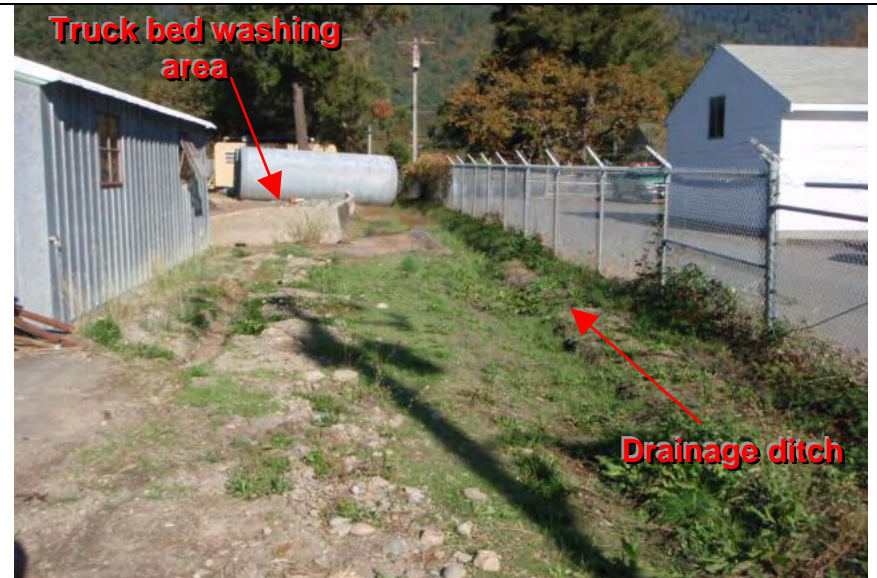
Photograph 14 – View of drainage ditch along southern edge of facility

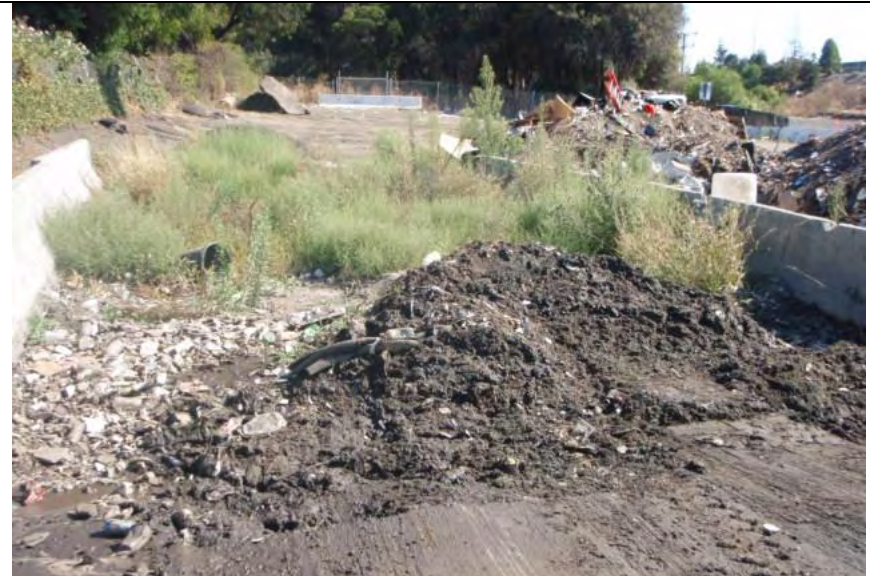
Photograph 2 – Close-up view of excavated vector waste dump site at the facility

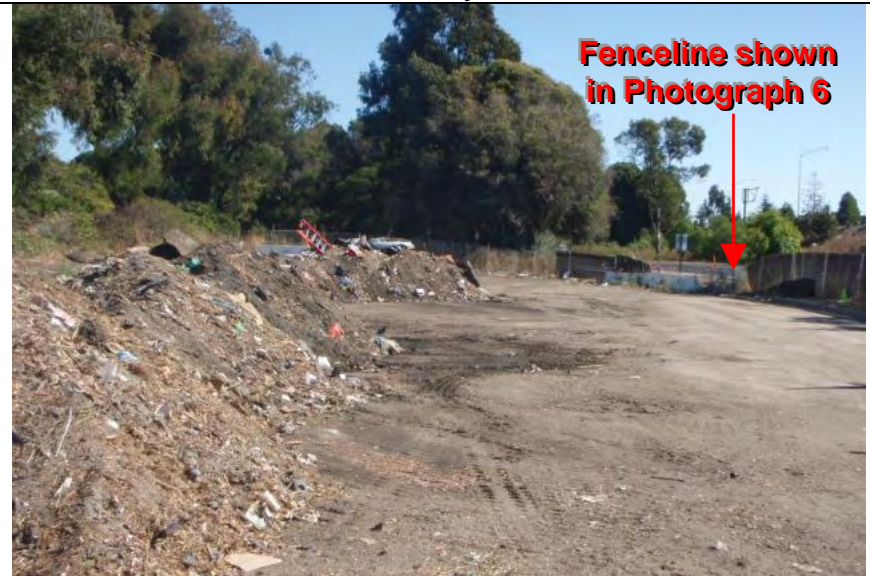
Photograph 4 – View of waste stockpiles and proximity to fenceline

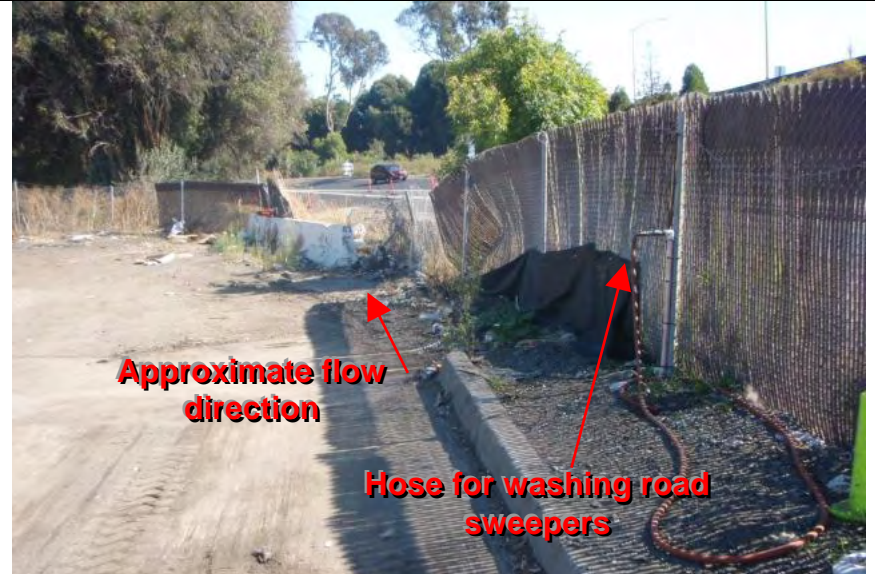
Photograph 6 – Location of road sweeper pre-washing area

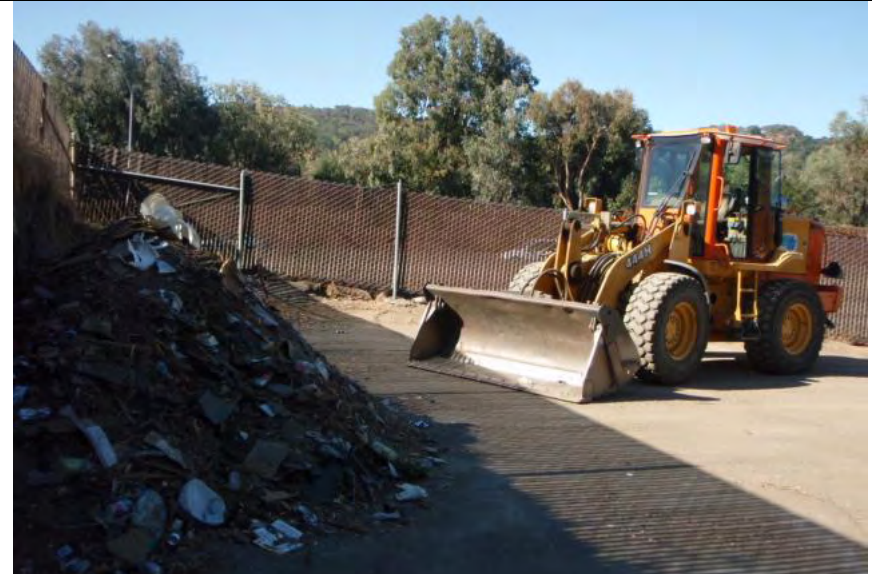
Photograph 2 – Waste from road sweeping and other road cleaning activities

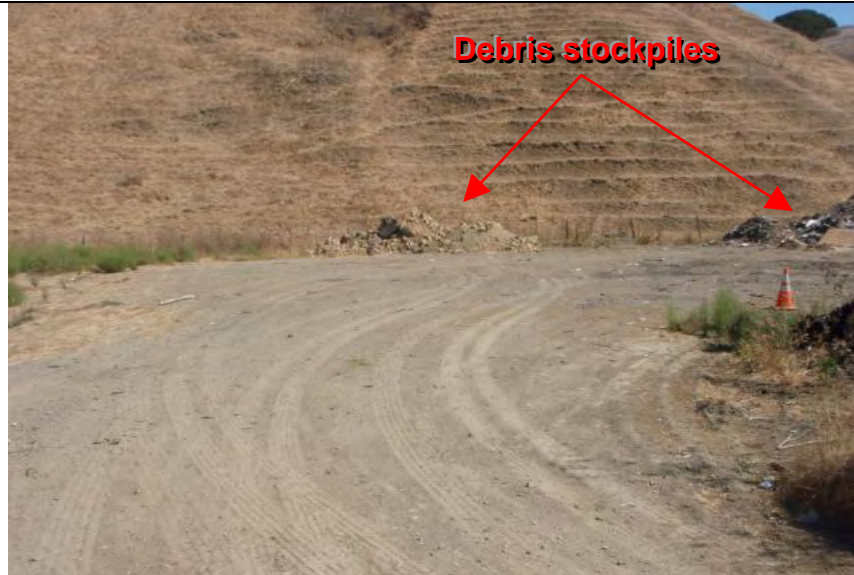
Photograph 1 – Entrance to temporary storage site

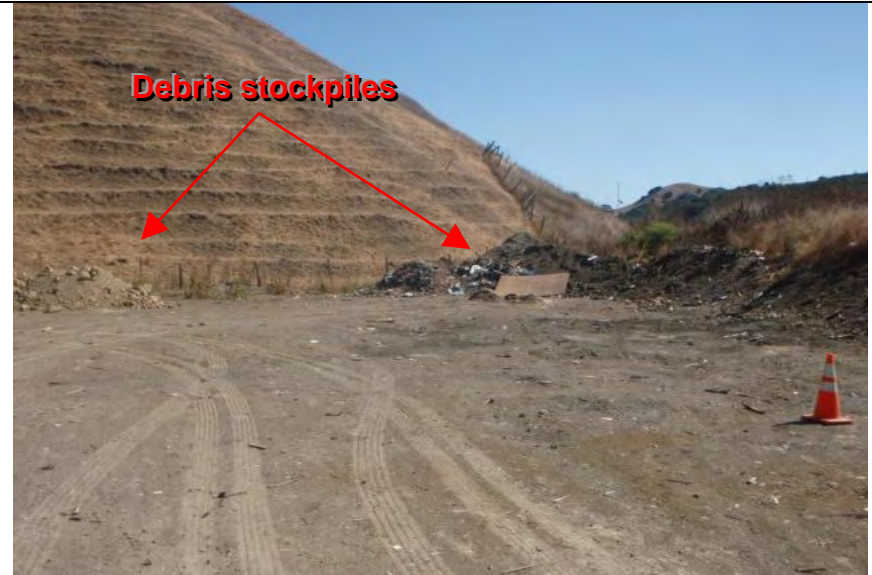
Photograph 2 –Lack of BMPs for containment or coverage of stockpiles

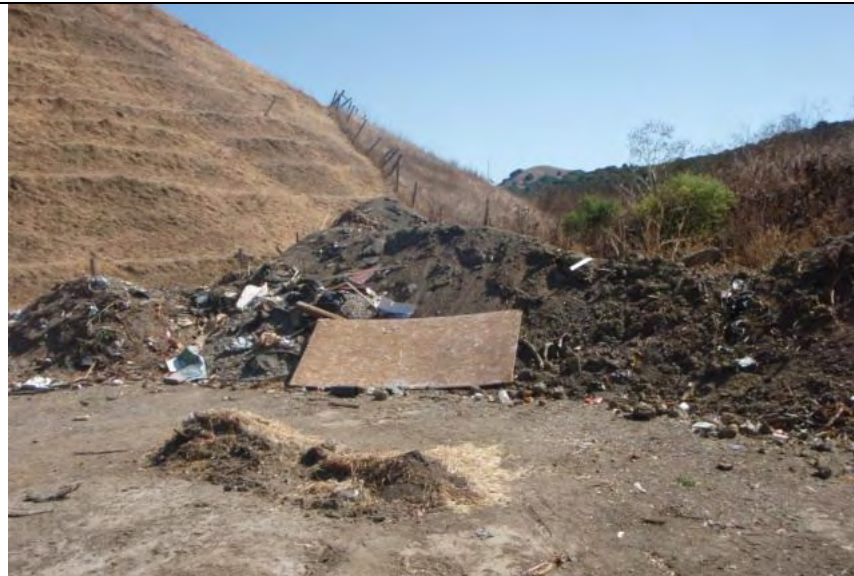
Photograph 3 – Close-up view of debris stockpile from road sweeping and other road cleaning activity

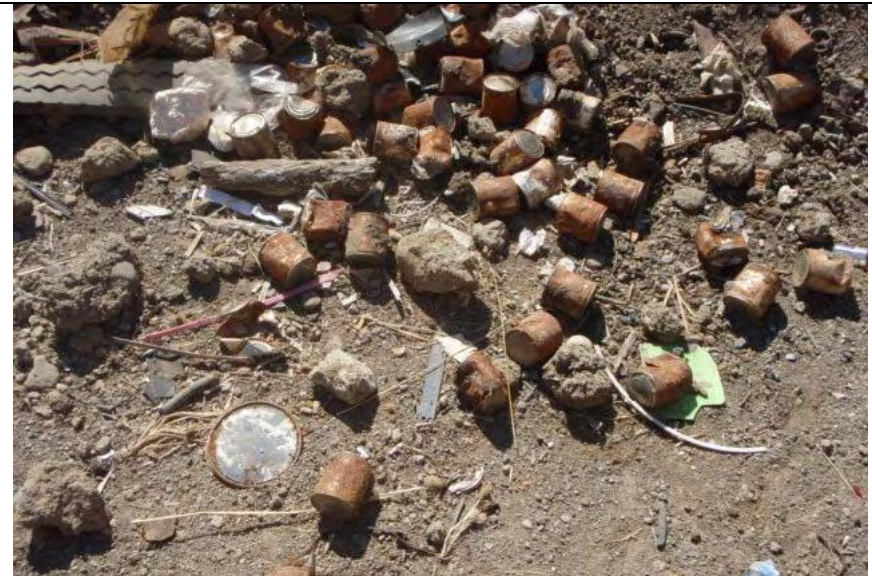
Photograph 4 – Close-up view of debris in stockpile pictured in Photograph 3. The metal cans appeared to contain a liquid milk substance.

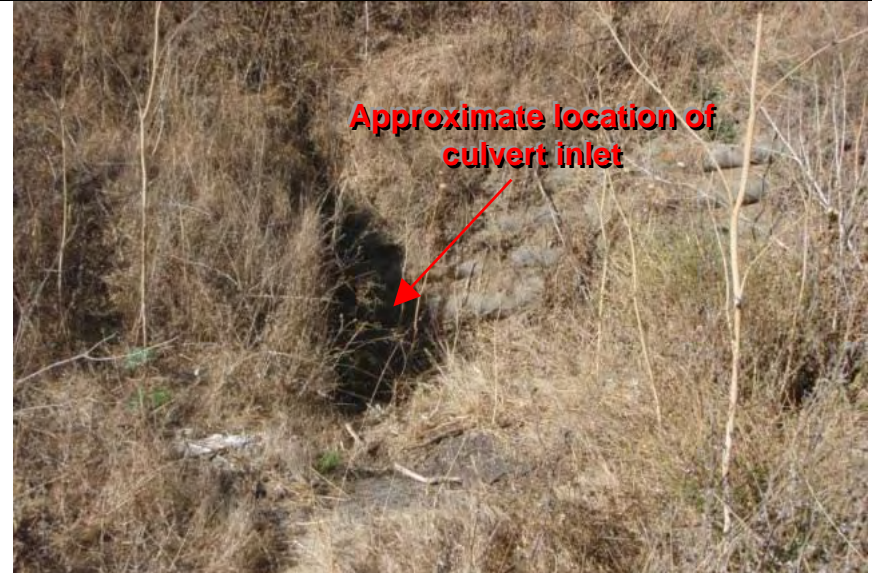
Photograph 6 – Location of culvert inlet in the northwestern portion of the waste storage site

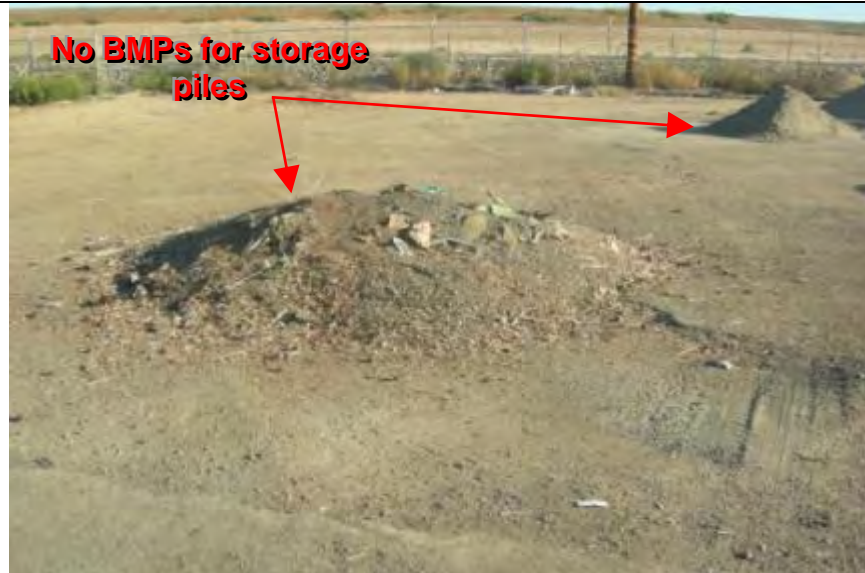
Photograph 1 – View of sweeper waste storage pile at the Marysville Maintenance Station

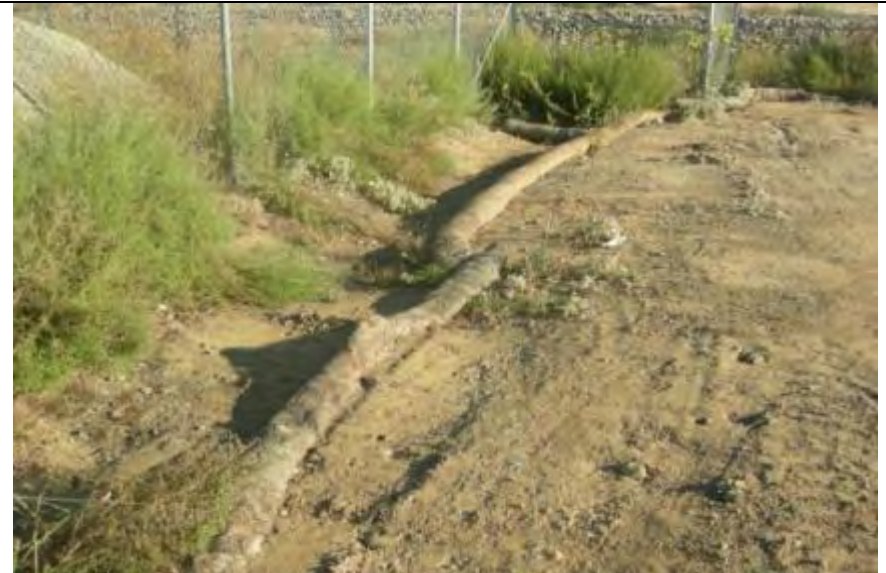
Photograph 2 – View of straw wattle BMPs, not adequately installed

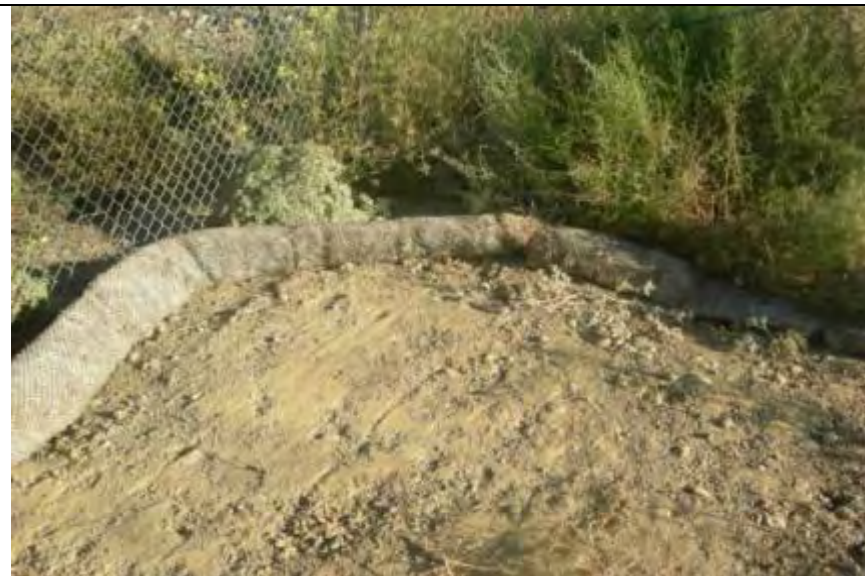
Photograph 3 – Close up view of straw wattle installation shown in Photograph 2

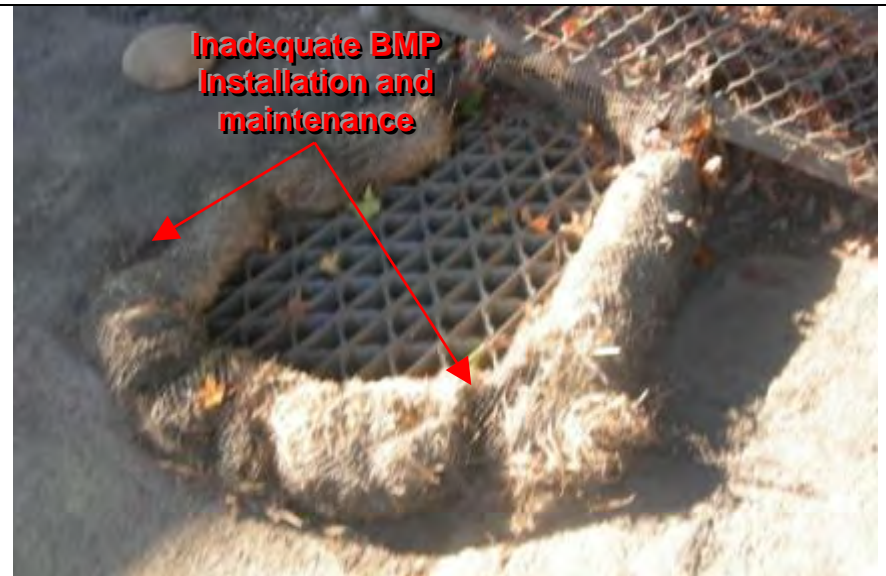
Provision I.3.b of the Permit requires Caltrans to provide appropriate site-specific BMPs for all maintenance facilities. Coverage and containment BMPs had not been implemented for a sweeper waste stockpile in the northwest portion of the facility (see Photograph 1). Although straw wattles had been installed along the perimeter of the maintenance yard, the straw wattles were not properly installed or maintained. Specifically, the straw wattles utilized along the northwestern perimeter of site, adjacent to the FEMA Ditch Project, were not properly entrenched or anchored (see Photographs 2 and 3). Additionally, straw wattles utilized at the storm drain inlets at the southern perimeter of site were installed on an impervious surface and, therefore, were not properly entrenched or anchored to create an adequate seal (see Photographs 4 and 5).

Photograph 4 – Storm drain inlet on the east side of the Marysville Maintenance Station office building

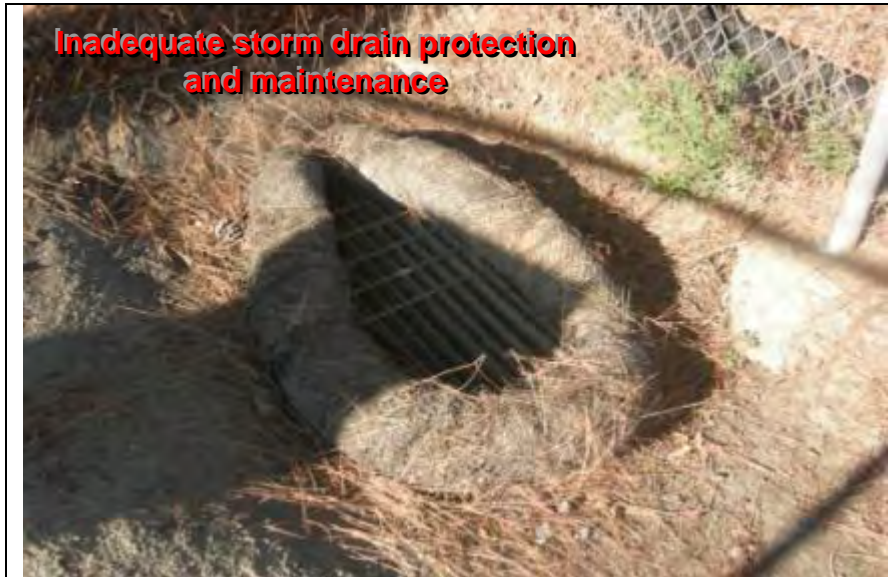
**Inadequate storm drain protection
and maintenance**

**Photograph 5— Storm drain inlet to the west of the Marysville Maintenance
Station office building**

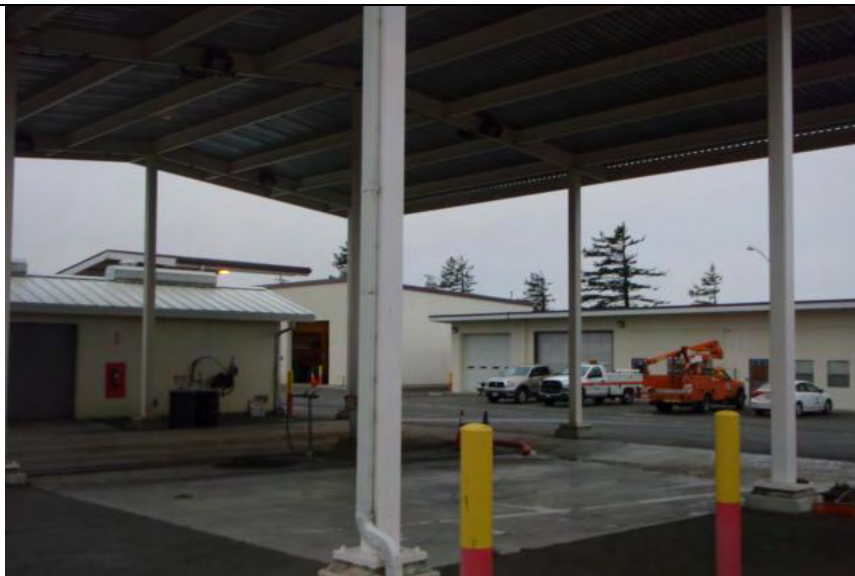
Photograph 1 – Covered wash rack

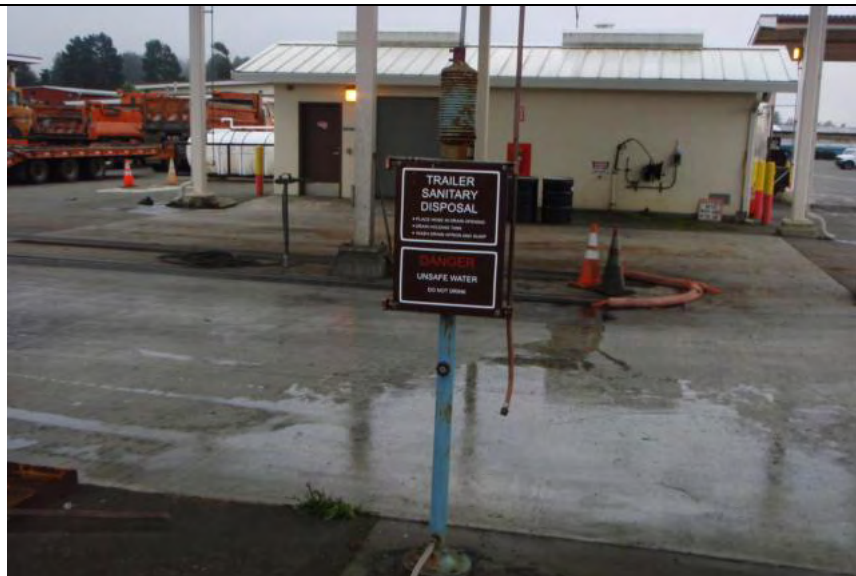
Photograph 2 – Another view of covered wash rack

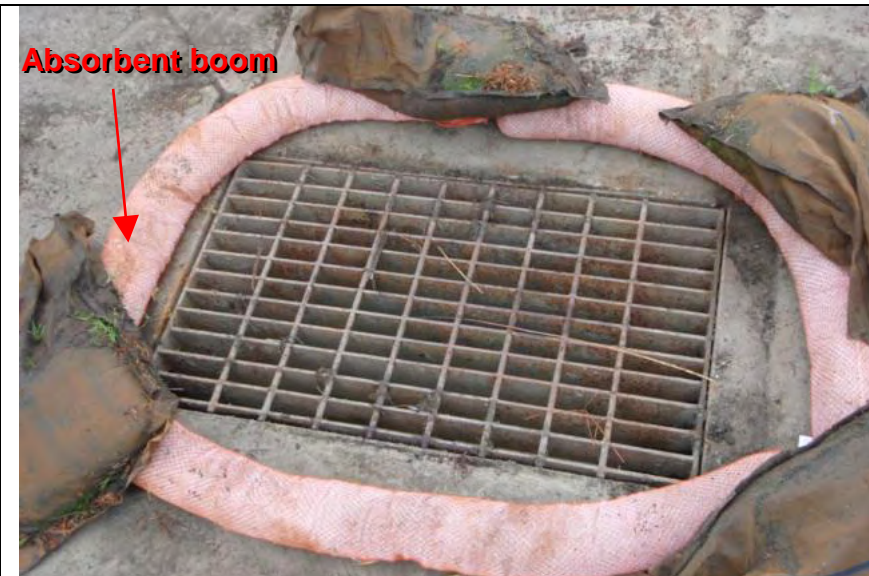
Filter fabric had been installed in one of the adjacent storm drain inlets and absorbent booms had been placed around the other inlet (see [Photographs 4 and 5](#)). However, the BMPs implemented for inlet protection were not properly maintained and significant pollutant accumulation was observed around the inlets. Furthermore, sand bags containing debris had been used for weights on top of the absorbent booms placed around one of the storm drain inlets, and several of the bags were no longer securely closed (see [Photograph 6](#)).

Photograph 5— Closer view of storm drain inlet shown in Photograph 3

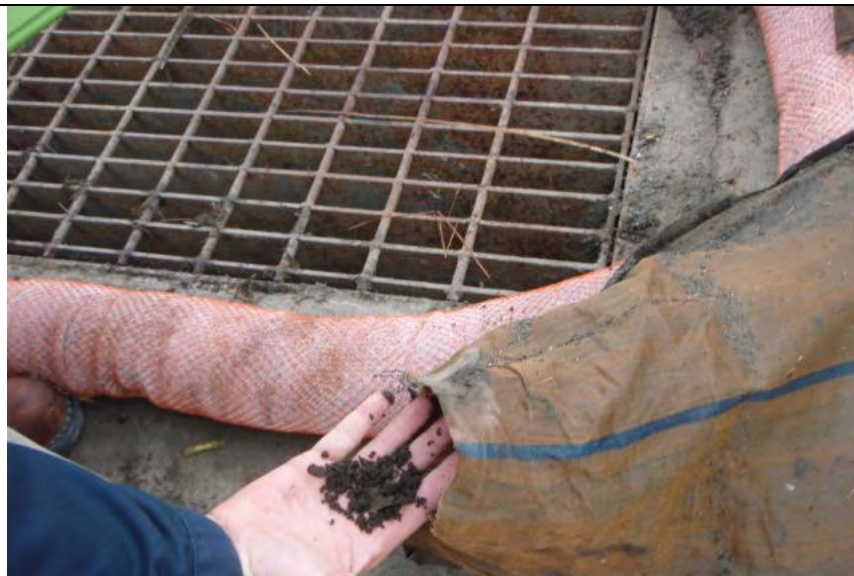
Photograph 6 – View of debris contained in bags used for securing absorbent booms

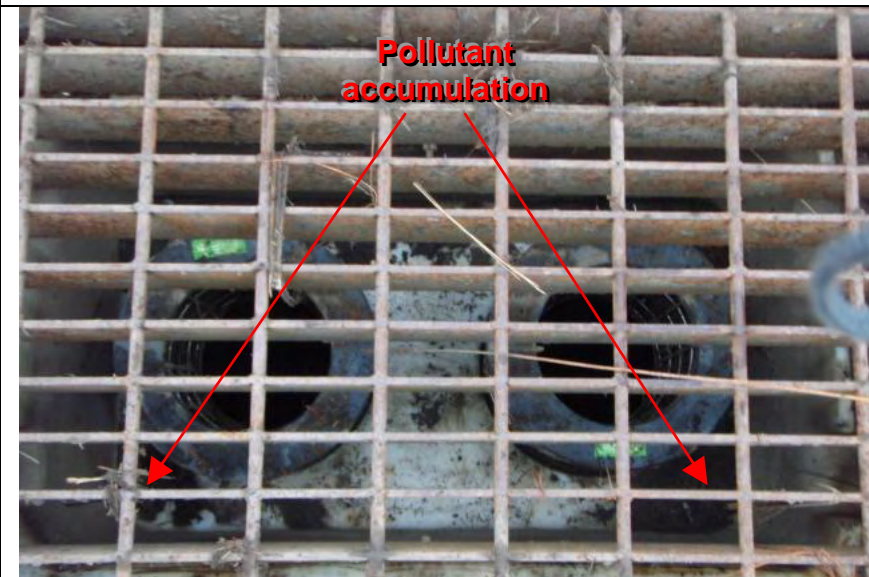
Although storm drain inlets at the facility were equipped with filters, evidence of pollutant accumulation was observed within one of the storm drain inlets near the road sweeper washing area (see [Photograph 7](#)), which indicated that an unknown quantity of sweeper wash water had been discharged to the MS4. The discharge location of the storm drain inlets associated with the road sweeper washing area was unclear. Prohibition A.7 of the Permit states “wastes or wastewater from road sweeping vehicles or from other maintenance or construction activities shall not be discharged to any surface waters or to any storm drain leading to surface water bodies.”

Photograph 7— View into storm drain inlet shown in Photographs 3, 5 & 6

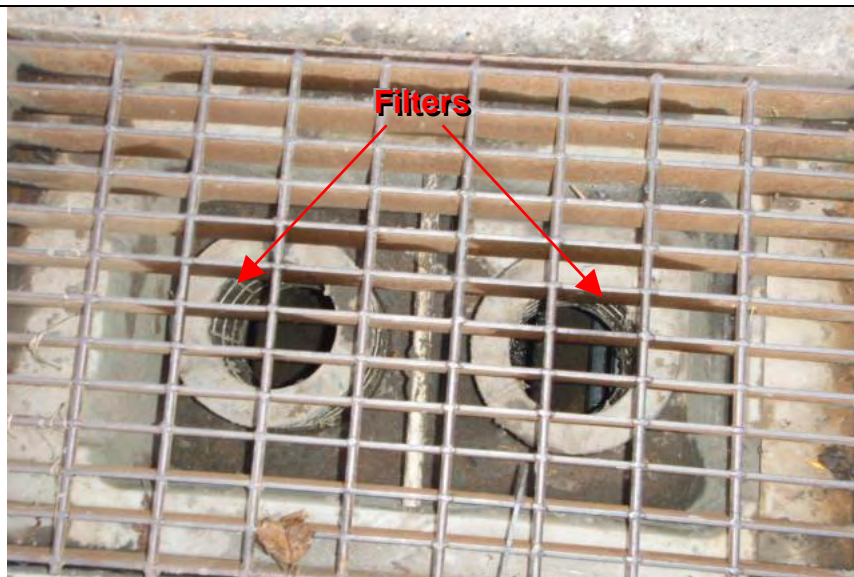
Additional storm drain inlet filters at the facility (see [Photograph 8](#)) did not appear to have been recently cleaned or maintained and debris accumulation was observed in the filter units and inlets (see [Photograph 9](#)). It was not clear when maintenance had been last performed on the filters.

Photograph 8 – View into another storm drain inlet at the facility

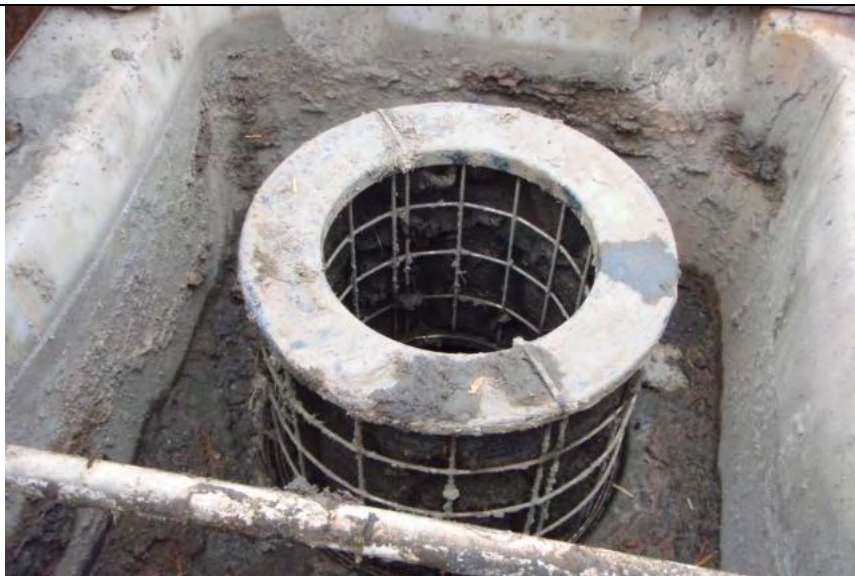
Photograph 9— Closer view of filter shown in Photograph 8.
(Note: Pollutant accumulation within filter and inlet)

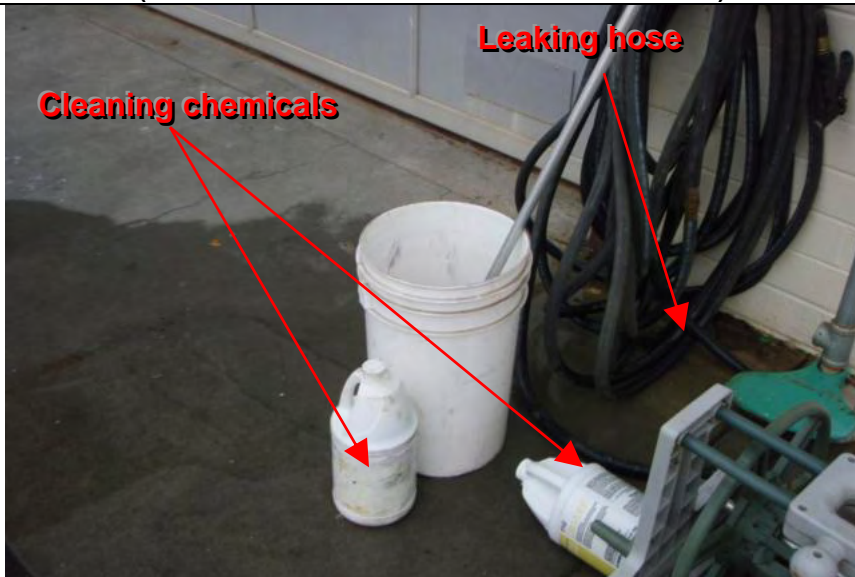
Two containers of a cleaning agent were improperly stored adjacent to a concrete drainage swale and leaking hose along the eastern side of the facility (see Photograph 11). The containers were not stored within secondary containment, and as a result, there was a potential for the contribution of wash water and pollutants to storm water runoff, and subsequently to a down-gradient storm drain inlet (see Photograph 12).

Photograph 11— Cleaning/washing chemicals stored on impervious ground surface adjacent to leaking hose

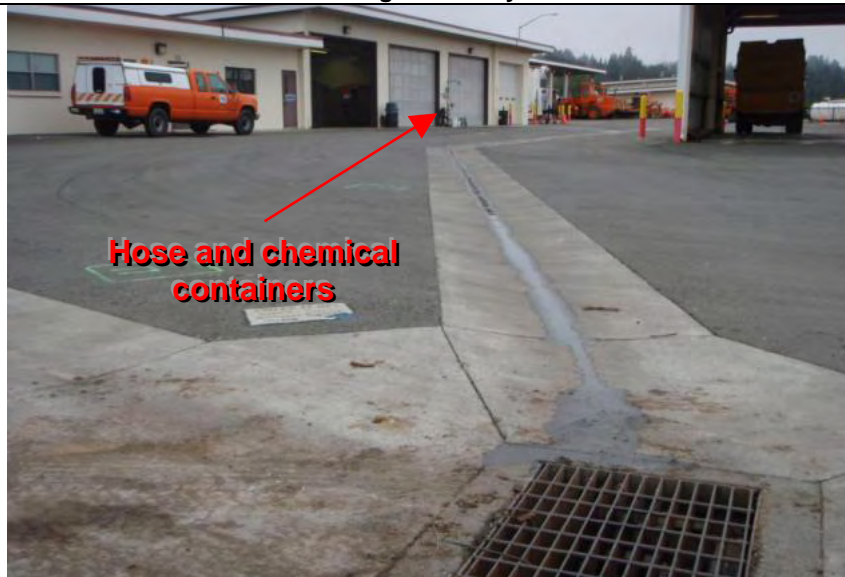
Photograph 12— View from down-gradient storm drain inlet to location of hose and chemical containers pictured in Photograph 11

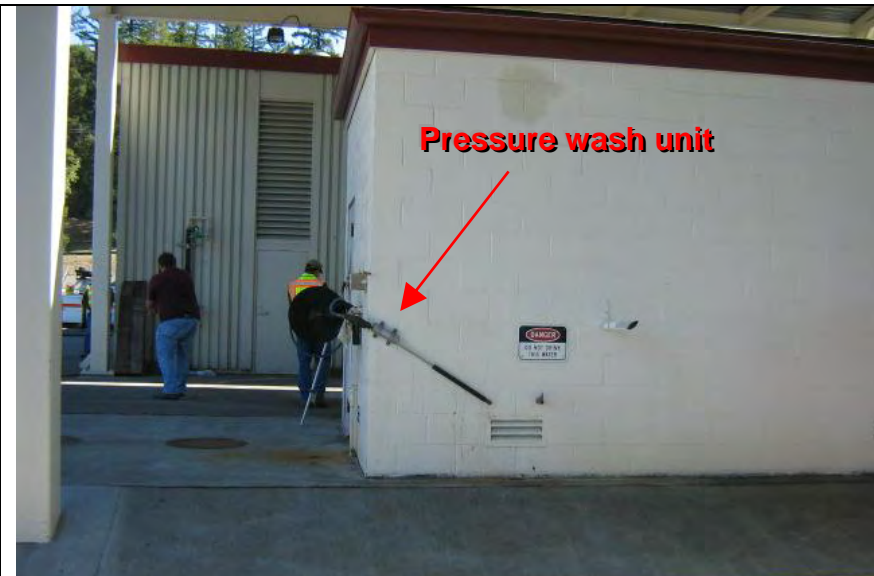
Photograph 1 – Covered wash rack

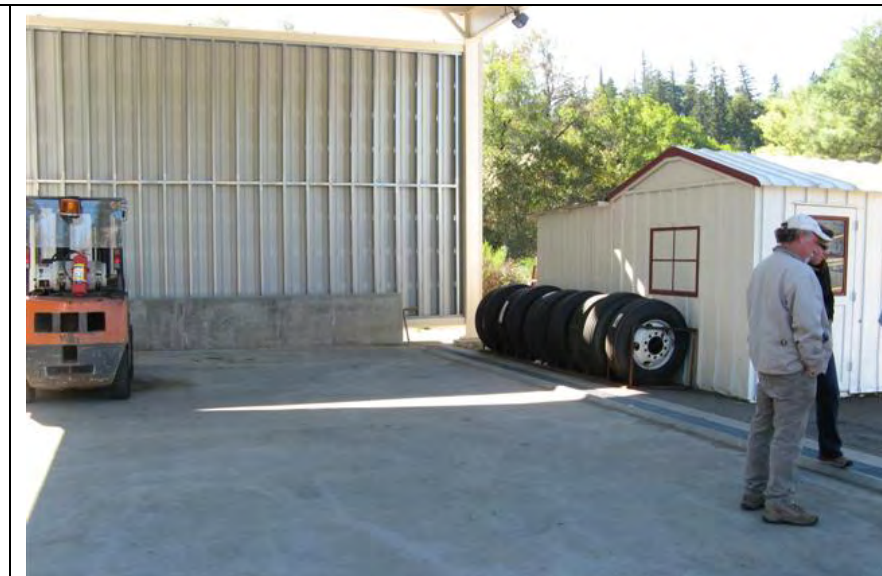
Photograph 2 – Covered wash rack

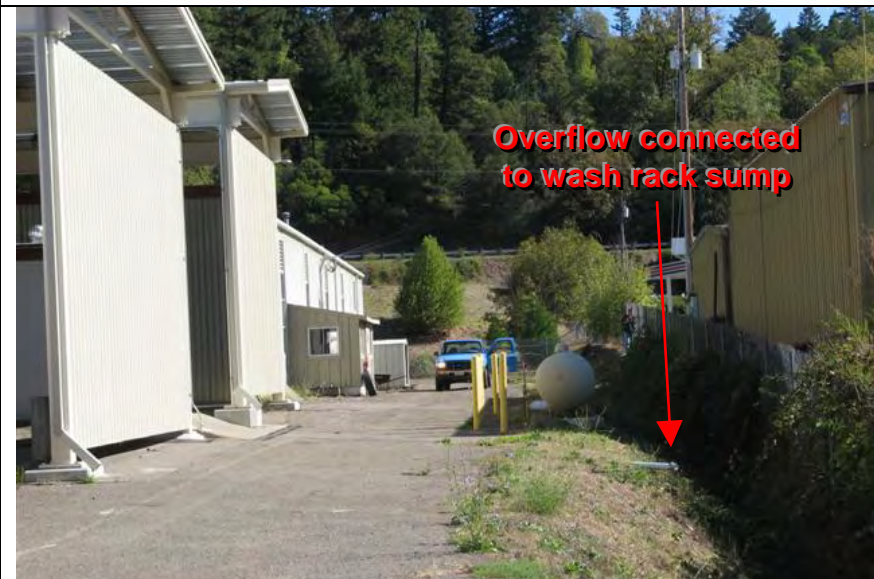
Photograph 3 – Sump overflow leading to drainage ditch

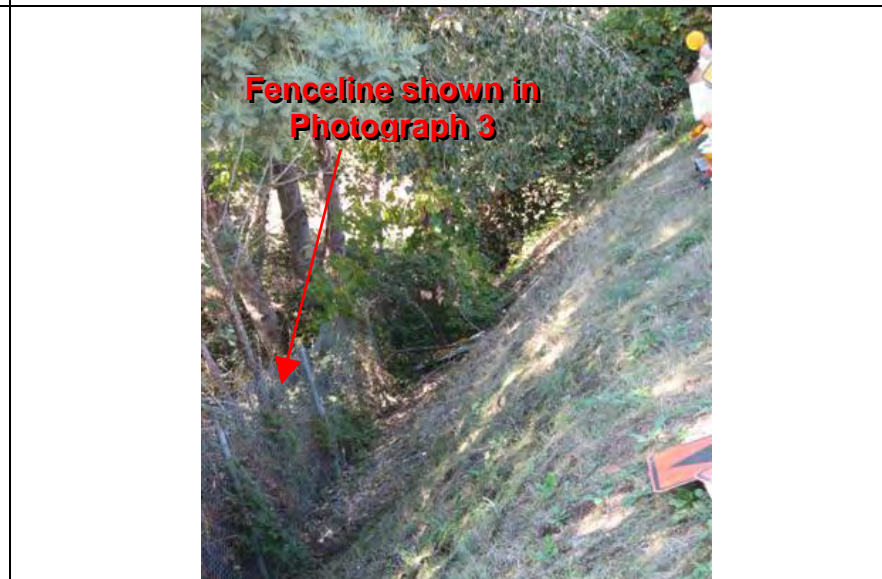
Photograph 4 – View of drainage ditch leading toward South Fork Eel River

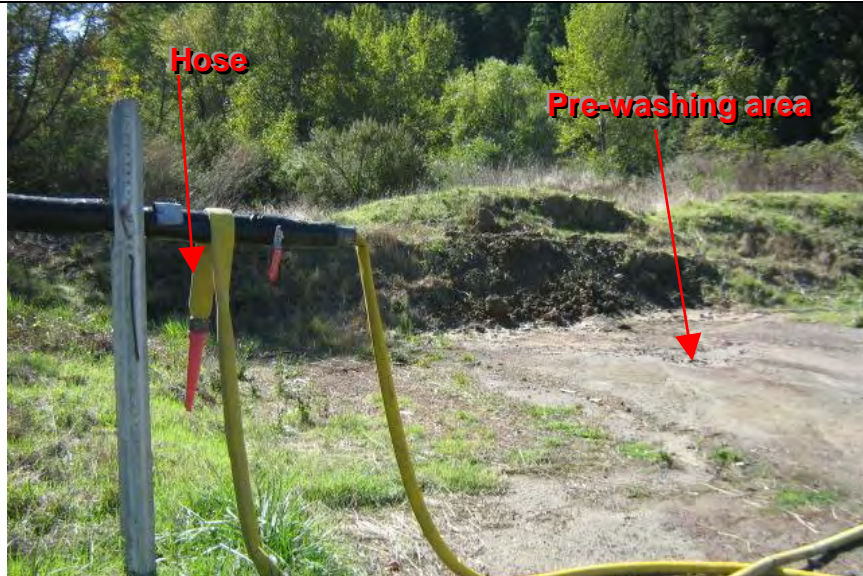
Despite the availability of the designated wash rack, a vehicle pre-washing area was observed in the lower yard (see [Photograph 5](#)). The lower yard is located west of the main office and maintenance facility, in much closer proximity to the South Fork Eel River. The pre-washing area is not equipped to properly capture, treat, re-use, or dispose of vehicle wash water and associated pollutants. Additionally, a berm installed down-gradient of the vehicle pre-washing area showed signs of standing water and had been damaged (see [Photographs 6 and 7](#)).

Photograph 5— Vehicle pre-washing area in the lower yard
