Appendix E

Maintenance Program Site Visit Reports

Site Visit No. 16

**Willow Creek Highway Maintenance Facility
Site Visit Date: 10/22/2009**

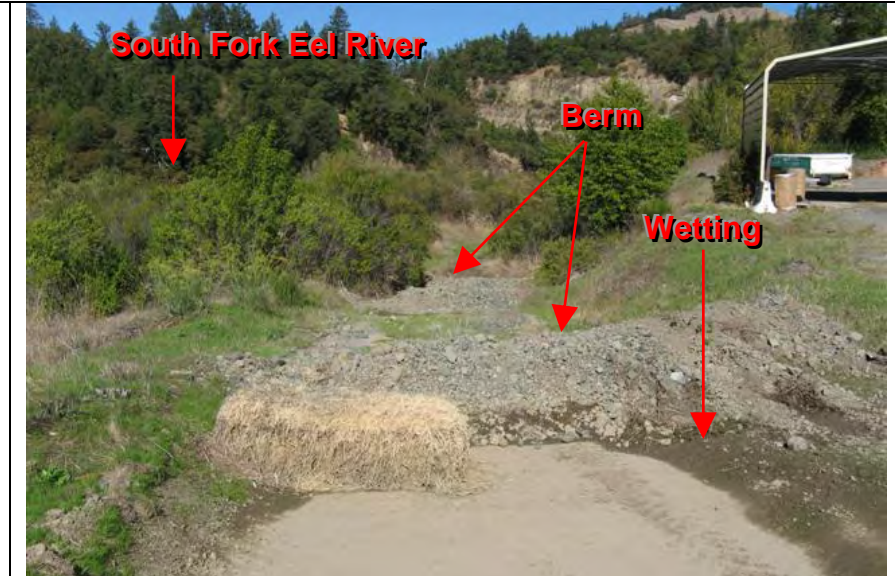
Despite the availability of the designated wash rack, a vehicle pre-washing area was observed in the lower yard (see [Photograph 5](#)). The lower yard is located west of the main office and maintenance facility, in much closer proximity to the South Fork Eel River. The pre-washing area is not equipped to properly capture, treat, re-use, or dispose of vehicle wash water and associated pollutants. Additionally, a berm installed down-gradient of the vehicle pre-washing area showed signs of standing water and had been damaged (see [Photographs 6 and 7](#)).

Photograph 6 – View down-gradient of pre-washing area

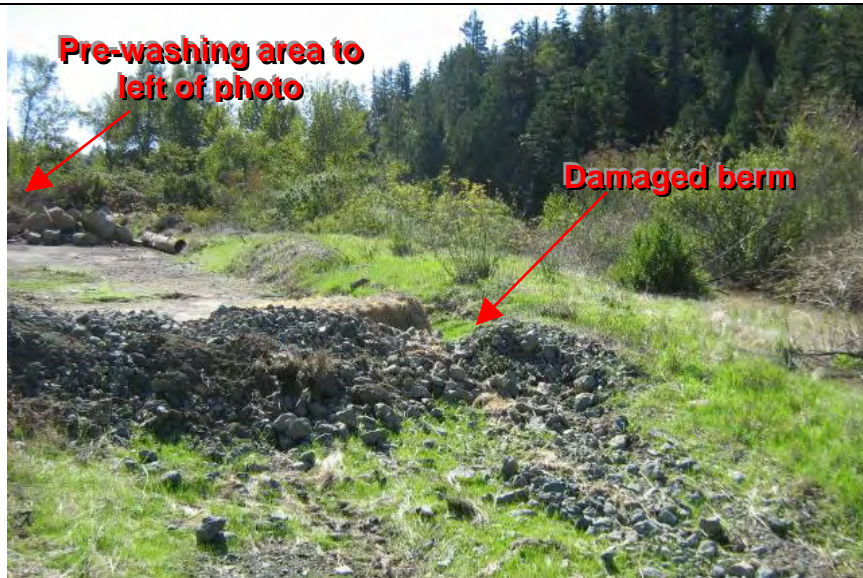
Photograph 7— Damaged berm shown in Photograph 6

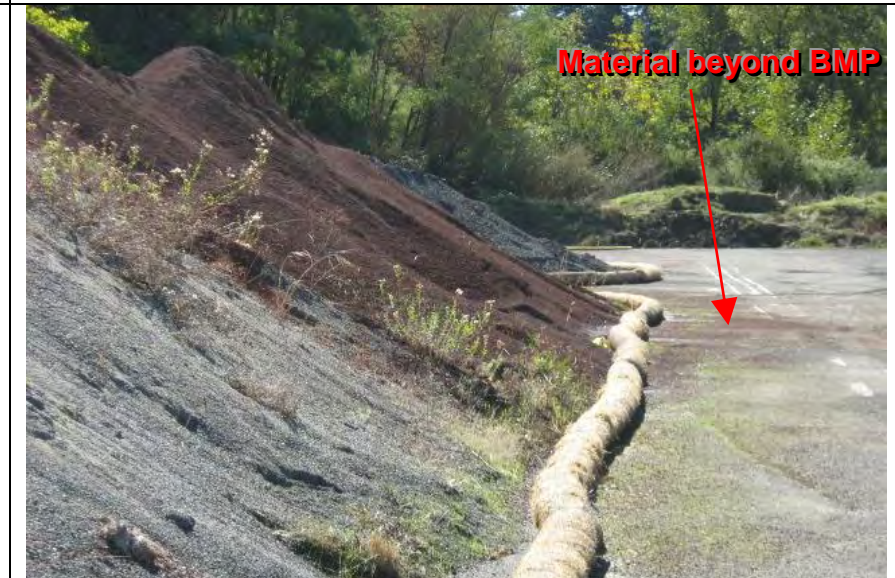
In addition, straw wattle BMPs used for stockpile management were improperly installed on impervious surfaces throughout the facility and were not properly entrenched in the ground to retain the stockpiled materials (see [Photographs 8 and 9](#)). Although located under cover, a second stockpile area containing salt also had a straw wattle BMP improperly installed on an impervious surface (see [Photograph 9](#)). Furthermore, straw wattle BMPs are not intended to control salt products or other pollutants that will dissolve upon contact with water. As a result, adequate BMPs were not implemented for stockpile management.

Photograph 8 – Inappropriate application of wattles on impervious surface

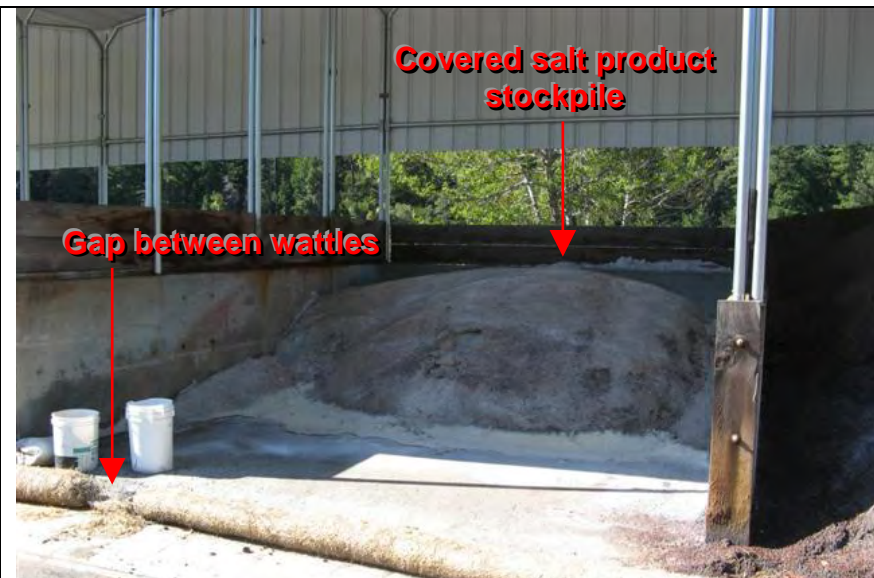
Photograph 9— Inappropriate application of wattles

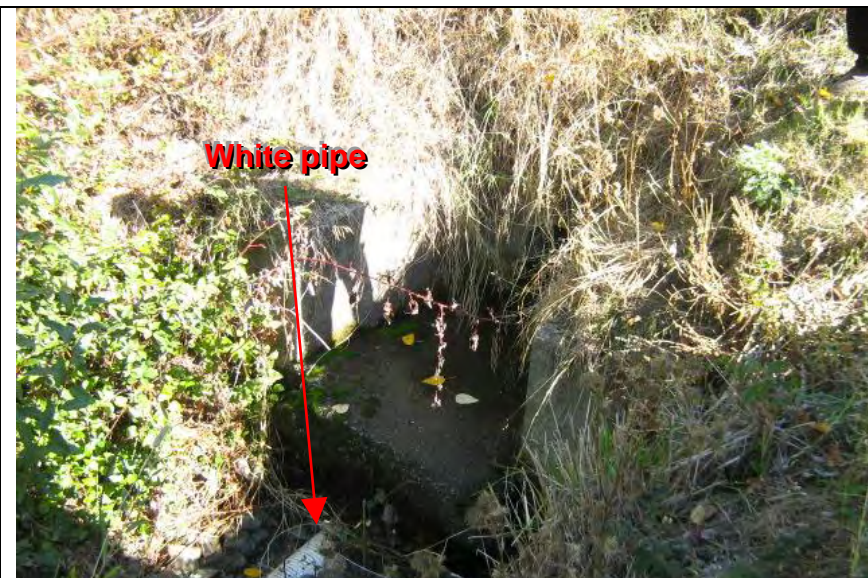
Photograph 10 – Facility outfall

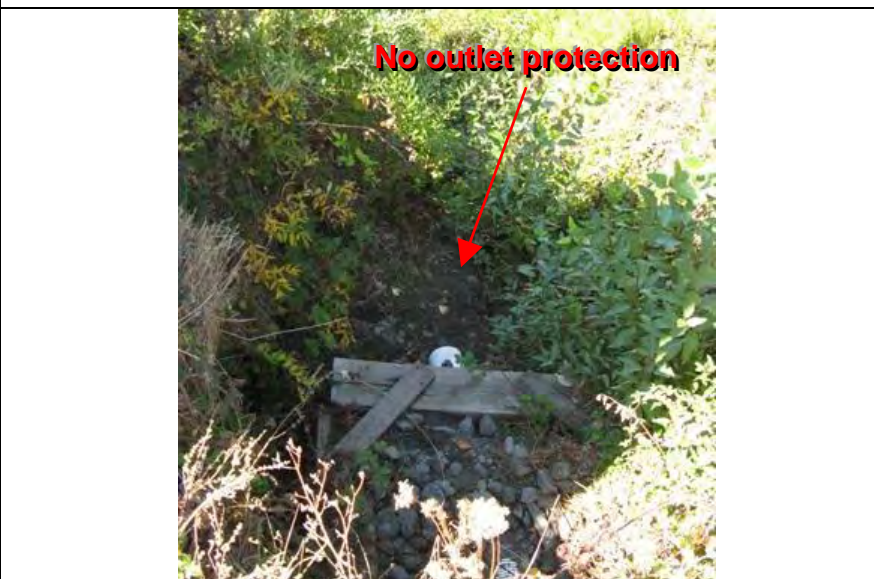
Photograph 11— Outlet pipe down-gradient of facility outfall

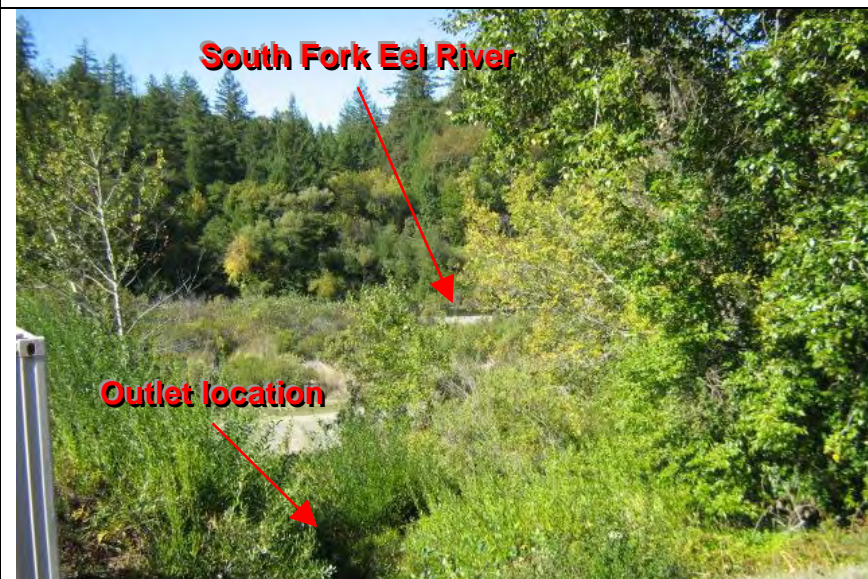
Photograph 12— Proximity of outlet to receiving water

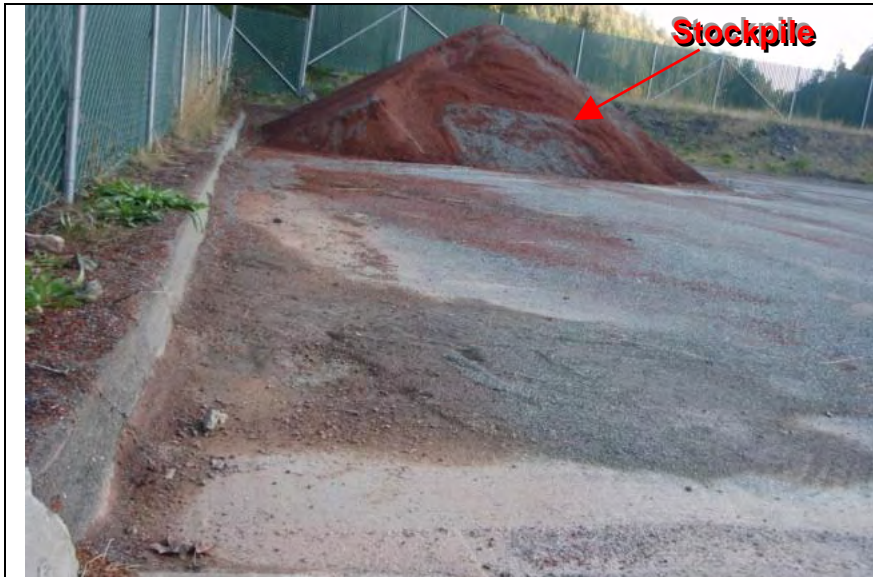
Photograph 1 – Stockpile without BMPs for coverage or containment

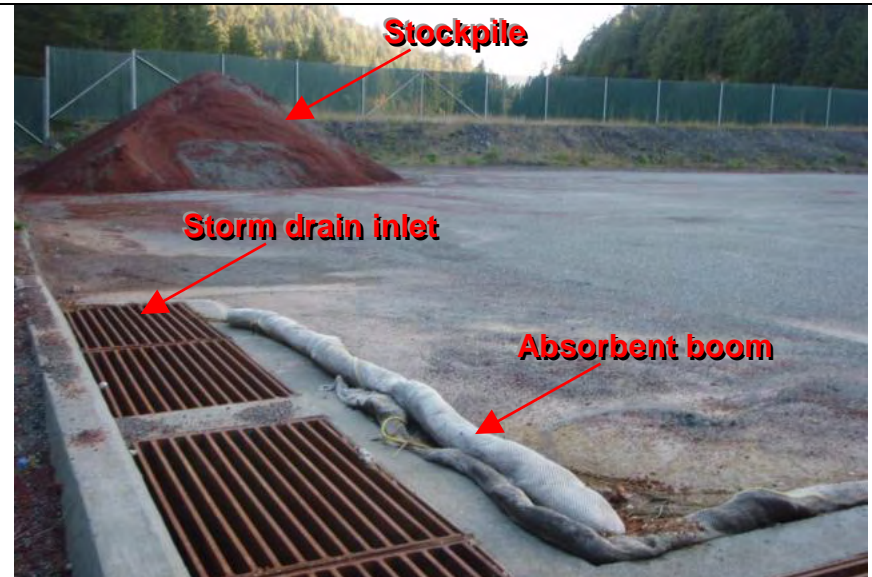
Photograph 2 – View of storm drain inlet and stockpile shown in Photograph 1

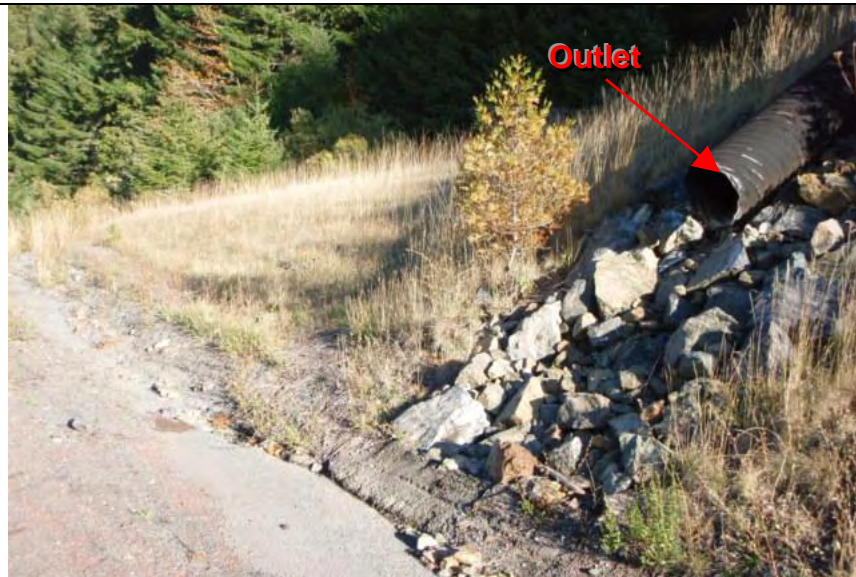
Photograph 3 – Discharge location from inlet shown in Photograph 2

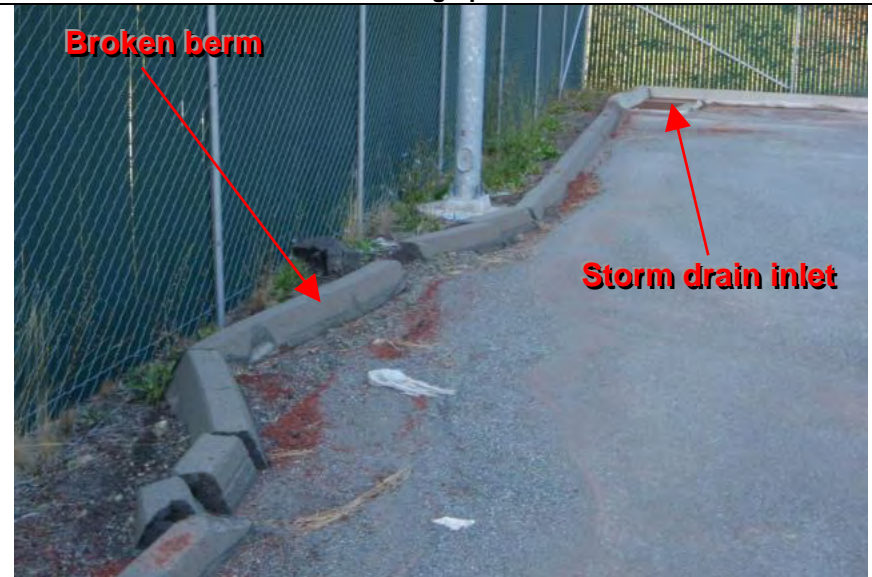
In addition, a 10 to 20 foot section of the berm along the northern perimeter of the site was not intact and accumulated roadway abrasives were observed adjacent to the failed berm (see Photograph 4). Roadway abrasives were also observed on the impervious ground surface in other various areas at the facility and beyond the perimeter fenceline (see Photographs 5, 6 and 7). As a result, there was a discharge of pollutants beyond the bermed perimeter, and the potential for subsequent off-site discharge.

Photograph 4 – Broken berm along northern perimeter of facility
(Note: Accumulation of roadway abrasives adjacent to berm)

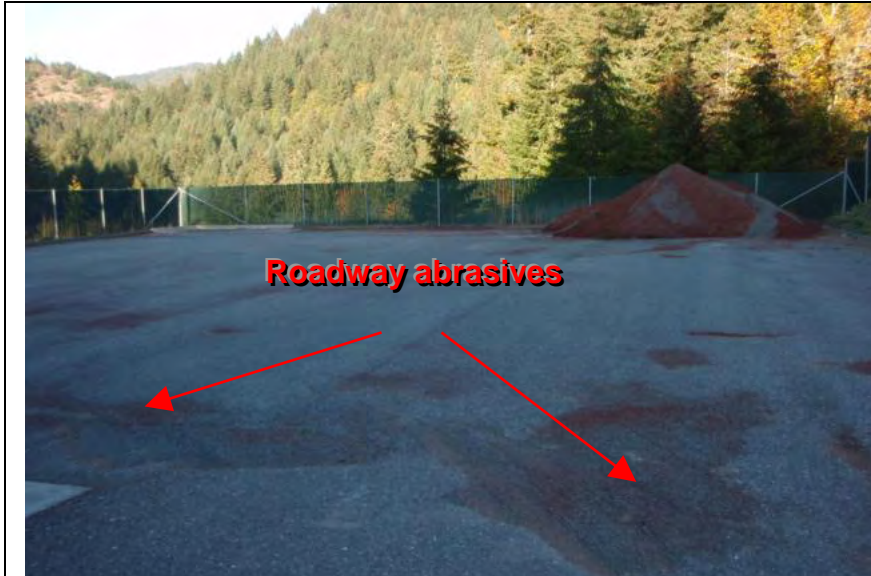
Photograph 5— Roadway abrasives on impervious ground surface

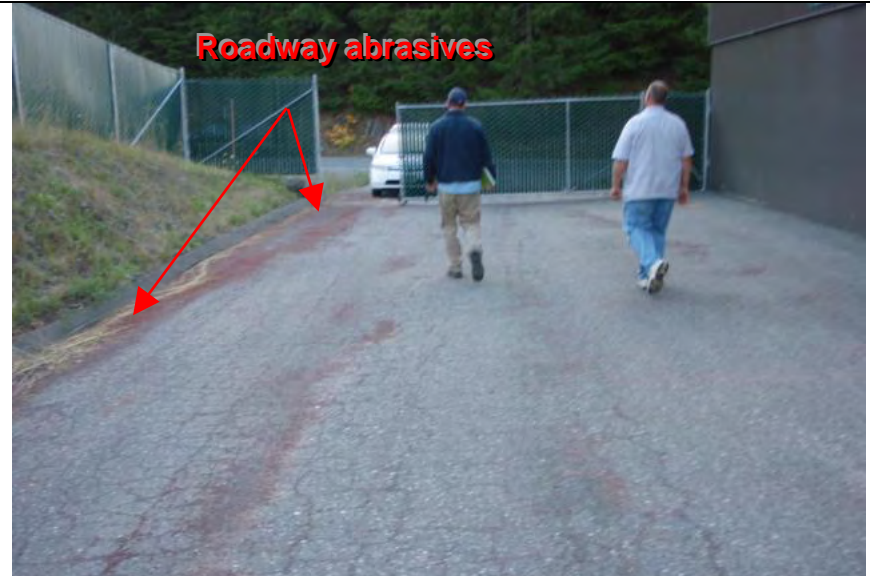
Photograph 6 – Roadway abrasives on impervious ground surface

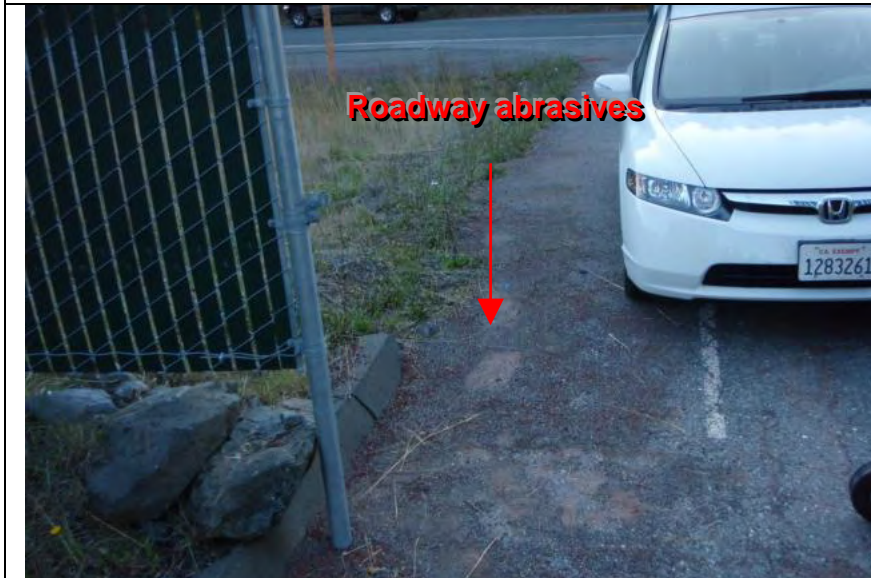
Photograph 7— Roadway abrasives outside facility entrance

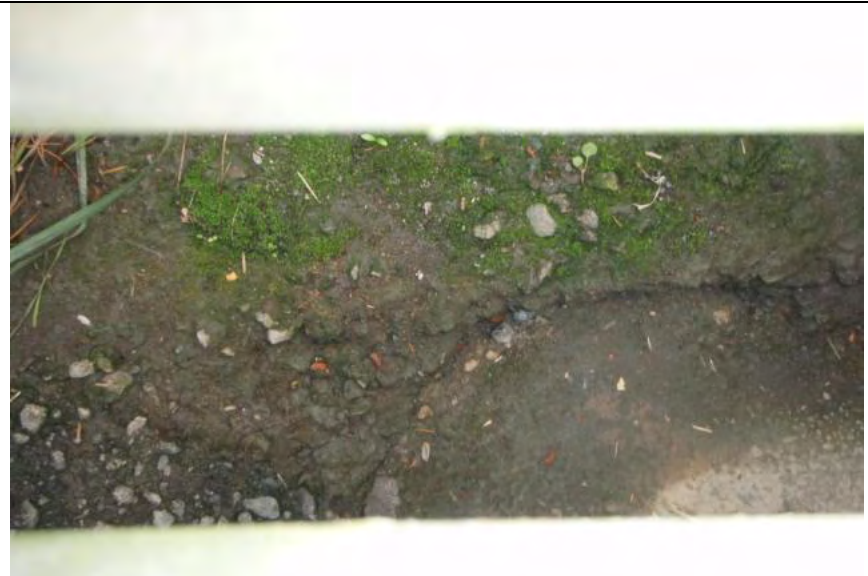
Photograph 2 – View into storm drain inlet pictured in Photograph 1
(Note: Sediment accumulation within inlet)

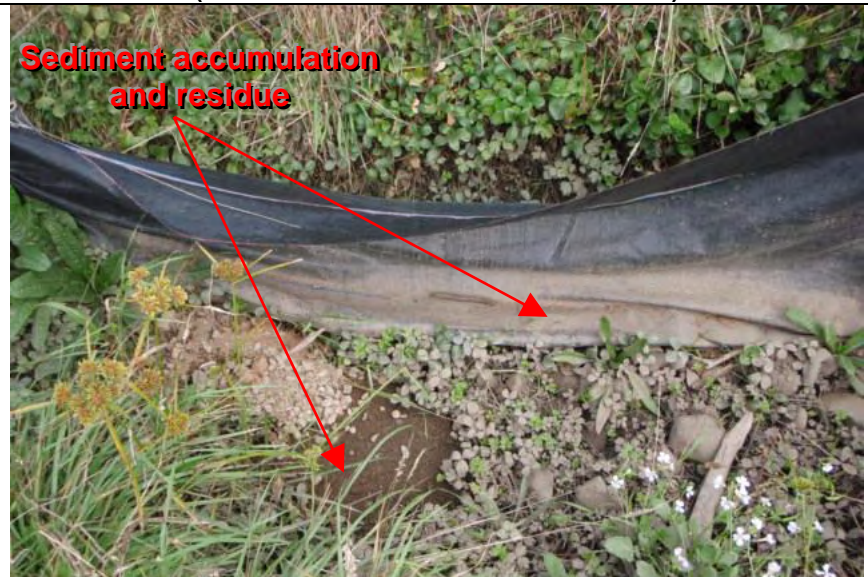
Provision I.3.b of the Permit requires Caltrans to provide appropriate site-specific BMPs for all maintenance facilities. A significant amount of sediment accumulation was observed within a storm drain inlet at the facility that did not appear to have been recently cleaned (see [Photographs 1 and 2](#)). As explained by the Highway Maintenance Supervisor, storm drain inlets at the facility flow to the drainage ditch in the southeast corner of the facility (see [Photograph 3](#)). He added that storm water runoff does not generally discharge off-site from this location but rather ponds and remains as standing water until it infiltrates into the ground. Nonetheless, evidence of sediment discharged to the drainage ditch as well as sediment accumulation within the culvert pipe that discharges to the southeast corner of the facility was observed (see [Photograph 5](#)). Furthermore, a silt fence BMP had been installed in the flow pathway of the culvert outlet and was not entrenched into the ground to retain sediment and prevent failure (see [Photograph 3](#)).

Photograph 4 – Closer view of silt fence BMP shown in Photograph 3

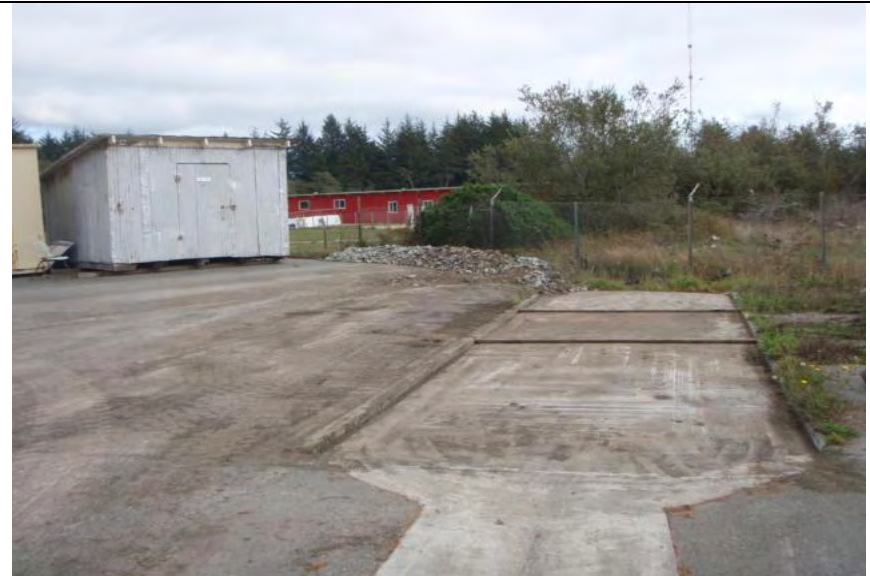
In addition, a significant amount of sediment accumulation was observed on the impervious ground surface near the southeast corner of the facility (see [Photographs 6 and 7](#)). As explained by the Highway Maintenance Supervisor, the area was used as a temporary stockpile location for washout material from front loaders and dump trucks. Whether the equipment washout operation was conducted with dry or wet processes was unclear. Appendix D of the Caltrans SWMP, Section 2.15.1, Vehicle and Equipment Cleaning, states “when possible, truck beds should be cleaned using dry cleanup technique (sweep up or shovel out).” It should also be noted that the stockpile area was located directly in the flow pathway of the surface drainage system at the facility (see [Photograph 8](#)). As a result, there was a potential for the discharge of sediment and other pollutants to the drainage ditch along the southern edge of the facility (see [Photograph 9](#)).

Photograph 6 – Area used for stockpiling washout material
(Note: Sediment accumulation on impervious ground surface)

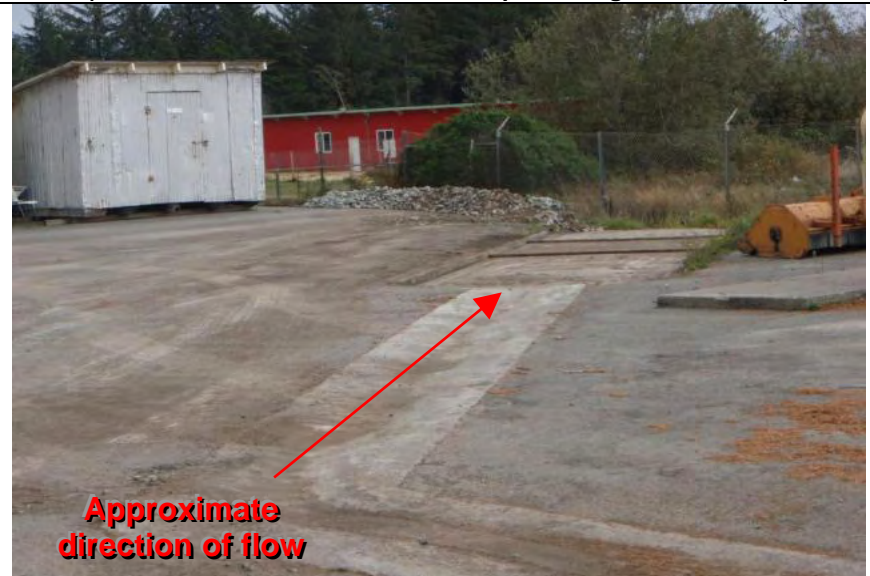
Photograph 8 – View of surface drainage system through stockpile area

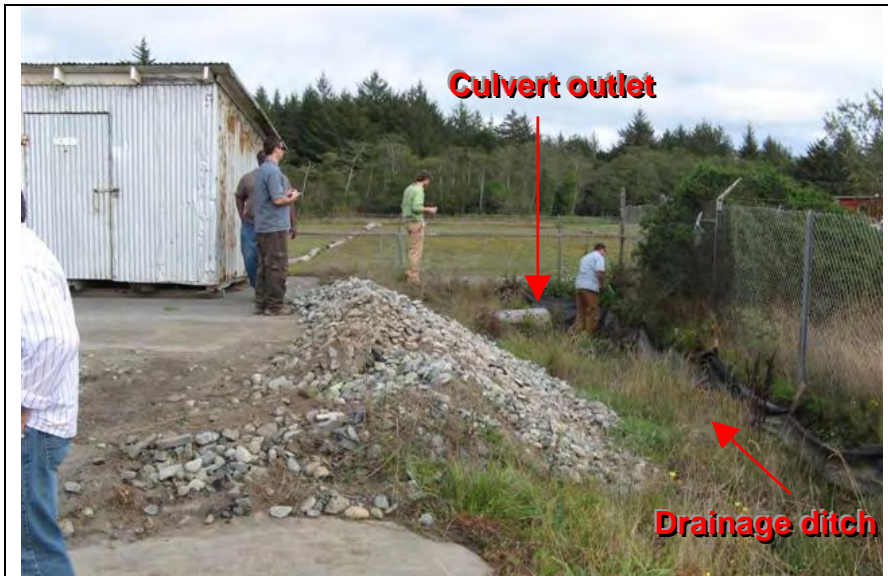
Photograph 9— View of drainage ditch and storm drain system culvert outlet

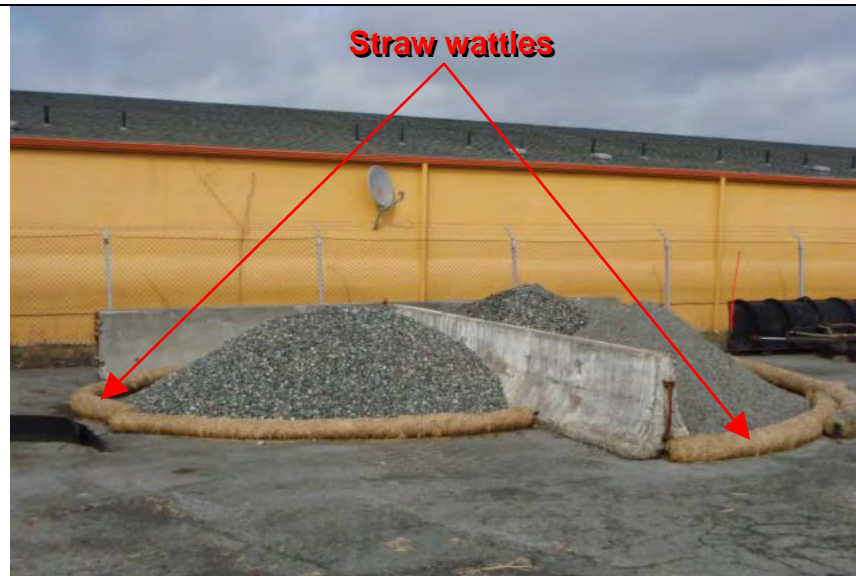
In addition, straw wattle BMPs used for stockpile management were improperly installed on impervious surfaces at the facility, and therefore were not properly entrenched in the ground to retain the stockpiled materials (see [Photograph 10](#)).

Photograph 10 – Inappropriate application of wattles on impervious surface

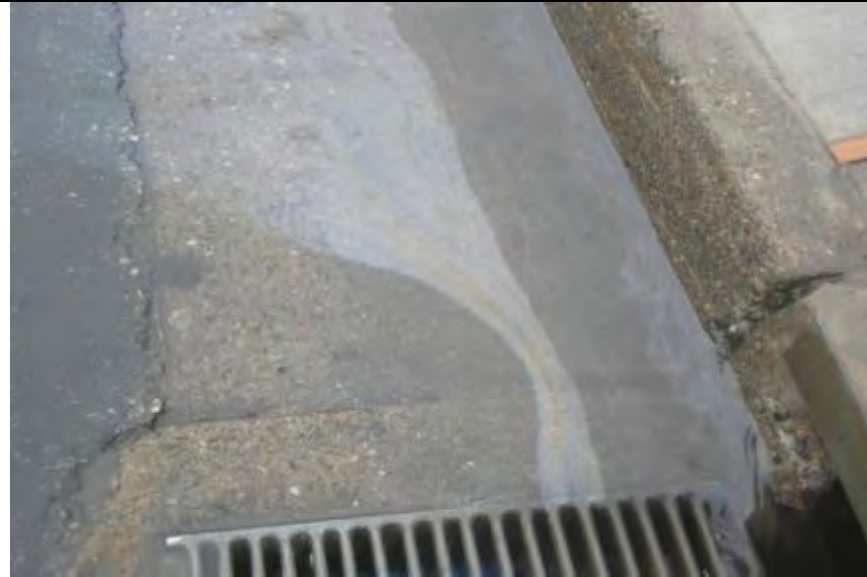
Provision I.3.b of the Permit requires Caltrans to provide appropriate site-specific BMPs for all maintenance facilities. A visible sheen was observed flowing into the storm drain located along the curb and gutter line of the northern portion of the rest area (see Photographs 1 and 2). The Caltrans Maintenance representative stated that an oil water separator BMP had been installed at this location because it drained directly into Shasta Lake. However, site plans or maintenance activity schedules were not produced to confirm that the treatment BMP was installed at this location.

Photograph 1 – Visible sheen entering storm drain

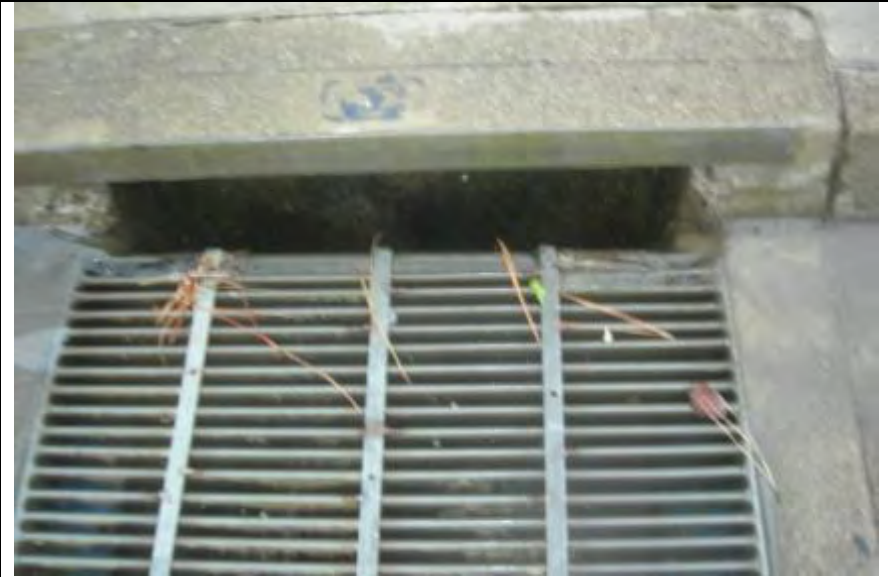
Photograph 2 – Storm drain from Photograph 1

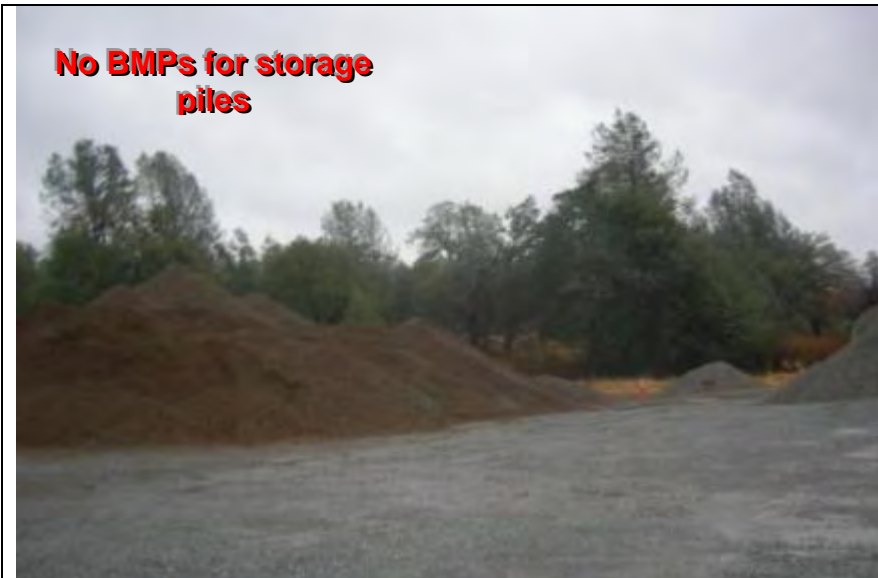
Photograph 1 – View of stockpiles

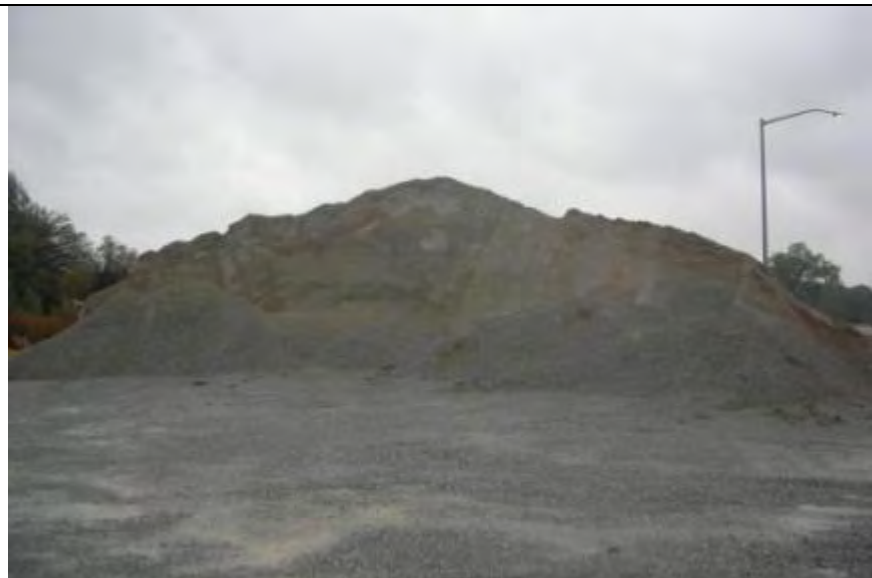
Photograph 2 – Lack of BMPs to contain stockpiled materials

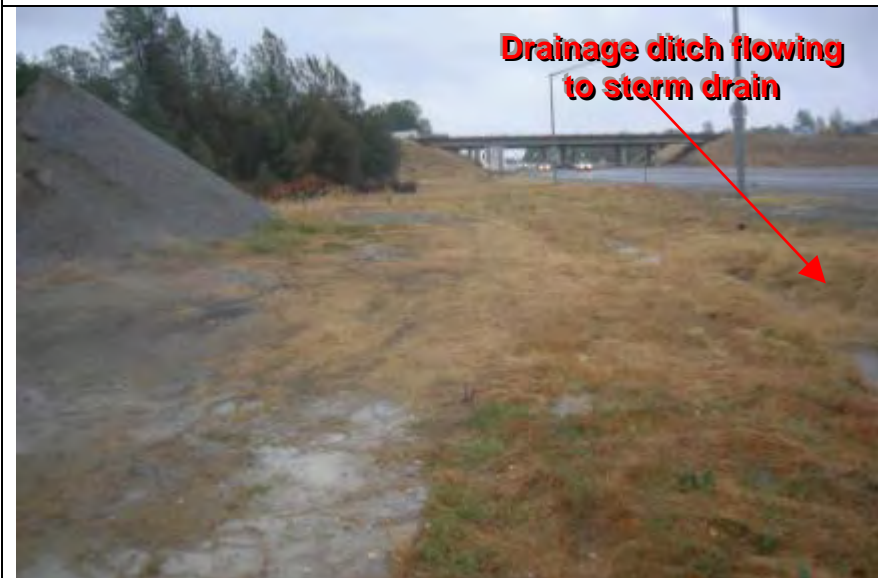
Photograph 3 – View of Photograph 2 stockpile proximity to drainage ditch

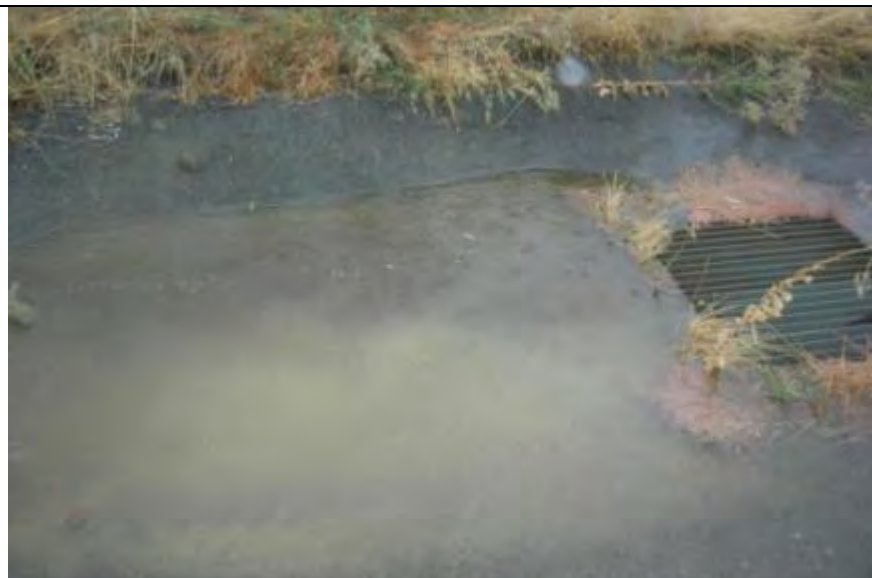
Photograph 4 – Storm drain inlet adjacent to temporary storage area
