**SEWAGE COLLECTION SYSTEM INSPECTION FORM  
City of Alameda, CA**

Inspection Date: **April 2 – 3, 2009**

Utility Name: City of Alameda
Address: City Hall West, 950 W. Mall Square, Room 110, Alameda, CA 94501 Maintenance Service Center, 1616 Fortmann Way, Alameda, CA 94501
Contact Person: Paul Soo, Jr. (City Hall West), Larry Strunk (Maintenance)
Phone: (510) 749-5840, (510) 747-7400 Cell: (510) 919-9301 (Larry)
Fax: (510) 749-5867 (City Hall West), (510) 521-8762 (Maintenance)
Email: <a href="mailto:psoo@ci.alameda.ca.us">psoo@ci.alameda.ca.us</a> , <a href="mailto:lstrunk@ci.alameda.ca.us">lstrunk@ci.alameda.ca.us</a>

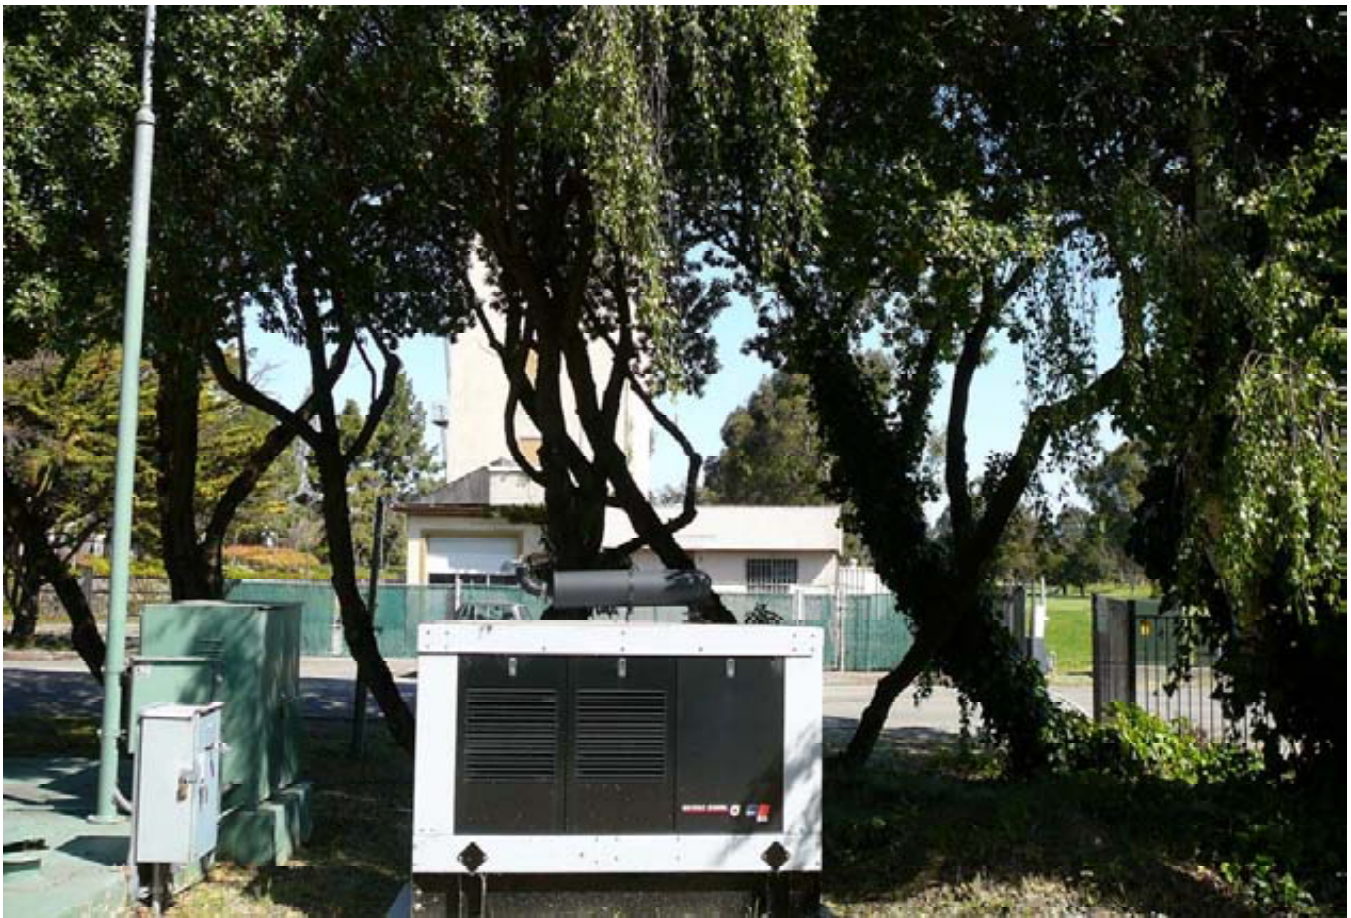
- BFI (Photos 1 and 2) – located on Bay Farm Island next to a golf course. This station is not fenced. SCADA is present. A spill occurred on 6/24/05 due to a power failure. A generator has since been installed. City staff identified where the spill entered a storm drain inlet.

Alameda Photo 1 - BFI pump station

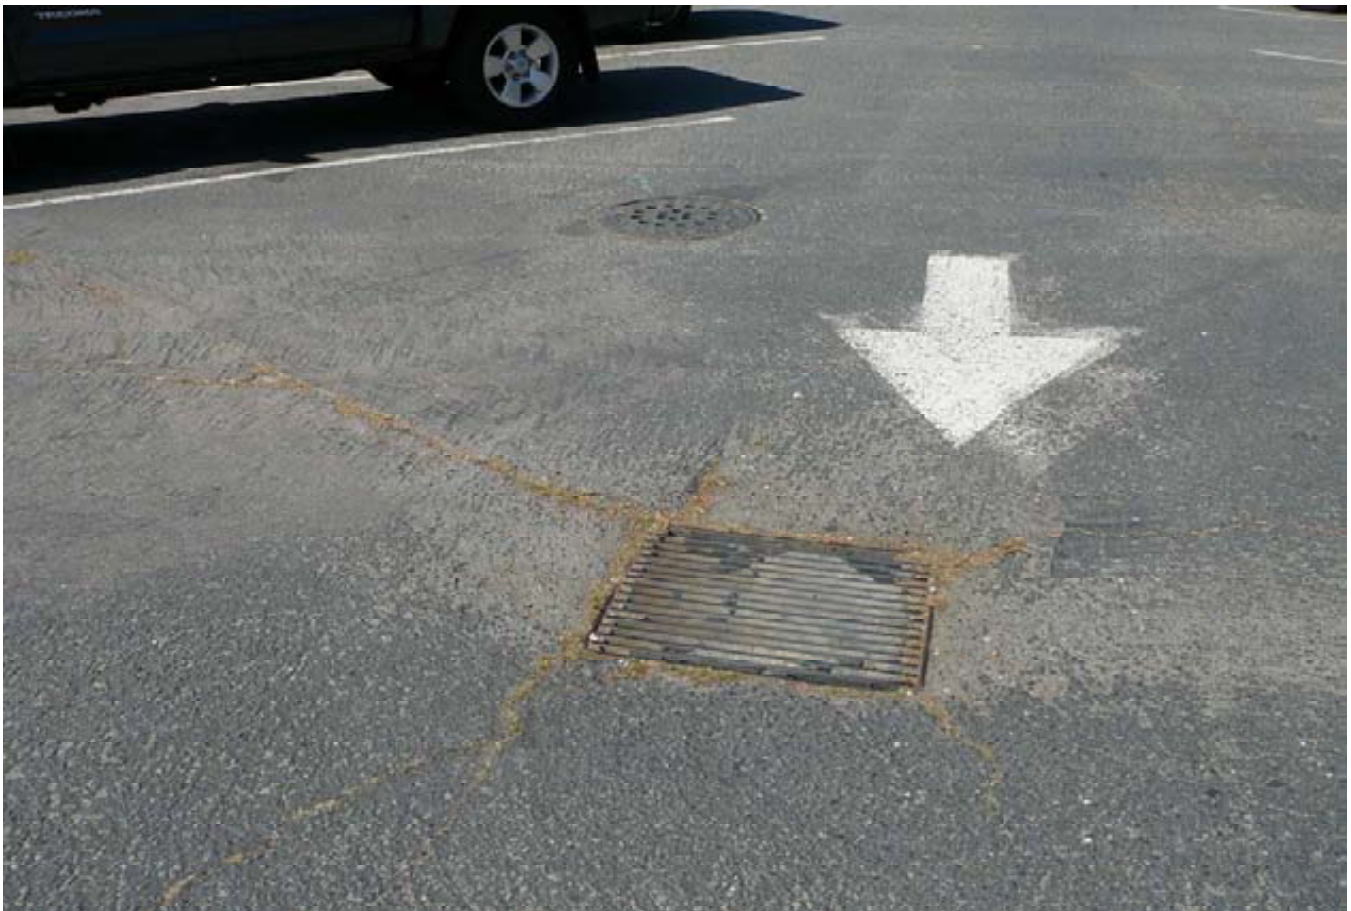
Alameda Photo 2 - Location of overflow from BFI pump station

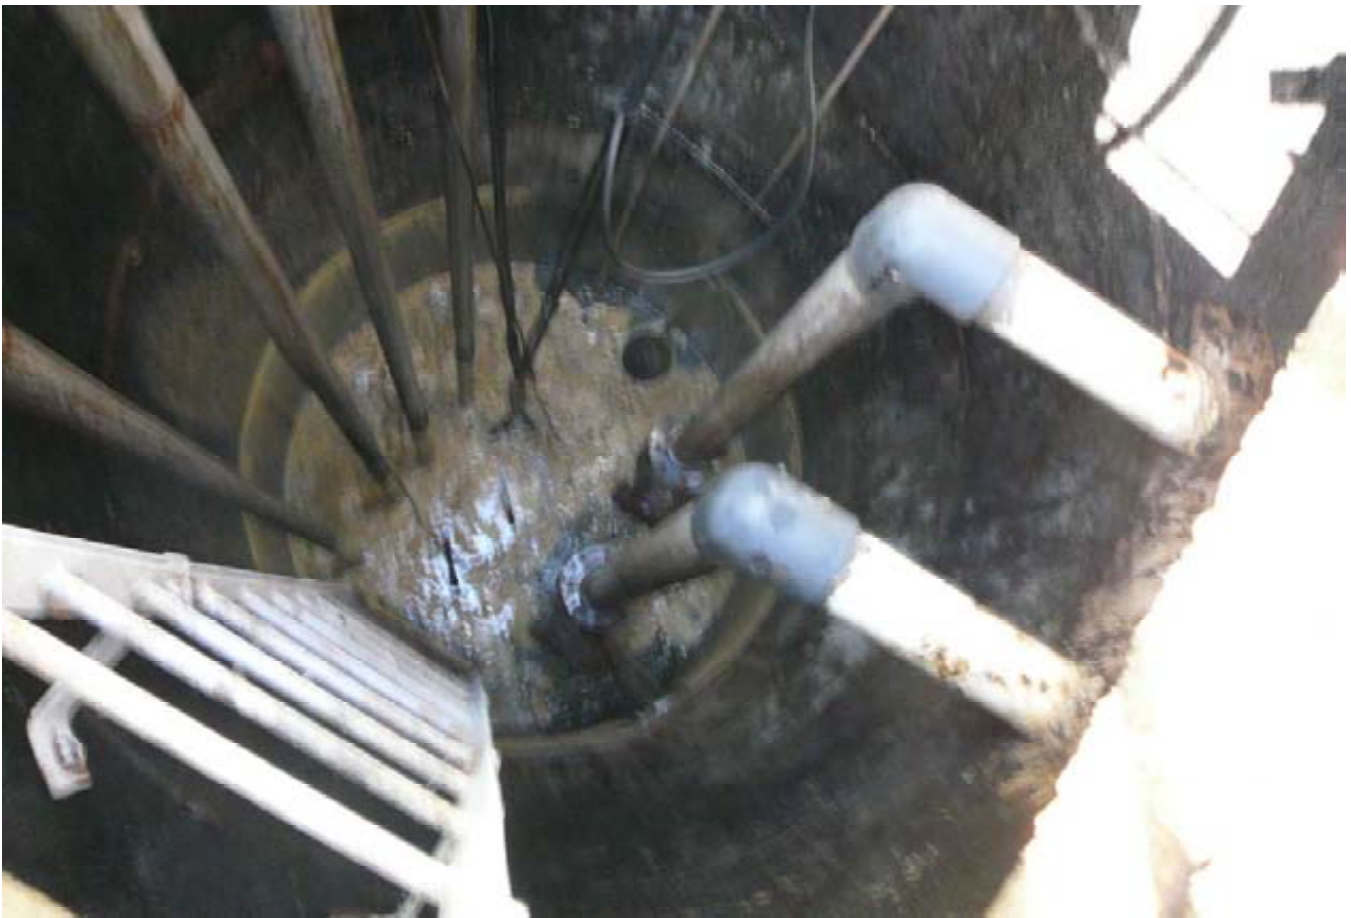
- Dublin (Photos 3 and 4) – located in a residential area. This station is not fenced. SCADA is located across the street. Some grease visible in wet well.

Alameda Photo 3 - Dublin pump station wet well

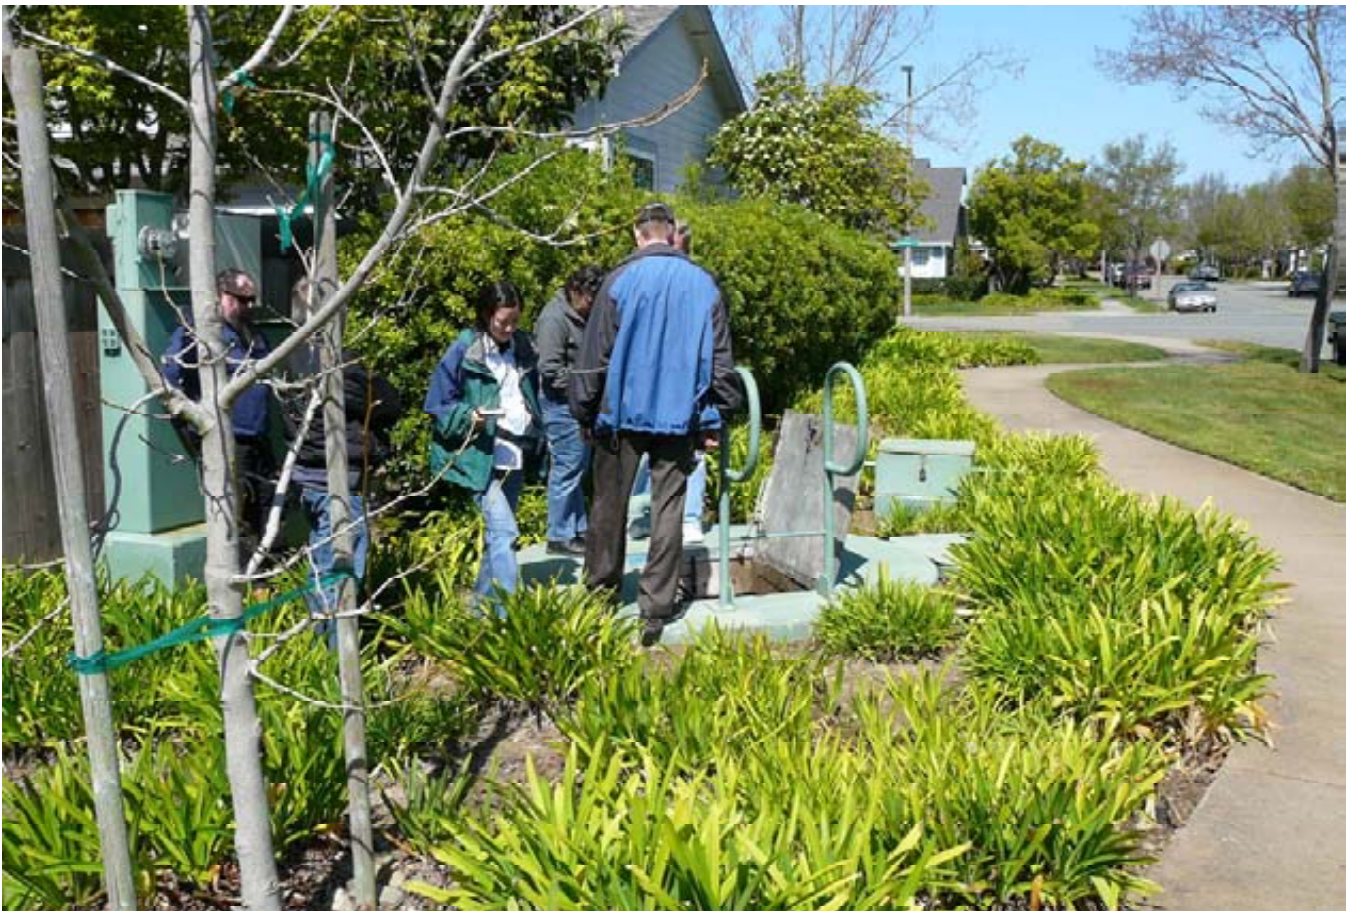
Alameda Photo 4 - Dublin pump station

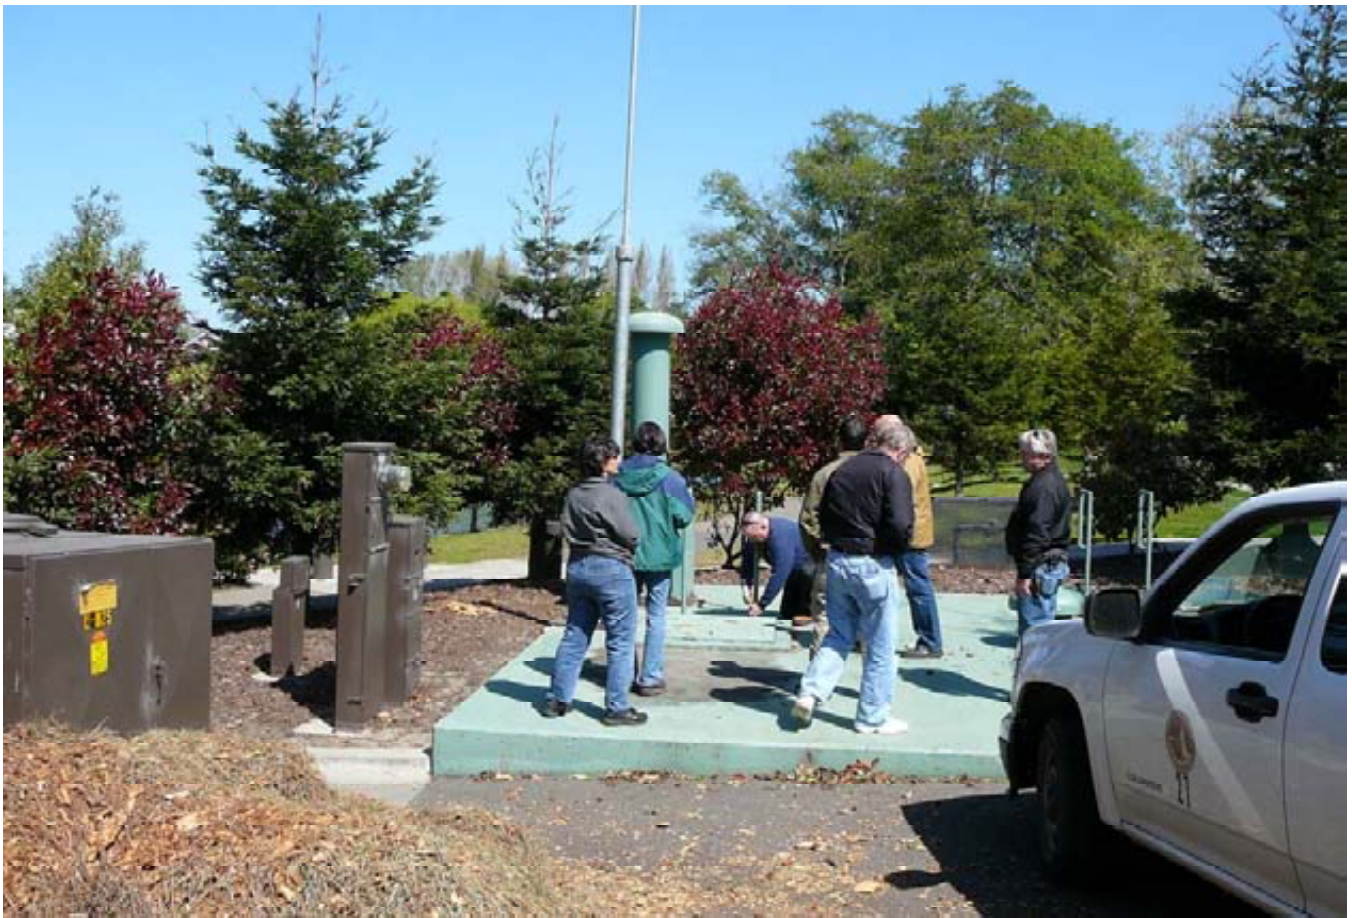
- Catalina (Photos 5 and 6) – located next to a lagoon. This station is not fenced. SCADA is present. A contractor cleans the wet well about every two years.

Alameda Photo 5 - Catalina pump station

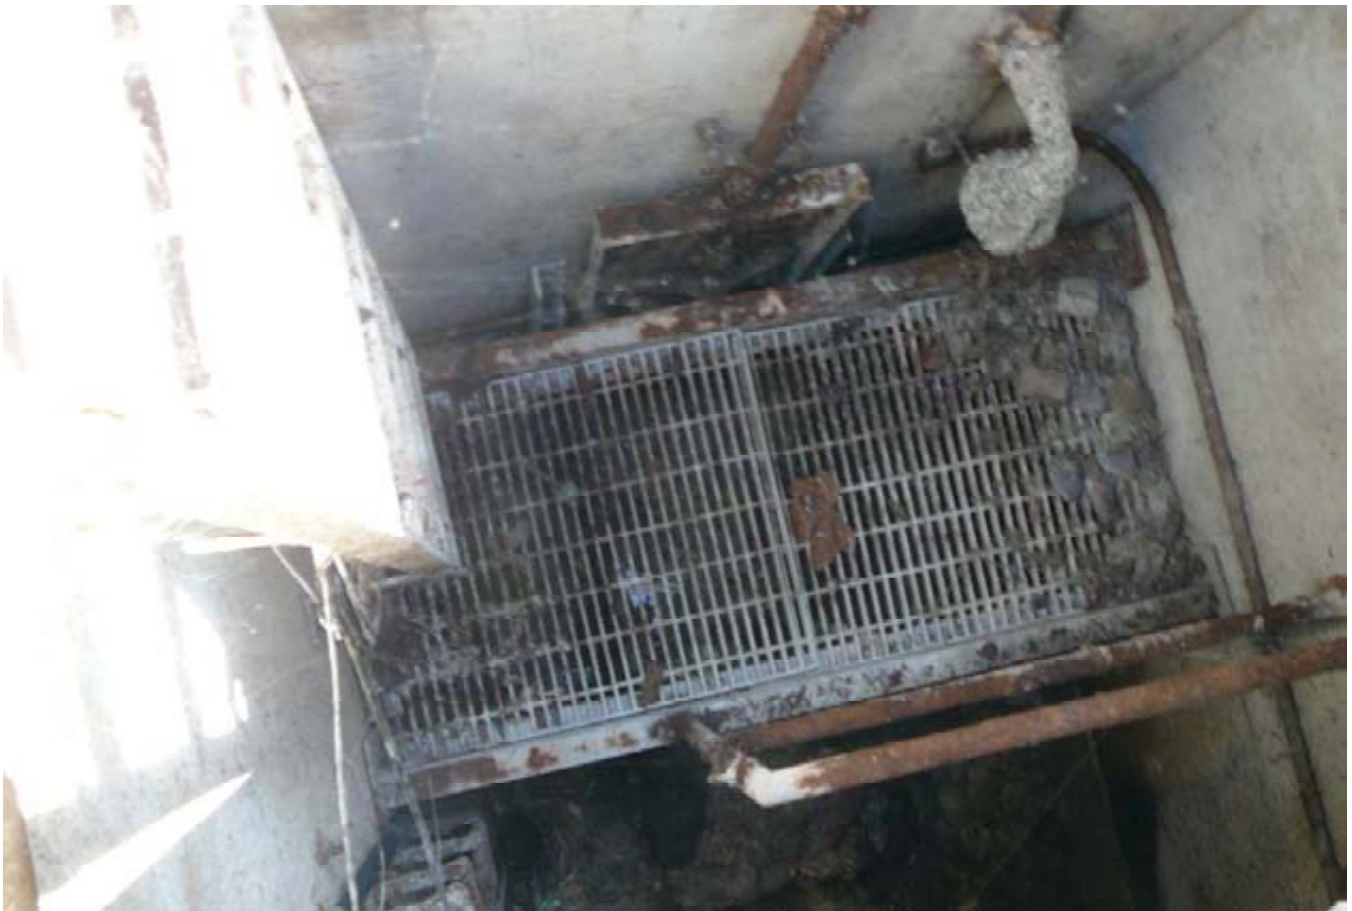
Alameda Photo 6 - Catalina pump station wet well

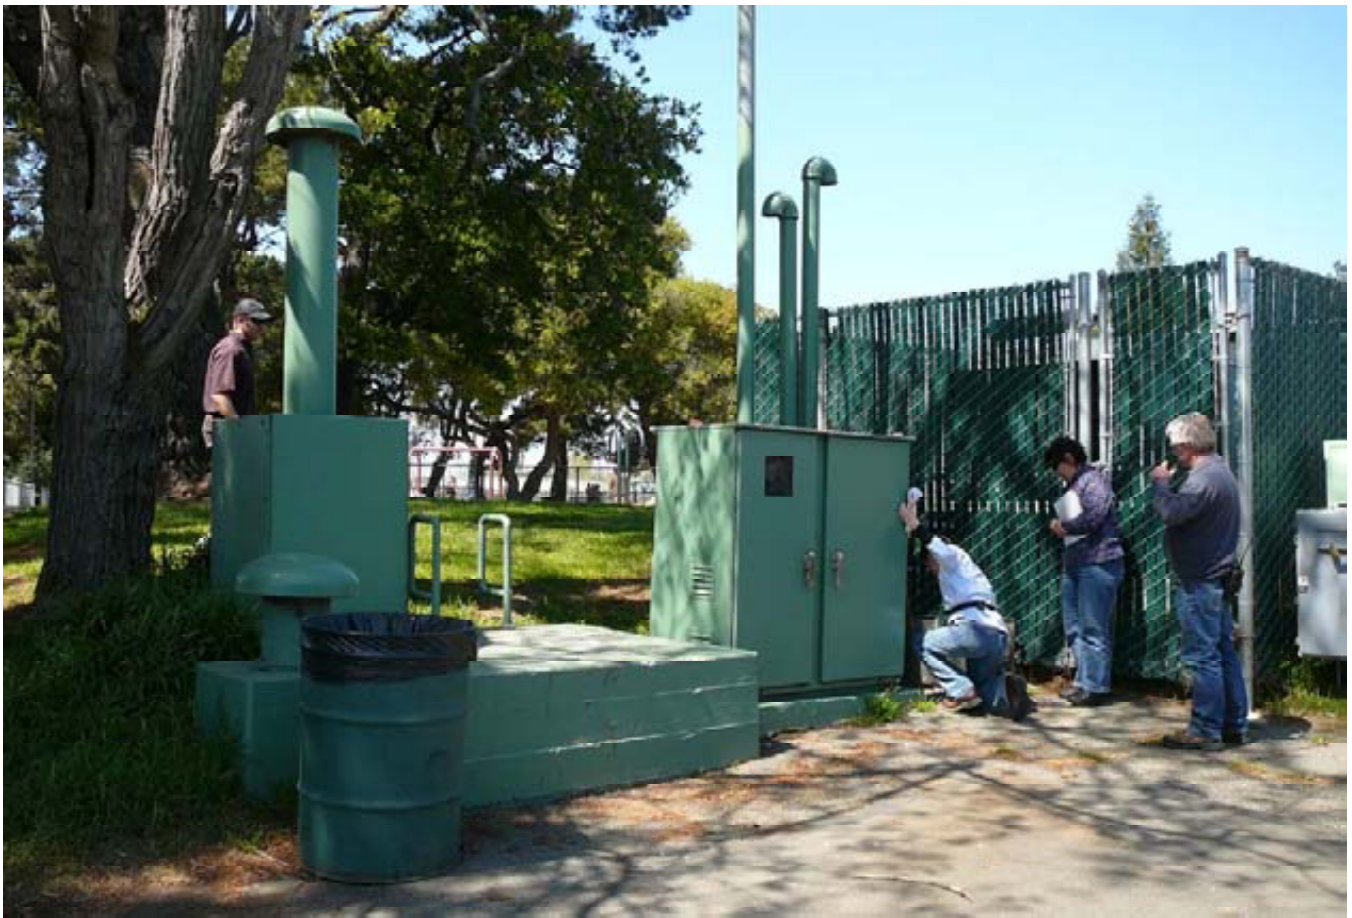
- 8<sup>th</sup> and Portola (Photo 7) – located next to a park and children’s play area. This is the largest pump station. Only the generator is fenced. SCADA is present. The incoming gravity main failed at this location (date unknown). City staff stated that the main failure did not cause a spill. However, a spill did occur due to an operator error when vactoring out the wet well during the main failure. The City did not report this spill because a contractor was operating the vactor.

Alameda Photo 7 - 8th and Portola pump station

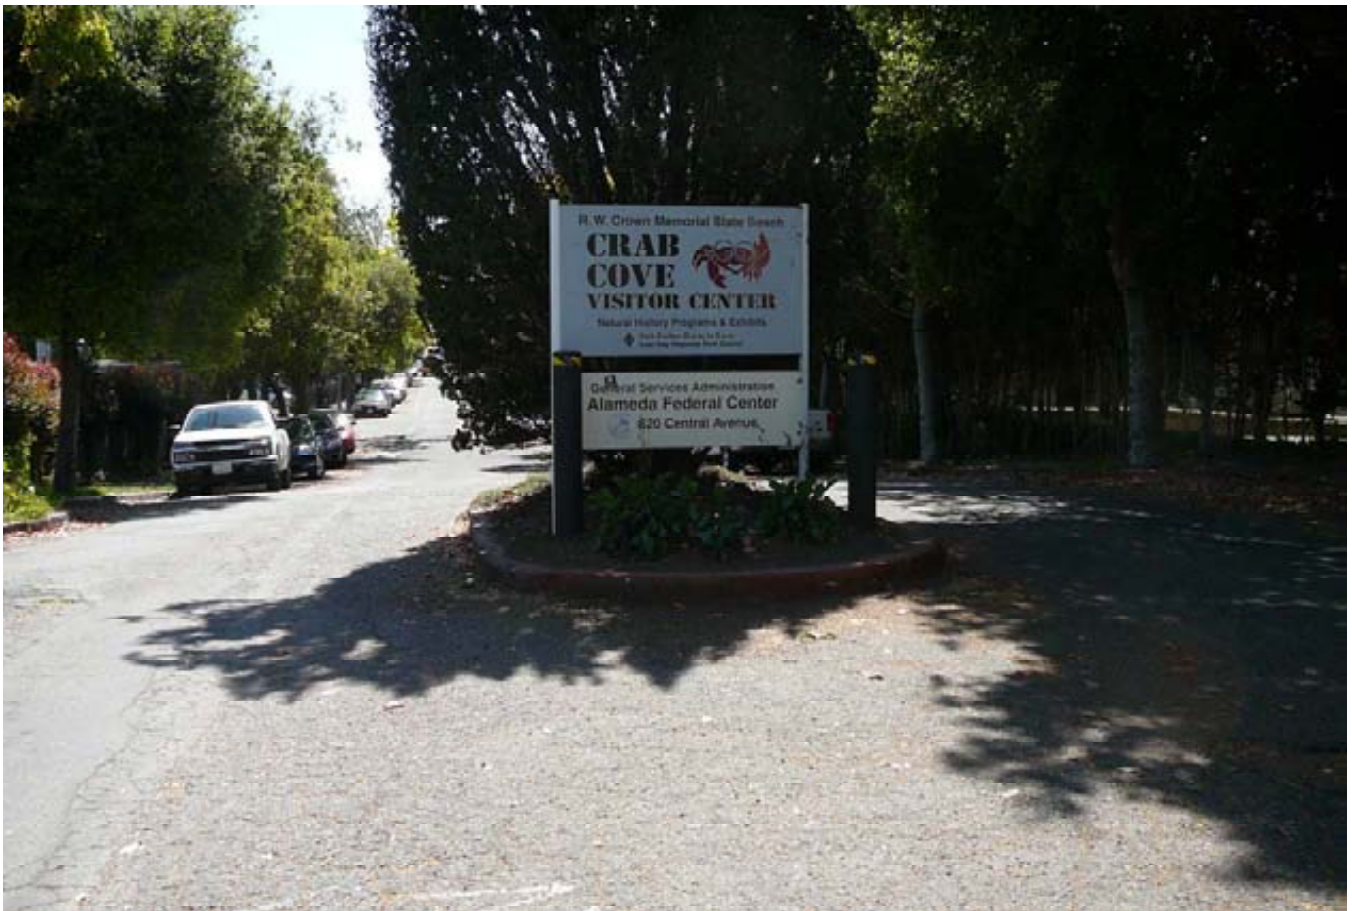
Alameda Photo 8 - Spill site at Alameda Federal Center

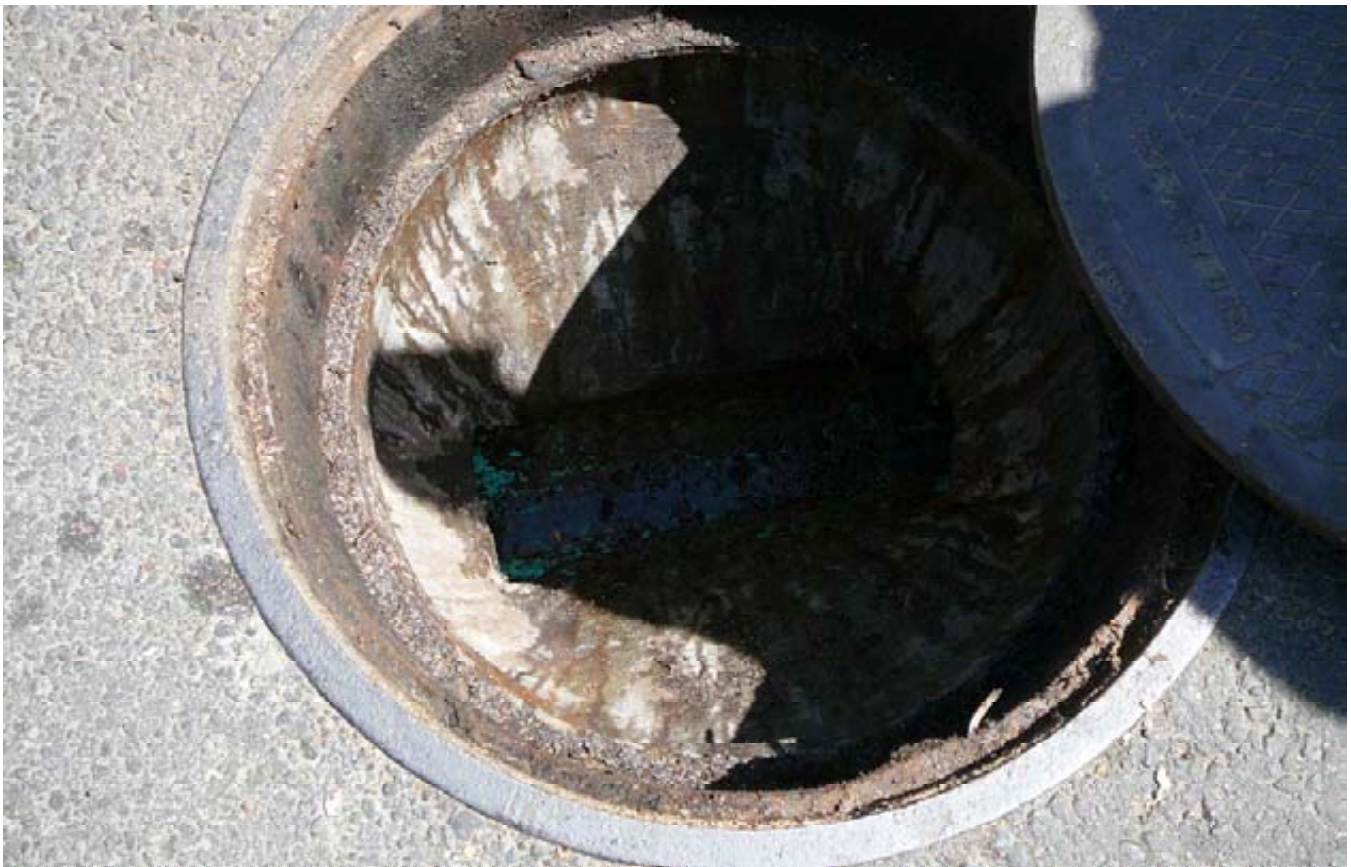
Alameda Photo 9 - Spill site at Alameda Federal Center - Manhole that overflowed

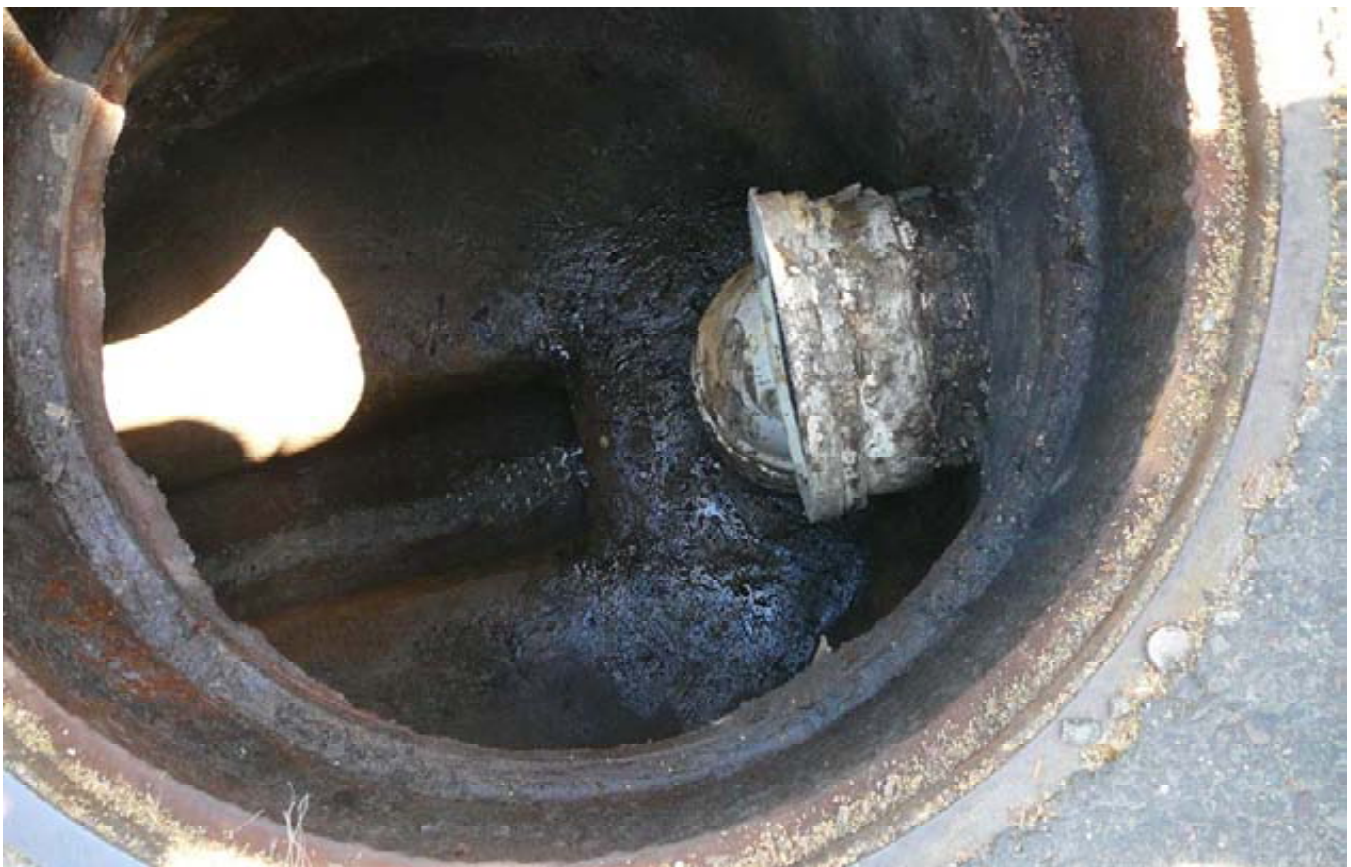
Alameda Photo 10 - Spill site at Alameda Federal Center - Second manhole showing pipe fix

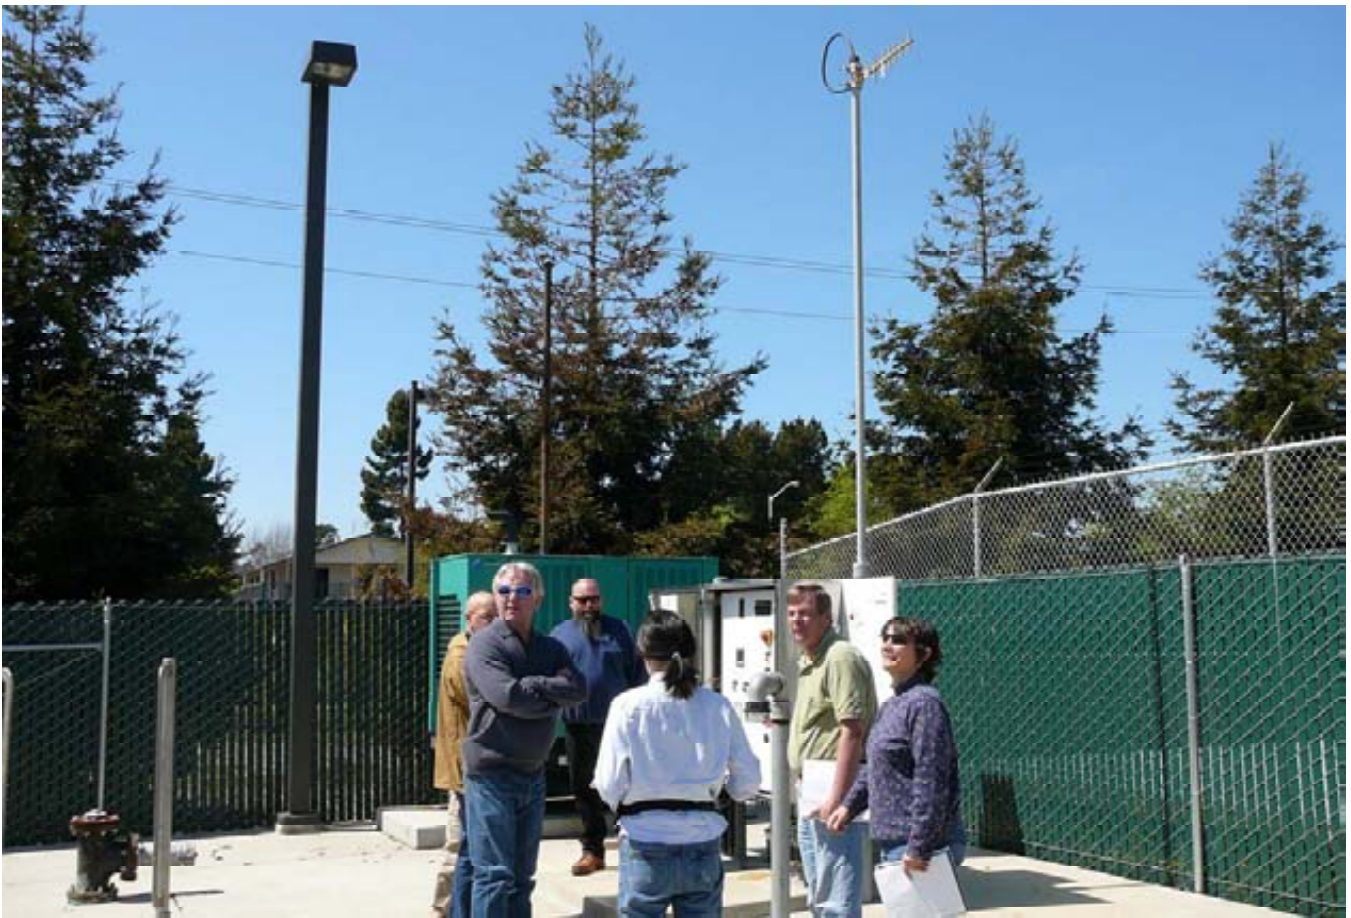
- Lift Station 6 (Photos 11 and 12) – located next to new Coast Guard housing. This is the newest station. It is fenced. SCADA is present. The new force main from this station was broken by a backhoe during installation of irrigation piping. The spill entered a storm water detention pond and was recovered. The spill was reported three times during the period 11/7-8/06, for a combined volume of 7,900 gallons.

City staff stated that there was a spill due to a force main break from Lift Station 6 (Photos 11 and 12) on 11/7-8/2006. The spill entered a storm water detention pond and was fully recovered. This spill was not reflected in the table above filled out by the City. City staff believed that the force main break was indicated as one of the two spills for 2006 from pump stations, but review of the reported spills indicates that there were two pump station spills in 2006. Therefore, SAIC has added the force main spill to the tables above.

Alameda Photo 11 - Lift station 6

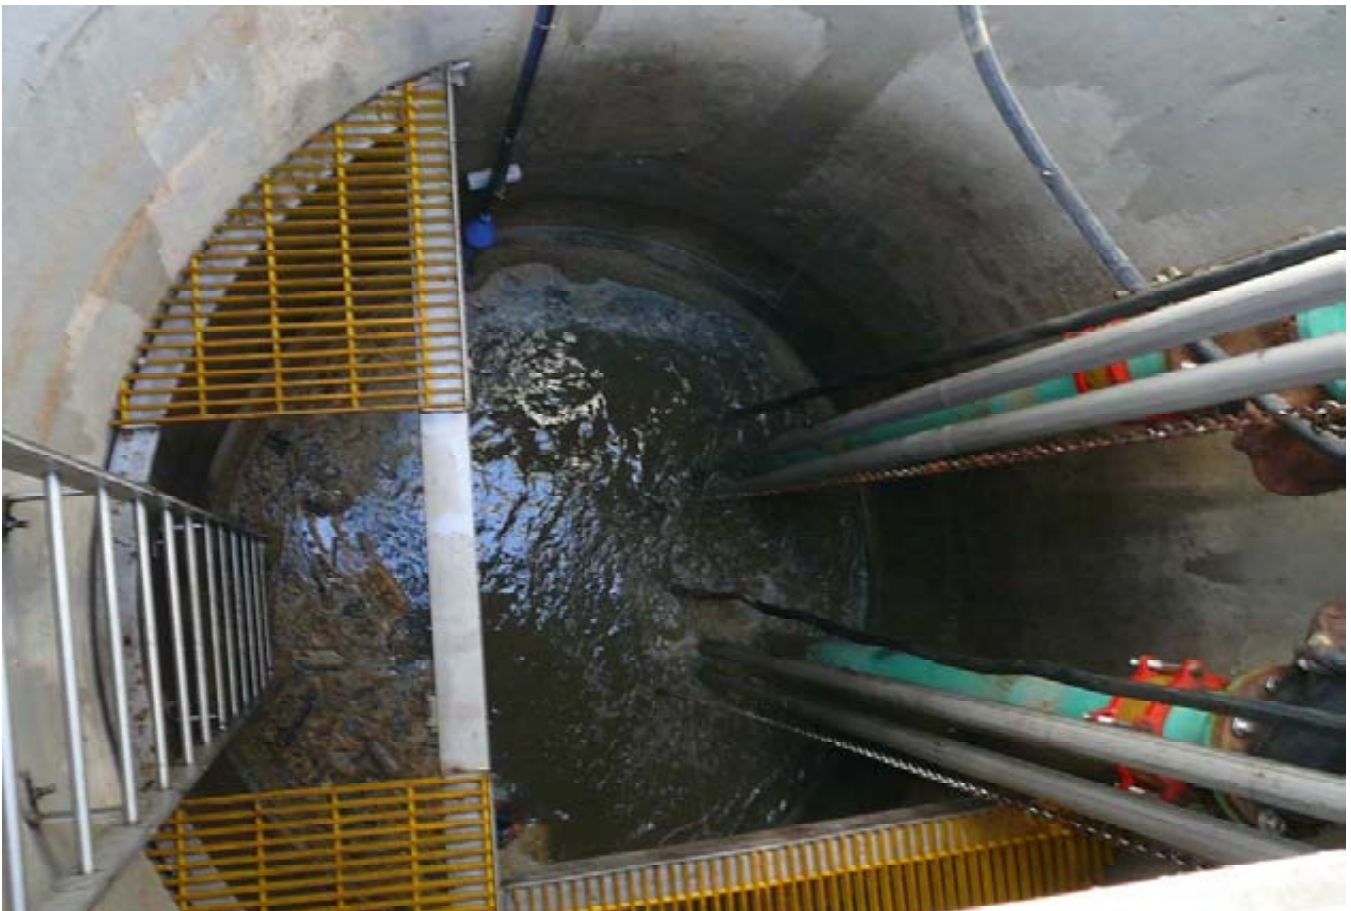
Alameda Photo 12 - Lift station 6 wet well

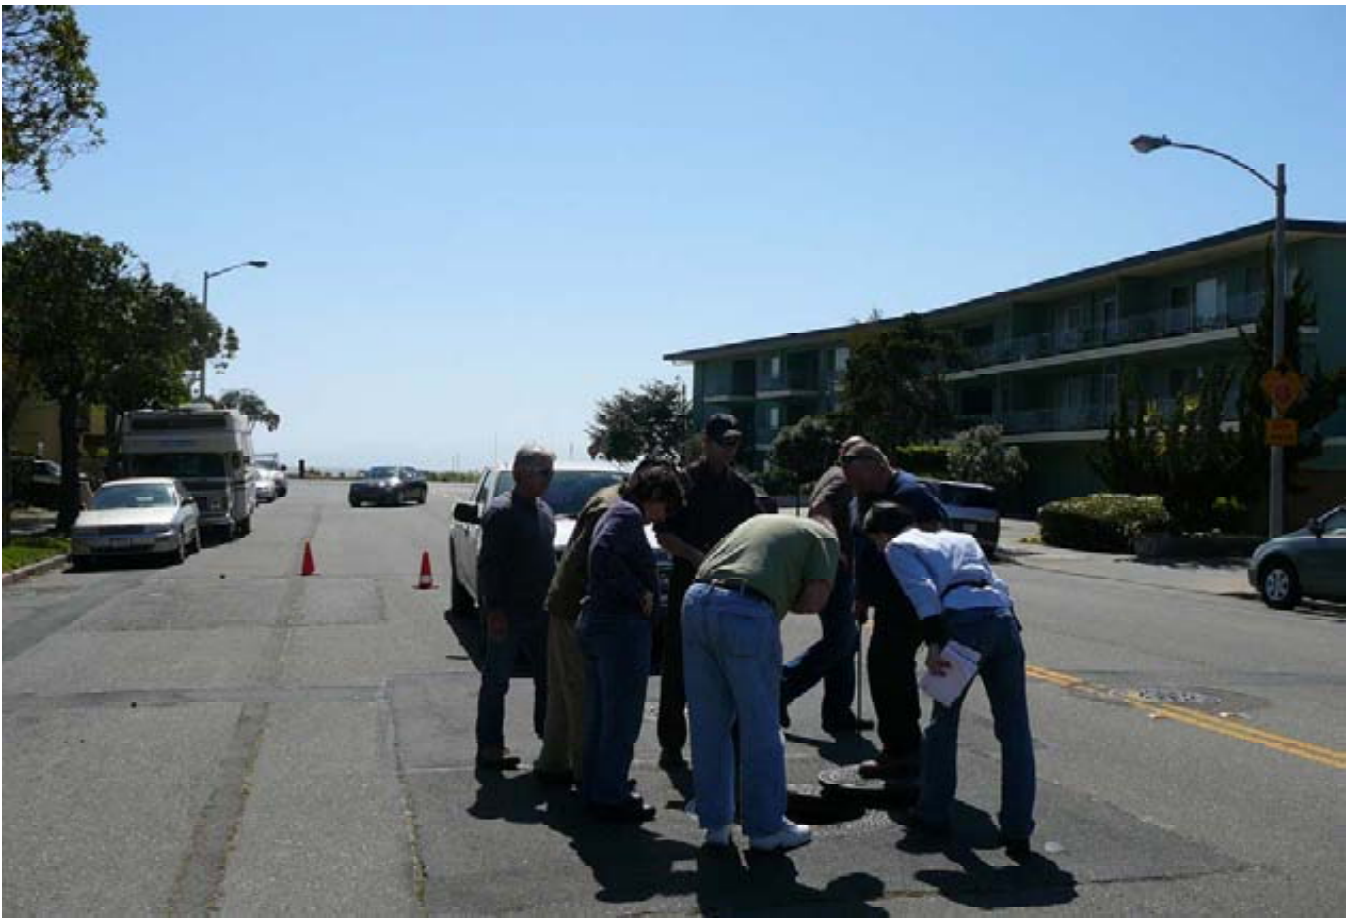
- Willow (Photos 13 – 15) – located in street in residential area near San Francisco Bay. SCADA is present. Any overflow from this station would flow by gravity back to a sewer main.

Alameda Photo 13 - Willow pump station

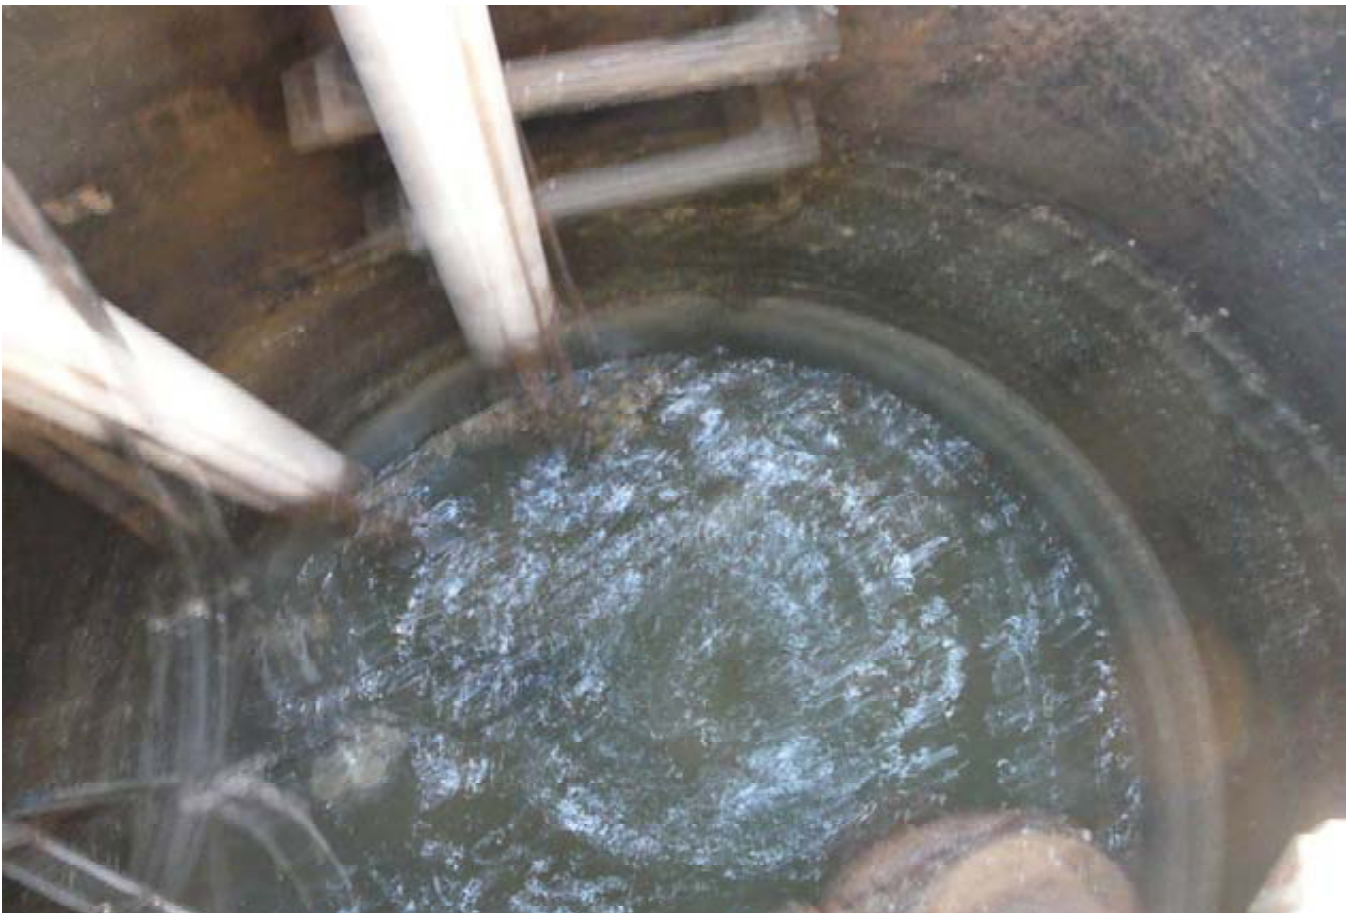
Alameda Photo 14 - Willow pump station wet well

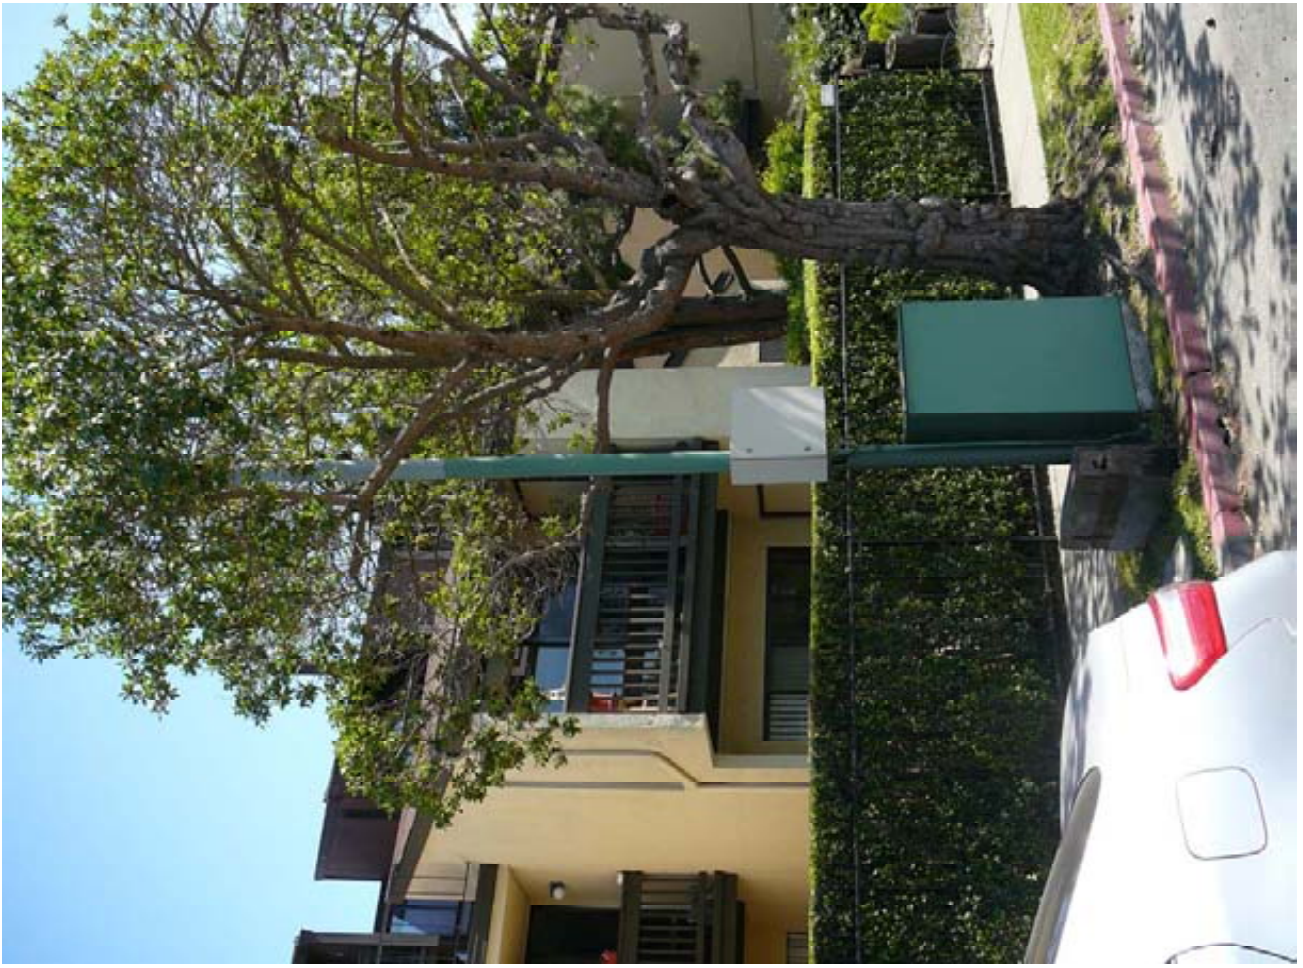
Alameda Photo 15 - Willow pump station SCADA

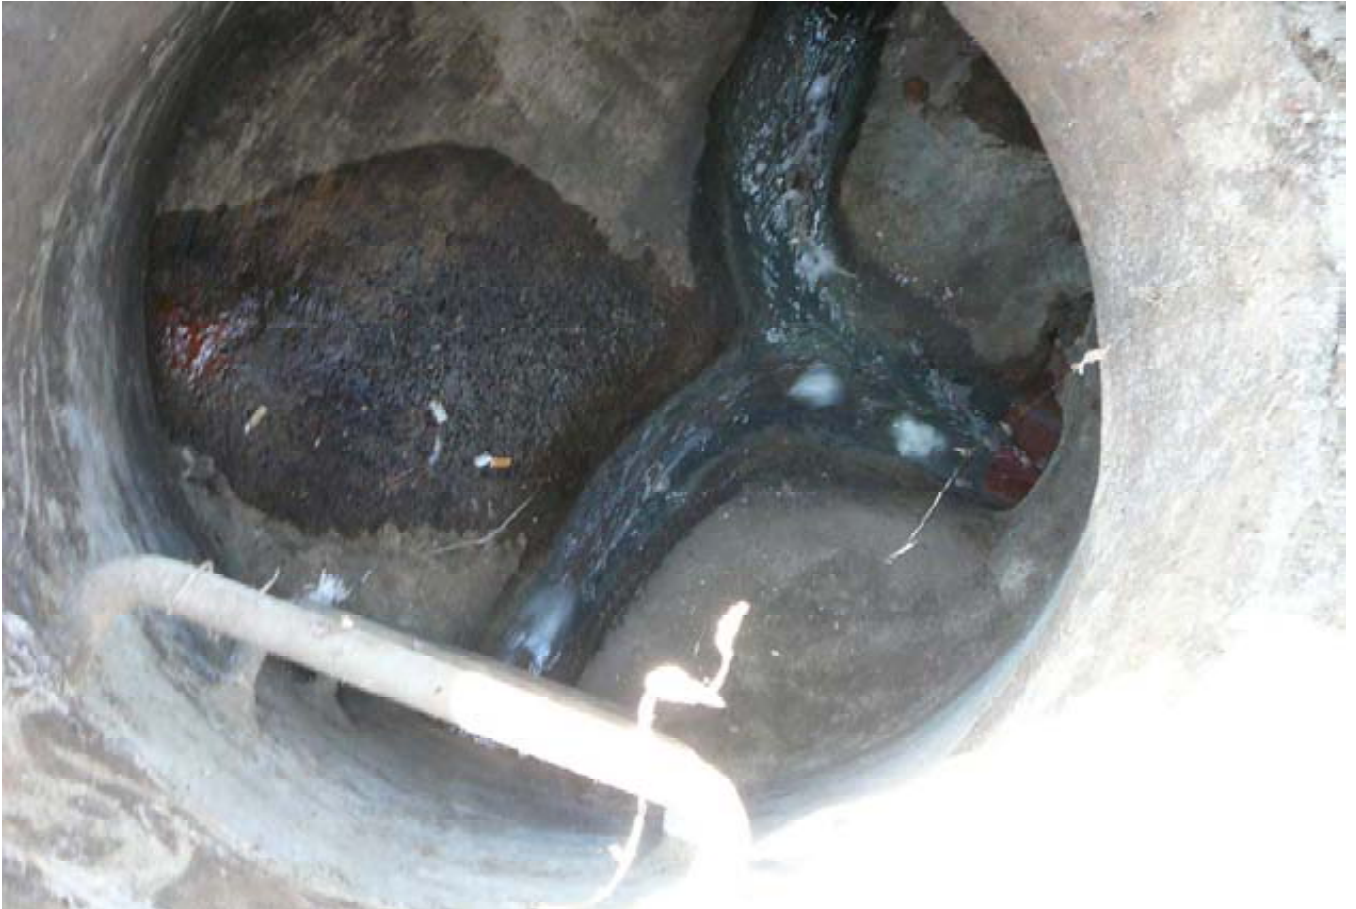
The three spills at 100 and 300 Kitty Hawk Road were due to grease from several apartment complexes at these locations. The inspection team visited the manhole that overflows (Photo 16). City staff stated that they now clean the main every three months to prevent further spills. They have also cooperated with EBMUD to do outreach on grease issues to the nearby residents.

Alameda Photo 16 - Kitty Hawk spill site manhole

SAIC added one location to the hot spot cleaning schedule table above, because the City stated that they clean the Kitty Hawk spill site quarterly.
