**SEWAGE COLLECTION SYSTEM INSPECTION FORM  
City of Emeryville**

**Inspection Date: April 6, 2009**

Utility Name: City of Emeryville		
Address: 1333 Park Avenue, Emeryville, CA 94608		
Contact Person: Maurice Kaufman Public Works Director/City Engineer		
Phone: 510-596-4334	Cell:	Fax: 510-596-4389
Email: <a href="mailto:mkaufman@ci.emeryville.ca.us">mkaufman@ci.emeryville.ca.us</a>

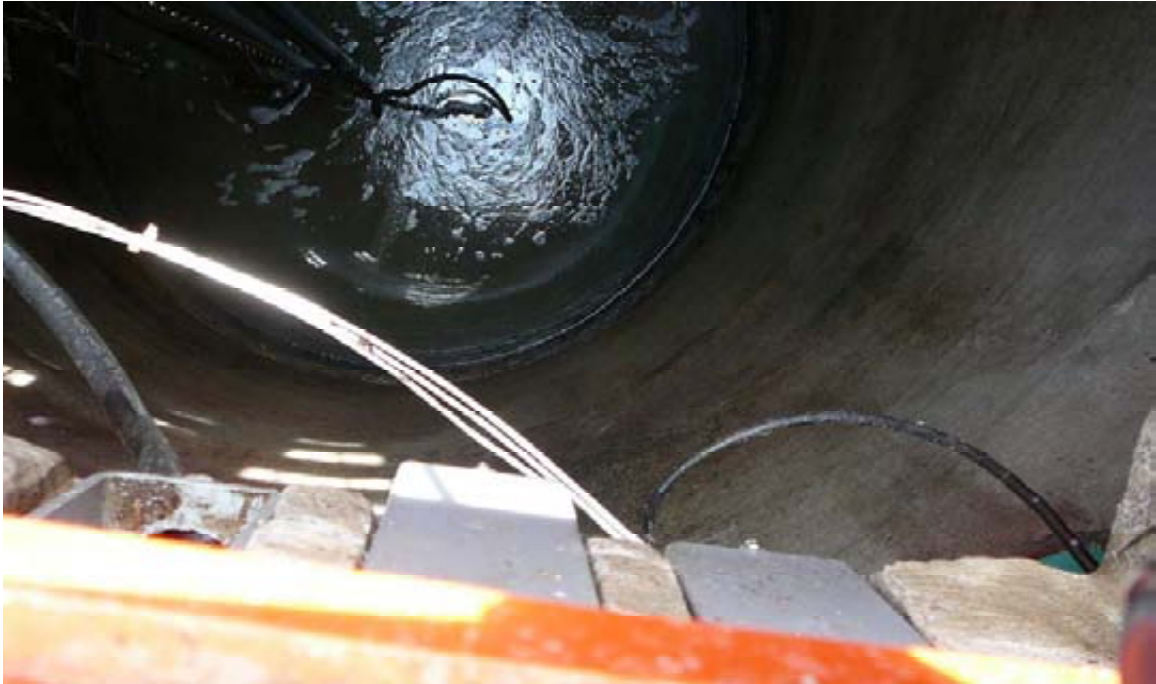
The inspection team visited the Marina pump station (Photos 1 – 4). This is the City’s only pump station, and it serves a large restaurant and some bathrooms. There was some grease visible in the wet well. A visible alarm is present, and alarms are also sent to City staff. The station does not have a backup generator onsite, but the City does have a portable generator that can be brought out in case of power loss. According to City staff, there has never been a spill from this pump station.

Emeryville Photo 1: Marina pump station wet well. Some grease visible.

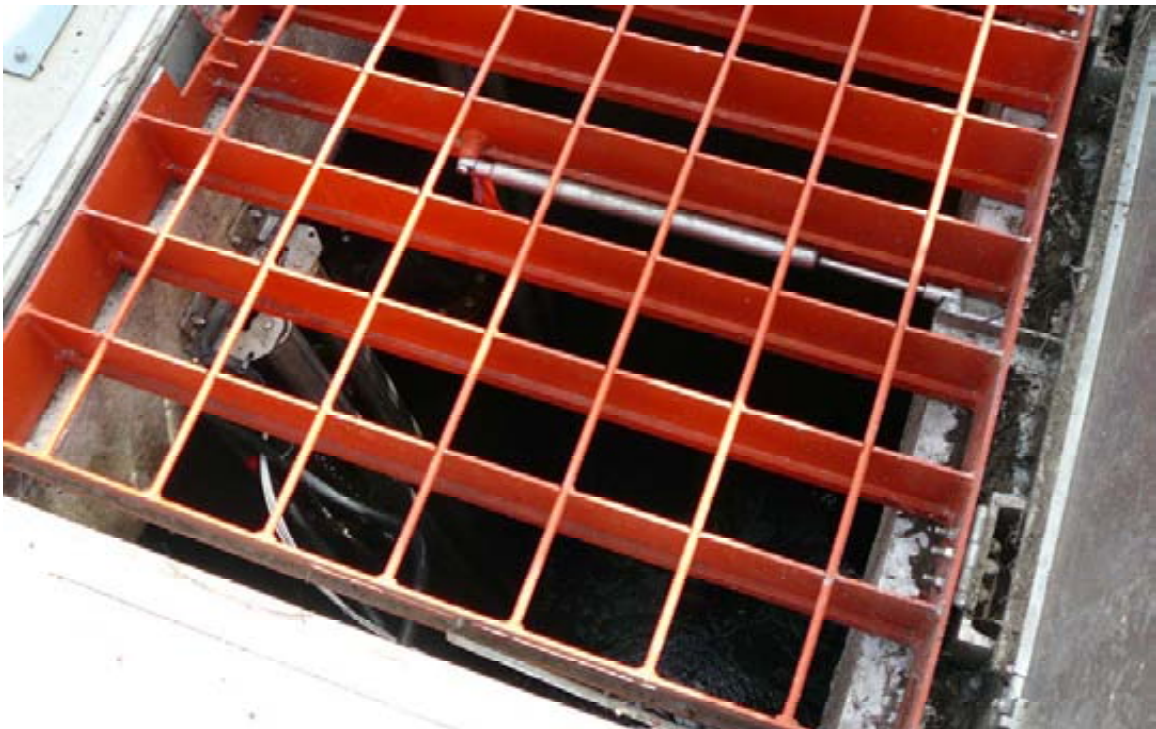
Emeryville Photo 2: Safety cover over Marina pump station wet well.

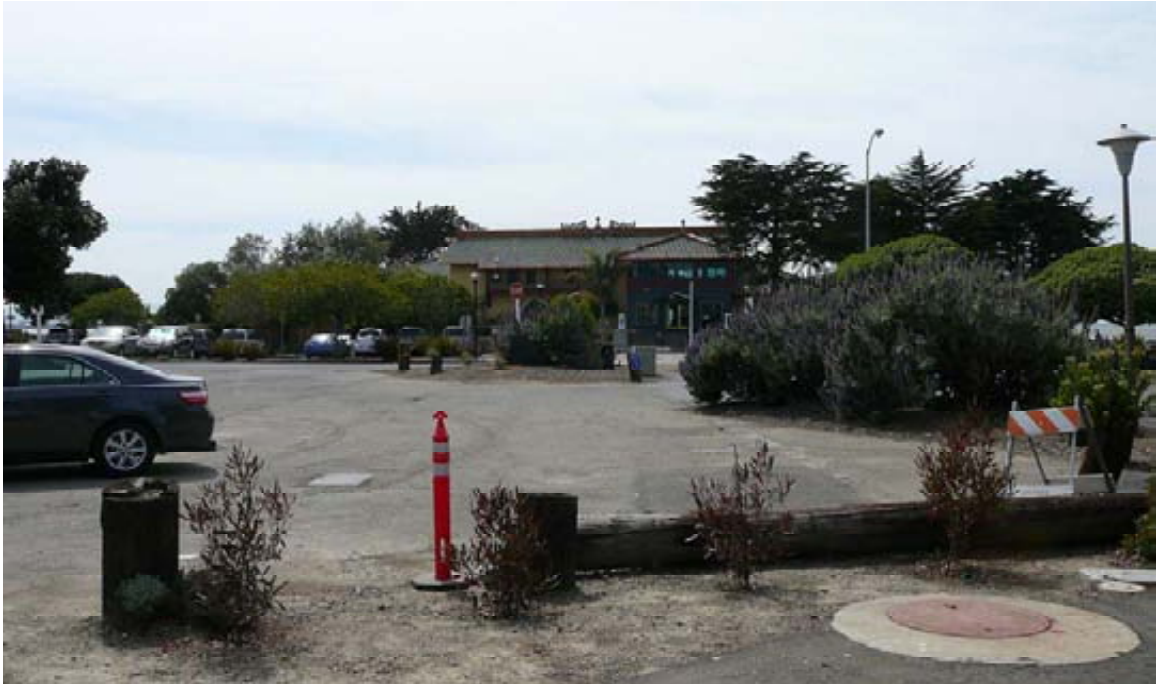
Emeryville Photo 3: View of Hong Kong restaurant from Marina pump station.

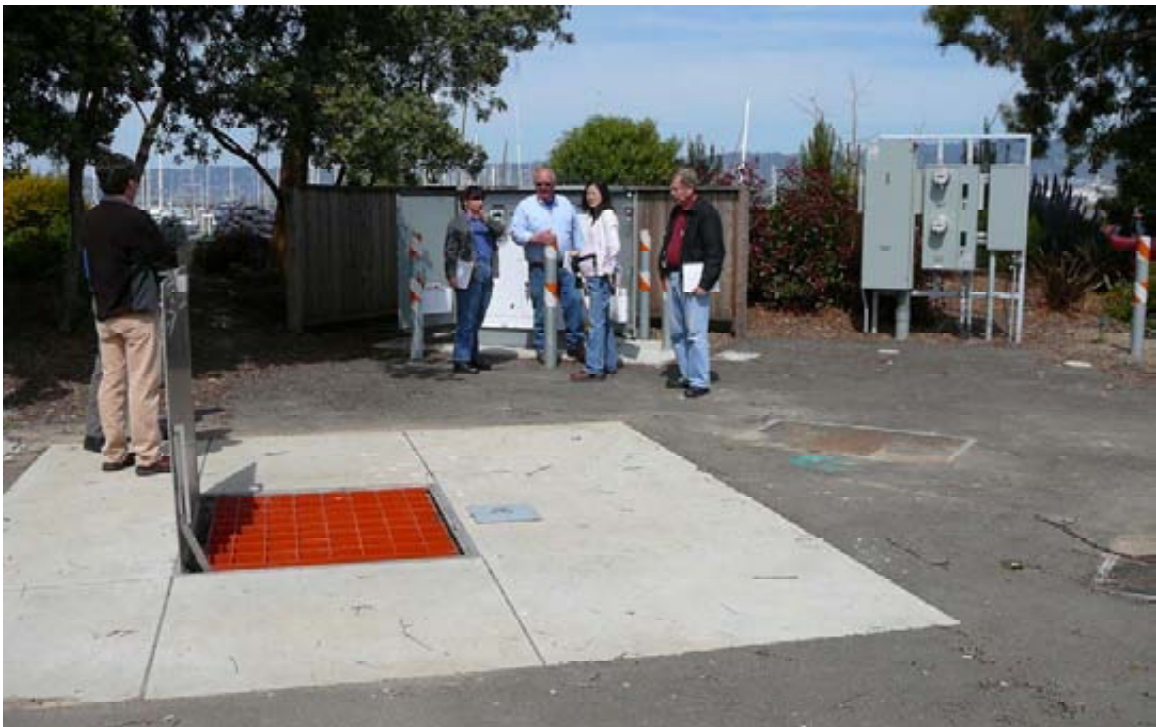
Emeryville Photo 4: Marina pump station and controller box.

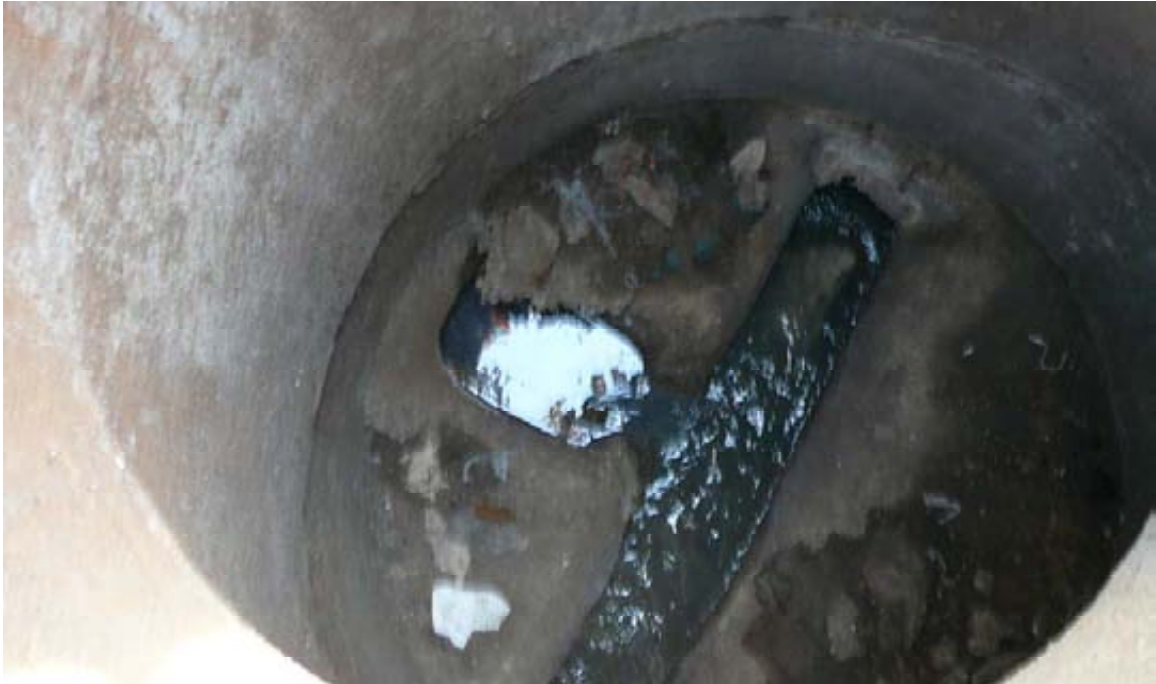
City staff noted that their hydraulic model indicates that the main where the 2/15/09 spill occurred may be undersized. This spill occurred during a rainfall event. The City plans to replace this main. The inspection team visited this spill site (Photos 7 and 8). The inspection team also visited the location of the spill on 11/16/07 (Photos 5 and 6).

Emeryville Photo 5: Manhole outside 1400 65th Street, where grease blockage occurred.

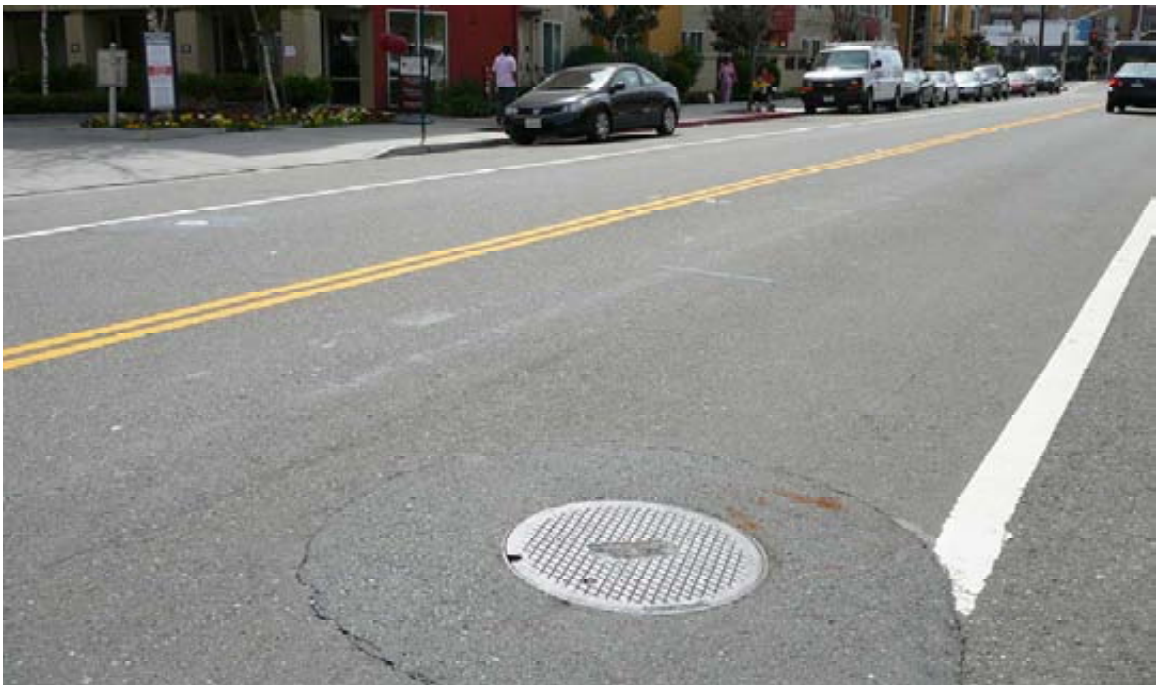
Emeryville Photo 6: 1400 65th Street - manhole cover showing pickhole that wastewater came out of.

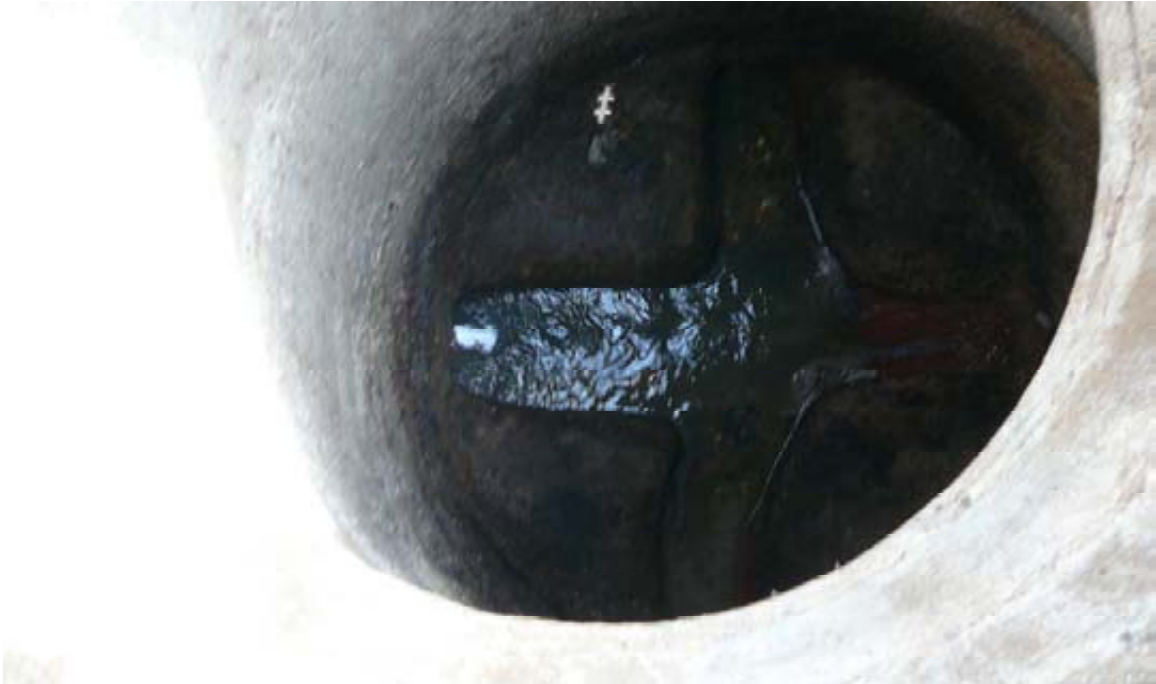
The area at 63<sup>rd</sup> and Vallejo where there have been blockages due to debris thought to be coming from Oakland is not on the hotspot schedule. The debris contained beer cans, so there is also concern that a cross connection might be involved. City staff did not contact Oakland about this issue.

Emeryville Photo 7: Manhole that overflowed at 63rd Street due to debris. Oakland flow enters from left.

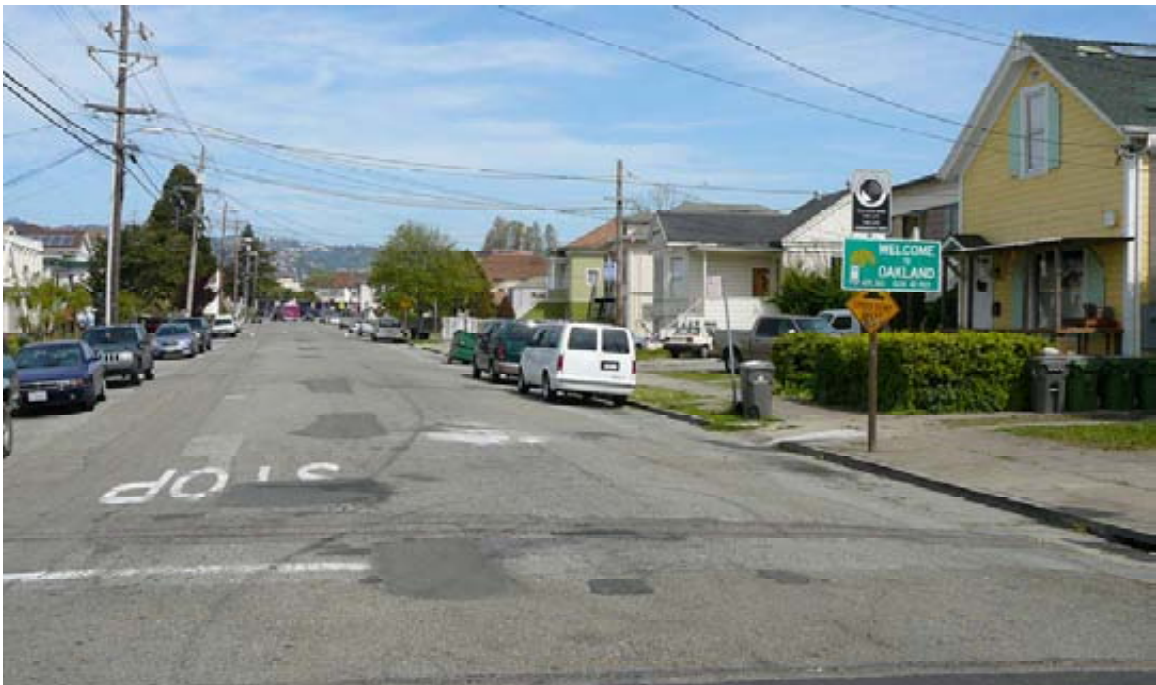
Emeryville Photo 8: 63rd Street spill site - Oakland boundary is just feet from the spill site.
