SEWAGE COLLECTION SYSTEM INSPECTION FORM
Stege Sanitary District

Inspection Date: March 30 – 31, 2009

Utility Name: Stege Sanitary District (SSD)		
Address: 7500 Schmidt Lane El Cerrito, CA 94530		
Contact Person: Douglas Humphrey		
Phone: 510/524-4667	Cell:	Fax: 510/524-4697
Email: doug@stegesd.dst.ca.us

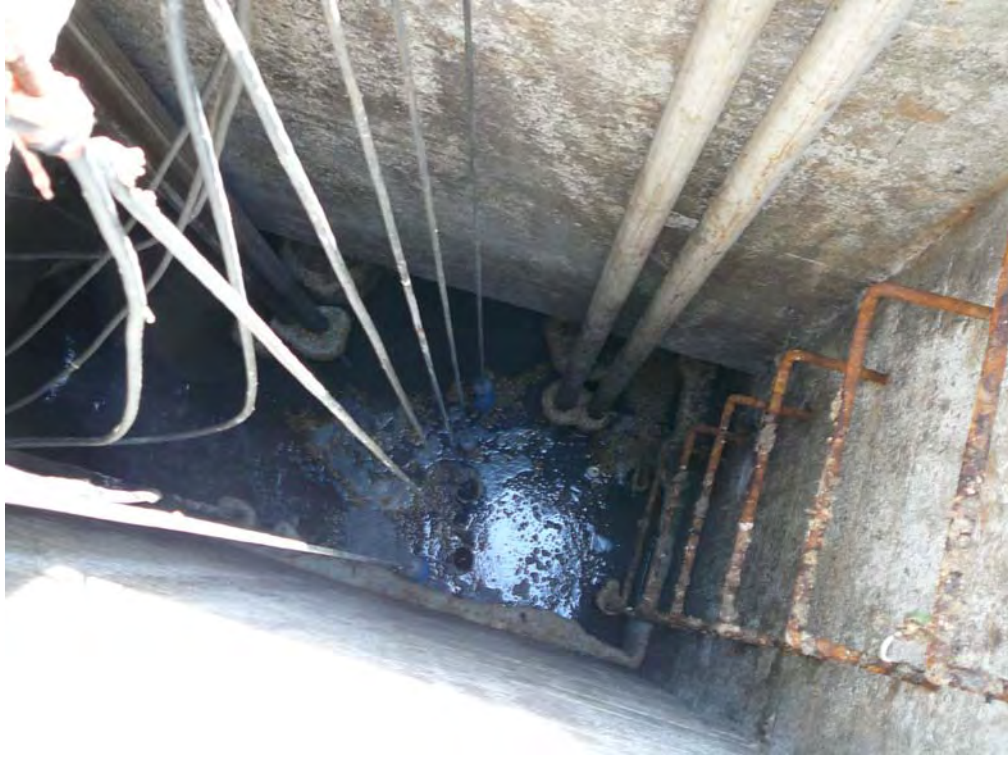
Photo 1 Burlingame pump station wet well

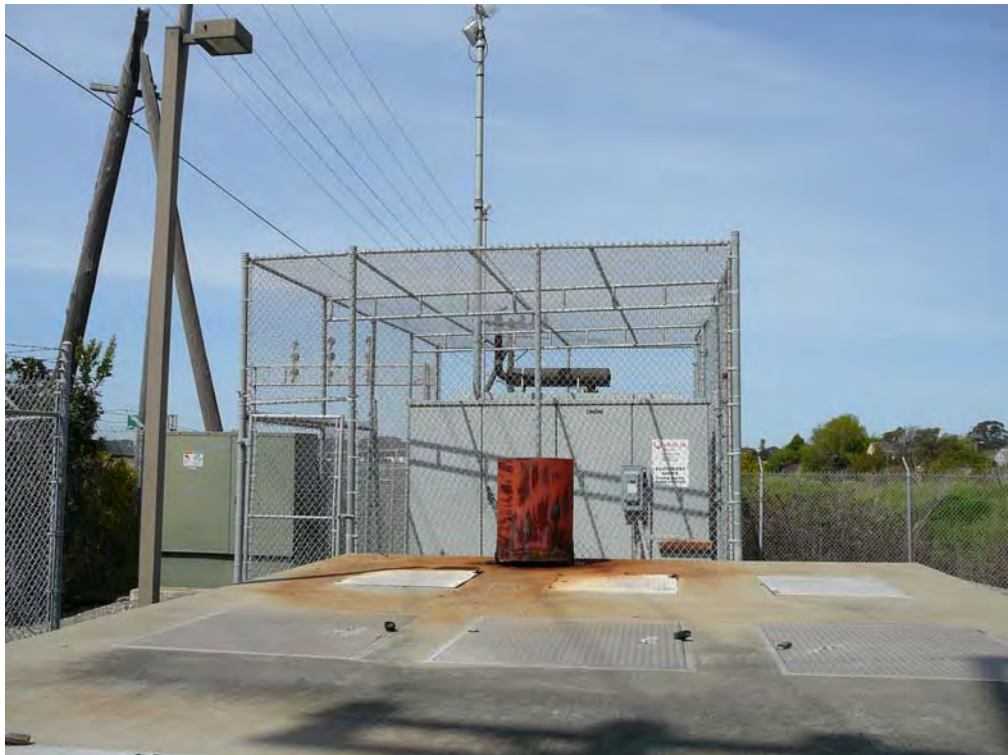
Photo 2 Generator for Burlingame pump station

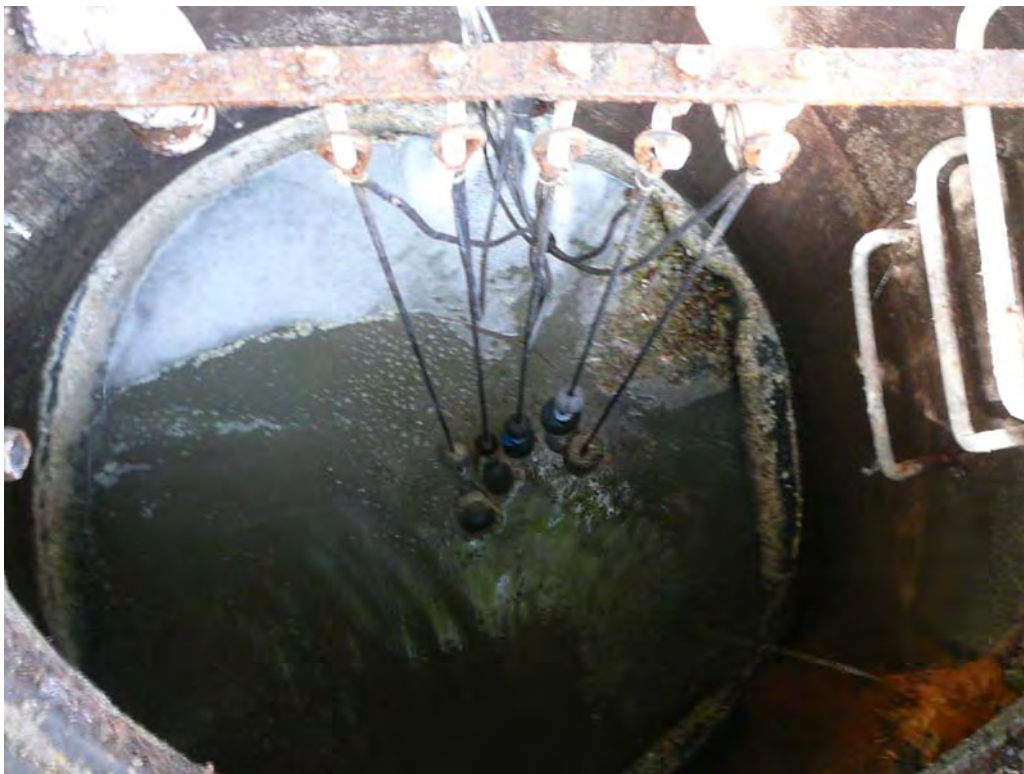
Photo 6 Cannon pump station wet well

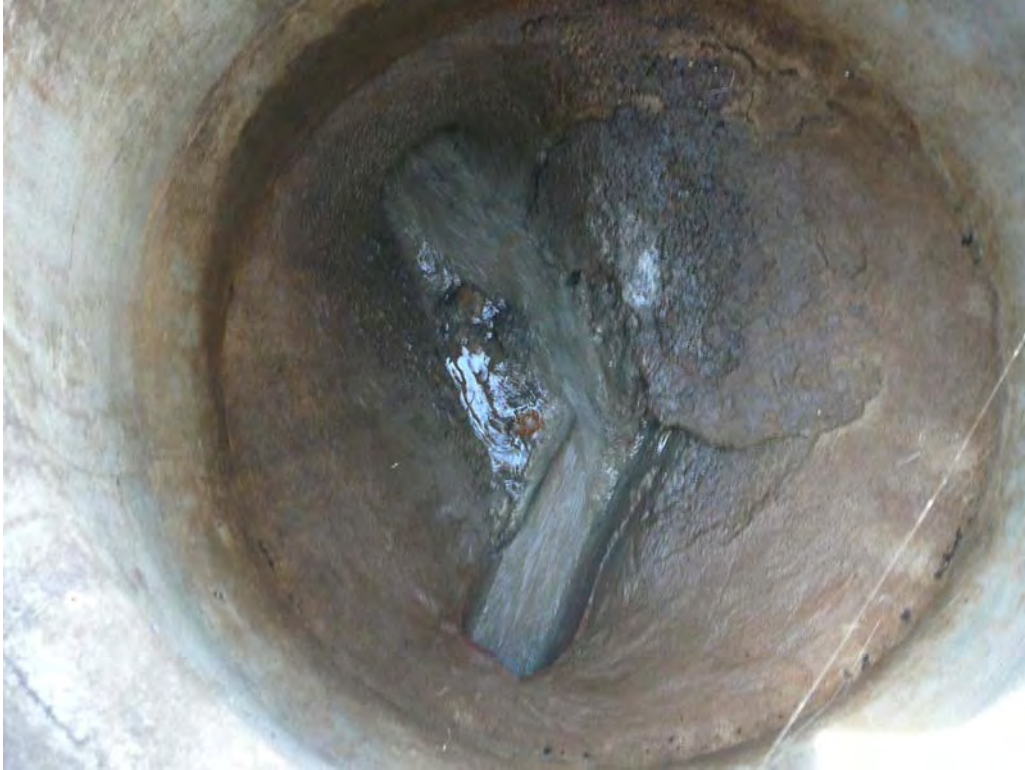
The inspection team also visited capacity spill sites at Stanford & Wellesley (Photos 7 and 8) and Ocean View & Coventry (Photo 9) where spills occurred in 2005. SSD performed work at these locations to prevent further spills. This may not have completely resolved the situation, however. SSD continues to look for ways to address these situations. They smoke tested the Stanford & Wellesley area last fall and found that laterals contribute heavily to I/I in this area. SSD tells the homeowner about the problem but can’t make them replace the laterals (outside of a change of ownership). They haven’t found many connected roof leaders or sump pumps. They believe that the problem is made worse by holes in the corrugated metal storm drain pipes, which allows storm water to seep into the sanitary sewer.

Photo 9 "Ocean View & Coventry" - reduced 90 degree bend in pipe to prevent overflows
