NPDES Storm Water Inspection Report

Facility Location Information			
Name/Location/ Mailing Address	Sims Metal Management (Sims) 699 Seaport Blvd. Redwood City, CA		
GPS Coordinates	Latitude	37° 30' 40.6"	Longitude 122° 12' 29.6"
Receiving Water(s)	Redwood Creek – Navigable estuary to San Francisco Bay		
	Name	Telephone	
Owner	Steven Shinn – Regional General Manager	510-412-5300	
Operator	Joe Barco – Operations General Manager	510-412-5300	
Environmental Coordinator	Matt Zeiter – On-site Rep	510-715-7569

<u>General</u>	
Inspection Objective, Attendees, and Opening Conference Summary.	<p>The inspection's objective was to determine compliance with the California Industrial General Permit No. CAS000001.</p> <p>In addition to EPA inspectors previously identified, the inspection was attended by Estuardo Montufar (650.372.6240) and Sabrina Mih (650.372.6235) with San Mateo County Environmental Health Services Division (Certified Unified Program Agencies – CUPA), and Matt Zierter (510.412.5300), Mariya Semeit (650.369.4161), Dale Leuer (650.369.4161), and Vistasp Patel (650.369.4161) with Sims Metals Management (Sims or Facility Representatives)</p> <p>Prior to commencing the inspection

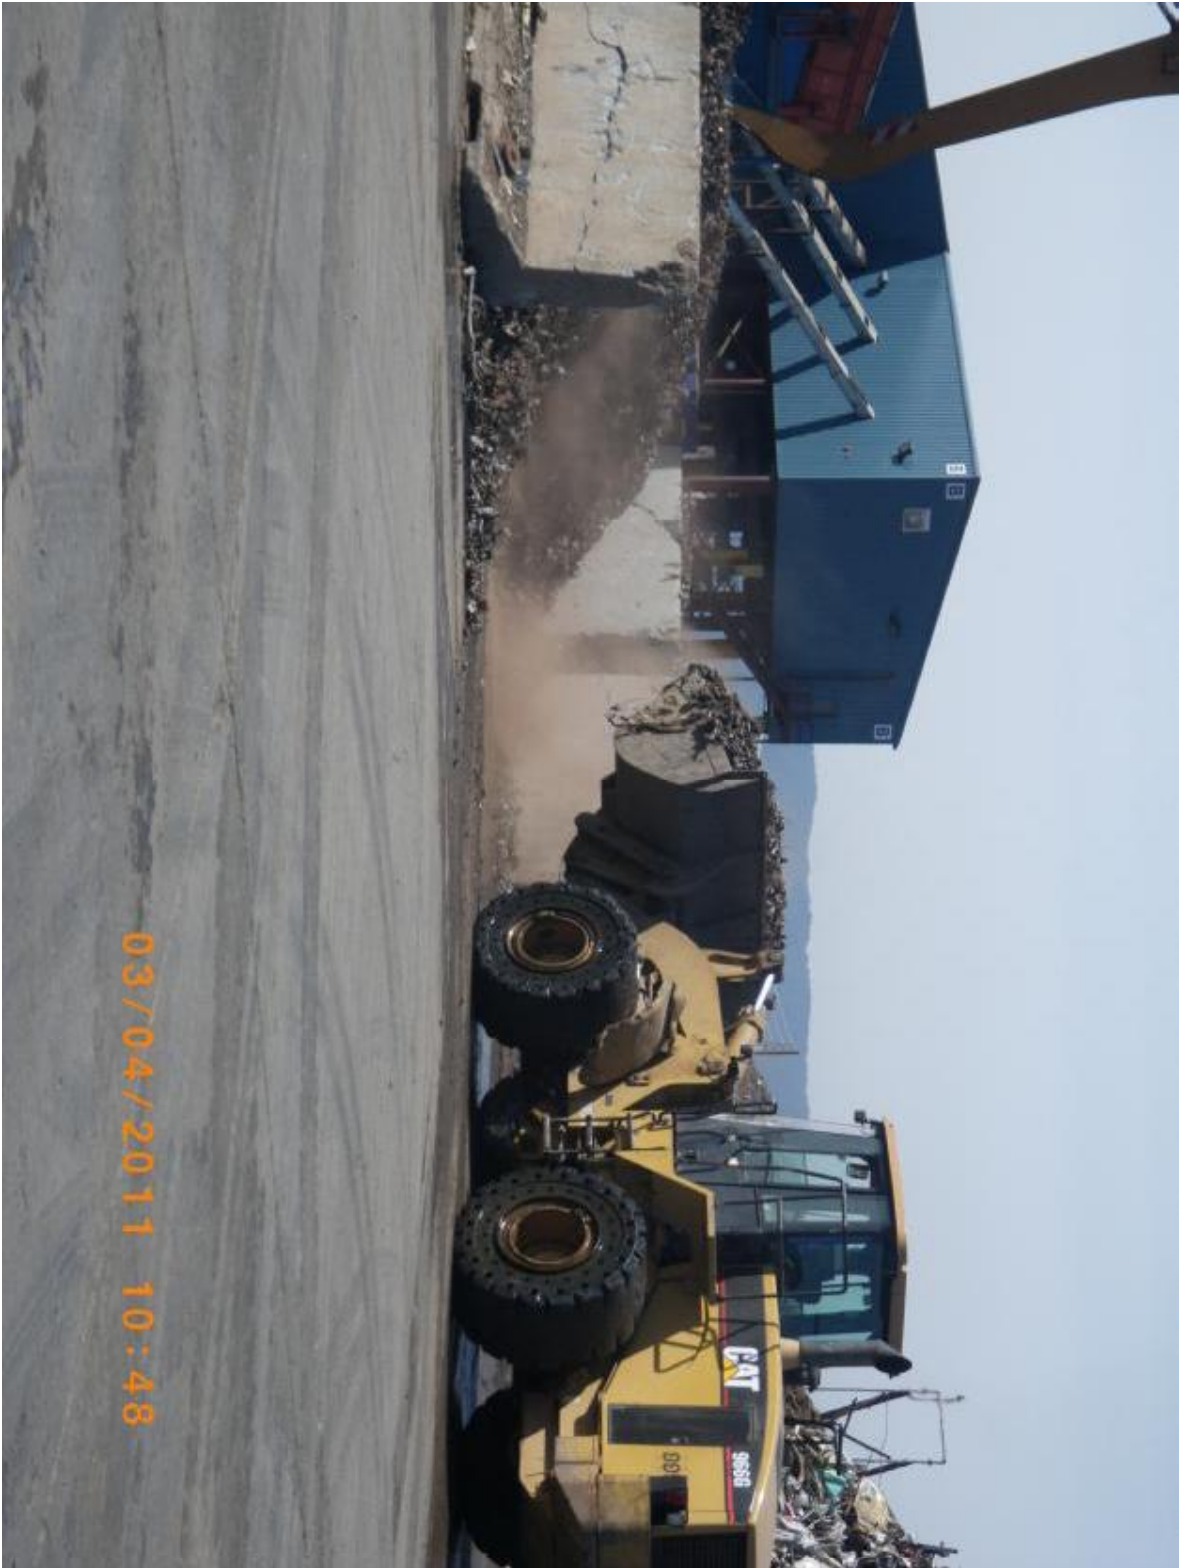
IMGP0197.JPG

IMGP0197 – Rubber-tired loader is moving shredded metals to a pile within pond 2. (Note: rust-colored dust was observed being generated by this operation.)

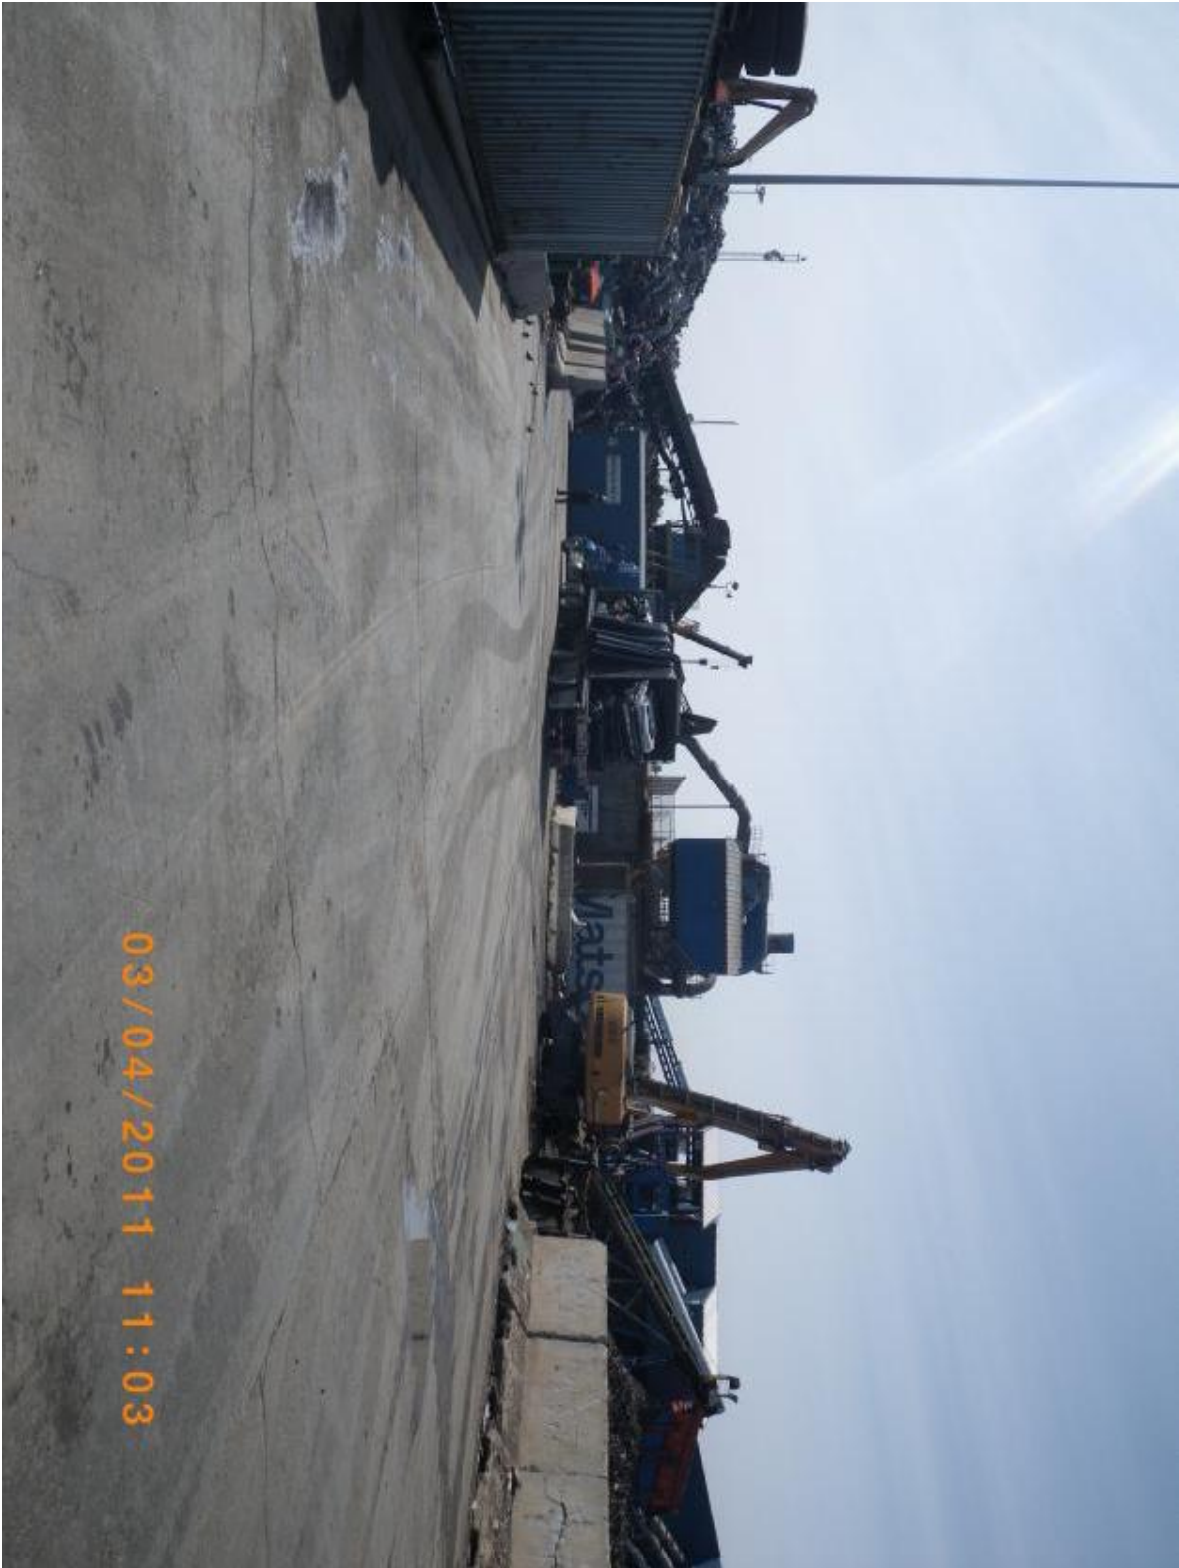
IMGP0198.JPG

IMGP0198 – Same location and activity as IMGP0197, and observed dust generation.

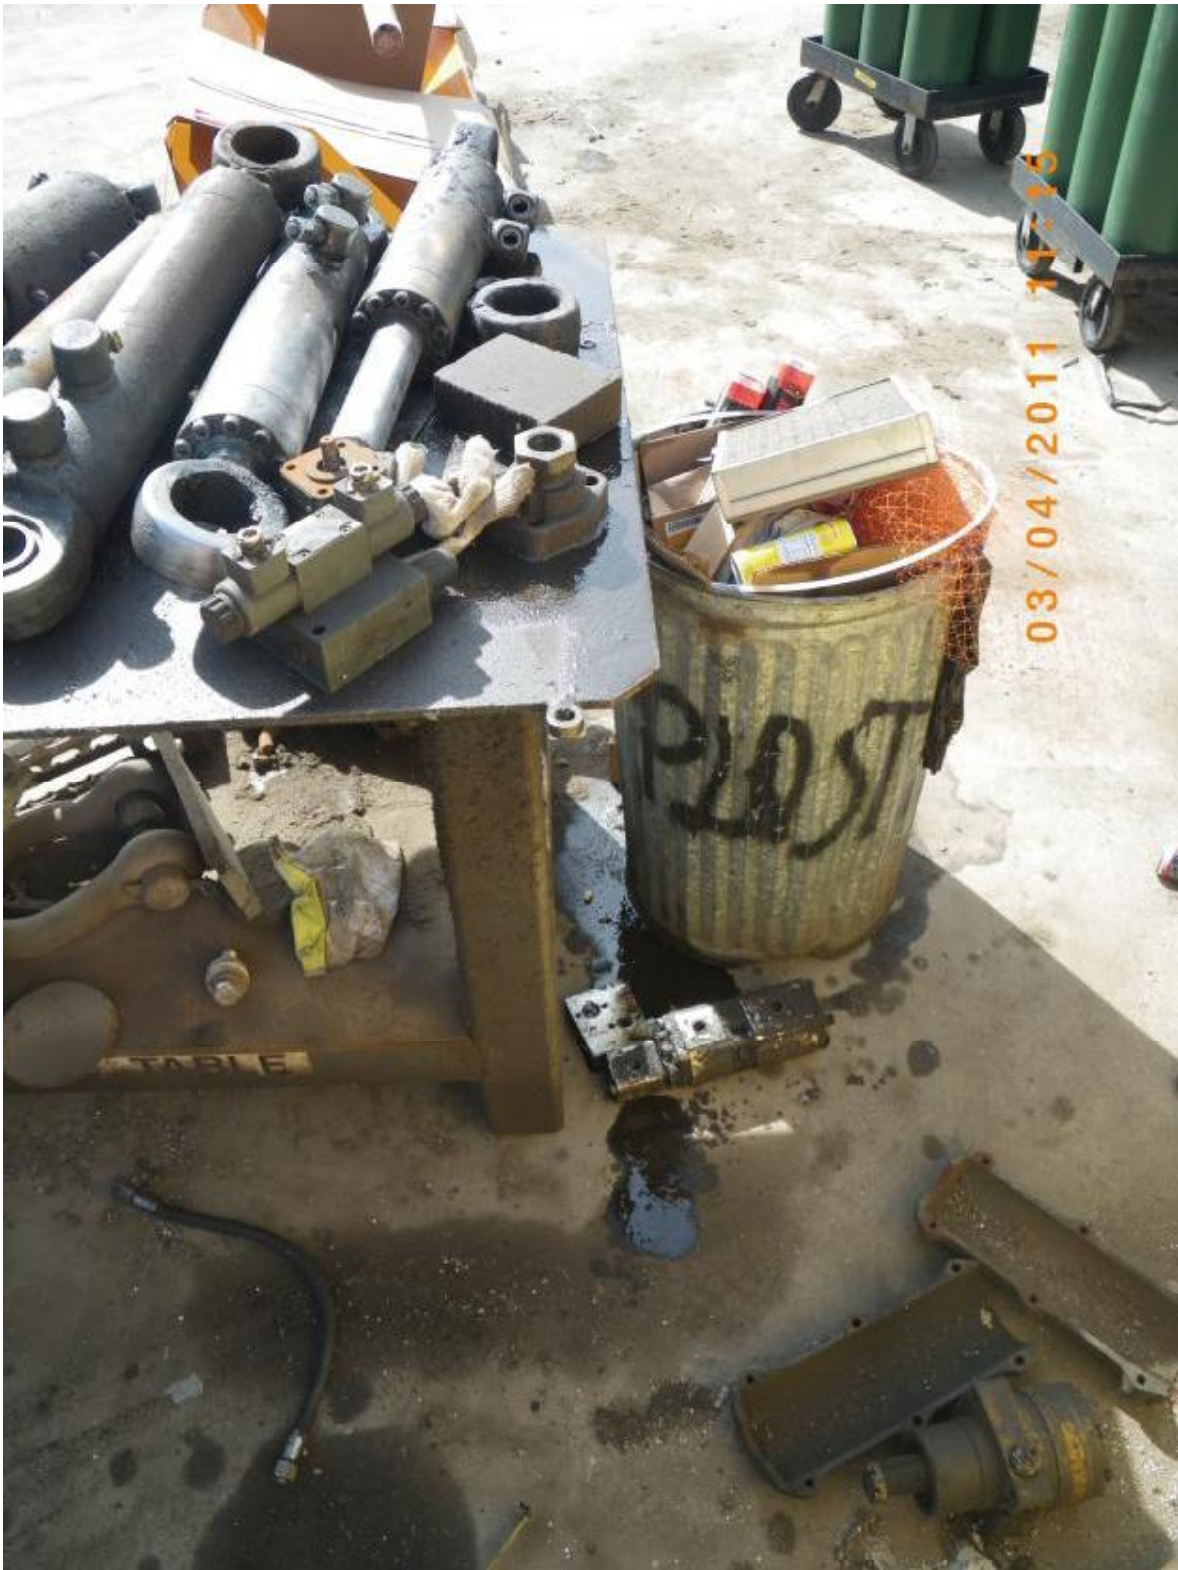
IMG0208.JPG

IMGP0208 – Maintenance area, northwest corner looking east; area is bermed and accumulated debris (absorbent material and trash) was observed.

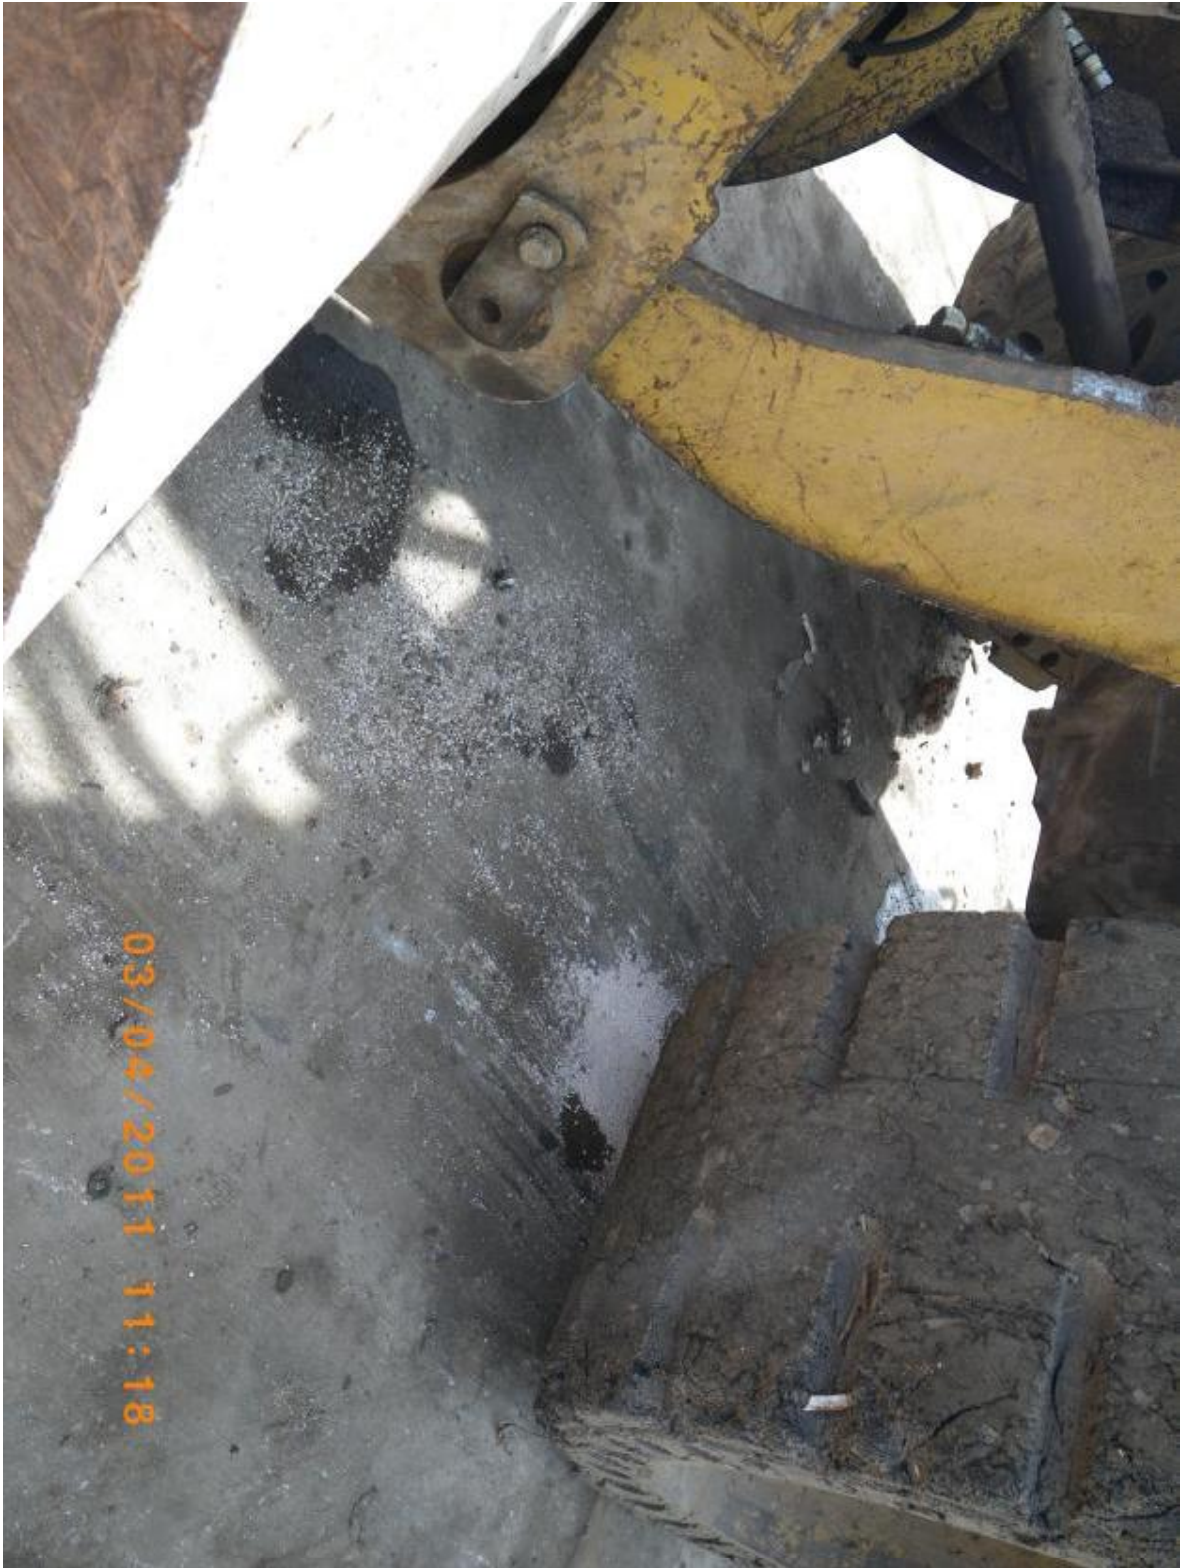
IMGP0211.JPG

IMGP0211 – Maintenance area, leaking oil from loader was observed on the ground.

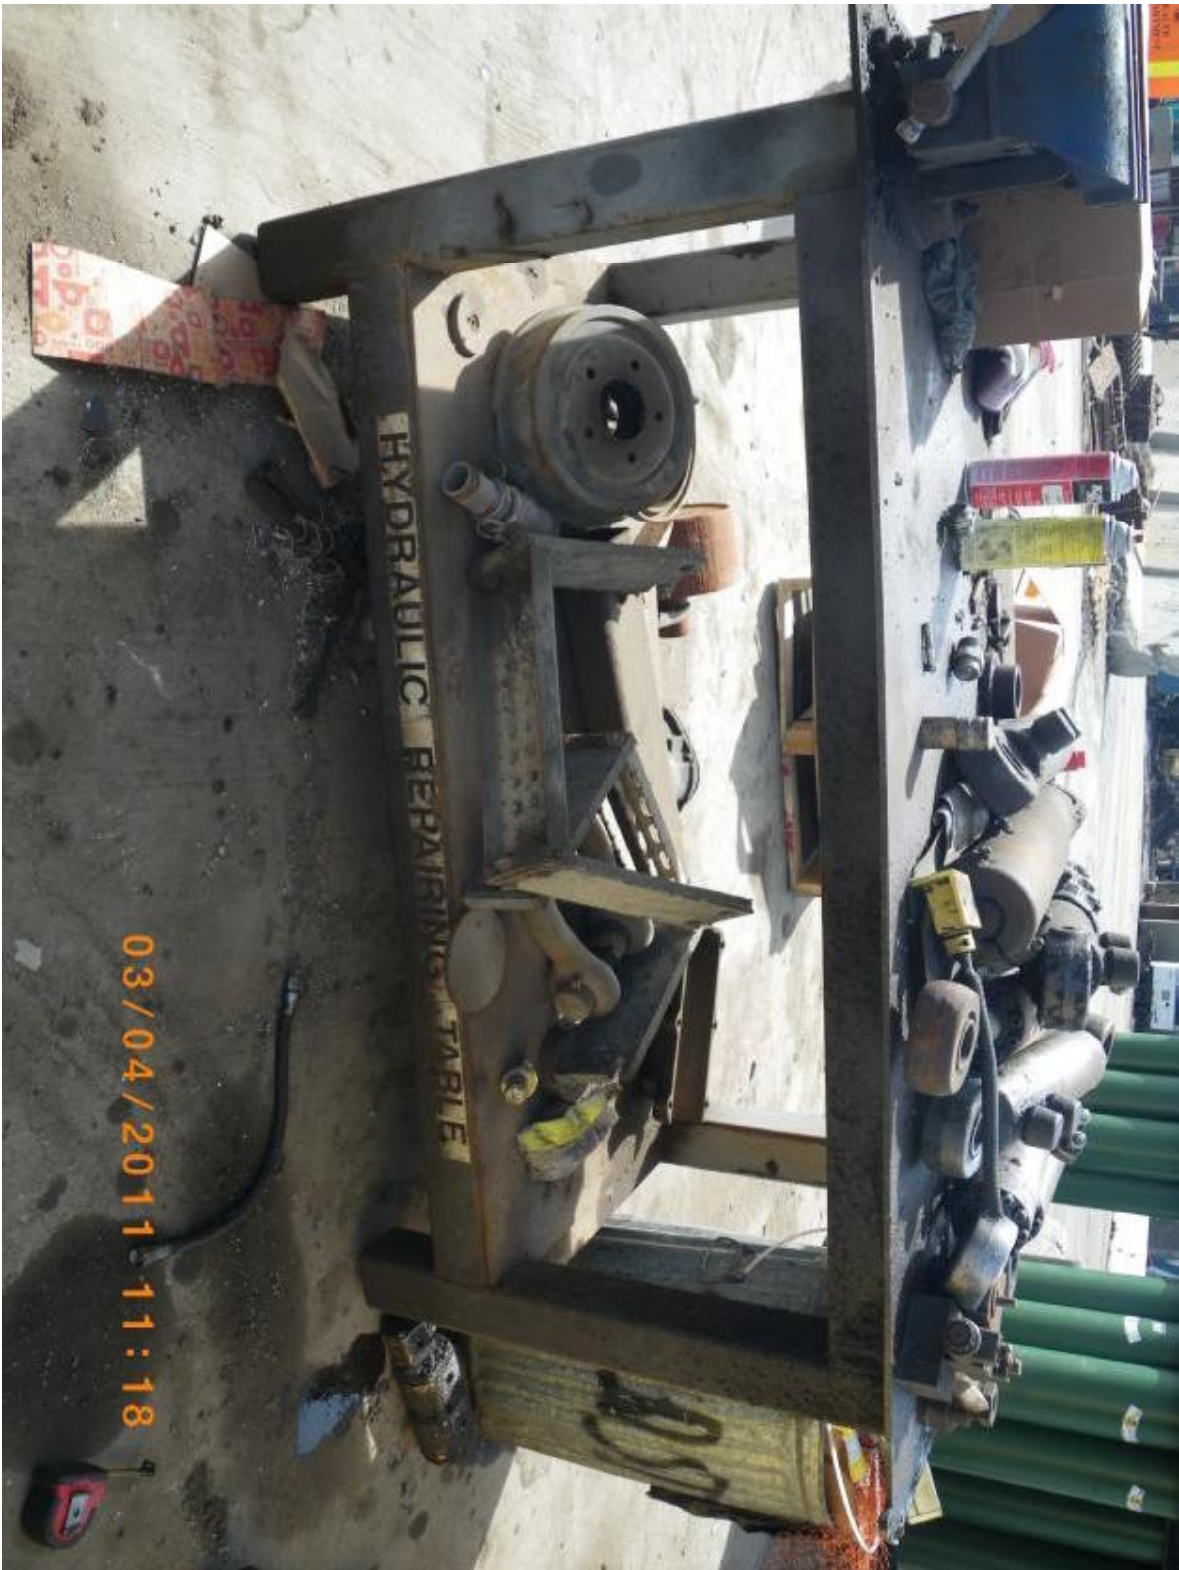
IMGP0212.JPG

IMGP0212 – Maintenance area, oil staining and deployed absorbent was observed.

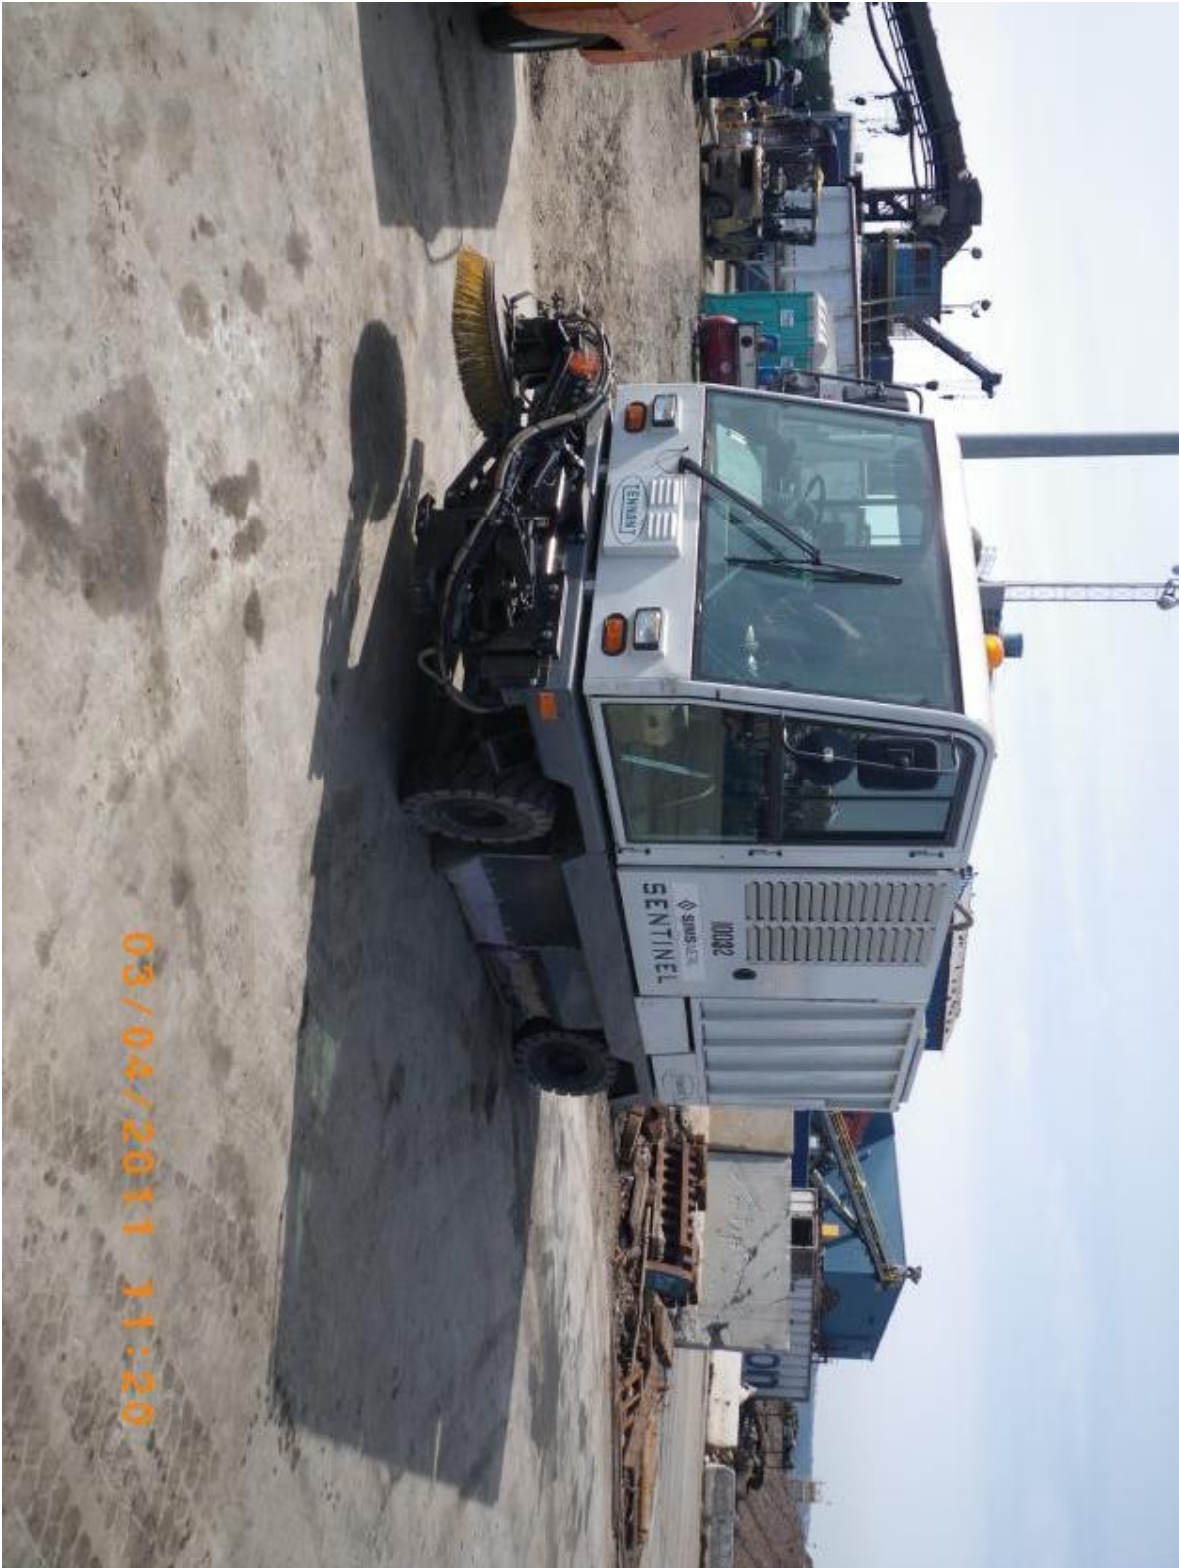
IMGP0215.JPG

IMGP0215 – Maintenance area (center of the area looking east), with oils staining and tire tracks through oil stains were observed.

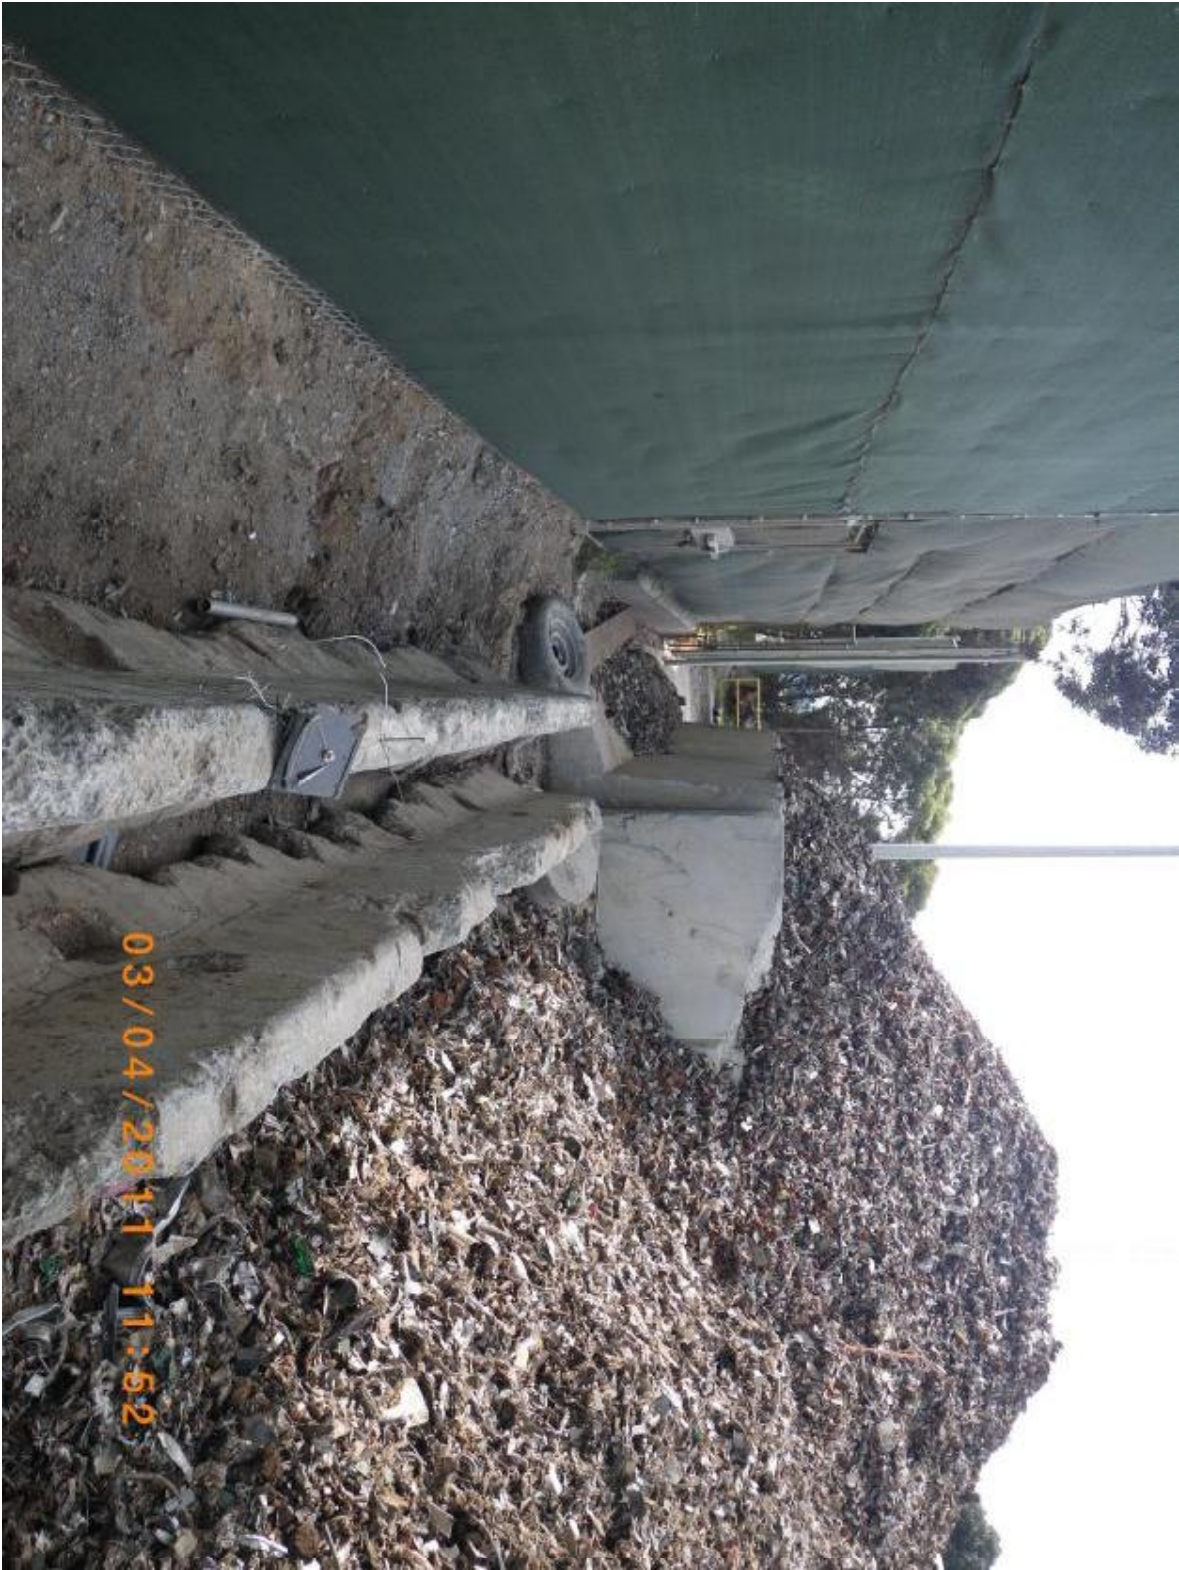
IMGP0230.JPG

<p>condition?</p>	<p>assessed. Inspectors observed covers on most of the inlets might prevent the introduction of debris (IMGP0230, 0236, 0238, and 0240), though it was unclear if the coverings might also impede the flow of storm water into the inlets. The ponds appeared to be retaining (or detaining?) water as designed, with the potential for greater capacity. IMGP0242 depicts minor seepage along pond 2's western berm. Site contouring would appear to direct any significant seepage to the storm sewer collection system, and subsequently back into the pond.</p> <p>Inspectors observed facility personnel washing a sweeper, and observed collection of the rinsate for treatment (IMGP0224 and 0225).</p> <p>Inspectors observed dust suppression controls, except "wetting" dust suppression was not observed in operation.</p> <p>As stated above, material and waste storage practices did appear appropriate and effective to minimize exposure of pollutant sources to storm water.</p> <p>Inspectors observed sediments with potential for track-out throughout a significant portion of the facility's driving surface area, despite representations made to inspectors that regular sweeping occurs. The sweeping that occurs is not sufficient to minimize the discharge of pollutants from track out.</p> <p>Inspectors observed multiple spill kits throughout the facility, and absorbent deployed in multiple locations. A significant amount of residual oil staining observed at the facility indicates that spill response measures and leak detection practices may not be adequate to sufficiently minimize the discharge of pollutants resulting from the track-out of oil residue or from leaking equipment parked, staged, or operating beyond the perimeter containment berm.</p> <p>Facility personnel provided training logs and syllabi for review during the inspection. Inspectors did not request copies during the inspection.</p> <p>Inspectors reviewed the facility inspection reports required by the permit, and found the reports were incomplete since the reports' focus was limited to only those areas within the perimeter containment berm, and did not address areas outside the perimeter containment berm where industrial activity and associated pollutant sources could also result in the discharge of pollutants in storm water to the Creek, such as from operation of the ship loading conveyor, its underlying catchment platform, and from the operation and maintenance of equipment associated with these industrial activities.</p> <p>As previously discussed, the ship loading conveyor's catchment platform was poorly maintained, and gaps in the containment wall were not cleared of debris (IMGP0262).</p>

IMGP0230 – Along the eastern boundary the facility near an electrical station, steel plates cover an inlet for the onsite storm collection system. Scattered debris and welding torch were observed.

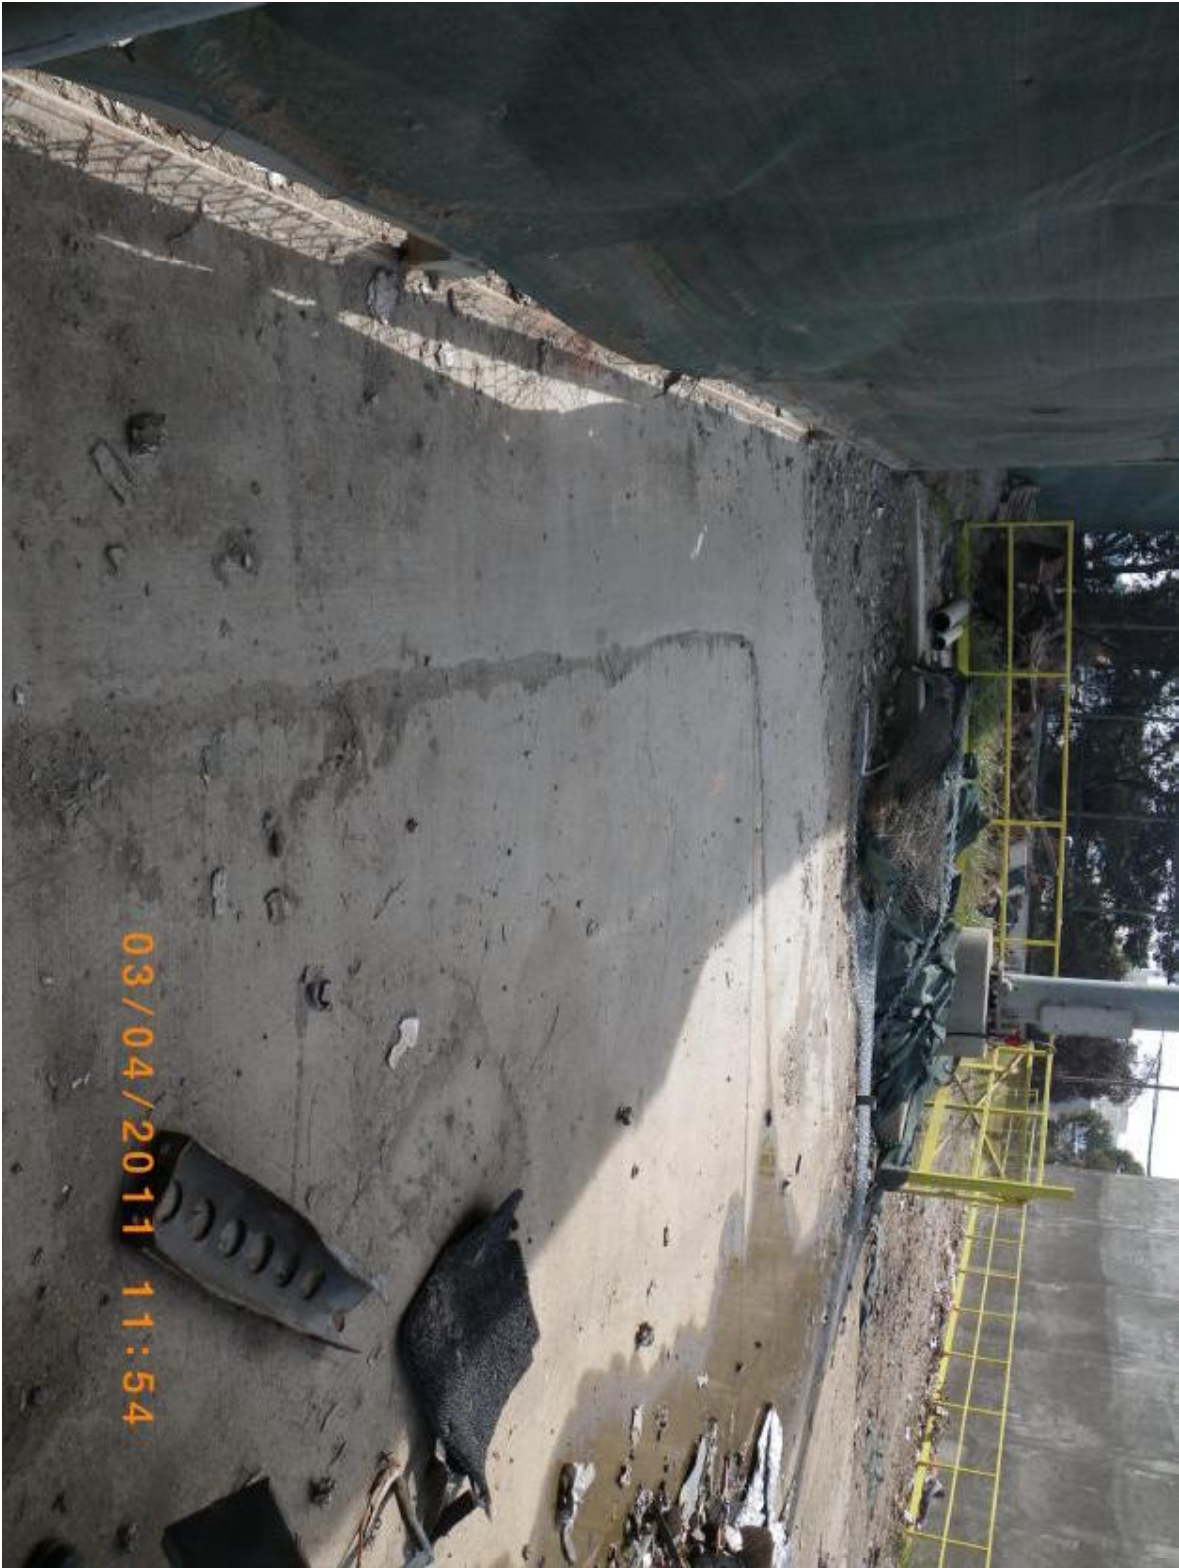
IMGP0231.JPG

IMGP0231 – Eastern boundary of the facility looking south, in-sloped berm with scattered debris was observed.

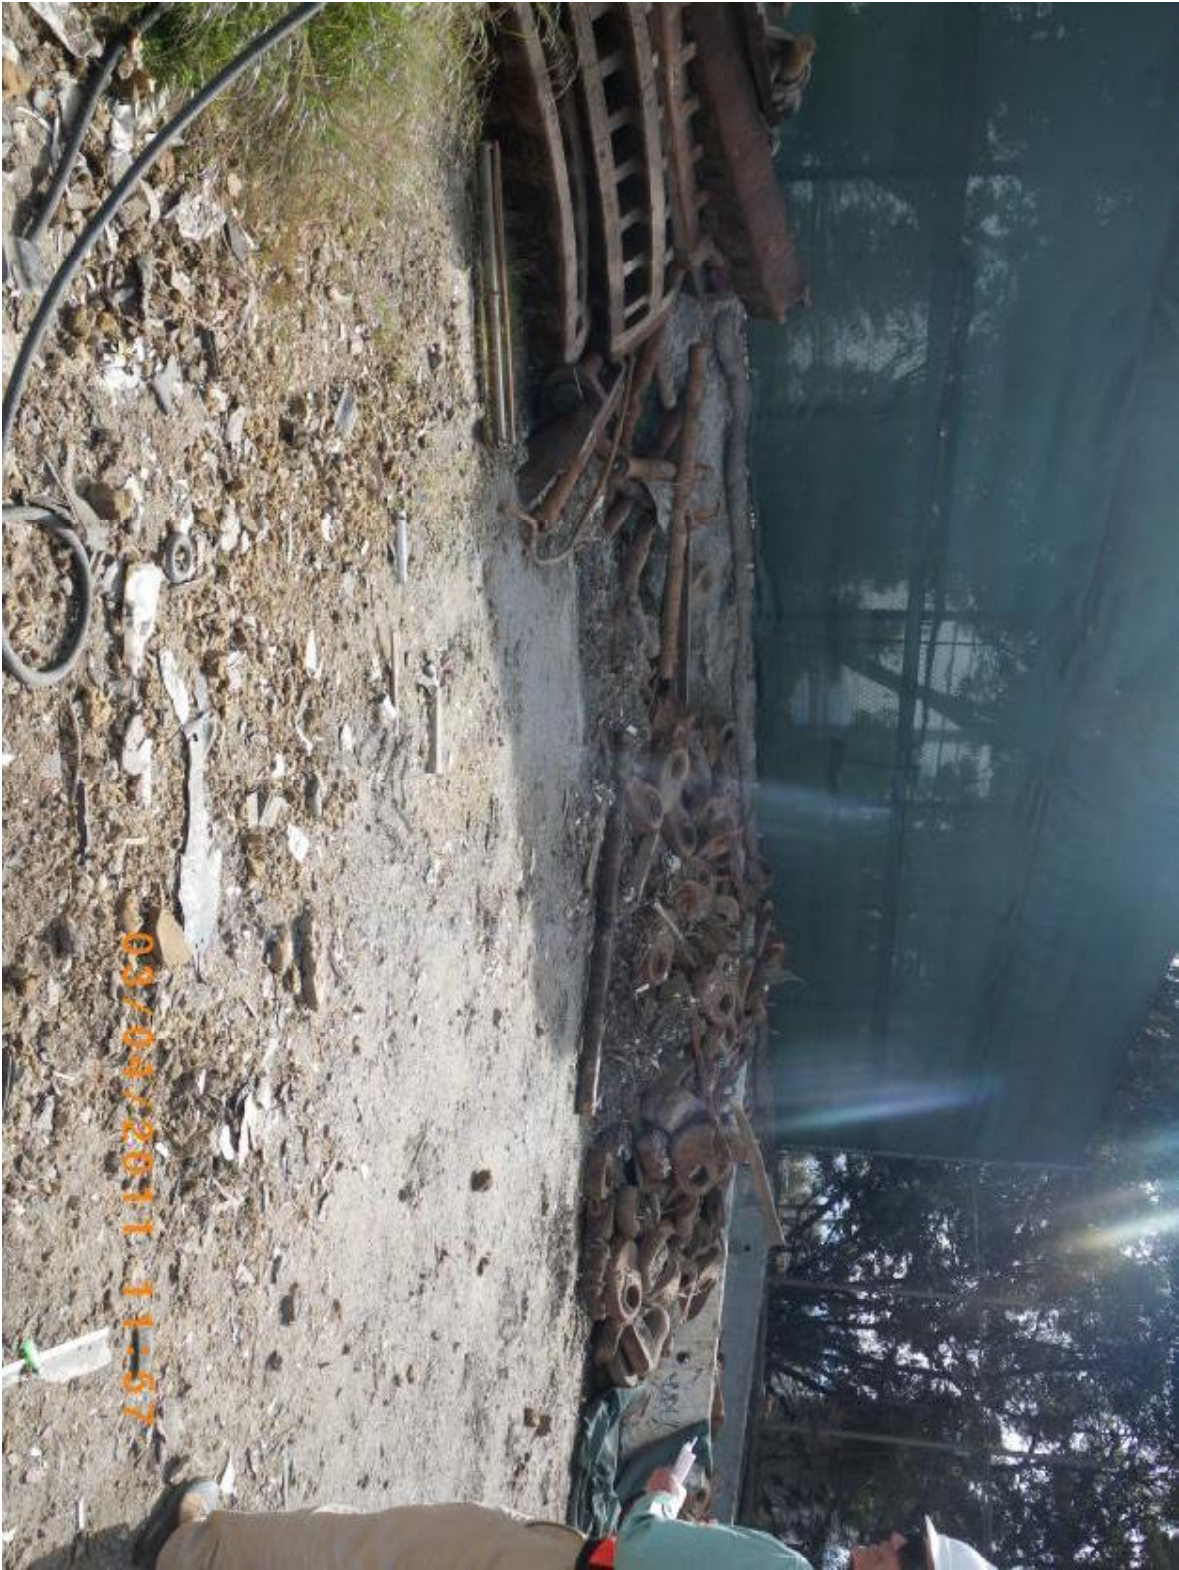
IMGP0232.JPG

The perimeter berm was not continuous, and not all-encompassing of facility-related activities. IMGP0232 demonstrates a break in the perimeter berm near the southeast emergency gate, and IMGP0273 also demonstrates a break in the perimeter berm near the northwest gate. IMGP0241 demonstrates facility-related utility work outside of the perimeter berm to the west of building B, adjacent to Herkner Rd. IMGP0242 and 0244 demonstrate ship loading activities also outside of the containment berm. The facility needs to make additional efforts to accomplish a continuous perimeter berm. The facility needs additional controls, which were either not identified by facility personnel or employed at the time of the inspection, to address activities occurring beyond the berm.

IMGP0232 – South east fire-access gate, break in the facility perimeter berm, scattered debris and ponded water were observed.

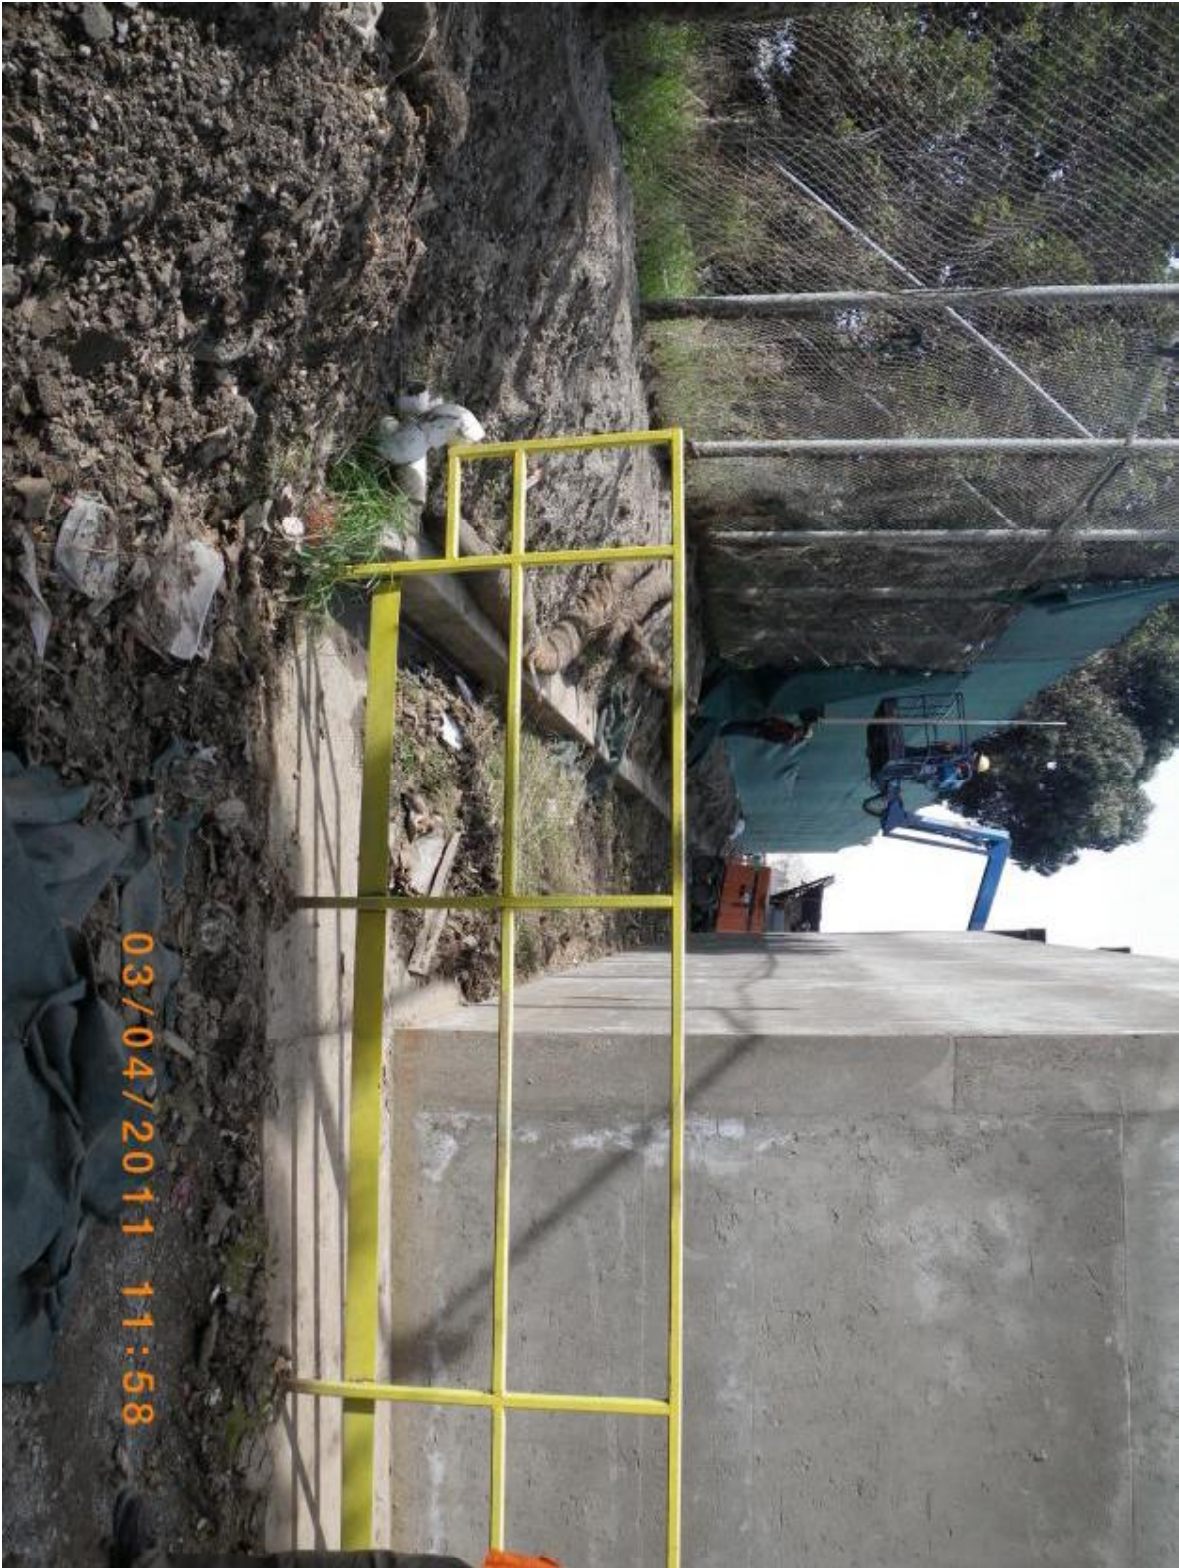
IMGP0233.JPG

IMGP0233 – South east corner of the facility, in-sloped berm and scattered debris was observed.

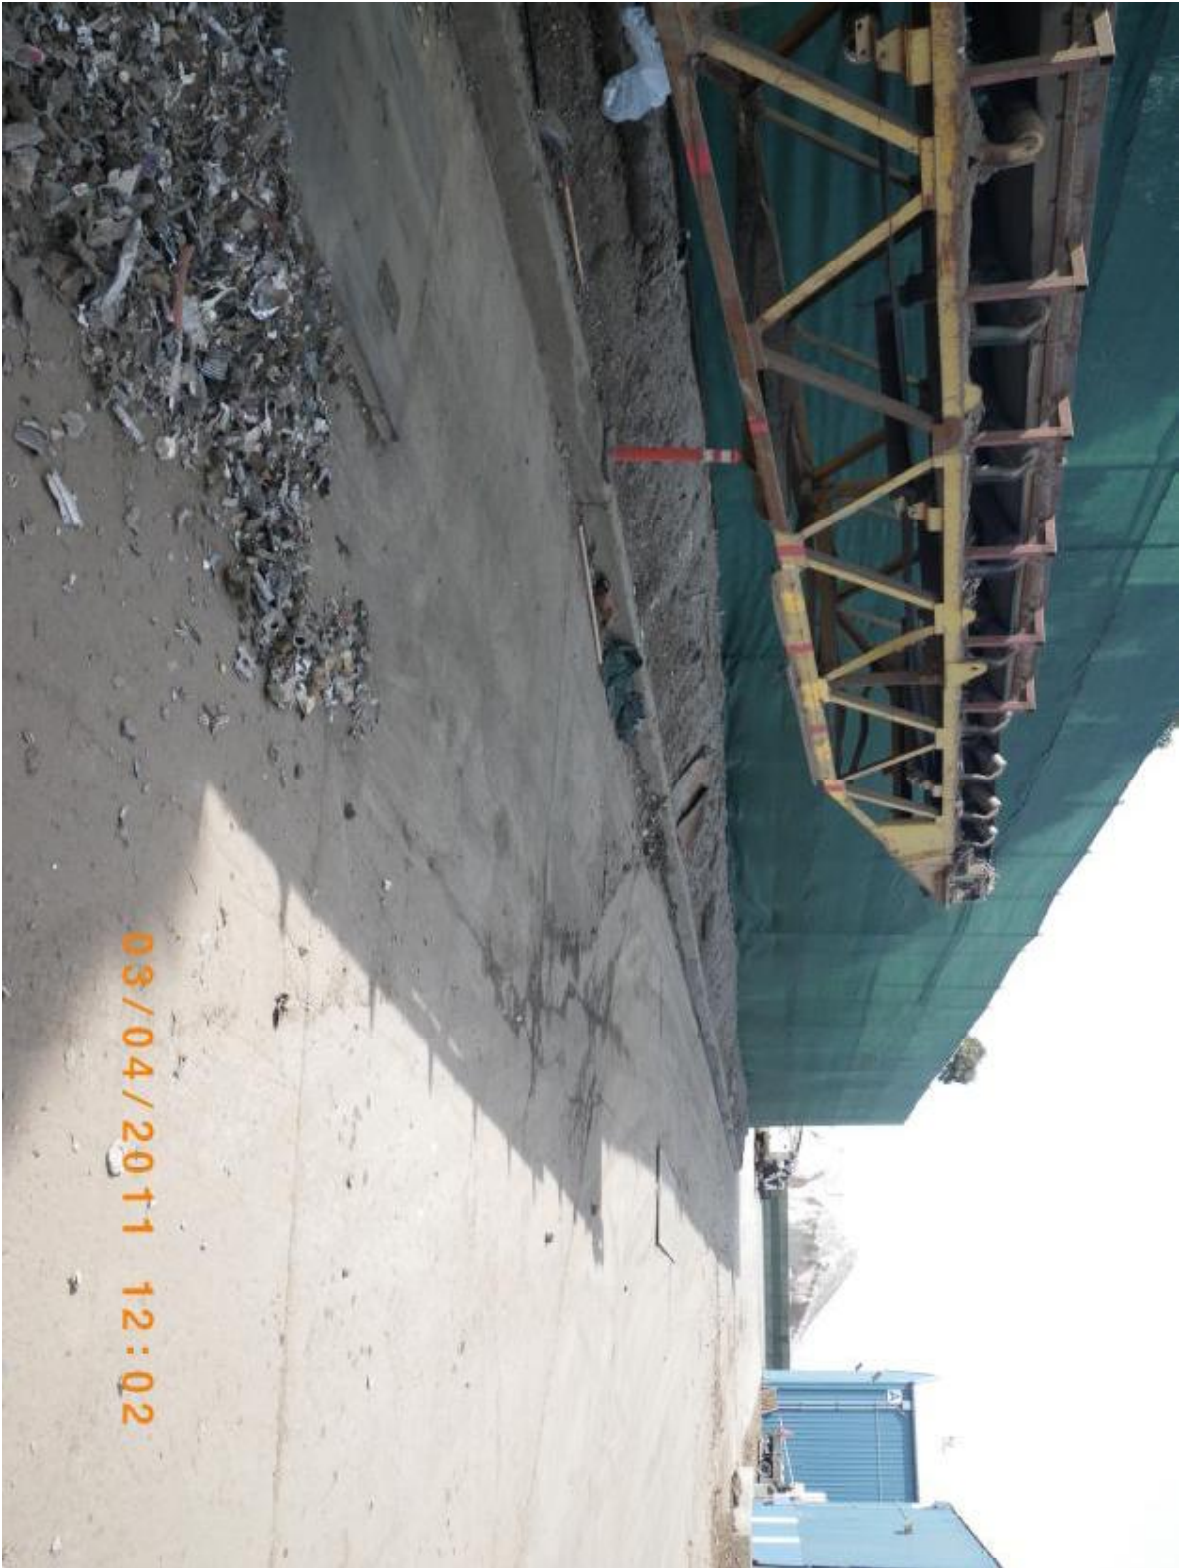
IMGP0234.JPG

IMGP0234 – Southern facility boundary, looking west, in-sloped berm and scattered debris was observed. Photo was taken from the east side of the non-ferrous storage stalls.
