NPDES Storm Water Inspection Report

Facility Location Information			
Name/Location/ Mailing Address	Sims Metal Management (Sims) 699 Seaport Blvd. Redwood City, CA		
GPS Coordinates	Latitude	37° 30' 40.6"	Longitude 122° 12' 29.6"
Receiving Water(s)	Redwood Creek – Navigable estuary to San Francisco Bay		
	Name	Telephone	
Owner	Steven Shinn – Regional General Manager	510-412-5300	
Operator	Joe Barco – Operations General Manager	510-412-5300	
Environmental Coordinator	Matt Zeiter – On-site Rep	510-715-7569

<u>General</u>	
Inspection Objective, Attendees, and Opening Conference Summary.	<p>The inspection's objective was to determine compliance with the California Industrial General Permit No. CAS000001.</p> <p>In addition to EPA inspectors previously identified, the inspection was attended by Estuardo Montufar (650.372.6240) and Sabrina Mih (650.372.6235) with San Mateo County Environmental Health Services Division (Certified Unified Program Agencies – CUPA), and Matt Zierter (510.412.5300), Mariya Semeit (650.369.4161), Dale Leuer (650.369.4161), and Vistasp Patel (650.369.4161) with Sims Metals Management (Sims or Facility Representatives)</p> <p>Prior to commencing the inspection

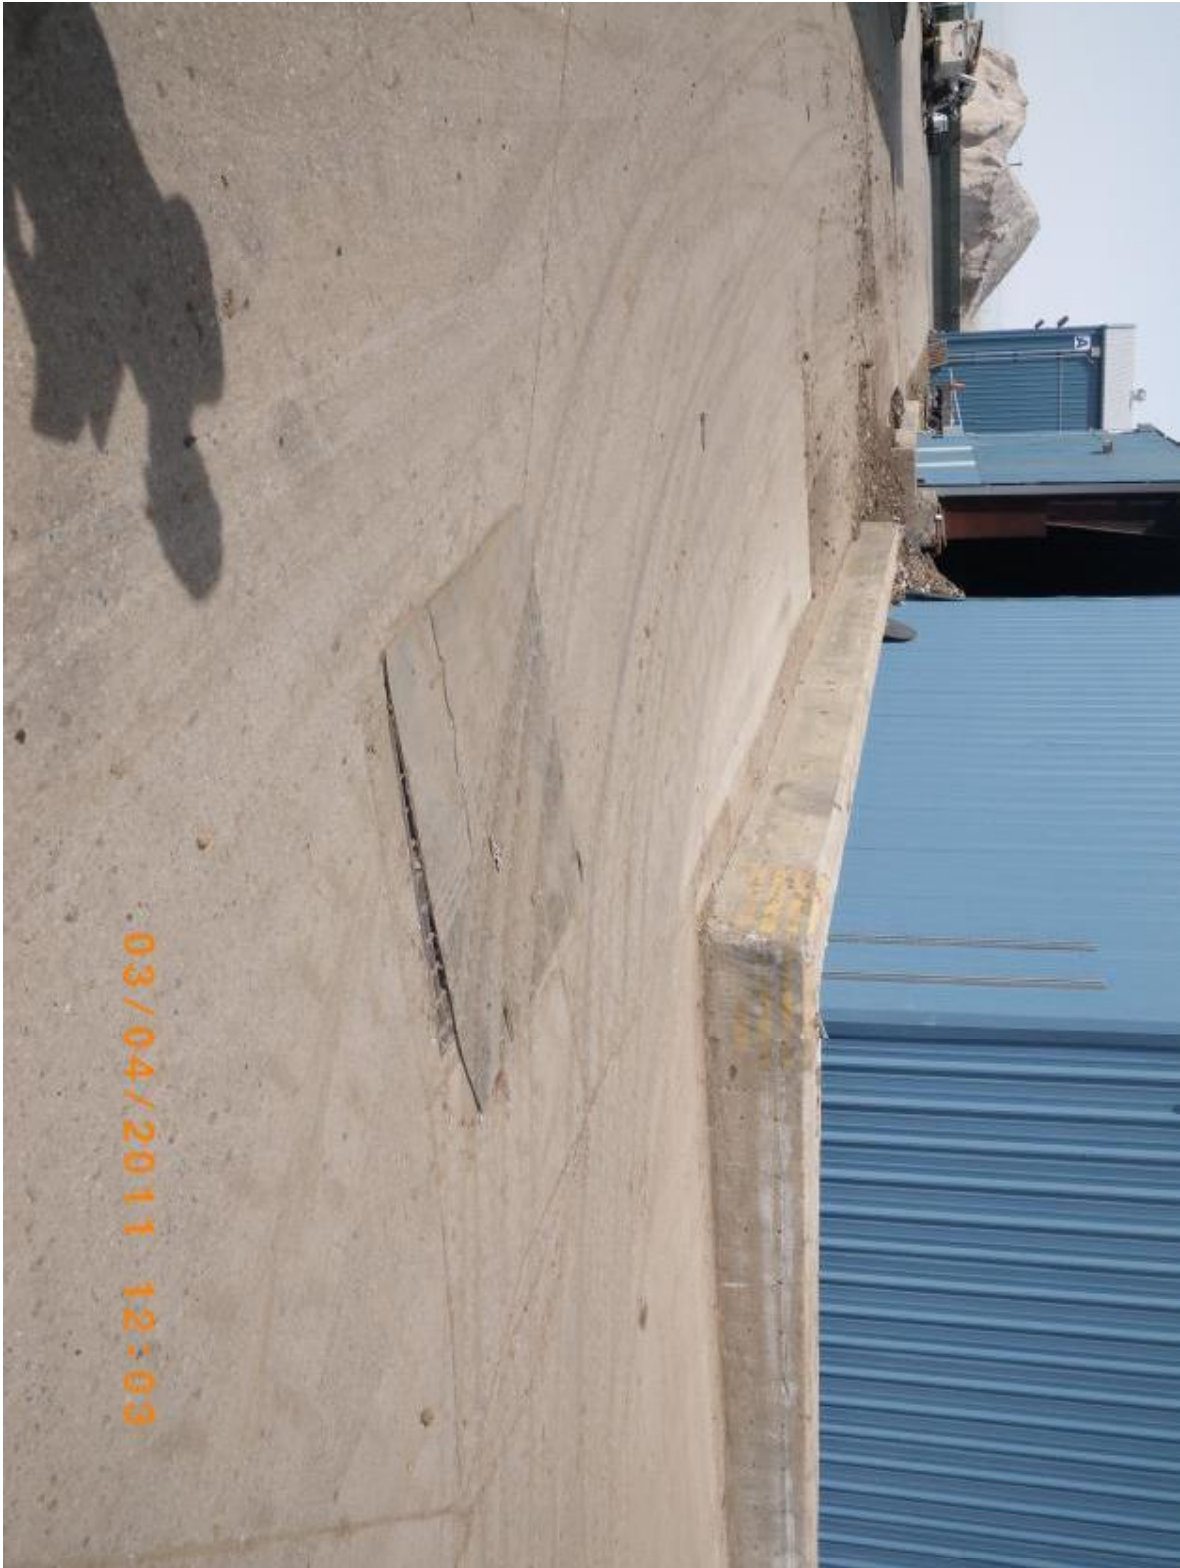
IMGP0235.JPG

IMGP0235 – Southern facility boundary, looking west, in-sloped berm and scattered debris was observed. Photo was taken from the west side of the non-ferrous storage stalls.

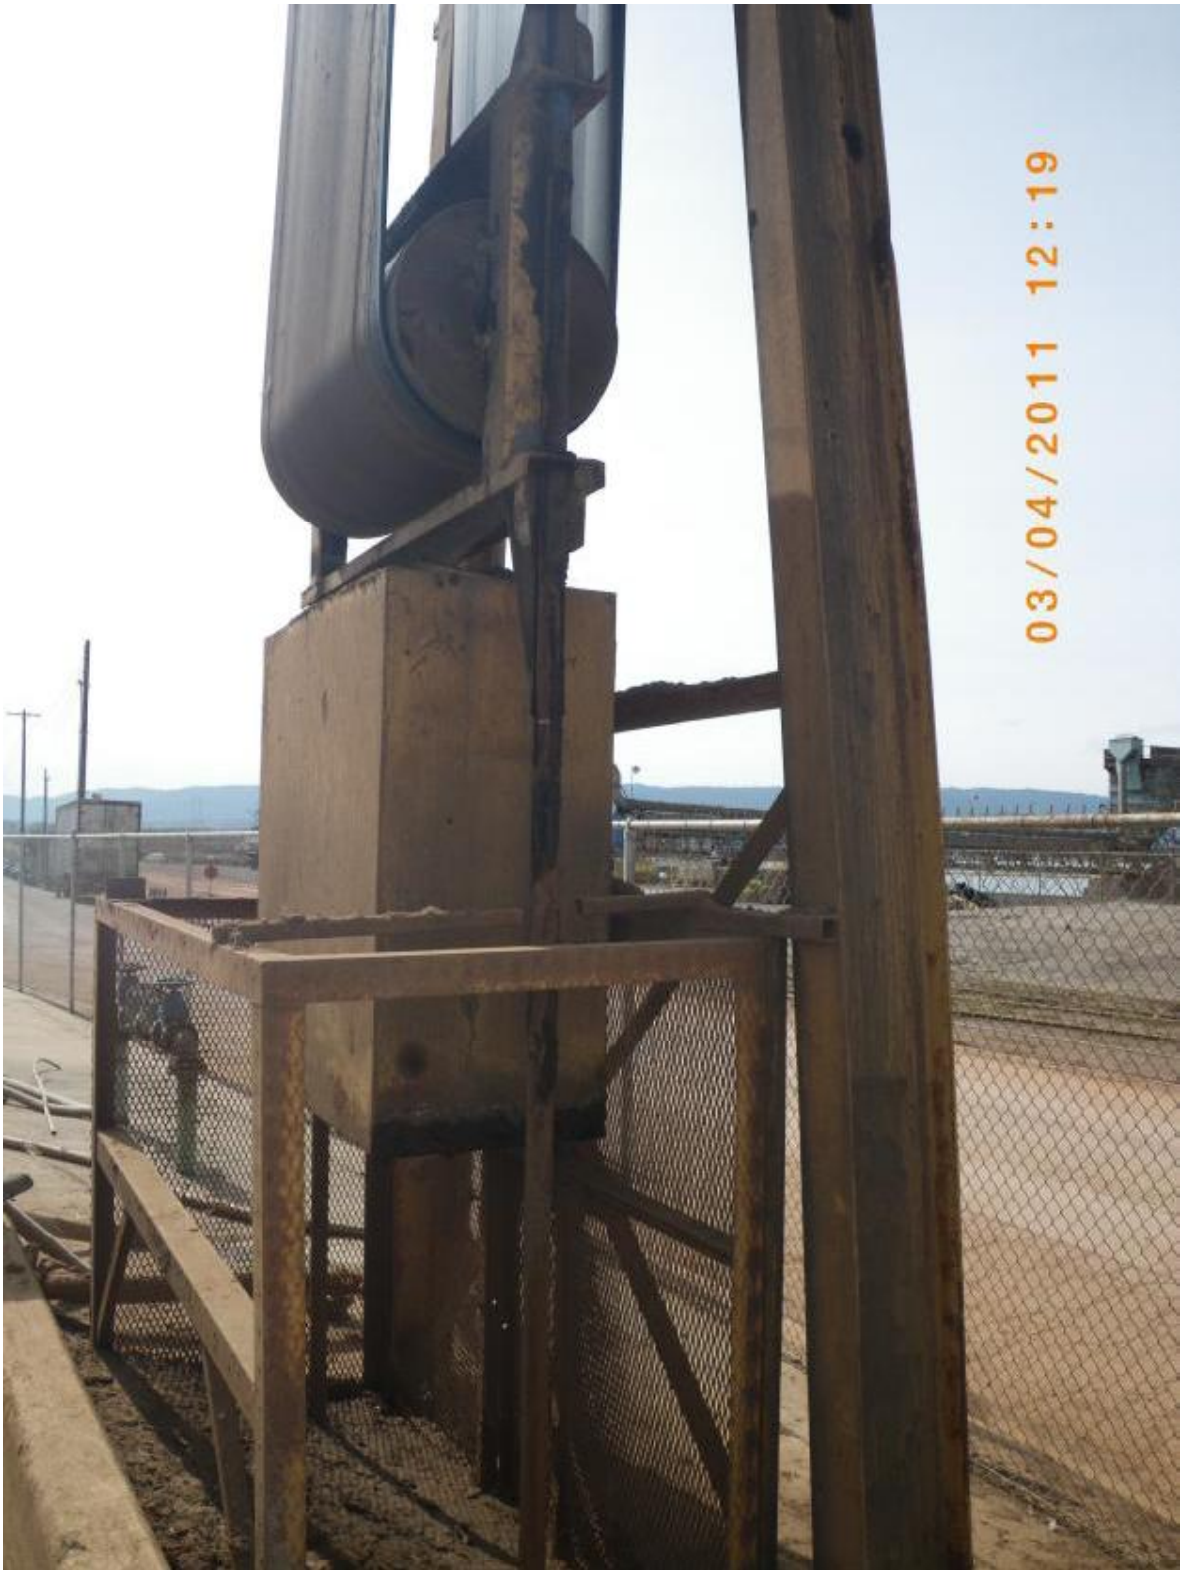
IMGP0244.JPG

IMGP0244 – Base of the conveyor belt tension system on the water-side of the k-rail containment berm. This photo was taken from the north side of the system, looking south. Accumulated rust-colored sediment was observed at the base of the tension system. IMGP0270 and 0271 were taken from west side of the chain-link fence and demonstrate how this accumulated material discharges off site.

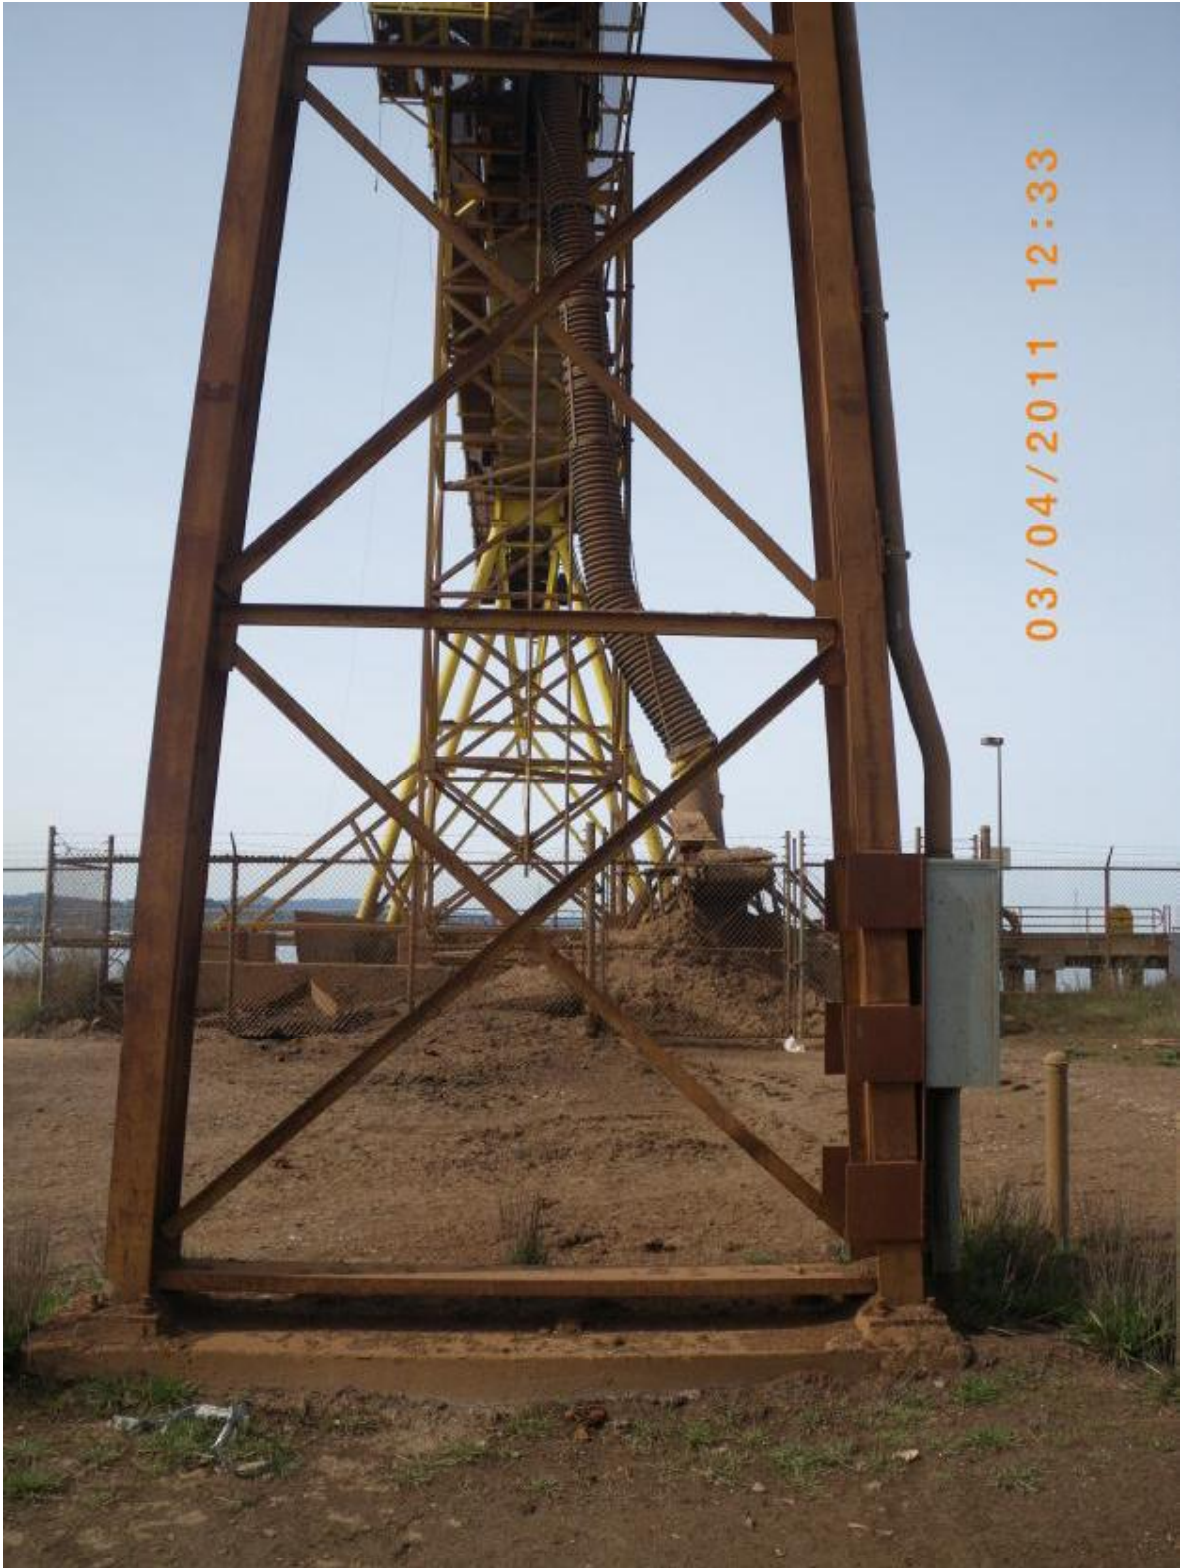
IMGP0252.JPG

IMGP0252 – Photo was taken standing directly underneath the ship loading conveyor looking east back towards the facility. Sediments along the rail lines and a storm sewer inlet were observed in this area.

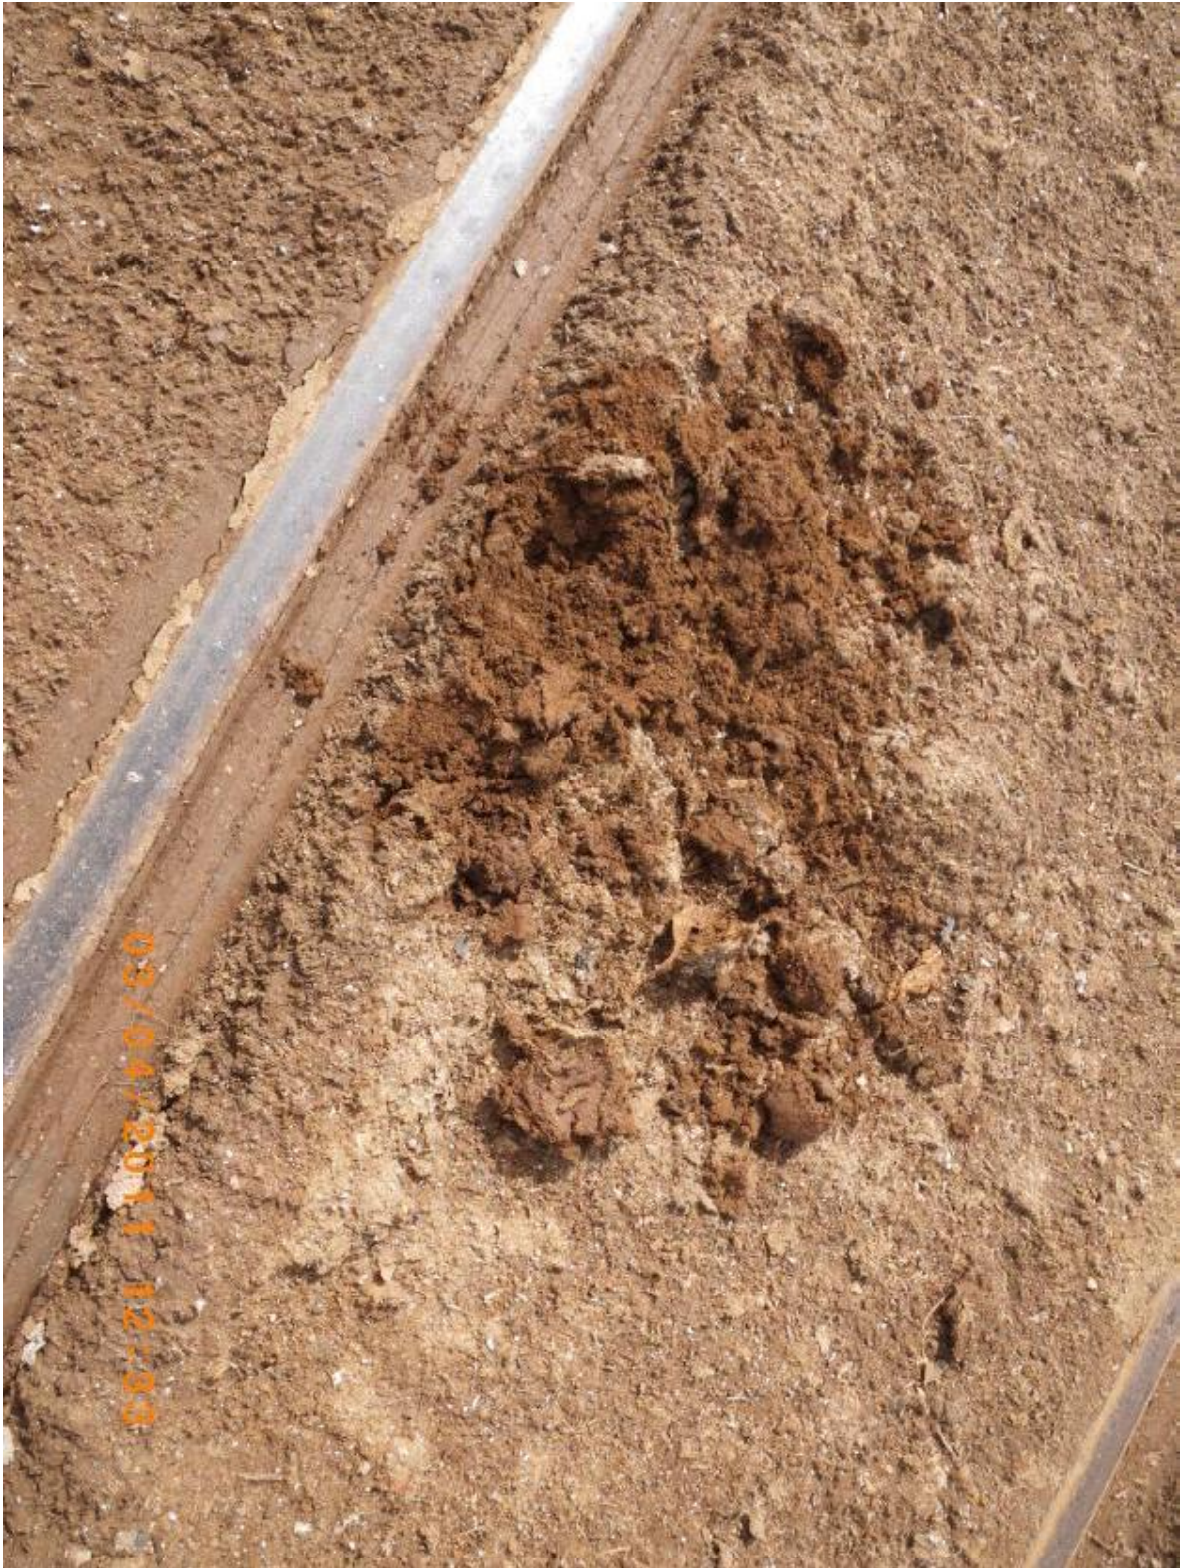
IMGP0253.JPG

IMGP0253 – Photo was taken standing directly underneath the ship loading conveyor looking west towards the water (180 degrees from IMGP0252). Accumulated sediments were observed along the ground.

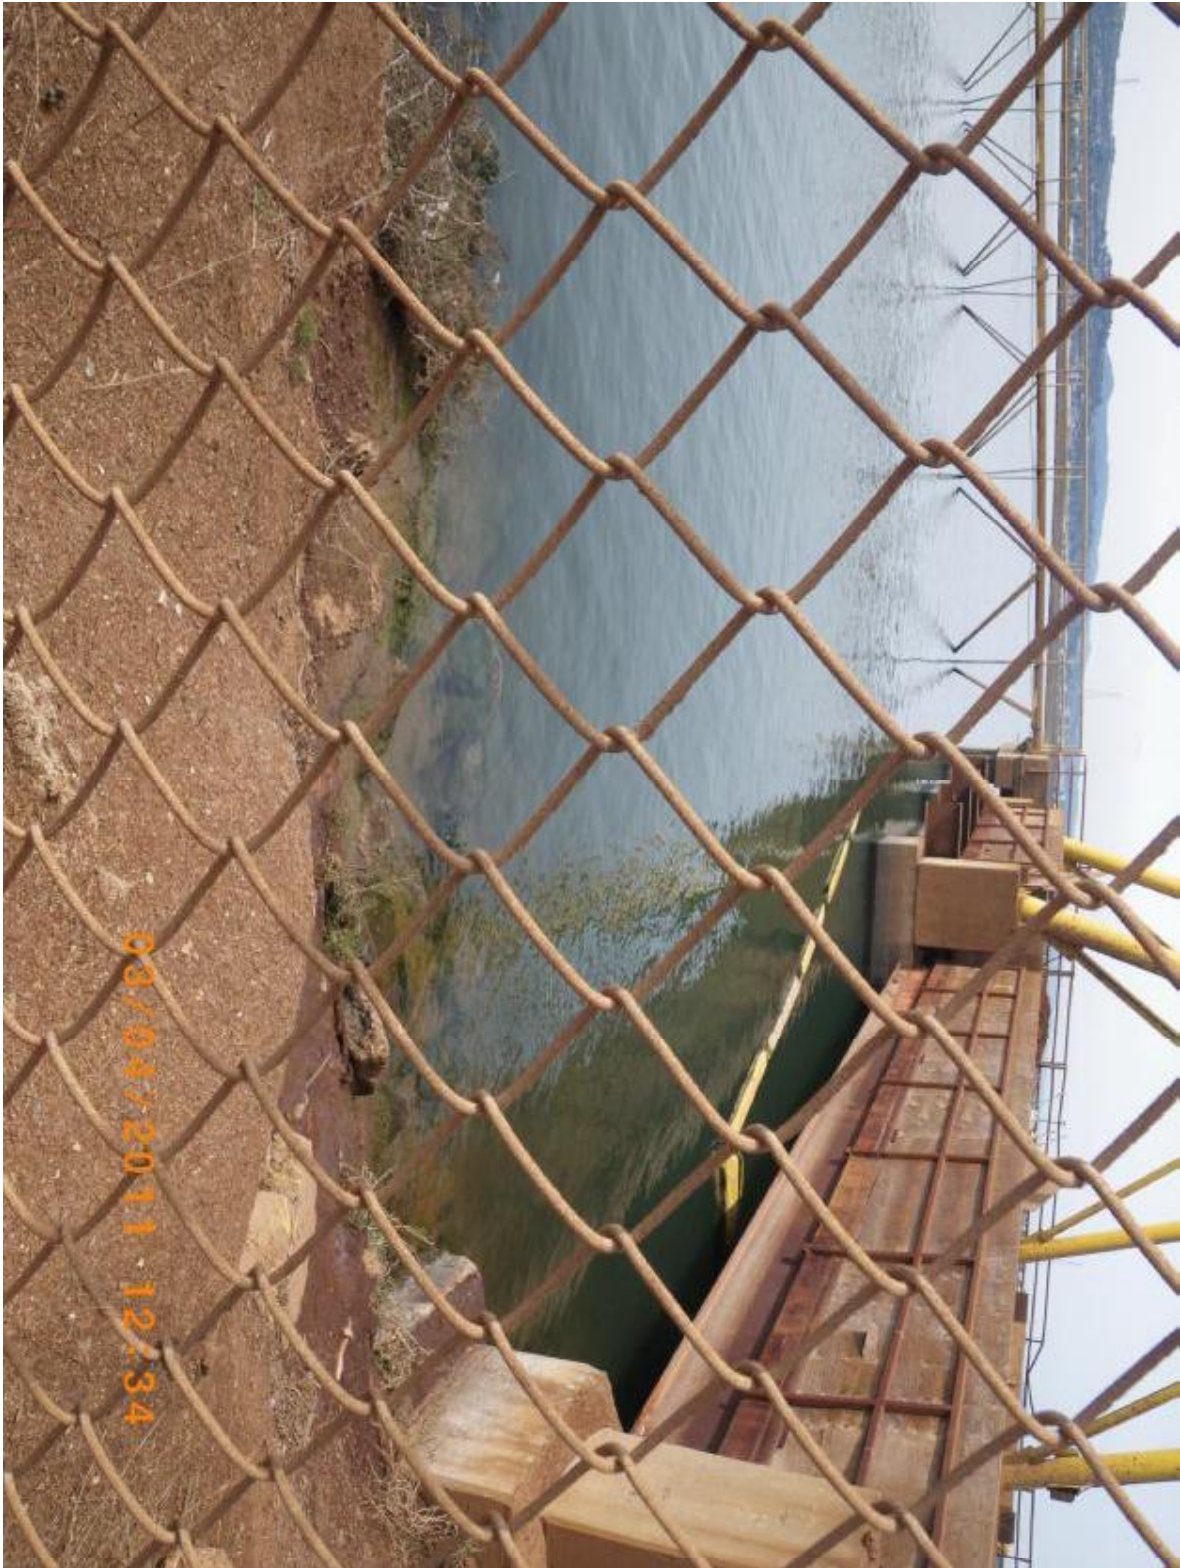
IMGP0255.JPG

Any evidence of Non-Storm water Discharge?	<p>Inspectors did not observe active non-storm water discharges during the inspection. However, IMGP0255-0269 shows rust-colored debris perched over or submerged in Redwood Creek indicating non-storm water discharge or potential discharge.</p>
Do the storm water inlets correspond with site map?	<p>The site map has no storm water inlets indicated. The site map should identify all storm drain inlets or other storm water outfalls that are on or adjacent to the facility, including inlets located at adjacent facilities or areas owned or operated by other tenants or the Port of Redwood City.</p>

IMGP0255 – Ship loading conveyor footings (south side) with accumulated debris along the footings and shoreline. A catchment platform with plywood walls has been placed over the water to catch materials that are cast off from conveyor maintenance and cleaning activities. A floating boom was observed in the water. Debris was also observed on the submerged rocks.

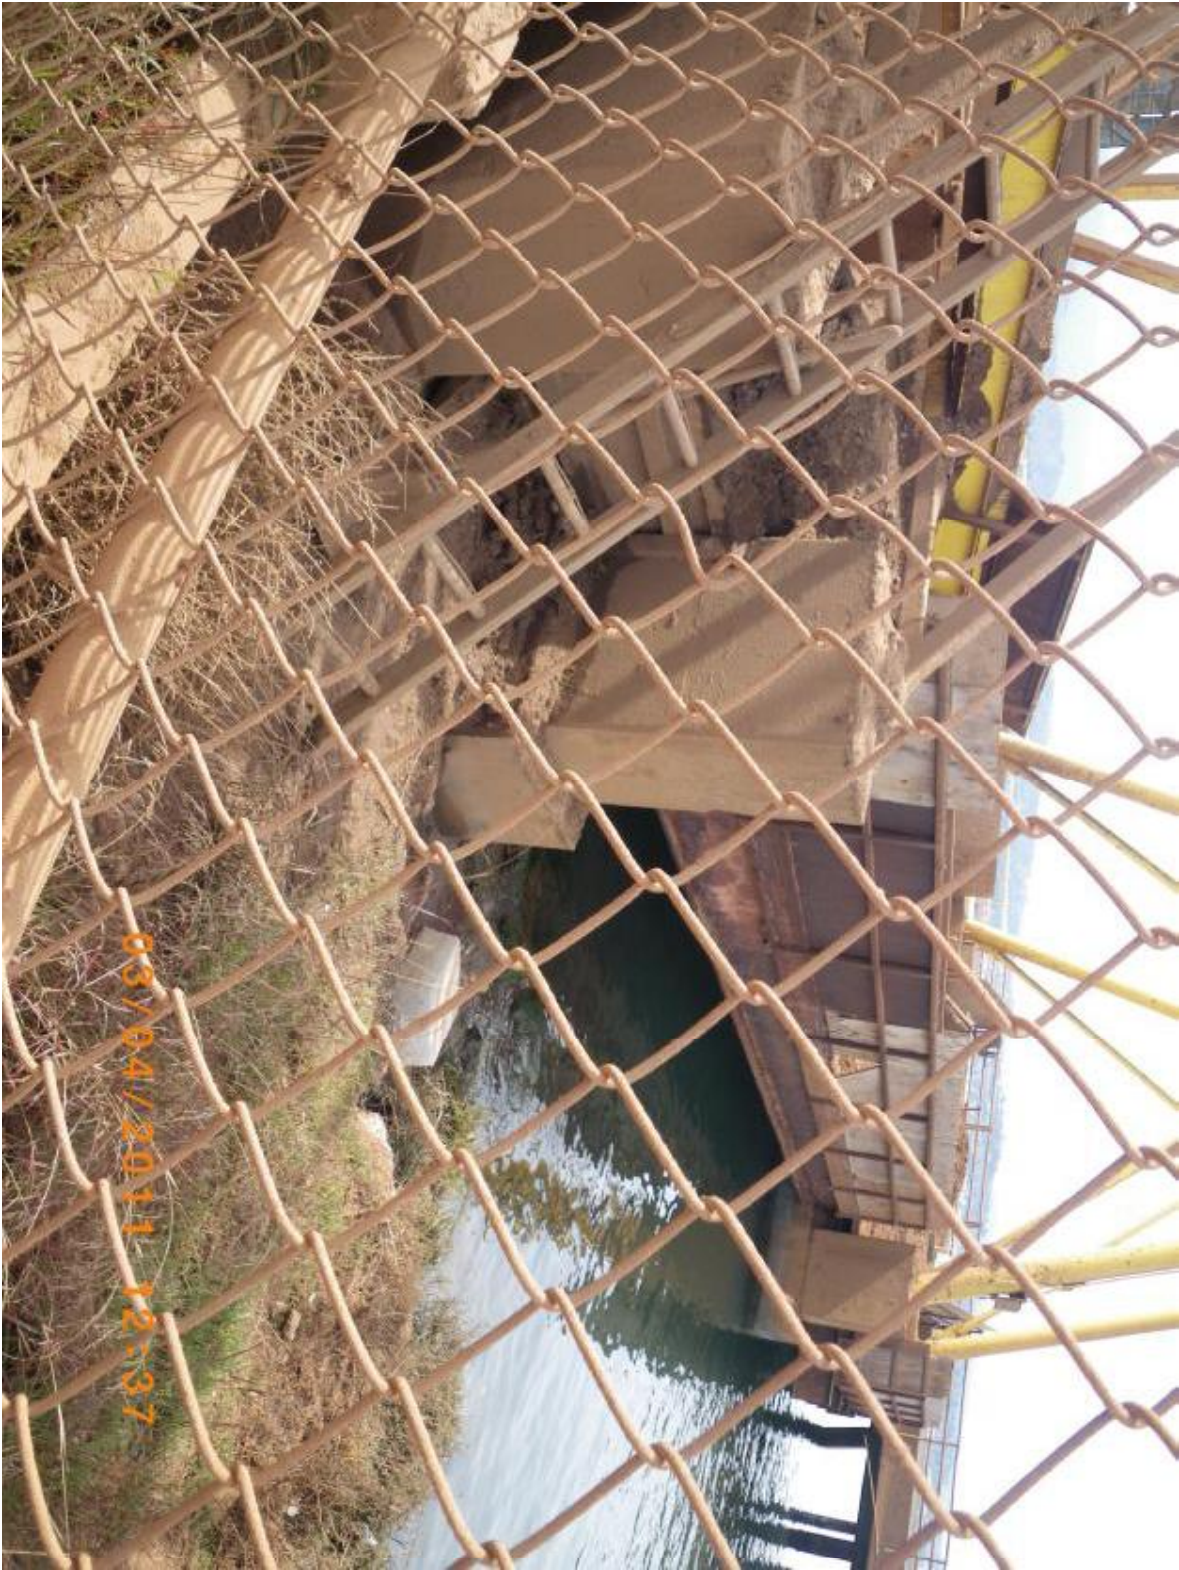
IMGP0257.JPG

IMGP0257 – The land-side footing of the ship-loading conveyor (north side). The conveyor in the photo is used to facilitate cleaning the catchment platform. Accumulated debris was observed at this location.

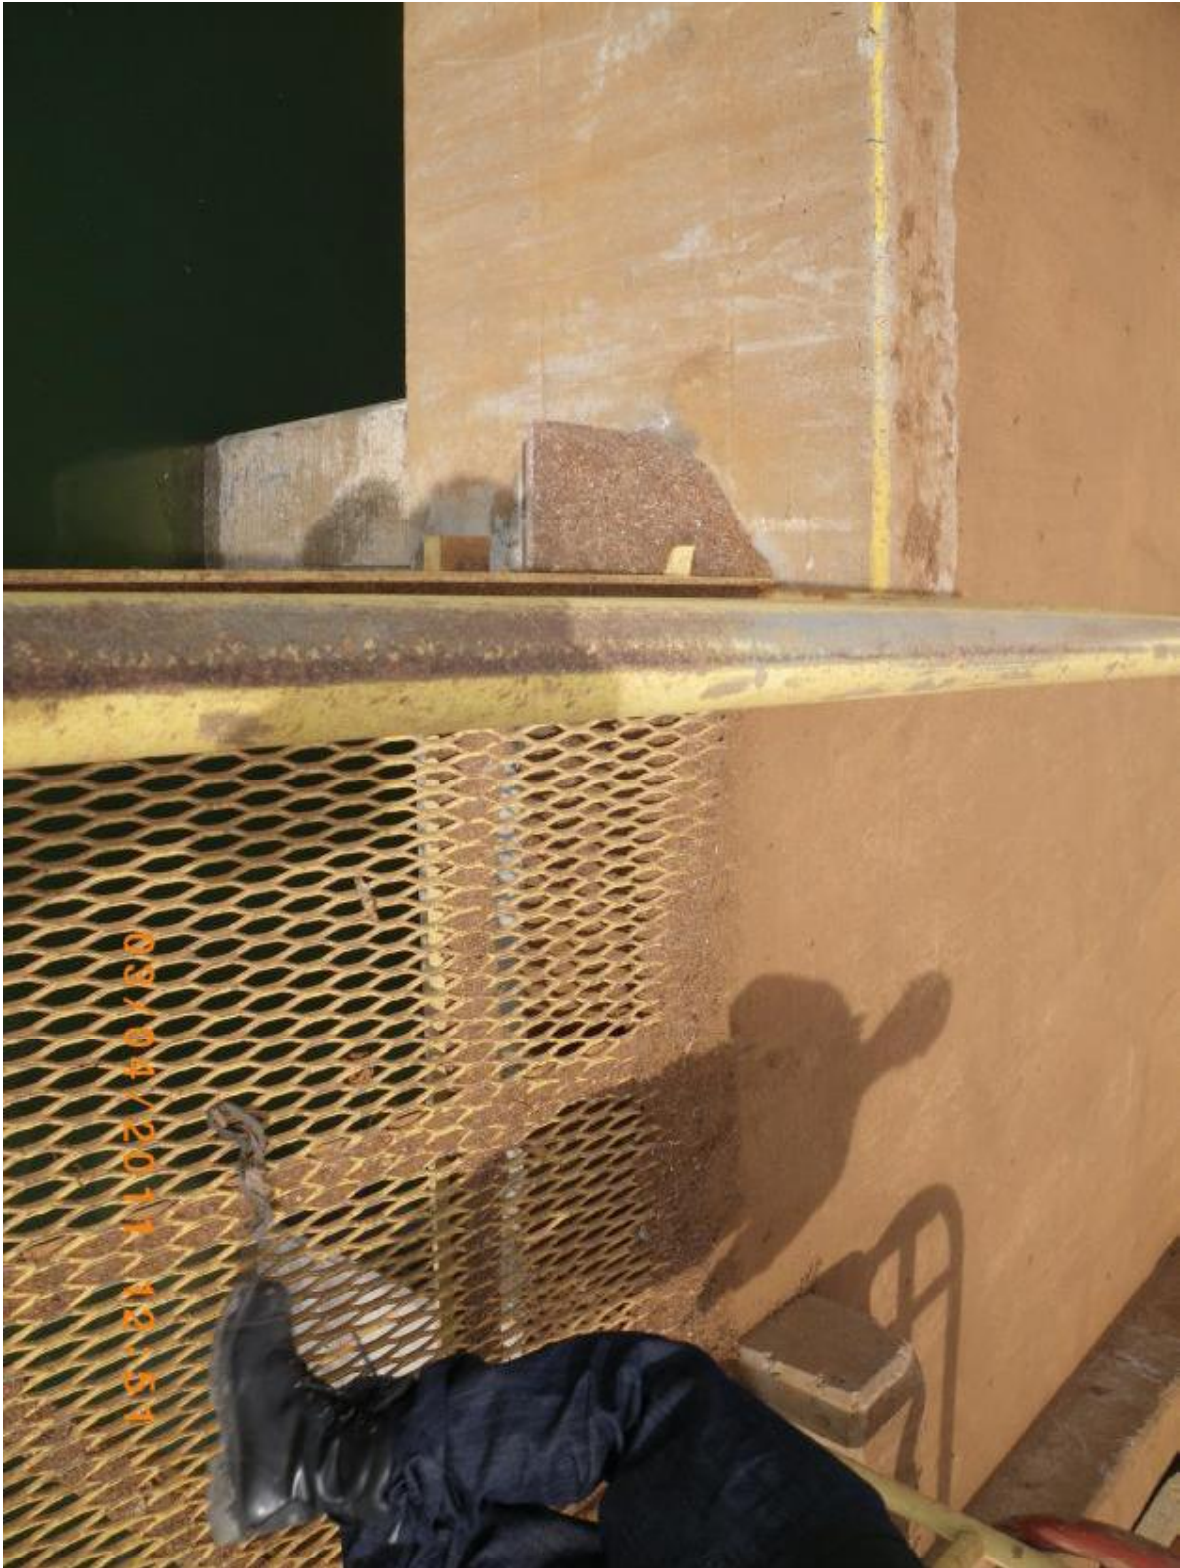
IMGP0264.JPG

IMGP0264 – Essentially the same as IMGP0263, though with greater focus on accumulated debris on the shore. Accumulated debris was also observed on the aerial portions of the ship loading conveyor structure.

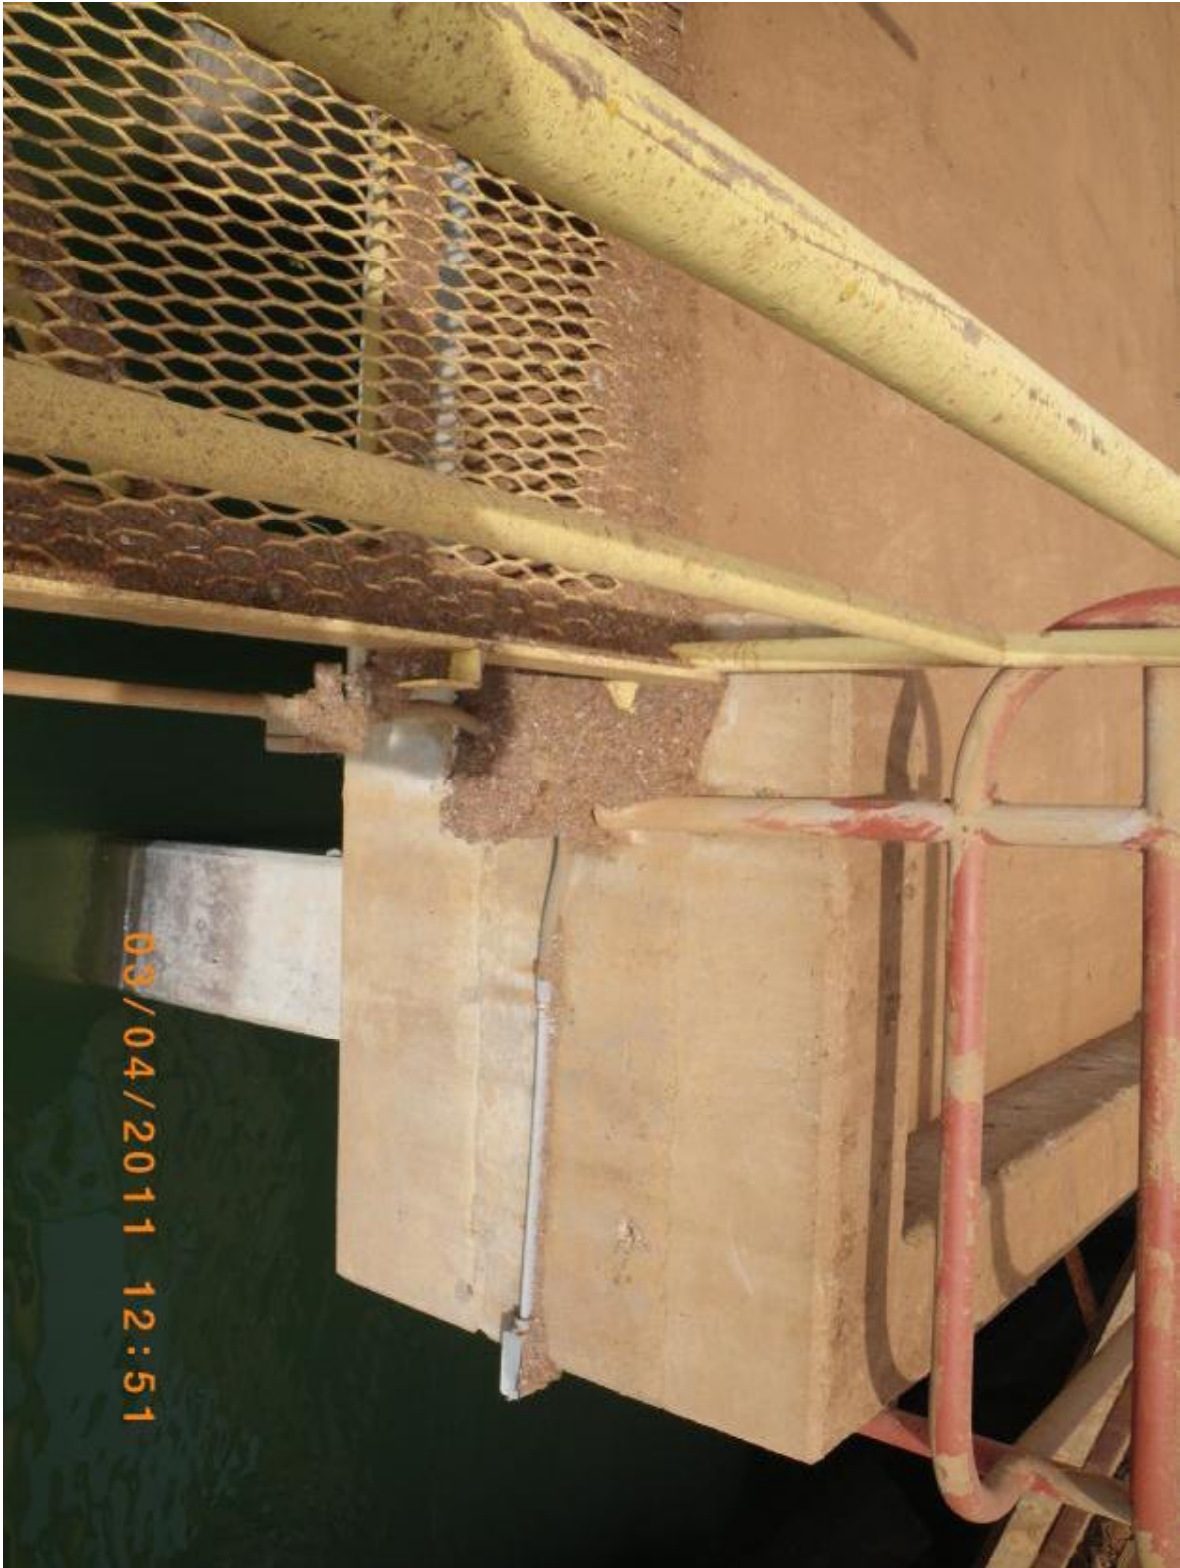
IMGP0265.JPG

IMGP0265 – Accumulated debris was observed on the west side of the catwalk structure to the south of the ship loading conveyor area.

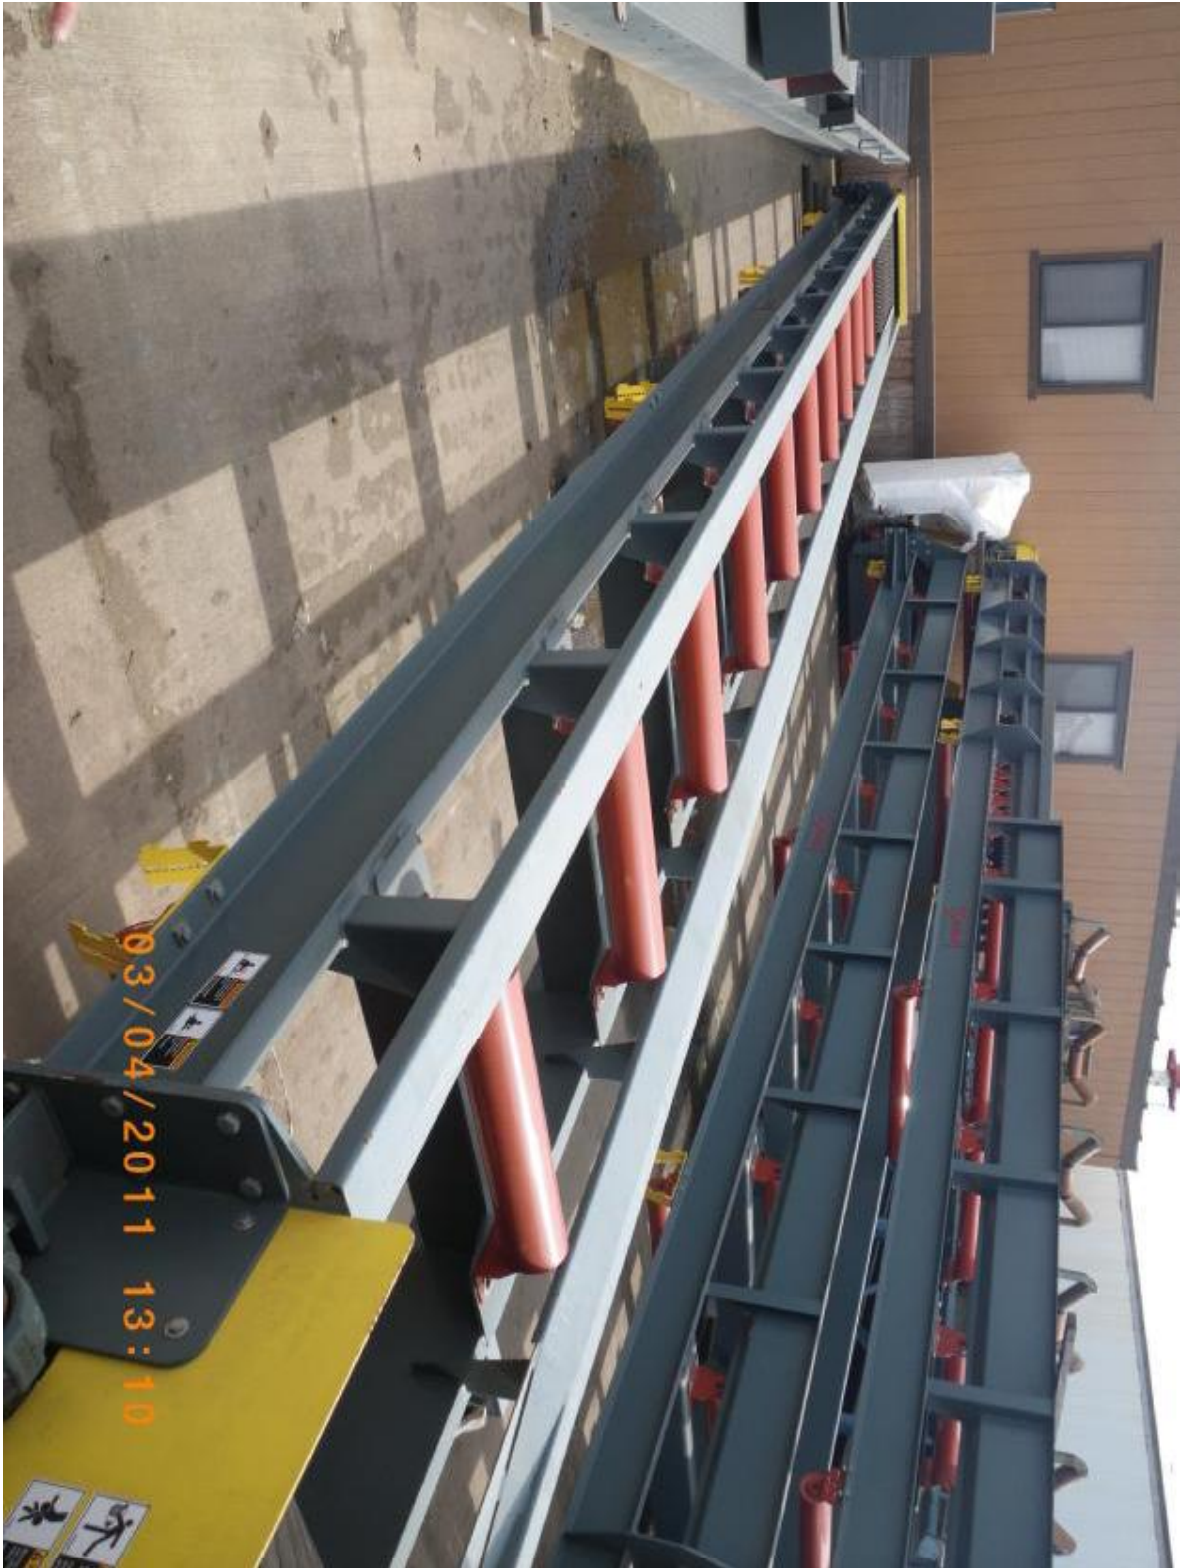
IMG0275.JPG

IMGP0274 and 0275 – North west corner of the facility, berms, staged equipment and scattered debris were observed.

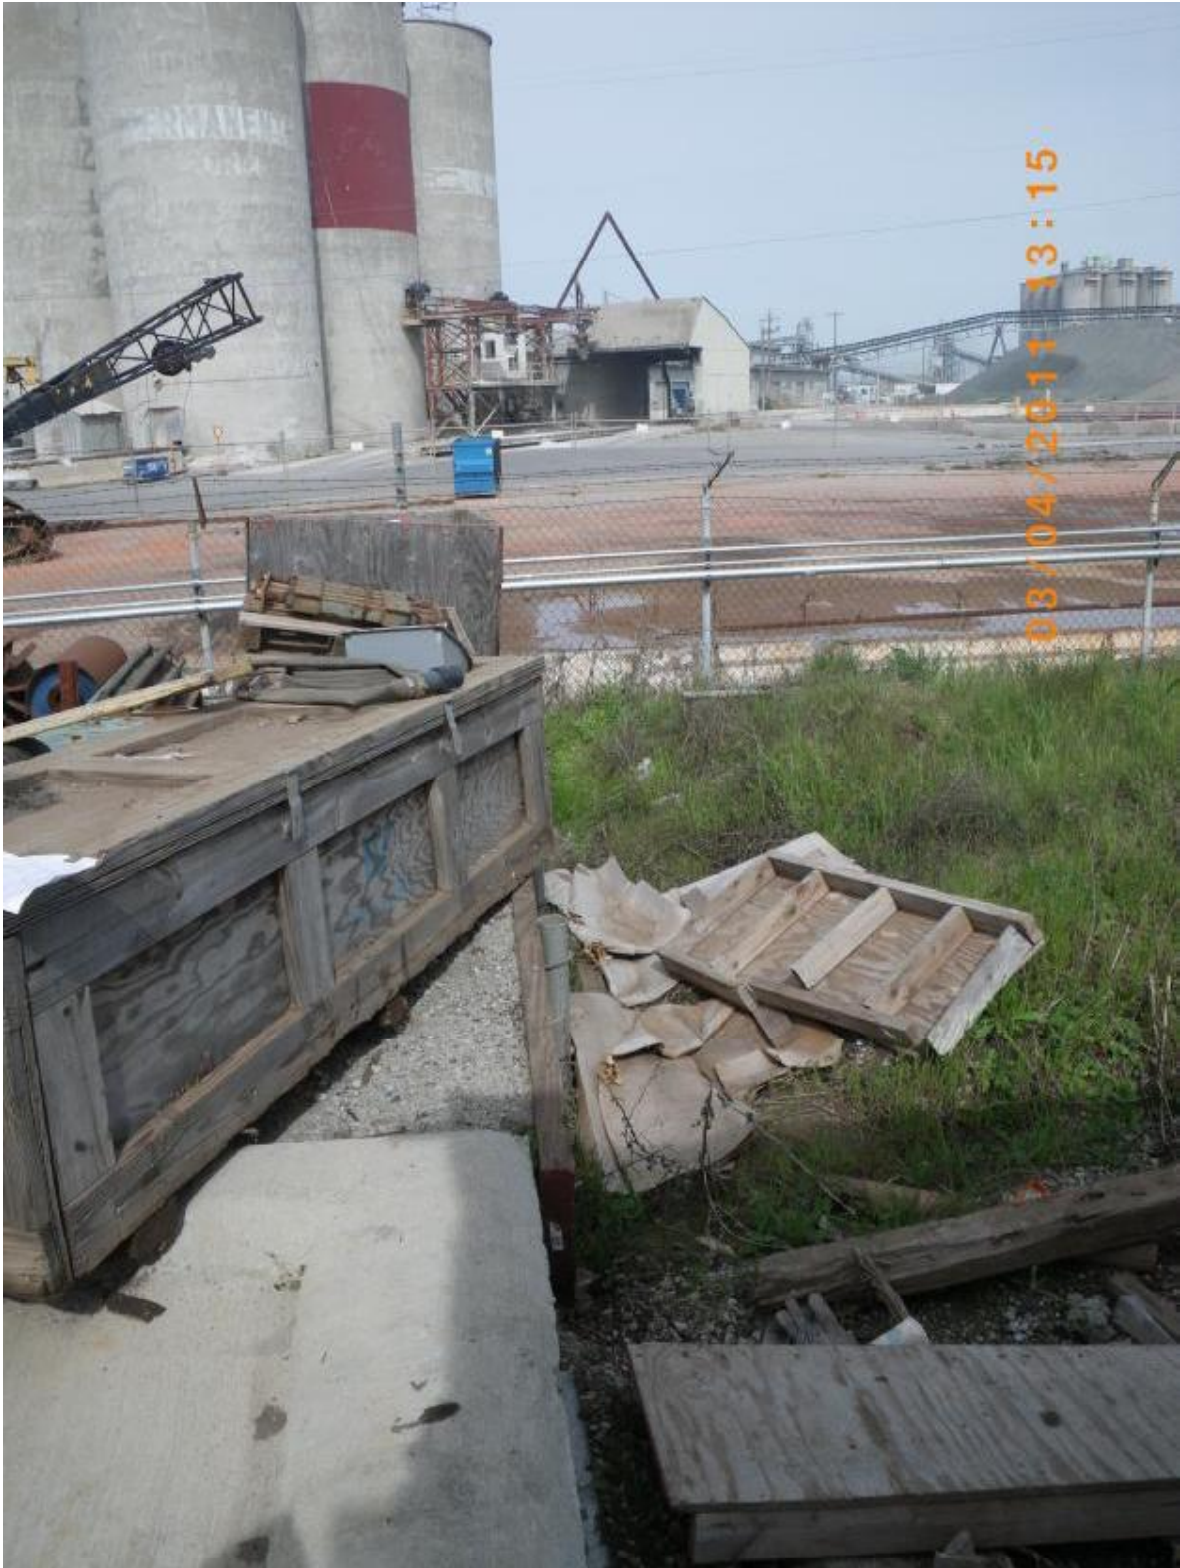
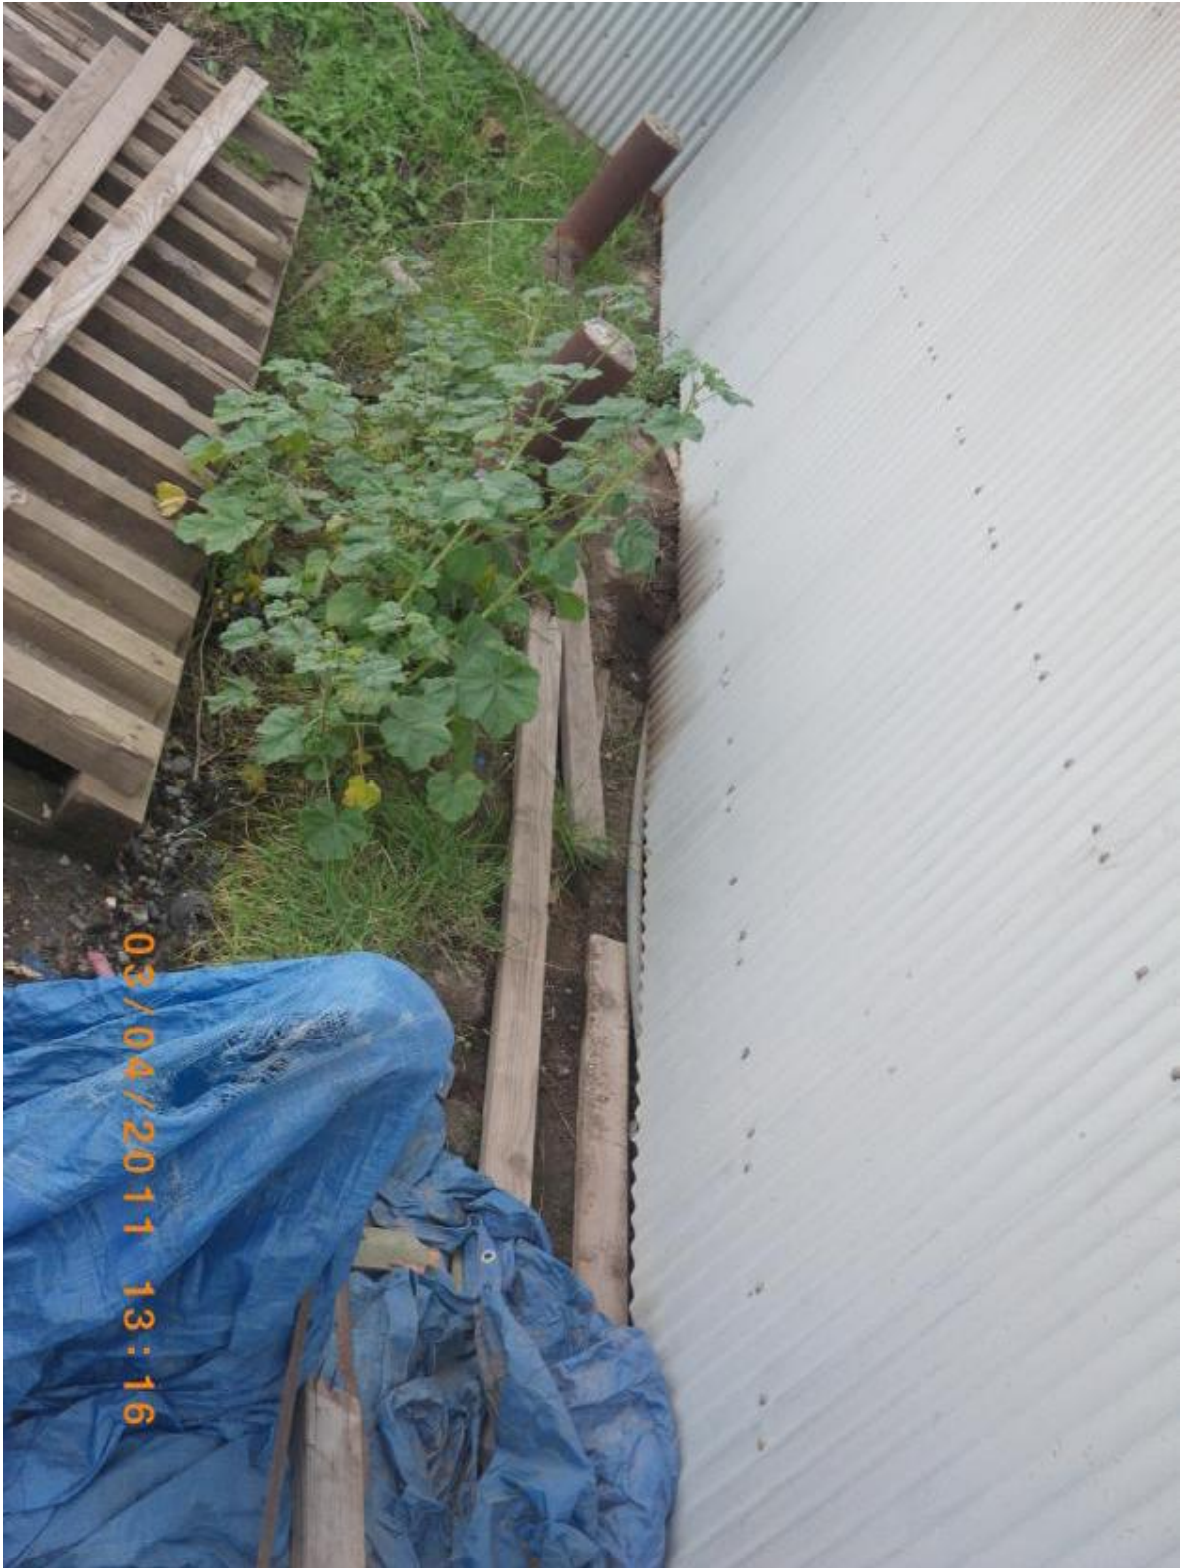
IMGP0279 thru 0281 – Staged equipment in the storage yard to the west of the fueling and oiling depot. Some staged equipment was observed over-hanging the berms and had potential to discharge storm water to areas where runoff could occur.
