NPDES Storm Water Inspection Report

Facility Location Information			
Name/Location/ Mailing Address	Sims Metal Management (Sims) 699 Seaport Blvd. Redwood City, CA		
GPS Coordinates	Latitude	37° 30' 40.6"	Longitude 122° 12' 29.6"
Receiving Water(s)	Redwood Creek – Navigable estuary to San Francisco Bay		
	Name	Telephone	
Owner	Steven Shinn – Regional General Manager	510-412-5300	
Operator	Joe Barco – Operations General Manager	510-412-5300	
Environmental Coordinator	Matt Zeiter – On-site Rep	510-715-7569

<u>General</u>	
Inspection Objective, Attendees, and Opening Conference Summary.	<p>The inspection's objective was to determine compliance with the California Industrial General Permit No. CAS000001.</p> <p>In addition to EPA inspectors previously identified, the inspection was attended by Estuardo Montufar (650.372.6240) and Sabrina Mih (650.372.6235) with San Mateo County Environmental Health Services Division (Certified Unified Program Agencies – CUPA), and Matt Zierter (510.412.5300), Mariya Semeit (650.369.4161), Dale Leuer (650.369.4161), and Vistasp Patel (650.369.4161) with Sims Metals Management (Sims or Facility Representatives)</p> <p>Prior to commencing the inspection

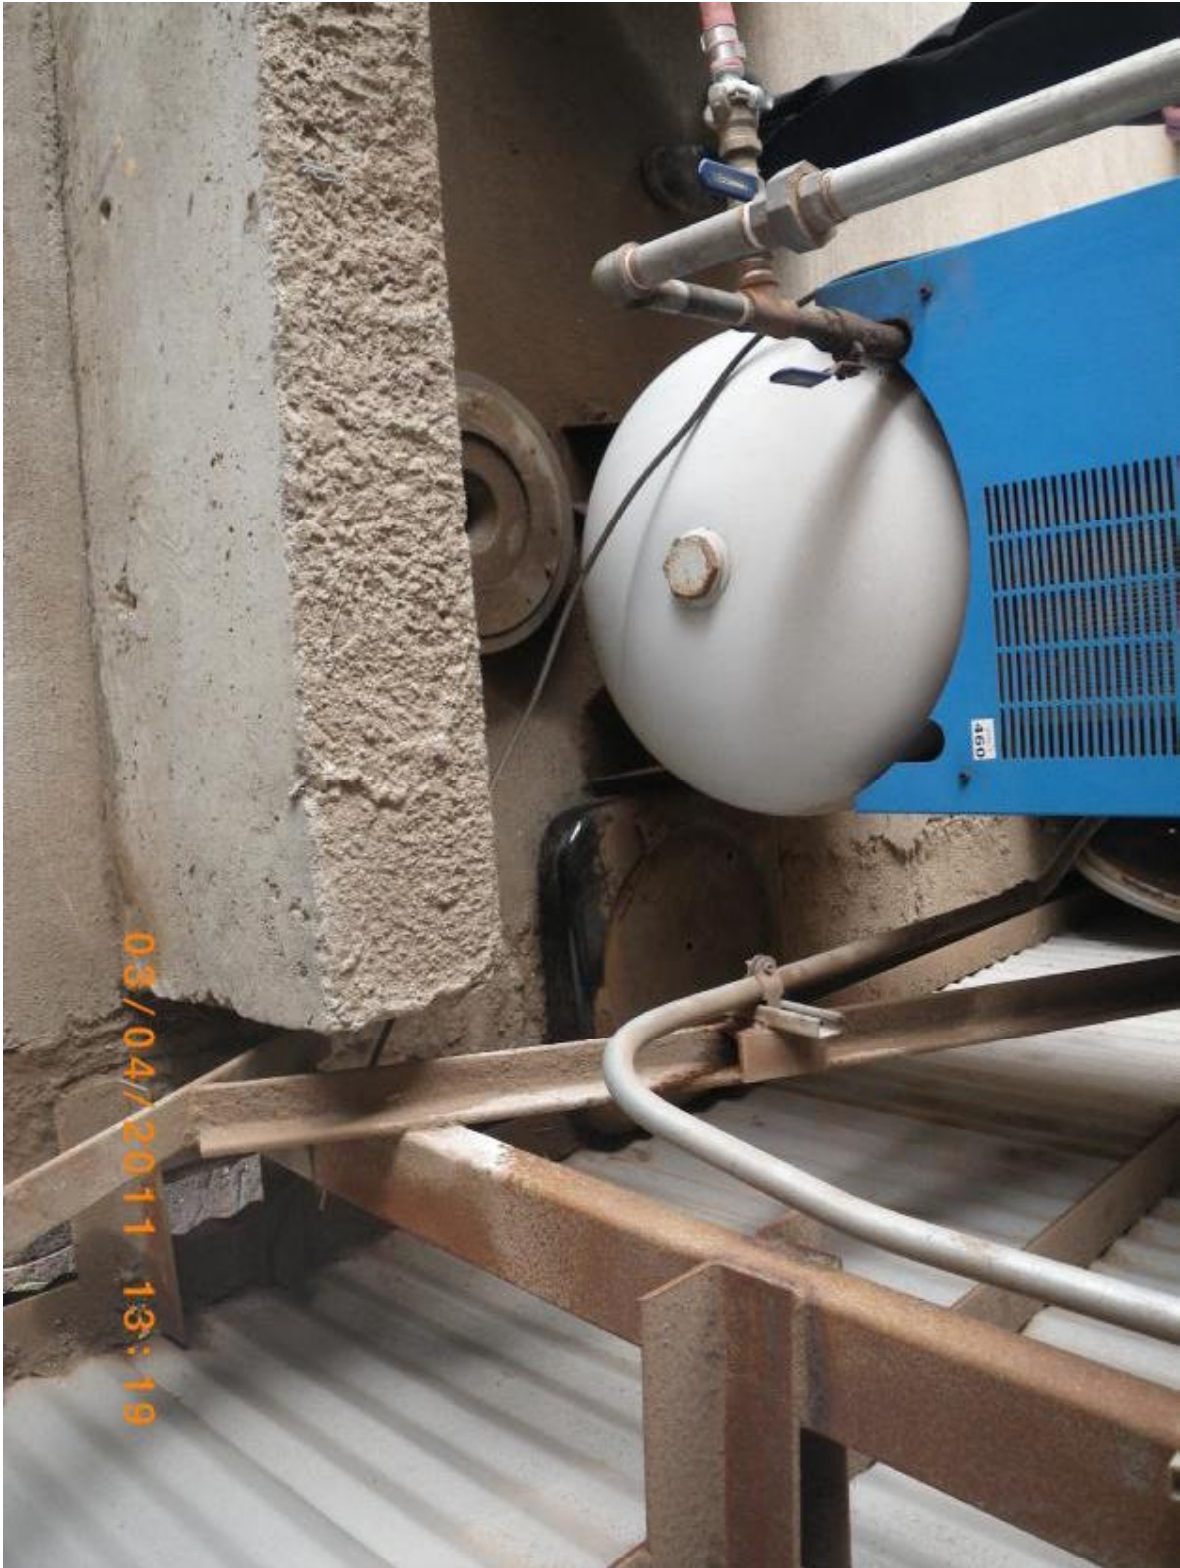
IMGP0285.JPG

IMGP0282 – Oil staining was observed on the exterior wall and earthen ground on the north side of the fueling and oiling depot. IMGP0285 and 0286 demonstrate that this area is exterior to the air compressor.

IMGP0285 and 0286 – Area behind the air compressor where oil staining was observed as mentioned regarding IMGP0282.

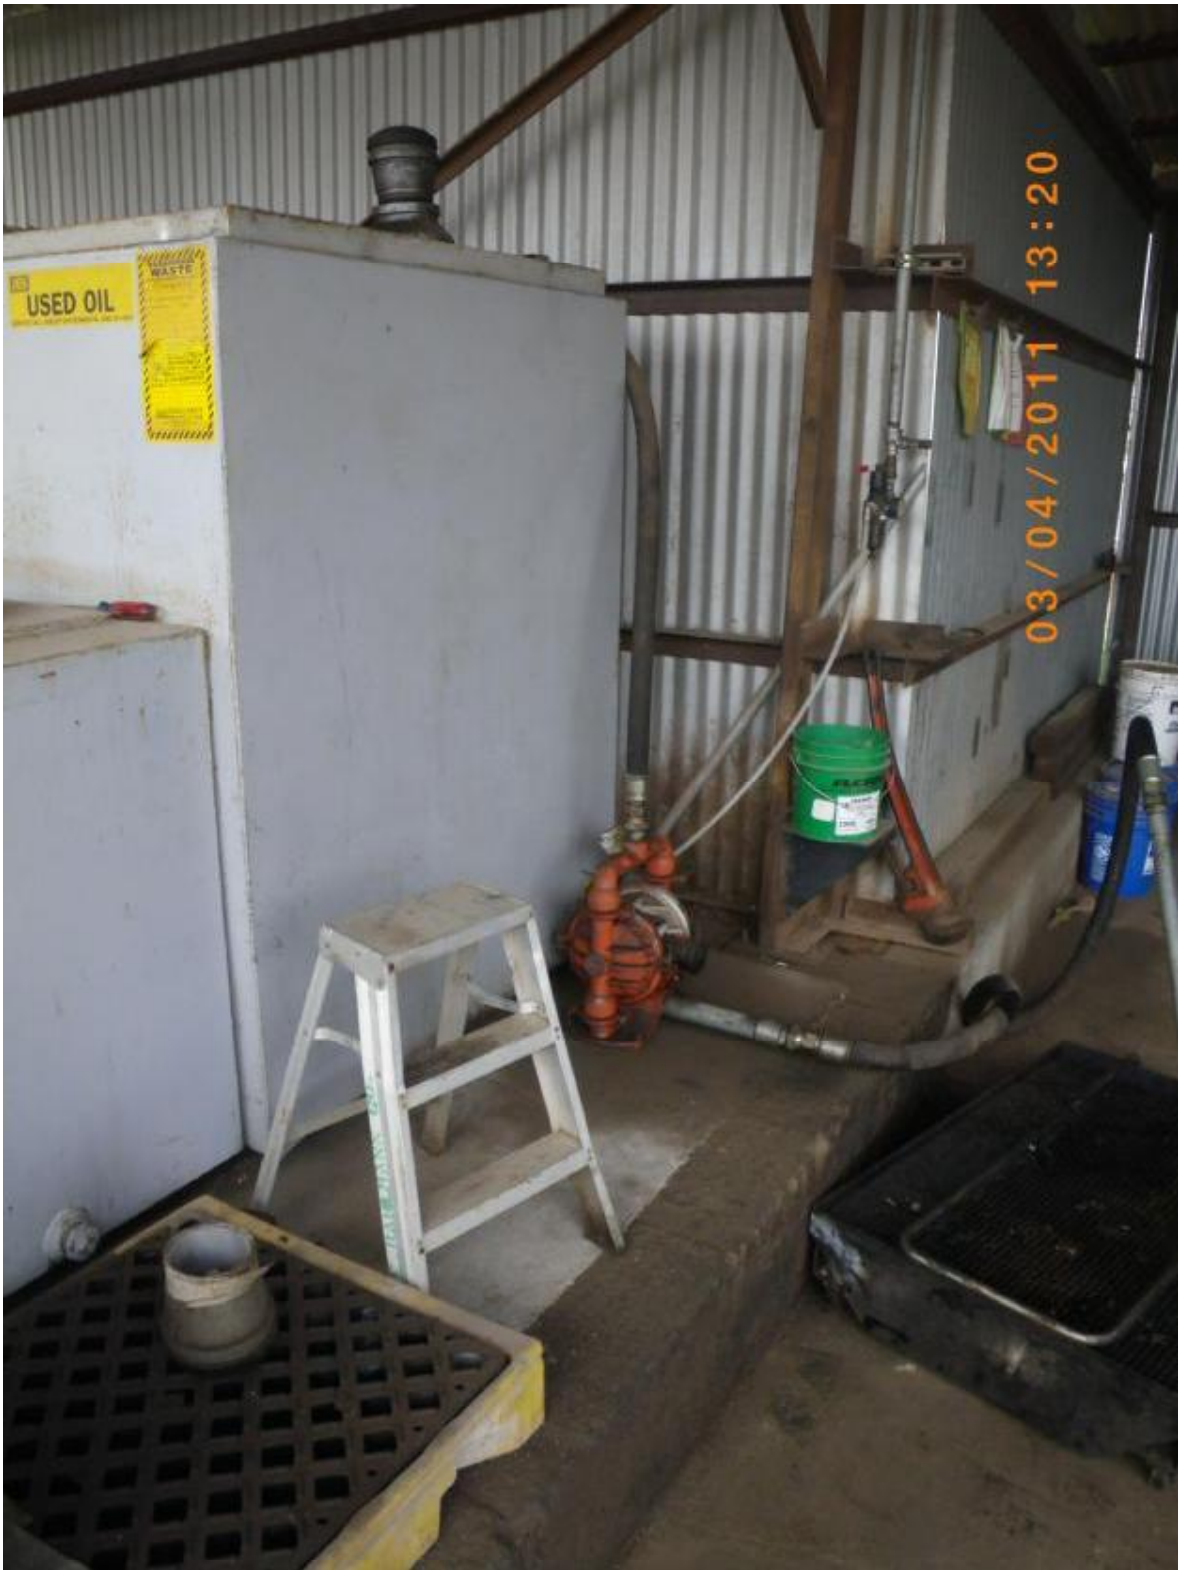
IMGP0287.JPG

IMGP0287 – Stock pile of absorbent material, drums and waste oil containers observed in the covered fueling and oiling depot.

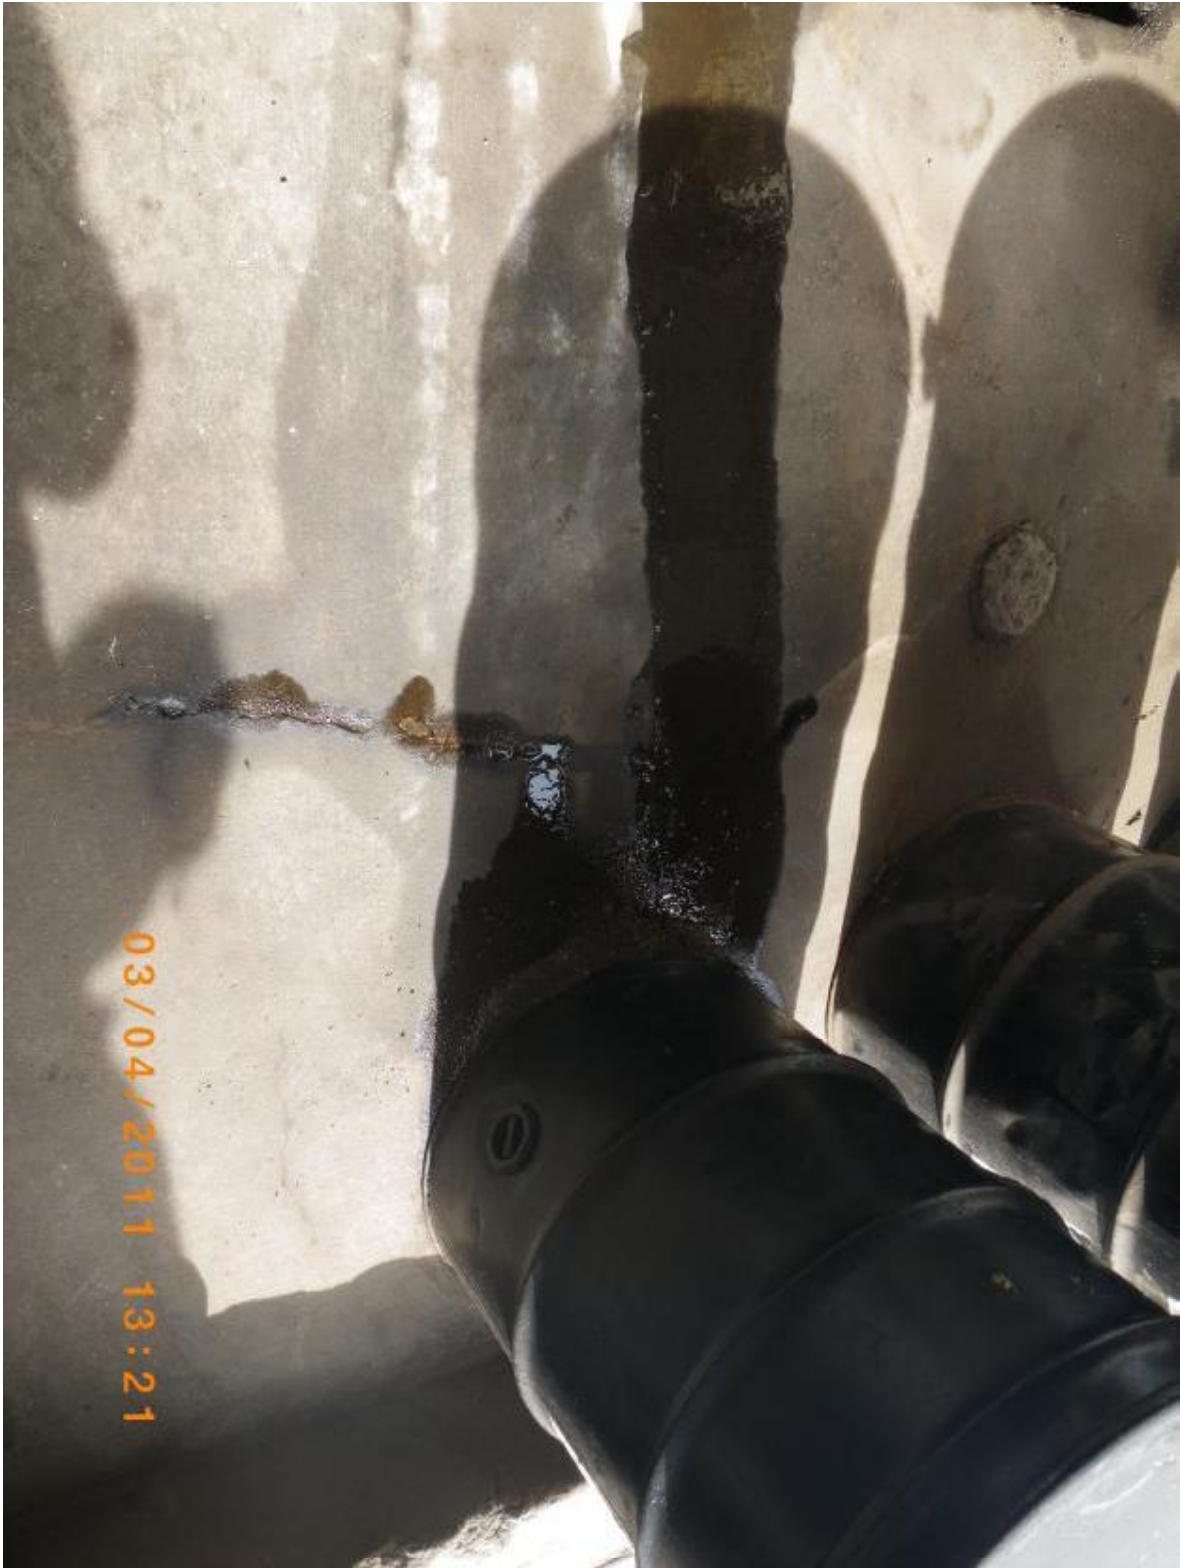
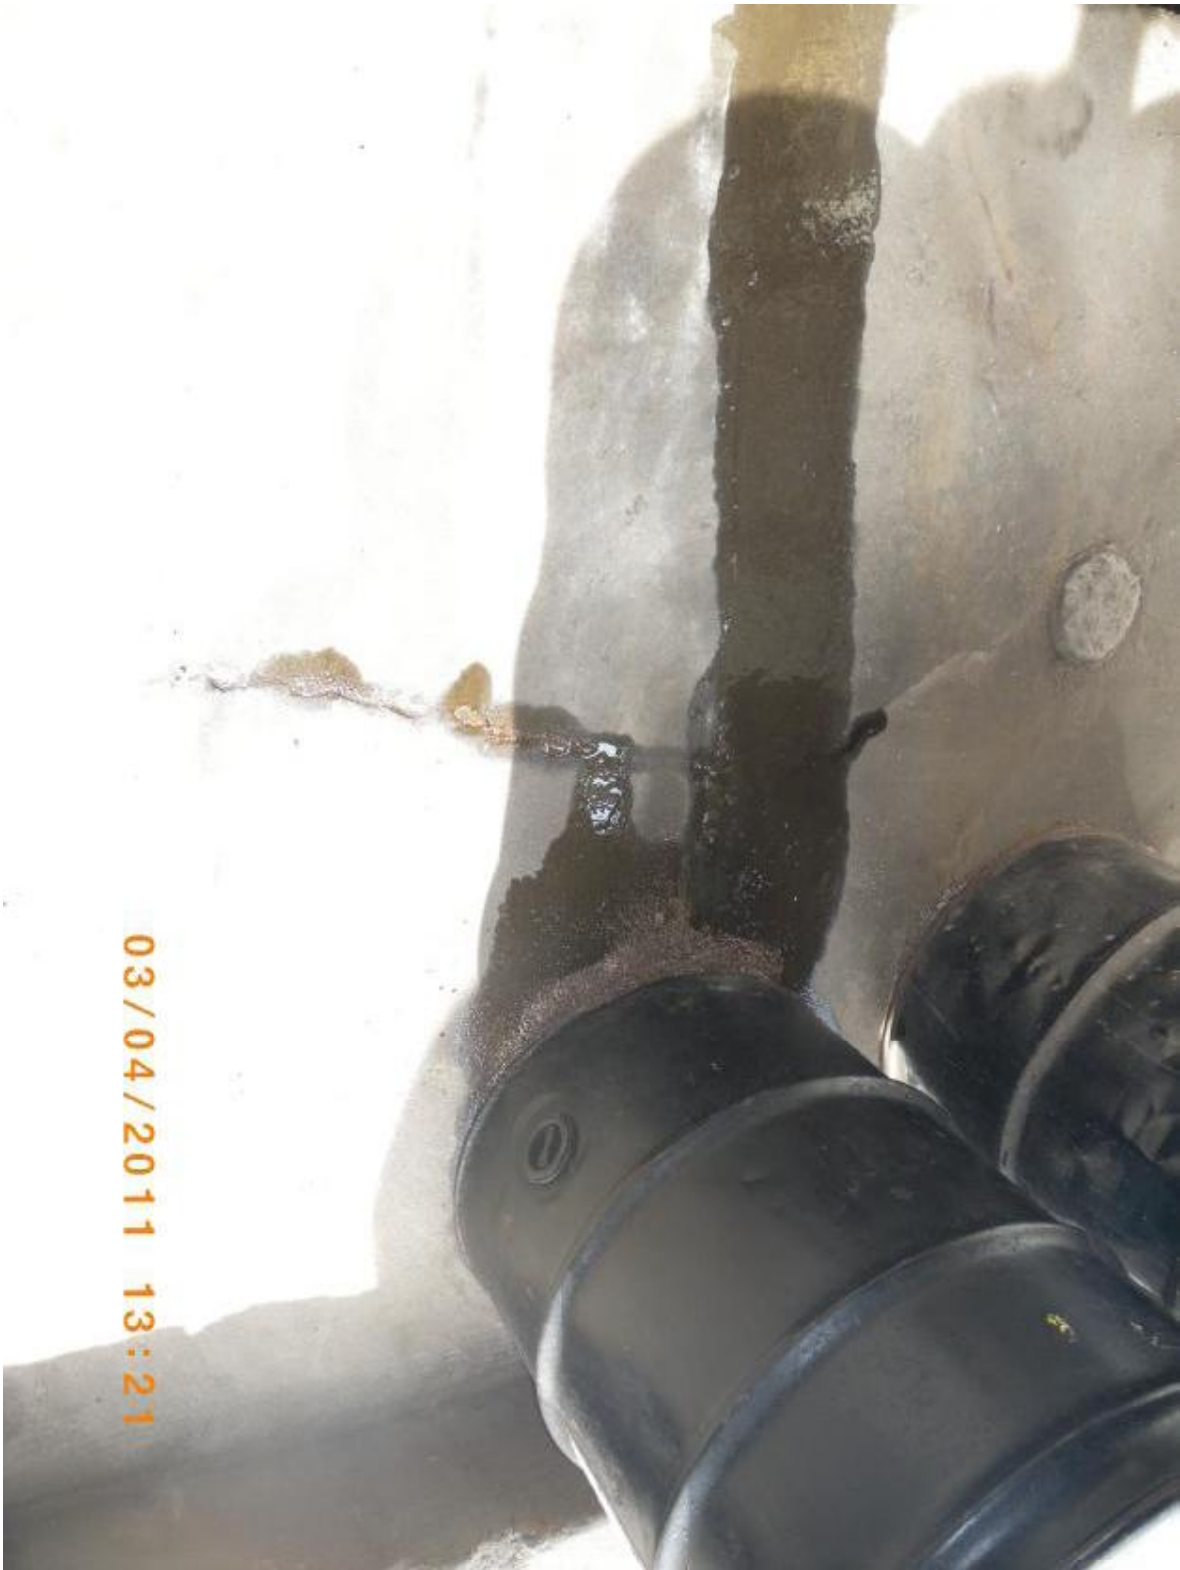
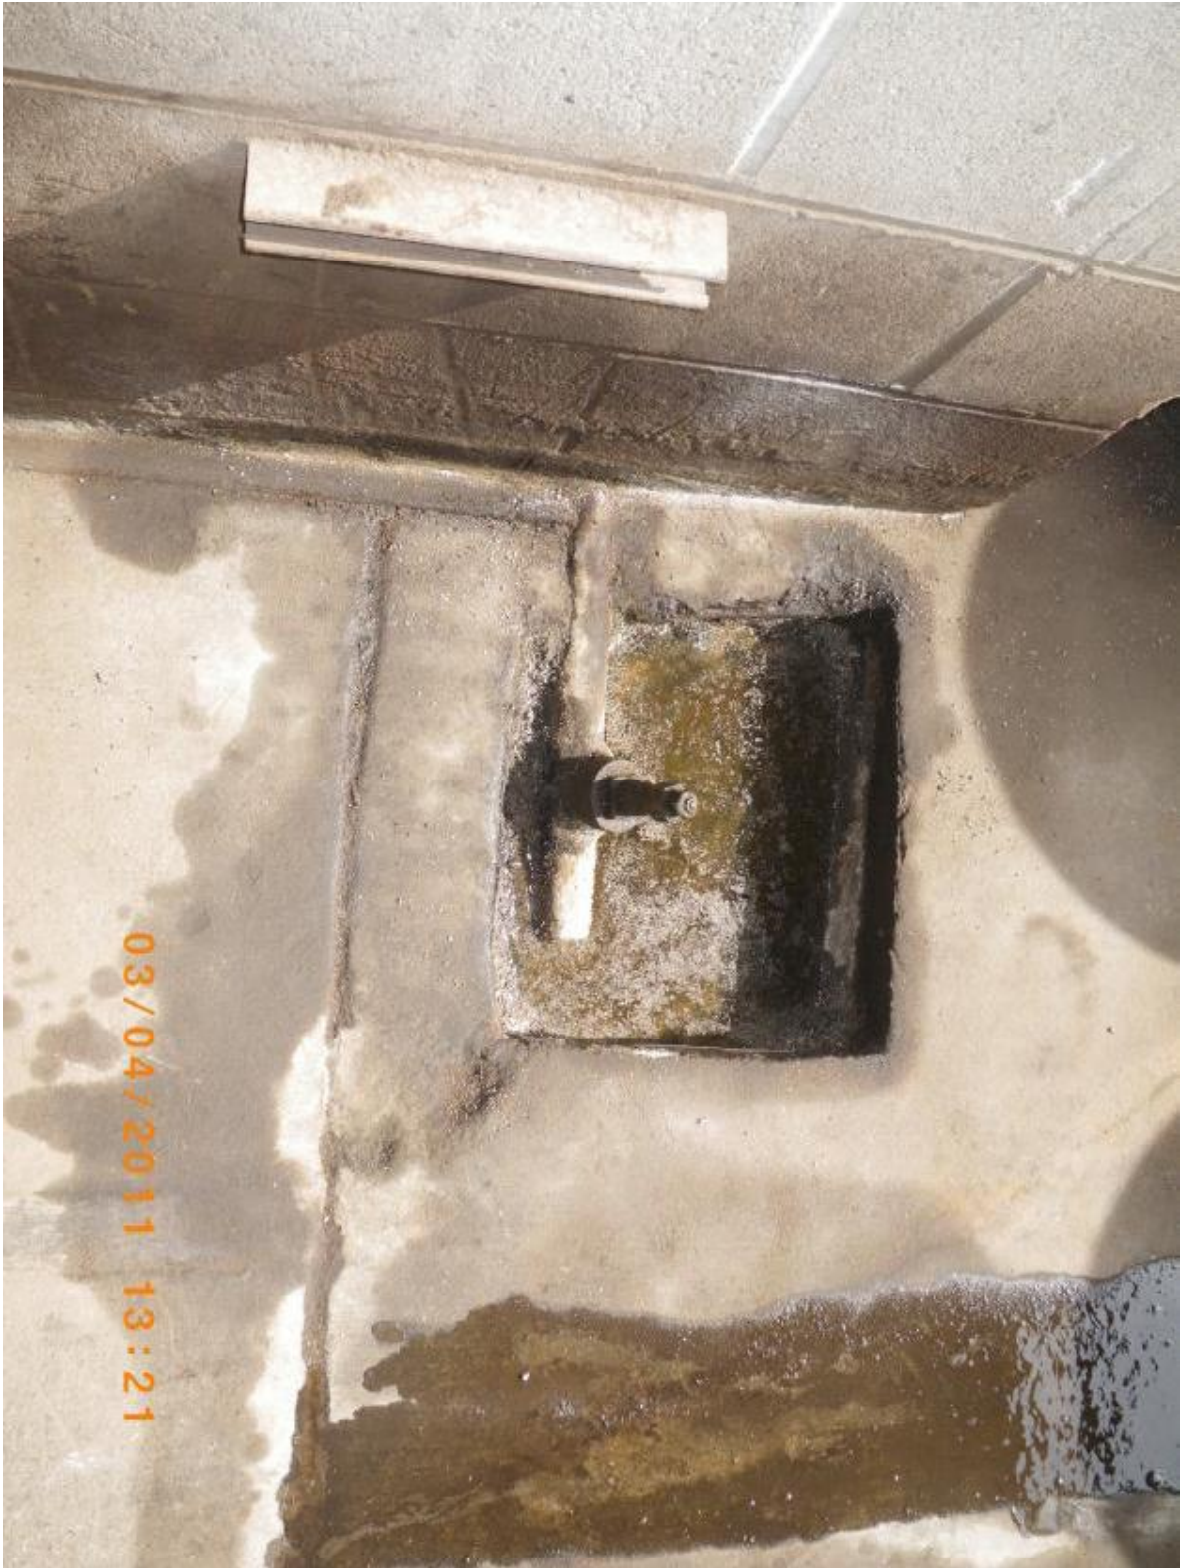
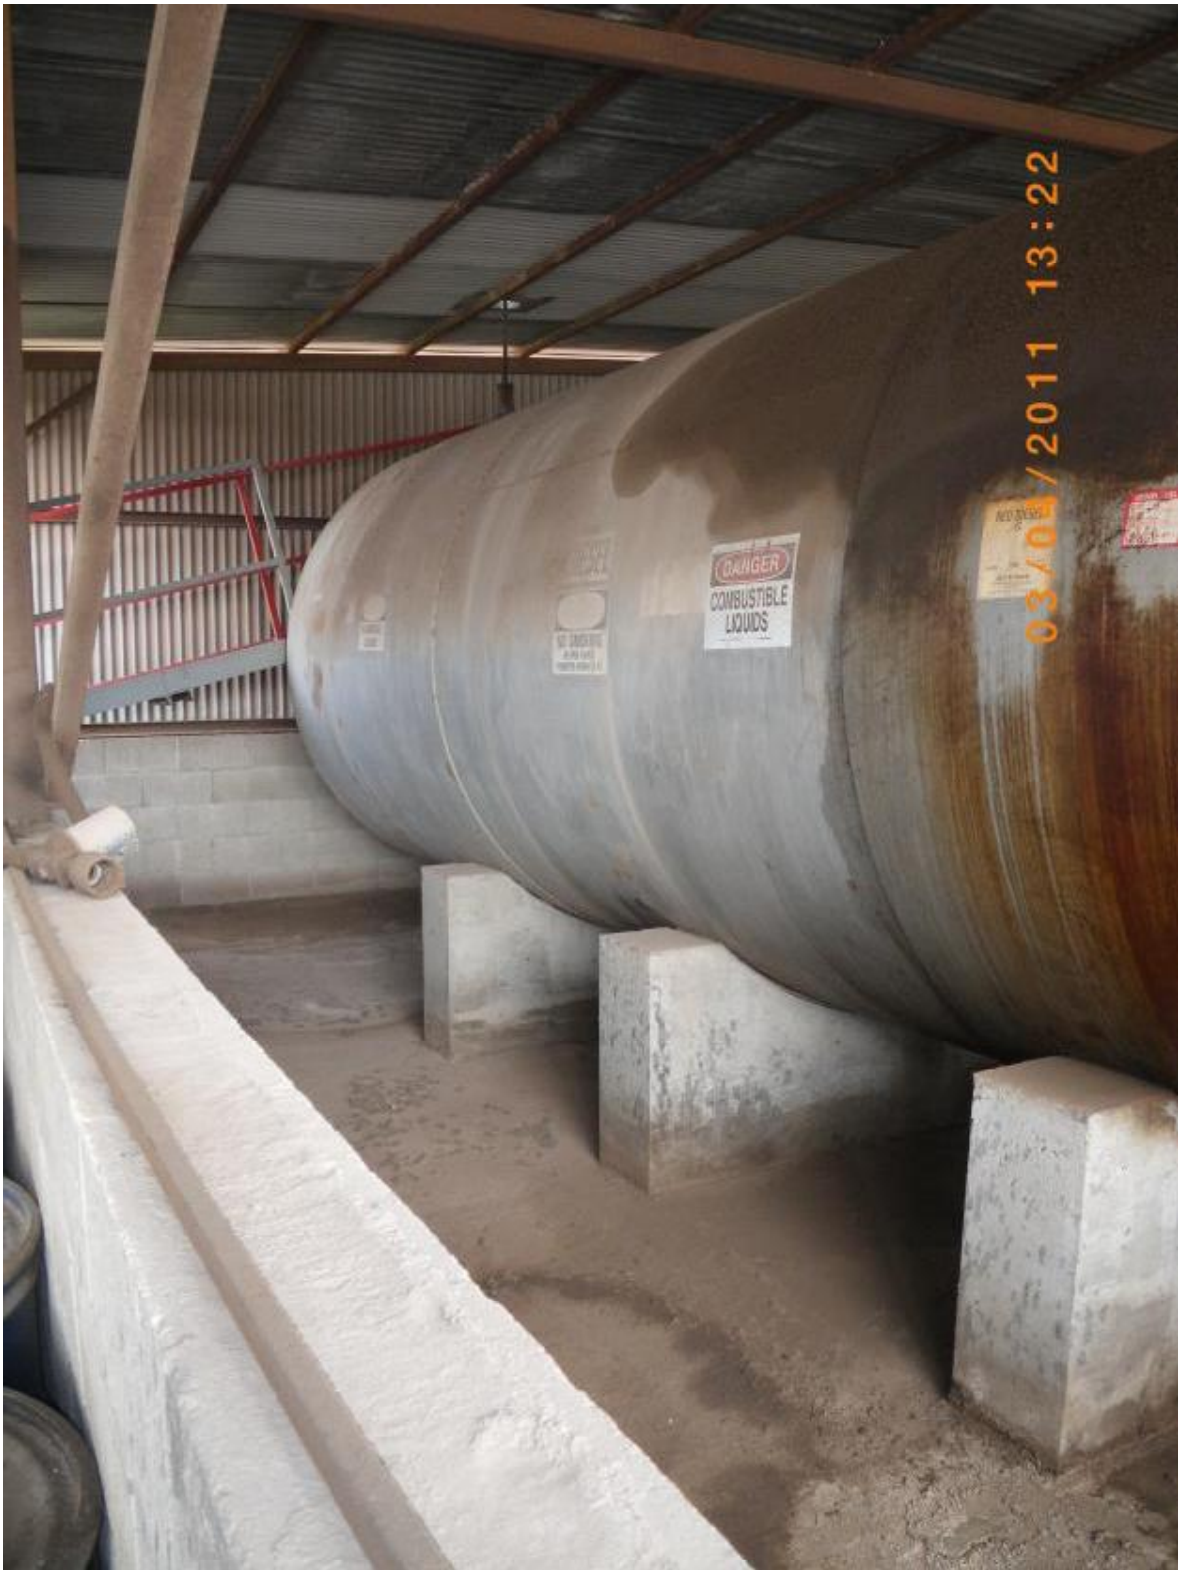
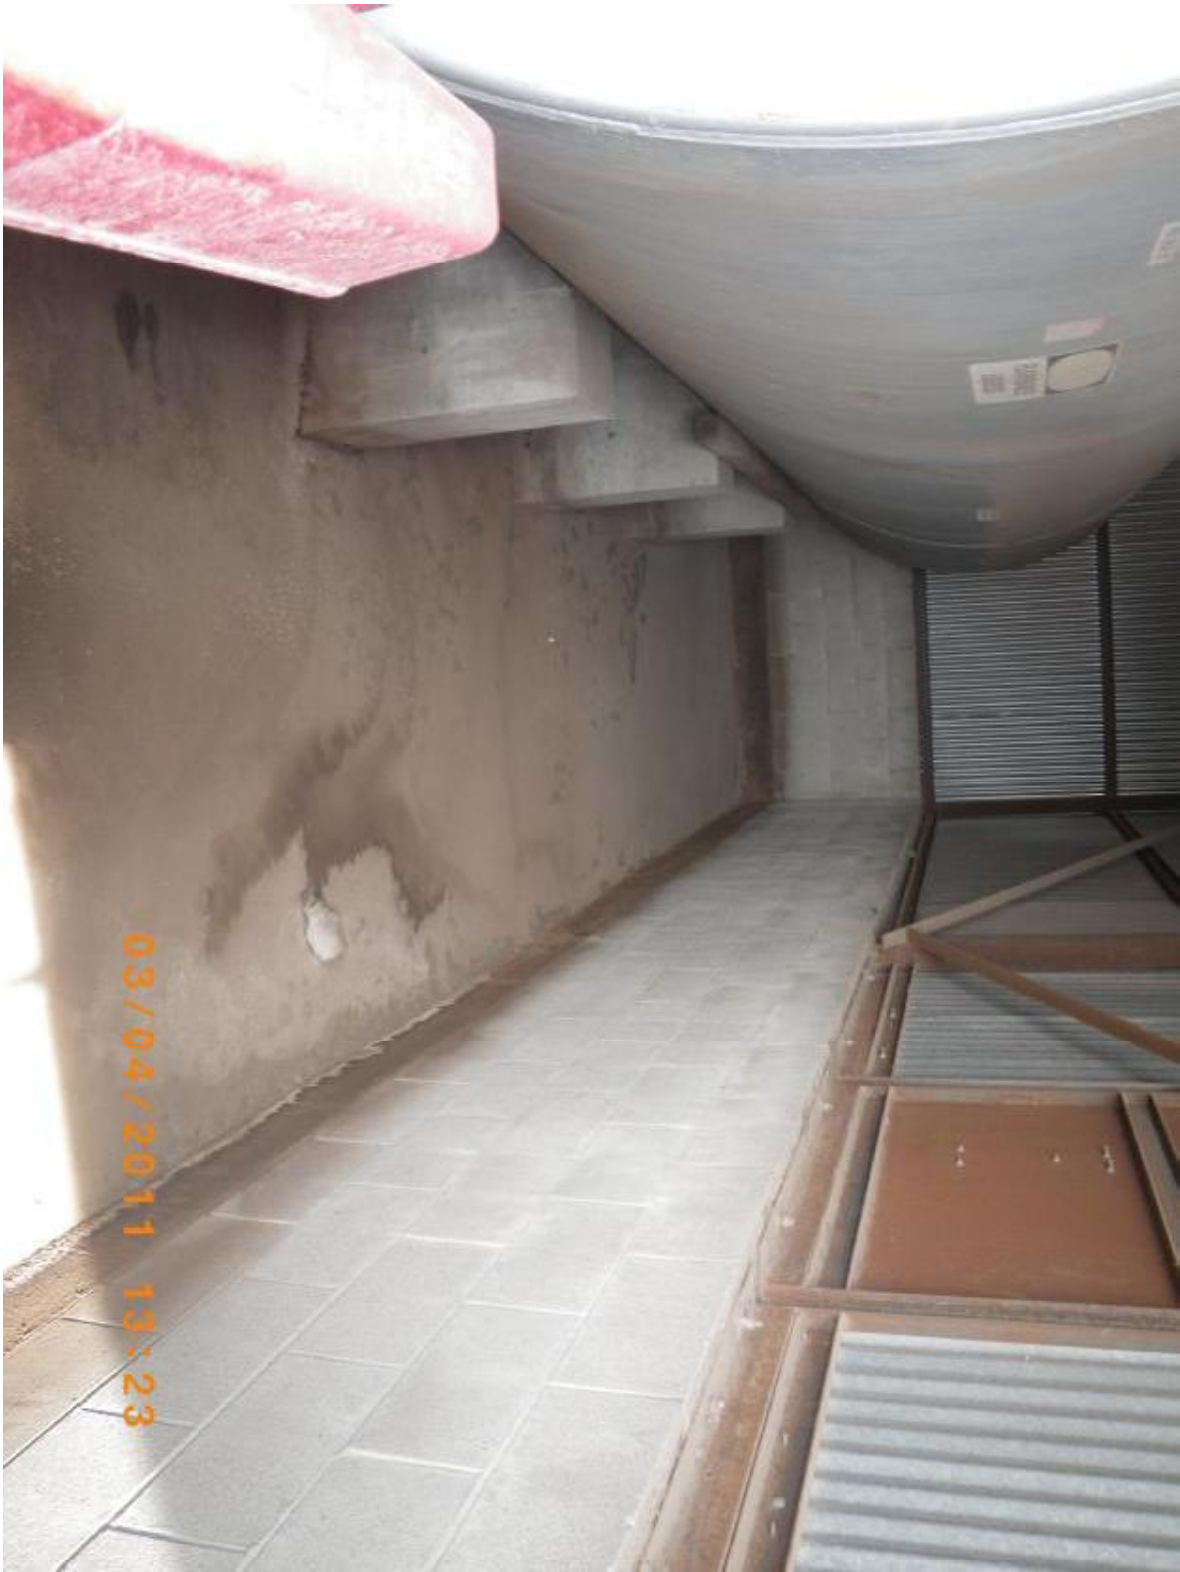
IMGP0288 thru 0293 – Oil lines, drums, and oil leaks observed within the covered fueling and oiling depot. The spigot in IMGP0293 is a drain line for the secondary containment basin for the diesel tank depicted in IMGP0294 thru 0298 – Diesel AST and secondary containment basin. Diesel dispensing nozzle is stored over a bucket to catch incidental drips.
