Title	Guam Waterworks Authority (VP0989)
Subject	Northern System
Latitude	██████████
Longitude	██████████
Photo Direction	██████
Elevation	████
Date Time Stamp	4/27/2012 9:37:55 AM
Photographer	K. Sable
Comment	Y 15 Well
Description	Overview of Y 15 well

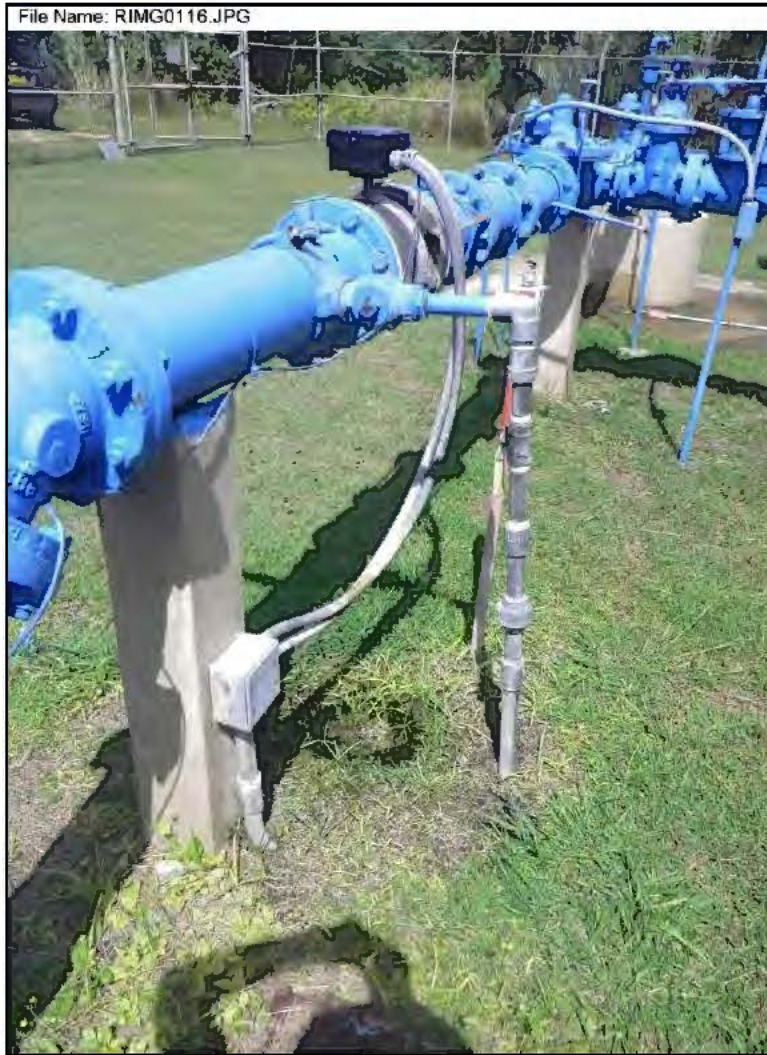
Attributes	
Title	Guam Waterworks Authority (VP0989)
Subject	Northern System
Latitude	██████████
Longitude	██████████
Photo Direction	██████████
Elevation	██████
Date Time Stamp	4/27/2012 10:00:52 AM
Photographer	K. Sable
Comment	Y 15 Well
Description	Leak in well assembly chlorine make-up valve

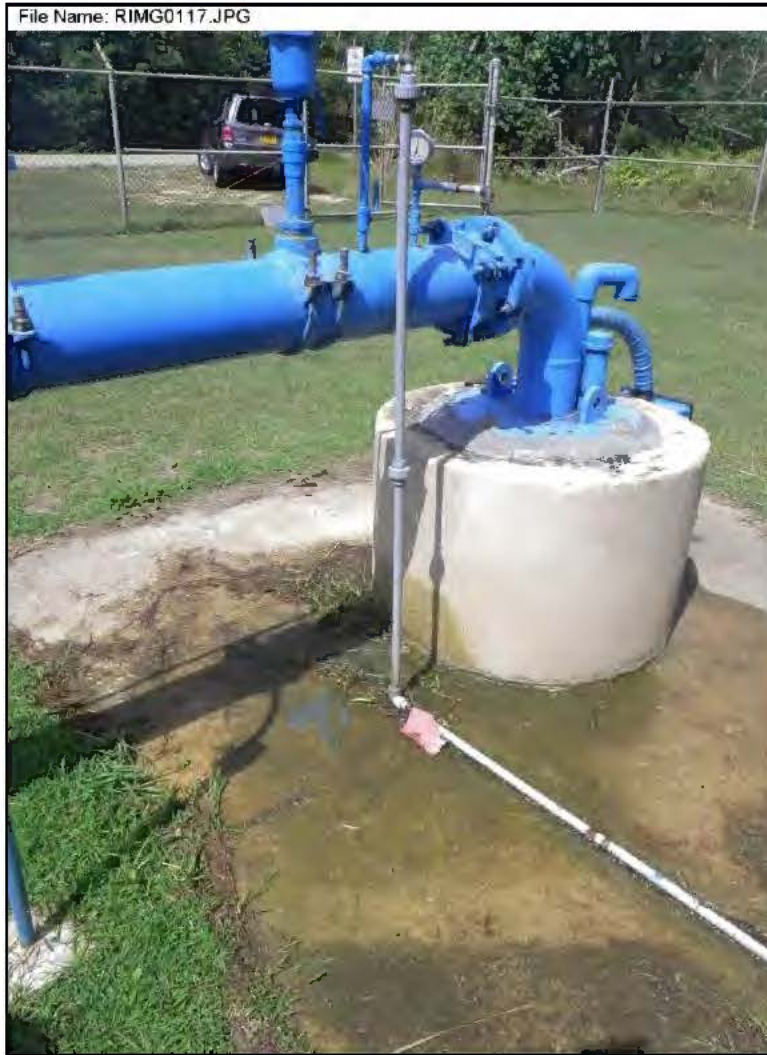
Attributes	
Title	Guam Waterworks Authority (VP0989)
Subject	Northern System
Latitude	██████████
Longitude	██████████
Photo Direction	██████████
Elevation	██████
Date Time Stamp	4/27/2012 10:01:22 AM
Photographer	K. Sable
Comment	Y 15 Well
Description	Leak in well assembly

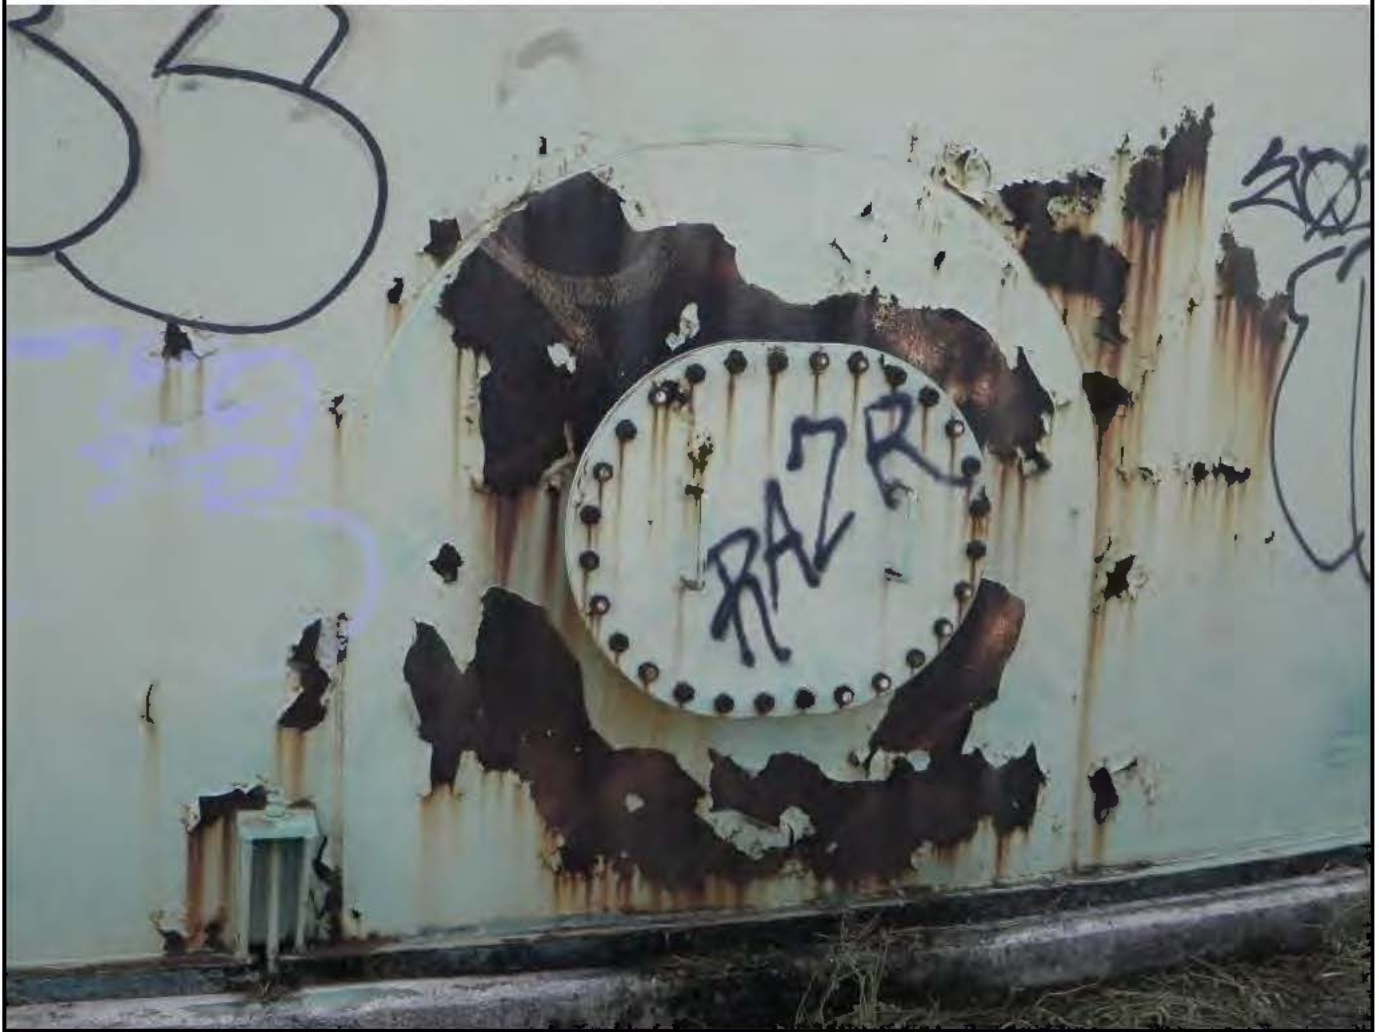
File Name: RIMG0124.JPG

Title	Guam Waterworks Authority (VP0989)
Subject	Northern System
Latitude	██████████
Longitude	██████████
Photo Direction	██████
Elevation	████
Date Time Stamp	4/27/2012 10:35:16 AM
Photographer	K. Sable
Comment	Santa Rosa Tank
Description	Rust areas on tank

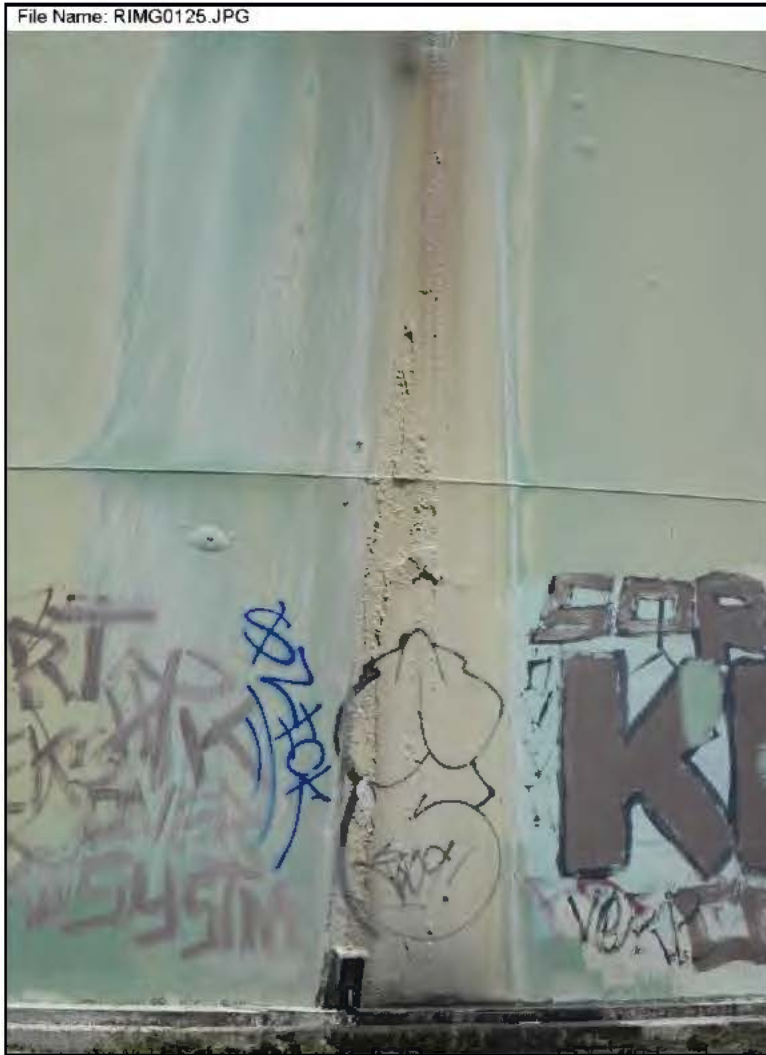
Attributes	
Title	Guam Waterworks Authority (VP0989)
Subject	Northern System
Latitude	██████████
Longitude	██████████
Photo Direction	██████████
██████████	██████████
Date Time Stamp	4/27/2012 10:39:30 AM
Photographer	K. Sable
Comment	Santa Rosa Tank
Description	Previously patched area with precipitate build-up on outside of tank

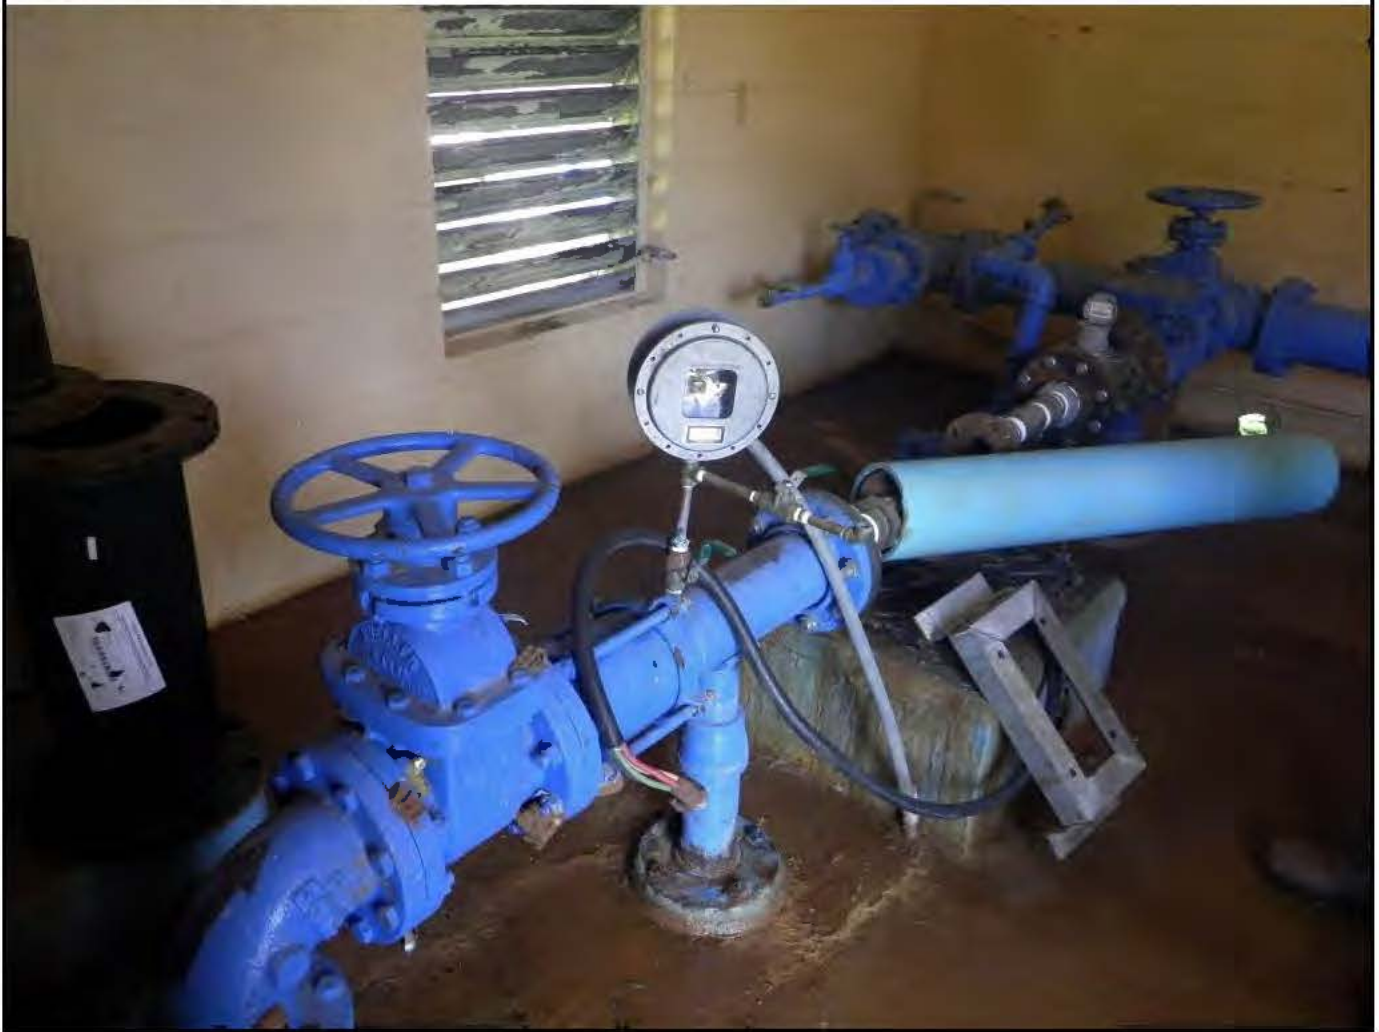
File Name: RIMG0130.JPG

Title	Guam Waterworks Authority (VP0989)
Subject	Northern System
Latitude	██████████
Longitude	██████████
Photo Direction	██████████
Elevation	745 ft
Date Time Stamp	4/27/2012 10:53:56 AM
Photographer	K. Sable
Comment	Santa Rosa Pump Station
Description	Missing motor

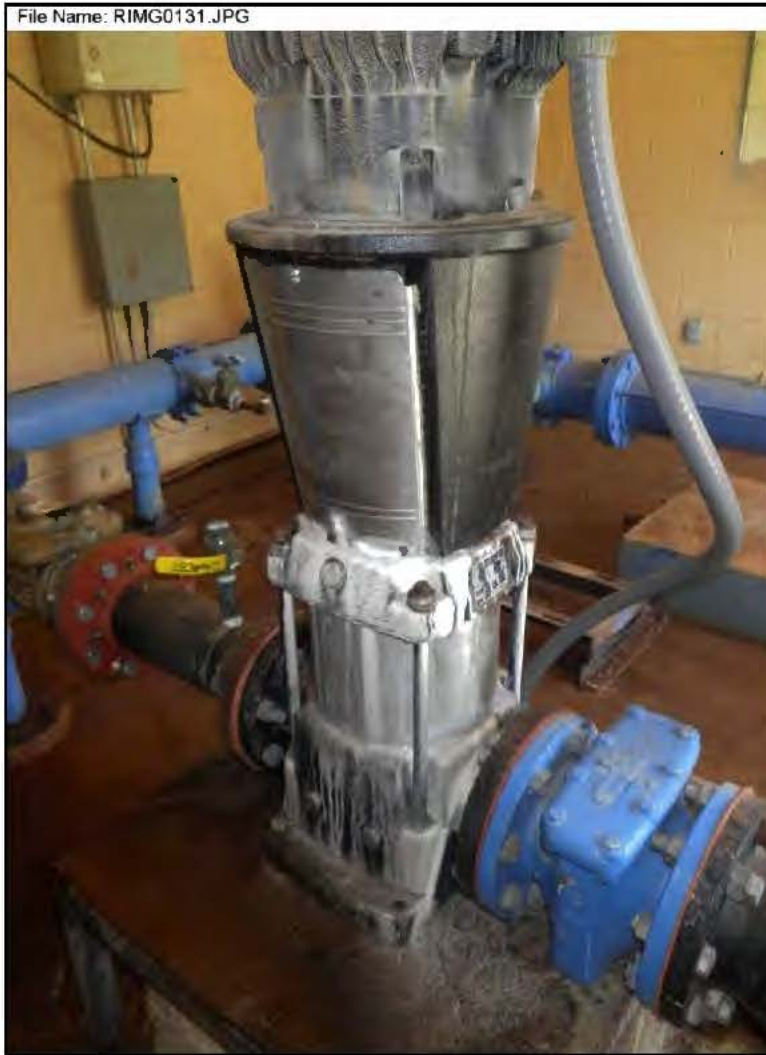
Attributes	
Title	Guam Waterworks Authority (VP0989)
Subject	Northern System
Latitude	██████████
Longitude	██████████
Photo Direction	██████
Elevation	██████
Date Time Stamp	4/27/2012 10:54:23 AM
Photographer	K. Sable
Comment	Santa Rosa Pump Station
Description	Leaking pump

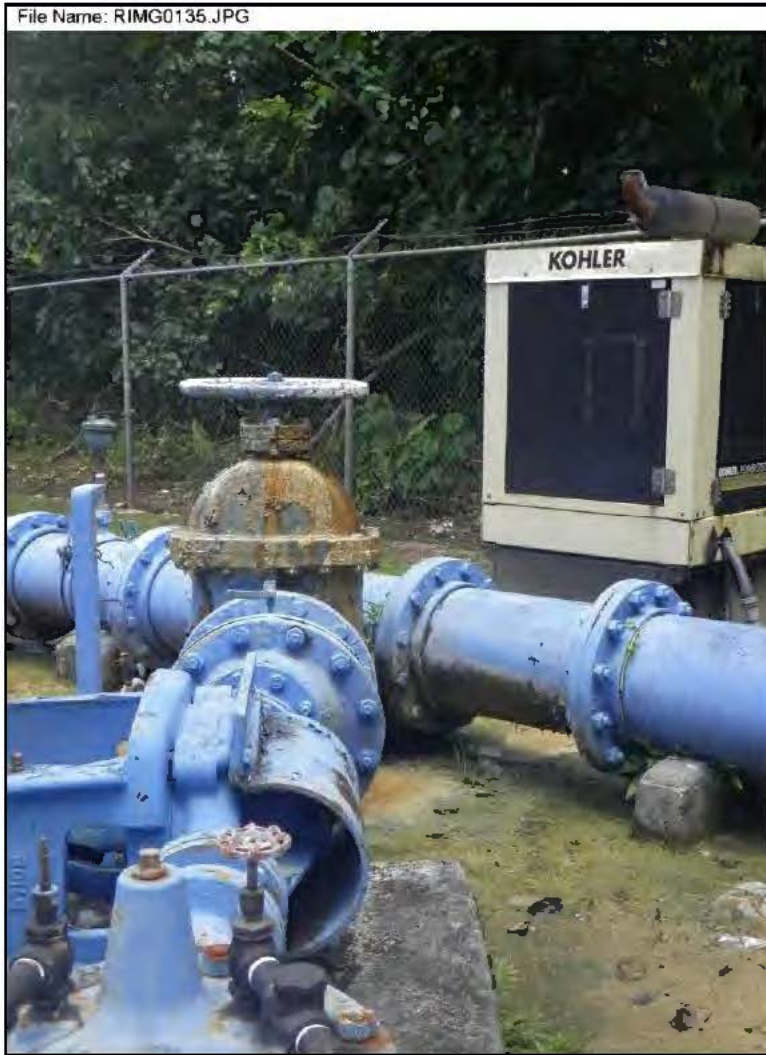
Attributes	
Title	Guam Waterworks Authority (VP0989)
Subject	Northern System
Latitude	██████████
Longitude	██████████
Photo Direction	██████████
Elevation	██████
Date Time Stamp	4/27/2012 11:20:14 AM
Photographer	K. Sable
Comment	Gayinero Pump Station
Description	Leaking isolation valve in line # 2

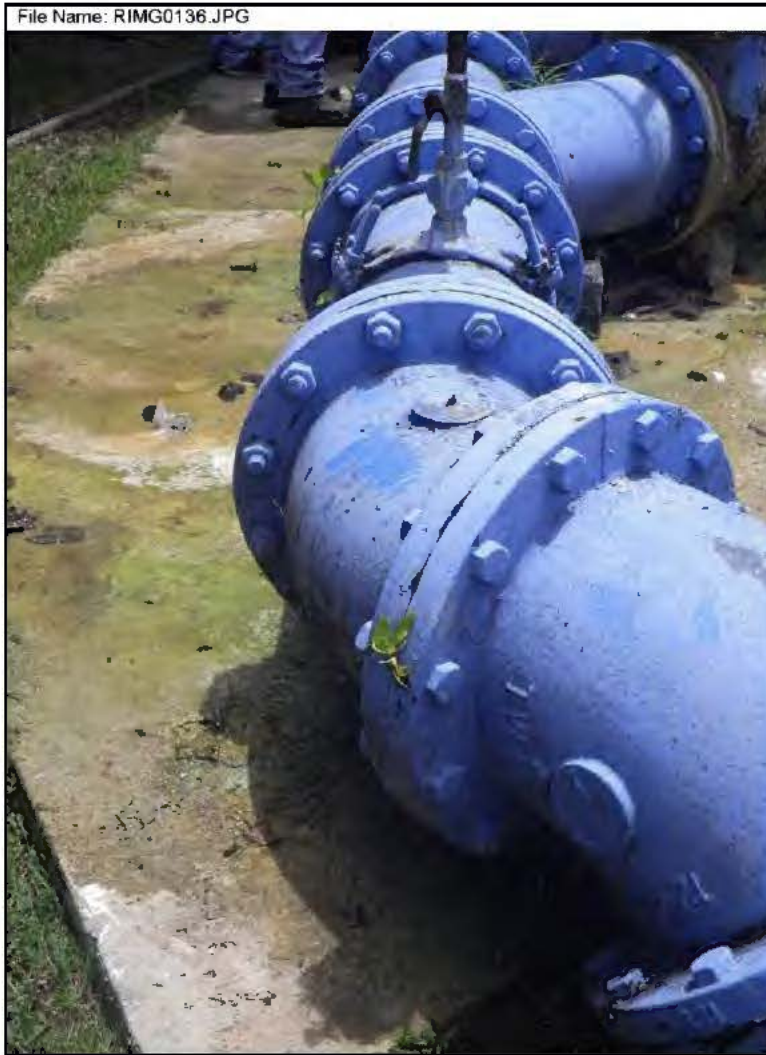
Attributes	
Title	Guam Waterworks Authority (VP0989)
Subject	Northern System
Latitude	██████████
Longitude	██████████
Photo Direction	██████
Elevation	██████
Date Time Stamp	4/27/2012 11:21:25 AM
Photographer	K. Sable
Comment	Gayinero Pump Station
Description	Vegetation growing out of pipe flange

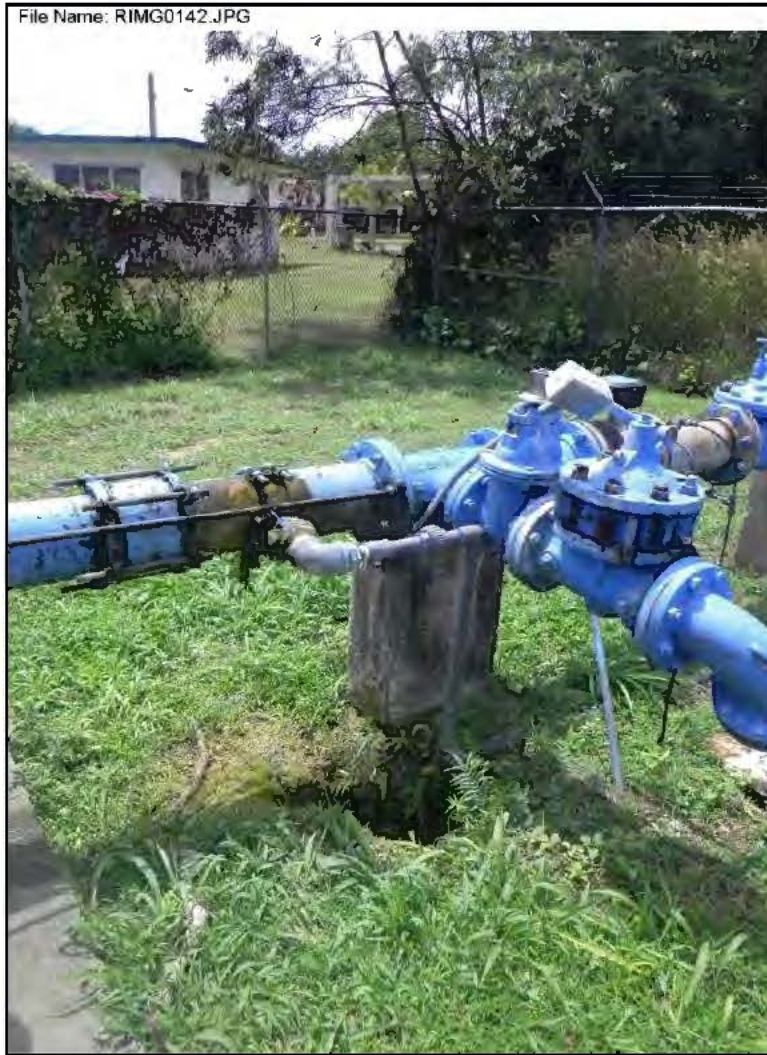
Attributes	
Title	Guam Waterworks Authority (VP0989)
Subject	Northern System
Latitude	██████████
Longitude	██████████
Photo Direction	██████████
Elevation	██████
Date Time Stamp	4/27/2012 1:41:46 PM
Photographer	K. Sable
Comment	Y 9 Well
Description	Leaking inlet for suction line for chlorine

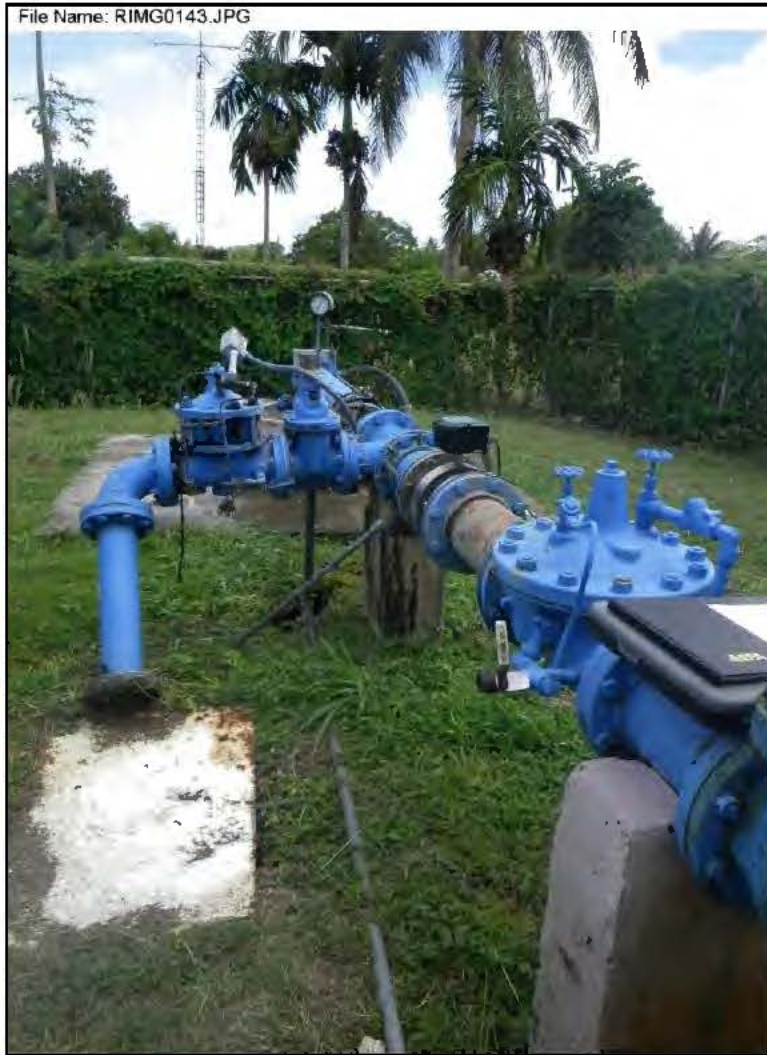
Attributes	
Title	Guam Waterworks Authority (VP0989)
Subject	Northern System
Latitude	[REDACTED]
Longitude	[REDACTED]
Photo Direction	[REDACTED]
Elevation	[REDACTED]
Date Time Stamp	4/27/2012 1:47:32 PM
Photographer	K. Sable
Comment	Y 9 Well
Description	Bypass assembly dead ending to the ground

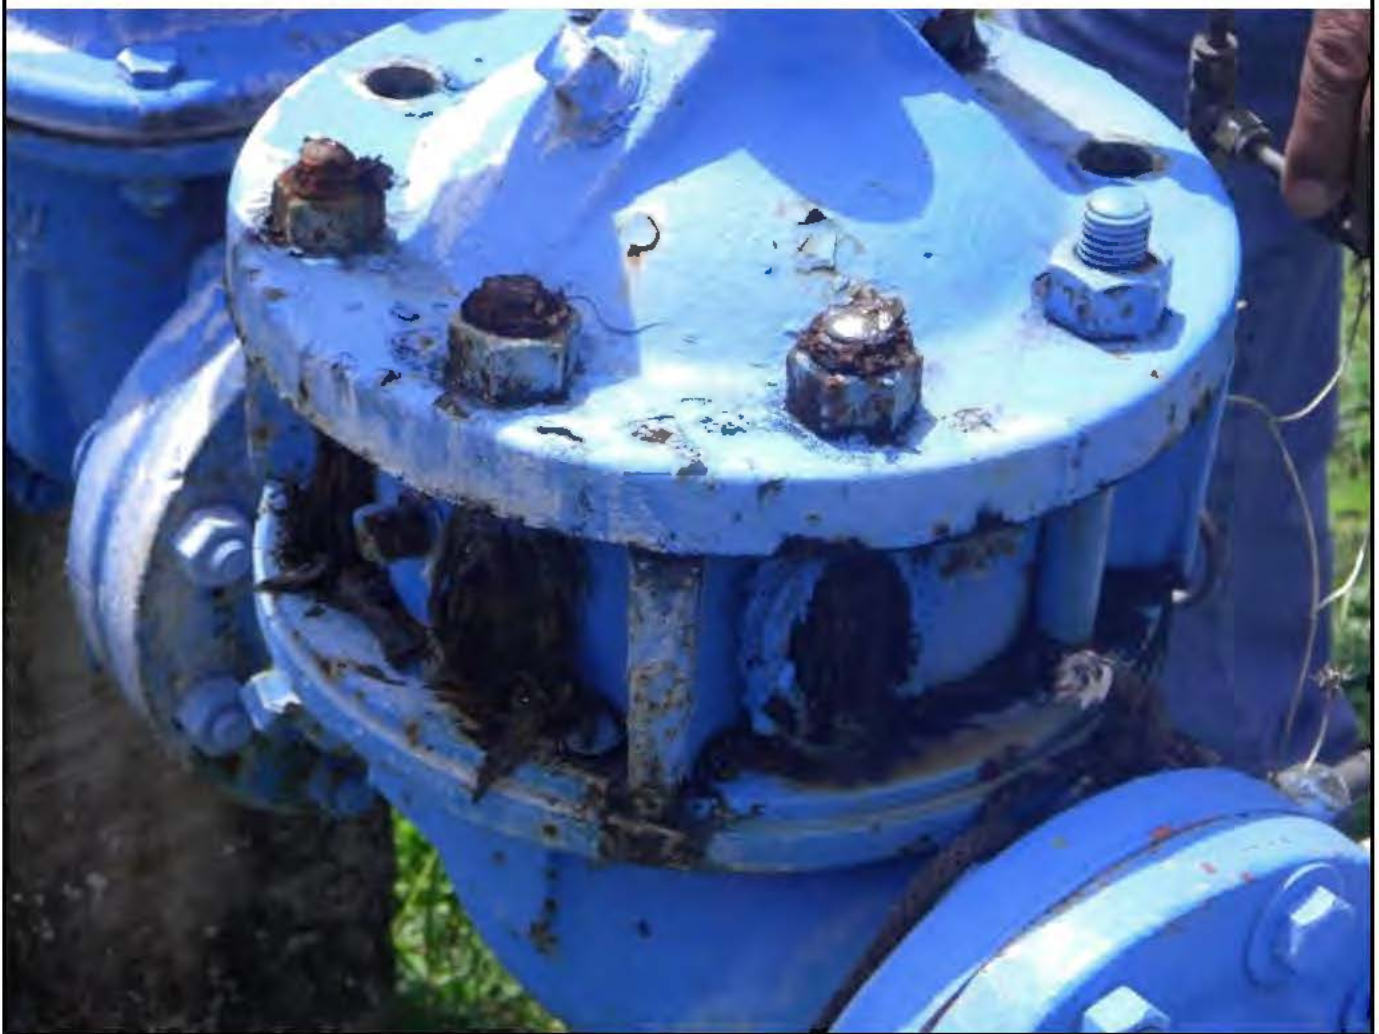
File Name: RIMG0144.JPG

Title	Guam Waterworks Authority (VP0989)
Subject	Northern System
Latitude	██████████
Longitude	██████████
Photo Direction	██████ /
██████████	██████
Date Time Stamp	4/27/2012 1:48:51 PM
Photographer	K. Sable
Comment	Y 9 Well
Description	Bypass valve rusting retaining bolts

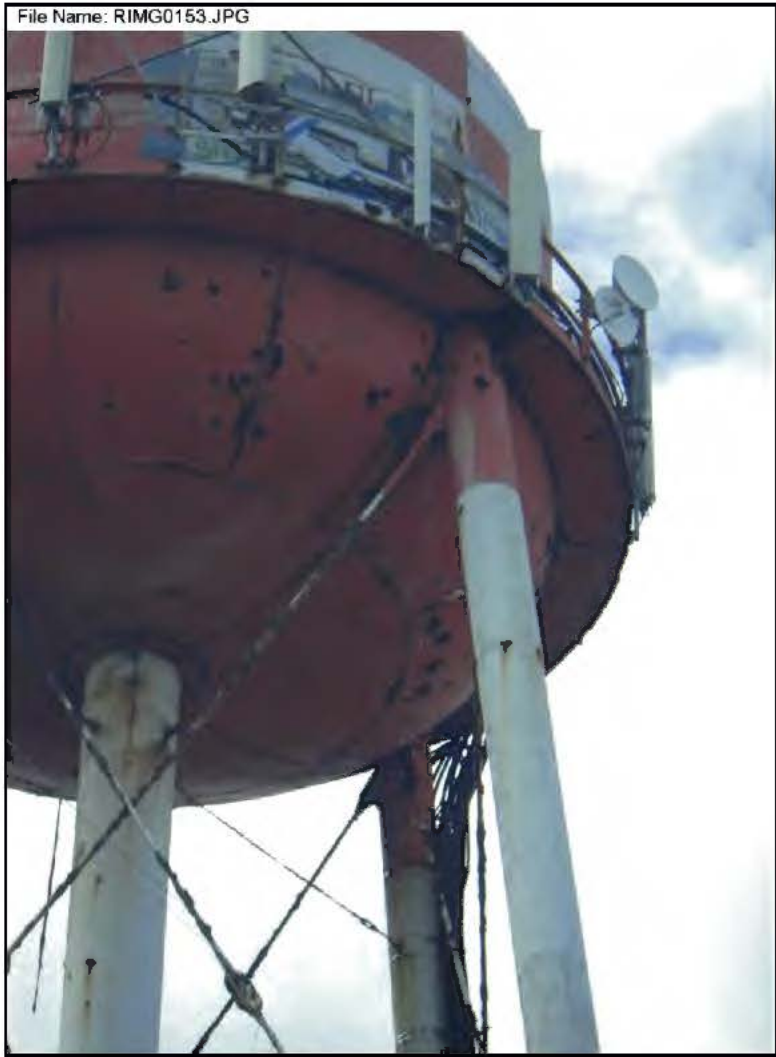
Attributes	
Title	Guam Waterworks Authority (VP0989)
Subject	Northern System
Latitude	██████████
Longitude	██████████
Photo Direction	██████
Elevation	██████
Date Time Stamp	4/27/2012 2:37:06 PM
Photographer	K. Sable
Comment	Yigo # 3 Elevated Tank
Description	Close-up of leak from tank

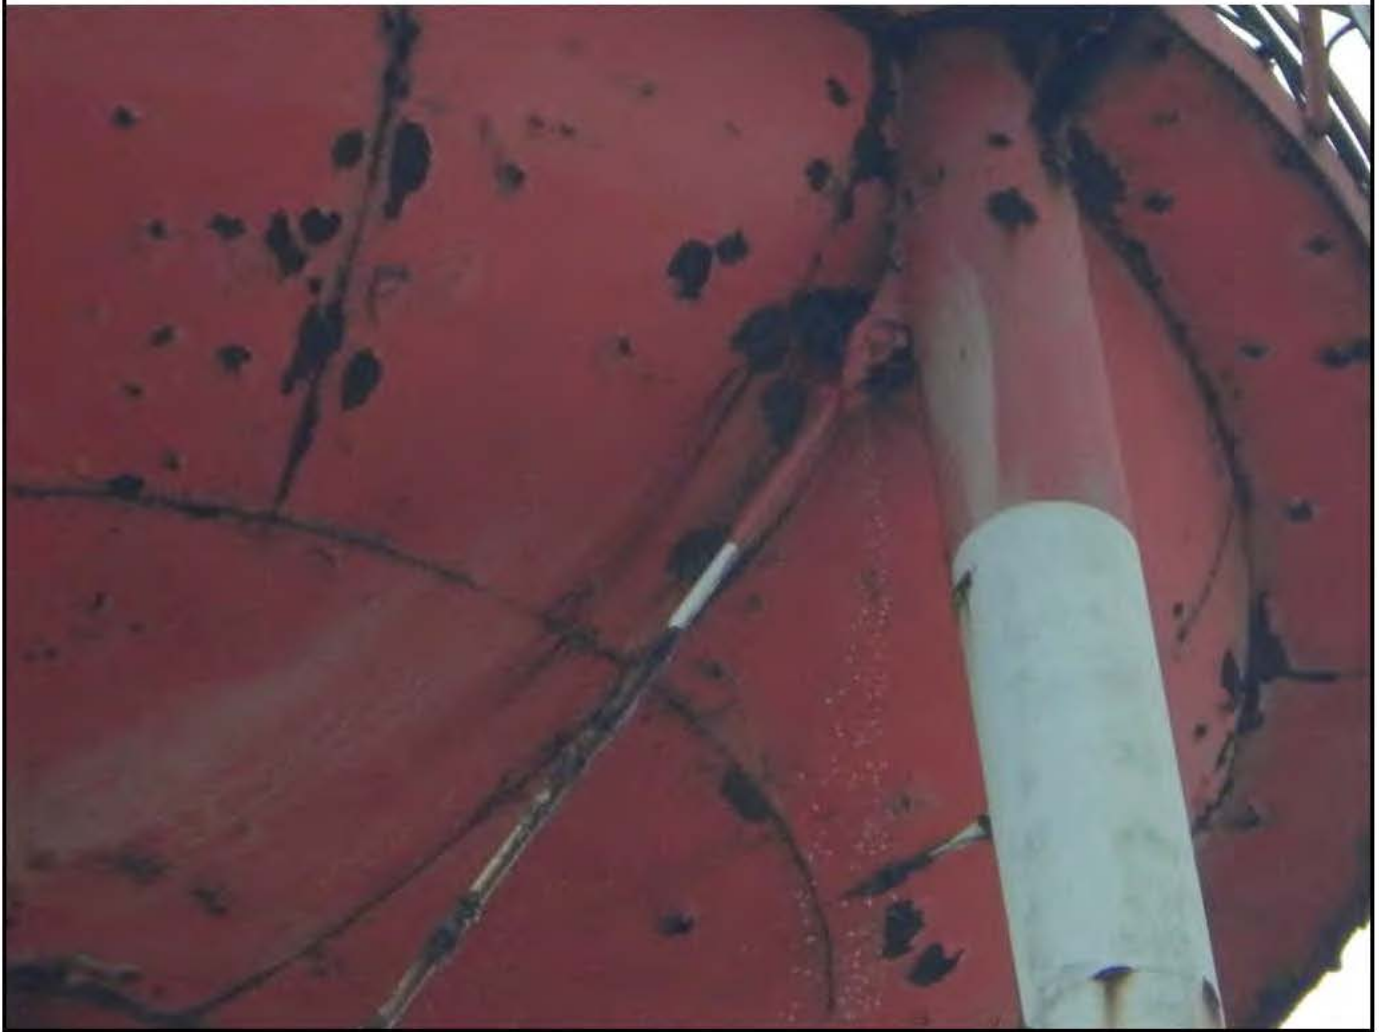
File Name: RIMG0154.JPG

Title	Guam Waterworks Authority (VP0989)
Subject	Northern System
Latitude	██████████
Longitude	██████████
Photo Direction	██████
Elevation	██████
Date Time Stamp	4/27/2012 2:37:27 PM
Photographer	K. Sable
Comment	Yigo # 3 Elevated Tank
Description	Close-up of leak from tank

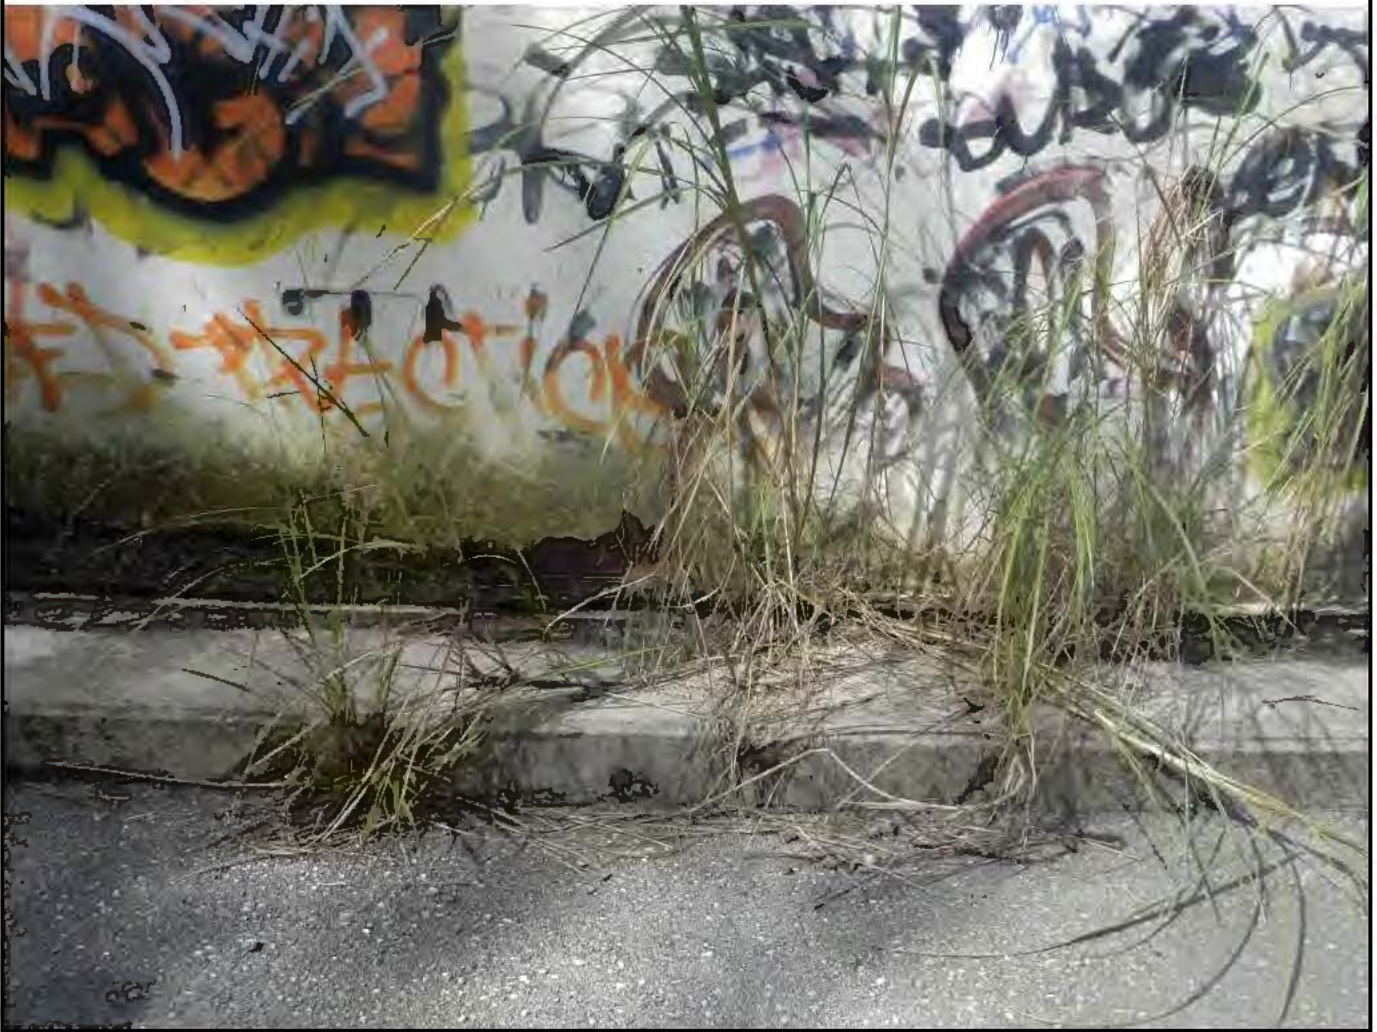
File Name: RIMG0159.JPG

Title	Guam Waterworks Authority (VP0989)
Subject	Northern System
Latitude	██████████
Longitude	██████████
Photo Direction	██████
Elevation	████
Date Time Stamp	4/27/2012 3:27:51 PM
Photographer	K. Sable
Comment	Barrigada # 3 Tank
Description	Damaged side of tank

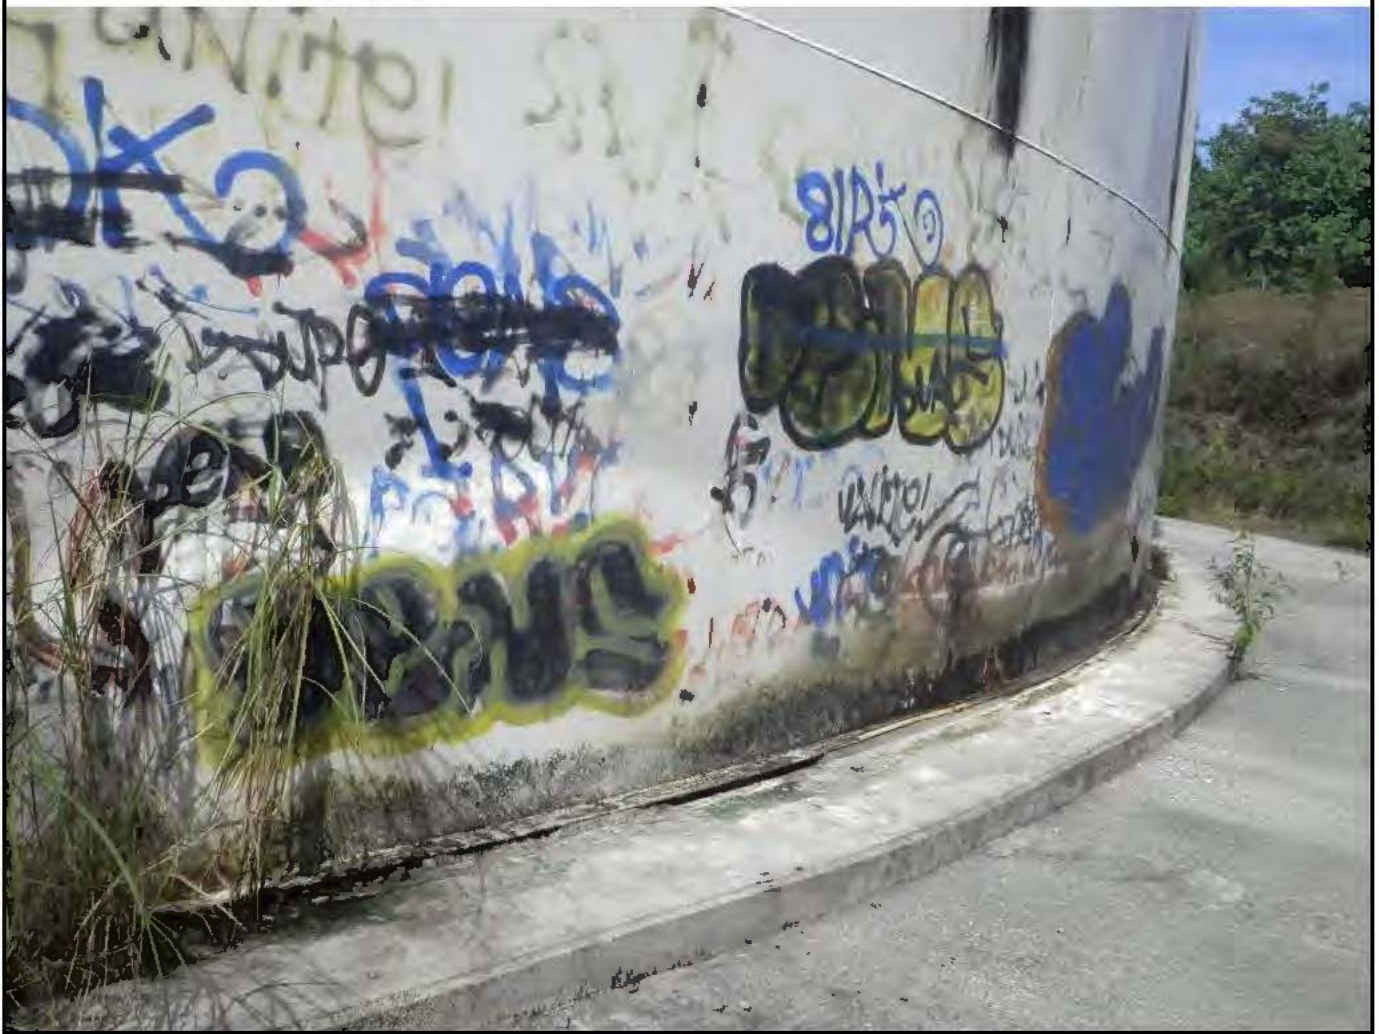
File Name: RIMG0160.JPG

Title	Guam Waterworks Authority (VP0989)
Subject	Northern System
Latitude	██████████
Longitude	██████████
Photo Direction	██████
Elevation	██████
Date Time Stamp	4/27/2012 3:28:00 PM
Photographer	K. Sable
Comment	Barrigada # 3 Tank
Description	Damaged side of tank

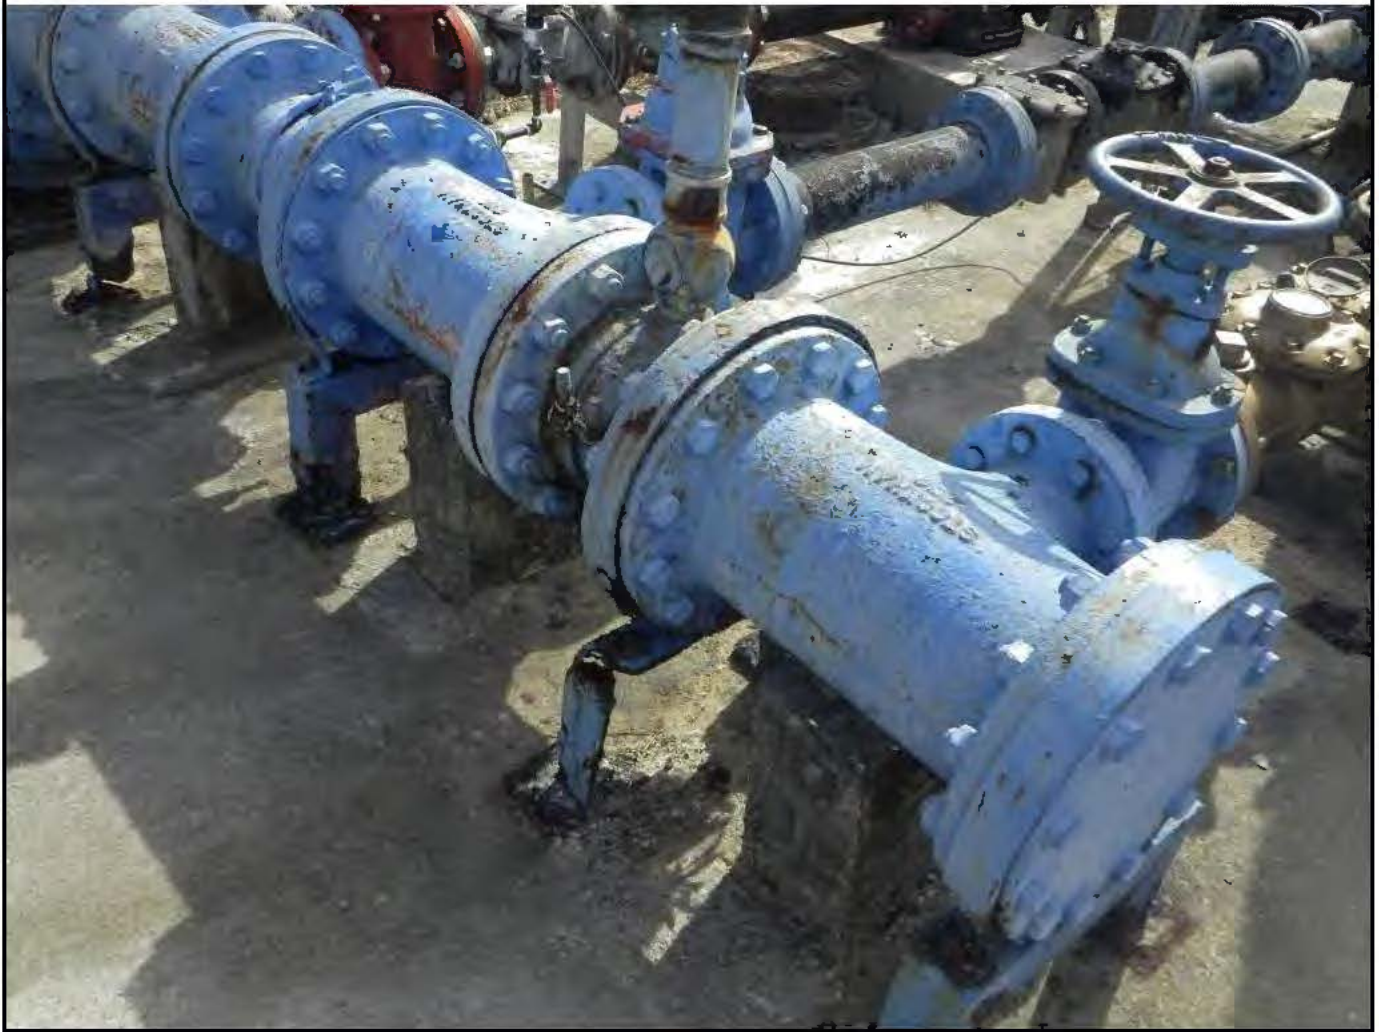
File Name: RIMG0162.JPG

Title	Guam Waterworks Authority (VP0989)
Subject	Northern System
Latitude	██████████
Longitude	██████████
Photo Direction	██████████
Elevation	██████
Date Time Stamp	4/27/2012 3:36:40 PM
Photographer	K. Sable
Comment	Hyundai Pump Station
Description	Rusted support

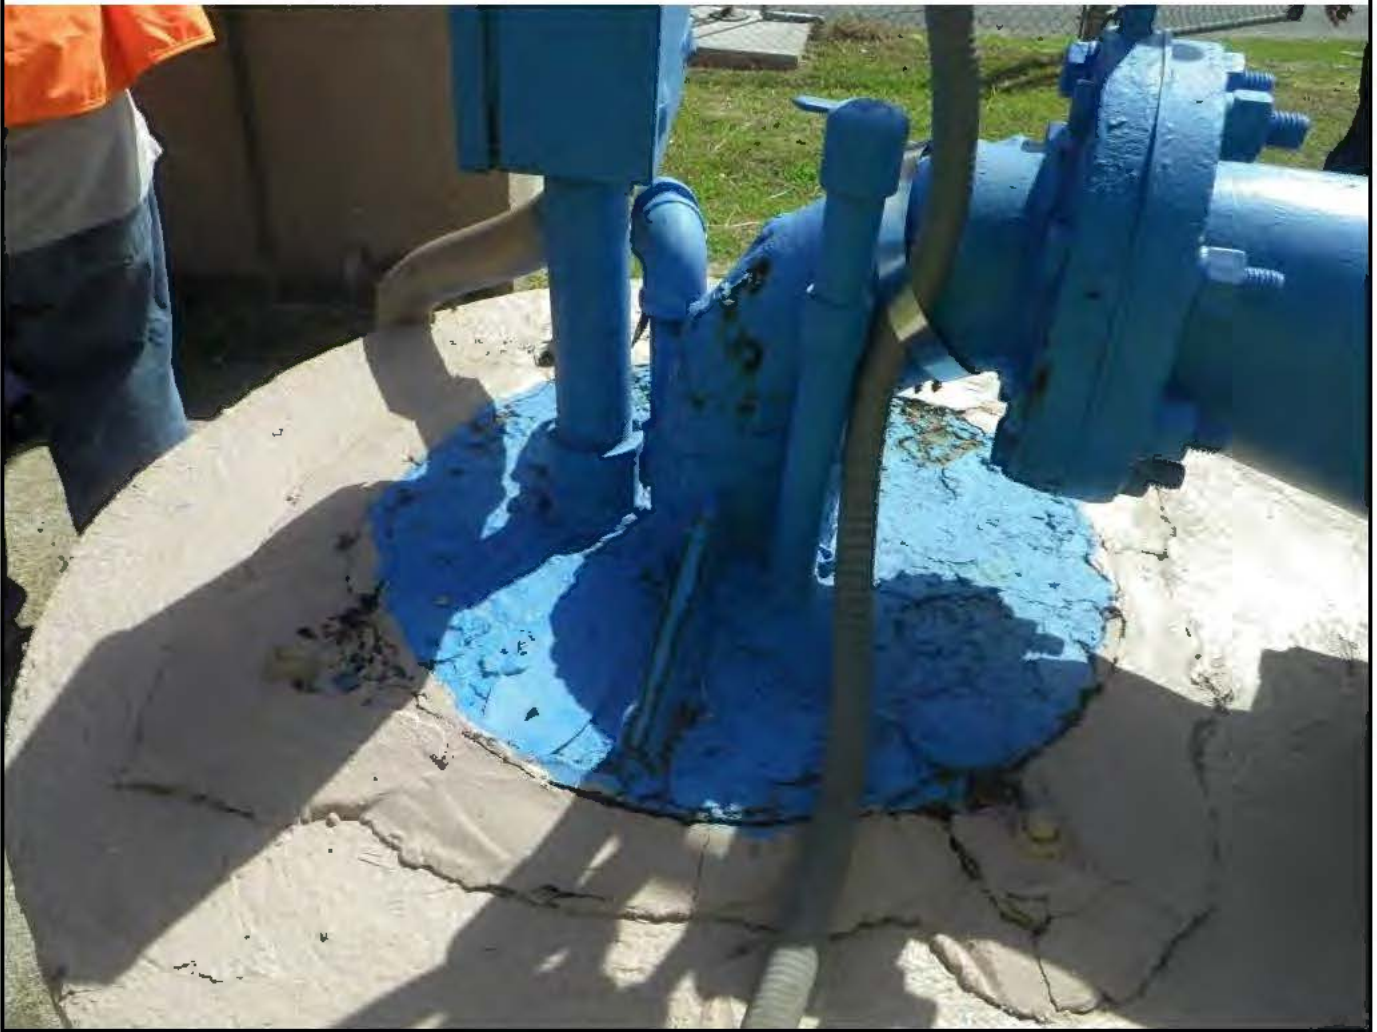
File Name: RIMG0165.JPG

Title	Guam Waterworks Authority (VP0989)
Subject	Northern System
Latitude	██████████
Longitude	██████████
Photo Direction	██████
██████	██████
Date Time Stamp	4/30/2012 9:30:52 AM
Photographer	K. Sable
Comment	A 31 Well
Description	Well head cracks and pitting

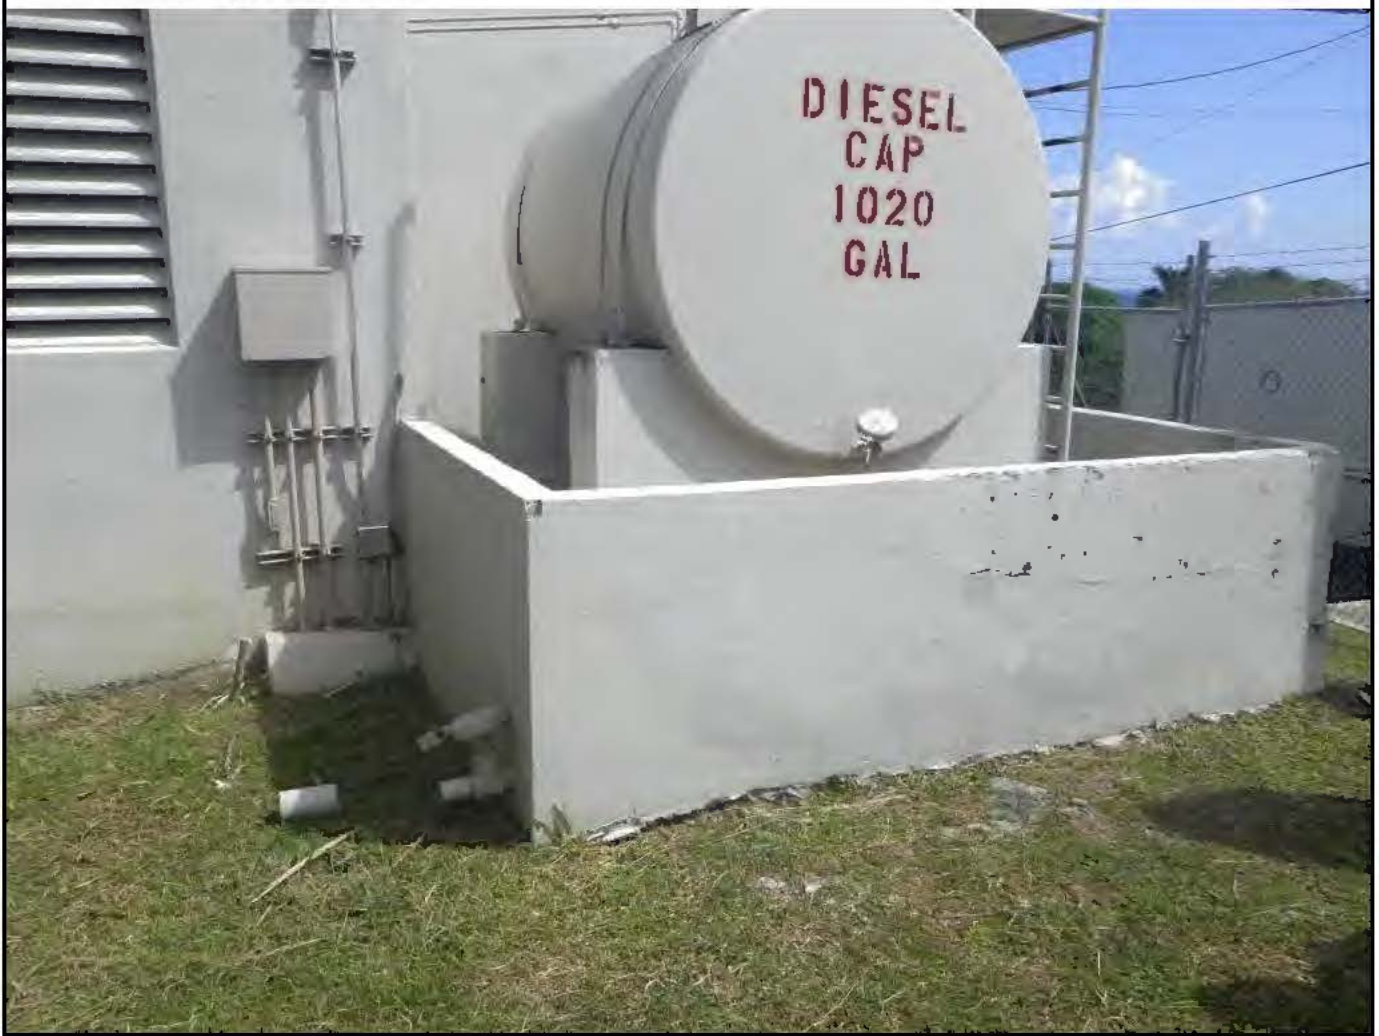
File Name: RIMG0168.JPG

Title	Guam Waterworks Authority (VP0989)
Subject	Northern System
Latitude	██████████
Longitude	██████████
Photo Direction	██████████
Elevation	██████
Date Time Stamp	4/30/2012 9:45:15 AM
Photographer	K. Sable
Comment	A 31 Well
Description	Diesel drain near well head

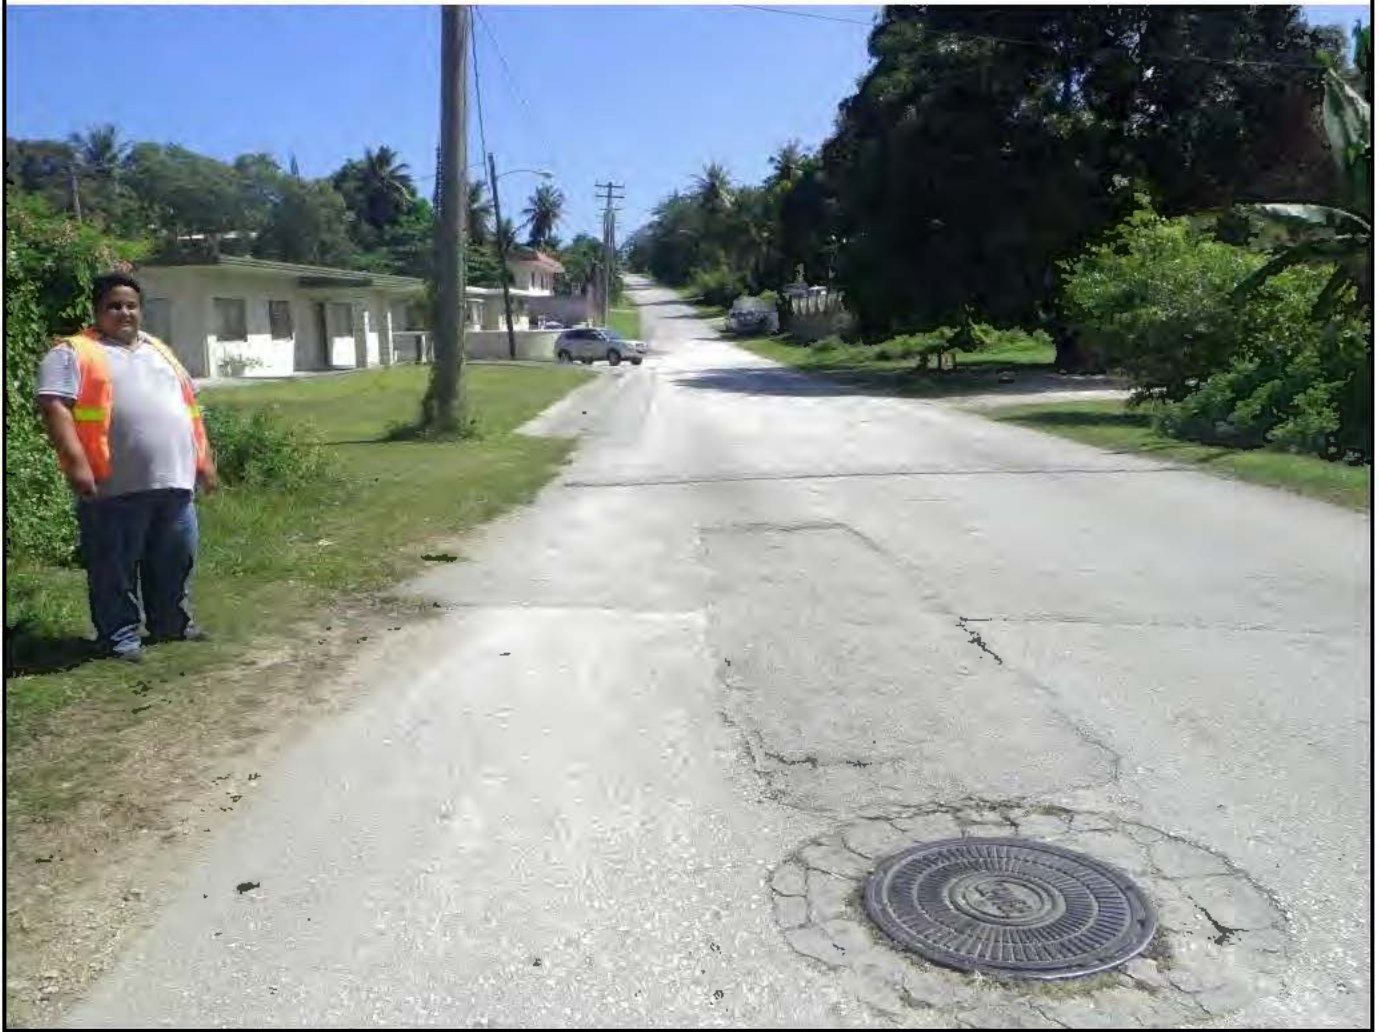
File Name: RIMG0171.JPG

Title	Guam Waterworks Authority (VP0989)
Subject	Northern System
Latitude	██████████
Longitude	██████████
Photo Direction	██████
Elevation	████
Date Time Stamp	4/30/2012 10:01:58 AM
Photographer	K. Sable
Comment	Manhole upstream of UIC ponding basin that has overflowed
Description	Manhole that has overflowed in the past
