Title	Guam Waterworks Authority (VP0989)
Subject	Northern System
Latitude	██████████
Longitude	██████████
Photo Direction	██████
Elevation	████
Date Time Stamp	4/27/2012 9:37:55 AM
Photographer	K. Sable
Comment	Y 15 Well
Description	Overview of Y 15 well

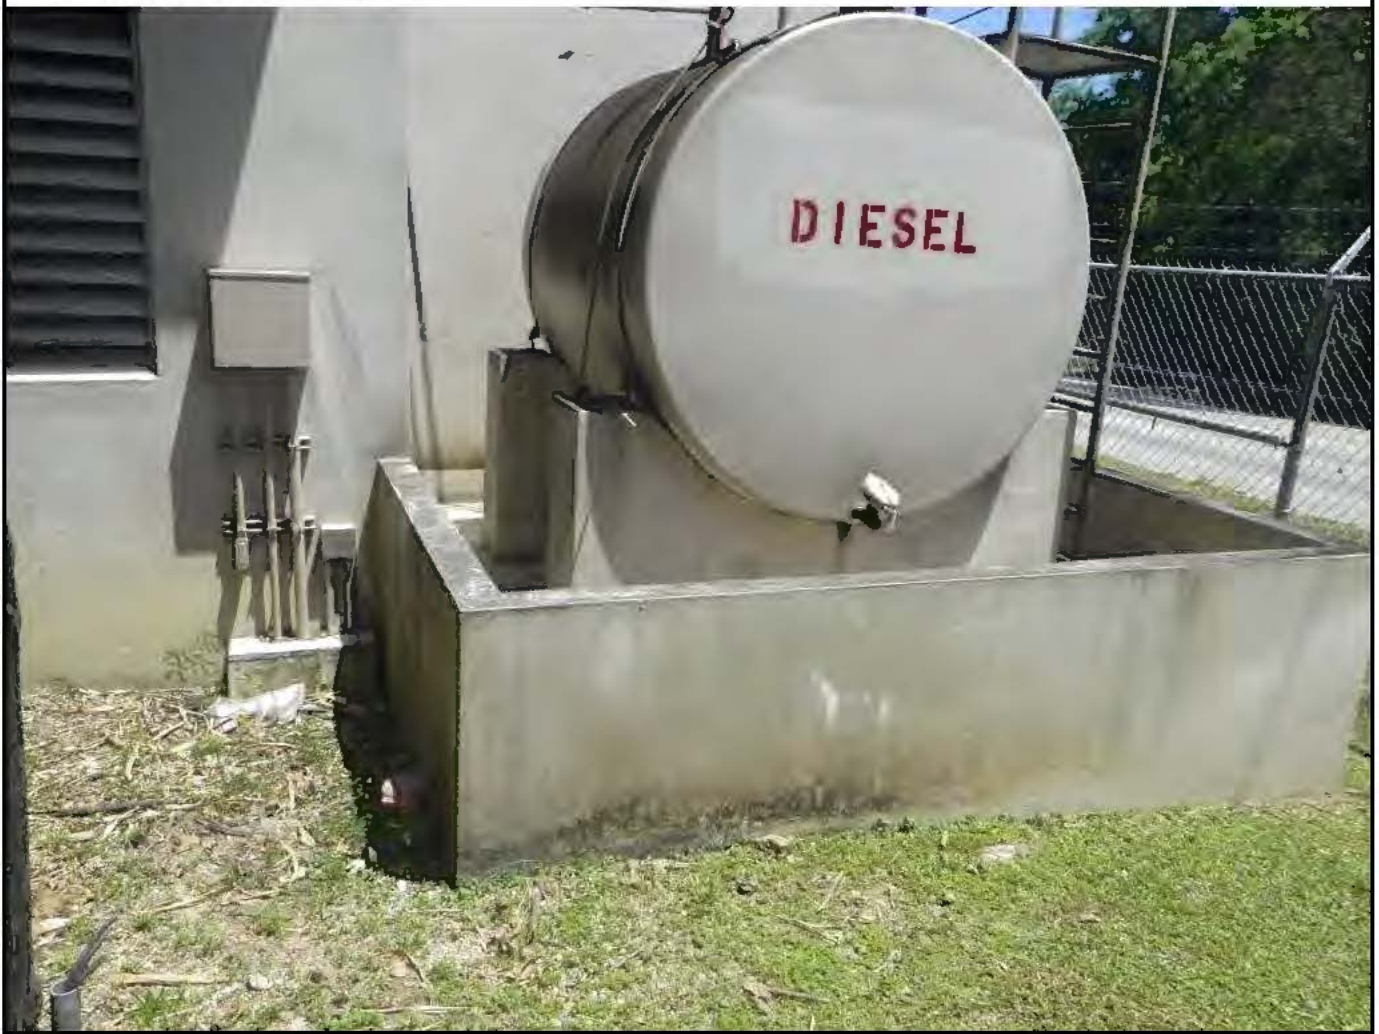
File Name: RIMG0178.JPG

Title	Guam Waterworks Authority (VP0989)
Subject	Northern System
Latitude	██████████
Longitude	██████████
Photo Direction	██████████
██████████	██████████
Date Time Stamp	4/30/2012 11:00:22 AM
Photographer	K. Sable
Comment	A 25 Well
Description	Deisel fuel tank with discharge to ground near well head

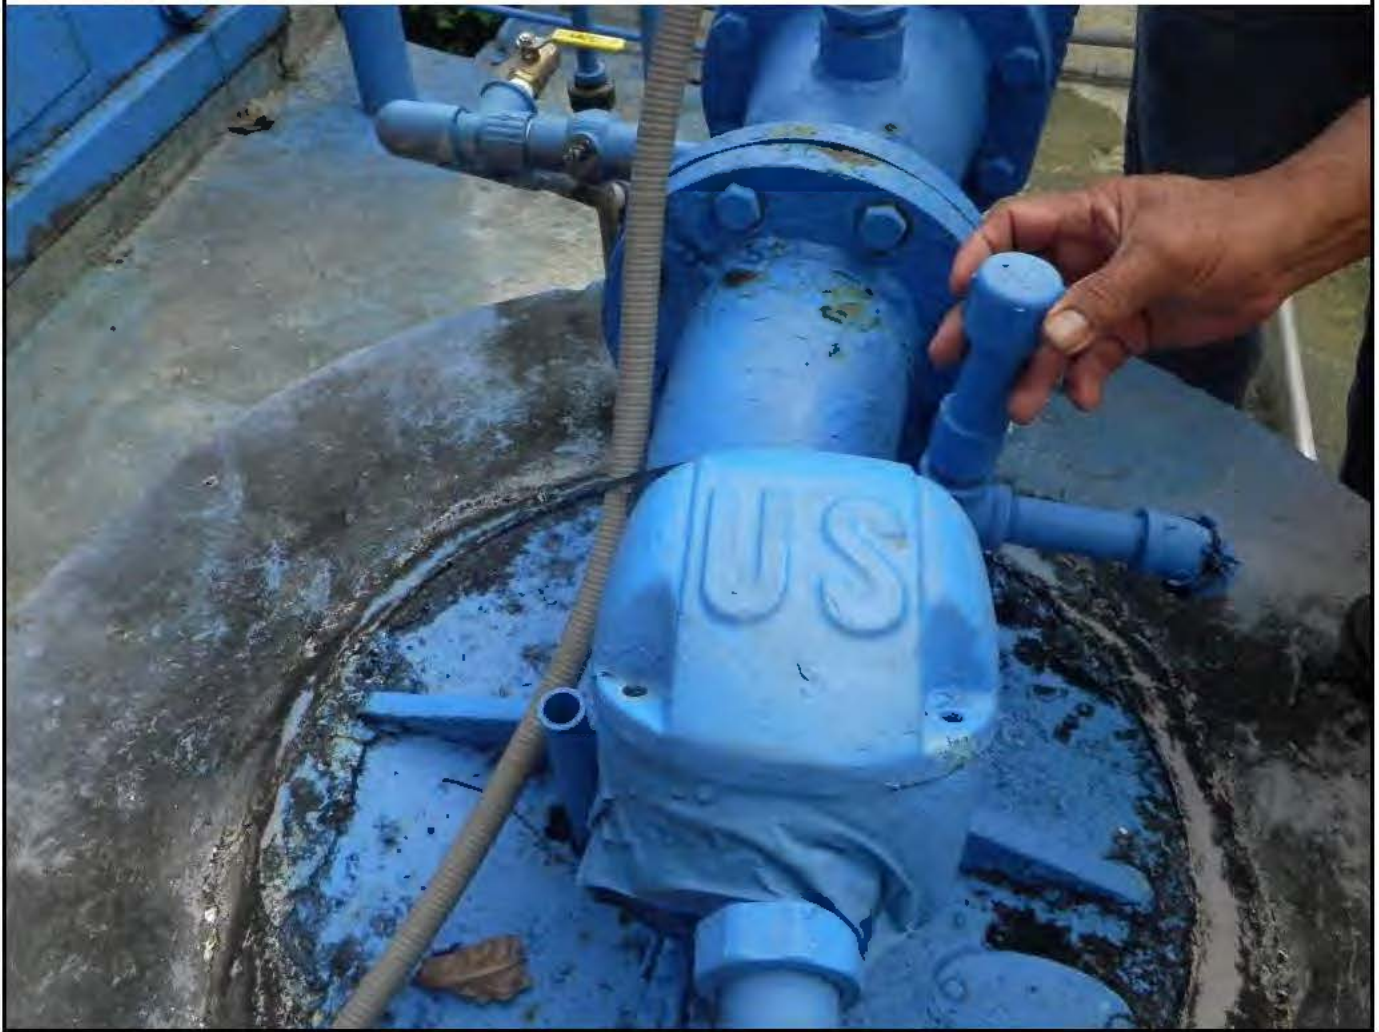
File Name: RIMG0180.JPG

Title	Guam Waterworks Authority (VP0989)
Subject	Northern System
Latitude	[REDACTED]
Longitude	[REDACTED]
Photo Direction	[REDACTED]
Elevation	[REDACTED]
Date Time Stamp	4/30/2012 1:29:22 PM
Photographer	K. Sable
Comment	A 1 Well
Description	Broken air valve

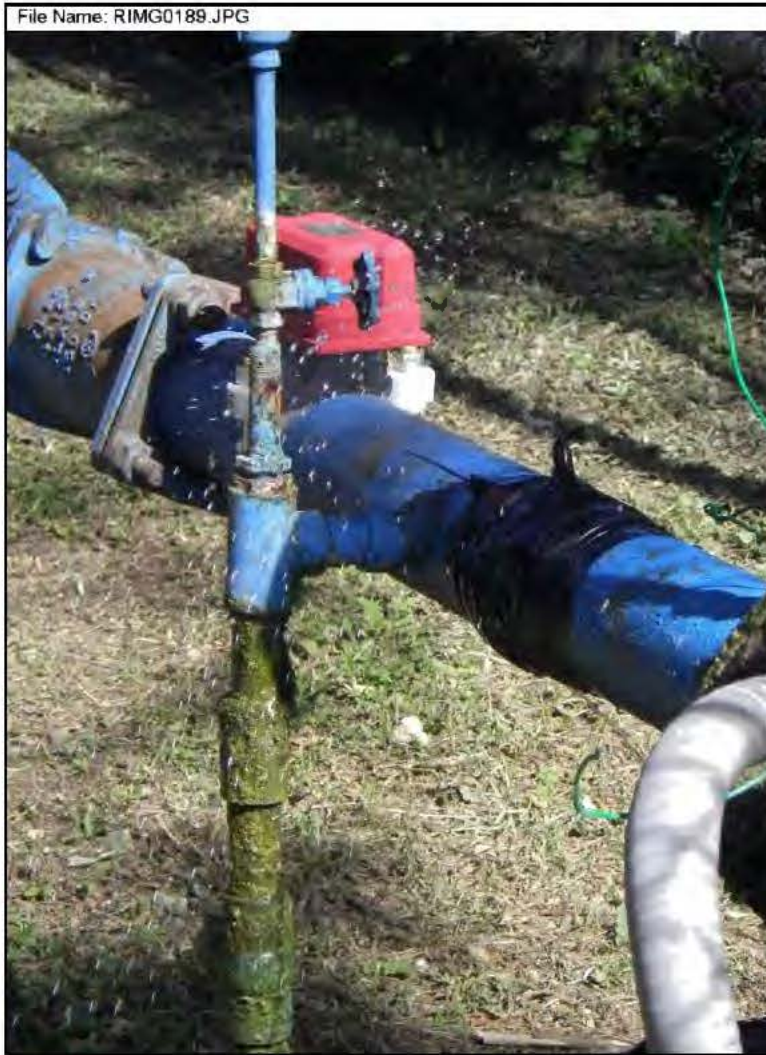
Attributes	
Title	Guam Waterworks Authority (VP0989)
Subject	Northern System
Latitude	██████████
Longitude	██████████
Photo Direction	██████
██████	██████
Date Time Stamp	4/30/2012 3:20:25 PM
Photographer	K. Sable
Comment	A 21 Well
Description	Close-up of leak

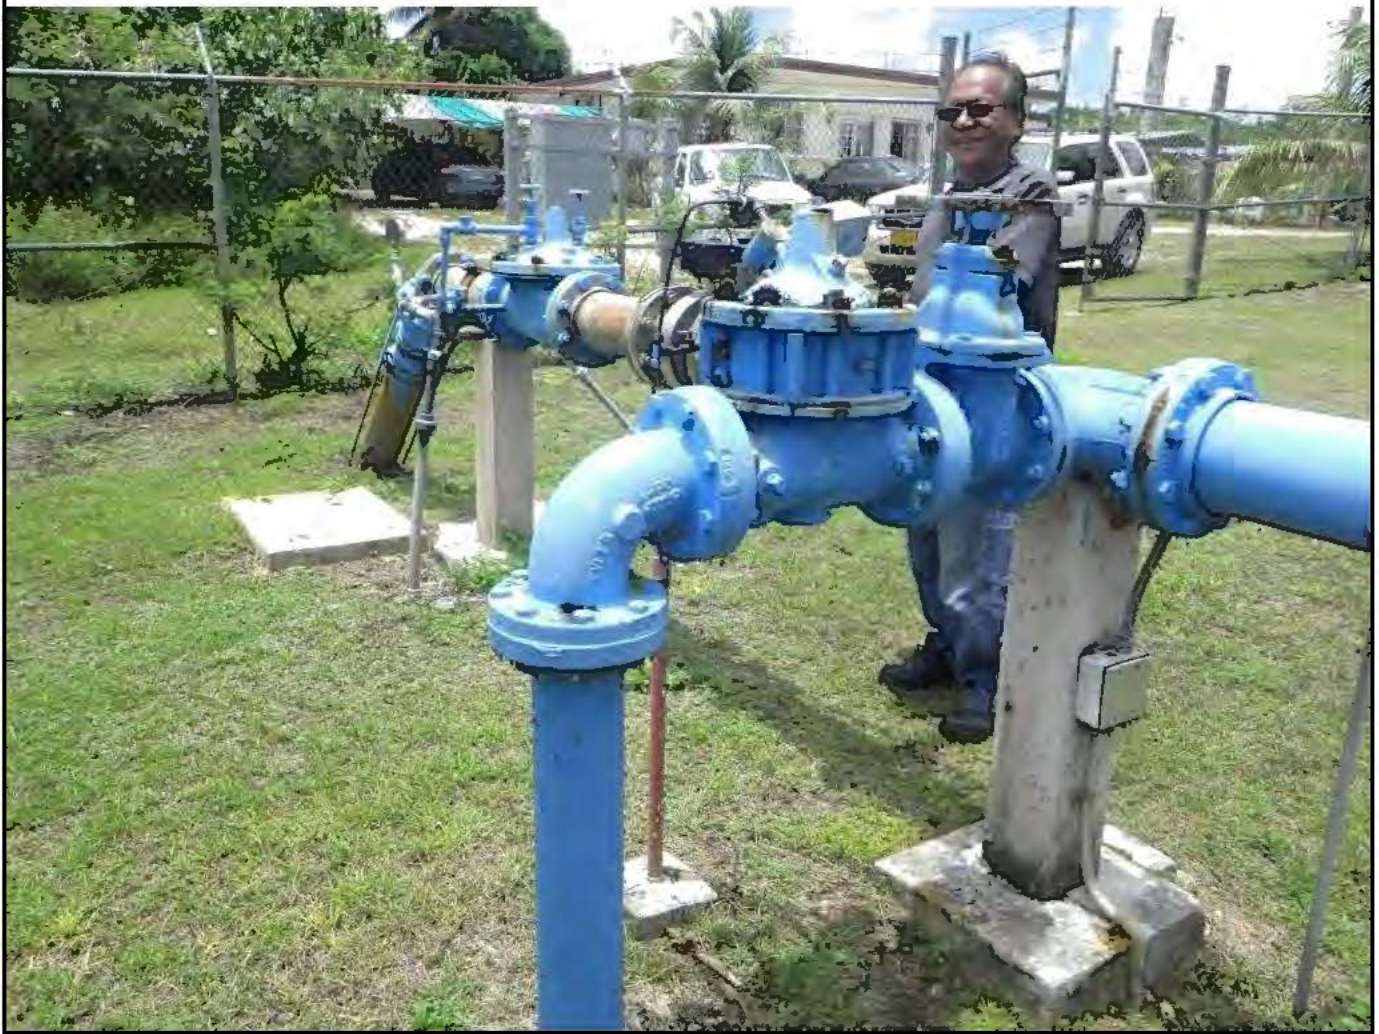
File Name: RIMG0195.JPG

Title	Guam Waterworks Authority (VP0989)
Subject	Northern System
Latitude	██████████
Longitude	██████████
Photo Direction	██████
Elevation	██████
Date Time Stamp	5/1/2012 12:37:55 PM
Photographer	K. Sable
Comment	F 13 Well
Description	Rusted bypass valve
