Guam Waterworks Authority (VP0989)

SDWA Sanitary Survey

Central System

NEIC Field Investigation Photographs

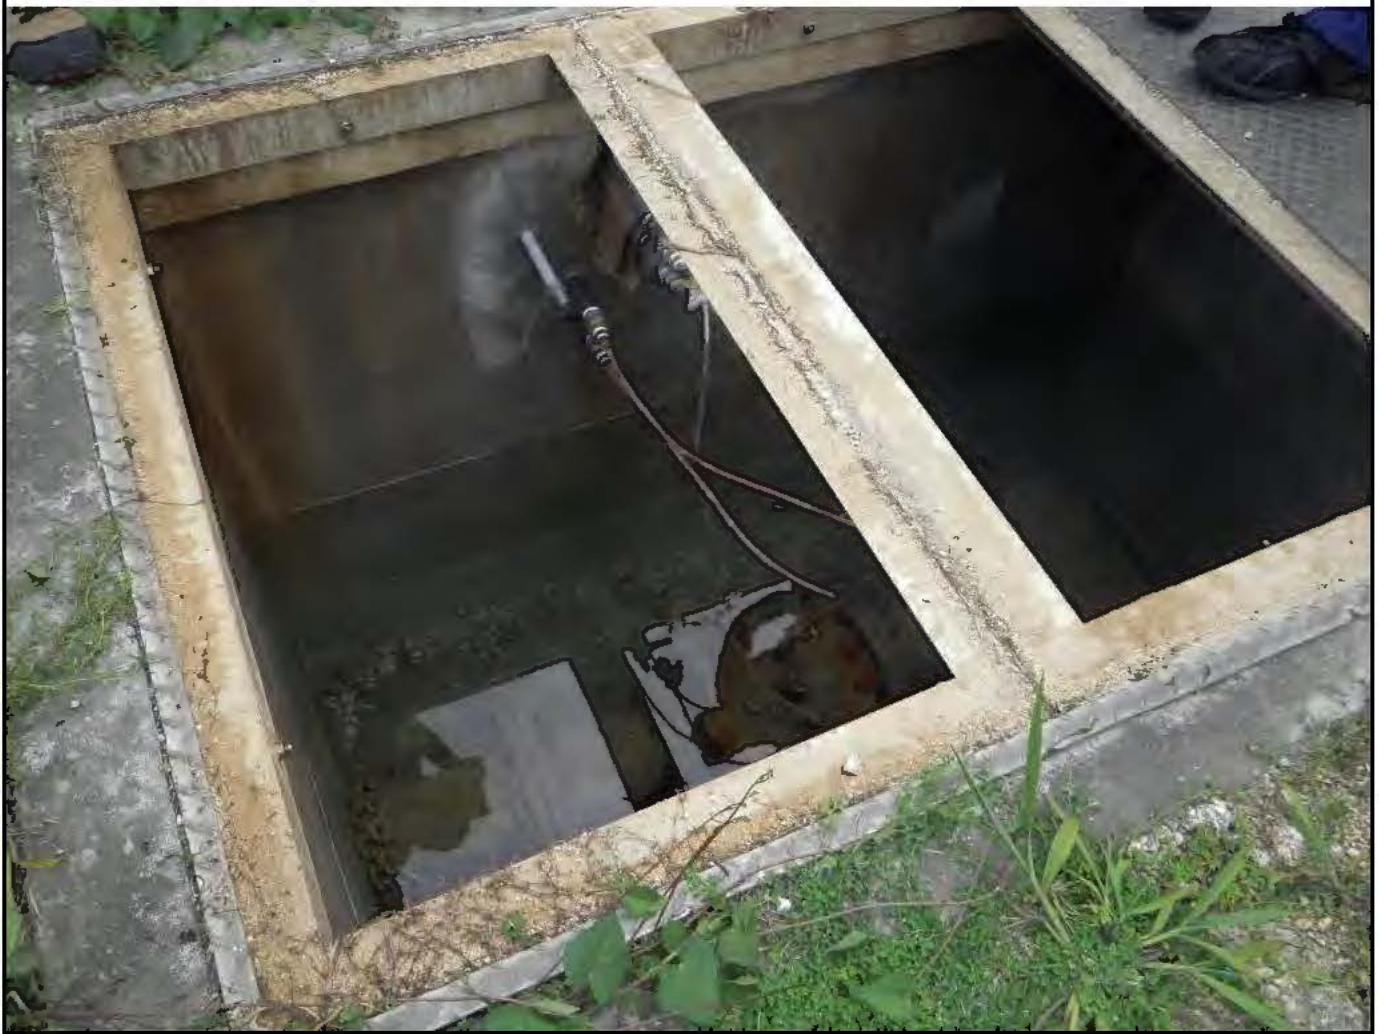
File Name: RIMG0101.JPG

Title	Guam Waterworks Authority (VP0989)
Subject	Central System
Latitude	██████████
Longitude	██████████
Photo Direction	██████
Elevation	████
Date Time Stamp	4/26/2012 3:40:51 PM
Photographer	K. Sable
Comment	Santa Rita Spring
Description	Water inlet pipe from Navy

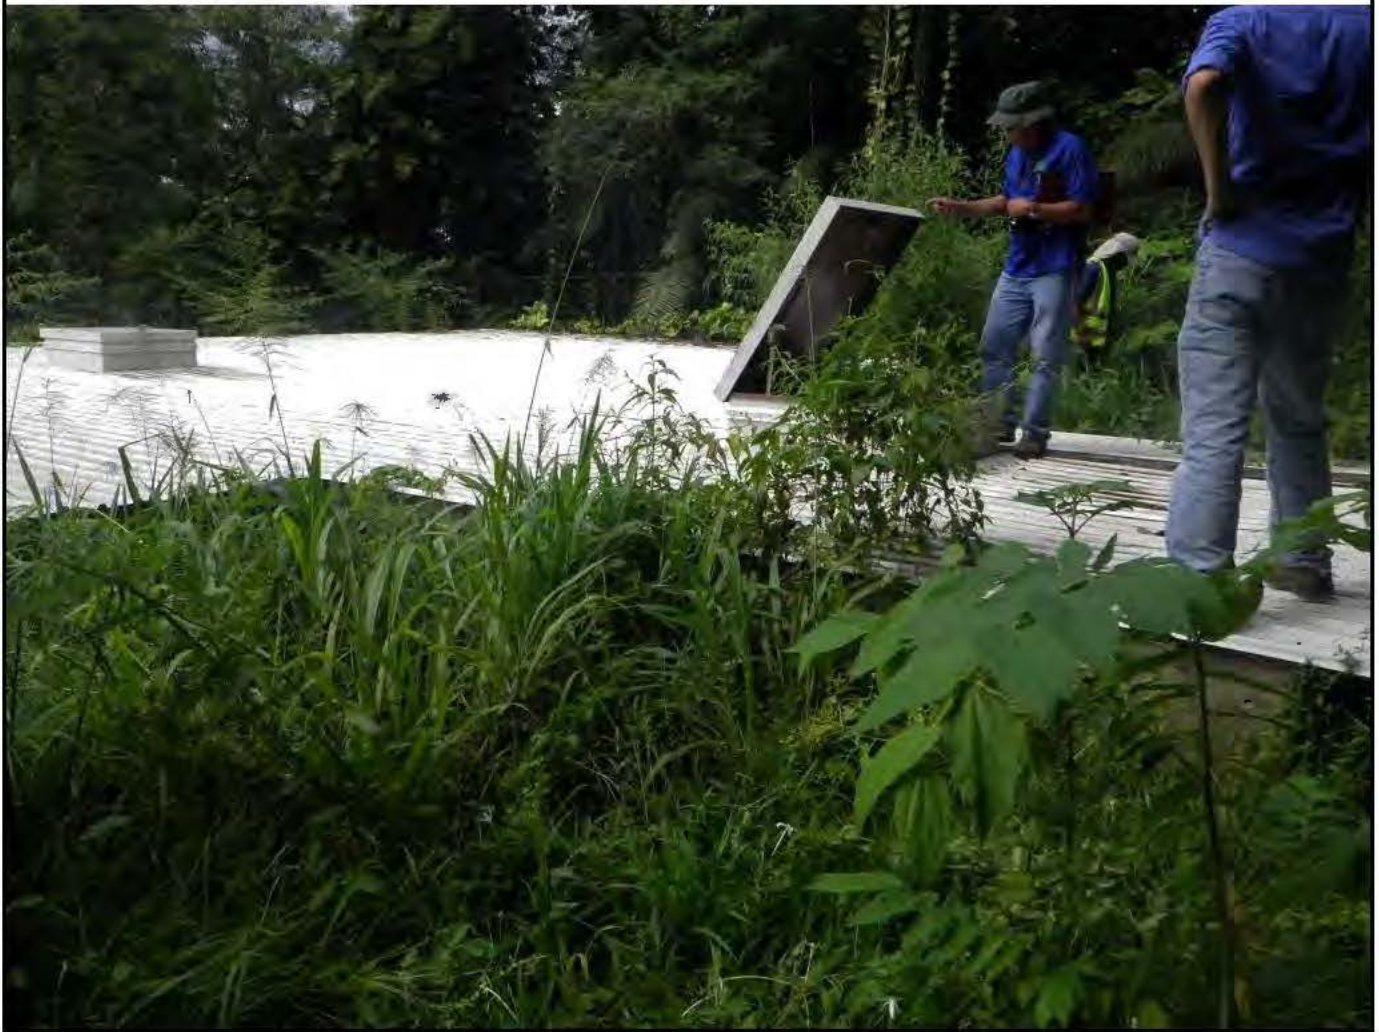
File Name: RIMG0102.JPG

Title	Guam Waterworks Authority (VP0989)
Subject	Central System
Latitude	██████████
Longitude	██████████
Photo Direction	██████
Elevation	████
Date Time Stamp	4/26/2012 3:45:21 PM
Photographer	K. Sable
Comment	Santa Rita Spring
Description	Clear well with vegetation

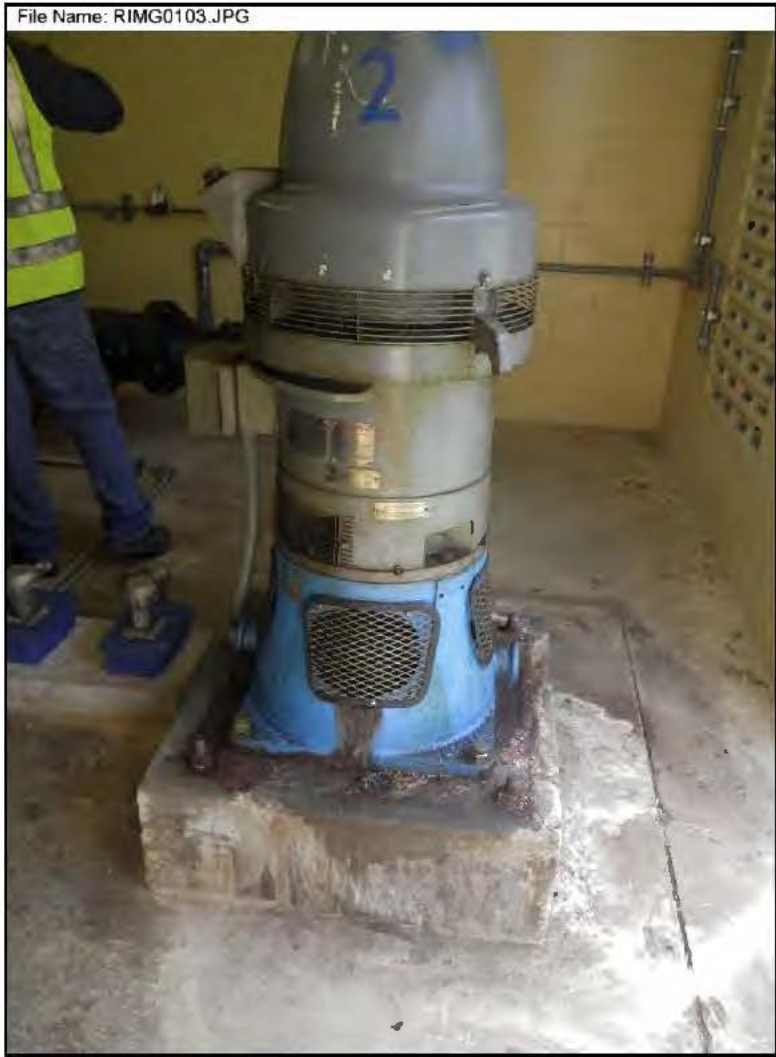
Attributes	
Title	Guam Waterworks Authority (VP0989)
Subject	Central System
Latitude	[REDACTED]
Longitude	[REDACTED]
Photo Direction	[REDACTED]
Elevation	[REDACTED]
Date Time Stamp	4/26/2012 3:50:58 PM
Photographer	K. Sable
Comment	Santa Rita Spring
Description	Pump # 2 leaking

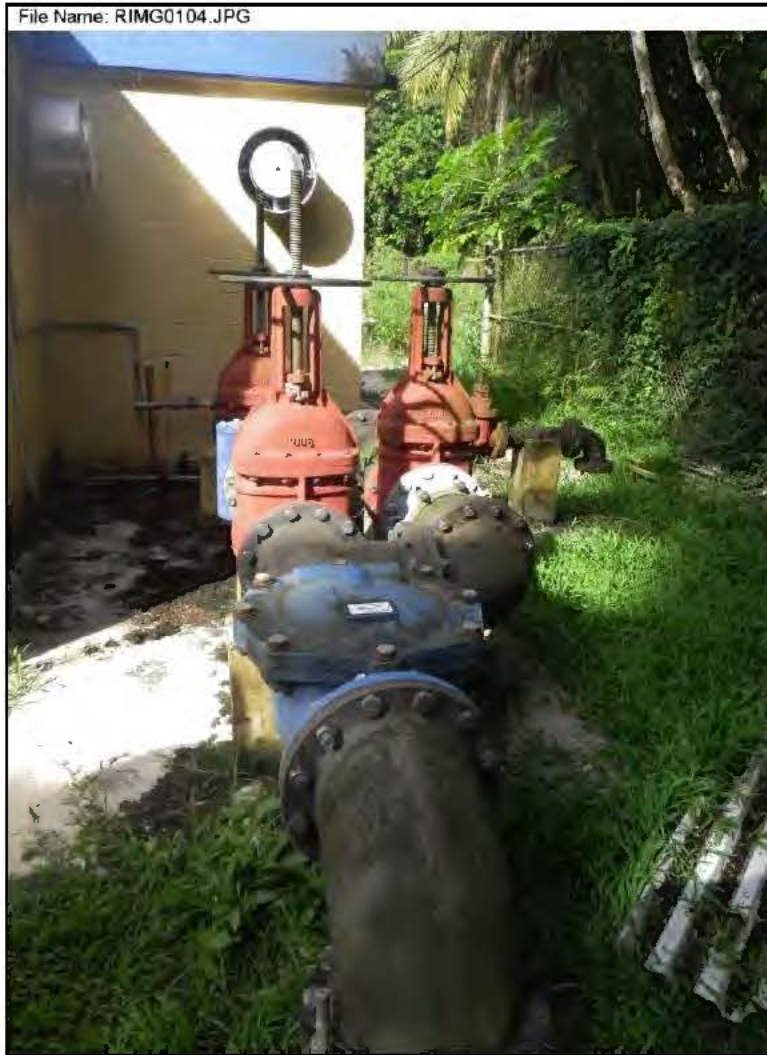
Attributes	
Title	Guam Waterworks Authority (VP0989)
Subject	Central System
Latitude	██████████
Longitude	██████████
Photo Direction	██████
Elevation	████
Date Time Stamp	4/26/2012 3:55:36 PM
Photographer	K. Sable
Comment	Santa Rita Spring
Description	Assembly with bypass and water leaving spring

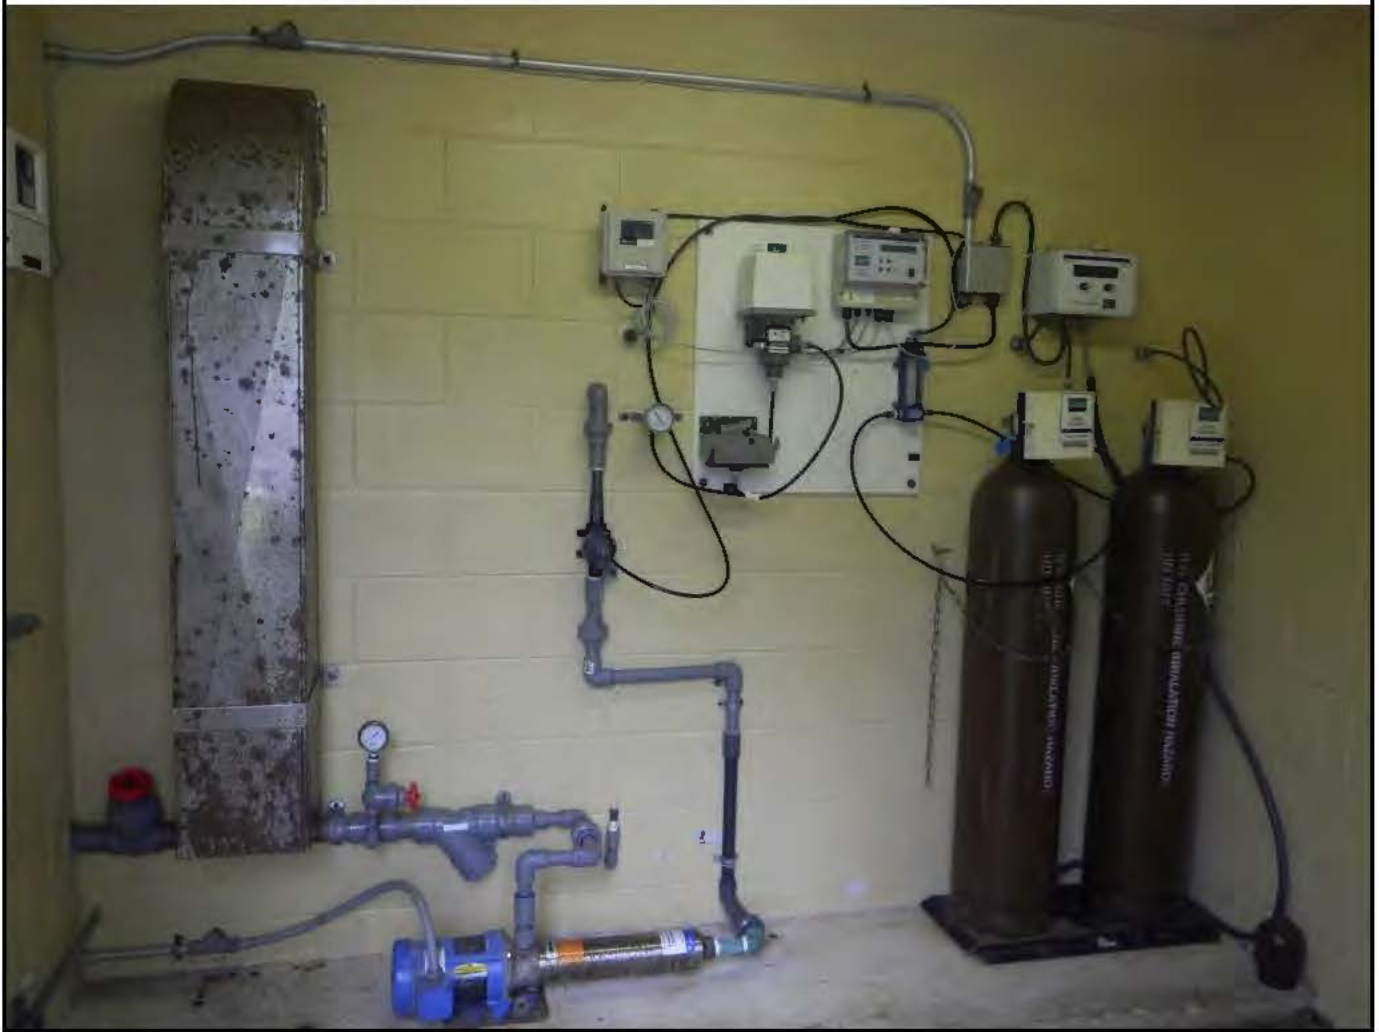
File Name: RIMG0105.JPG

Title	Guam Waterworks Authority (VP0989)
Subject	Central System
Latitude	██████████
Longitude	██████████
Photo Direction	██████
Elevation	██████
Date Time Stamp	4/26/2012 4:05:16 PM
Photographer	K. Sable
Comment	Santa Rita Spring
Description	Chlorine building

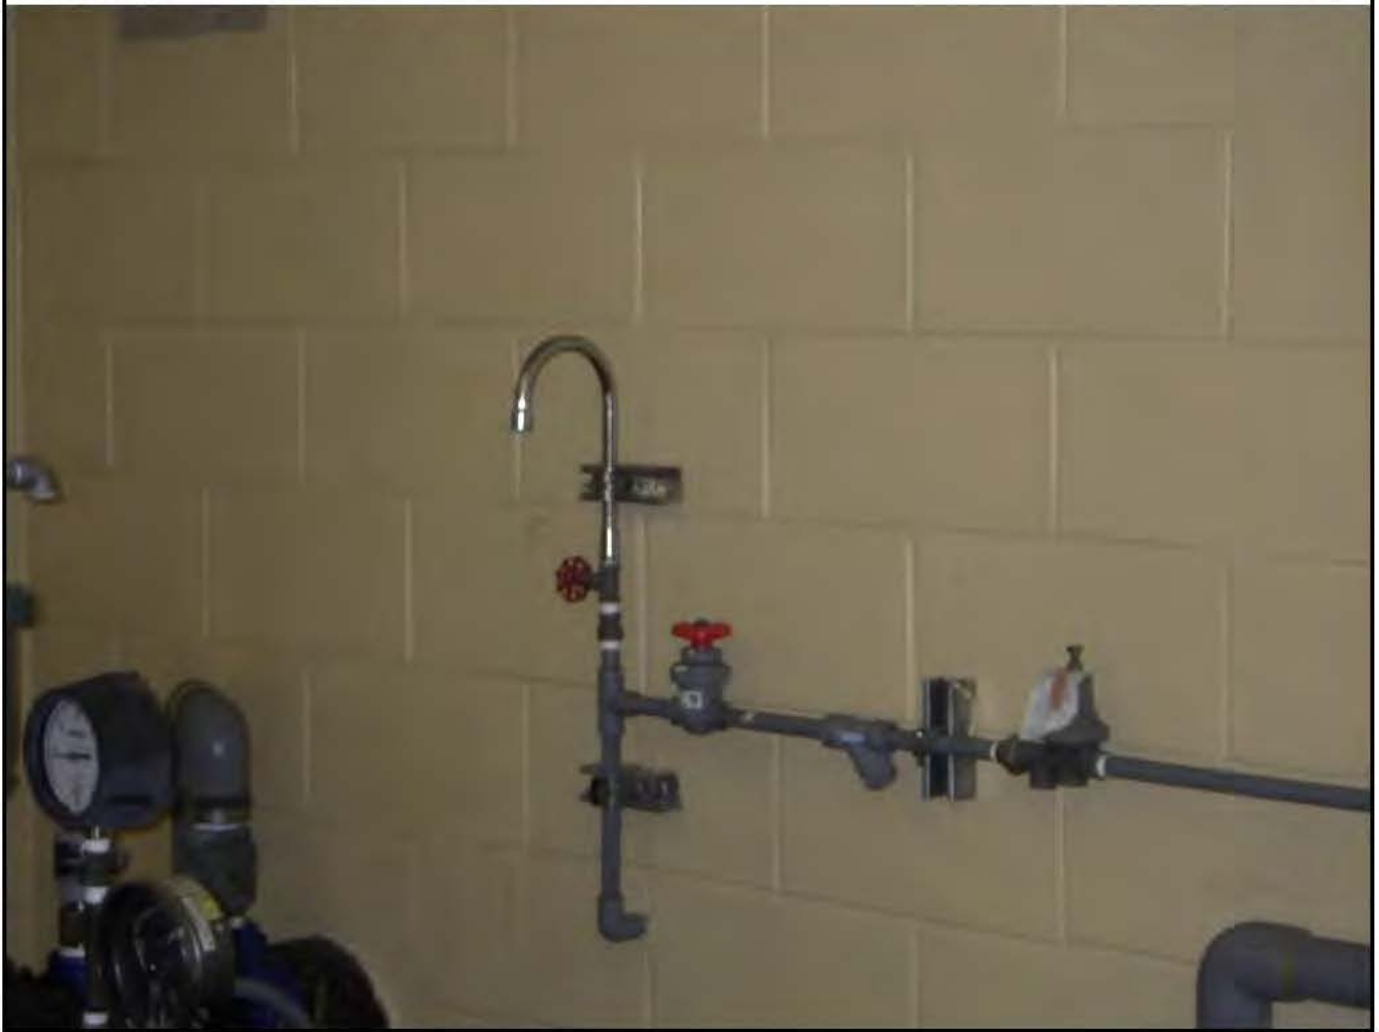
File Name: RIMG0106.JPG

Title	Guam Waterworks Authority (VP0989)
Subject	Central System
Latitude	██████████
Longitude	██████████
Photo Direction	██████████
Elevation	██████
Date Time Stamp	4/26/2012 4:05:53 PM
Photographer	K. Sable
Comment	Santa Rita Spring
Description	Sample tap for chlorine grab samples

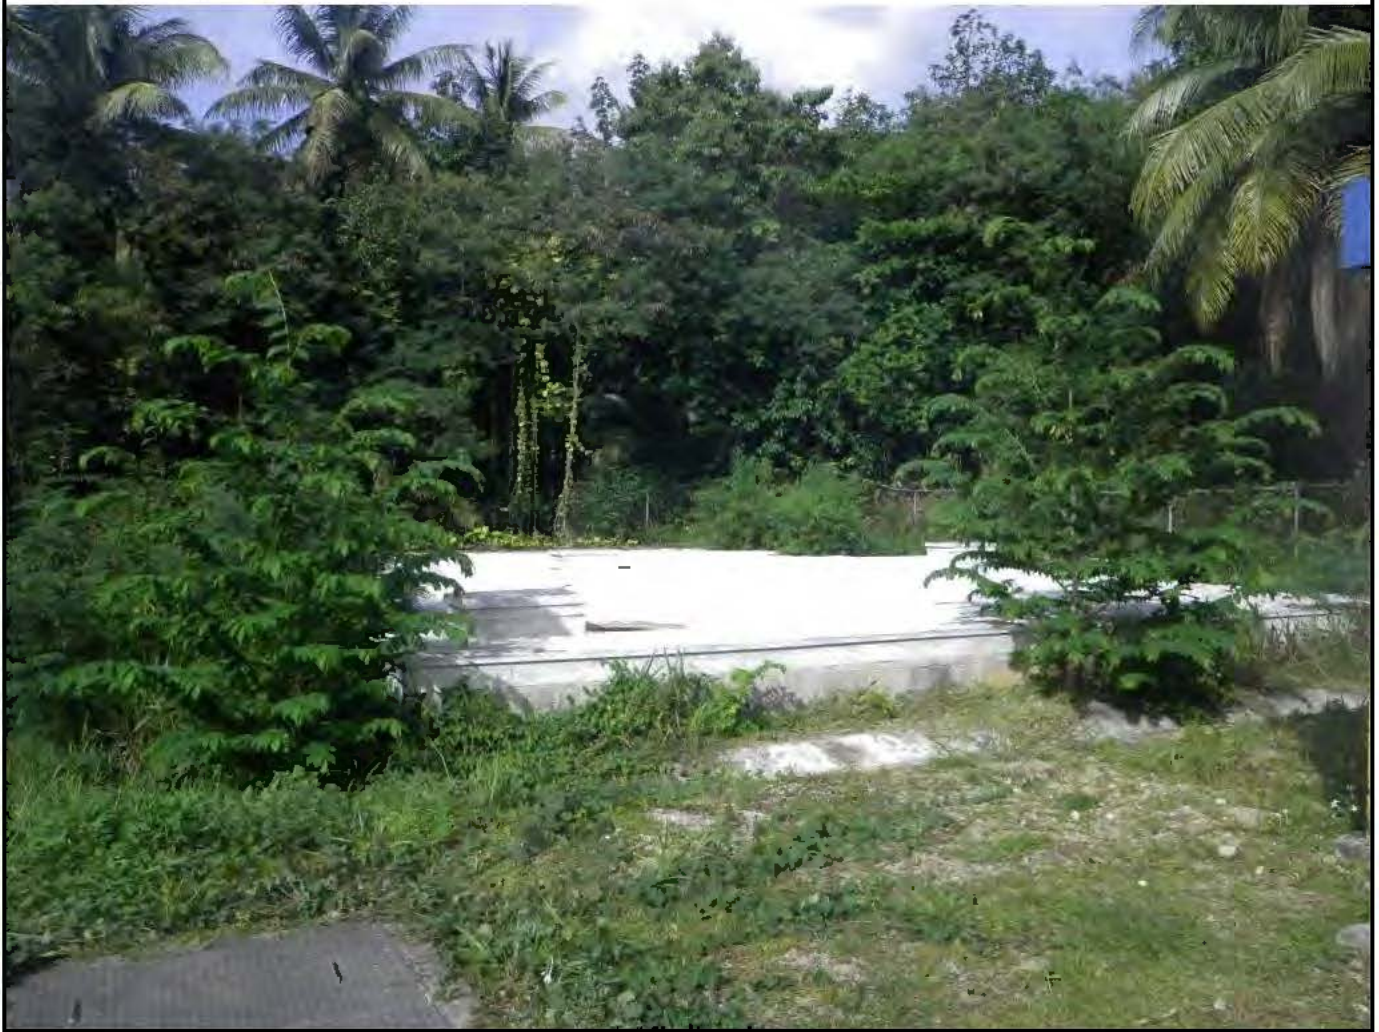
File Name: RIMG0107.JPG

Title	Guam Waterworks Authority (VP0989)
Subject	Central System
Latitude	██████████
Longitude	██████████
Photo Direction	██████
Elevation	████
Date Time Stamp	4/26/2012 4:07:13 PM
Photographer	K. Sable
Comment	Santa Rita Spring
Description	Vegetation around clear well

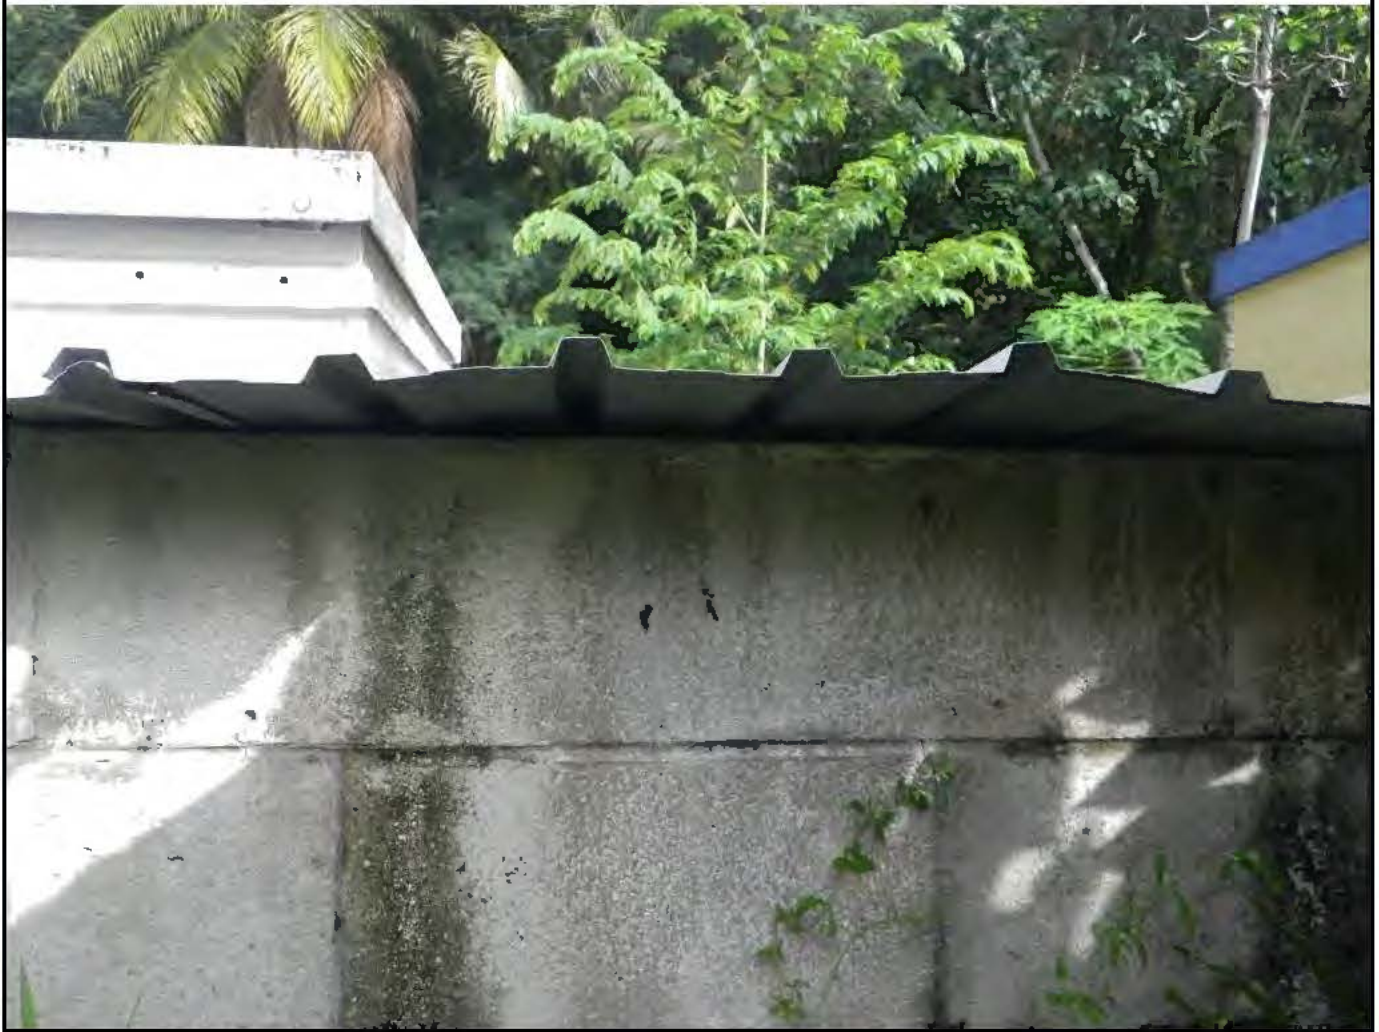
File Name: RIMG0108.JPG

Title	Guam Waterworks Authority (VP0989)
Subject	Central System
Latitude	██████████
Longitude	██████████
Photo Direction	██████
Elevation	████
Date Time Stamp	4/26/2012 4:14:23 PM
Photographer	K. Sable
Comment	Santa Rita Spring
Description	Gaps in clear well roof and wall

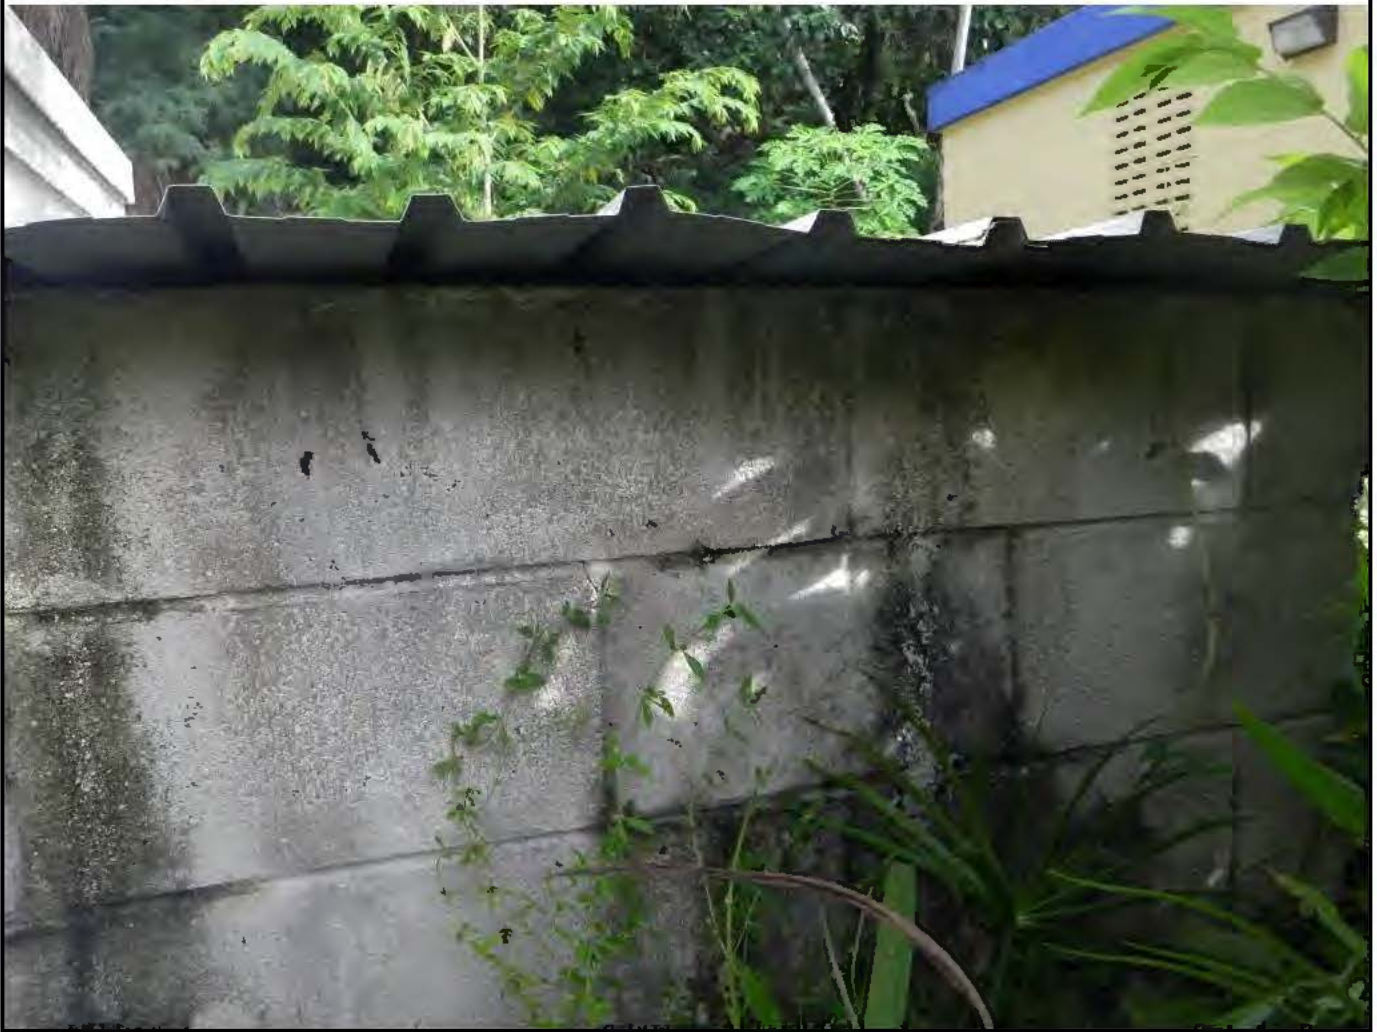
File Name: RIMG0109.JPG

Title	Guam Waterworks Authority (VP0989)
Subject	Central System
Latitude	██████████
Longitude	██████████
Photo Direction	██████
Elevation	████
Date Time Stamp	4/26/2012 4:14:33 PM
Photographer	K. Sable
Comment	Santa Rita Spring
Description	Gaps in clear well roof and wall

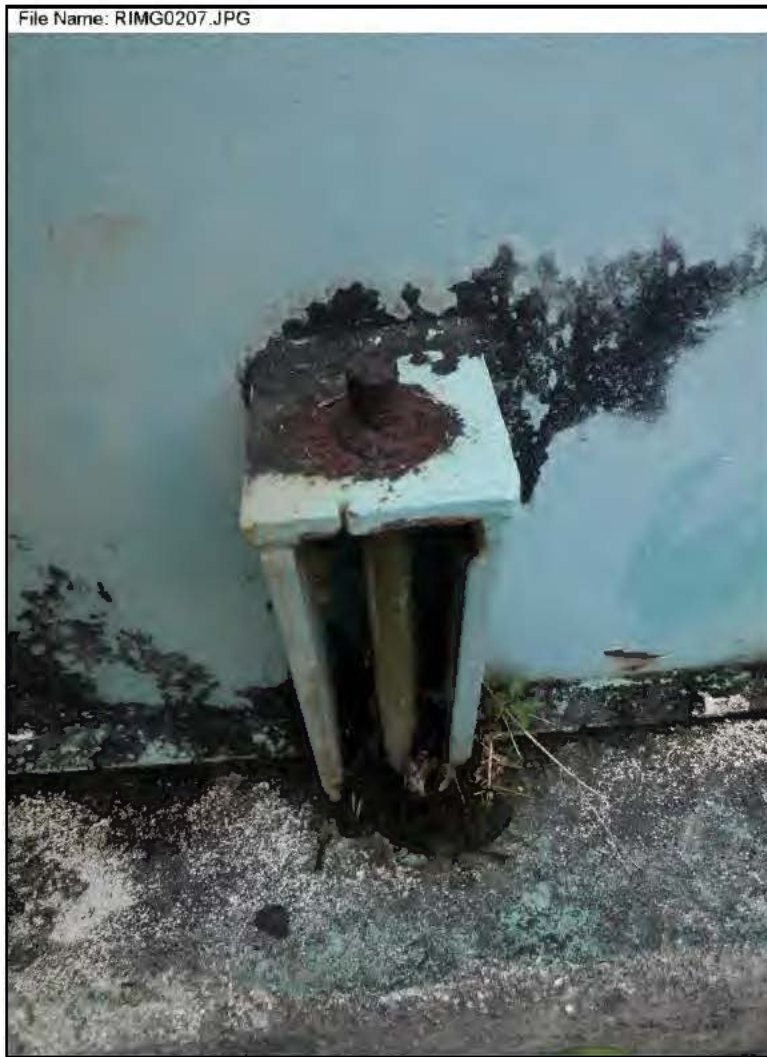
Attributes	
Title	Guam Waterworks Authority (VP0989)
Subject	Central System
Latitude	[REDACTED]
Longitude	[REDACTED]
Photo Direction	[REDACTED]
Elevation	[REDACTED]
Date Time Stamp	5/2/2012 1:06:50 PM
Photographer	K. Sable
Comment	Santa Rita Tank
Description	Welded, rusted anchor bolts

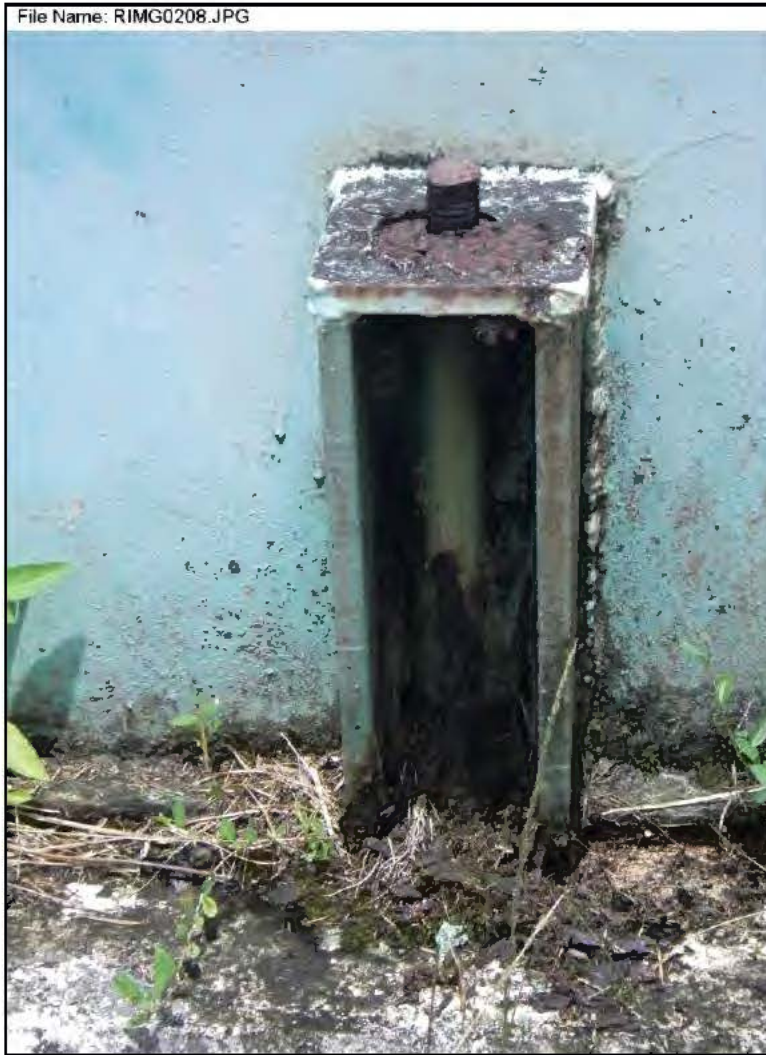
Attributes	
Title	Guam Waterworks Authority (VP0989)
Subject	Central System
Latitude	██████████
Longitude	██████████
Photo Direction	██████
Elevation	████
Date Time Stamp	5/2/2012 1:11:08 PM
Photographer	K. Sable
Comment	Santa Rita Tank
Description	Welded, rusted anchor bolts

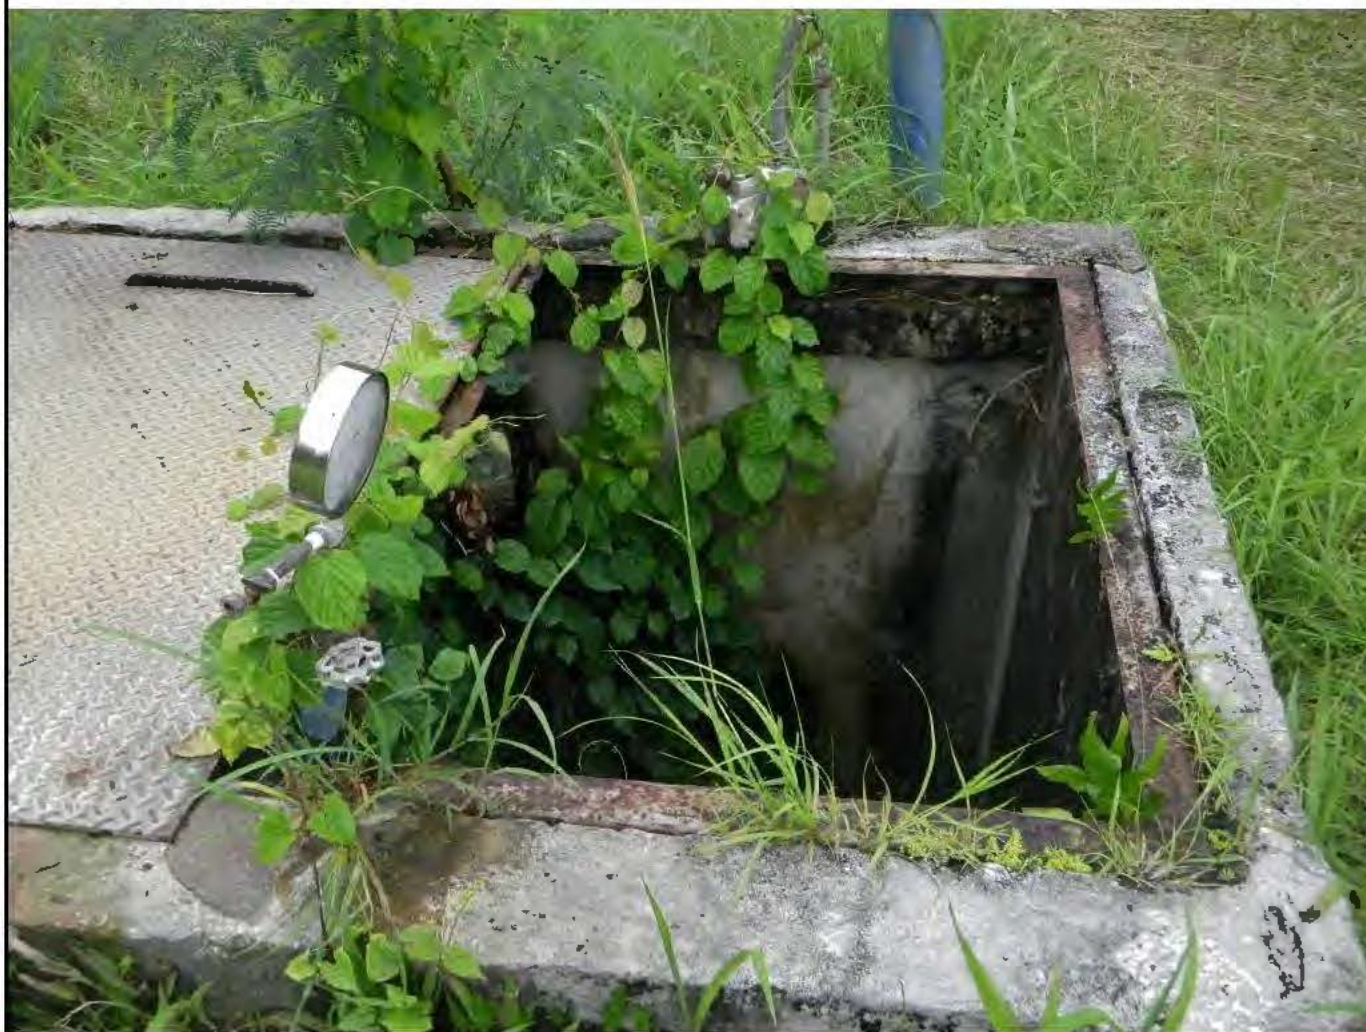
File Name: RIMG0209.JPG

Title	Guam Waterworks Authority (VP0989)
Subject	Central System
Latitude	[REDACTED]
Longitude	[REDACTED]
Photo Direction	[REDACTED]
Elevation	[REDACTED]
Date Time Stamp	5/2/2012 1:20:35 PM
Photographer	K. Sable
Comment	Santa Rita Tank
Description	Leaking valve with constant flow

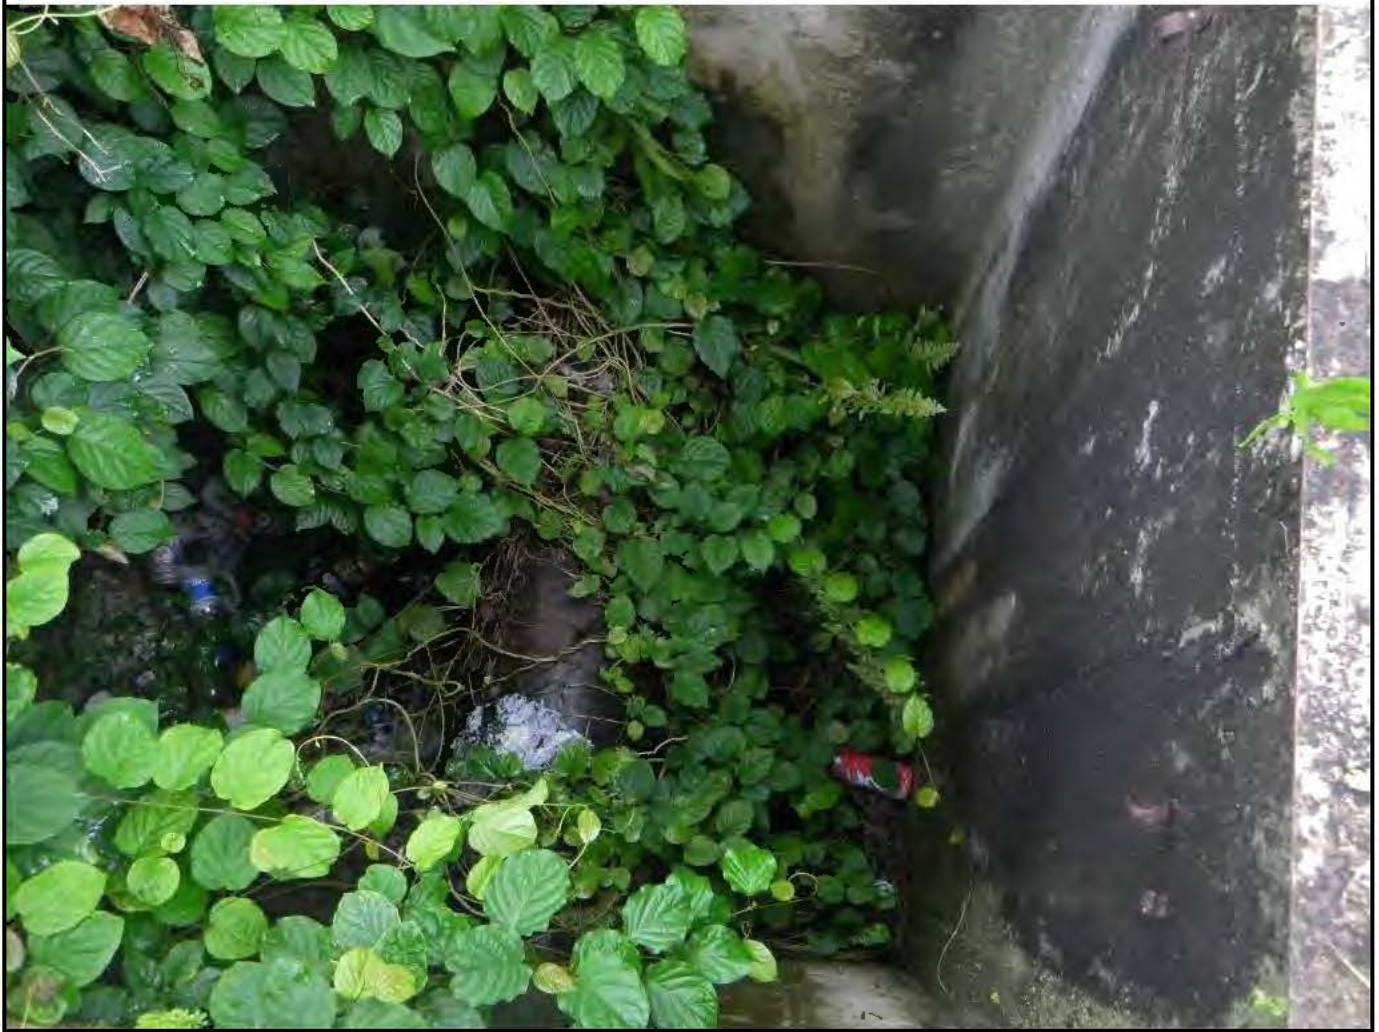
File Name: RIMG0210.JPG

Title	Guam Waterworks Authority (VP0989)
Subject	Central System
Latitude	[REDACTED]
Longitude	[REDACTED]
Photo Direction	[REDACTED]
Elevation	[REDACTED]
Date Time Stamp	5/2/2012 1:20:47 PM
Photographer	K. Sable
Comment	Santa Rita Tank
Description	Line containing leaking valve with constant flow

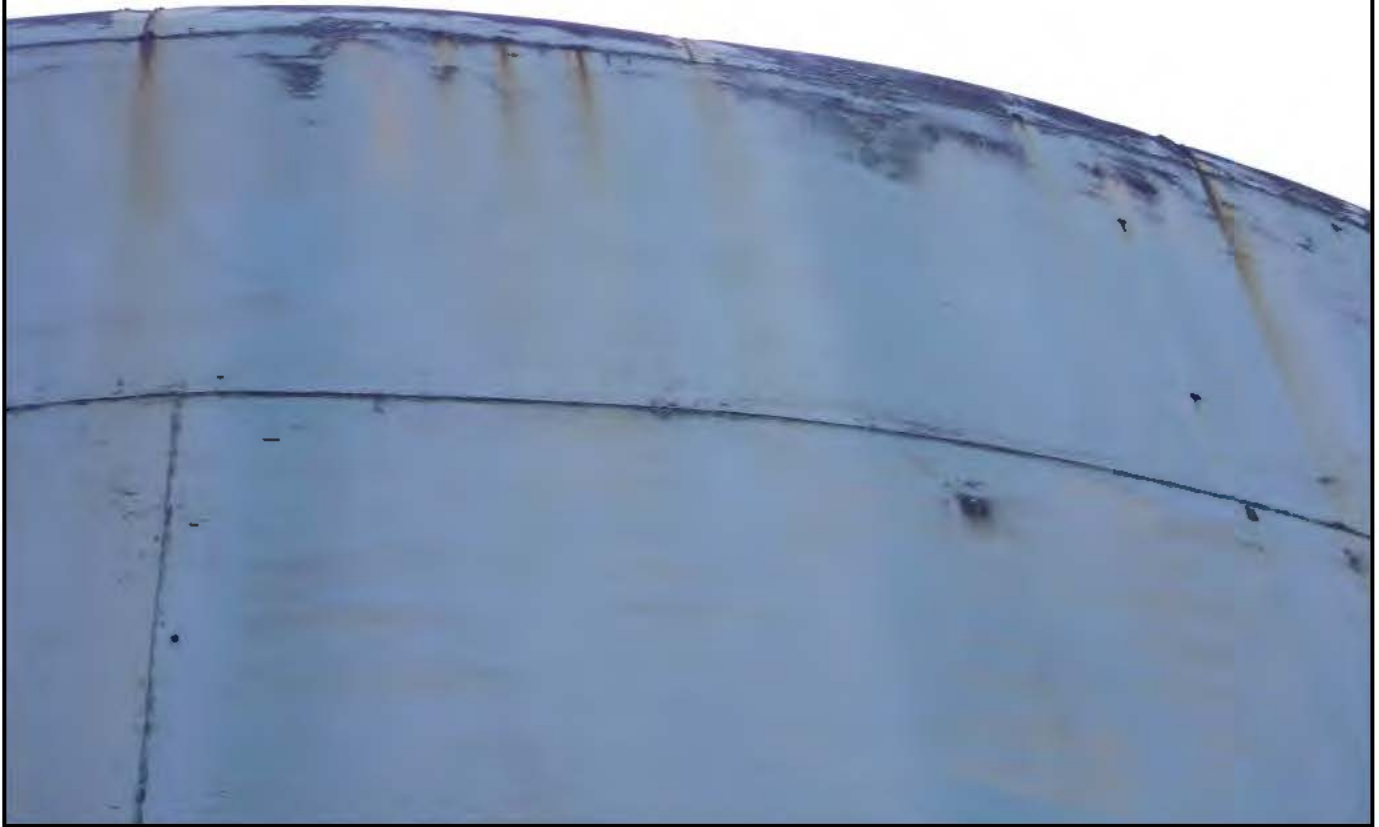
File Name: RIMG0211.JPG

Title	Guam Waterworks Authority (VP0989)
Subject	Central System
Latitude	[REDACTED]
Longitude	[REDACTED]
Photo Direction	[REDACTED]
Elevation	[REDACTED]
Date Time Stamp	5/2/2012 1:23:09 PM
Photographer	K. Sable
Comment	Santa Rita Tank
Description	Sucked in knuckles at top of tank

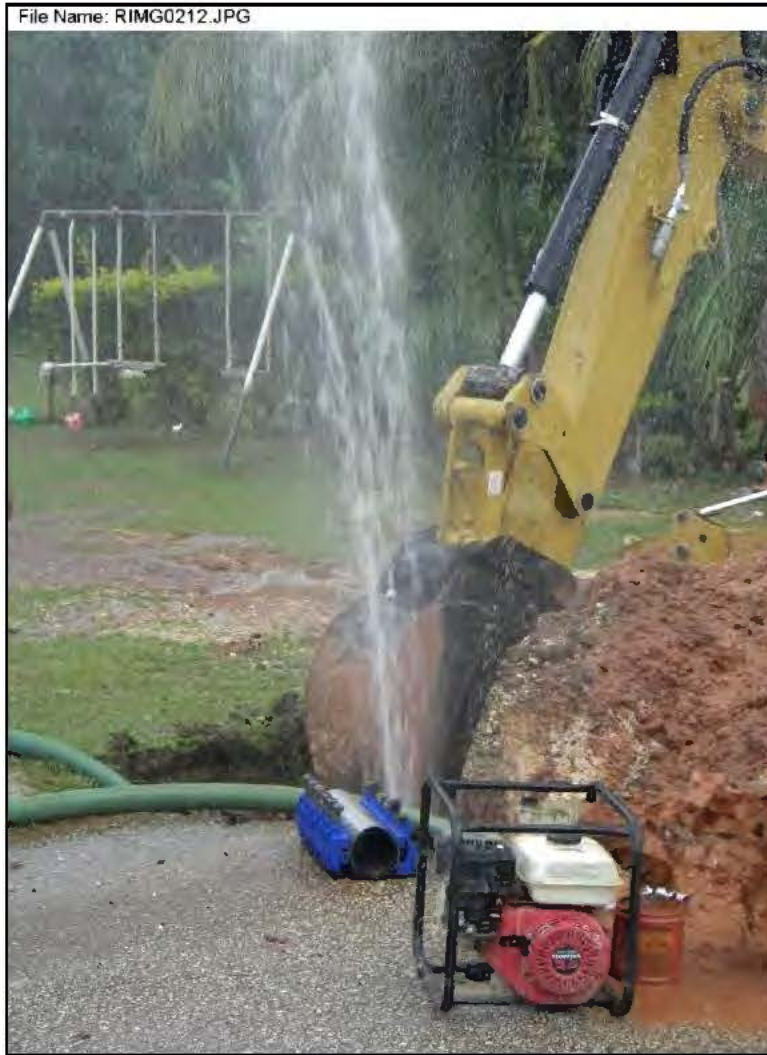
Attributes	
Title	Guam Waterworks Authority (VP0989)
Subject	Central System
Latitude	██████████
Longitude	██████████
Photo Direction	██████████
Elevation	██████
Date Time Stamp	5/2/2012 1:35:05 PM
Photographer	K. Sable
Comment	Distribution System
Description	Water line repair

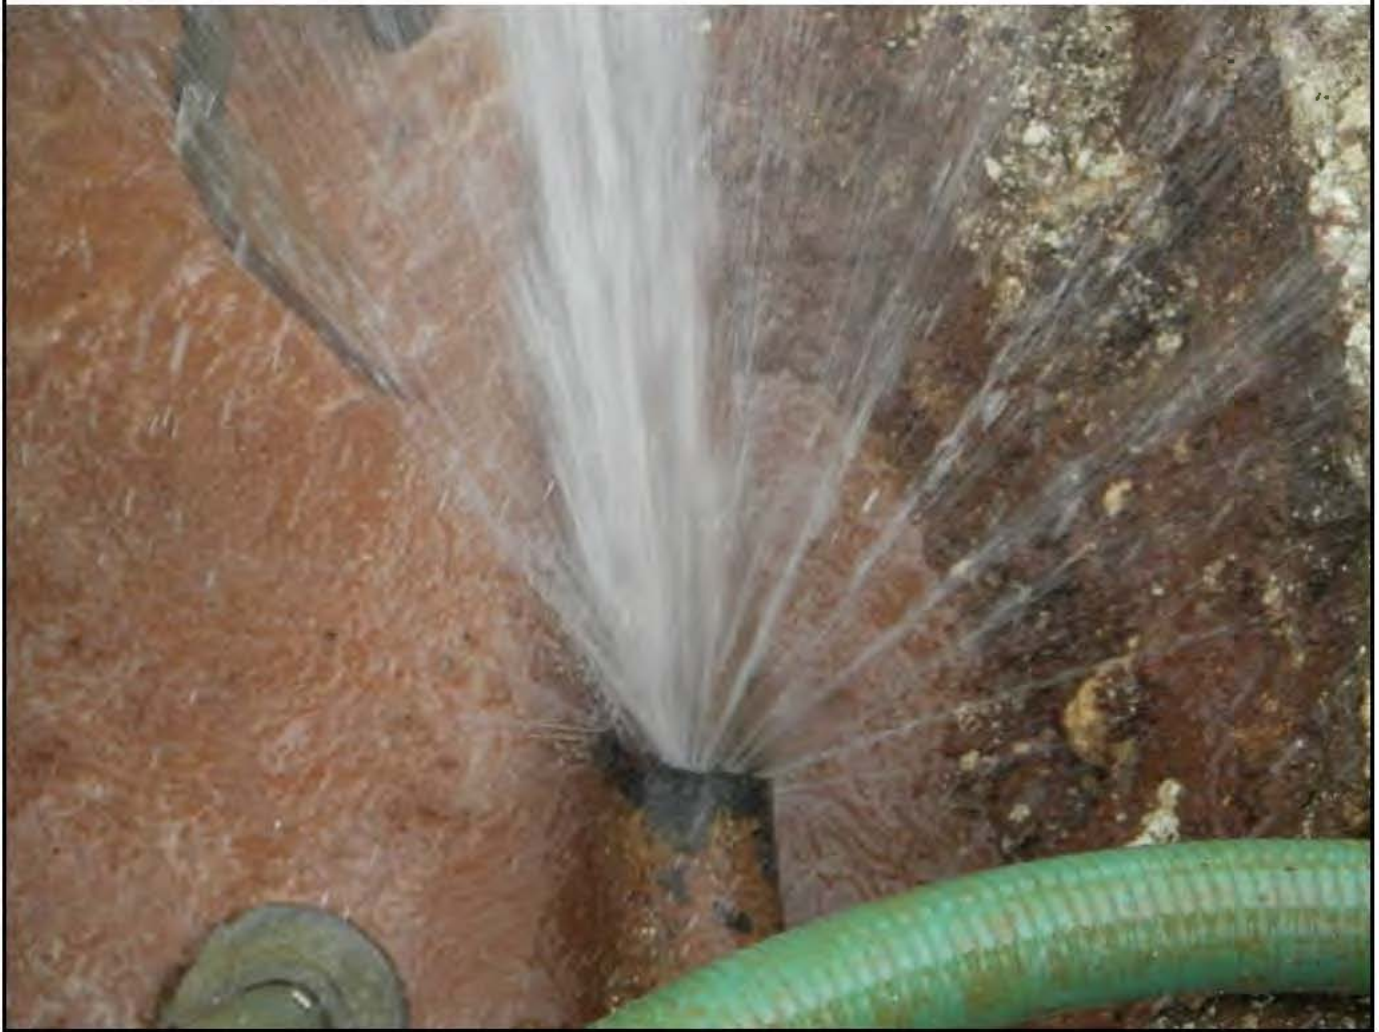
File Name: RIMG0213.JPG

Title	Guam Waterworks Authority (VP0989)
Subject	Central System
Latitude	██████████
Longitude	██████████
Photo Direction	██████████
Elevation	██████
Date Time Stamp	5/2/2012 1:36:02 PM
Photographer	K. Sable
Comment	Distribution System
Description	Water line repair

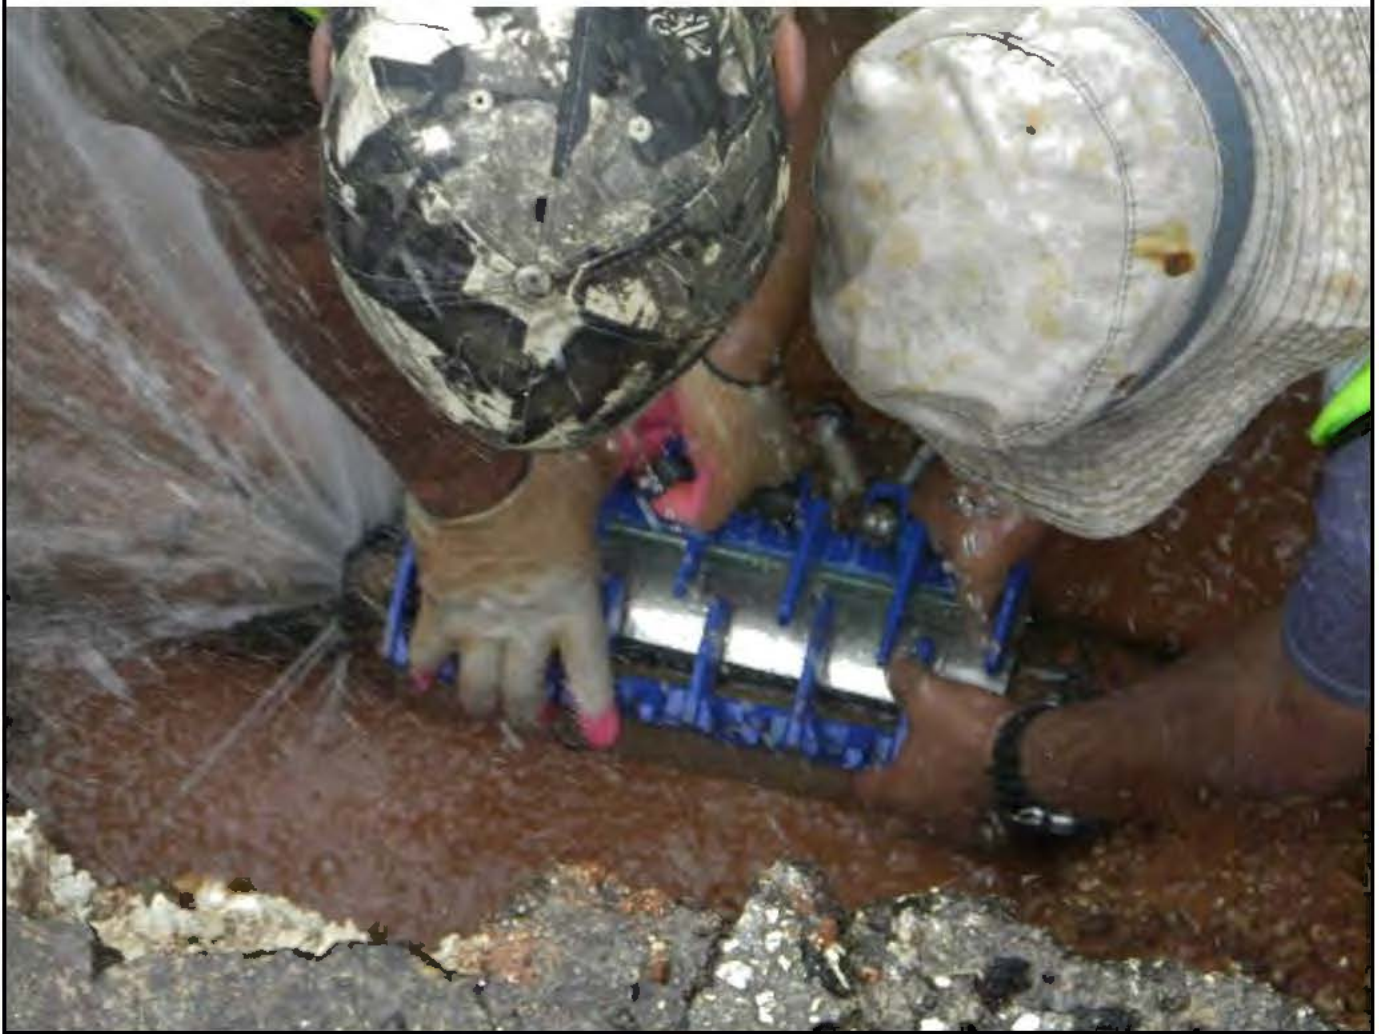
File Name: RIMG0214.JPG

Title	Guam Waterworks Authority (VP0989)
Subject	Central System
Latitude	██████████
Longitude	██████████
Photo Direction	██████
Elevation	██████
Date Time Stamp	5/2/2012 1:37:42 PM
Photographer	K. Sable
Comment	Distribution System
Description	Water line repair
