Guam Waterworks Authority (VP0989)

SDWA Sanitary Survey

Central System

NEIC Field Investigation Photographs

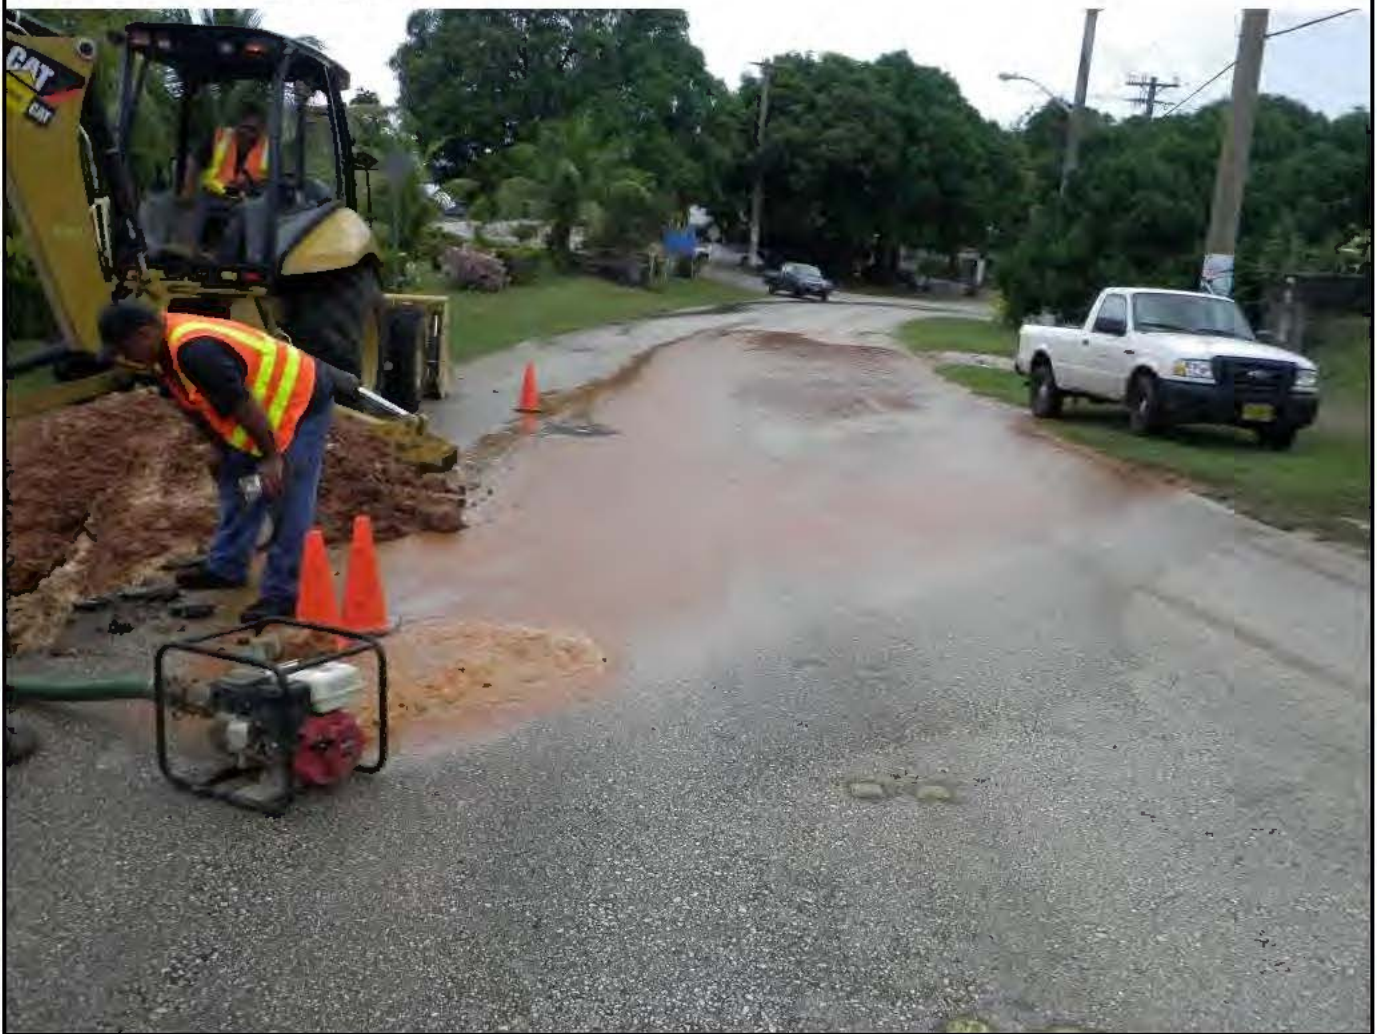
File Name: RIMG0215.JPG

Title	Guam Waterworks Authority (VP0989)
Subject	Central System
Latitude	██████████
Longitude	██████████
Photo Direction	██████████
Elevation	██████
Date Time Stamp	5/2/2012 1:39:45 PM
Photographer	K. Sable
Comment	Distribution System
Description	Water line repair

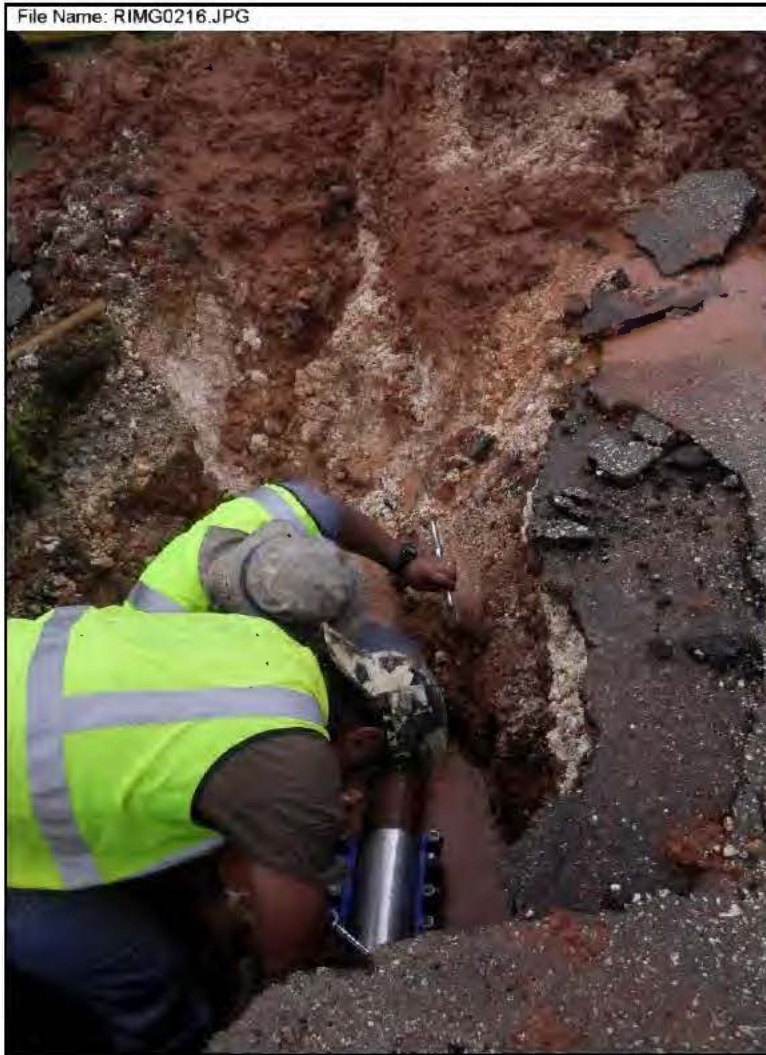
Attributes	
Title	Guam Waterworks Authority (VP0989)
Subject	Central System
Latitude	██████████
Longitude	██████████
Photo Direction	██████
Elevation	██████
Date Time Stamp	5/2/2012 1:39:59 PM
Photographer	K. Sable
Comment	Distribution System
Description	Water line repair
