United States Environmental Protection Agency
Office of Enforcement and Compliance Assurance
Office of Criminal Enforcement, Forensics and Training

**WASTEWATER COLLECTION AND TREATMENT
INSPECTION FOR THE GUAM WATERWORKS AUTHORITY**

Wastewater Collection and Treatment
Guam, United States Territory
Inspection Dates: April 23–May 4, 2012

January 2013

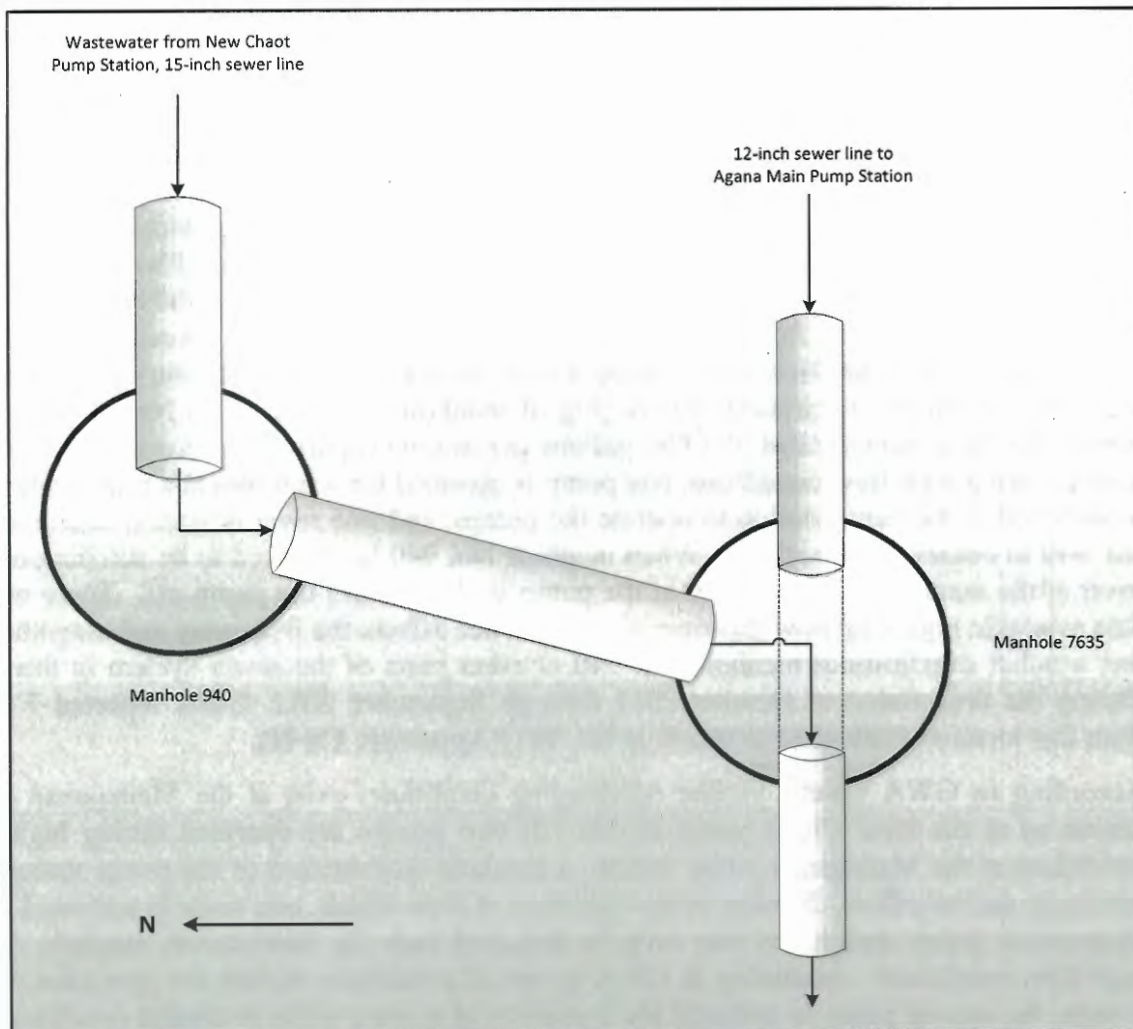
Figure 3. Manhole No. 940 and manhole No. 7635 wastewater flow and configuration.
Guam Waterworks Authority
Guam, United States Territory

- GWA rovers identified a manhole located in Route 4 in the sewer line downstream of the New Chaot pump station as a frequent overflow point during wet weather conditions. The manhole (identified as No. 940 during the inspection, but also identified as No. 941 in GWA SSO reports) is located on the downslope side of a hill on Route 4 in Hagatna, downstream of the New Chaot pump station force main. Wastewater flowing west enters manhole No. 940

through a 15-inch sewer line and takes an immediate right angle turn south to an adjacent manhole (No. 7635) approximately 8 feet south. The wastewater enters manhole No. 7635 which discharges into a 12-inch sewer line, making a right-angle turn west, and flows by gravity, eventually to the Agana Main pump station. Therefore, insufficient capacity of the gravity sewers downstream of the New Chaot pump station is likely a major contributing cause of the overflows at manhole No. 940. Aerial images of the area with the sewer lines and manholes overlaid on the images are included in **Appendix CS-L**. Photographs of the area and manholes are included in **Appendix CS-A (Photographs RIMG0097–100)**. Figure 3 depicts the wastewater flow and arrangement of the two manholes. According to GWA rovers, the pumps at the New Chaot pump station are operated manually during wet weather high-flow conditions to prevent surcharging of manhole No. 940. The New Chaot pump station has three pumps rated at 3,800 gallons per minute (gpm) each. According to GWA rovers, during high-flow conditions, one pump is operated for 4 minutes at a time. One rover is stationed at the pump station to operate the pumps, and one rover is station near manhole No. 940 to observe the manhole. When manhole No. 940 is observed to be surcharging, the rover at the manhole tells the rover at the pump station to turn the pump off. There was no data available regarding how this operational practice affects the frequency and magnitude of wet weather overflows at manhole No. 940 or other parts of the sewer system in this area. During the time frame of October 2011 through September 2012, GWA reported 7 SSOs from this location (identified as manhole No. 941)(**Appendix CS-H**).
