Picture 1: Umatac STP sign.

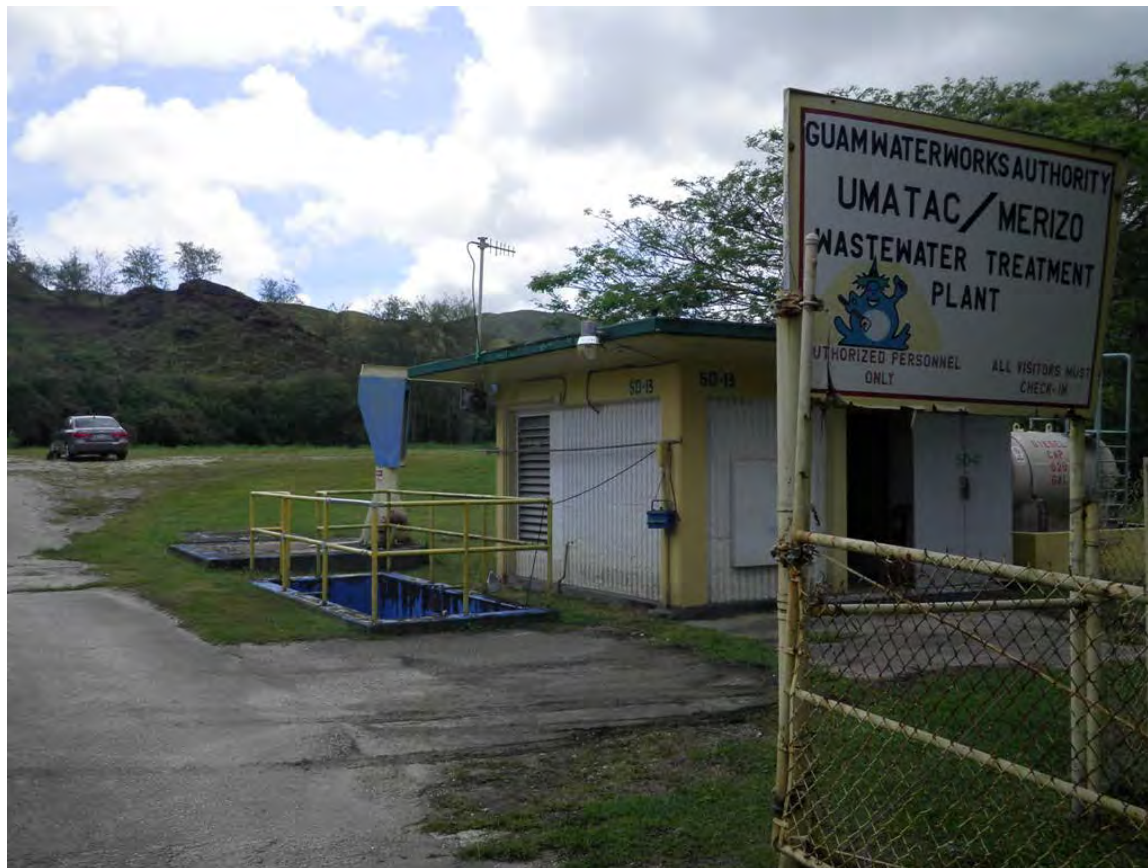
Picture 2: Pump Station 13 and pit where influent flow was being monitored.

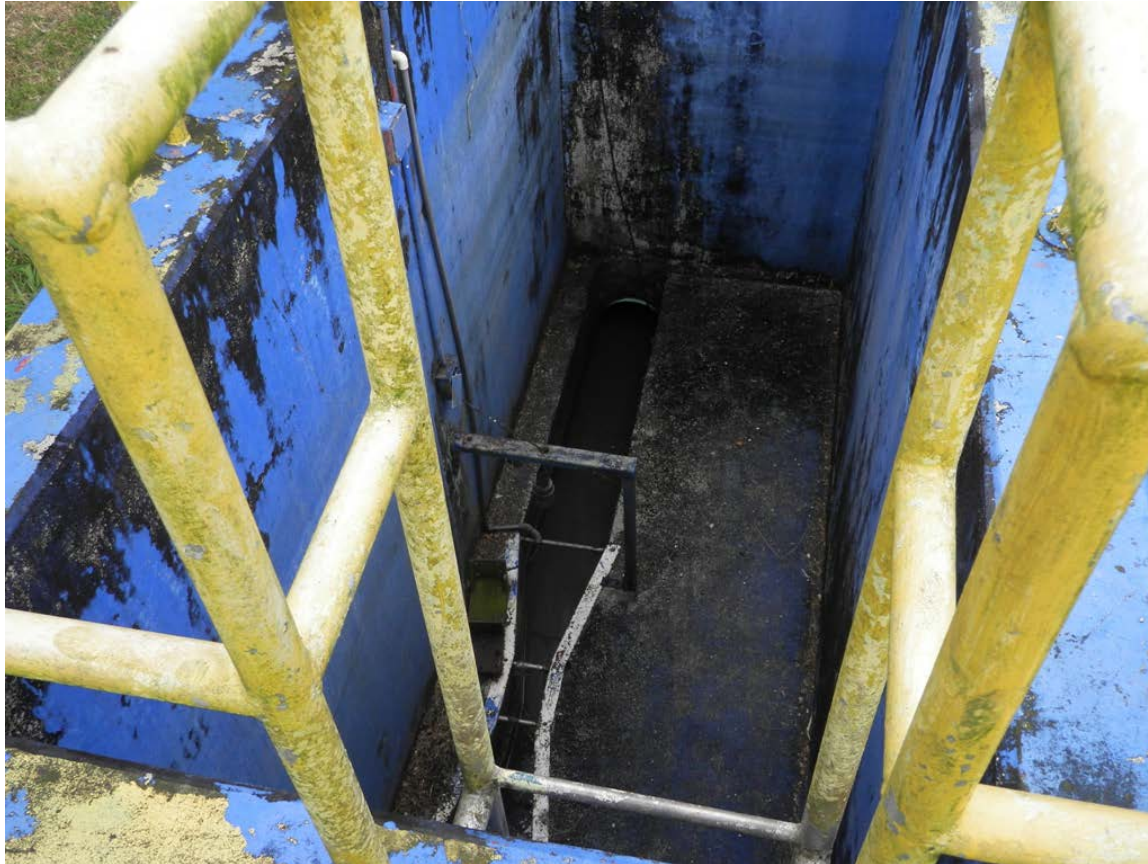
Picture 3: Unused Parshall flume for measuring influent flow rate. A depth monitoring device is installed in the pipe discharging into the flume at the top of the photo.

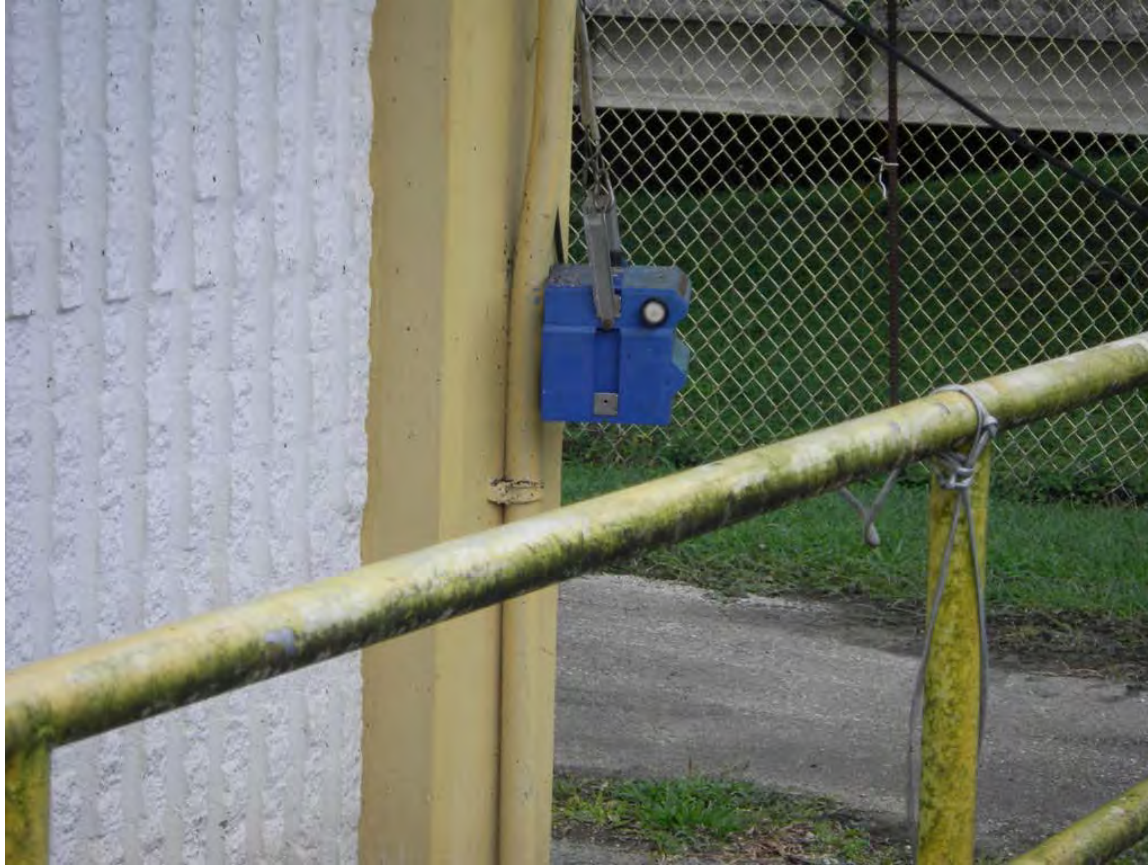
Picture 4: Data logger storing depth measurements.

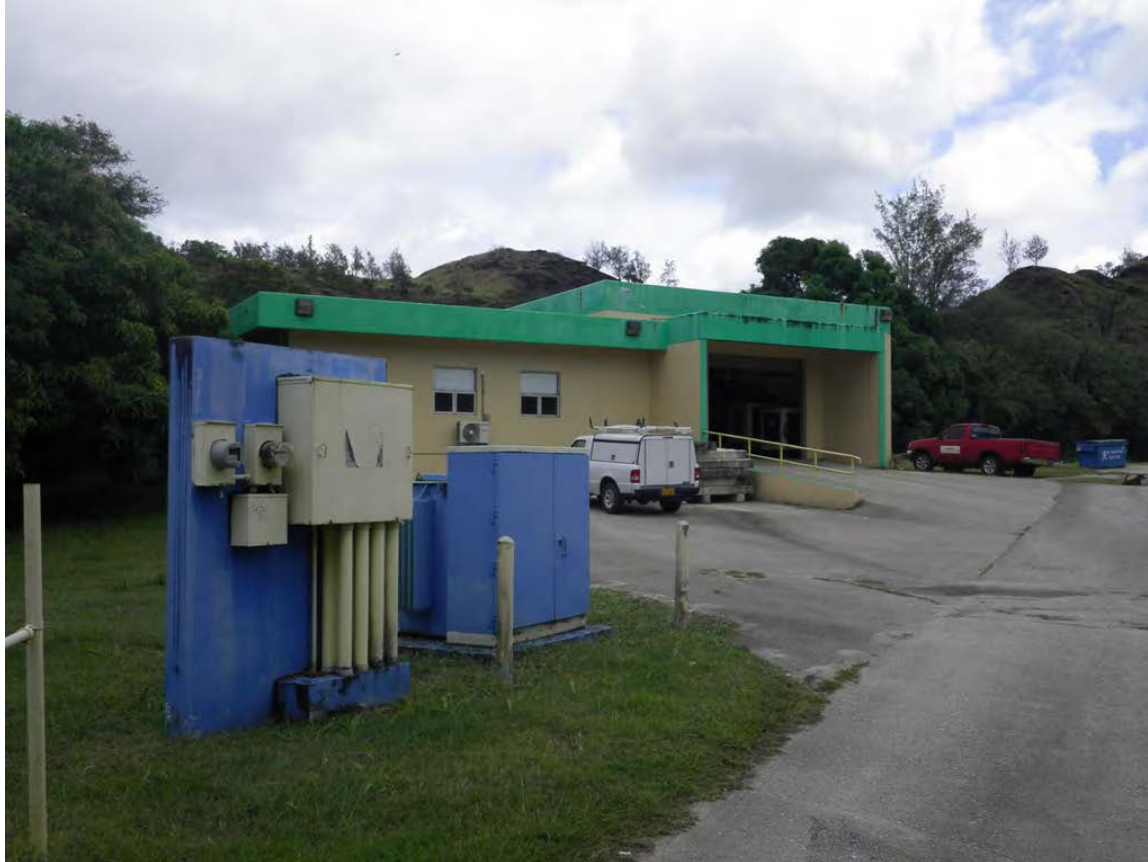
Picture 5: Umatac maintenance building.

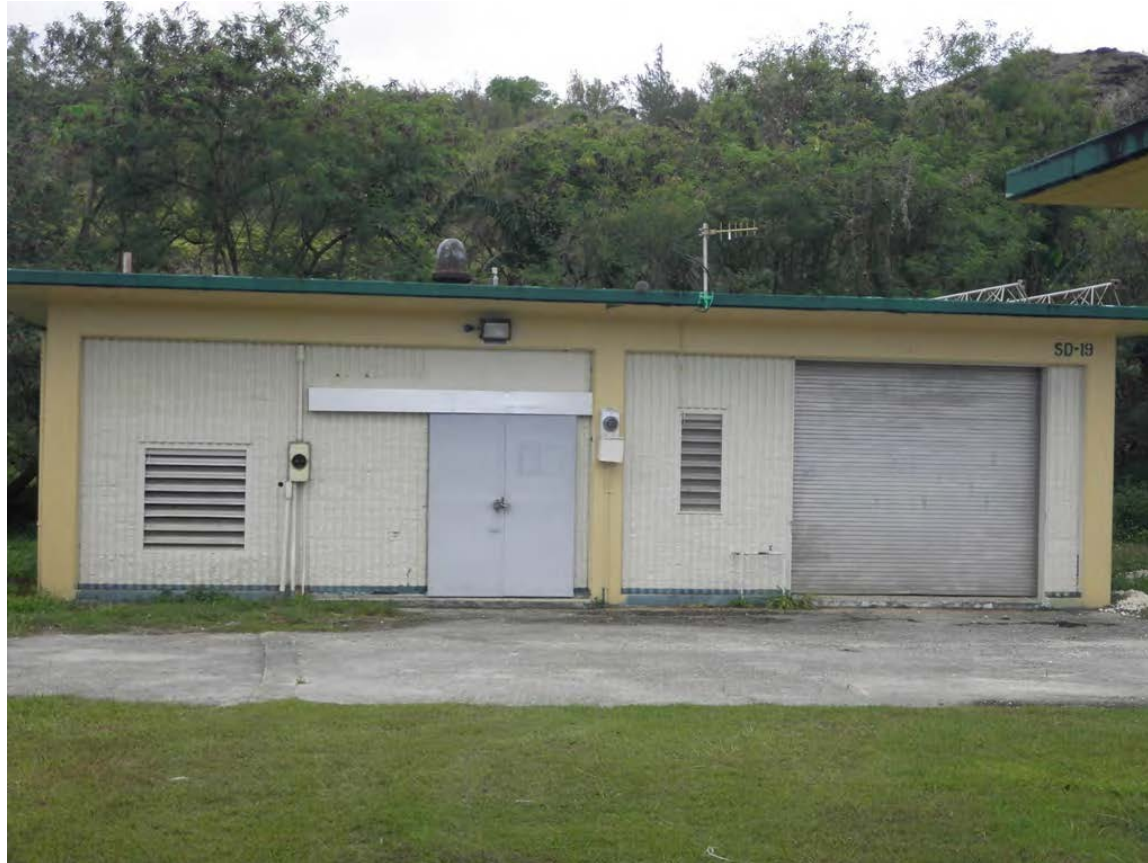
Picture 6: Umatac STP control room building.

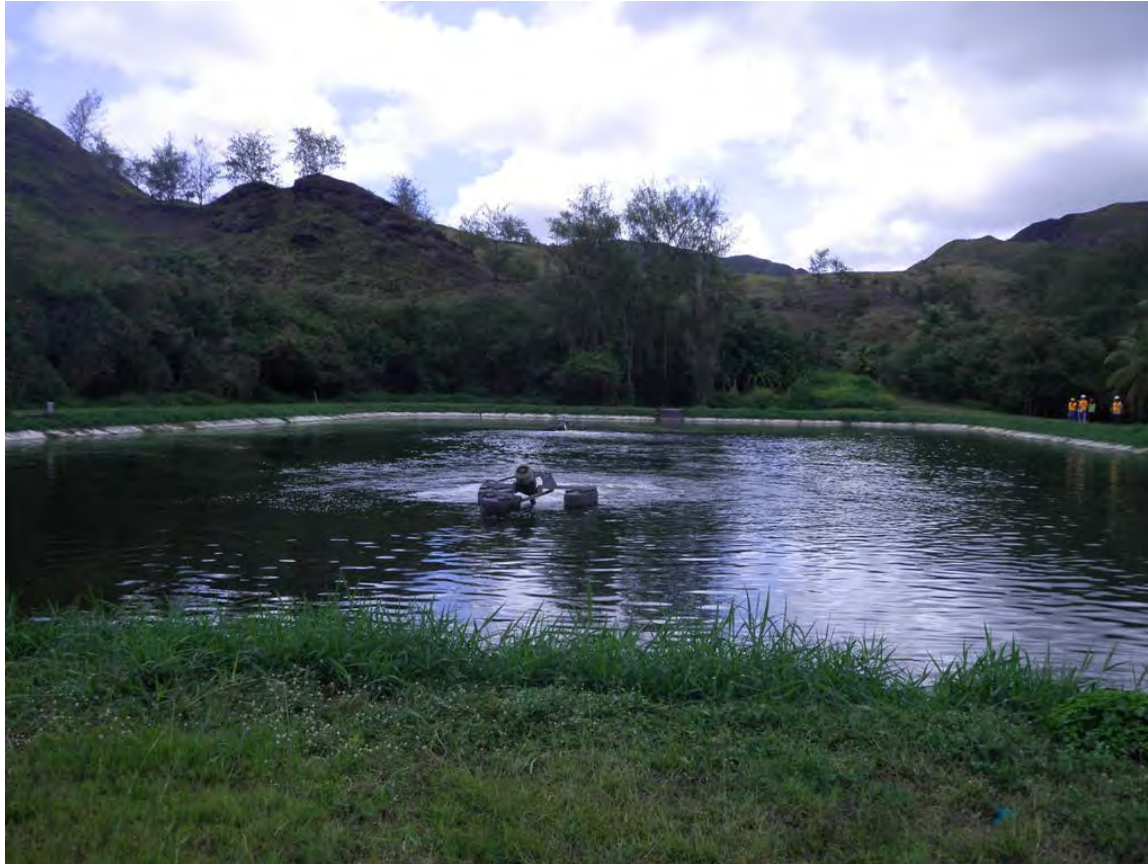
Picture 7: Overview of facultative lagoon looking from the inlet side to the discharge side.

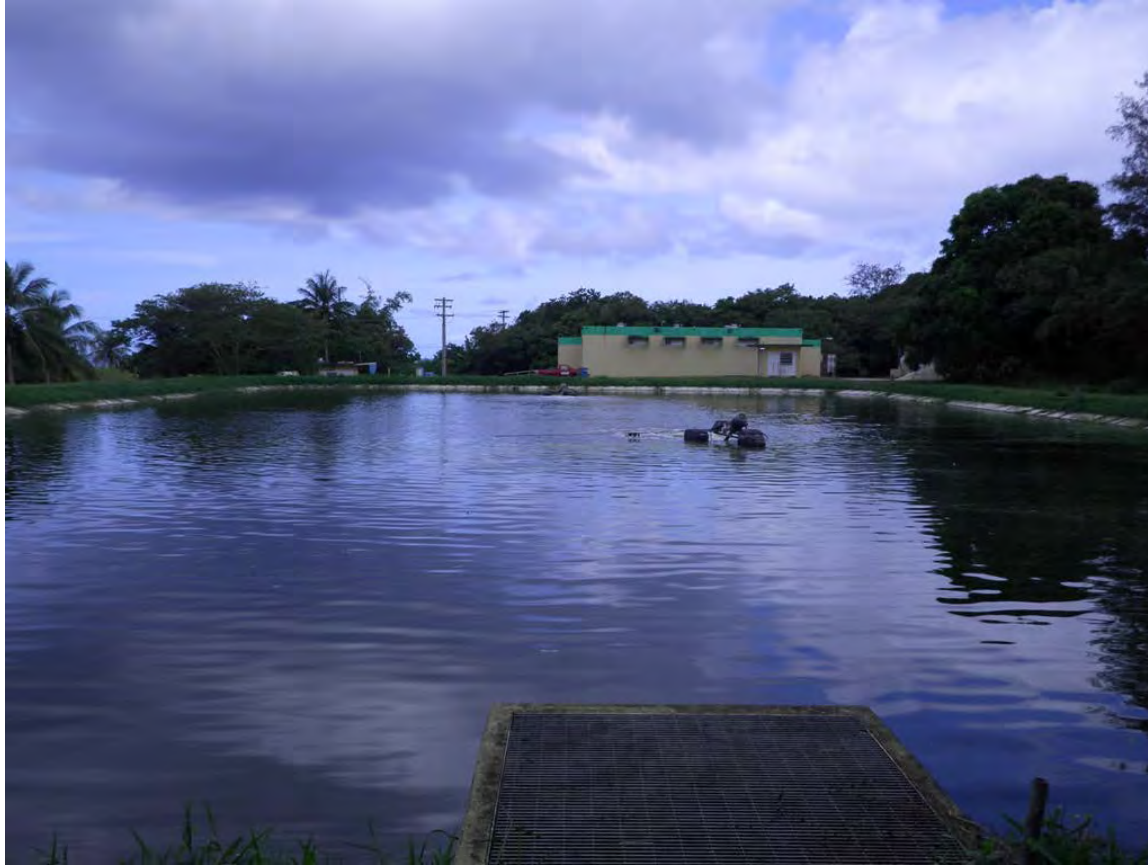
Picture 8: View across facultative pond from discharge side towards inlet side.

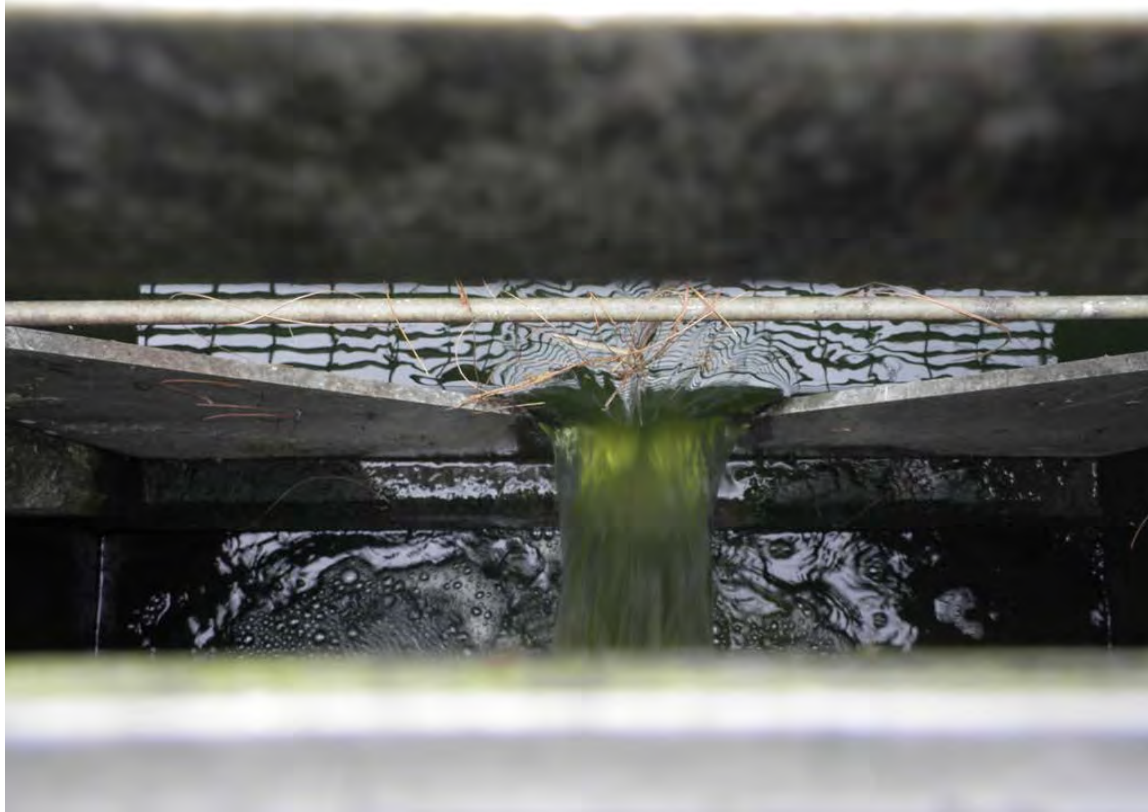
Picture 9: Facultative pond effluent discharge v-notch weir.

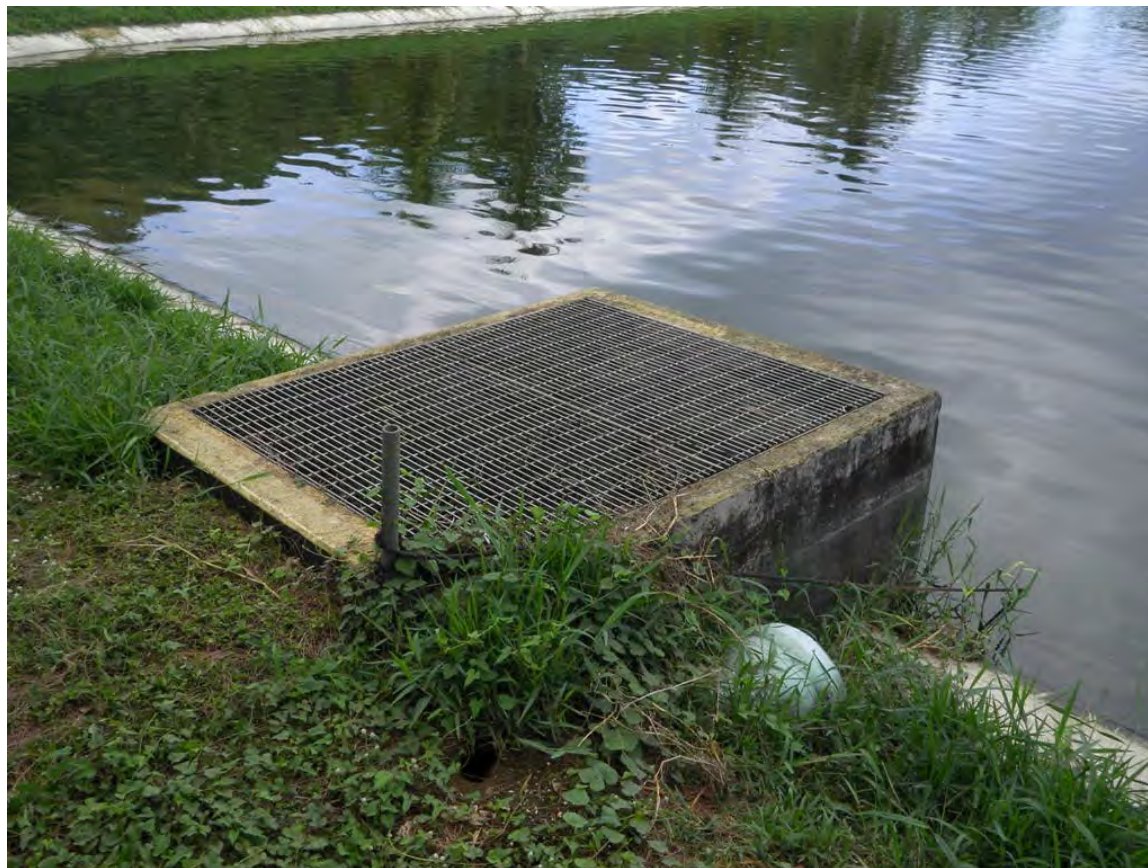
Picture 10: Facultative pond discharge structure.

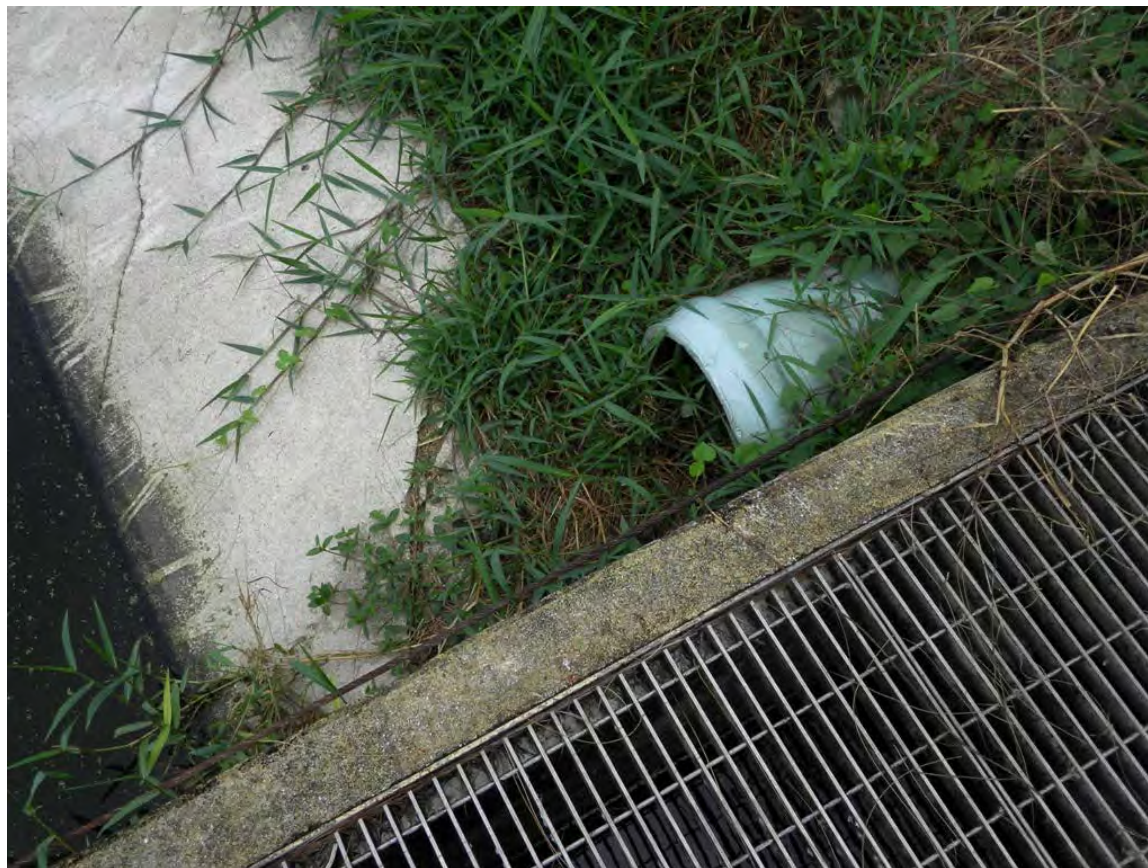
Picture 11: High level bypass pipe inlet for facultative pond.

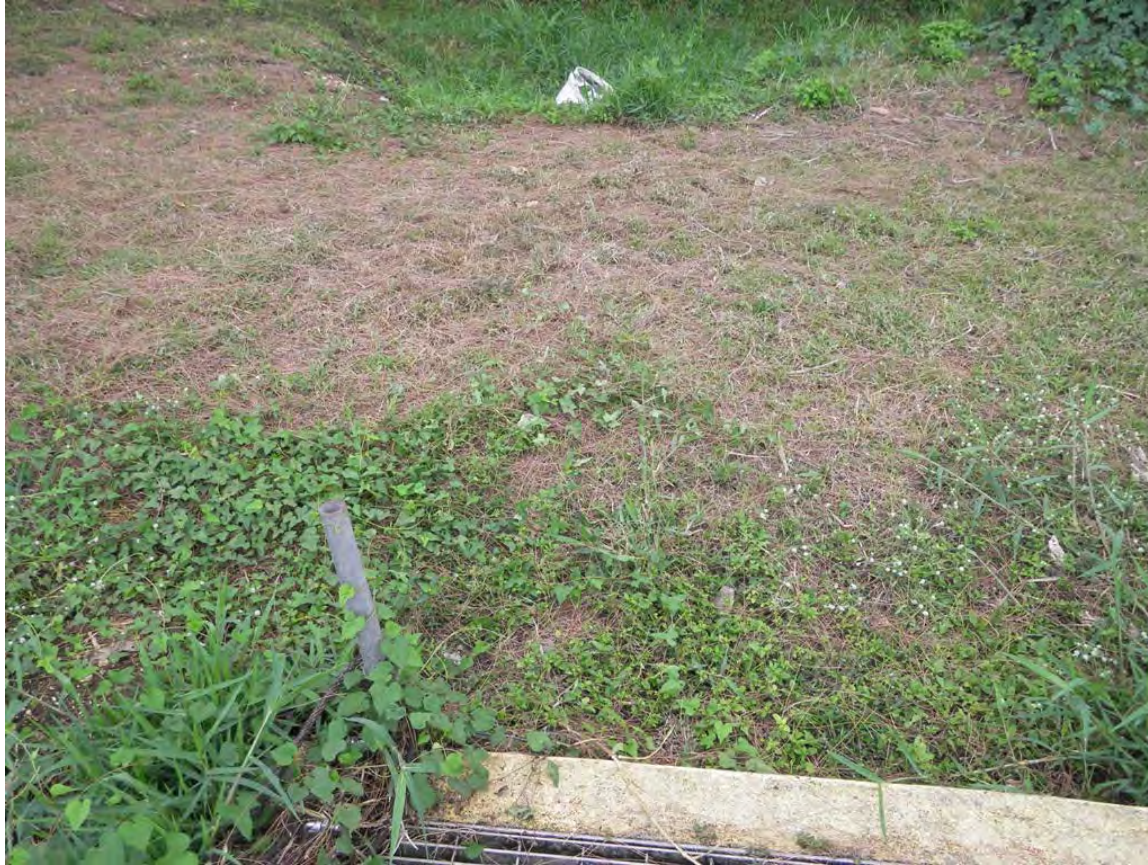
Picture 12: Discharge end of high level bypass pipe.

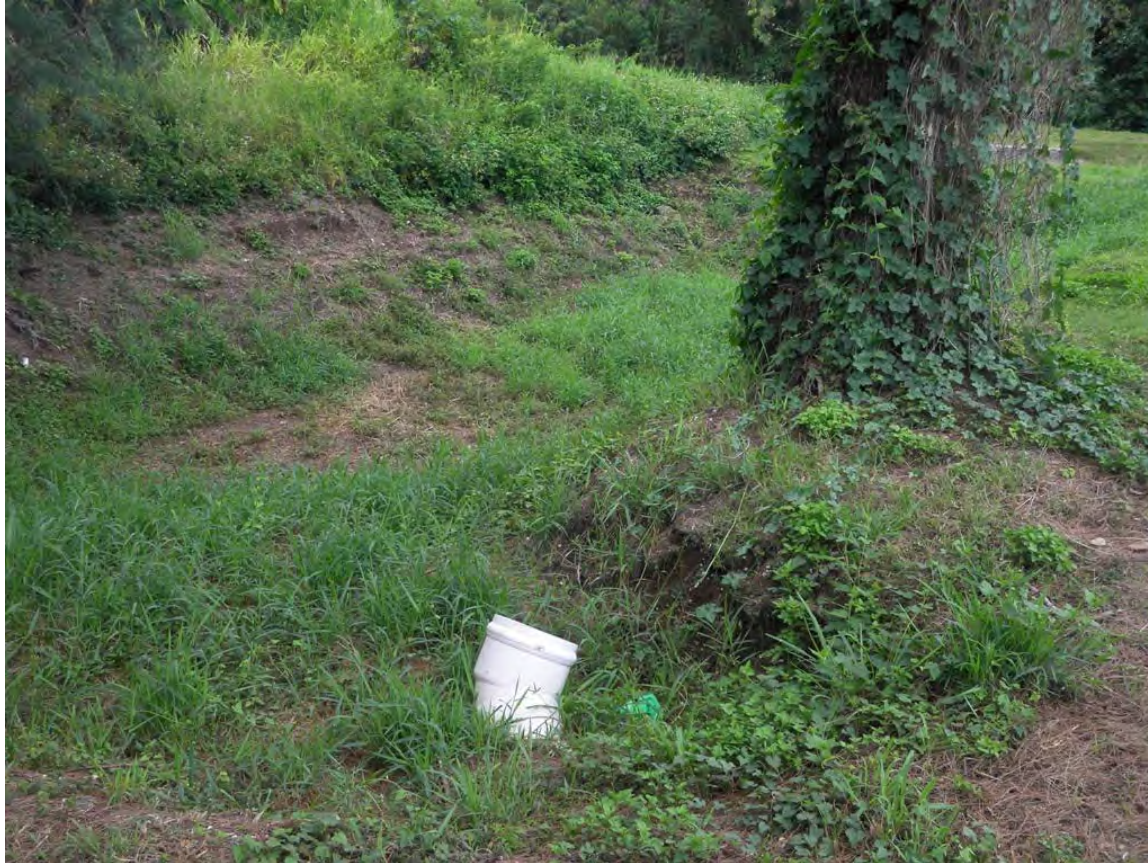
Picture 13: By-pass retention basin.

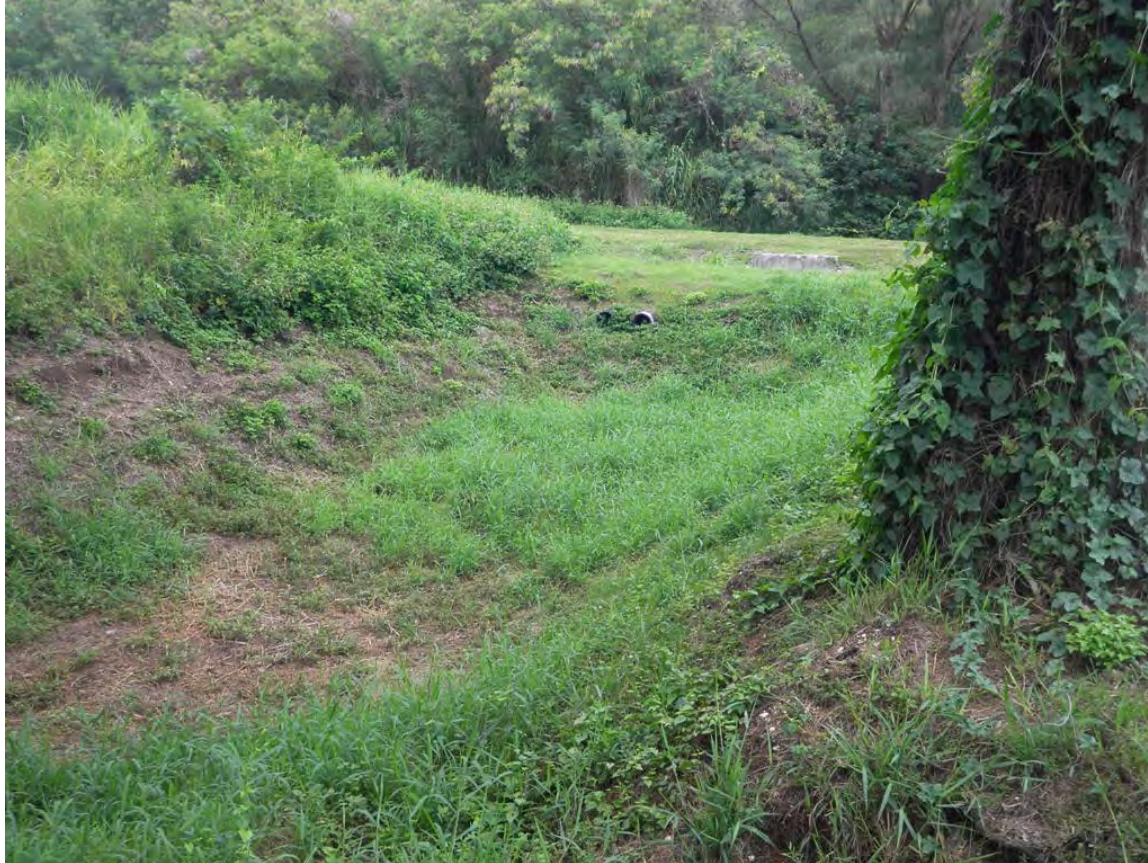
Picture 14: Discharge pipe in by-pass retention basin.

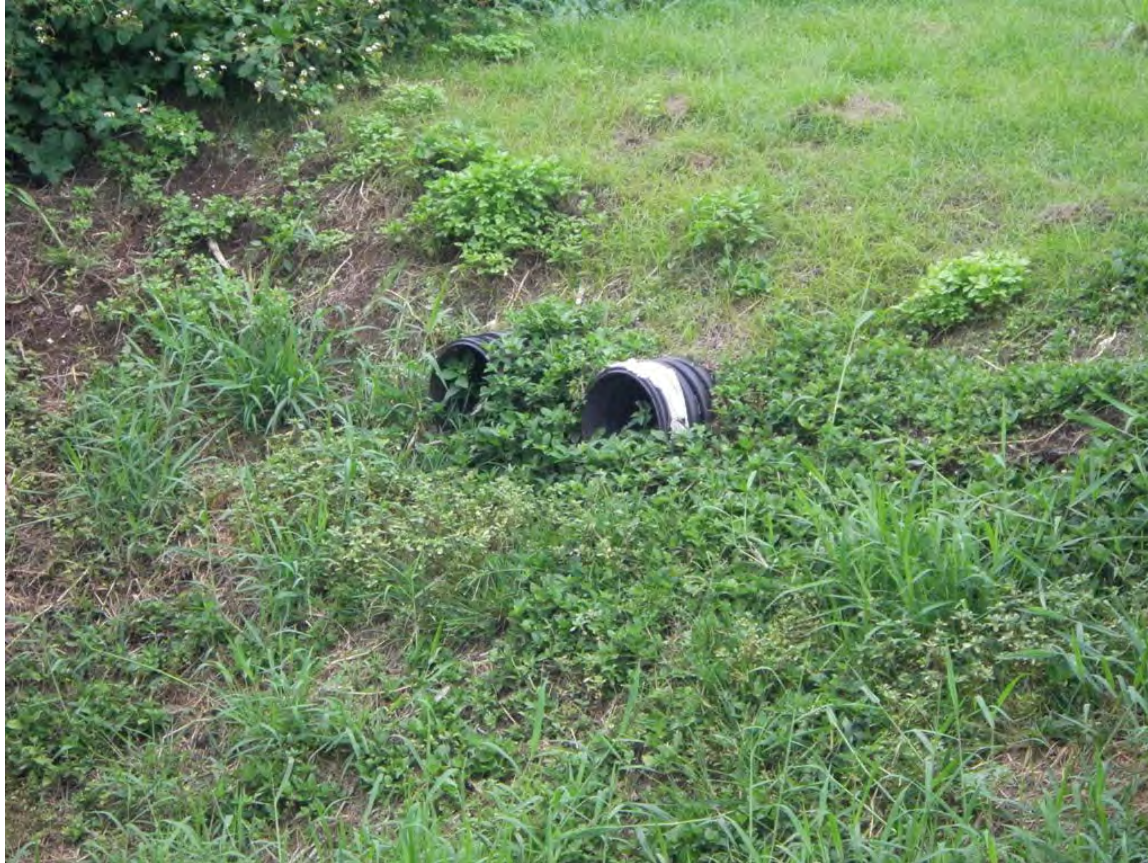
Picture 15: Close up look of discharge pipes for by-pass retention basin.

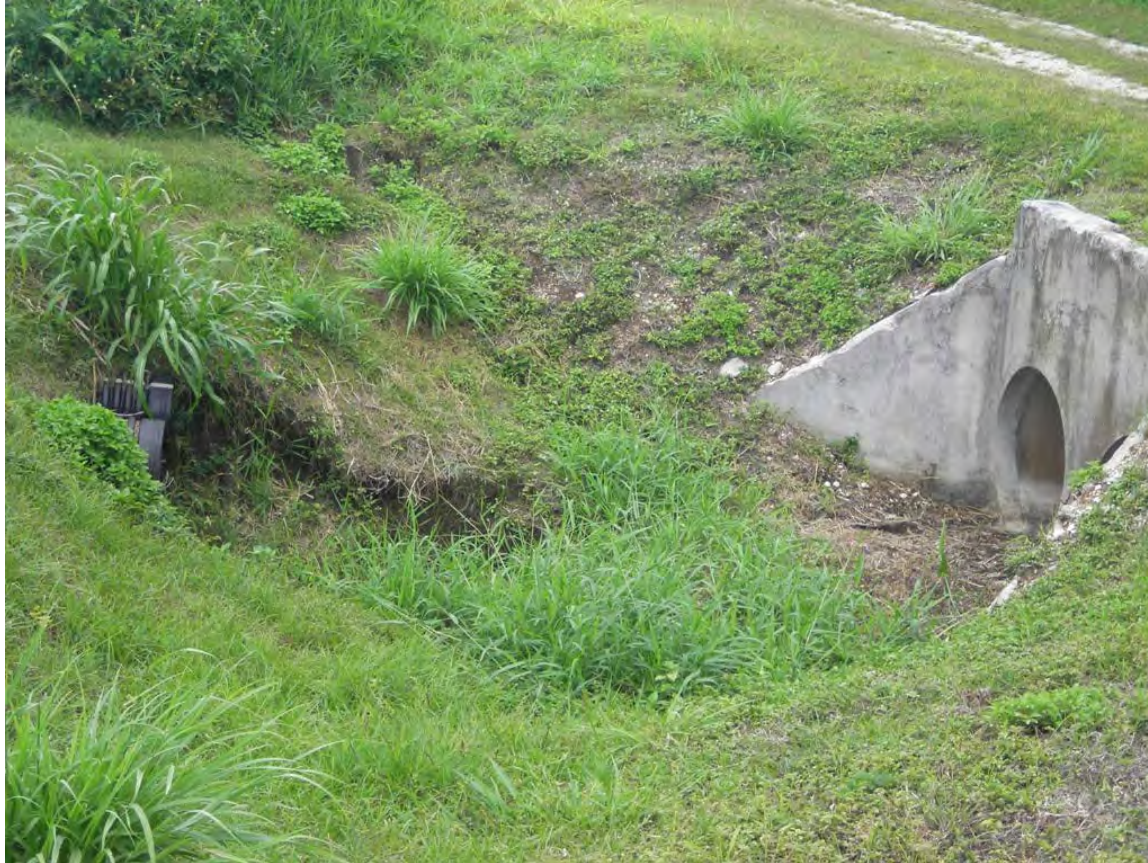
Picture 16: Discharge from by-pass retention basin to culvert to river.

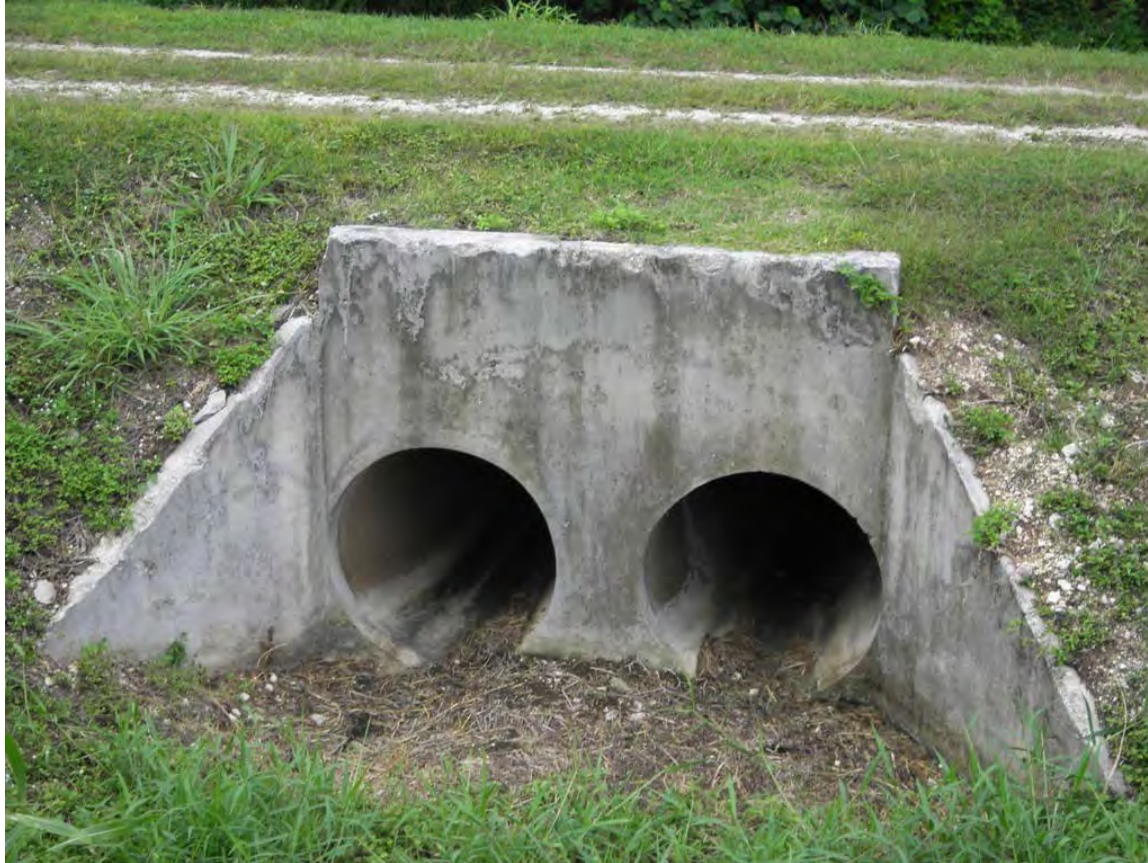
Picture 17: Inlet of culvert to river.

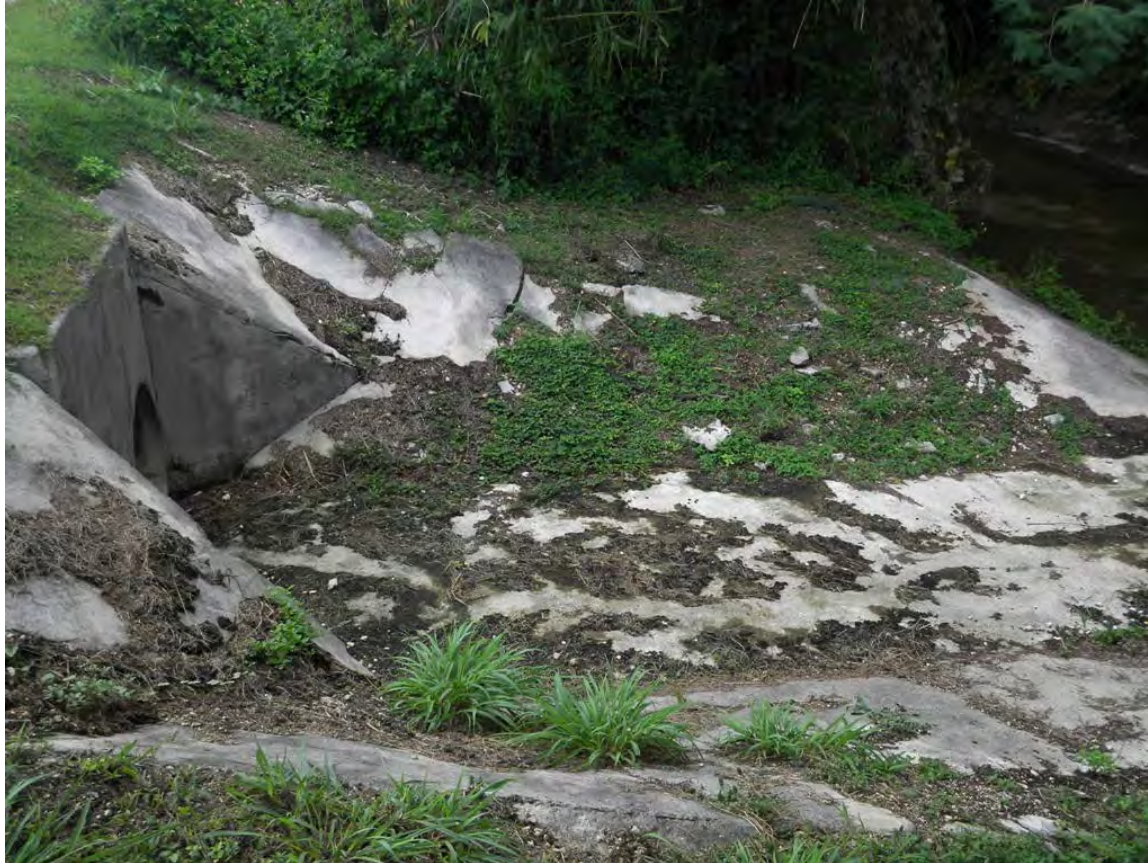
Picture 18: Discharge of culvert to river.

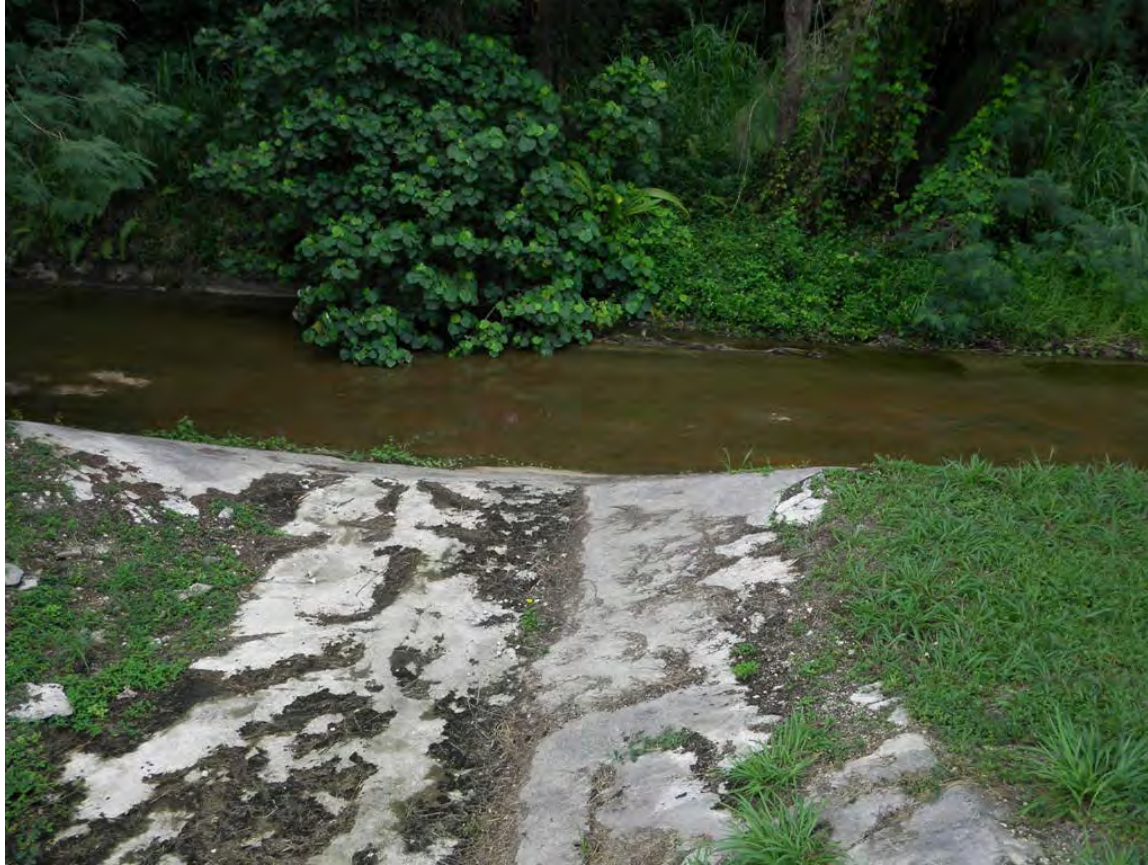
Picture 19: Discharge channel of culvert to river.

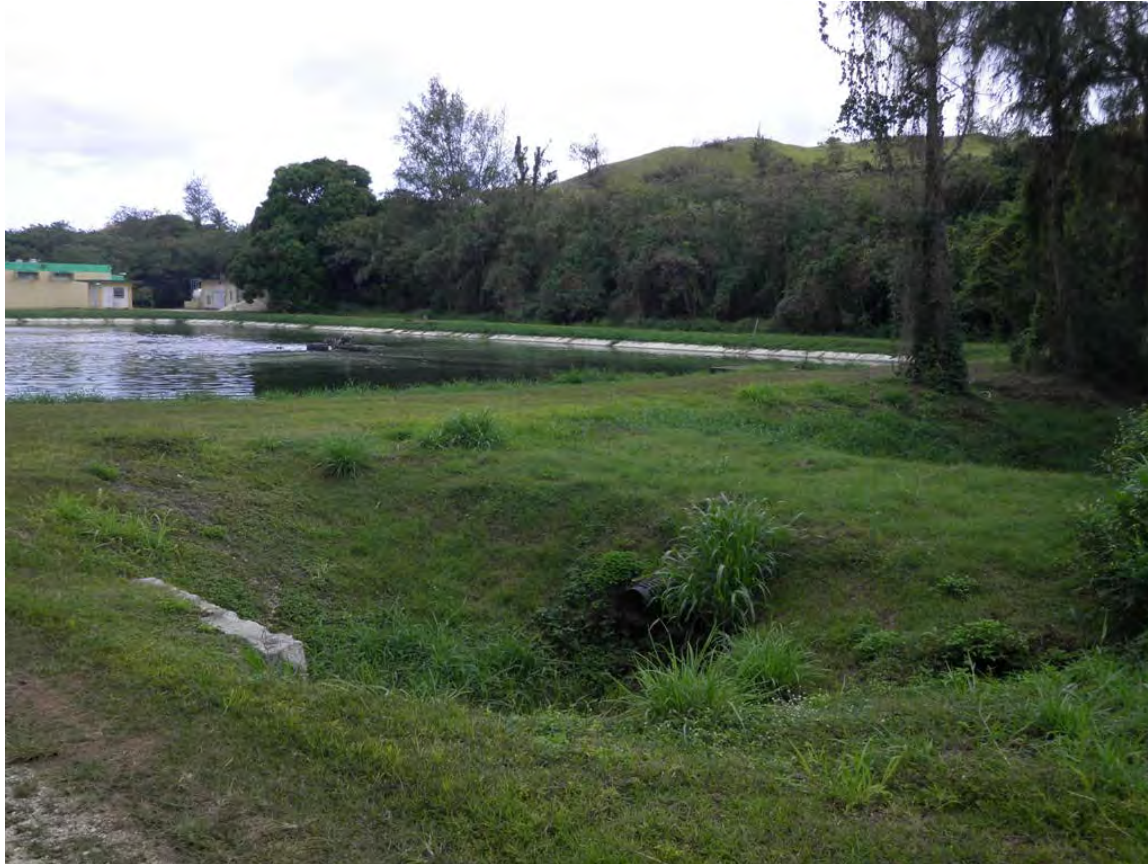
Picture20: Overview showing facultative pond, high level by-pass retention pond, in inlet side of culvert to river.

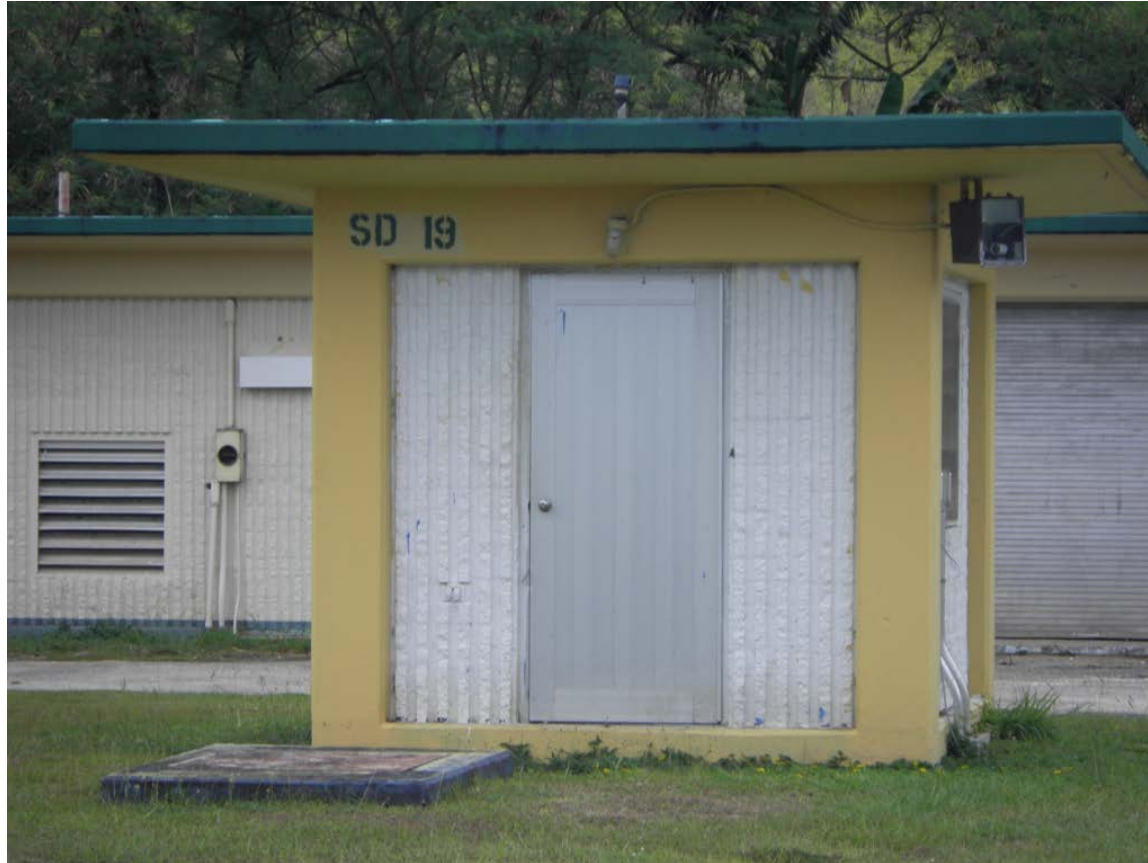
Picture 21: Pump Station 19 pumps effluent from the facultative lagoon to the recirculation pond.

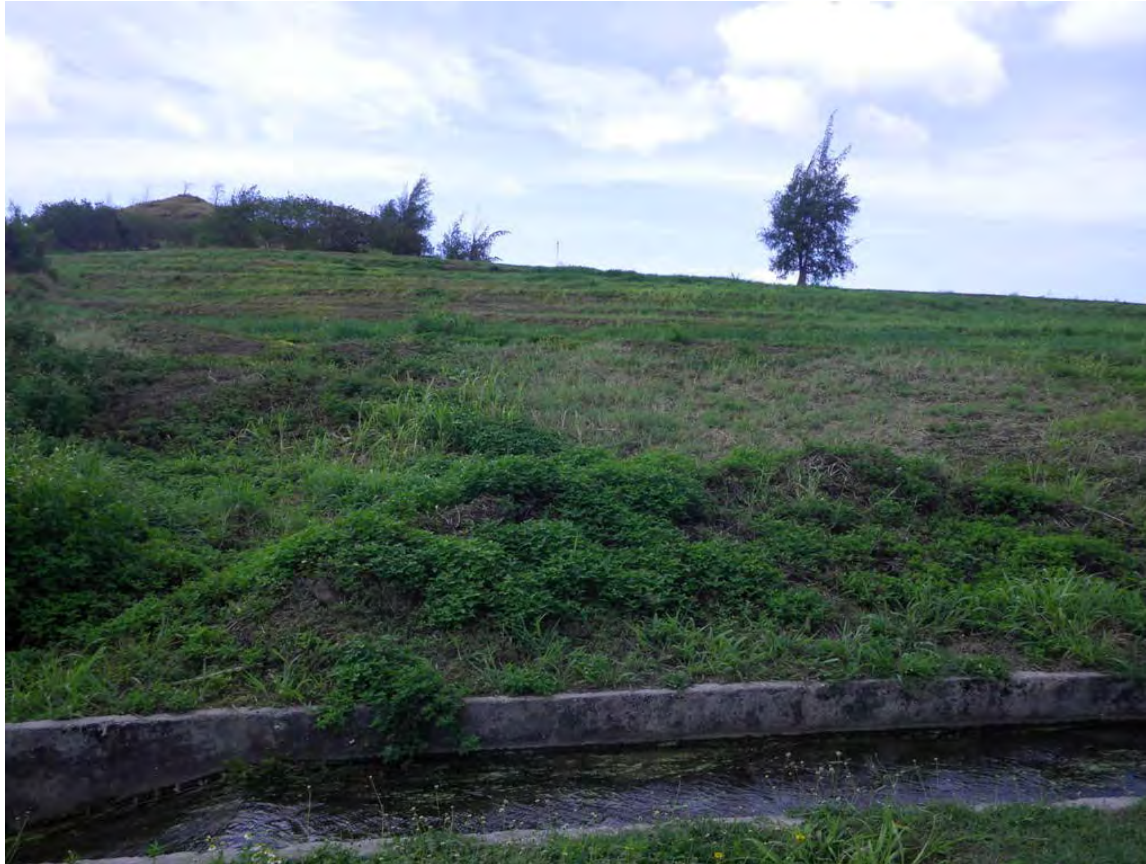
Picture 22: Looking up hill to Land Application Site A. Channel at bottom is returning runoff from land application sites back to recirculation pond.

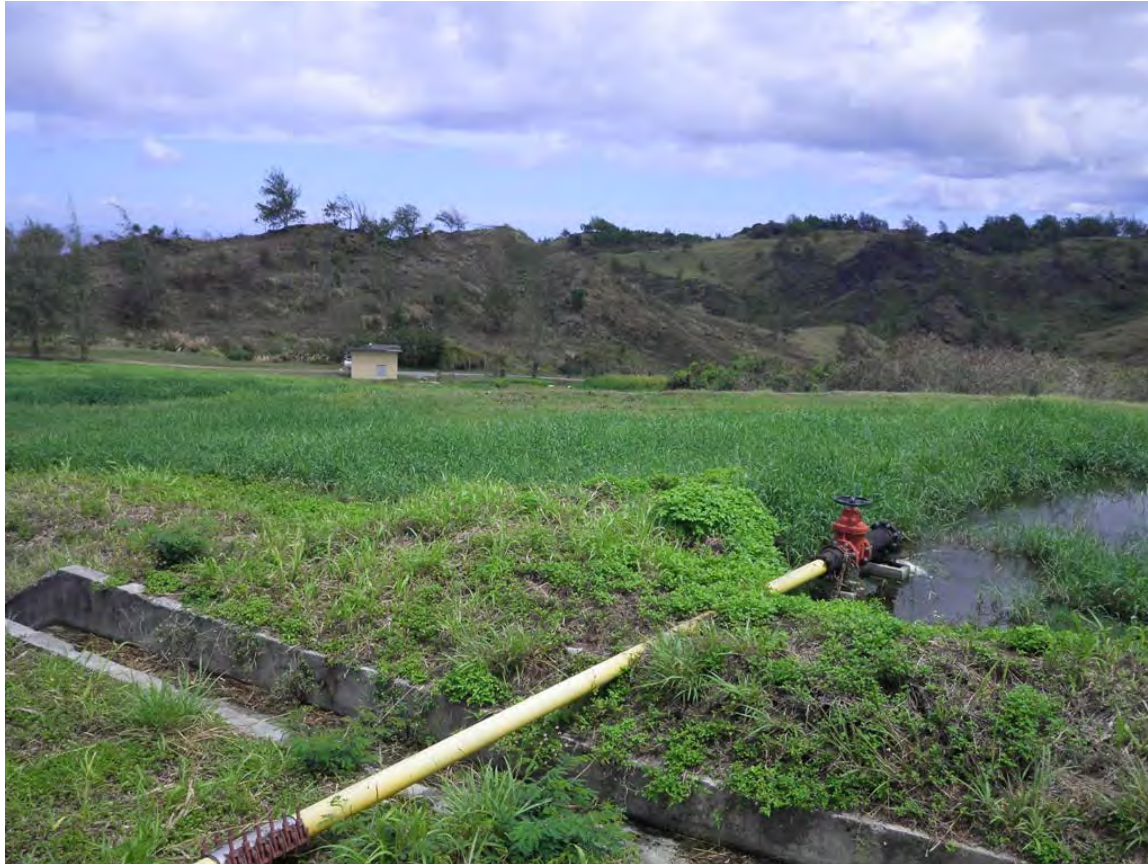
Picture 23: Looking down hill across Land Application Site A towards recirculation pond. Line in foreground is discharging water pumped from the recirculation pond by the pump station near upper left corner of photo.

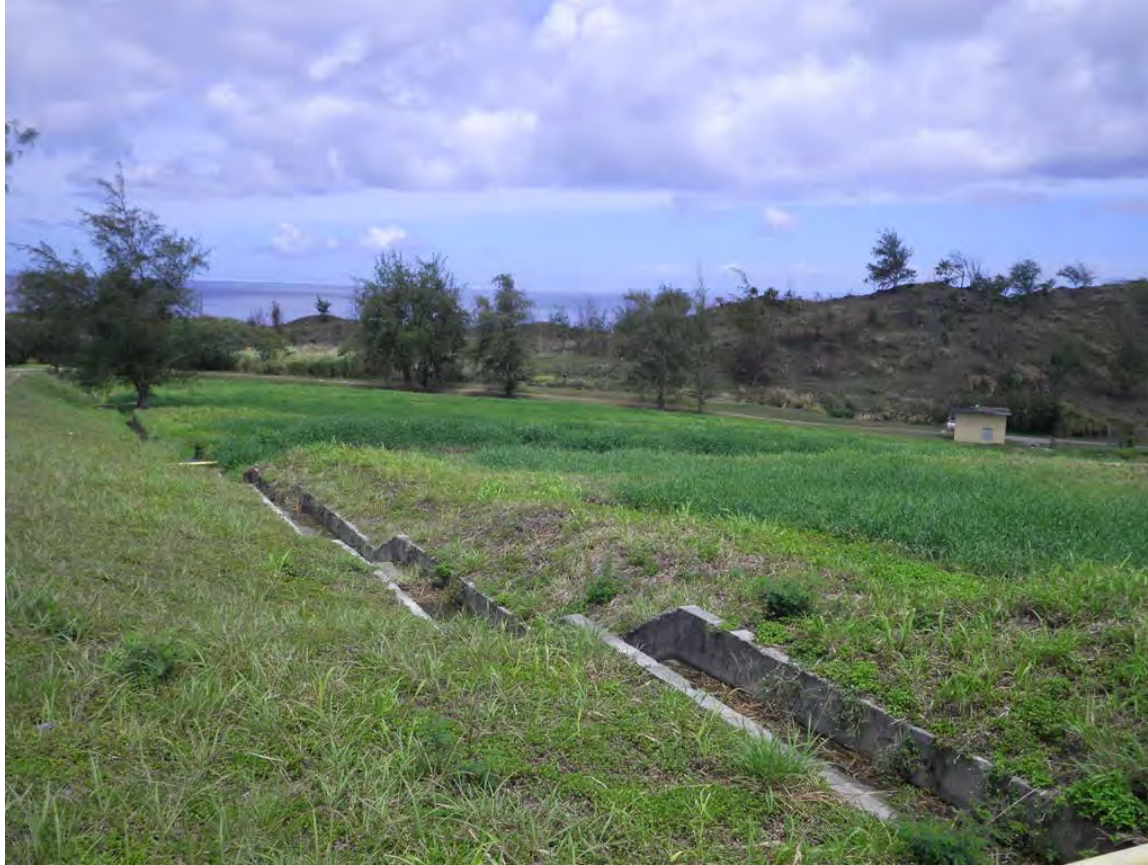
Picture 24: Runoff collection channel that returns excess water to recirculation pond.
