Picture 1: Umatac STP sign.

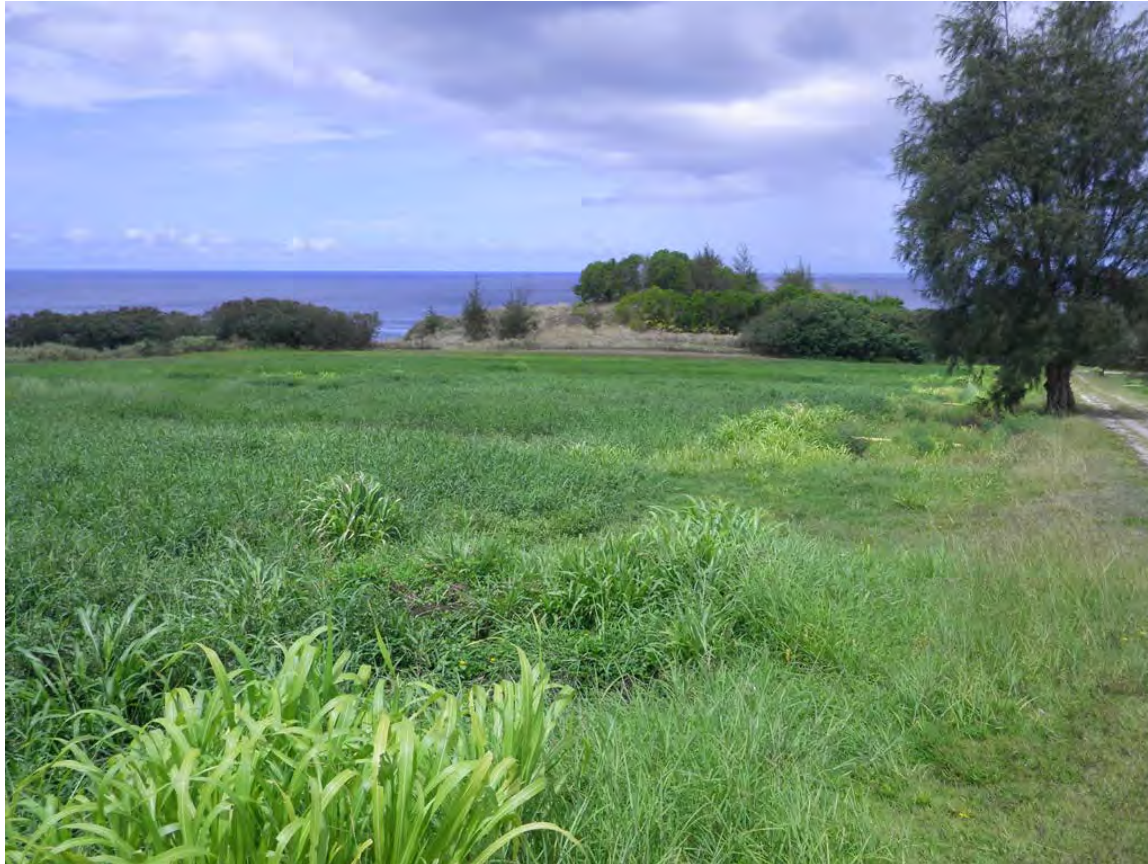
Picture 25: Looking down hill over Land Application Site B. This site was not being used during day of the inspection

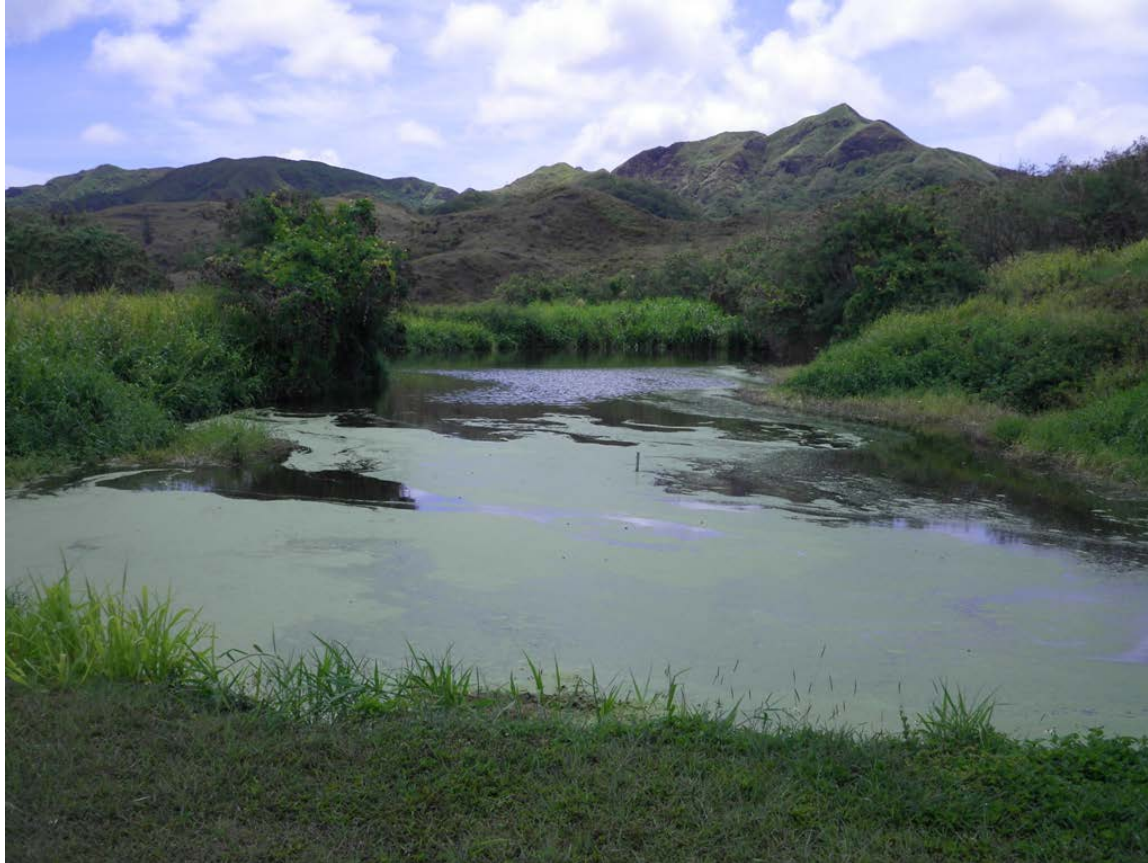
Picture 26: Recirculation pond from the pump station to the land application sites.

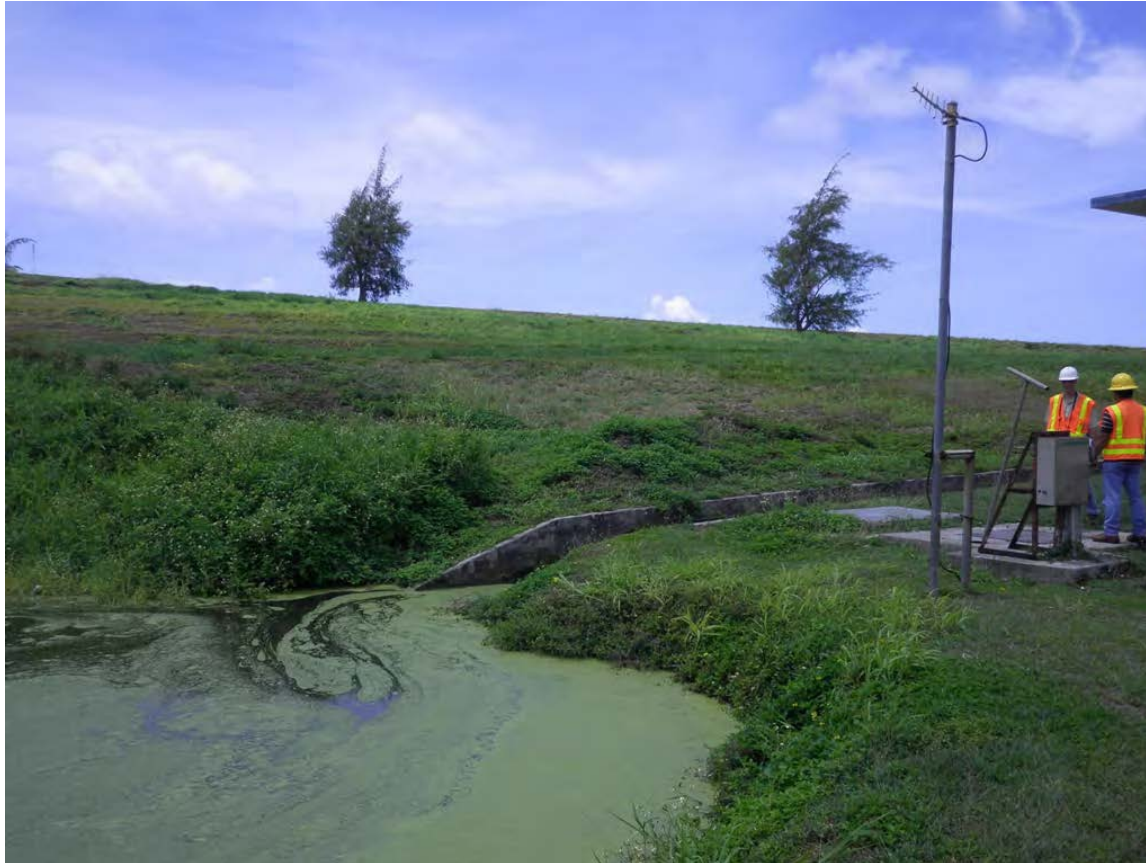
Picture 27: Excess water from the land application sites discharging into the recirculation pond.

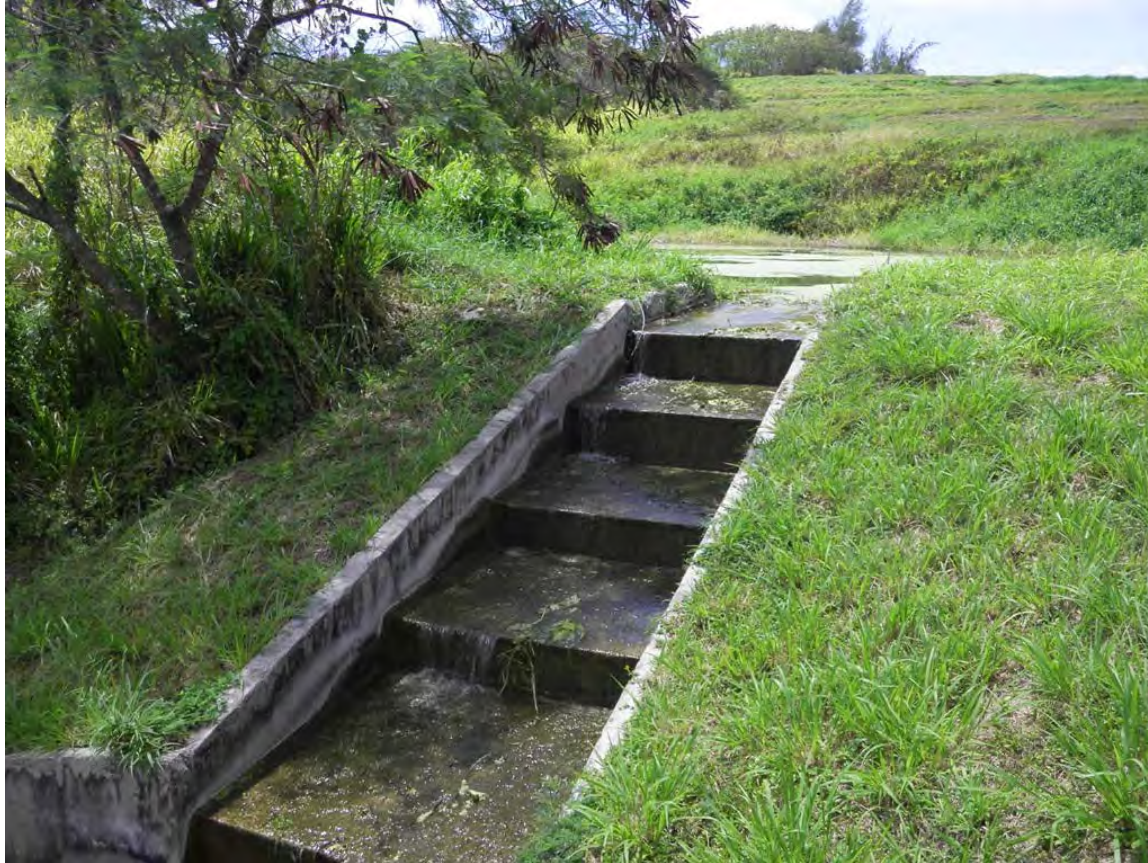
Picture 28: Recirculation pond overflow discharge to Tocguan River.

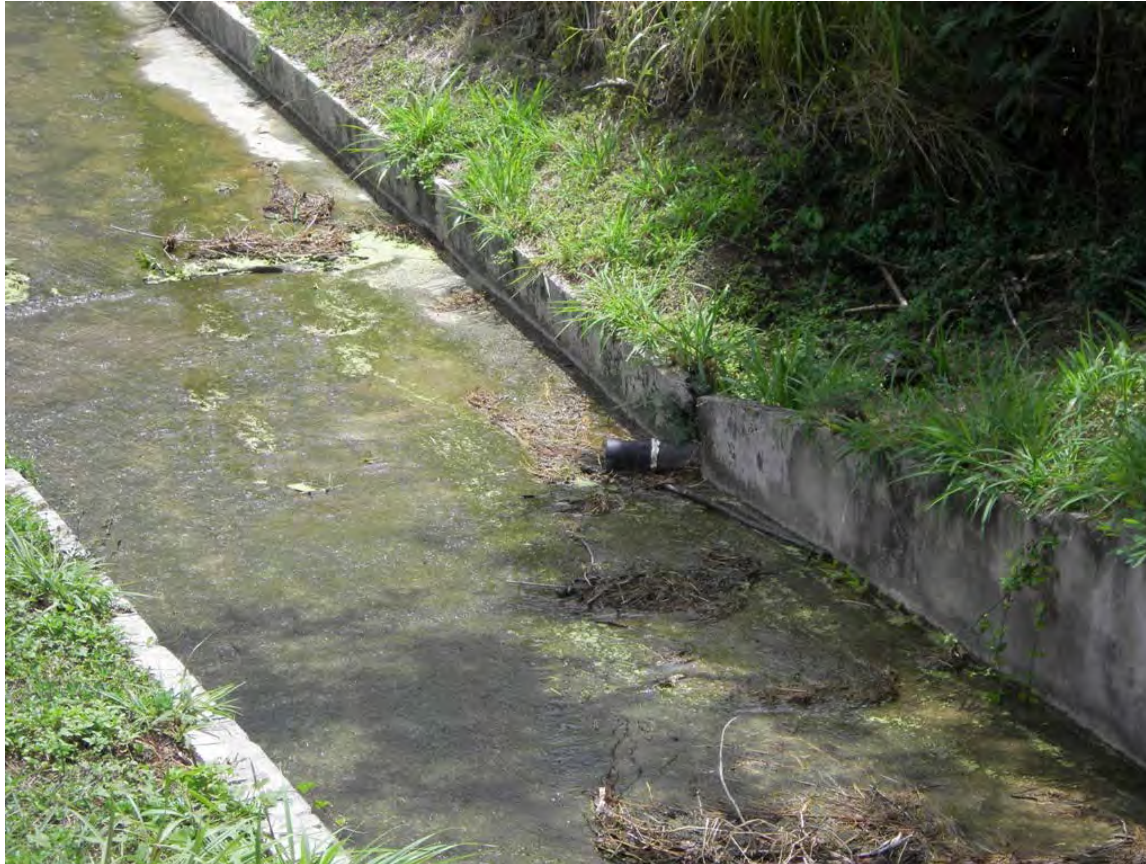
Picture 29: Capped line used to drain recirculation pond. Channel discharges to the Tocguan River. This location is downstream of the sample collection point.

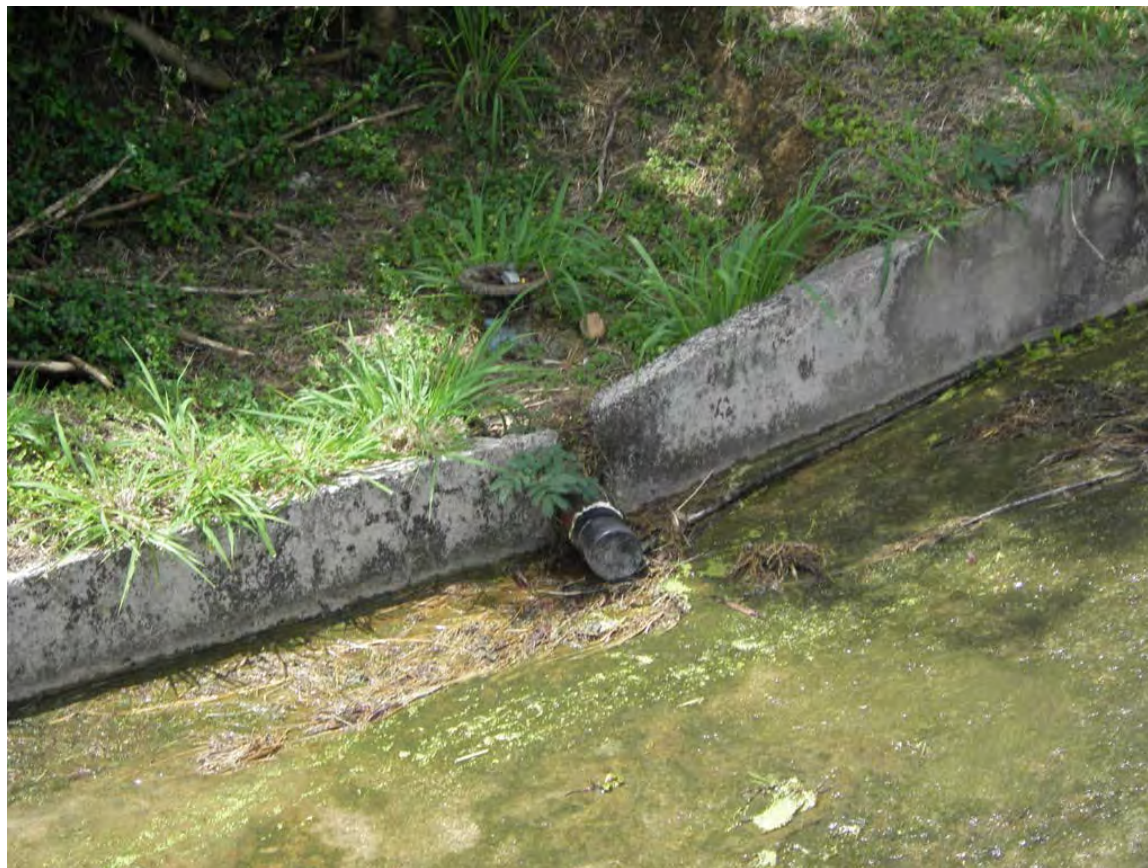
Picture 30: Valved and capped pond drain line.
