UNITED STATES ENVIRONMENTAL PROTECTION AGENCY
REGION IX
75 Hawthorne Street
San Francisco, CA 94105-3901

Mr. Richard Aschieris, Director
Port of Stockton
P.O. Box 2089
Stockton, CA 95201

Subject: Transmittal of "Port of Stockton Municipal Separate Storm Sewer Audit Report"

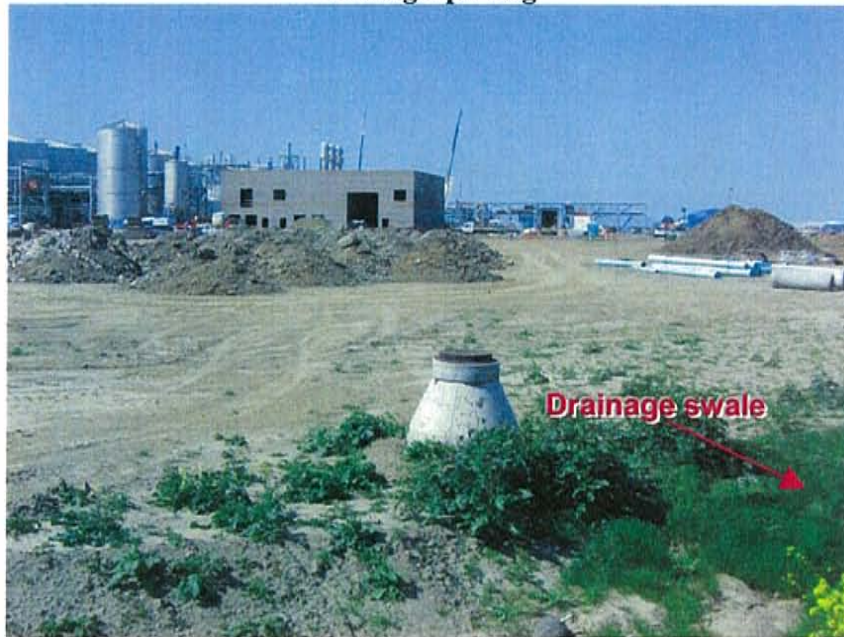
Photograph 3: BMPs were not implemented between a large expanse of disturbed soils, a number of uncontrolled soil stockpiles, and the adjacent drainage swale.

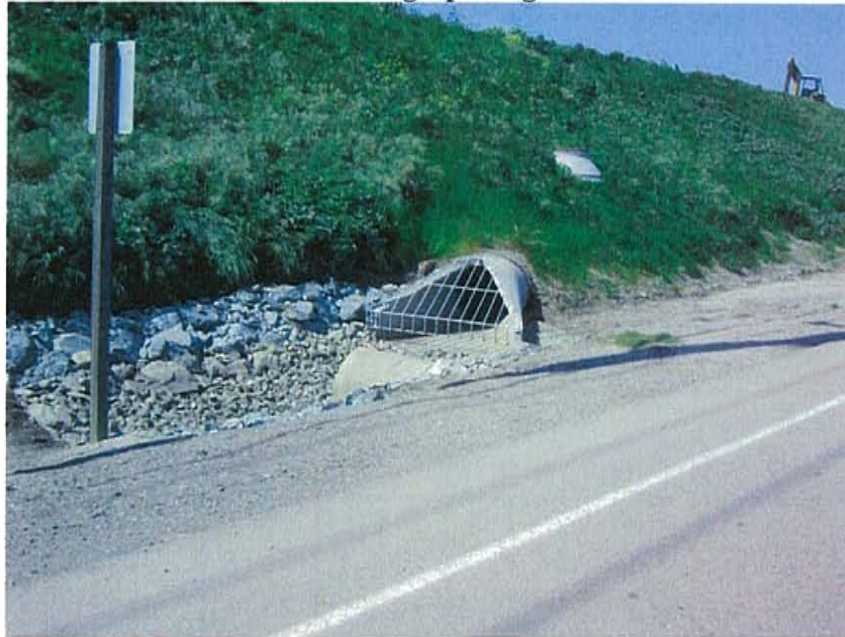
Photograph 5: Pacific Ethanol storm drain outfall into the drainage channel along Navy Drive.

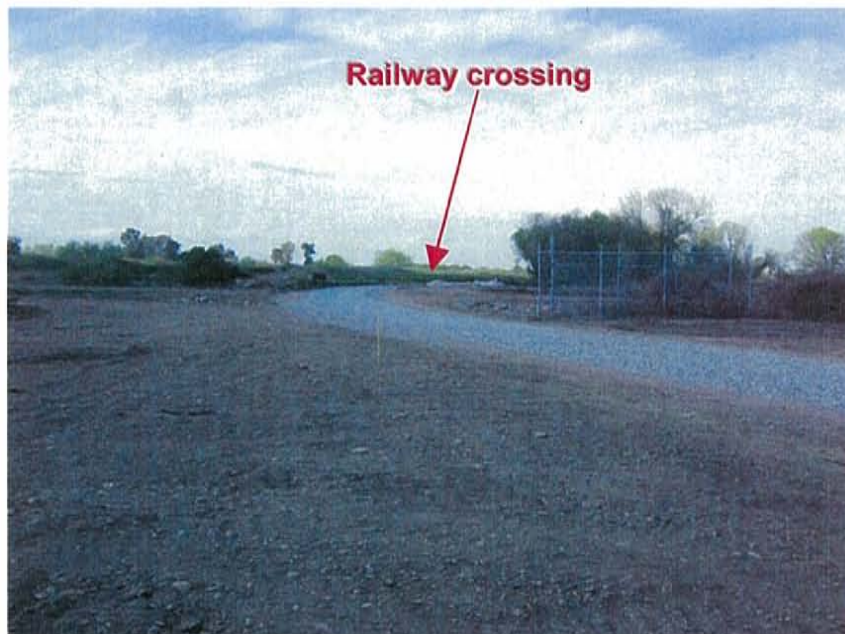
Photograph 6: Location of the new railway crossing spanning a unnamed waterway north of the construction site entrance off Humphreys Drive.

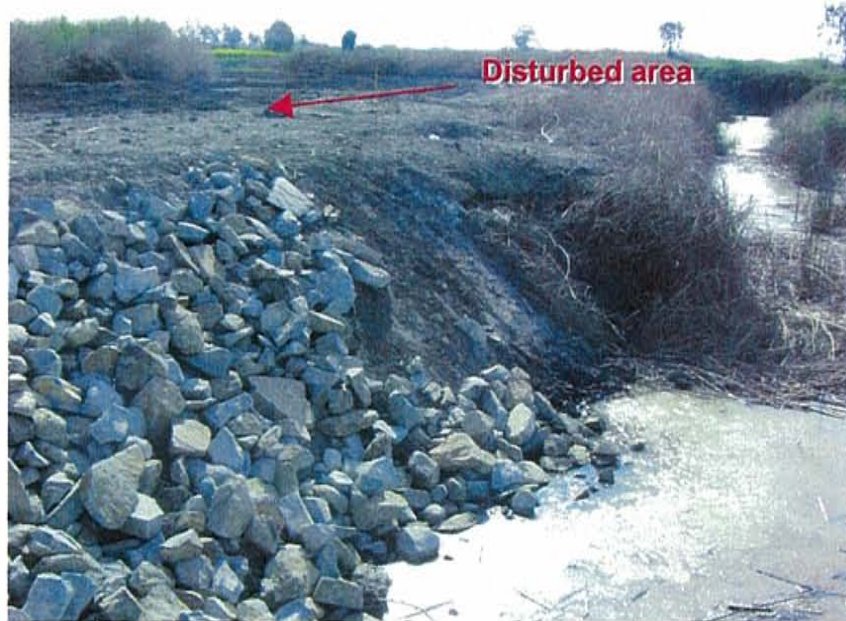
Photograph 7: BMPs were not implemented between the disturbed area on the northeast side of the railway crossing and the adjacent unnamed waterway.

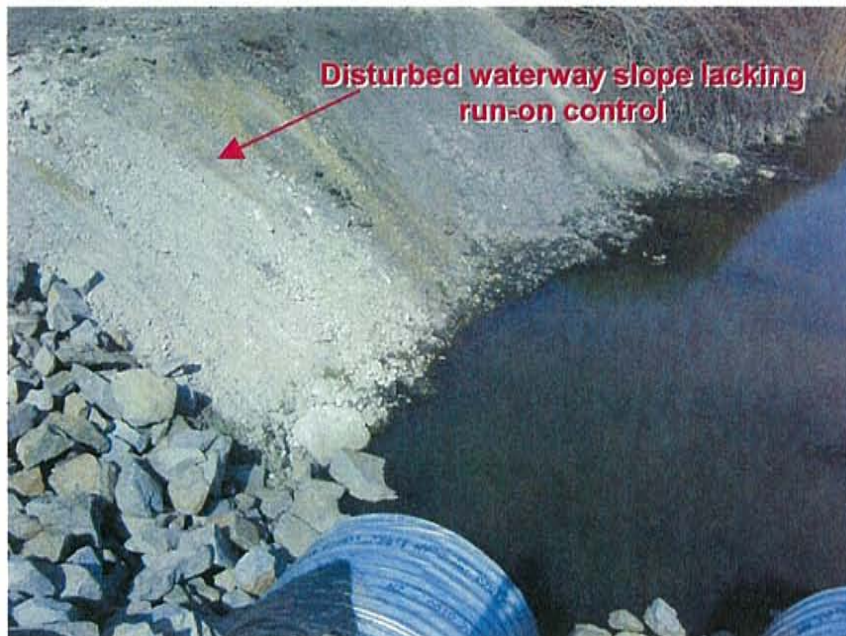
Photograph 8: Run-on control BMPs were not implemented between the disturbed area on the southwest side of the railway crossing and the adjacent unnamed waterway.

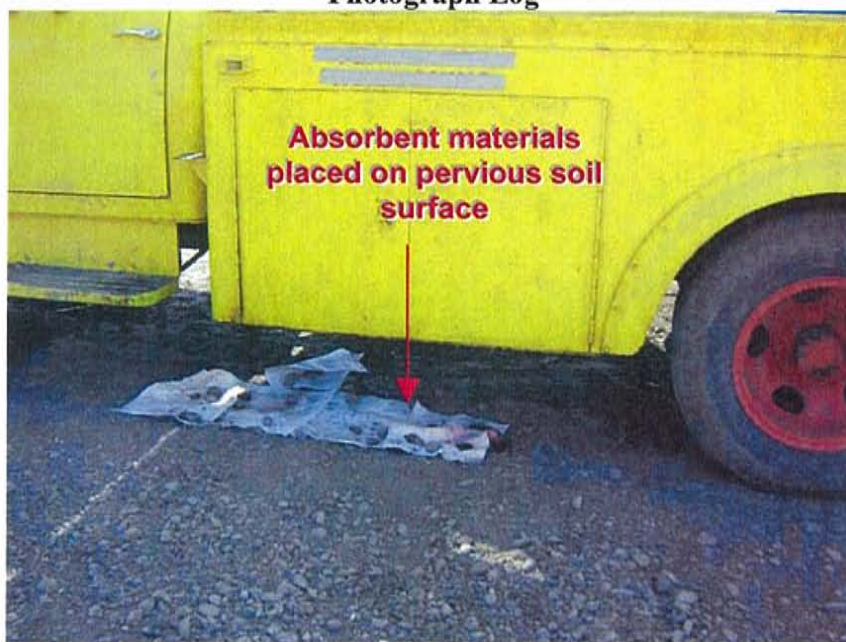
Photograph 9: A mobile fueling truck was actively leaking diesel fuel, and the source of the leak had not been addressed.

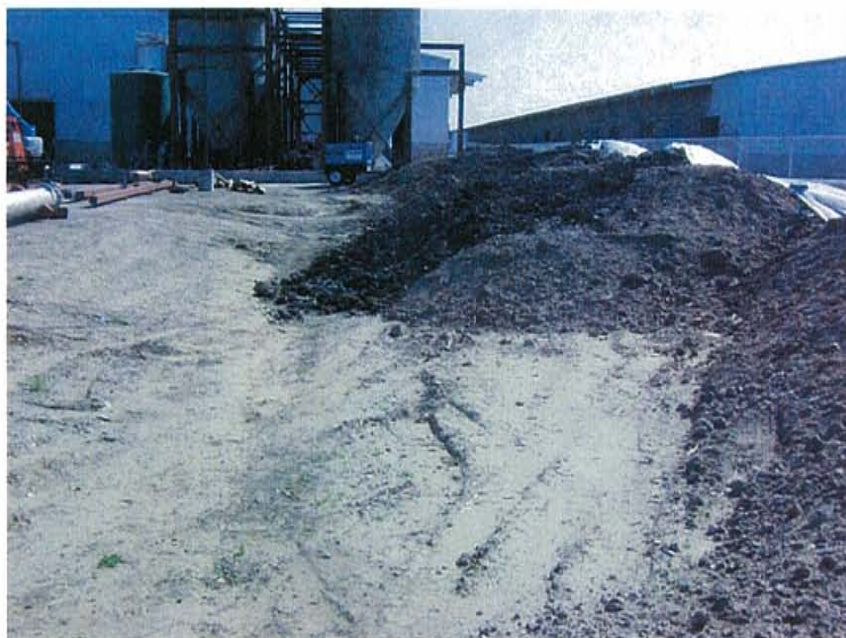
Snedeker Ave.) on March 19, 2008, the Port inspector noted soil stockpiles improperly placed in a drainage pathway and without down-gradient BMPs. In a follow-up audit activity on March 20, 2008, it was noted that these issues had not been corrected (Photograph 10). As a result, the Port exhibited a lack of adequate private construction oversight to prevent the contribution of pollutants to storm water from the aforementioned locations. These outstanding issues and Finding 2.4.2 were considered collectively in making this determination. The Port must correct the outstanding issues and Finding 2.4.2 through prompt and effective enforcement of its tenant agreements. *Furthermore, it is strongly recommended that the Port develop and implement an Enforcement Response Plan (ERP) to establish clear direction and procedures for enforcement based on Port inspections of construction and industrial sites and other compliance activities.*

Photograph 10: In a follow-up audit activity on March 20, 2008, soil stockpiles were still located in a drainage pathway and temporary perimeter controls had not been installed.

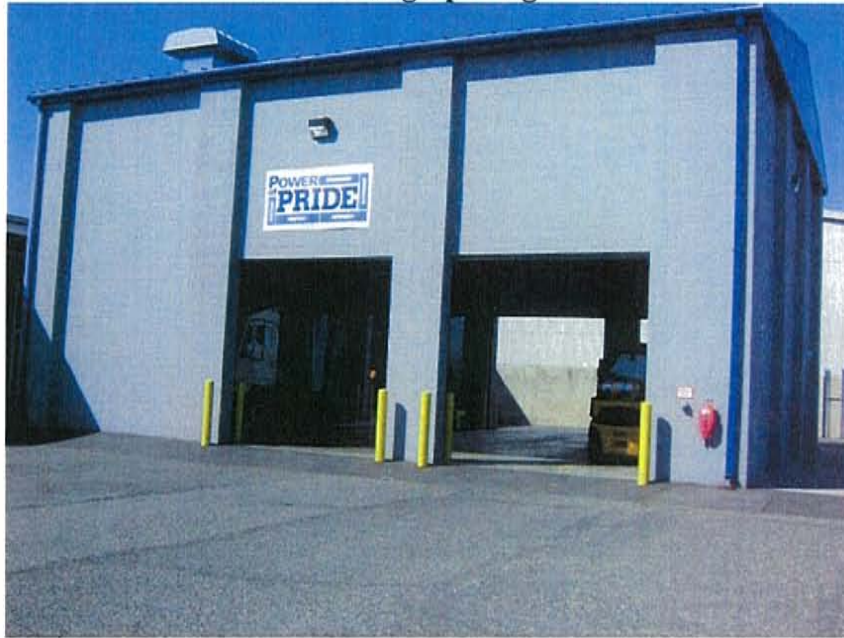
Photograph 11: View of Lowe's Distribution Center equipment maintenance shop.

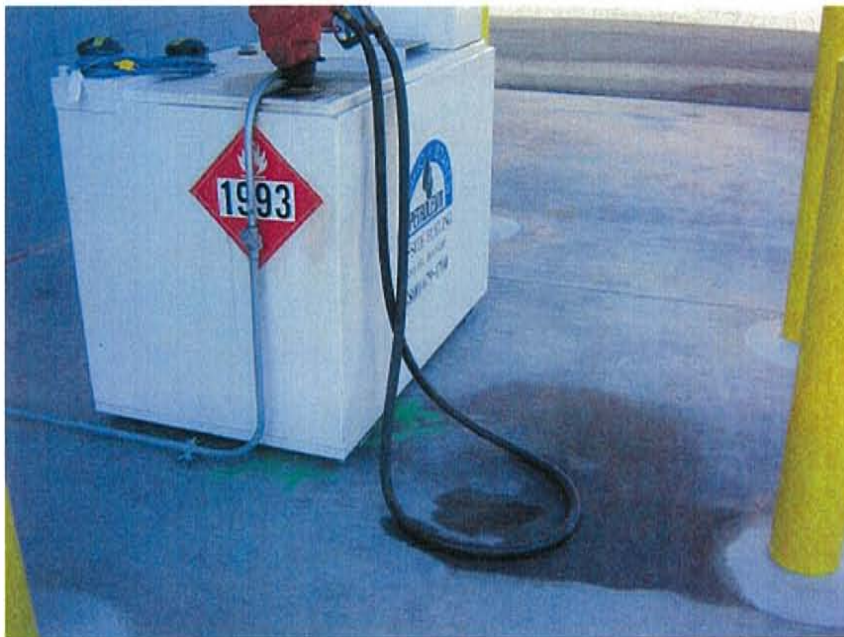
Photograph 12: View of Lowe's Distribution Center fuel storage tank located adjacent to the maintenance shop.

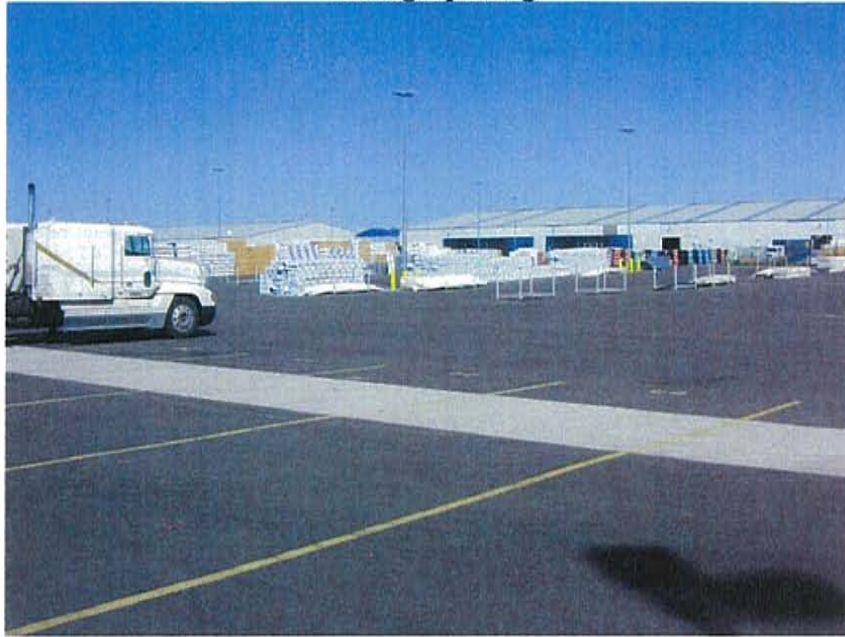
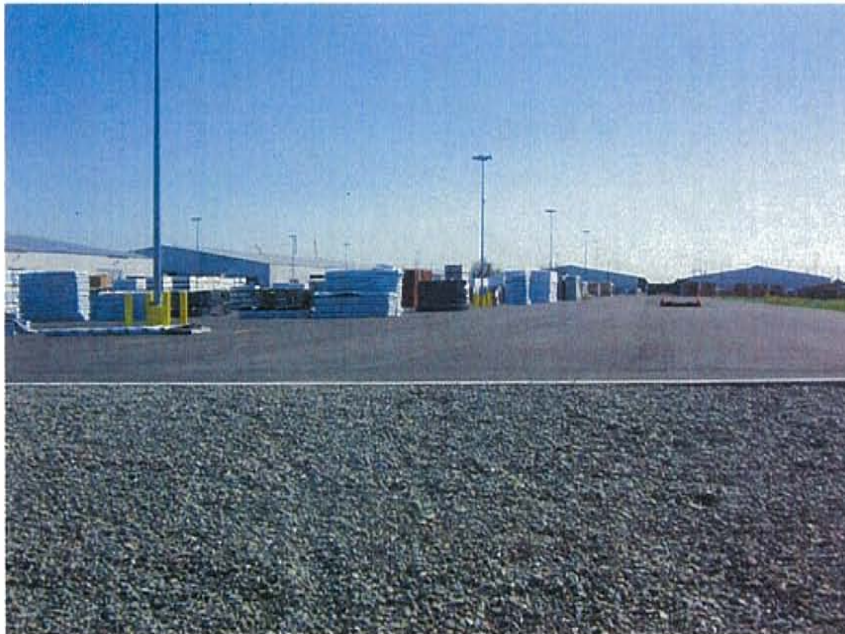
impervious parking improvements (Photographs 13 and 14). As a result, this project likely qualifies as a Priority Development Project under both the commercial and parking lot categories. Based on Port records provided during the audit, the Lowe's HIW, Inc., lease approval date (September 5, 2006) and construction start date occurred after the February 17, 2006, DSP compliance date (Exhibit 4) and therefore should have been reviewed and conditioned for compliance with the Development Standards.

Photograph 13: Impervious parking improvements at the Lowe's Distribution Center (looking north).

Photograph 14: Impervious parking improvements at the Lowe's Distribution Center (looking east).

Furthermore, the Port must ensure that all current and future Priority Development Projects are reviewed for DSP applicability and that subsequent project plans are adequately conditioned and implemented for compliance with the Development Standards. This will become increasingly imperative because of the anticipated redevelopment of the West Complex.

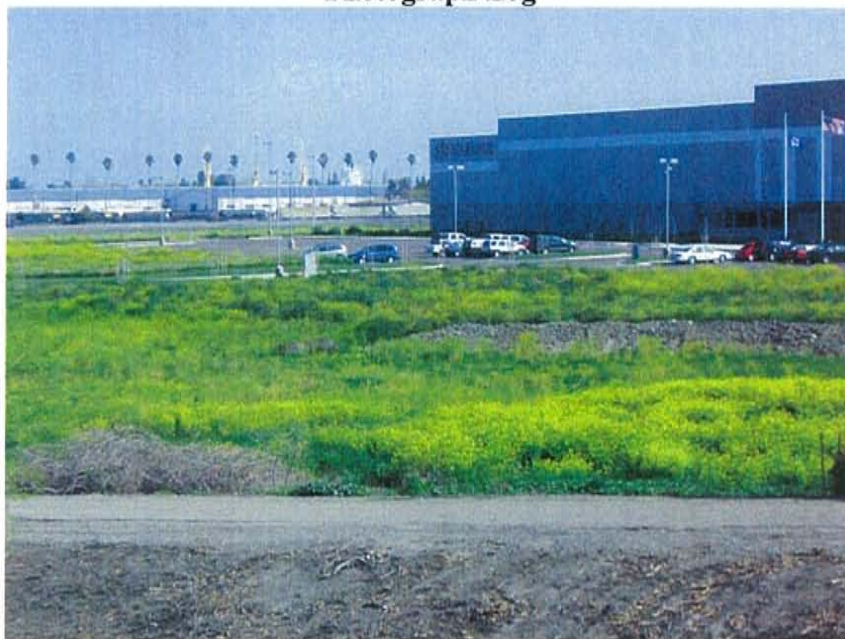
Photograph 15: Newly constructed warehouse structure and impervious parking improvements at the Ferguson Distribution Center (looking east).

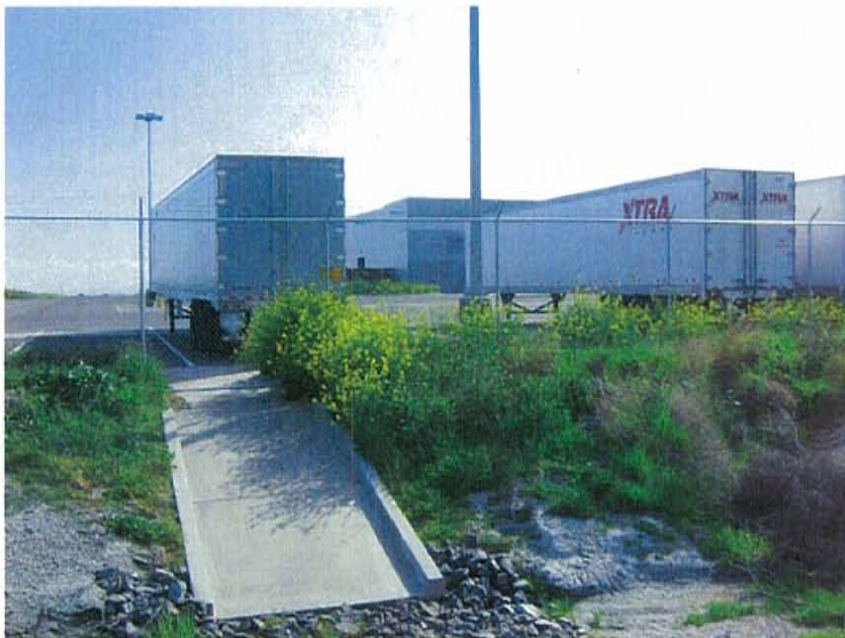
Photograph 16: Newly constructed parking improvements at the Ferguson Distribution Center (looking south).
