**City of Temecula
Municipal Separate Storm Sewer System (MS4)
Inspection Report**

City of Temecula - Municipal Separate Storm Sewer System (MS4)
(Order No. R9-2004-001)
Photograph Log
Inspected by: Scott Coulson (PG Environmental, LLC)

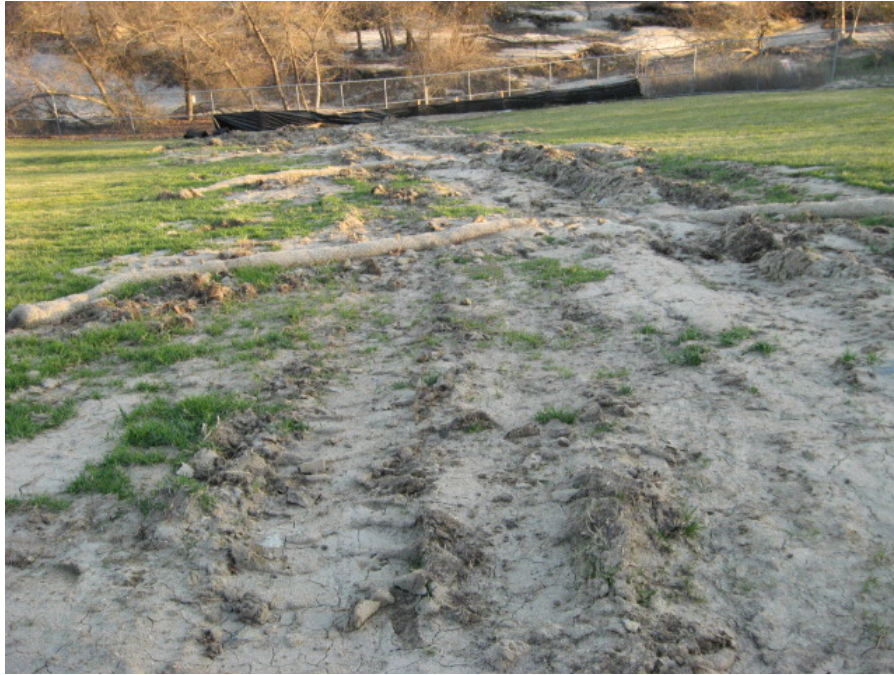
designated minimum BMPs at each construction site within its jurisdiction year round.” It was observed during the inspection that adequate BMPs were not implemented to prevent the discharge of sediment from the disturbed slope area at the northern perimeter of the site (see attached Photograph 1). Adequate BMPs were not implemented to dissipate flow velocity on the slope and the surface of the slope was not stabilized. Slope erosion was observed, including rill and gully formation at the base of the slope (see attached Photograph 2). Furthermore, evidence of a previous failure event was observed, including a section of silt fence at the base of the slope that had been undercut (see attached Photograph 3) and erosion beyond the silt fence BMP (see attached Photograph 4). As a result, there was a discharge of sediment from the disturbed slope area leading offsite toward Empire Creek. BMPs must be adequately installed, inspected, and maintained to prevent the discharge of sediment from the disturbed slope area leading offsite toward Empire Creek. Moreover, the City must ensure erosion prevention, slope stabilization, and maintenance of all source control and treatment control BMPs at the YMCA project site.

Photograph 1: View of the disturbed slope area at the northern perimeter of the YMCA site

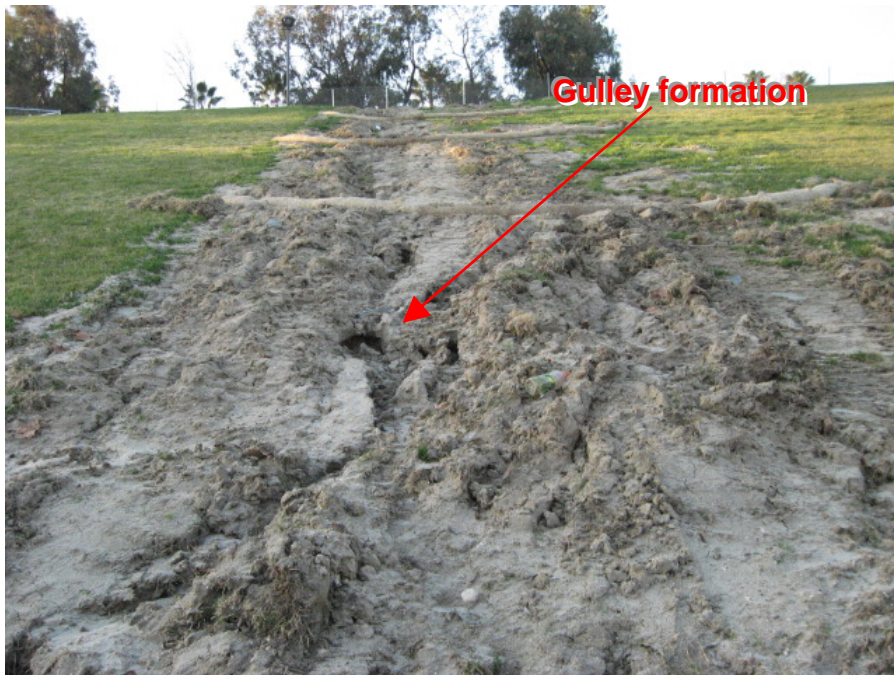
Photograph 2: Slope erosion was observed, including rill and gulley formation at the base of the slope

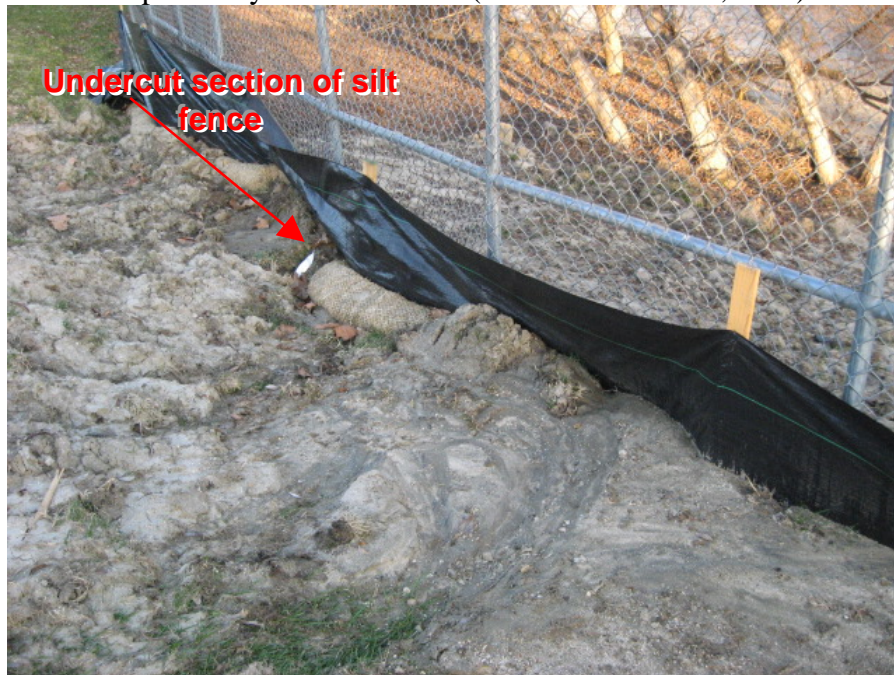
Photograph 3: A section of silt fence at the base of the slope had been undercut by a previous flow event

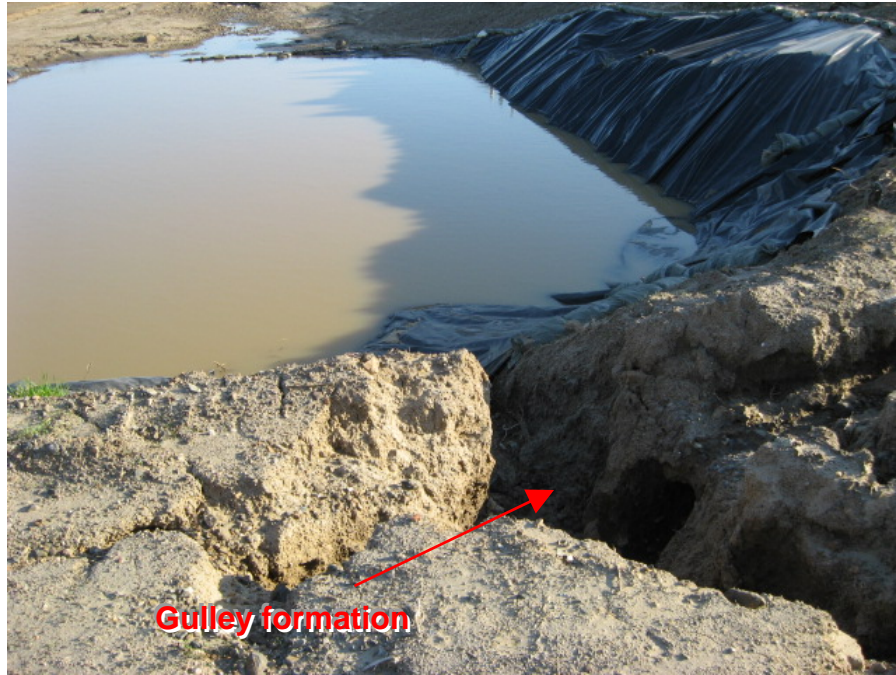
Photograph 5: Sediment laden water in the structural control and gulley erosion present at the inlet area

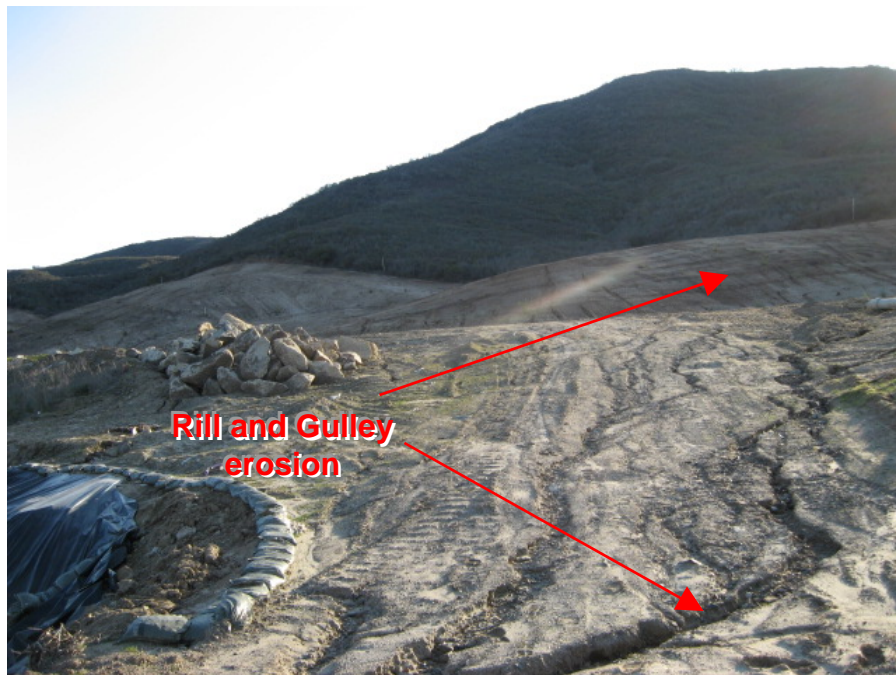
Photograph 6: Rill and gulley formations on the disturbed slope leading to the sediment trap BMP

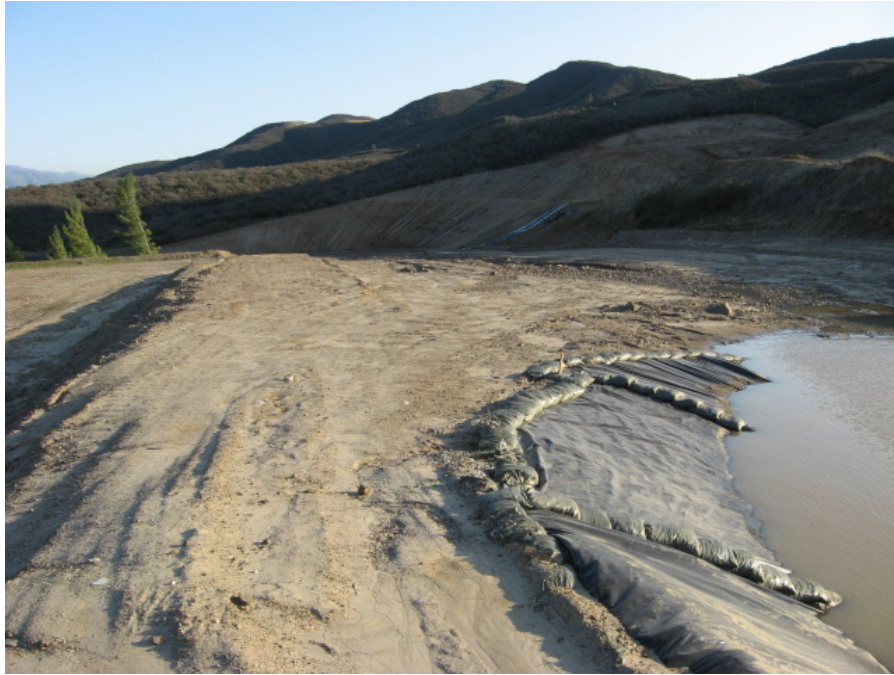
Photograph 7: A large area of exposed soil was observed down-gradient of the sediment trap BMP

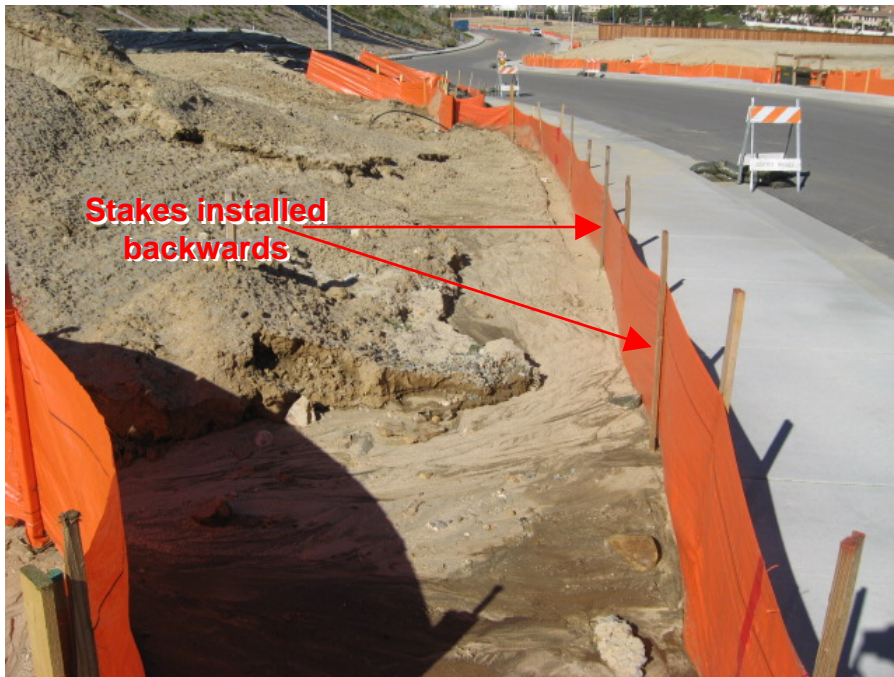
Photograph 8: The silt fence was not installed on the contour and stakes were incorrectly positioned on the up-gradient side of the silt fence

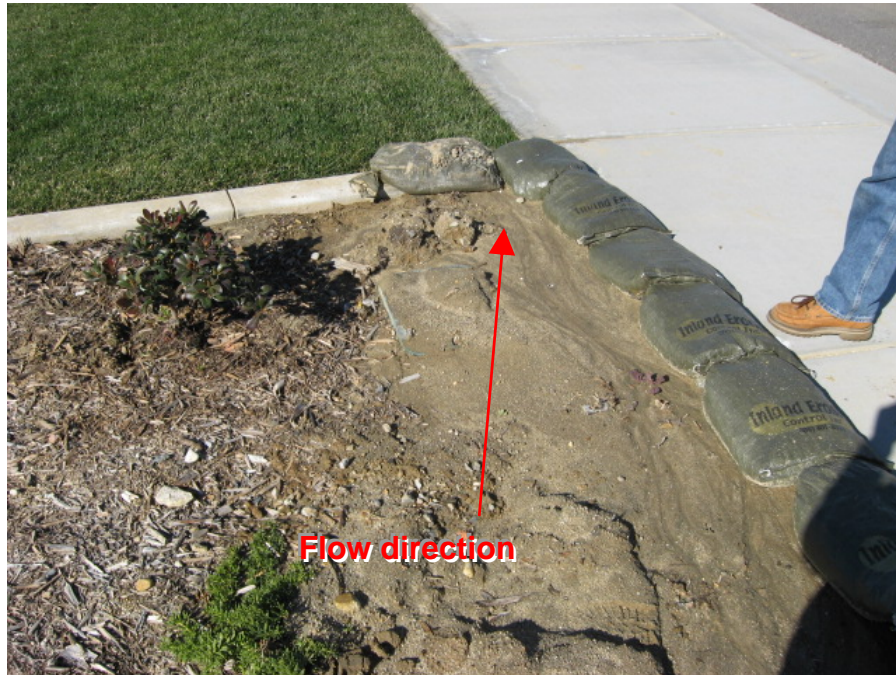
Photograph 9: Sediment accumulated in the down-gradient landscaping

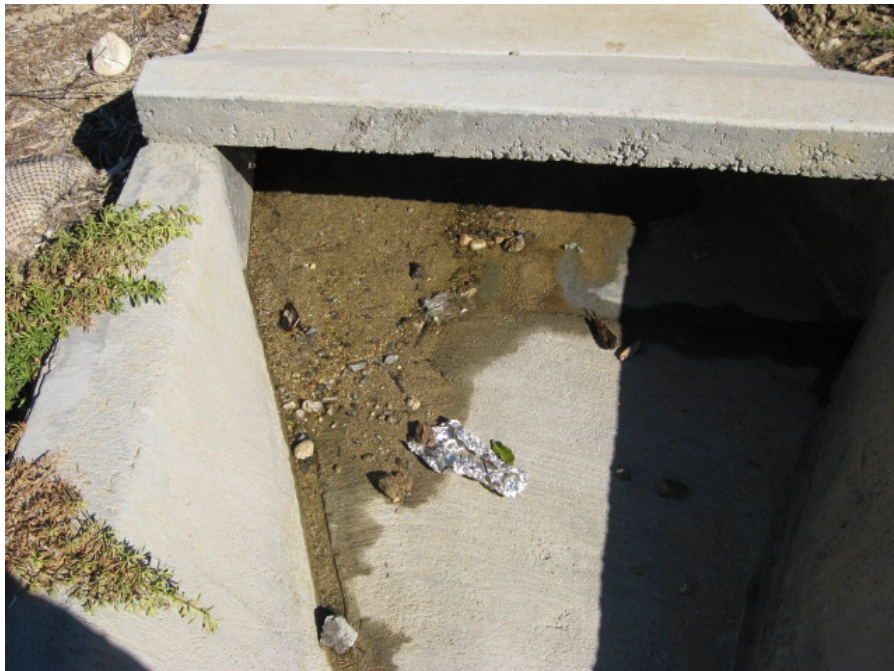
Photograph 10: Sediment accumulated in the drainage conveyance located down-gradient of Photographs 8 and 9

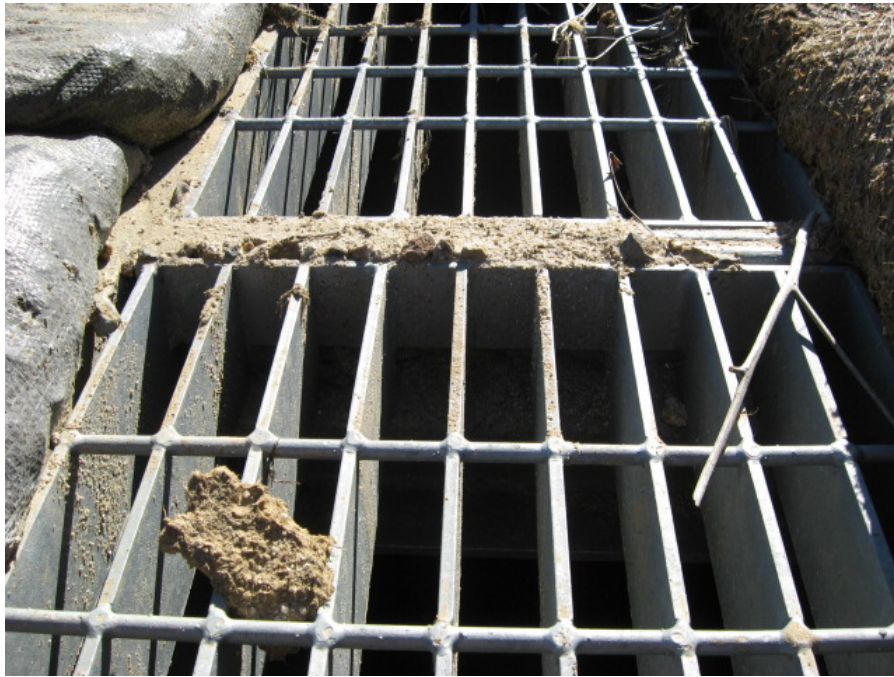
Photograph 11: Evidence of a previous failure event was observed, including sediment that had been discharged to a down-gradient storm drain inlet

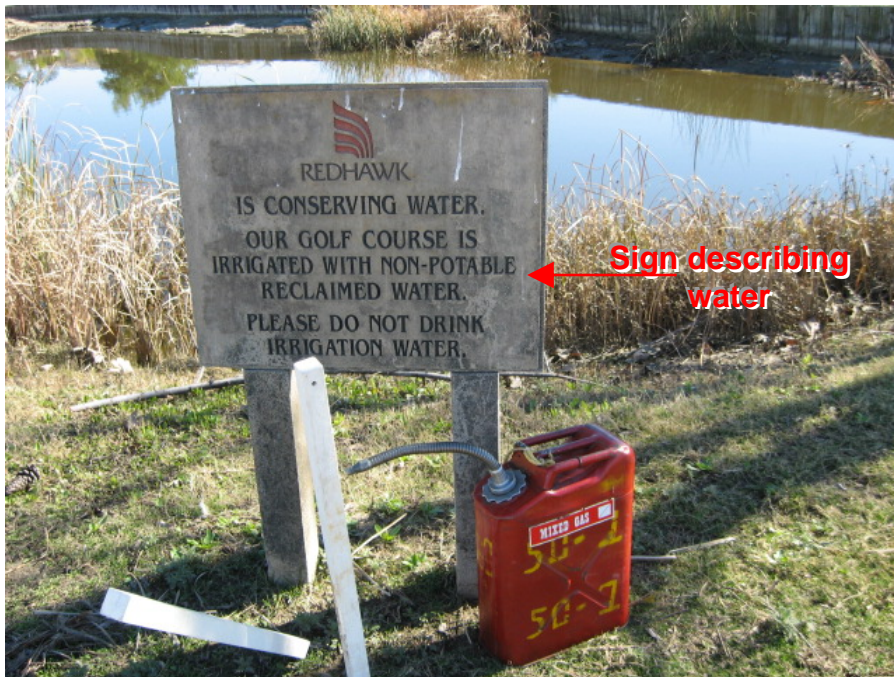
10. Regional Water Board Order No. R9-2004-001, Requirement B.1, requires the City to “effectively prohibit all types of non-storm water discharges into its MS4 unless such discharges are either authorized by a separate NPDES permit; or are authorized in accordance with Requirements B.2 and B.3 [of the Order].” It was observed during the inspection that pond draining activities were actively causing an unauthorized non-storm water discharge to a drainage inlet located southwest of the pond. The water drained from the golf course irrigation pond was from a non-potable reclaimed water source (see attached Photograph 12), and potentially contained high levels of nutrients, pesticides, and other pollutants. Actively operating pumps (see attached Photograph 13) were discharging the reclaimed water across a grass drainage swale (see attached Photograph 14) to a storm drain inlet leading to the Pechanga Parkway Drainage Channel. As provided by Mr. Ben Neill (Water Resource Control Engineer, Regional Water Board), this discharge was not authorized by a separate NPDES permit. As a result, there was an illicit non-storm water discharge to the storm drain

Photograph 12: The water drained from the golf course irrigation pond was from a non-potable reclaimed water source

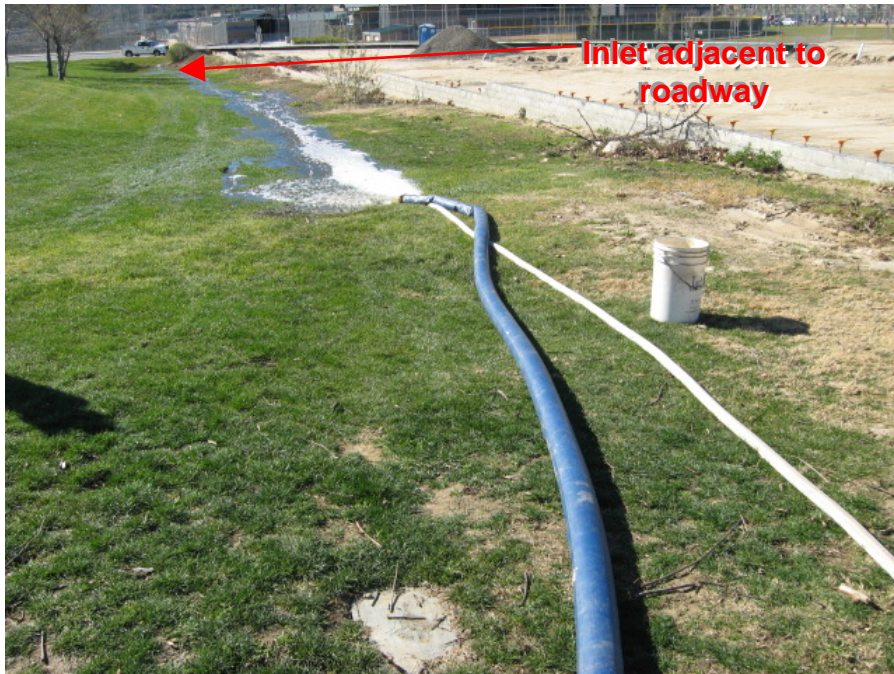
Photograph 14: Non-potable reclaimed water was pumped to a grass drainage swale and subsequent storm drain inlet leading to the Pechanga Parkway Drainage Channel

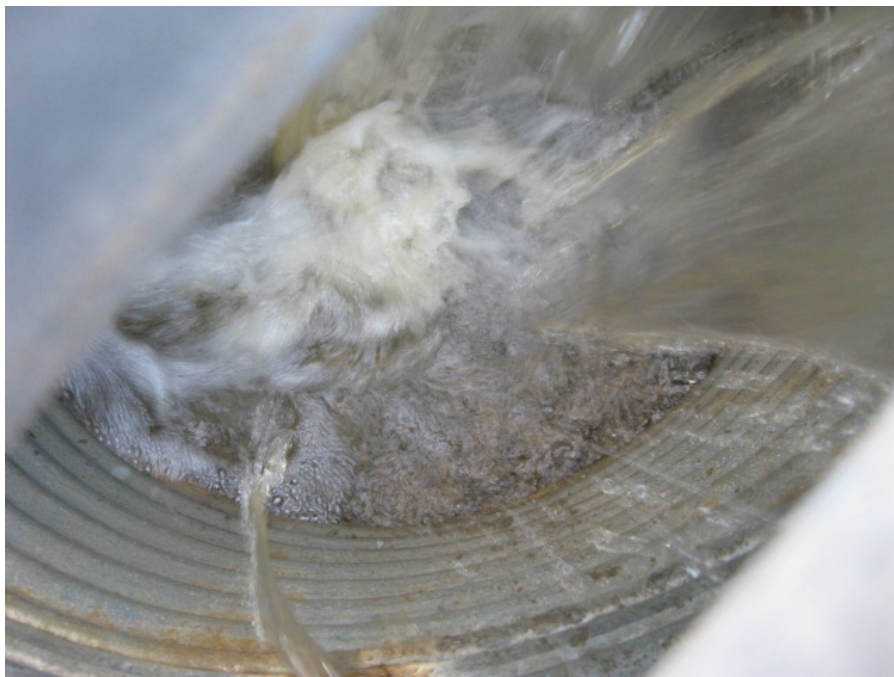
and subsequent Pechanga Parkway Drainage Channel (see attached Photographs 15 and 16). The Temecula Municipal Code, Chapter 8.28, Section 200, Prohibited discharges, does not clearly prohibit this type of non-storm water discharge into the City's MS4 (see attached Exhibit 3). In addition, a fuel can filled with gasoline was stored outdoors where it could be exposed to storm water contact (see attached Photograph 12). The City must effectively prohibit all types of illicit non-storm water discharges into its MS4. Furthermore, the City's Illicit Discharge Detection and Elimination Program must be designed to emphasize frequent, geographically widespread inspections, monitoring, and follow-up investigations to detect illicit discharges such as the non-storm water discharge described above.

Photograph 16: View inside storm drain inlet leading to the Pechanga Parkway Drainage Channel
