UNITED STATES ENVIRONMENTAL PROTECTION AGENCY
REGION IX
75 Hawthorne Street
San Francisco, CA 94105-3901

Enclosed is the U.S. Environmental Protection Agency's (EPA) report of the Nevada Department on the Transportation (NDOT) Storm Water Management Program (Program) Audit. Representatives from EPA Region 9 and the Nevada Department of Environmental Protection (NDEP) conducted the Audit from August 9 – 12, 2011.

MS4 Audit Report

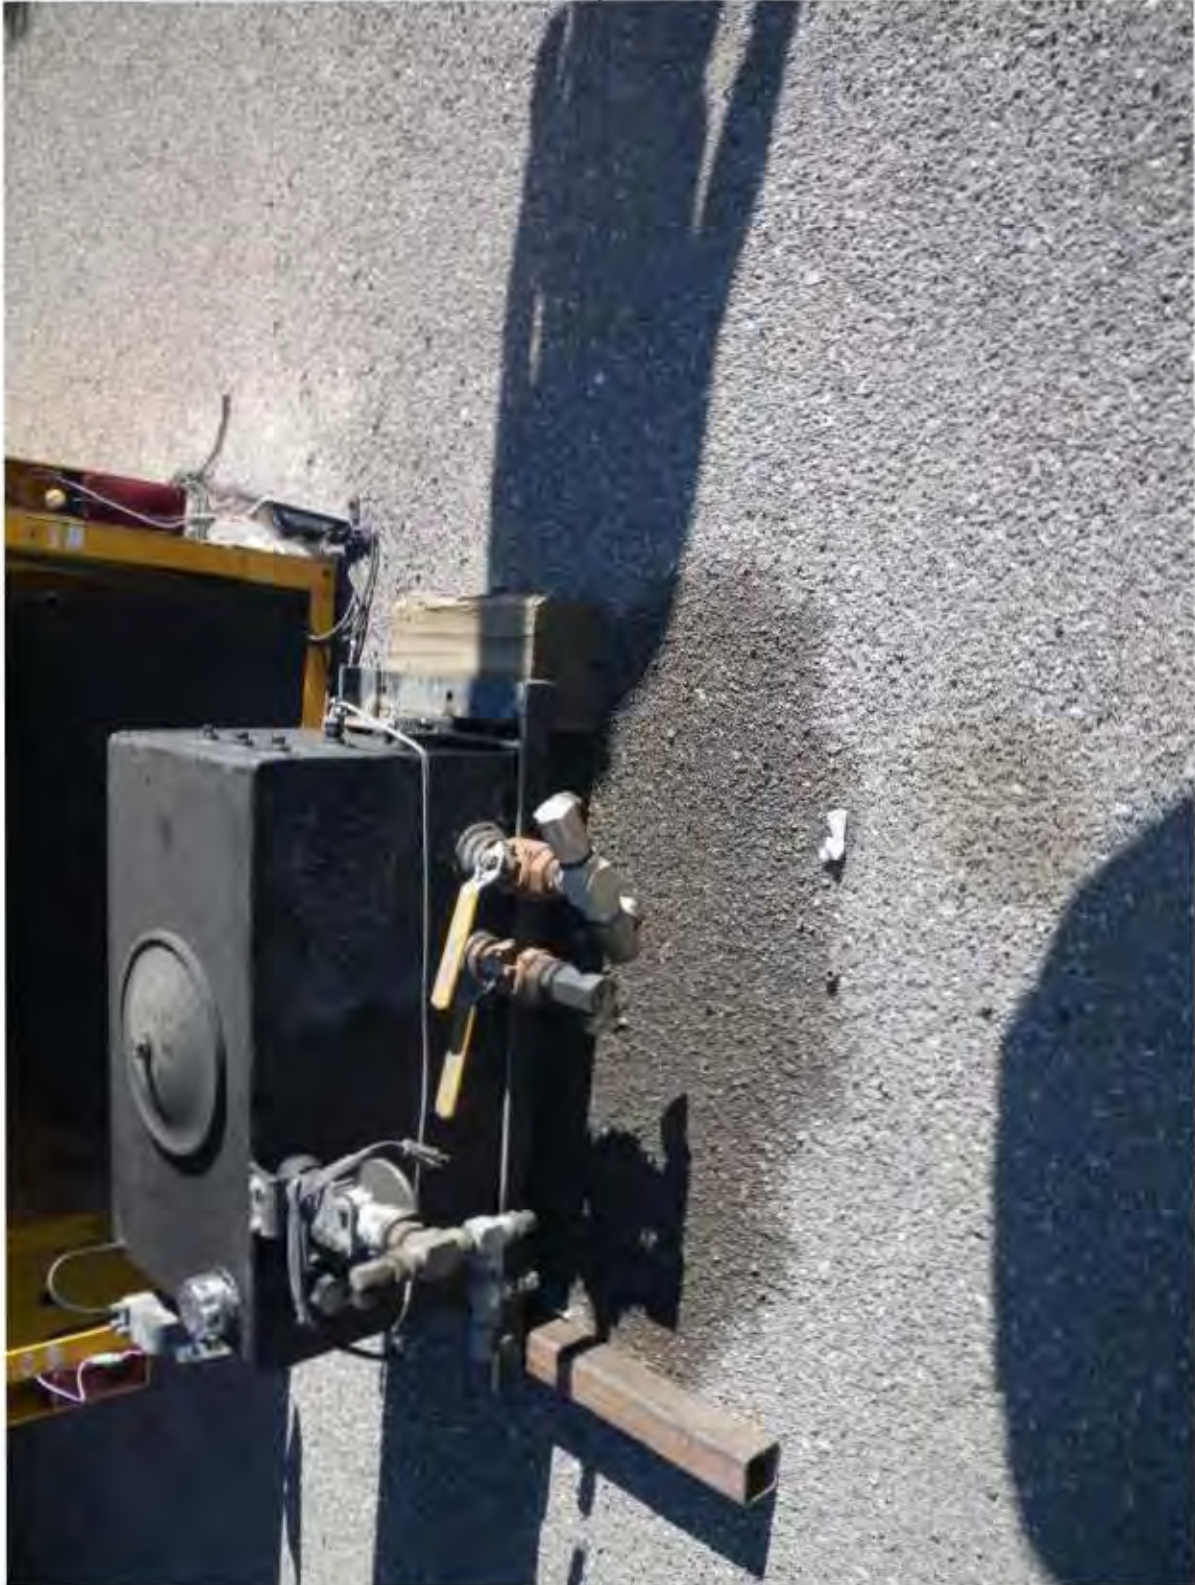
IMGP0579.JPG

IMGP0579 – Accumulated salt residue at the discharge nozzle for the brine system, blistering paint and rust on the sand spreading chute.

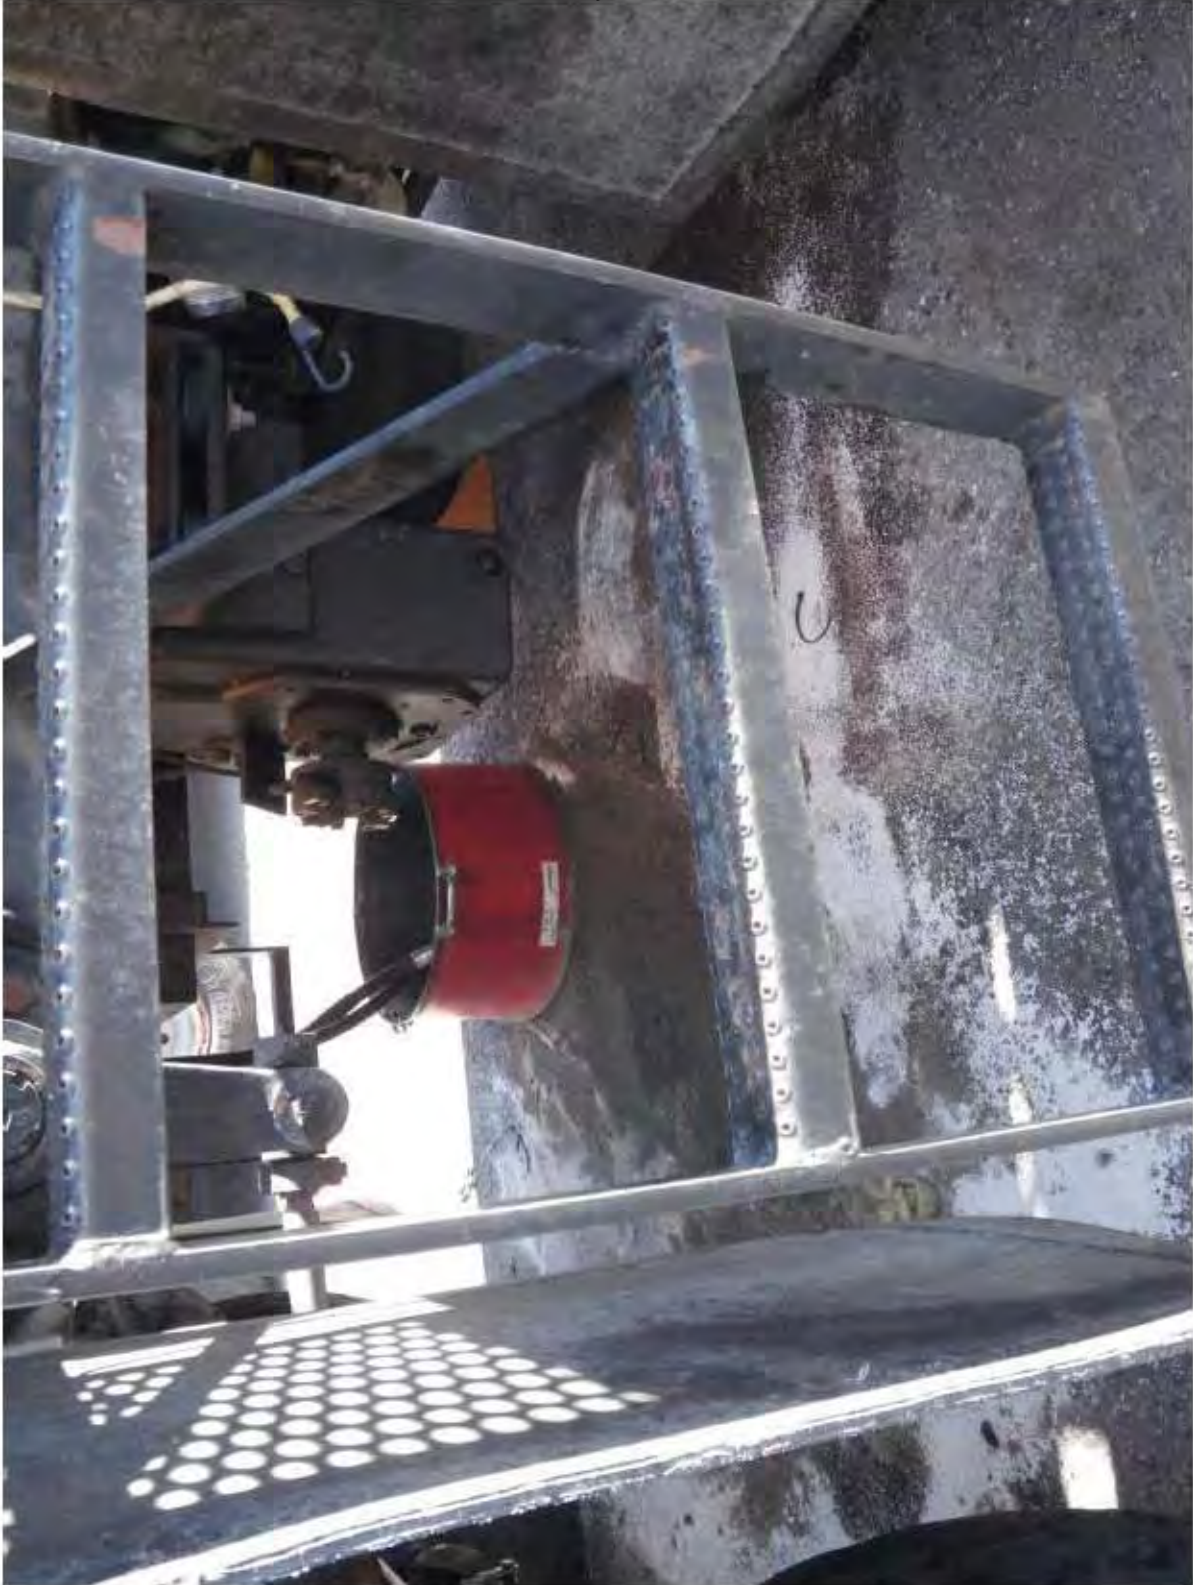
IMGP0580.JPG

IMGP0580 – Presumed hydraulic oil tank, with underlying staining presumed from the depicted tank.

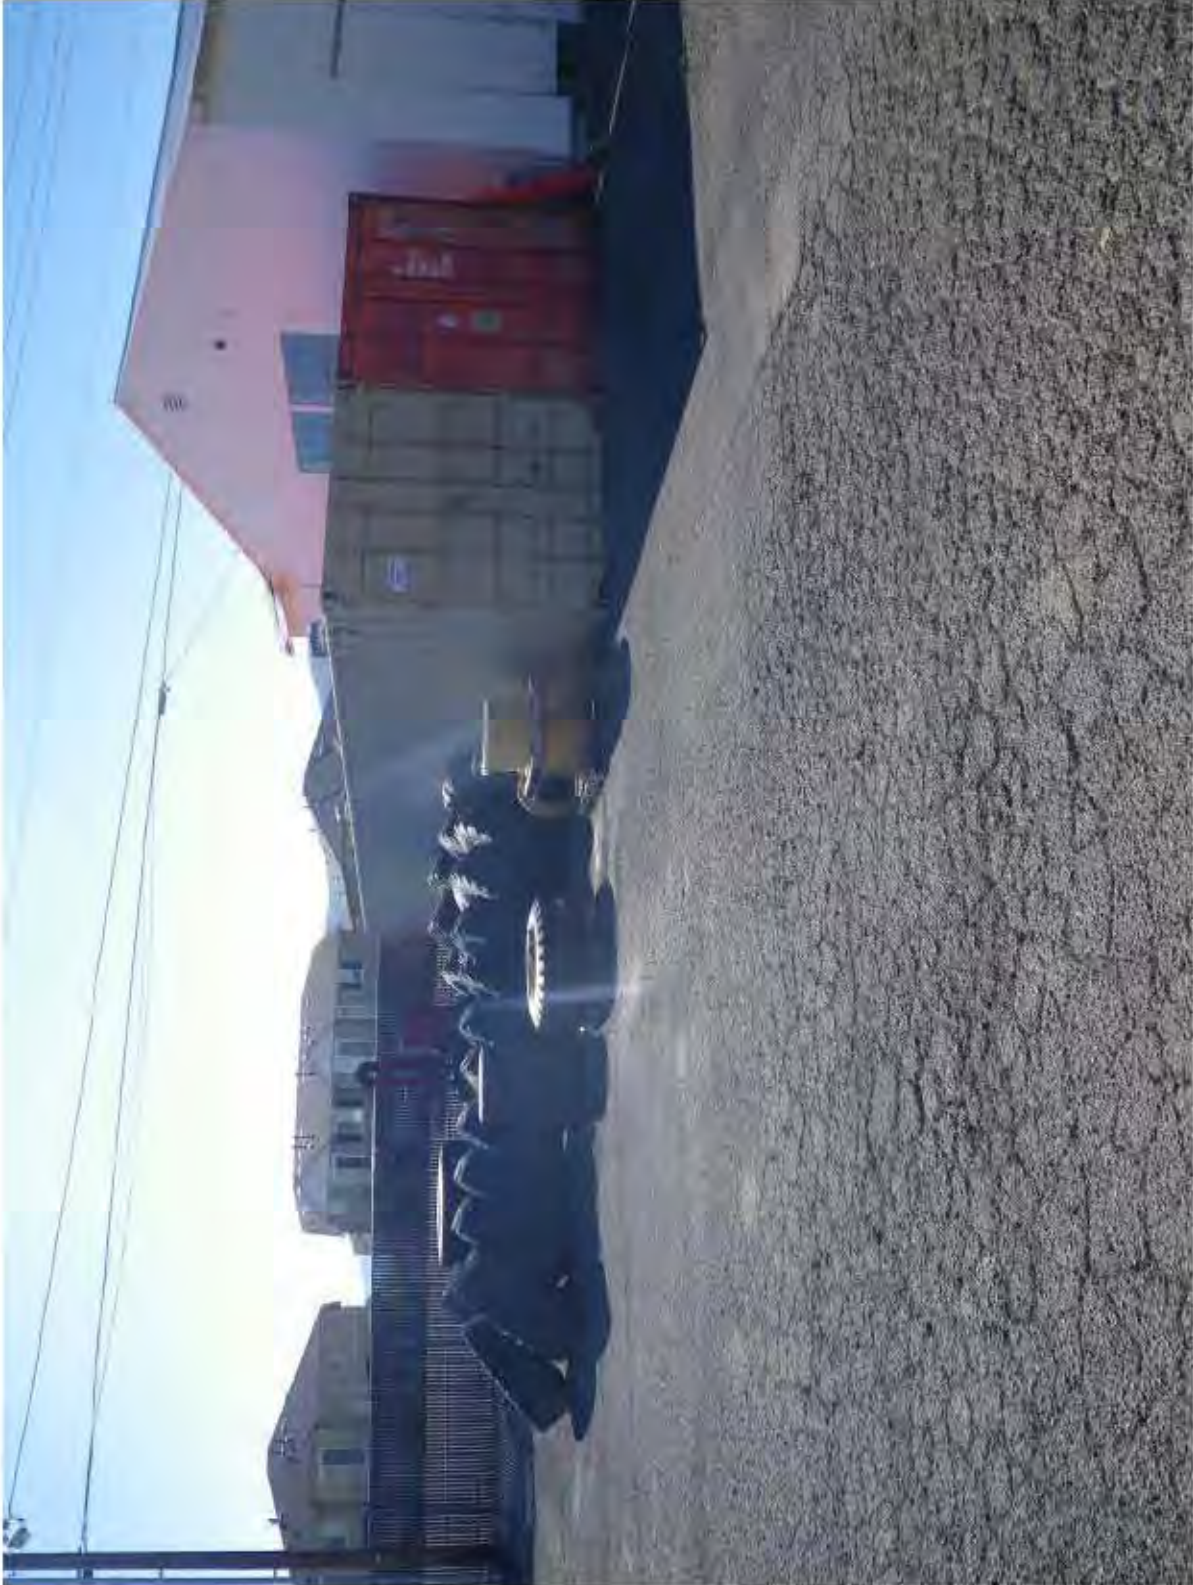
IMG0587.JPG

IMGP0587 – Uncovered empty-barrel storage area with staining on the ground.

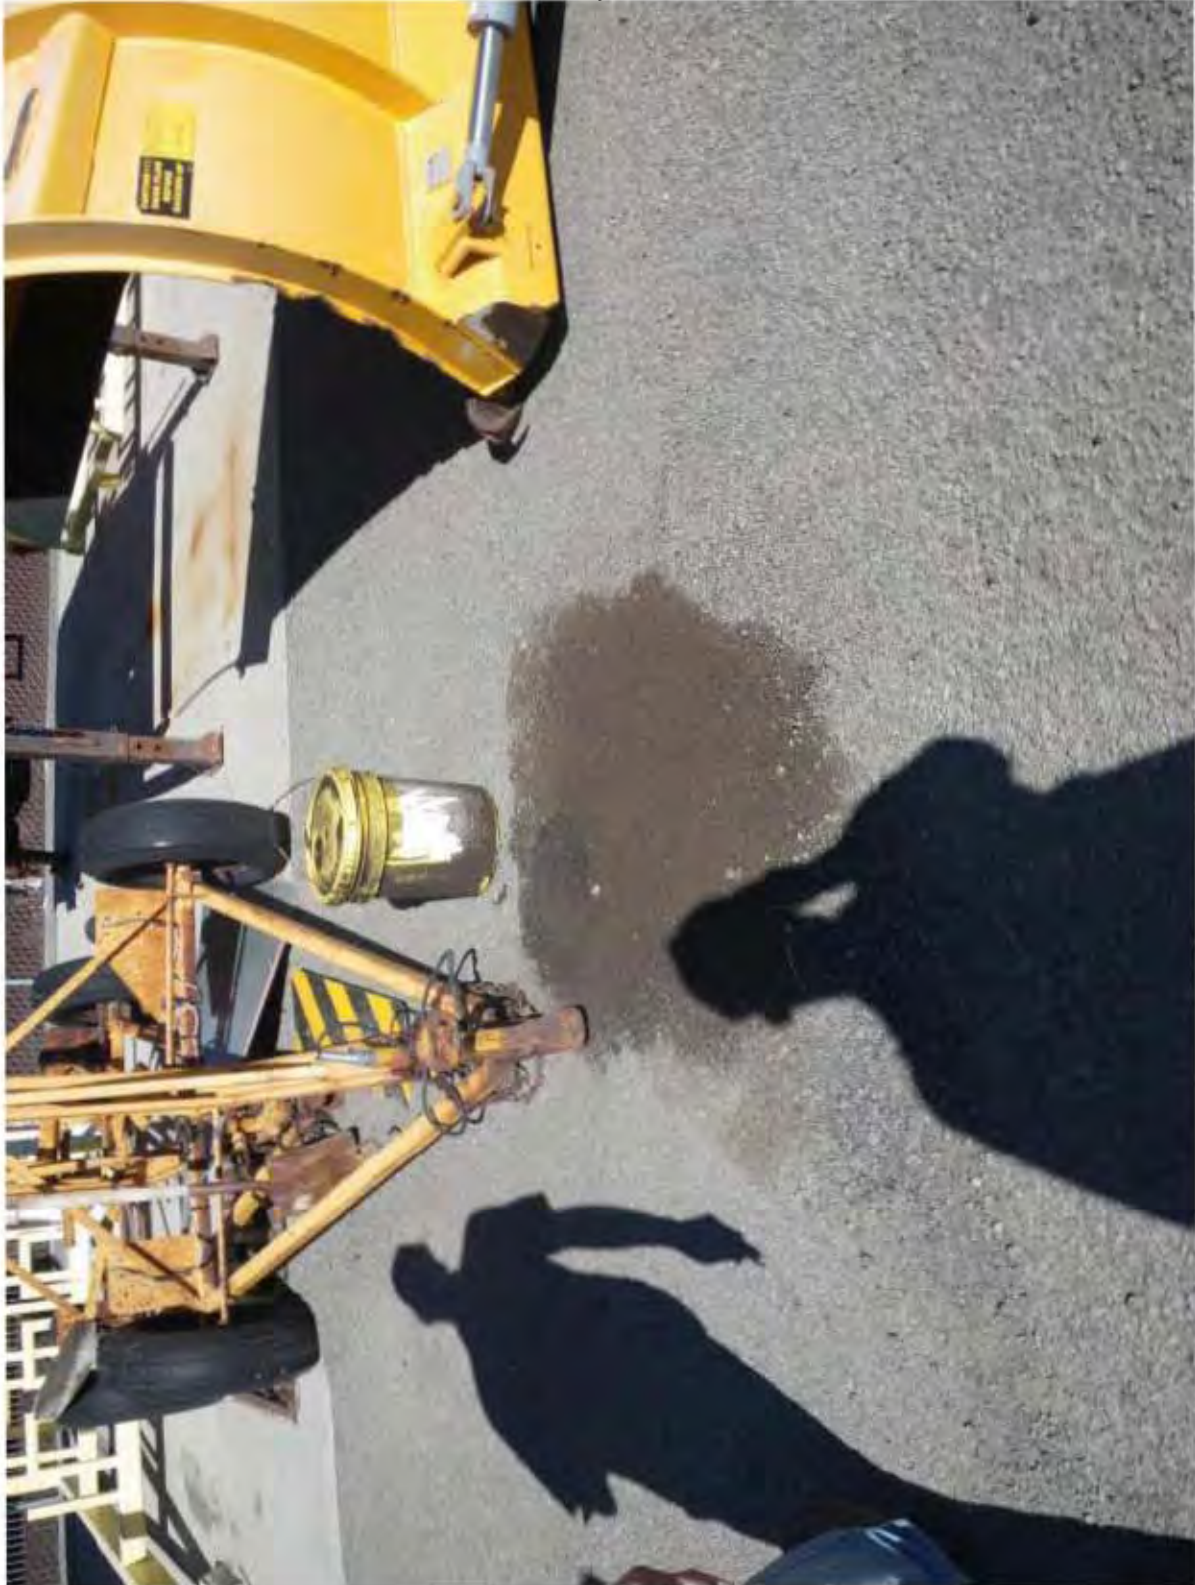
IMGP0602.JPG

IMGP0602 – The only rig with hydraulic lines tucked away, and the only rig with no oil staining at the front of the rig. The other rigs down the line had hanging hydraulic lines and had oil staining underneath.

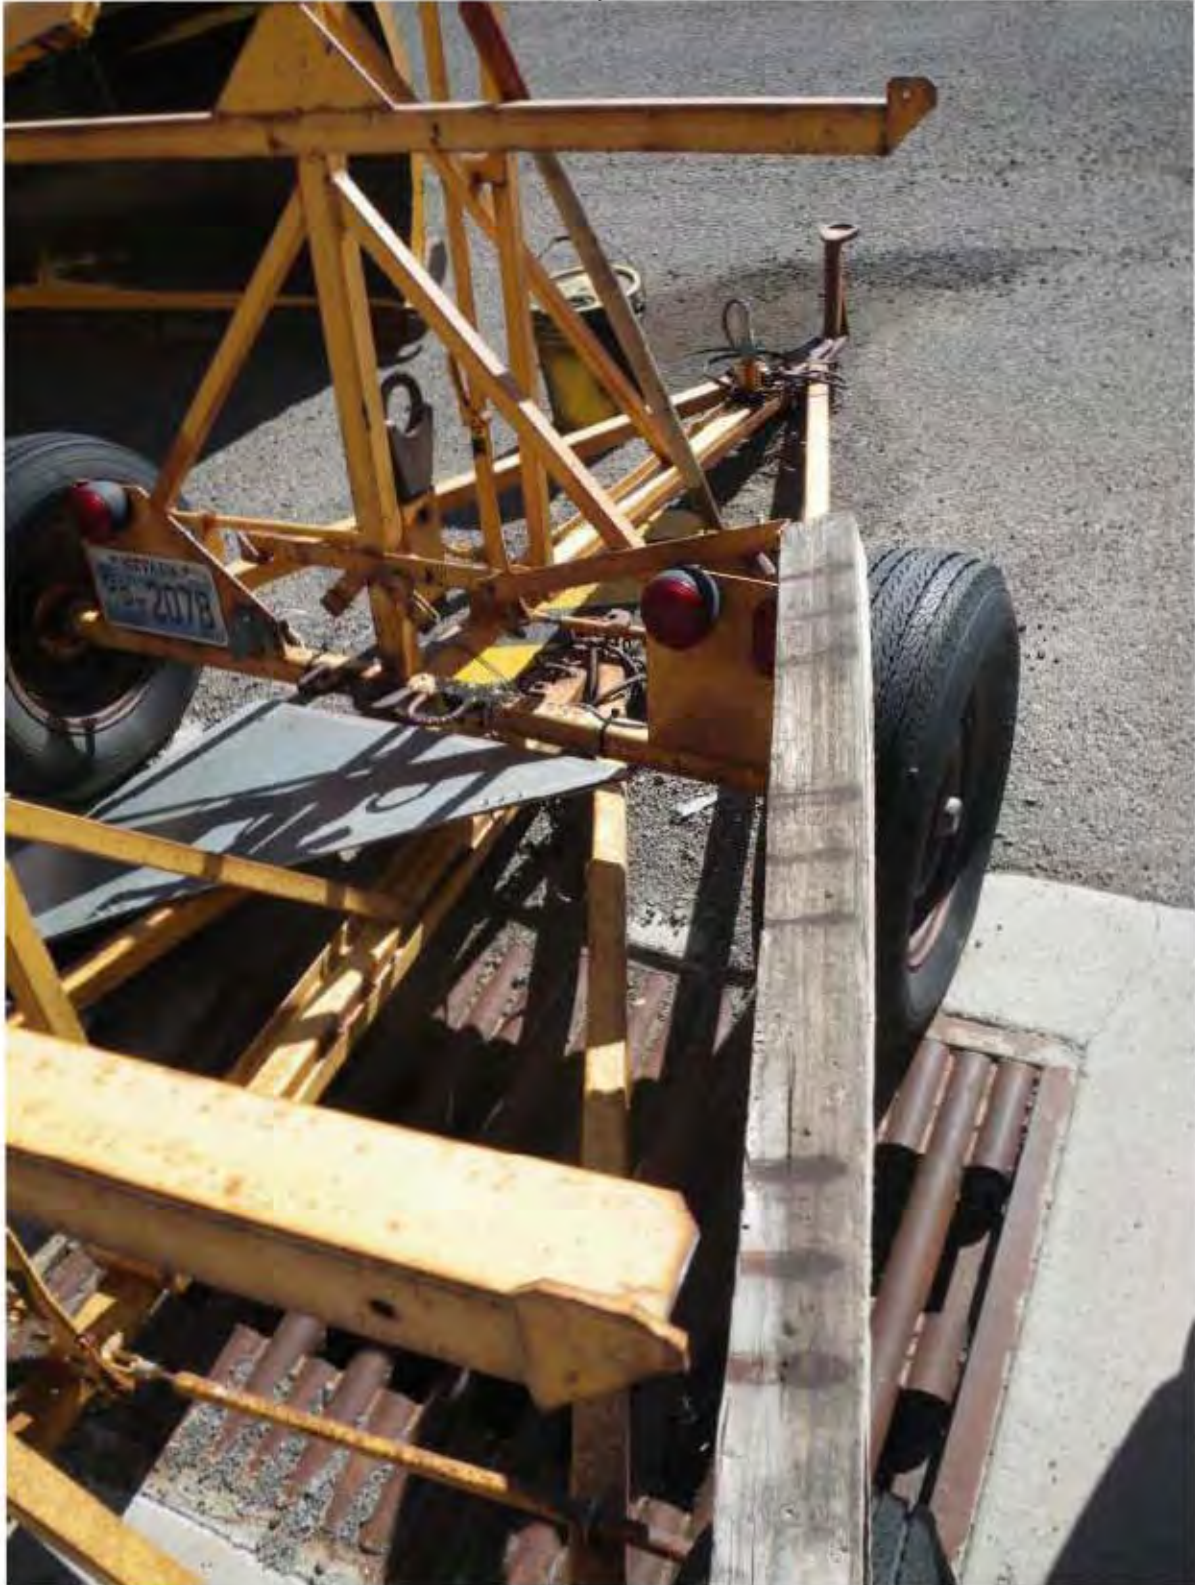
IMGP0603.JPG

IMGP0603 – Bucket of ‘Tractor Oil’ with oil staining in the foreground. Trailers to the left of the bucket are situated over a drop inlet where flowing water has heard.

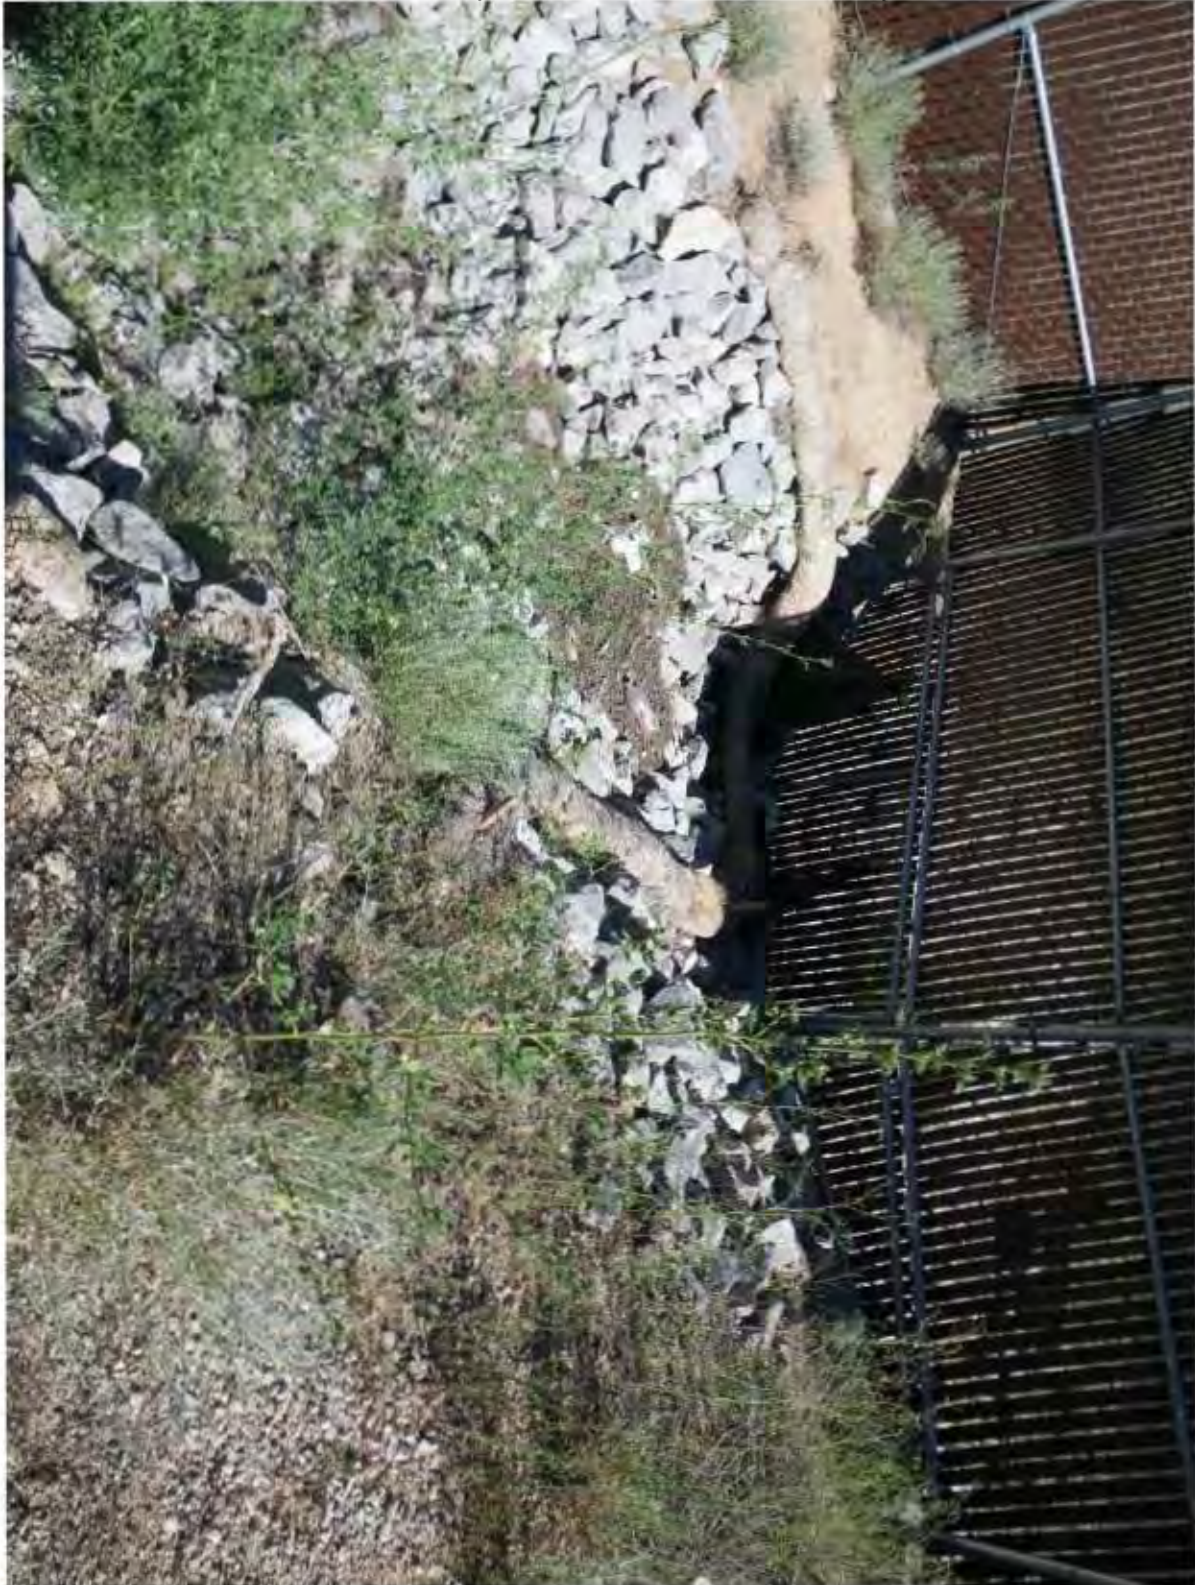
IMGP0643.JPG

IMG0643 – The outfall culvert discharges into a rock-lined drainage channel. Accumulated sediment was observed in the channel resulting from opening the outfall gate during heavy runoff that was causing the pond to over-top its berm.
