**Appendix A**  
**Storm Water Management Plan: Comments from NDEP and Co-Permittee Response**

## Storm Water Management Plan: Comments from NDEP and Co-Permittee Response

**Appendix B**  
**Clark County**

**Appendix B.1**  
**Documentation of Findings**

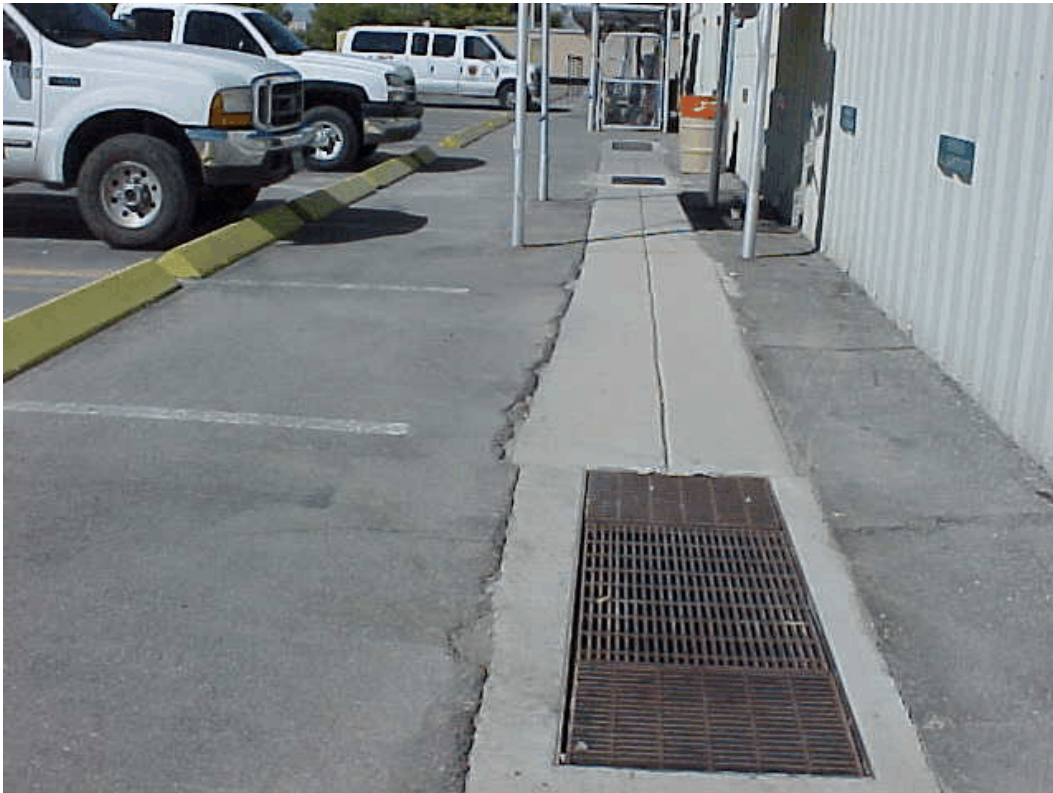
**Photo 1.** Fleet (primary) facility: Unprotected storm water inlets at north edge of parking area.

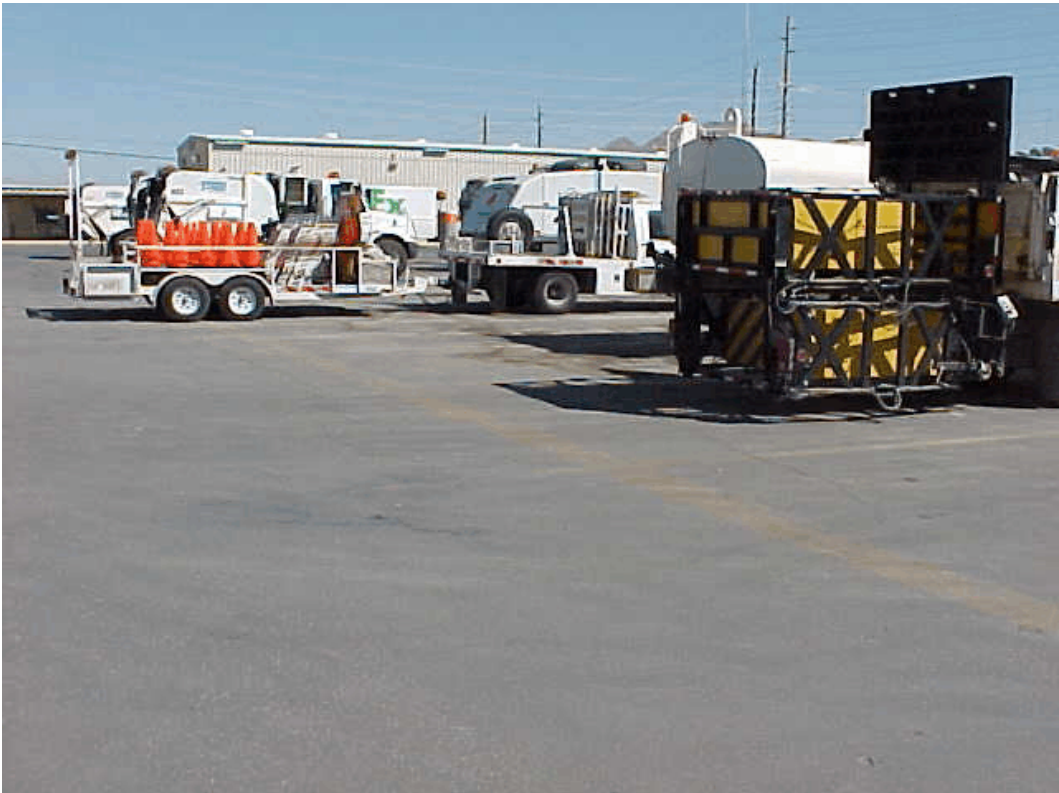
8. The Fleet facility had numerous locations with pavement staining due to petroleum product spills/leakage from parked vehicles.
9. The Vector Control facility had cut open 55-gallon drums of biological larvicide and spilled residue to the pavement.

**Photo 7.** Fleet (primary) facility: Truck parking area with spills/leakage staining on pavement.

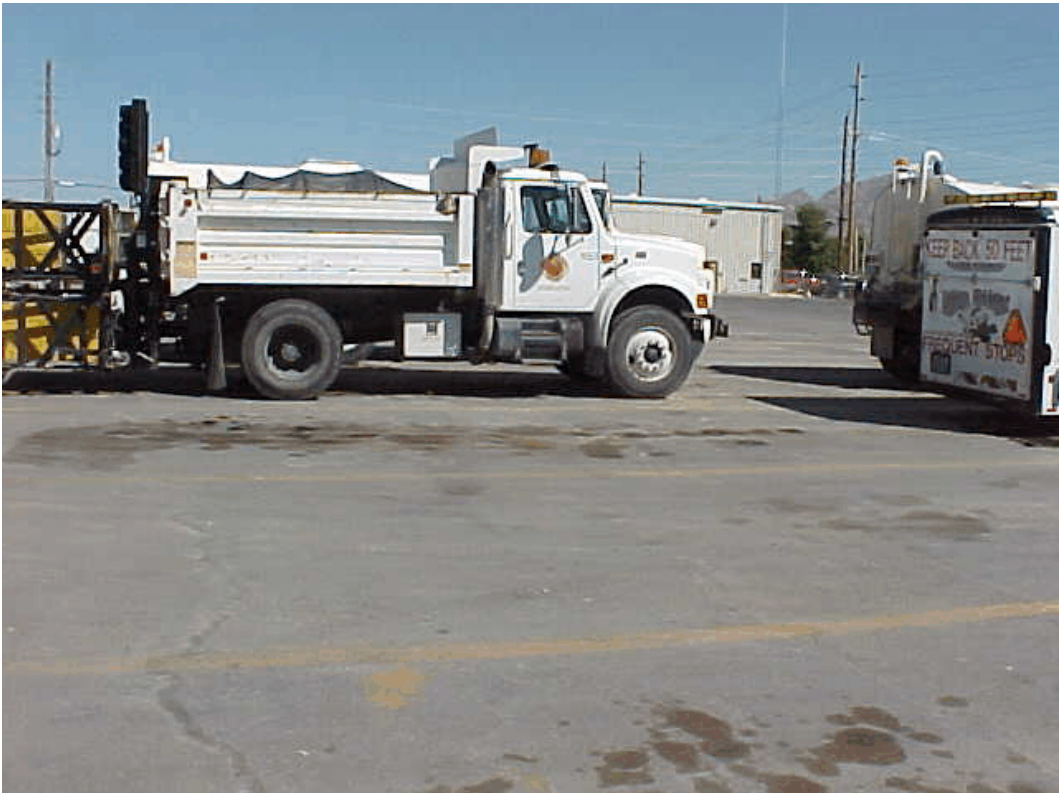
**Photo 8.** Fleet (primary) facility: Truck parking area with spills/leakage staining on pavement.

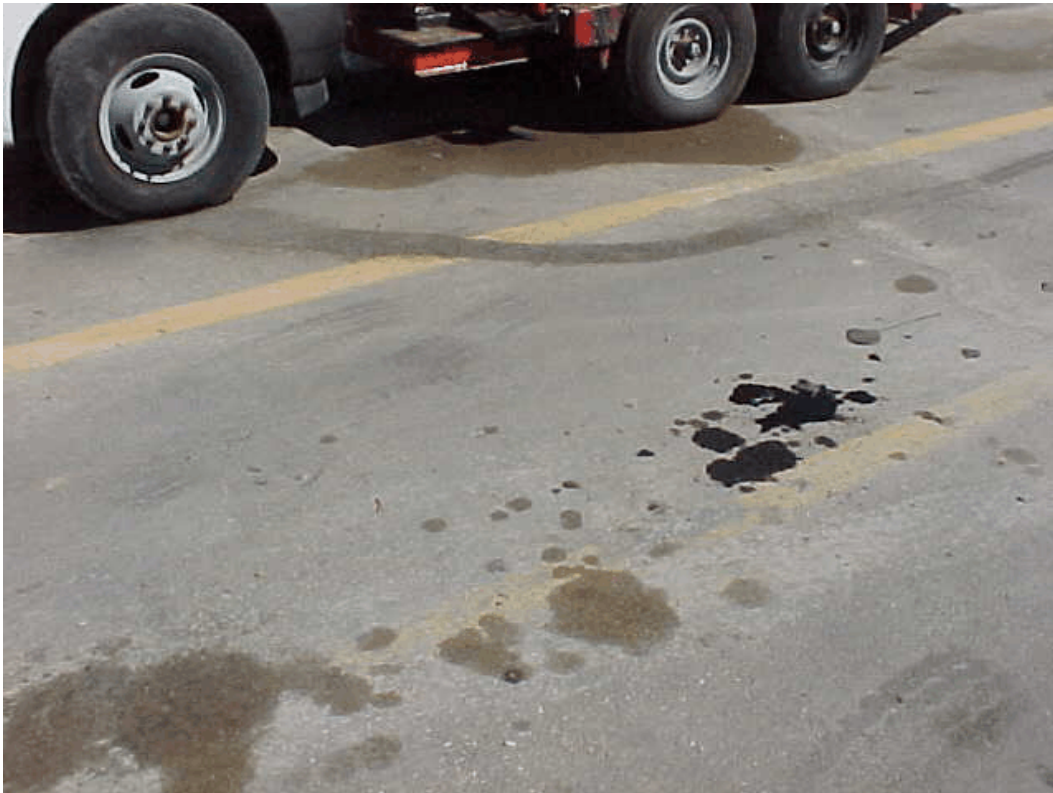
**Photo 9.** Fleet (primary) facility: Truck parking area with spills/leakage staining on pavement.

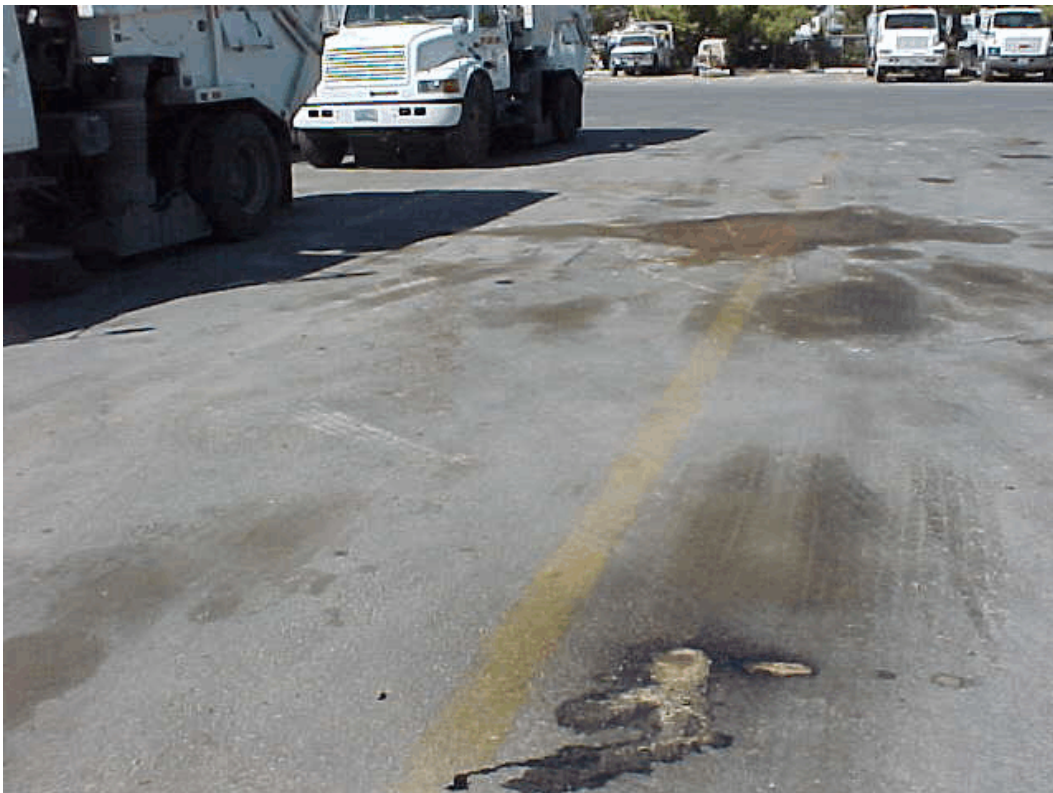
**Photo 10.** Fleet (primary) facility: Truck parking area with spills/leakage staining on pavement.

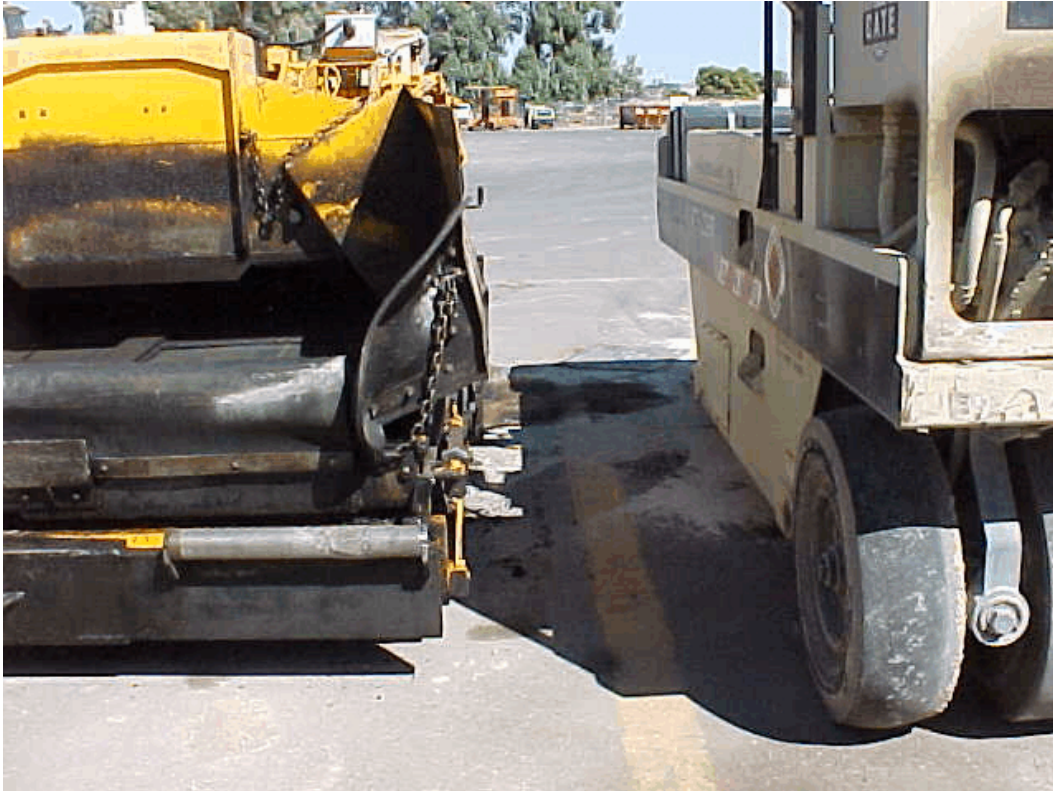
5. The secondary Fleet facility parking lot petroleum product pavement staining was upslope from offsite locations at the southern property boundary. The petroleum product would be carried in storm water runoff from the pavement.
6. The spilled residue biological larvicide was in a uncontained, uncovered area of pavement at the Vector Control facility. Storm water runoff would potentially carry the larvicide off site.
7. The Traffic facility had chemical containers that were uncontained and exposed to rain and rupture from vehicle accident. Storm water would carry any spillage that might occur.

**Photo 11.** Fleet (secondary) facility: Truck and paving equipment parking area with spills/leakage staining on pavement.

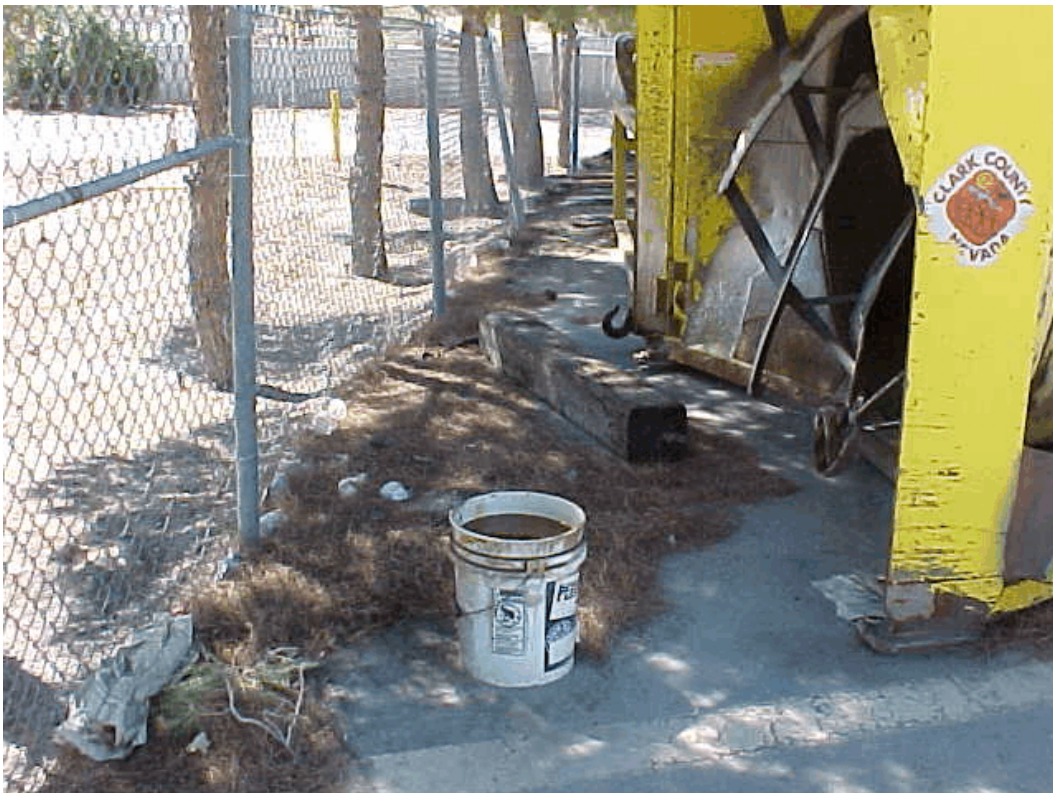
**Photo 12.** Fleet (secondary) facility: Open 5-gallon pail of oily water in truck and paving equipment parking area.

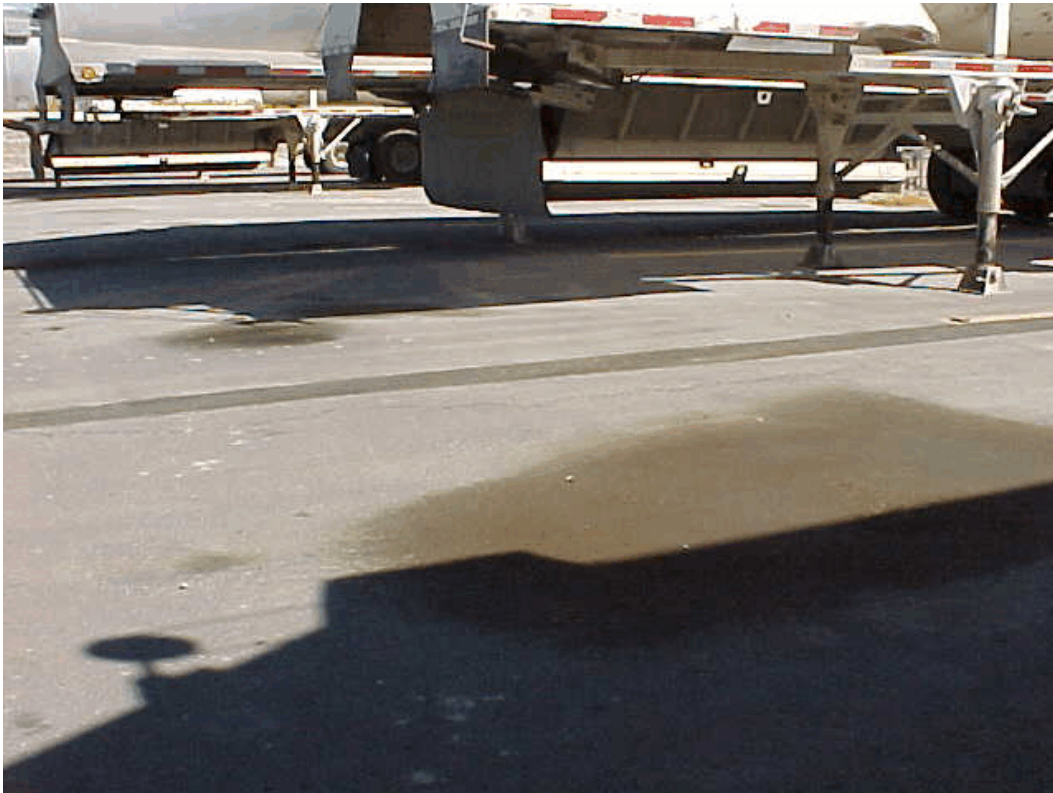
**Photo 13.** Fleet (secondary) facility: Truck and paving equipment parking area with spills/leakage staining on pavement.

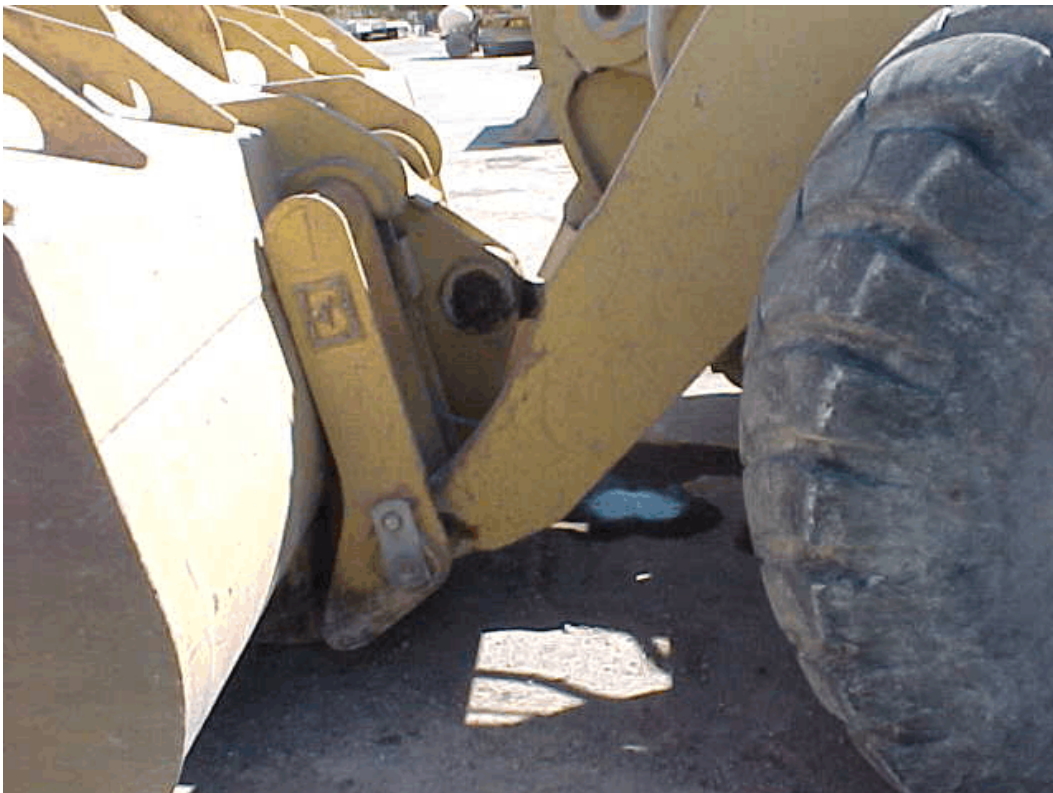
**Photo 14.** Fleet (secondary) facility: Front loader with an active leak.

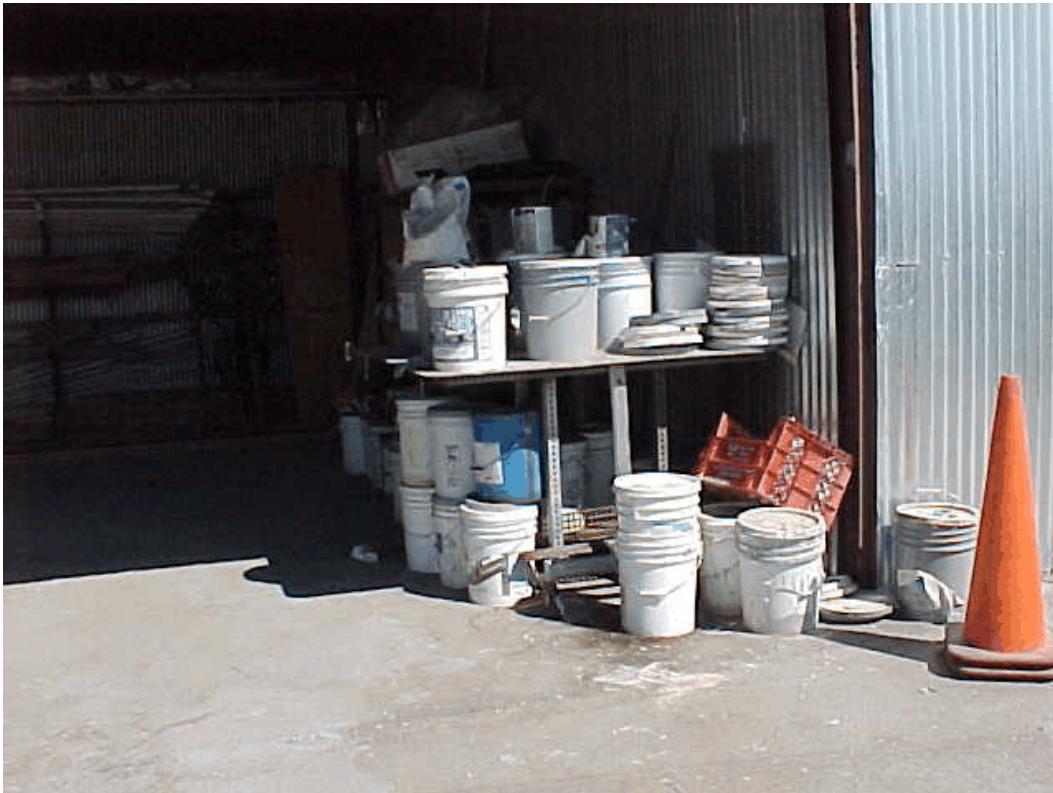
**Photo 15.** Fleet (secondary) facility: Full and partially full 5-gallon pails of stucco and form oil.

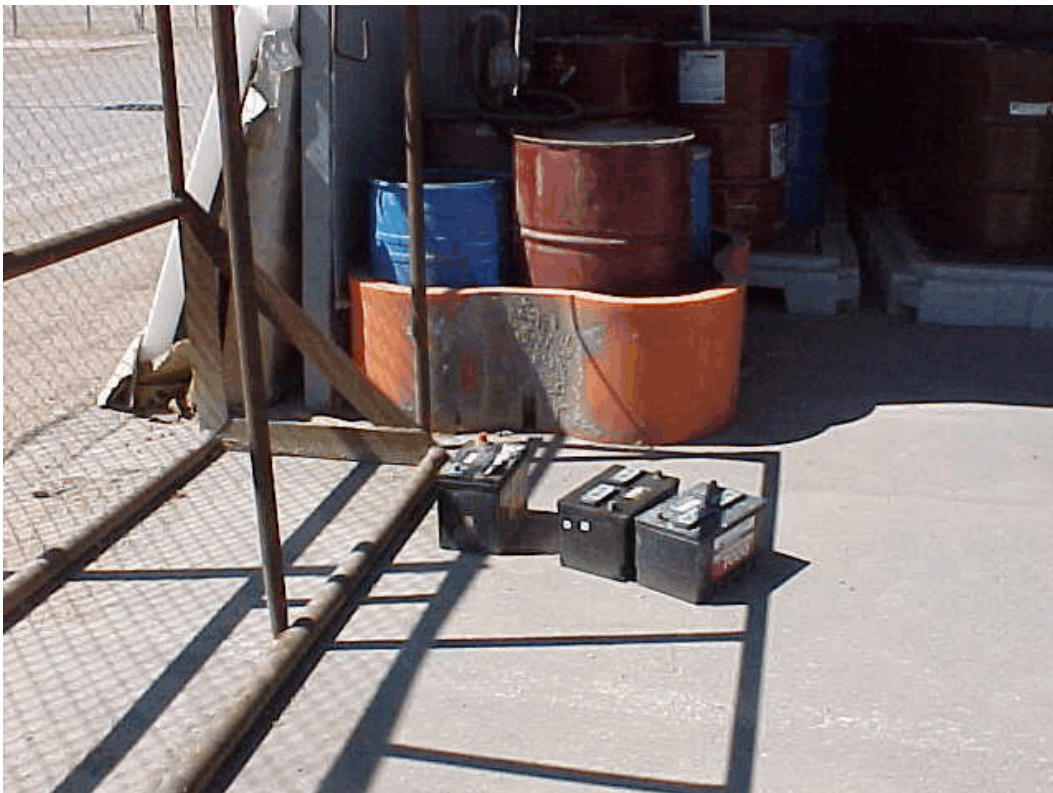
**Photo 2.** Three used exposed and uncontained batteries located outside the Automotive Repair facility.

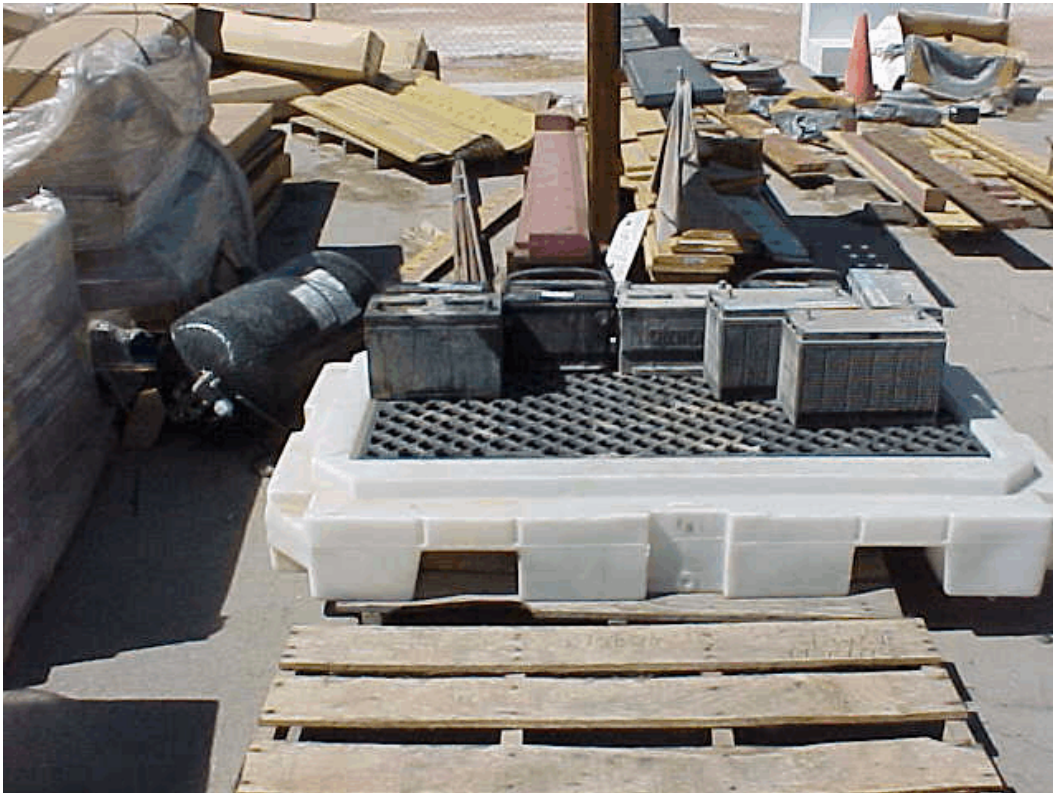
**Photo 3.** Exposed, but contained used batteries located outside the Automotive Repair facility.

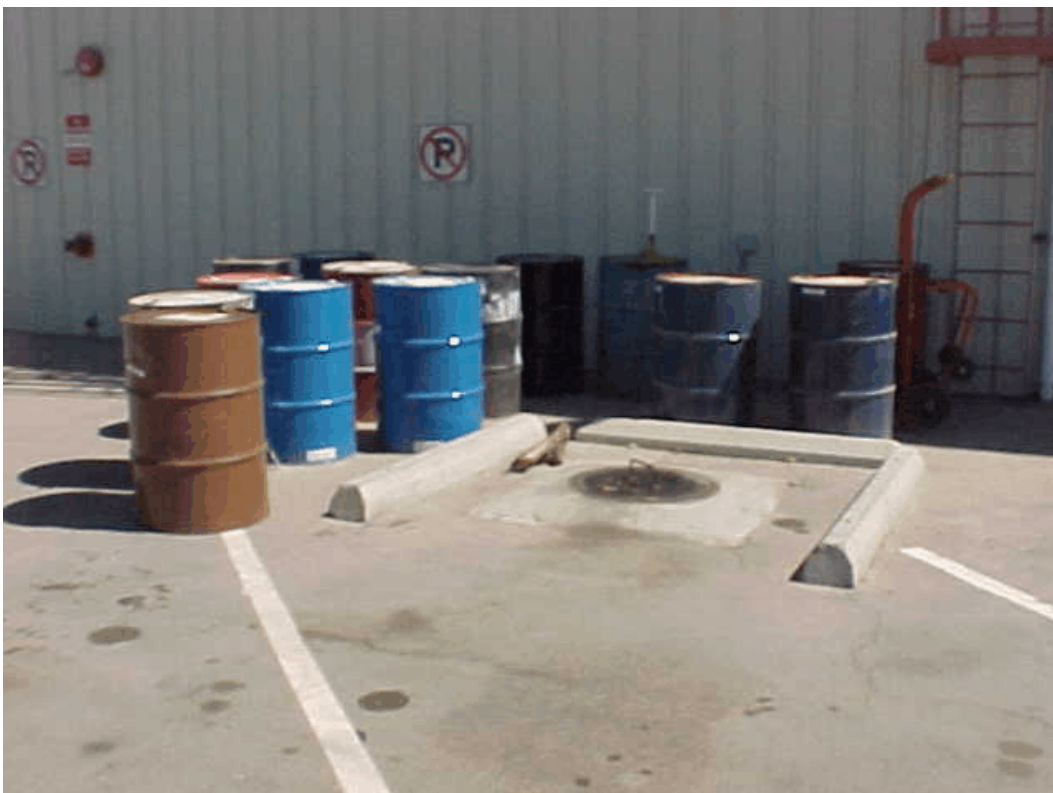
**Photo 4.** Waste oil pit and multiple 55-gallon drums that are full, partially full, and empty at the Automotive Repair facility.

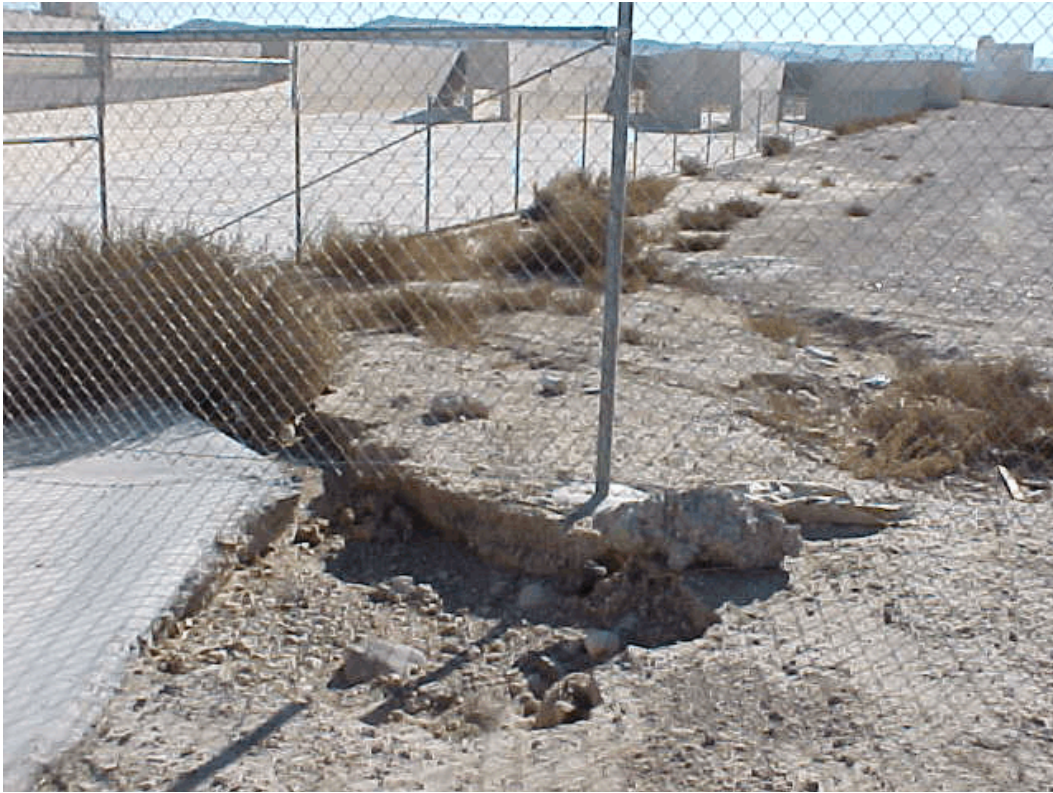
1. Erosion into the detention basin was observed at several locations. Some erosion channels in the west wall of the detention basin were at least four feet deep and six feet wide. Mr. Suckow stated that the erosion in the west wall had occurred several months ago.
2. Utility work was ongoing outside the east fence of the detention basin. The heavy equipment was parked inside a locked gate to the detention basin area. Mr. Suckow was unaware of the ongoing work.
3. An approximately 36-inch pipe for storm water discharge to the detention basin had recently been installed at the northwest corner of the detention basin. The pipe appeared to have been installed by the developer of an adjacent subdivision. Mr. Suckow was unaware of the installation.

1. Clark County is not actively repairing erosion into the detention basin and has not implemented Best Management Practices (BMPs) such as stabilization and/or riprap of the basin walls. Loose soils eroded into the basin will potentially be carried by storm water to the Duck Creek Channel when a rain event occurs.

**Photo 1.** Erosion to the detention basin at the northeast corner.

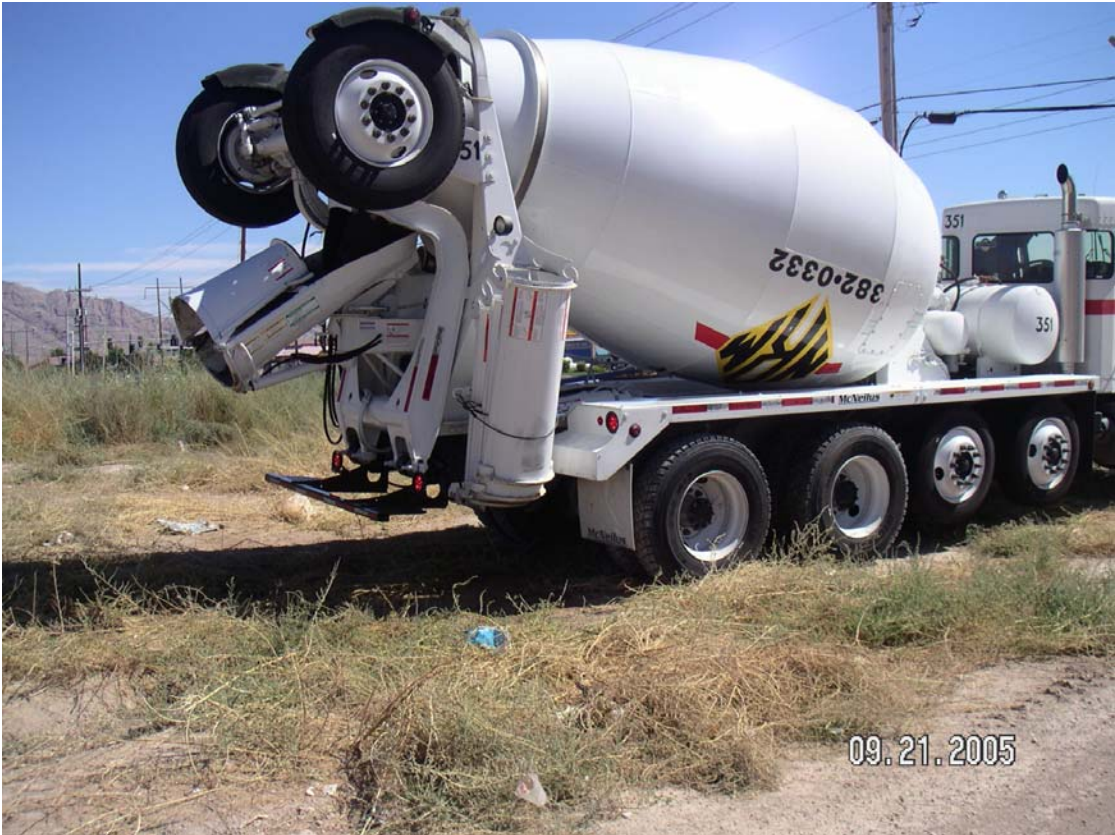
Photo 1. Concrete truck that just completed wash-out.

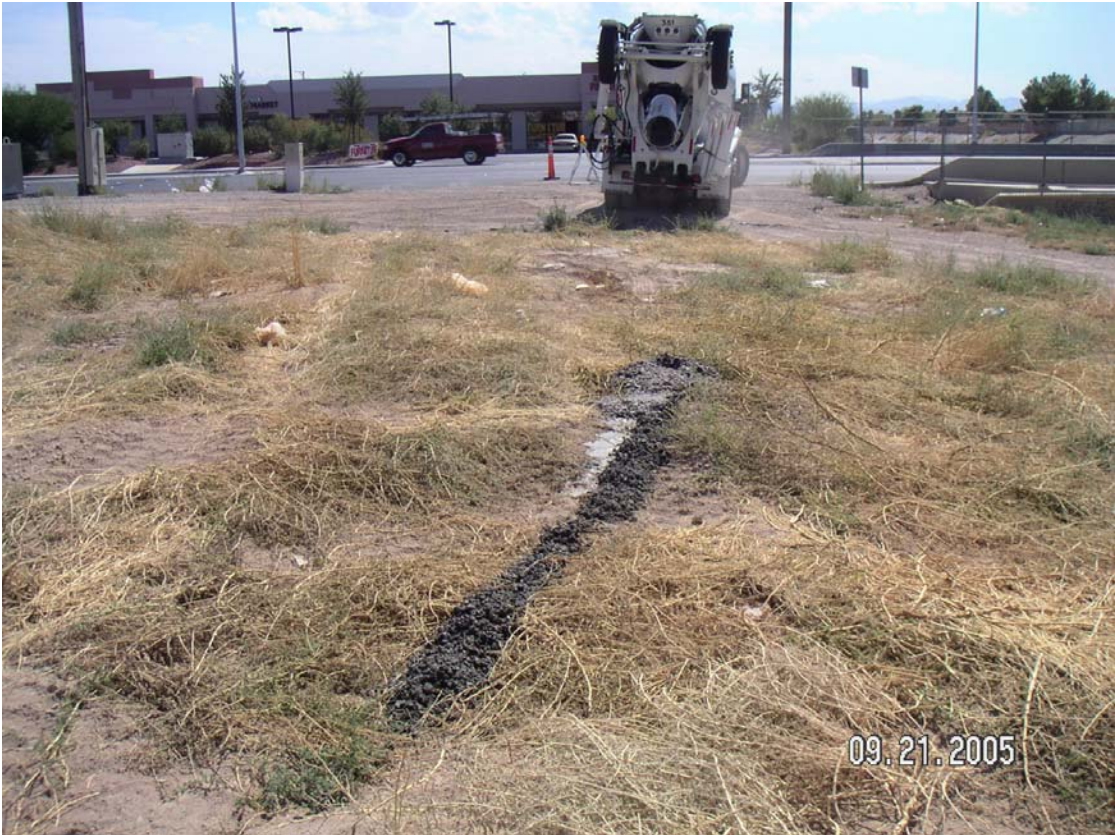
Photo 2. Wash-out material left by concrete truck.

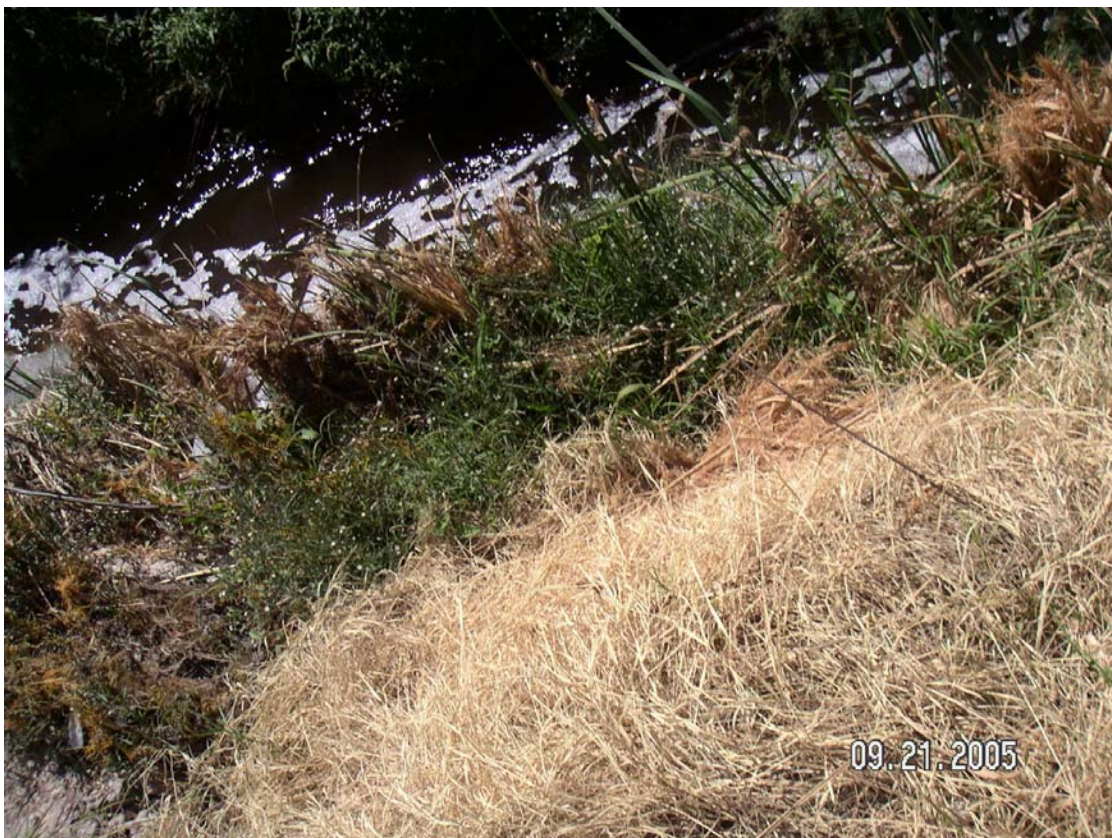
**Photo 4.** Las Vegas Wash - Appearance is brown with suds.

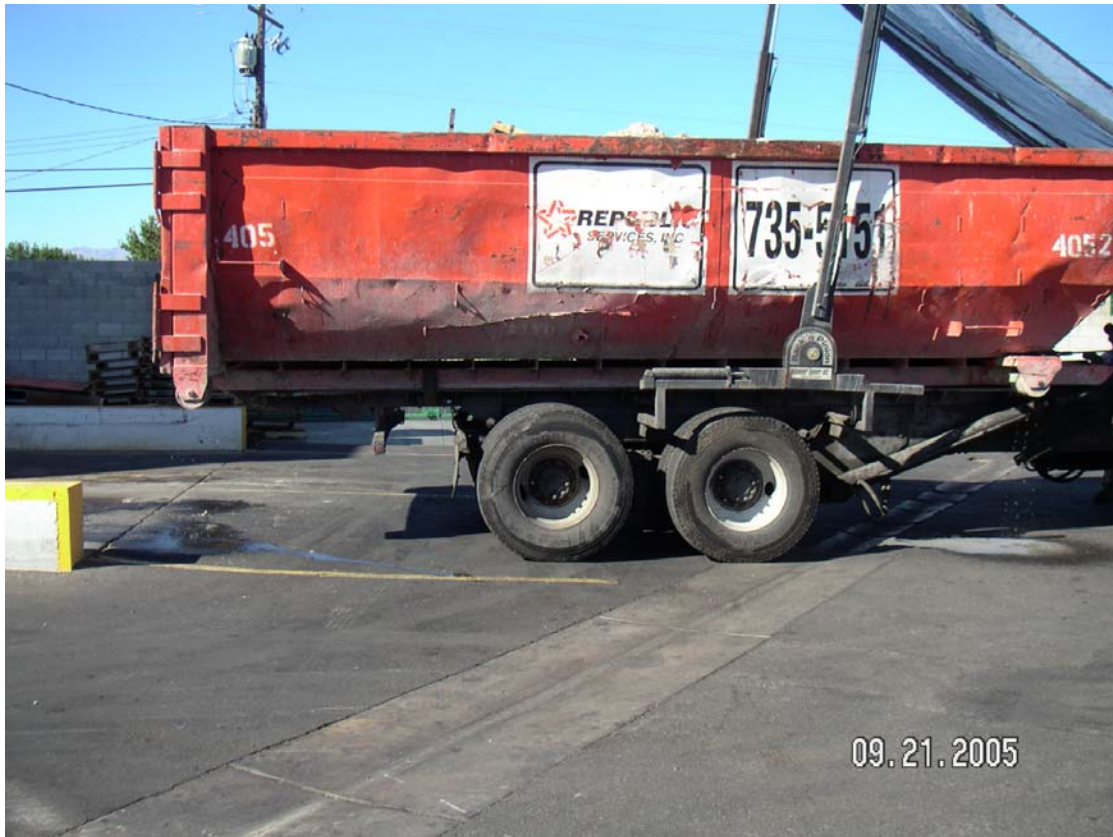
**Photo 1.** Roll-off container is leaking.

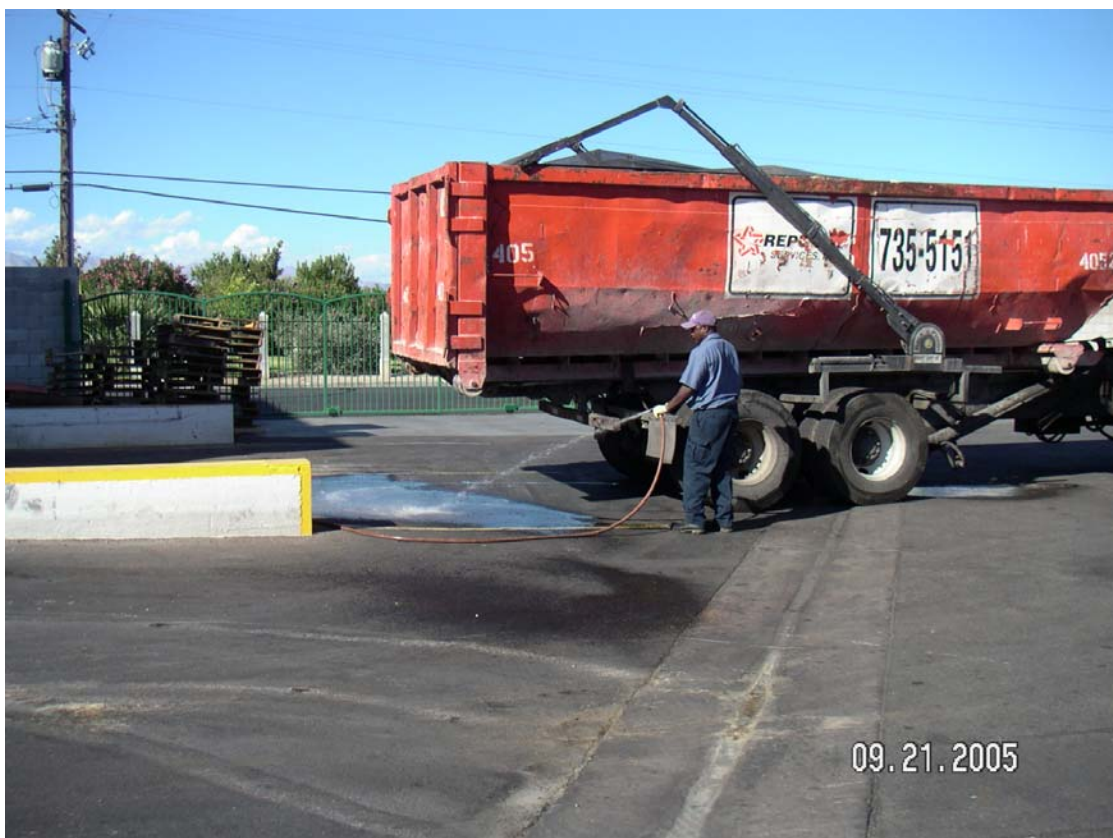
**Photo 2.** Roll-off container is leaking.

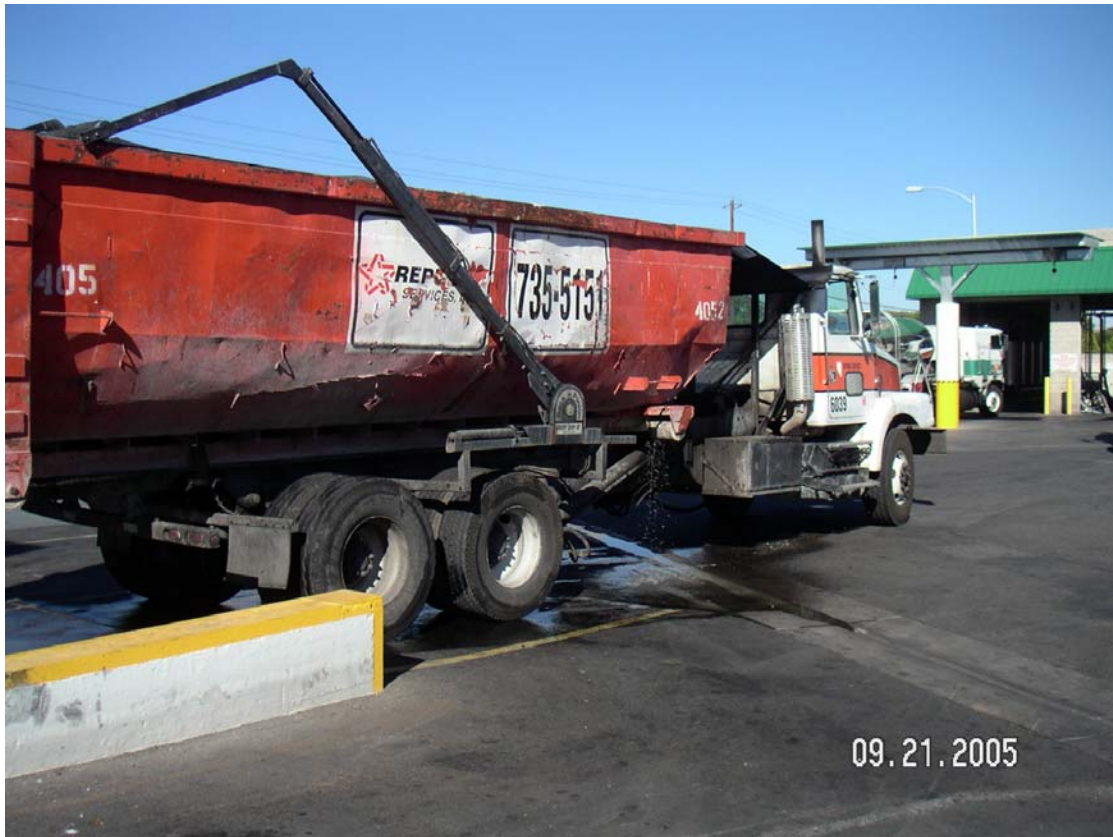
**Photo 3.** Roll-off container is leaking.

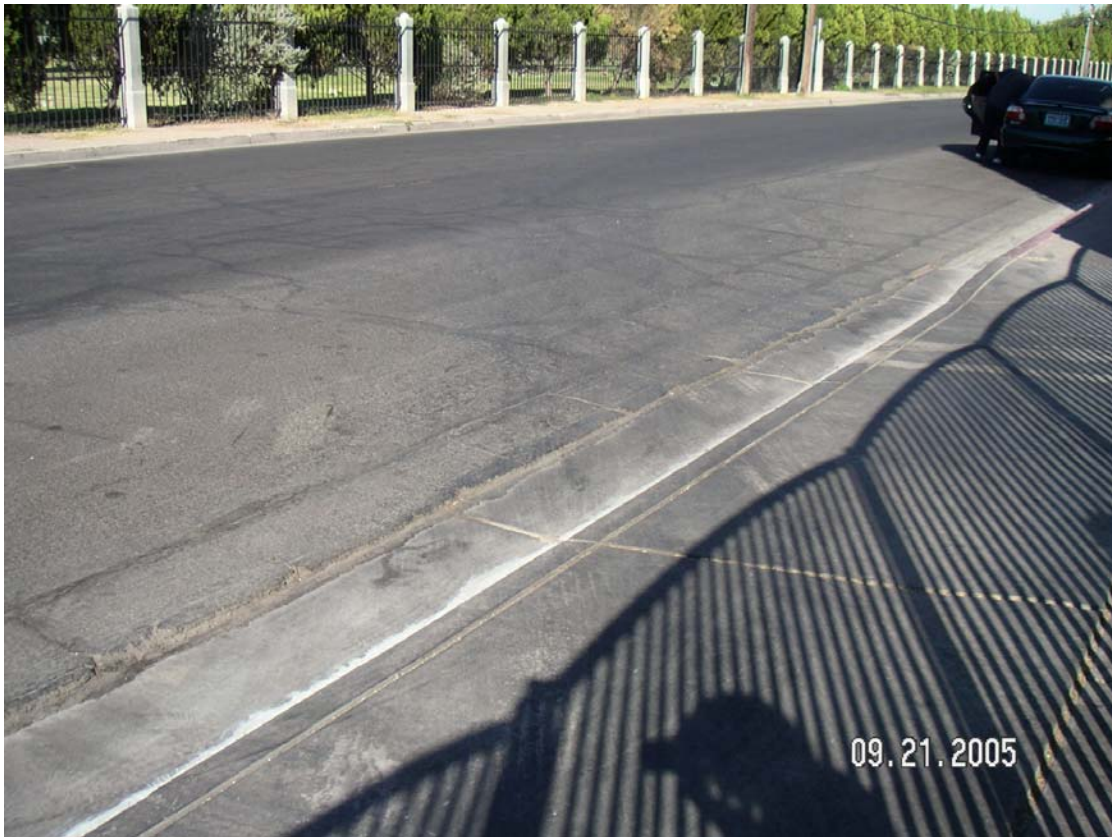
**Photo 7.** Dried milk solids in street gutter outside facility.

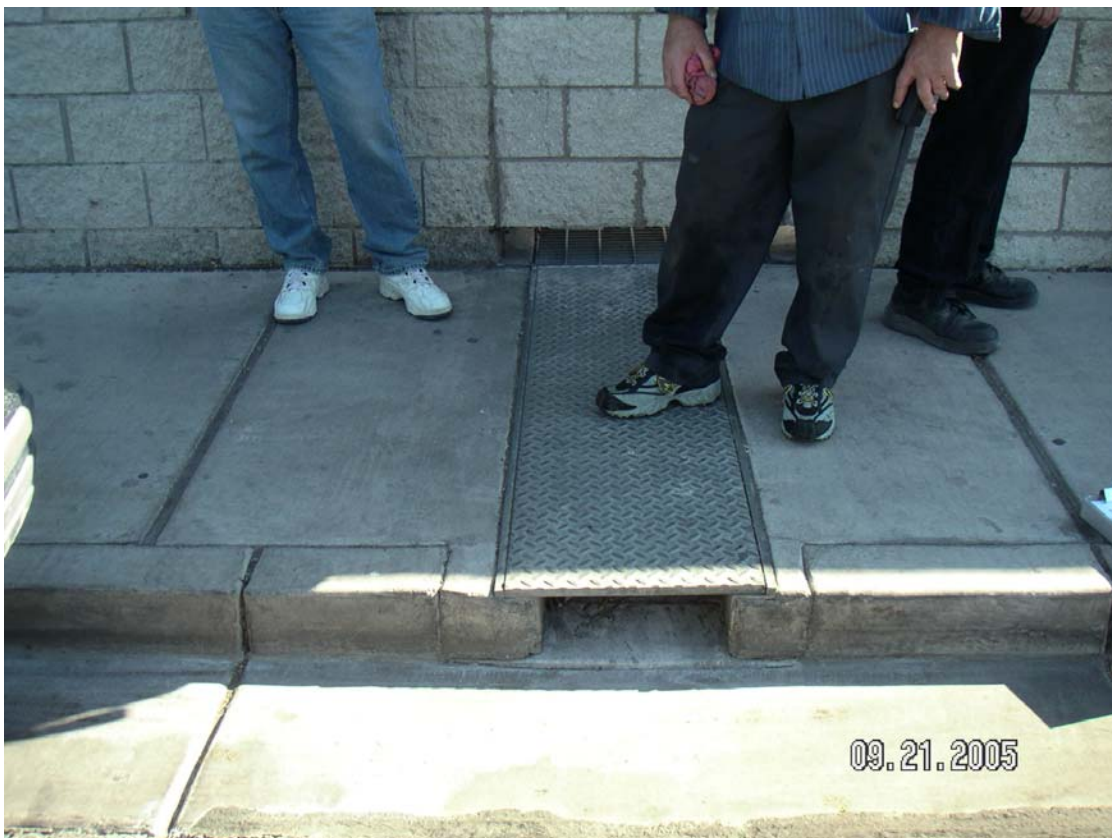
**Photo 8.** Dried milk solids entered street gutter from facility drain.

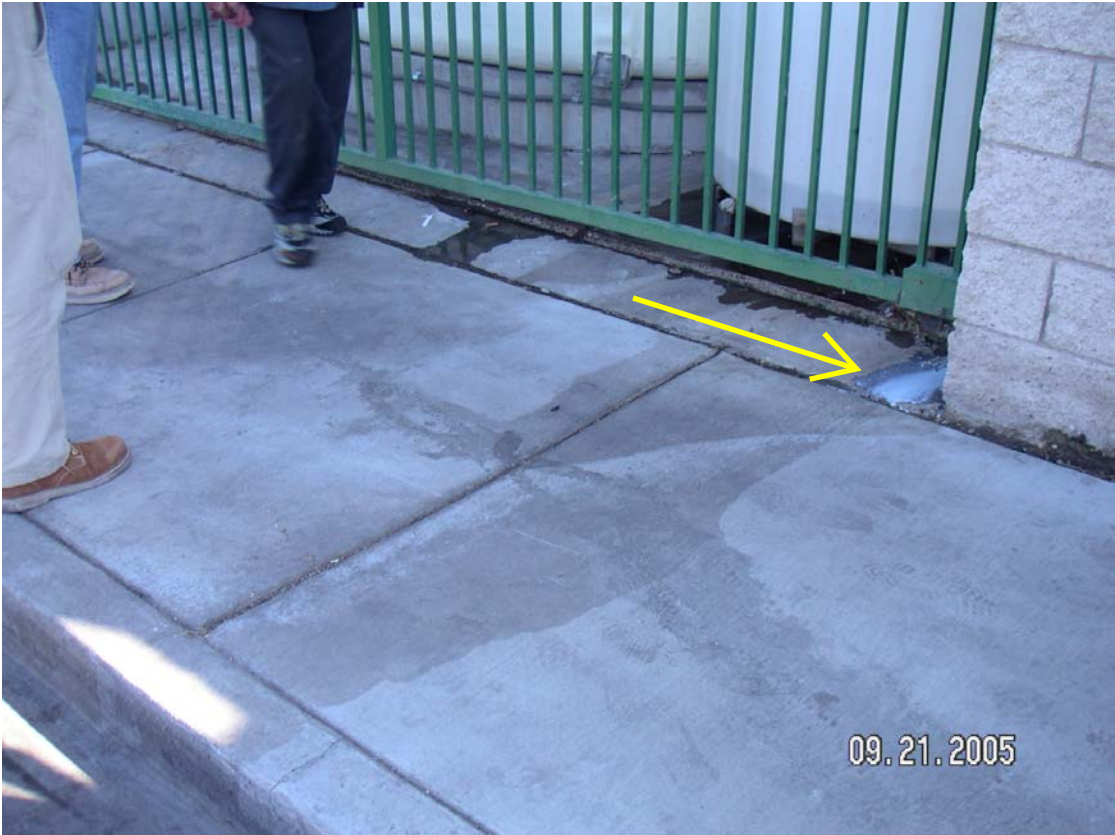
**Photo 9.** Discharge to street from leaking tank.

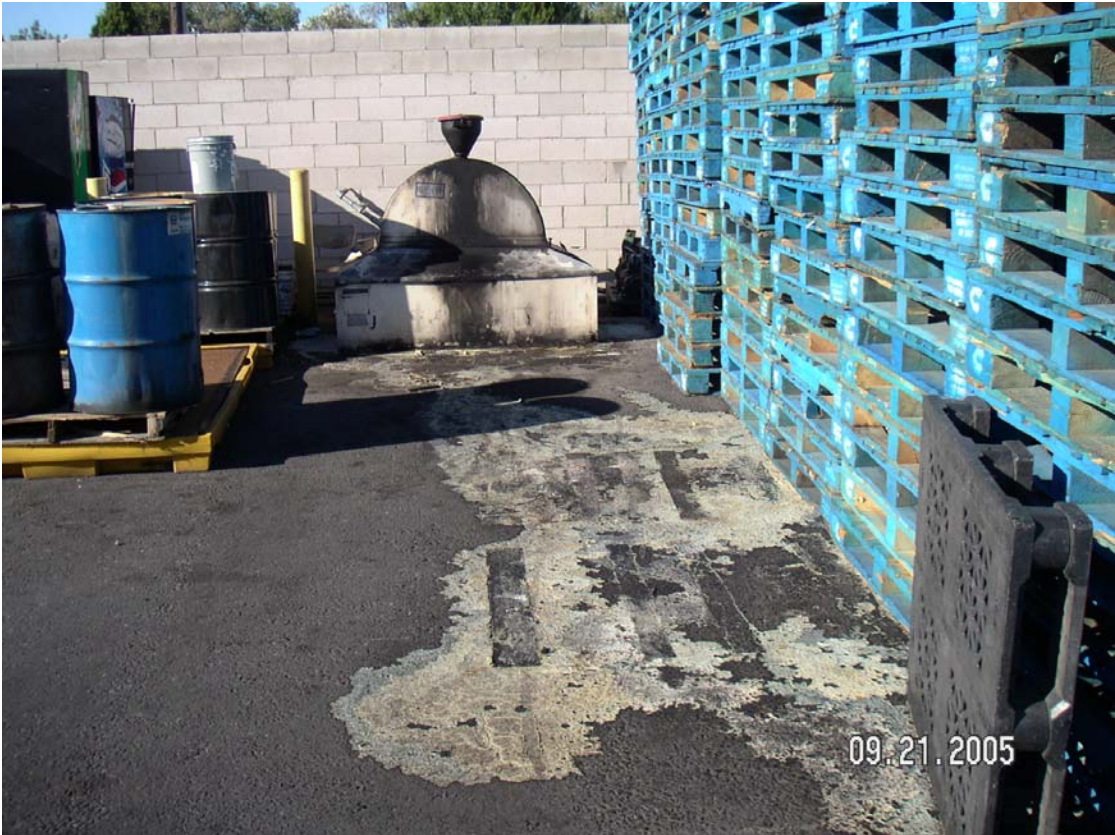
**Photo 10.** Dried milk solids on asphalt inside facility.

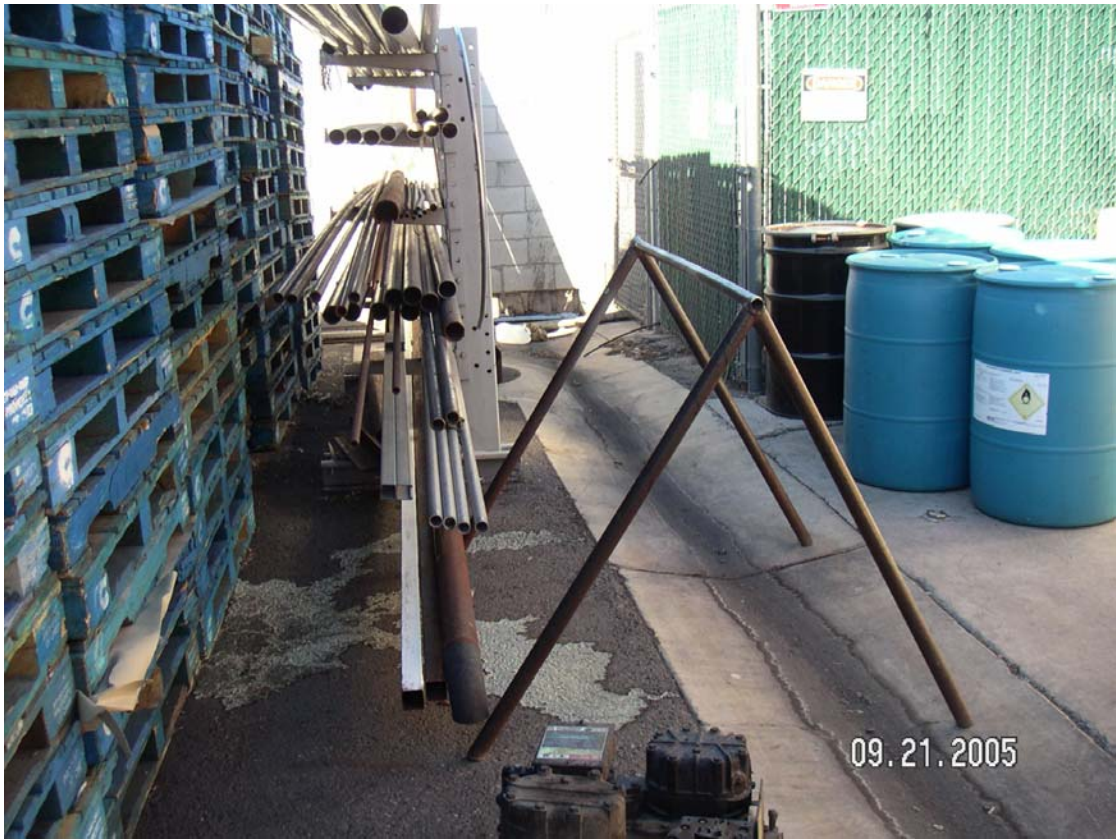
**Photo 11.** Dried milk solids spilled next to drain to street seen in Photo 8.
