**Appendix A**  
**Storm Water Management Plan: Comments from NDEP and Co-Permittee Response**

## Storm Water Management Plan: Comments from NDEP and Co-Permittee Response

**Appendix B**  
**Clark County**

**Appendix B.1**  
**Documentation of Findings**

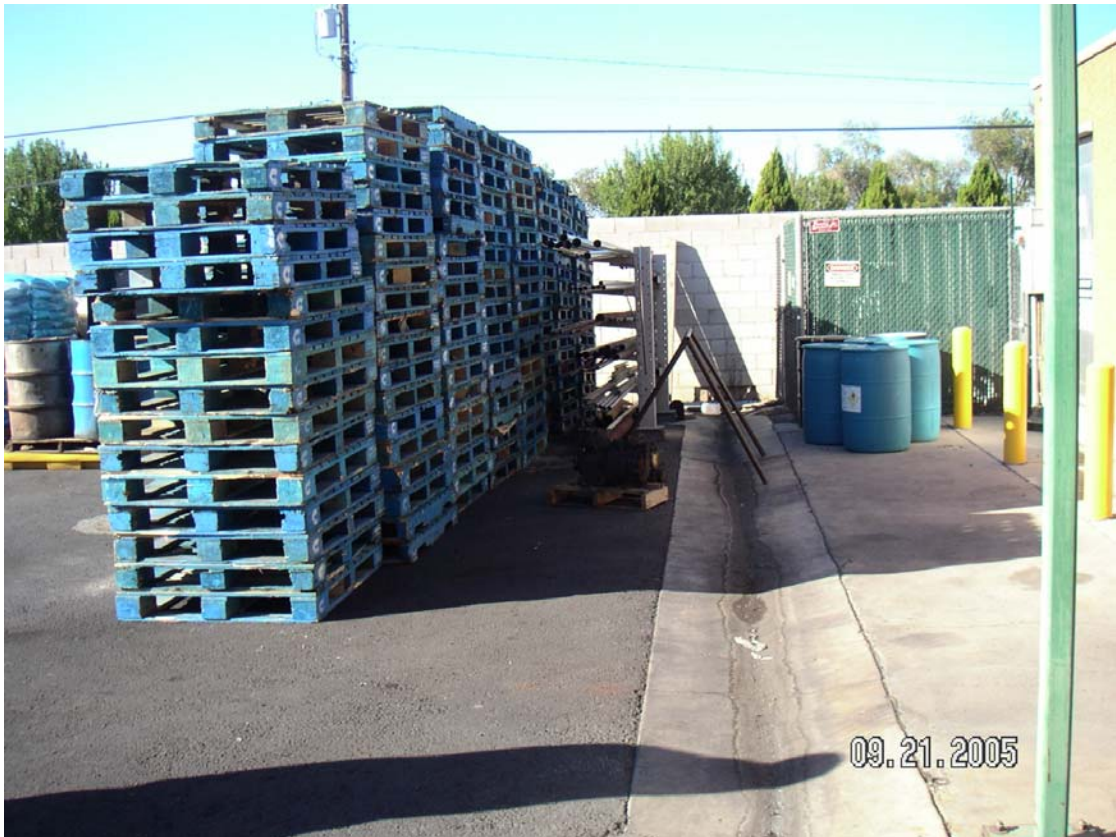
**Photo 12.** Dried milk solids spilled next to drain to street seen in Photo 8.

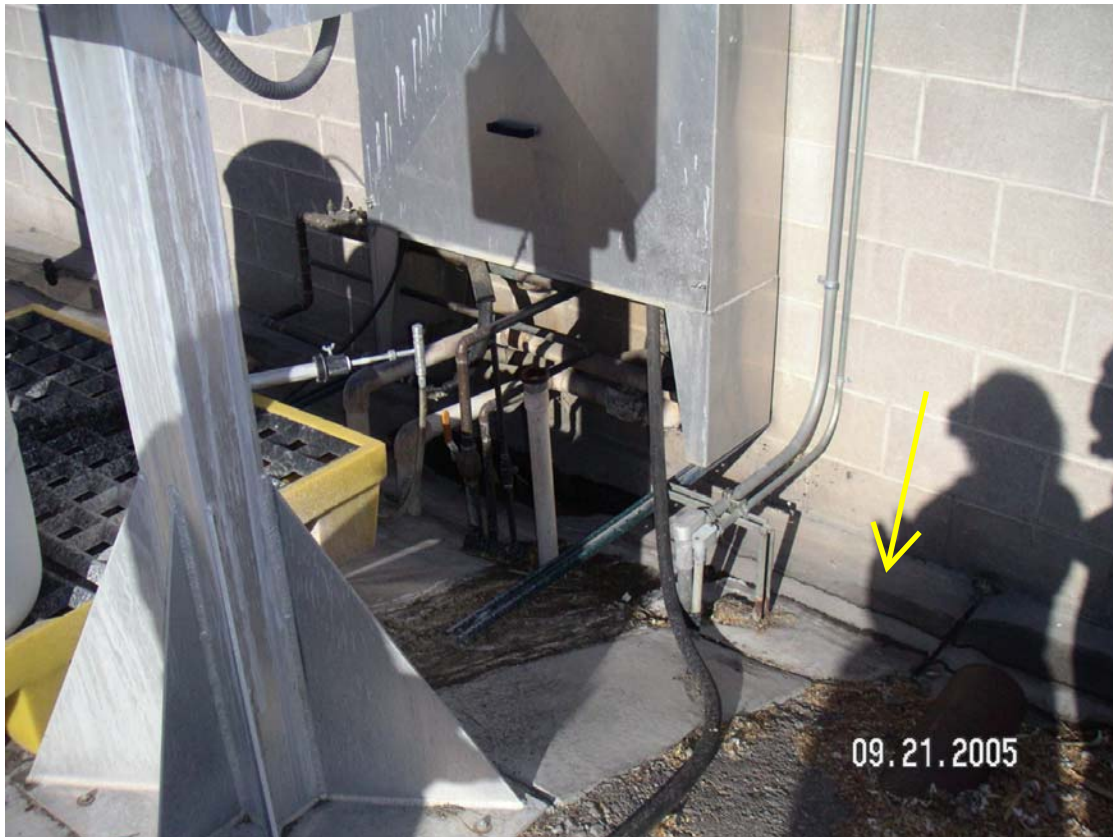
**Photo 13.** Detergent leaking from wash rack; drain to street in right foreground.

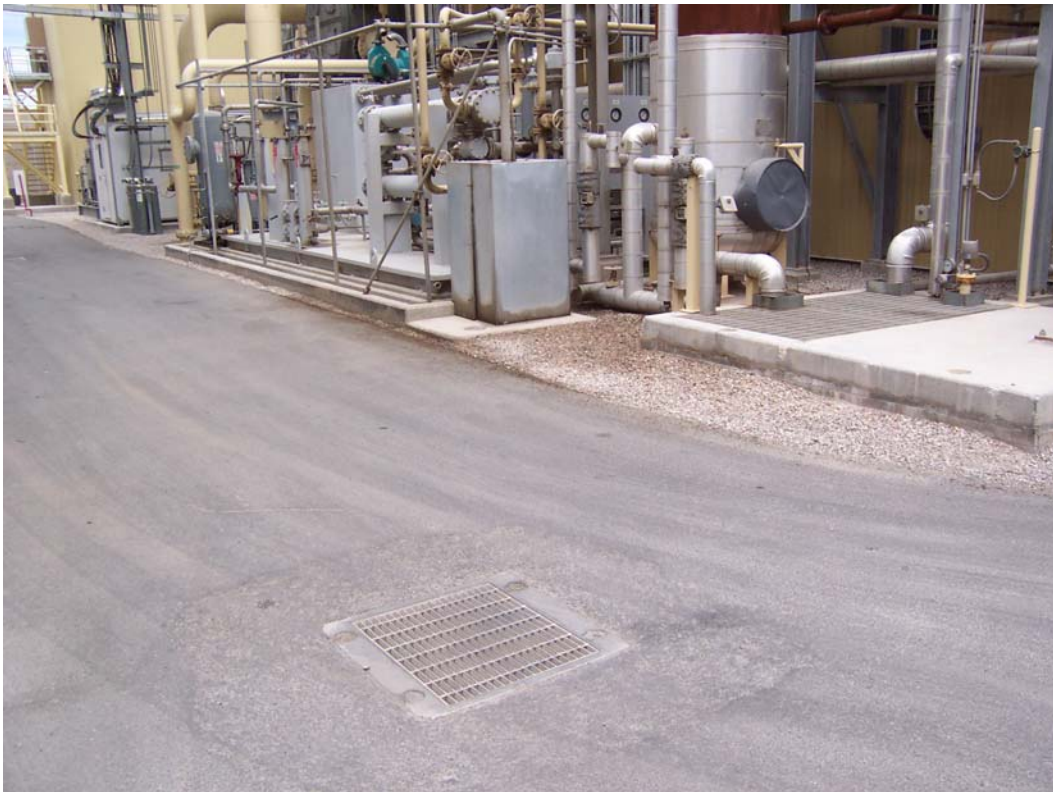
**Photo 3.** The inspector noted the presence of oil stains (center photo) on the rock landscaping and an electrical cabinet next to turbine number one.

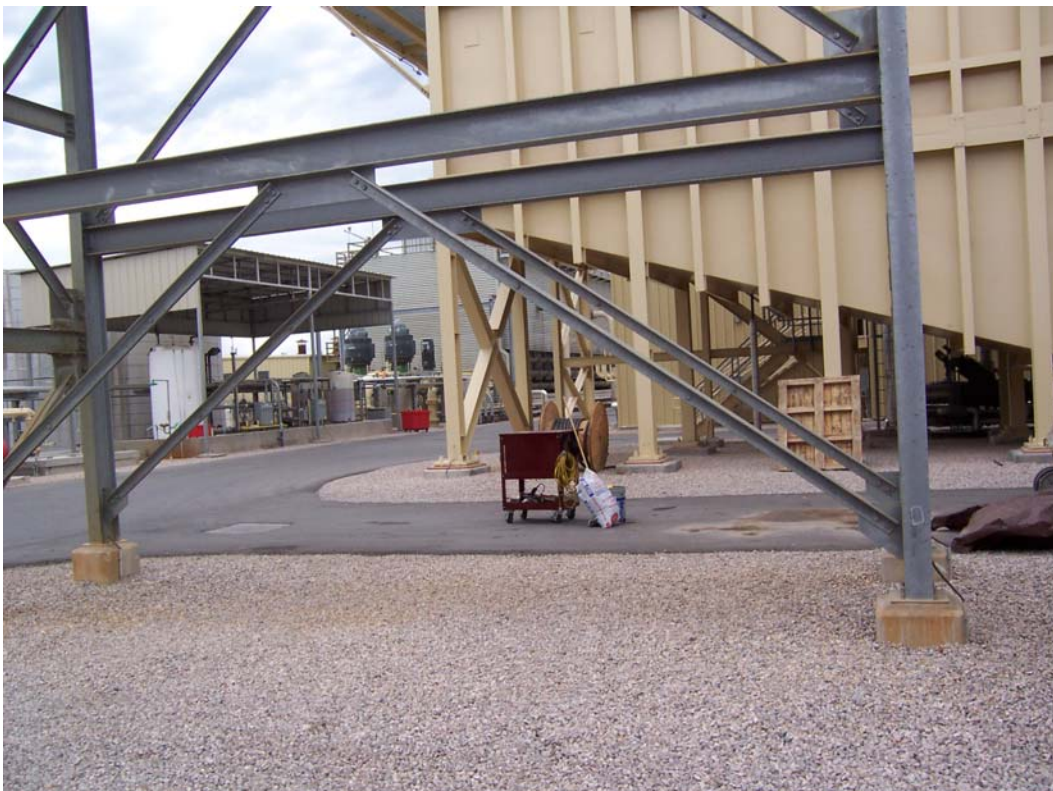
**Photo 4.** The inspector did note some oil spills on the pavement where adsorbent had been applied. He advised the facility to sweep up the adsorbent.

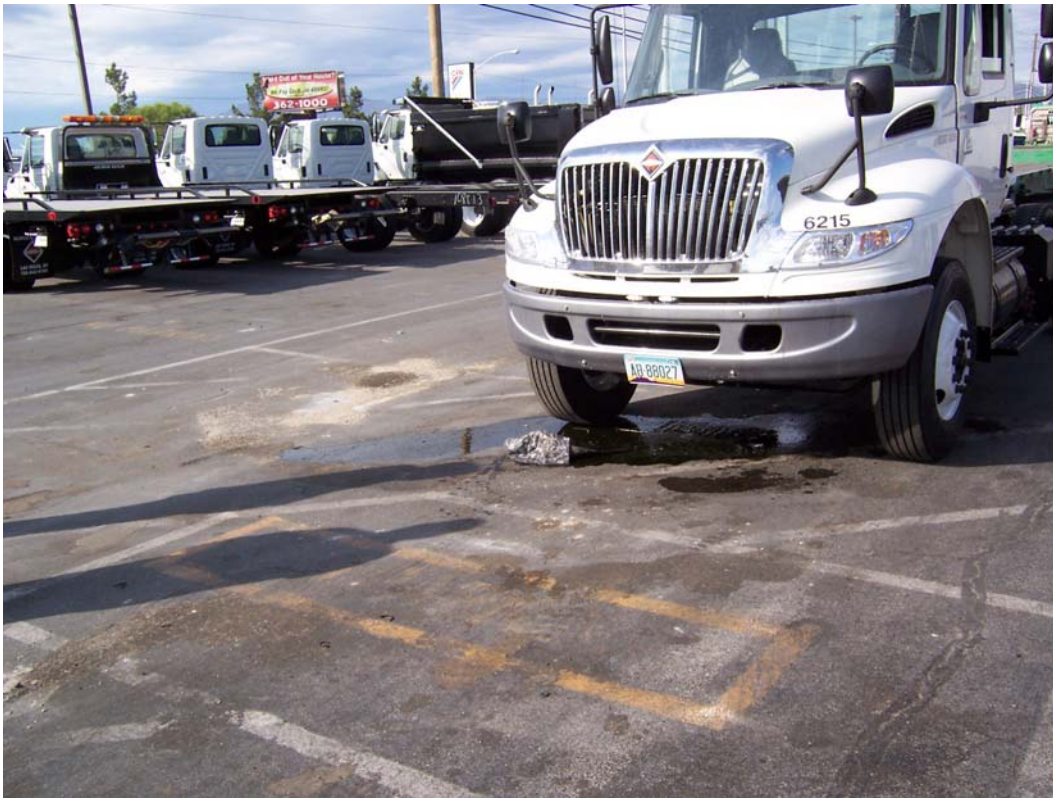
**Photo 1.** Oil leaking from truck stored in the parking area.

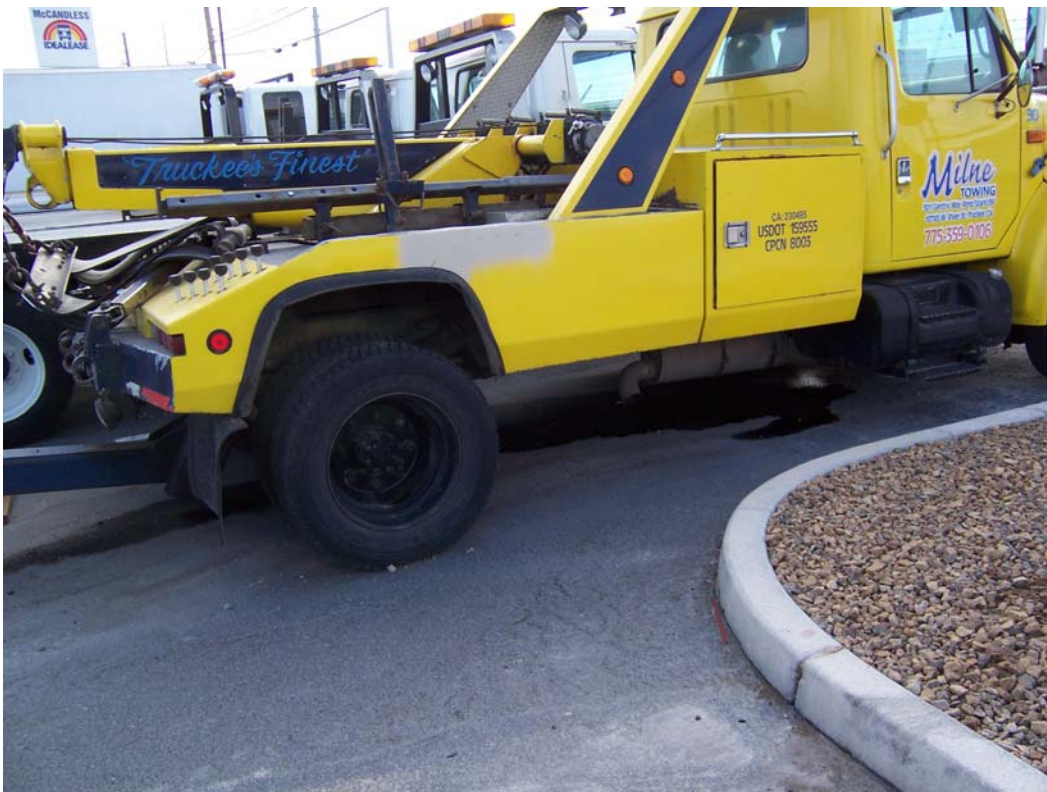
**Photo 2.** Oil leaking under tow truck stored in the parking area.

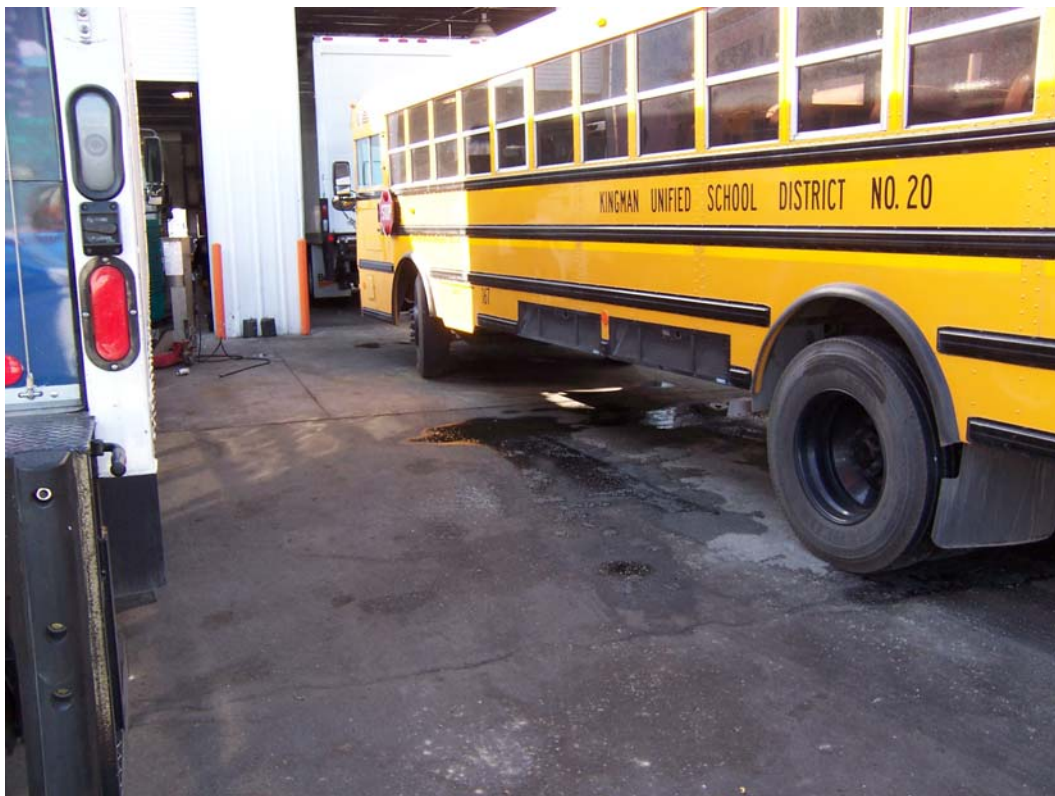
**Photo 3.** Apparent leakage under bus being maintained outside of shop area.

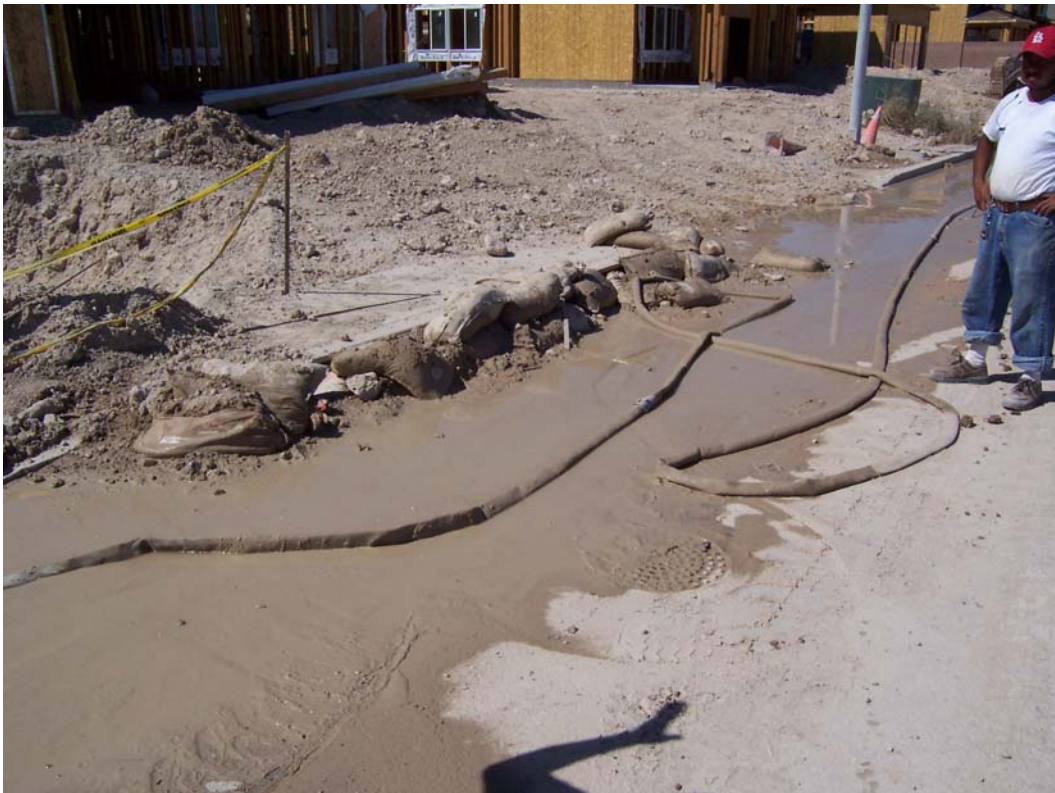
**Photo 2.** Storm inlet at the site. Sediment is also entering the storm sewer through the pick hole in the manhole in front of the inlet. Hose in the photo is the fire hose the site had been using to clean the street. Note poor condition of sand bags used for inlet protection and dirt extending past curb line.

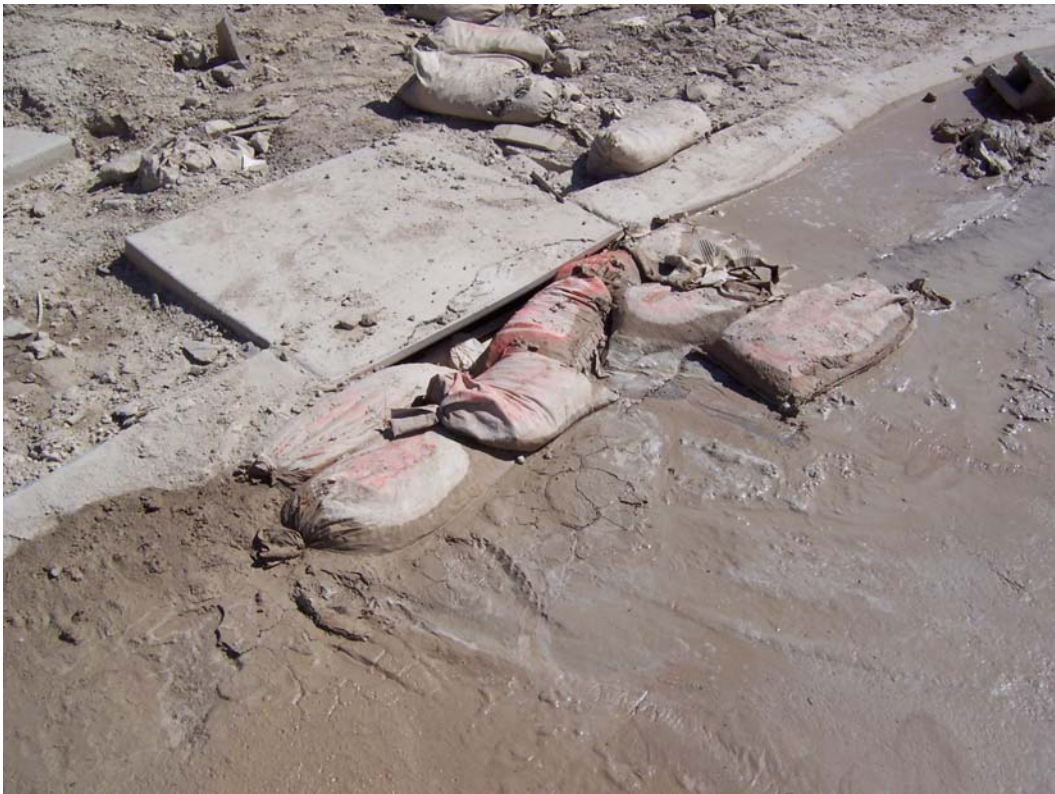
**Photo 3.** Different storm inlet at the site. Separation between sand bag at the right and curb allows sediment to enter the inlet.

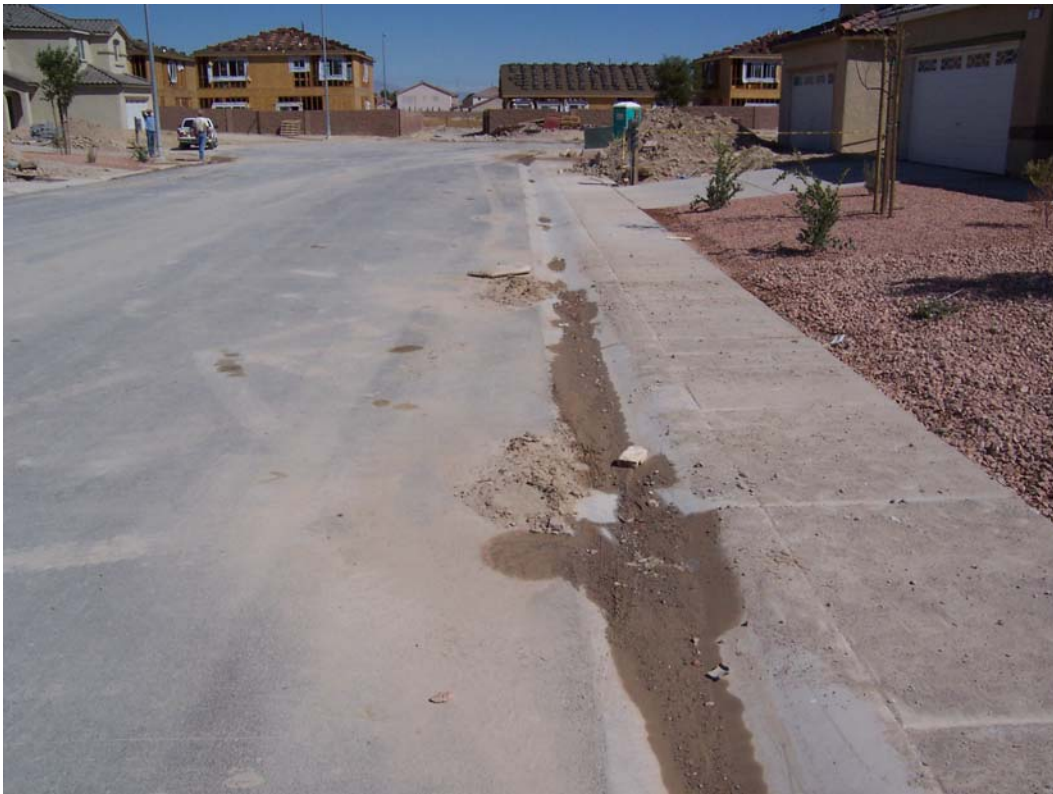
**Photo 5.** Sediment in the street. Moisture indicates street was washed earlier in the day. Note sand bag, center rear of photo, pulled back from the curb.

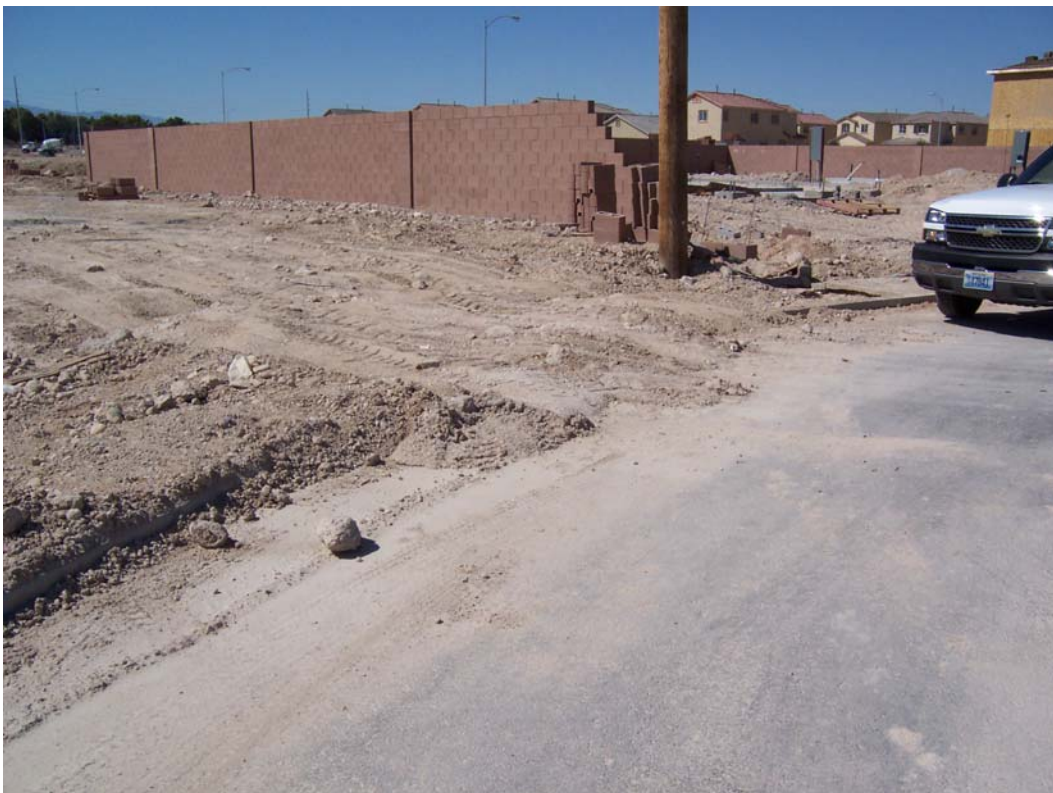
**Photo 6.** Absence of trackout controls at a site entrance. Note dirt extended past curb line into the street.

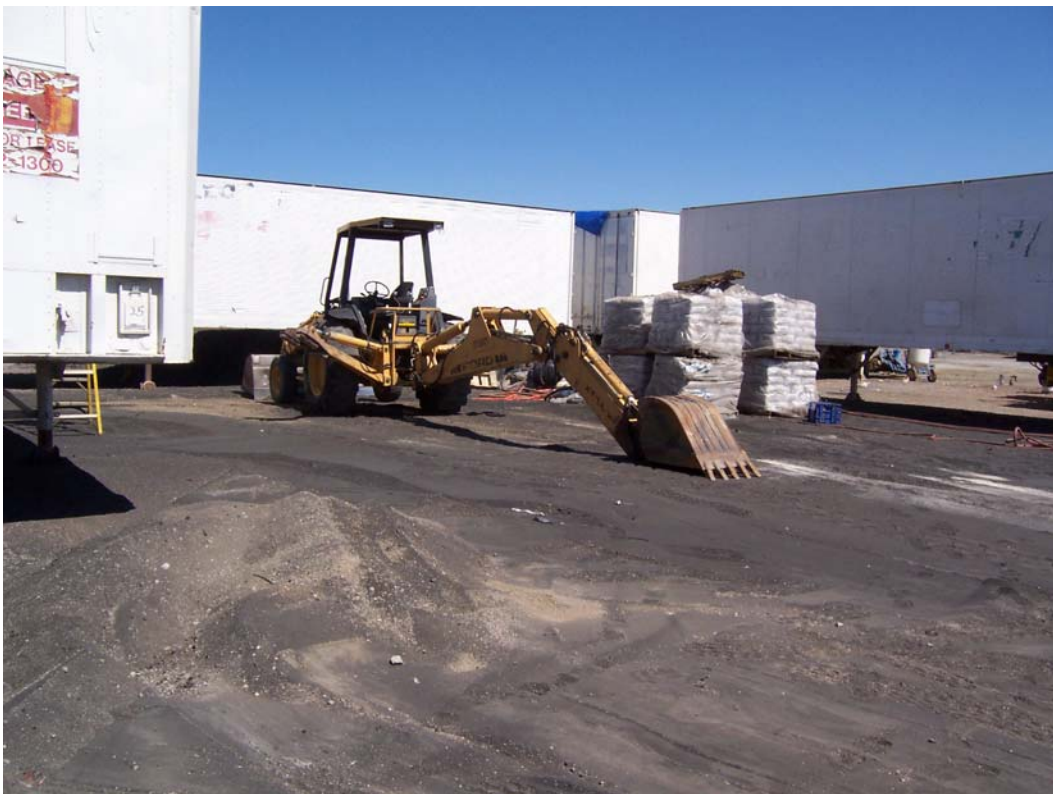
**Photo 1.** Open air sand blasting activity at the site. Dark material around the backhoe being sand blasted is spent sand blast grit. White bags on pallets at photo right are additional unused grit. No containment was provided around the area.

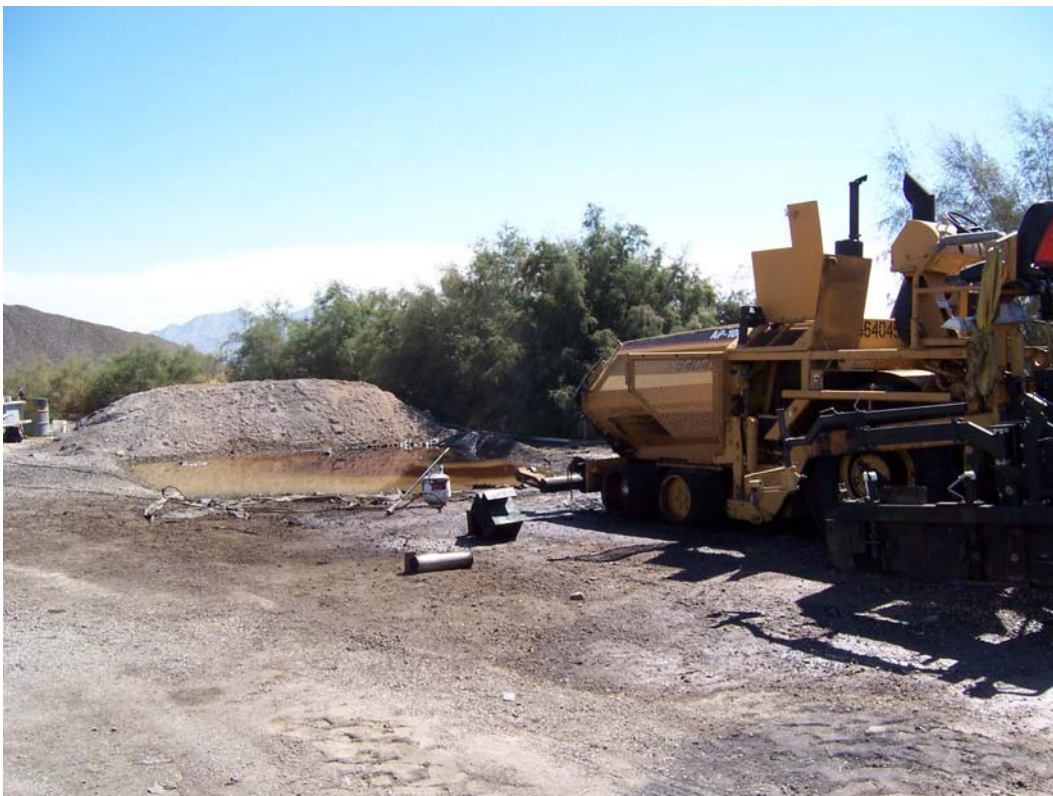
5. A pit had been dug at the site to receive wash water from an equipment cleaning operation that had been set up. The pit contained contaminated, oily water from the cleaning operation. Although a plastic liner had been placed in the pit, the area where equipment was being cleaned was not lined. The soil in this area was heavily stained with oil.

**Photo 4.** Paving machine being cleaned with wash water discharged to the pit shown in Photo 3. Note oil stains on the ground in front of and around the machine.

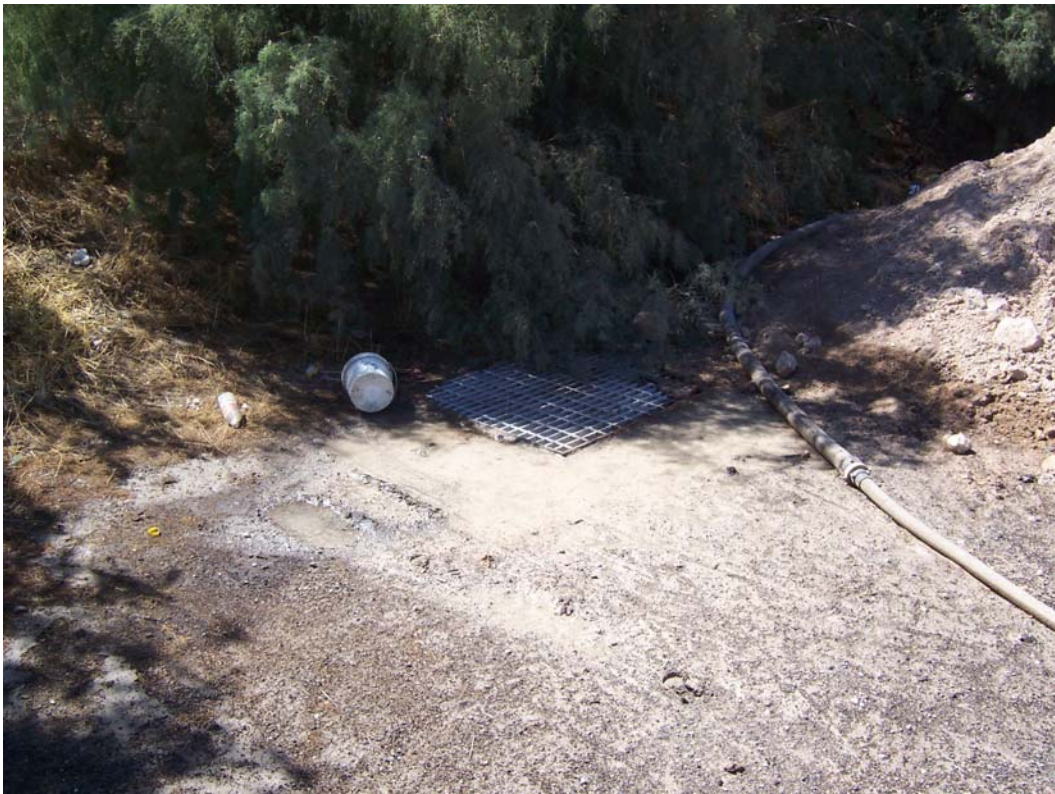
6. Contaminated water from the site was entering an inlet at the site. The discharge from this inlet went to Dehli Avenue, where it entered a storm sewer inlet.

**Photo 5.** Storm inlet located behind the pile of dirt shown in Photos 3 and 4. Note contaminated runoff from the site entering the inlet.

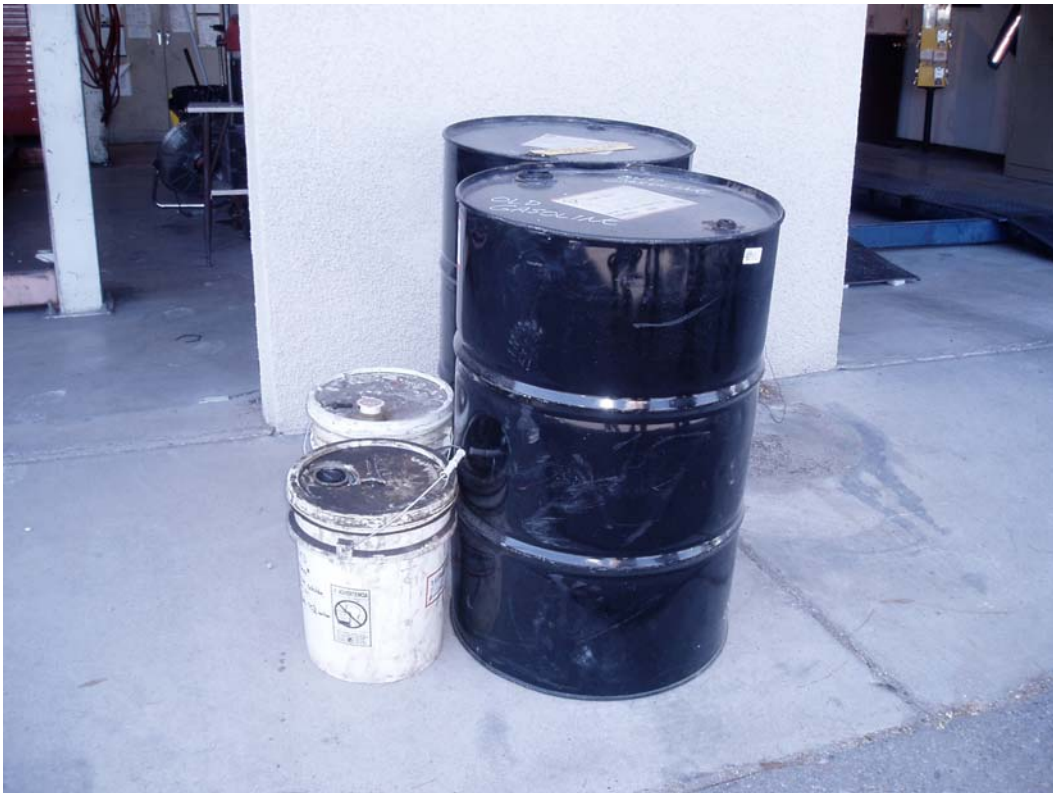
1. Self-inspections of the municipal facilities are not occurring.
2. Containers of used oil were observed outside without secondary containment.
3. The site was clean and well-maintained.

**Photo 1.** Two 55-gallon drums of used gasoline and two smaller buckets located outside the garage and without secondary containment.

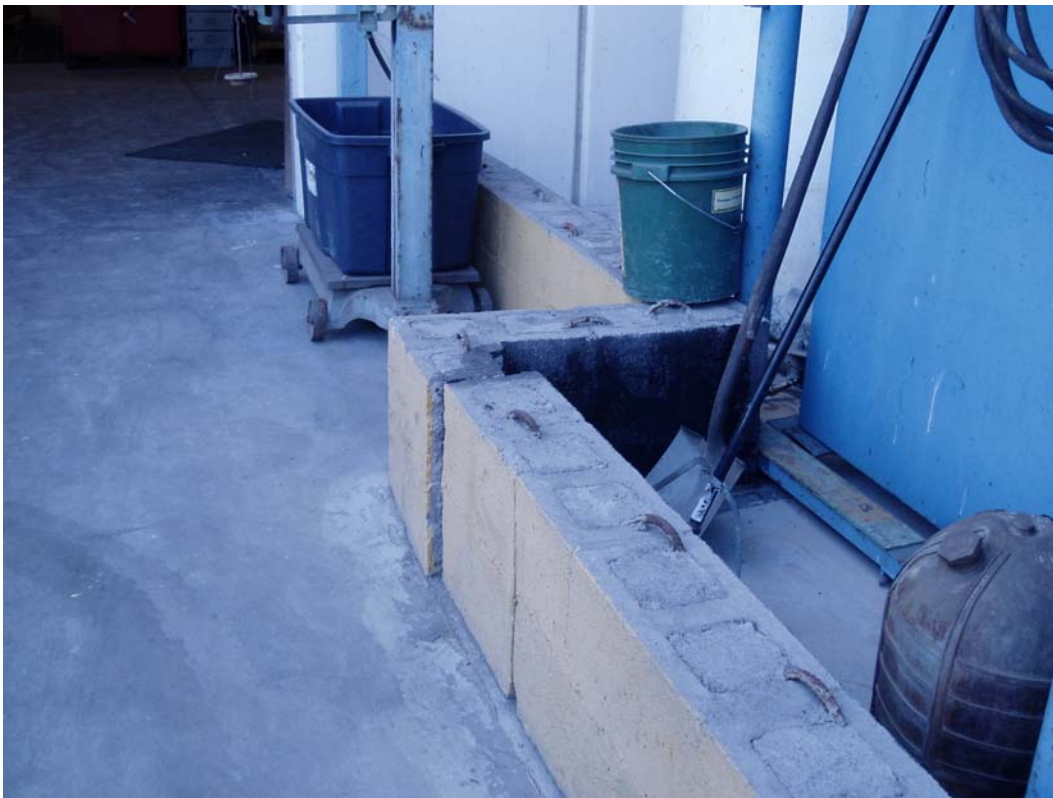
**Photo 1.** Crack in secondary containment.

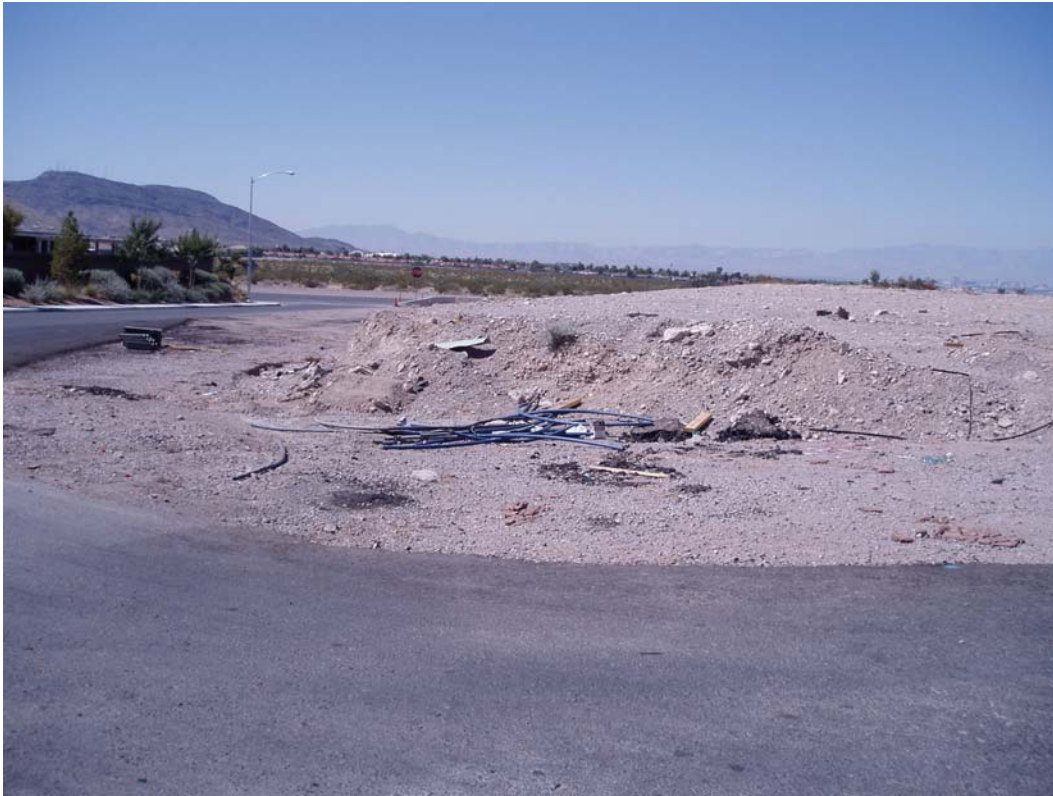
**Photo 1.** Debris at construction site entrance.
