Re: November 26, 2007 Clean Water Act Inspection

**U.S. Environmental Protection Agency
Region 9
Clean Water Act Compliance Office**

NPDES Compliance Evaluation Inspection Report

Industrial User: Patmont Motor Werks
Industrial User Address: 2220 Meridian Blvd., Minden, NV 89423
Inspection Date: November 26, 2007

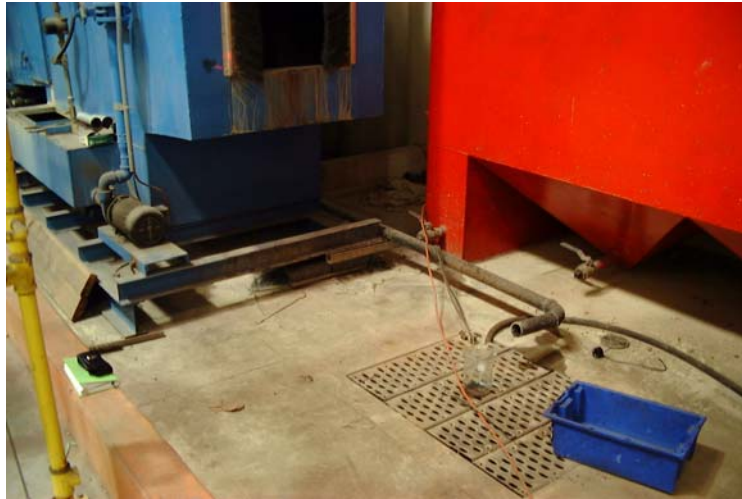
The spray rinse discharge from the phosphating line drains to a sump. *See Photo 1 in the Appendix.* A sump pump then pumps the wastewater to the first part of the wastewater treatment system: a 1500-gallon holding tank. *See Photo 2 in the Appendix.* The wastewater then flows into a horizontal, baffled tank containing lime chips. *See Photo 3 in the Appendix.* The wastewater exits the tank into a floor drain which leads to the sewer system. *See Photo 4 in the Appendix.* The wastewater treatment system, as well as the two-stage machine with the phosphating line, is located in an area that has secondary containment.

Photo #1: Sump from which wastewater is pumped to the onsite wastewater treatment system

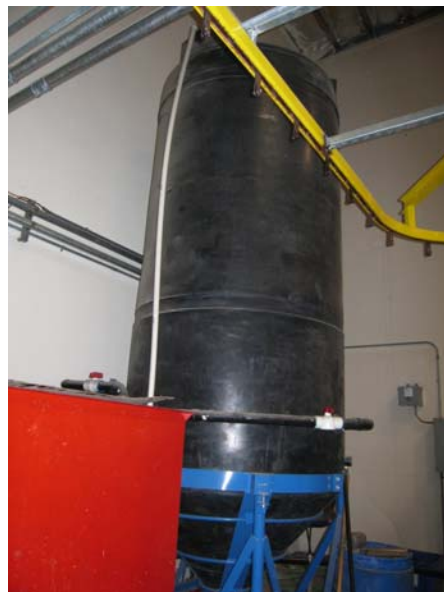
Photo 2

Photo #2: Wastewater treatment system - holding tank

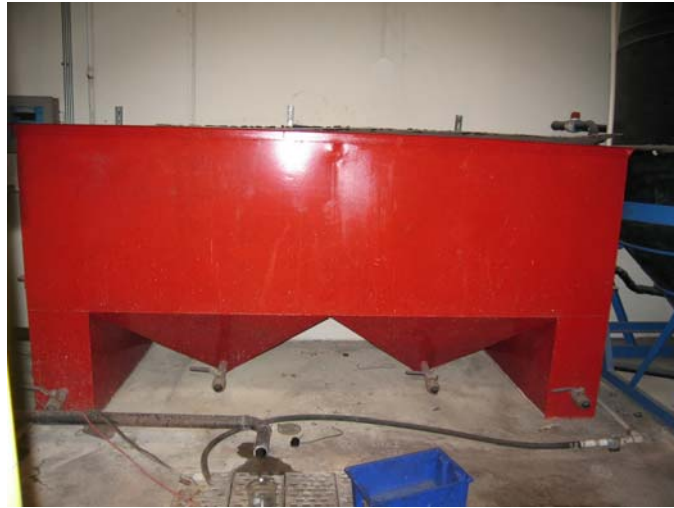
Photo 3

After looking at the facility's written records of pH measurements taken both upstream and downstream of the holding tank, EPA inspectors concluded that the lime in the horizontal tank was spent. The facility's records indicated no substantial increase in pH after the wastewater flowed through the lime chips.

Photo #3: Wastewater treatment system - horizontal tank containing lime chips
Taken by Anna Yen on November 26, 2007

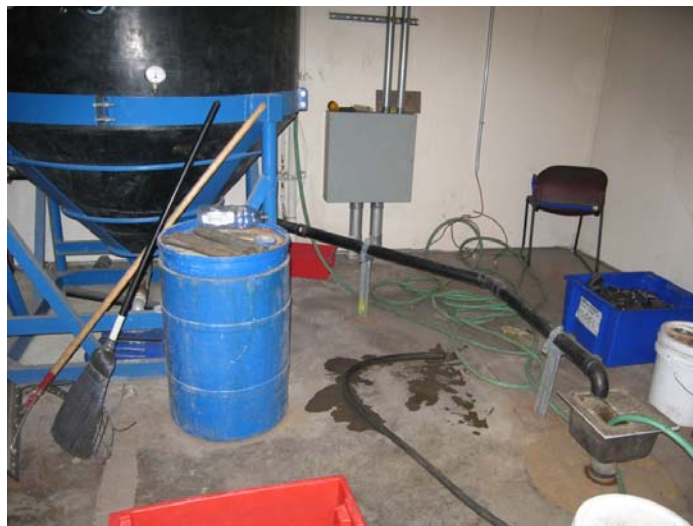
Photo 4

Photo #4: Discharge line from horizontal tank to floor drain
Taken by Anna Yen on November 26, 2007

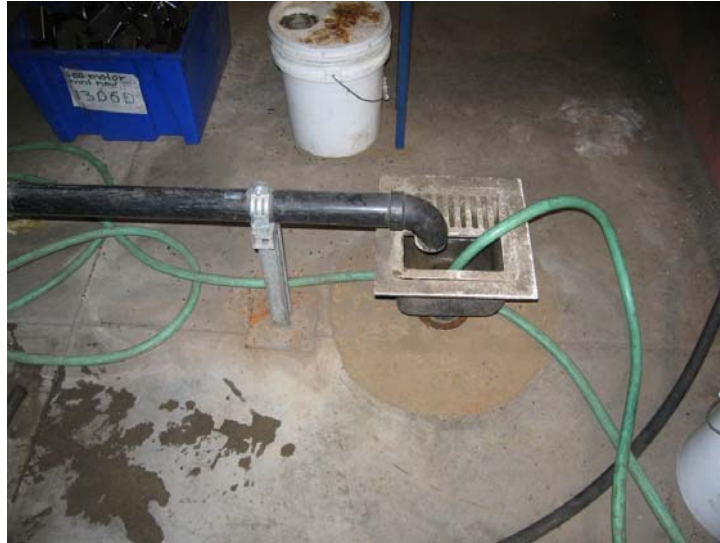
EPA inspectors observed a hose with one end in the floor drain. *See Photo 5 in the Appendix.* Though nothing was being transferred by hose at the time of the inspection, EPA recommends that hoses be removed from the area and, particularly, the floor drain. All flows should be draining to the sump to be pumped to the wastewater treatment system.

Photo #5: Hose in the floor drain
Taken by Anna Yen on November 26, 2007
