Section 319

NONPOINT SOURCE PROGRAM SUCCESS STORY

Restoring Stream Channel and Floodplain Reduces Turbidity

EPA 841-F-11-001P
February 2011

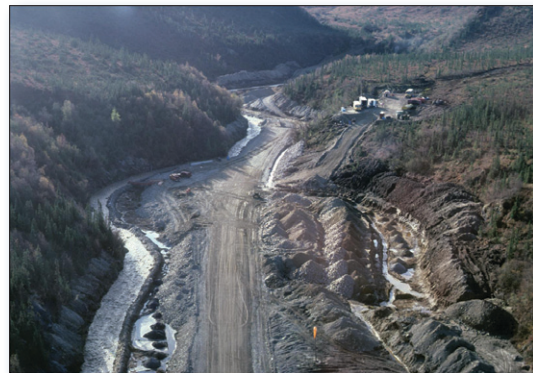
Eroding sediment from the damaged areas of the Caribou Creek watershed produced high levels of turbidity. Data from the early 1980s showed that turbidity exceeded water quality standards 64 percent of the time. These data, combined with best professional judgment concerning ongoing disturbances from past placer mining, prompted NPS to request that ADEC consider Caribou Creek impaired. On the basis of this request, ADEC added a 16.1-mile-long segment of Caribou Creek to the 1994 CWA section 303(d) list of impaired waters for turbidity.

Figure 2. Before reclamation efforts, piles of tailings covered the Caribou Creek floodplain and restricted creek flow.

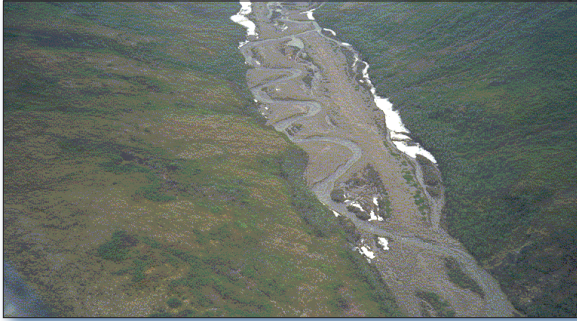
Figure 3. Caribou Creek in 2002 after NPS leveled and contoured large tailings piles to restore natural channel meanders and riparian function.

Between 2001 and 2010, NPS removed hazardous materials and equipment from five former mining claim areas, removed an abandoned airstrip, leveled and contoured large tailings piles to restore natural channel meanders (Figure 3), installed coir (coconut fiber) logs, and reestablished vegetation to control erosion.

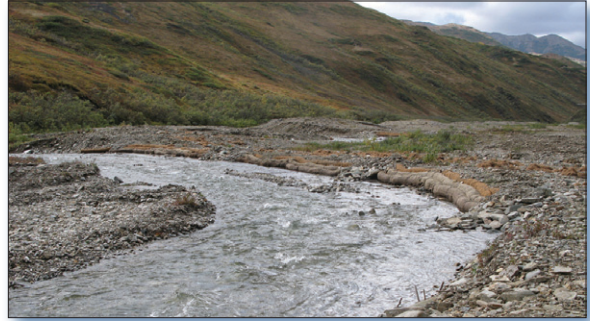
Figure 4. In 2010 NPS reinforced previously restored curves in the main channel with coir logs (background) and rock vanes (foreground).

In 2010 NPS implemented additional restoration efforts with the help of contracted specialists at Hydraulic Mapping and Modeling (design), Environmental Compliance Consultants and Oasis Environmental (construction). They widened and smoothed the upper portion of the disturbed floodplain (last mined in the mid-1980s), creating a relief channel for flood events. They also reinforced some previously restored curves in the main channel of Caribou Creek (Figure 4).
