RCRA Compliance Evaluation Inspection

Siemens Water Technologies Corporation

June 22, 2009

July 29, 2009

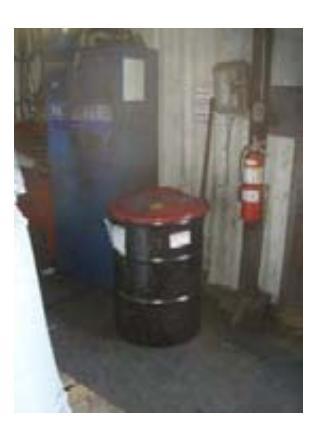
In addition to the containers of spent carbon from offsite facilities pending regeneration, the inspectors observed one 55-gallon satellite accumulation container for warehouse debris, dated 6/12/09, in this area (see photograph to the right). No potential violations were noted.

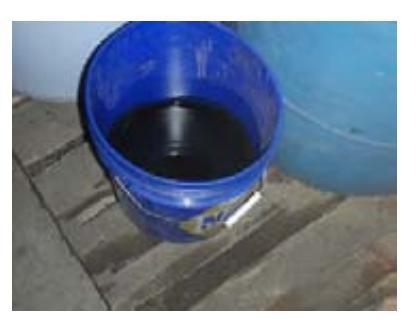
• One 5-gallon container of used oil (approximately 1/5 full) that was not labeled as used oil. This container was added to the properly labeled 55-gallon used oil container during the inspection.

Findings: The inspectors observed one 5-gallon container of used oil that was not marked as required.

Facility Response: This issue was corrected during the inspection.

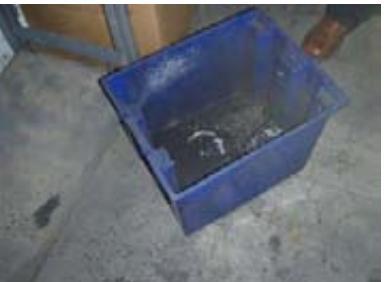
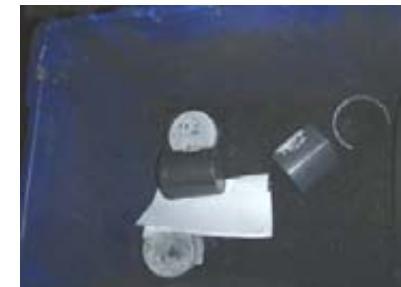
• Two open and unlabeled 5-gallon containers containing carbon from carbon samples (see photographs to the right). The carbon from these

containers was properly managed during the inspection.

Findings: The inspectors observed two containers of spent carbon samples that were open at the time of the inspection.

- Findings: The inspectors observed two containers of spent carbon samples that were not labeled at the time of the inspection.
- Facility Response: This issue was corrected during the inspection.

Facility Response: This issue was corrected during the inspection.

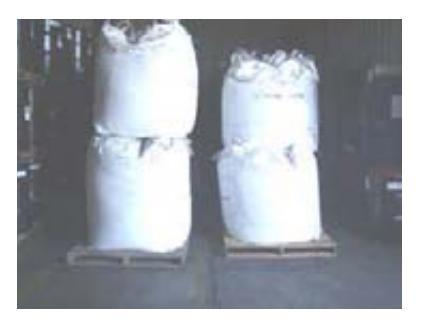
The inspectors noted that the aisle space between two of the rows in the warehouse was small (i.e., smaller than the aisle space distance marked on the floor between the other aisles (see photograph to the right). During the record review it was confirmed that the contents in these two rows were non-RCRA wastes. The inspectors recommended that Siemens maintain the same aisle space between all rows in the warehouse. No potential violations were noted.

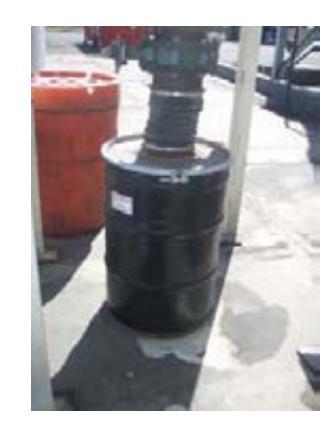
The container attached to the unit was dated March 24, 2009 (see photograph to the right). No potential violations were noted.

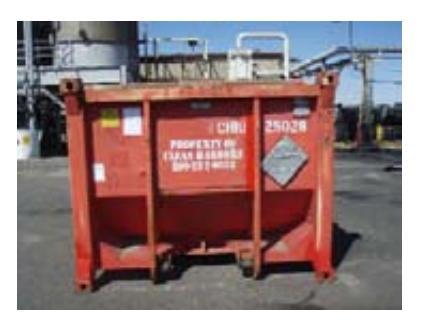
The 20-cubic yard roll-off bin was dated June 12, 2009 (see photograph to the right). No potential violations were noted.

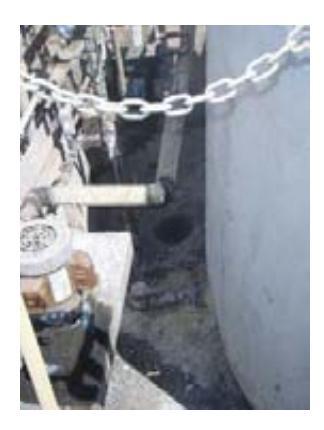
The inspectors observed some caustic residue from the product tank underneath one of the pipes (see photograph to the right). The inspectors informed the facility representative that this caustic should be cleaned up.

- Findings: The inspectors observed dried caustic waste underneath a pipe next to the caustic product tank.
- Facility Response: This area was cleaned up subsequent to the inspection.

Subsequent to the inspection, the facility representatives provided photographs showing that this issue was resolved.
