> Subject: Findings of Violations and Order for Compliance EPA Docket No. CWA-309(a)-11-006

Electrochem Solutions, LLC 32500 Central Avenue Union City, CA 94587 Docket No. CWA 309(a)-11-006

FINDINGS OF VIOLATION AND ORDER FOR COMPLIANCE

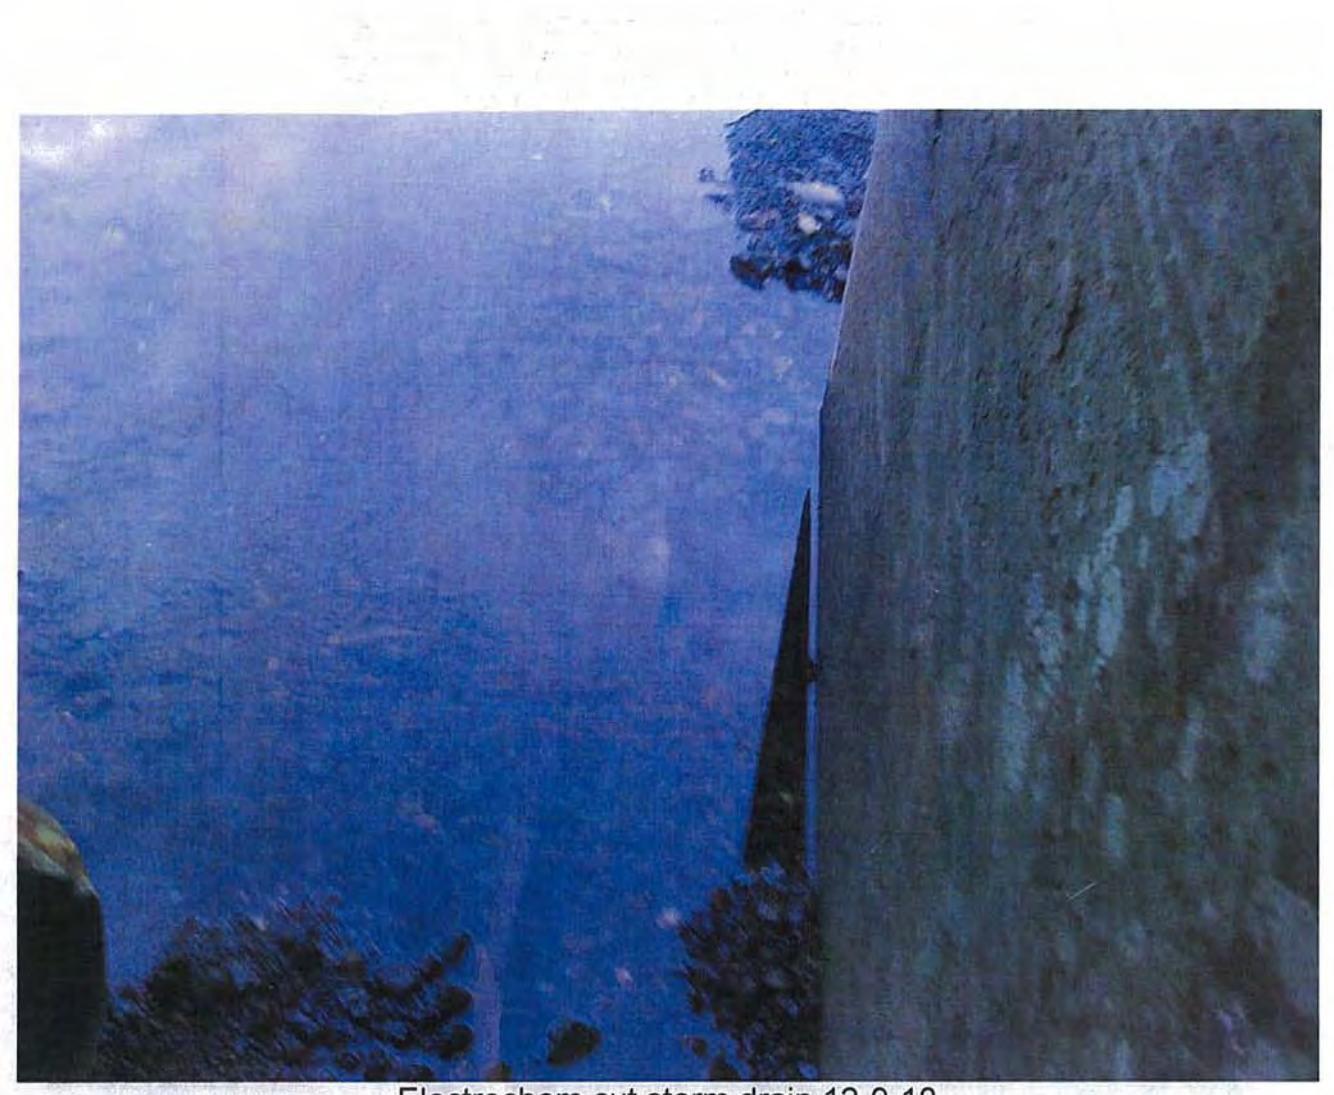
Electrochem cut storm drain 12-9-10

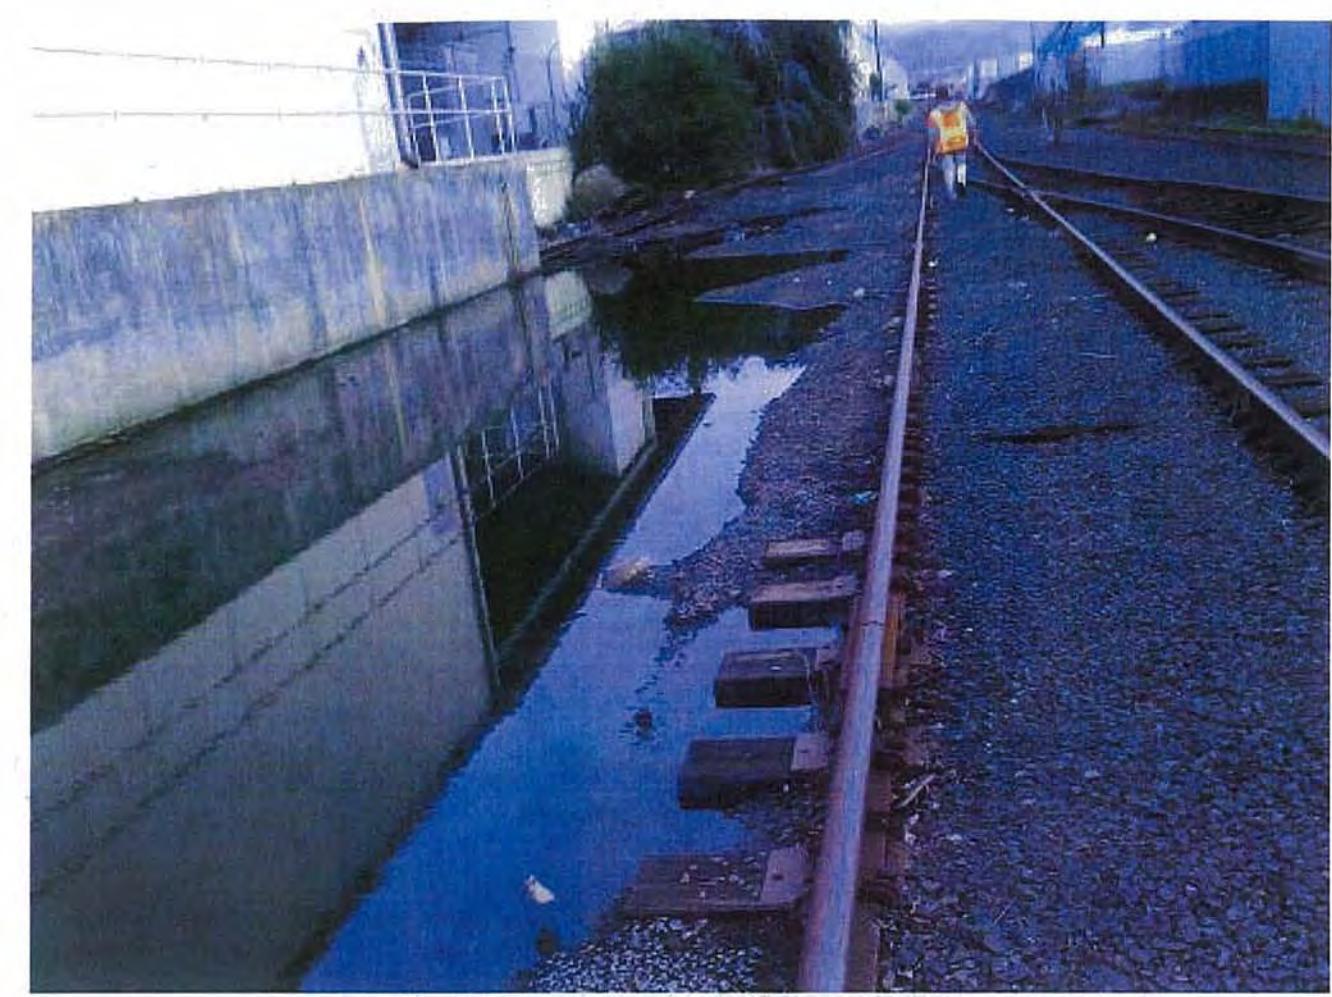
Storm water ponding rail spur 12-9-10

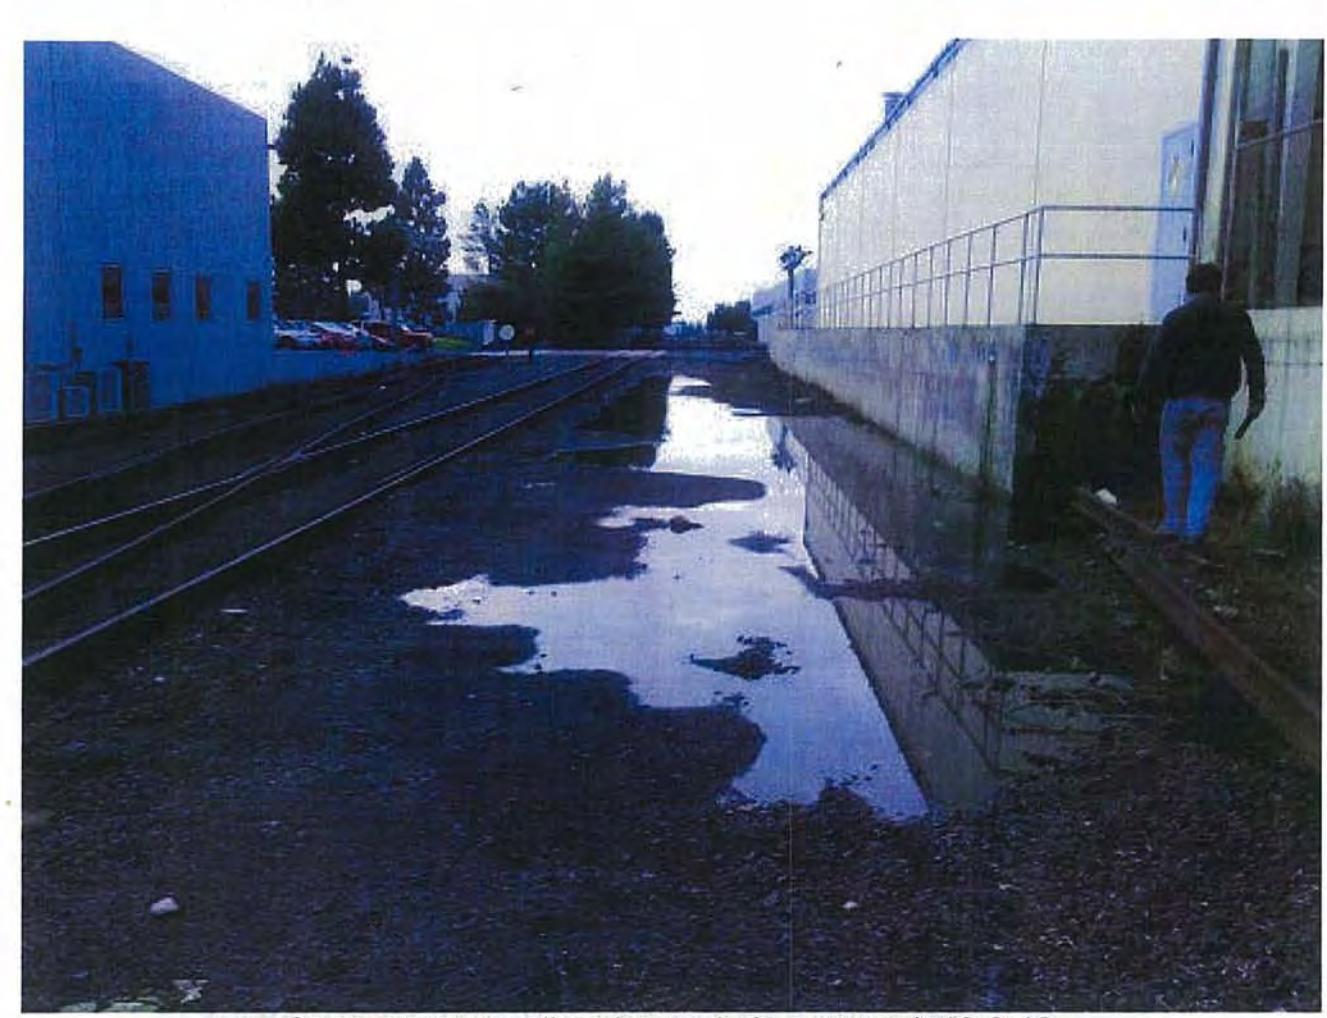
Storm water ponding due to drain cut at exit 12-9-10

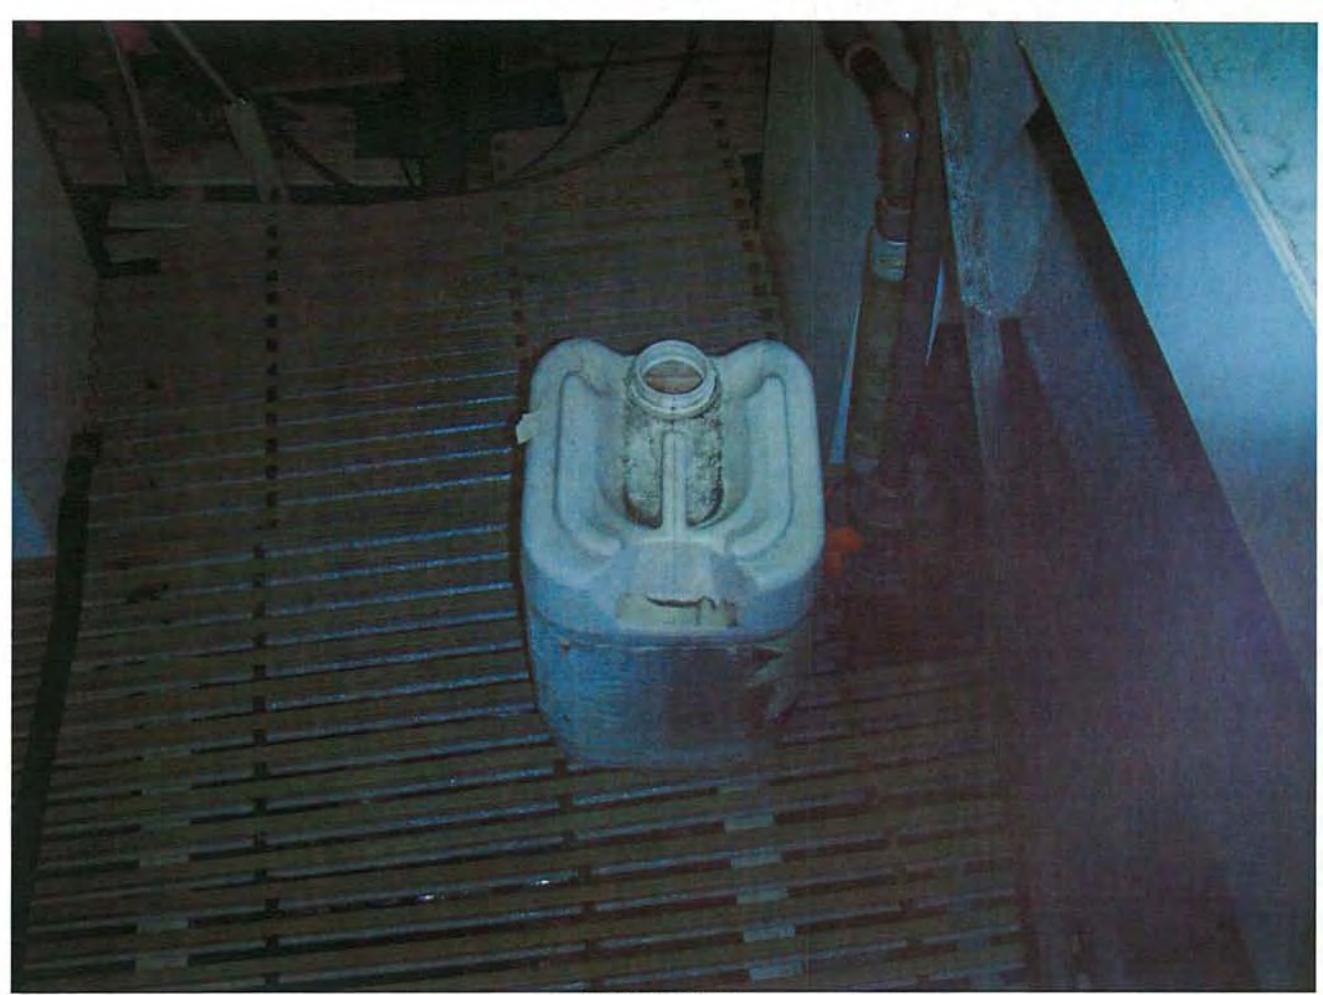
PC030023

- 022. Anodizing Area: An open 5-gallon container of unknown substance.
- 023. Anodizing Area: Open cut top 55-gallon container labeled "waste water." Facility representative stated it was placed in the location to collect rain water from a leak in the roof.

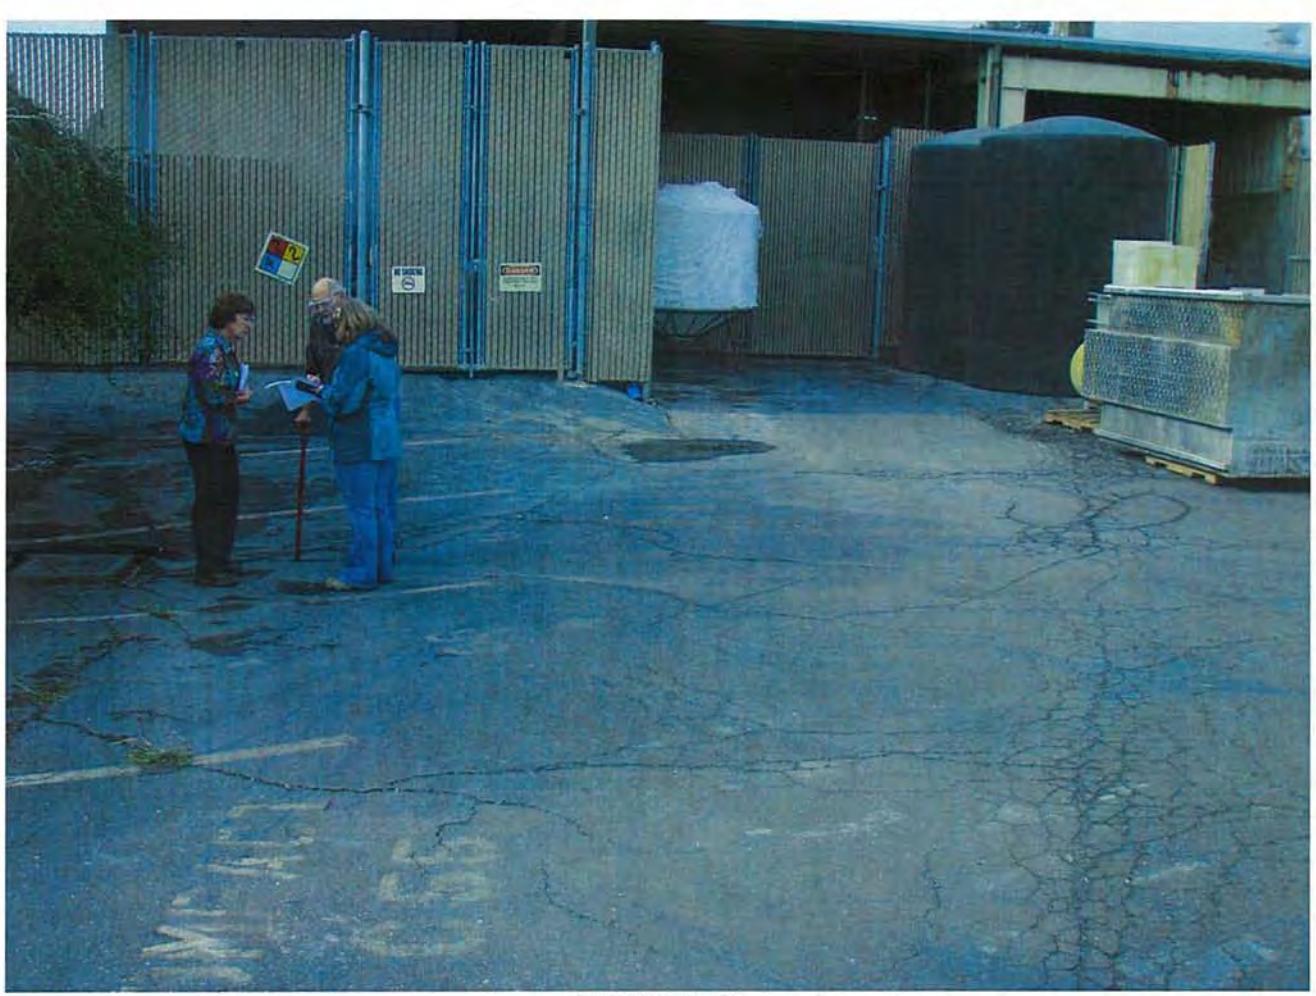
PC030058

General Yard: The pavement throughout the yard was generally deteriorating, especially the area around the eastern storm drain (see Attachment 3: PC030056-060). Additionally, obsolete equipment was stored throughout the yard, with a heavy concentration along the southeastern end of the property (see Attachment 3: PC030061-069). Old process tanks were located in this area. Attachment 3: PC030069 shows an old processing tank approximately ¹/₄ full of unknown material.

- 058. Outdoor Area: storm drain approximately 30 feet from the back of the building.
- 059. Outdoor Area: View of storm drain in relationship to the building. Closest part of the building is the Less than 90-day Hazardous Waste Accumulation Area (Waste Chemical Storage).

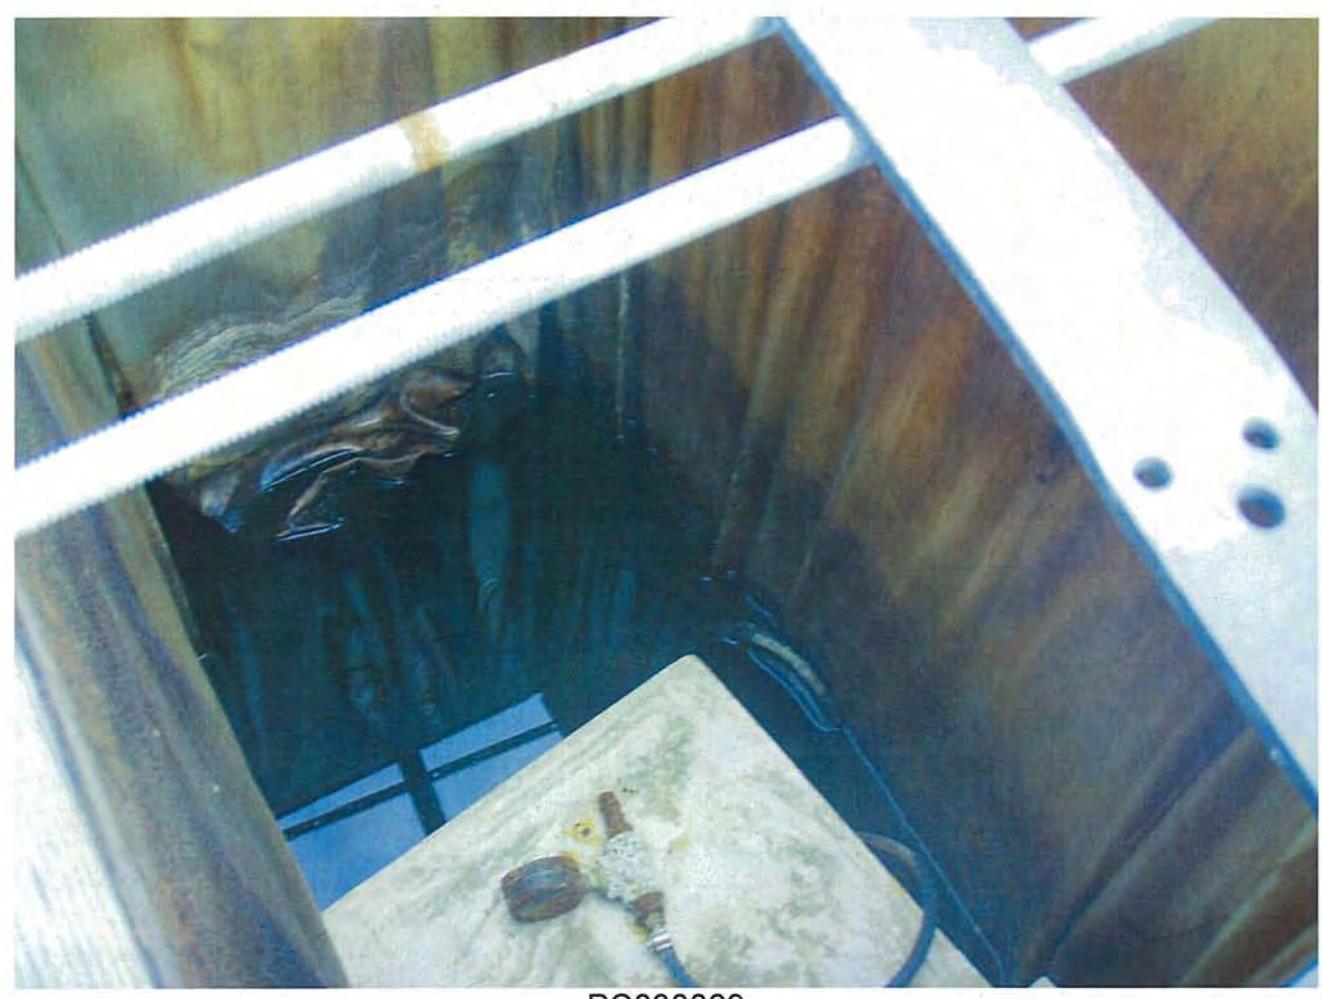
PC030071

- 071. Water Treatment and Equipment Area: Close up of pH meter. Note: the pH meter is not functioning.
- 072. Less than 90-day Hazardous Waste Accumulation Area (Waste Chemical Storage): Areas is lined. There are approximately thirty 55-gallon containers and approximately two 5-gallon containers in the photograph. Containers along the short wall are open and labeled as "filters" and "liners." The floor in this area is stained, but lined. Many labels on the containers could not be read. One container label in view reads "nickel strip" and another states "gold alodine."

- 31. Within 45 days of the receipt of this Order, Respondent shall submit a report to EPA on the costs associated with: development of the revised SWPPP, projected incremental annual costs associated with implementation of the revised SWPPP, and any other costs associated with complying with this Order, including costs to repair and calibrate the pH meter.

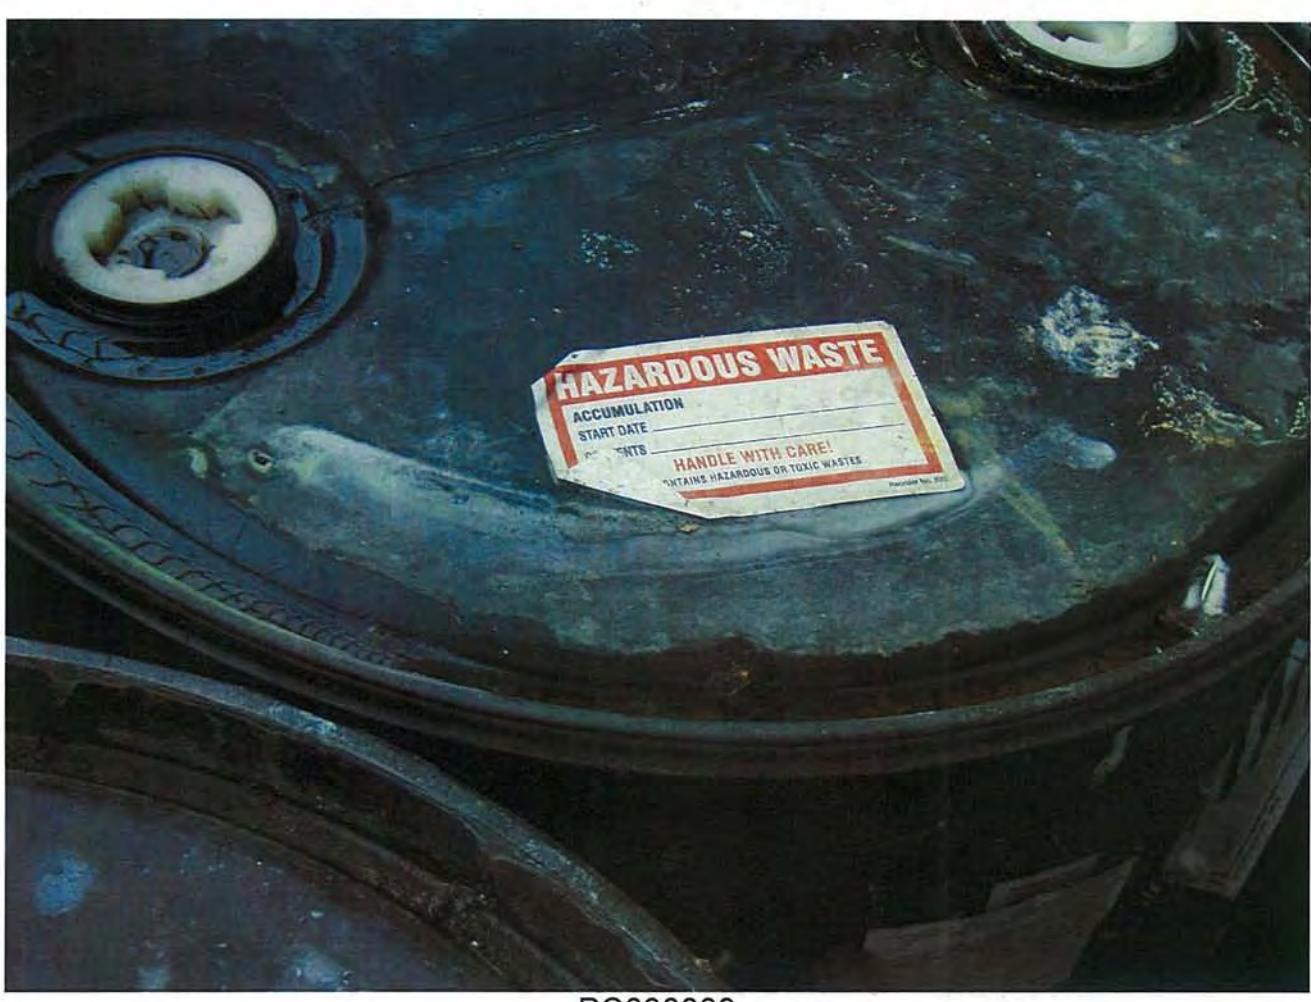
PC030089

- 089. Less than 90-day Hazardous Waste Accumulation Area (Waste Chemical Storage): Same 55-gallon container in photograph 084. Note that the container has liquid on top and is corroded (*photograph taken by John Schofield*).

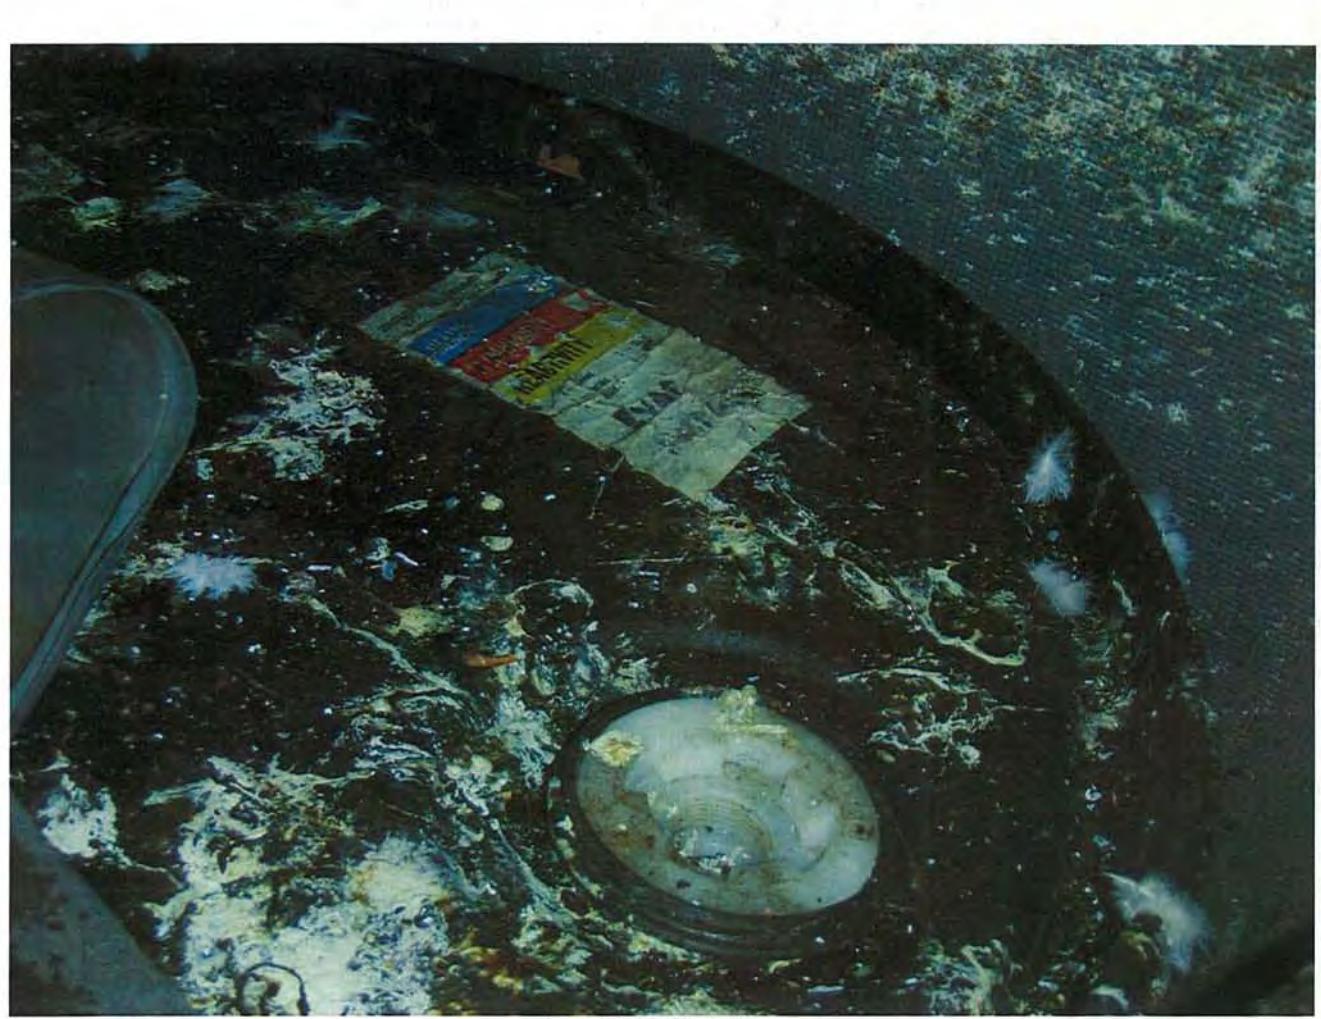
PC030090

- 090. Less than 90-day Hazardous Waste Accumulation Area (Waste Chemical Storage): 55-gallon container is covered with bird waste. Label is smudged (*photograph taken by John Schofield*).
