## Weekly Field Report Week: 11-24-13 through 11-30-13 New Bedford Harbor Lower Harbor CAD Cell (LHCC)

This Weekly Field Report was prepared to serve as a summary of field activities conducted throughout the week for Phase I dredging of the New Bedford Harbor Lower Harbor CAD Cell (LHCC) in New Bedford, Massachusetts.

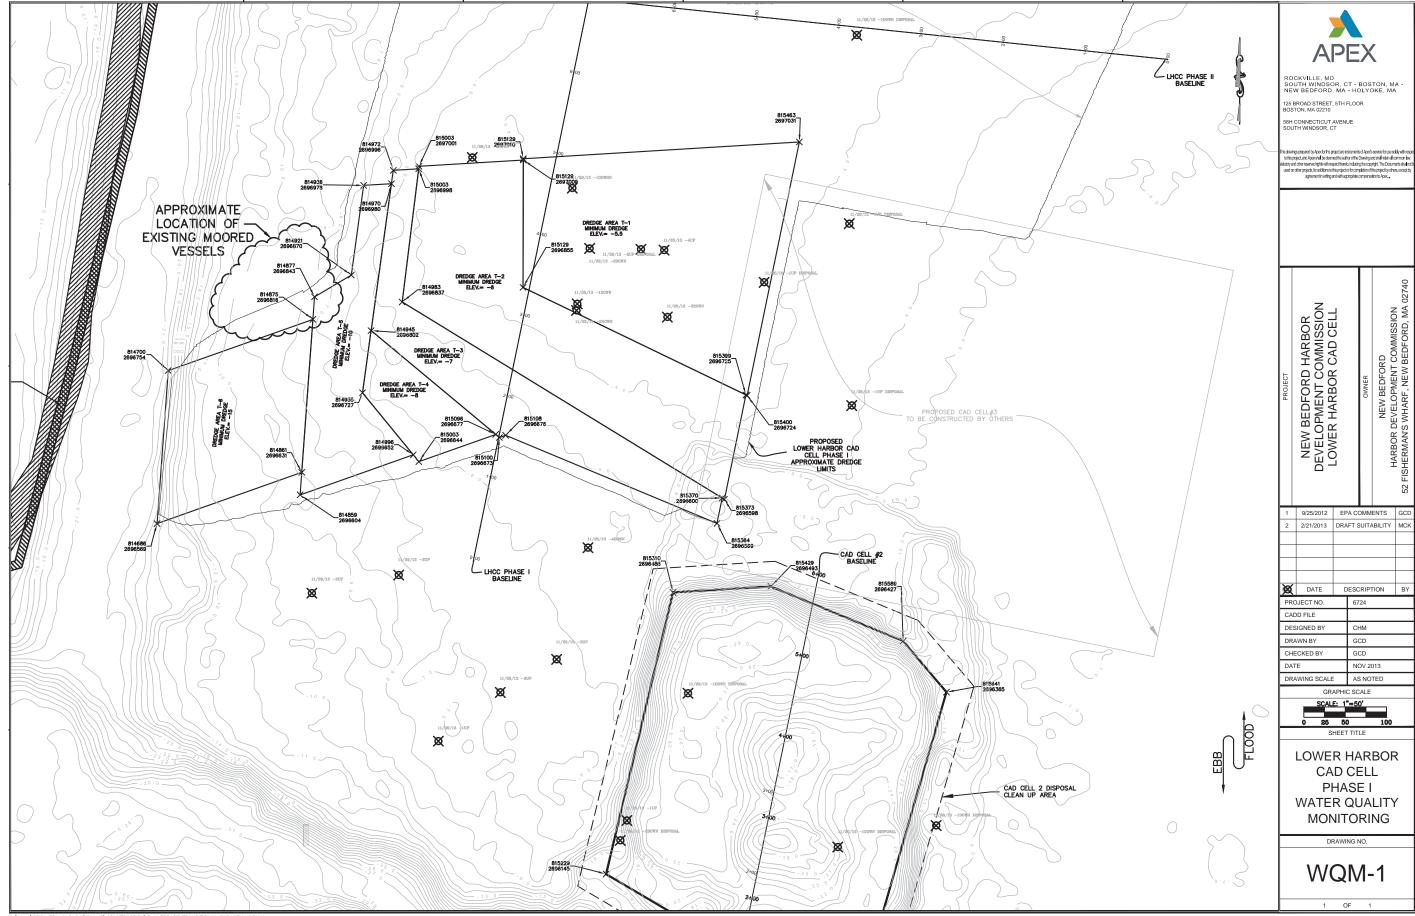
## Figure 1 Lower Harbor CAD Cell Phase I – Water Quality Monitoring

- Water Quality Monitoring Forms completed for the week of November 24<sup>th</sup> through November 30<sup>th</sup> are attached (Attachment 2). Included with the attached forms is Figure 1 *Lower Harbor CAD Cell Phase I Water Quality Monitoring Plan*, which shows the locations of the water quality monitoring events conducted during this reporting period. Per the approved Water Quality Monitoring Plan and associated performance standards for the dredging efforts being conducted during this reporting period Apex has;
