**Subject: CERCLA Emergency Response Action Report
Bio-Labs, Inc.
Conyers, Rockdale County, Georgia
EPA Contract No. 68-W-00-120
TDD No. 4T-04-05-B-006**

**CERCLA EMERGENCY RESPONSE ACTION REPORT
BIO-LABS, INC.
CONYERS, ROCKDALE COUNTY, GEORGIA
EPA CONTRACT NO. 68-W-00-120
TDD NO. 4T-04-05-B-006**

**CERCLA EMERGENCY RESPONSE ACTION REPORT
BIO-LABS, INC.
CONYERS, ROCKDALE COUNTY, GEORGIA**

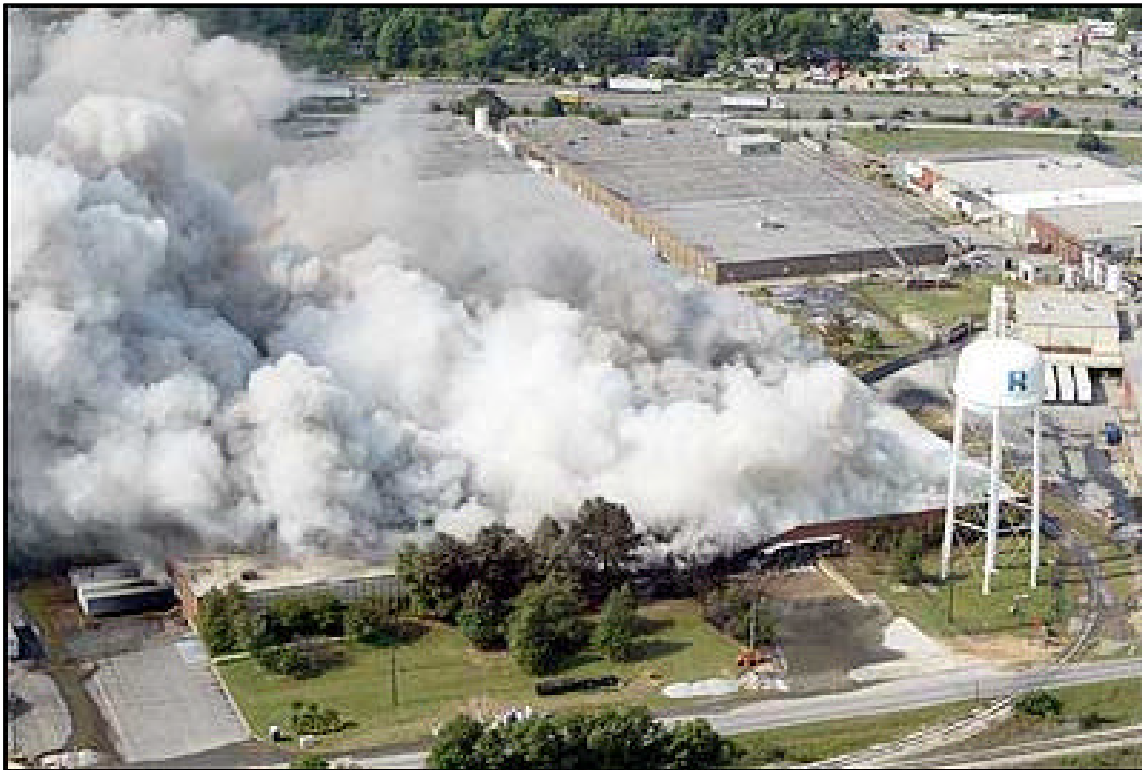
OFFICIAL PHOTOGRAPH NO. 1
U.S. ENVIRONMENTAL PROTECTION AGENCY

Subject: Smoke plume originating from Plant Warehouse 14. Note: Old Covington Highway is in the lower right portion of the photograph.

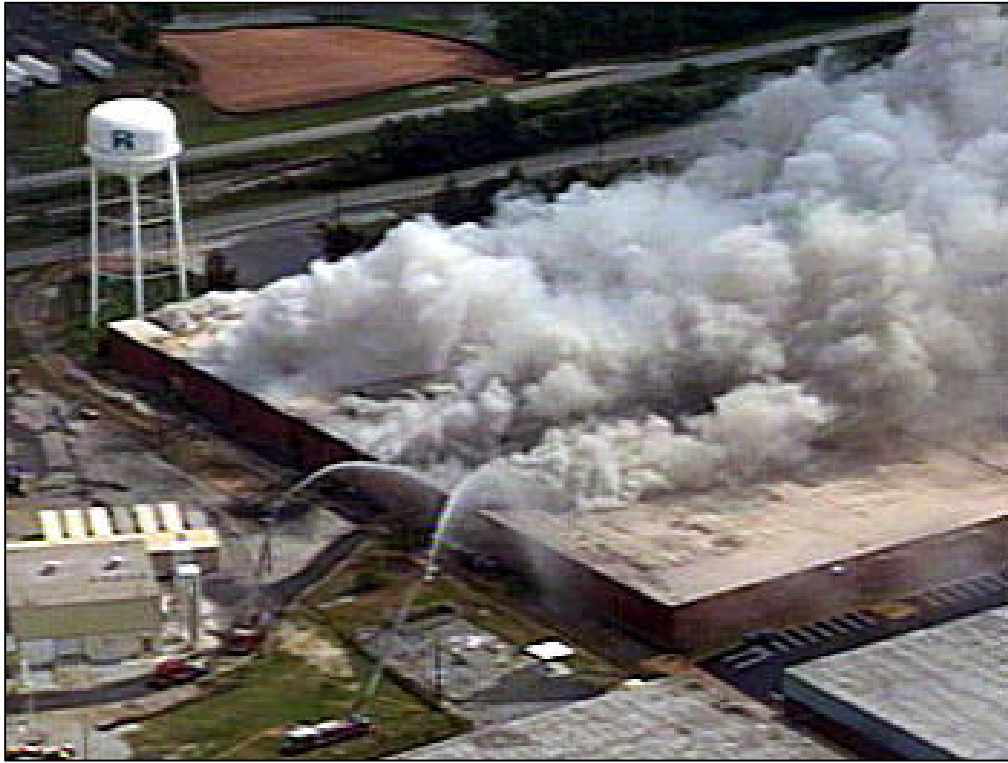
OFFICIAL PHOTOGRAPH NO. 2
U.S. ENVIRONMENTAL PROTECTION AGENCY

Subject: Firefighters dousing Plant 14 Warehouse with water. Note: Old Covington Highway (top of photograph) and Rockdale Industrial Boulevard (extreme top) are shown in the background.

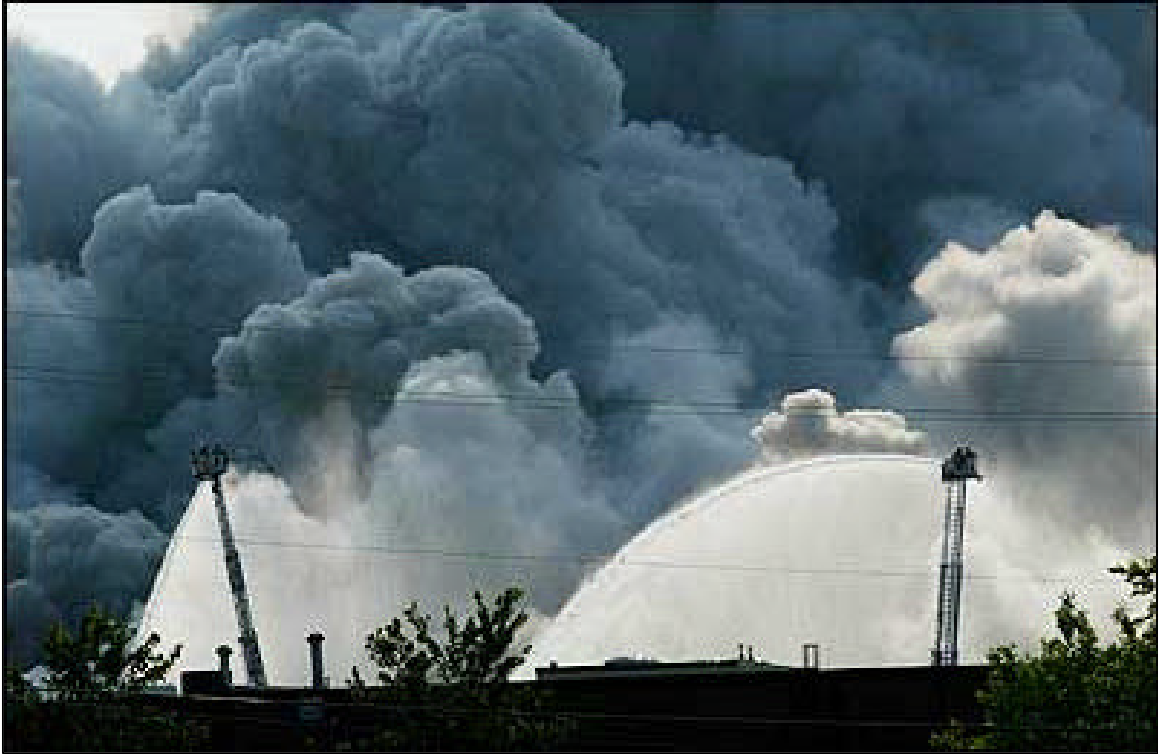
OFFICIAL PHOTOGRAPH NO. 3
U.S. ENVIRONMENTAL PROTECTION AGENCY

Subject: Firefighters using ladder trucks to spray water on the fire.

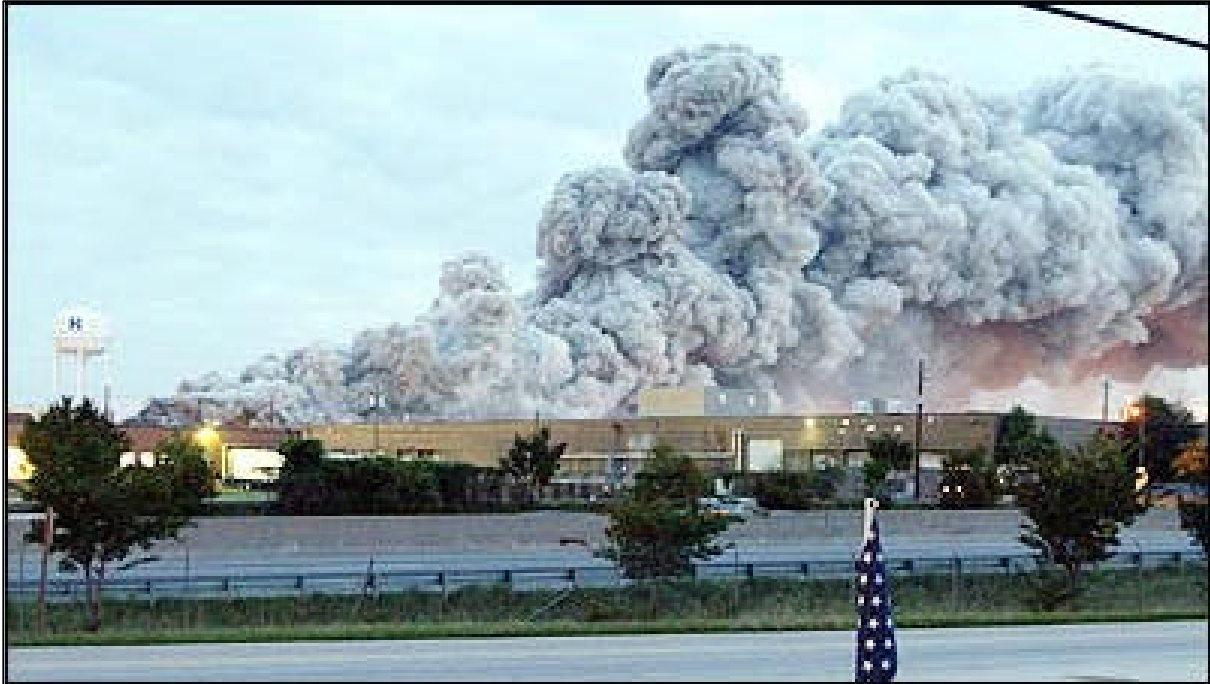
OFFICIAL PHOTOGRAPH NO. 4
U.S. ENVIRONMENTAL PROTECTION AGENCY

Subject: Smoke plume parallel to Interstate 20 (foreground).

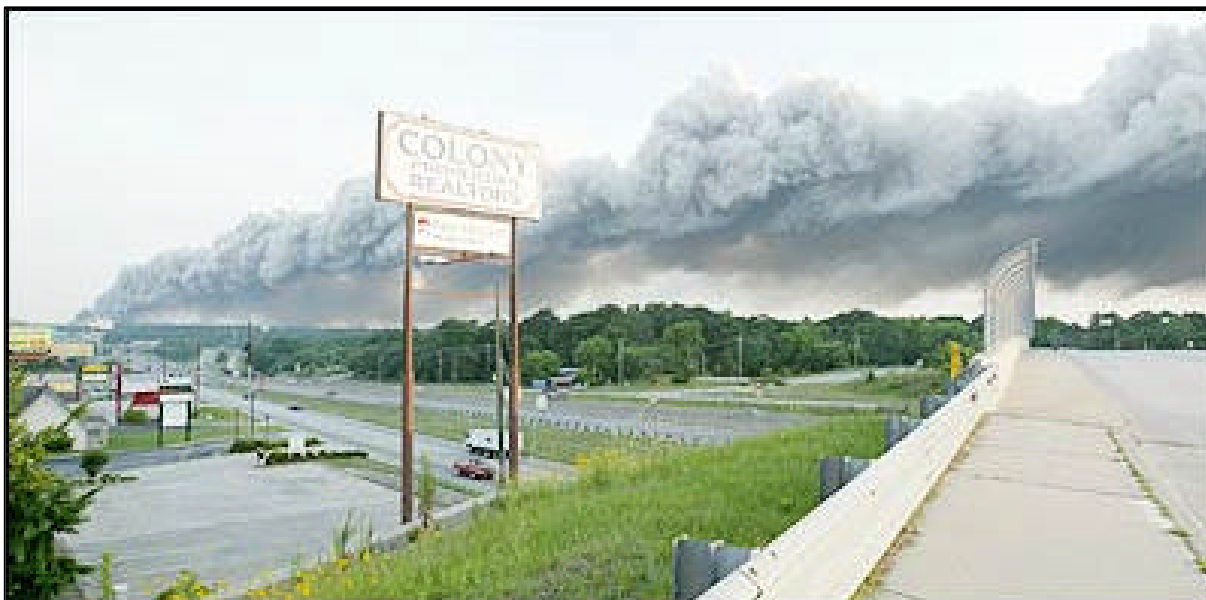
OFFICIAL PHOTOGRAPH NO. 5
U.S. ENVIRONMENTAL PROTECTION AGENCY

Subject: Upwind view of the smoke plume.

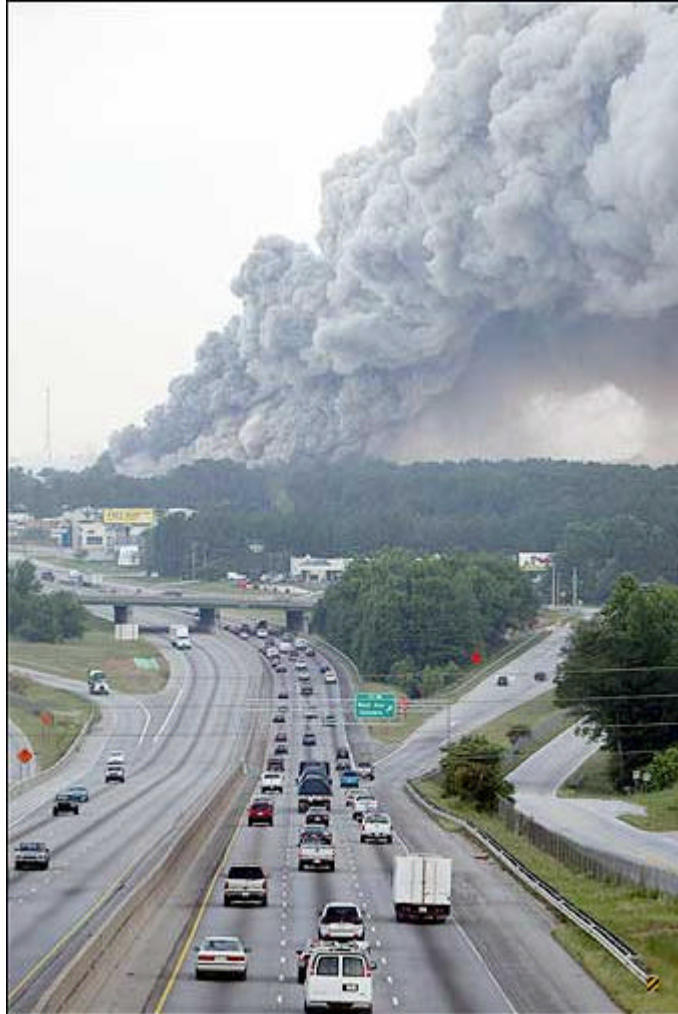
OFFICIAL PHOTOGRAPH NO. 6
U.S. ENVIRONMENTAL PROTECTION AGENCY

Subject: Upwind view of the plume as seen from the Bernie Bourdon Bridge.

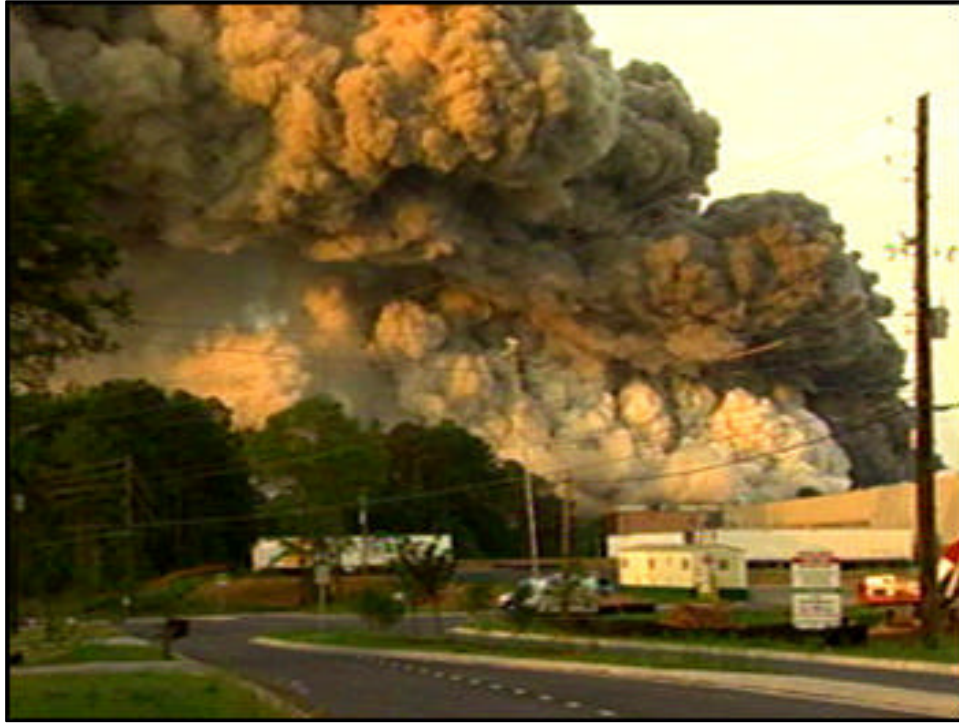
OFFICIAL PHOTOGRAPH NO. 7
U.S. ENVIRONMENTAL PROTECTION AGENCY

Subject: Color changes in the smoke plume.

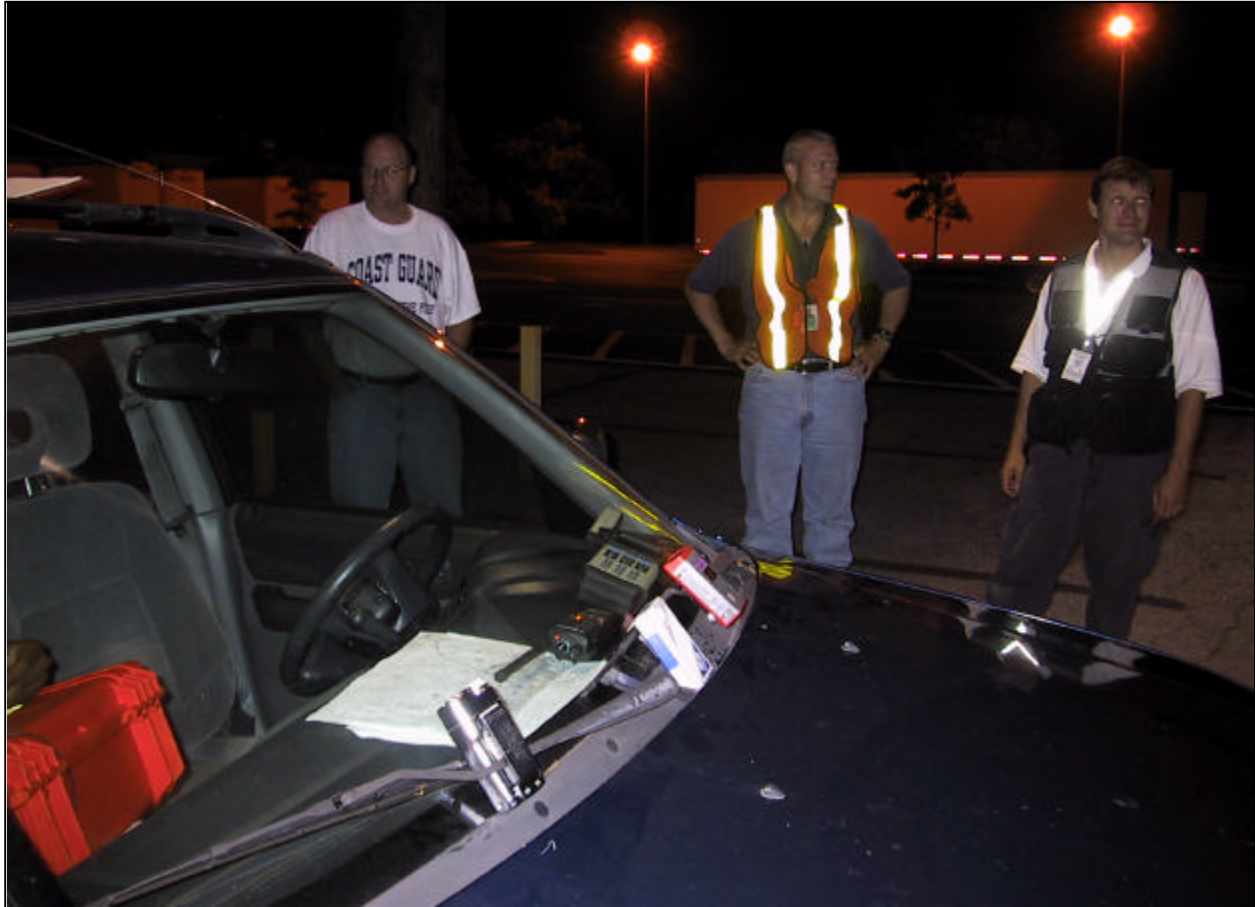
**OFFICIAL PHOTOGRAPH NO. 9
U.S. ENVIRONMENTAL PROTECTION AGENCY**

Subject: Air monitoring equipment set up for collecting data from the plume. Note: Additional air monitoring equipment used by START and EPA is inside the vehicle, with the intake hoses deployed outside of the vehicle.

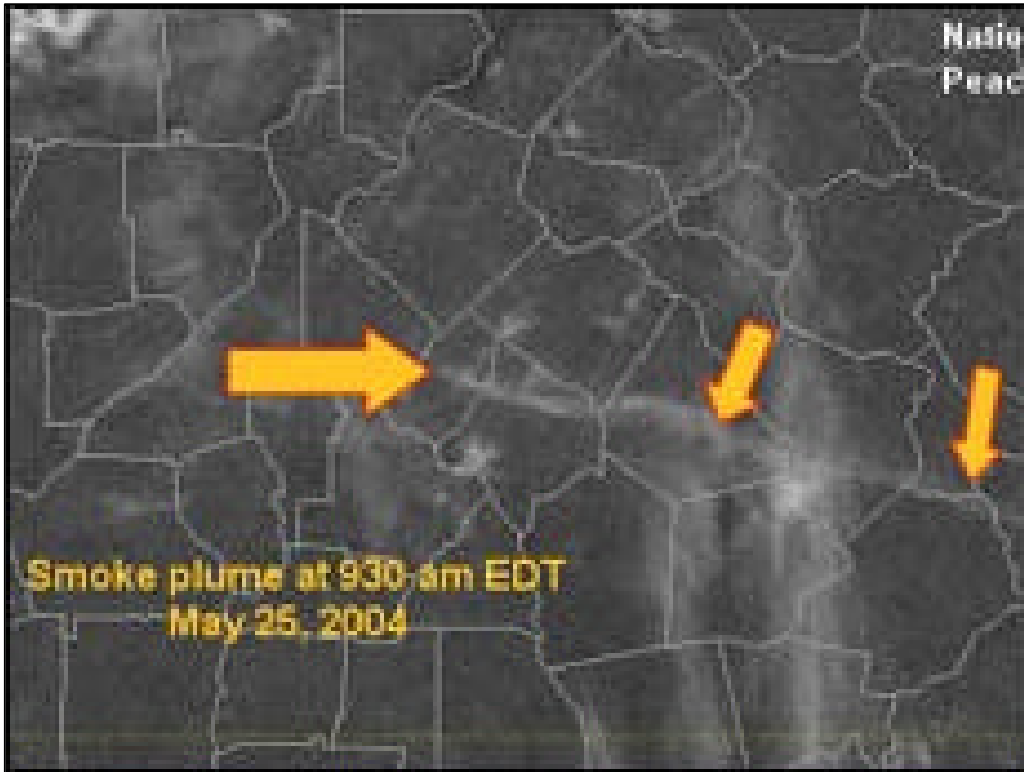
OFFICIAL PHOTOGRAPH NO. 10
U.S. ENVIRONMENTAL PROTECTION AGENCY

Subject: GOES Satellite image of the smoke plume.

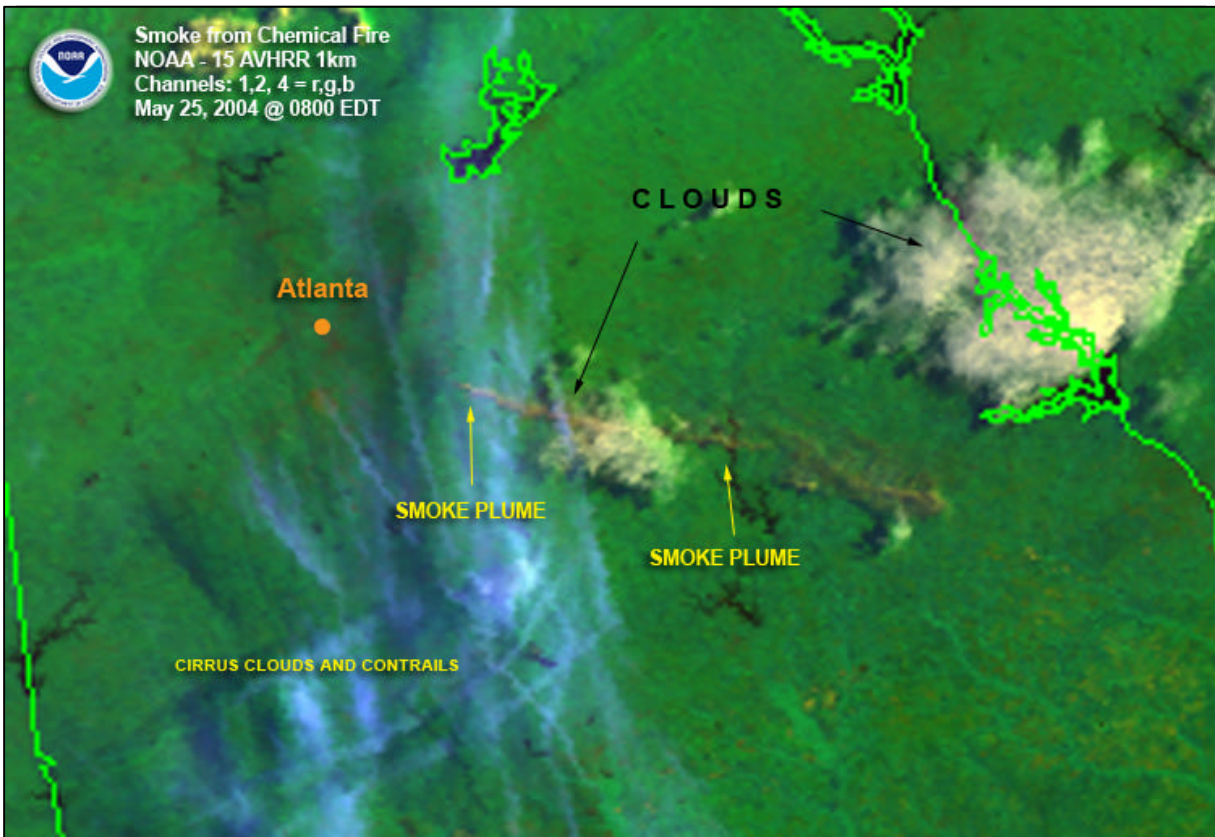
**OFFICIAL PHOTOGRAPH NO. 11
U.S. ENVIRONMENTAL PROTECTION AGENCY**

Subject: One kilometer spatial resolution satellite image of the smoke plume. Note: the smoke plume is well over 100 miles long from the origination point.
