Craters of the Moon Water Reduction

EPA Federal Green Challenge Webinar
February 26, 2015

Presented by Dwayne Moates & Dan Buckley

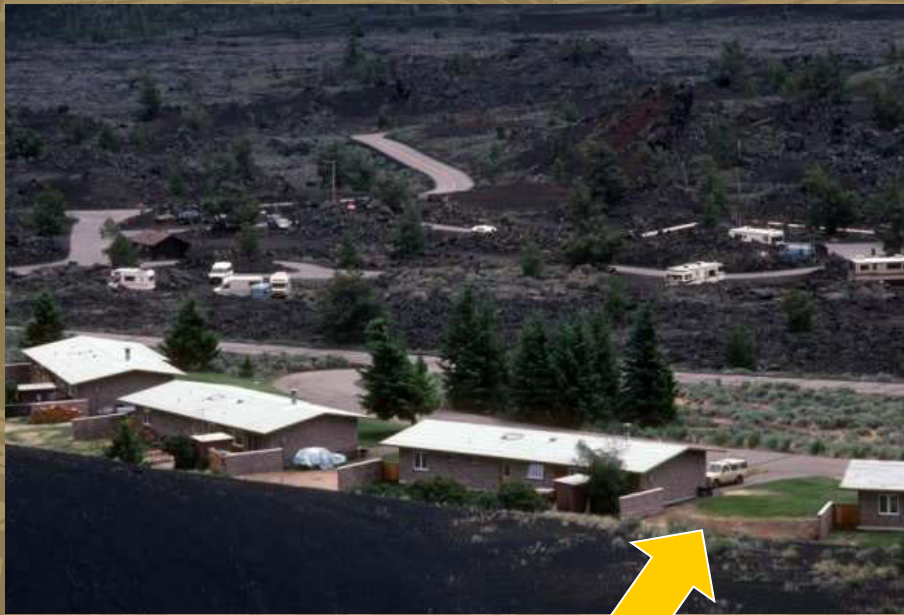
Went from this....

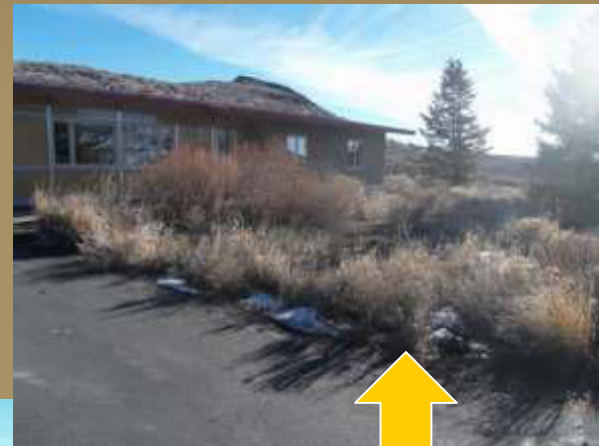
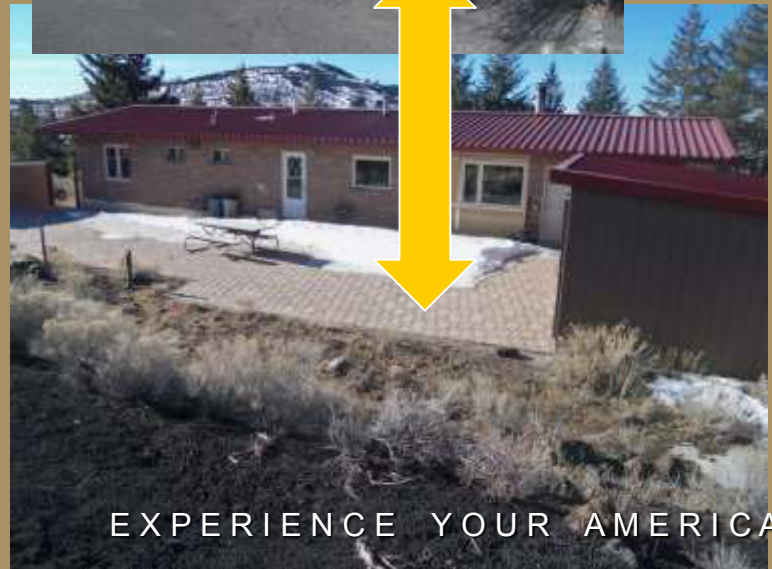
To this....

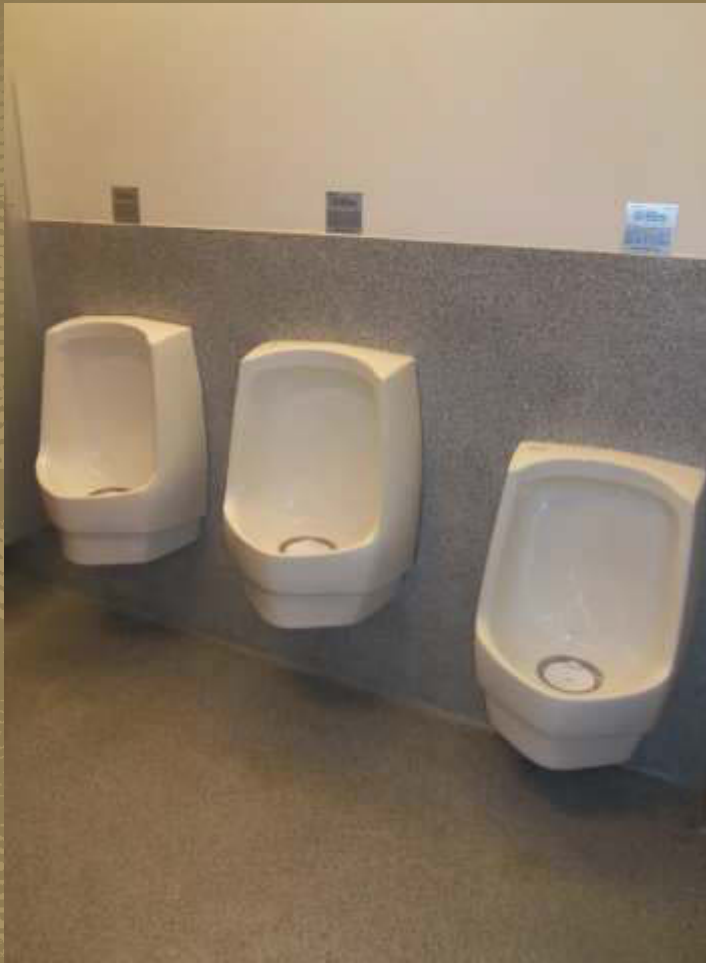
Touch-Free Hygienic

FALCON
WATERFREE
TECHNOLOGIES™

This facility is committed to protecting and preserving our environment. By using this touch-free, completely hygienic Falcon Waterfree system, you are helping the environment to conserve an average of 40,000 gallons of fresh water per urinal, per year.

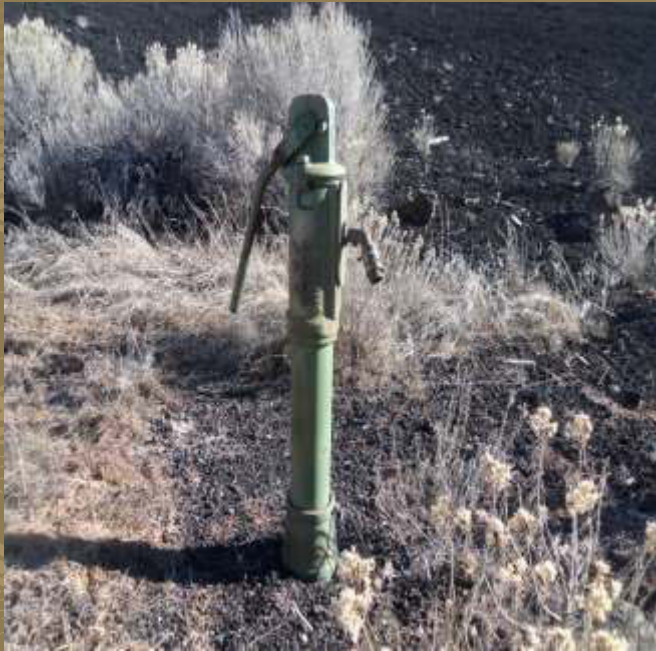
- Auto-closing hydrants & faucets
- Energy & water efficient appliances
- Water conservation messaging to employees & visitors

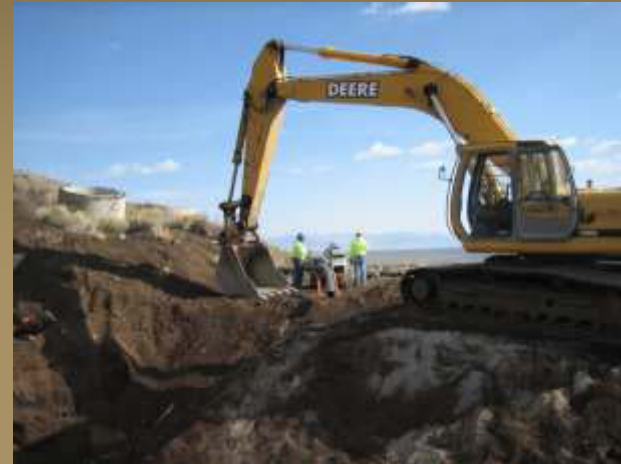
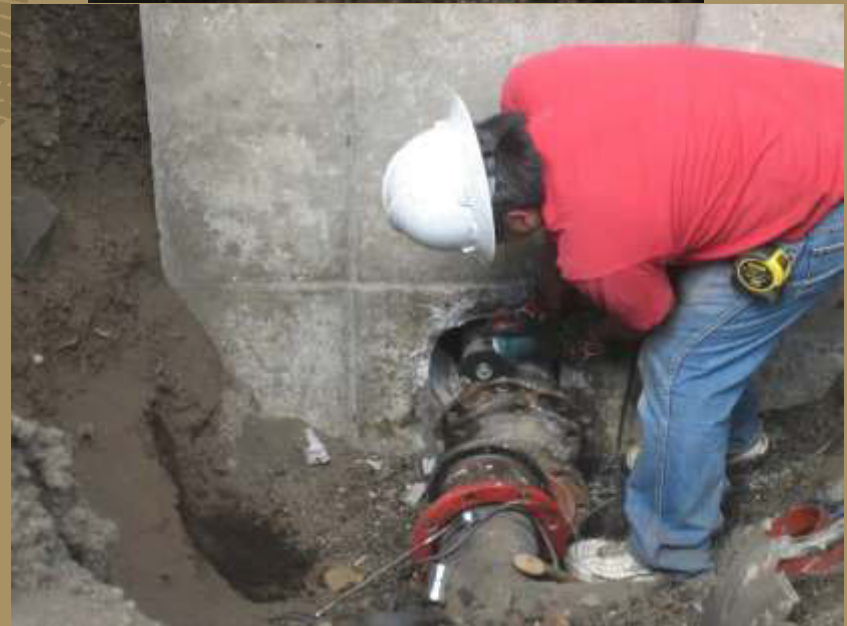
- Replaced over two miles of water lines
- Repaired/replaced valves and drains
- Began to suspect underground reservoirs...50K and 100K capacity tanks

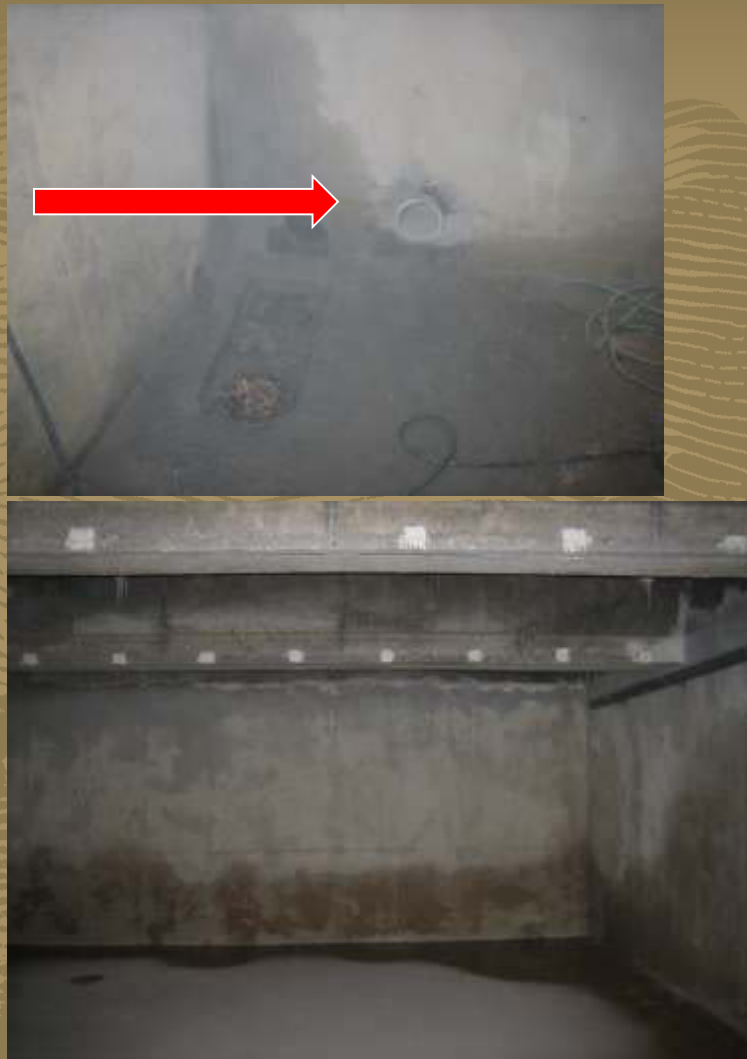
- No spalling or cracks
- Lava made it difficult to see leaks outside
- Suspected a **drain** at the bottom of the tanks.....replaced that, but still had 8500 gallons a day leaking....

- While washing the tanks, a contractor discovered water sprayed on one side of a baffle wall was leaking to the other side
- Still, no visible or obvious holes or cracks!
- Looking closer, tiny nearly microscopic holes in the concrete were detected.
- Not big holes, but many of them... any guesses how they got there?
- Rusted cable ties left in walls from the forming boards when the concrete tanks were built!
- 8500 gallons a day out numerous pinholes!

- Tanks were sprayed with new polyurea liner
- Reduced peak season water demand by 10gpm. (from 20 gpm to 15 to 5 gpm)
- Reduced park water needs by 2/3rds
- 75% reduction overall with the other previous projects included
