**TABLE ROCK LAKE WATER QUALITY  
DECENTRALIZED WASTEWATER  
DEMONSTRATION PROJECT**

*FINAL TECHNICAL REPORT*

*December 31, 2007*

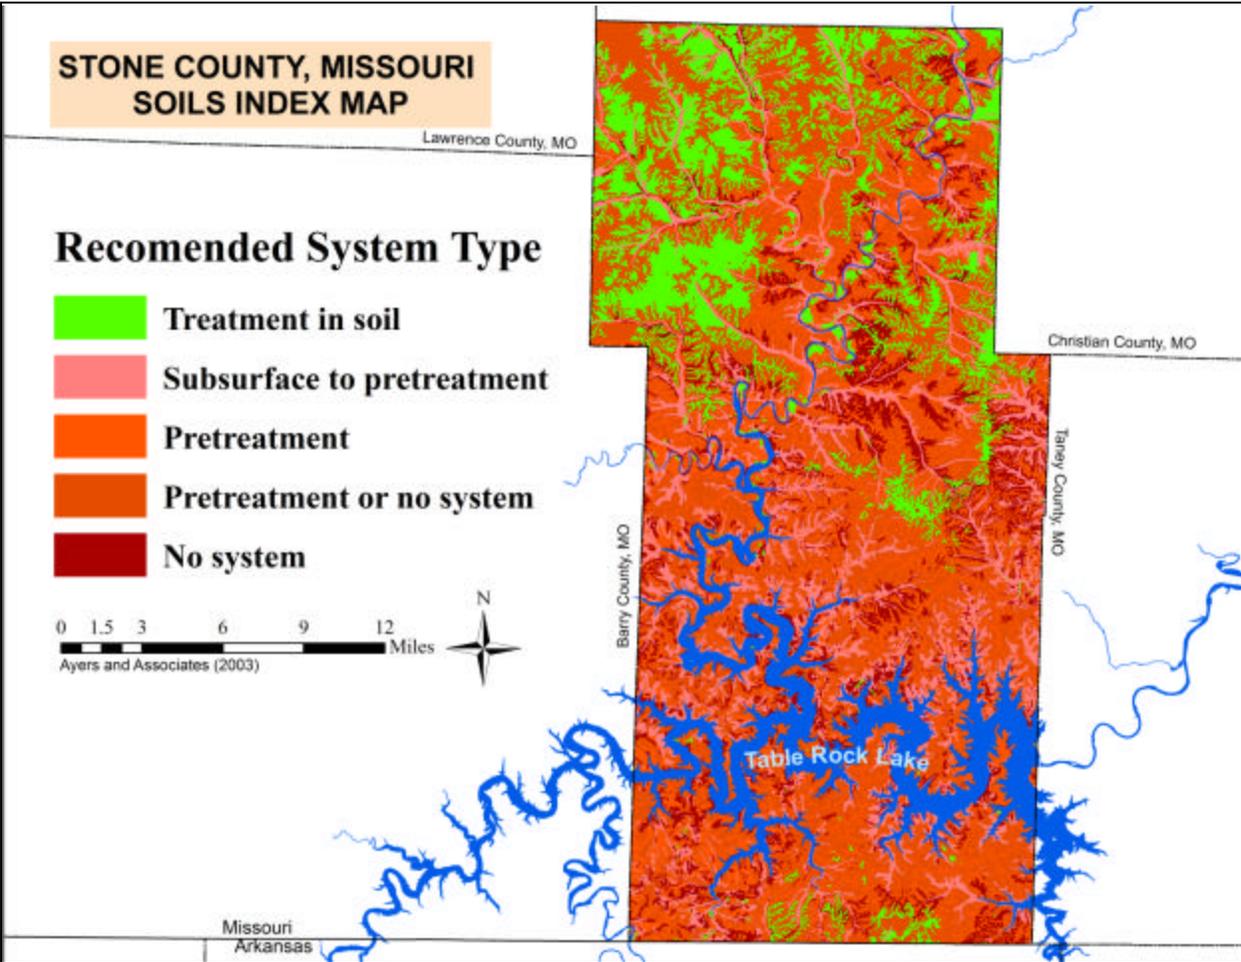
Figure 1.1: Stone County, Missouri soil potential map

However, the precision of the soil map or scoring system does not replace a soil survey and field investigation when installing a septic system. A soil profile study is needed to determine site-specific septic requirements while the soil potential map provides a general idea of what types of conditions to expect for areas in Stone County.

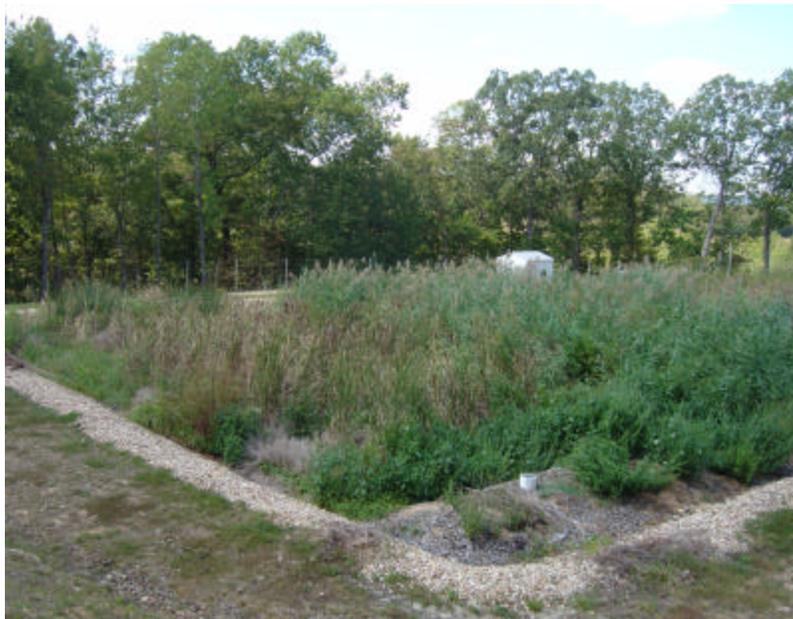
**Figure 3.1: Constructed wetlands systems treatment system**

Constructed wetlands simulate natural wastewater treatment systems and are designed to provide clean water discharge and prevent pollution to Table Rock Lake. These systems use raised flow beds to support water-loving plants. The roots of these plants help provide an aerobic environment to break down contaminants and absorb nutrients (Figure 3.1). Constructed wetlands can offer an affordable solution to wastewater for sites with failed conventional absorption fields or low soil absorption and percolation.

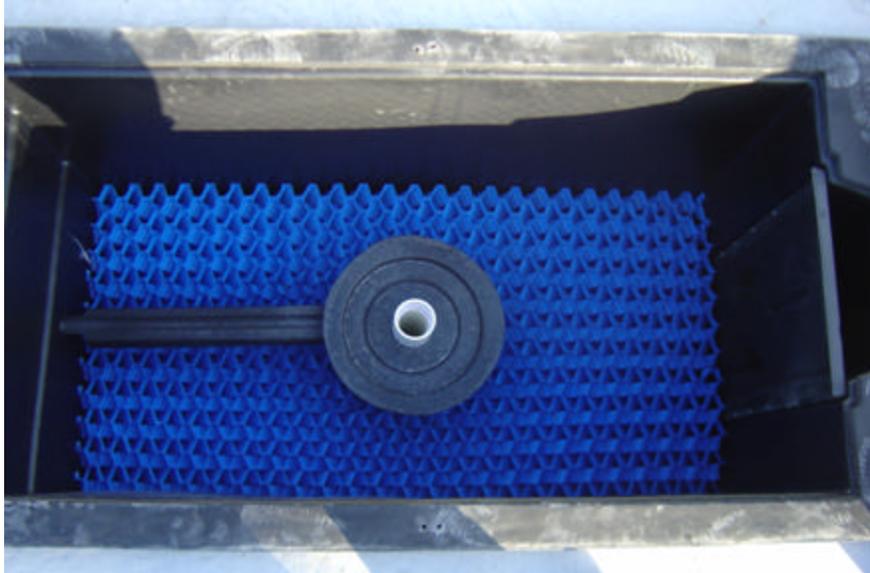
**Figure 3.2: Fixed film media for bio-microbial treatment colonies**

The first compartment of the two-compartment septic tank can be used as the primary settling zone. The second compartment houses the FAST treatment insert and is the aerobic zone. Two separate tanks can also be used as the settling tank and treatment tank. Once installed, the FAST system is low maintenance, clean, and odorless. The FAST wastewater treatment system is located below ground level and the aerating blower is placed in housing above ground. FAST technology is well suited for high strength waste, residential development, remediation of failing systems and severely limited sites such as those with poor or thin soils around Table Rock Lake. The innovative combination of the stability of fixed film media and the effectiveness of activated sludge through aeration treatment make FAST wastewater treatment reliable and environmentally sound.

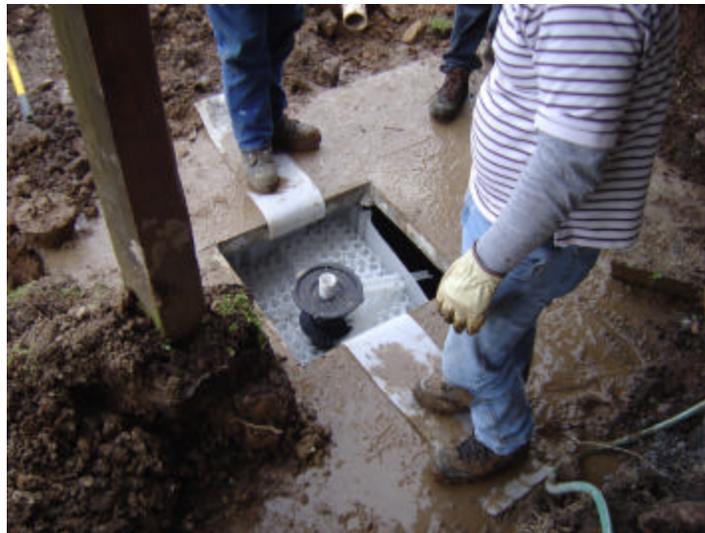
**Figure 3.4: RetroFAST unit installation in an existing septic system**

Many conventional systems or failed systems due to clogged lateral fields are good candidates for RetroFAST units. Upgrading an onsite wastewater treatment system with a RetroFAST unit may not only help prevent system failures, but may also greatly increase the treatment value of the system, protect the environment and increase the value of the property.

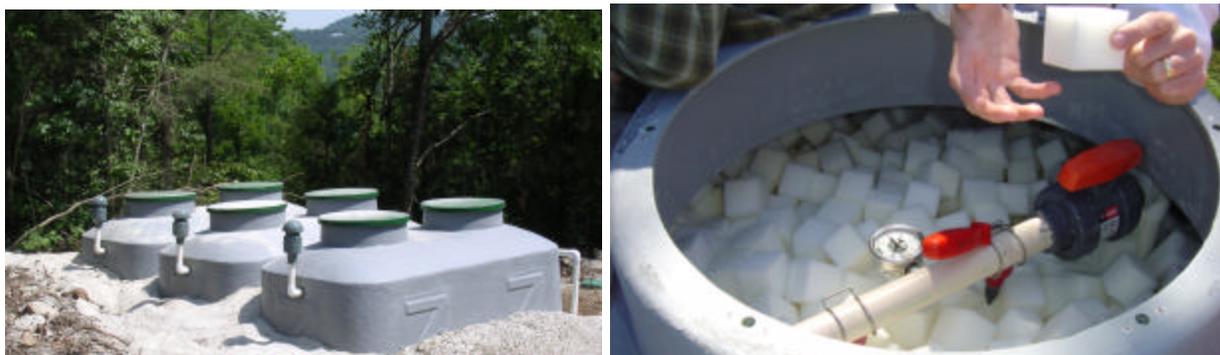
**Figure 3.5 ZABEL units and Foam cube filter.** Each lid opens up to a foam cube media filter and spray nozzle in the ZABEL wastewater treatment unit.

The design of the foam cube filter systems in alternative wastewater treatment systems is dependent upon equal distribution of the wastewater effluent over the entire surface of the foam cube filter units. However, the spray nozzles can become clogged in these systems which reduce the effectiveness of the filter by providing uneven effluent distribution. An advantage of the foam cube septic media system for wastewater treatment is its relatively easy maintenance with the clog prone top of the filter and nozzles easily accessible for removal or replacement. Another advantage is that this type of system can facilitate wastewater treatment on very small lots or even completely above ground where space or soil conditions do not permit a conventional tank system.

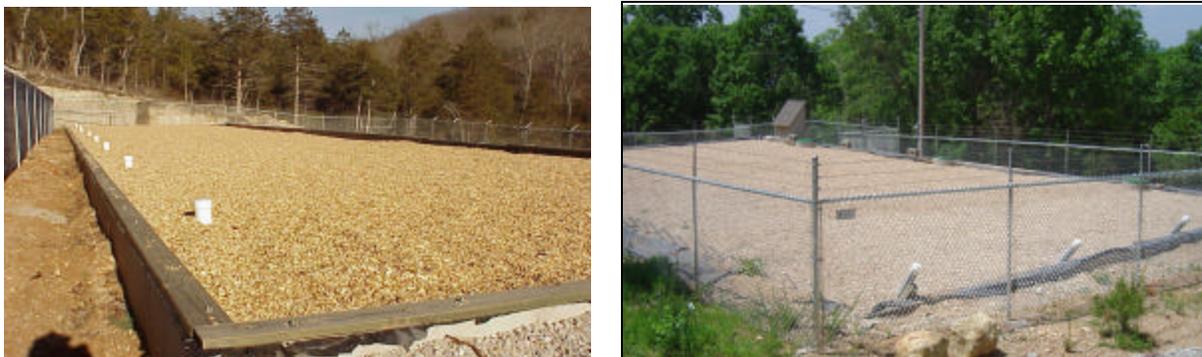
**Figure 3.6: Recirculating sand filters.** Large systems like the ones pictured can treat wastewater from a subdivision or housing complex.

Recirculating sand filters can be used for a broad range of applications, including single-family residences, large commercial establishments, and small communities. They are frequently used to pre-treat wastewater prior to subsurface infiltration on sites where soil has insufficient unsaturated depth above ground water or bedrock to achieve adequate treatment. RSF are primarily used to treat domestic wastewater, but they have also been used successfully in treatment trains to treat wastewaters high in organic materials such as those from restaurants and supermarkets. Sand filters are used on sites that have shallow soil cover, inadequate permeability, and limited land area. An advantage to RSF is that they provide very good effluent quality with over 95% removal of biochemical oxygen demand (BOD) and total suspended solids (TSS), along with significant reduction in nitrogen levels. A disadvantage to the sand filter is that maintenance on this type of system is needed frequently.

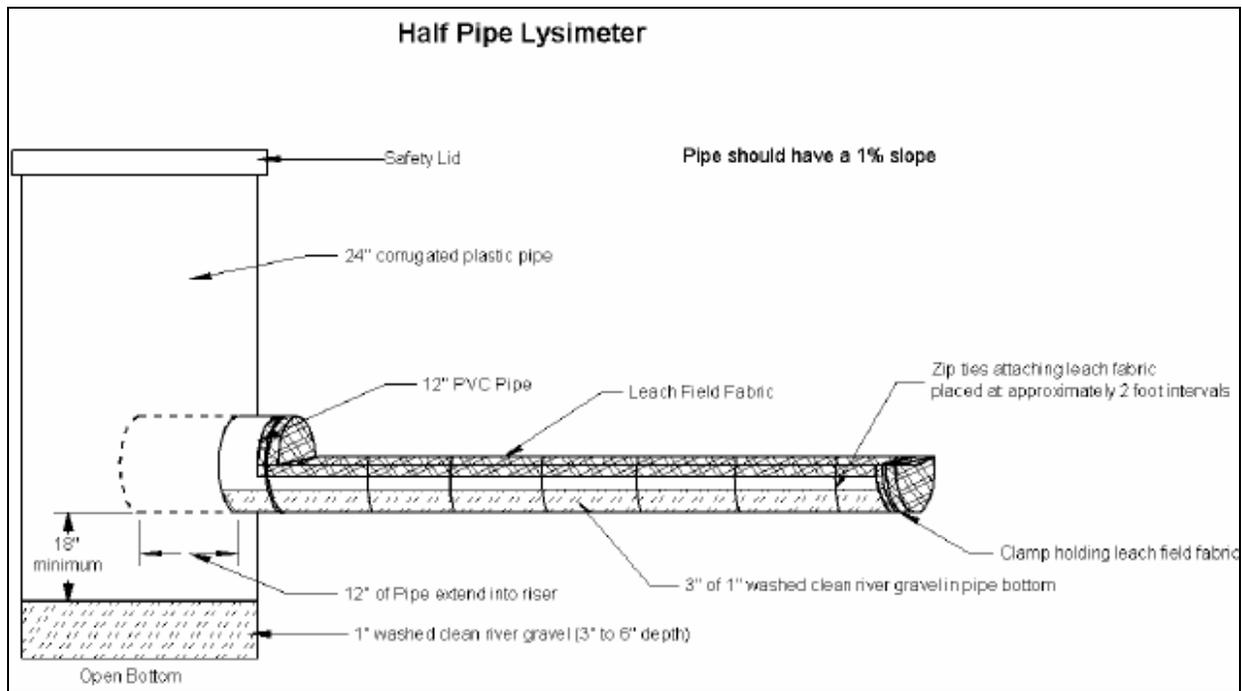
**Figure 4.3: Half-pipe lysimeter sketch**

The half-pipe lysimeters consisted of 12-inch PVC pipe that was cut in half lengthwise to create a 15 to 20 foot long trough under the drip tubing (Figure 4.3). The half pipe drained to a 24-inch corrugated polyethylene riser installed at the edge of the drip field. The bottom of the riser was open and filled with 3 to 6 inches of washed clean river gravel. The 12-inch pipe invert was approximately 18 inches above the gravel bottom of the riser. The pipe was inserted approximately one foot into the riser with a slope of approximately 0.5% to 1%. Once in place, the cracks around the 12-inch pipe (inside and outside of the riser) were sealed with silicone to keep soil from entering the riser. The half-pipe trough was filled with 3 inches of washed river gravel and covered with leach field fabric, which acts as a barrier layer keeping soil from entering the lysimeter. The fabric was cut large enough to overlap the ends and sides and clamped to the pipe at approximately two foot intervals. Half of a 5-gallon bucket was placed over the solid section of pipe near the riser to protect leach field fabric from being punctured. Drip lines were installed over the lysimeter following the addition of dispersal field soil. Figures 4.4 shows the installation and riser assembly of a half-pipe lysimeter.

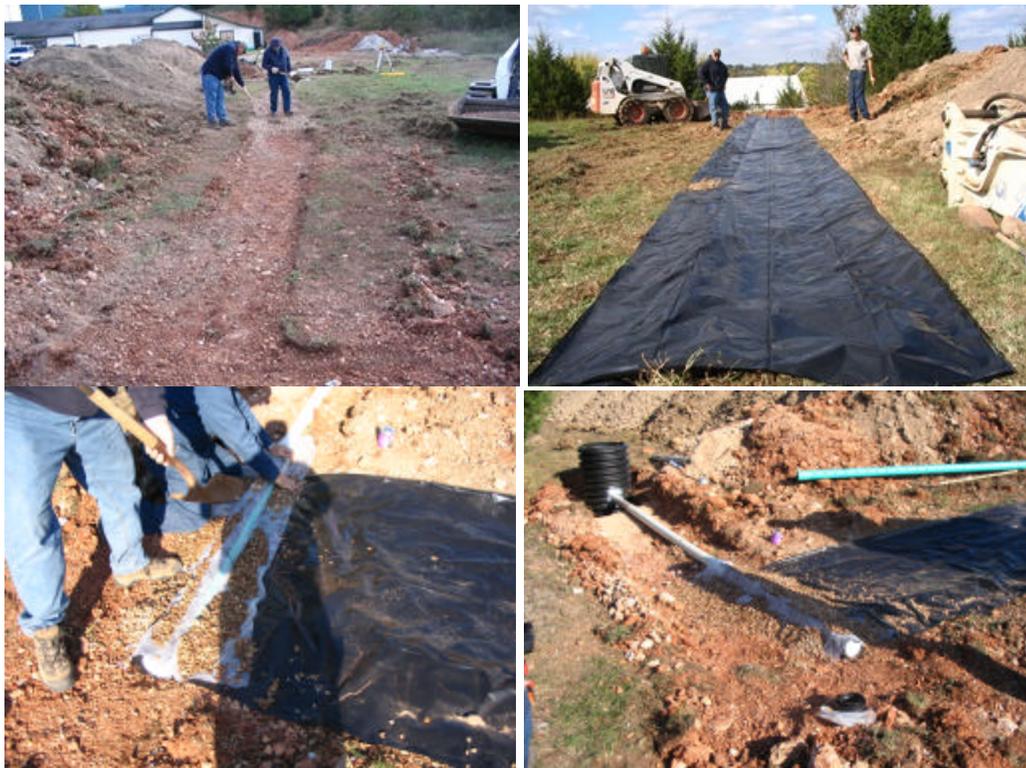
**Figure 4.5: Photographs of plastic sheet lysimeter installation**

The bottom of the collector channel was below the original grade to create a depressed area to pool subsurface water. Leach field fabric was wrapped around the pipe with extra fabric extended beyond the perforations and beyond the capped end. The excess plastic was wrapped around the pipe and attached to the apex with rubber weather stripping and screws. The remainder of the plastic was wrapped over the capped end of the perforated pipe and securely fastened around the solid wall pipe with the weather strip. Another piece of leach field fabric was laid over the pipe and sheeting and clean river gravel was poured over it to secure it in place prior to backfilling. The 4-inch collector pipe drained into a 24-inch corrugated polyethylene riser pipe where a sample container was placed to collect sample.

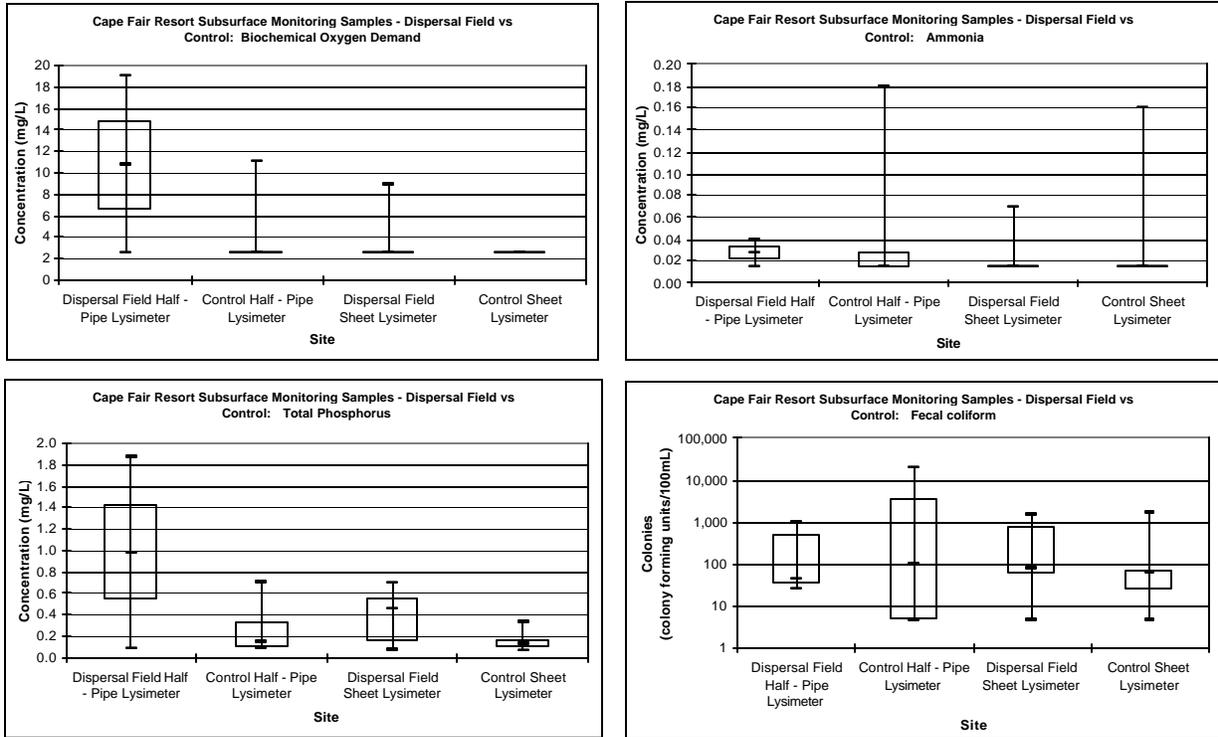
**Figure 4.9: Cape Fair Resort subsurface box plots. Dispersal field versus control concentrations**

The median value is the 50th percentile of the dataset. Median values best reflected the dataset as a whole and therefore were used in the comparative analysis as a single number to represent the dataset. Control sample concentrations were generally lower than dispersal field samples (Figures 4.9, 4.10 and 4.11). There were intermittent spikes in control datasets, such as fecal coliform concentrations for Cape Fair Resort half-pipe lysimeter. All median concentrations in control datasets were at/below dispersal field concentrations (Table 4.5)

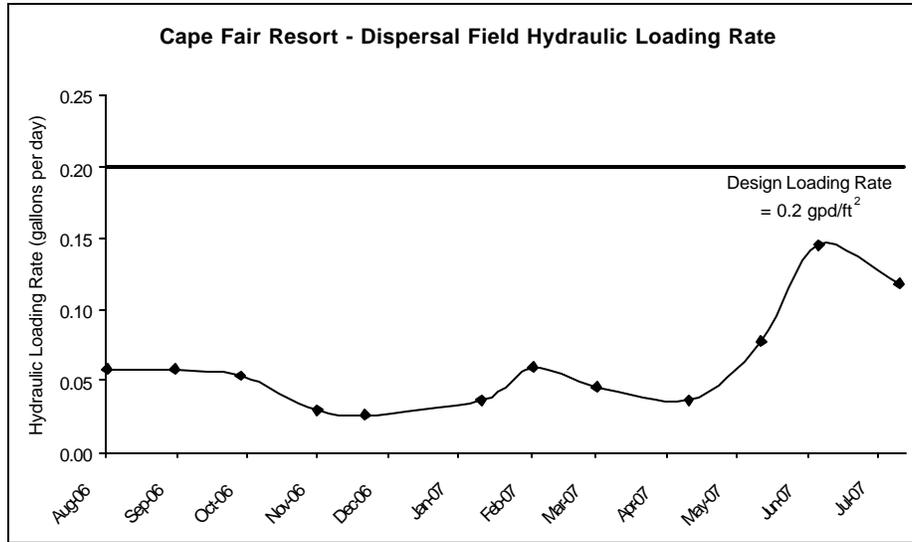
**Figure 5.2: Cape Fair Resort dispersal field hydraulic loading rate**

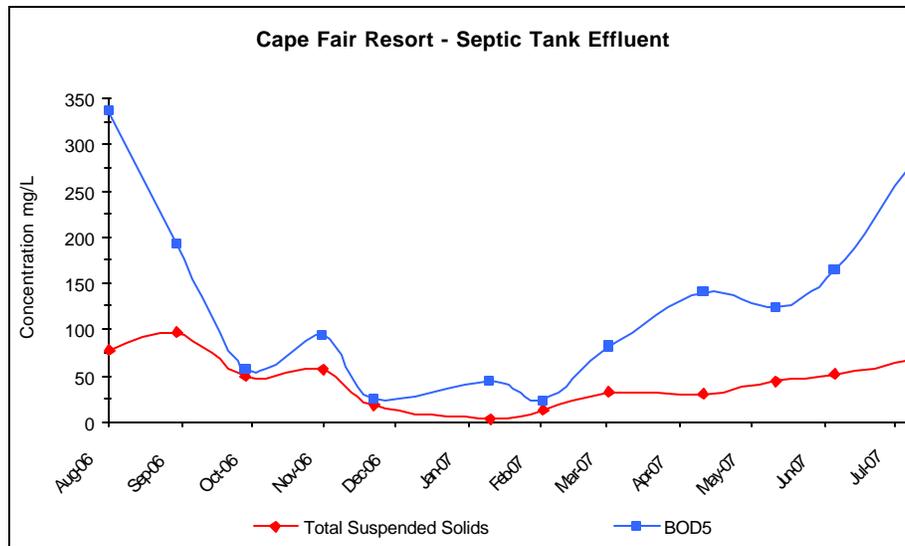
**Figure 5.3: Cape Fair Resort – TSS and BOD<sub>5</sub> in septic tank effluent**

Septic tank effluent BOD<sub>5</sub> and TSS concentrations were low (near or below 50 mg/L) during the off-season months (Figure 5.3). BOD<sub>5</sub> increased markedly during the busier summer season with concentrations ranging between 123 mg/L and 335 mg/L. TSS concentrations remained below 100 mg/L during the summer season which indicated good settling conditions in the septic tank system.

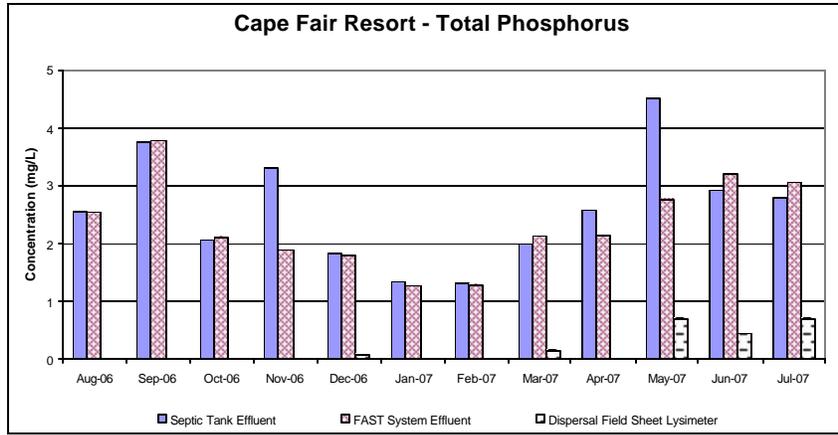
**Figure 5.9: Cape Fair Resort - monthly total phosphorus in septic tank, FAST effluent and plastic sheet lysimeter**

<sup>2</sup> Table Rock Lake watershed phosphorus effluent limitations are found in Missouri Code of State Regulations 10 CSR 20-7.015 (3)(g). These regulations do not apply to onsite systems with subsurface effluent dispersal but are referenced as a comparison.

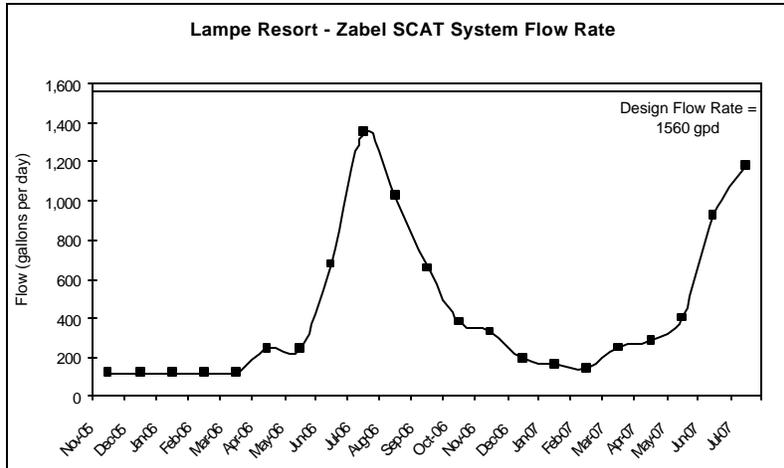
**Figure 5.13: Lampe Resort – Zabel SCAT system flow rate**

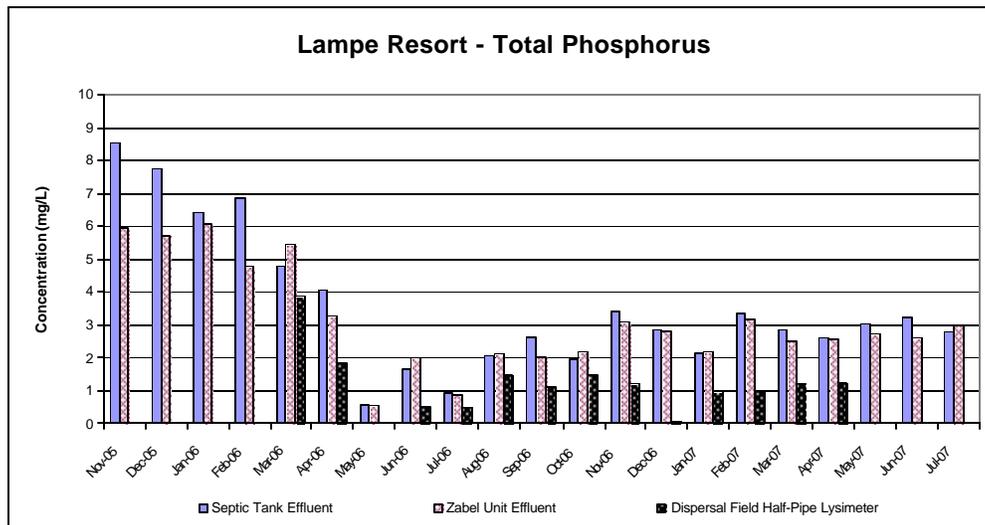
**Figure 5.21: Lampe Resort – total phosphorus in septic, Zabel SCAT and lysimeter effluent**

There was little if any reduction in phosphorus observed through the SCAT system at the Lampe Resort (Figure 5.21). However, the subsurface samples indicated appreciable reductions in phosphorus concentrations through the soil as the effluent made its way from the Zabel unit to the half-pipe lysimeter (Figure 5.22) even though the soil layer between the drip tubing and half-pipe lysimeter was minimal. Lysimeter sample total phosphorus, concentrations were generally below 1.5 mg/L representing phosphorus concentration reductions consistently over 40% (Figure 5.22).

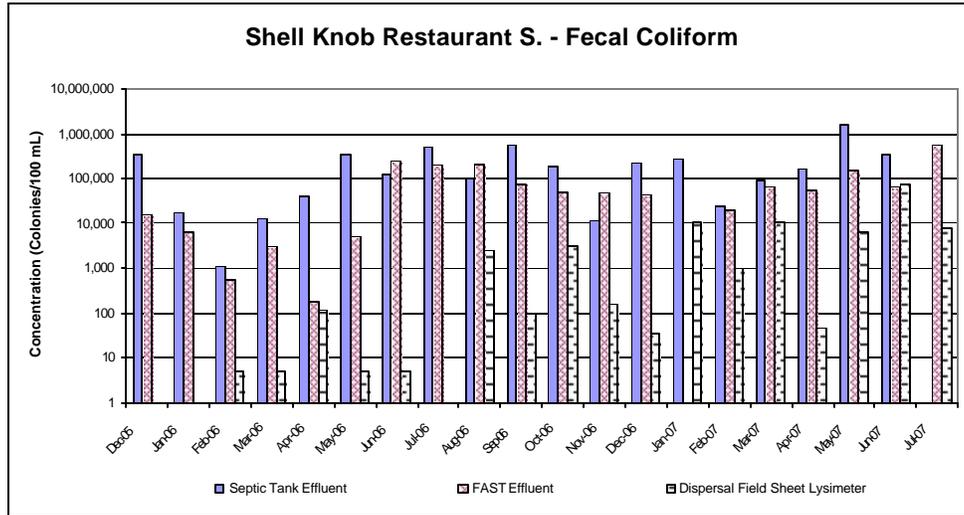
**Figure 5.35: Shell Knob Restaurant S. – fecal Coliform concentrations in septic, FAST and lysimeter samples**

As with total phosphorus, fecal coliform reductions through the FAST system were consistent but marginal, with typically less than one log reduction observed (Figure 5.35). Subsurface concentrations were also lower, but to varying extents (Figure 5.36). Greater than two log reductions were observed for several events.

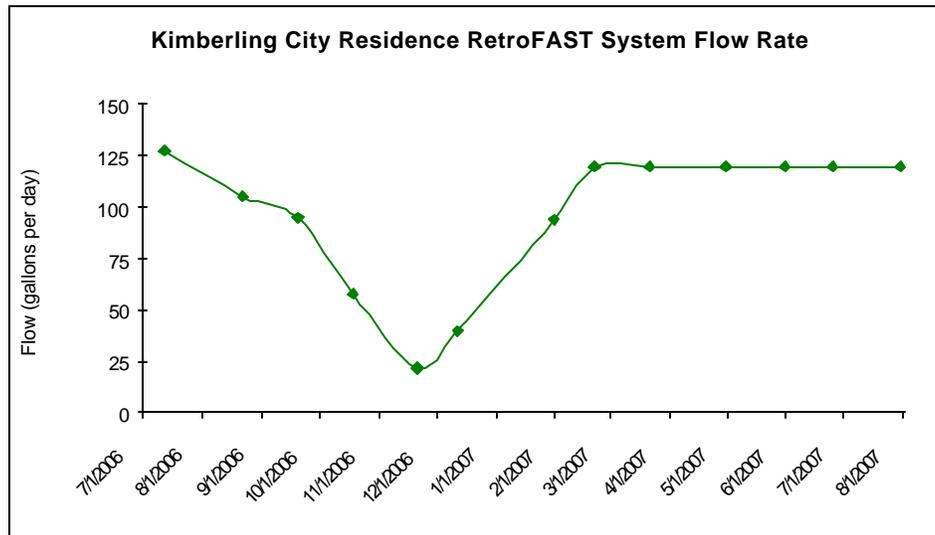
**Figure 5.37: Kimberling City Residence – RetroFAST system flow rate**

The Kimberling City Residence RetroFAST system (Figure 5.37) operated dependably through the study with no known blower malfunctions. Hydraulic loading was estimated based on days of occupancy per month for a one bedroom home with the two adult residents.

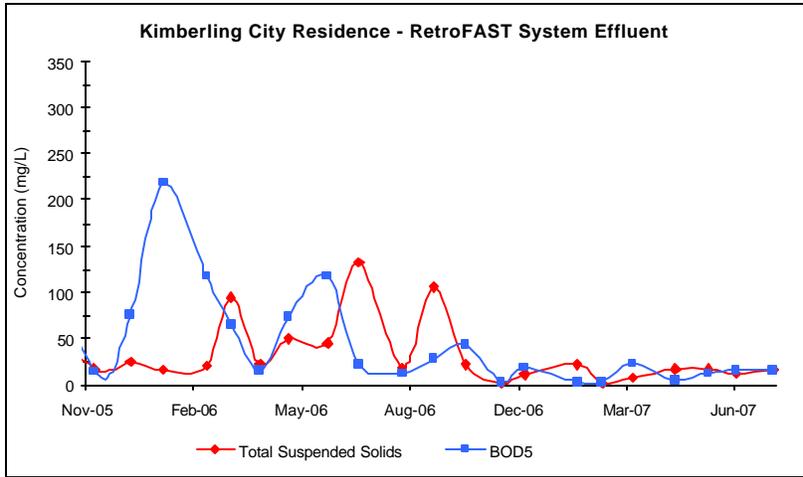
**Figure 5.38: Kimberling City Residence – TSS and BOD5 in RetroFAST system effluent**

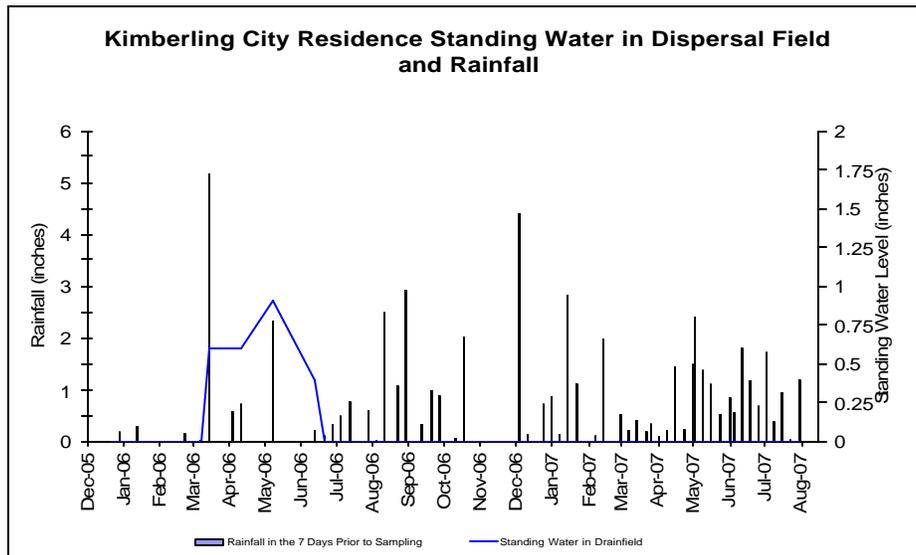
**Figure 5.41: Kimberling City Residence – rainfall and standing water in dispersal field**

The Bio-Microbics RetroFAST® unit was installed in the existing concrete watertight septic tank. Beginning in November 2005, monitoring staff measured water levels in a vertical PVC pipe inserted through the soil into a dispersal pipe chamber. Standing water depths of up to 0.9 inches were measured in the spring of 2006 during a period of heavy rainfall (Figure 5.41). No standing water was detected in subsequent measurements which included periods of comparable rainfall. These data indicated favorable flow distribution in the lateral field compared to initial conditions. The improvement may have been attributed to reduced biomass buildup in the drainfield following the RetroFAST unit installation. The RetroFAST unit’s high-quality, aerobic effluent was favorable for minimal biomass production in the drainfield.

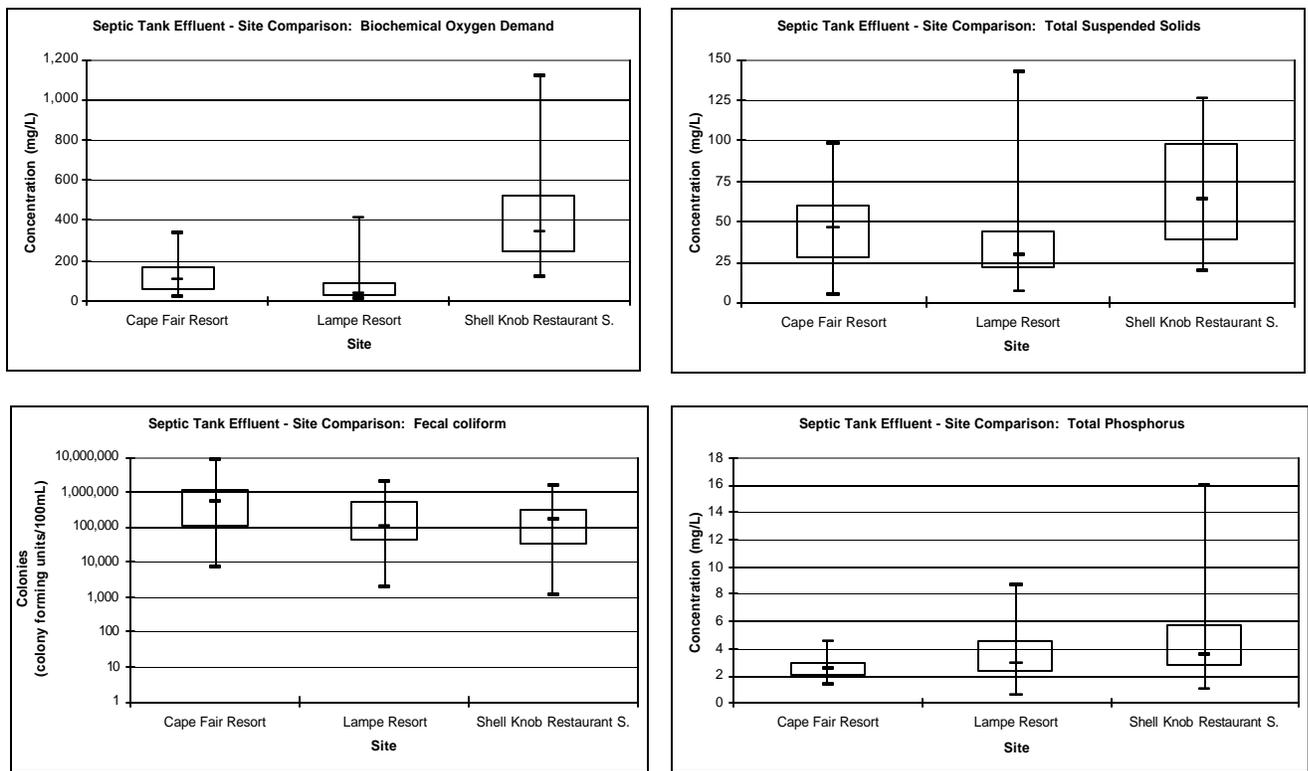
**Figure 5.42: Box Plots of septic tank effluent concentrations at each site**

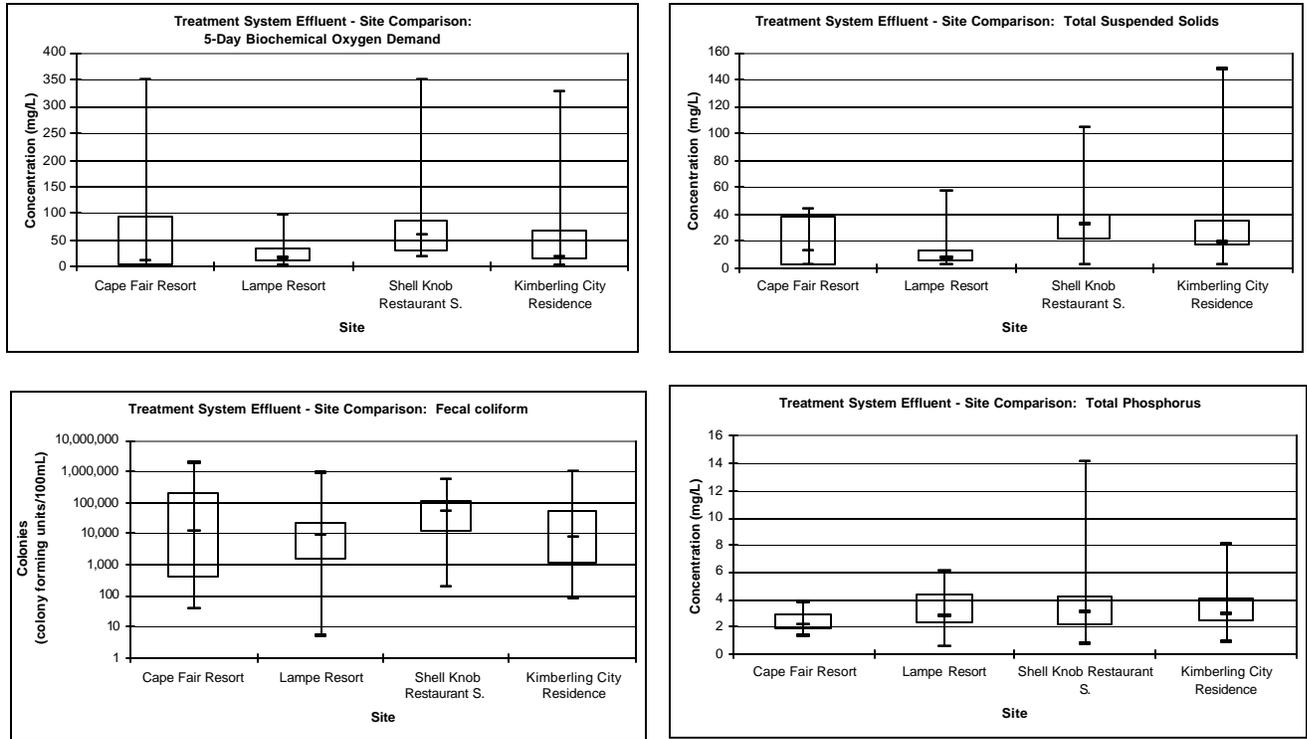
**Figure 5.43: Box plots of treatment system effluent concentrations at each site**

Total phosphorus concentrations were comparable in all four systems with median concentrations ranging between 2 and 3 mg/L (Table 5.1). Median fecal coliform concentrations in the Cape Fair Resort, Lampe Resort and Kimberling City Residence were similar, ranging from 7,600 to 12,000 colonies/100 mLs. Fecal coliform concentrations were greater in the Shell Knob Restaurant S. treated effluent with a median concentration of 50,000 colonies/100 mLs.

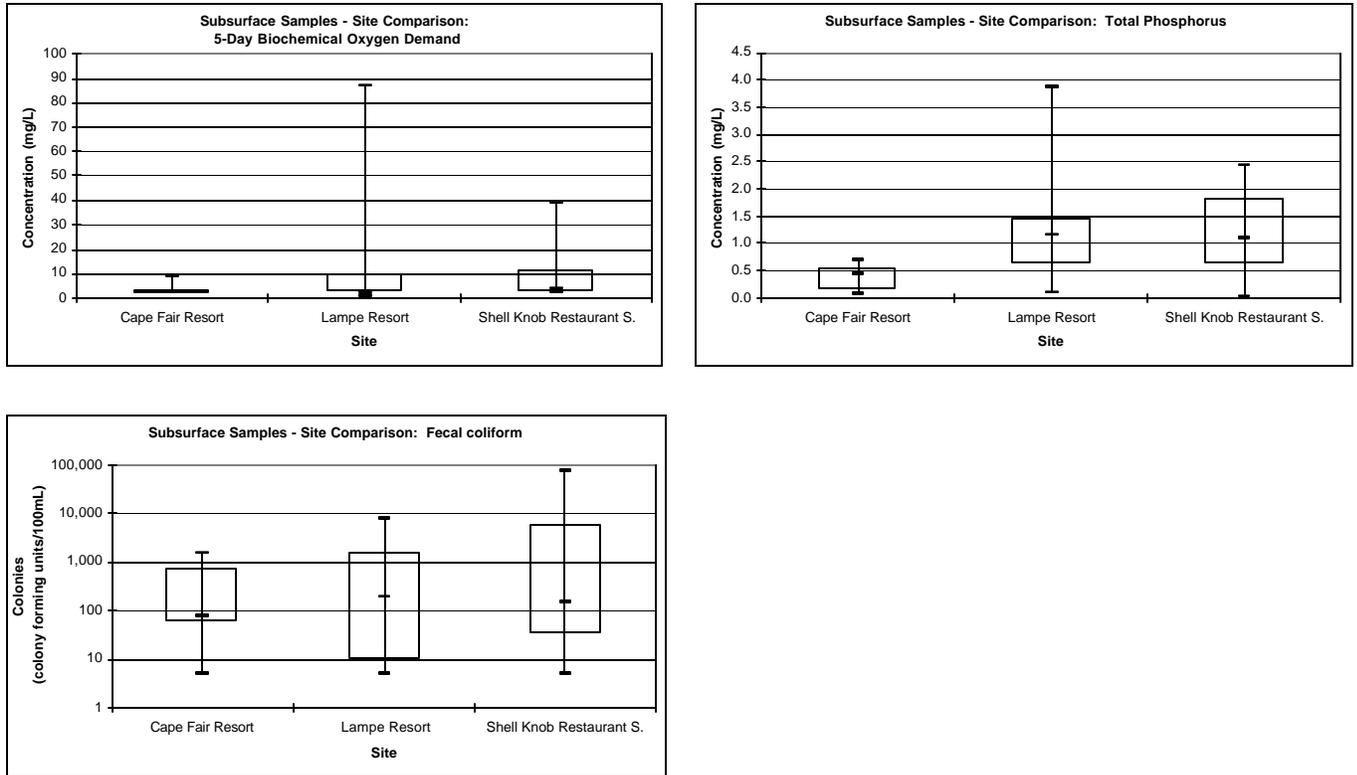
**Figure 5.44: Box plots of subsurface sample concentrations at each site**

Subsurface concentrations for all parameters were lowest at Cape Fair Resort (Figure 5.44). BOD<sub>5</sub> and ammonia concentrations were frequently at or below method detection limits. Median total phosphorous and fecal coliform concentrations were at or below water the water quality criteria for surface discharging mechanical treatment plants in the Table Rock Lake watershed (Table 5.1). Wide ranges in all parameters were observed in the Lampe Resort and Shell Knob Restaurant S. subsurface samples. However, median BOD<sub>5</sub>, ammonia and fecal coliform concentrations for these two sites were all less than typical surface water discharge effluent limits for a disinfected effluent. Median total phosphorus concentrations for Lampe Resort and Shell Knob Restaurant S. were 1.2 and 1.1 mg/L, respectively.

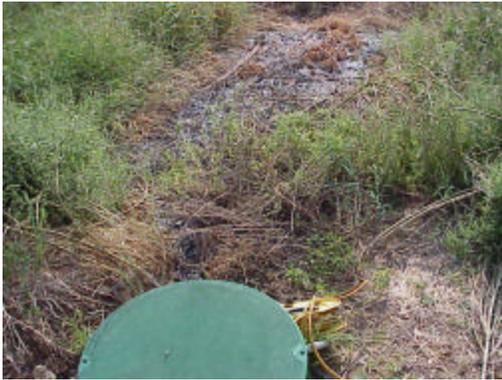
Effluent flowing to lake due to pump failure

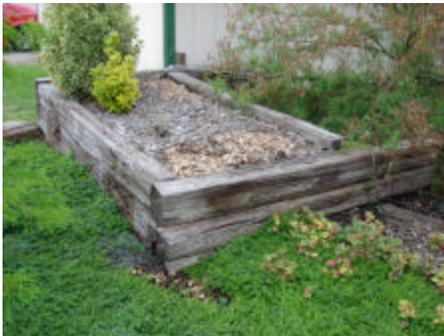
Failing wood chip system

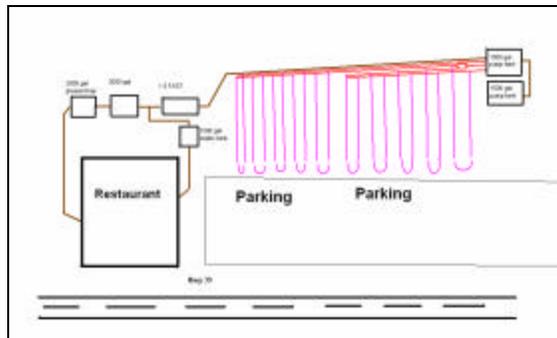
Diagram of advanced treatment system

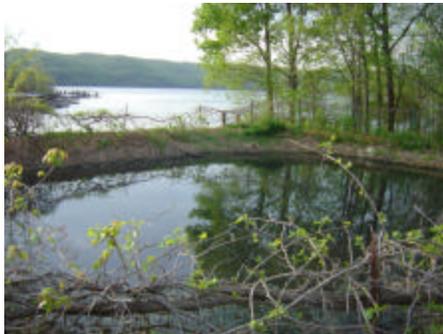
Failing lake front lagoon

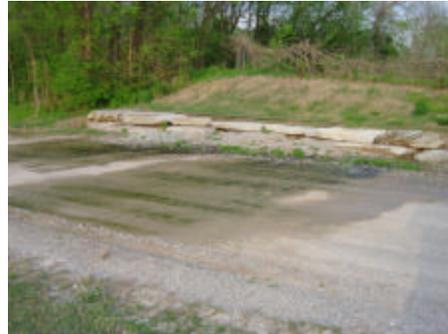
Untreated sewage leaking directly into the lake

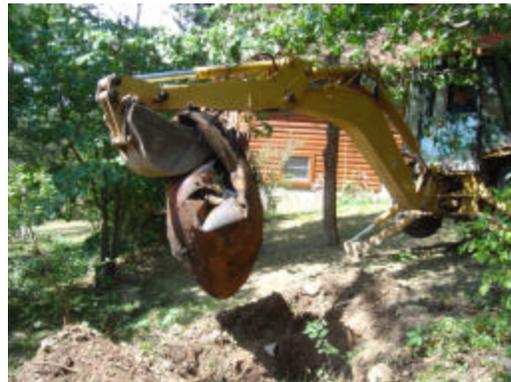
Effluent left tank through rusted out bottom

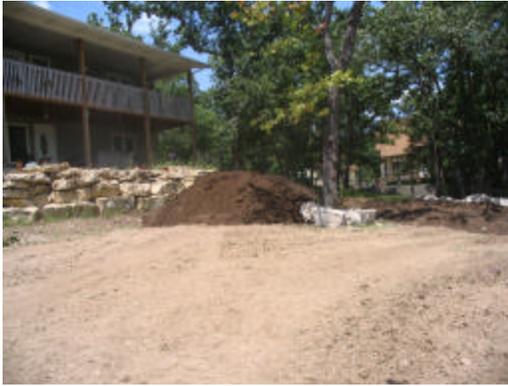
Repair begins on drip field with imported soil

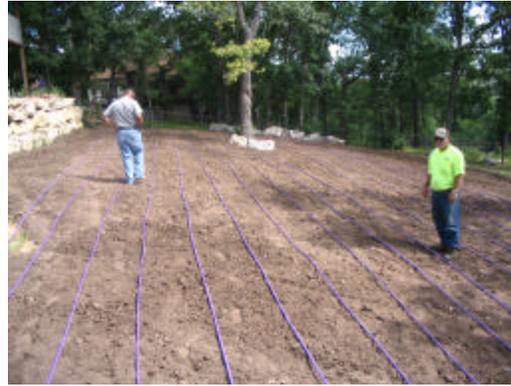
Drip tubing installed on imported soil

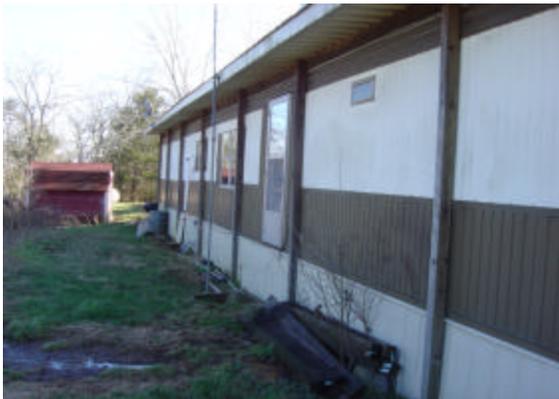
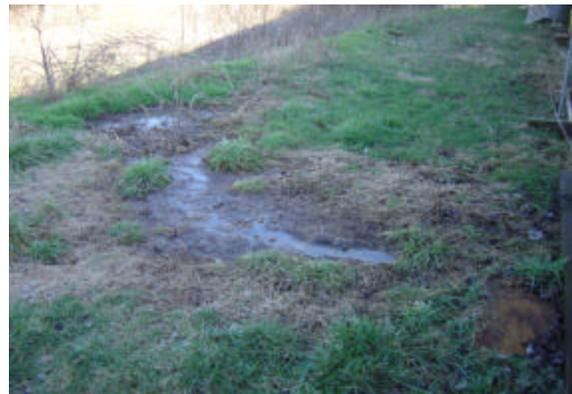
Raw sewage flowing from sewer pipe and flowing across yard

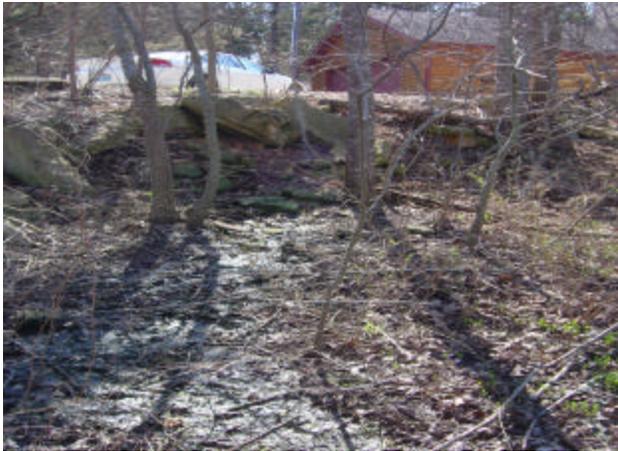
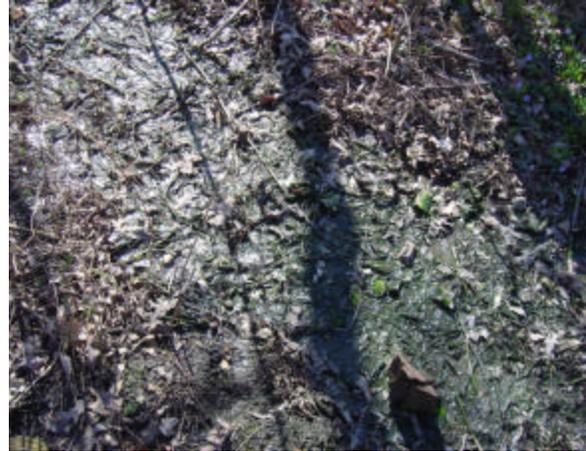
Failing septic system showing flow over the ground from inadequate lateral line
