Methyl Bromide Field Operation Guidance (MB FOG) Report

April 13, 2015

Based on an Operational Decontamination Assessment of Methyl Bromide Fumigant on *Bacillus anthracis* Sterne

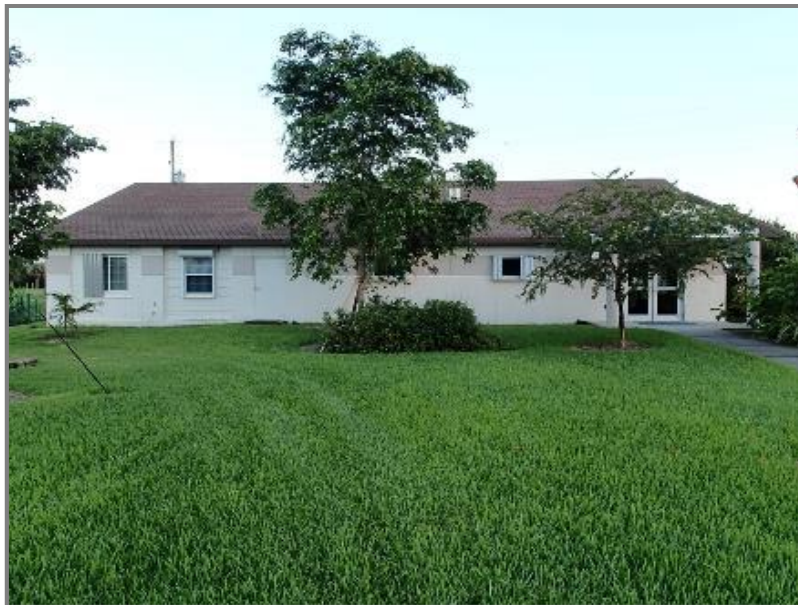
Figure 1. The House used for this Study on the Campus of the Fort Lauderdale Research and Education Center, University of Florida, Davie, FL

The study building was the University of Florida “Hurricane Resistant Model Home” (house) (Figures 1, 2). The house encompassed 1,444 cubic meters (m³) (51,000 cubic feet [ft³]), including the exterior volume contained below the edge of the eaves. Constructed in 2005, the ranch-style house is used for teaching and meeting functions and contains two large open meeting areas, an office, a kitchen (with refrigerator and oven), two restrooms, two utility closets, an HVAC room, and a storage/computer room. The house also contains two desktop computers, a computer router, two LED monitors, and an LCD projector (Figure 3). The house is on the campus of the Fort Lauderdale Research and Education Center, Institute of Food and Agricultural Sciences, University of Florida, 3205 College Avenue, Davie, FL 33314 (26.08343, -80.24115, two meter elev.). Adjacent to the study house were two buildings that served as student housing. As part of the health and safety protocols, these two buildings were evacuated during the fumigation. A diagram of the campus grounds is shown in Figure 4. As an additional safety precaution, a nine meter (30 ft) radius away from the perimeter of the house was cordoned off to non-authorized personnel.

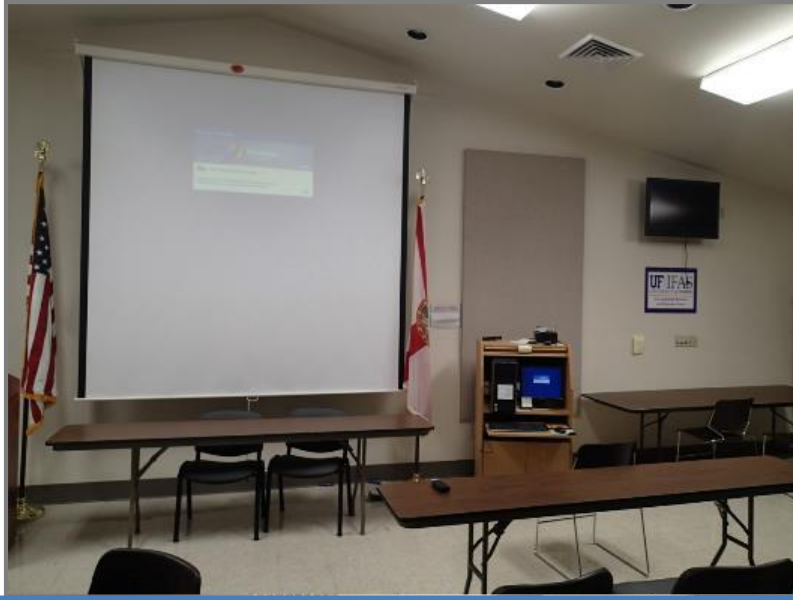
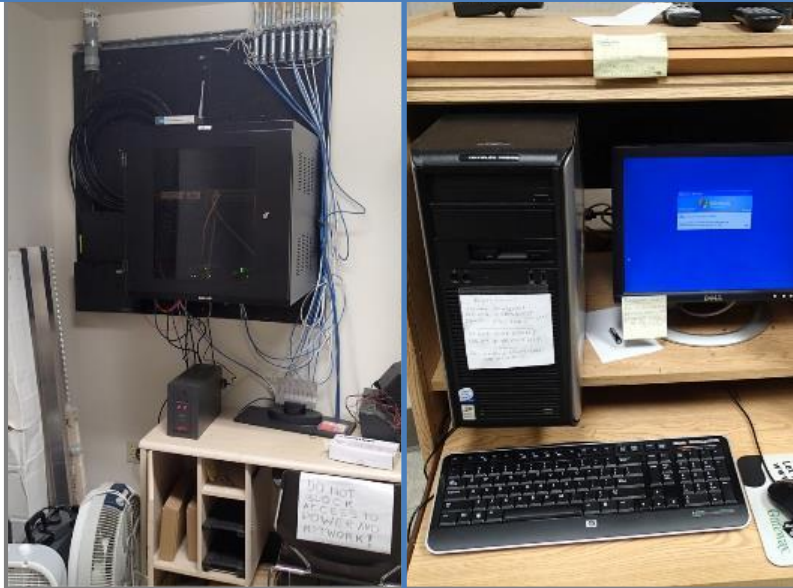
Figure 3. The Electronics that Remained in the House during Fumigation

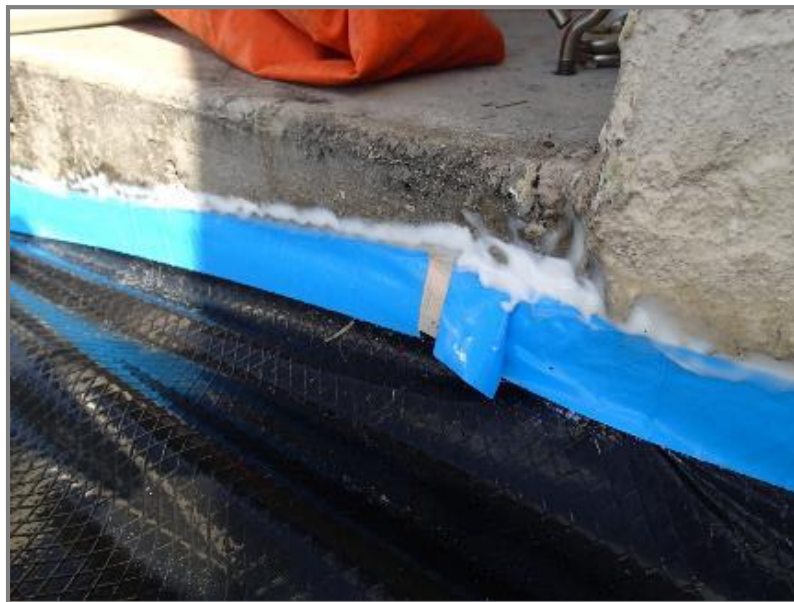
Figure 5. Attachment of Tarp Apron to Foundation of House with Tape and Caulk

meter-wide tarpaulin (tarp) apron made of 6-mil high diffusion-resistant polyethylene vinyl alcohol (EVOH) with polyester scrim reinforcement (GeoCHEM Inc., Renton, WA) was taped to the house at ground level around the entire perimeter of the house using 8-cm-wide resilient tape (Shurtape, Cardinal Pro. Prod., Anaheim, CA). A narrow bead of silicone sealer was also applied over the edge of the tape where it adhered to the house foundation (Figure 5). The EVOH tarp has a white surface on one side and a black surface on the other side. For the apron installation, the tarp was used white side down. Three 80 x 100 ft sections of EVOH tarps were hoisted onto the roof and arranged to cover the entire house, black side out, by the tenting contractor (Dead Bug Edwards, Fort Lauderdale, FL). The sections were joined by overlapping and rolling adjacent edges together and binding them with plastic-tipped, metal spring fumigation clamps. As the house was covered, horizontal “skirts” were dropped from the roof onto the apron (Figure 6). The skirt and apron were held down on the ground directly below the roofline with overlapping 40-lb sand “snakes” bags. The edges of the skirt and apron were then tightly rolled and secured with clamps (Figure 7). To add physical strength and protect the first tarp in the case of strong winds, a second commercial fumigation tarp, vinyl-coated nylon fabric, 12 ounces per square yard, white in color (Figure 8), was placed over the first tarp in the same manner as the first and was secured to the ground atop the skirt and apron with additional overlapping sand snakes (Figure 9).

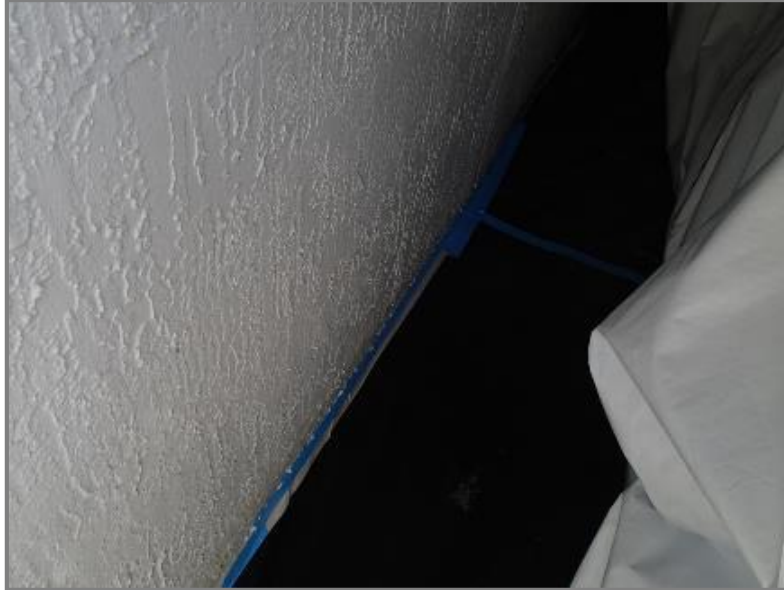
Figure 6. View of the Skirt of EVOH Tarp Dropped to the Apron on the Ground

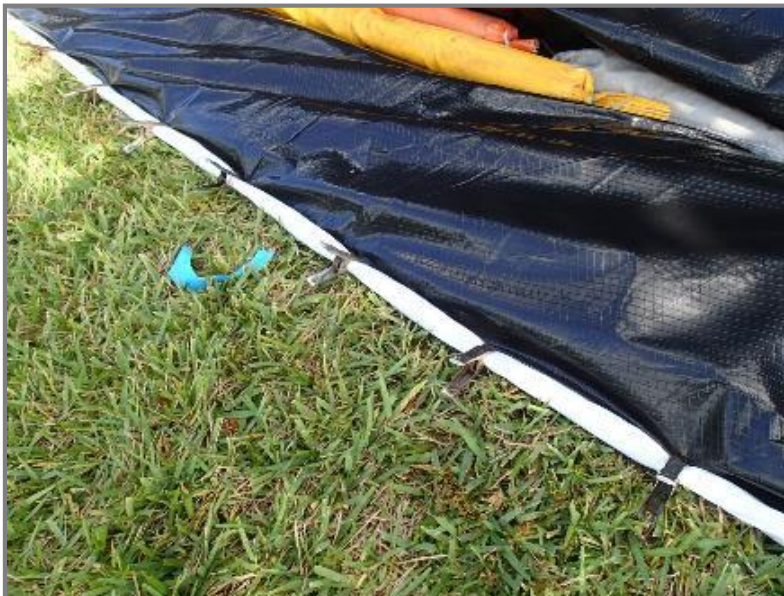
Figure 7. To Seal, the Skirt and Tarp Covering the House Were Rolled and Clamped at Edges and Weighed Down with Sand Snakes

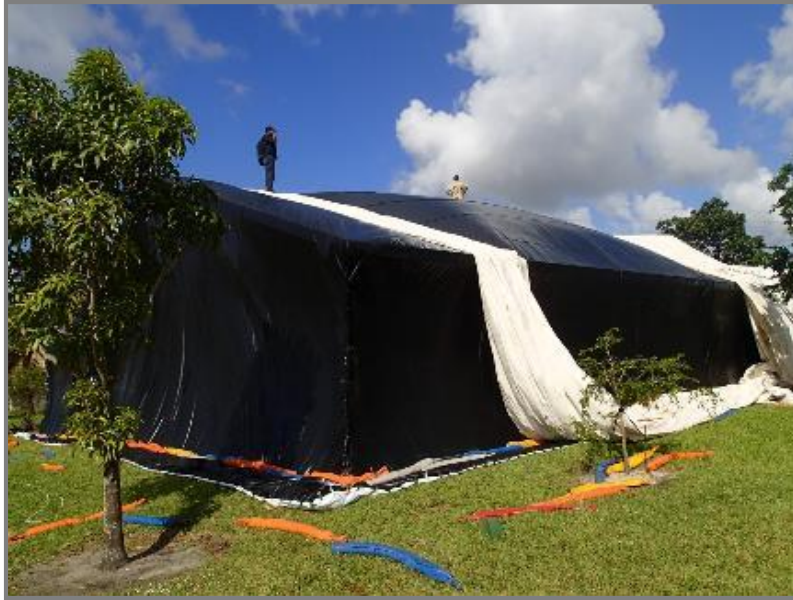
Figure 8. Second Tarp (White) Positioned Over Black EVOH Tarp

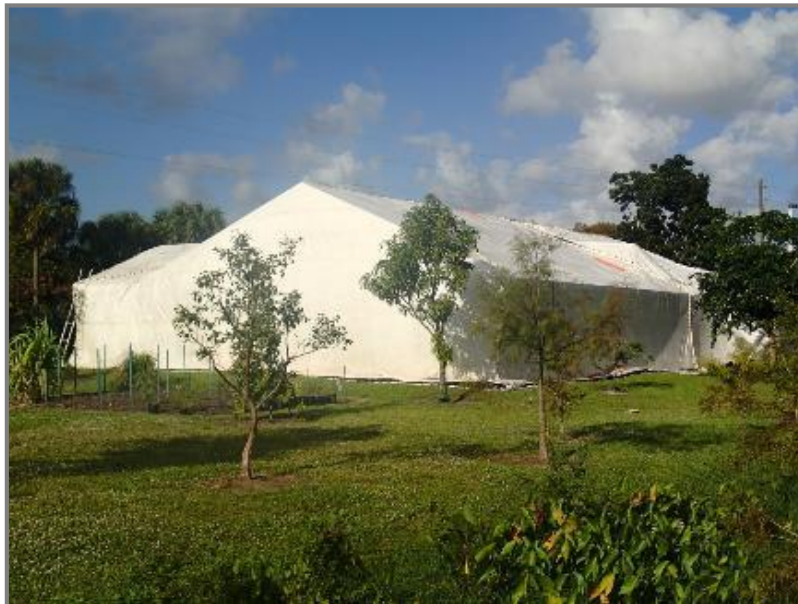
Figure 9. In Preparation to Fumigate, the House was Sealed with Two Tarps

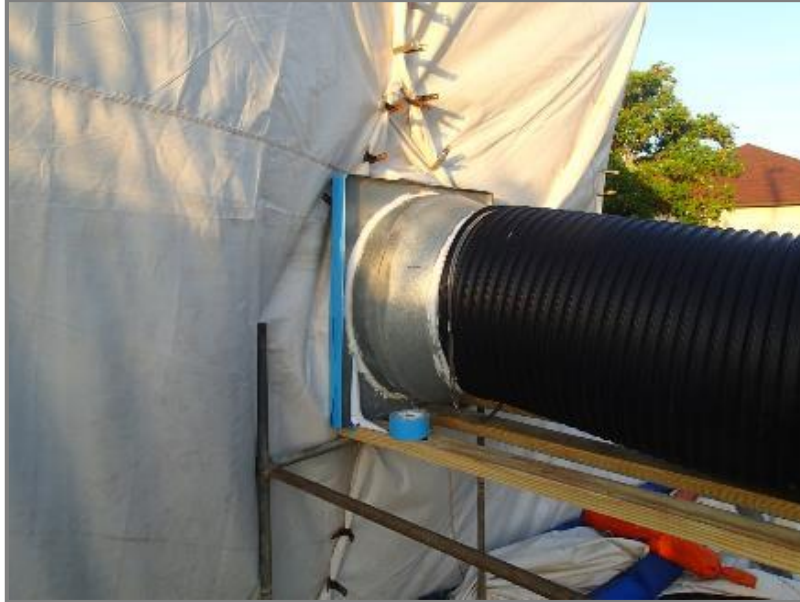
Figure 11. Flange of Carbon Scrubber Exhaust Port Joined to Tarp at a Seam

The tarp seal around the house was opened at two skirt seams to accommodate the 24-inch diameter, fresh-air inlet port (Figure 10) and 24-inch diameter, exhaust port (Figure 11) for the aeration procedure. Both the inlet port and the exhaust port were sealed with metal lids during the fumigation. The ground seal was also opened between the skirt and apron of the first tarp and the second tarp to allow the insertion of 4-inch diameter, polyvinyl chloride (PVC) pipes that were used as conduits for two MB introduction or “shooting” hoses (3/4" braided chemical resistant, high temperature [149 °C rating], and high pressure [> 200 pounds per square inch rating]), monitoring lines (6.4 millimeter outer diameter, nylon), and a test coupon slide designed to extract test coupons during intermediate phases of the fumigation (Figure 12). The two MB shooting hoses were extended into the tested house with a similar inside diameter polyethylene tubing connected together with compression fittings. These hoses were clamped and taped into the bottom of a 5 gallon plastic bucket placed in the entry way of the tested house (Figure 13). The bucket also contained a concrete block as weight for stability. The bucket was used as the release point for the fumigation inside the tested, house and to protect the house floor. As MB gas flows out of the shooting hoses, the bucket collects oils, rust, or other non-volatile contaminants that might be present in the cylinders. After the shooting and monitoring lines were routed through two pipes, any voids in the PVC pipe and pipe chases were filled and sealed with expanding polyurethane foam (Figure 14). The test coupon slide (PVC-pipe construction) was sealed at its exterior terminus with a threaded PVC cap.

The inlet to the scrubber system was connected to the office-room window (Figure 11) located on the northeastern side of the house. The window was removed and a 4-foot x 24-inch ID galvanized duct extension was used to penetrate inside the house and connect to the gate valve,

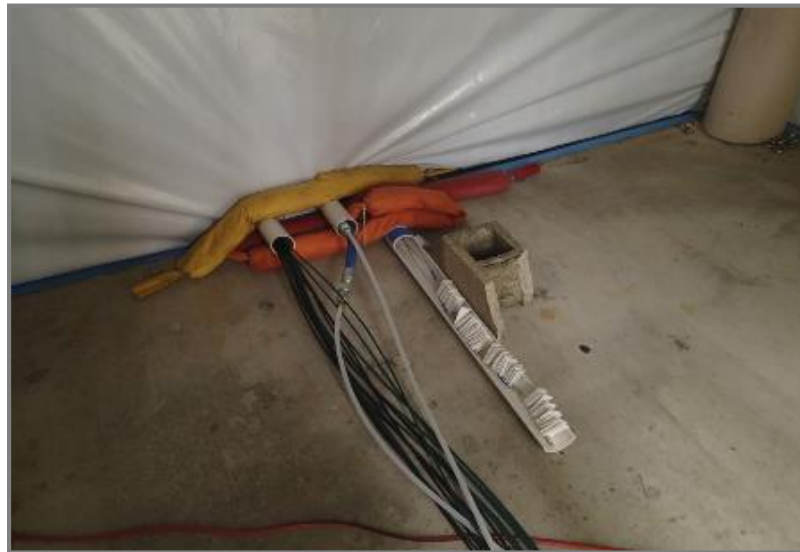
**Figure 12. Monitoring Lines, Shooting Lines and Coupon Slide Inserted
Between the Skirt and Apron (View from Inside House)**

Two types of test coupons were utilized during the test to evaluate the efficacy of the MB fumigation (Table 3). These included: (1) BIs deployed throughout the house to qualitatively assess fumigant efficacy spatially; and (2) collocated coupons positioned inside the house (at the extraction port) and collected at specified time intervals to quantitatively assess fumigant efficacy temporally (Figure 12 & 14).

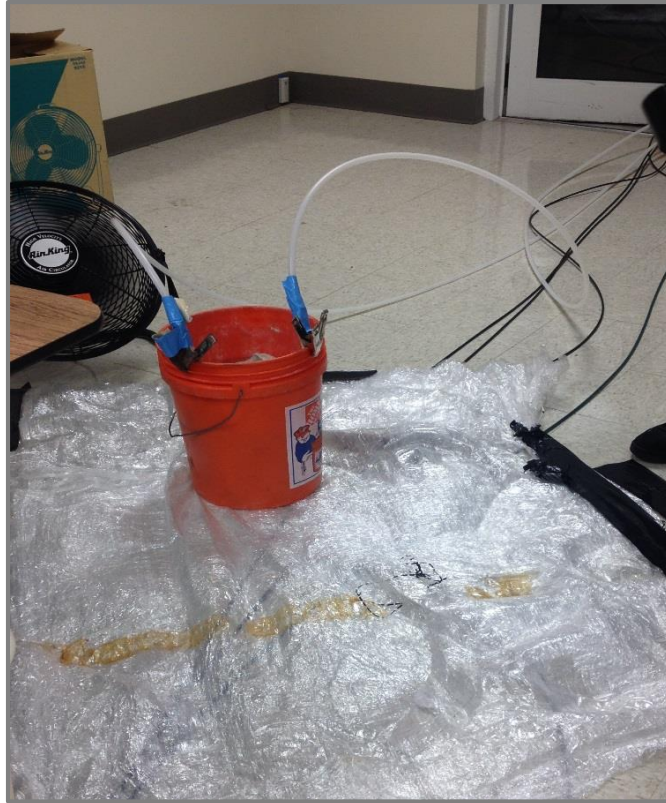
Figure 13. Bucket Release Point of Fumigant Inside House with Mixing Fan

Interior preparation of the house included the placement of seven 3,000 cubic feet per minute (cfm) fans (Figure 13), sixteen 1-gallon capacity warm steam vaporizers (Figures 15 & 16) (Walgreens Brand Model 21413kct, Springfield, IL), and four 1,500 watt radiant heaters (DeLonghi, Model EW7707CM, Woodridge, N.J.) (Figures 15 & 16). The fans ran continuously during the fumigation (including during scrubbing and aeration) to maintain temperature and RH equilibrium throughout the house and to help disperse the MB gas when it was introduced into the house. The power supply for the radiant heaters and steam vaporizers were extended with two extension cords each and routed outside so they could be powered on or off as needed to maintain temperature and RH, 27 °C and 75%, respectively. The day before fumigating the house, the air conditioning system was turned off and the 16 steam vaporizers were turned on to increase the humidity of the materials within the house. The steam vaporizers were refilled prior to sealing the house and just before fumigation.

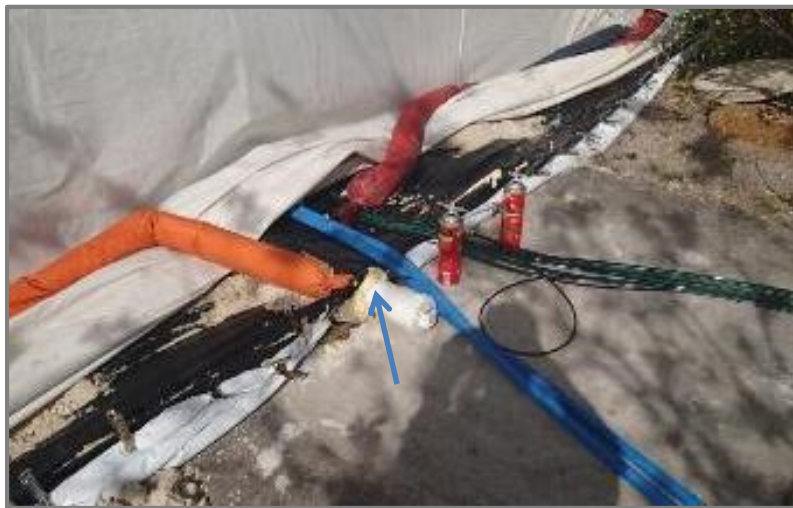
Figure 14. PVC Pipe Voids and Pipe Chases Filled with Expanding Polyurethane Foam.

**Note: Threaded Cap on Coupon Slide (White PVC Pipe) in Center of Photograph
(Outside House View)**

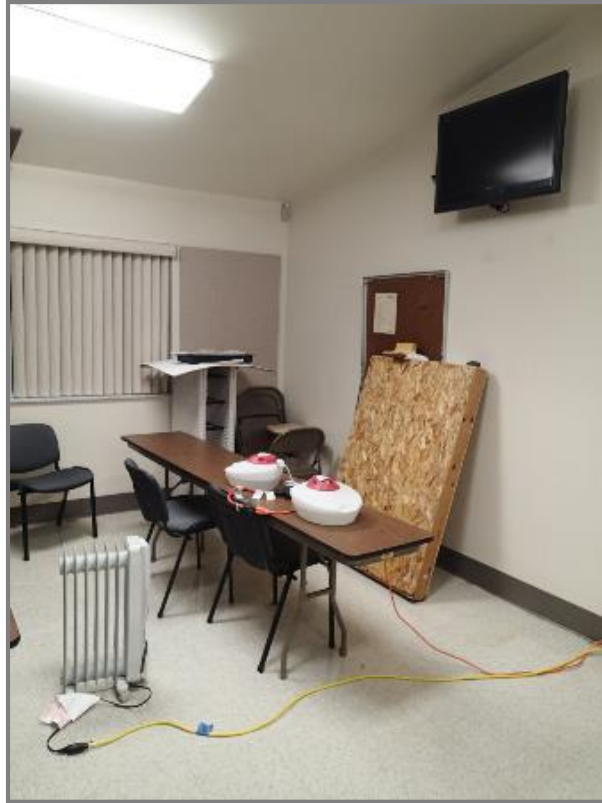
**Figure 15. Radiant Heater and Two Steam Vaporizers in the House
(Fans not Shown)**

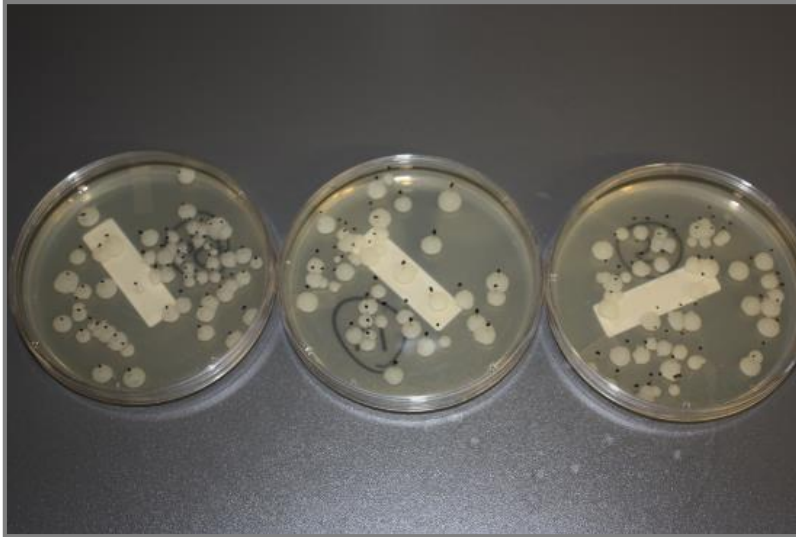
Figure 20. Representative Dilution Plates Containing *Ba* Sterne Colonies Recovered from Biological Indicators

In order to assess fumigation efficacy as a function of time, six replicates of each coupon type (wood and glass) along with two procedural blanks of each coupon type (non-inoculated wood and glass coupons) were retrieved from the tented enclosure at the 16th, 24th, 32nd, and 40th hour into the fumigation. All coupons for a particular time-point were collocated at the coupon slide on a stainless steel spring, and retrieved from the house by pulling on a metal wire attached to the spring (Figures 12 & 14). Samples were allowed to off gas MB then they were packaged (with cold packs) and transported to RTP NHSRC EPA Microbiology Laboratory for extraction and analysis. Using aseptic technique in the laboratory, the coupons were placed into 18 mm x 150 mm sterile borosilicate glass tubes (glass coupons) or 25 mm by 150 mm sterile Pyrex[®] tubes (wood coupons) each containing 10 ml phosphate buffered saline with Tween20 (PBST). Each vial was then sonicated for 10 minutes at 42 kilohertz and 135 Watts (MOP 6566). Then tubes were vortexed two-continuous minutes to further dislodge spores from the glass, wood or metal coupon. Immediately before dilution or plating, each vial was briefly re-vortexed to homogenize the sample. The resulting extracts were subjected to five sequential 10-fold serial dilutions (MOP 6535a), and 0.1 ml of each dilution was inoculated onto TSA plates, spread with sterile beads (MOP 6555), and incubated at 35 °± 2 °C for 18-24 hours. Following incubation, CFUs were enumerated manually. A photograph depicting representative dilution plates is shown in Figure 20.

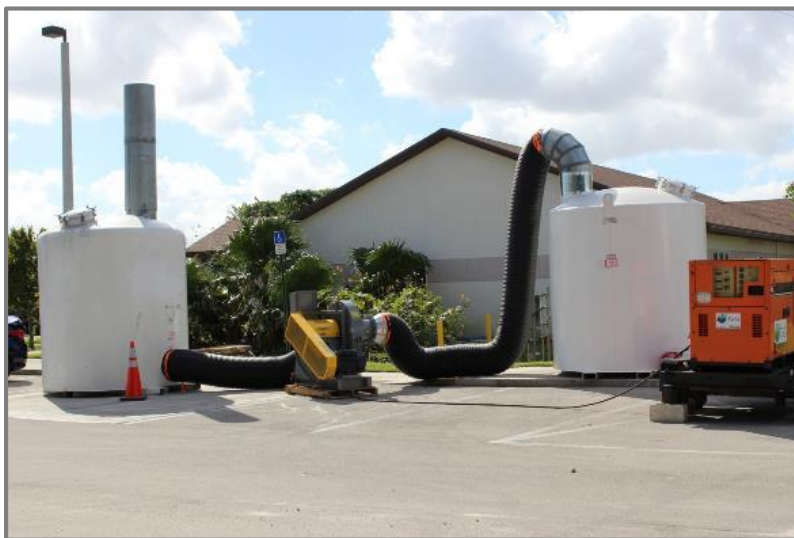
Figure 21. Activated Carbon Scrubber Installed at the House

with the balance of the window space blocked with cardboard held in place with duct tape. Ten feet of the flex duct were connected on the outlet side of the gate valve to an 8-foot section of 20-inch ID straight galvanized duct. This straight section was used to perform flow measurements as described in Section 2.10.1. Following the straight section, ten feet of the flex duct were used to connect to the inlet of the first activated carbon vessel. Twenty-five feet of the rubber flex duct was used to connect from the outlet of the 1st vessel to the inlet of the blower that was positioned ten feet from the vessel. Ten feet of flex duct were used to connect the outlet of the blower to the inlet of the second carbon vessel. After traveling through both vessels, the scrubbed gas would be exhausted to the atmosphere through a 7-foot stack located on top of the second carbon vessel. The generator was positioned approximately 25 feet from the blower. The entire system took three people approximately 16 hours to install (Figure 21).

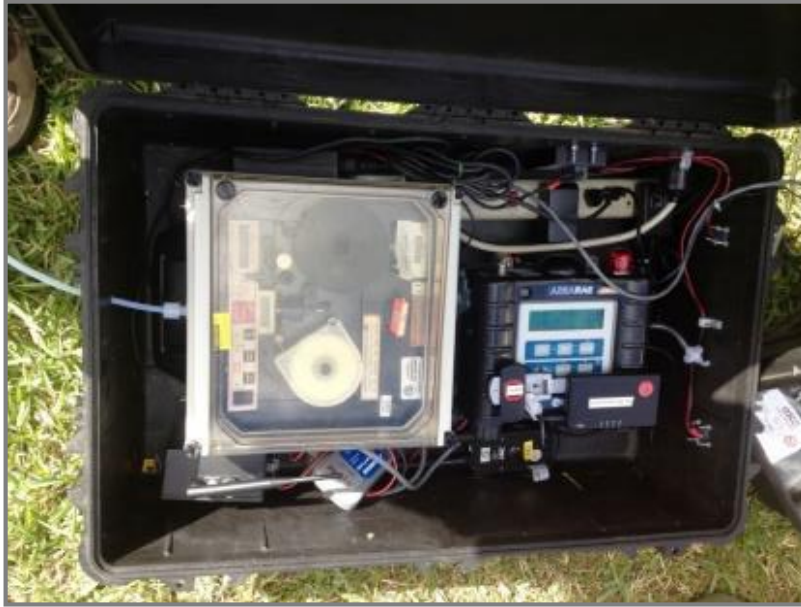
Figure 22. Air Monitoring Unit Containing an SPM (left) and an AreaRAE (right).

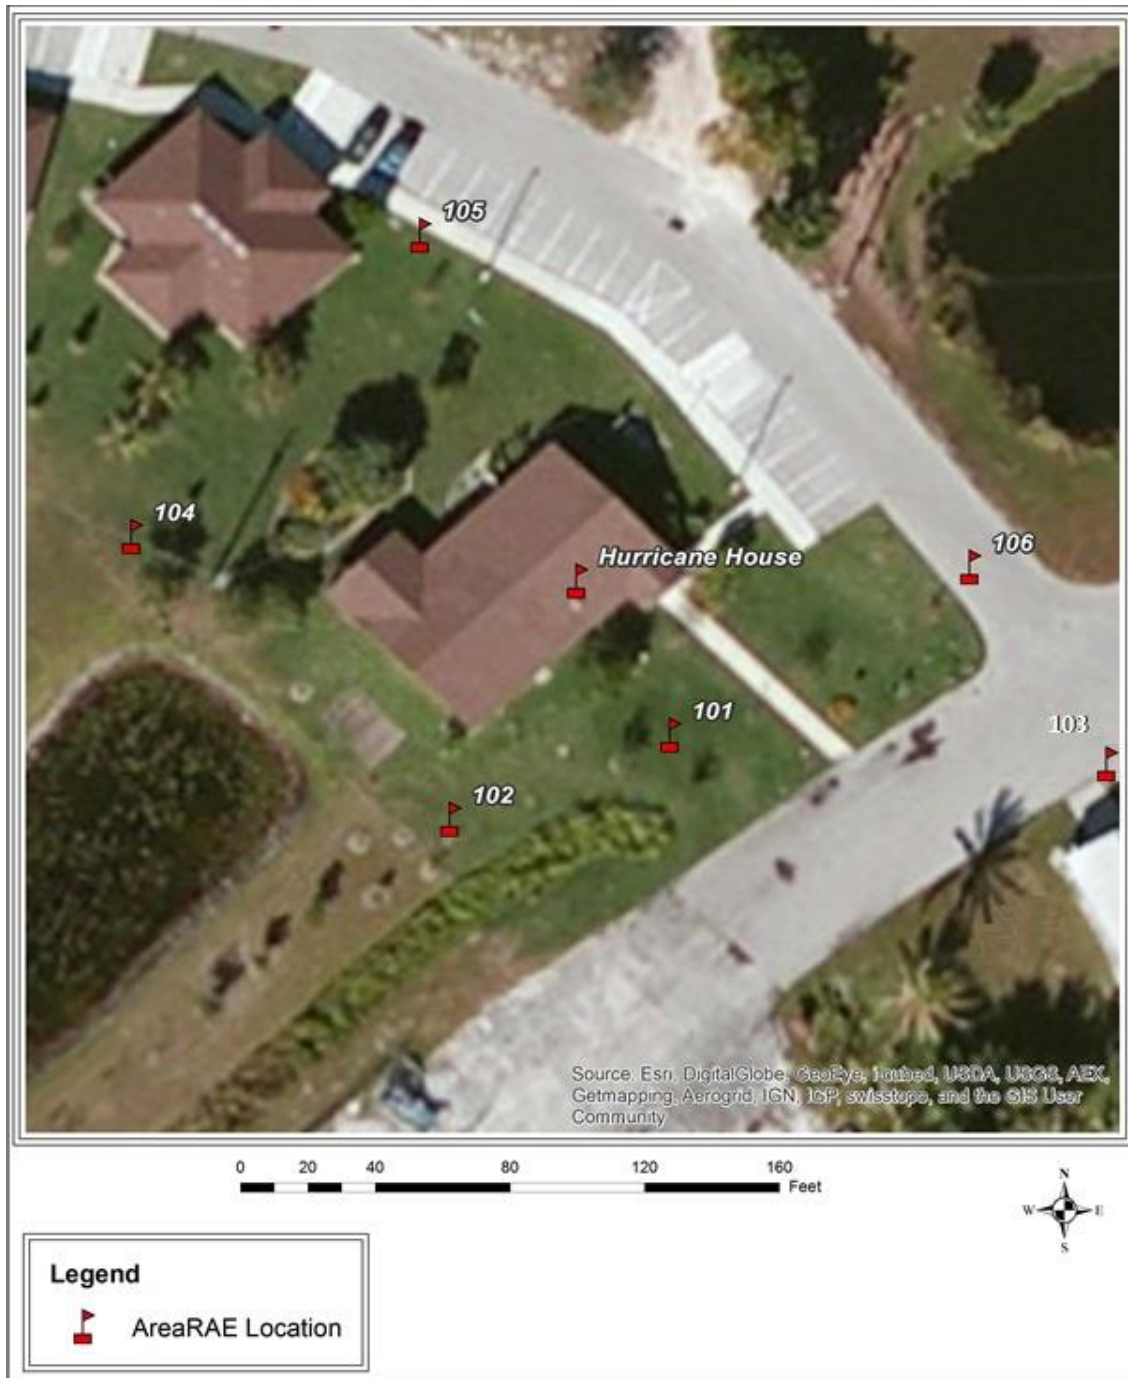
Figure 23. Ambient Air Monitoring Locations.

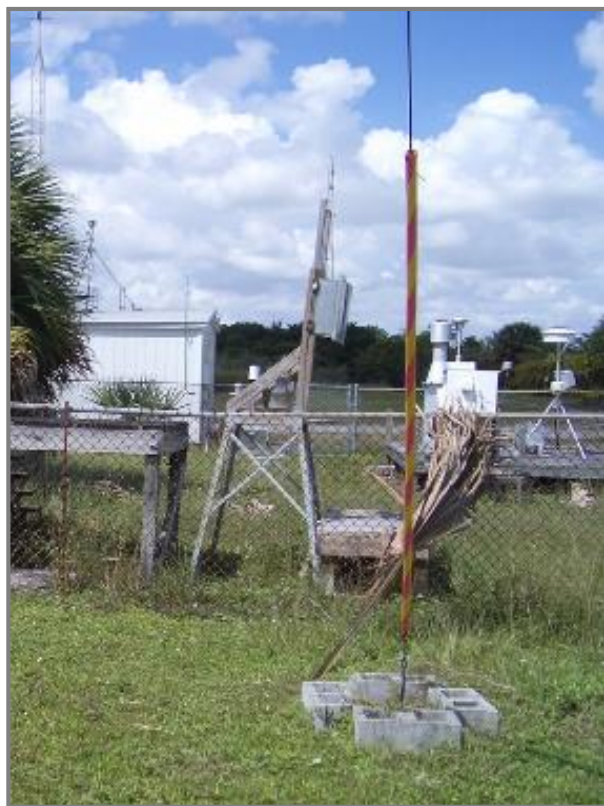
Figure 24. FAWN Permanent Weather Station on the University of Florida

Weathering stations used to monitor ambient conditions included the Florida Automated Weather Network (FAWN) and a mobile weather station (Figure 24). FAWN is a group of permanent weather stations positioned around the State of Florida. A permanent station is located on the Fort Lauderdale campus just north east of the house. A 600 Series mobile weather station (Weatherhawk, Logan, UT) was brought by EPA, and positioned just southeast of the house (Figure 25). Data from both units were read via wireless transmission.

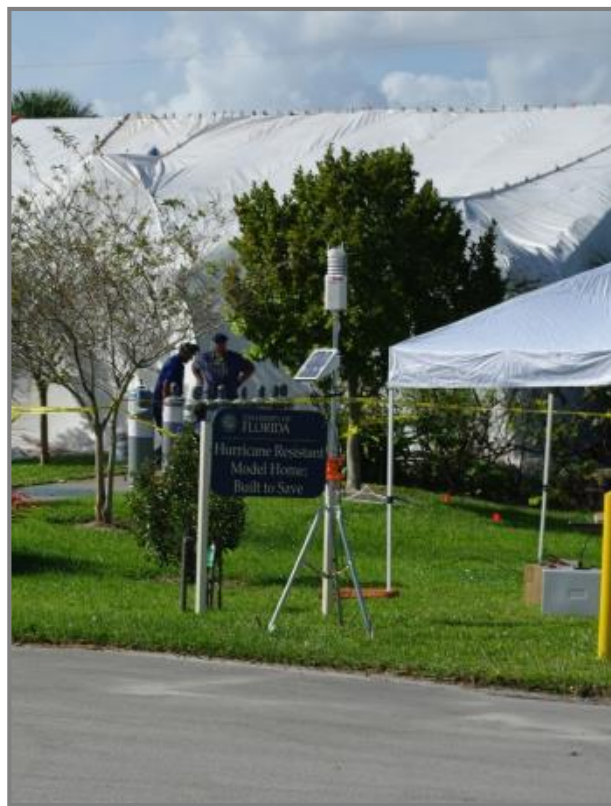
Figure 25. Portable Weatherhawk Weather Station Deployed on Site

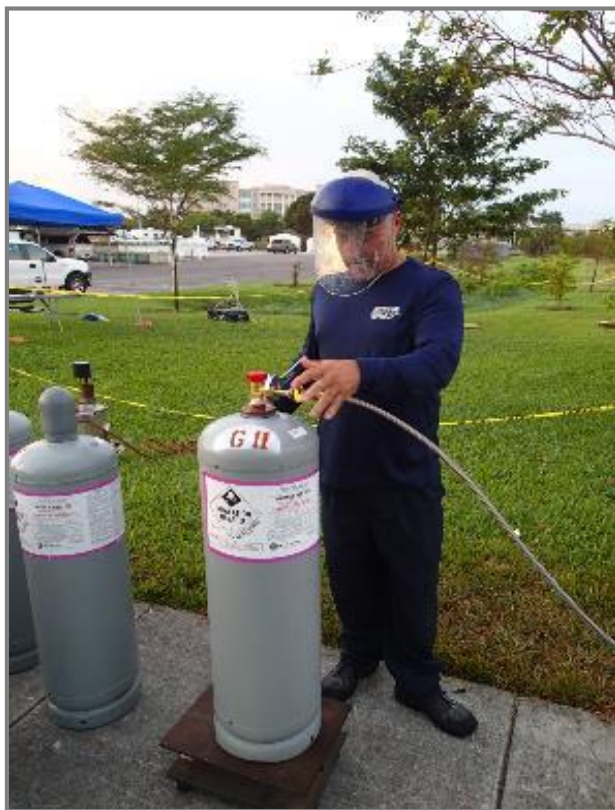
Figure 26. MB Cylinder Being Opened

The MB (100%, Meth-O-Gas 100[®], Great Lakes Chemical Co., West Lafayette, IN) was contained as a liquid in commercial 100-lb. metal cylinders (Figure 26). MB without chloropicrin was used to avoid the potential corrosive damage caused by chloropicrin. Since MB has a boiling point of 3.6°C, heat was added during introduction to insure that only gaseous MB was released from the end of the shooting hose. This was done by affixing the cylinder valve, by hose, to a 5-gallon-capacity heat exchanger (Figure 27). The heat exchanger contained a coiled metal tube through which the MB passed. The coil was surrounded by a water/radiator coolant mixture (60:40) which was heated by a propane burner to 90°C. The gaseous MB exited the heat exchanger through the shooting hose at about 70°C and then traveled as a gas through the shooting hose and exited into the shooting bucket inside the house. The certified applicator (Hammerhead Termite Control, Big Pine Key, FL) placed the MB cylinder on a balance and donned a full-face shield before he opened the MB cylinder (Figure 26). All MB released was measured gravimetrically.

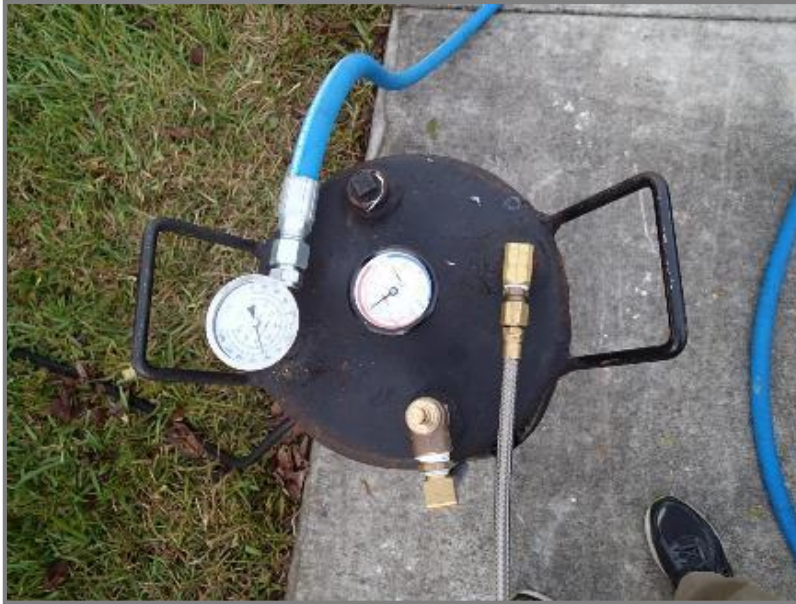
Figure 27. Heat Exchanger Used to Convert Liquid MB to Gaseous MB Exiting the Blue Shooting Hose

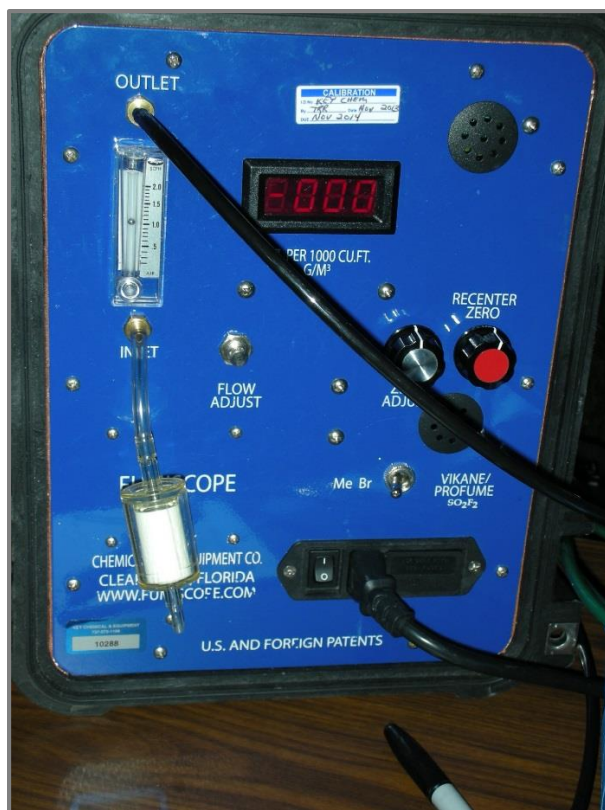
Figure 28. Fumiscope® Used to Monitor Working MB Concentrations

The working concentrations of MB during the fumigation were monitored at seven locations with two Fumiscopes® thermal conductivity detectors (Figure 28) (Key Chemical Co., Clearwater, FL, accuracy approximately ± 1 gram per cubic meter MB). One monitor was calibrated with MB in November, 2013 by Key Chemical Co., and the other Fumiscopes was calibrated for Sulfuryl Fluoride and a correction factor was added to obtain MB equivalence. Fumiscopes monitoring locations included the large classroom (southwest corner), the large classroom podium, the women's restroom (south), the attic and the room leading to the attic, the HVAC room (north), and inside the HVAC return duct. The Fumiscopes were fitted with air pumps that pull the interior MB-laden air through a monitoring line into the instrument which then gave a near real-time reading of MB concentration. During fumigation and aeration, the MB concentration was monitored 24hrs/day by authorized personnel (licensed and monitored by the state).

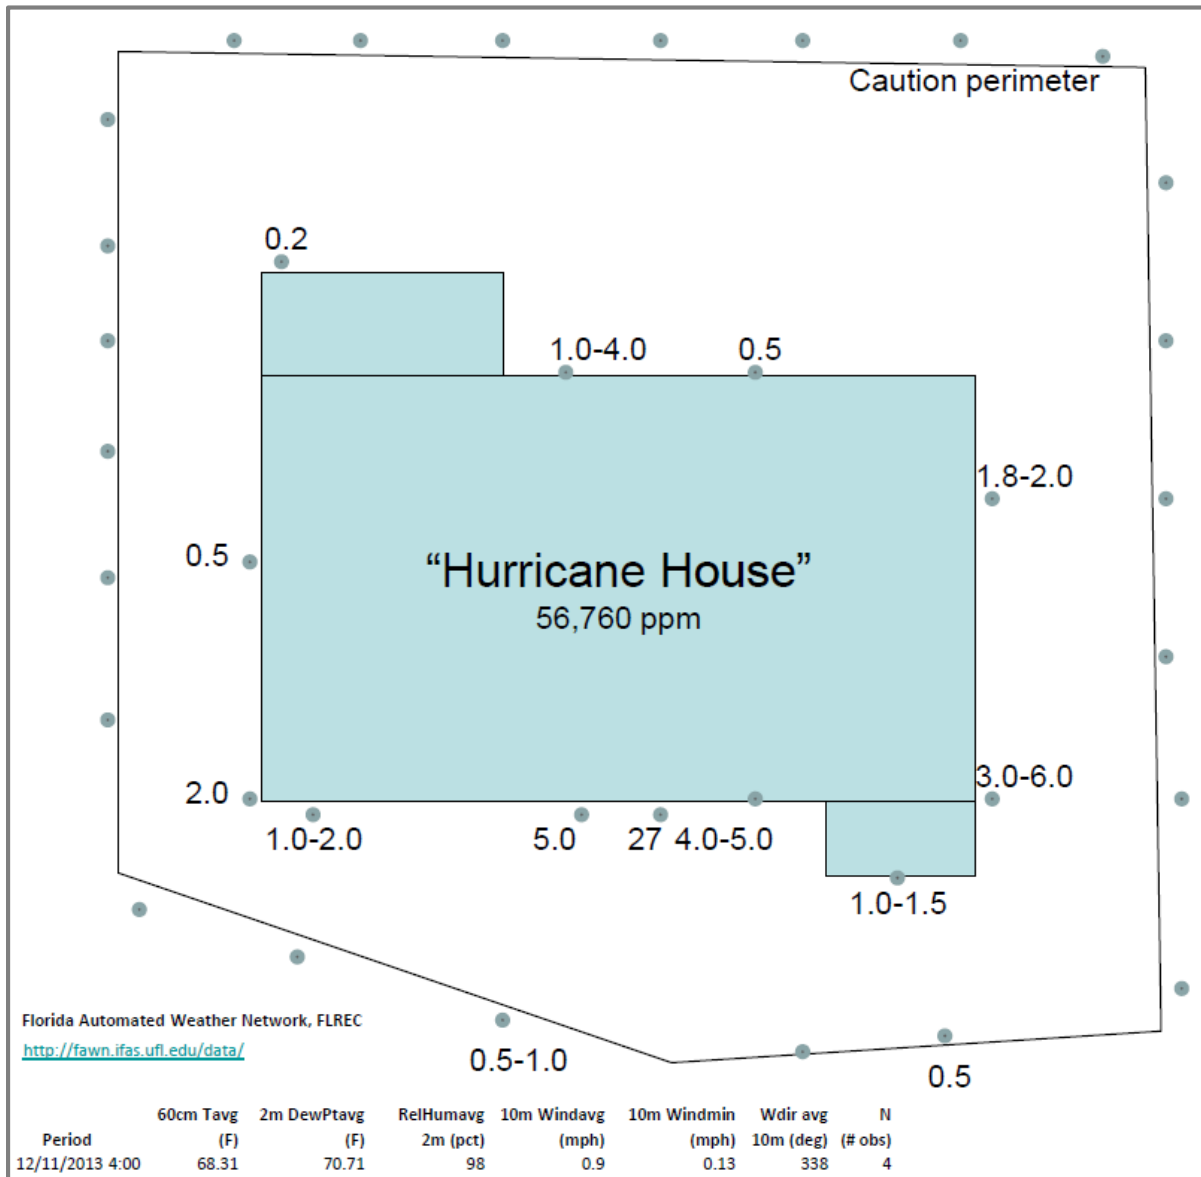
Figure 31. Leak Detection Results from December 11, 2013 at Approximately 4:30 a.m. Calm Wind Conditions. Dots without Numbers Indicate Zero MB Detected and Numbers Reflect Highest Instantaneous MB Concentrations (ppm).

affects and provided a worst case scenario leak detection). The readings recorded at the caution perimeter in Figure 31 (0.5-1.0 and 0.5 ppm) were the highest instantaneous readings; however, most readings were zero even at these locations. There were no sustained high (>0.5 ppm) readings recorded at any time at the caution perimeter. The concentration values near the house were obtained directly at the tarp fabric and do not reflect breathing zone concentrations. Breathing zone concentrations for the crew taking the readings were at least an order of magnitude lower than the concentrations obtained directly at the tarp using instrumentation extended away from body. Even when MB readings were high (an instantaneous high of 27 ppm in Figure 31) when touching the tarp there were no sustained high (>0.5 ppm) breathing zone readings for the monitoring crews.

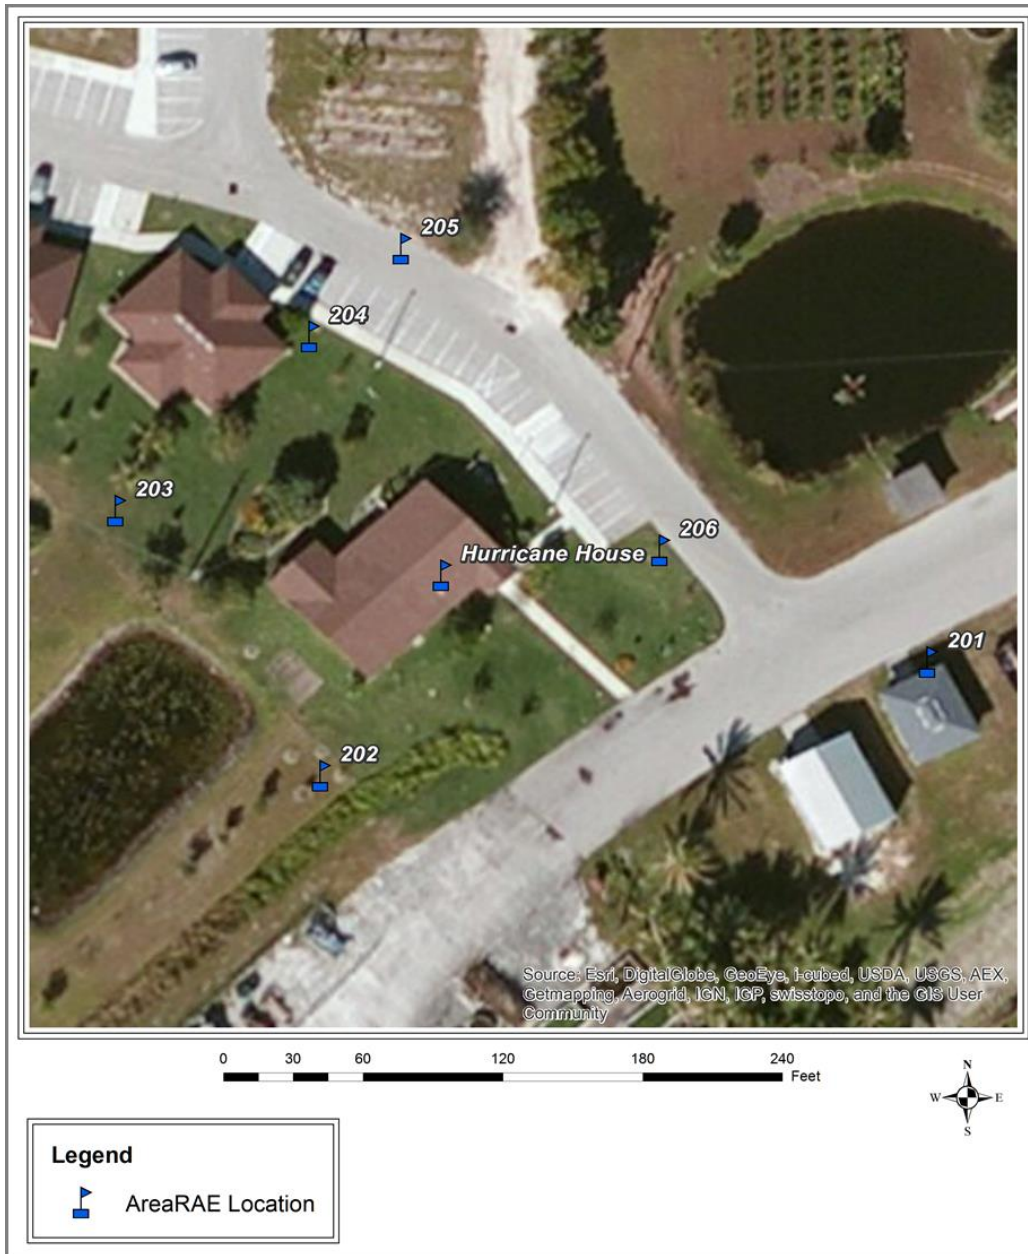
Figure 32. Re-Deployed Locations of Air Monitoring Units during the Aeration Process

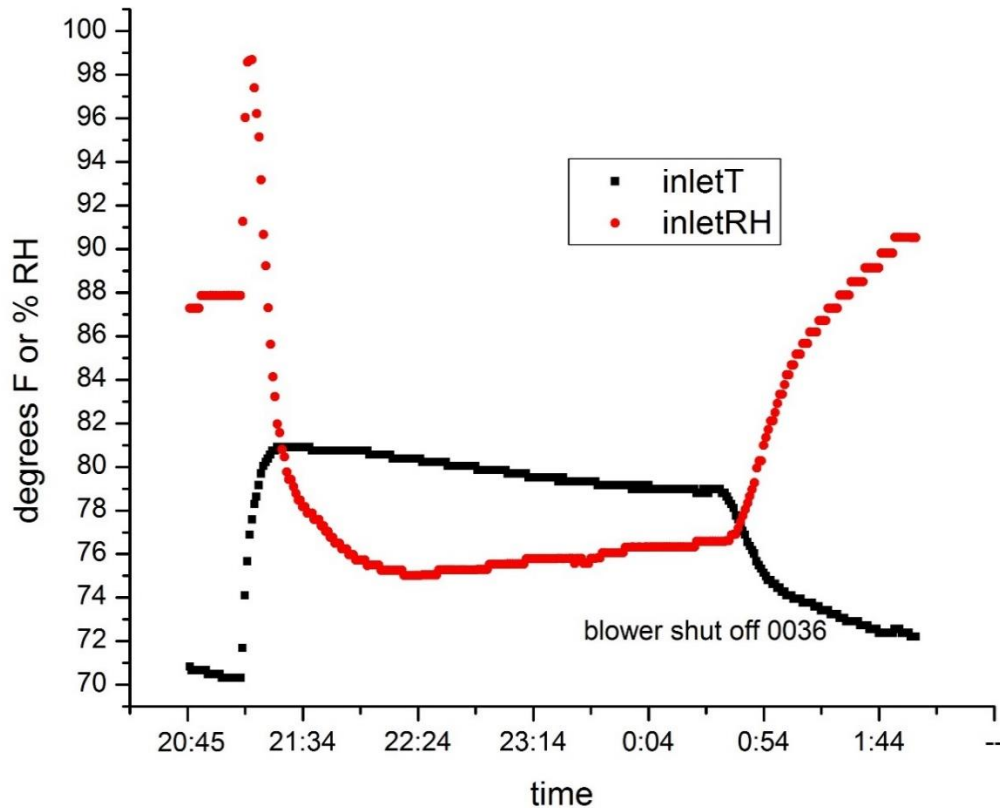
Once aeration began, the RH at the inlet spiked from a level of 88% (a level consistent with ambient RH) to over 98%. This initial spike in RH may have been due to excess moisture originating from the fumigation inside the house that had condensed within the duct near the gate valve. Following this initial spike, the RH fell to 80% during the next 15 minutes, a level consistent with the fumigation target RH. At this point, the RH level continued to decrease, but at a lower rate, until it reached a minimum of 75% at 2224 hrs (1-hr, 24-min scrubber time). Then the RH slowly began to increase again, in conjunction with a decrease in temperature. This is consistent with having no change in absolute humidity of a gas, resulting in an RH increase with a decrease in temperature.

Figure 33. Temperature and RH Levels at the Inlet to the First Carbon Bed

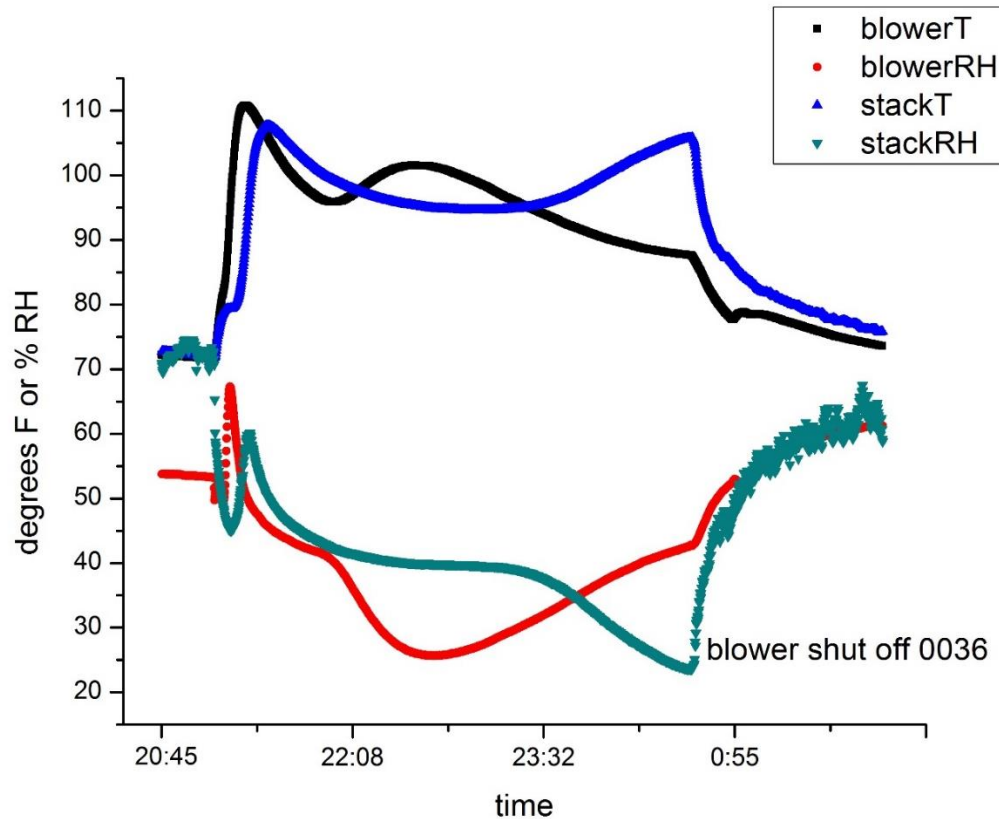
Figure 34. Temperature and RH Levels at the Blower and in the Stack, during Scrubbing

The blower RH level was initially at a level of ~ 54%, then spiked to nearly 70% when aeration began. This initial spike in RH may have been due to a number of factors, such as the driving off of moisture that had condensed and accumulated in the duct, similar to what may have happened at the carbon bed inlet. Following this short term initial increase in RH, at the blower, it trended downward to a minimum of 25%, by 2230 hrs (1-hr, 30-min scrubber time). The RH at the blower then increased, until it reached a level of about 45% at the time the blower was shut off. This fall in the blower location RH, followed by its subsequent increase, may be due to the first carbon bed’s adsorption of water vapor to the point of reaching its capacity. That is, we suspect that once all active adsorption sites on the first carbon bed were utilized for capture of water vapor and MB, no additional water vapor could be adsorbed onto the carbon. Additionally, preferential adsorption for MB rather than water vapor may also have contributed to the release of water vapor from the first carbon bed back into the gas stream. There is also the possibility that the RH at the blower may have been influenced by gas temperature at the blower, more so during the latter half of the carbon bed operation, when the temperature was decreasing.

temperature was likely due to MB breakthrough from the first carbon bed carrying over to the second bed, with the accompanying heat of adsorption in the second bed.

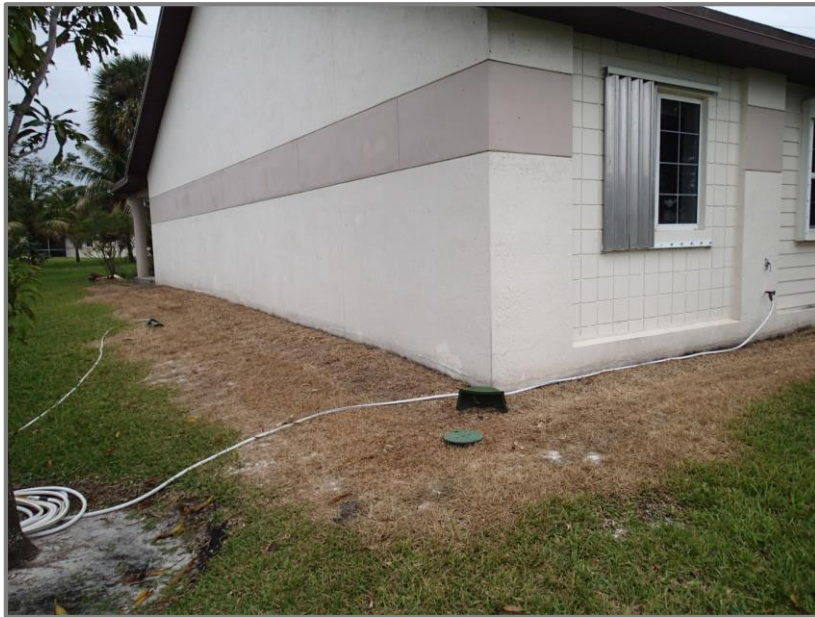
- As seen in Figure 42 below, grass kill was the result of constant MB diffusion through the ground-seal apron. Some diffusion plume trails are seen as brown grass extending beyond the ground seal apron. Similar diffusion must have also occurred through the entire raised surface resulting in loss of some 200 lbs of MB. The new aluminum-layered Insul-tarp® planned for a future fumigation should reduce diffusive loss greatly. As noted in the report, the other important loss of MB was related to ducting connections from the house to the scrubbers and increased pressure from adding gas to the enclosure.

Figure 42. Grass Kill as a Result of MB Diffusion Through the Ground-seal Apron.
